# IndianOil

## JOURNEY RISK MANAGEMENT (JRM) STUDY

### Salem Terminal TO JAI SRI RAM AGENCIES

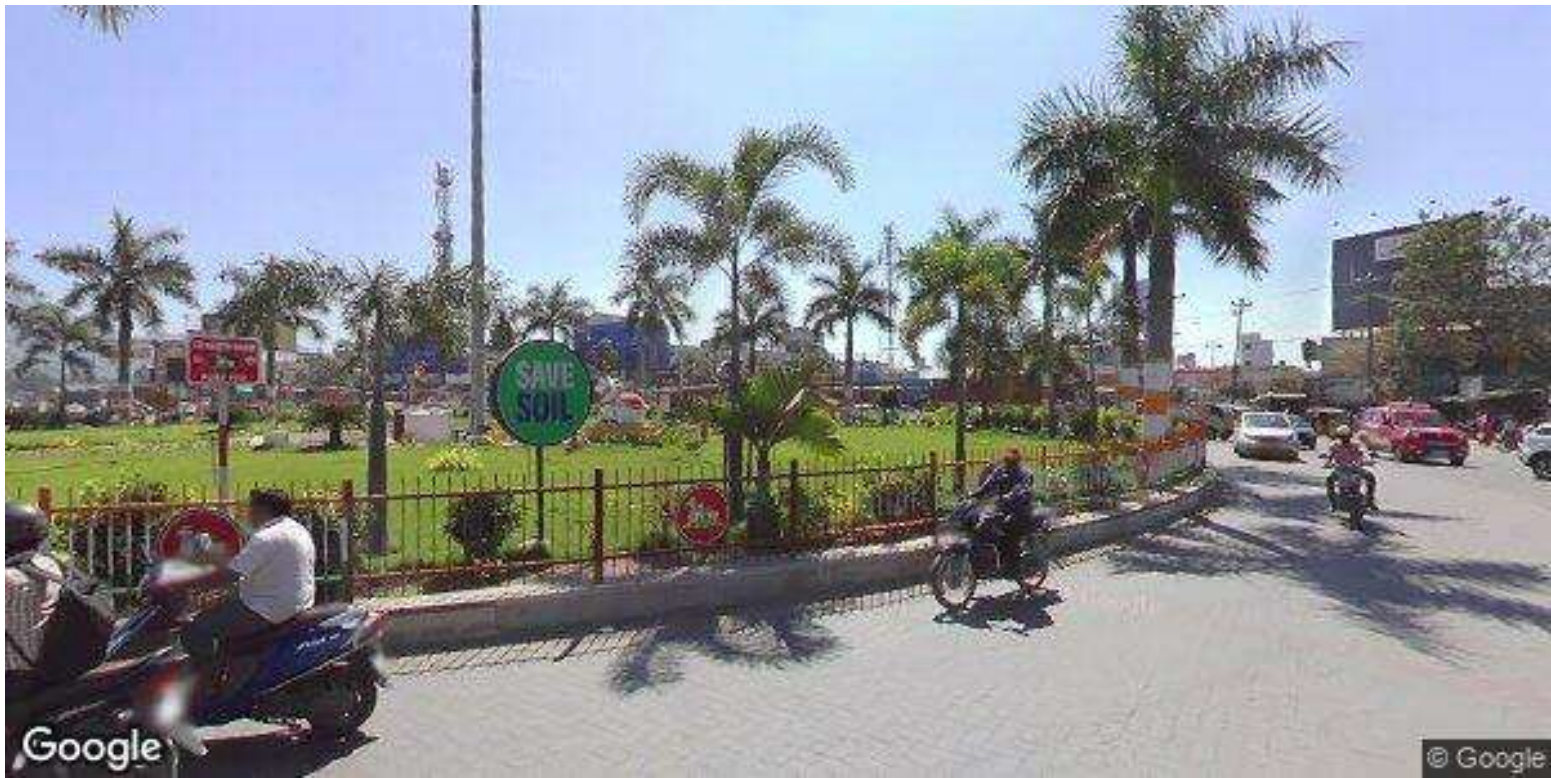
Risk Type: Roundabout  
Risk Level: High  
Speed Limit: 15 KM/Hr  
Coordinates: 11.63303, 78.12713

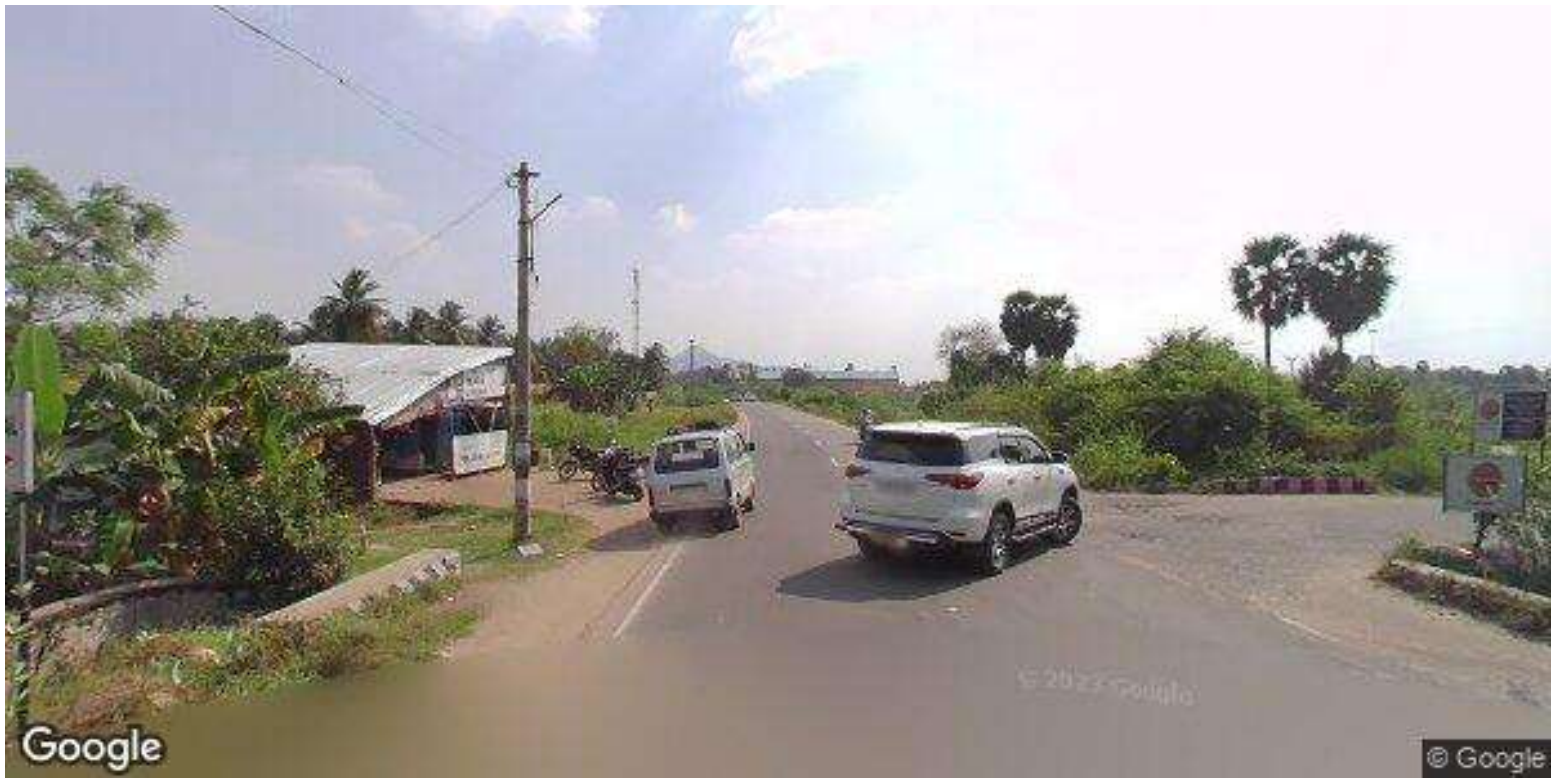
Risk Type: Turn  
Risk Level: High

**Speed Limit: 15 KM/Hr**  
**Coordinates: 11.44029, 77.87544**

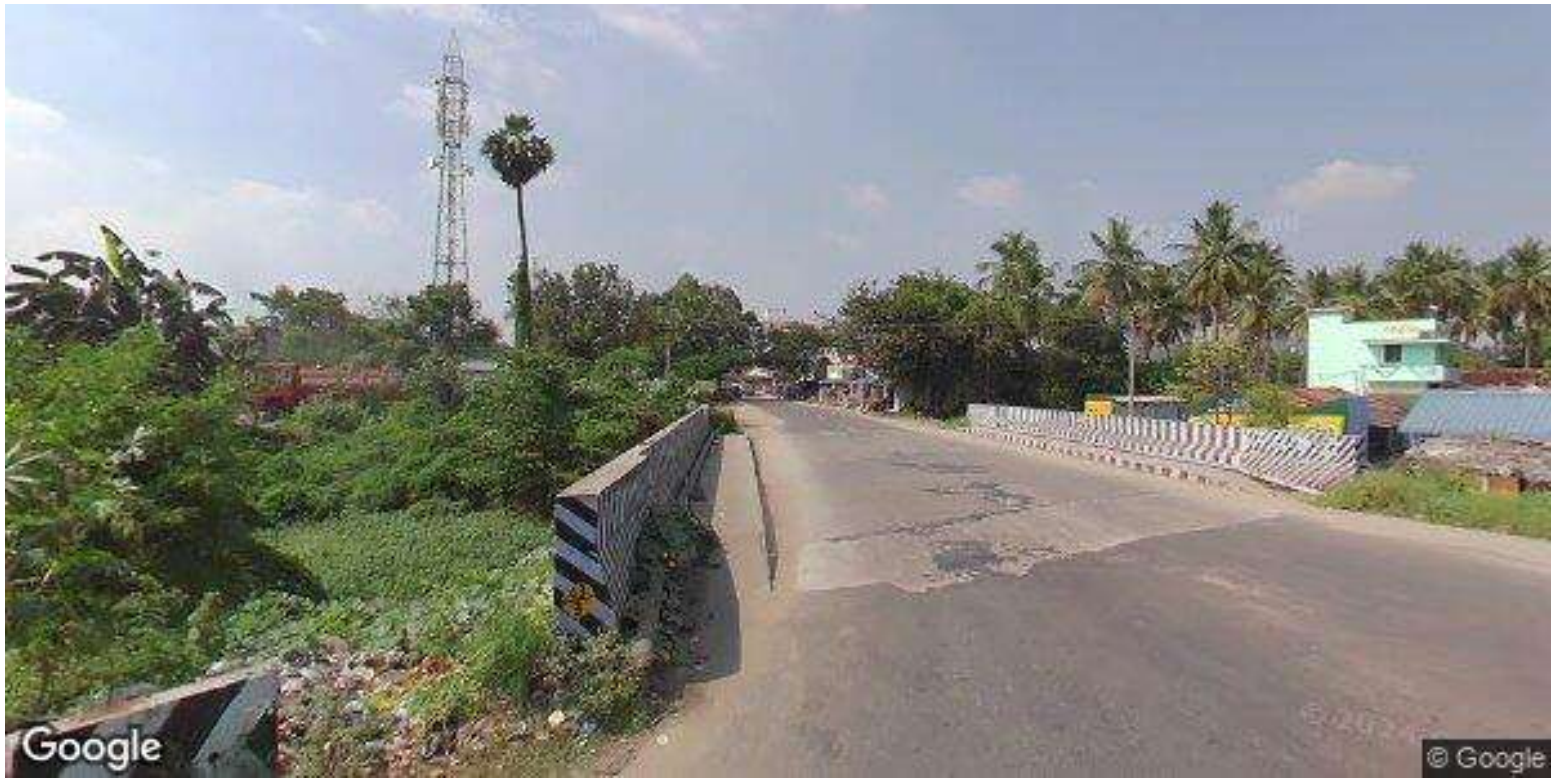
**Risk Type: Turn**  
**Risk Level: Medium**  
**Speed Limit: 30 KM/Hr**  
**Coordinates: 11.44900, 77.87406**

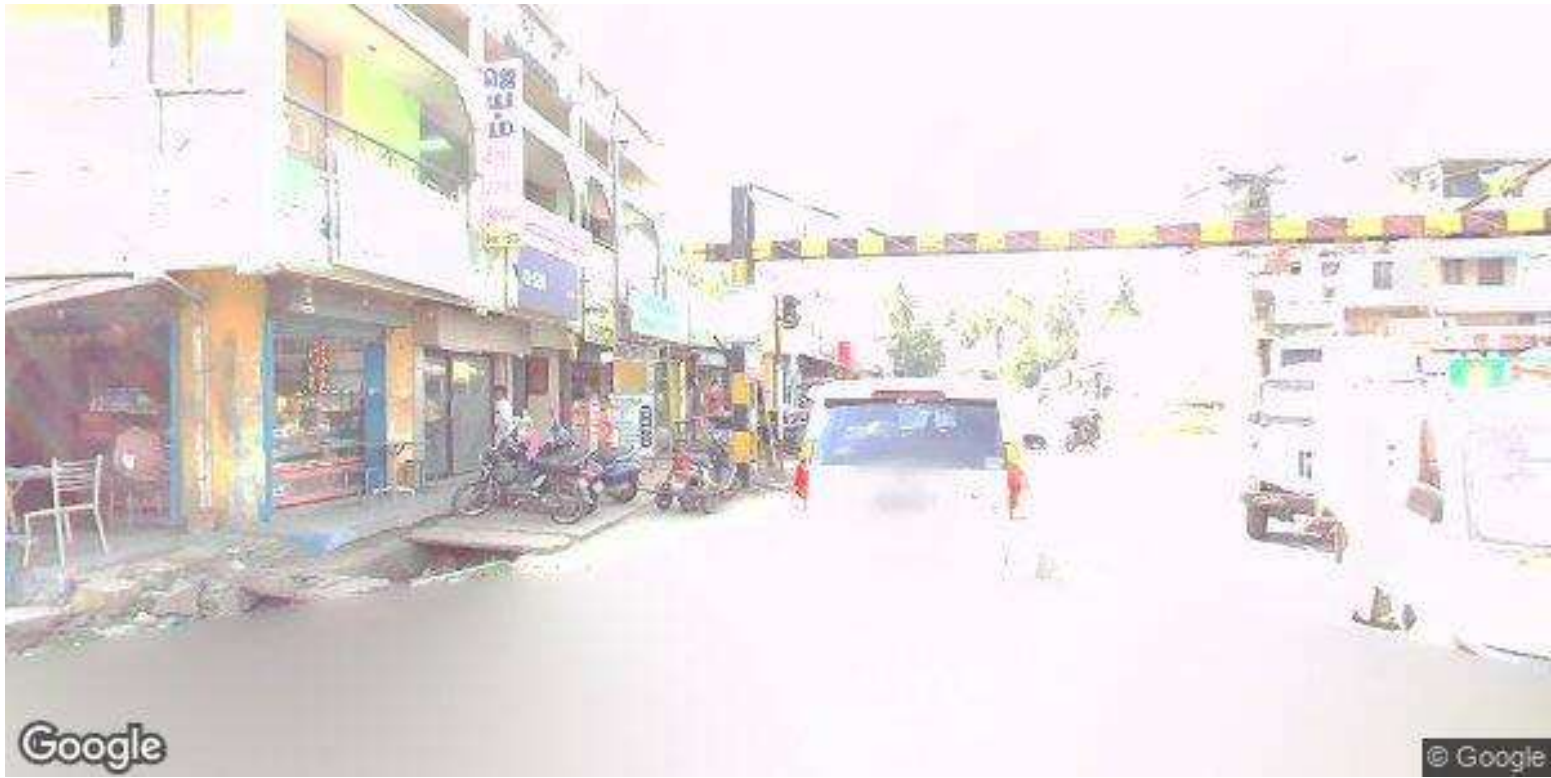
**Risk Type: Turn**  
**Risk Level: Medium**  
**Speed Limit: 30 KM/Hr**  
**Coordinates: 11.45000, 77.87213**

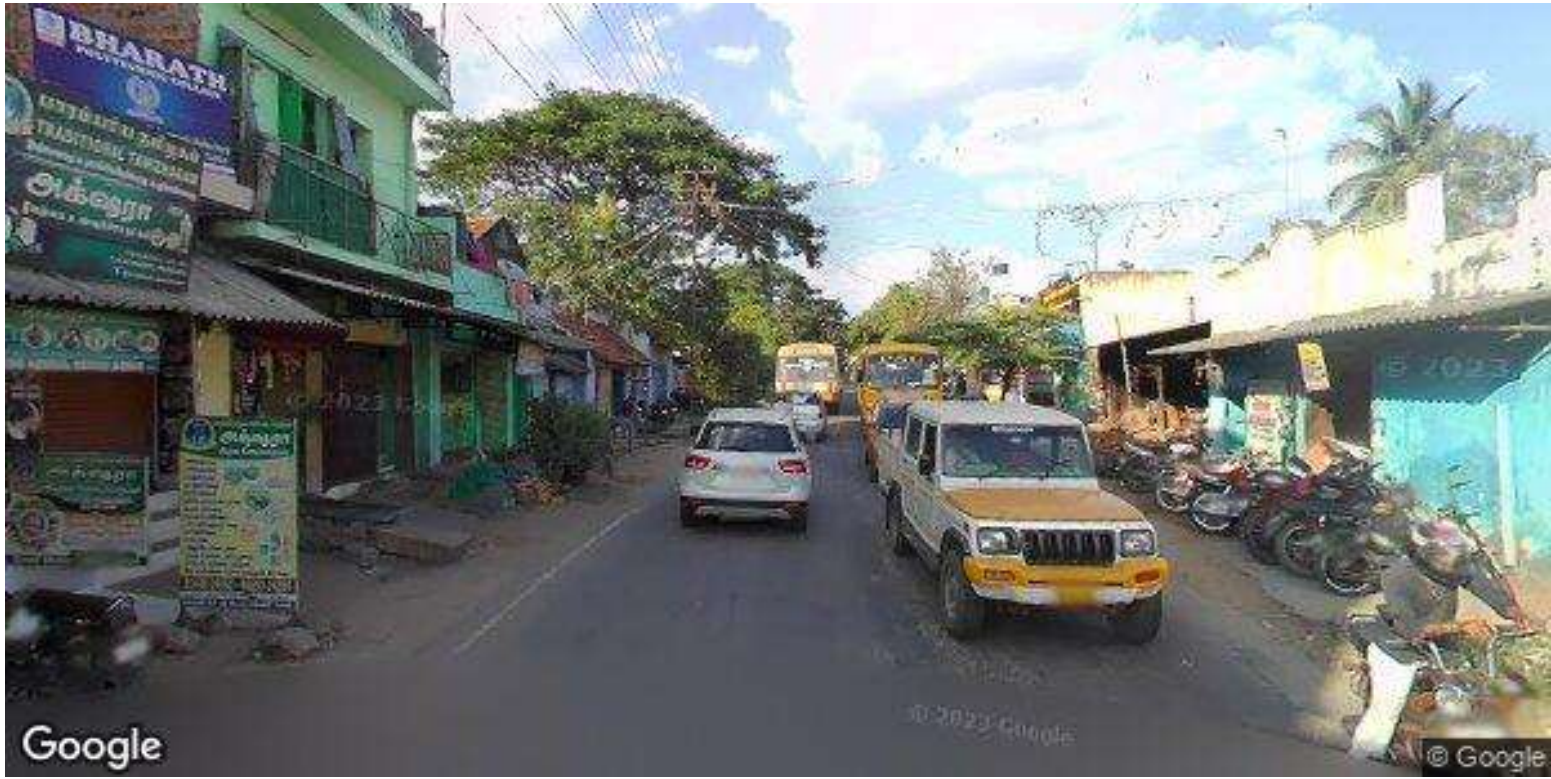
Risk Type: Turn  
Risk Level: High  
Speed Limit: 15 KM/Hr  
Coordinates: 11.45028, 77.87202

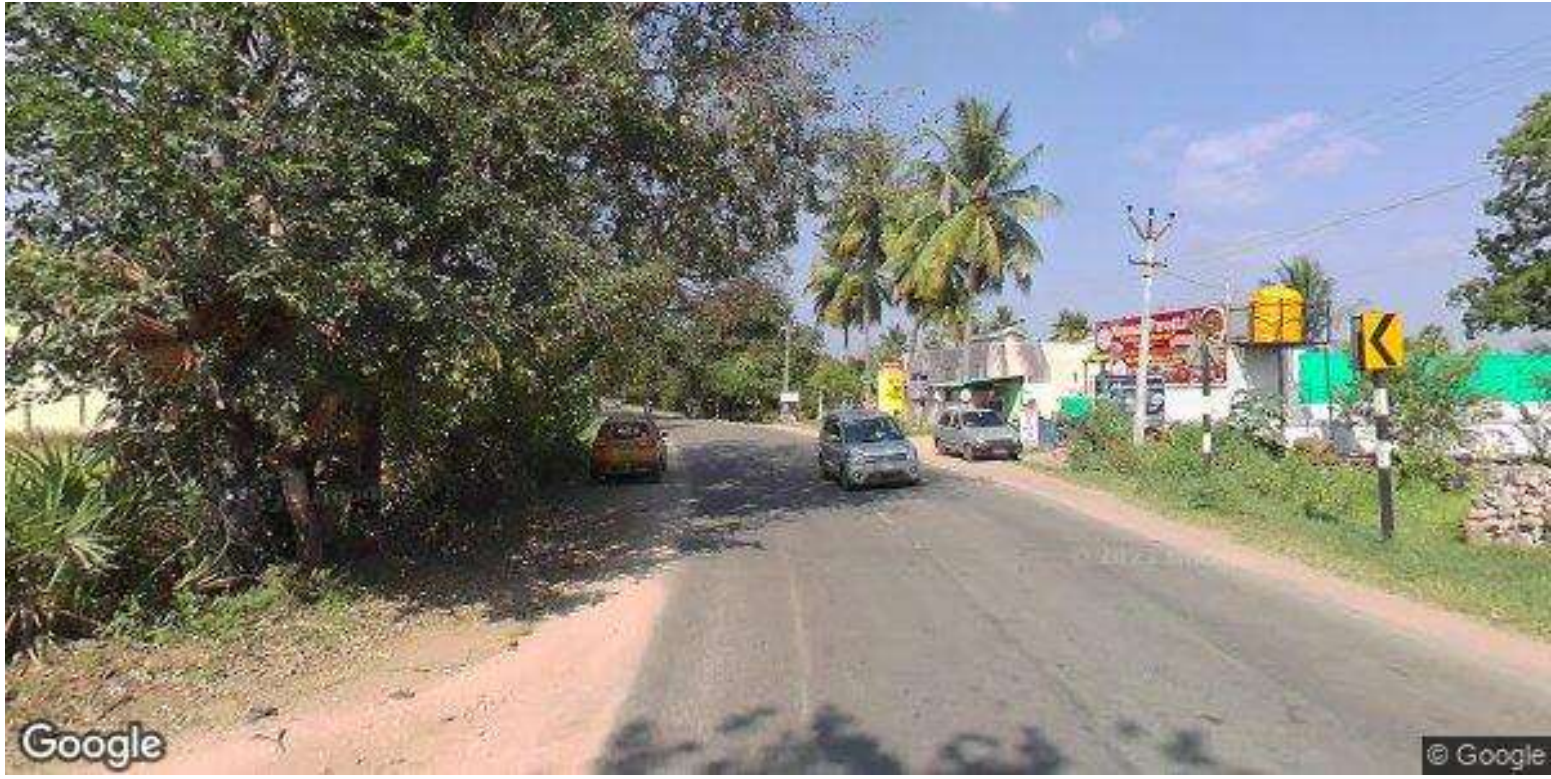
Risk Type: Turn  
Risk Level: Medium  
Speed Limit: 30 KM/Hr  
Coordinates: 11.45309, 77.87325

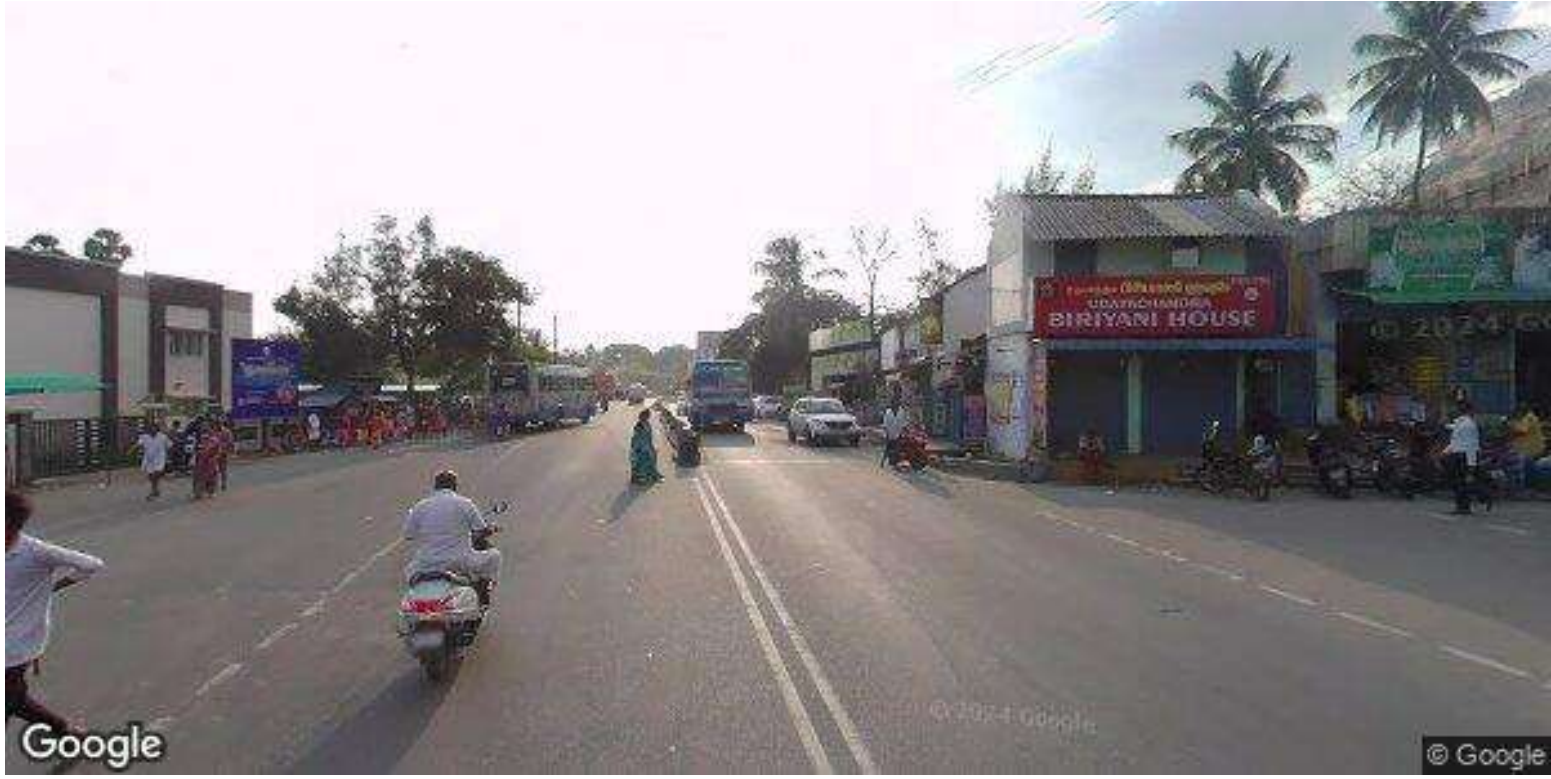
**Risk Type:** Turn  
**Risk Level:** High  
**Speed Limit:** 15 KM/Hr  
**Coordinates:** 11.47403, 77.86841

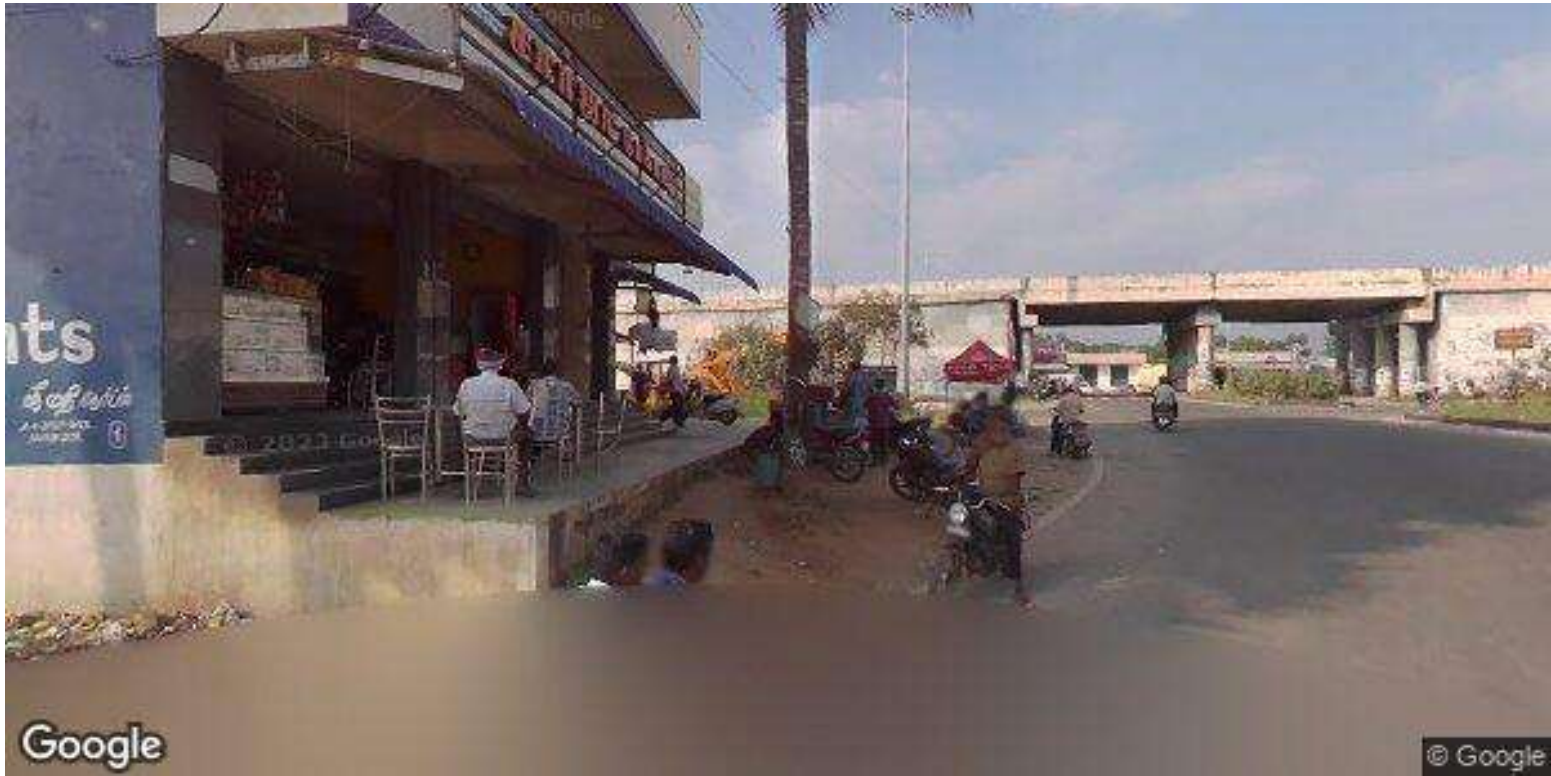
**Risk Type:** Turn  
**Risk Level:** High  
**Speed Limit:** 15 KM/Hr  
**Coordinates:** 11.49149, 77.89601

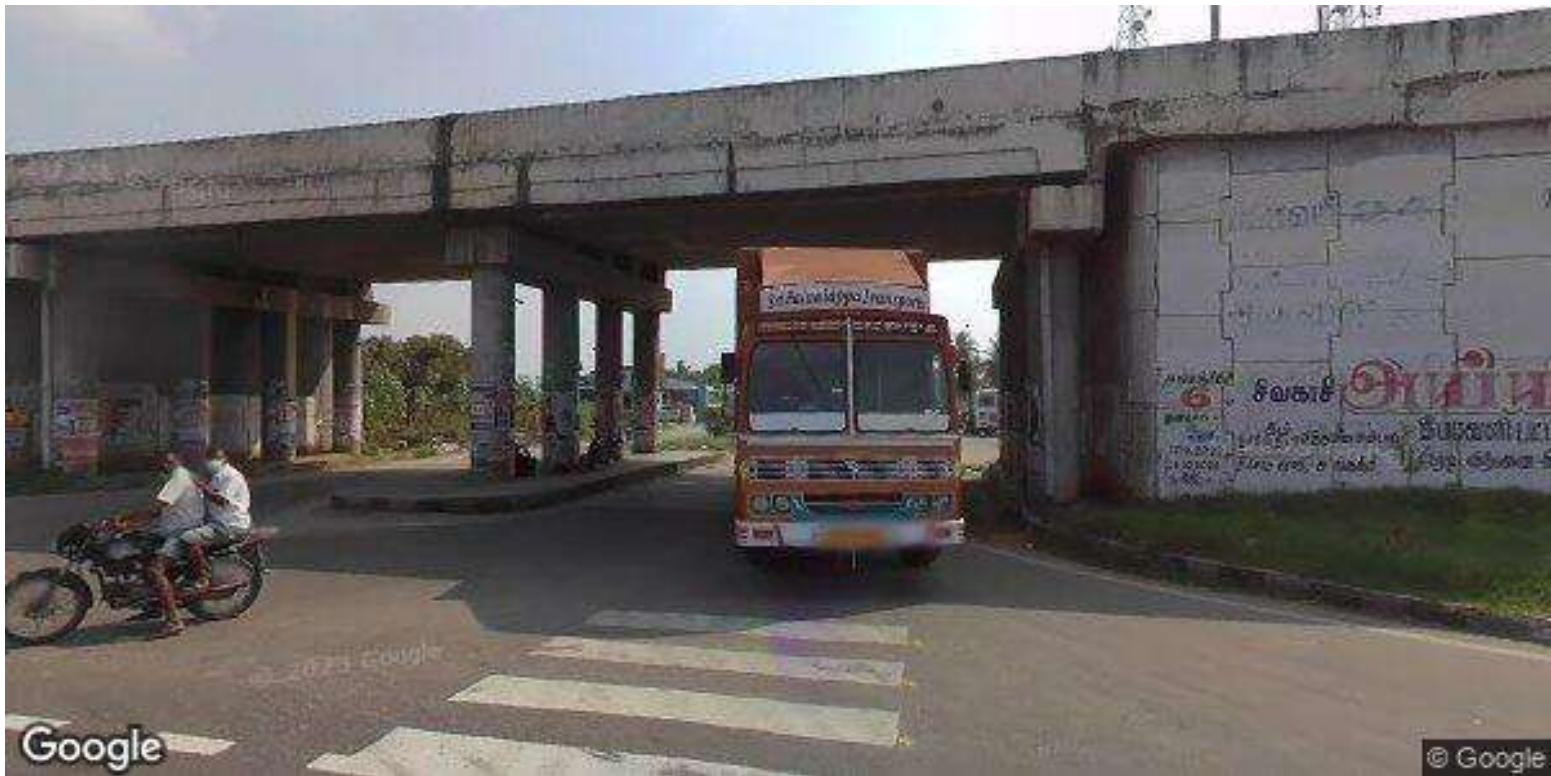
**Risk Type:** Turn  
**Risk Level:** High  
**Speed Limit:** 15 KM/Hr  
**Coordinates:** 11.49224, 77.89601

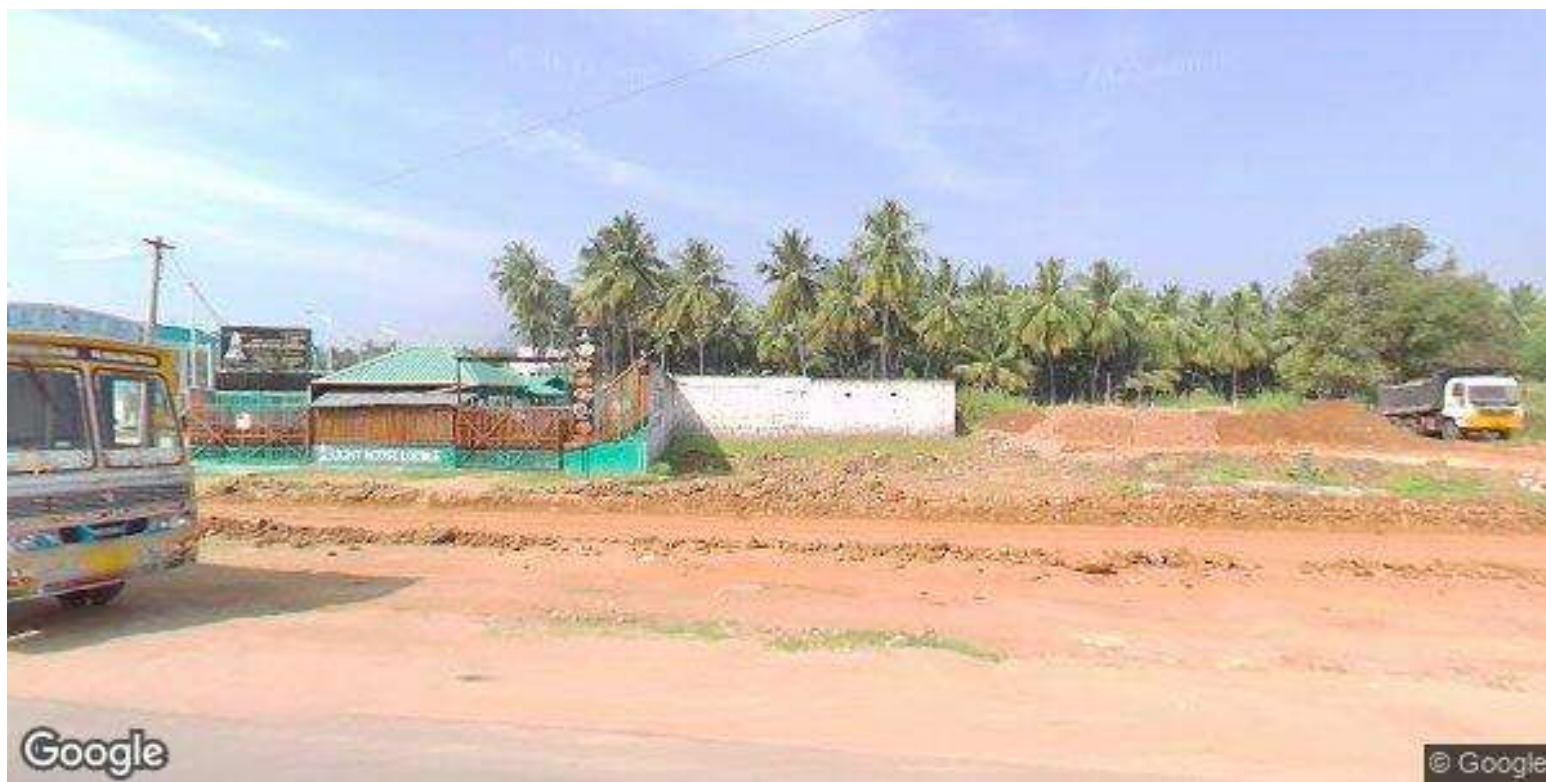
**Risk Type:** Turn

**Risk Level:** Medium

**Speed Limit:** 30 KM/Hr

**Coordinates:** 11.61736, 78.10588

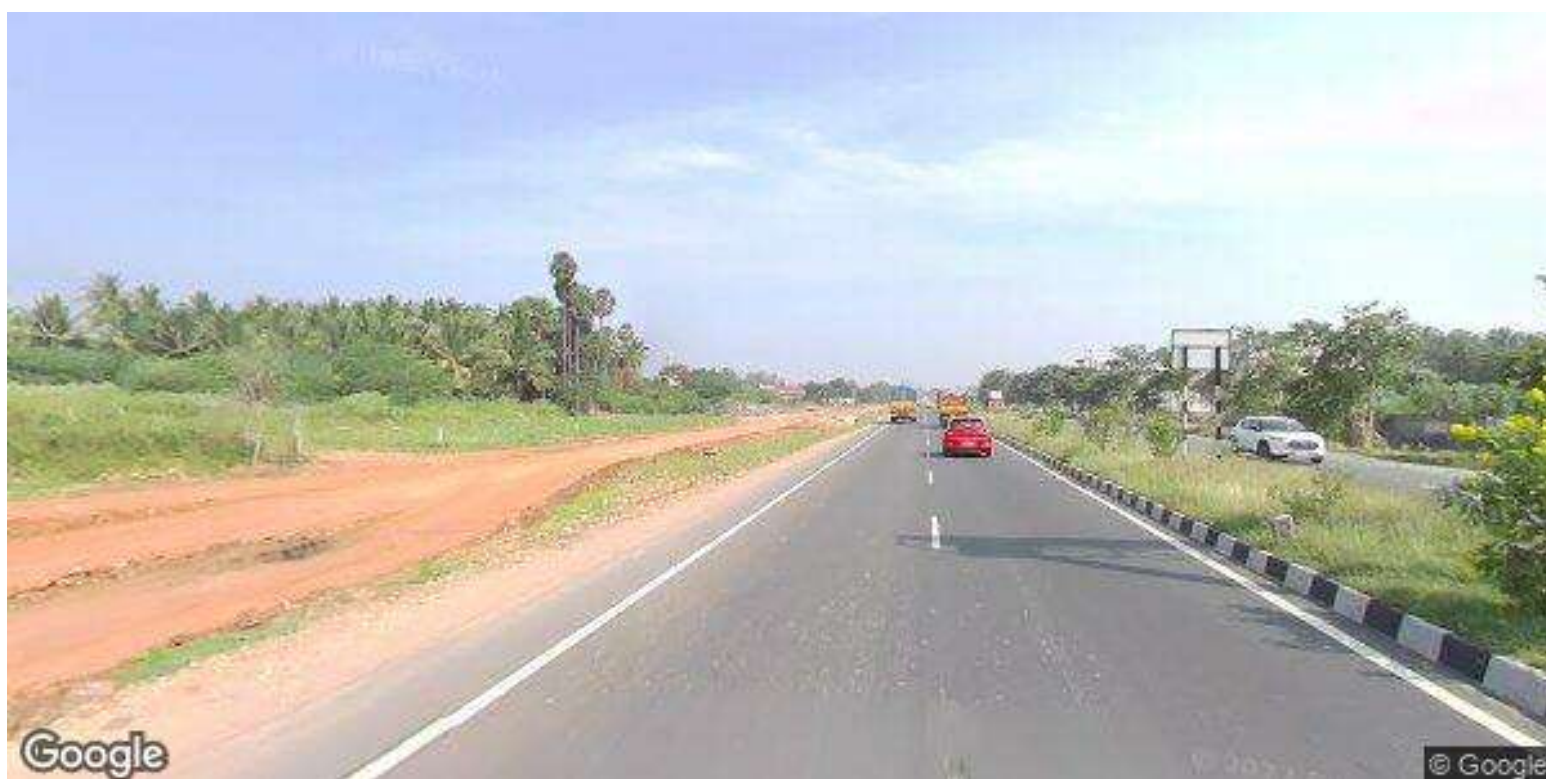
**Risk Type:** Turn

**Risk Level:** Medium

**Speed Limit:** 30 KM/Hr

**Coordinates:** 11.61753, 78.10608

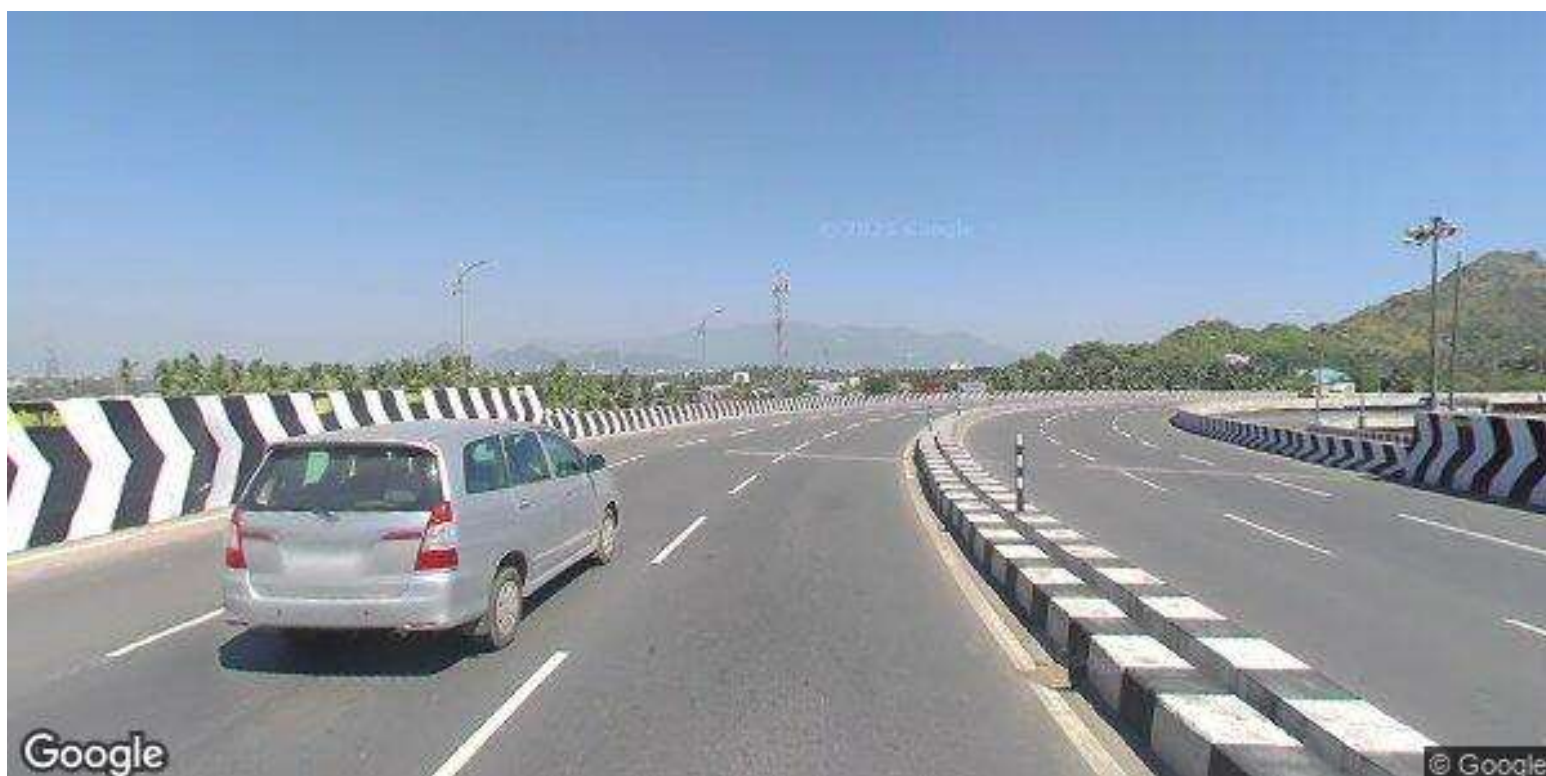
**Risk Type:** Turn  
**Risk Level:** Medium  
**Speed Limit:** 30 KM/Hr  
**Coordinates:** 11.64172, 78.11817

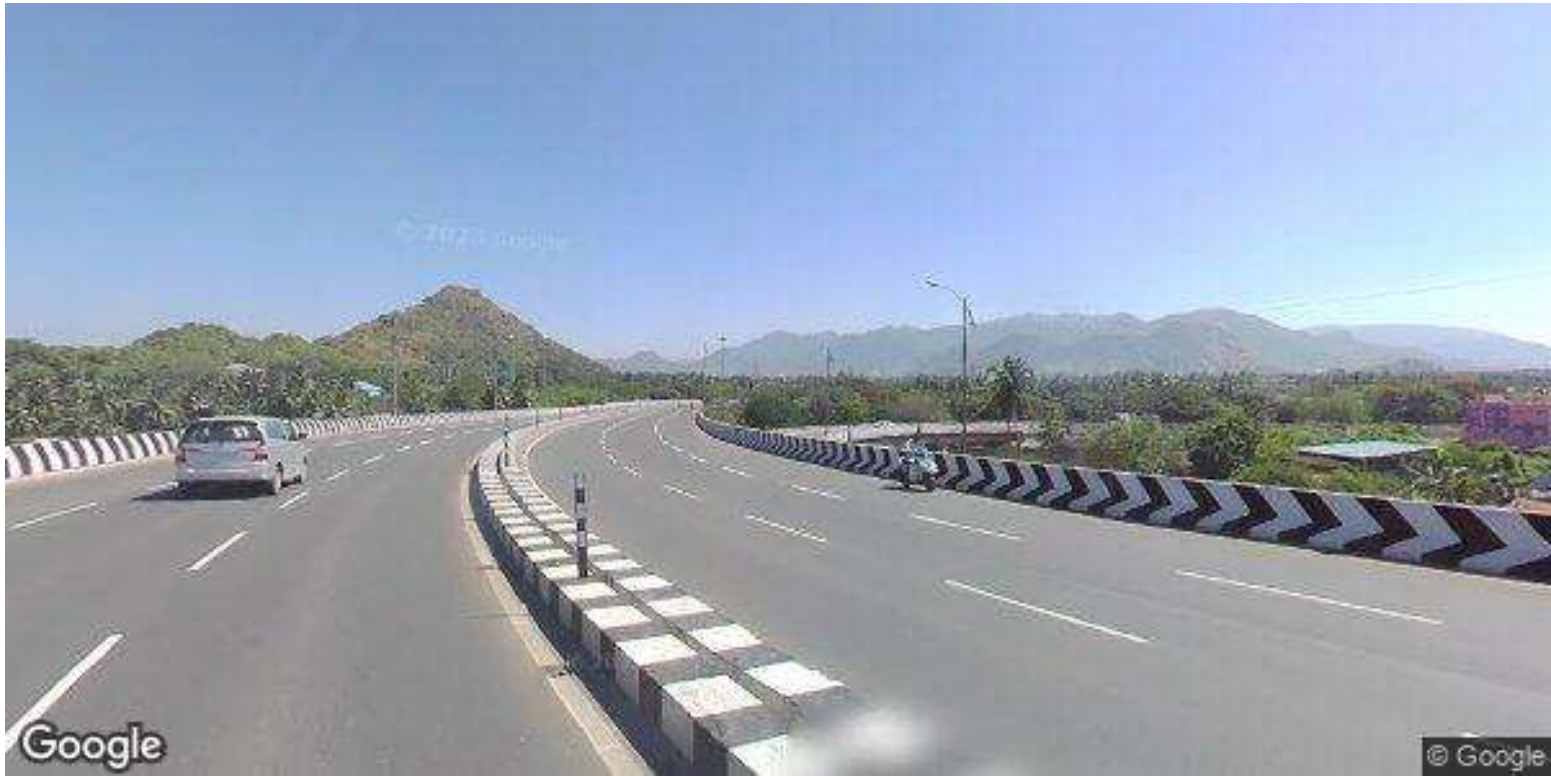
**Risk Type:** Turn  
**Risk Level:** Medium  
**Speed Limit:** 30 KM/Hr  
**Coordinates:** 11.64216, 78.11875

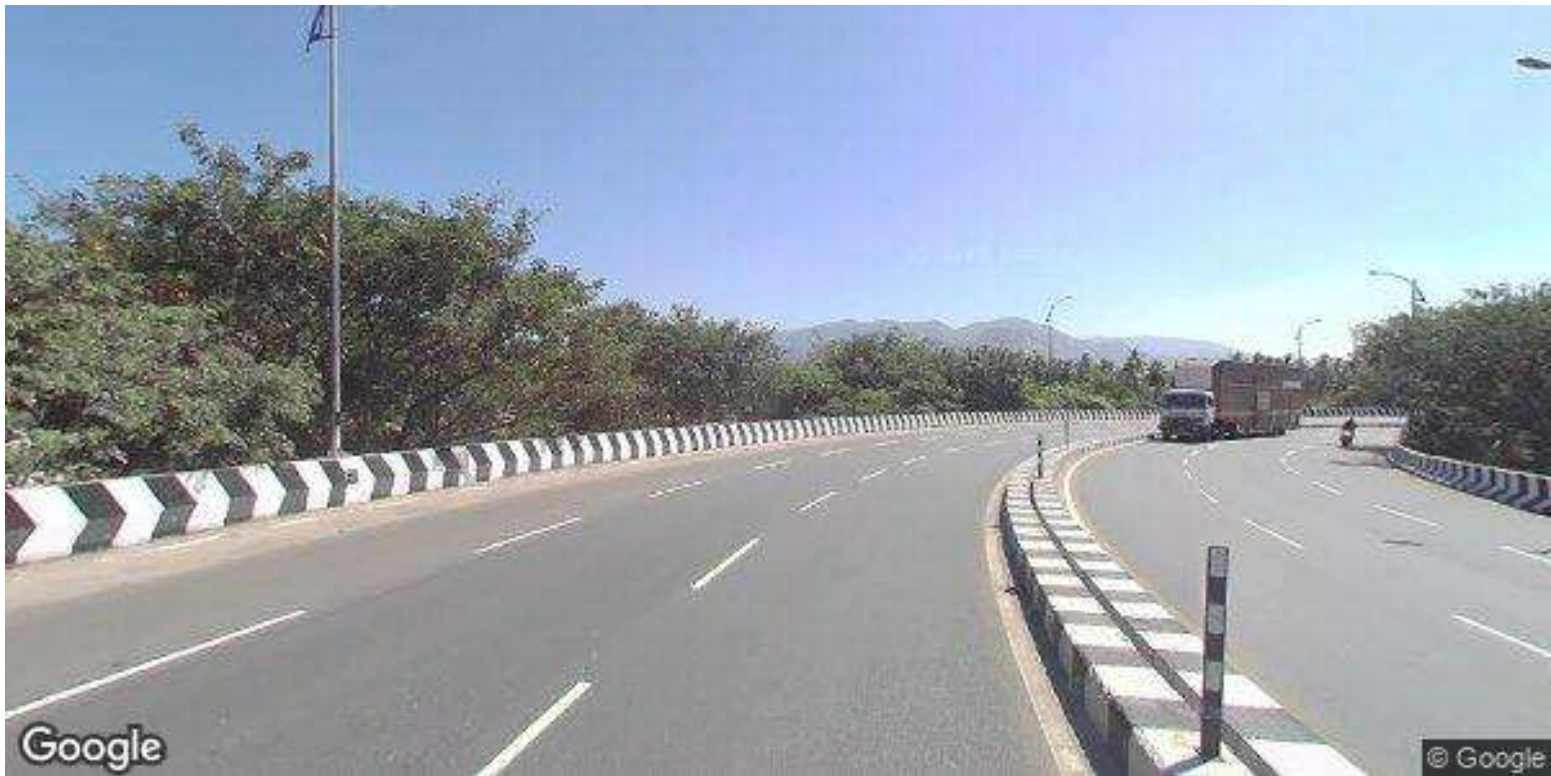
**Risk Type:** Turn  
**Risk Level:** Medium  
**Speed Limit:** 30 KM/Hr  
**Coordinates:** 11.64195, 78.12129

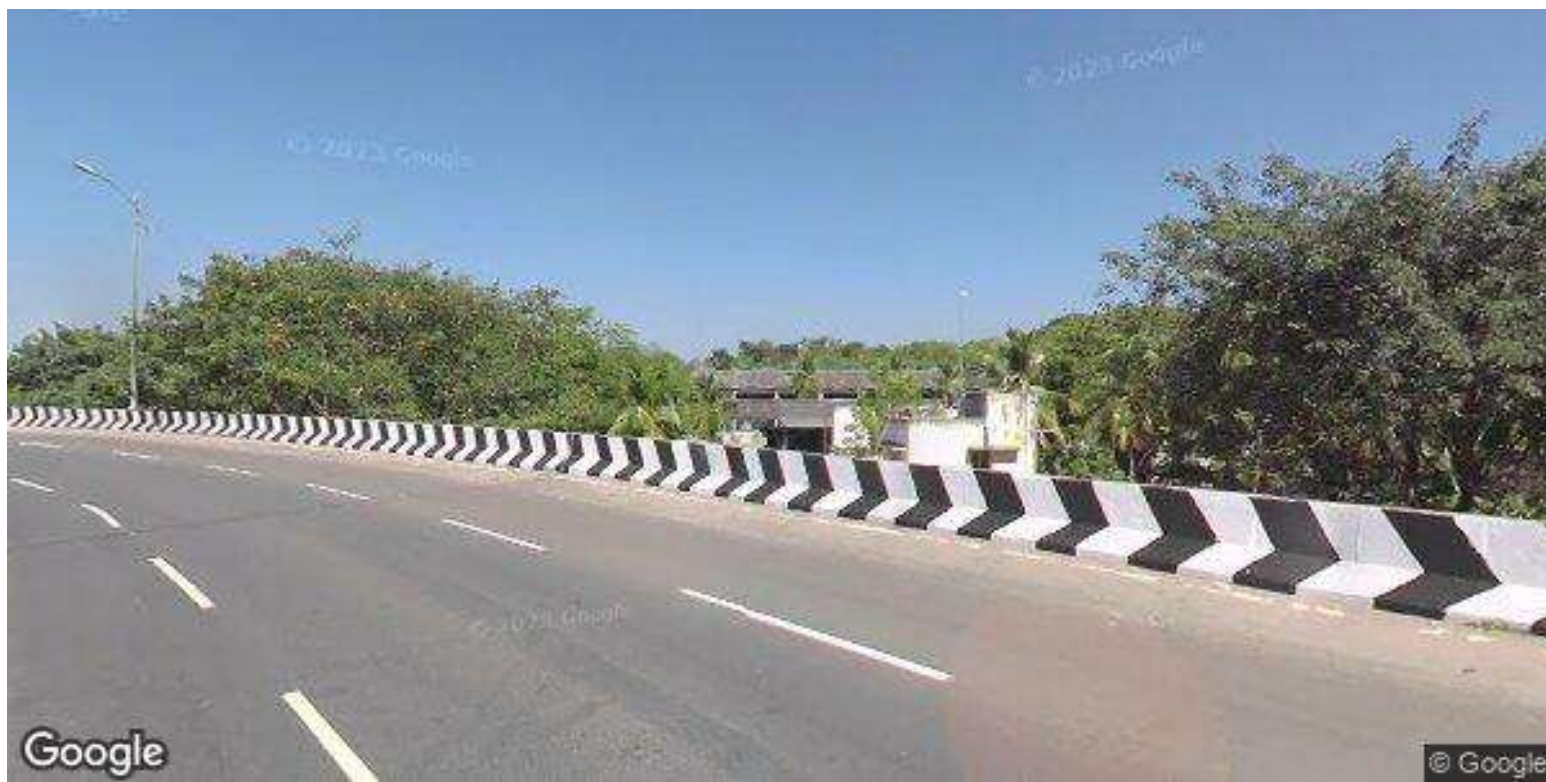
**Risk Type:** Turn

**Risk Level:** Medium

**Speed Limit:** 30 KM/Hr

**Coordinates:** 11.64162, 78.12160

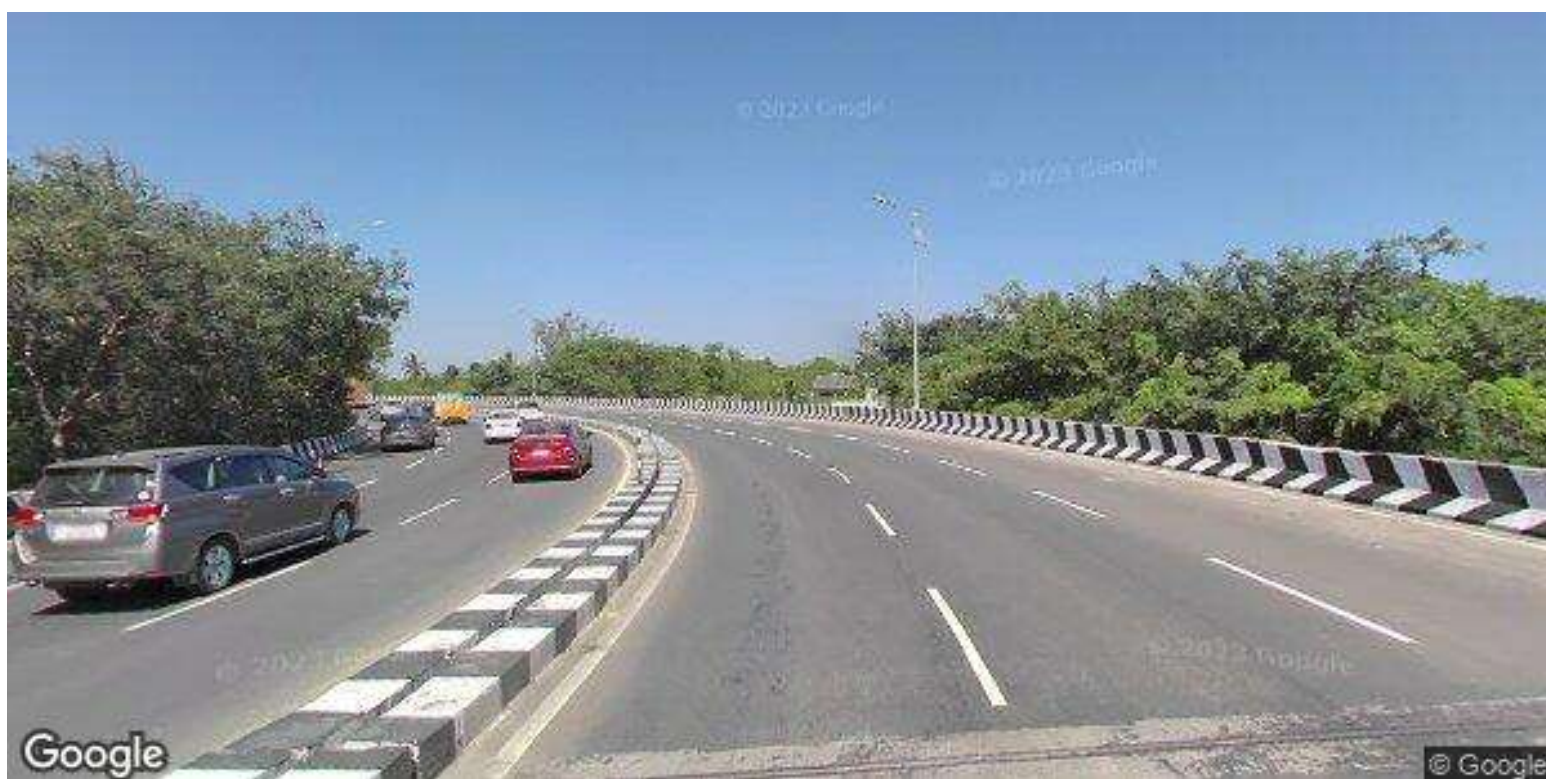
**Risk Type:** Turn

**Risk Level:** Medium

**Speed Limit:** 30 KM/Hr

**Coordinates:** 11.64120, 78.12168

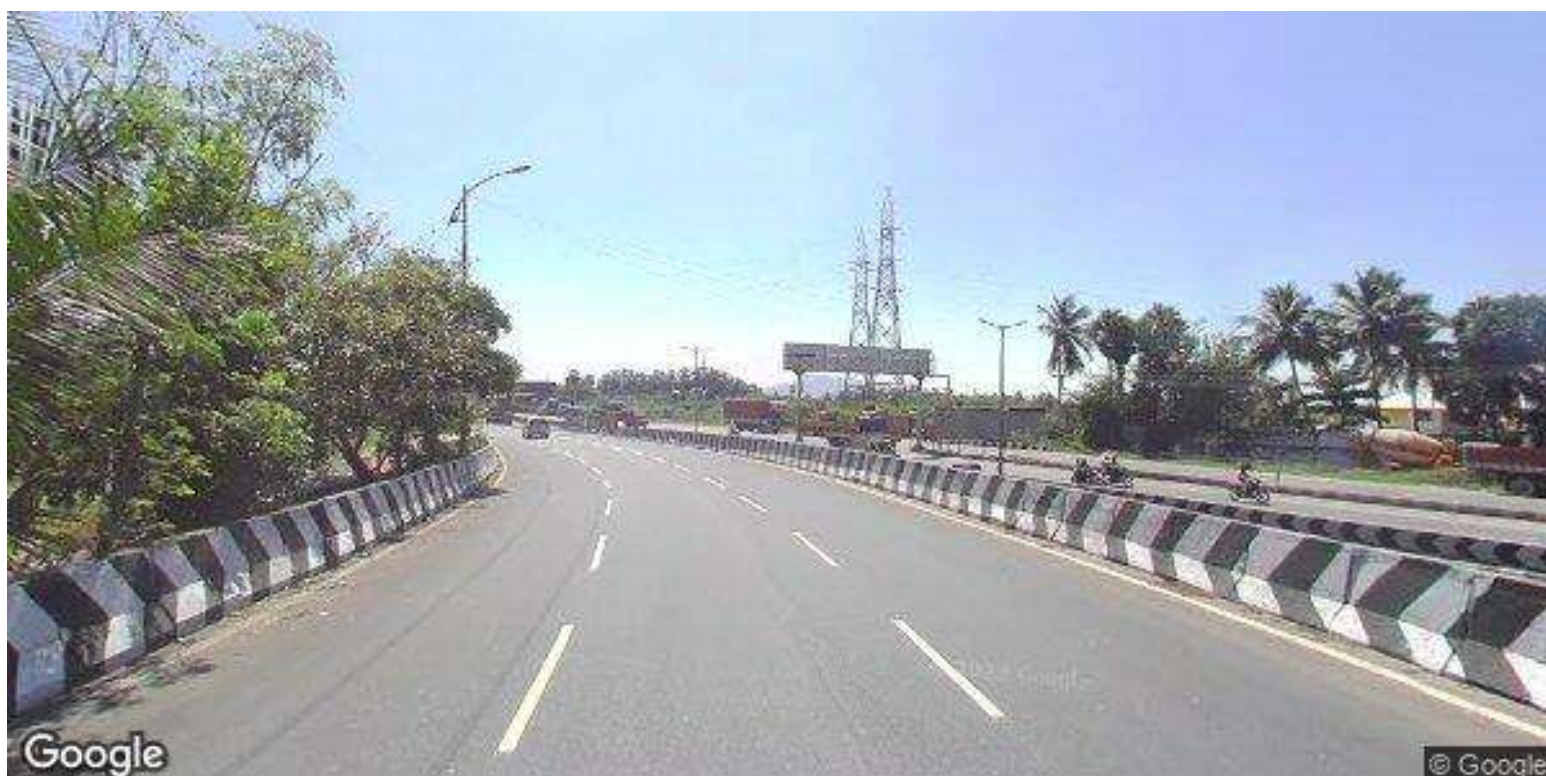
**Risk Type:** Turn  
**Risk Level:** Medium  
**Speed Limit:** 30 KM/Hr  
**Coordinates:** 11.63948, 78.12081

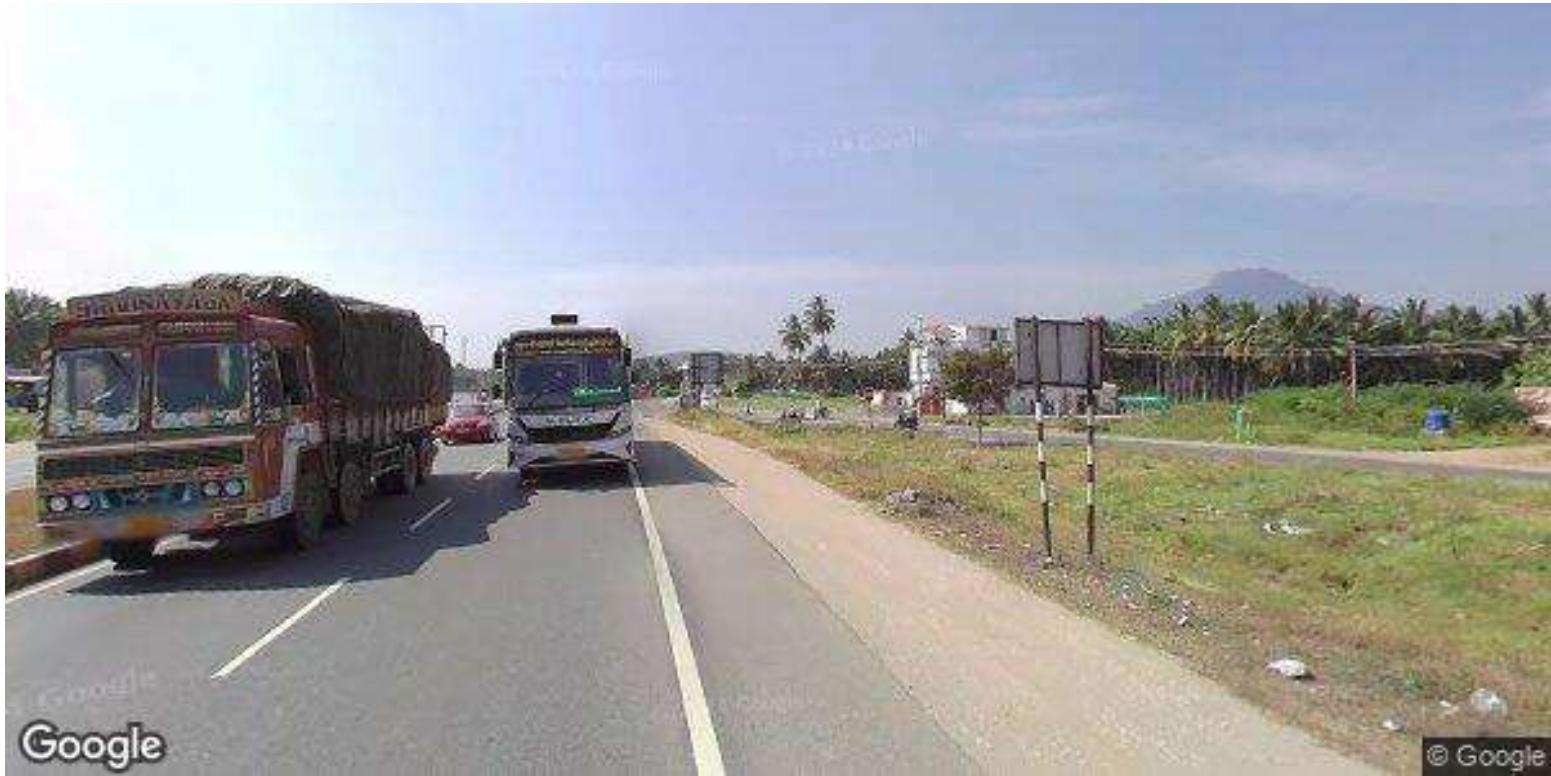
**Risk Type:** Turn  
**Risk Level:** High  
**Speed Limit:** 15 KM/Hr  
**Coordinates:** 11.65458, 78.37988
