# IndianOil

## JOURNEY RISK MANAGEMENT (JRM) STUDY

### Salem Terminal TO JAI SRI RAM AGENCIES

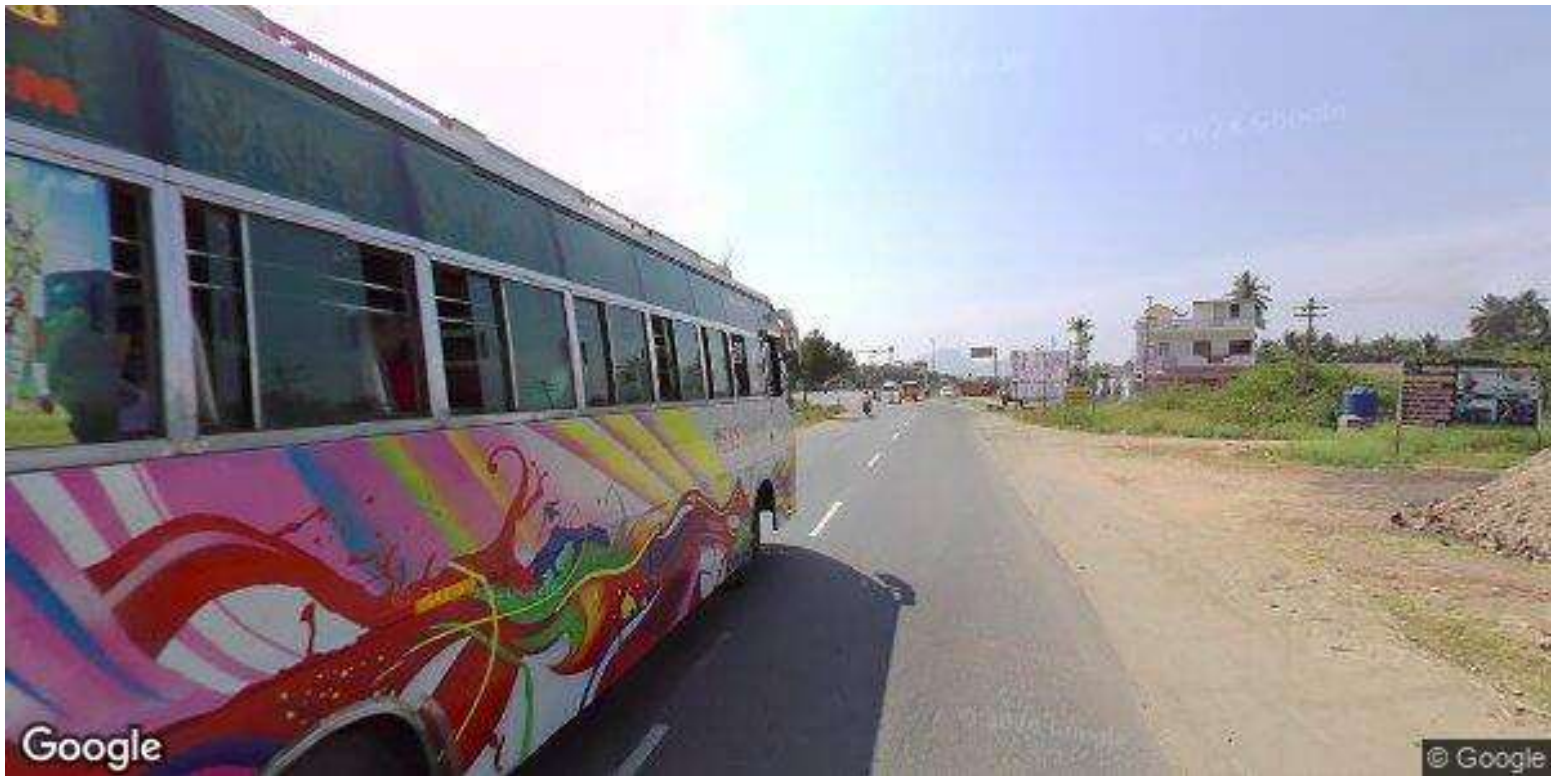
**Risk Type:** Turn  
**Risk Level:** Medium  
**Speed Limit:** 30 KM/Hr  
**Coordinates:** 11.65484, 78.38000

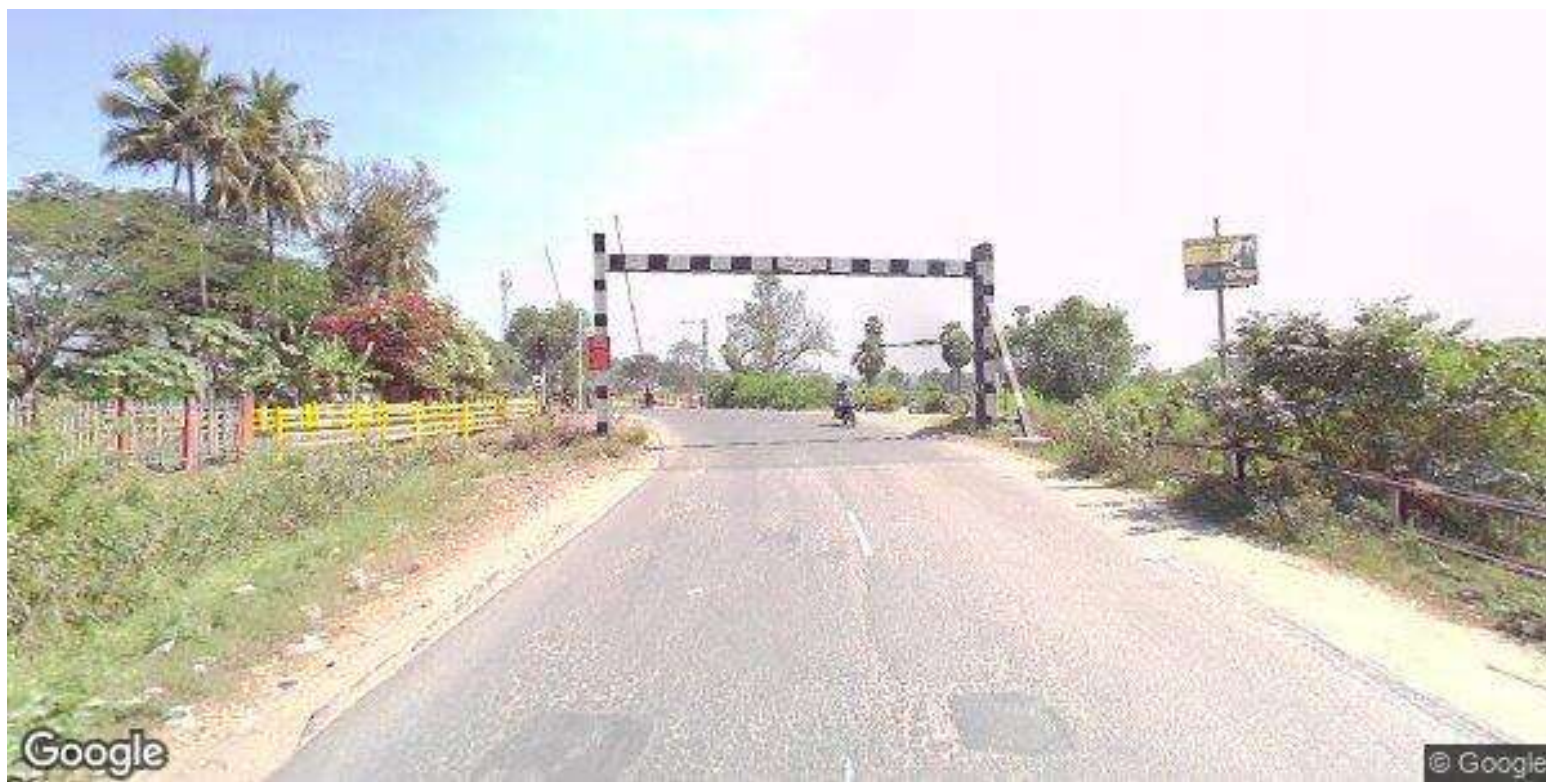
**Risk Type:** Turn

**Risk Level:** Medium

**Speed Limit:** 30 KM/Hr

**Coordinates:** 11.65602, 78.38711

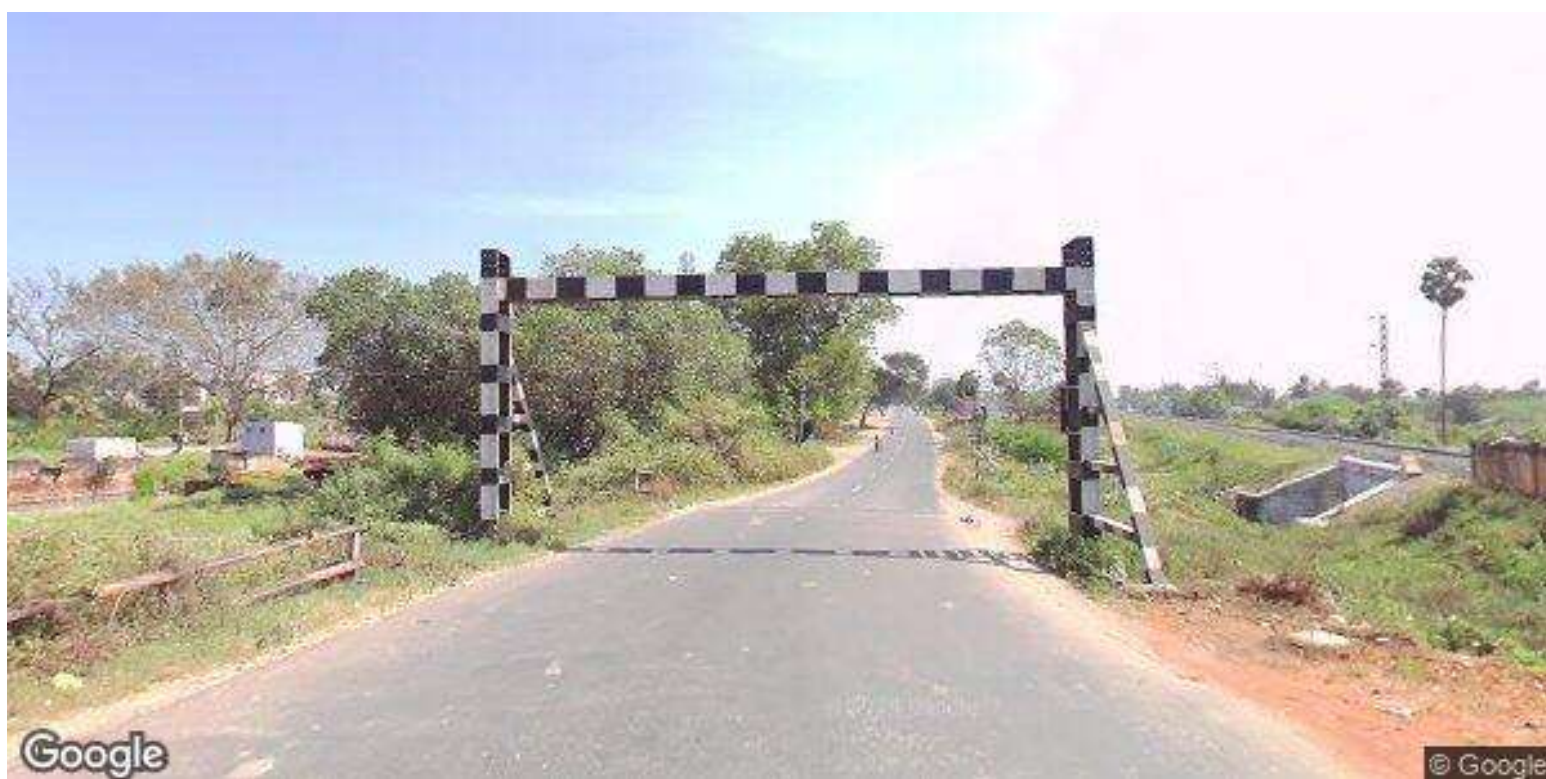
**Risk Type:** Turn

**Risk Level:** Medium

**Speed Limit:** 30 KM/Hr

**Coordinates:** 11.65631, 78.38769

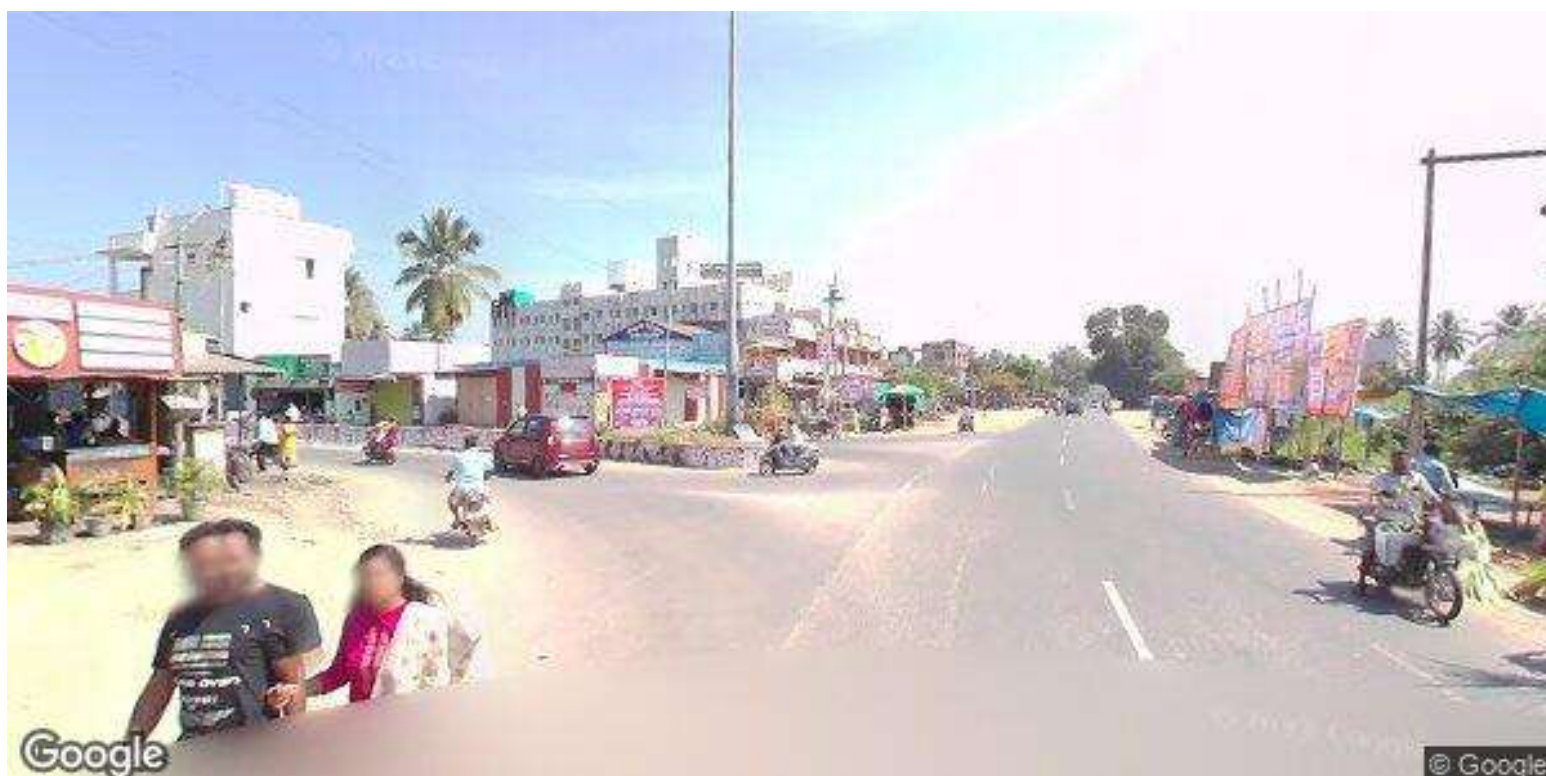
Risk Type: Turn

Risk Level: High

Speed Limit: 15 KM/Hr

Coordinates: 11.65716, 78.40570

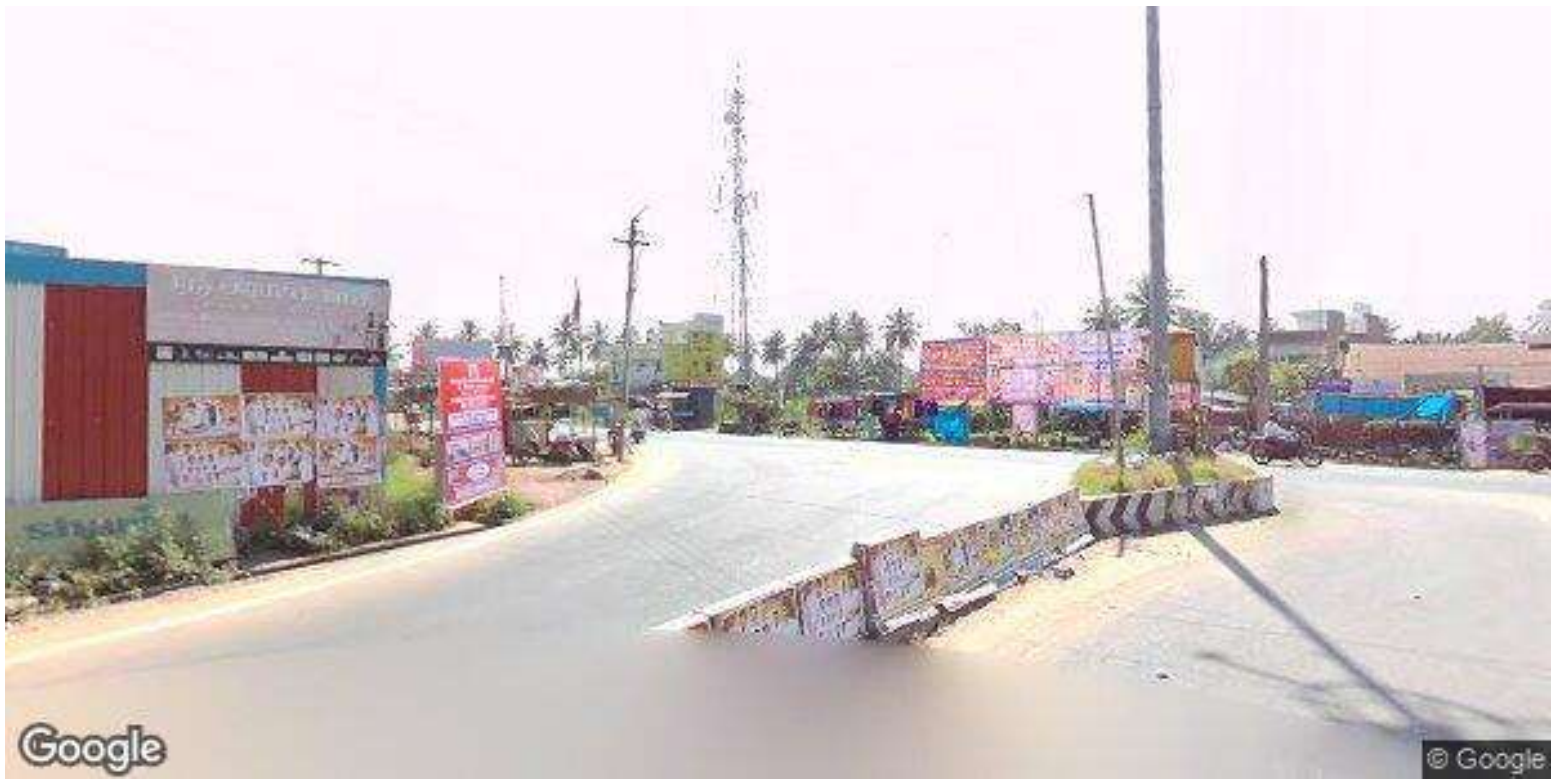
Risk Type: Turn

Risk Level: Medium

Speed Limit: 30 KM/Hr

Coordinates: 11.65743, 78.40584
