# IndianOil

## JOURNEY RISK MANAGEMENT (JRM) STUDY

### Salem Terminal to ADHOC SREE PALANIVEL TRADERS UNIT II

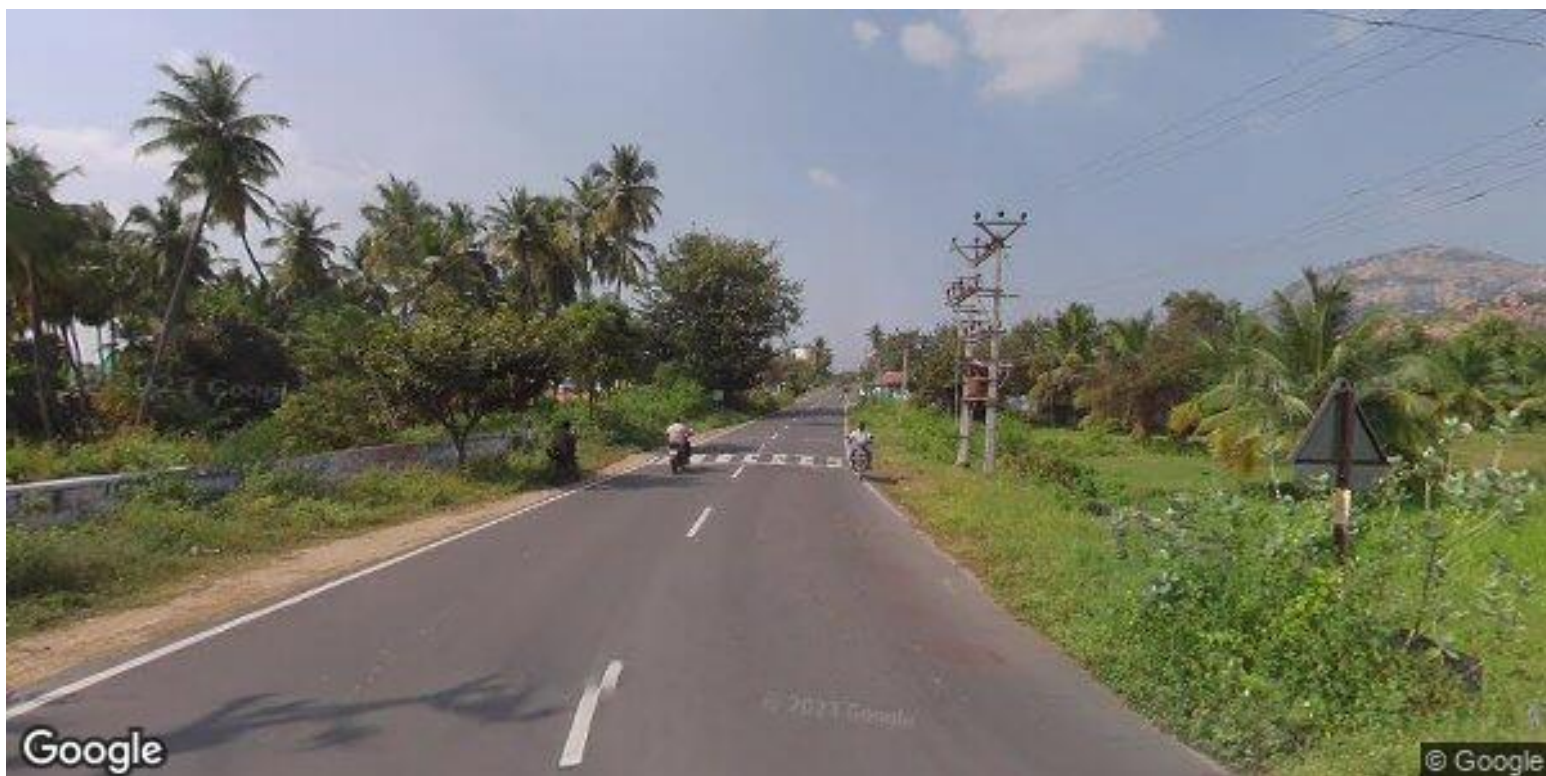
**Risk Type:** Turn  
**Risk Level:** Medium  
**Speed Limit:** 30 KM/Hr  
**Coordinates:** 11.45352, 77.85698

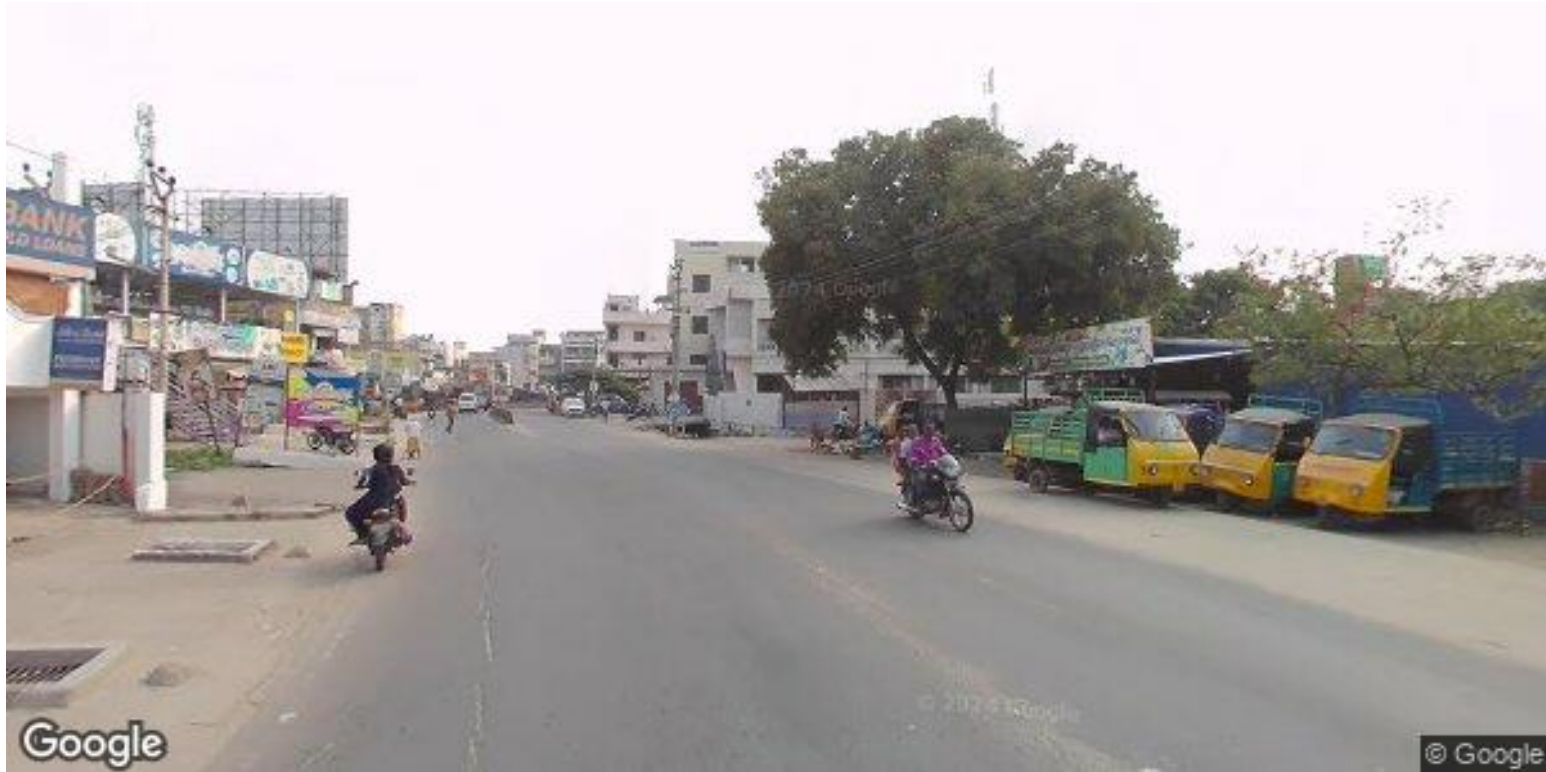
**Risk Type:** Turn  
**Risk Level:** Medium  
**Speed Limit:** 30 KM/Hr  
**Coordinates:** 11.36626, 77.74788

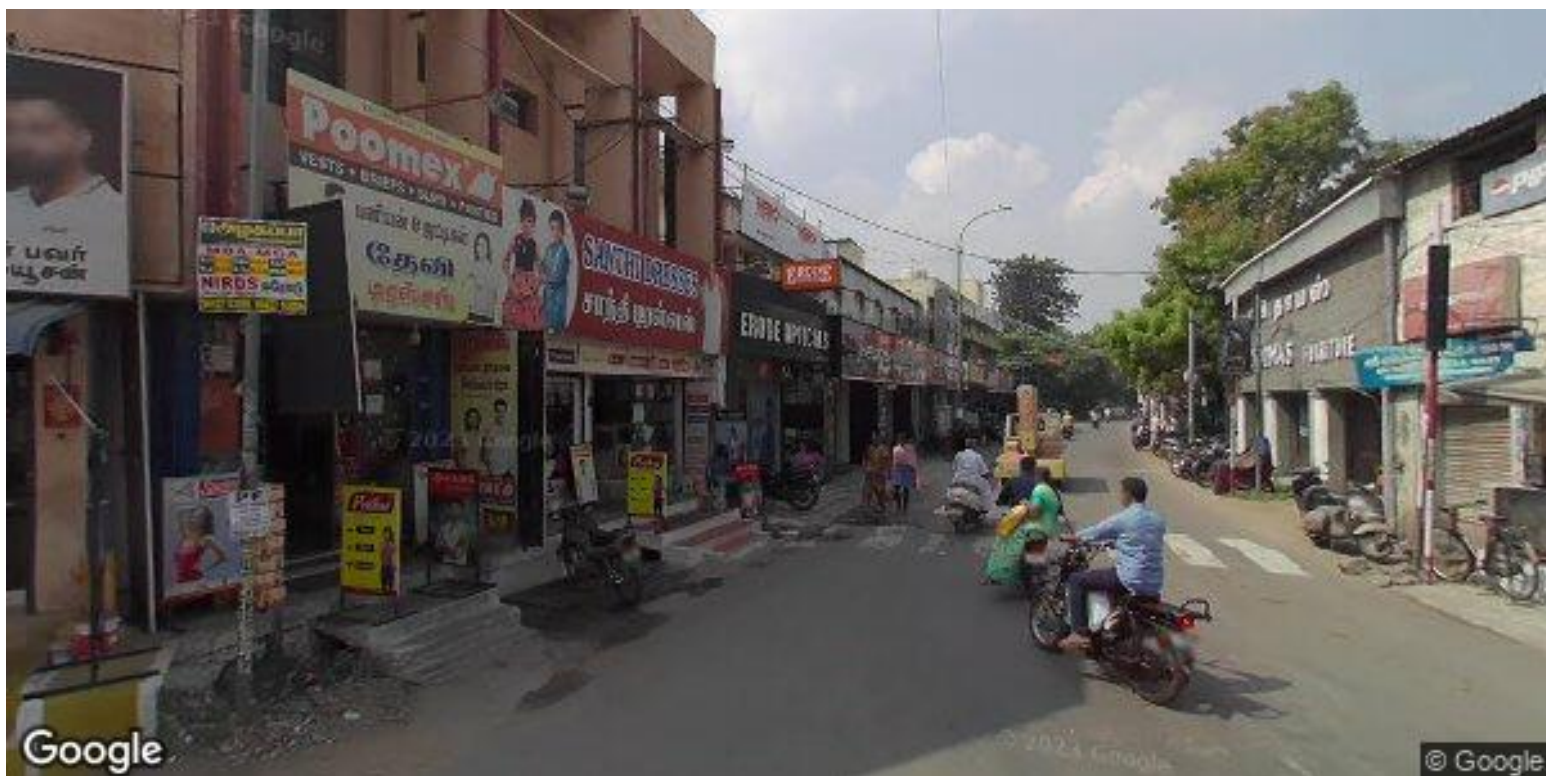
**Risk Type:** Blind Spot  
**Risk Level:** Blind Spot  
**Speed Limit:** 10 KM/Hr  
**Coordinates:** 11.33920, 77.72902

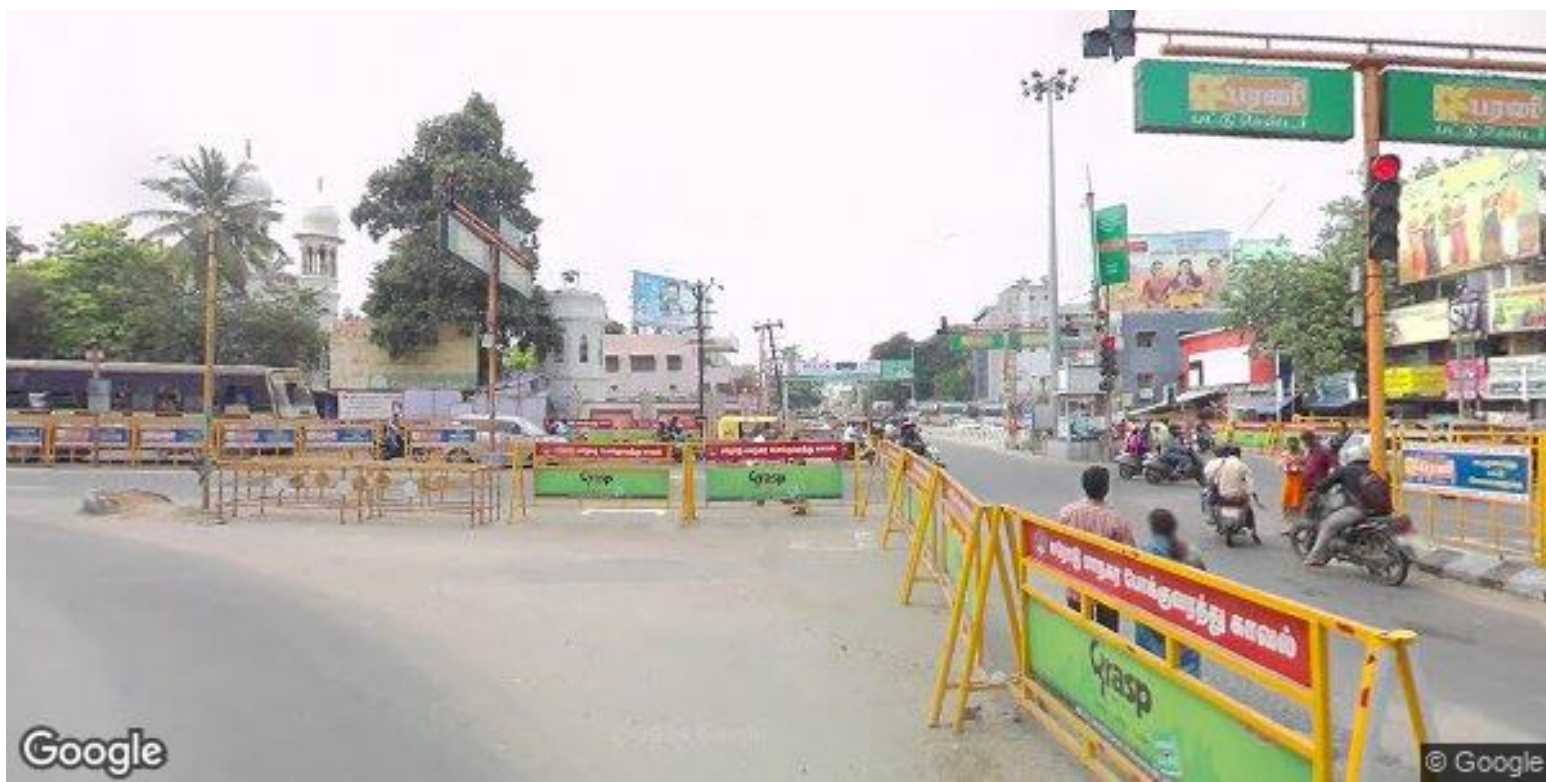
Coordinates: 11.33914, 77.72659

Risk Type: Turn

Risk Level: High

Speed Limit: 15 KM/Hr

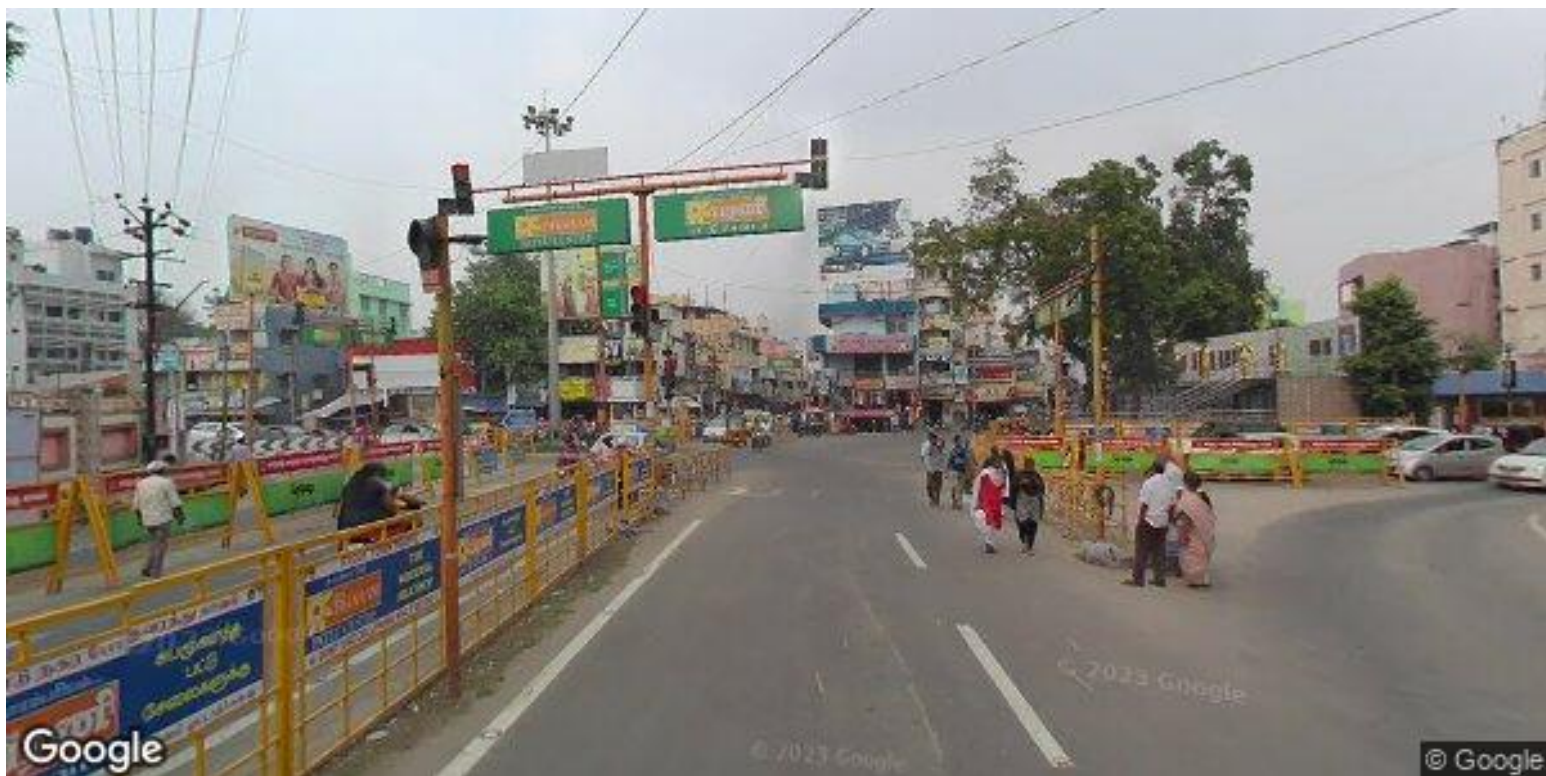
Coordinates: 11.33890, 77.72637

Risk Type: Turn

Risk Level: High

Speed Limit: 15 KM/Hr

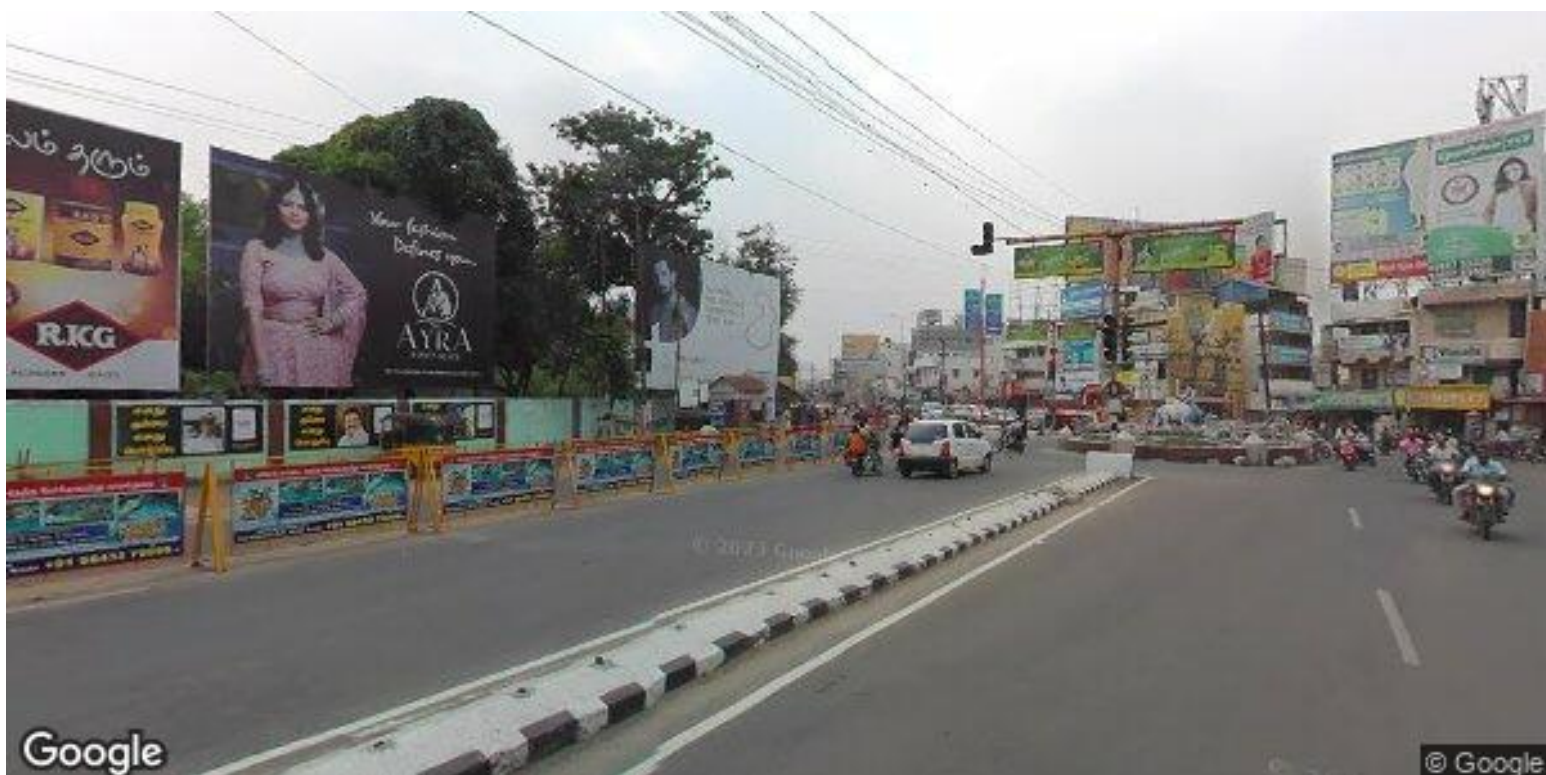
**Coordinates: 11.33093, 77.72776**

**Risk Type: Turn**

**Risk Level: Medium**

**Speed Limit: 30 KM/Hr**

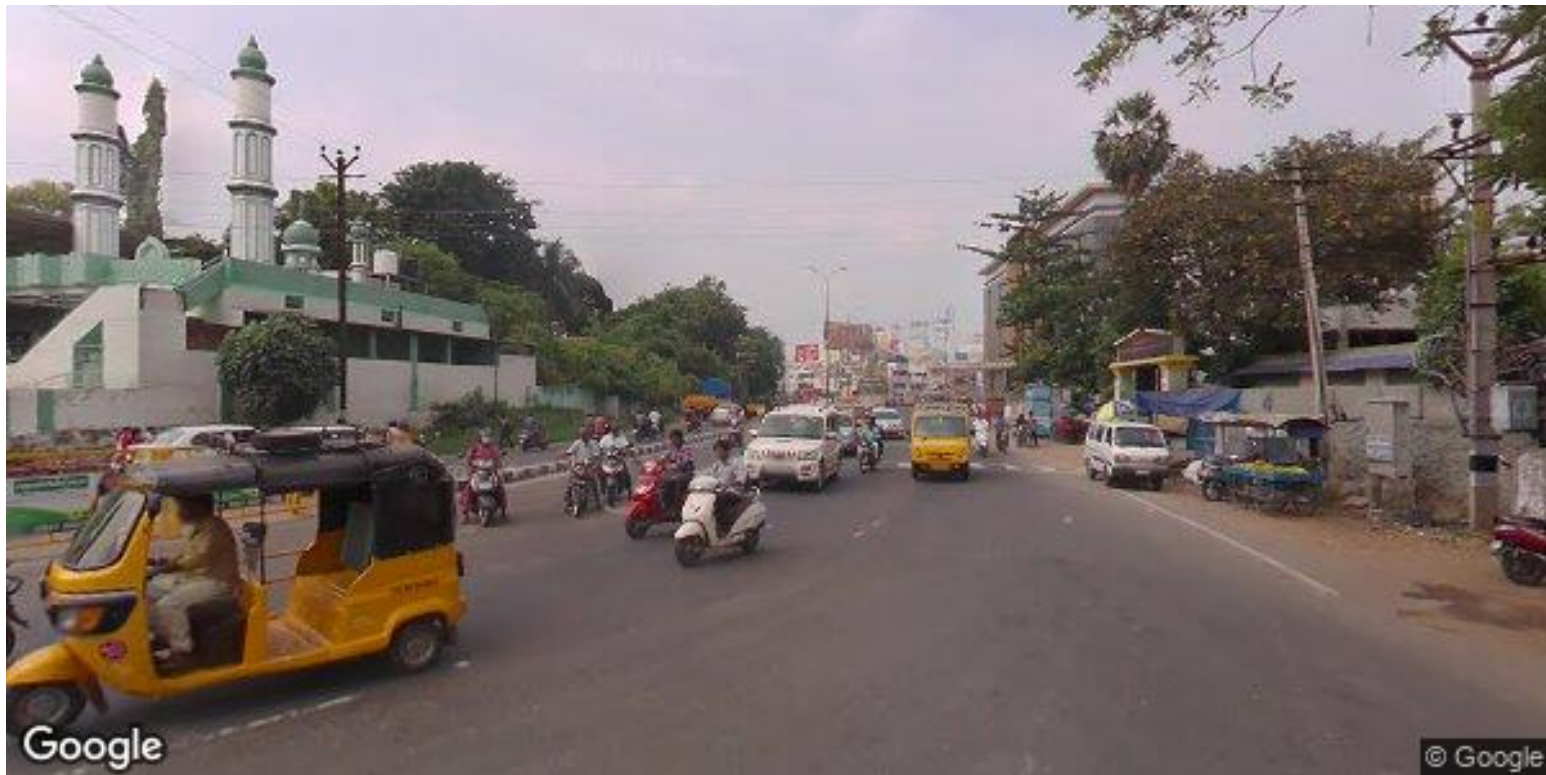
**Coordinates: 11.33076, 77.72884**

**Risk Type: Turn**

**Risk Level: Medium**

**Speed Limit: 30 KM/Hr**

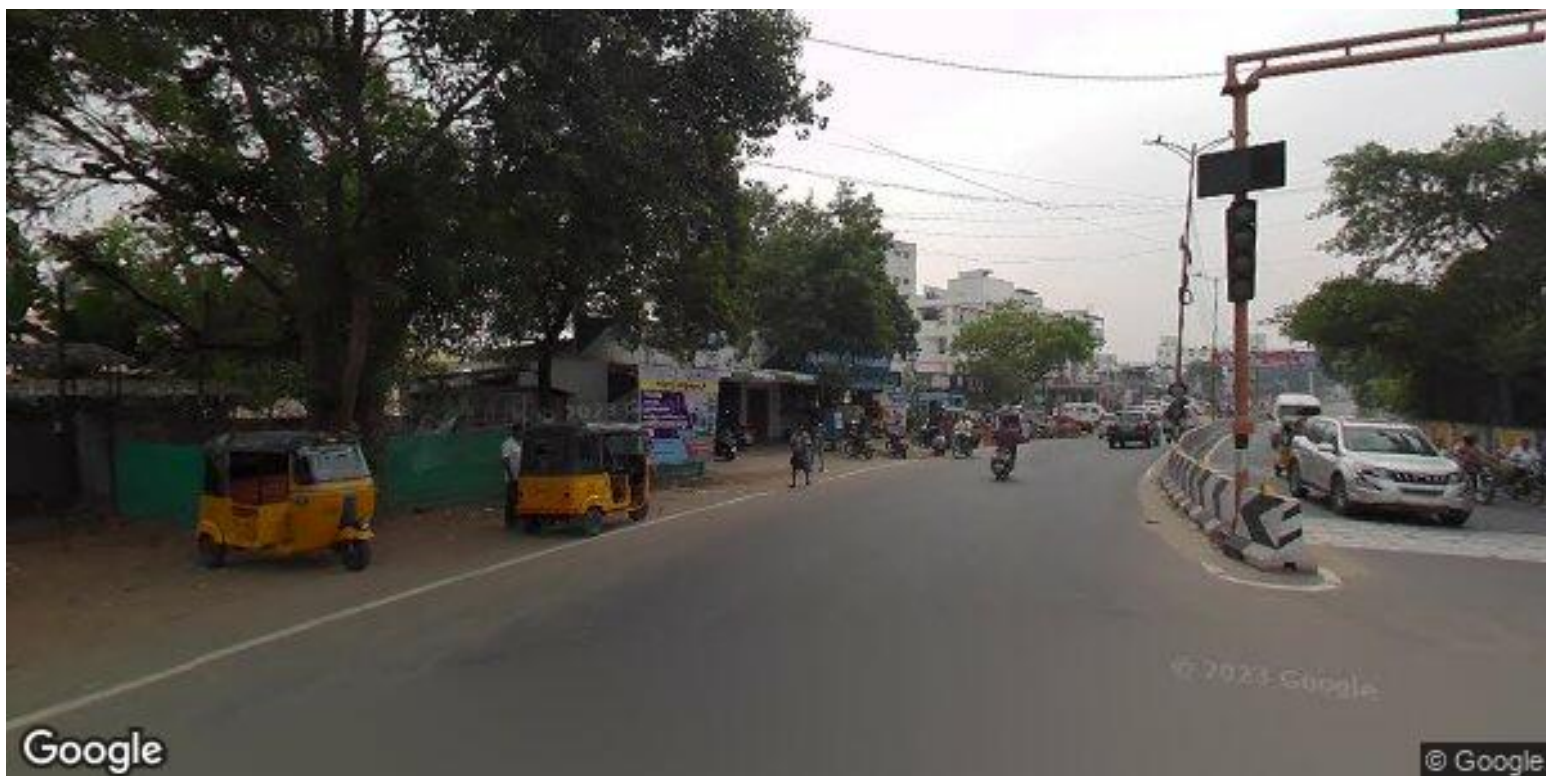
**Coordinates: 11.32694, 77.73073**

**Risk Type: Turn**

**Risk Level: High**

**Speed Limit: 15 KM/Hr**

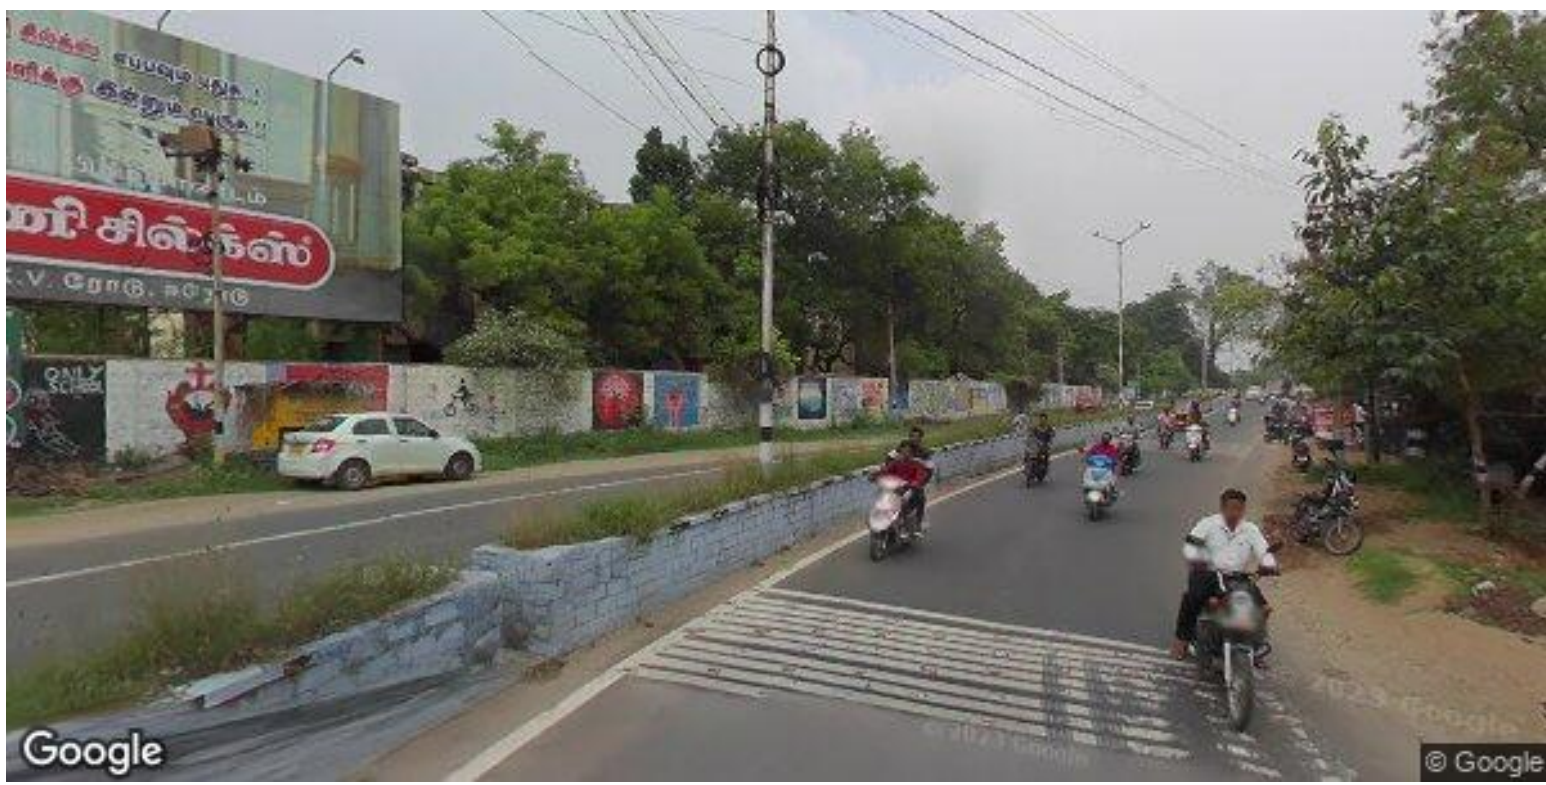
**Coordinates:** 11.32427, 77.72730

**Risk Type:** Turn

**Risk Level:** Medium

**Speed Limit:** 30 KM/Hr

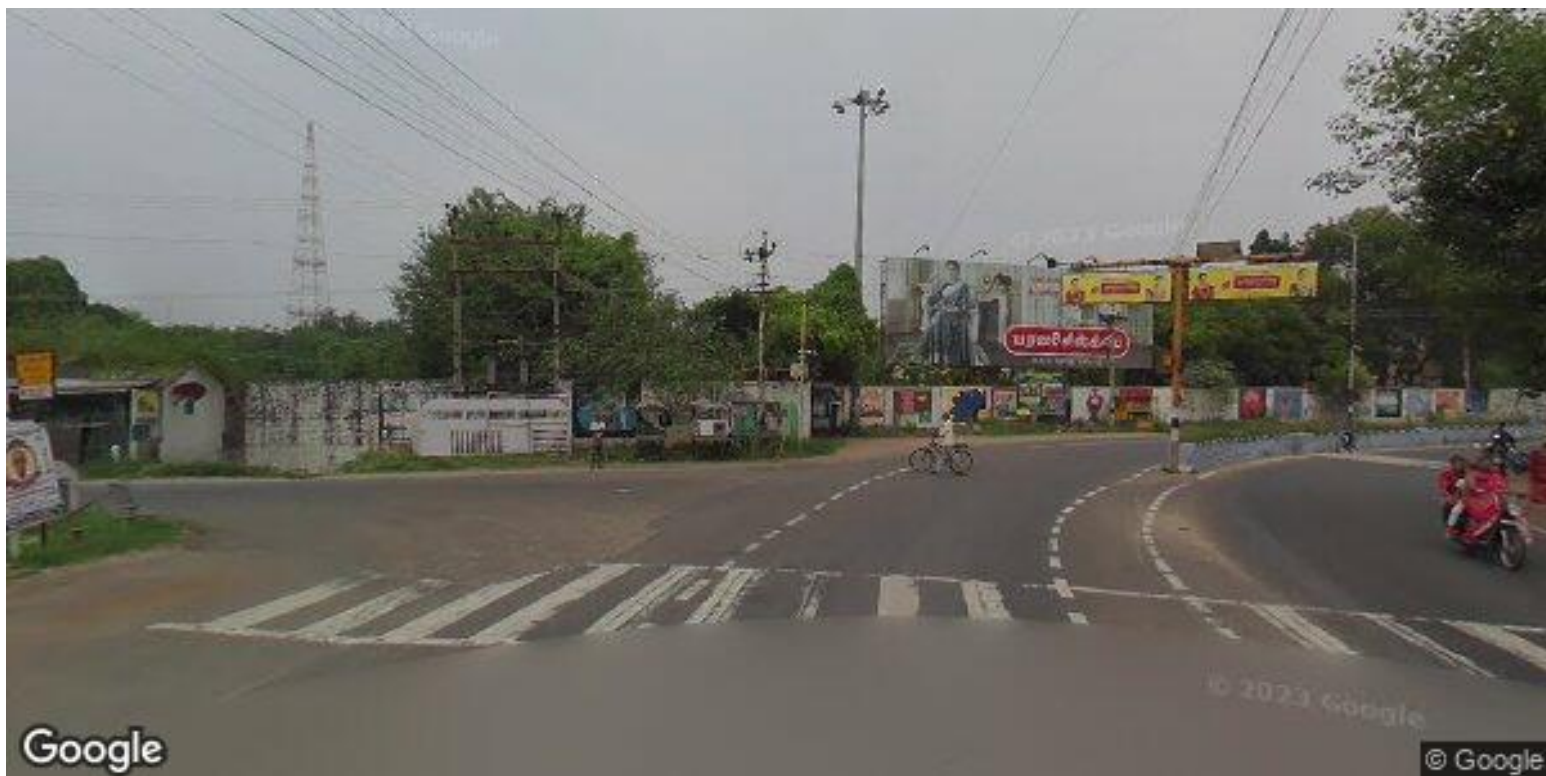
**Coordinates:** 11.32401, 77.72723

**Risk Type:** Turn

**Risk Level:** Medium

**Speed Limit:** 30 KM/Hr
