## JOURNEY RISK MANAGEMENT (JRM) STUDY

### Salem Terminal to SARAL PETROLEUM

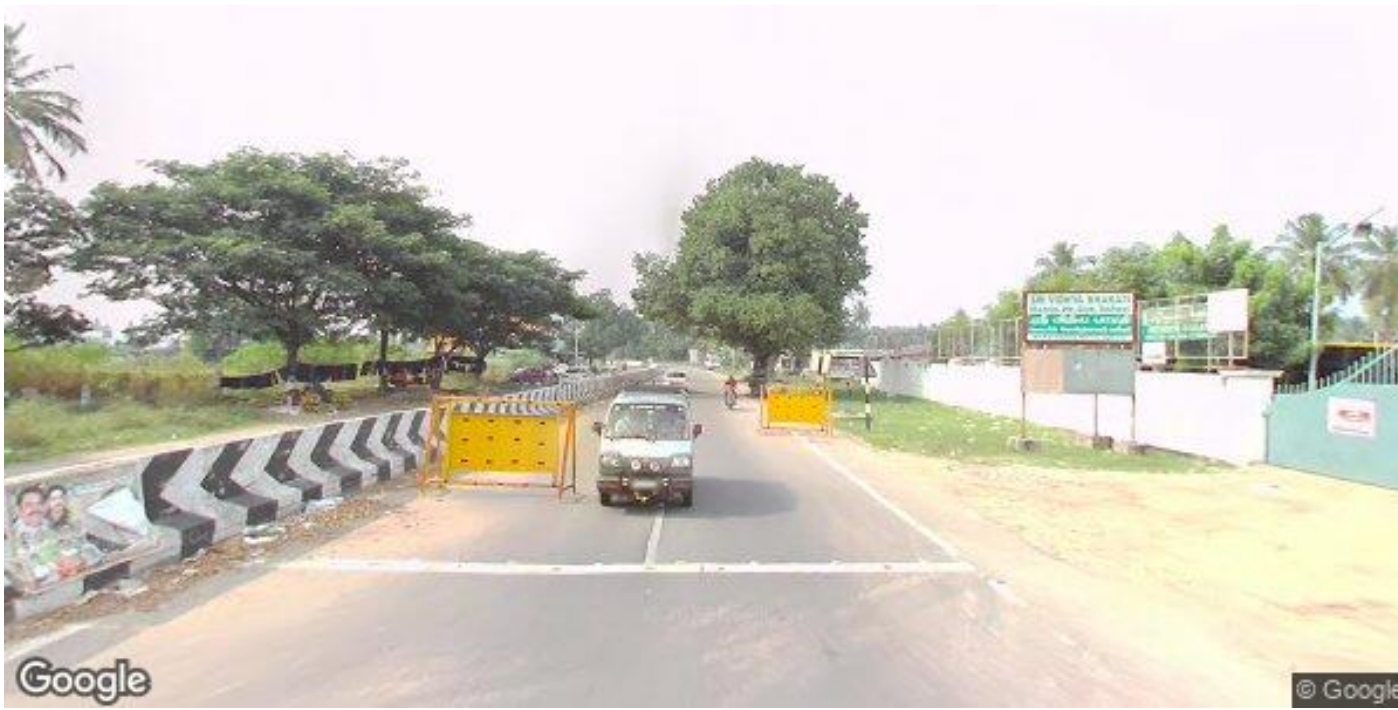
**Risk Type:** U-Turn  
**Risk Level:** High  
**Speed Limit:** 10 KM/Hr  
**Coordinates:** 11.6180669, 78.1109048

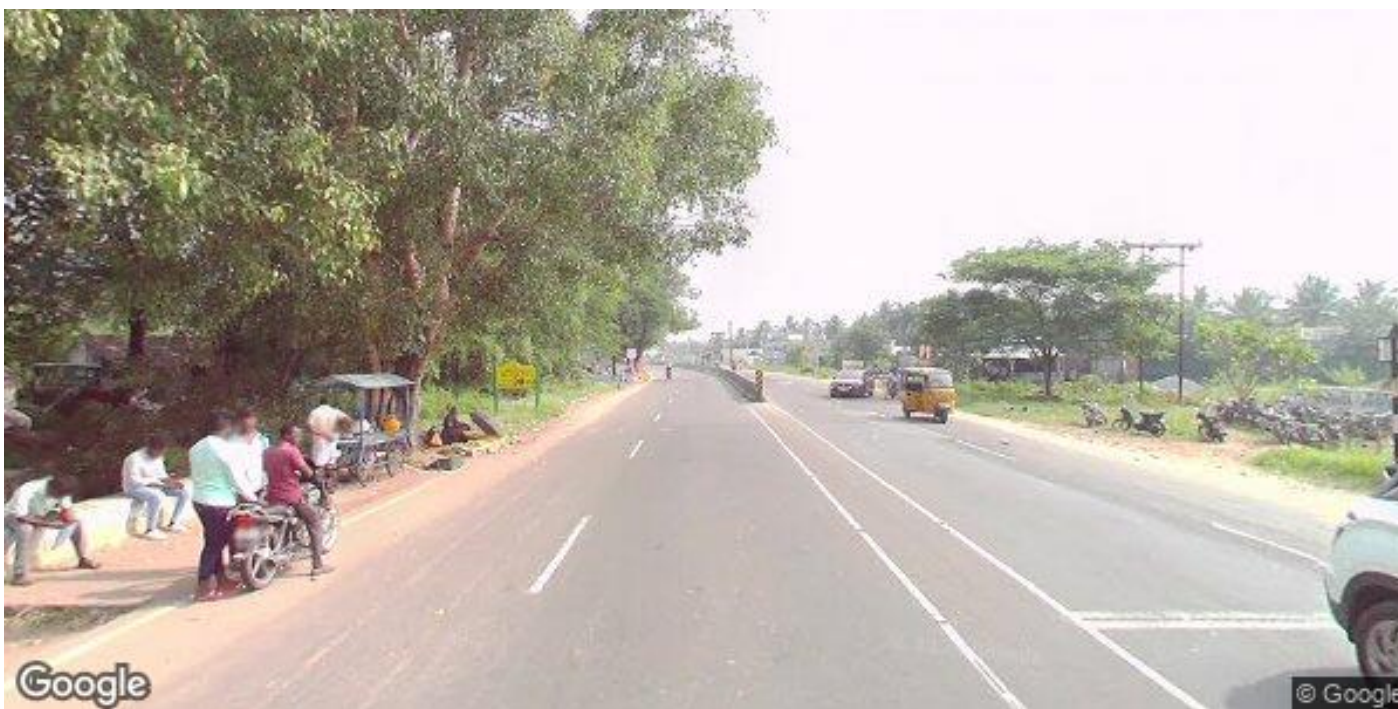
**Risk Type:** U-Turn  
**Risk Level:** High  
**Speed Limit:** 10 KM/Hr  
**Coordinates:** 11.6128439, 78.1059968

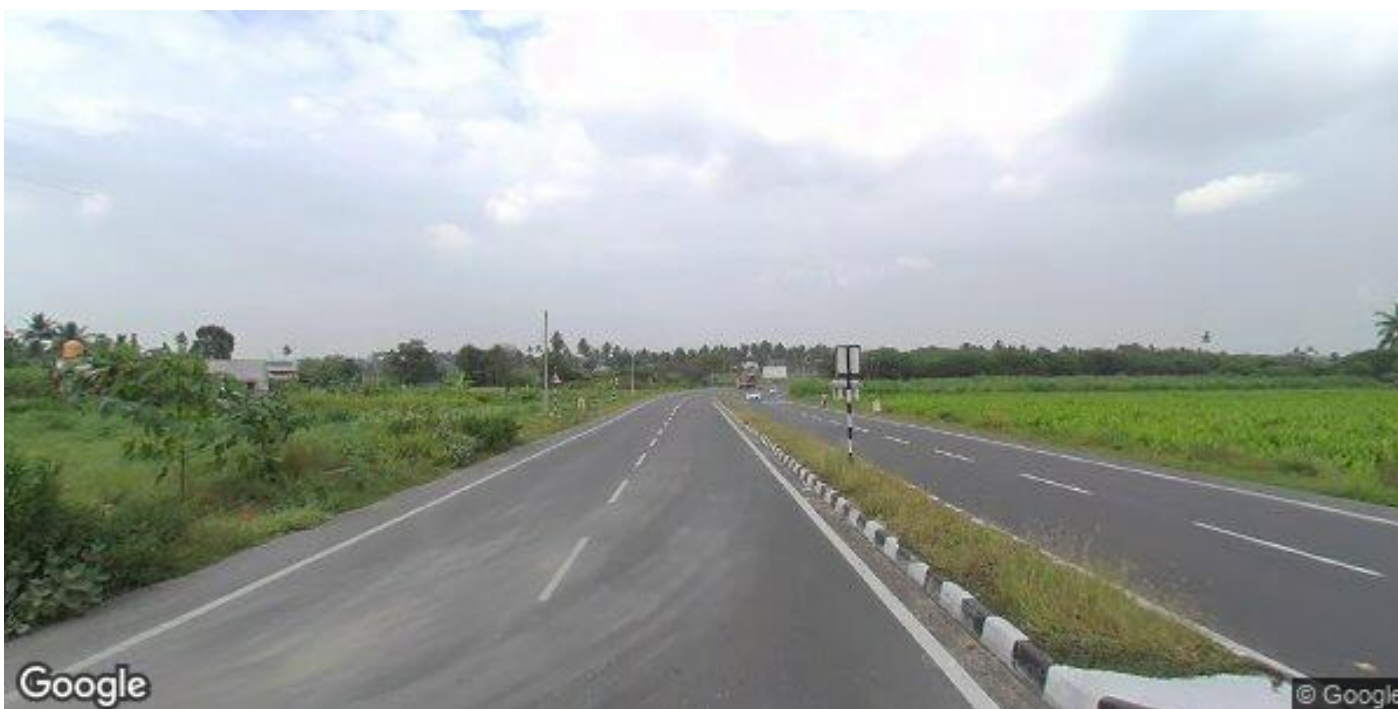
**Risk Type:** U-Turn  
**Risk Level:** High  
**Speed Limit:** 10 KM/Hr  
**Coordinates:** 12.1178163, 78.4982242

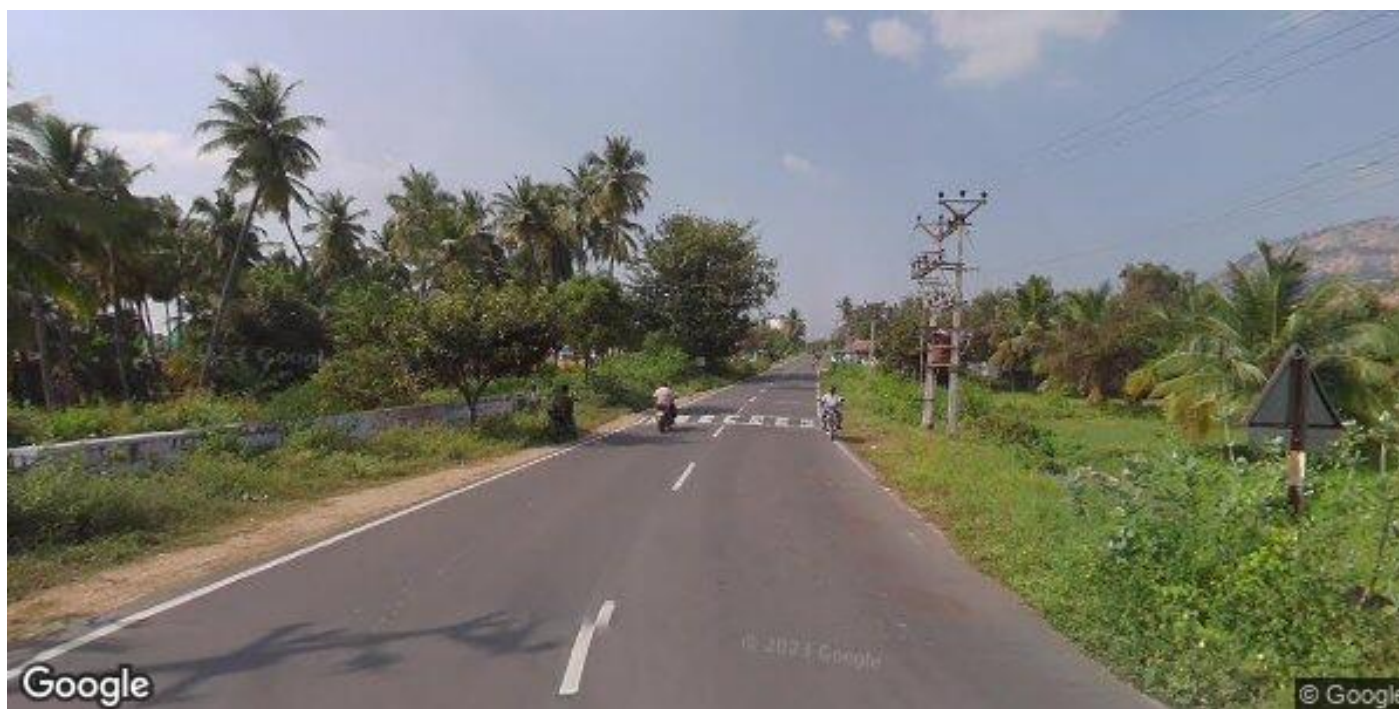
**Risk Type:** Turn  
**Risk Level:** High  
**Speed Limit:** 15 KM/Hr  
**Coordinates:** 11.45353, 77.85697

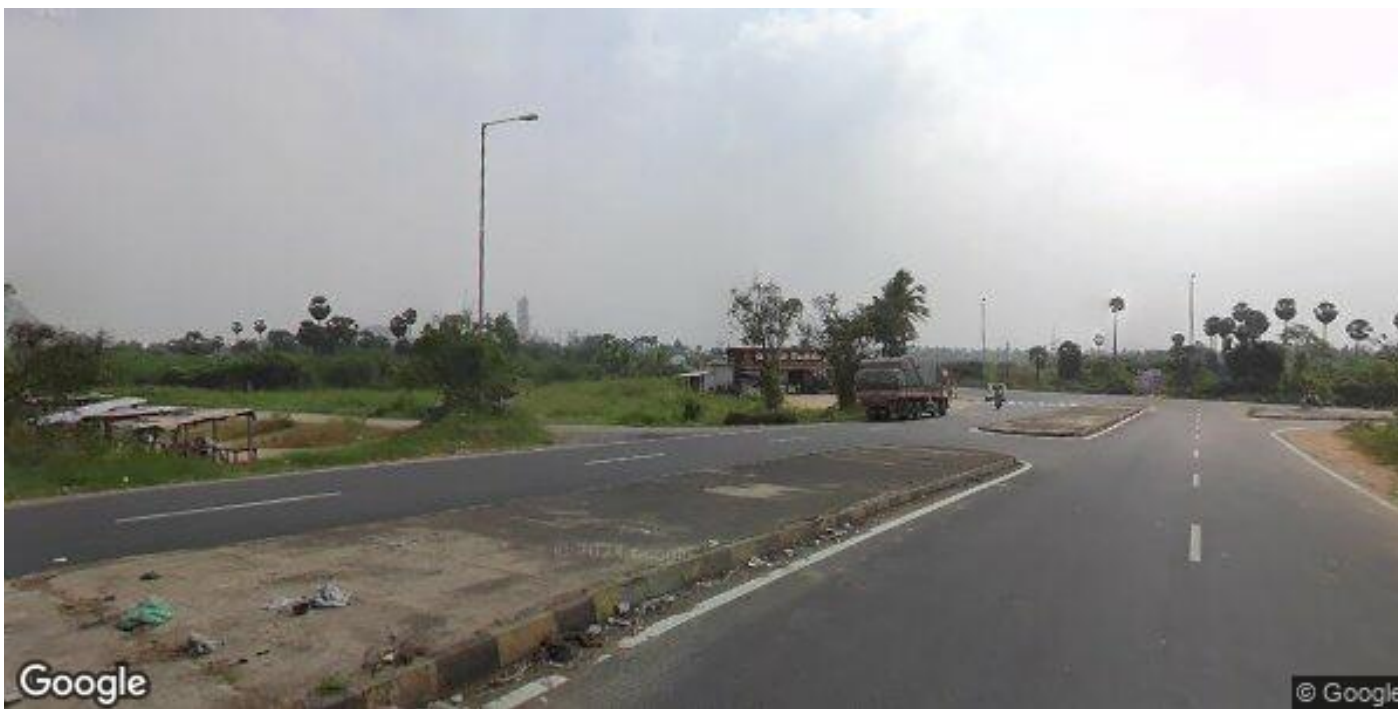
**Risk Type:** Turn  
**Risk Level:** High  
**Speed Limit:** 15 KM/Hr  
**Coordinates:** 11.45605, 77.81683

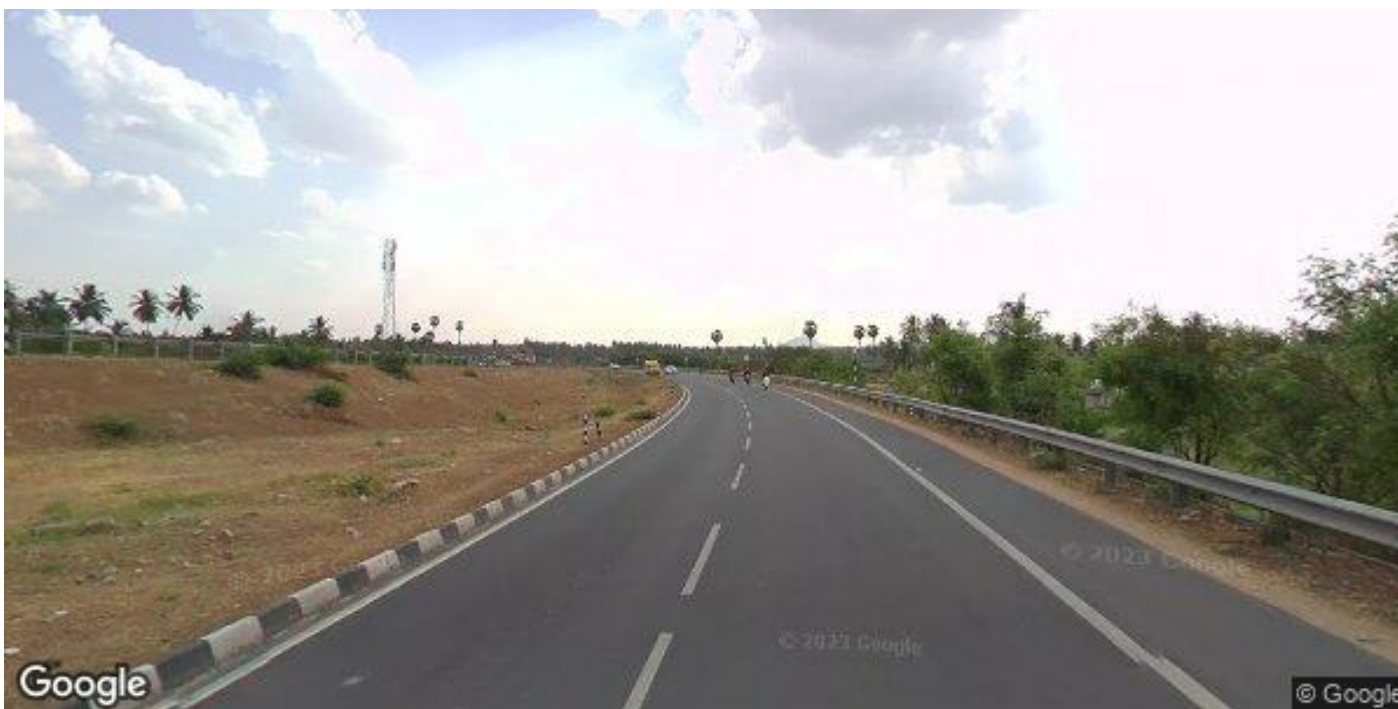
**Risk Type:** Turn  
**Risk Level:** Medium  
**Speed Limit:** 30 KM/Hr  
**Coordinates:** 11.53573, 77.95794

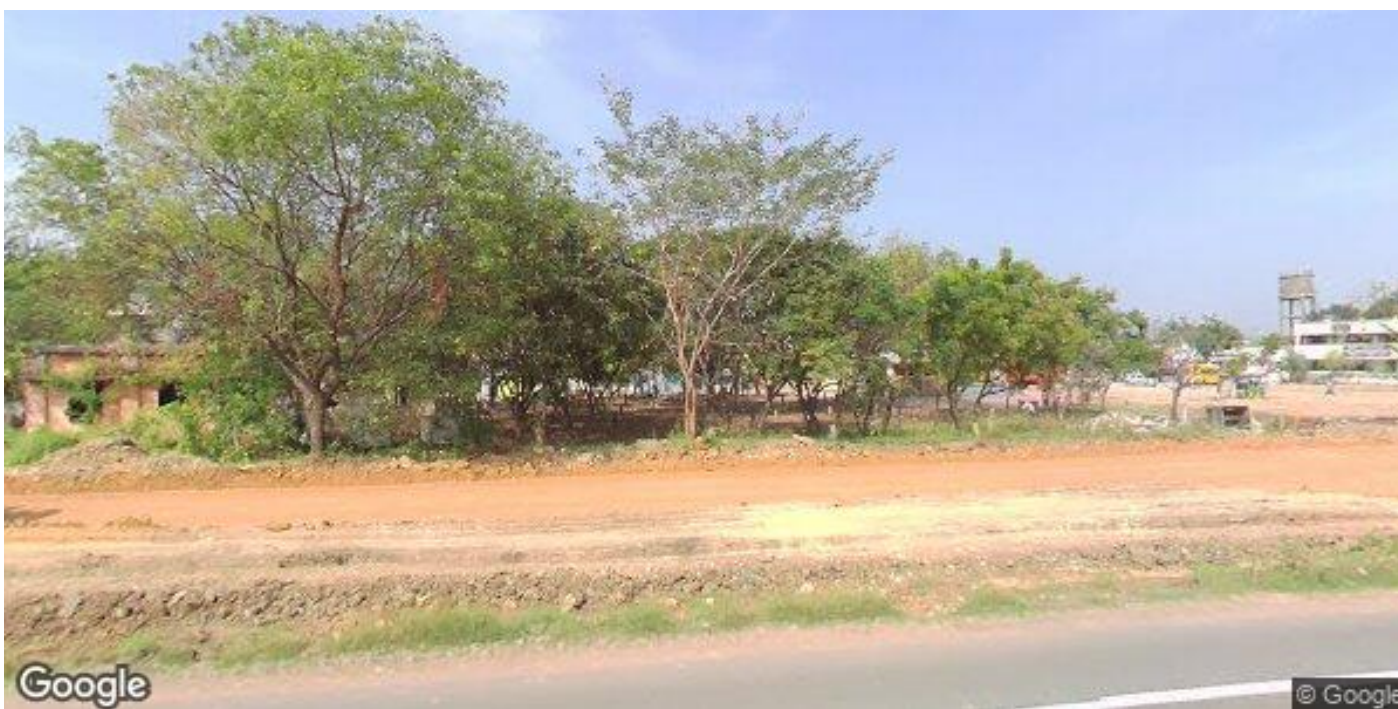
**Risk Type:** Turn  
**Risk Level:** Medium  
**Speed Limit:** 30 KM/Hr  
**Coordinates:** 11.62100, 78.10723

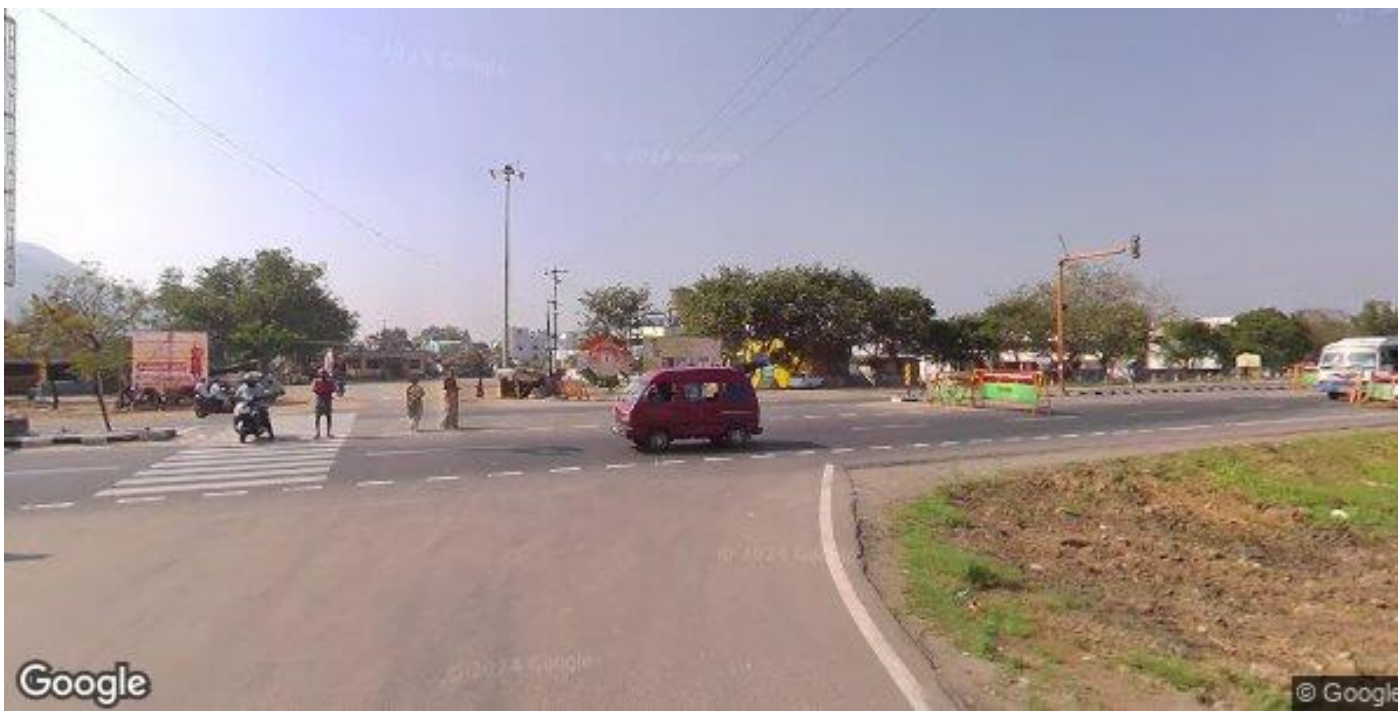
**Risk Type:** Blind Spot  
**Risk Level:** Blind Spot  
**Speed Limit:** 10 KM/Hr  
**Coordinates:** 11.62130, 78.10776

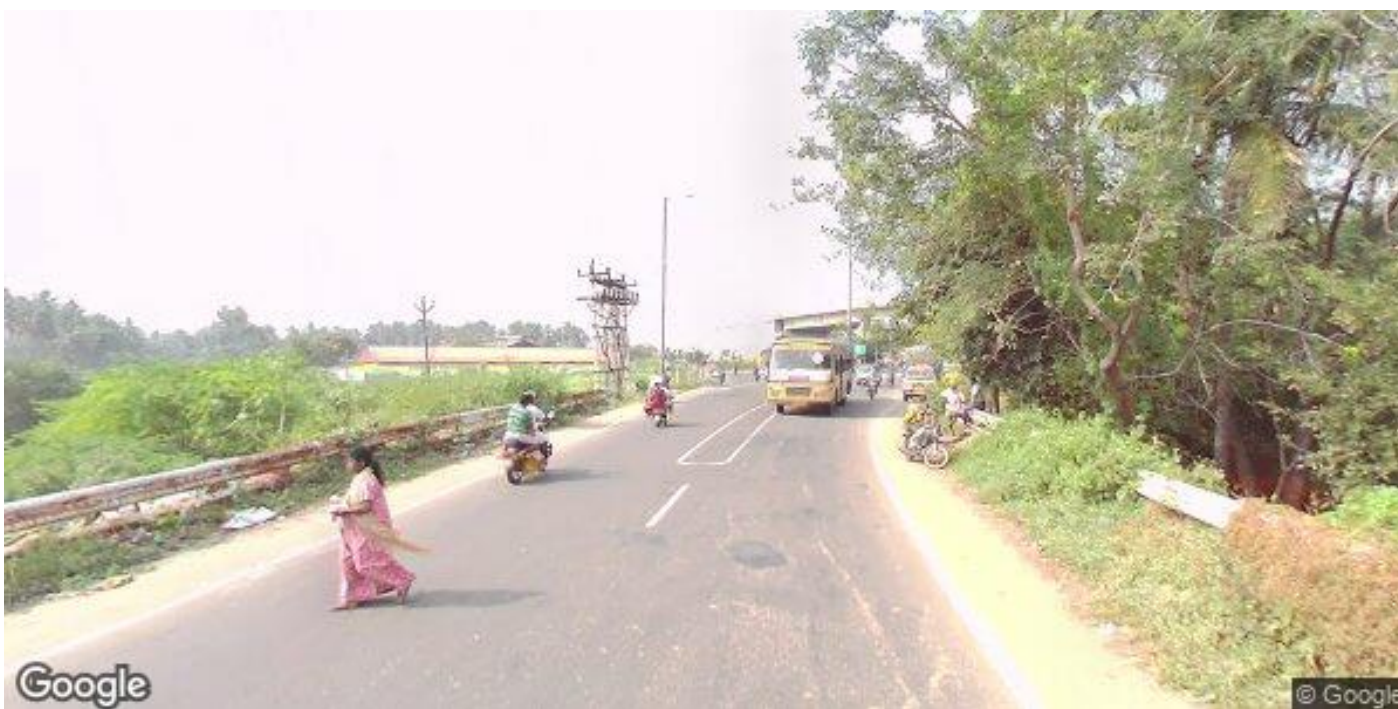
**Risk Type:** Turn  
**Risk Level:** Medium  
**Speed Limit:** 30 KM/Hr  
**Coordinates:** 11.61235, 78.10495

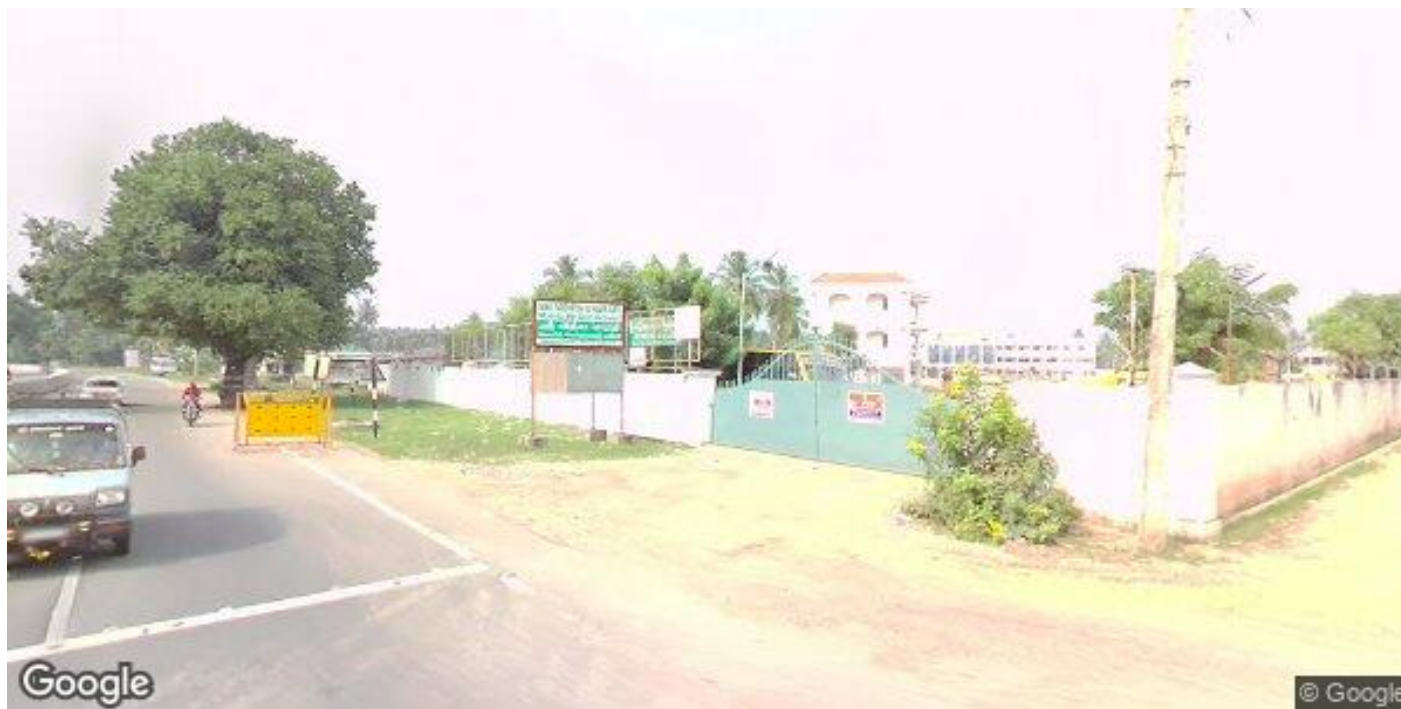
**Risk Type:** Blind Spot  
**Risk Level:** Blind Spot  
**Speed Limit:** 10 KM/Hr  
**Coordinates:** 11.61807, 78.11090

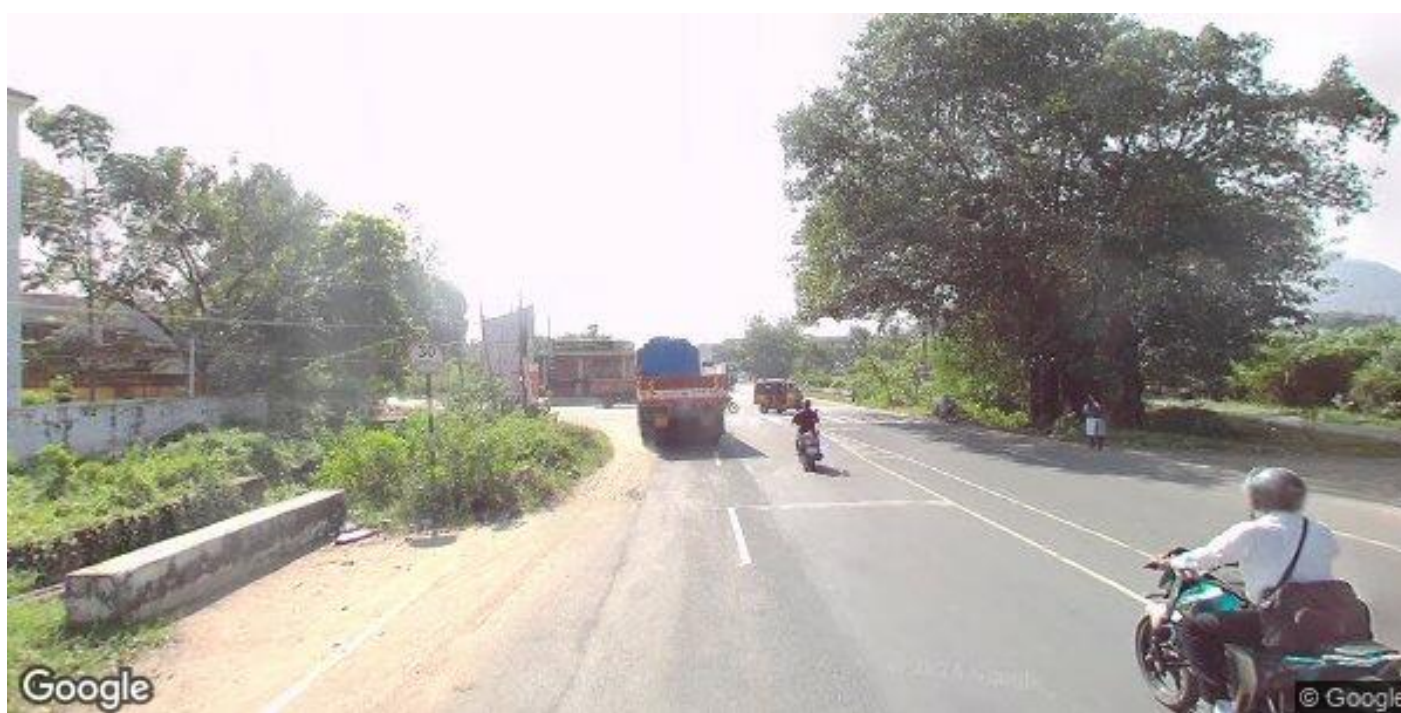
**Risk Type:** Blind Spot  
**Risk Level:** Blind Spot  
**Speed Limit:** 10 KM/Hr  
**Coordinates:** 11.61286, 78.10611

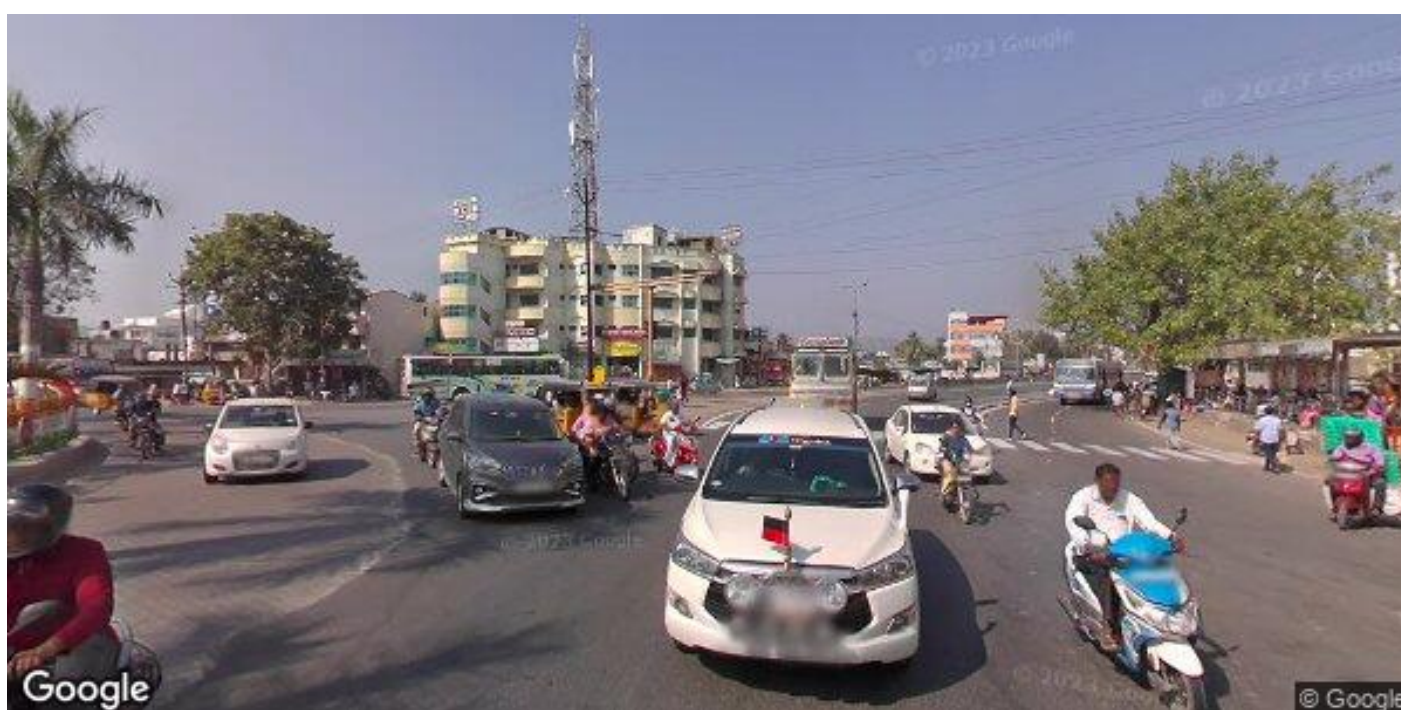
**Risk Type:** Blind Spot  
**Risk Level:** Blind Spot  
**Speed Limit:** 10 KM/Hr  
**Coordinates:** 11.63306, 78.12722

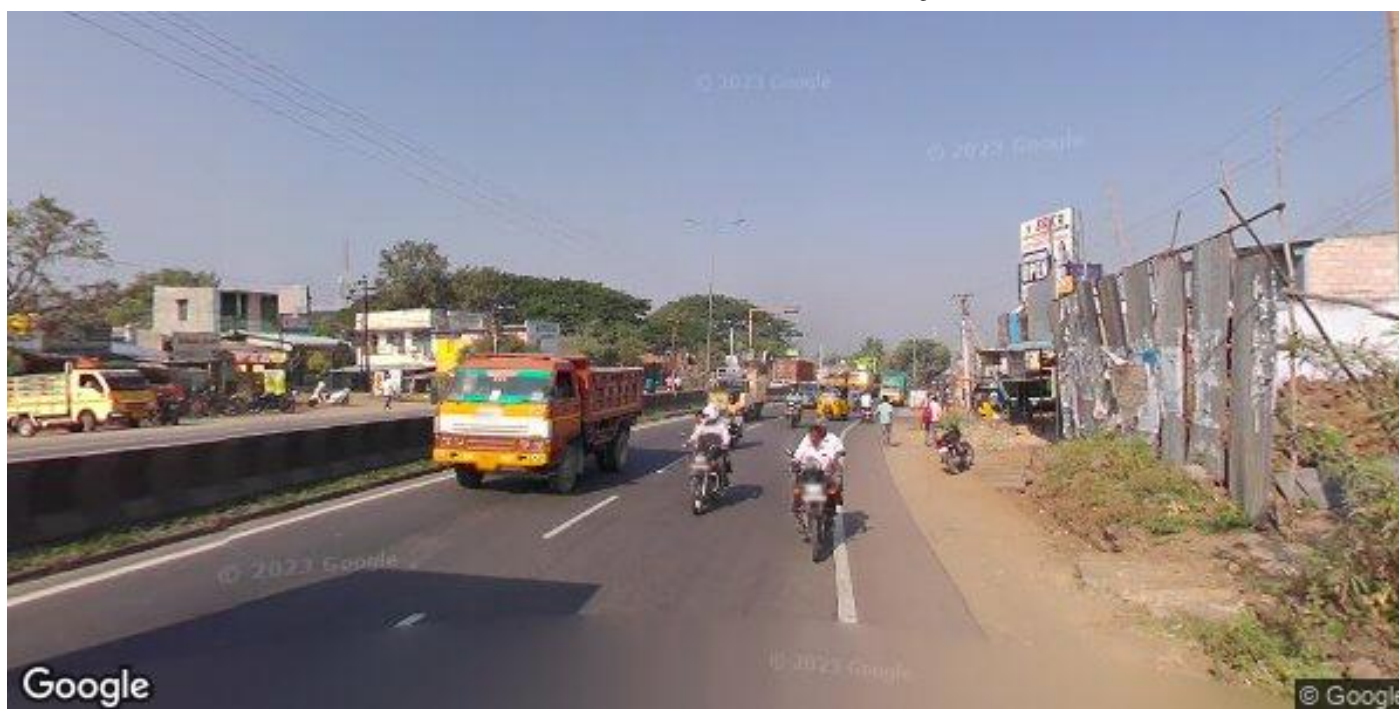
**Risk Type:** Turn  
**Risk Level:** Medium  
**Speed Limit:** 30 KM/Hr  
**Coordinates:** 11.62821, 78.13348

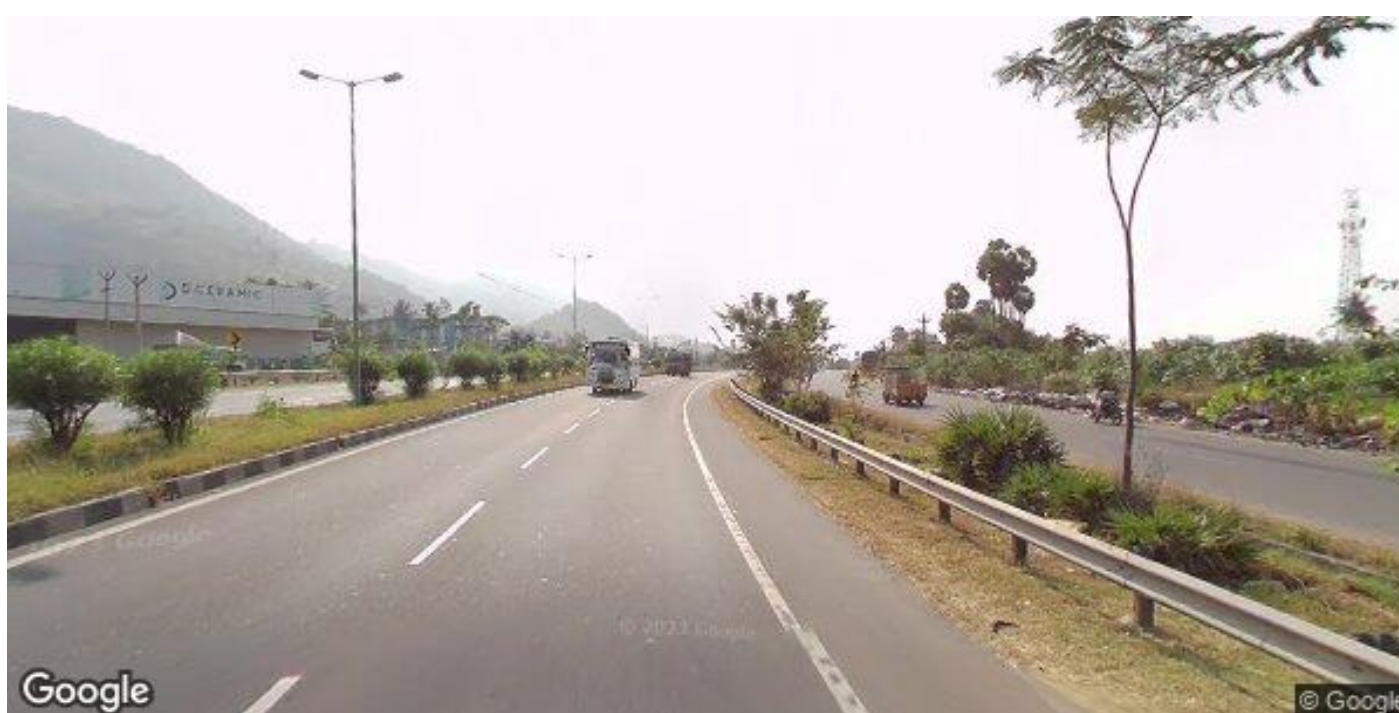
**Risk Type:** Turn  
**Risk Level:** Medium  
**Speed Limit:** 30 KM/Hr  
**Coordinates:** 11.62851, 78.16509

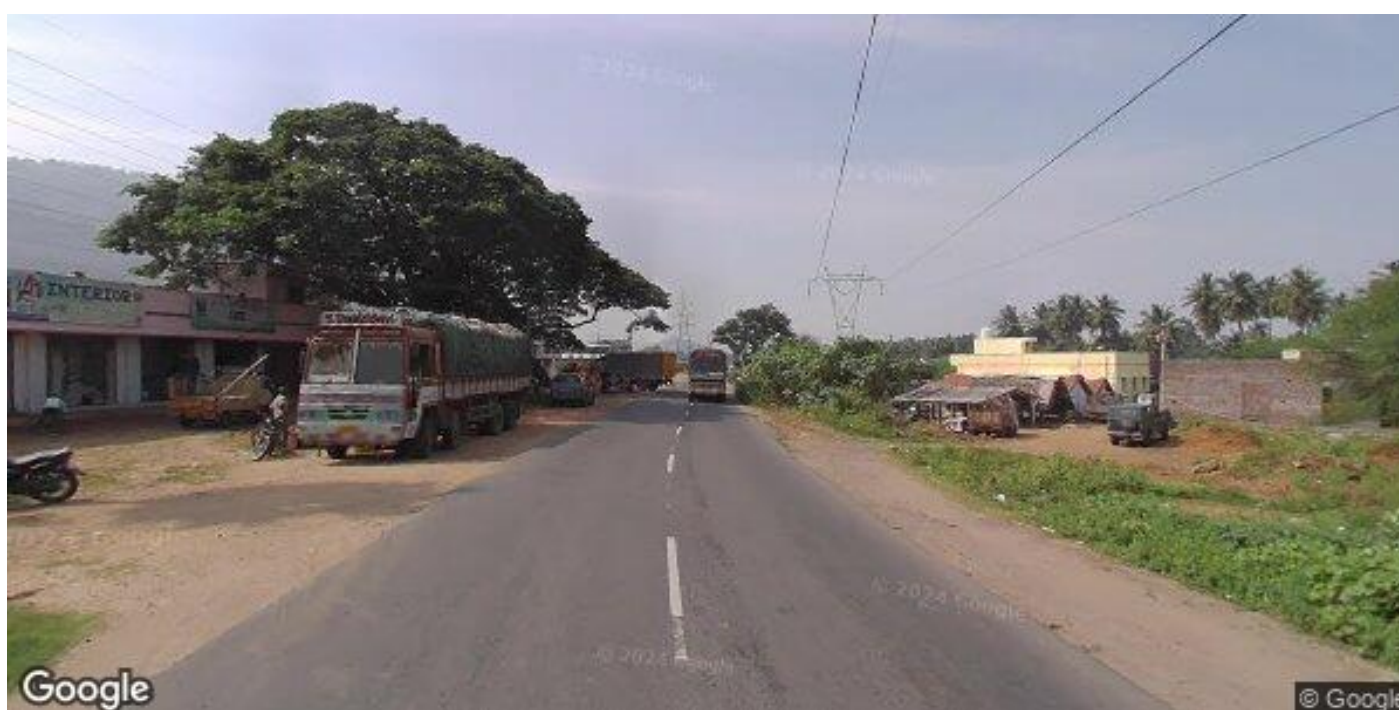
**Risk Type:** Turn  
**Risk Level:** Medium  
**Speed Limit:** 30 KM/Hr  
**Coordinates:** 11.65782, 78.20430

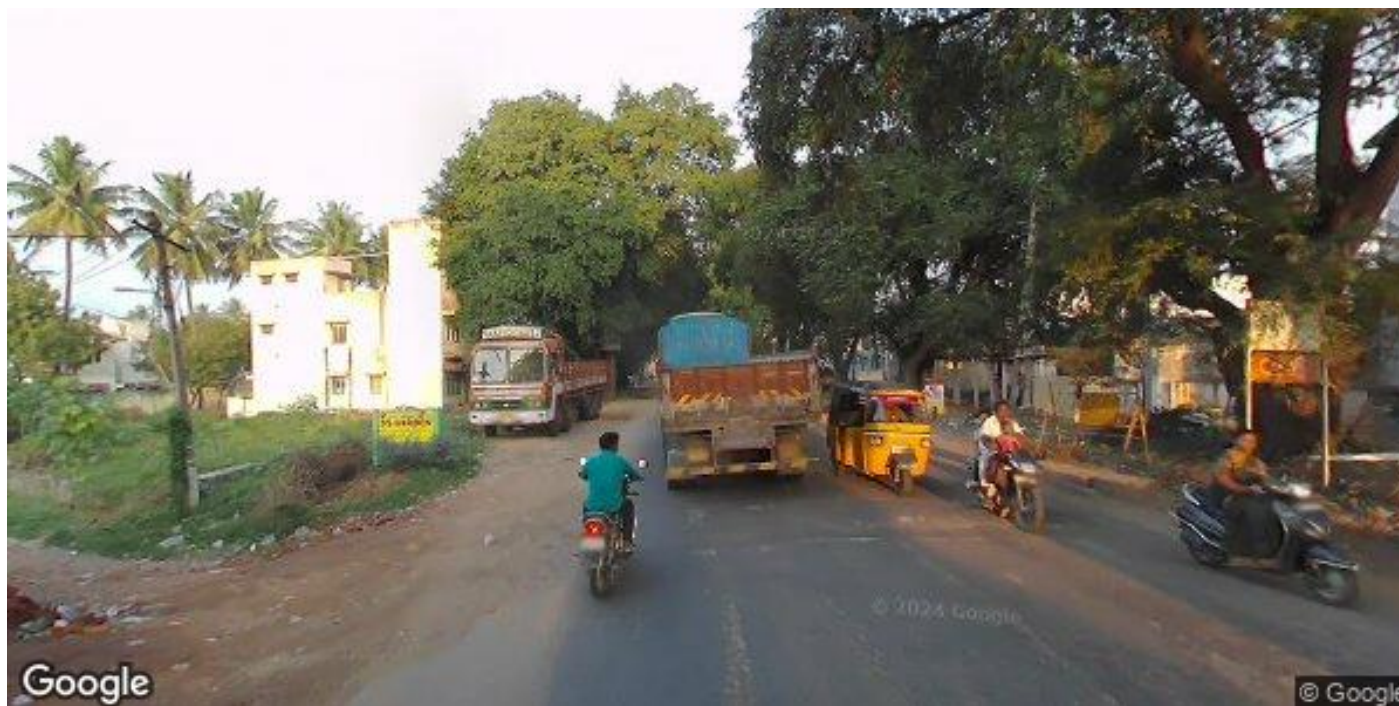
**Risk Type:** Turn  
**Risk Level:** High  
**Speed Limit:** 15 KM/Hr  
**Coordinates:** 11.66387, 78.20665

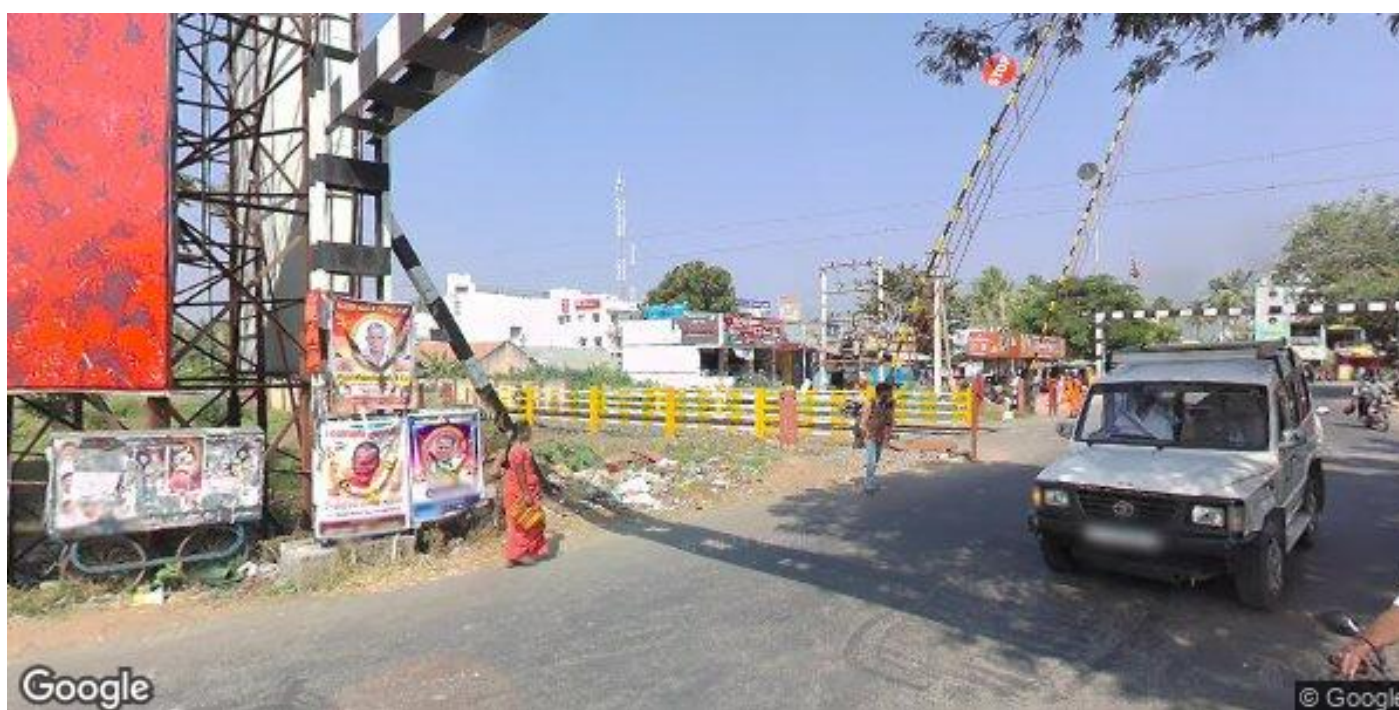
**Risk Type:** Turn  
**Risk Level:** High  
**Speed Limit:** 15 KM/Hr  
**Coordinates:** 11.67131, 78.23138

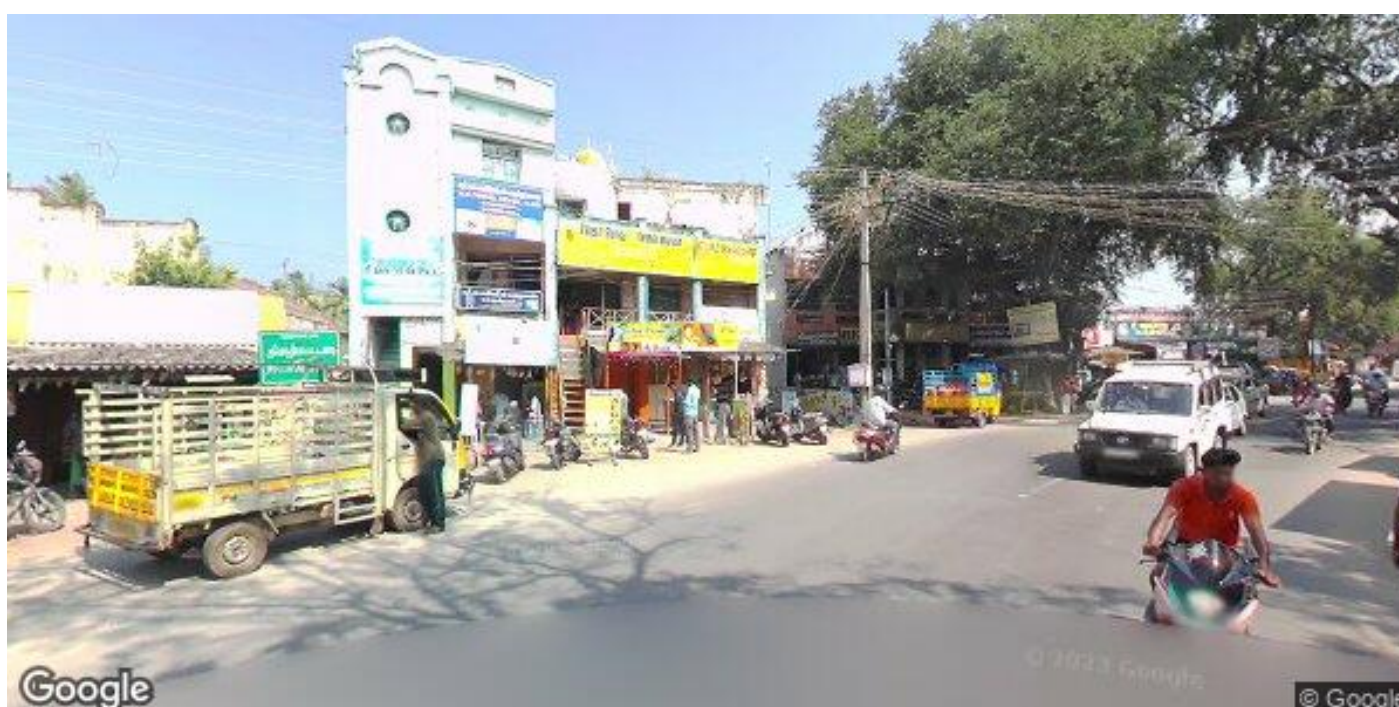
**Risk Type:** Turn  
**Risk Level:** High  
**Speed Limit:** 15 KM/Hr  
**Coordinates:** 11.67195, 78.23146

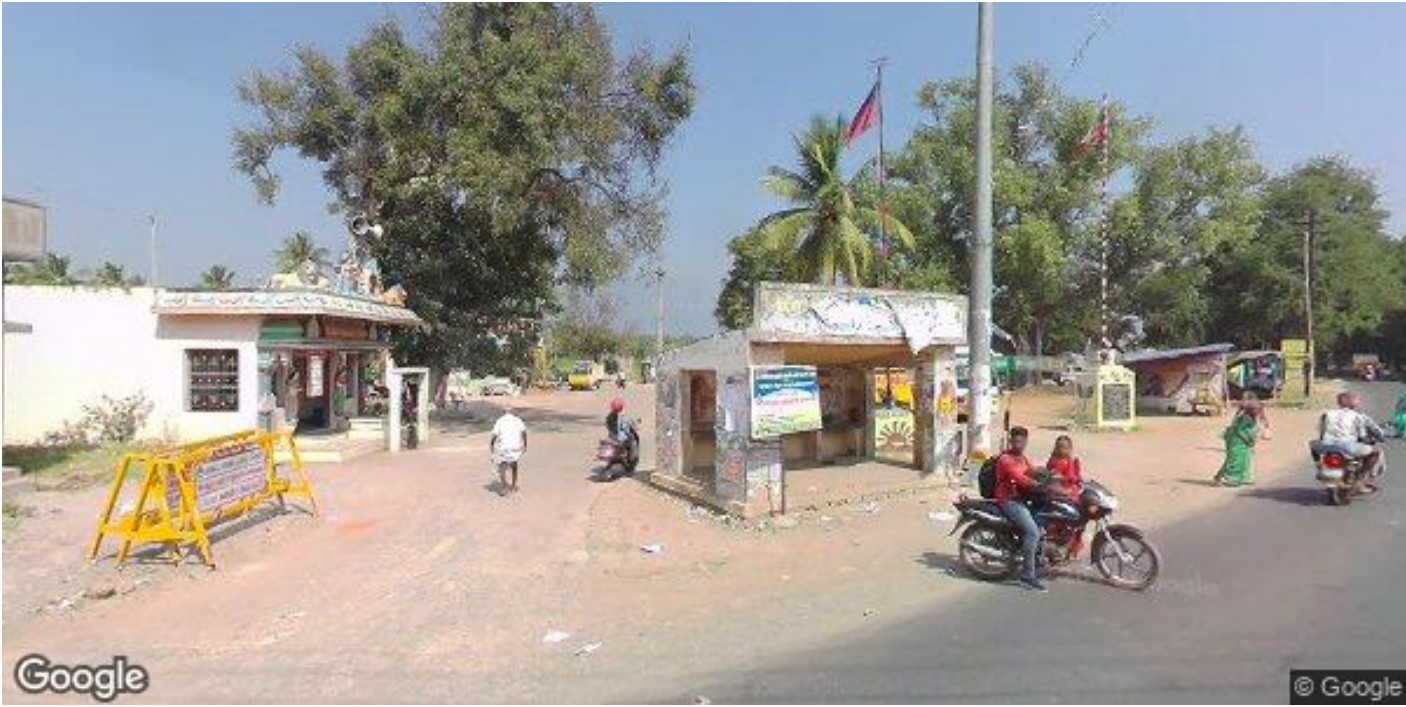
**Risk Type:** Turn  
**Risk Level:** Medium  
**Speed Limit:** 30 KM/Hr  
**Coordinates:** 11.67433, 78.23905

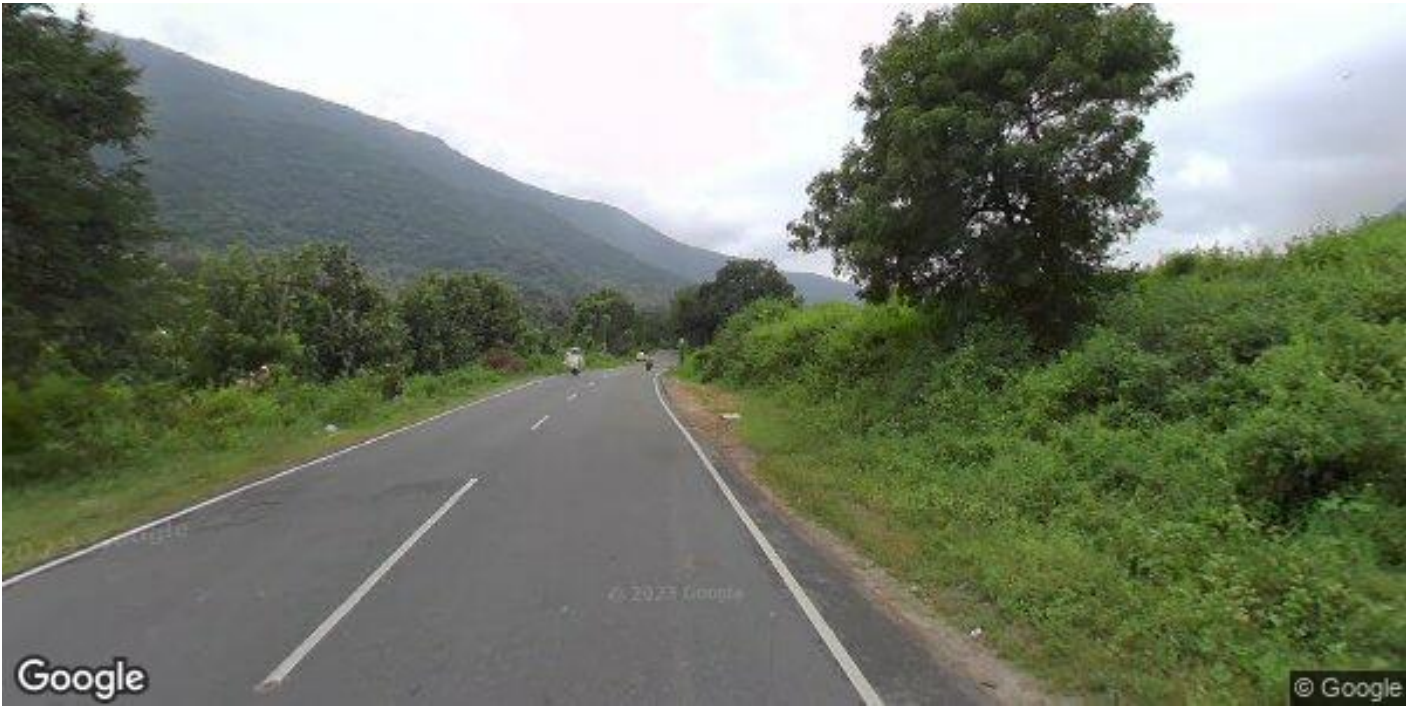
**Risk Type:** Turn  
**Risk Level:** Medium  
**Speed Limit:** 30 KM/Hr  
**Coordinates:** 11.80416, 78.33319

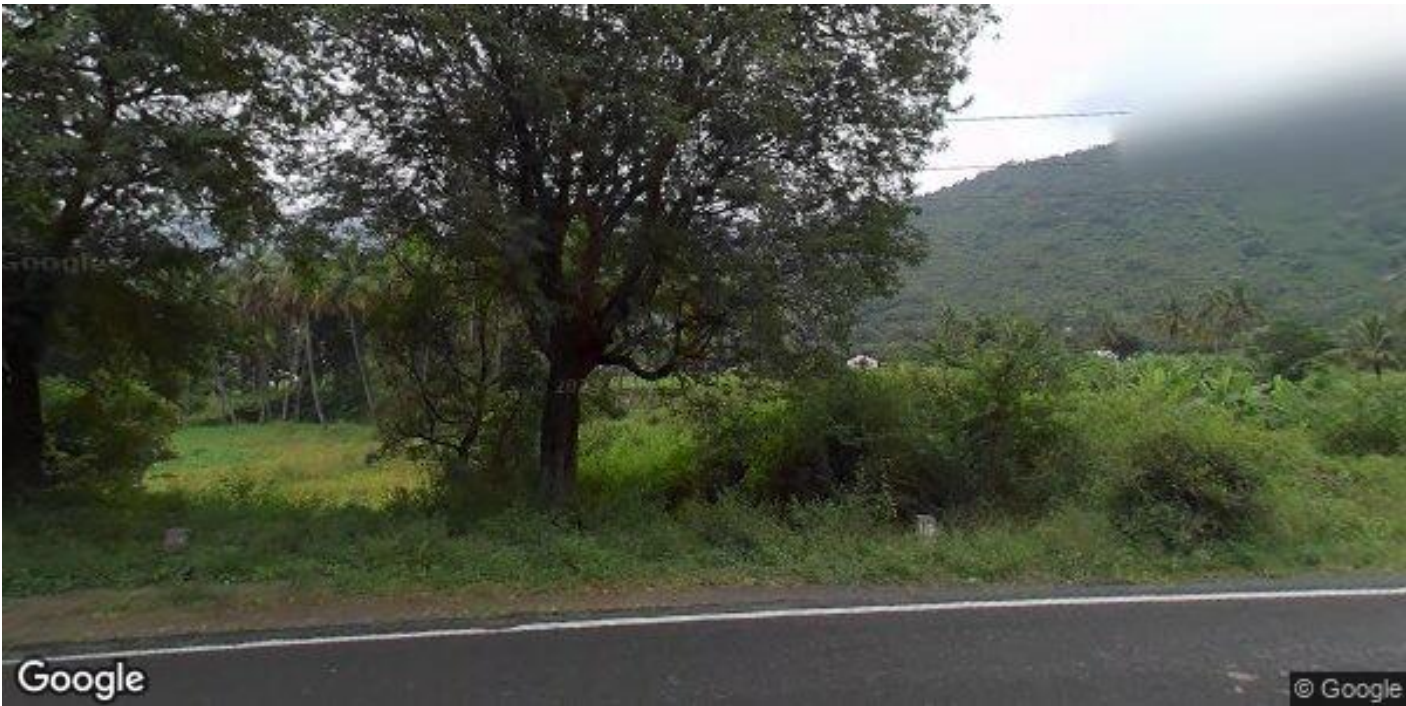
**Risk Type:** Turn  
**Risk Level:** Medium  
**Speed Limit:** 30 KM/Hr  
**Coordinates:** 11.81219, 78.34077

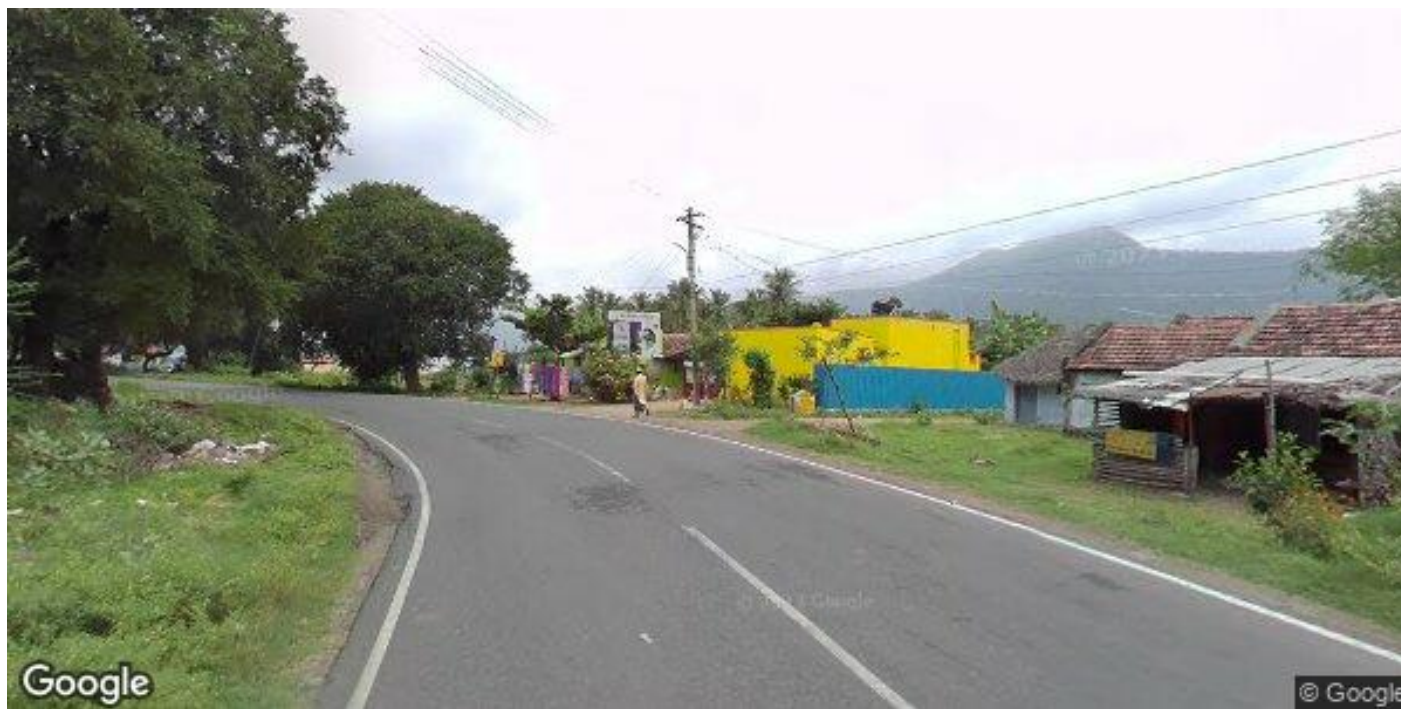
**Risk Type:** Turn  
**Risk Level:** Medium  
**Speed Limit:** 30 KM/Hr  
**Coordinates:** 11.83472, 78.35285
