## JOURNEY RISK MANAGEMENT (JRM) STUDY

### Salem Terminal to SARAL PETROLEUM

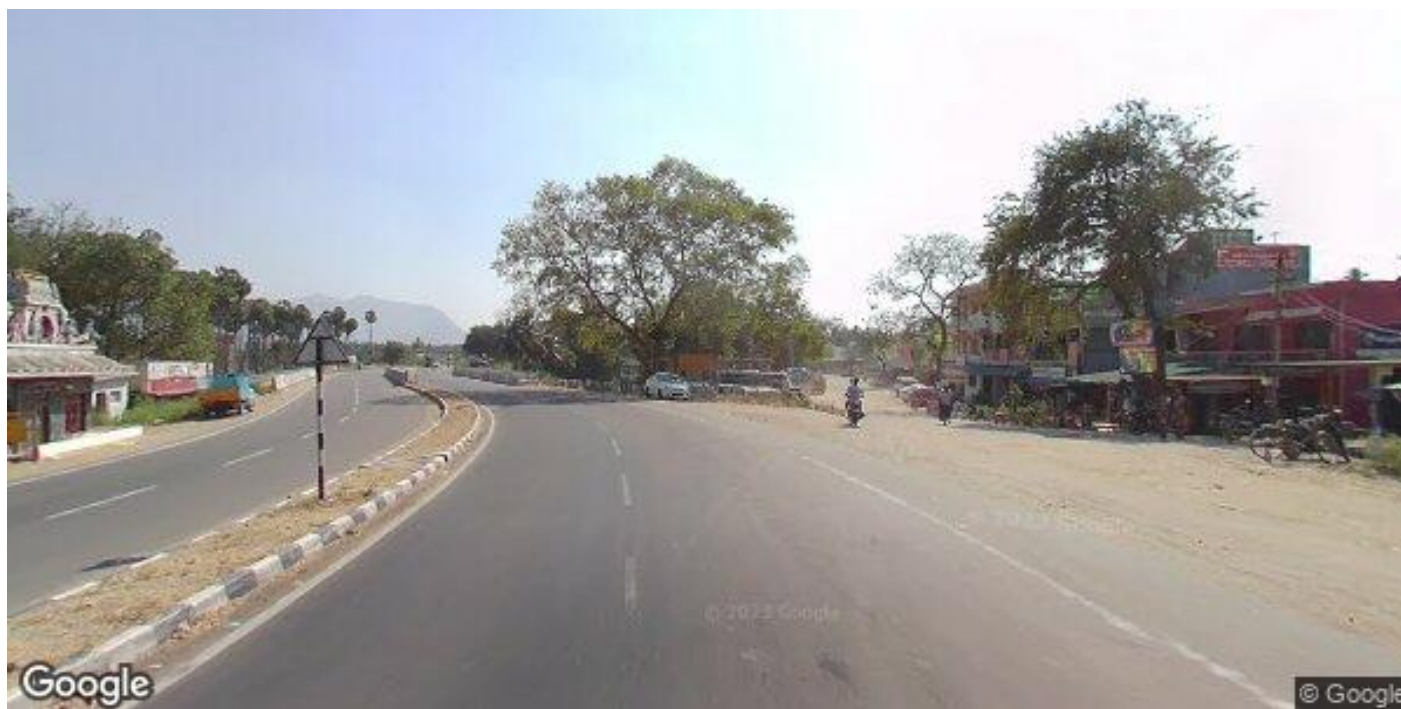
**Risk Type:** Turn  
**Risk Level:** Medium  
**Speed Limit:** 30 KM/Hr  
**Coordinates:** 11.99572, 78.44559

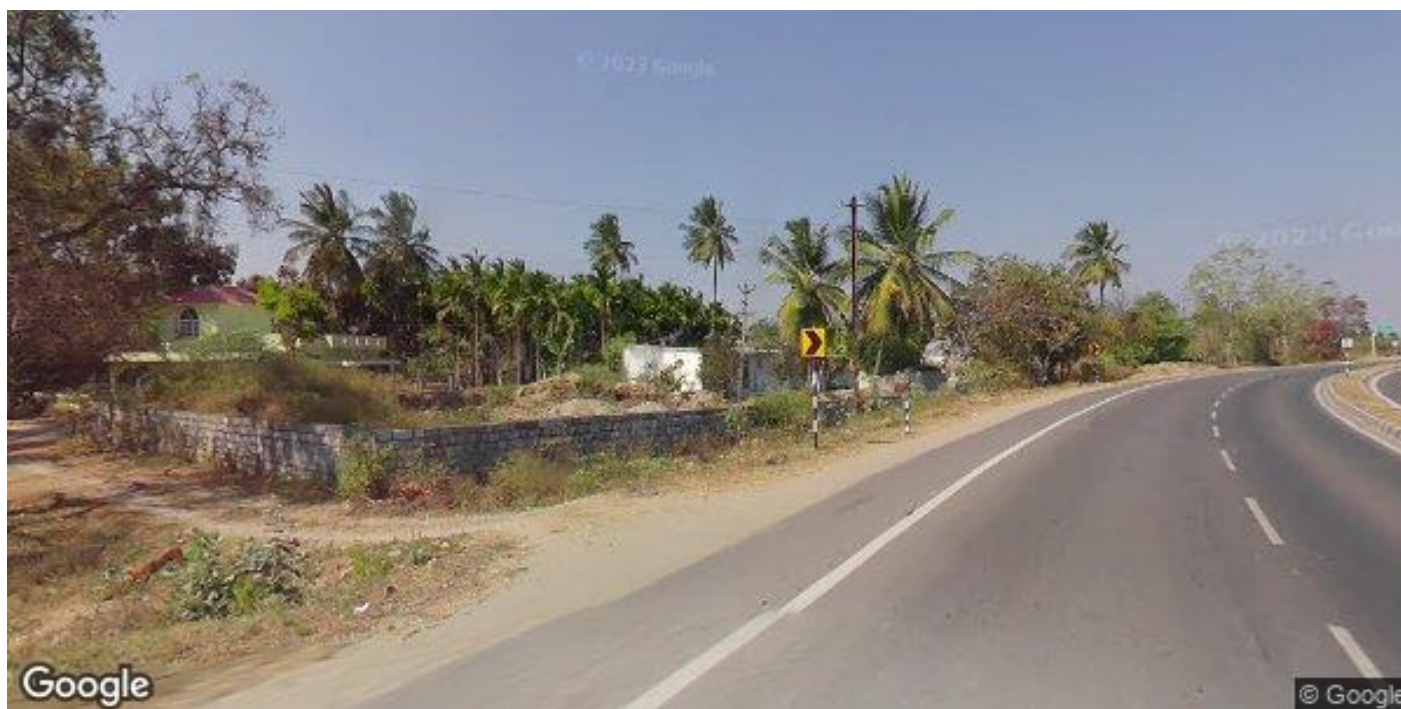
**Risk Type:** Turn  
**Risk Level:** Medium  
**Speed Limit:** 30 KM/Hr  
**Coordinates:** 12.01548, 78.45650

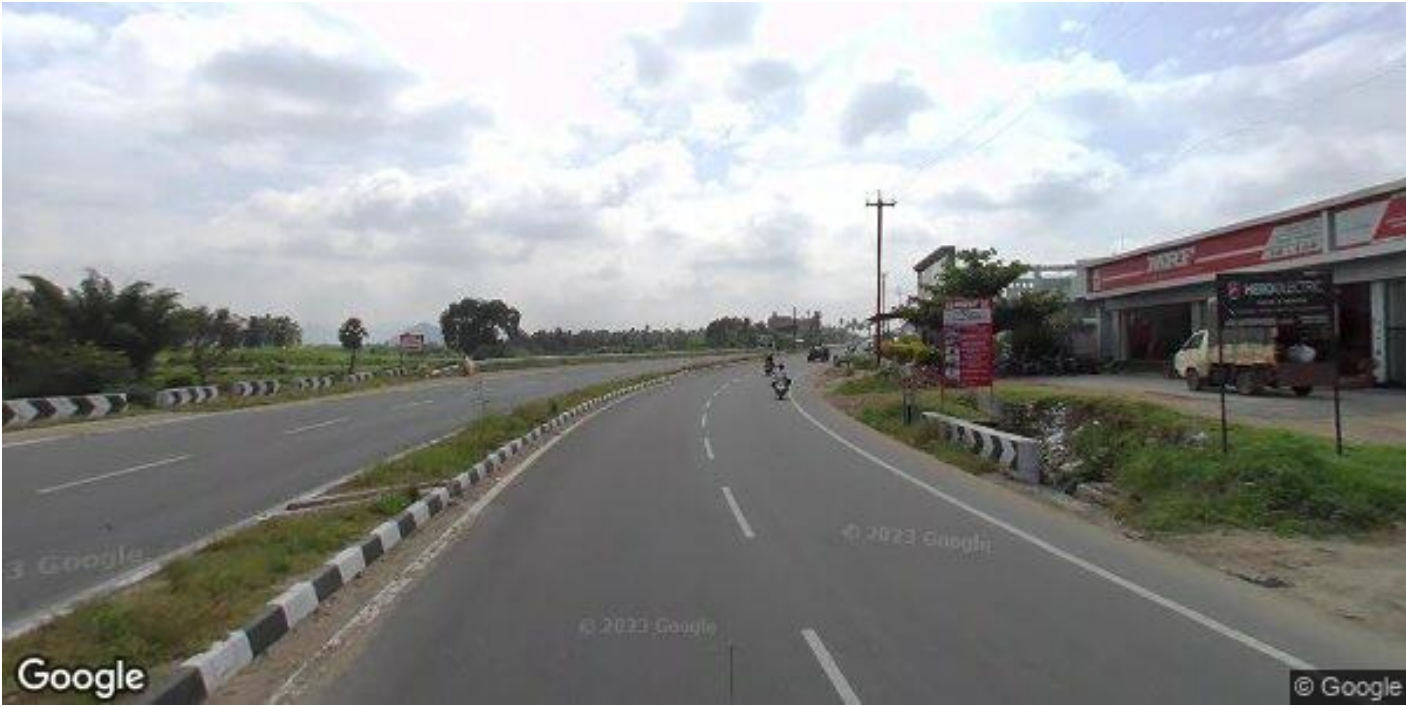
**Risk Type:** Turn  
**Risk Level:** Medium  
**Speed Limit:** 30 KM/Hr  
**Coordinates:** 12.04309, 78.48361

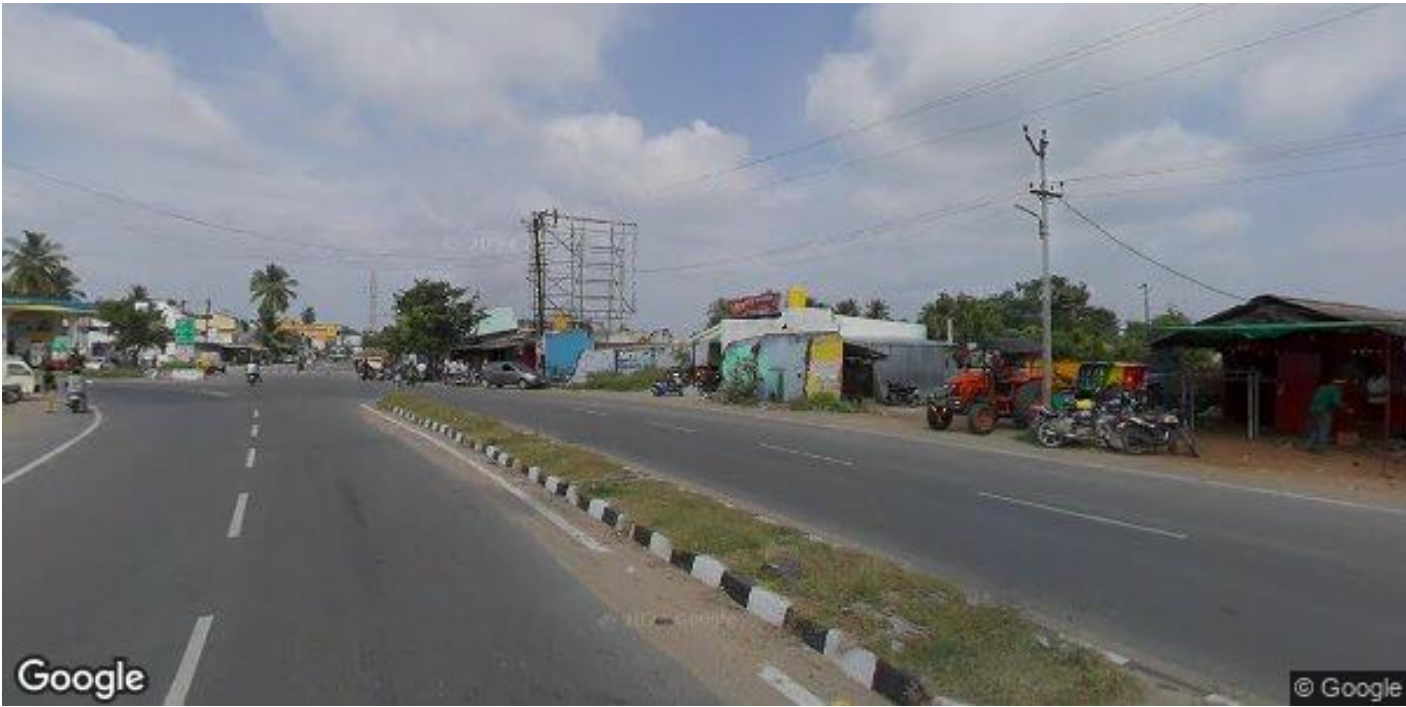
**Risk Type:** Turn  
**Risk Level:** Medium  
**Speed Limit:** 30 KM/Hr  
**Coordinates:** 12.04429, 78.48380

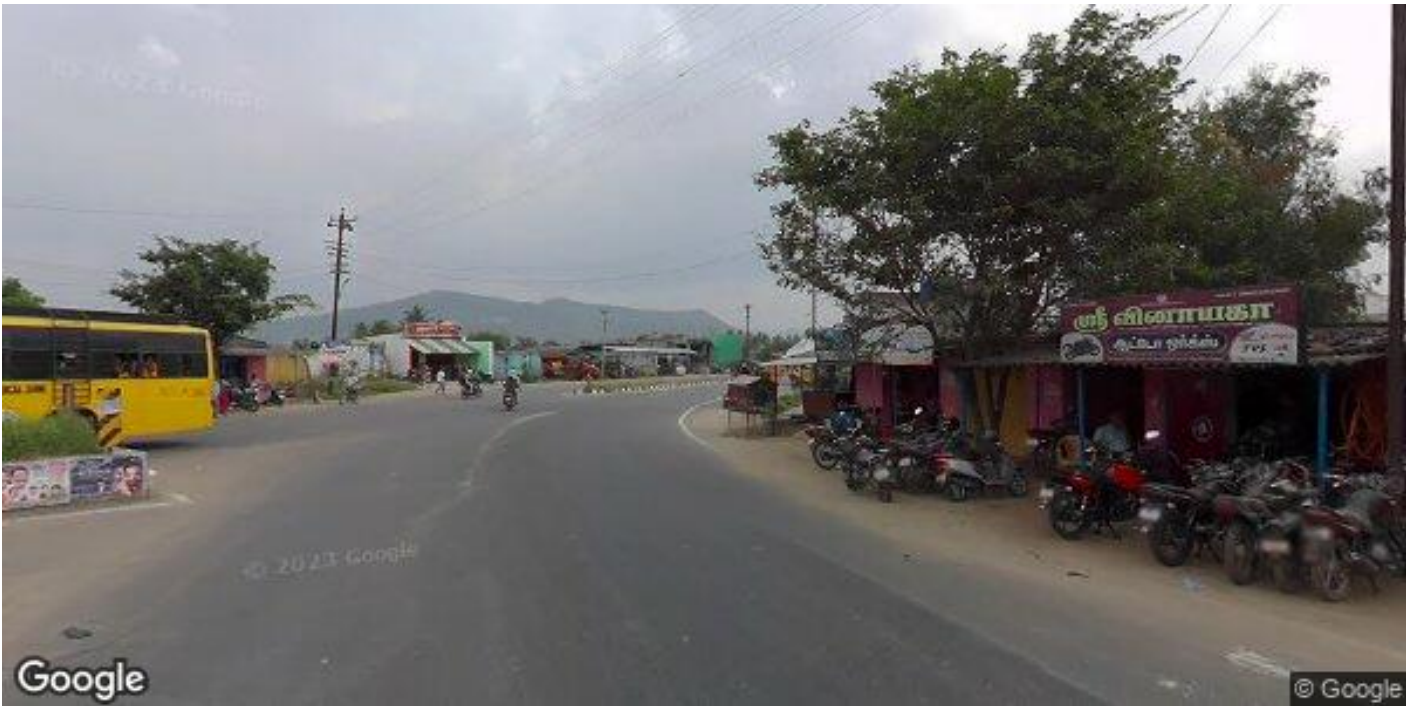
**Risk Type:** Turn  
**Risk Level:** Medium  
**Speed Limit:** 30 KM/Hr  
**Coordinates:** 12.04490, 78.48355

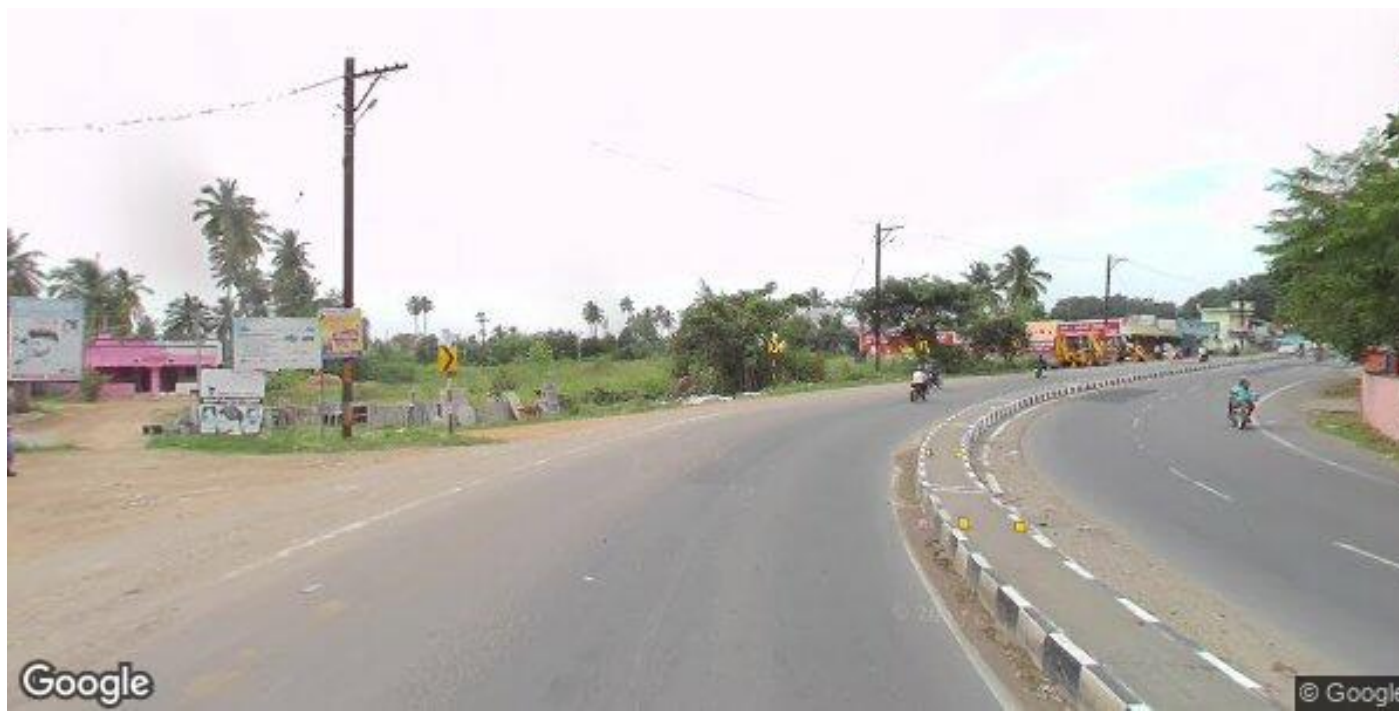
**Risk Type:** Turn  
**Risk Level:** High  
**Speed Limit:** 15 KM/Hr  
**Coordinates:** 12.04984, 78.47480

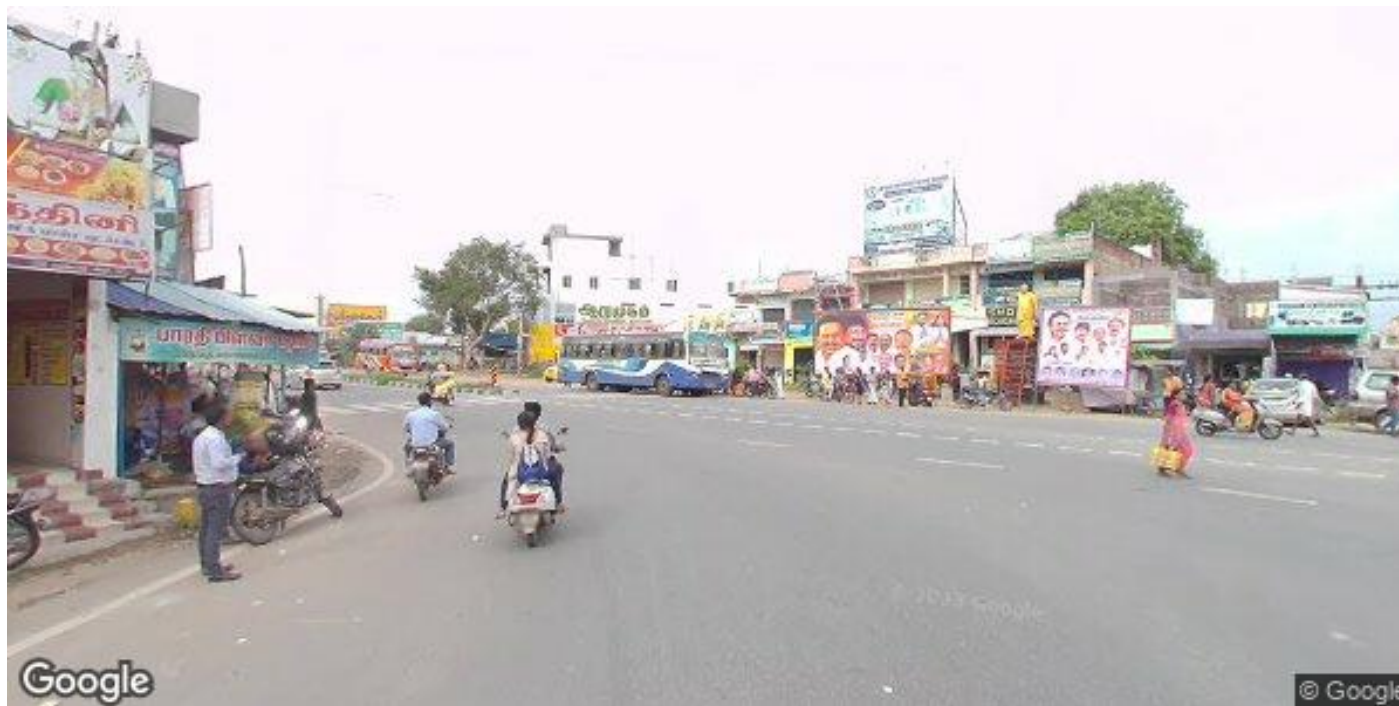
**Risk Type:** Turn  
**Risk Level:** Medium  
**Speed Limit:** 30 KM/Hr  
**Coordinates:** 12.06014, 78.47787

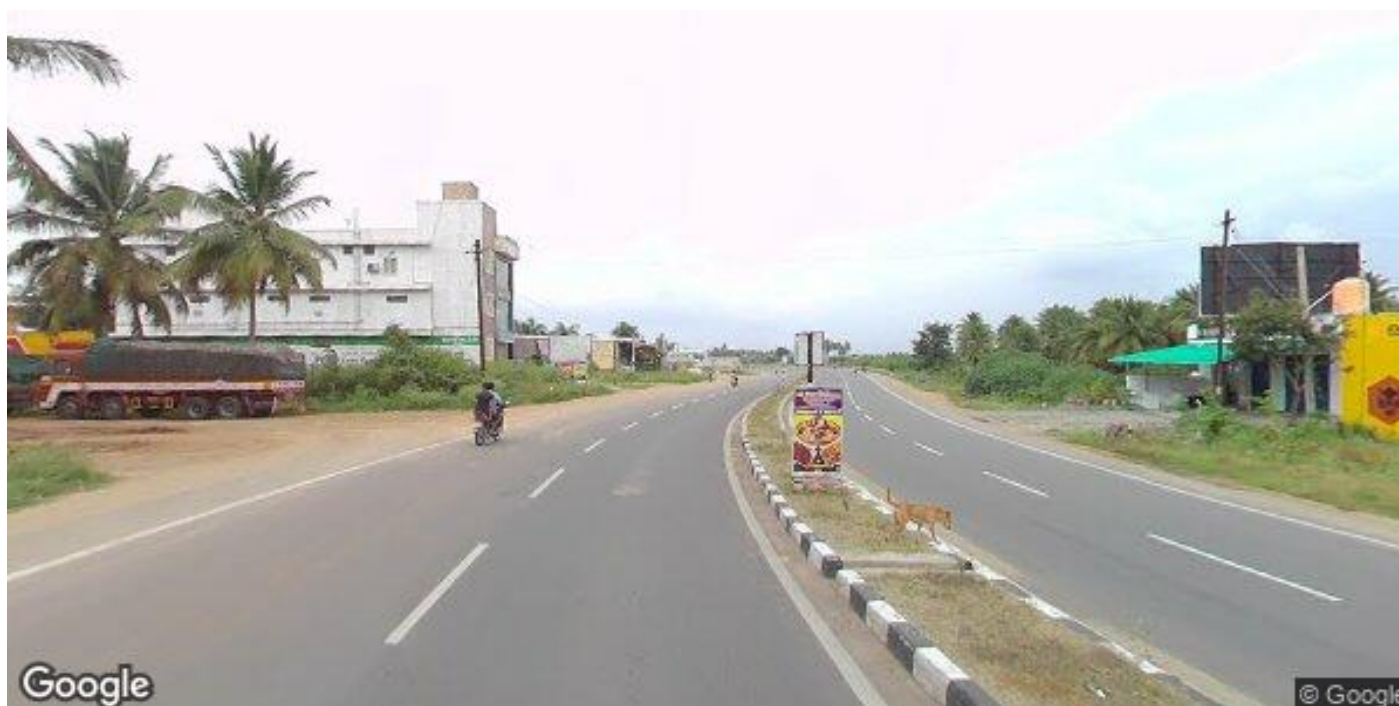
**Risk Type:** Turn  
**Risk Level:** Medium  
**Speed Limit:** 30 KM/Hr  
**Coordinates:** 12.06962, 78.47655

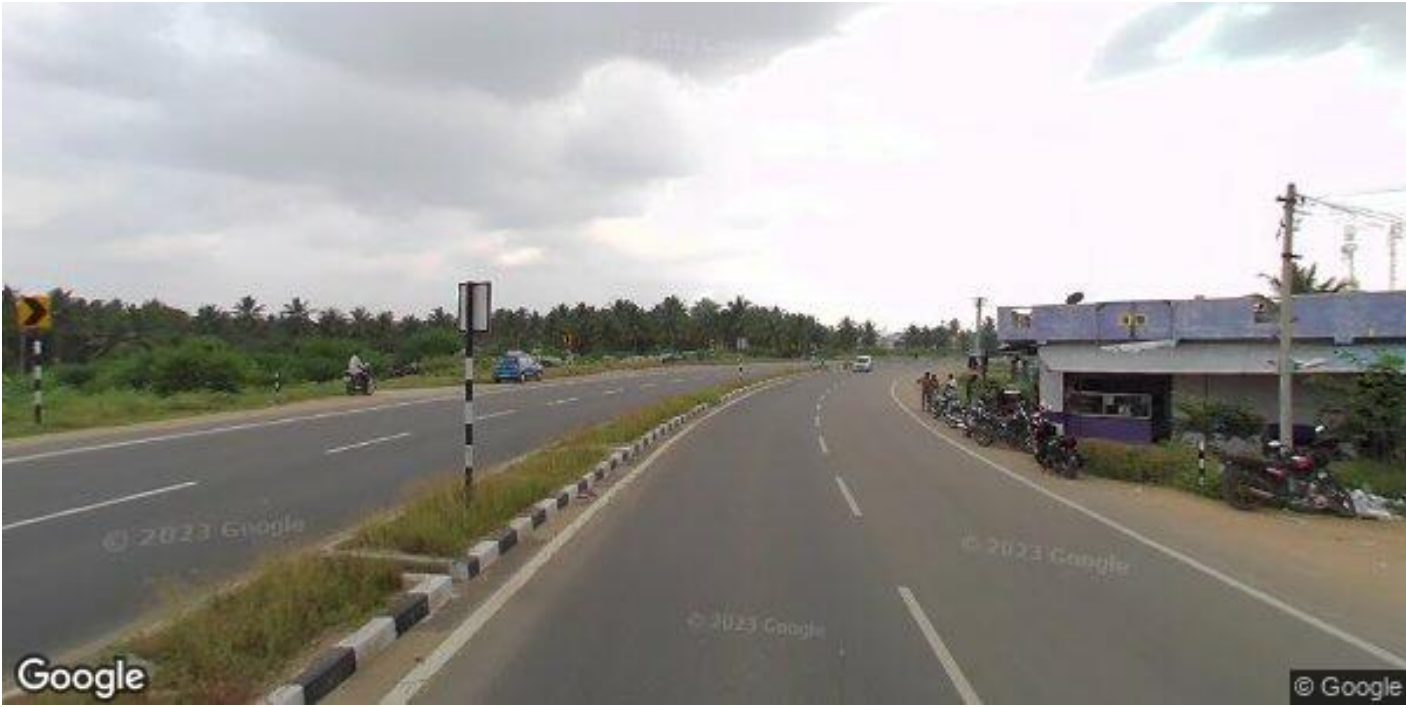
**Risk Type:** Turn  
**Risk Level:** Medium  
**Speed Limit:** 30 KM/Hr  
**Coordinates:** 12.07207, 78.47727

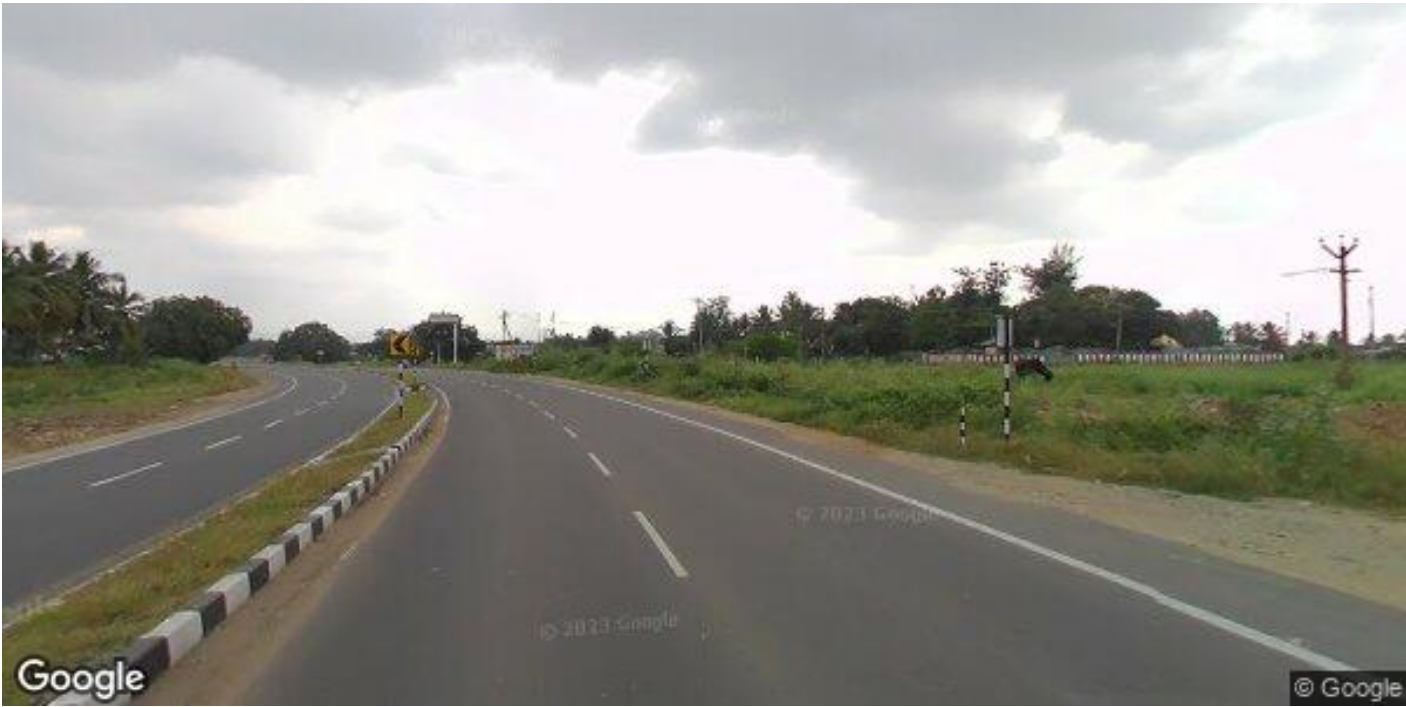
**Risk Type:** Turn  
**Risk Level:** Medium  
**Speed Limit:** 30 KM/Hr  
**Coordinates:** 12.07536, 78.47607

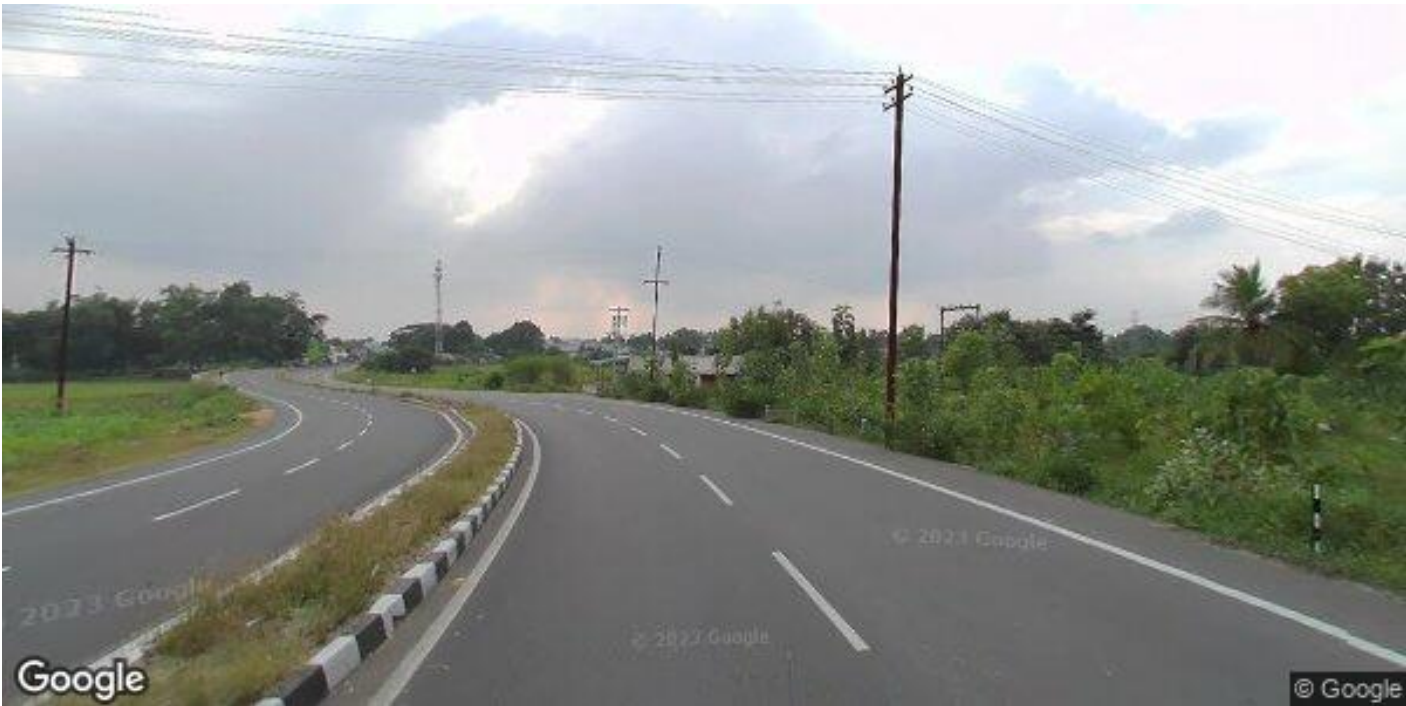
**Risk Type:** Turn  
**Risk Level:** Medium  
**Speed Limit:** 30 KM/Hr  
**Coordinates:** 12.11562, 78.49617

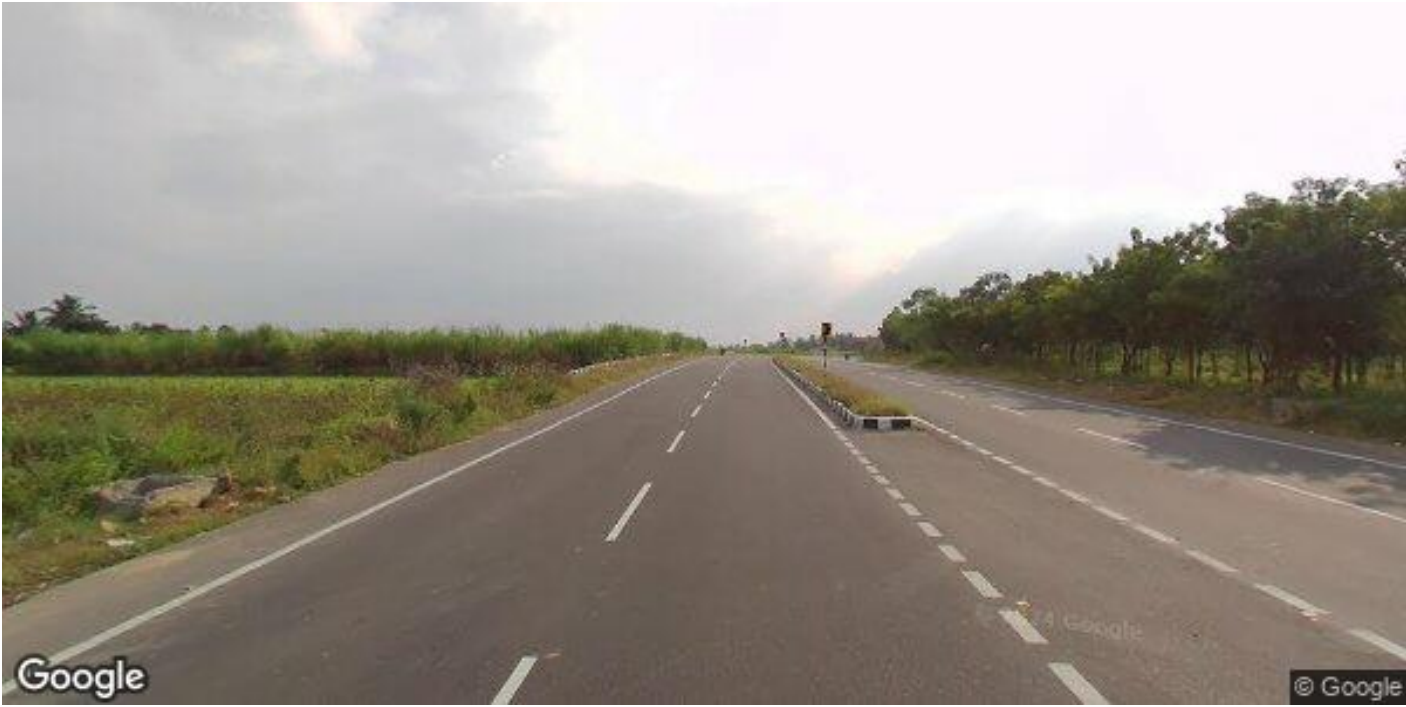
**Risk Type:** Blind Spot  
**Risk Level:** Blind Spot  
**Speed Limit:** 10 KM/Hr  
**Coordinates:** 12.11778, 78.49830

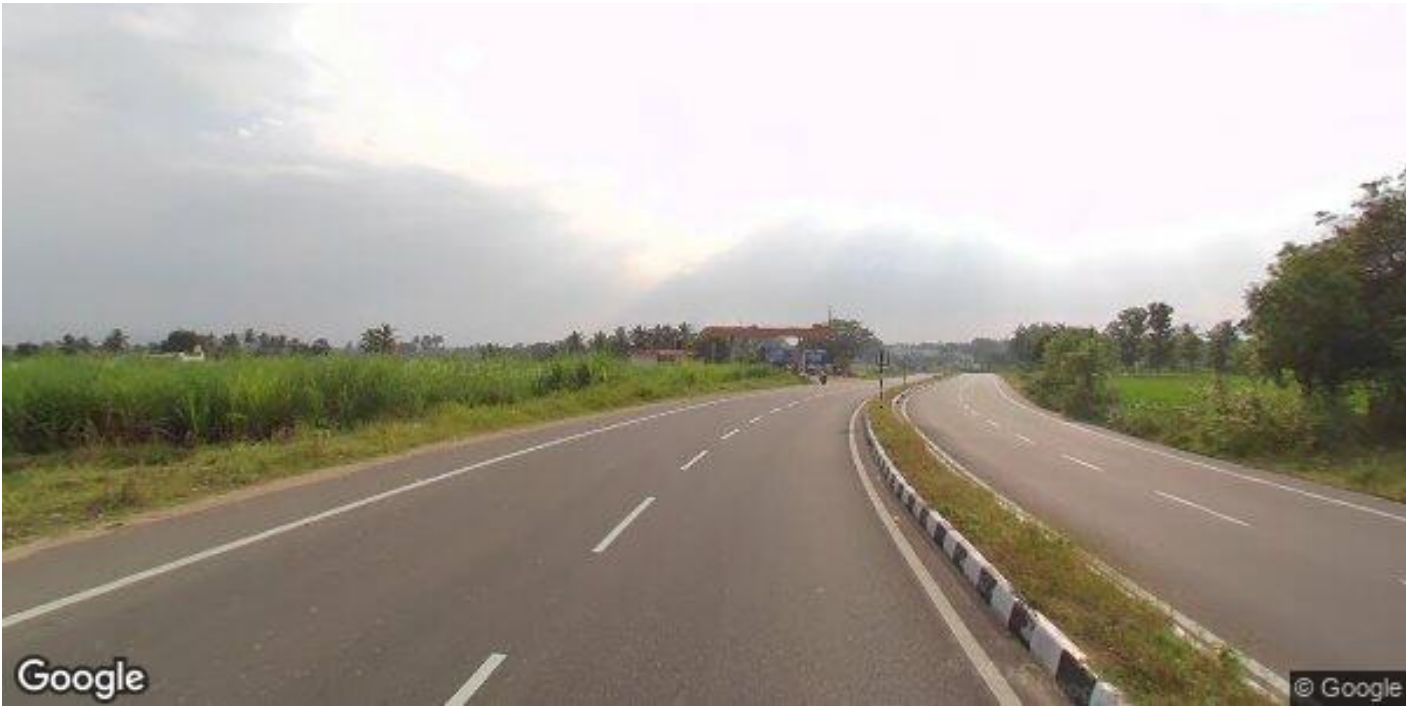
**Risk Type:** Turn  
**Risk Level:** Medium  
**Speed Limit:** 30 KM/Hr  
**Coordinates:** 12.11665, 78.49779
