# IndianOil

## JOURNEY RISK MANAGEMENT (JRM) STUDY

### Salem Terminal to TSP & CO

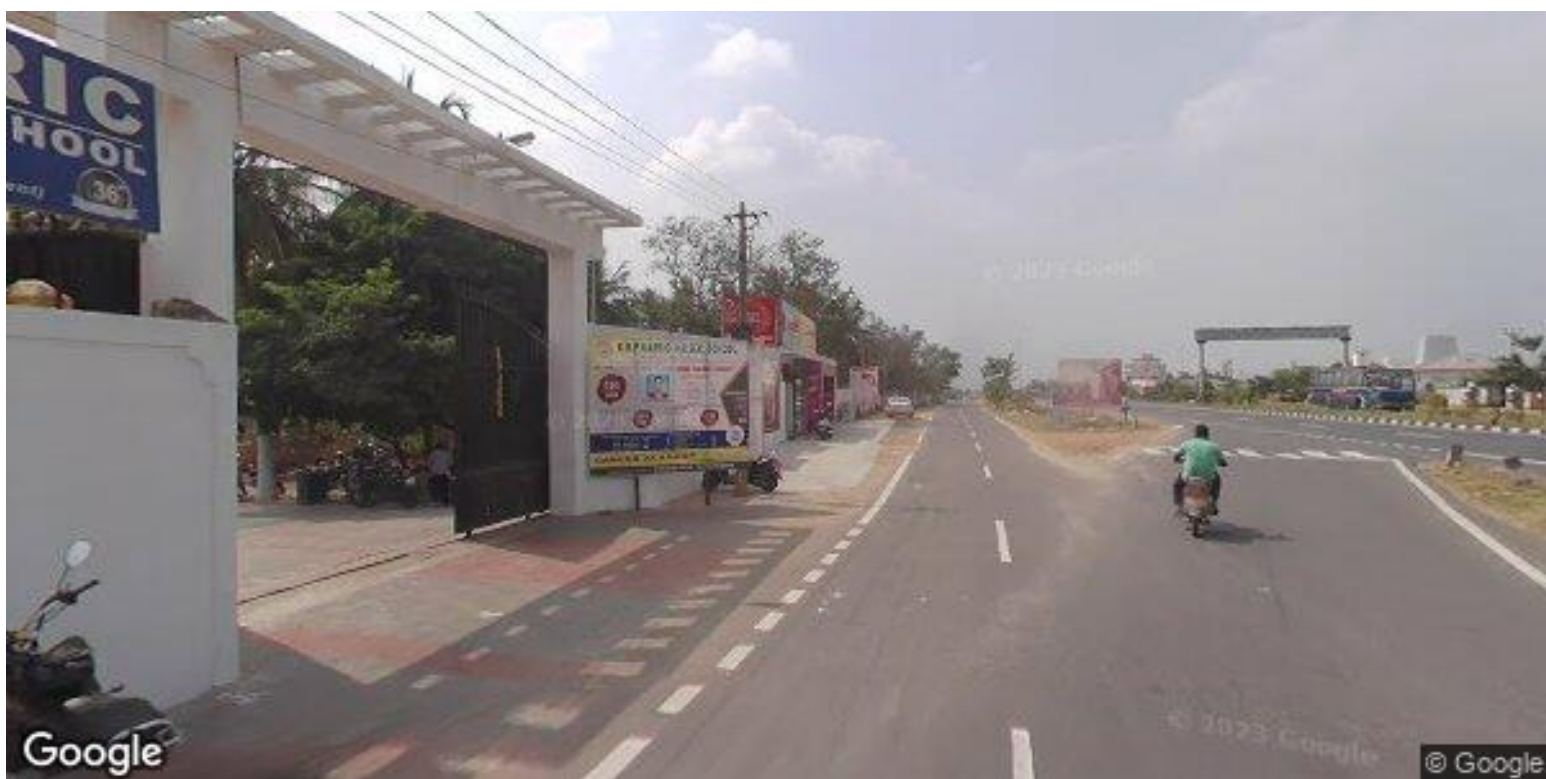
| | Risk Type | Risk Level | Coordinates | Speed Limit |
|---|---|---|---|---|
| 10 | Turn | Medium | 11.45509, 77.81383 | 30 KM/Hr |

**Risk Type:** Turn

**Risk Level:** Medium

**Speed Limit:** 30 KM/Hr

**Coordinates:** 11.45509, 77.81383

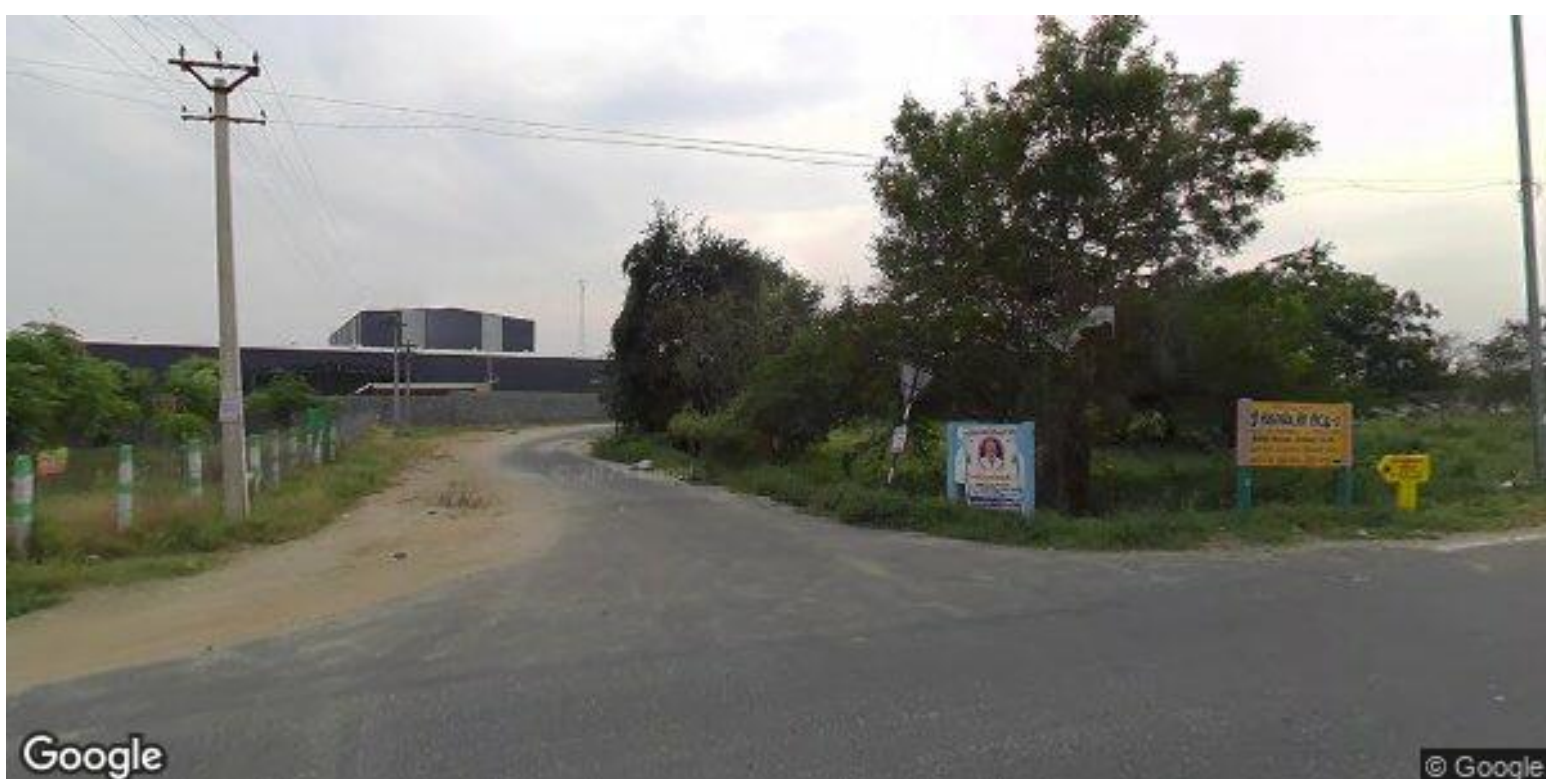
| | Risk Type | Risk Level | Coordinates | Speed Limit |
|---|---|---|---|---|
| 11 | Turn | High | 11.20025, 77.40116 | 15 KM/Hr |

**Risk Type:** Turn  
**Risk Level:** High  
**Speed Limit:** 15 KM/Hr  
**Coordinates:** 11.20025, 77.40116

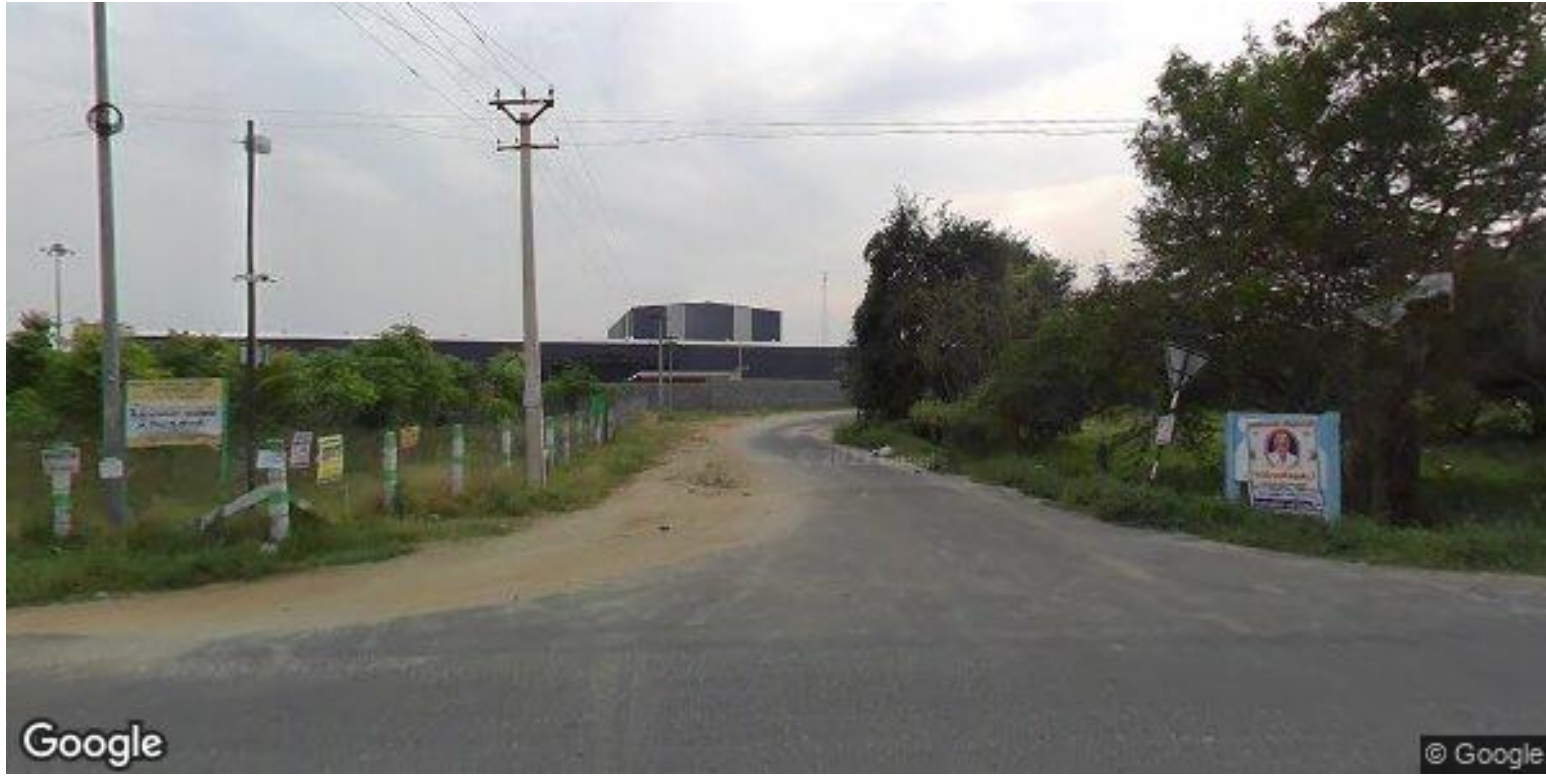
| | Risk Type | Risk Level | Coordinates | Speed Limit |
|---|---|---|---|---|
| 12 | Turn | Medium | 11.19997, 77.40107 | 30 KM/Hr |

**Risk Type:** Turn  
**Risk Level:** Medium  
**Speed Limit:** 30 KM/Hr  
**Coordinates:** 11.19997, 77.40107

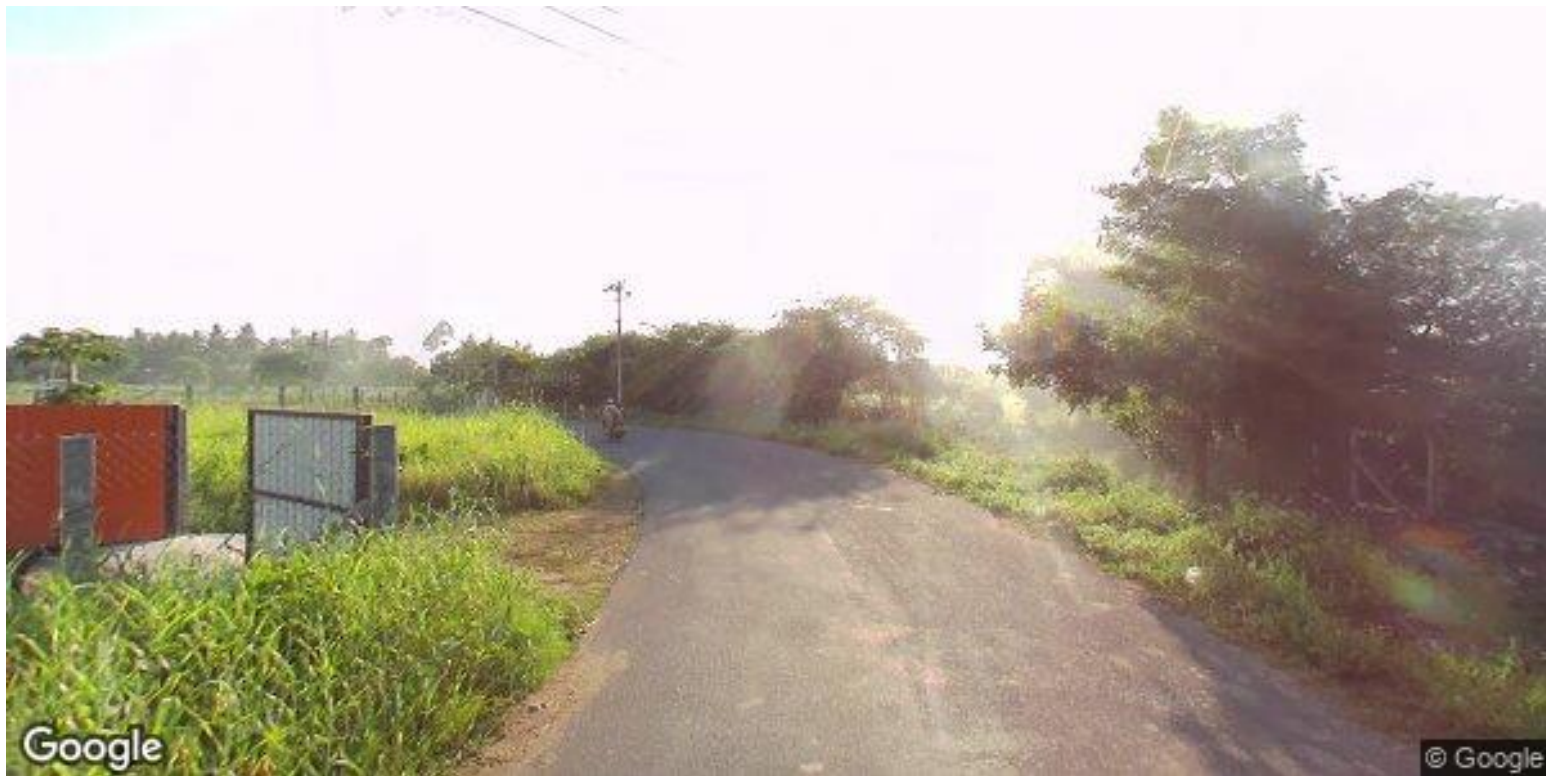
| | Risk Type | Risk Level | Coordinates | Speed Limit |
|---|---|---|---|---|
| 13 | Turn | Medium | 11.19631, 77.39488 | 30 KM/Hr |

**Risk Type:** Turn  
**Risk Level:** Medium  
**Speed Limit:** 30 KM/Hr  
**Coordinates:** 11.19631, 77.39488

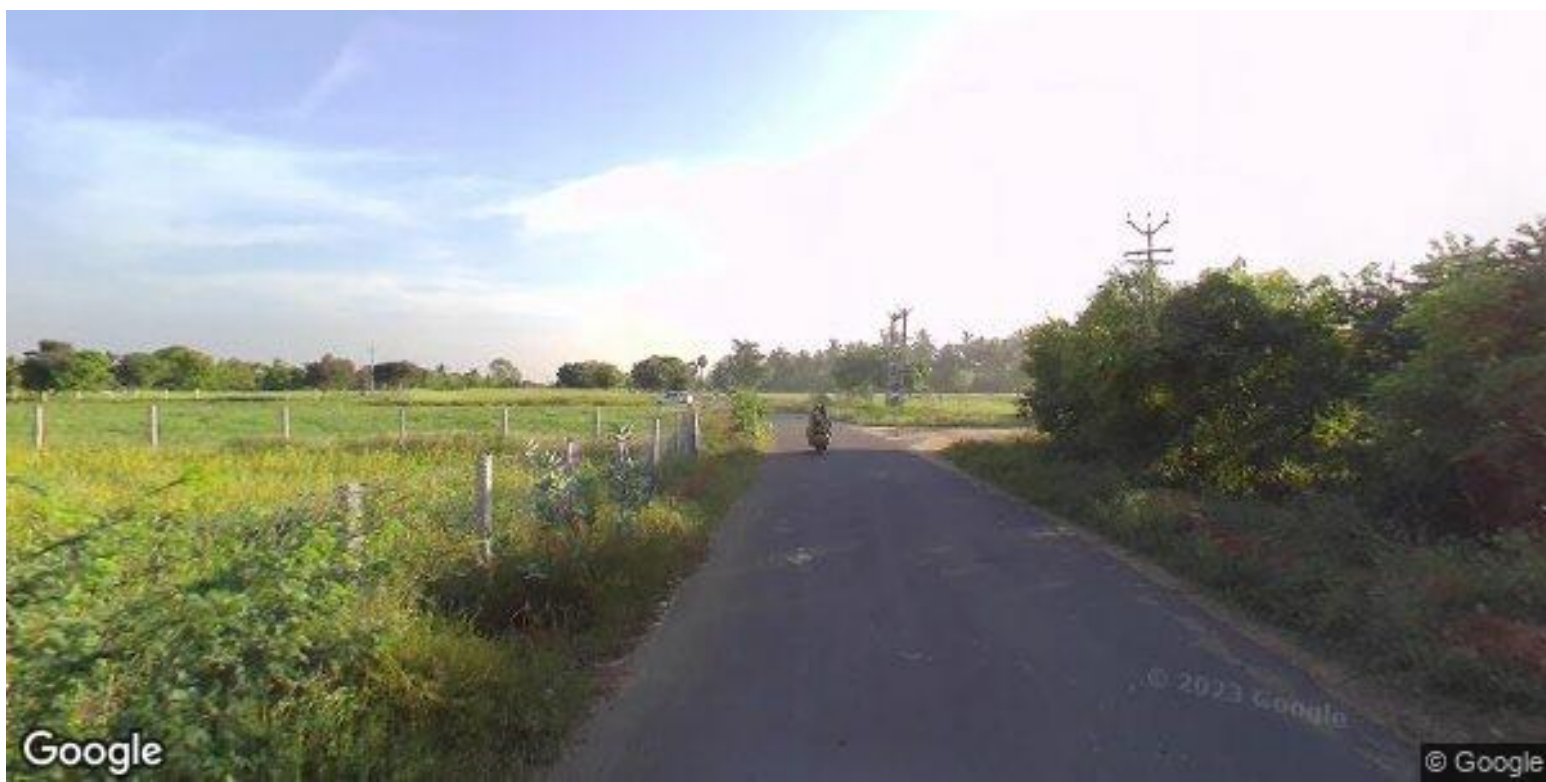
| | Risk Type | Risk Level | Coordinates | Speed Limit |
|---|---|---|---|---|
| 14 | Turn | Medium | 11.19598, 77.39467 | 30 KM/Hr |

**Risk Type:** Turn

**Risk Level:** Medium

**Speed Limit:** 30 KM/Hr

**Coordinates:** 11.19598, 77.39467

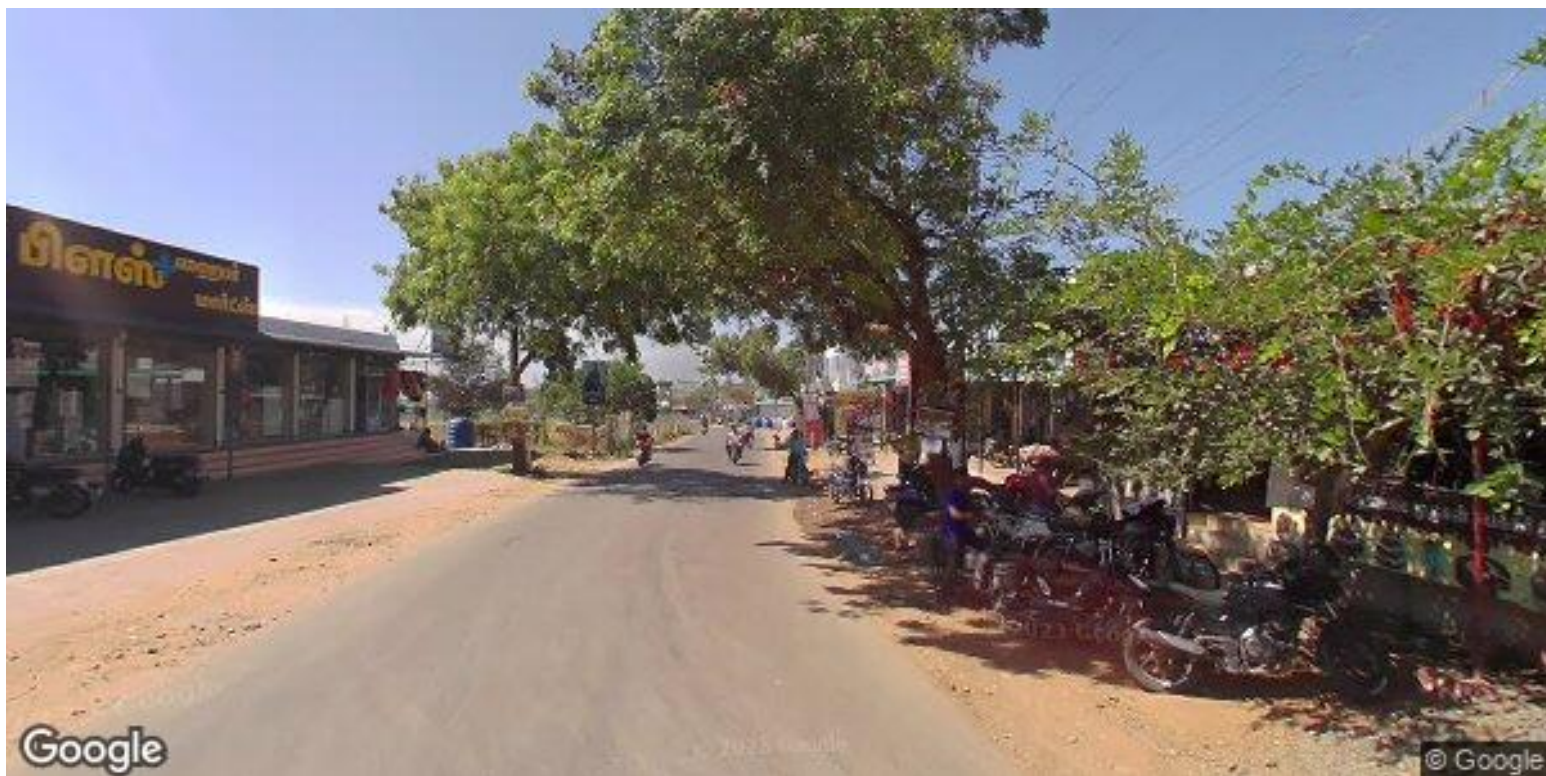
| | Risk Type | Risk Level | Coordinates | Speed Limit |
|---|---|---|---|---|
| 20 | Turn | High | 11.16402, 77.38920 | 15 KM/Hr |

**Risk Type:** Turn

**Risk Level:** High

**Speed Limit:** 15 KM/Hr

**Coordinates:** 11.16402, 77.38920

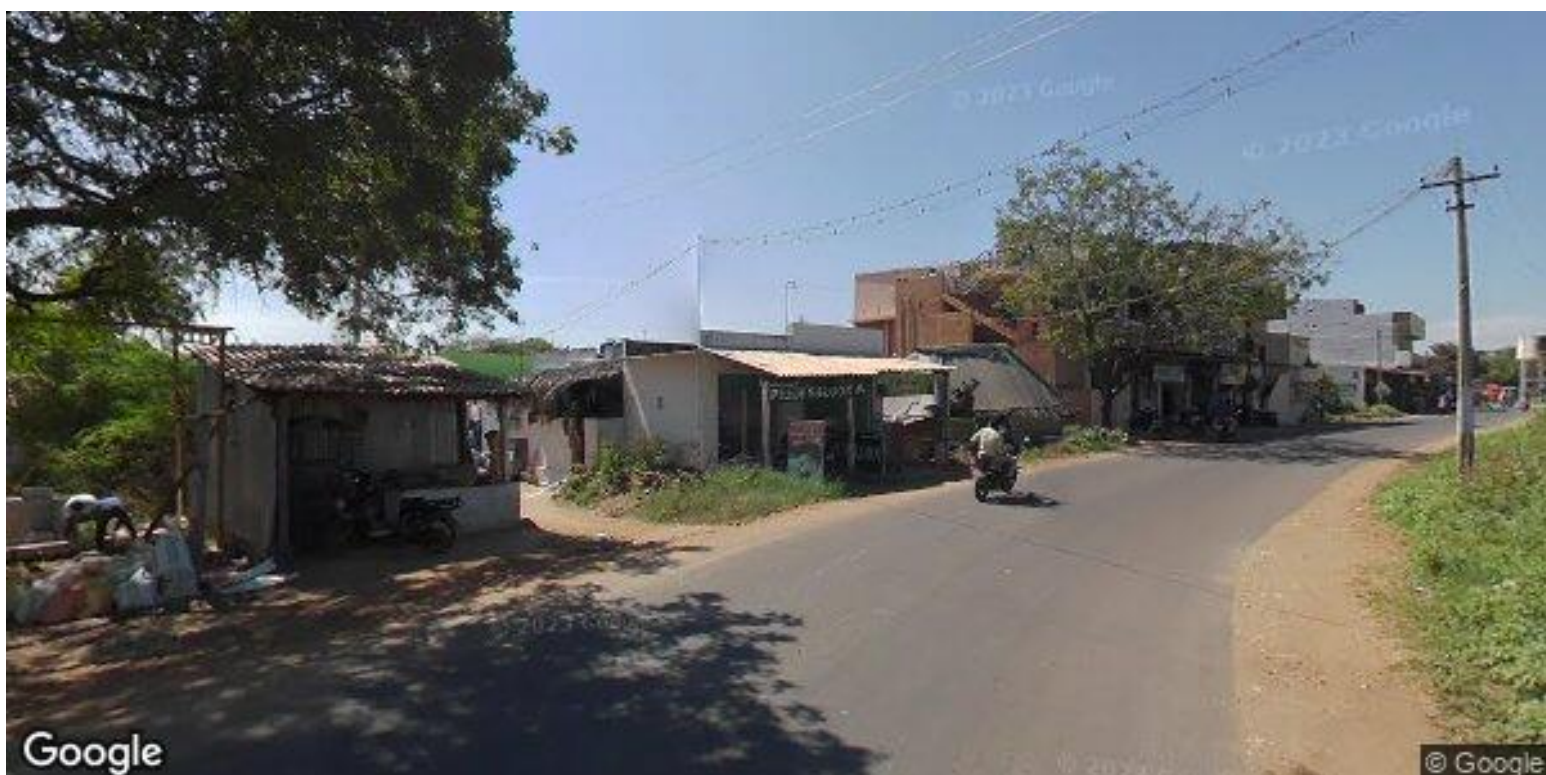
| | Risk Type | Risk Level | Coordinates | Speed Limit |
|---|---|---|---|---|
| 21 | Turn | Medium | 11.16111, 77.38425 | 30 KM/Hr |

### Risk Type: Turn

**Risk Level: Medium**

**Speed Limit: 30 KM/Hr**

**Coordinates:** 11.16111, 77.38425

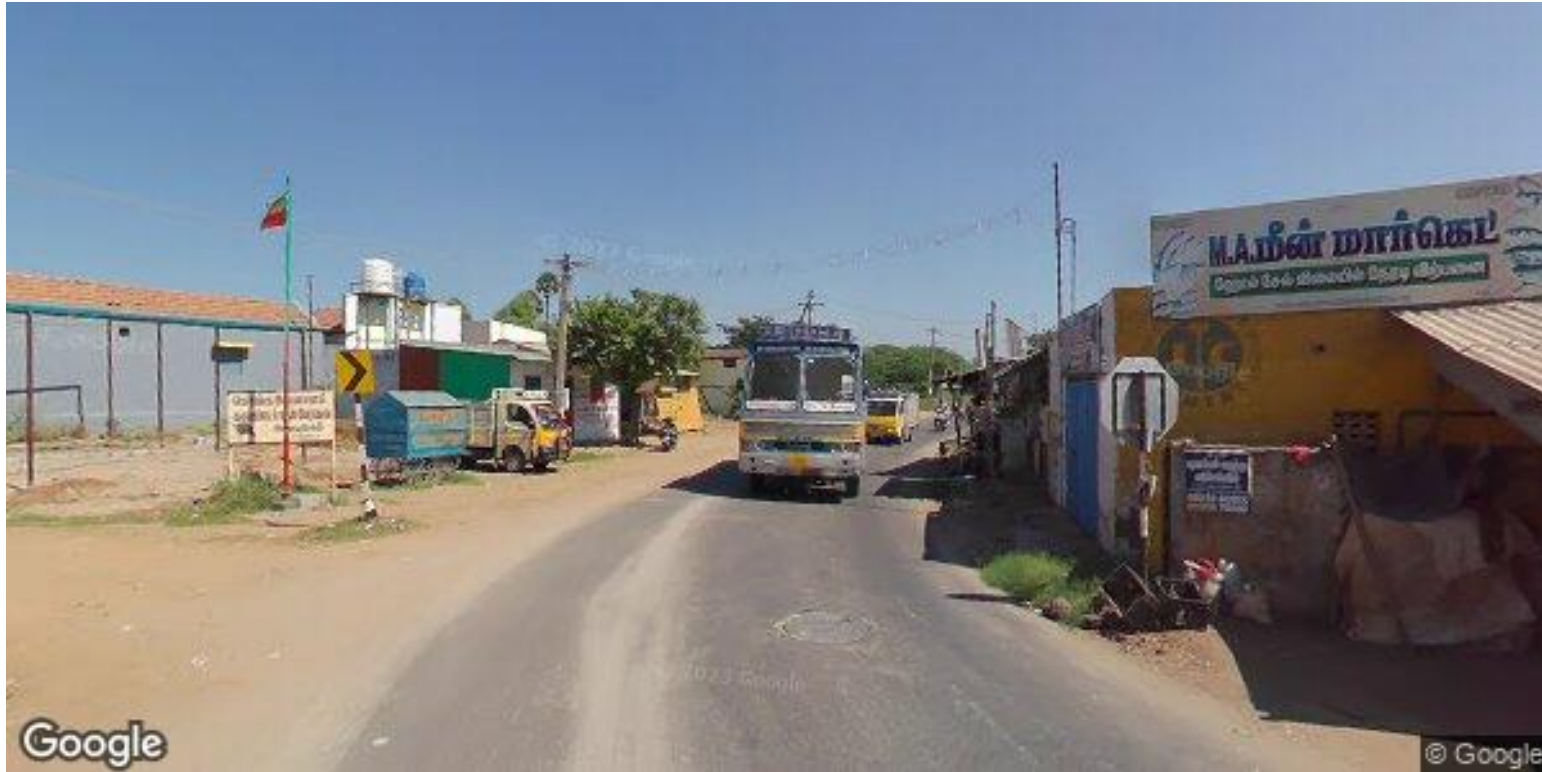
| | Risk Type | Risk Level | Coordinates | Speed Limit |
|---|---|---|---|---|
| 22 | Turn | Medium | 11.16092, 77.38279 | 30 KM/Hr |

### Risk Type: Turn

**Risk Level: Medium**

**Speed Limit: 30 KM/Hr**

Coordinates: 11.16092, 77.38279

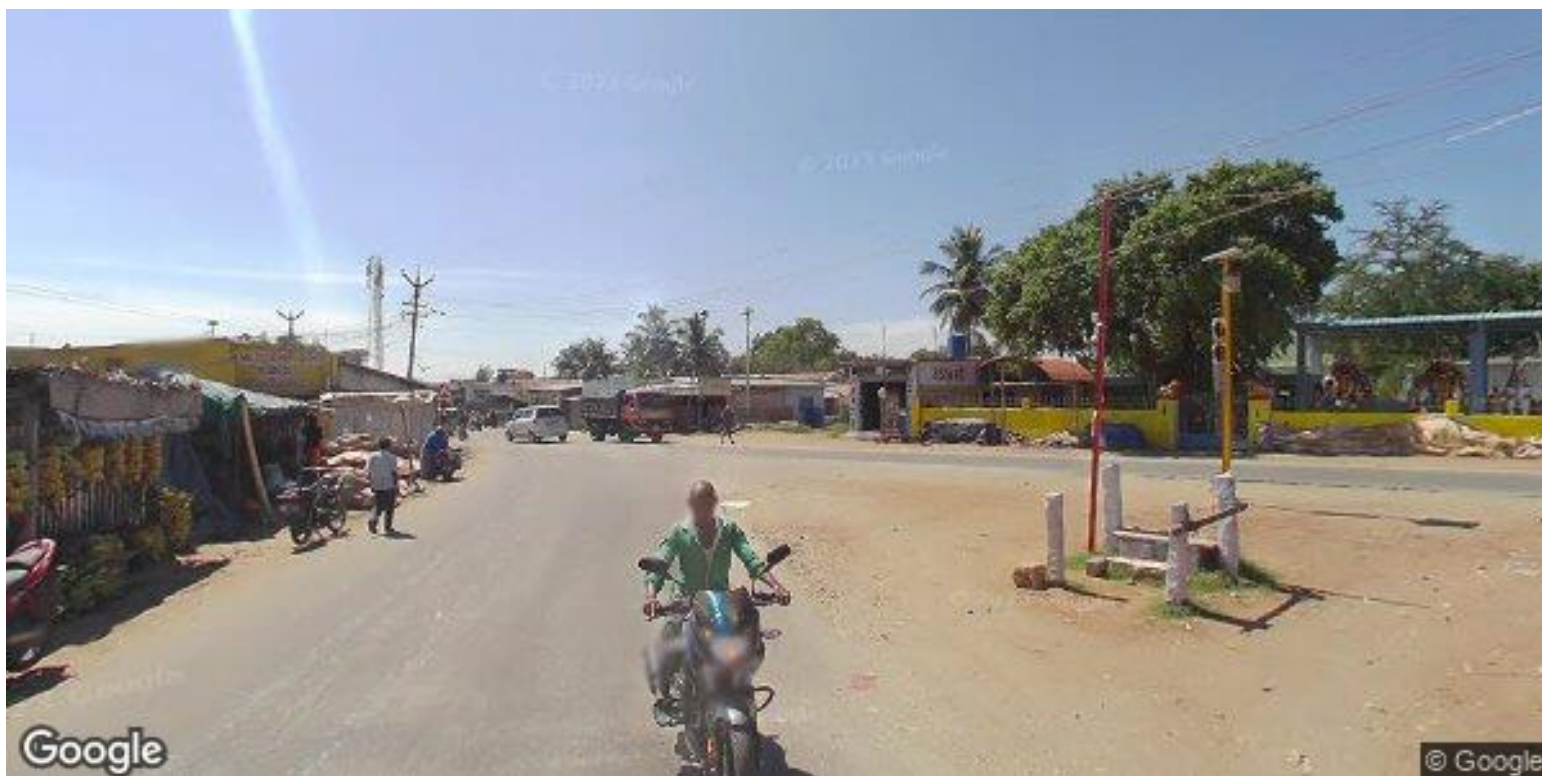
| | Risk Type | Risk Level | Coordinates | Speed Limit |
|---|---|---|---|---|
| 23 | Turn | Medium | 11.16081, 77.38267 | 30 KM/Hr |

### Risk Type: Turn

### Risk Level: Medium

**Speed Limit: 30 KM/Hr**

Coordinates: 11.16081, 77.38267

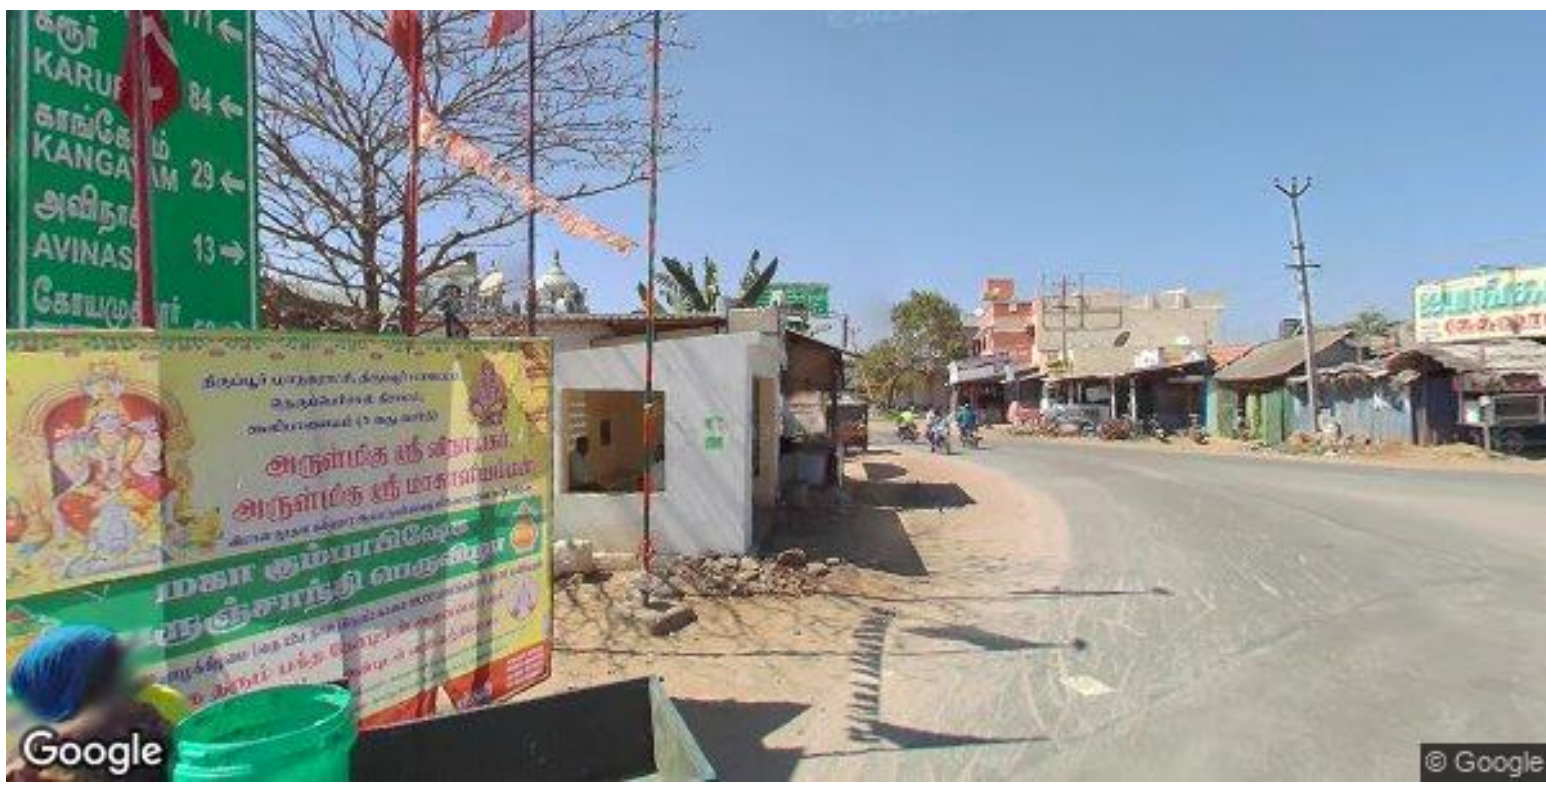
| | Risk Type | Risk Level | Coordinates | Speed Limit |
|---|---|---|---|---|
| 24 | Blind Spot | Blind Spot | 11.15926, 77.38262 | 10 KM/Hr |

**Risk Type:** Blind Spot

**Risk Level:** Blind Spot

**Speed Limit:** 10 KM/Hr

**Coordinates:** 11.15926, 77.38262
