# IndianOil

## JOURNEY RISK MANAGEMENT (JRM) STUDY

### Salem Terminal to D.V.S FUEL STATION

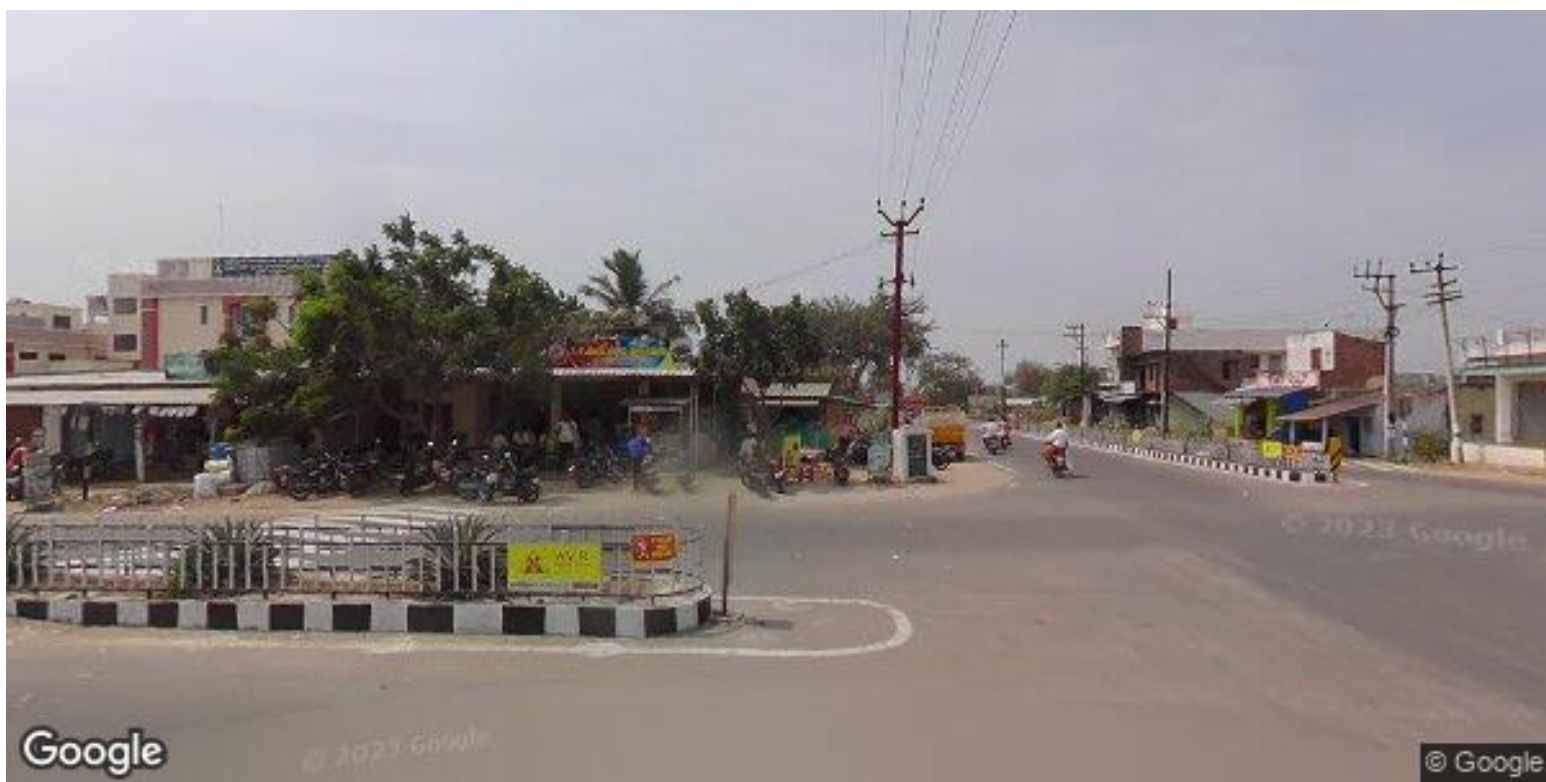
**Coordinates:** 11.58300, 77.85813

**Risk Type:** Roundabout

**Risk Level:** High

**Speed Limit:** 15 KM/Hr

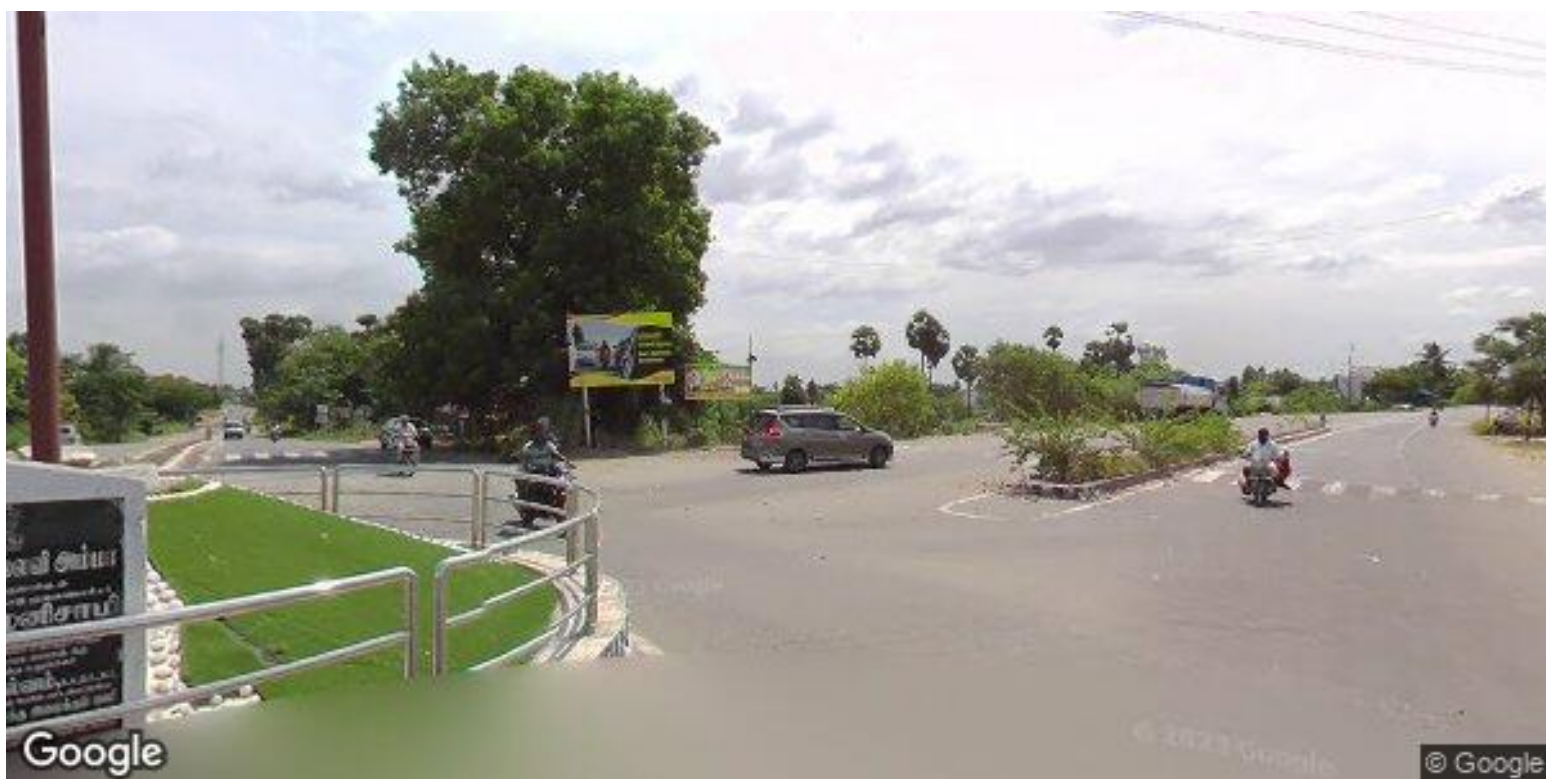
**Coordinates:** 11.60348, 77.83967

**Risk Type:** Roundabout

**Risk Level:** High

**Speed Limit:** 15 KM/Hr

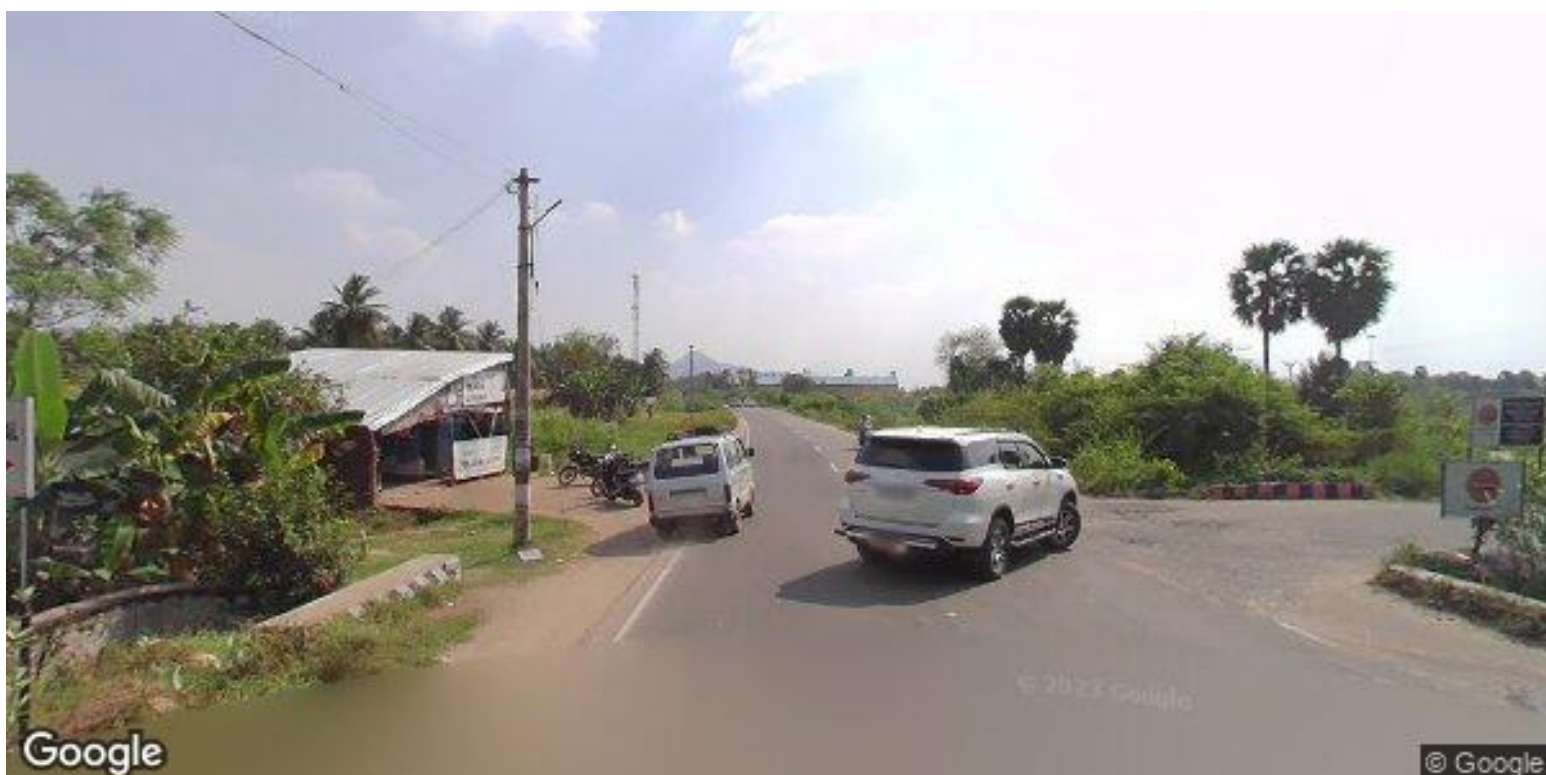
**Risk Type:** Turn  
**Risk Level:** High  
**Speed Limit:** 15 KM/Hr  
**Coordinates:** 11.44029, 77.87544

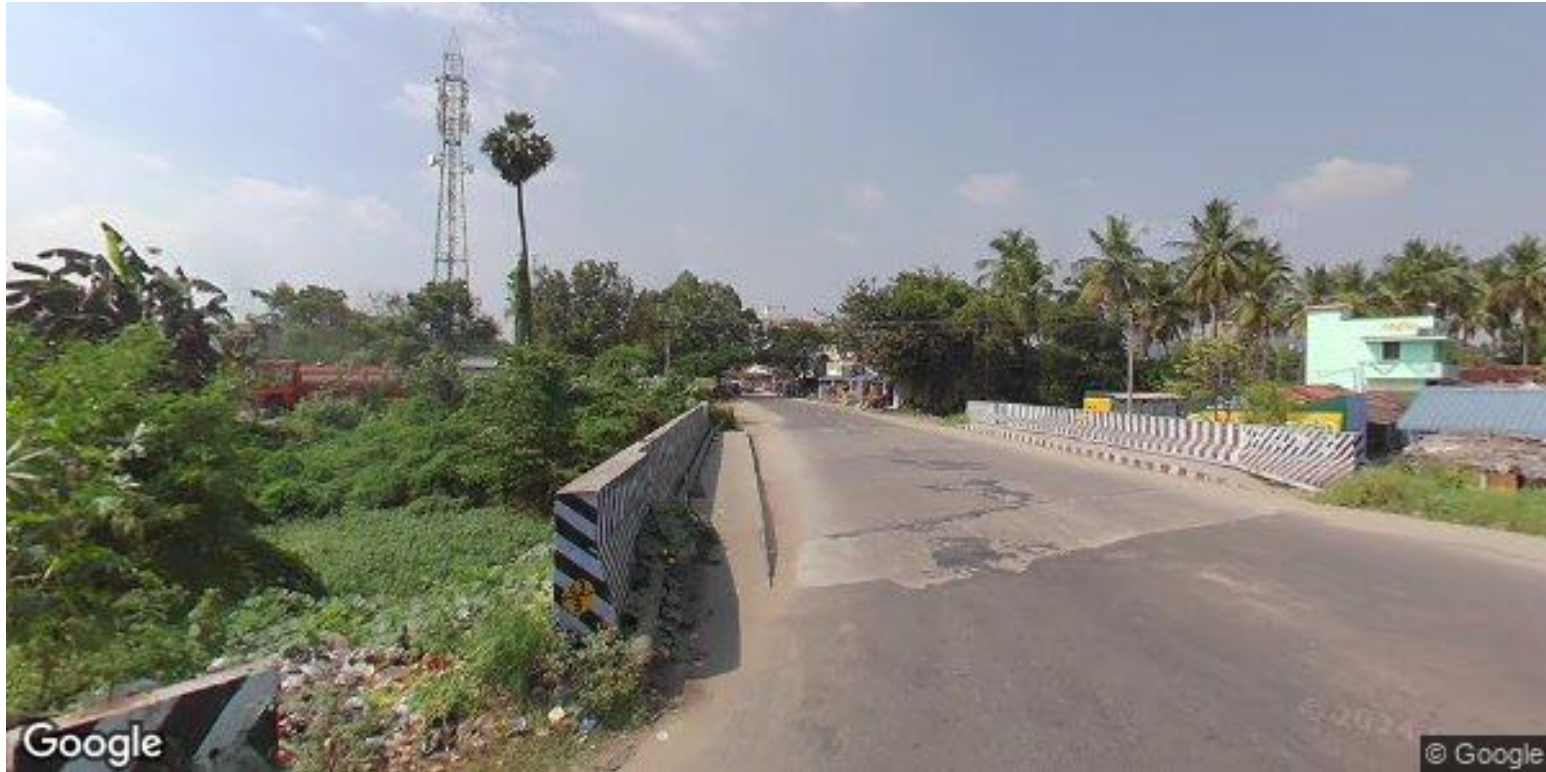
**Risk Type:** Turn  
**Risk Level:** Medium  
**Speed Limit:** 30 KM/Hr  
**Coordinates:** 11.44900, 77.87406

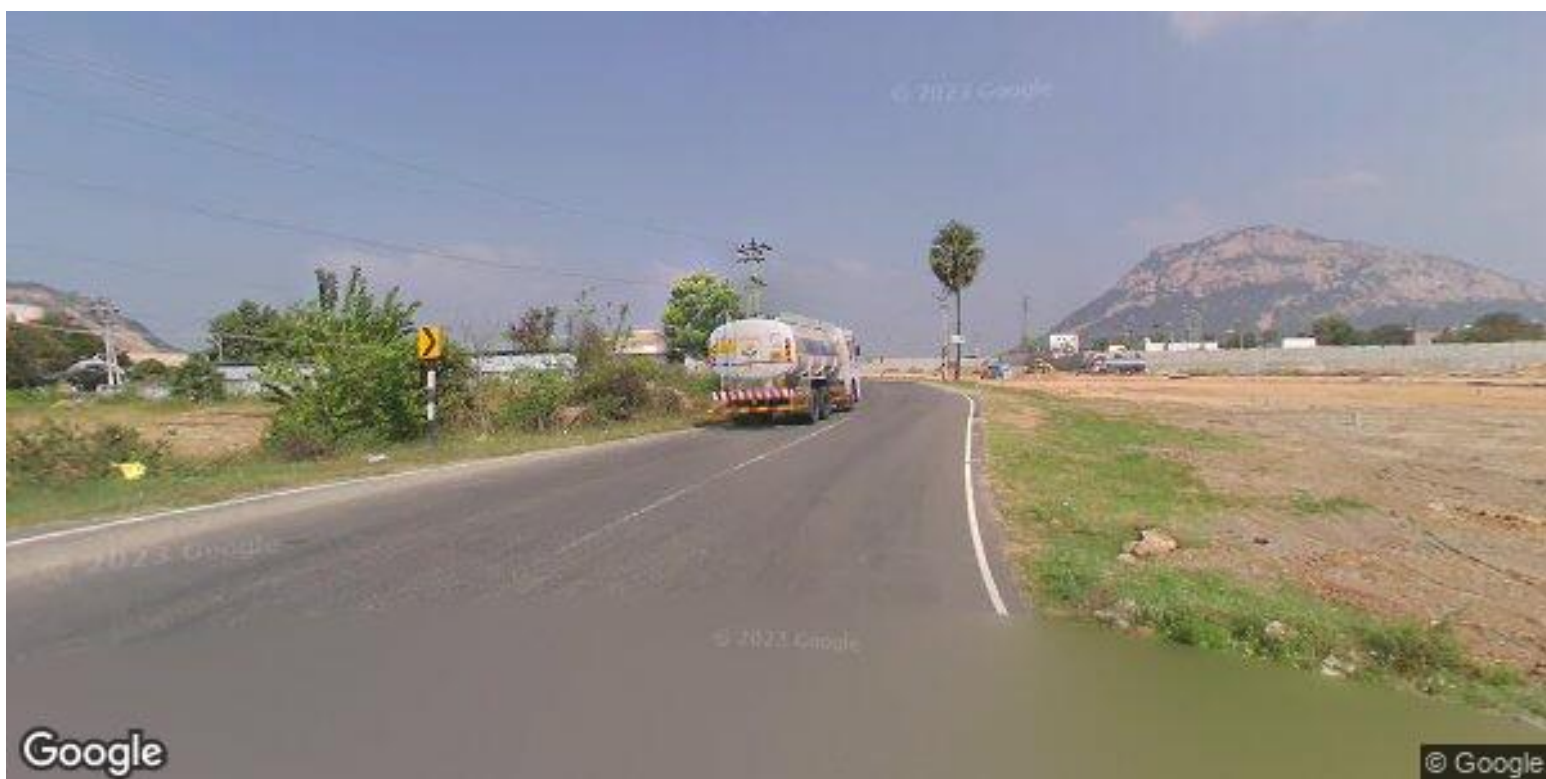
**Coordinates:** 11.45847, 77.85140

**Risk Type:** Turn

**Risk Level:** Medium

**Speed Limit:** 30 KM/Hr

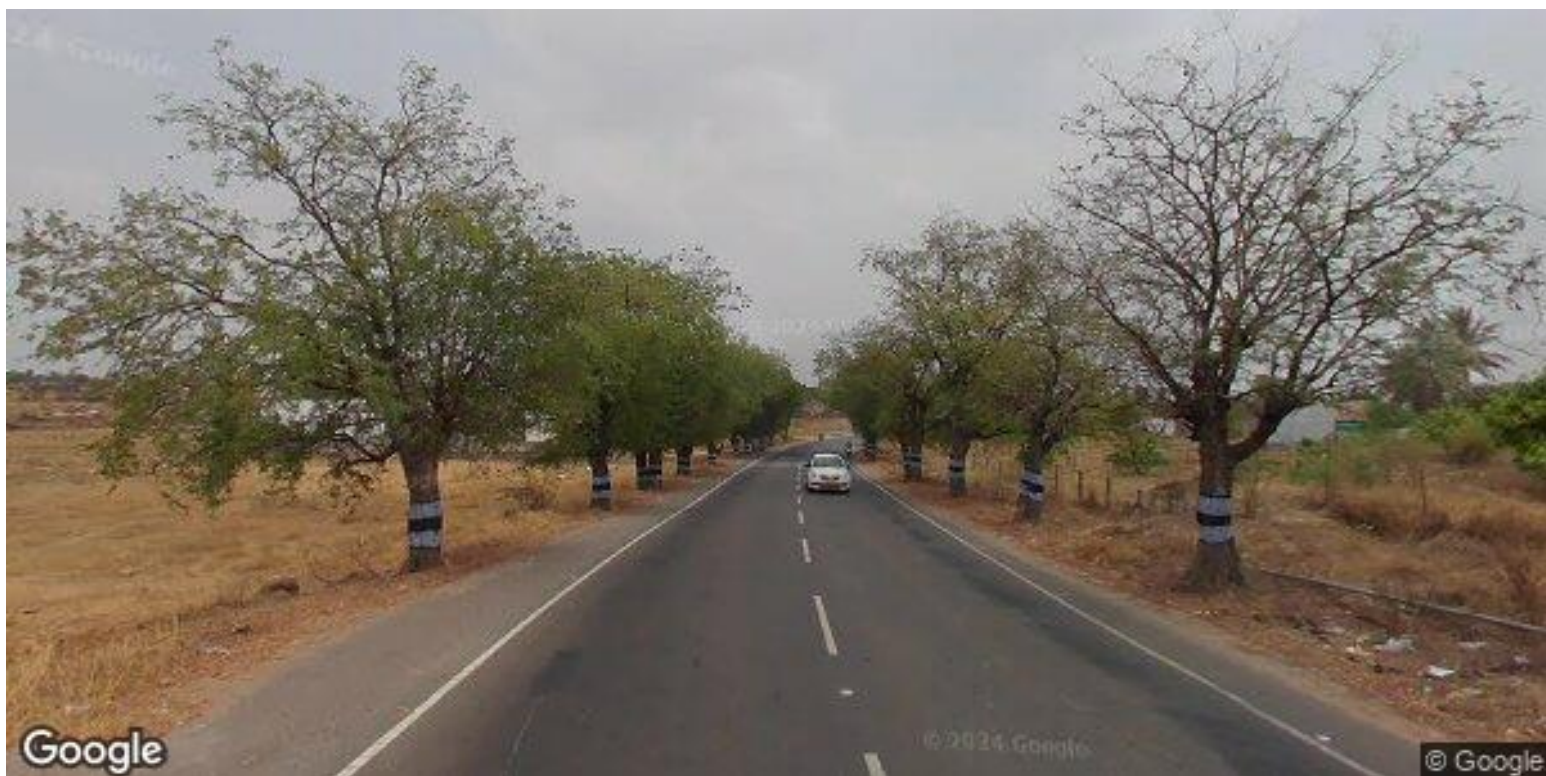
**Coordinates:** 11.54750, 77.85273

**Risk Type:** Turn

**Risk Level:** Medium

**Speed Limit:** 30 KM/Hr

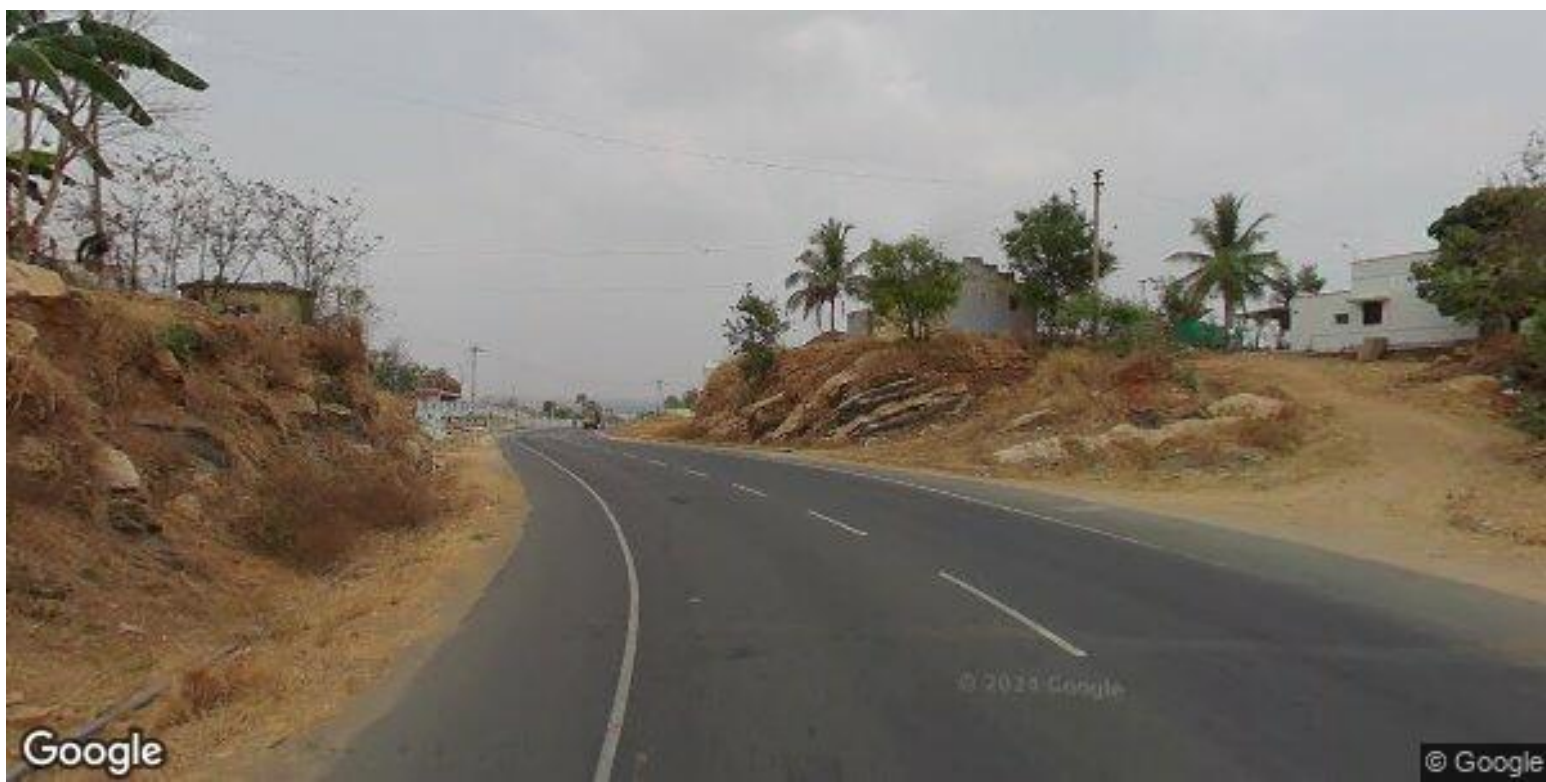
**Coordinates:** 11.55039, 77.85511

**Risk Type:** Turn

**Risk Level:** Medium

**Speed Limit:** 30 KM/Hr

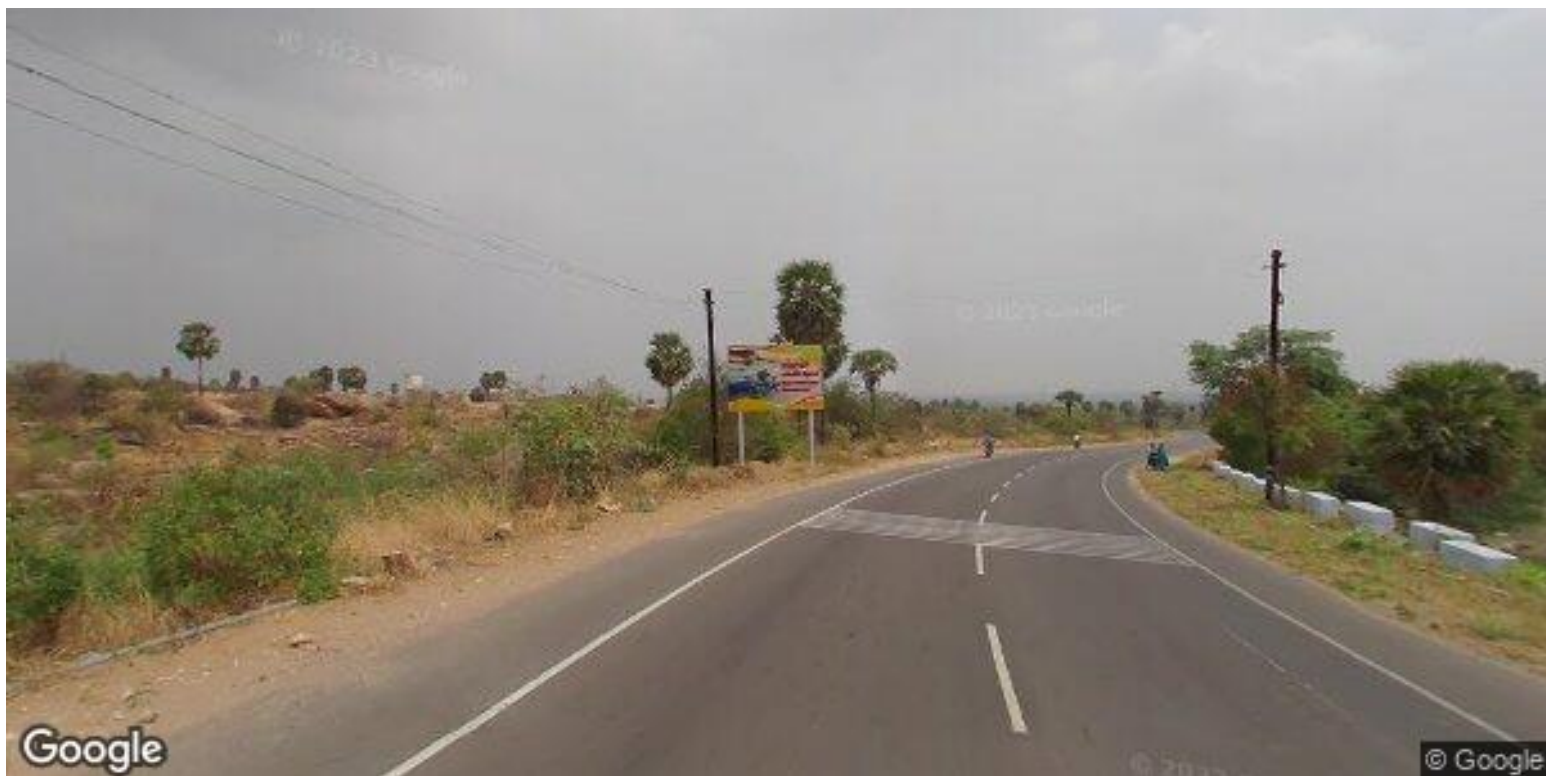
**Coordinates:** 11.55460, 77.85624

**Risk Type:** Turn

**Risk Level:** Medium

**Speed Limit:** 30 KM/Hr

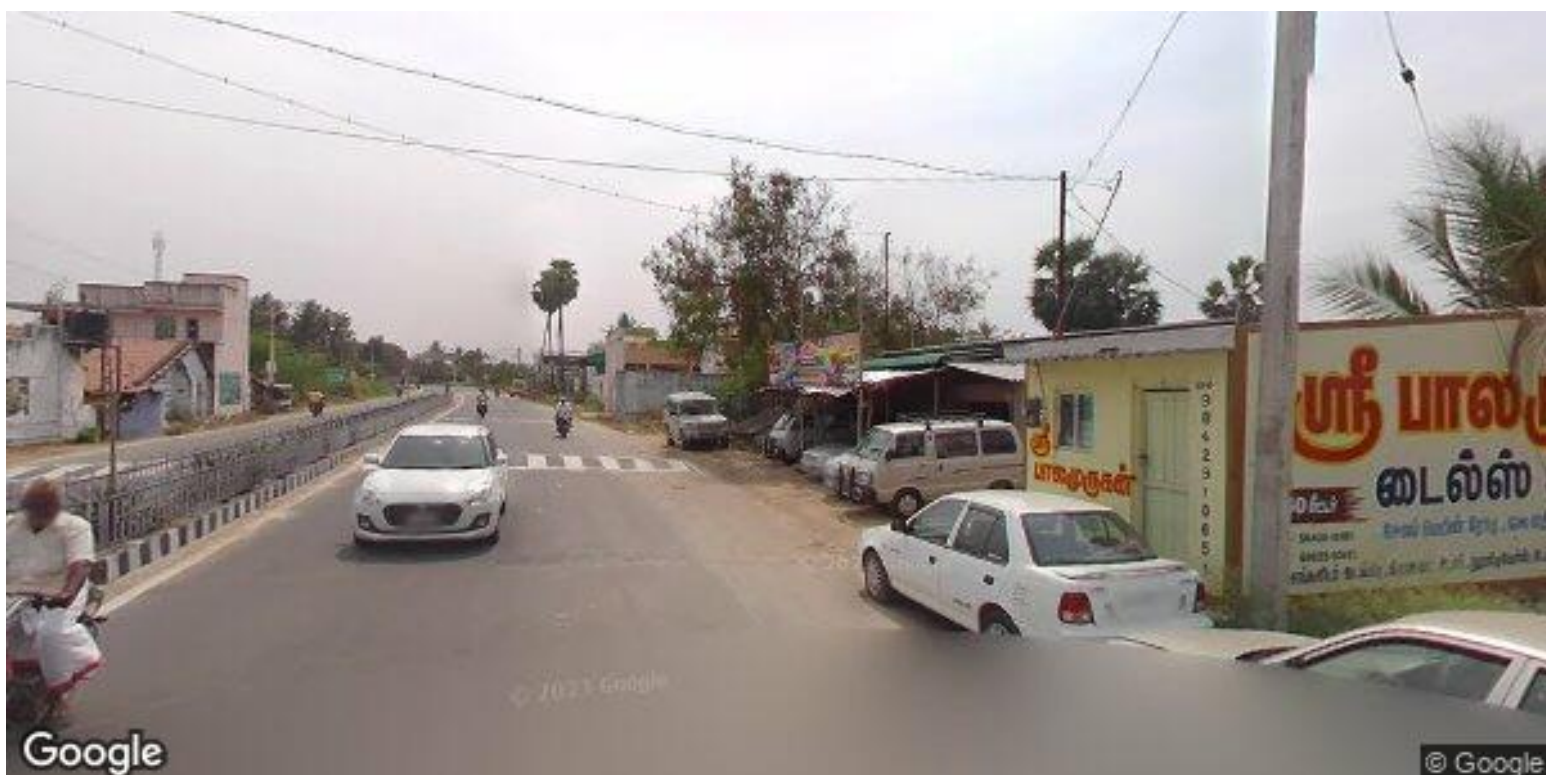
**Risk Type:** Turn  
**Risk Level:** High  
**Speed Limit:** 15 KM/Hr  
**Coordinates:** 11.57893, 77.85430

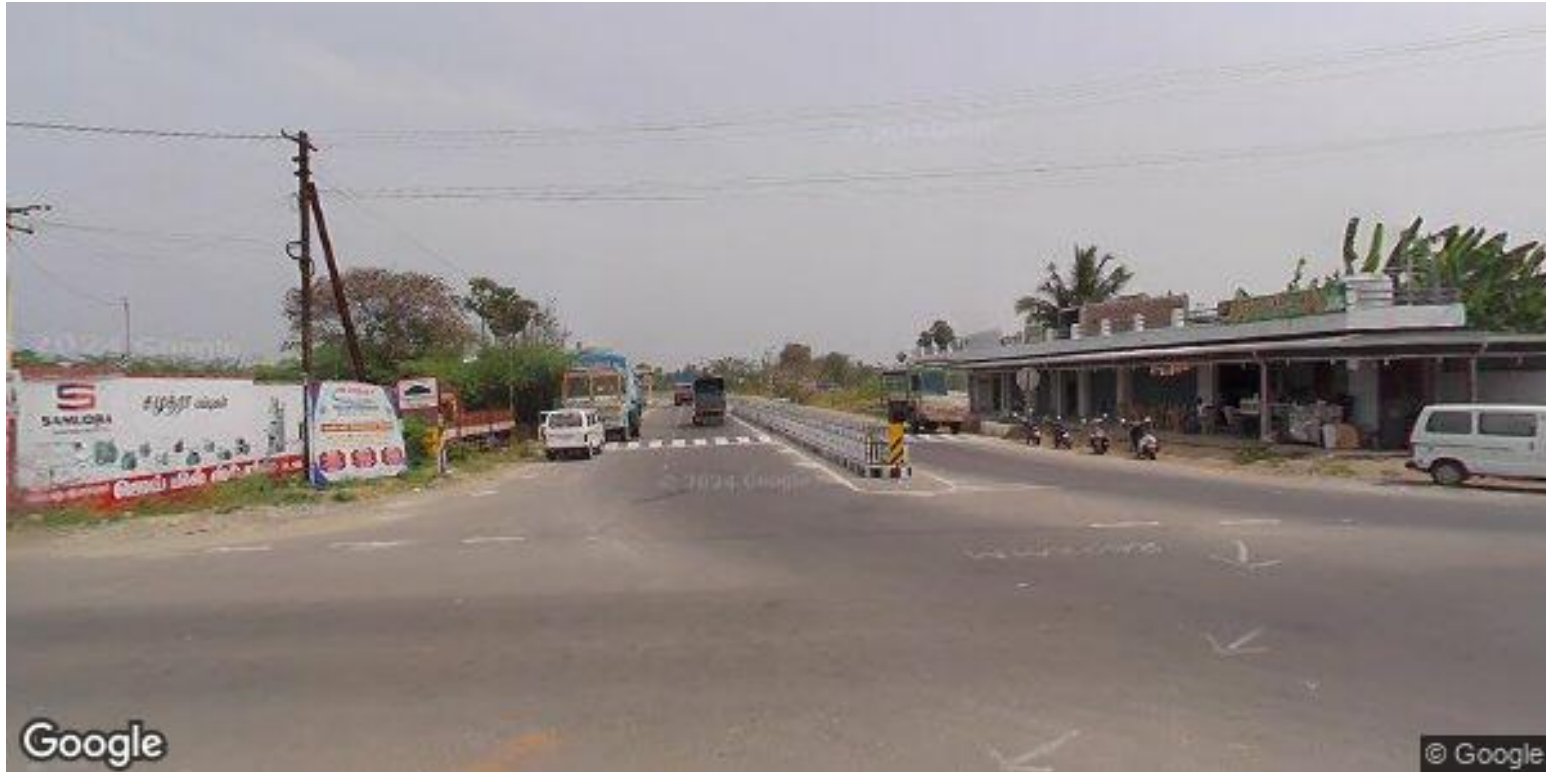
**Risk Type:** Turn  
**Risk Level:** Medium  
**Speed Limit:** 30 KM/Hr  
**Coordinates:** 11.57903, 77.85441

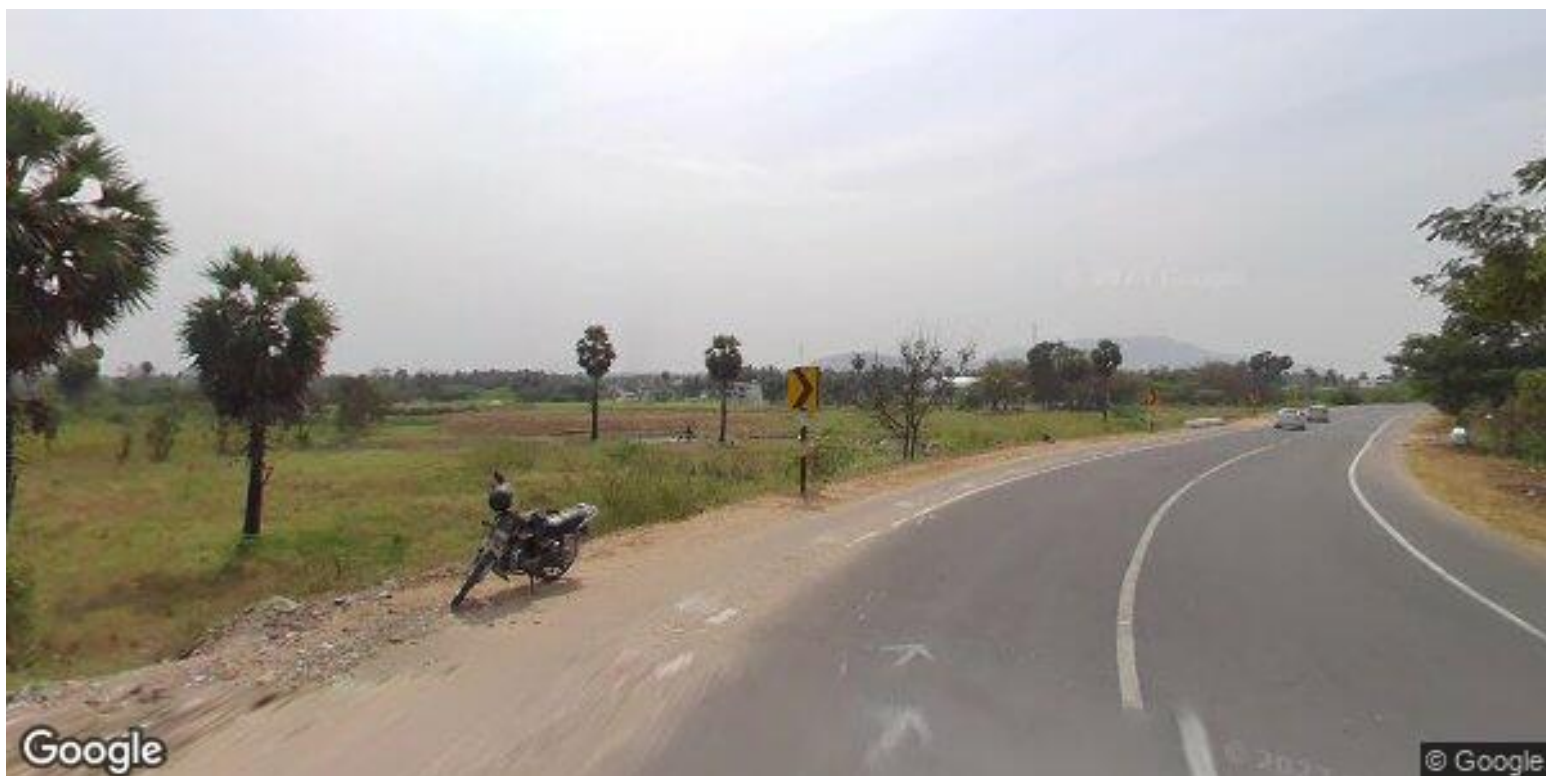
**Risk Type:** Turn  
**Risk Level:** Medium  
**Speed Limit:** 30 KM/Hr  
**Coordinates:** 11.58022, 77.85744

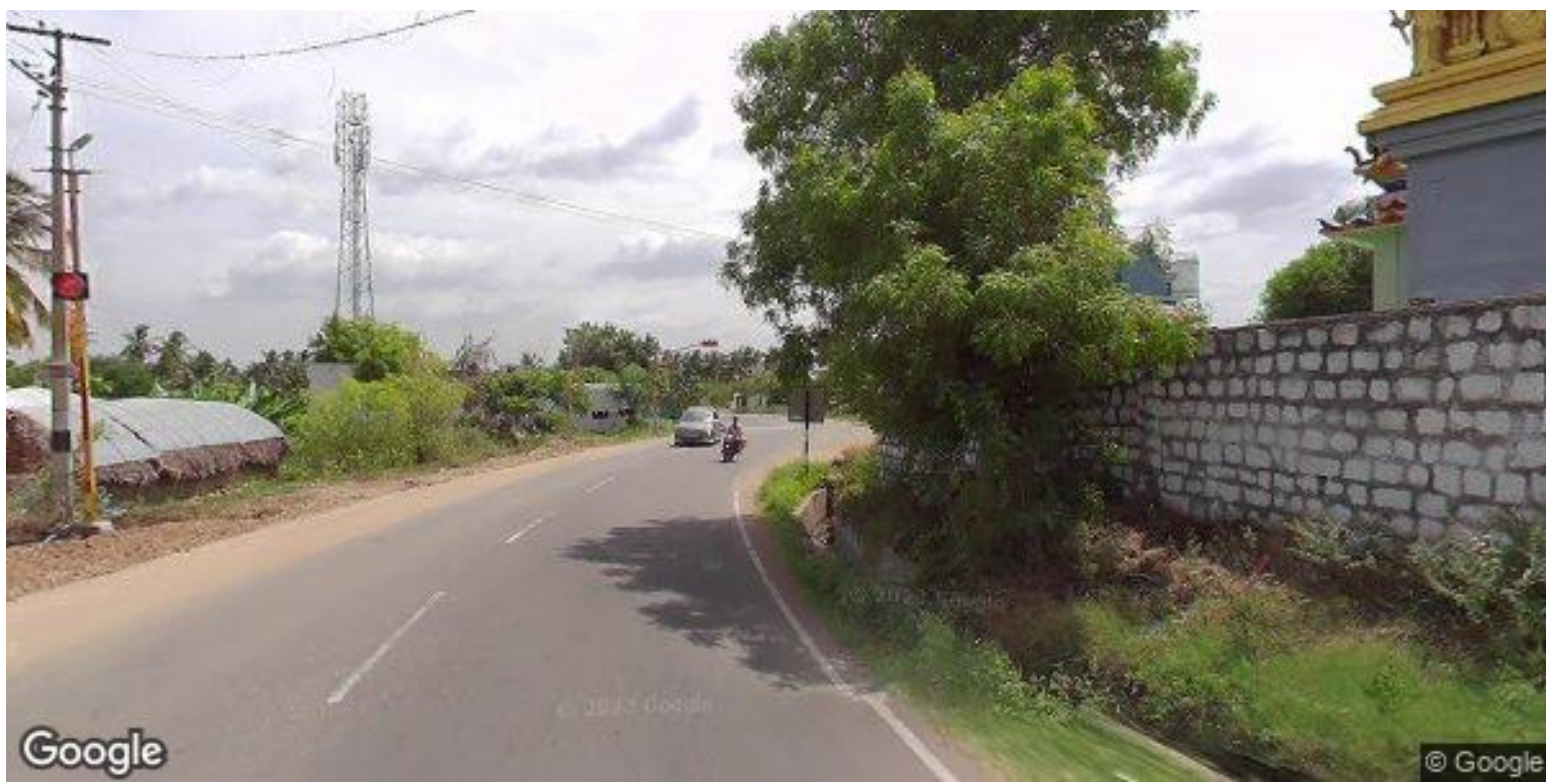
**Coordinates:** 11.60727, 77.84032

**Risk Type:** Turn

**Risk Level:** Medium

**Speed Limit:** 30 KM/Hr

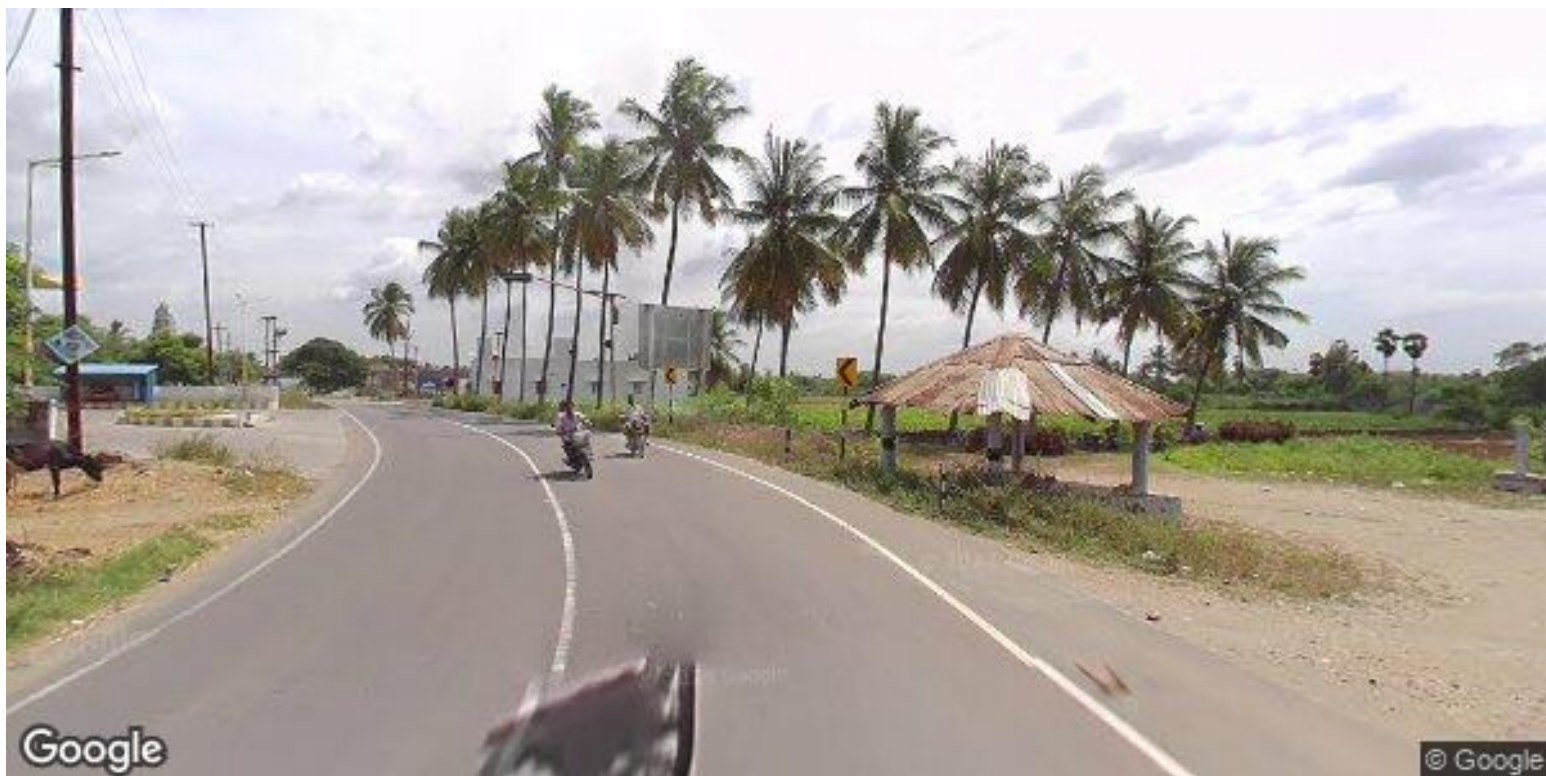
**Coordinates:** 11.60972, 77.84164

**Risk Type:** Turn

**Risk Level:** Medium

**Speed Limit:** 30 KM/Hr

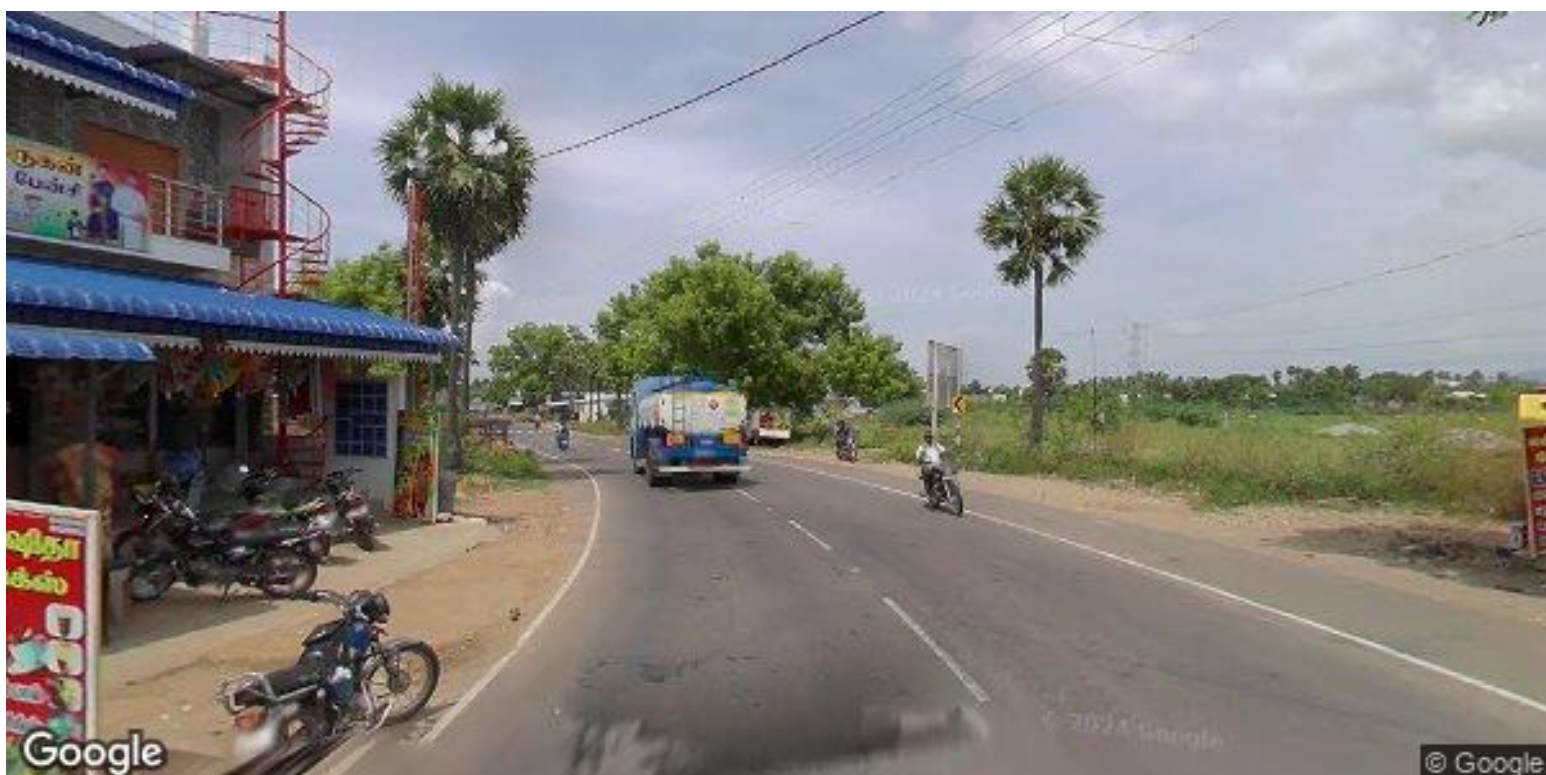
**Coordinates:** 11.64064, 77.84611

**Risk Type:** Turn

**Risk Level:** Medium

**Speed Limit:** 30 KM/Hr

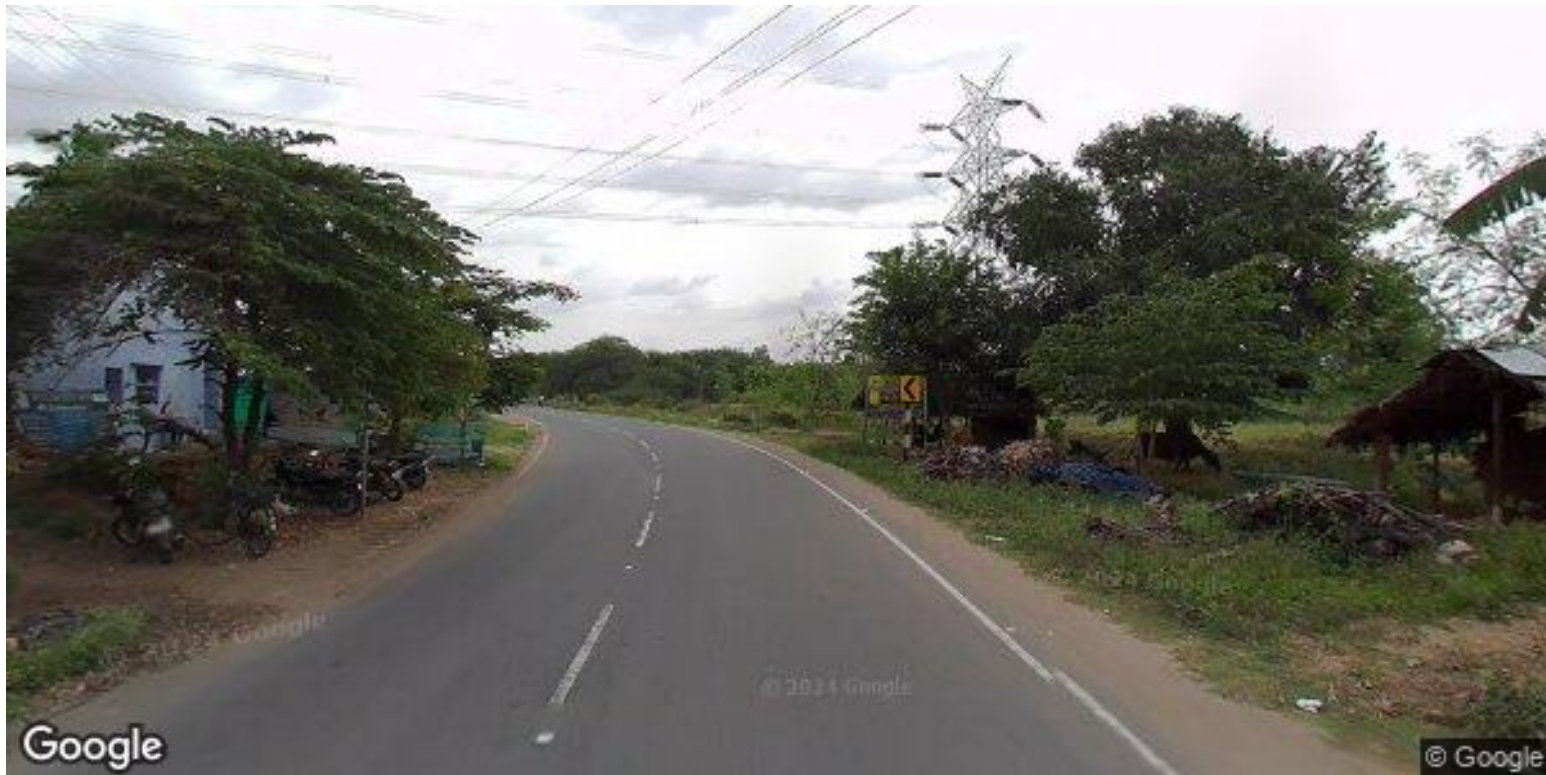
**Coordinates:** 11.64535, 77.85122

**Risk Type:** Turn

**Risk Level:** Medium

**Speed Limit:** 30 KM/Hr

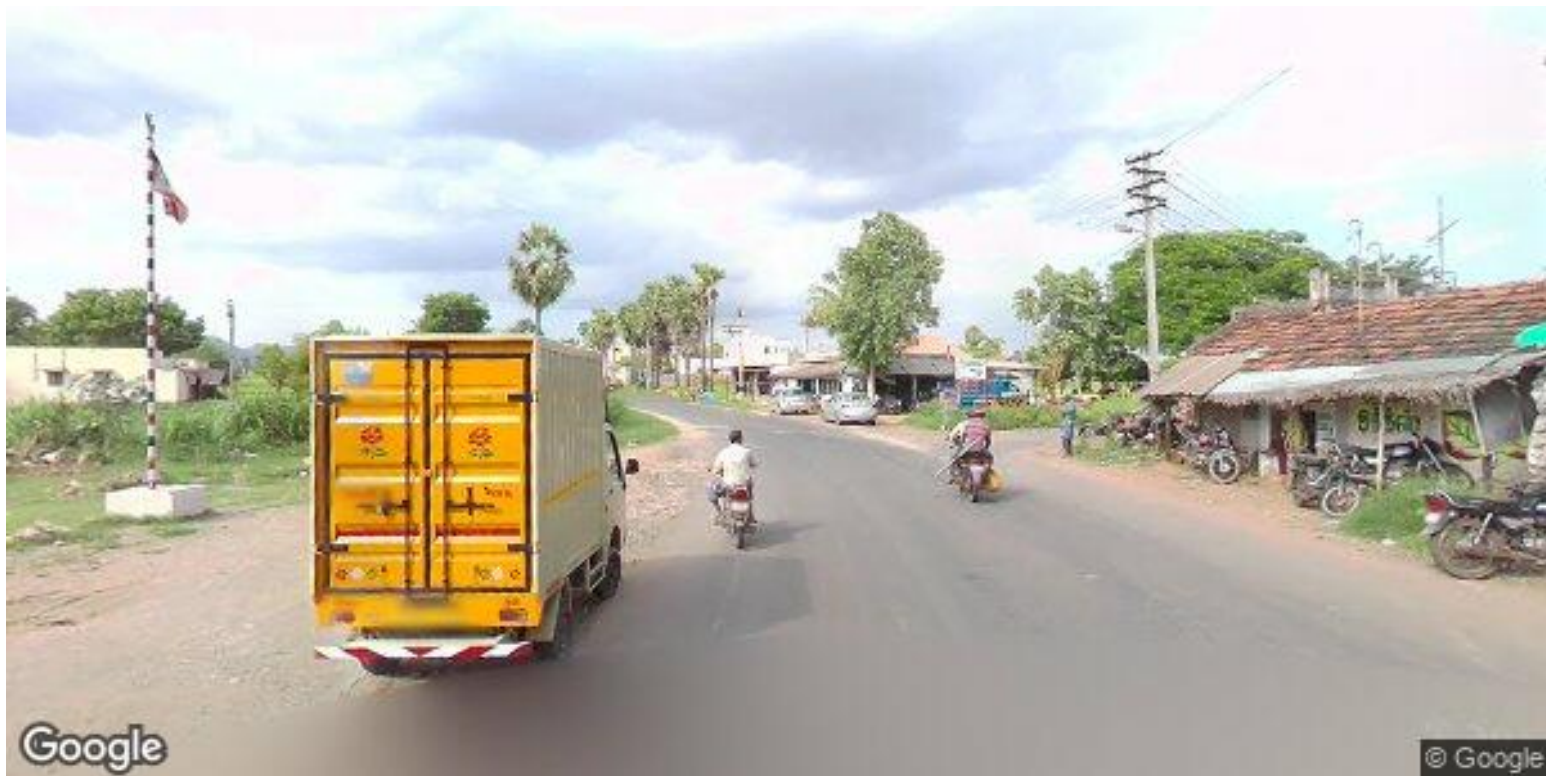
**Coordinates:** 11.65473, 77.85327

**Risk Type:** Turn

**Risk Level:** Medium

**Speed Limit:** 30 KM/Hr

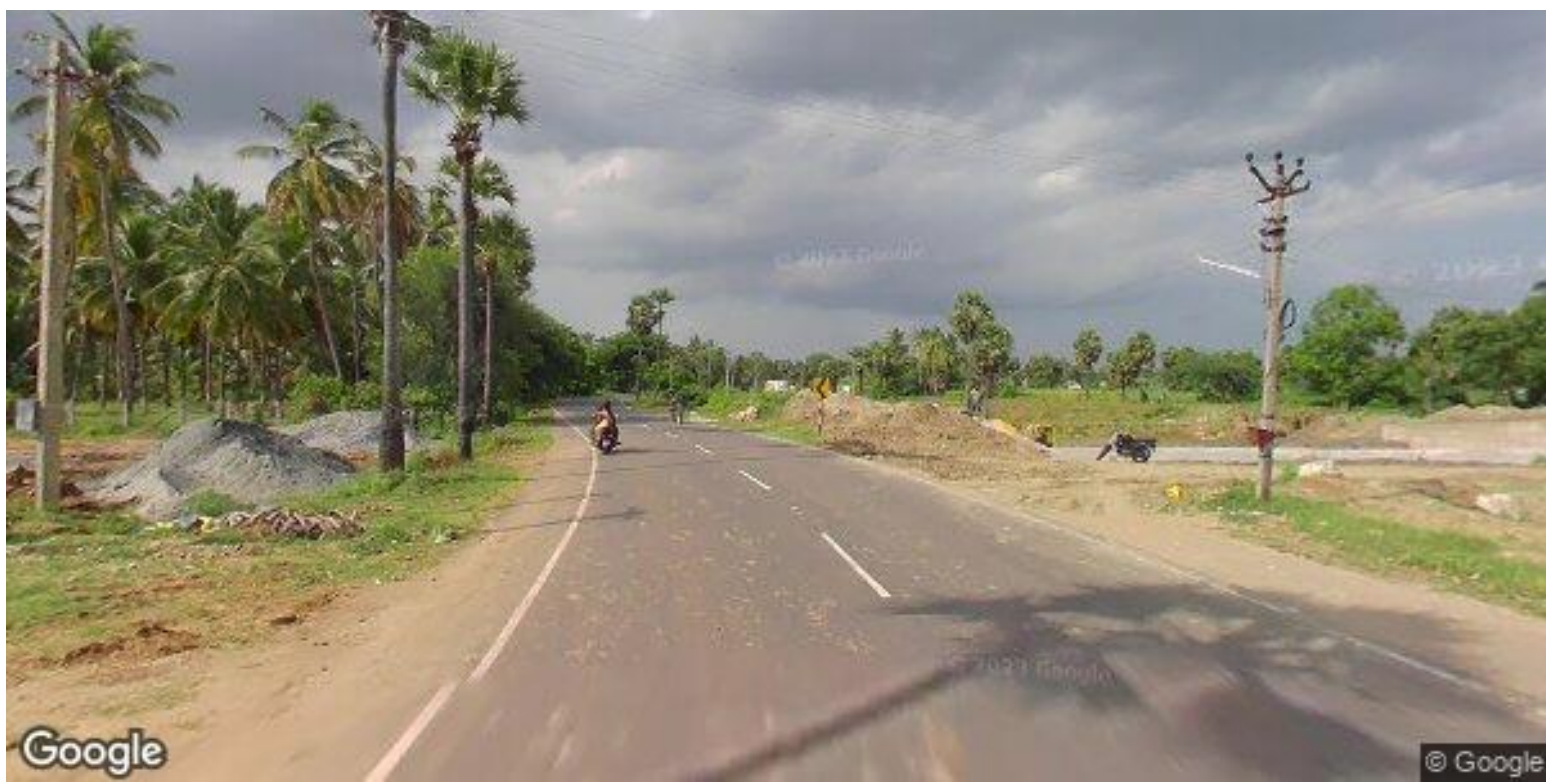
**Coordinates:** 11.66467, 77.85599

**Risk Type:** Turn

**Risk Level:** Medium

**Speed Limit:** 30 KM/Hr

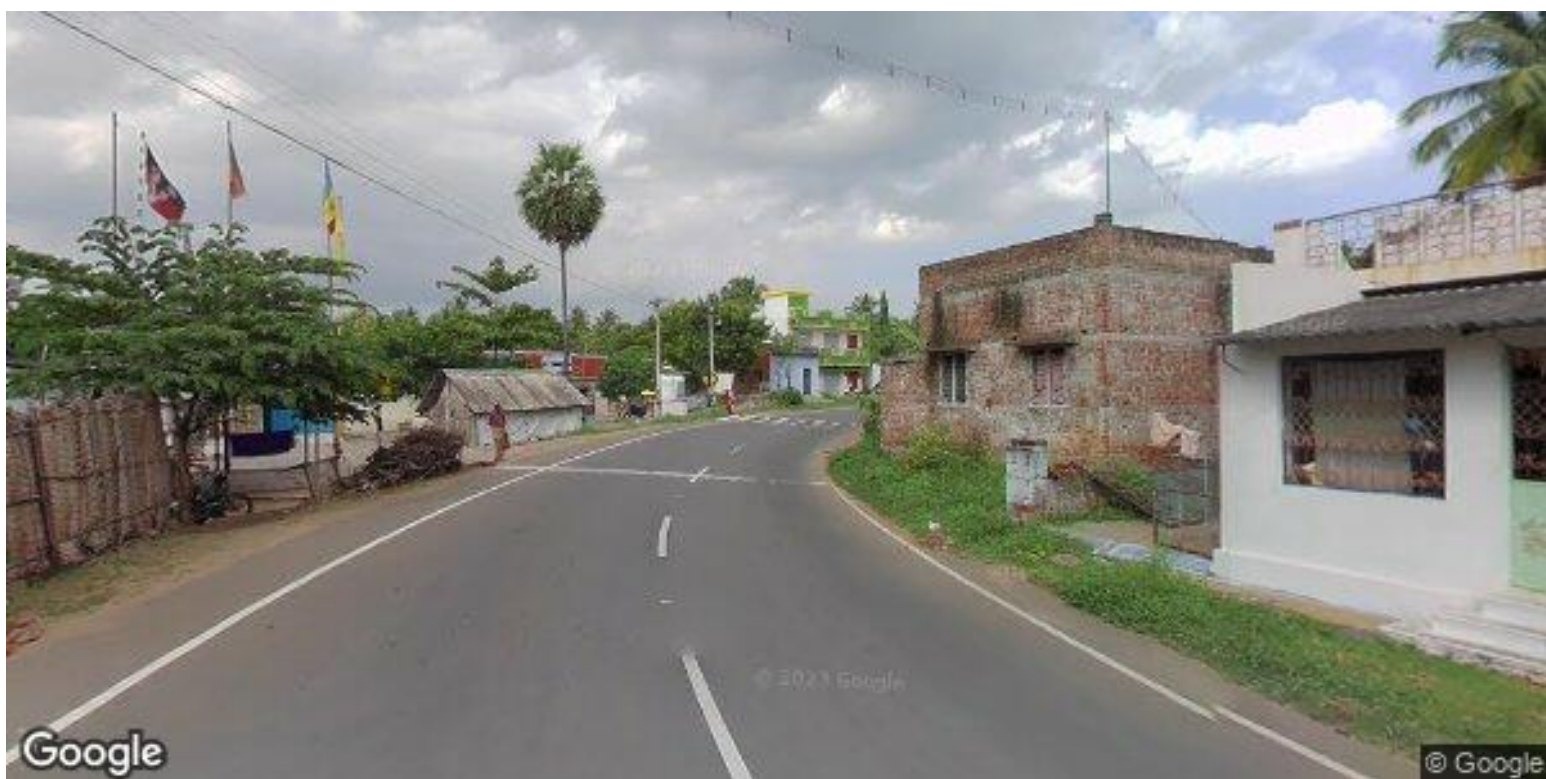
**Coordinates:** 11.67301, 77.86024

**Risk Type:** Turn

**Risk Level:** Medium

**Speed Limit:** 30 KM/Hr

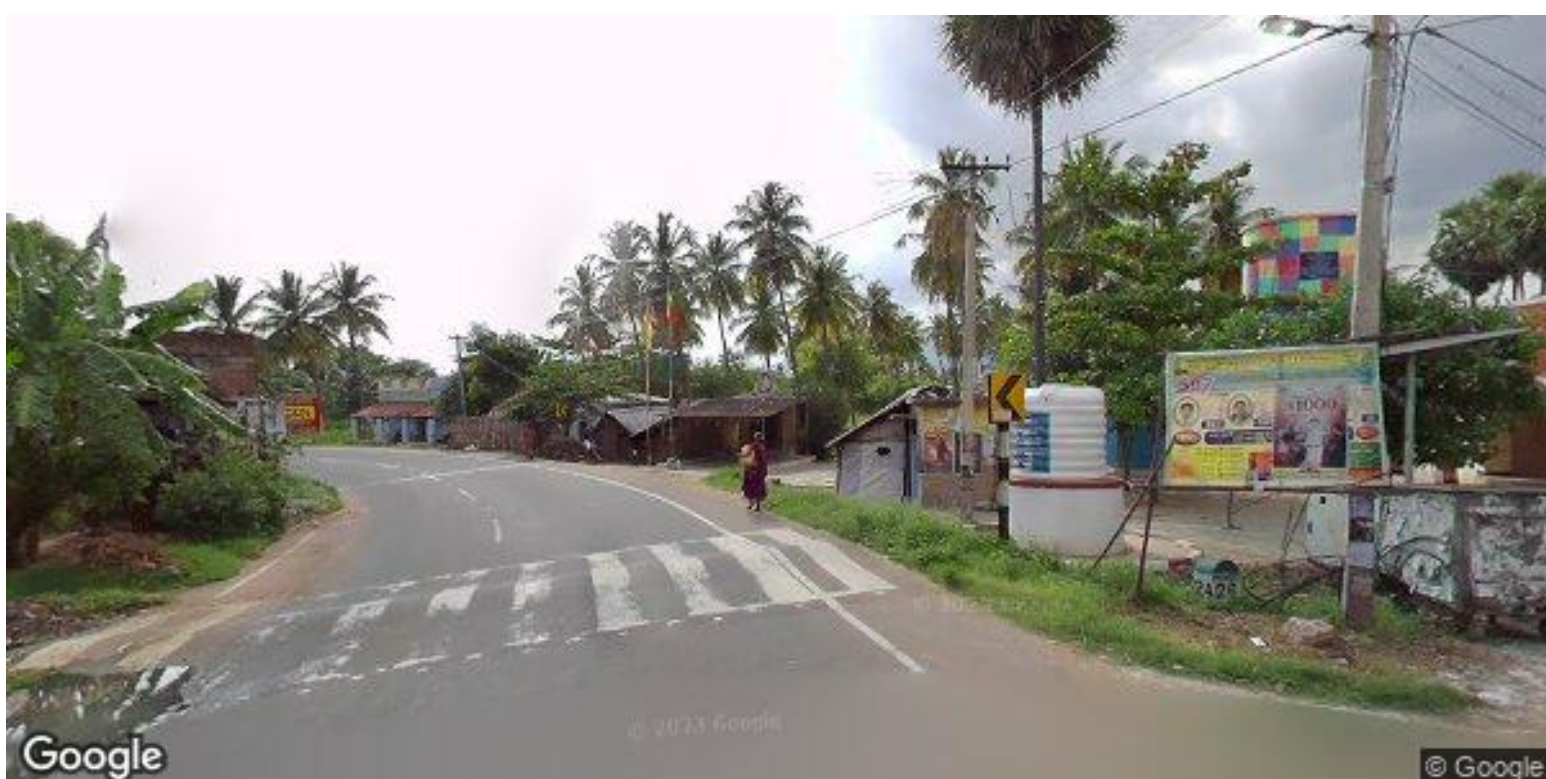
**Risk Type:** Turn  
**Risk Level:** Medium  
**Speed Limit:** 30 KM/Hr  
**Coordinates:** 11.67326, 77.86058
