# IndianOil

## JOURNEY RISK MANAGEMENT (JRM) STUDY

### Salem Terminal to D.V.S FUEL STATION

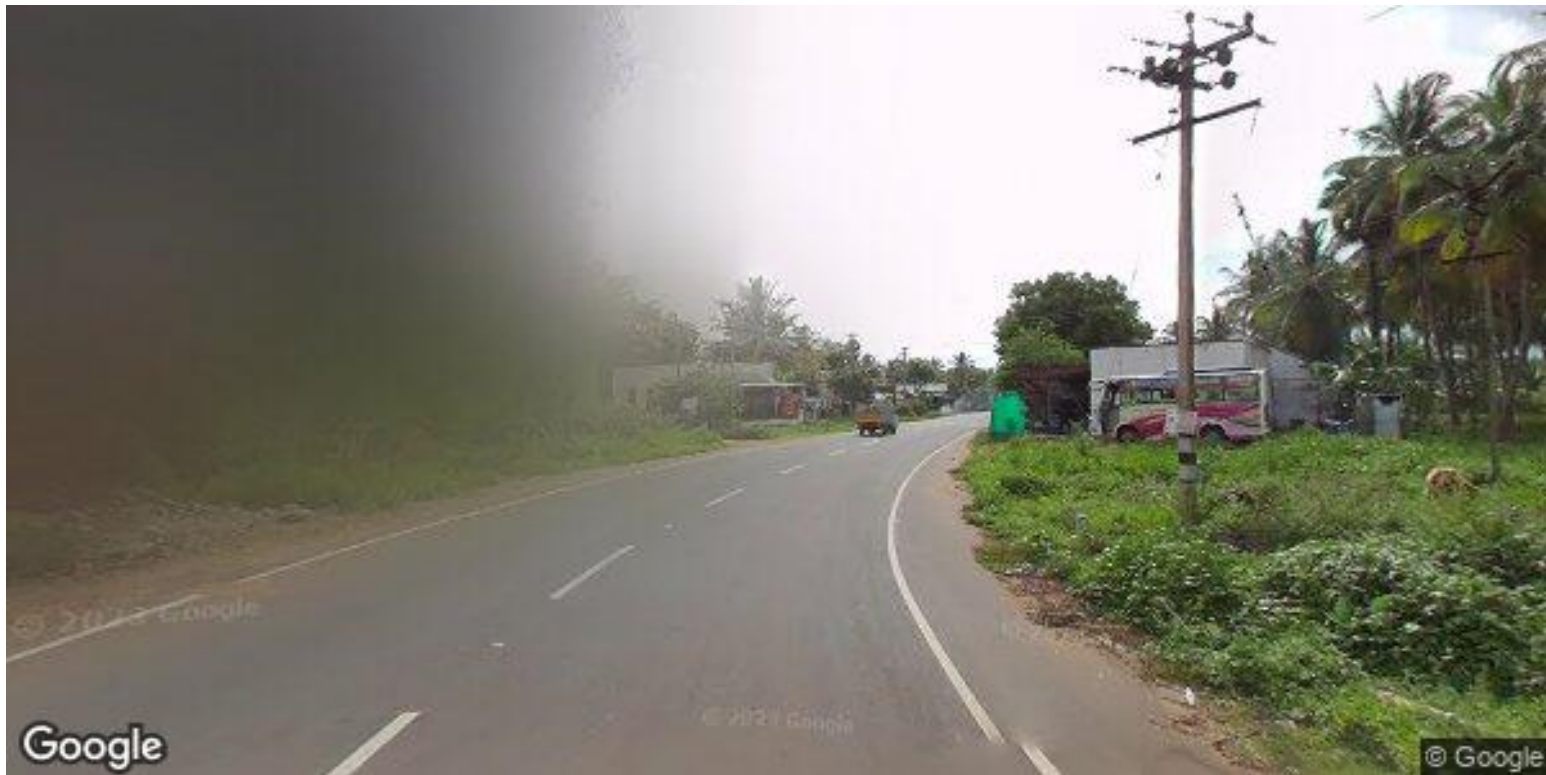
**Risk Type:** Turn  
**Risk Level:** Medium  
**Speed Limit:** 30 KM/Hr  
**Coordinates:** 11.67373, 77.86230

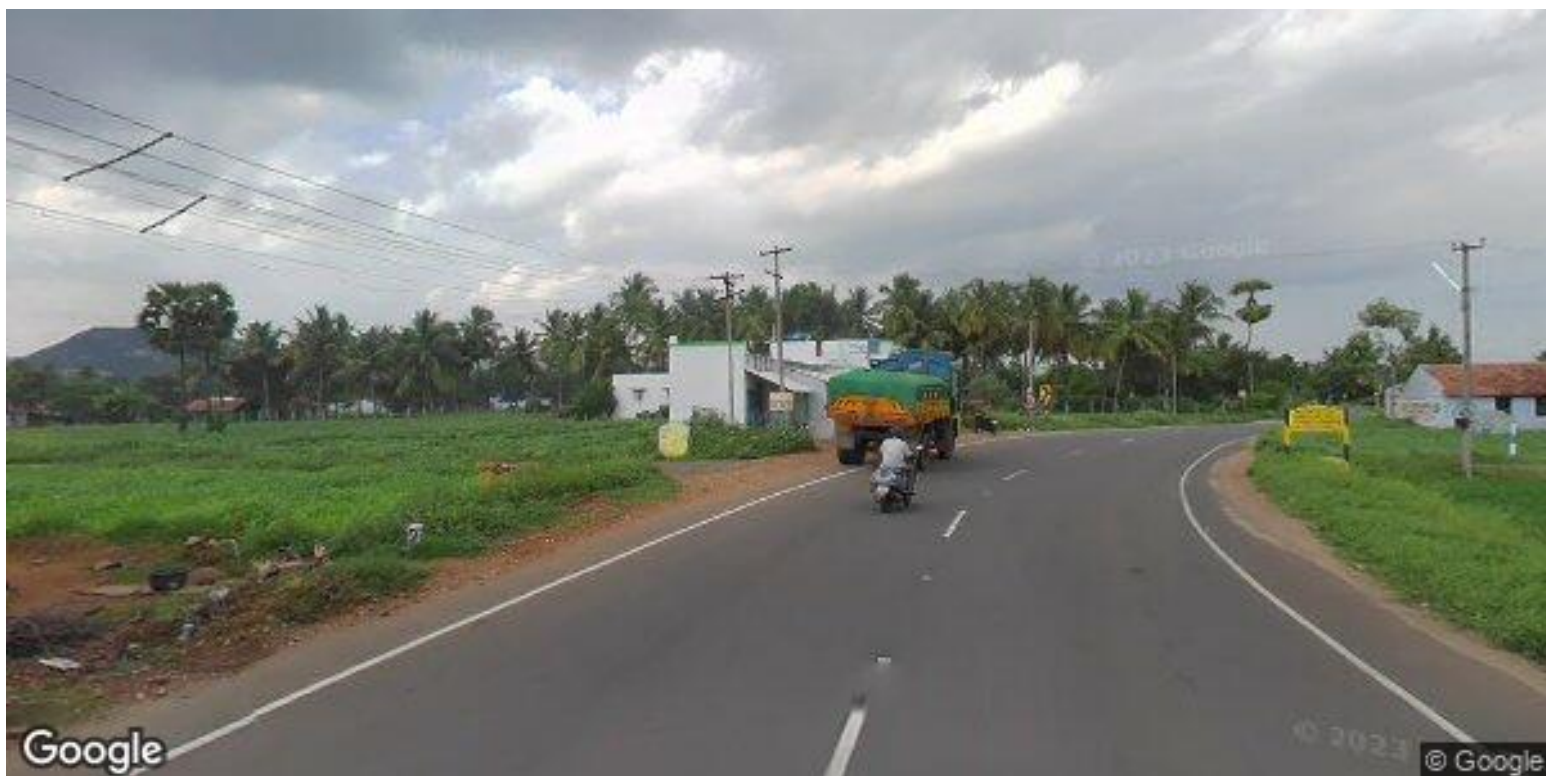
**Risk Type:** Turn  
**Risk Level:** Medium  
**Speed Limit:** 30 KM/Hr  
**Coordinates:** 11.68171, 77.86676

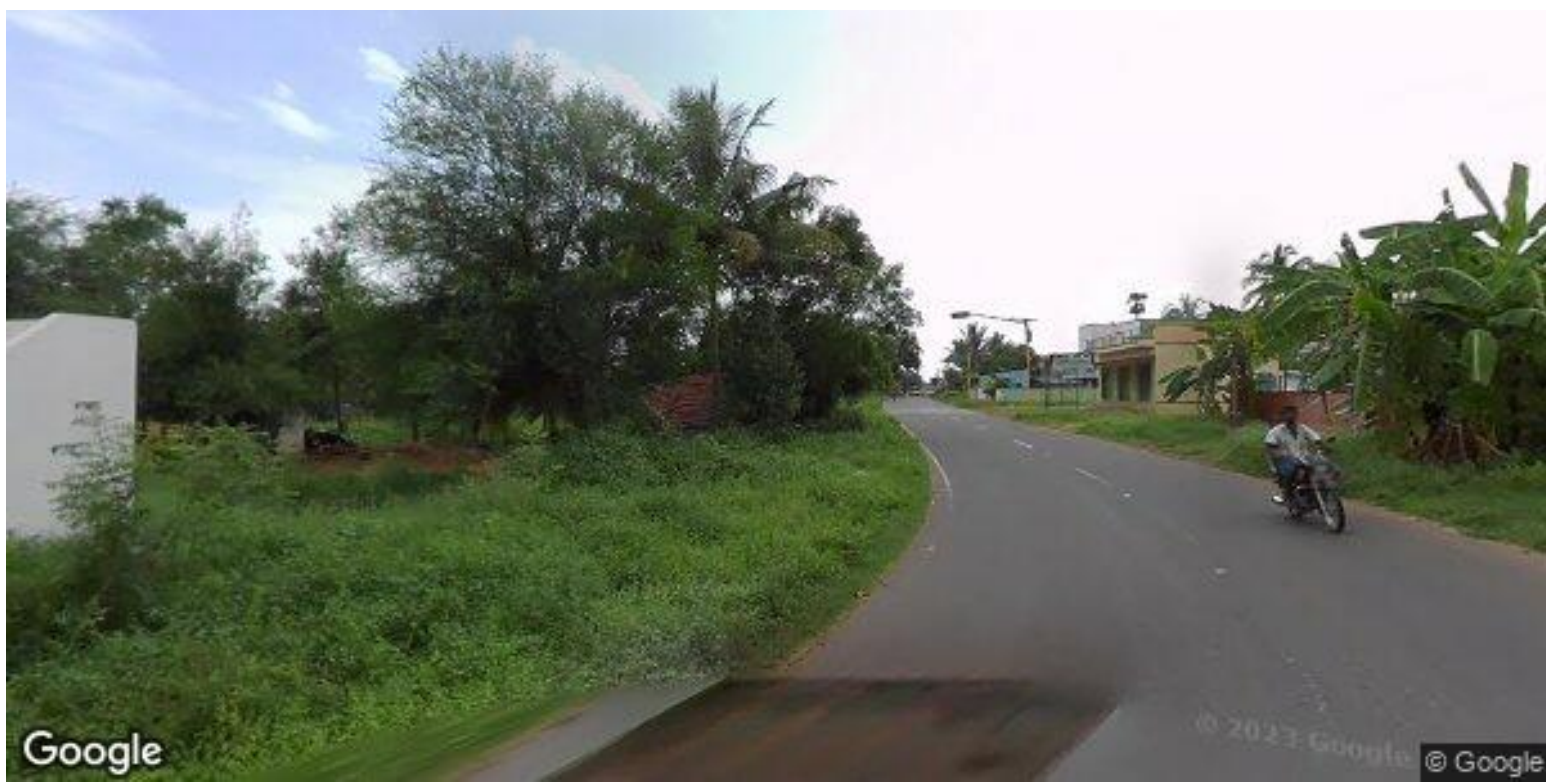
**Coordinates:** 11.68490, 77.86893

**Risk Type:** Turn

**Risk Level:** High

**Speed Limit:** 15 KM/Hr

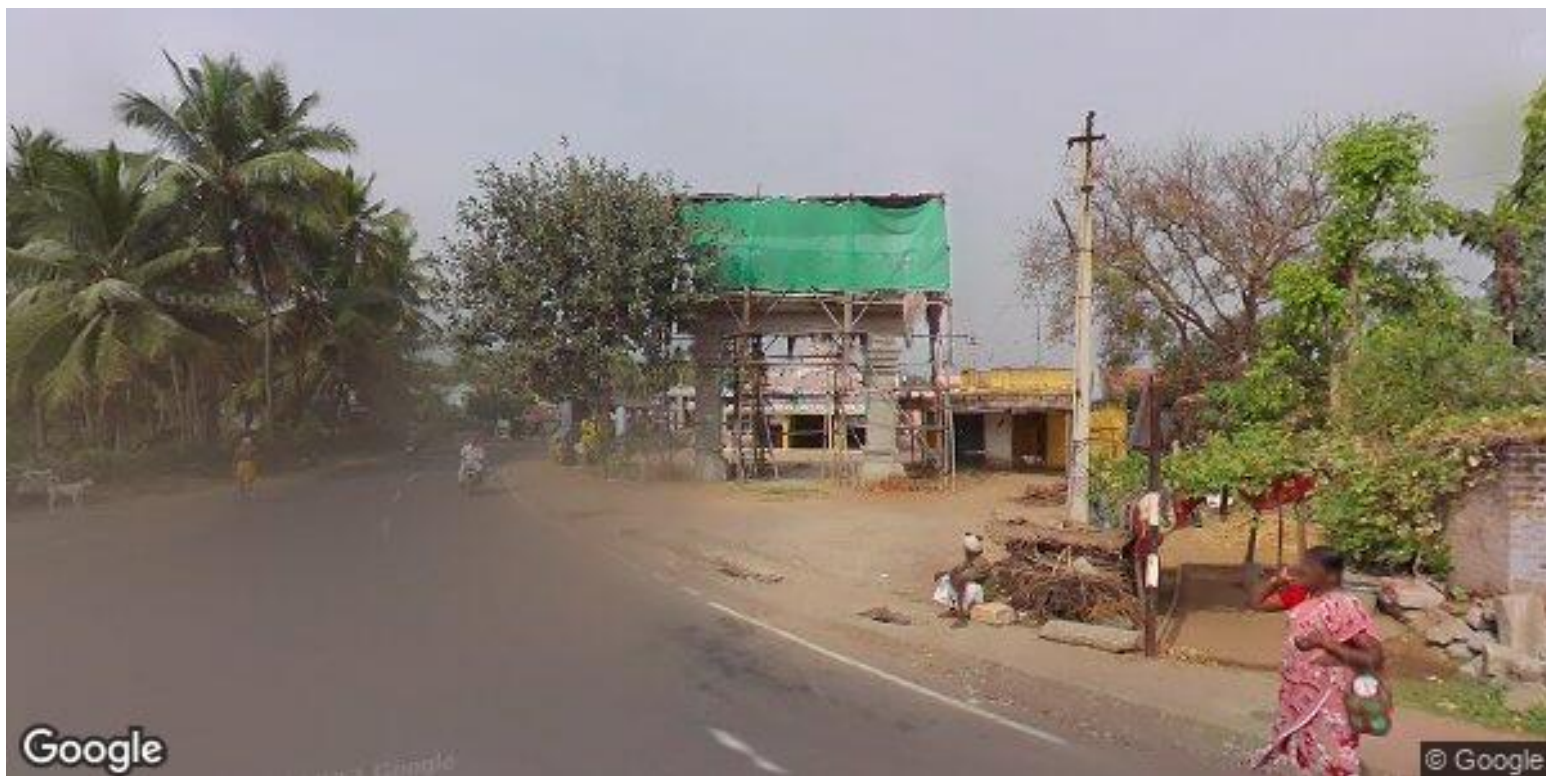
**Coordinates:** 11.68472, 77.87281

**Risk Type:** Turn

**Risk Level:** High

**Speed Limit:** 15 KM/Hr

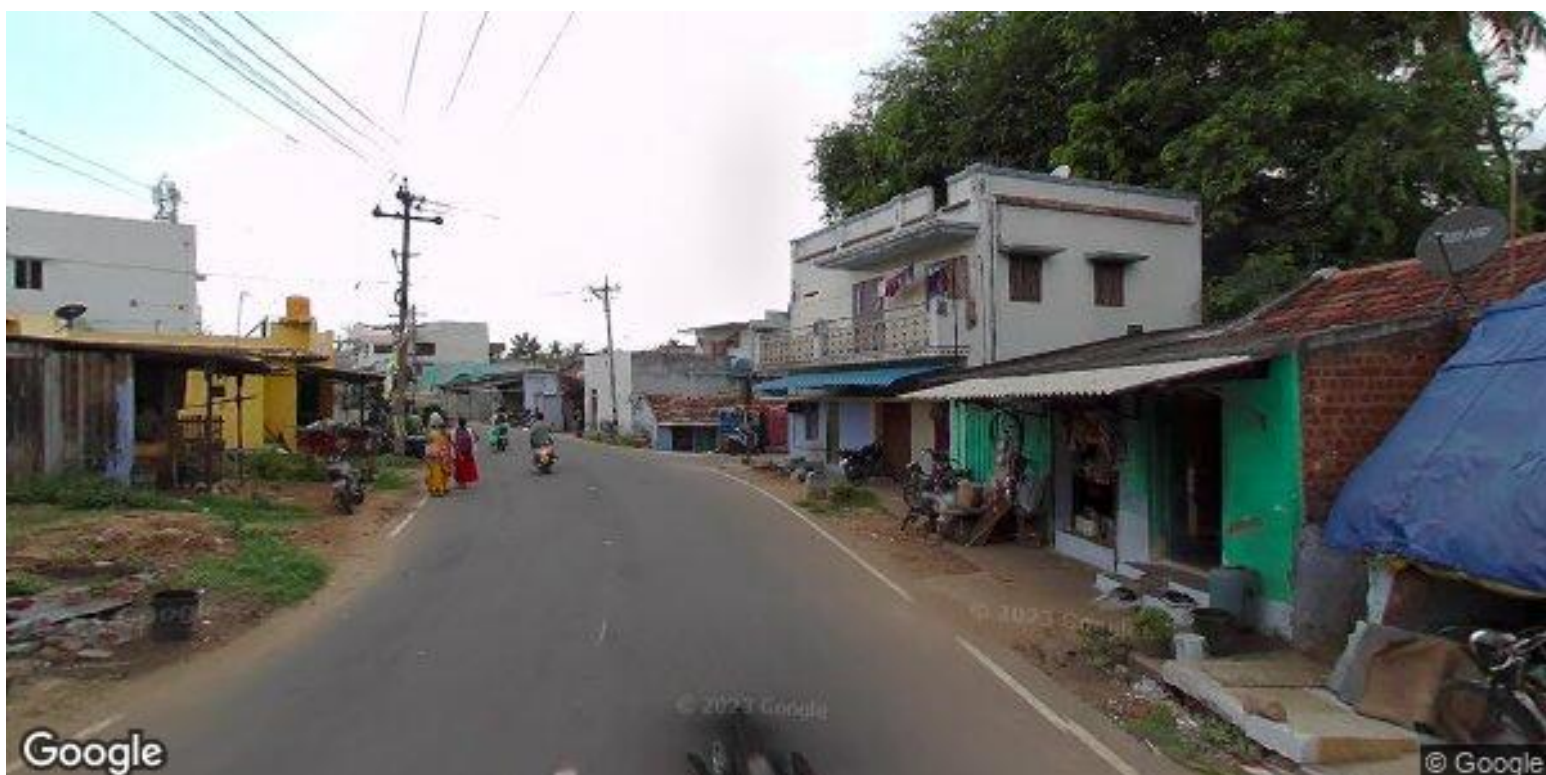
**Coordinates:** 11.69302, 77.87453

**Risk Type:** Turn

**Risk Level:** Medium

**Speed Limit:** 30 KM/Hr

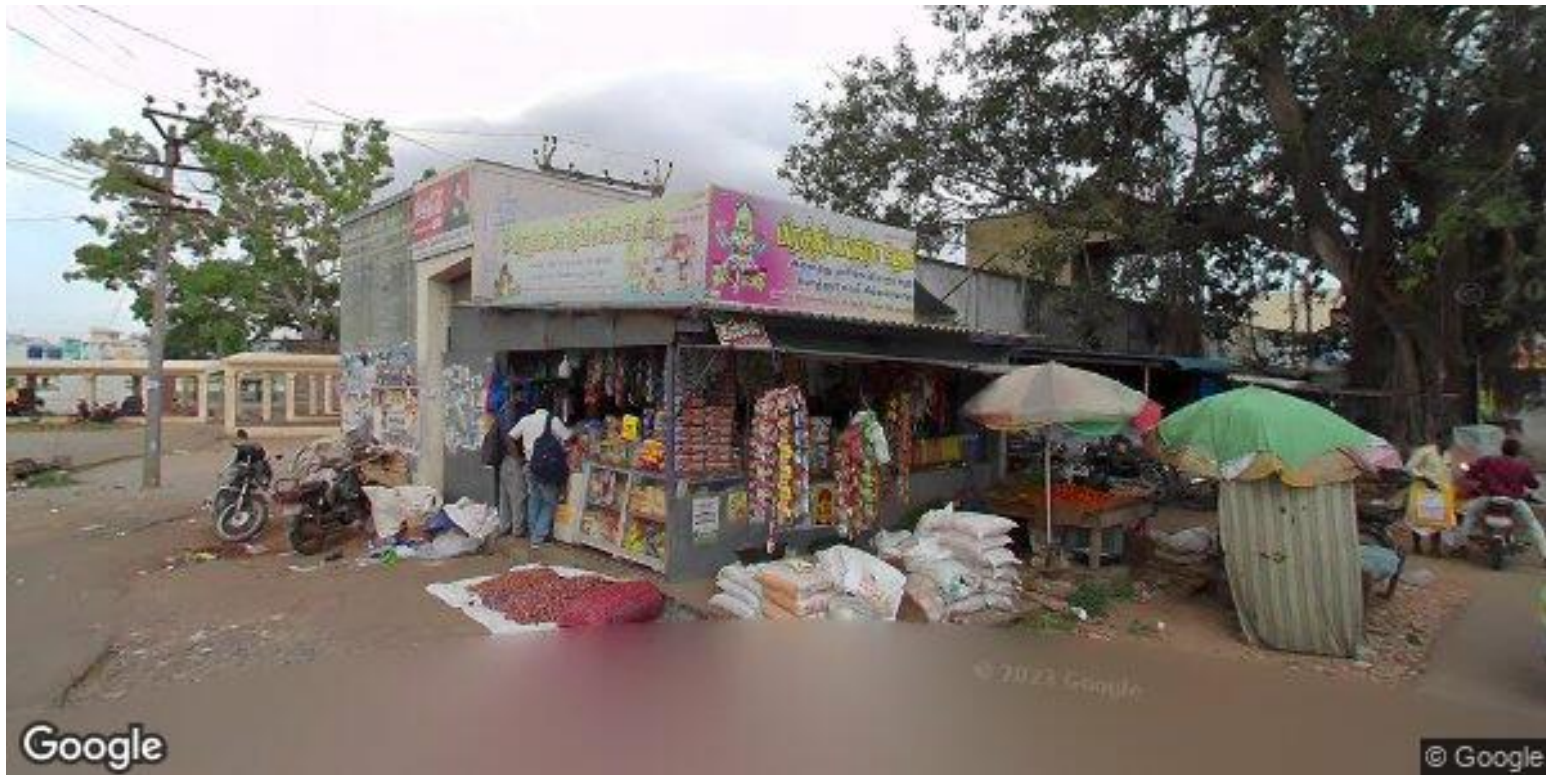
**Coordinates:** 11.69458, 77.87589

**Risk Type:** Turn

**Risk Level:** High

**Speed Limit:** 15 KM/Hr

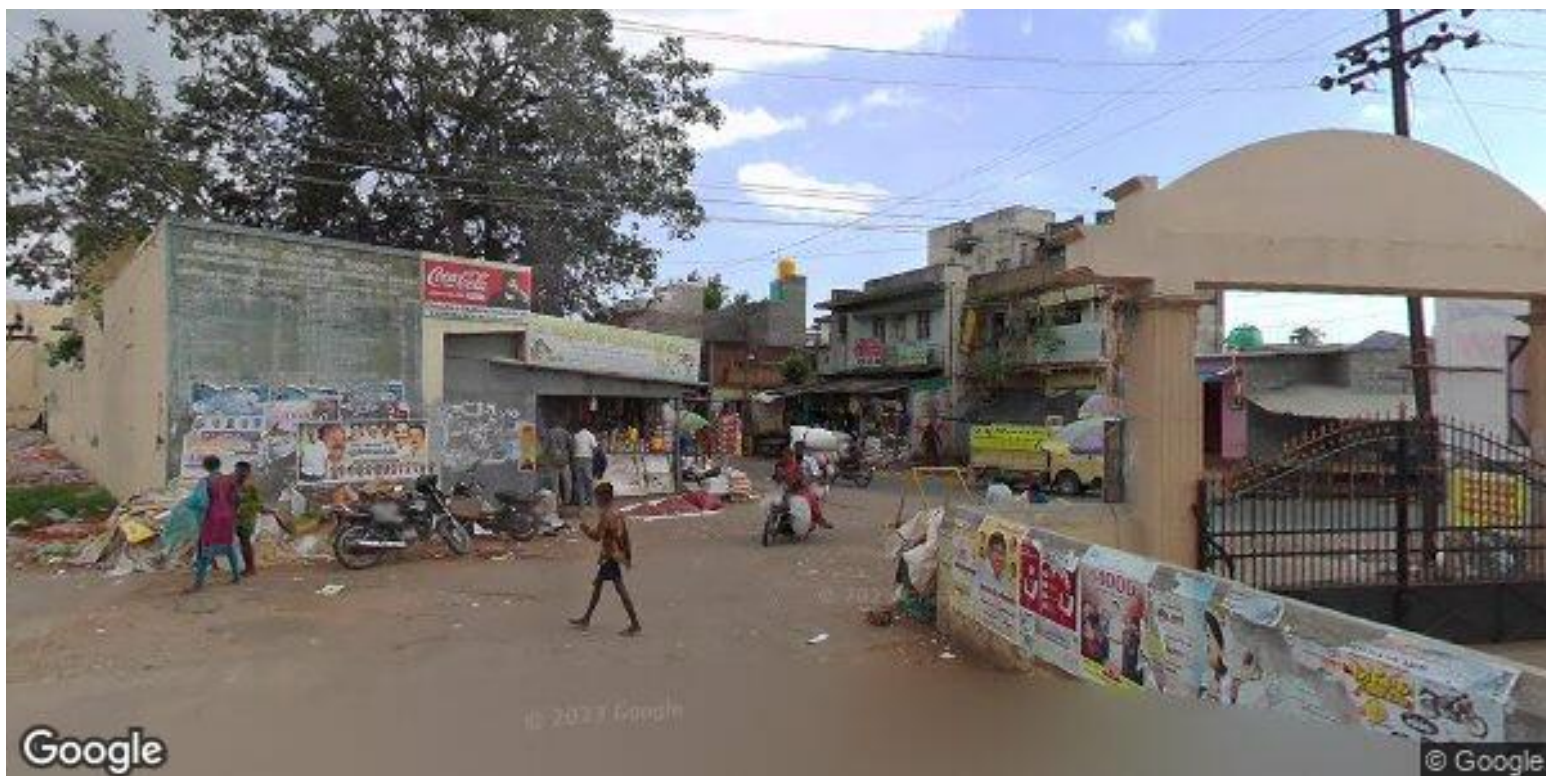
**Coordinates:** 11.69475, 77.87583

**Risk Type:** Turn

**Risk Level:** Medium

**Speed Limit:** 30 KM/Hr

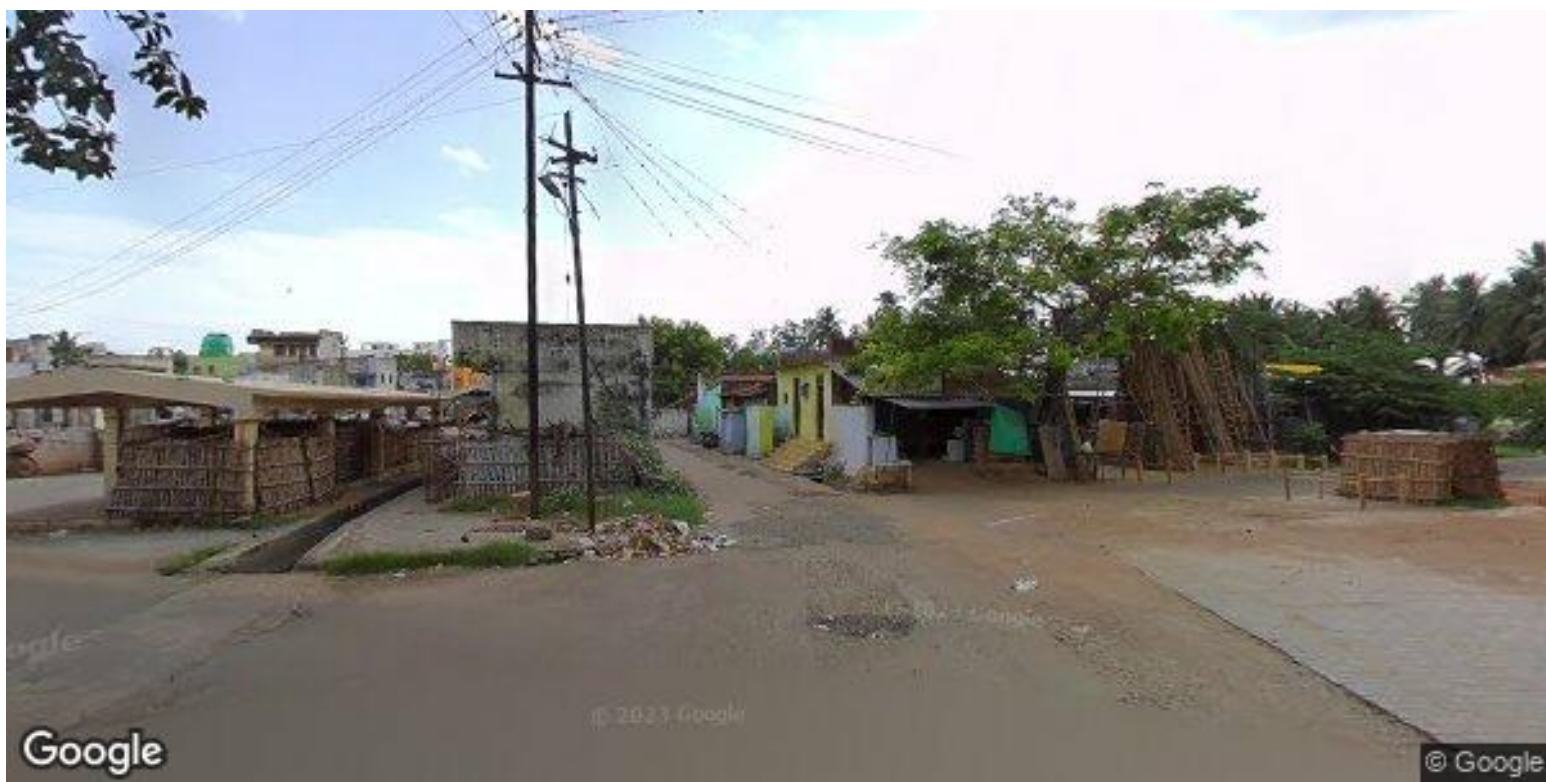
**Risk Type:** Turn  
**Risk Level:** High  
**Speed Limit:** 15 KM/Hr  
**Coordinates:** 11.69494, 77.87544

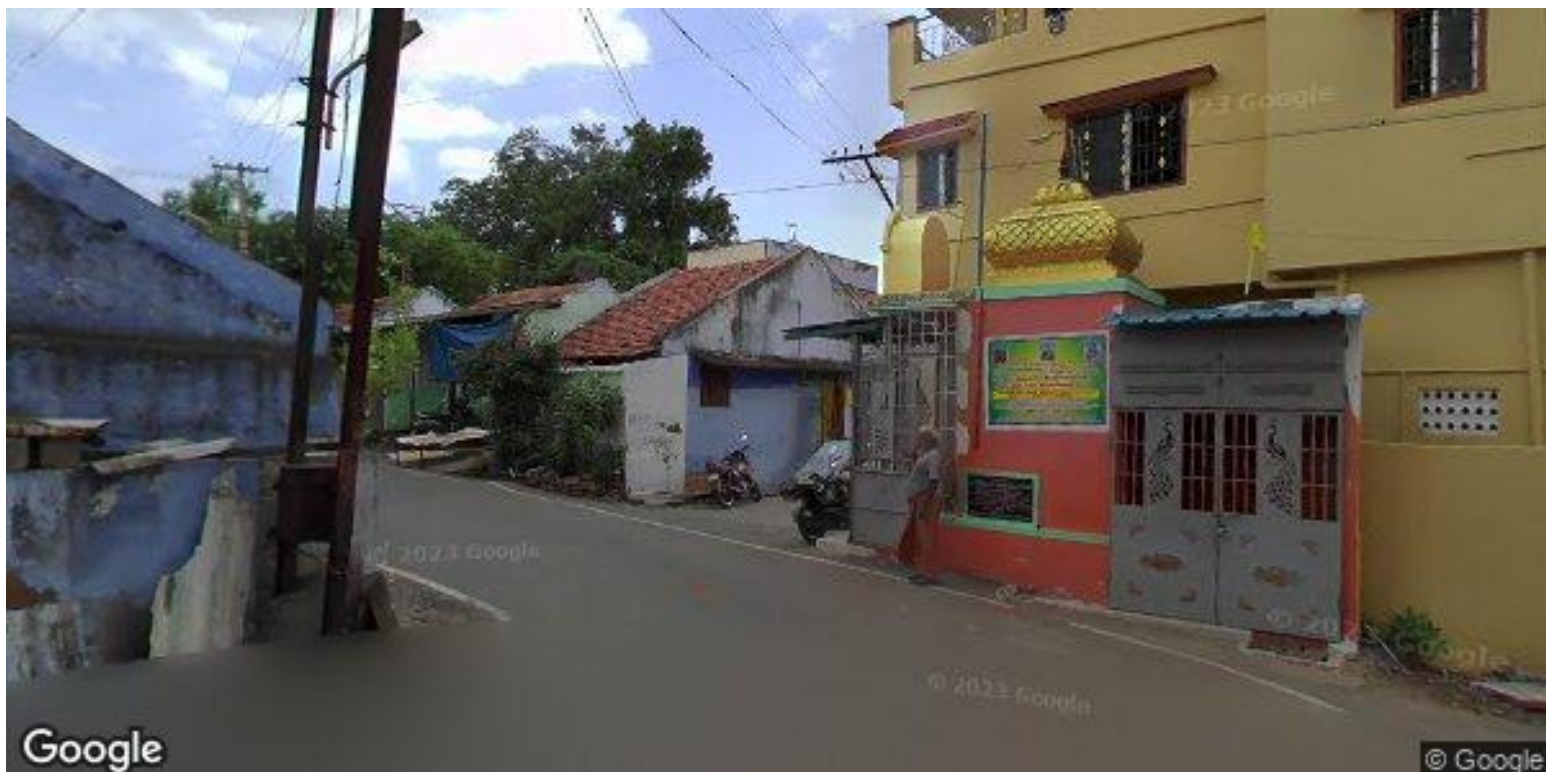
**Coordinates:** 11.69553, 77.87440

**Risk Type:** Turn

**Risk Level:** High

**Speed Limit:** 15 KM/Hr

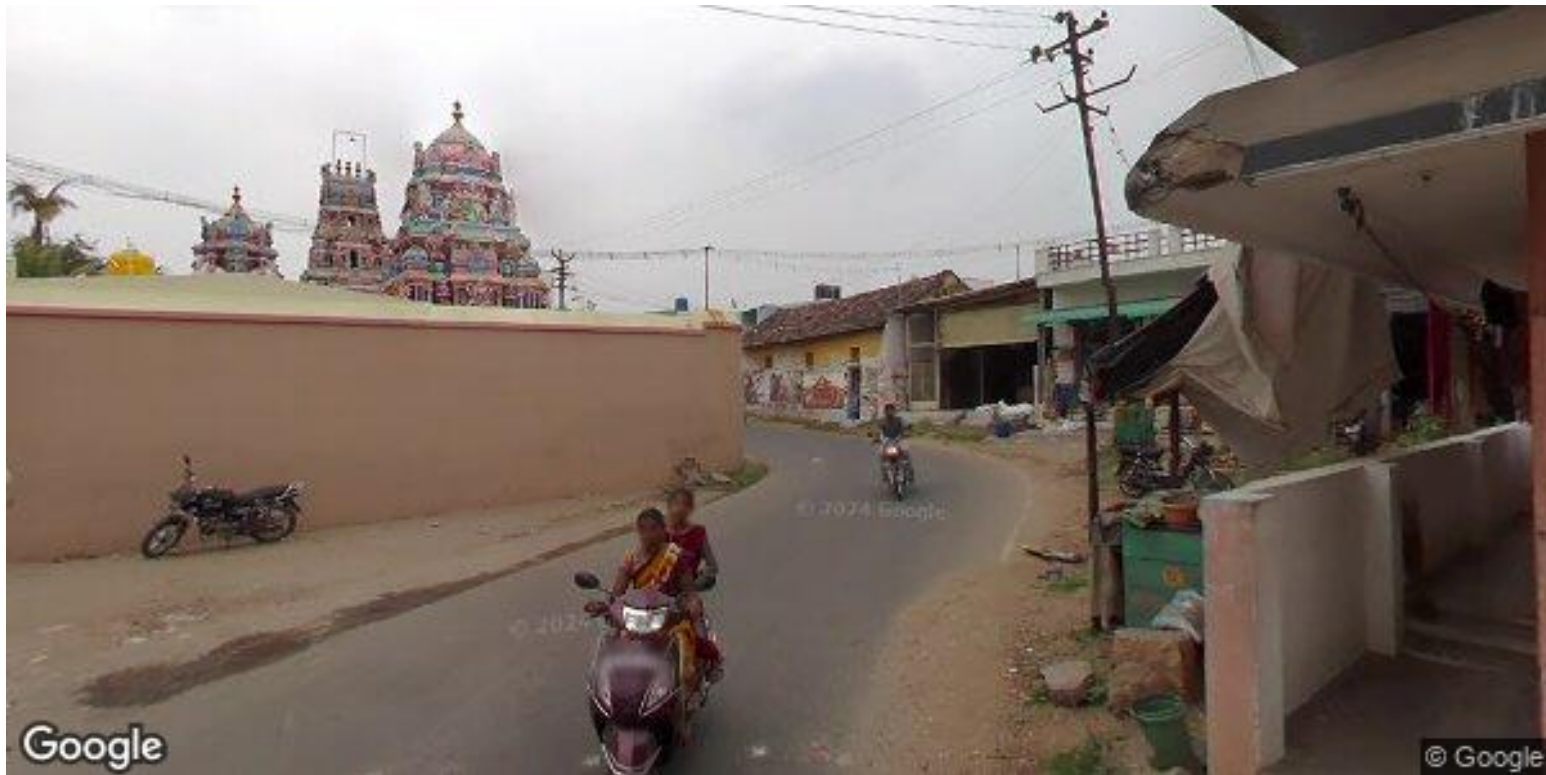
**Coordinates:** 11.69915, 77.87478

**Risk Type:** Turn

**Risk Level:** Medium

**Speed Limit:** 30 KM/Hr

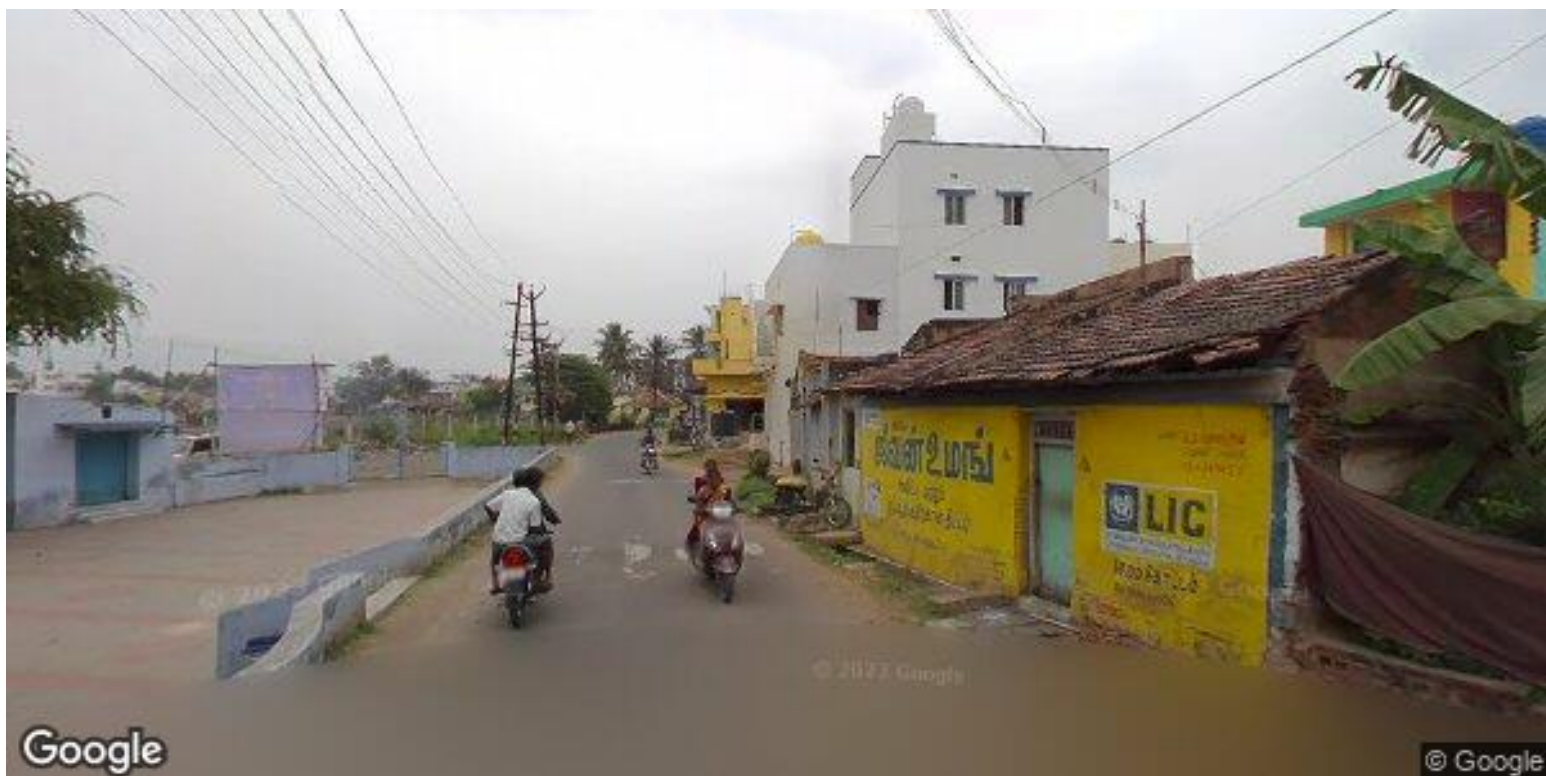
**Coordinates:** 11.69941, 77.87503

**Risk Type:** Turn

**Risk Level:** Medium

**Speed Limit:** 30 KM/Hr

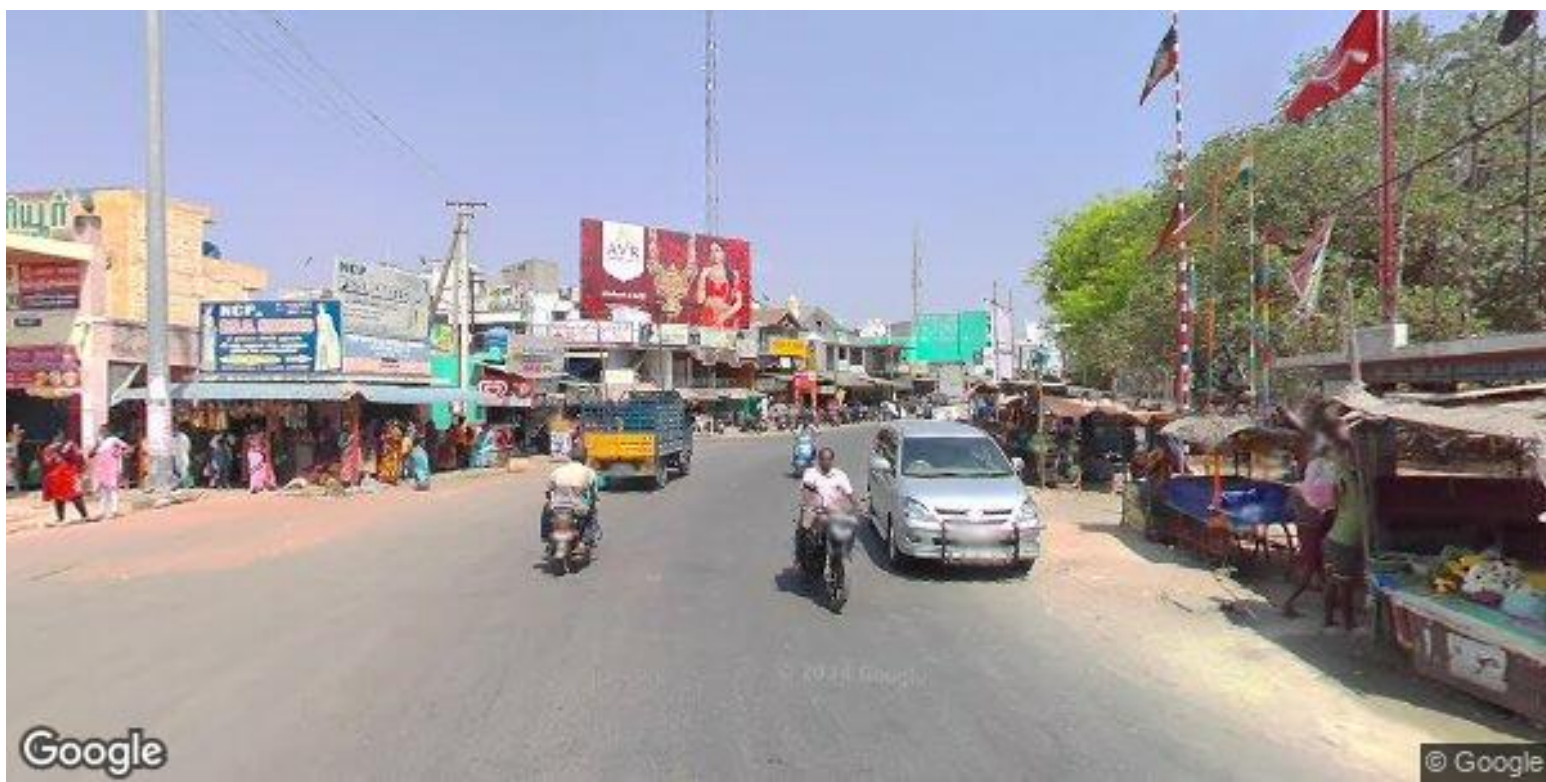
**Coordinates:** 11.76013, 77.89028

**Risk Type:** Turn

**Risk Level:** Medium

**Speed Limit:** 30 KM/Hr

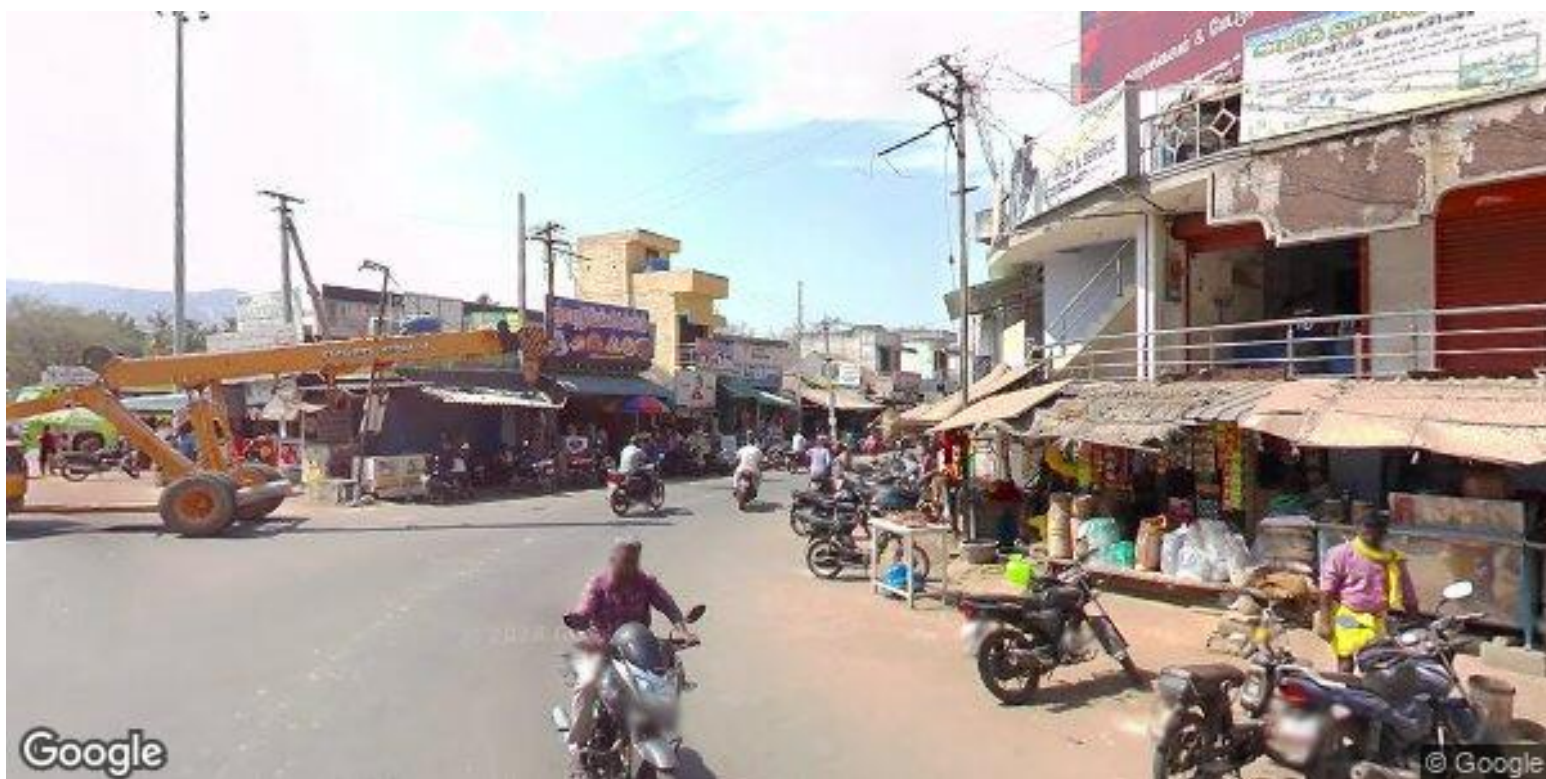
**Coordinates:** 11.76020, 77.89070

**Risk Type:** Turn

**Risk Level:** Medium

**Speed Limit:** 30 KM/Hr

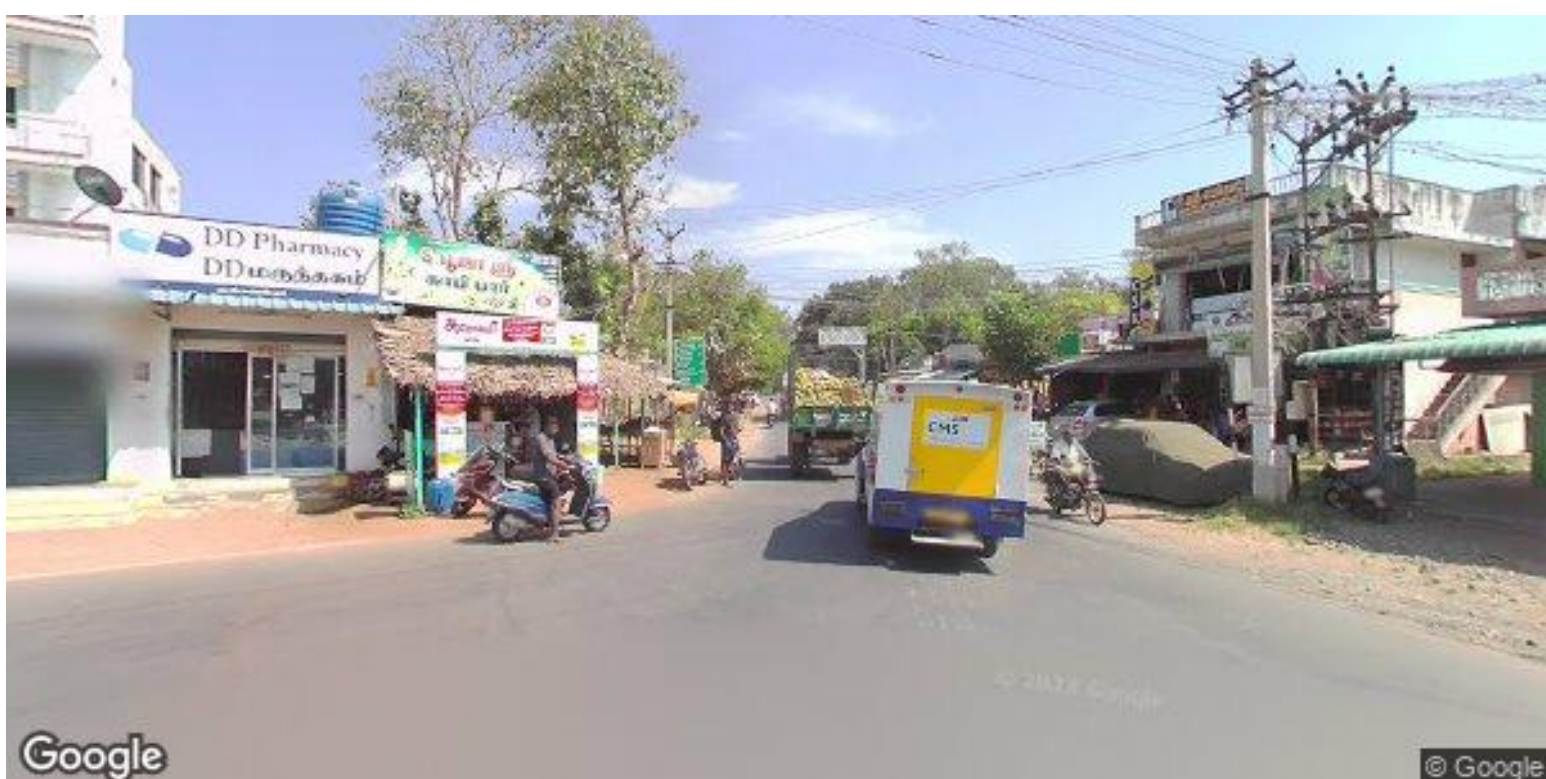
**Risk Type:** Blind Spot  
**Risk Level:** Blind Spot  
**Speed Limit:** 10 KM/Hr  
**Coordinates:** 11.75947, 77.89214

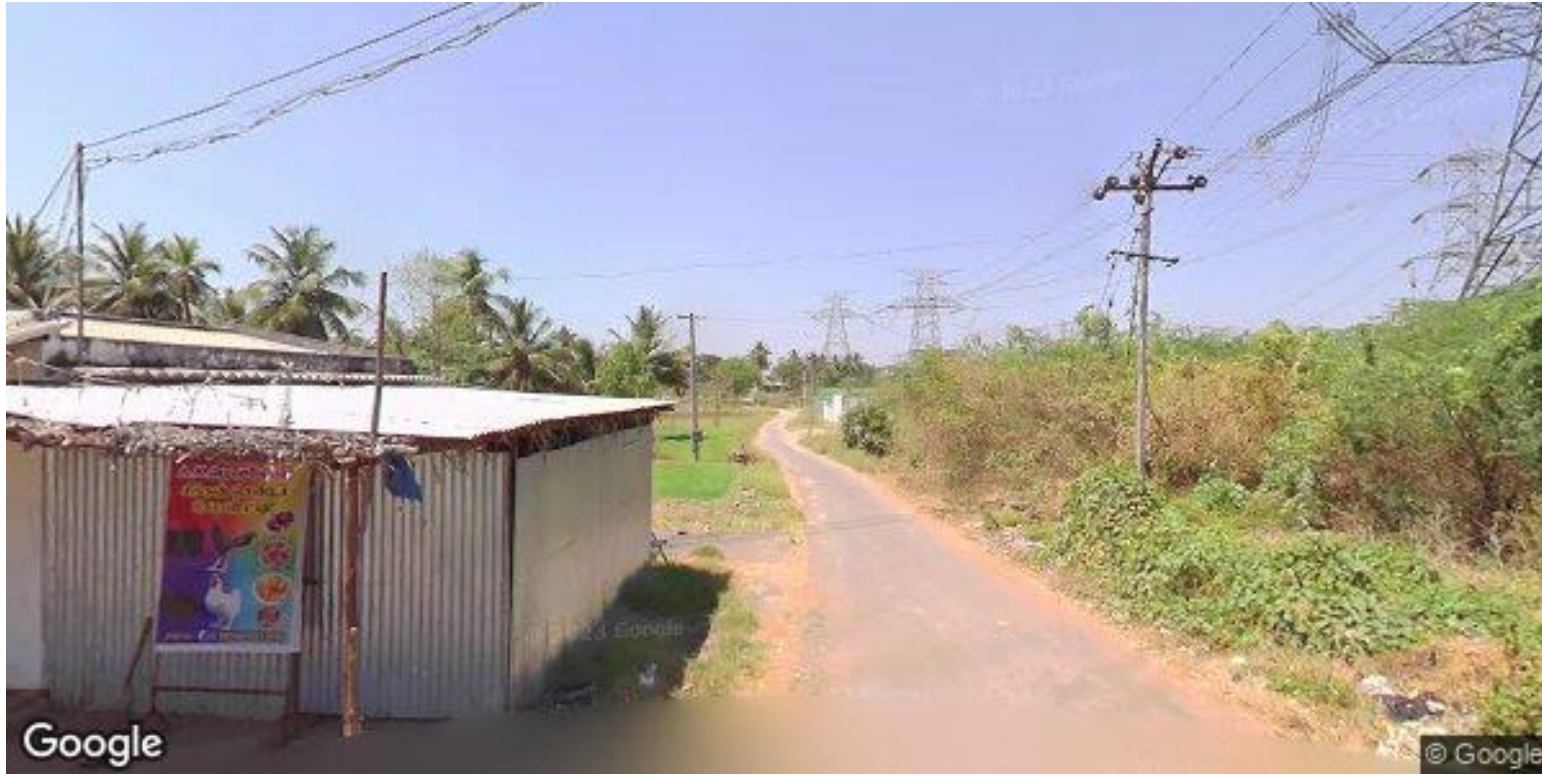
**Risk Type:** Turn  
**Risk Level:** High  
**Speed Limit:** 15 KM/Hr  
**Coordinates:** 11.81889, 77.93336
