# IndianOil

## JOURNEY RISK MANAGEMENT (JRM) STUDY

### Salem Terminal to A.S. FUEL ZONE

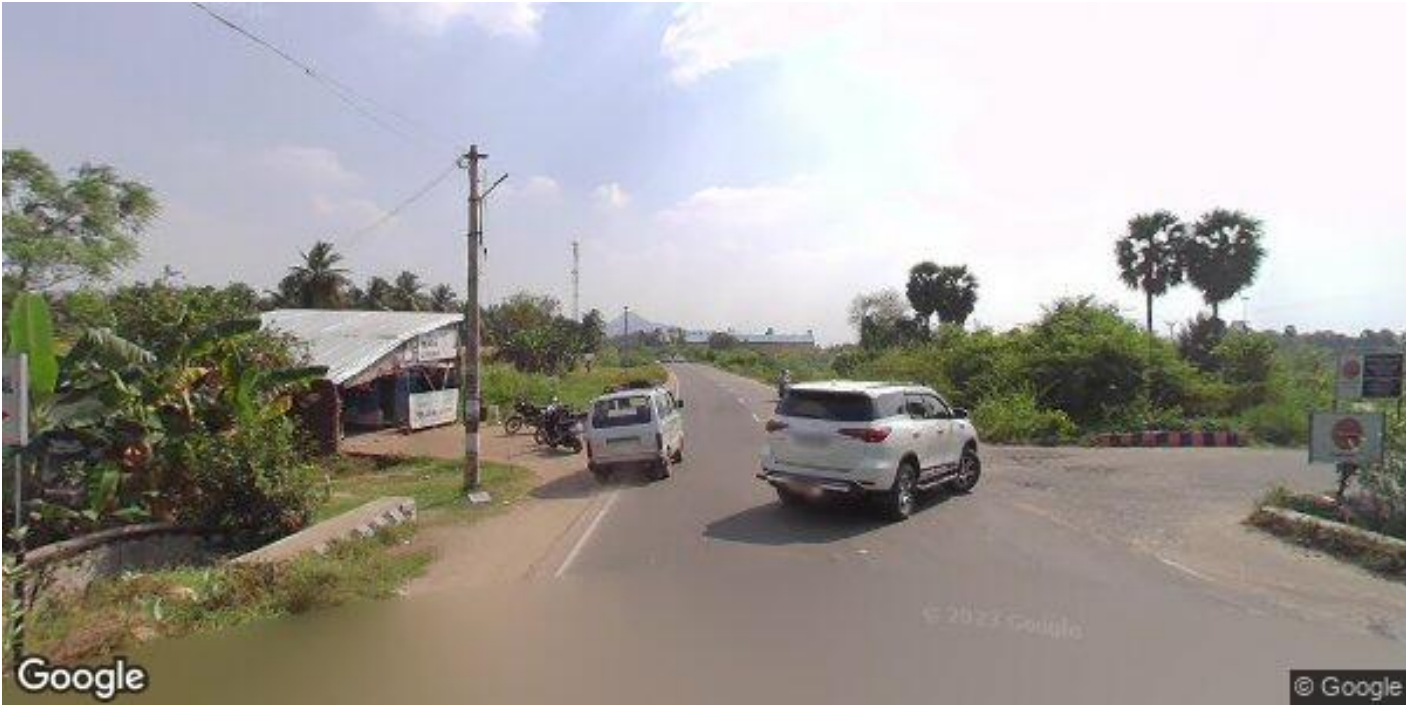
Risk Type: Turn  
Risk Level: High  
Speed Limit: 15 KM/Hr  
Coordinates: 11.44029, 77.87544

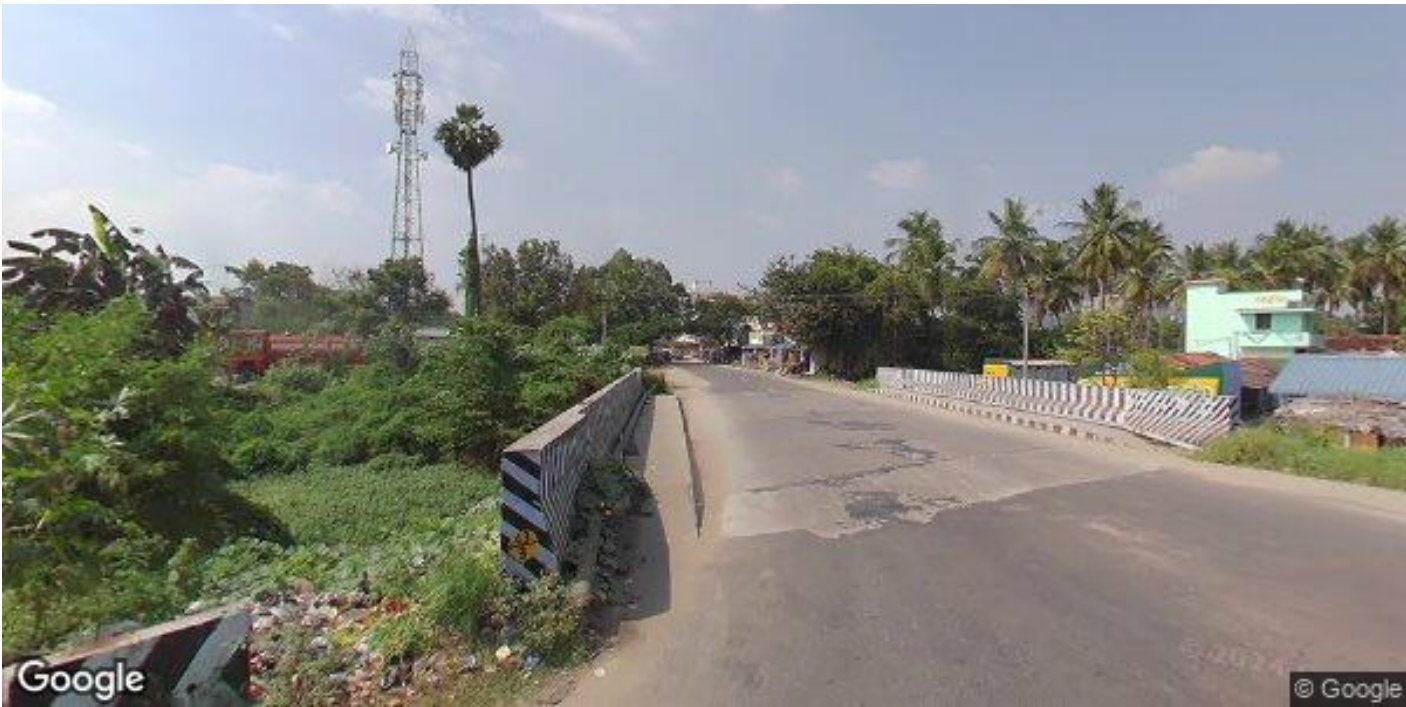
Risk Type: Turn  
Risk Level: High

Speed Limit: 15 KM/Hr  
Coordinates: 11.44900, 77.87406

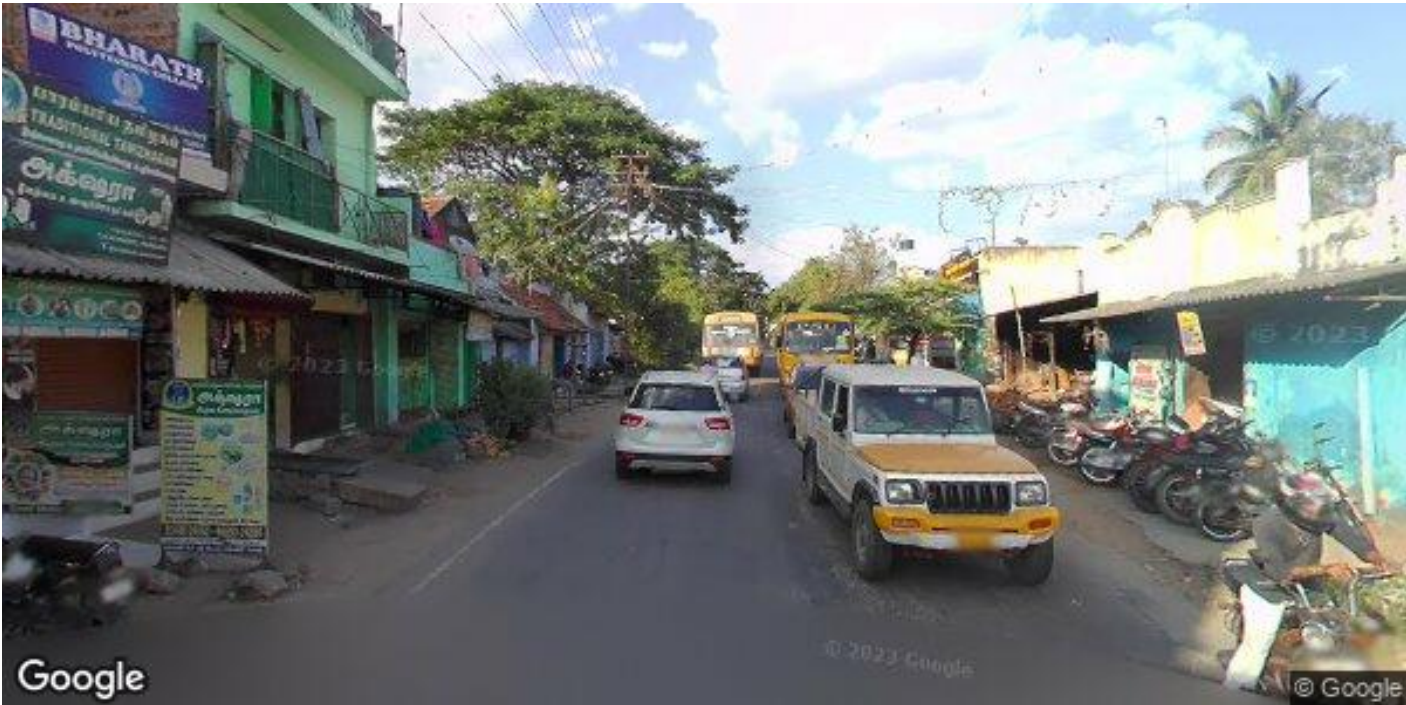
Risk Type: Turn  
Risk Level: High  
Speed Limit: 15 KM/Hr  
Coordinates: 11.45028, 77.87202

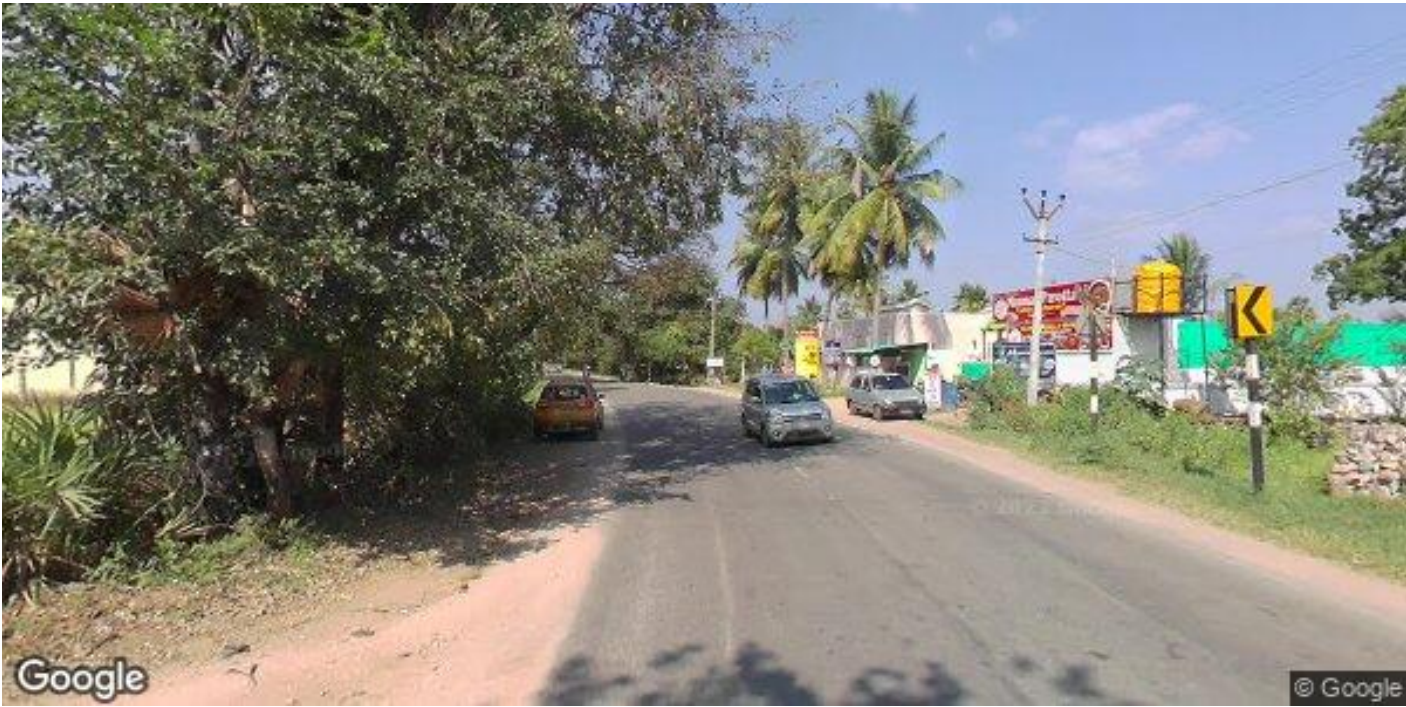
Risk Type: Turn  
Risk Level: Medium  
Speed Limit: 30 KM/Hr  
Coordinates: 11.45309, 77.87325

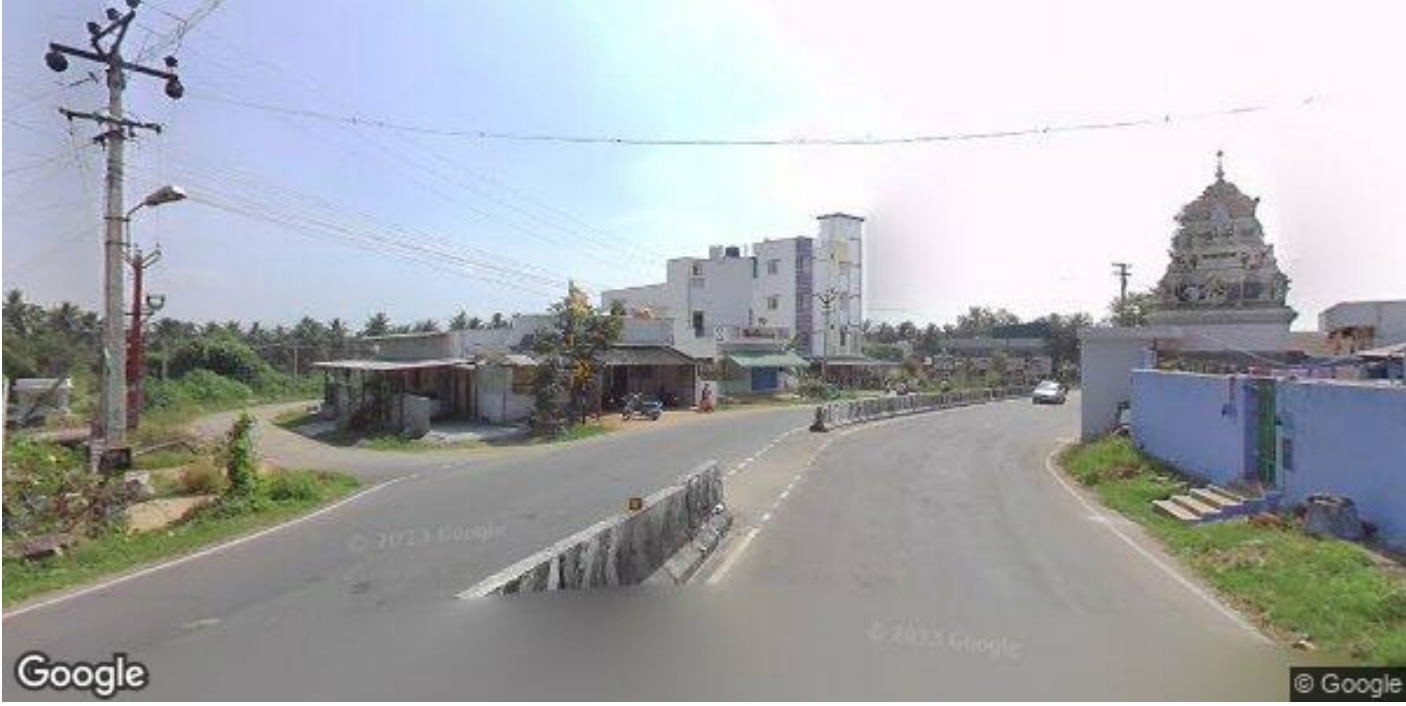
**Risk Type:** Turn  
**Risk Level:** Medium  
**Speed Limit:** 30 KM/Hr  
**Coordinates:** 11.46400, 77.87323

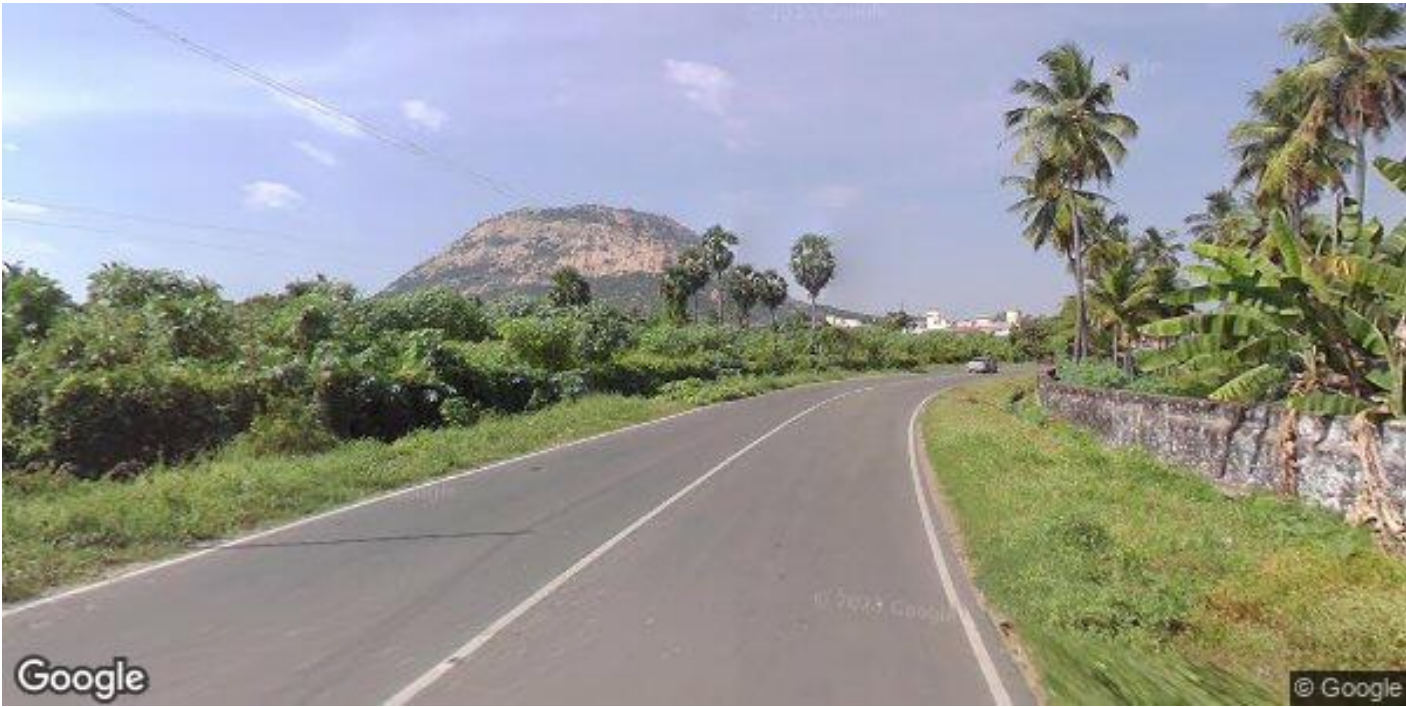
**Risk Type:** Turn  
**Risk Level:** Medium  
**Speed Limit:** 30 KM/Hr  
**Coordinates:** 11.46765, 77.87037

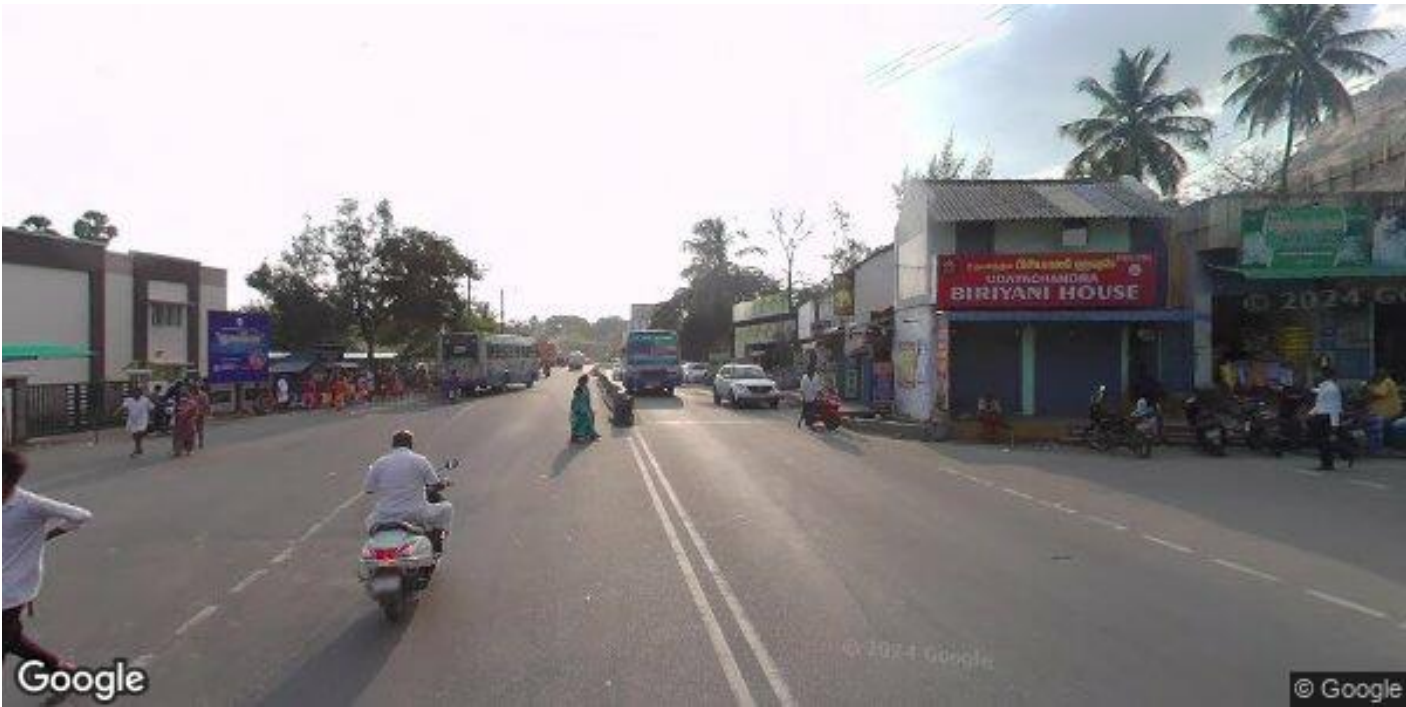
**Risk Type:** Turn  
**Risk Level:** High  
**Speed Limit:** 15 KM/Hr  
**Coordinates:** 11.47403, 77.86841

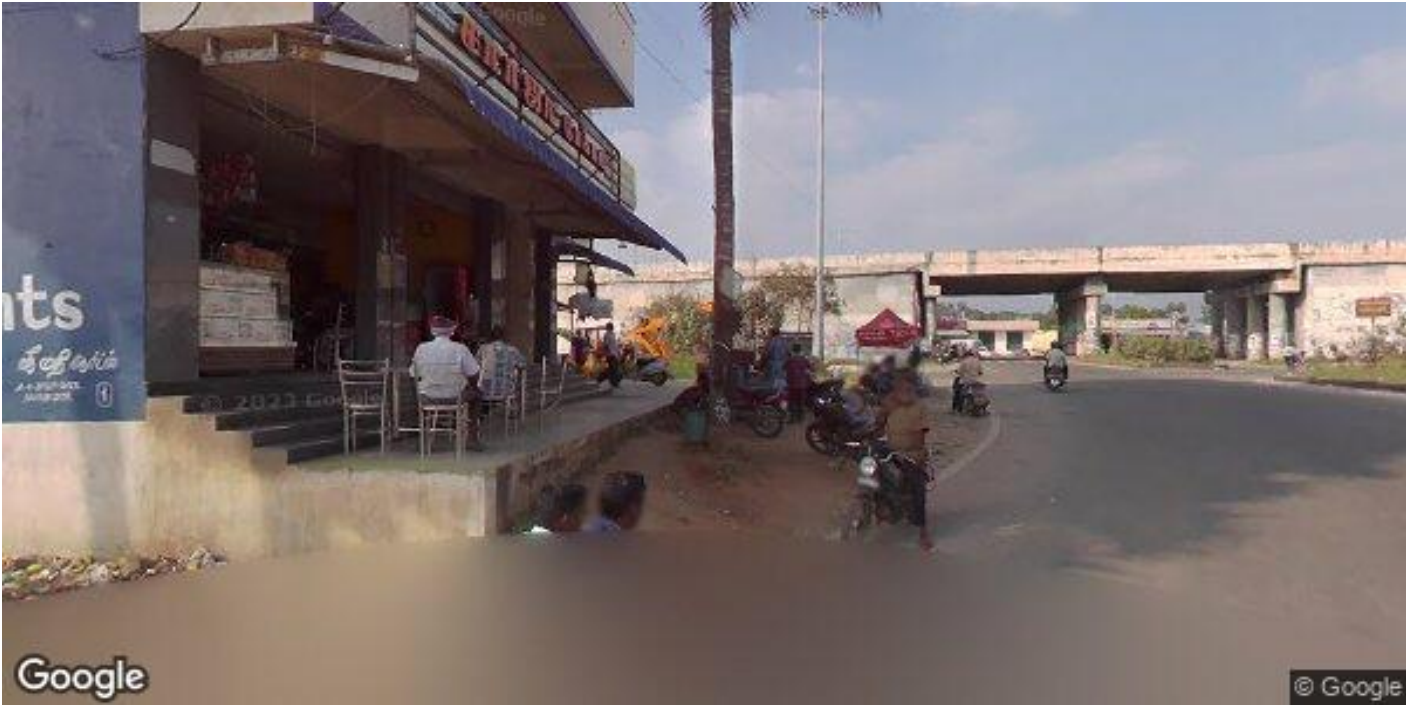
**Risk Type:** Turn  
**Risk Level:** High  
**Speed Limit:** 15 KM/Hr  
**Coordinates:** 11.49149, 77.89601

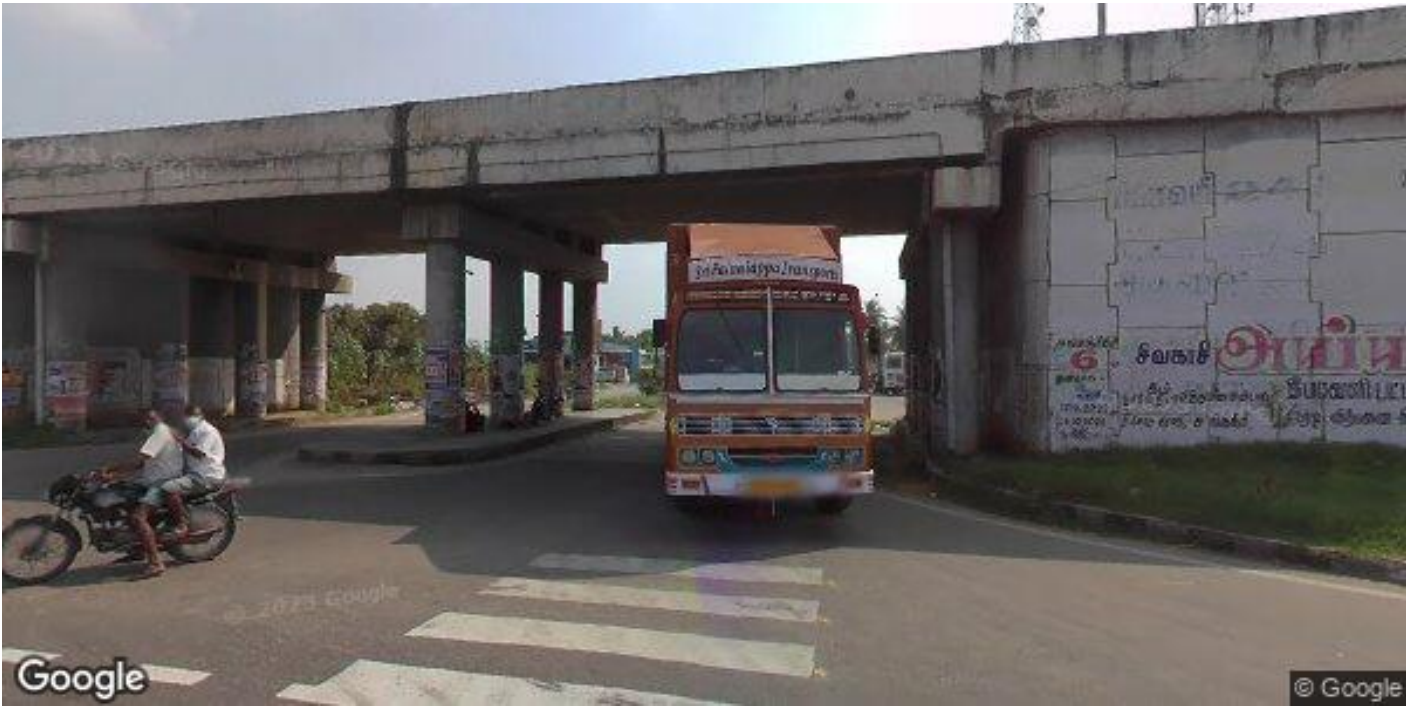
**Risk Type:** Turn  
**Risk Level:** High  
**Speed Limit:** 15 KM/Hr  
**Coordinates:** 11.49224, 77.89601

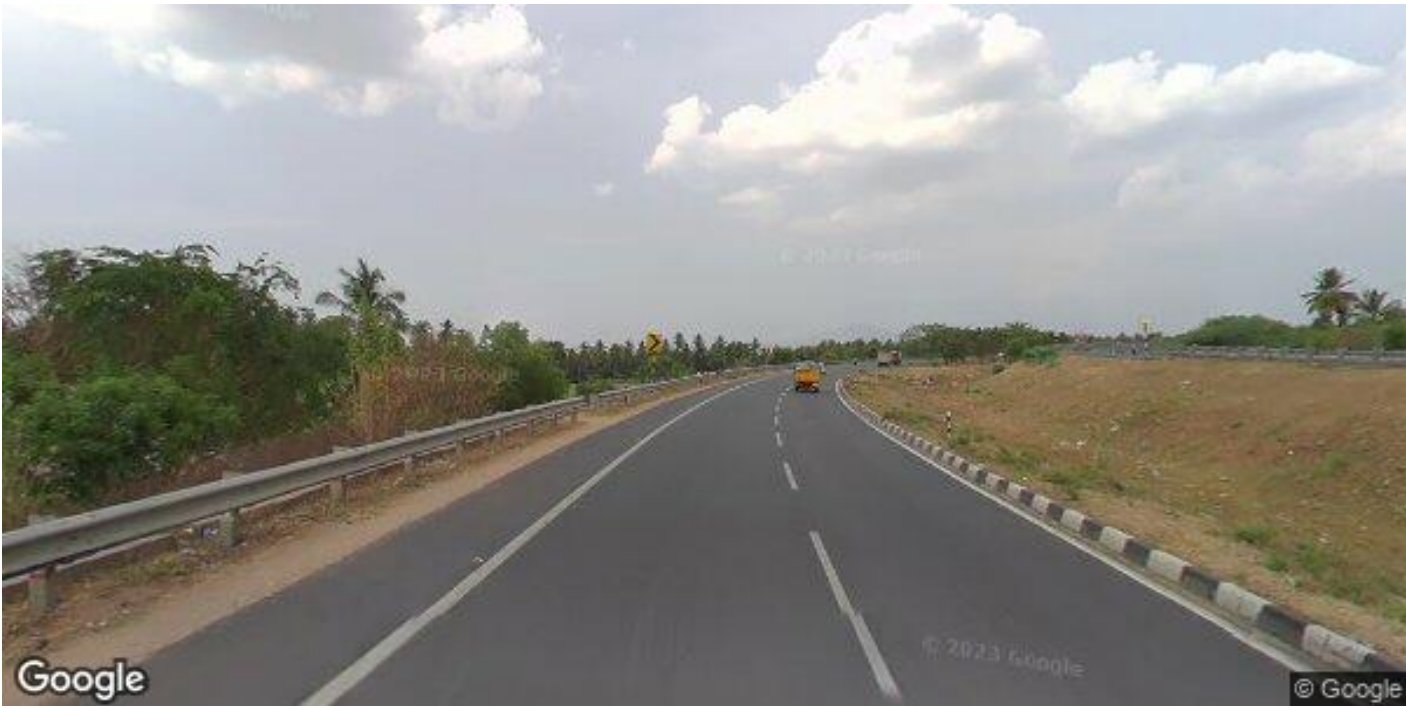
**Risk Type:** Turn  
**Risk Level:** Medium  
**Speed Limit:** 30 KM/Hr  
**Coordinates:** 11.53501, 77.95707

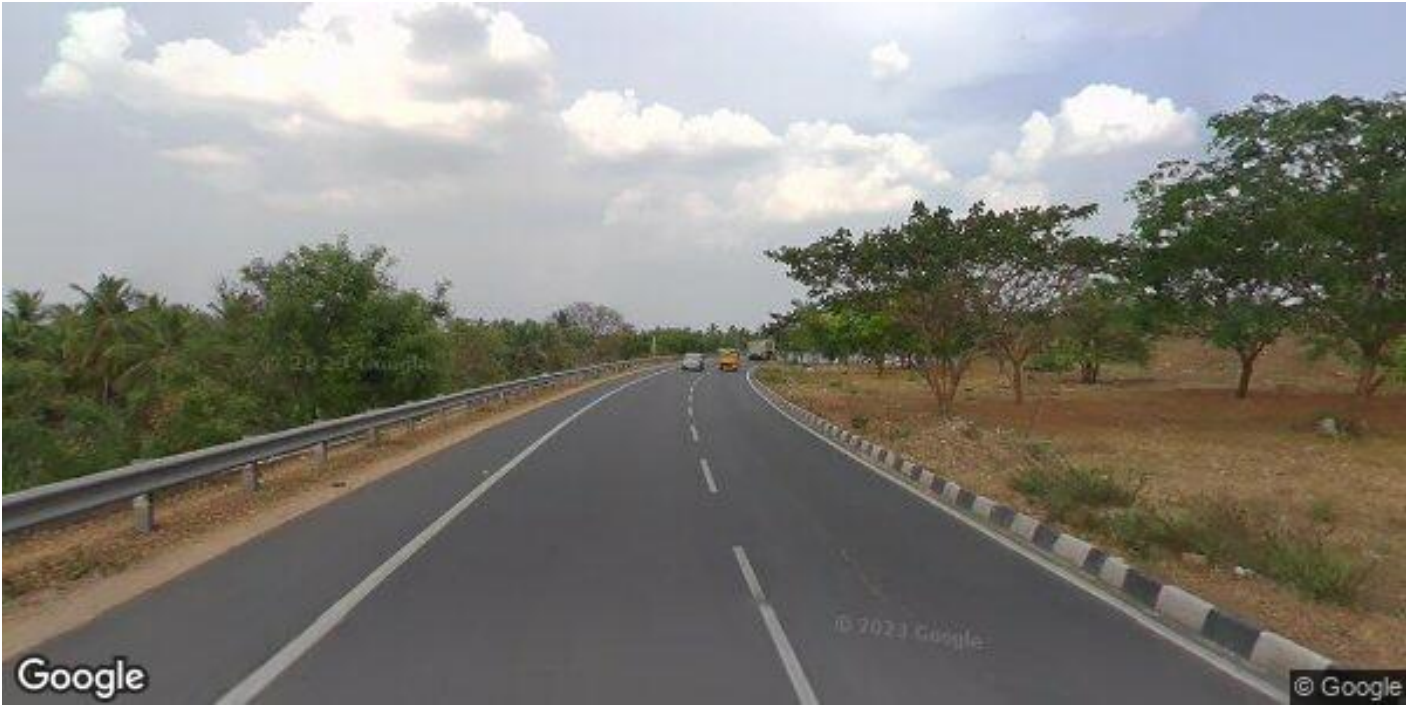
**Risk Type:** Turn  
**Risk Level:** Medium  
**Speed Limit:** 30 KM/Hr  
**Coordinates:** 11.53601, 77.95856

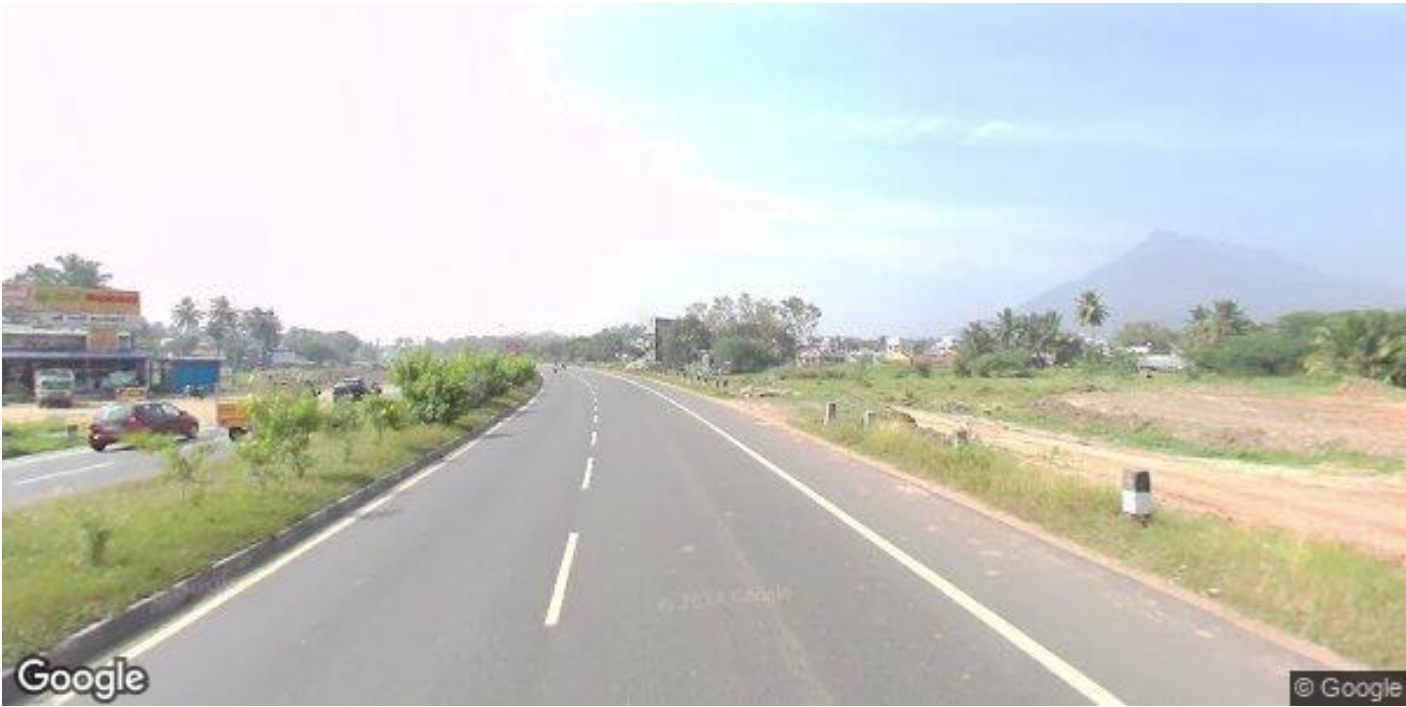
**Risk Type:** Turn  
**Risk Level:** Medium  
**Speed Limit:** 30 KM/Hr  
**Coordinates:** 11.62403, 78.10893

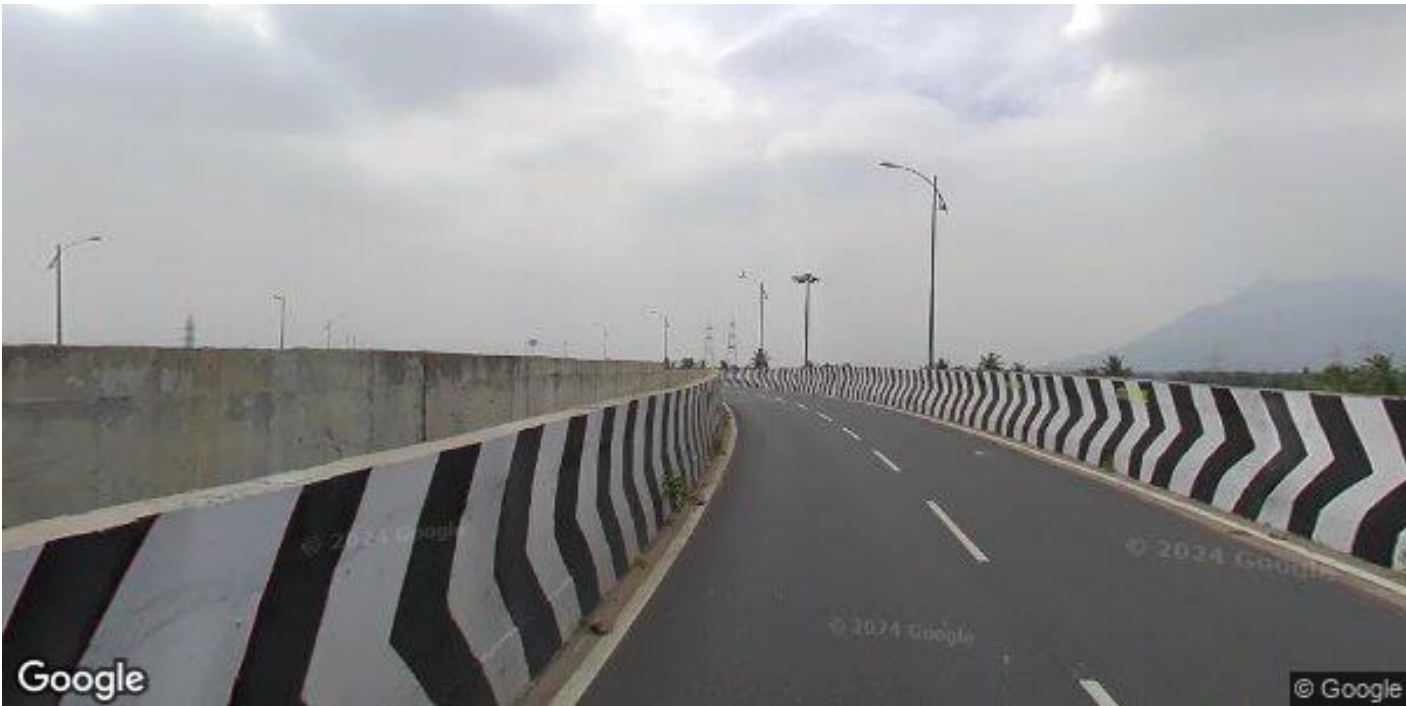
**Risk Type:** Turn  
**Risk Level:** Medium  
**Speed Limit:** 30 KM/Hr  
**Coordinates:** 11.64180, 78.11808

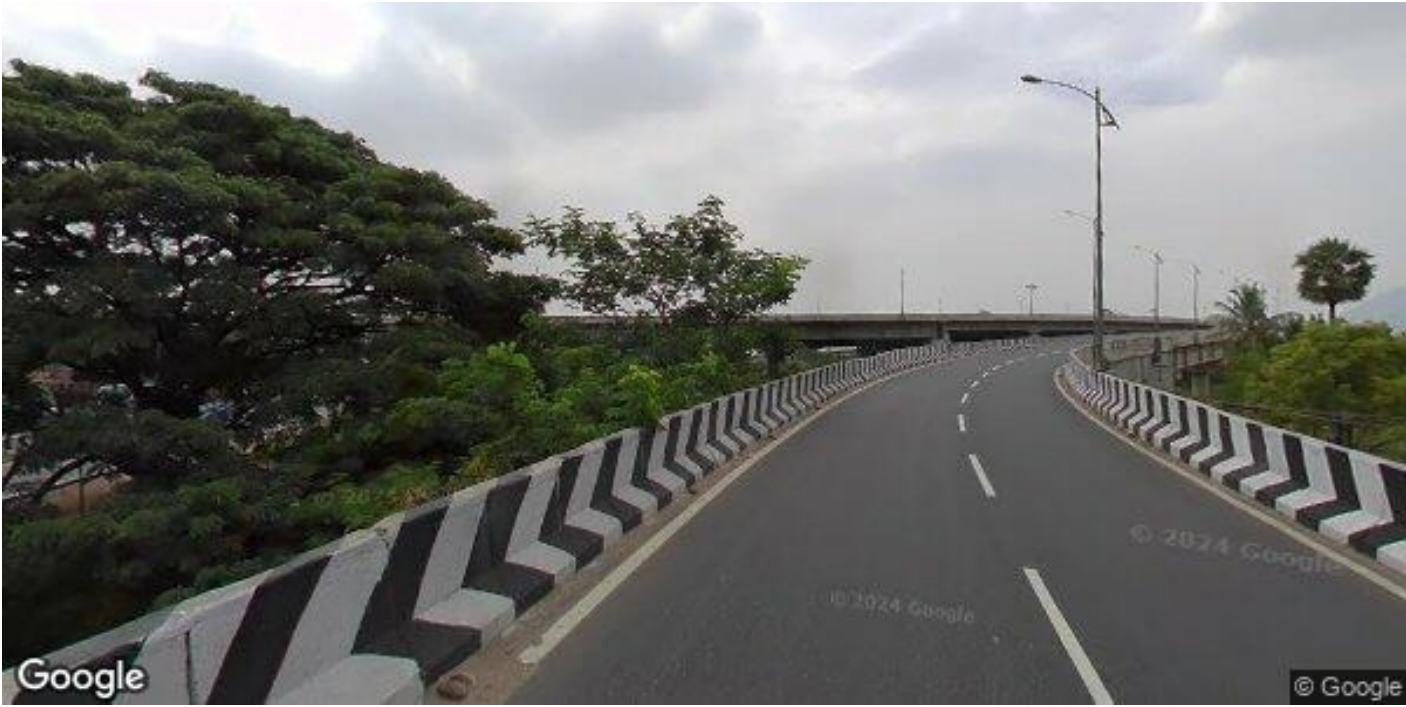
**Risk Type:** Turn  
**Risk Level:** Medium  
**Speed Limit:** 30 KM/Hr  
**Coordinates:** 11.64325, 78.11993

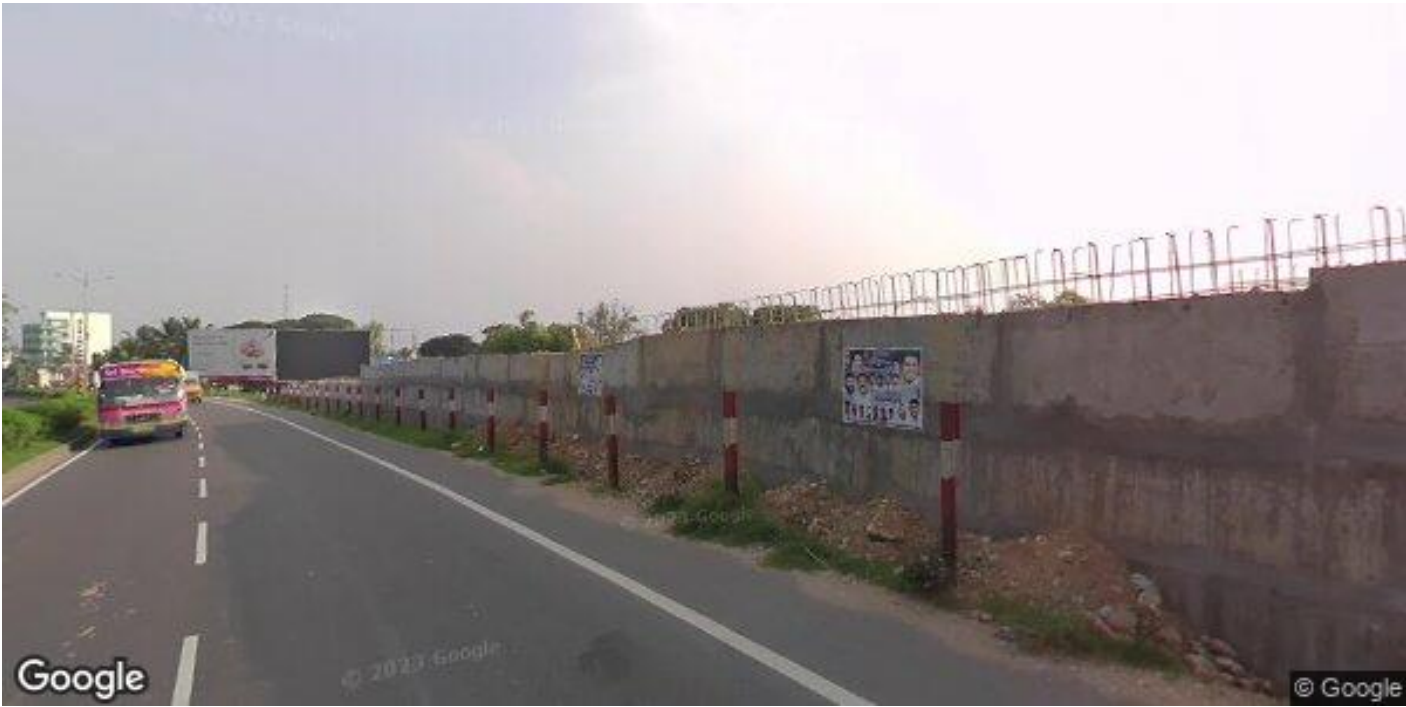
**Risk Type:** Turn  
**Risk Level:** Medium  
**Speed Limit:** 30 KM/Hr  
**Coordinates:** 11.69519, 78.10775

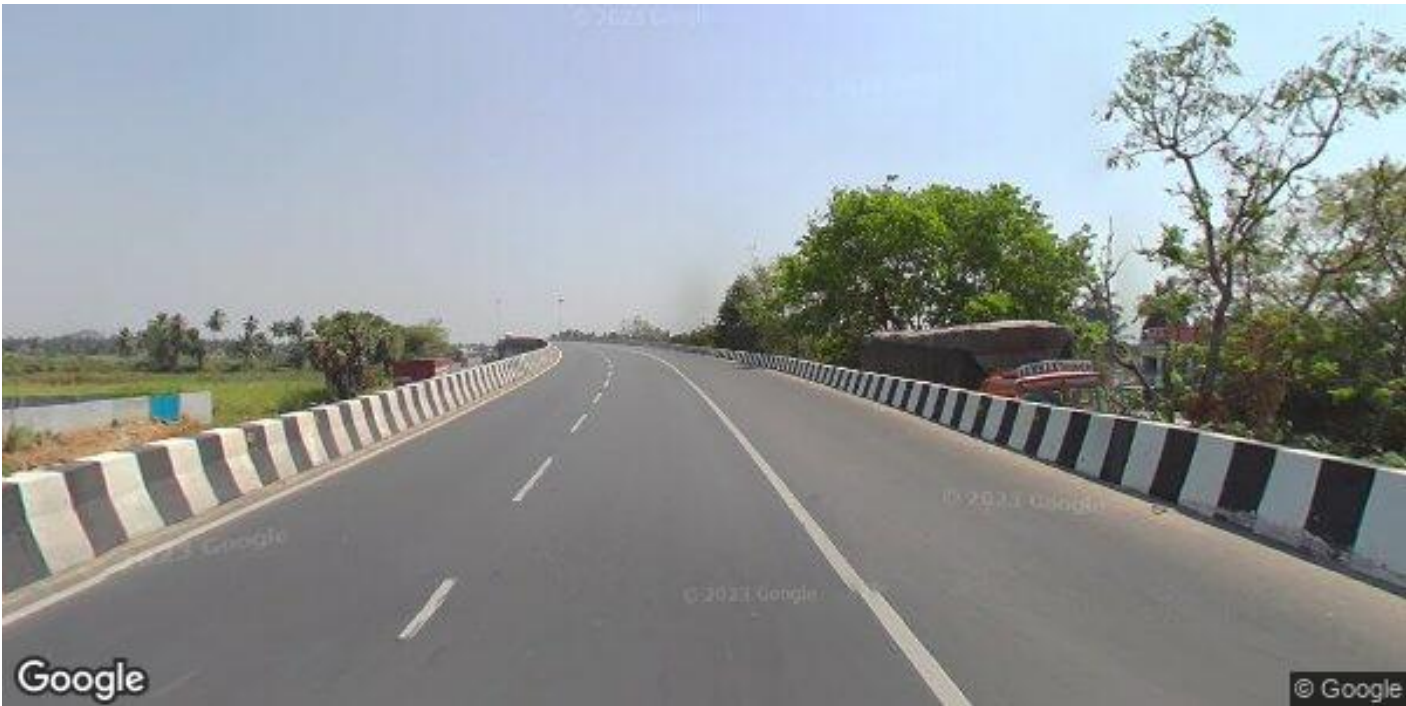
**Risk Type:** Turn  
**Risk Level:** Medium  
**Speed Limit:** 30 KM/Hr  
**Coordinates:** 11.73958, 78.05105

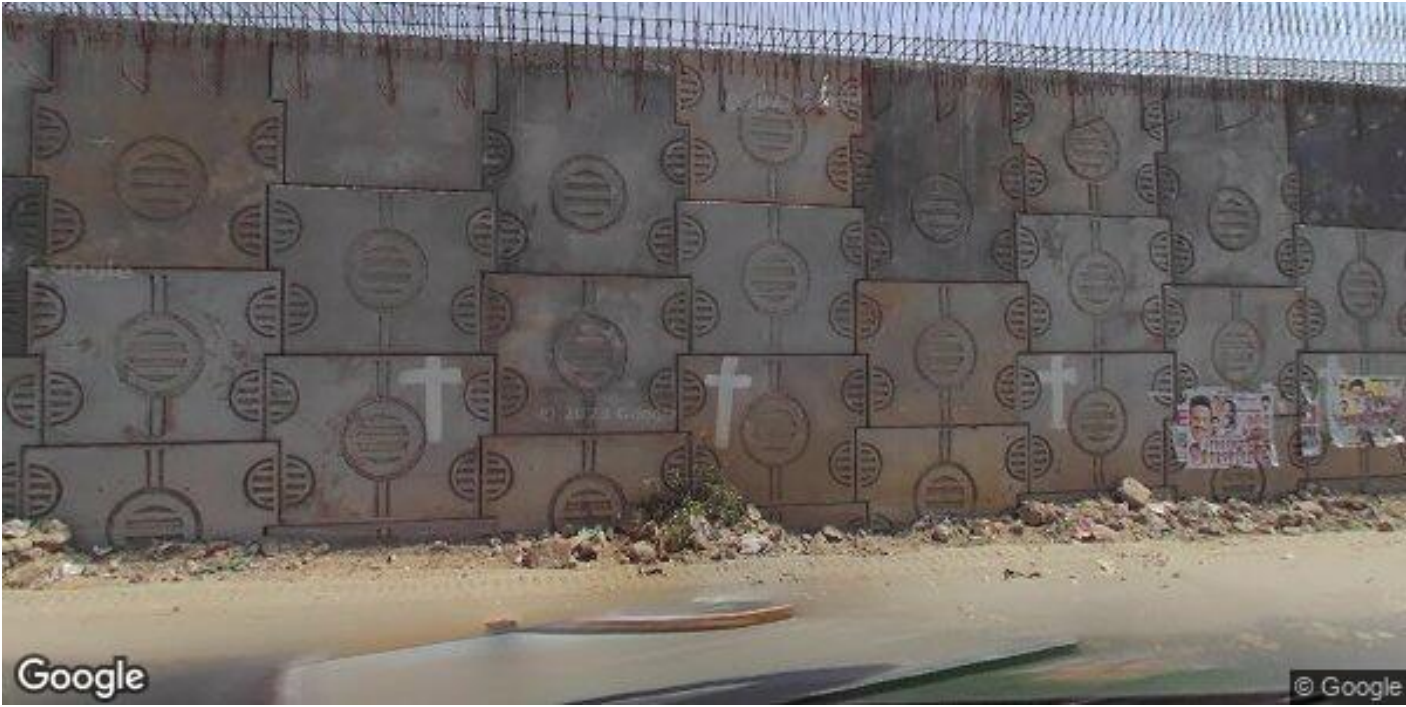
**Risk Type:** Turn  
**Risk Level:** Medium  
**Speed Limit:** 30 KM/Hr  
**Coordinates:** 11.75835, 78.05016

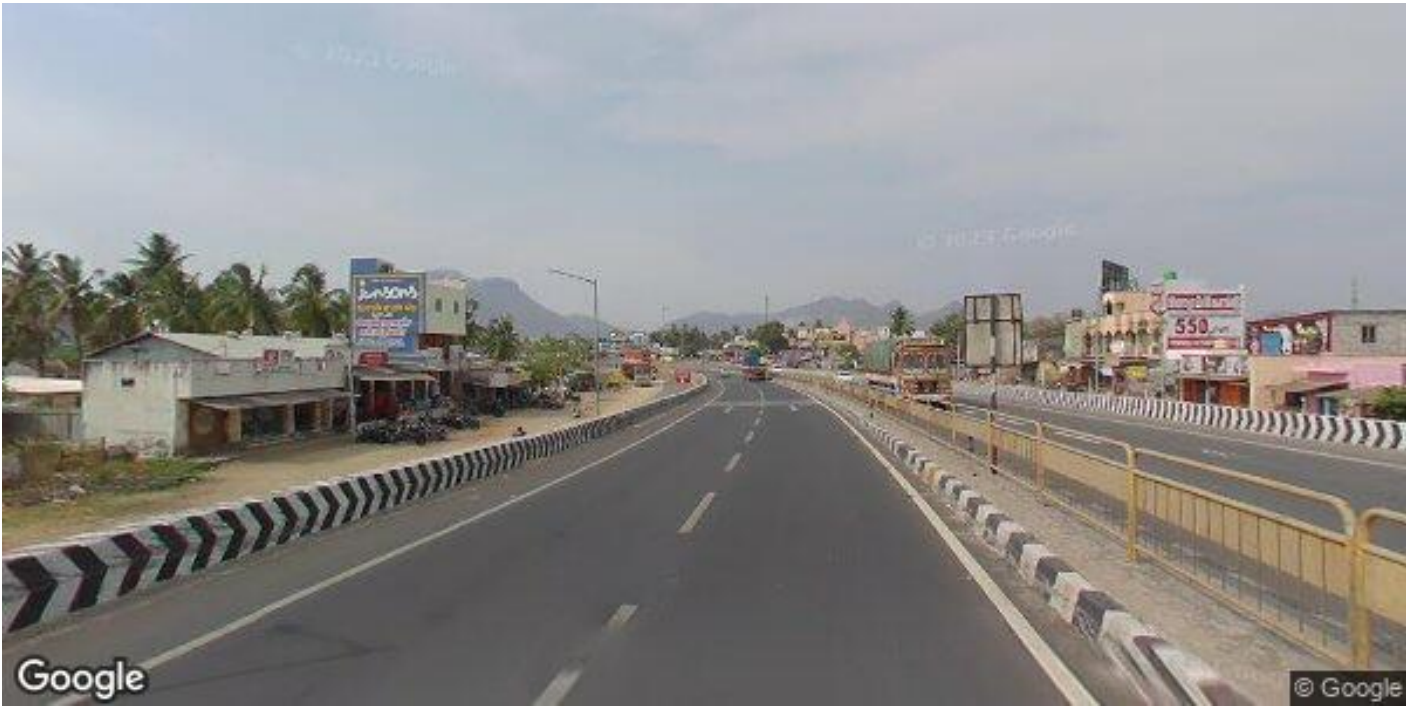
**Risk Type:** Turn  
**Risk Level:** Medium  
**Speed Limit:** 30 KM/Hr  
**Coordinates:** 11.86847, 78.08367

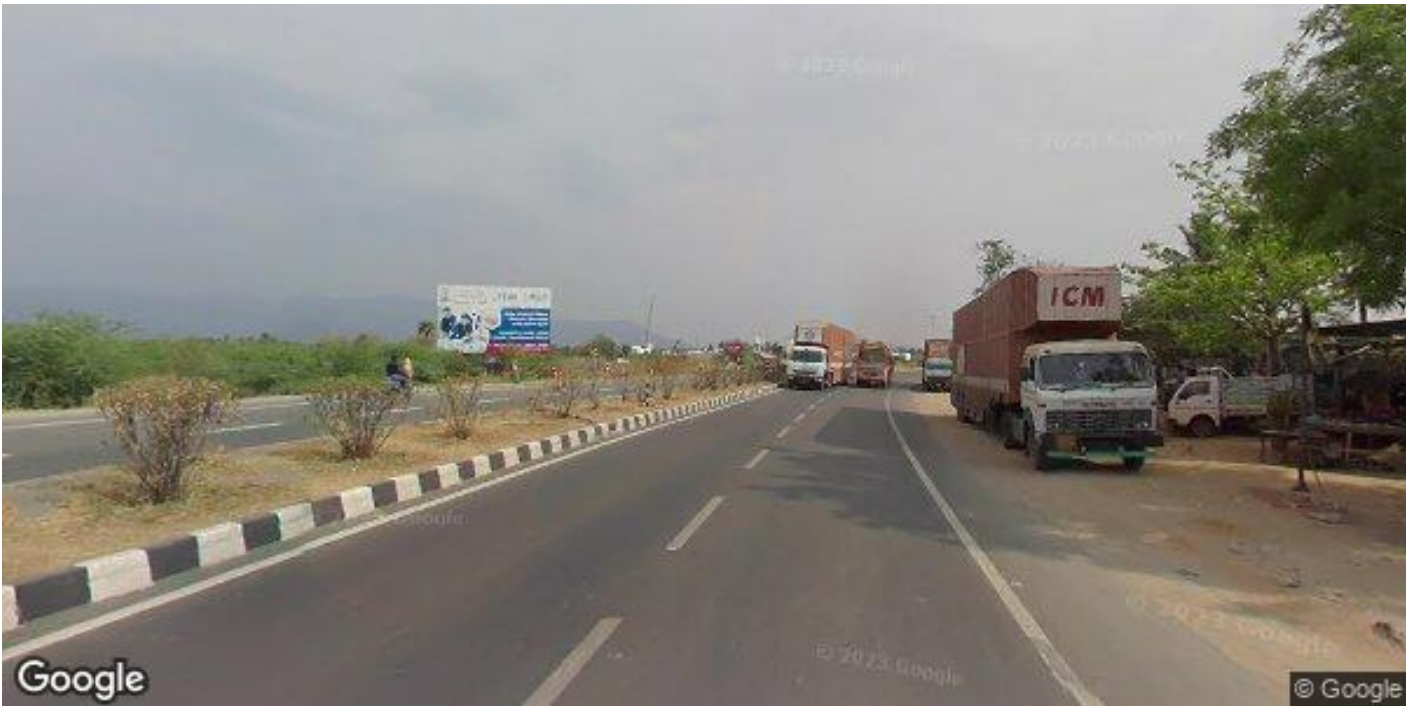
**Risk Type:** Turn  
**Risk Level:** Medium  
**Speed Limit:** 30 KM/Hr  
**Coordinates:** 11.87942, 78.08197

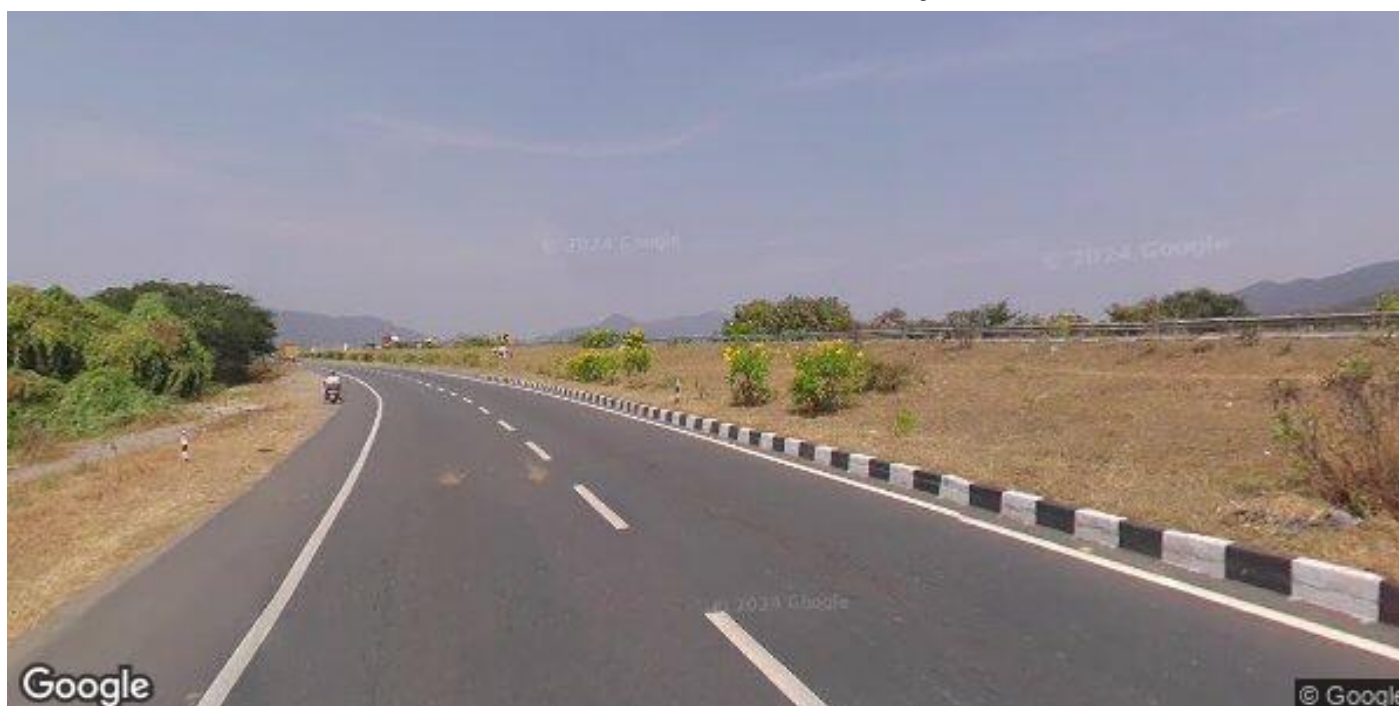
**Risk Type:** Turn  
**Risk Level:** Medium  
**Speed Limit:** 30 KM/Hr  
**Coordinates:** 11.92585, 78.06507

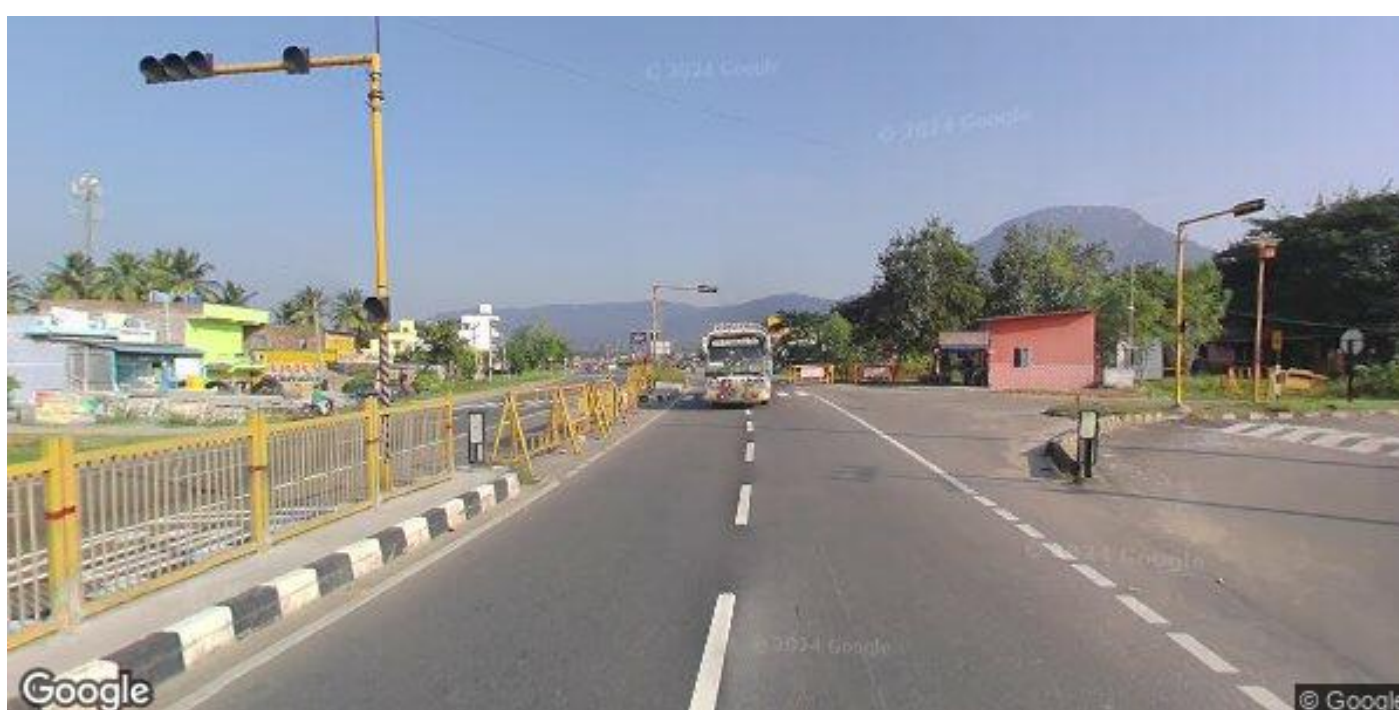
**Risk Type:** Turn  
**Risk Level:** Medium  
**Speed Limit:** 30 KM/Hr  
**Coordinates:** 11.93704, 78.05402

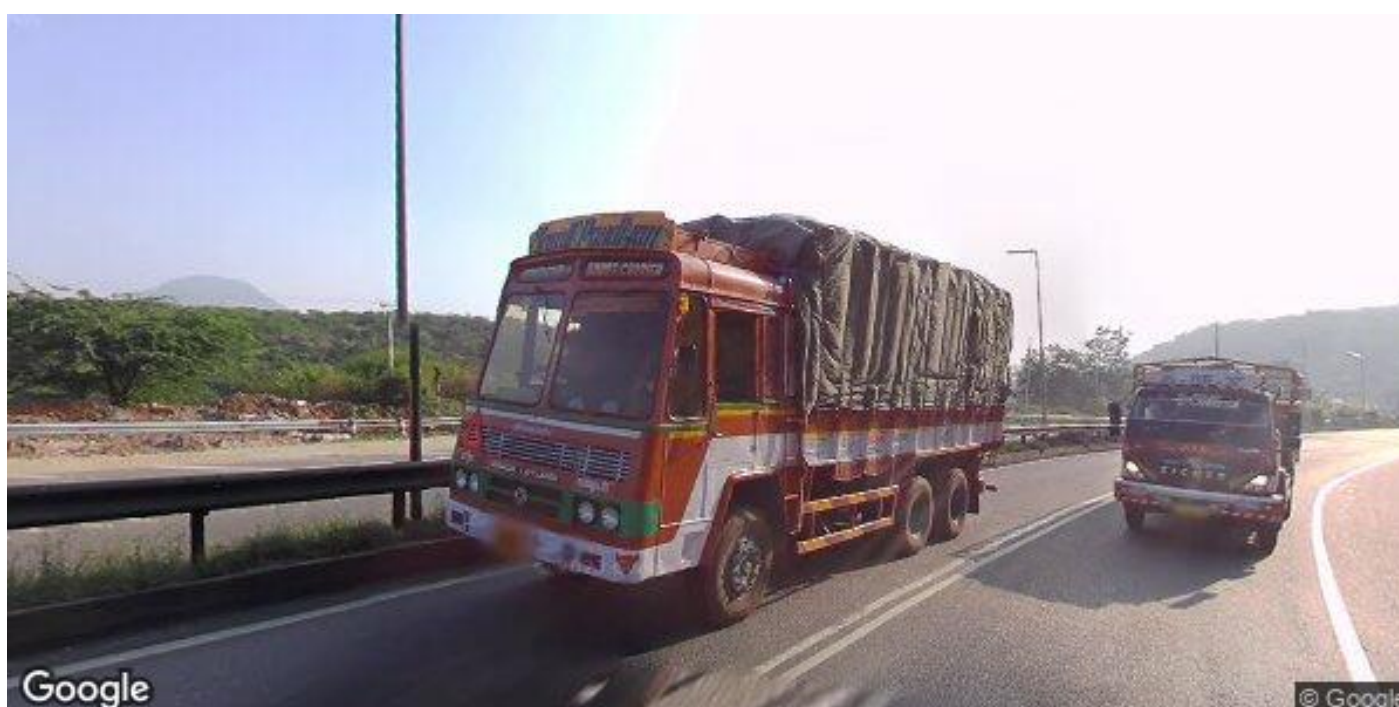
**Risk Type:** Turn  
**Risk Level:** High  
**Speed Limit:** 15 KM/Hr  
**Coordinates:** 11.95818, 78.04978
