# IndianOil

## JOURNEY RISK MANAGEMENT (JRM) STUDY

### Salem Terminal to A.S. FUEL ZONE

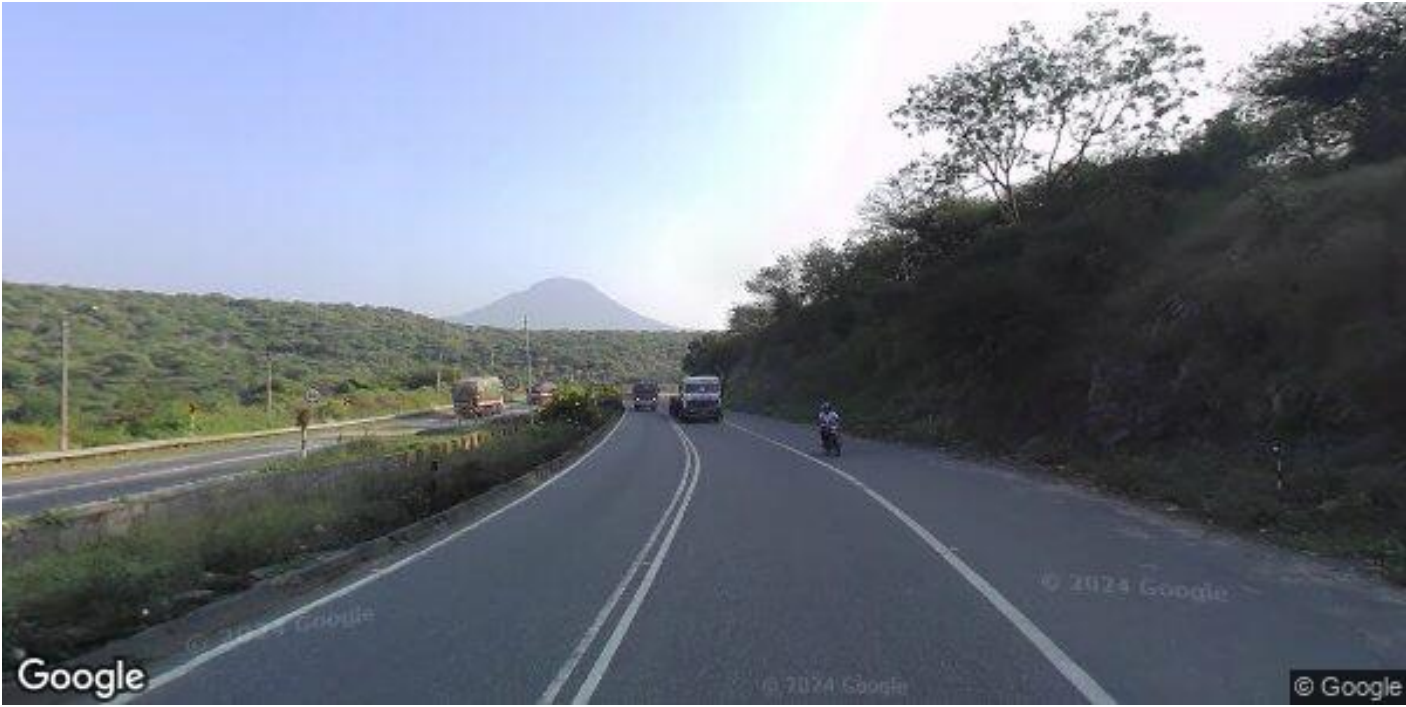
**Risk Type:** Turn  
**Risk Level:** Medium  
**Speed Limit:** 30 KM/Hr  
**Coordinates:** 11.95988, 78.04948

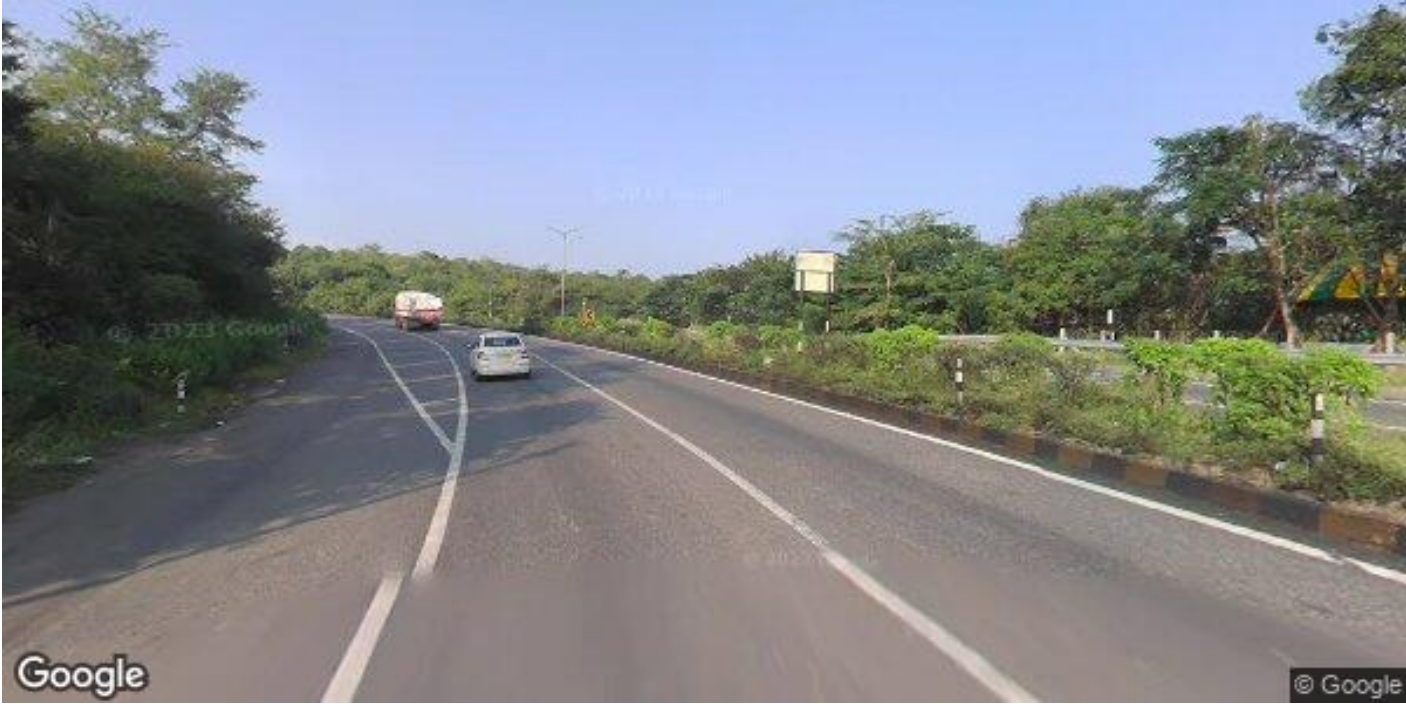
**Risk Type:** Turn  
**Risk Level:** Medium  
**Speed Limit:** 30 KM/Hr  
**Coordinates:** 11.96304, 78.05136

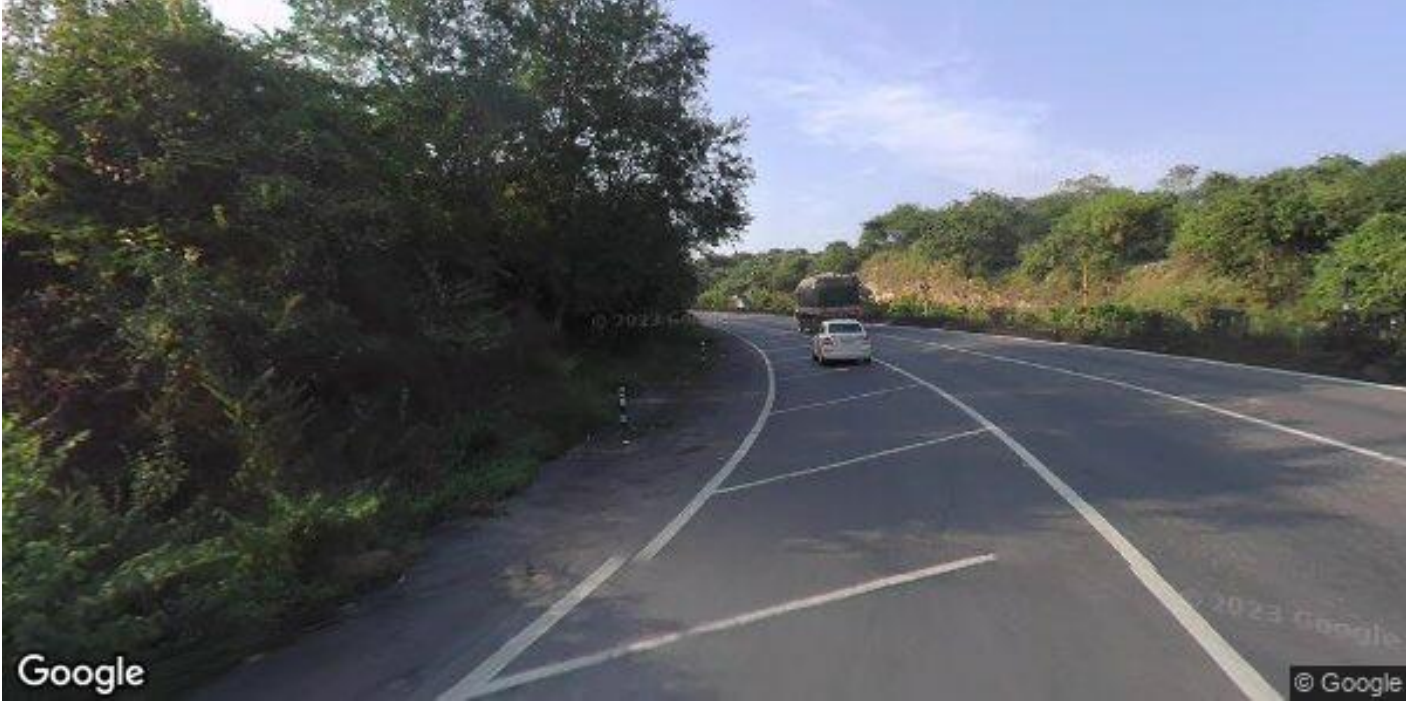
**Risk Type:** Turn  
**Risk Level:** High  
**Speed Limit:** 15 KM/Hr  
**Coordinates:** 11.96399, 78.05135

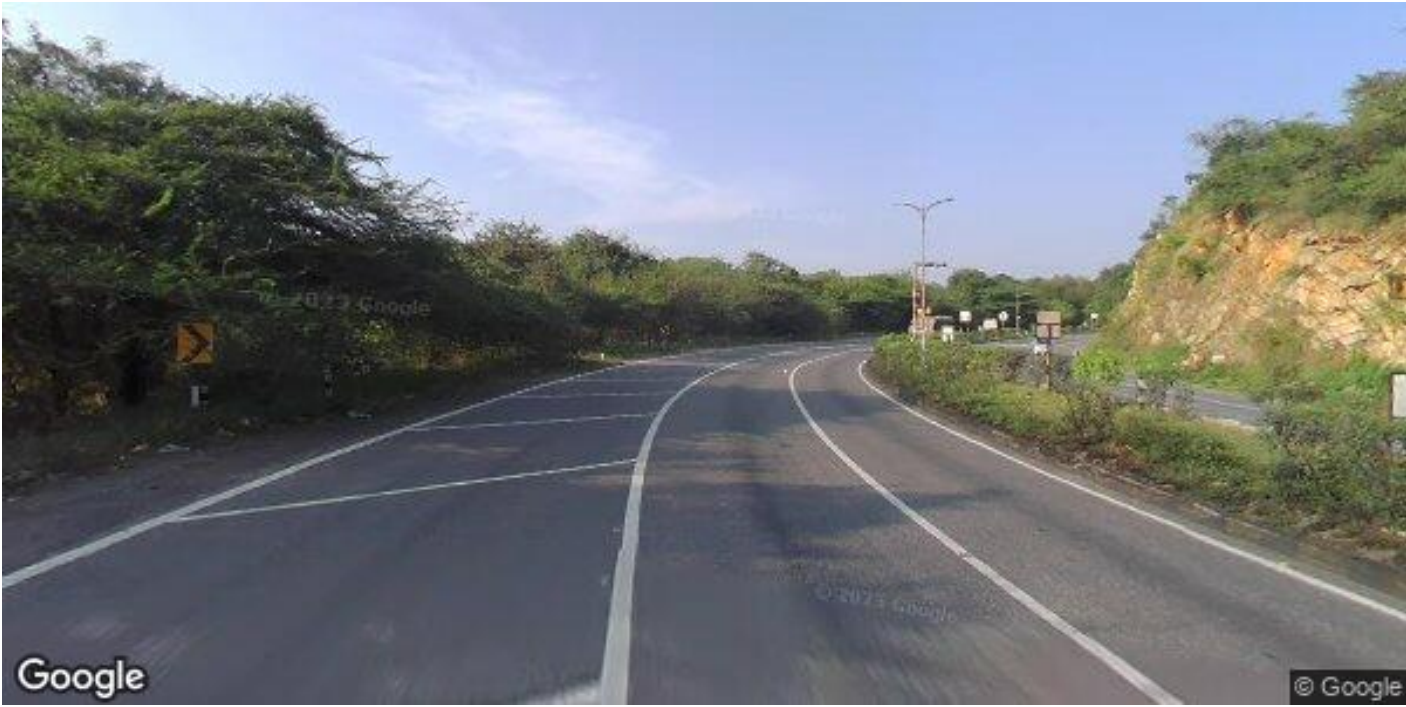
**Risk Type:** Turn  
**Risk Level:** High  
**Speed Limit:** 15 KM/Hr  
**Coordinates:** 11.96580, 78.04923

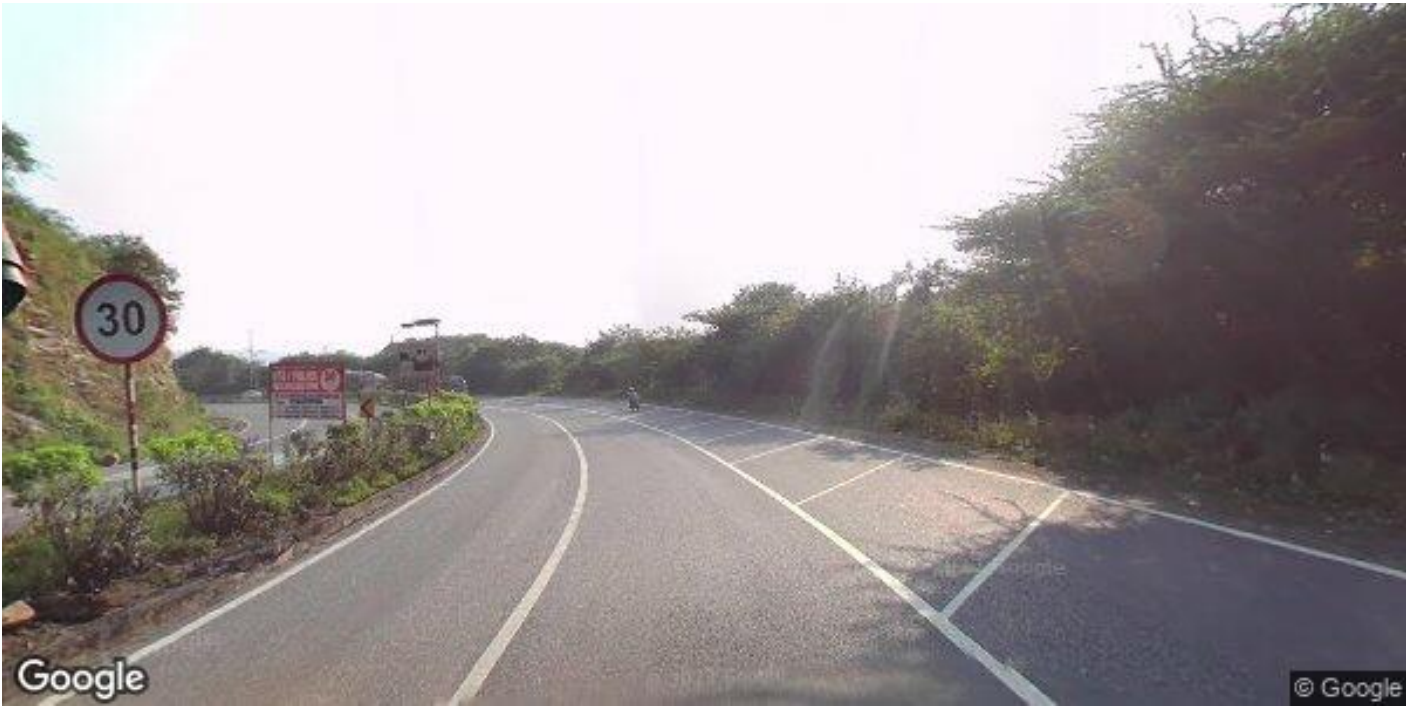
**Risk Type:** Turn  
**Risk Level:** Medium  
**Speed Limit:** 30 KM/Hr  
**Coordinates:** 11.96675, 78.04939

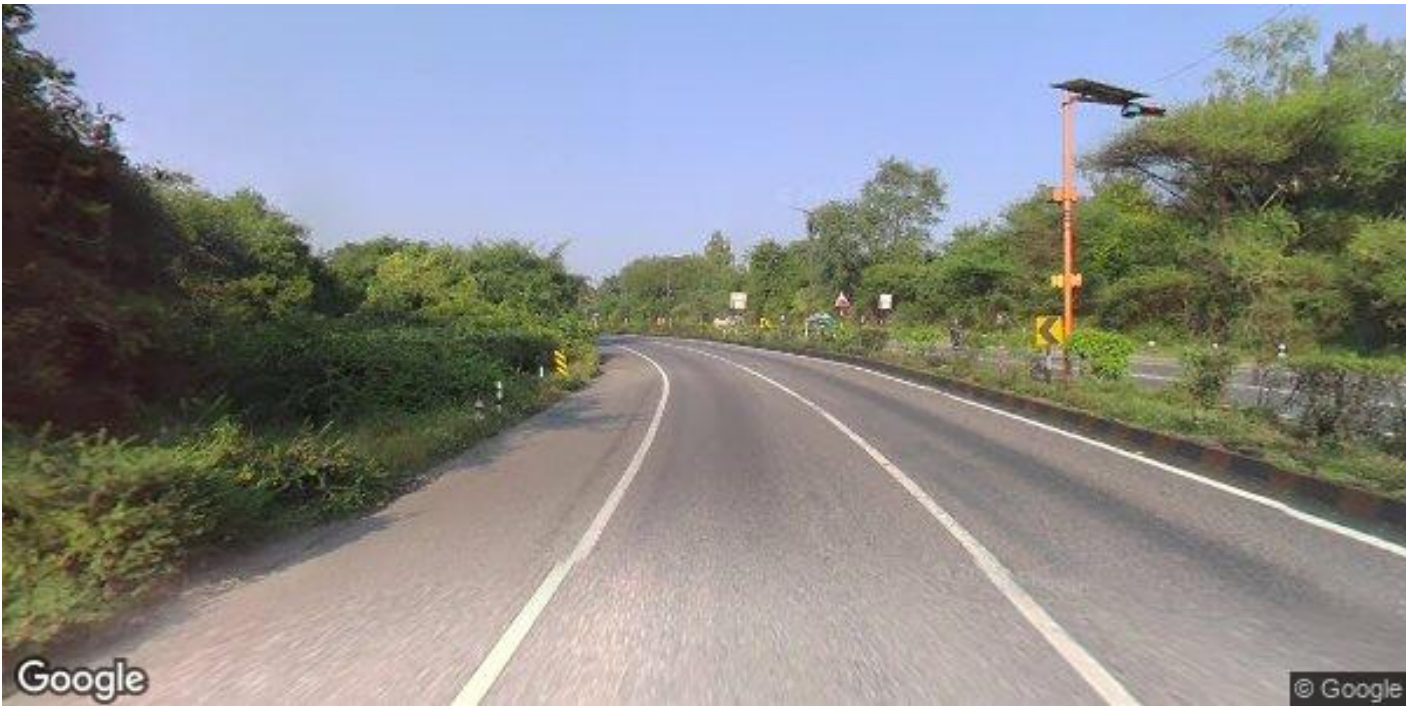
**Risk Type:** Turn  
**Risk Level:** Medium  
**Speed Limit:** 30 KM/Hr  
**Coordinates:** 11.96791, 78.05070

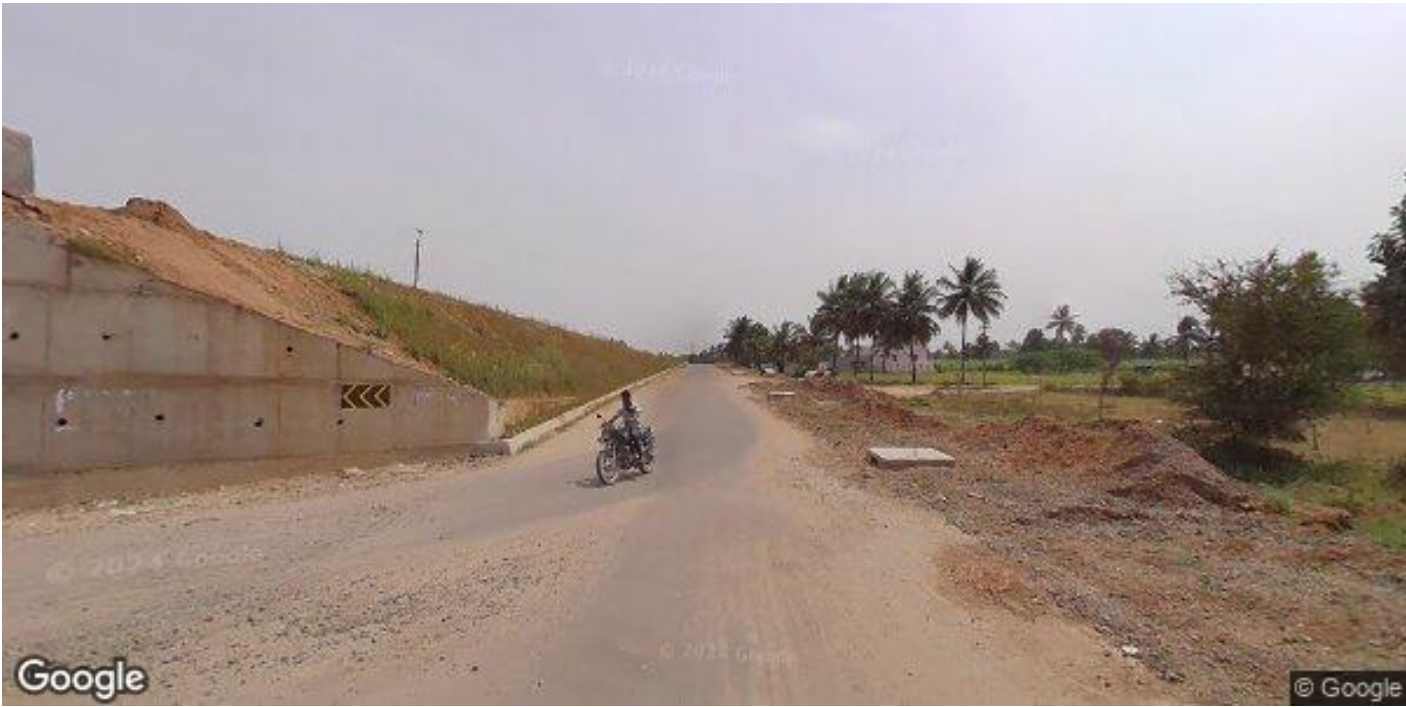
**Risk Type:** Turn  
**Risk Level:** High  
**Speed Limit:** 15 KM/Hr  
**Coordinates:** 12.26527, 78.08422

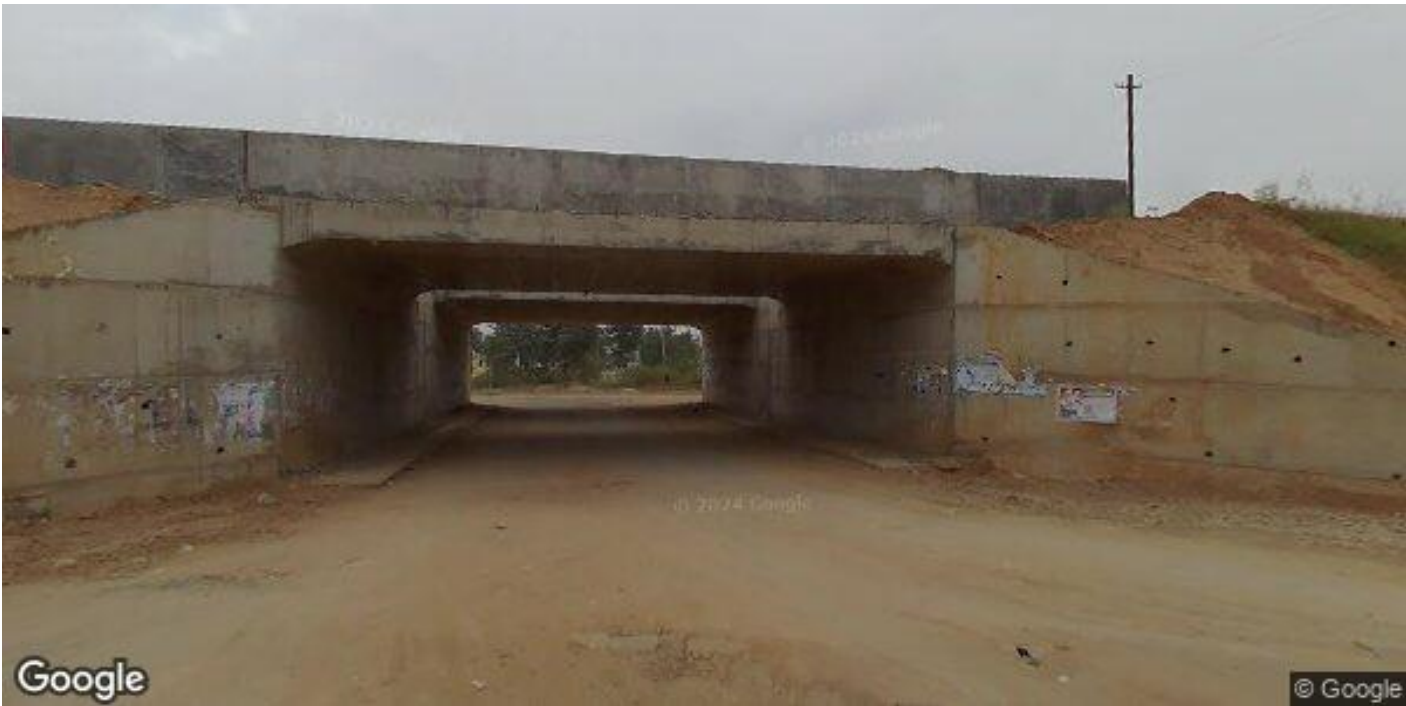
**Risk Type:** Turn  
**Risk Level:** High  
**Speed Limit:** 15 KM/Hr  
**Coordinates:** 12.26547, 78.08437

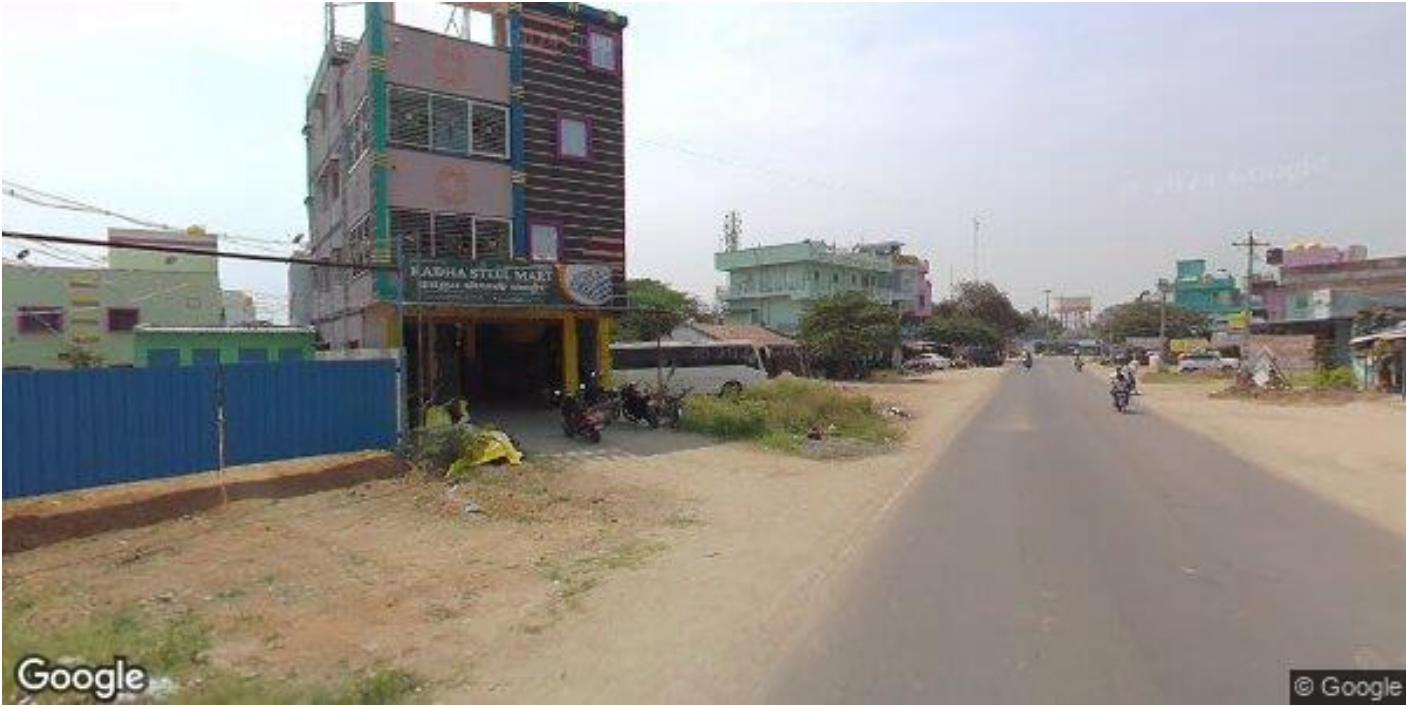
**Risk Type:** Turn  
**Risk Level:** Medium  
**Speed Limit:** 30 KM/Hr  
**Coordinates:** 12.29641, 78.07527

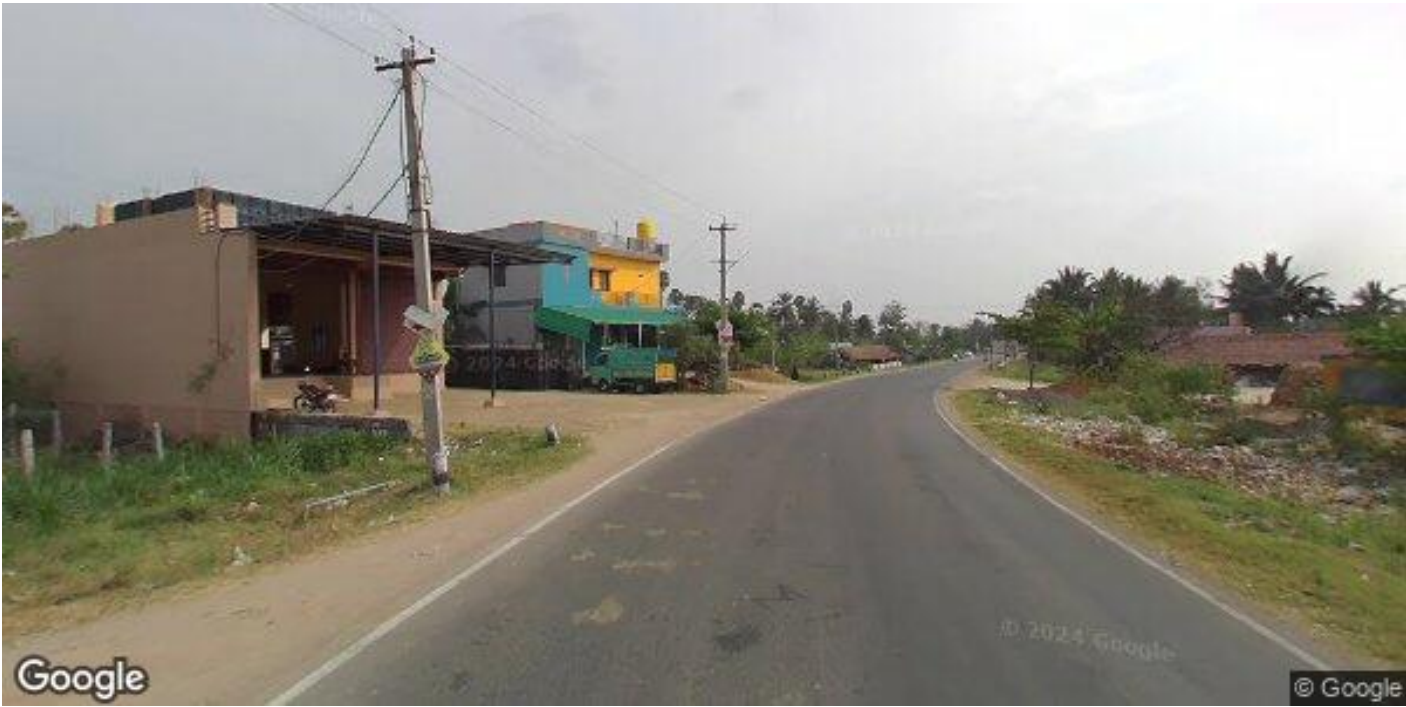
**Risk Type:** Turn  
**Risk Level:** Medium  
**Speed Limit:** 30 KM/Hr  
**Coordinates:** 12.31180, 78.07854

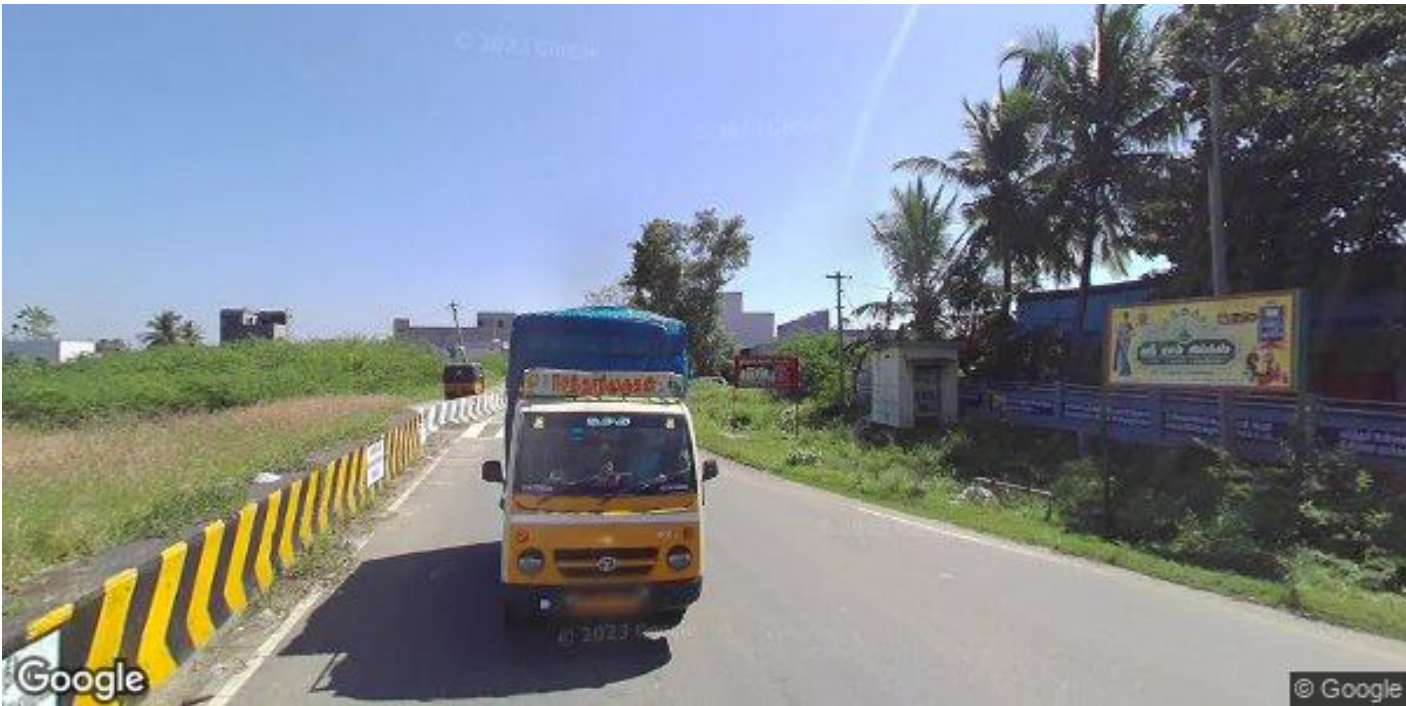
**Risk Type:** Blind Spot  
**Risk Level:** Blind Spot  
**Speed Limit:** 10 KM/Hr  
**Coordinates:** 12.31360, 78.07464

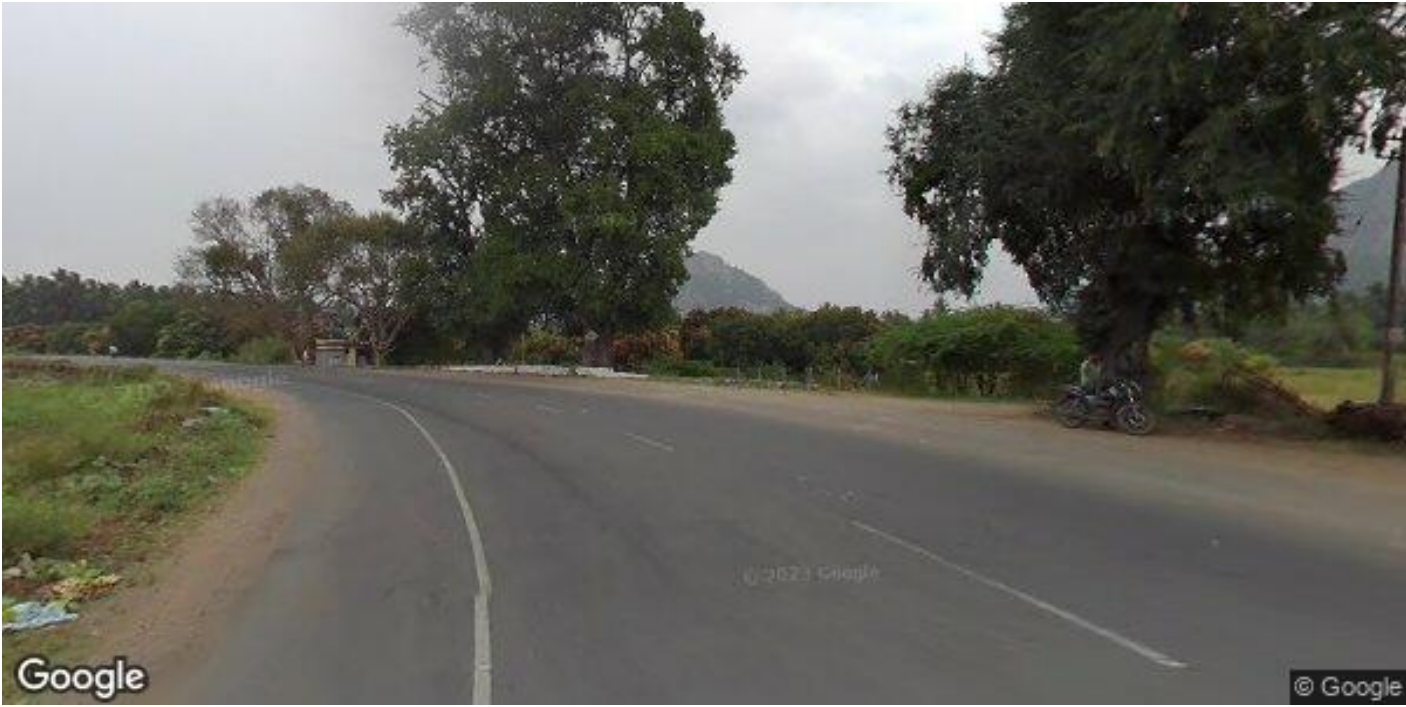
**Risk Type:** Turn  
**Risk Level:** Medium  
**Speed Limit:** 30 KM/Hr  
**Coordinates:** 12.37241, 78.08518

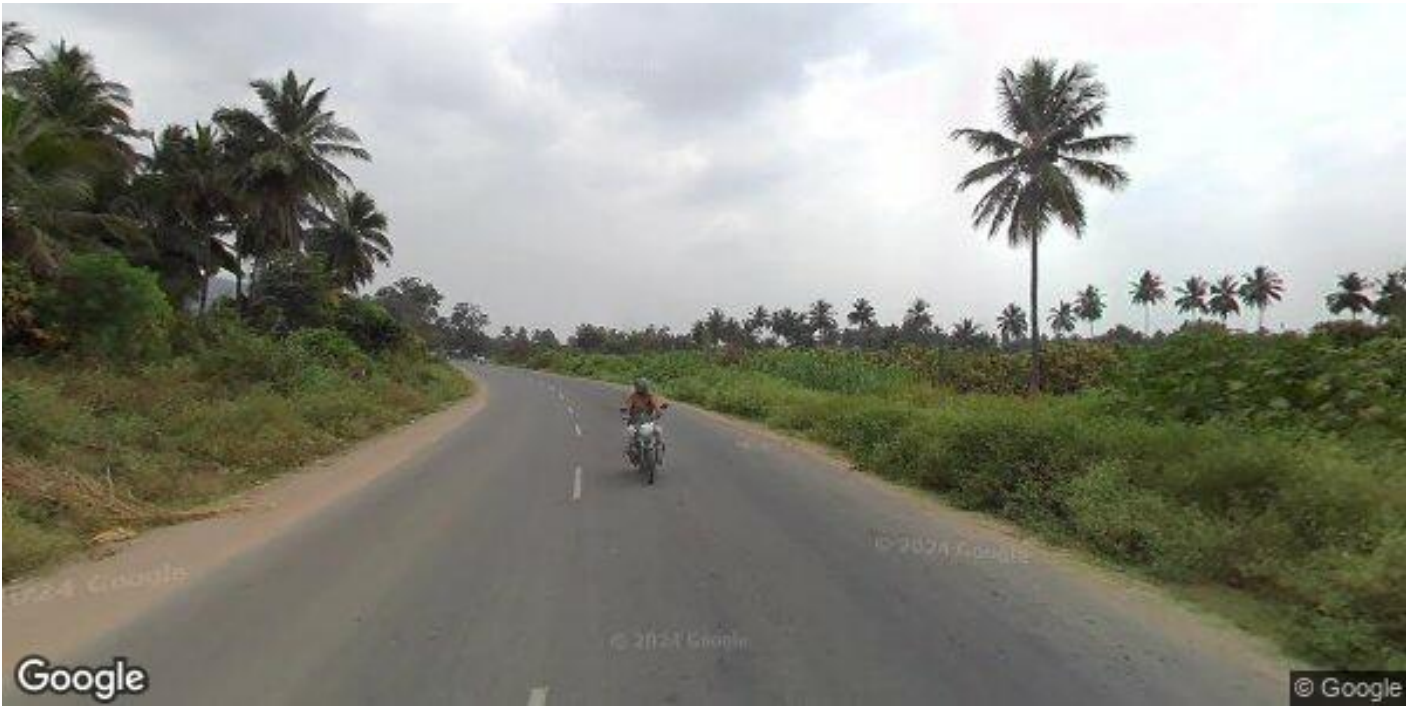
**Risk Type:** Turn  
**Risk Level:** Medium  
**Speed Limit:** 30 KM/Hr  
**Coordinates:** 12.37470, 78.08379

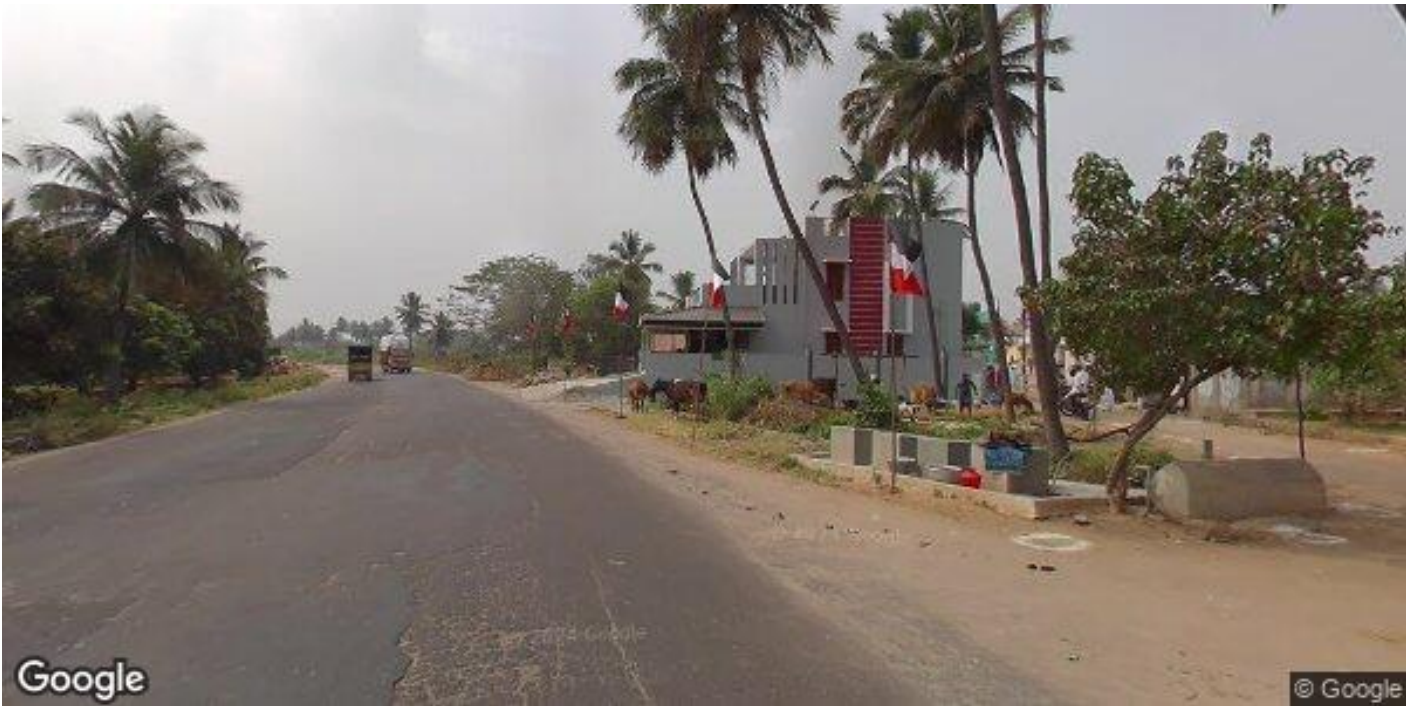
**Risk Type:** Turn  
**Risk Level:** Medium  
**Speed Limit:** 30 KM/Hr  
**Coordinates:** 12.37573, 78.08362

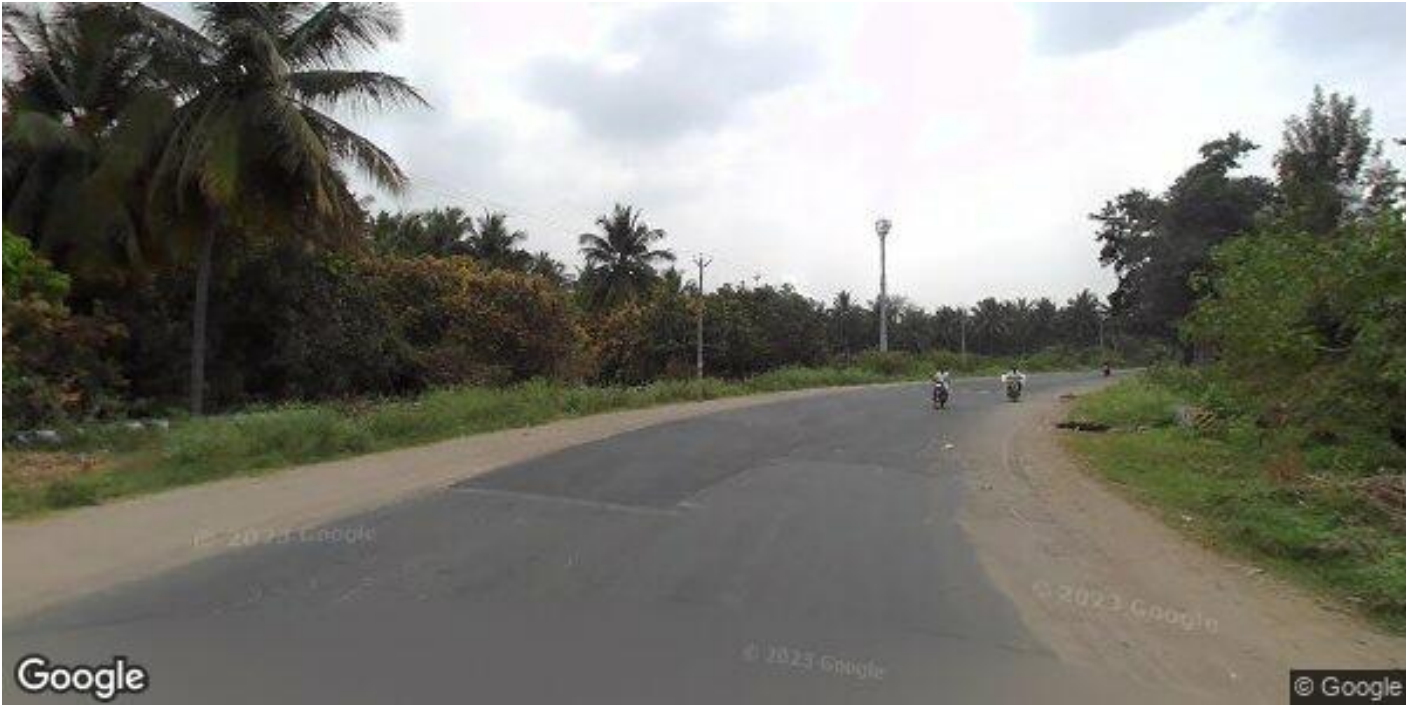
**Risk Type:** Turn  
**Risk Level:** High  
**Speed Limit:** 15 KM/Hr  
**Coordinates:** 12.37820, 78.08522

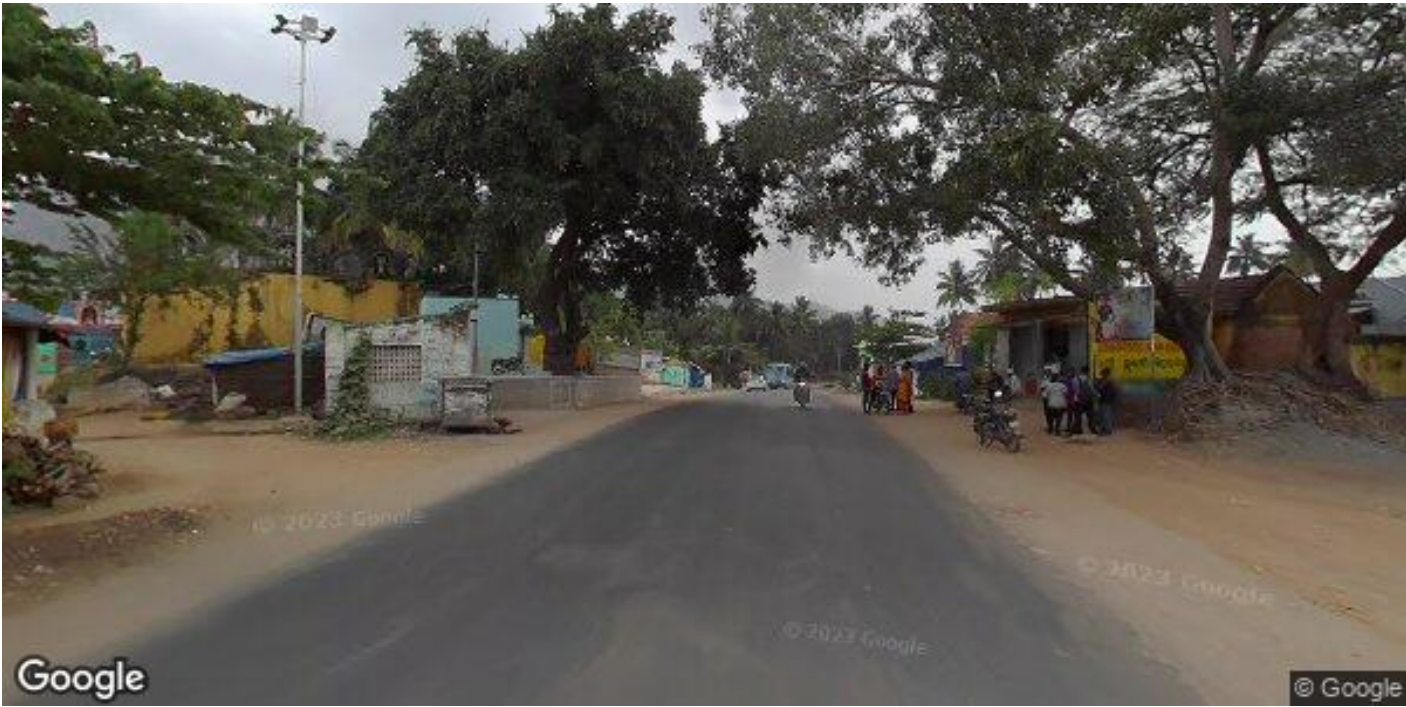
**Risk Type:** Turn  
**Risk Level:** Medium  
**Speed Limit:** 30 KM/Hr  
**Coordinates:** 12.37945, 78.08449

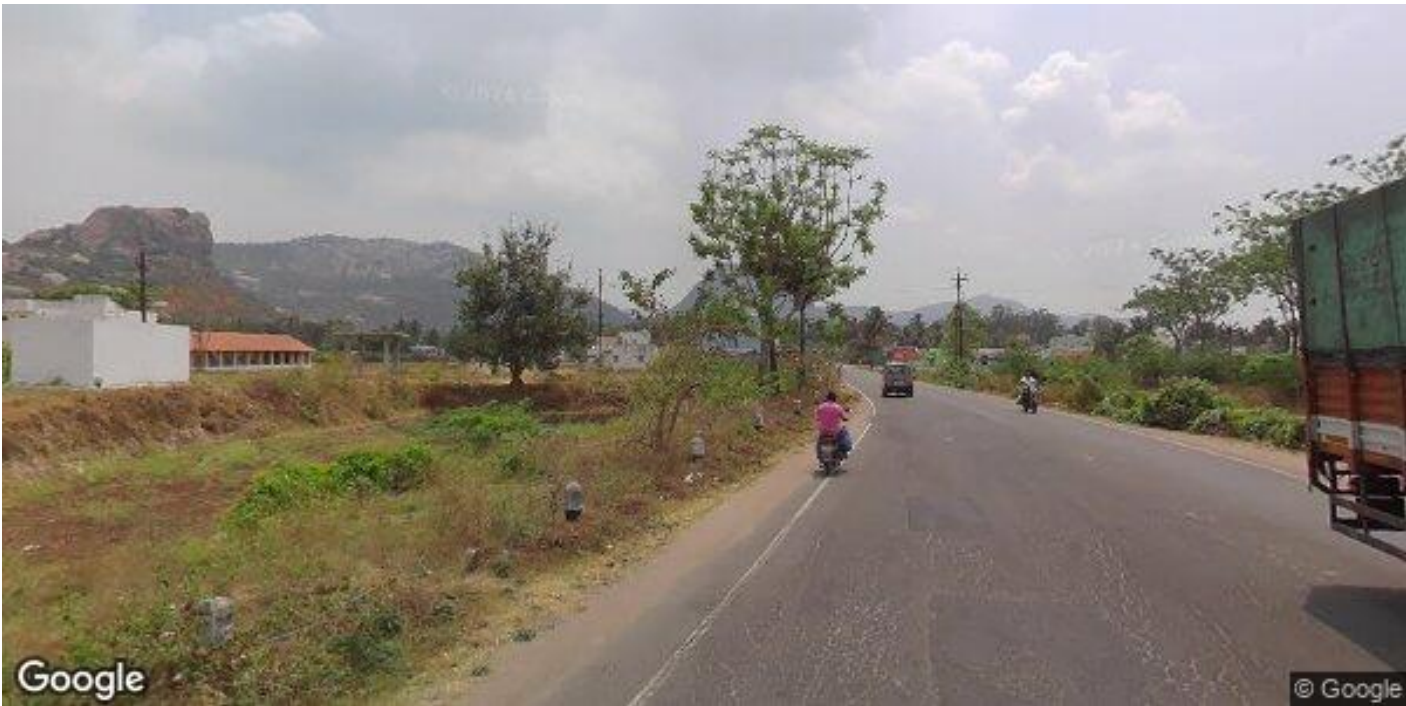
**Risk Type:** Turn  
**Risk Level:** Medium  
**Speed Limit:** 30 KM/Hr  
**Coordinates:** 12.38653, 78.07520

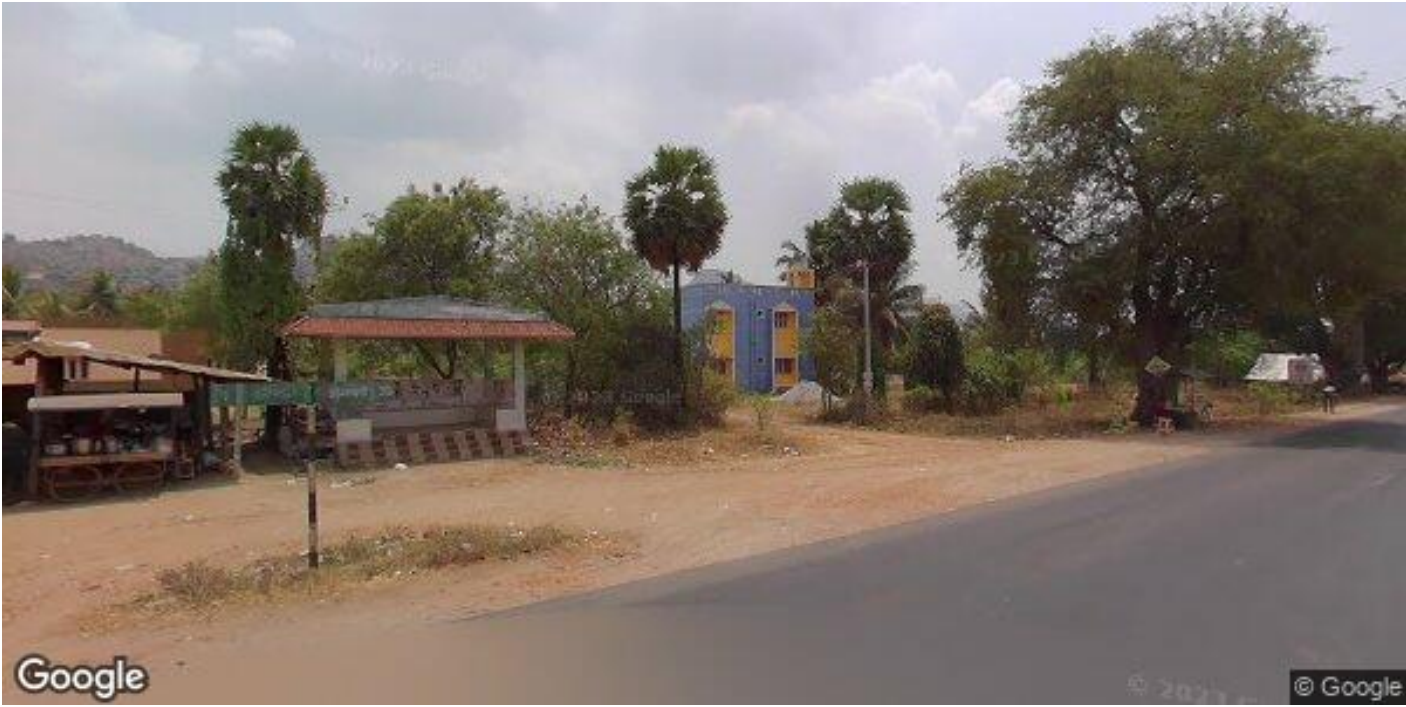
**Risk Type:** Turn  
**Risk Level:** High  
**Speed Limit:** 15 KM/Hr  
**Coordinates:** 12.38868, 78.07430

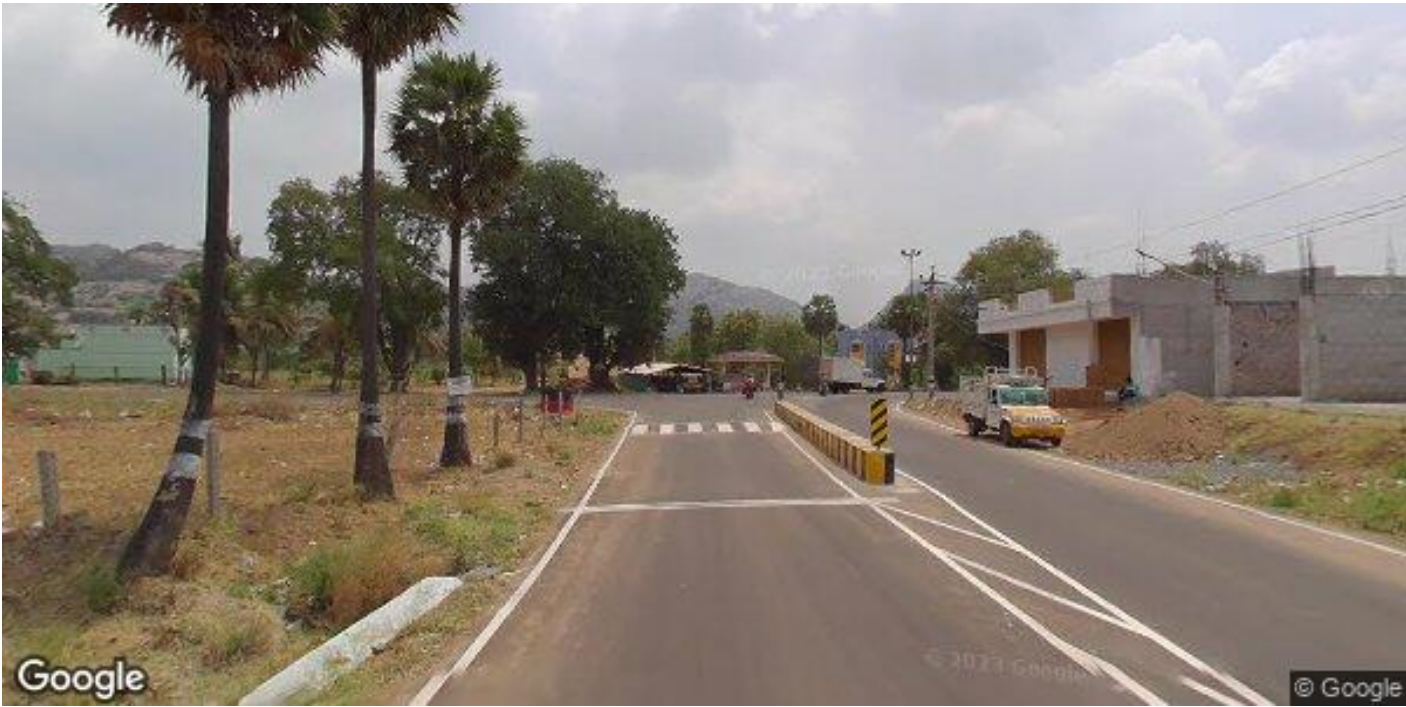
**Risk Type:** Turn  
**Risk Level:** High  
**Speed Limit:** 15 KM/Hr  
**Coordinates:** 12.38878, 78.07386
