# IndianOil

## JOURNEY RISK MANAGEMENT (JRM) STUDY

### Salem Terminal TO SENGAL ANNAI AGENCIES

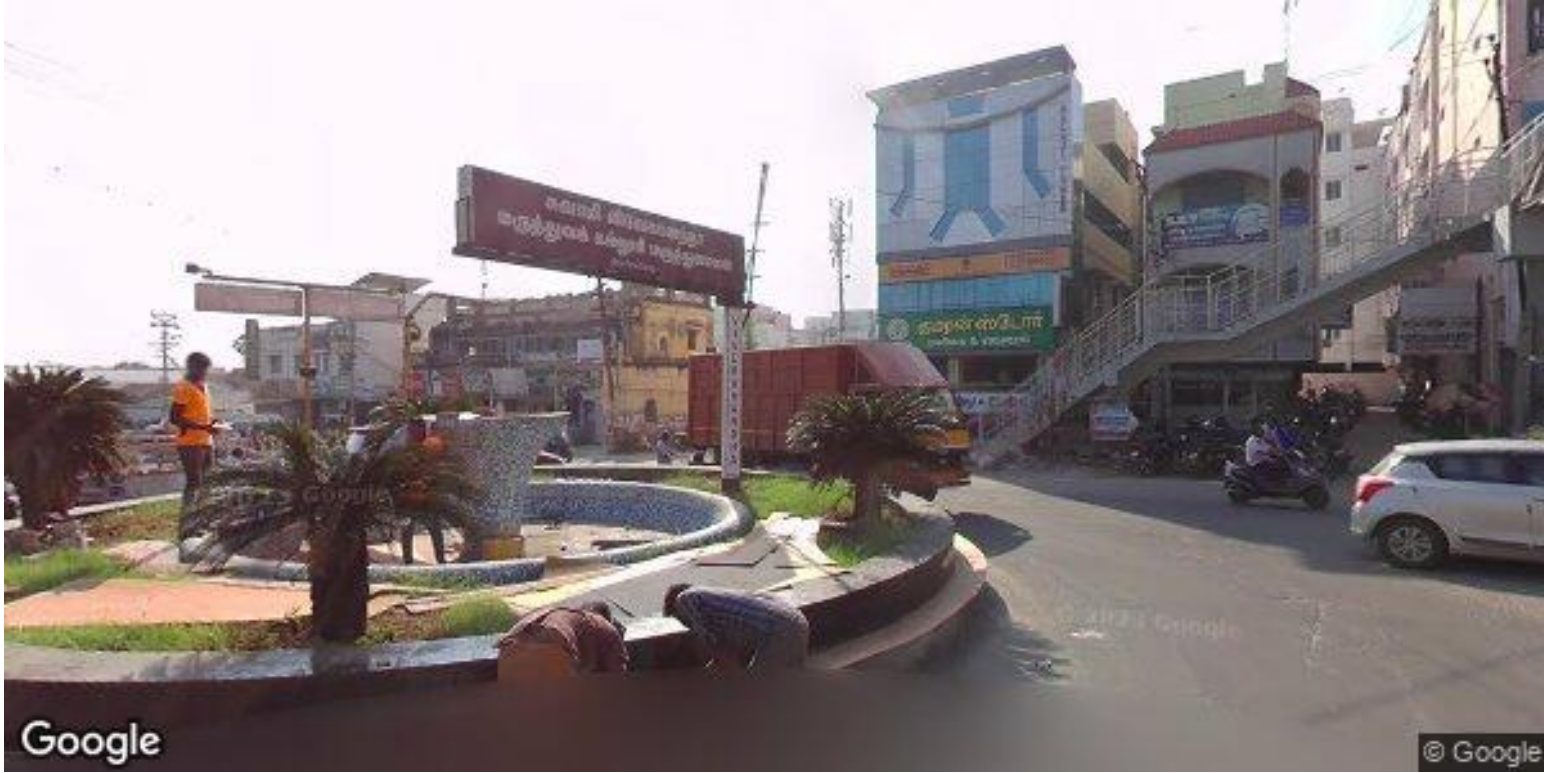
**Coordinates:** 11.38395, 77.89480

**Risk Type:** Roundabout

**Risk Level:** High

**Speed Limit:** 15 KM/Hr

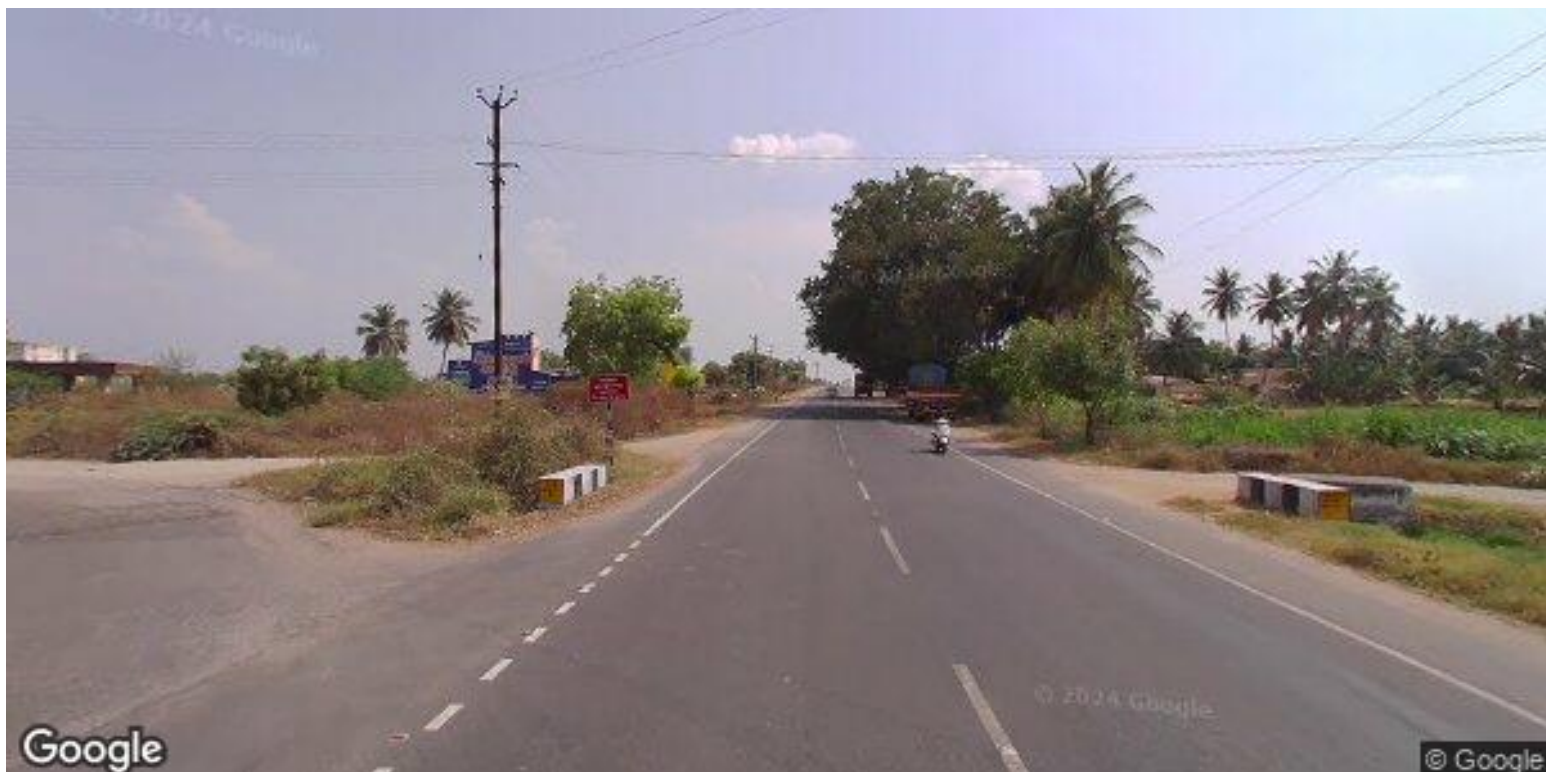
**Risk Type:** Turn  
**Risk Level:** High  
**Speed Limit:** 15 KM/Hr  
**Coordinates:** 11.14545, 78.02208

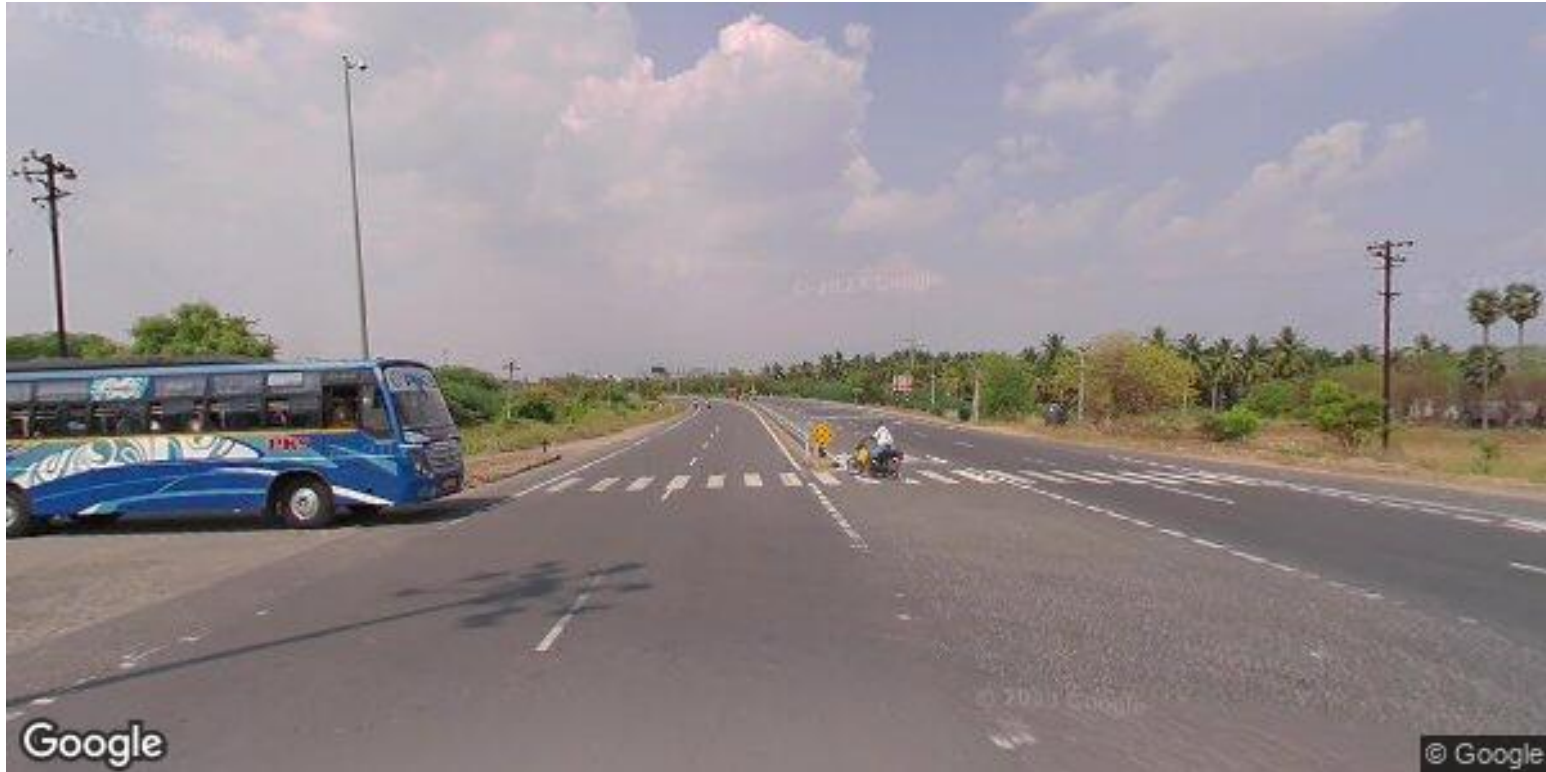
**Risk Type:** Turn  
**Risk Level:** High  
**Speed Limit:** 15 KM/Hr  
**Coordinates:** 11.14485, 78.02282

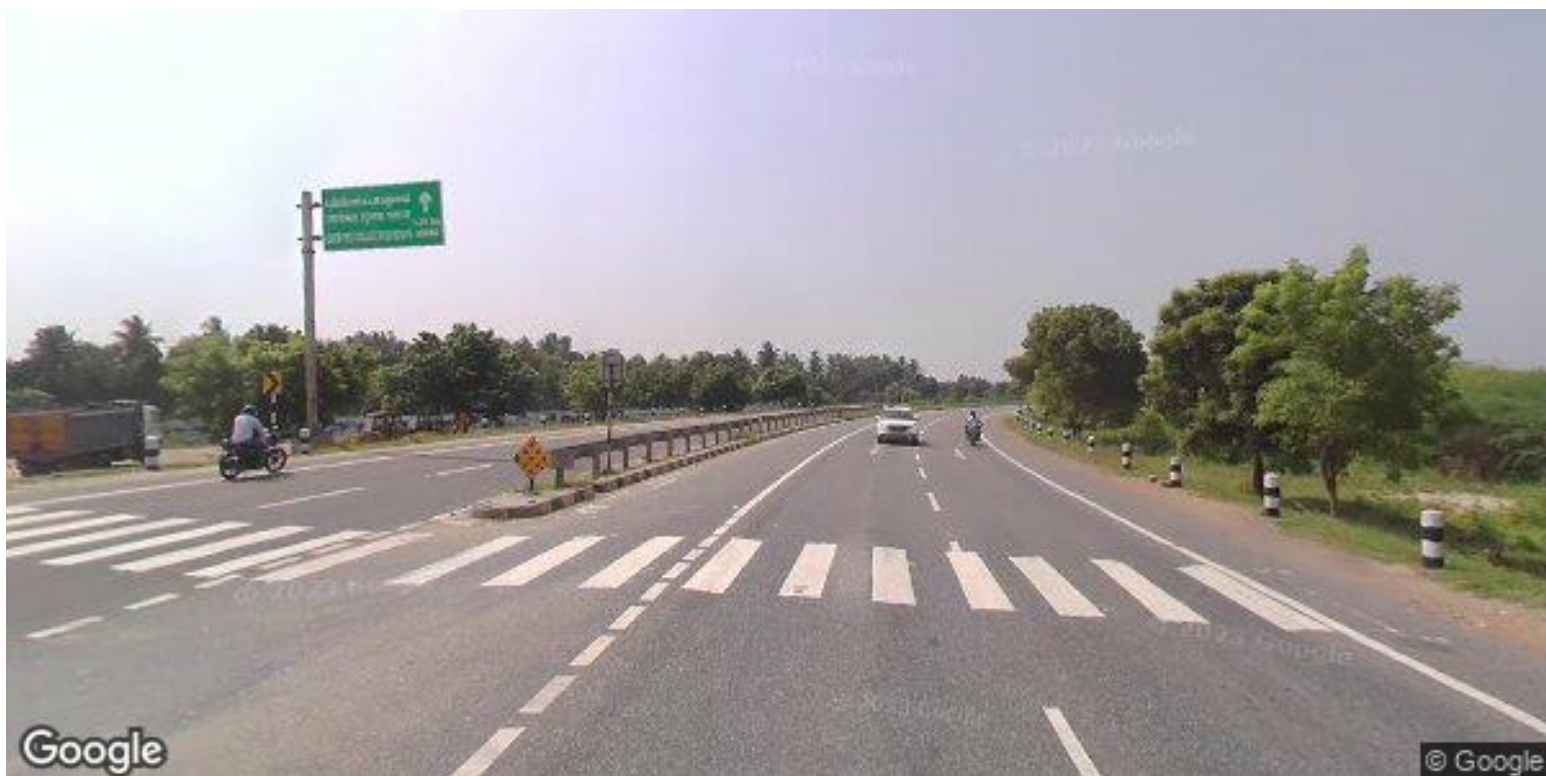
**Risk Type:** Turn  
**Risk Level:** High  
**Speed Limit:** 15 KM/Hr  
**Coordinates:** 10.93639, 78.22893

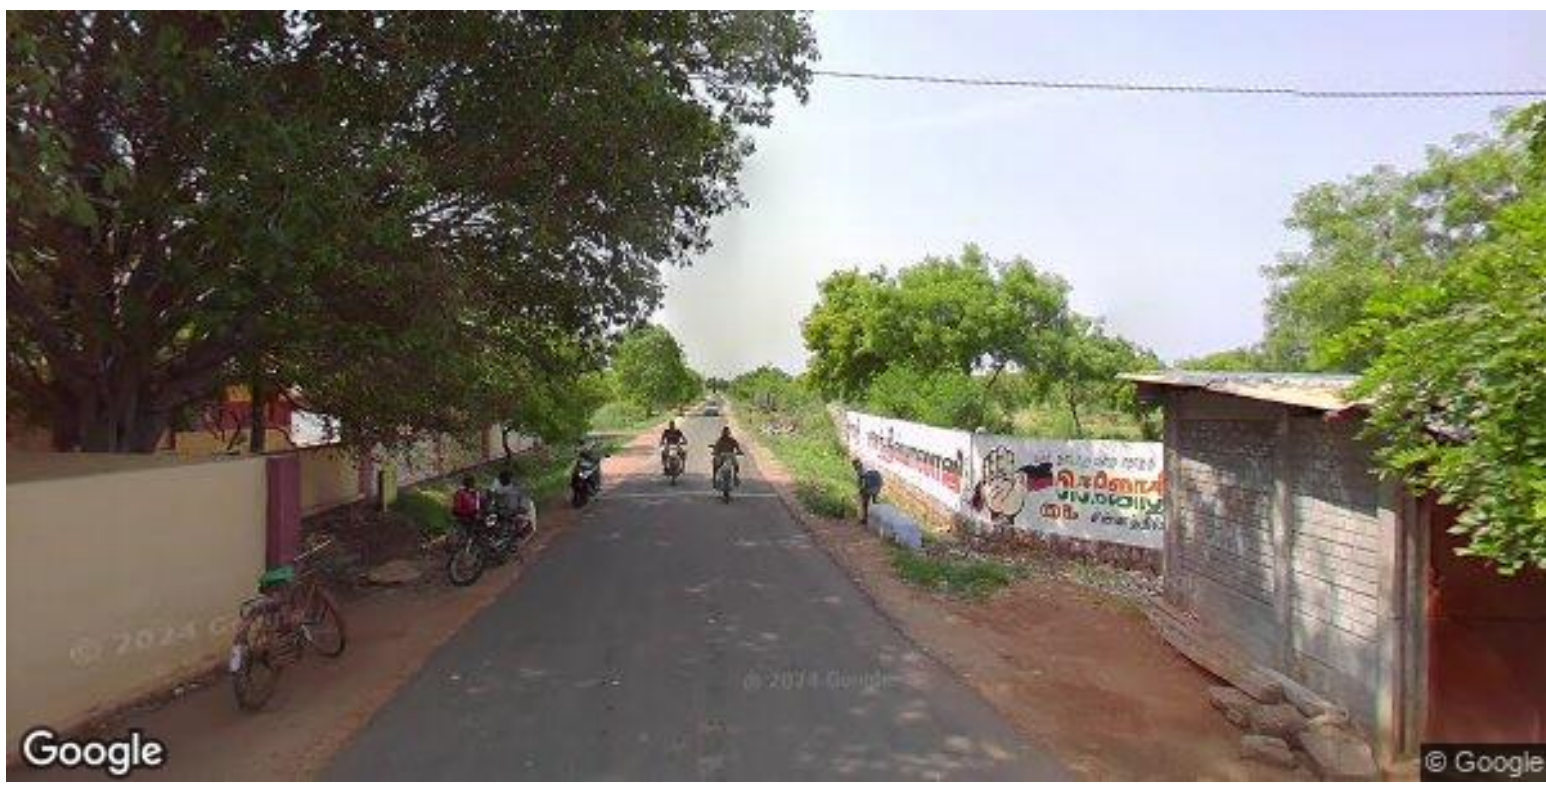
**Coordinates:** 10.93596, 78.22951

**Risk Type:** Turn

**Risk Level:** Medium

**Speed Limit:** 30 KM/Hr

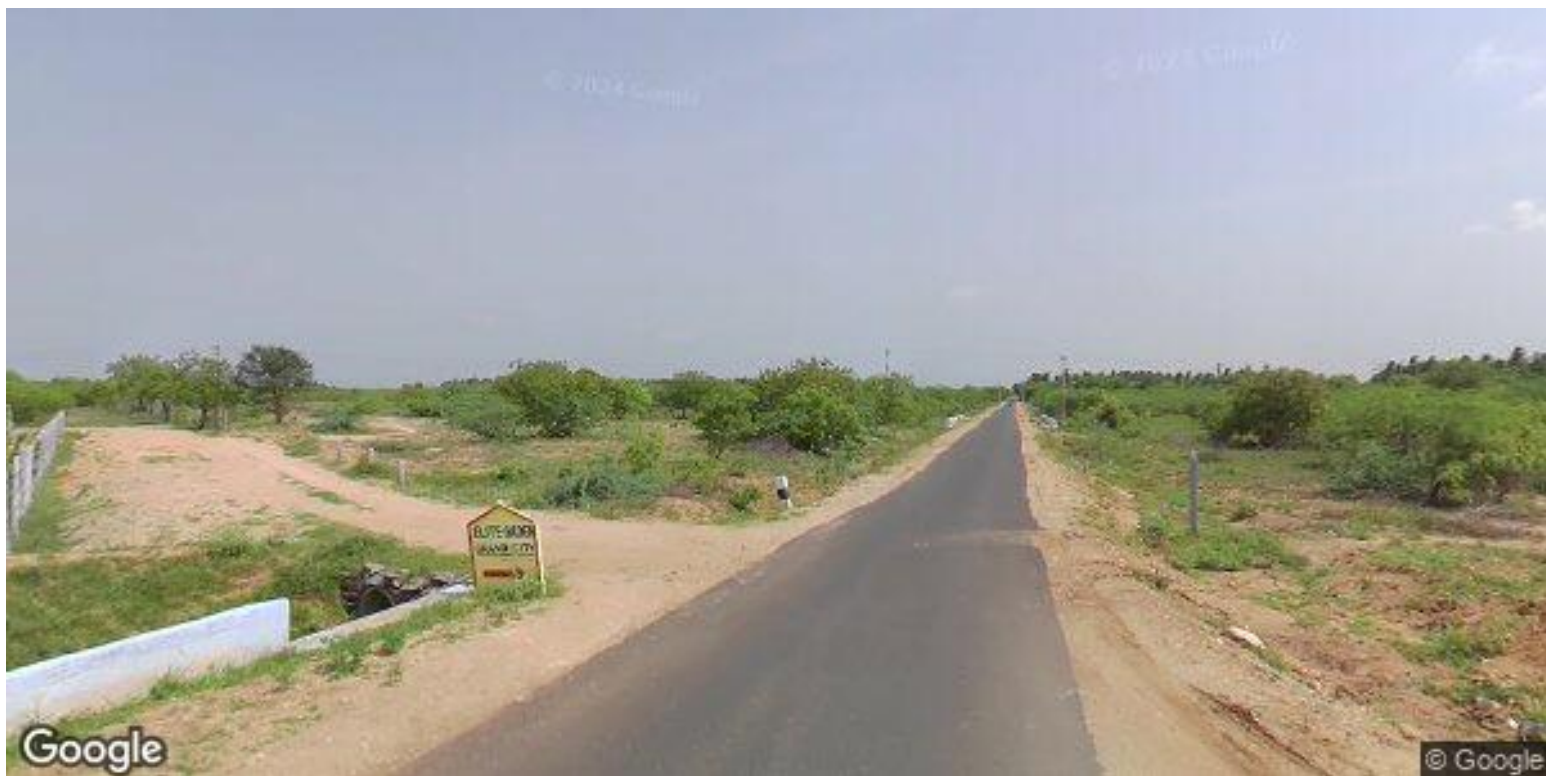
**Coordinates:** 10.93157, 78.23134

**Risk Type:** Turn

**Risk Level:** High

**Speed Limit:** 15 KM/Hr

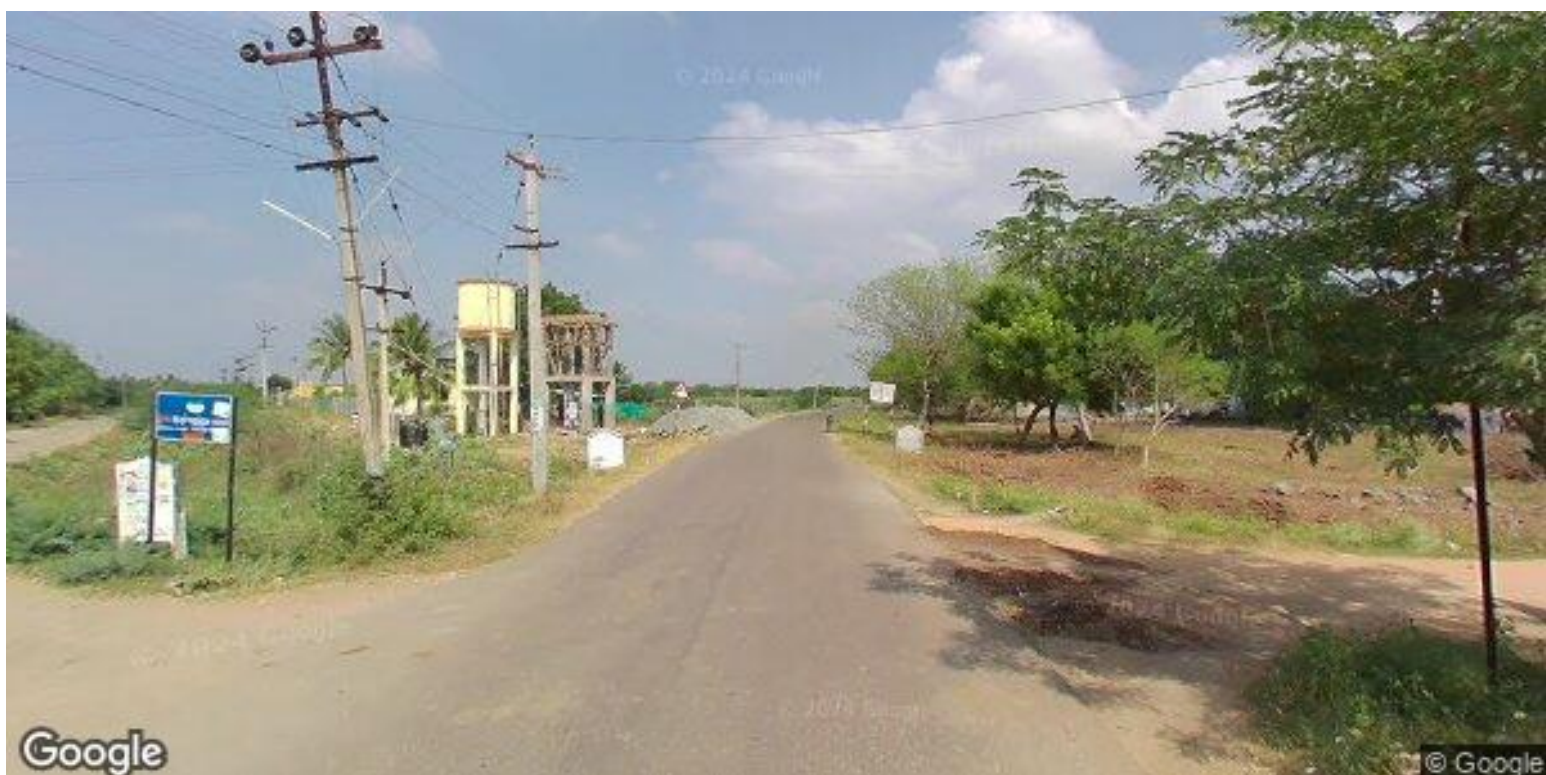
**Risk Type:** Turn  
**Risk Level:** Medium  
**Speed Limit:** 30 KM/Hr  
**Coordinates:** 10.92831, 78.23741

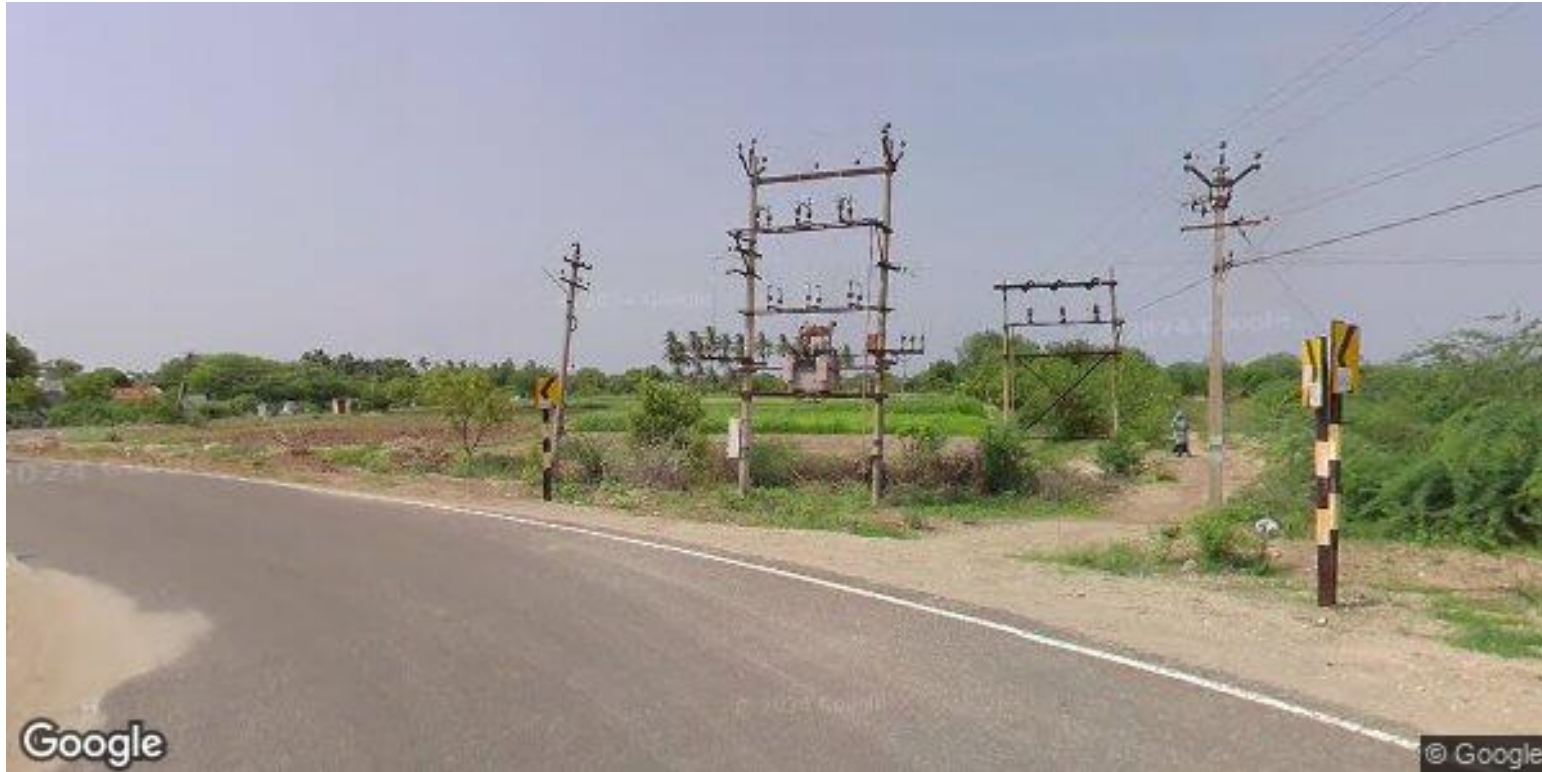
**Risk Type:** Turn  
**Risk Level:** High  
**Speed Limit:** 15 KM/Hr  
**Coordinates:** 10.91770, 78.23846

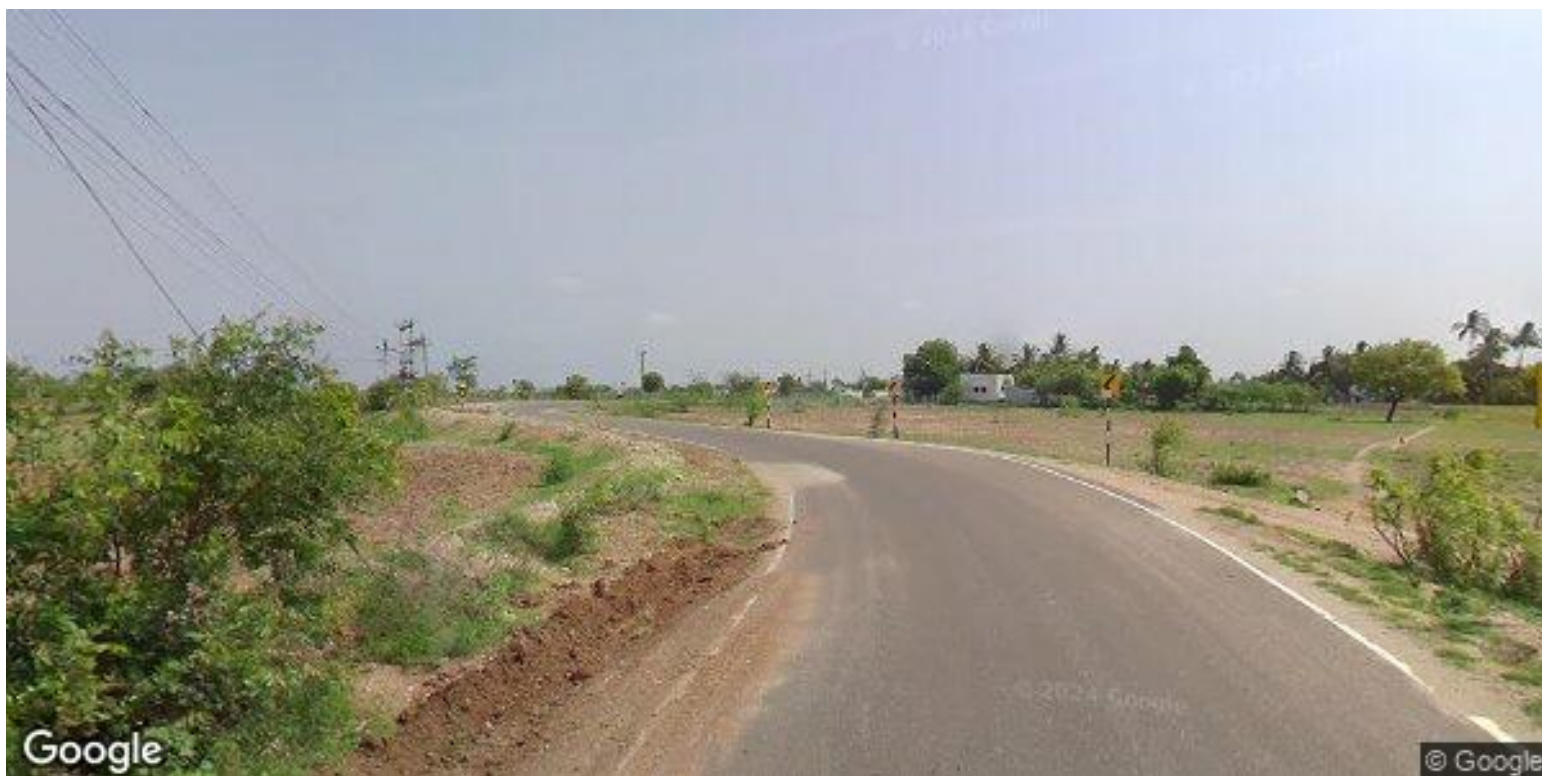
**Risk Type:** Turn  
**Risk Level:** Medium  
**Speed Limit:** 30 KM/Hr  
**Coordinates:** 10.91716, 78.23893

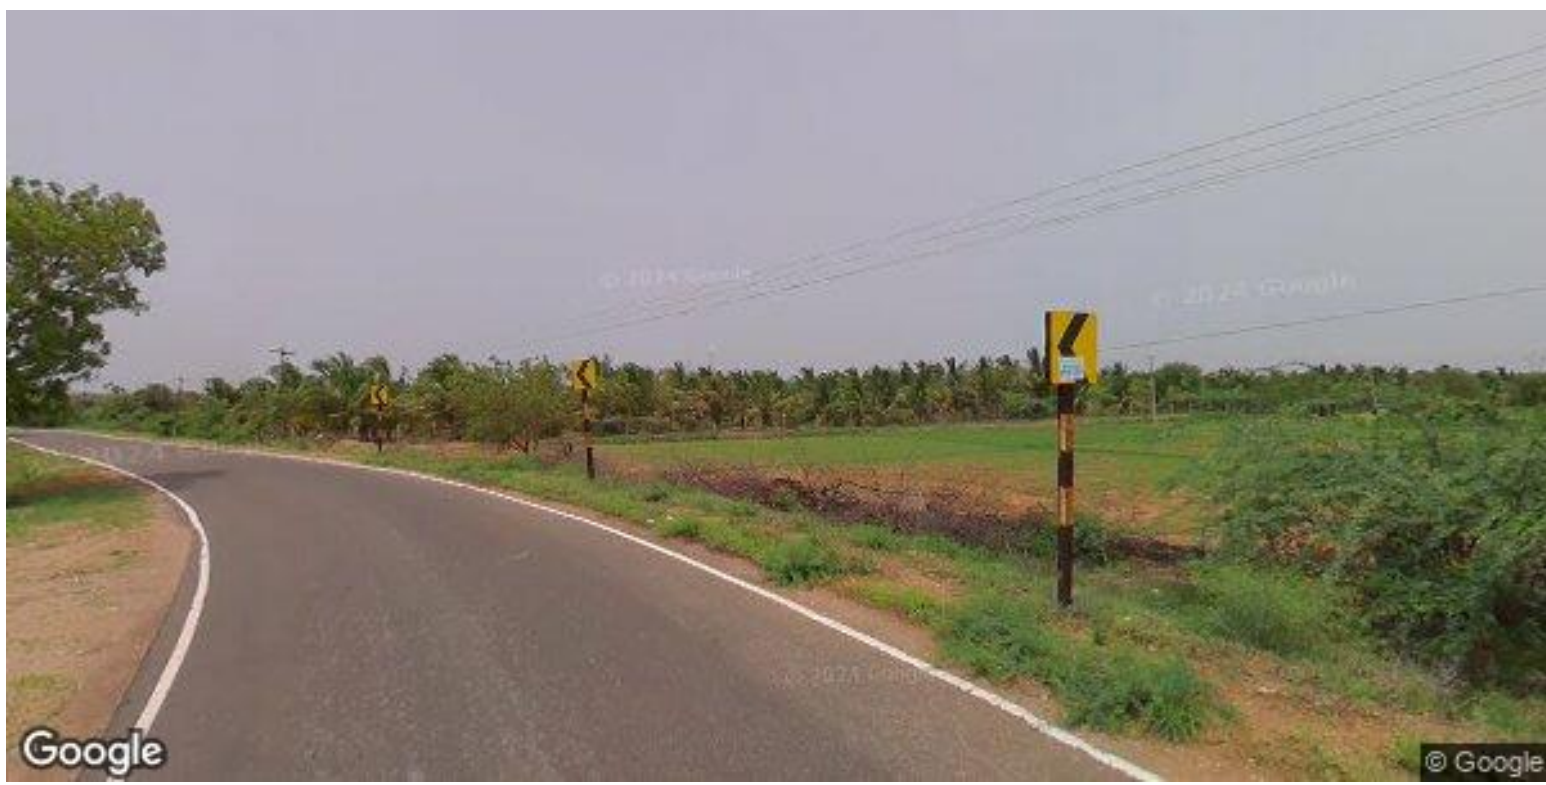
**Coordinates:** 10.90095, 78.23910

**Risk Type:** Turn

**Risk Level:** Medium

**Speed Limit:** 30 KM/Hr

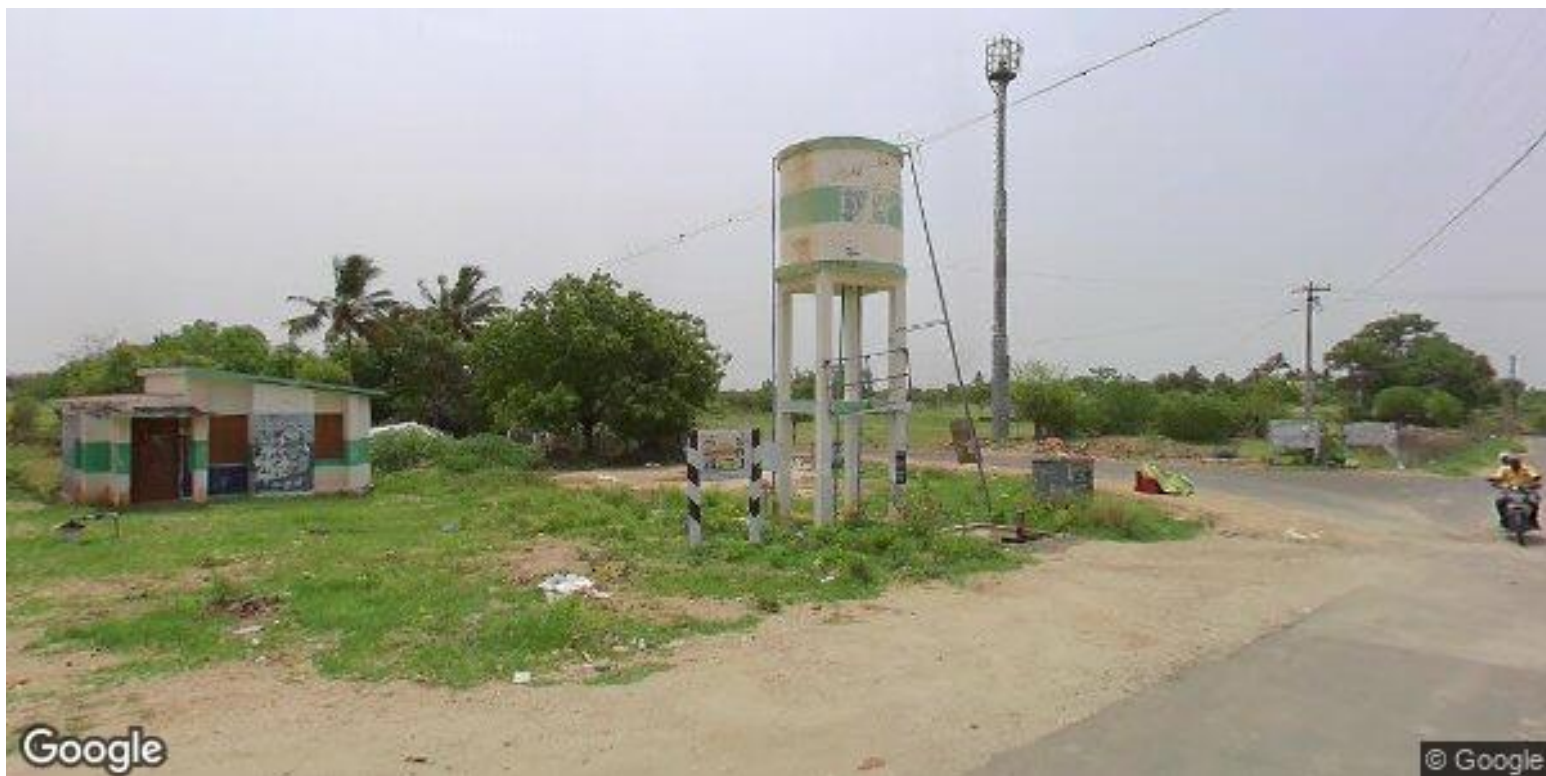
**Coordinates:** 10.89479, 78.24318

**Risk Type:** Turn

**Risk Level:** High

**Speed Limit:** 15 KM/Hr

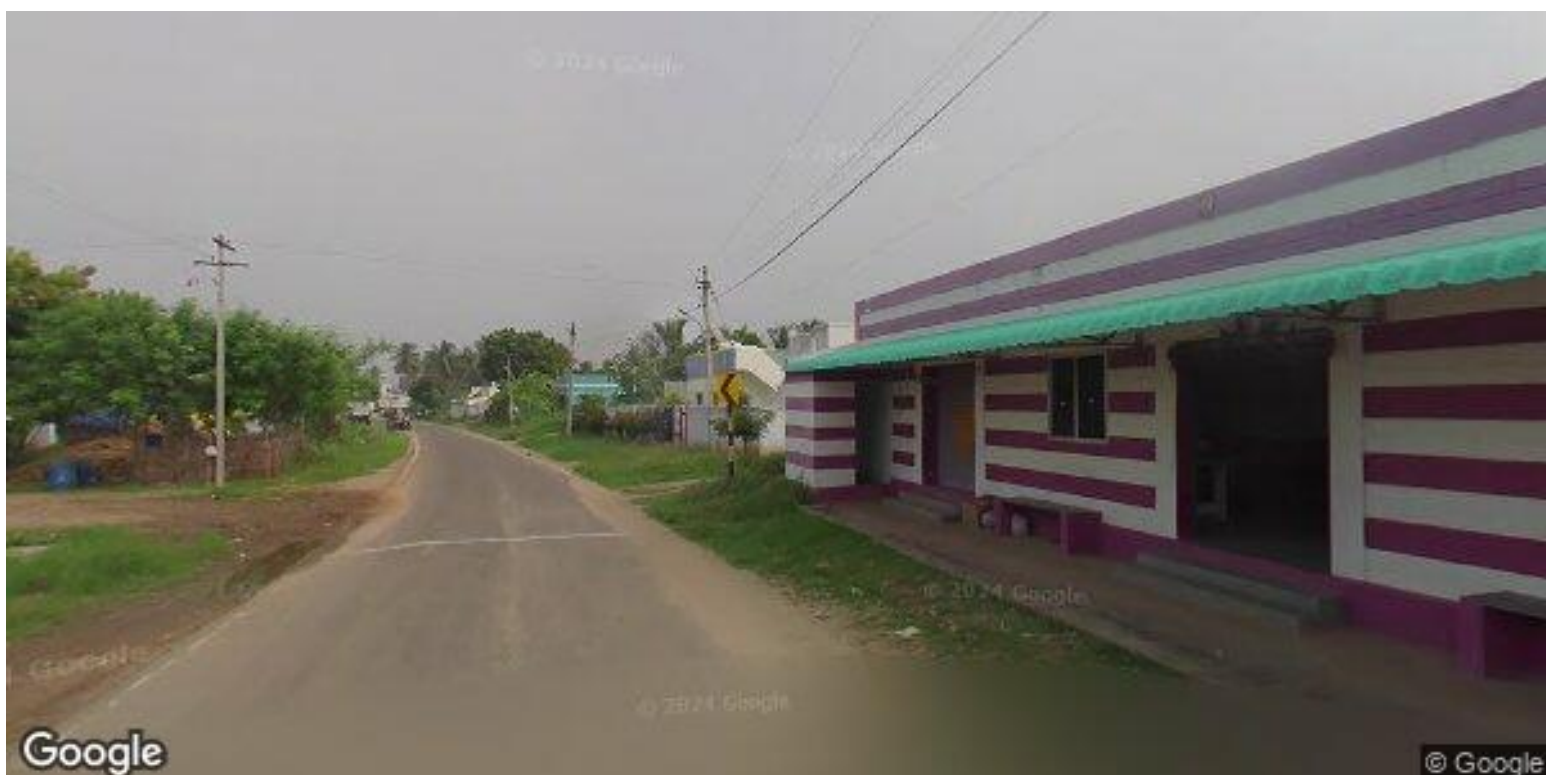
**Risk Type:** Turn  
**Risk Level:** Medium  
**Speed Limit:** 30 KM/Hr  
**Coordinates:** 10.89058, 78.24321

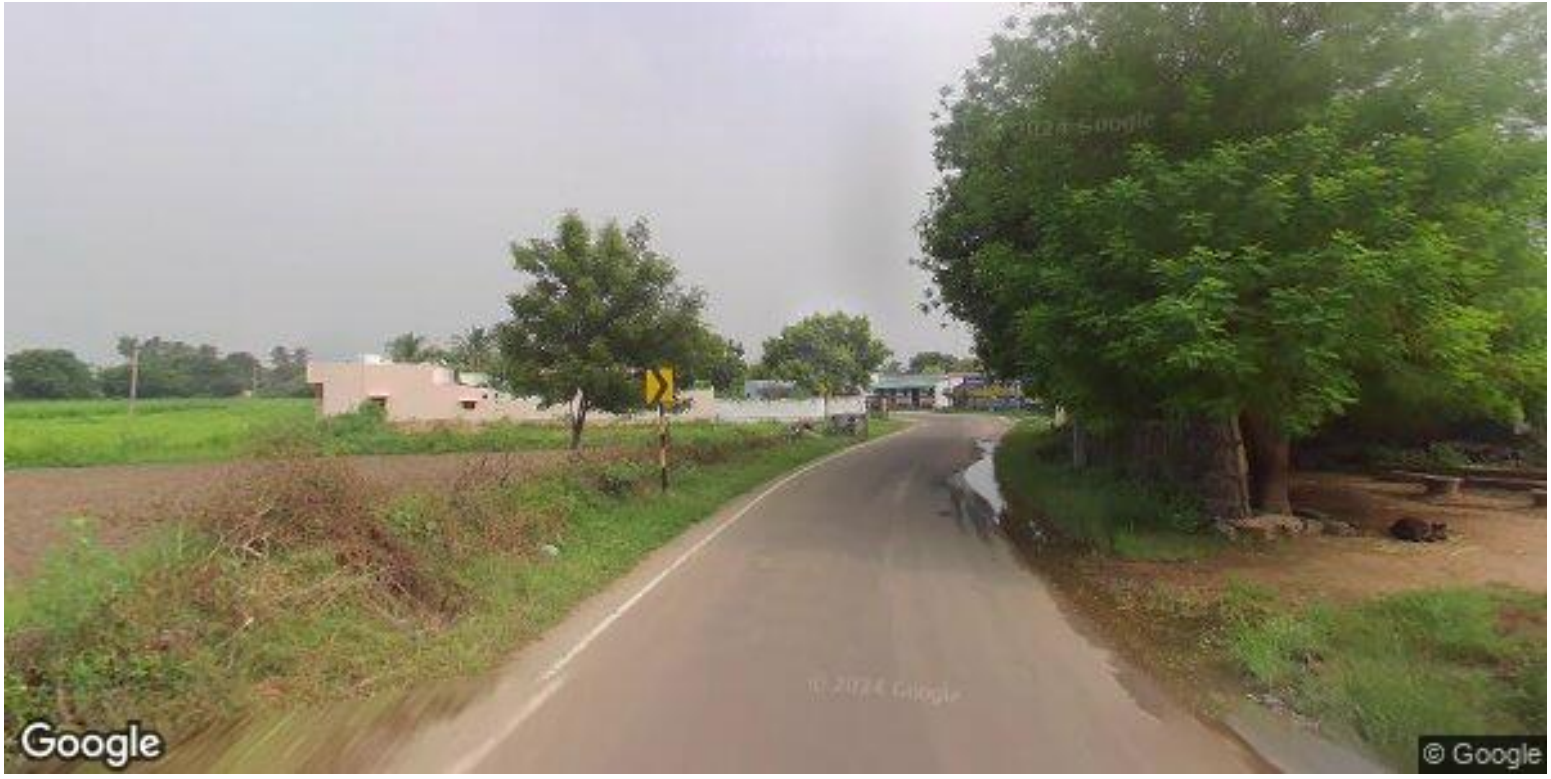
**Risk Type:** Turn  
**Risk Level:** Medium  
**Speed Limit:** 30 KM/Hr  
**Coordinates:** 10.88993, 78.24283
