## JOURNEY RISK MANAGEMENT (JRM) STUDY

Salem Terminal to DEPT. OF SUGAR -SUBRAMANYA  
SIVA CSM

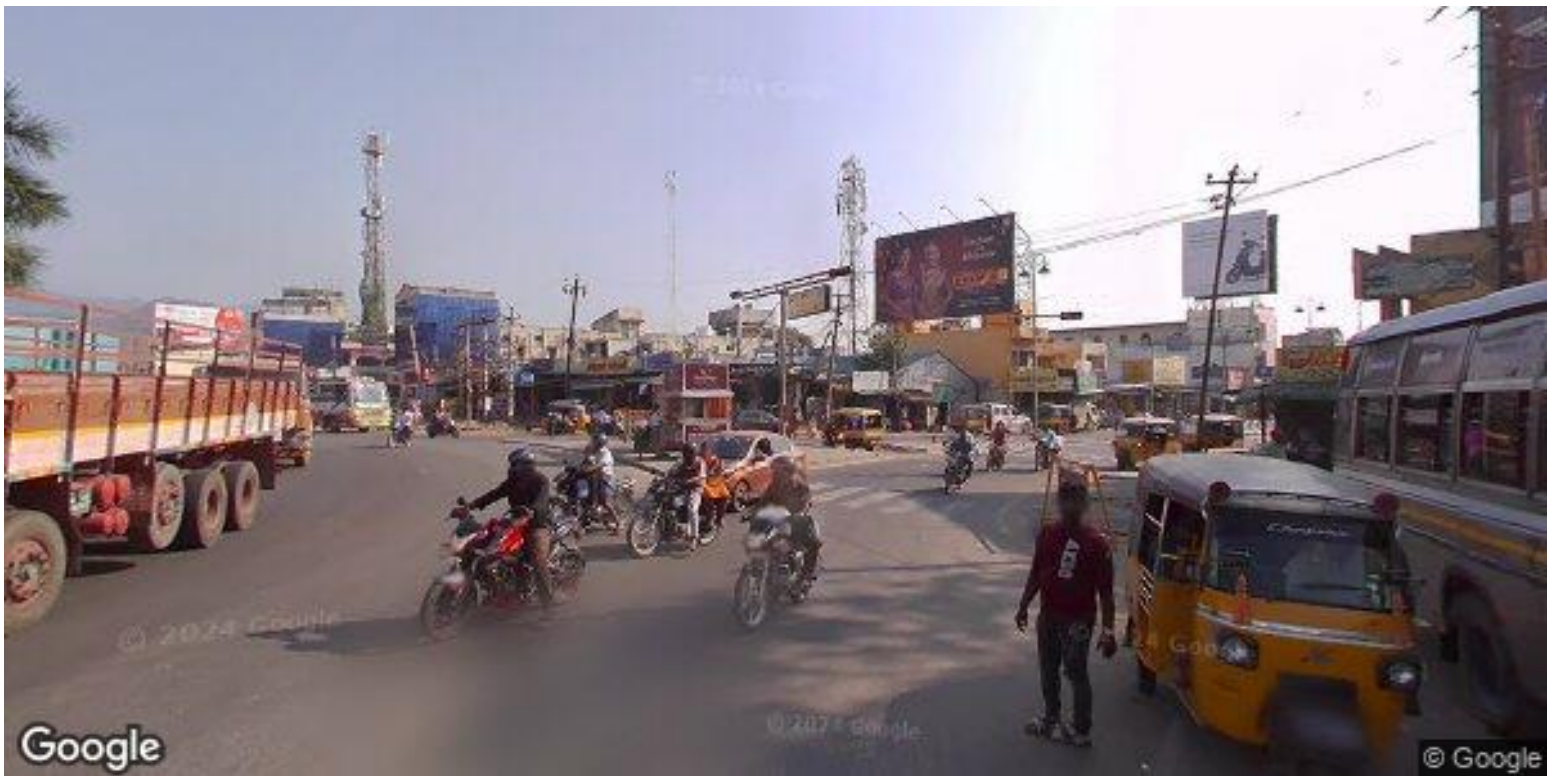
Coordinates: 11.63266, 78.12699

Risk Type: Roundabout

Risk Level: High

Speed Limit: 15 KM/Hr

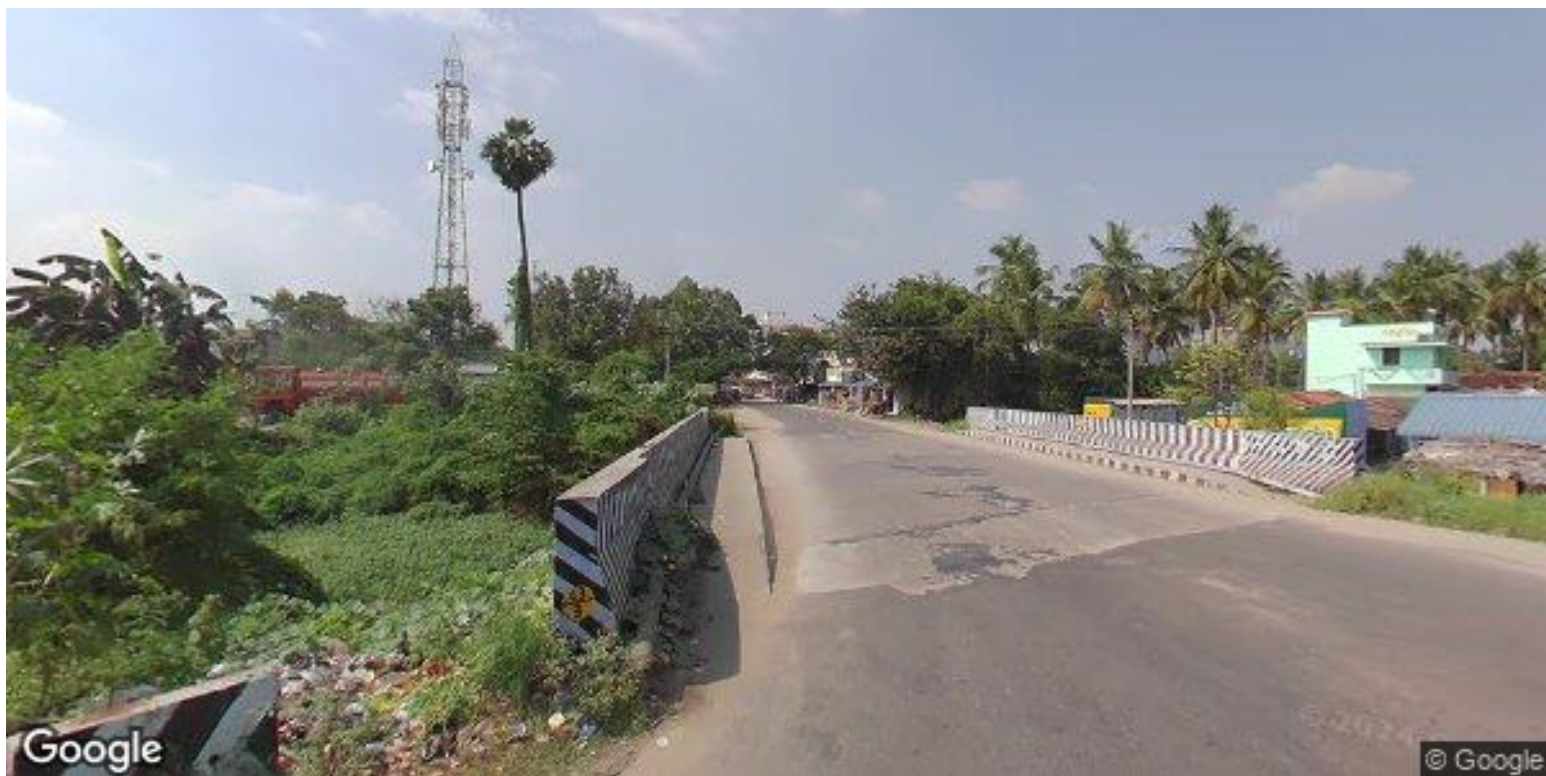
**Coordinates:** 11.44900, 77.87406

**Risk Type:** Turn

**Risk Level:** Medium

**Speed Limit:** 30 KM/Hr

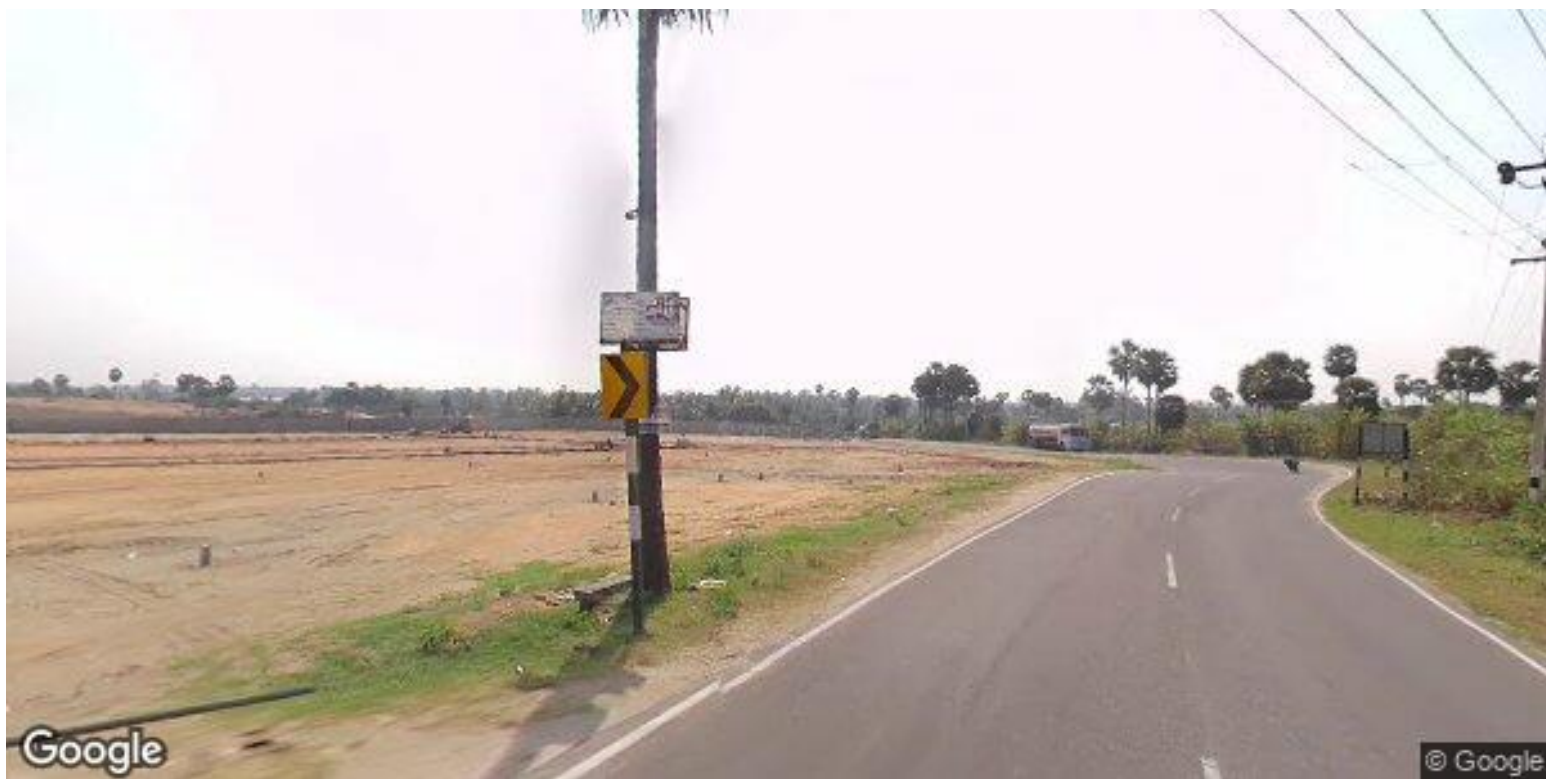
**Risk Type:** Turn  
**Risk Level:** Medium  
**Speed Limit:** 30 KM/Hr  
**Coordinates:** 11.45898, 77.85135

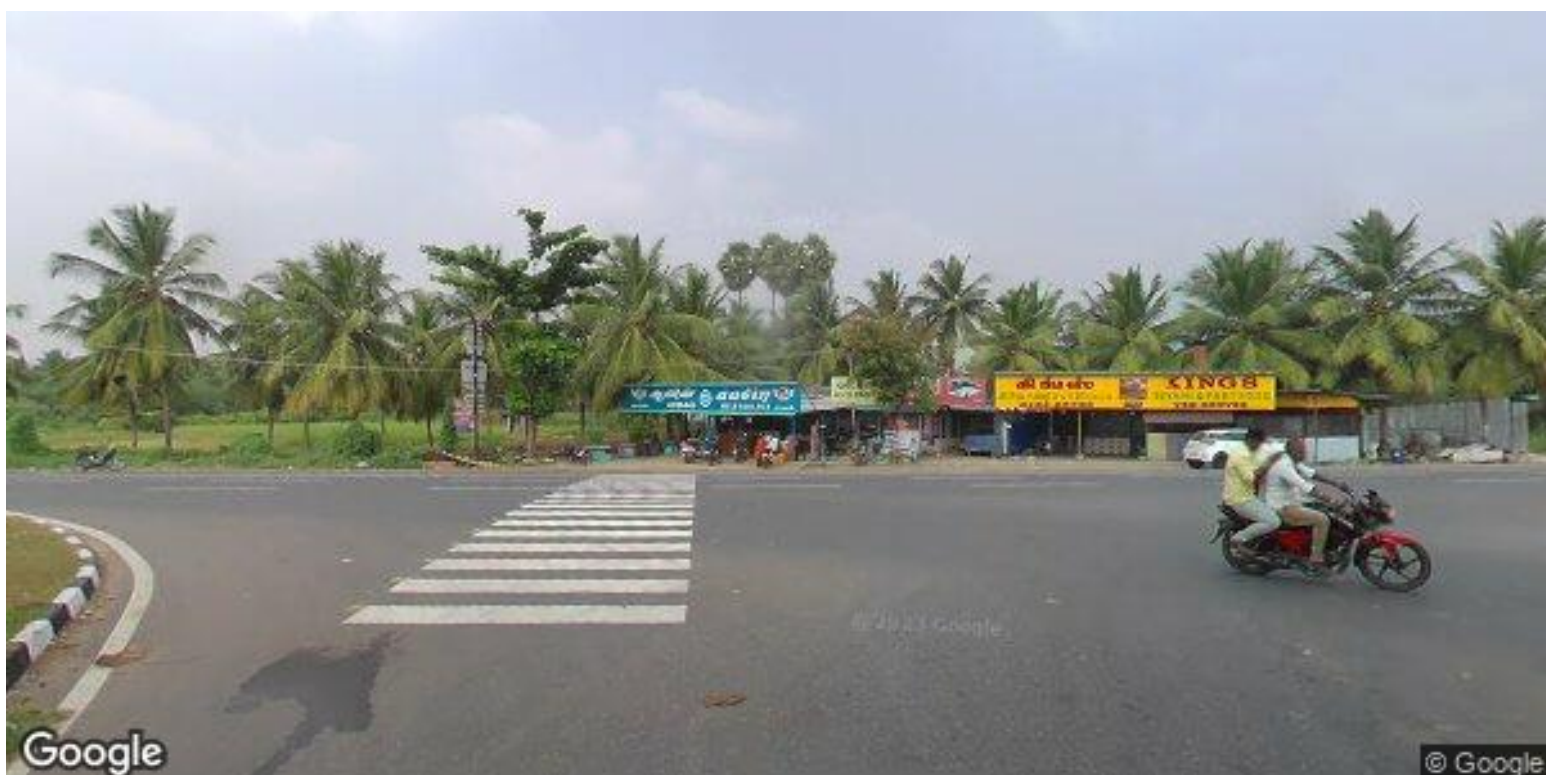
**Risk Type:** Turn  
**Risk Level:** High  
**Speed Limit:** 15 KM/Hr  
**Coordinates:** 11.45615, 77.81677

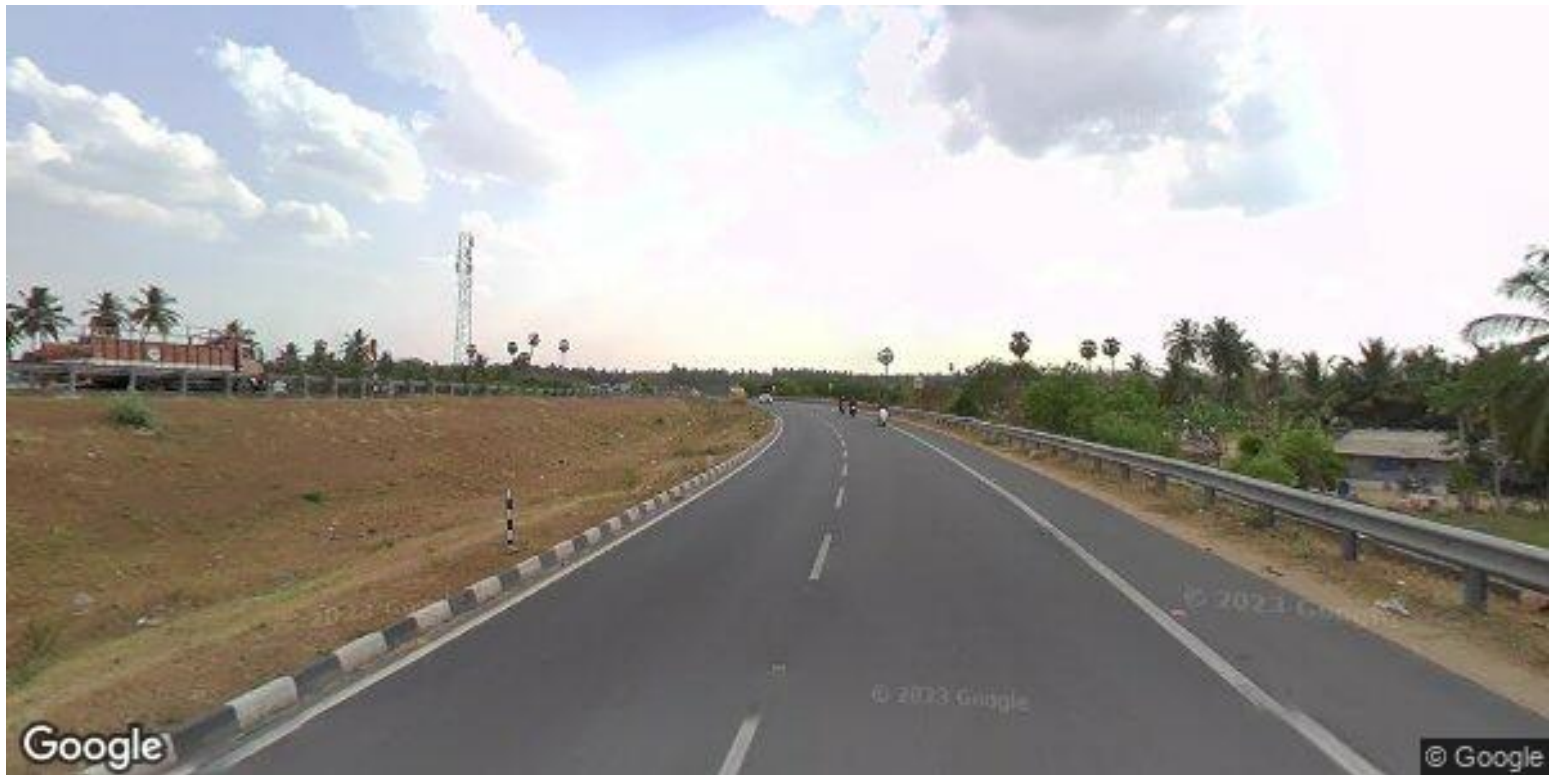
**Risk Type:** Turn  
**Risk Level:** Medium  
**Speed Limit:** 30 KM/Hr  
**Coordinates:** 11.53552, 77.95763

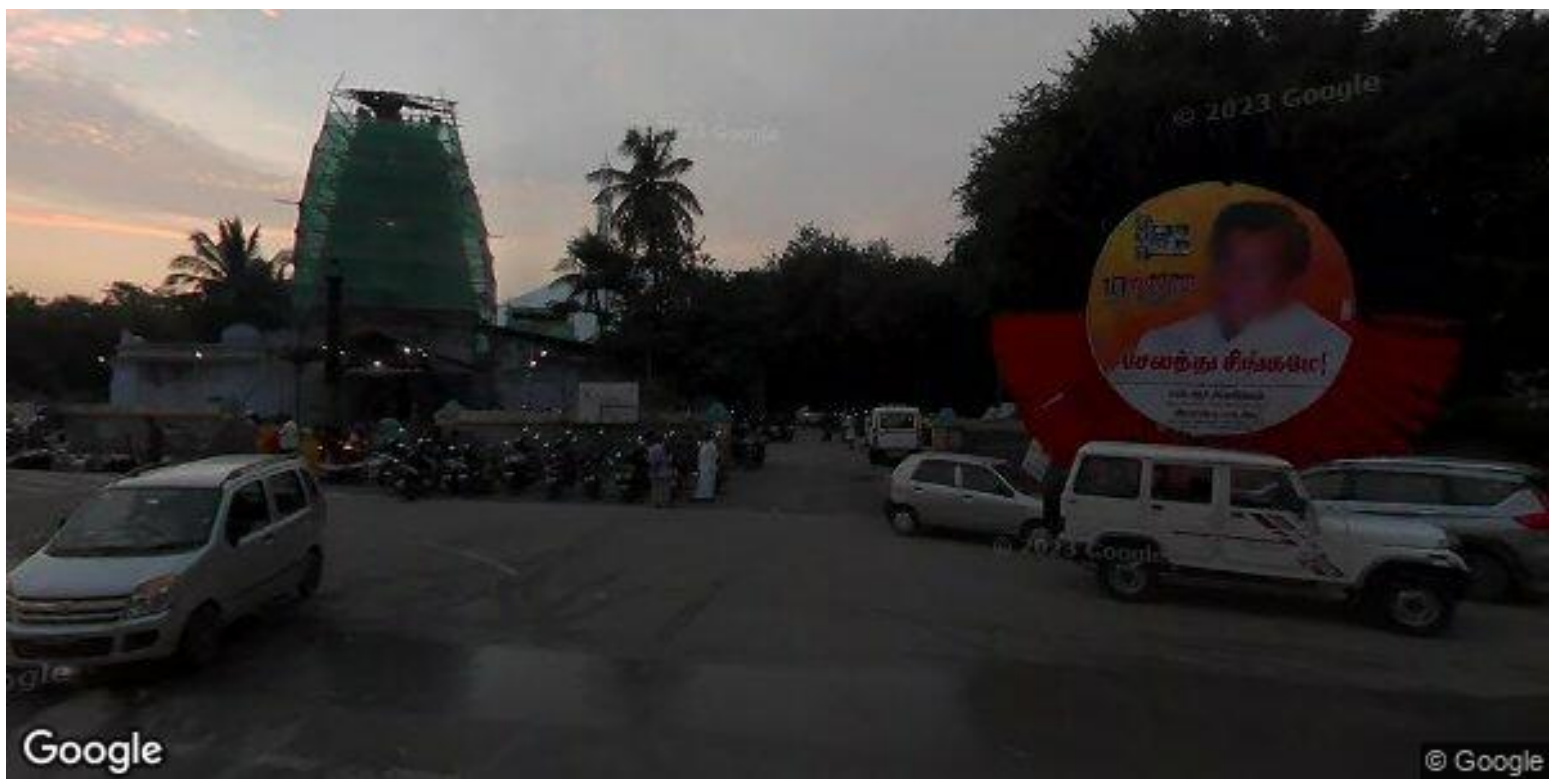
**Risk Type:** Turn  
**Risk Level:** High  
**Speed Limit:** 15 KM/Hr  
**Coordinates:** 11.61233, 78.10397

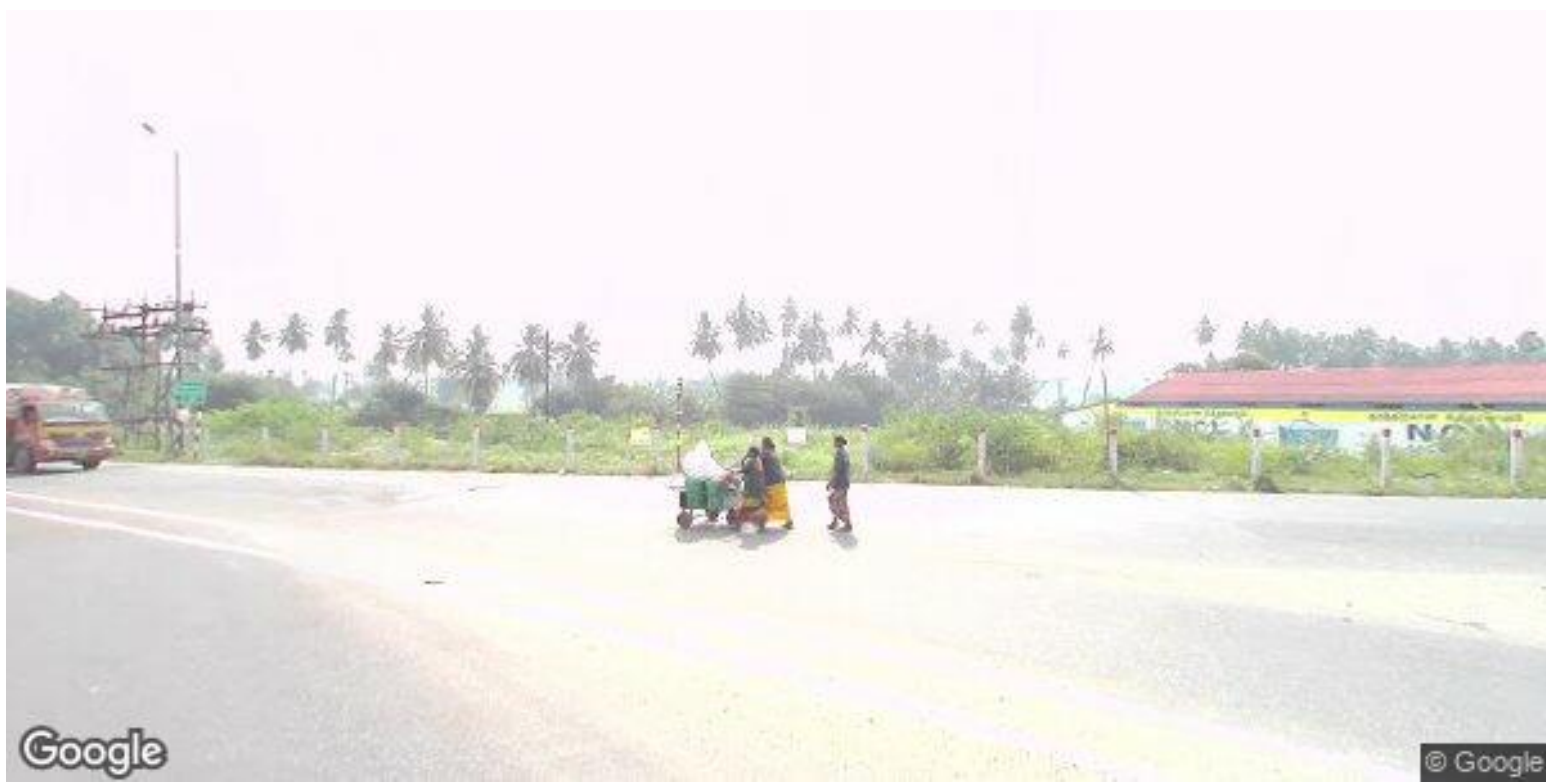
**Coordinates:** 11.61216, 78.10423

**Risk Type:** Turn

**Risk Level:** High

**Speed Limit:** 15 KM/Hr

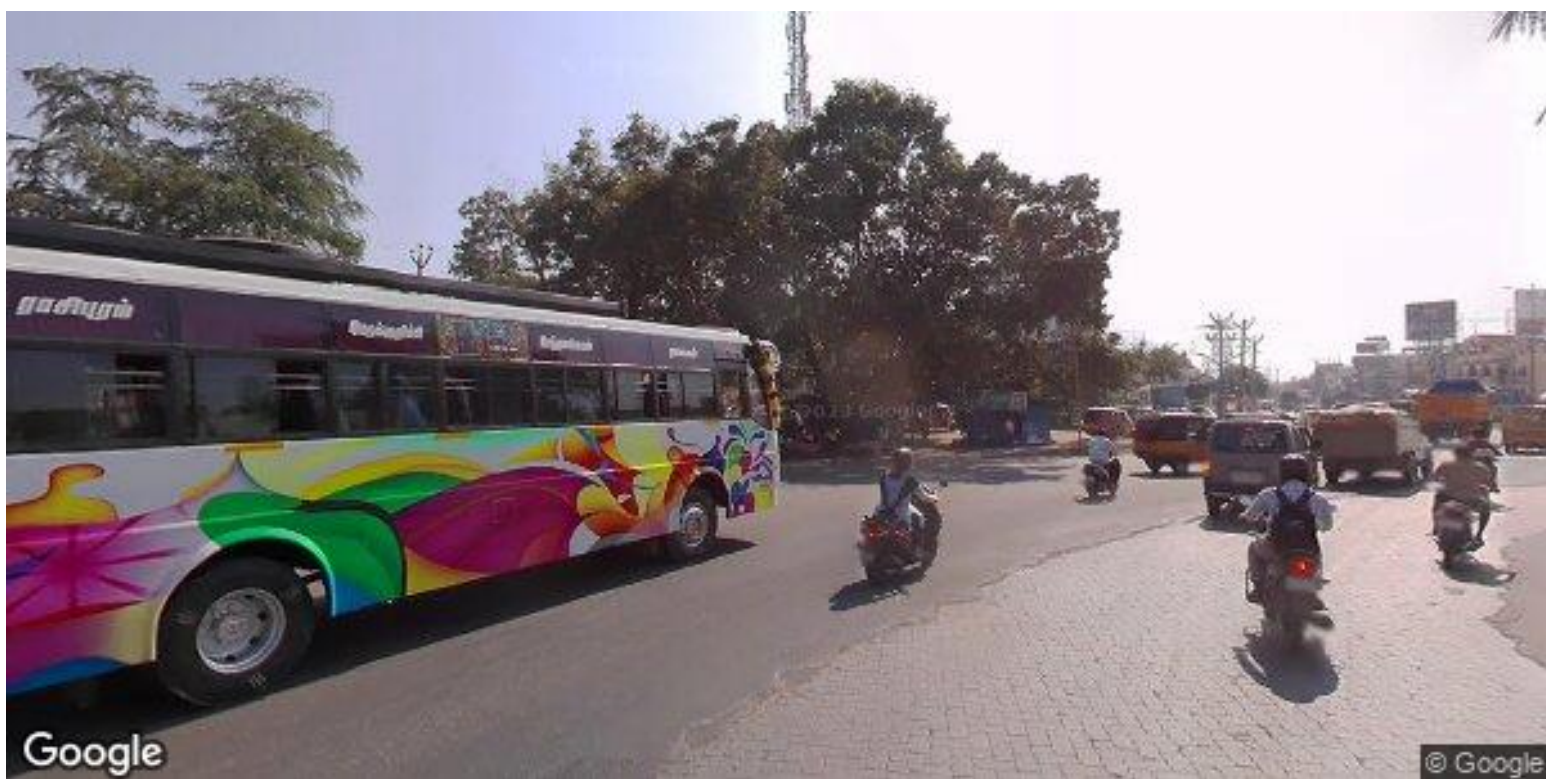
**Coordinates:** 11.63300, 78.12746

**Risk Type:** Turn

**Risk Level:** High

**Speed Limit:** 15 KM/Hr

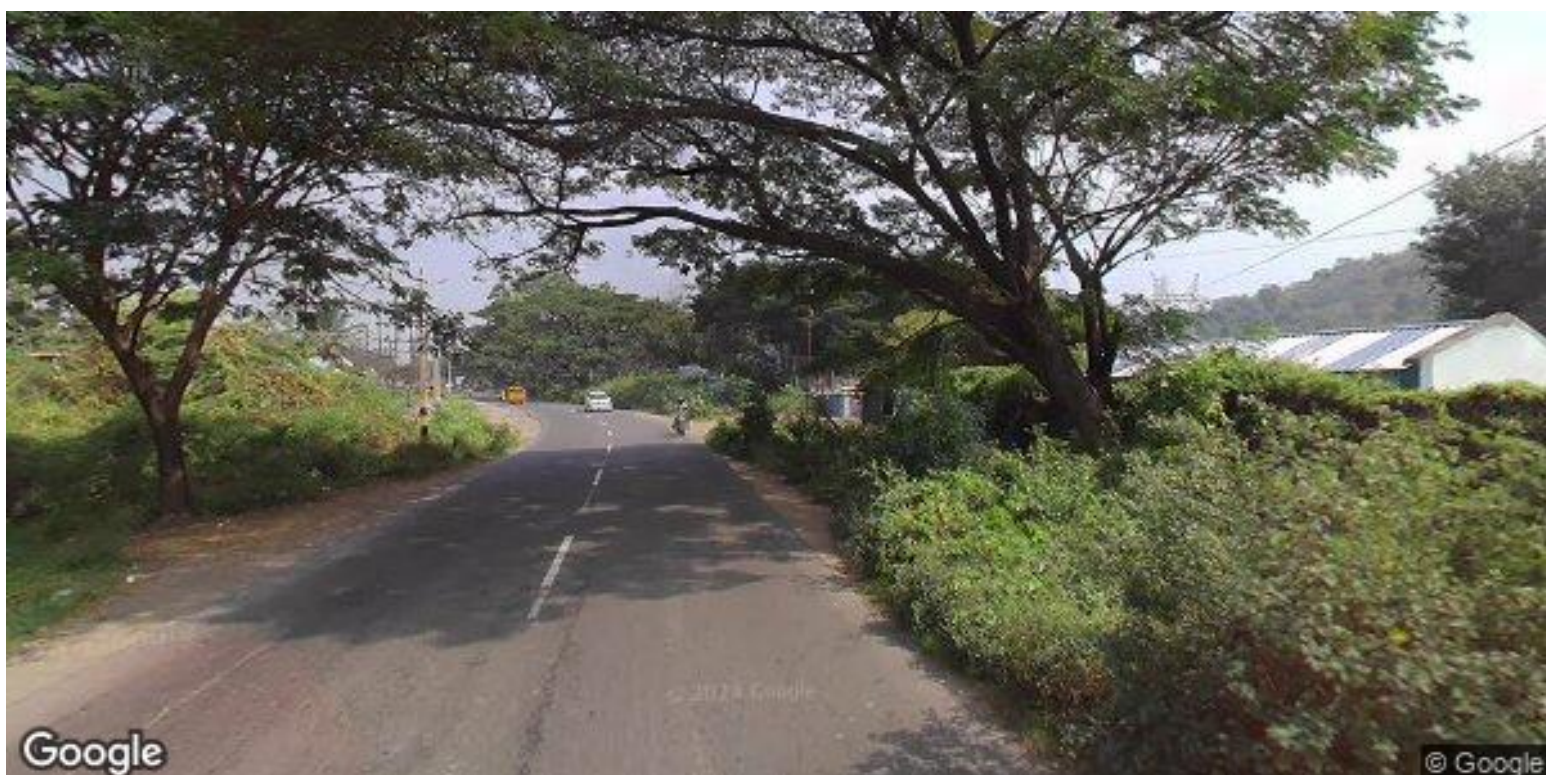
**Risk Type:** Turn  
**Risk Level:** Medium  
**Speed Limit:** 30 KM/Hr  
**Coordinates:** 11.65825, 78.20469

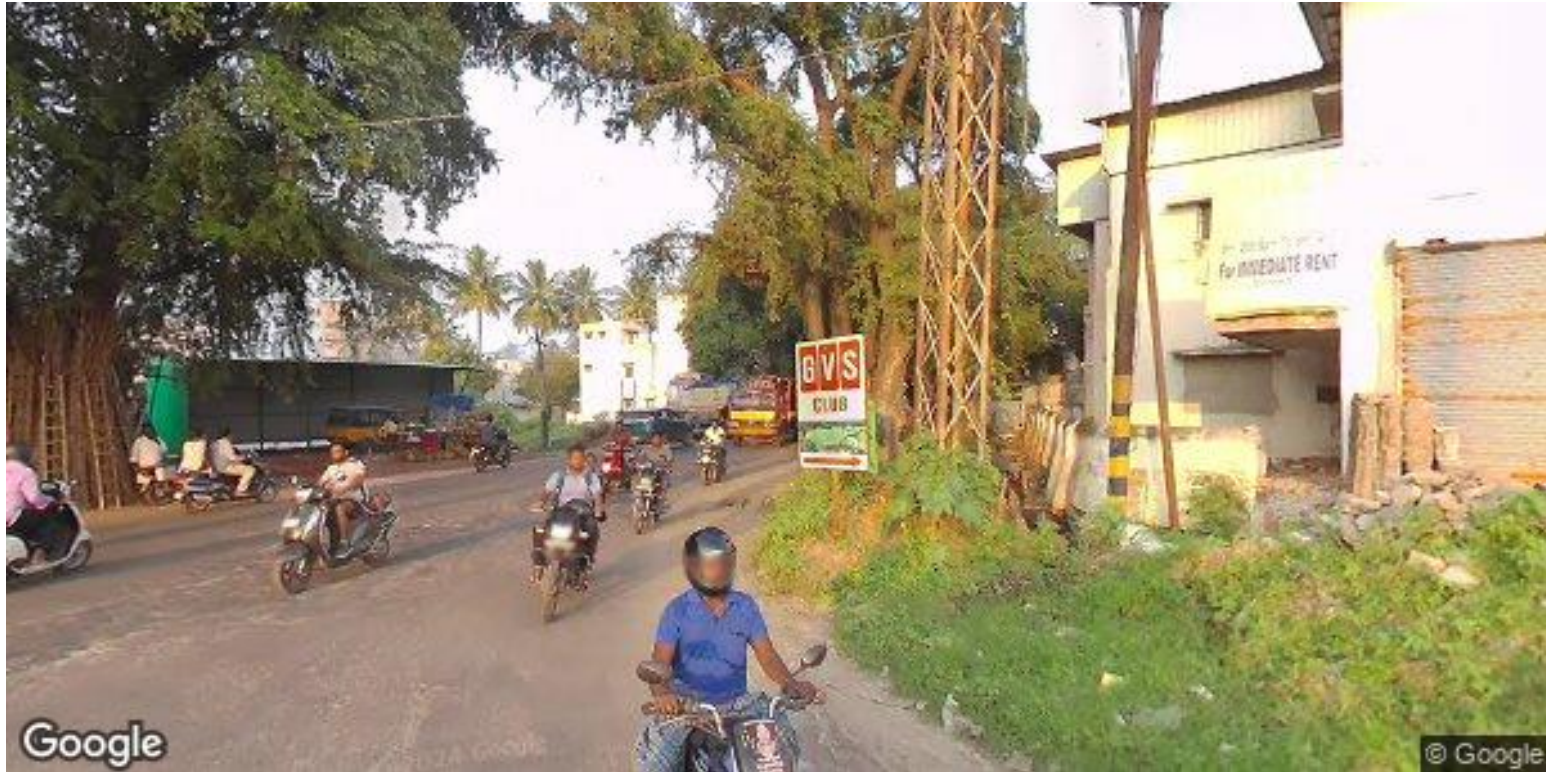
**Risk Type:** Turn  
**Risk Level:** Medium  
**Speed Limit:** 30 KM/Hr  
**Coordinates:** 11.66366, 78.20649

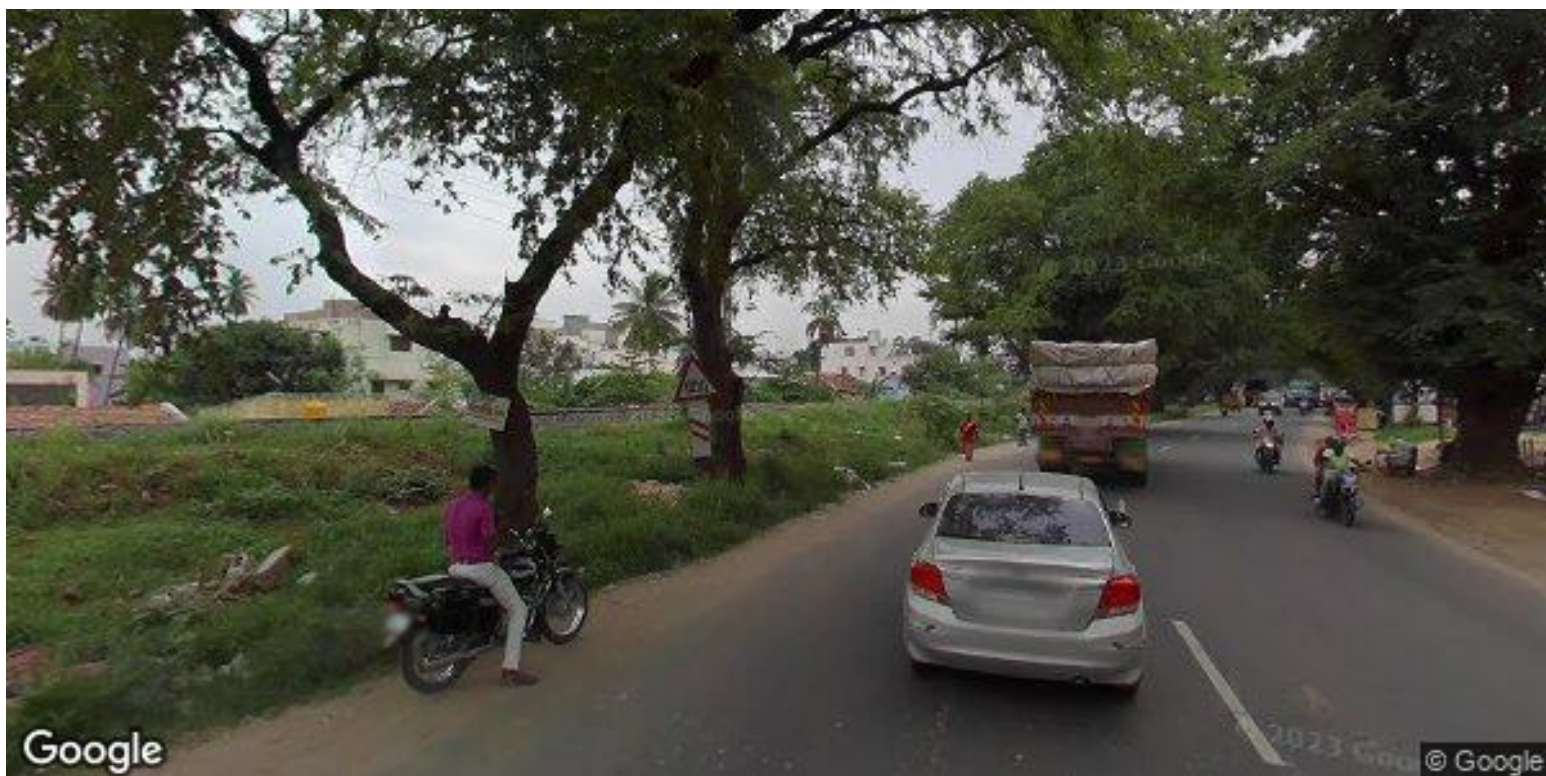
**Risk Type:** Turn  
**Risk Level:** Medium  
**Speed Limit:** 30 KM/Hr  
**Coordinates:** 11.67129, 78.22978

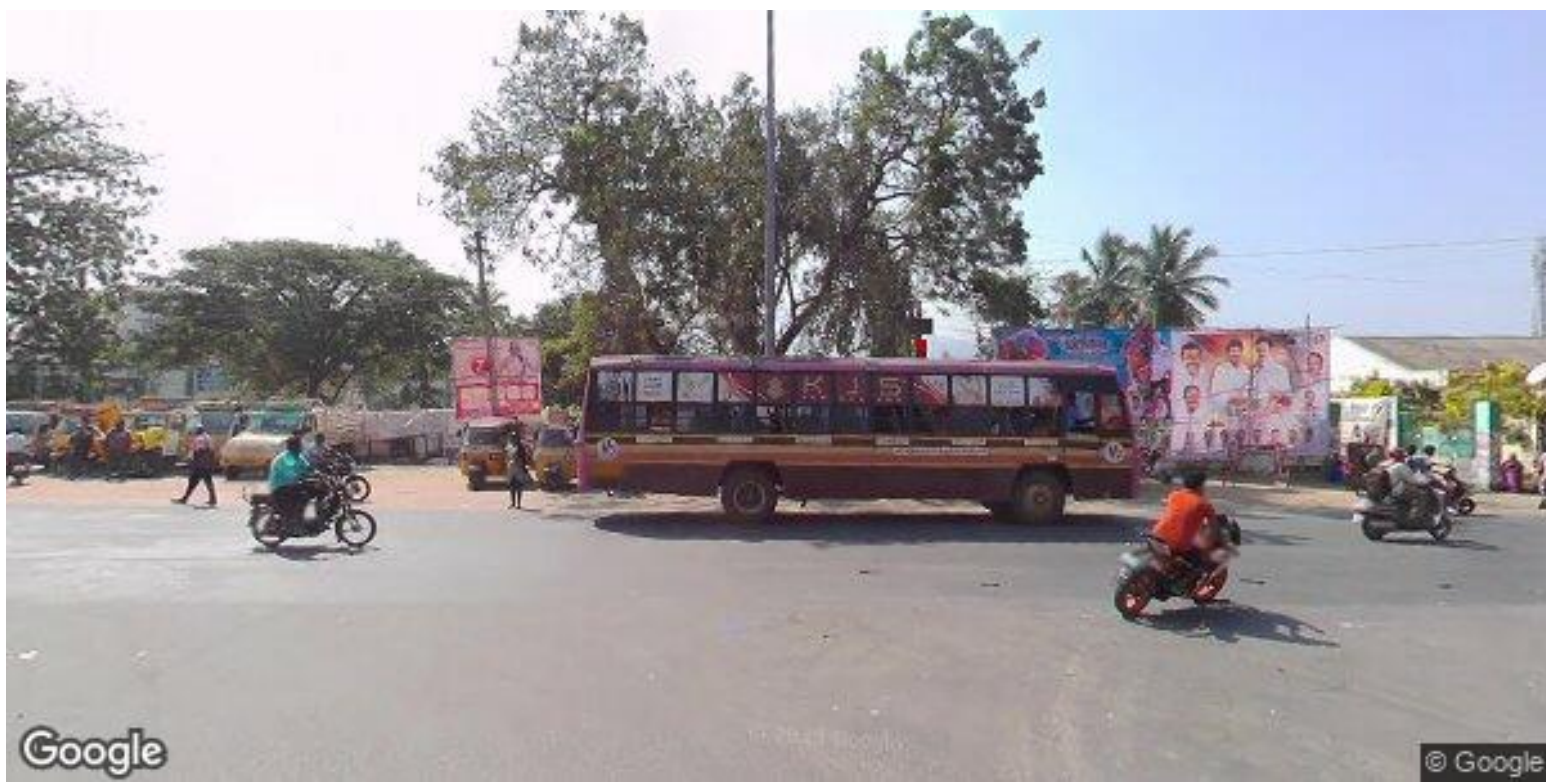
**Coordinates:** 11.67120, 78.23136

**Risk Type:** Turn

**Risk Level:** High

**Speed Limit:** 15 KM/Hr

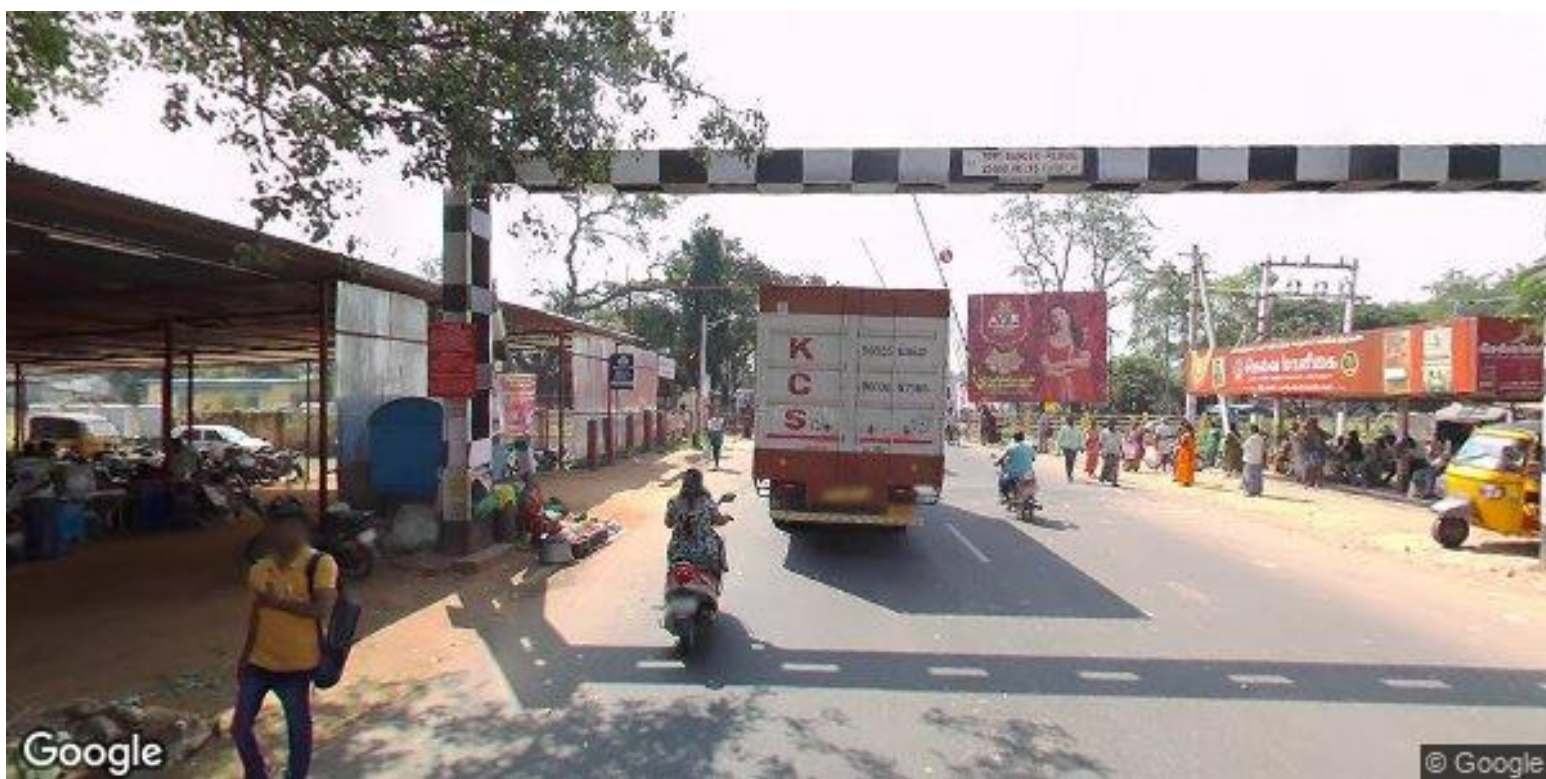
**Coordinates:** 11.67182, 78.23141

**Risk Type:** Turn

**Risk Level:** High

**Speed Limit:** 15 KM/Hr

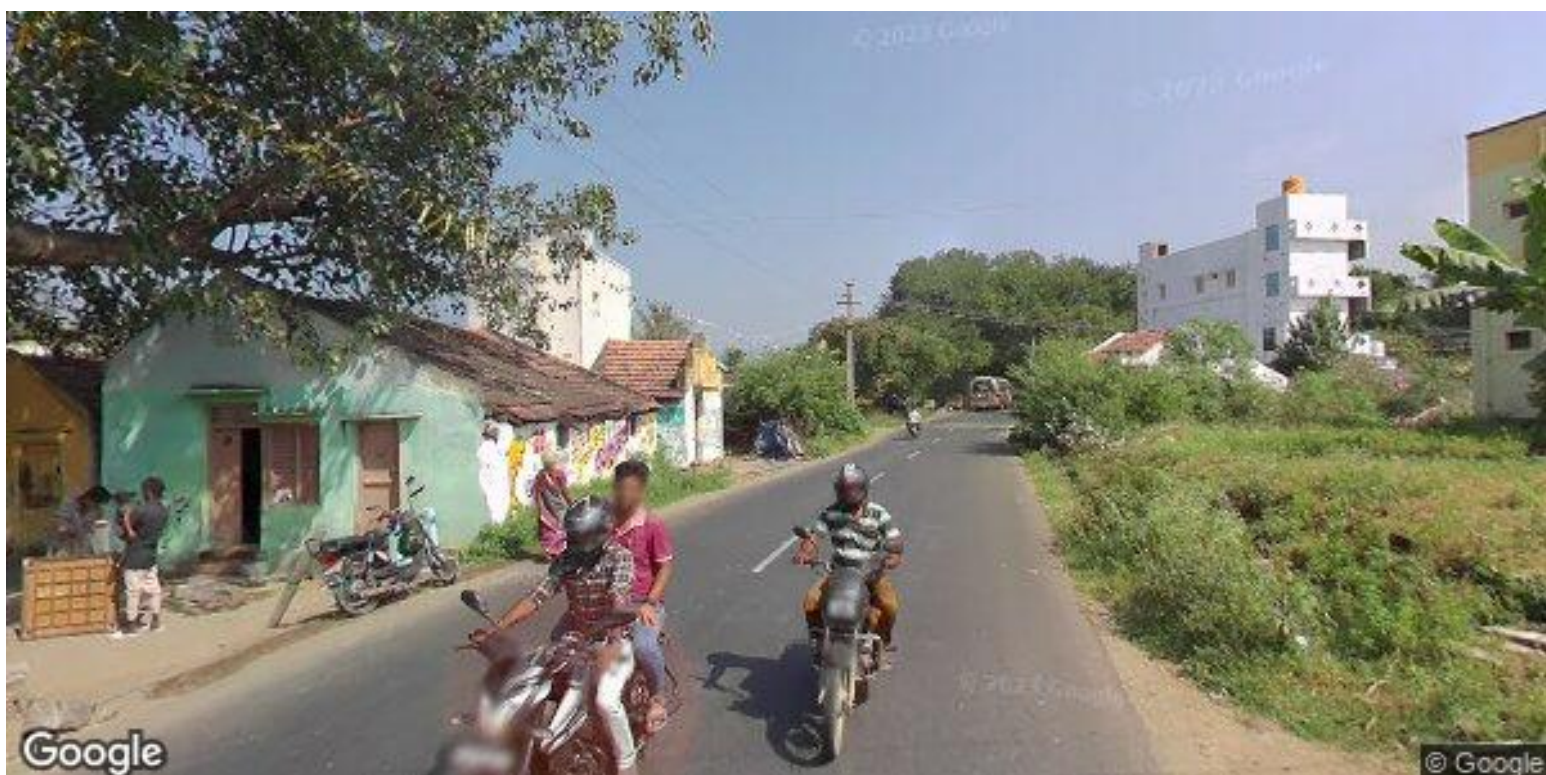
**Risk Type:** Turn  
**Risk Level:** Medium  
**Speed Limit:** 30 KM/Hr  
**Coordinates:** 11.68017, 78.24250

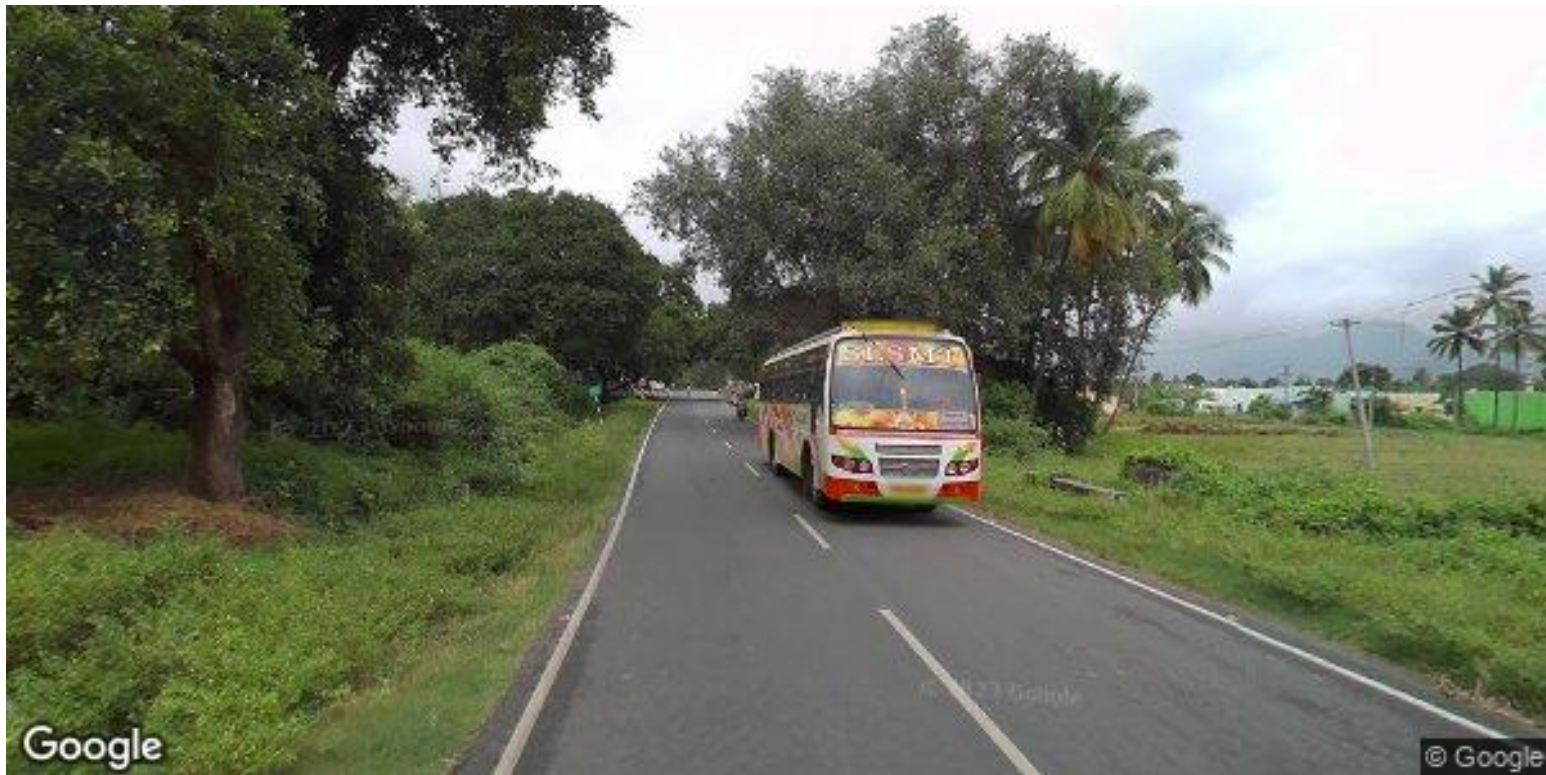
**Risk Type:** Turn  
**Risk Level:** Medium  
**Speed Limit:** 30 KM/Hr  
**Coordinates:** 11.83514, 78.35305

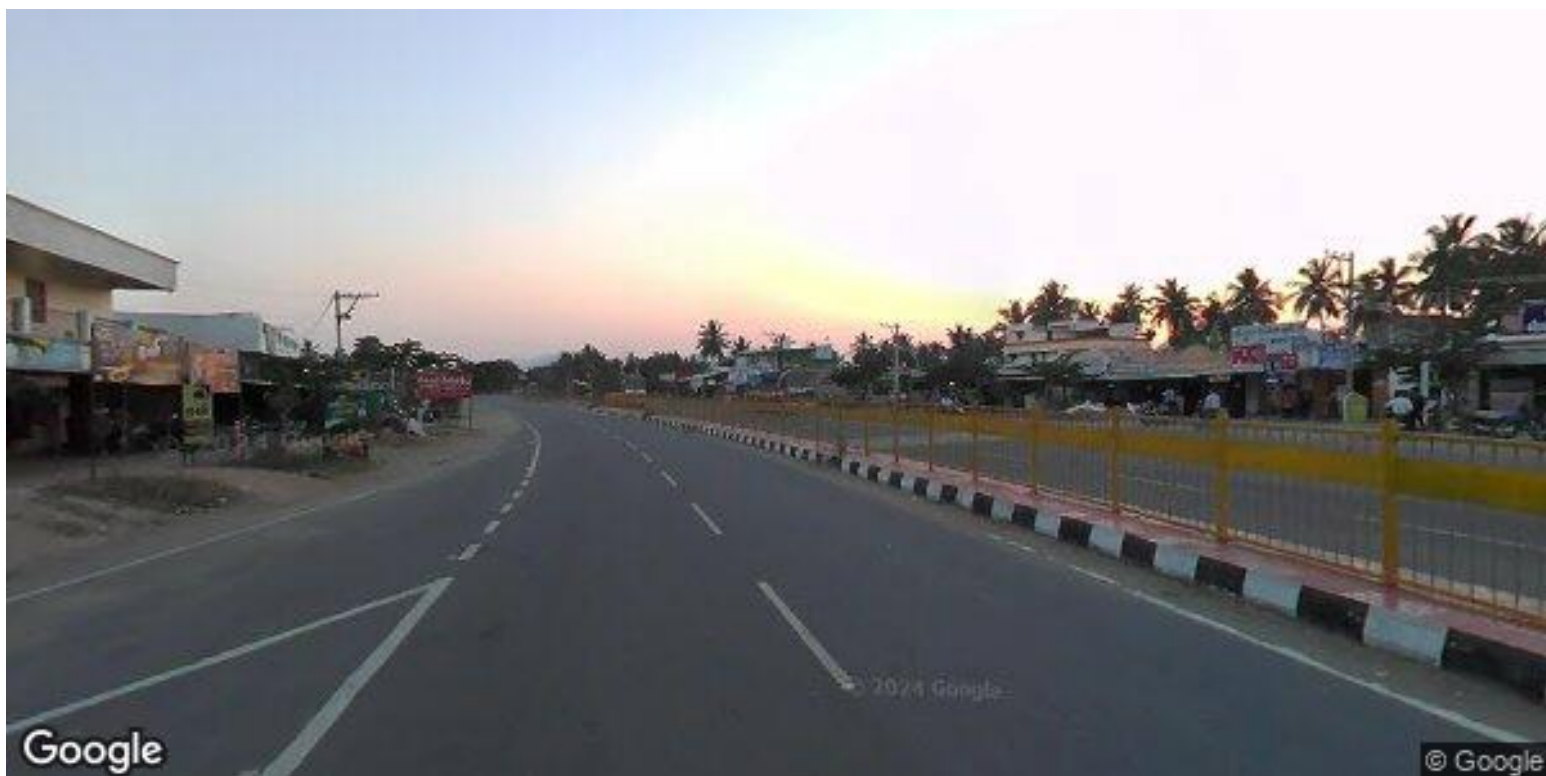
**Risk Type:** Turn  
**Risk Level:** High  
**Speed Limit:** 15 KM/Hr  
**Coordinates:** 11.93905, 78.40417

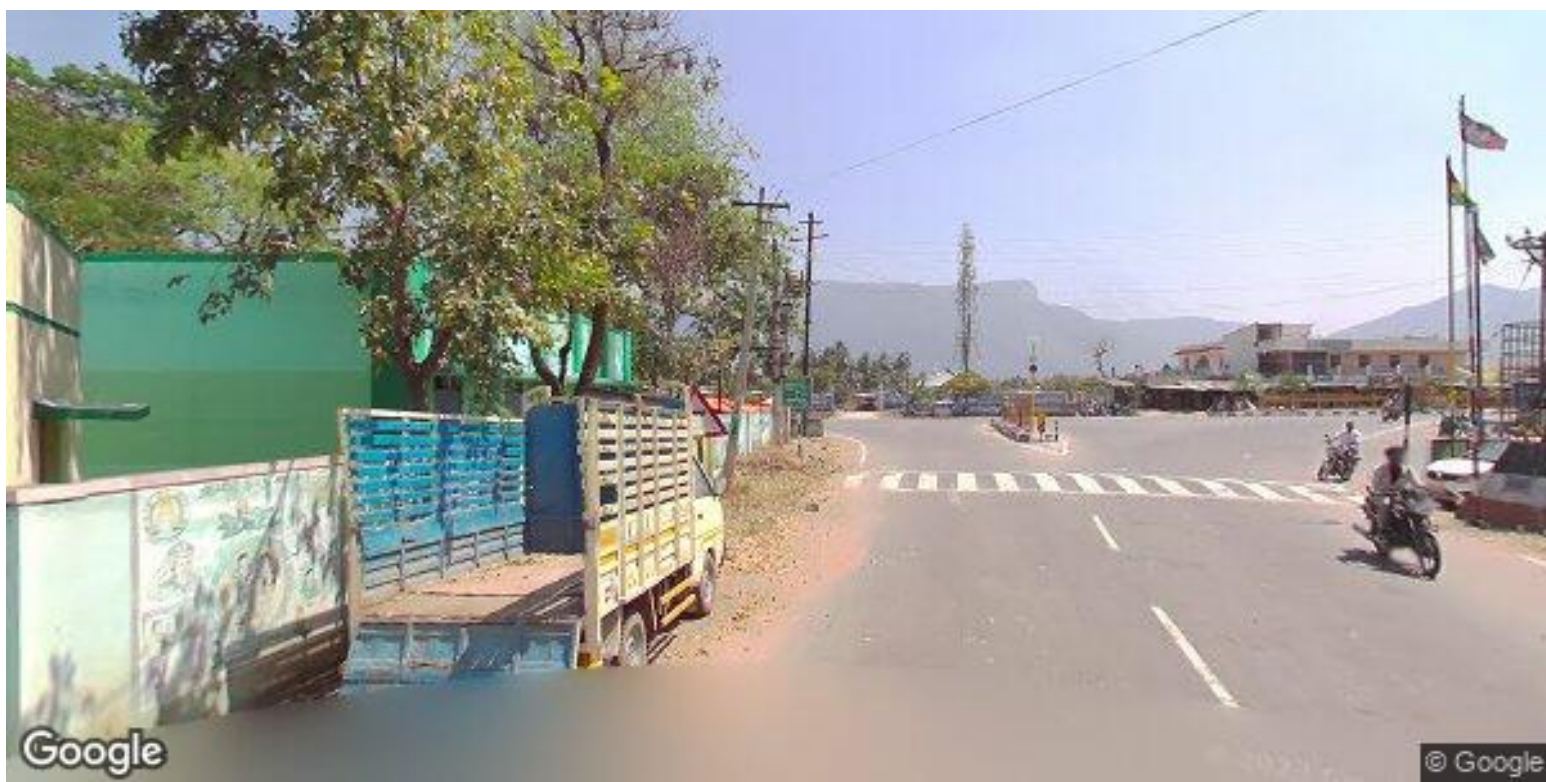
**Coordinates:** 11.93960, 78.40395

**Risk Type:** Turn

**Risk Level:** Medium

**Speed Limit:** 30 KM/Hr

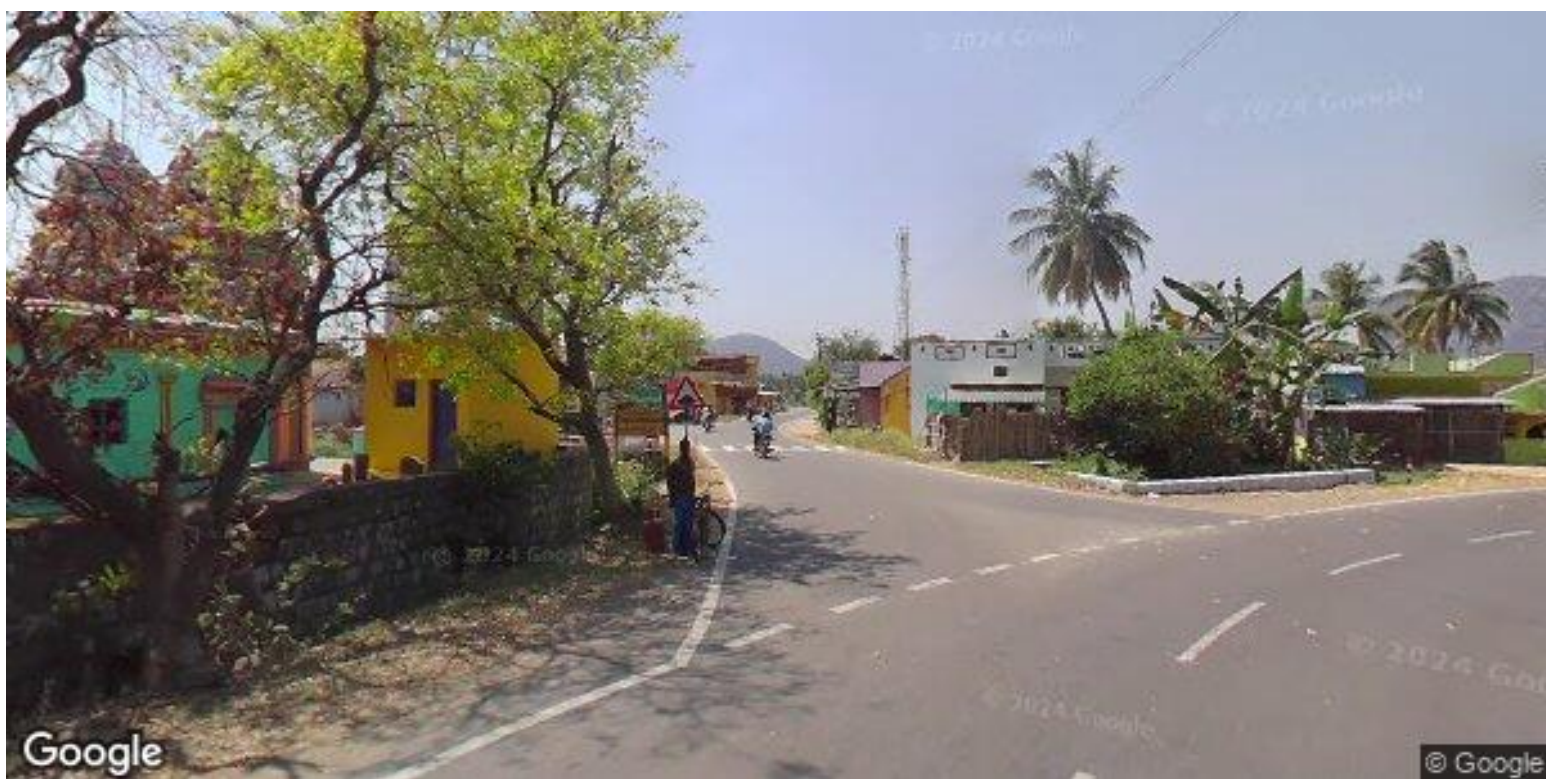
**Coordinates:** 11.94039, 78.40200

**Risk Type:** Turn

**Risk Level:** Medium

**Speed Limit:** 30 KM/Hr

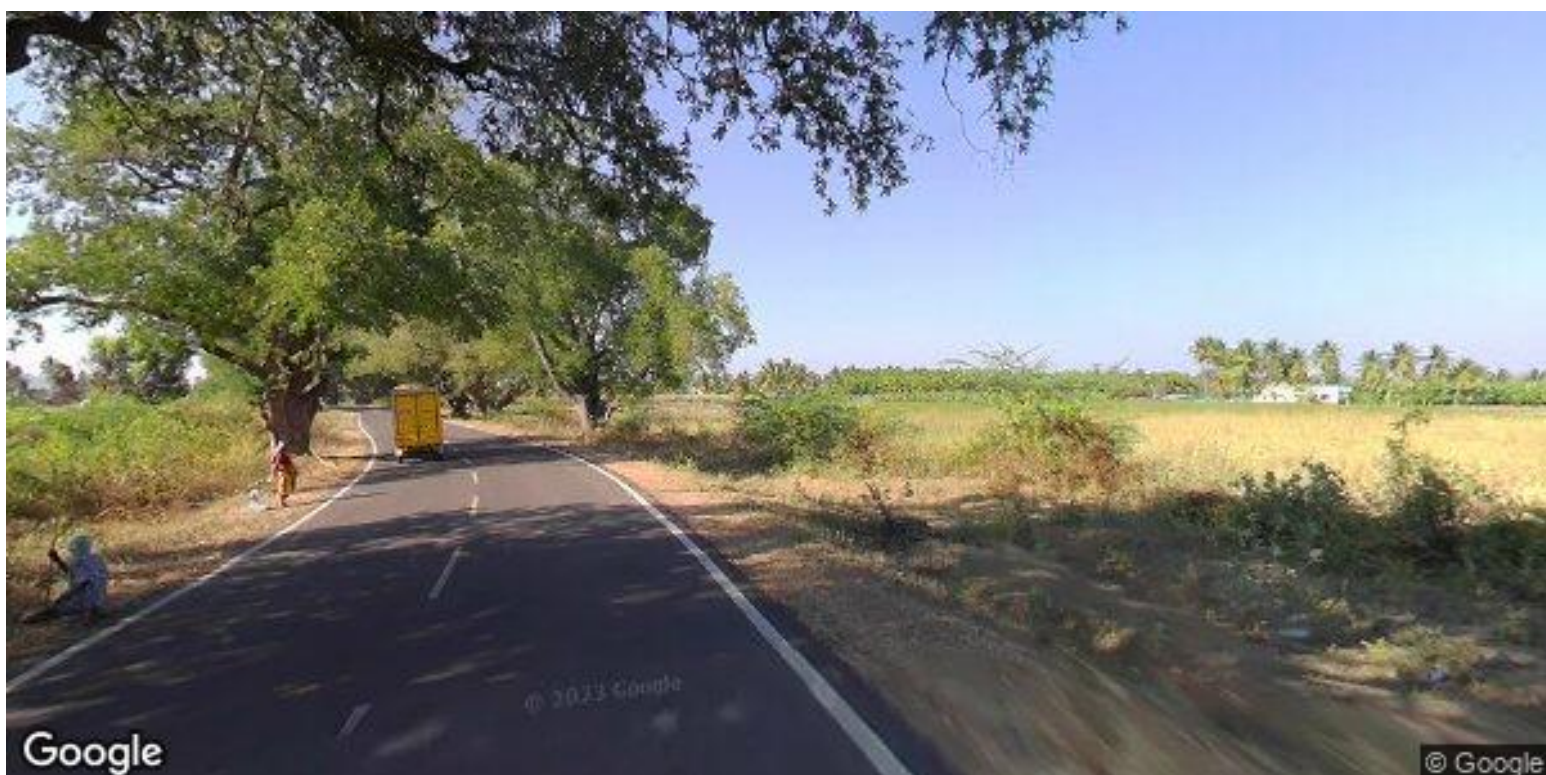
**Coordinates:** 11.95570, 78.39975

**Risk Type:** Turn

**Risk Level:** Medium

**Speed Limit:** 30 KM/Hr
