## JOURNEY RISK MANAGEMENT (JRM) STUDY

Salem Terminal to DEPT. OF SUGAR -SUBRAMANYA  
SIVA CSM

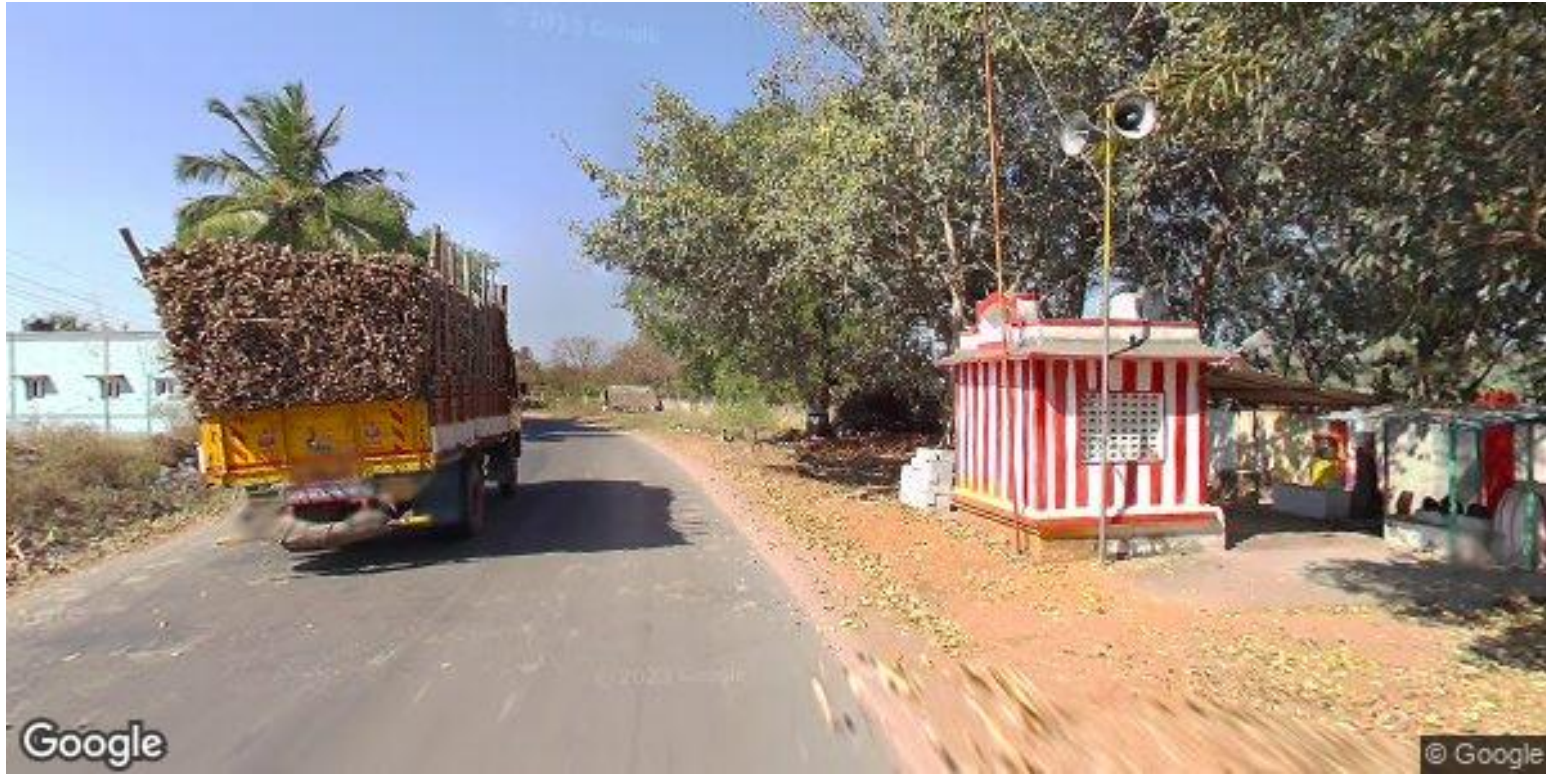
**Coordinates:** 11.98751, 78.39991

**Risk Type:** Turn

**Risk Level:** Medium

**Speed Limit:** 30 KM/Hr
