# IndianOil

## JOURNEY RISK MANAGEMENT (JRM) STUDY

### Salem Terminal TO SASTI MURUGAN AGENCY

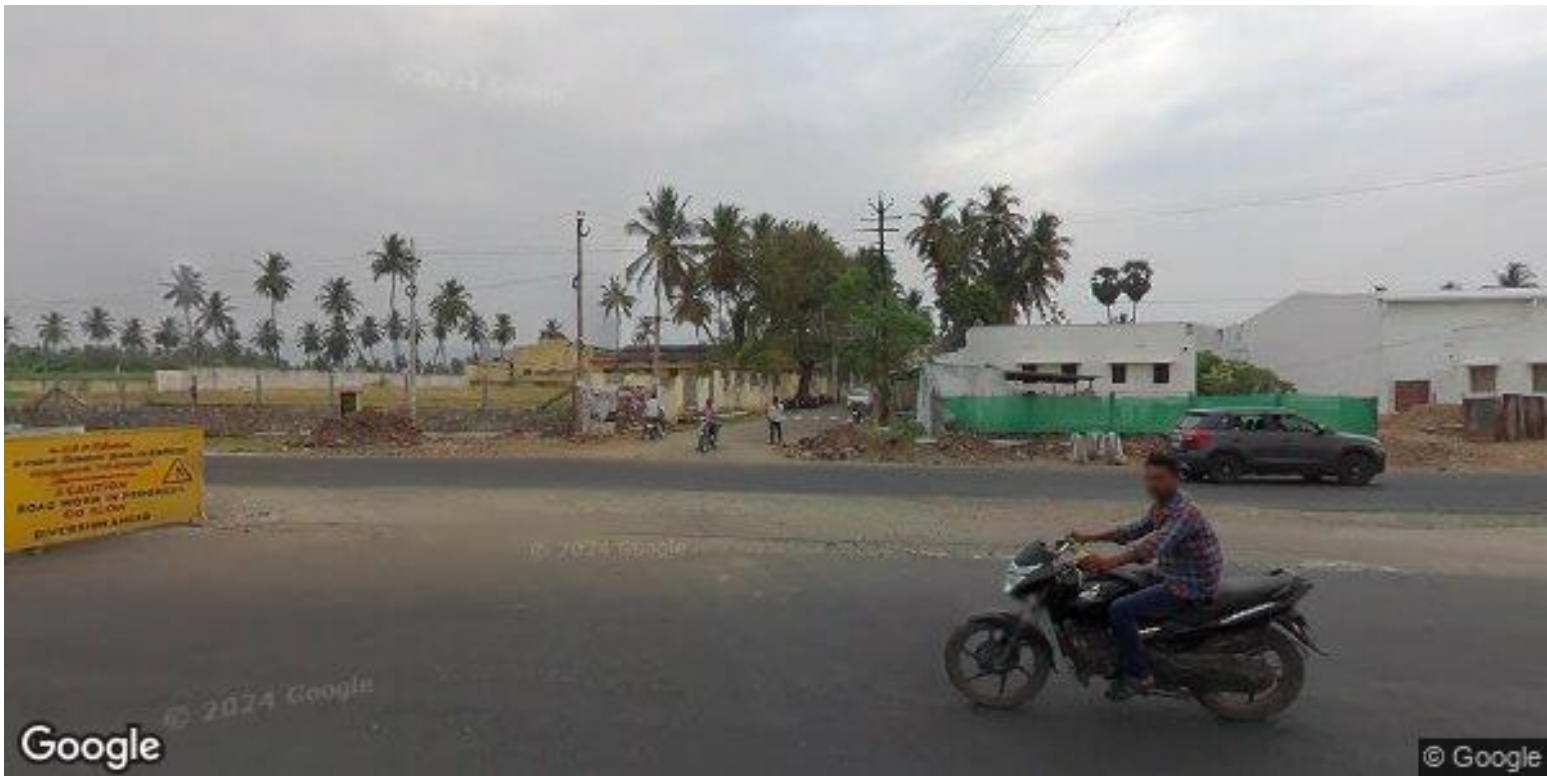
**Coordinates: 11.4518258, 77.4689619**

**Risk Type: U-Turn**

**Risk Level: High**

**Speed Limit: 10 KM/Hr**

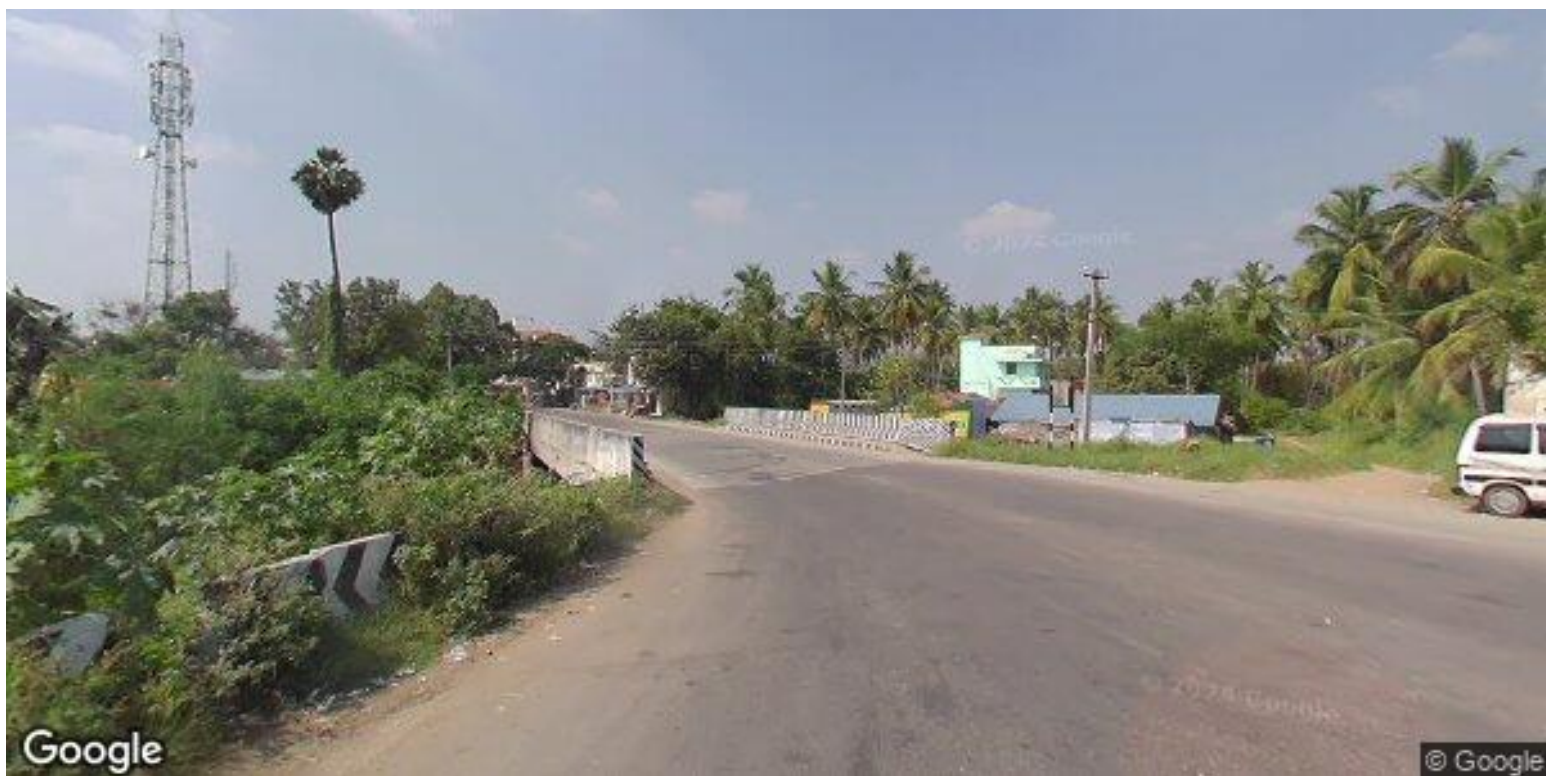
**Coordinates: 11.44893, 77.87413**

**Risk Type: Turn**

**Risk Level: Medium**

**Speed Limit: 30 KM/Hr**

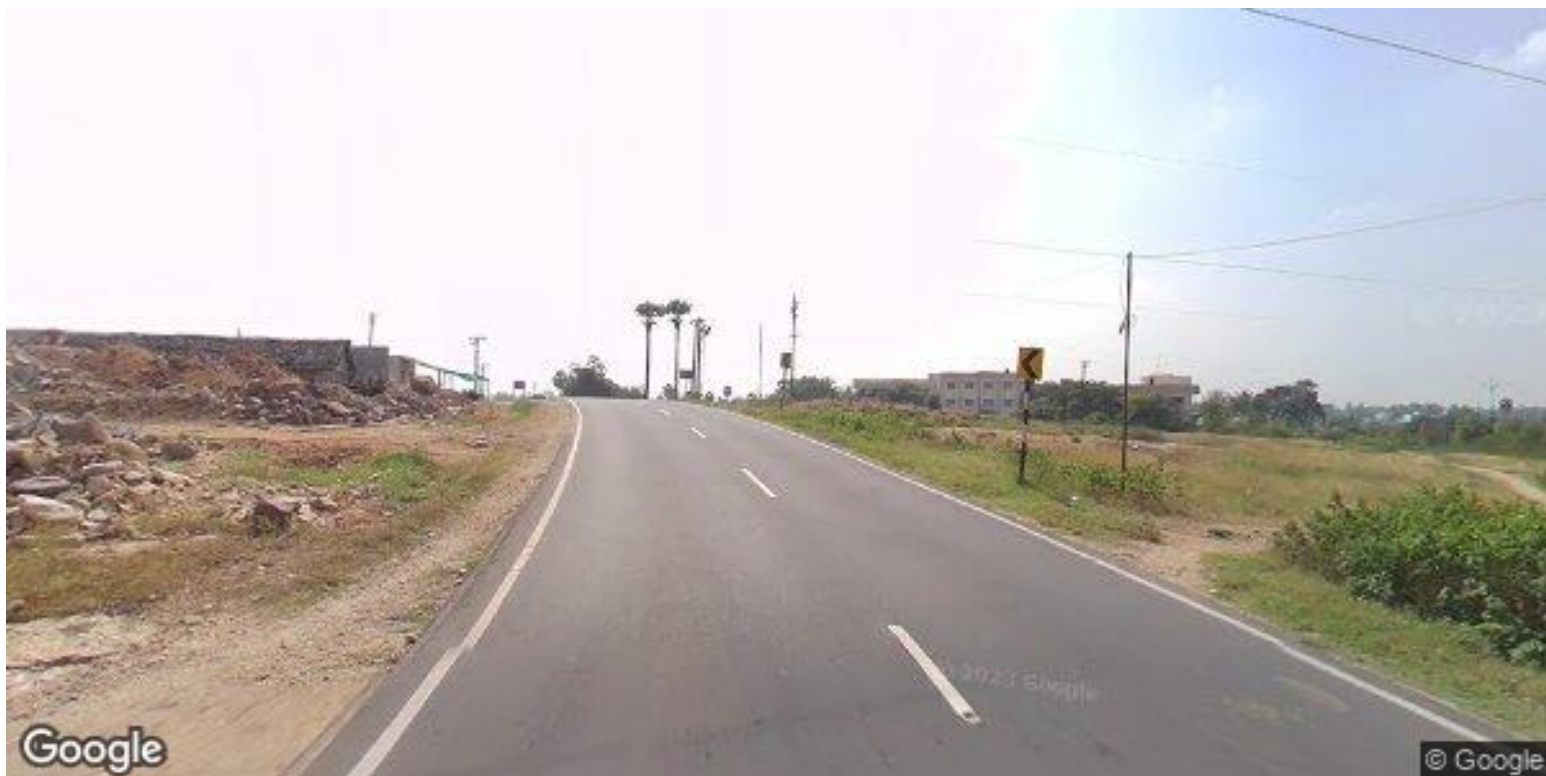
**Coordinates:** 11.46046, 77.85037

**Risk Type:** Turn

**Risk Level:** Medium

**Speed Limit:** 30 KM/Hr

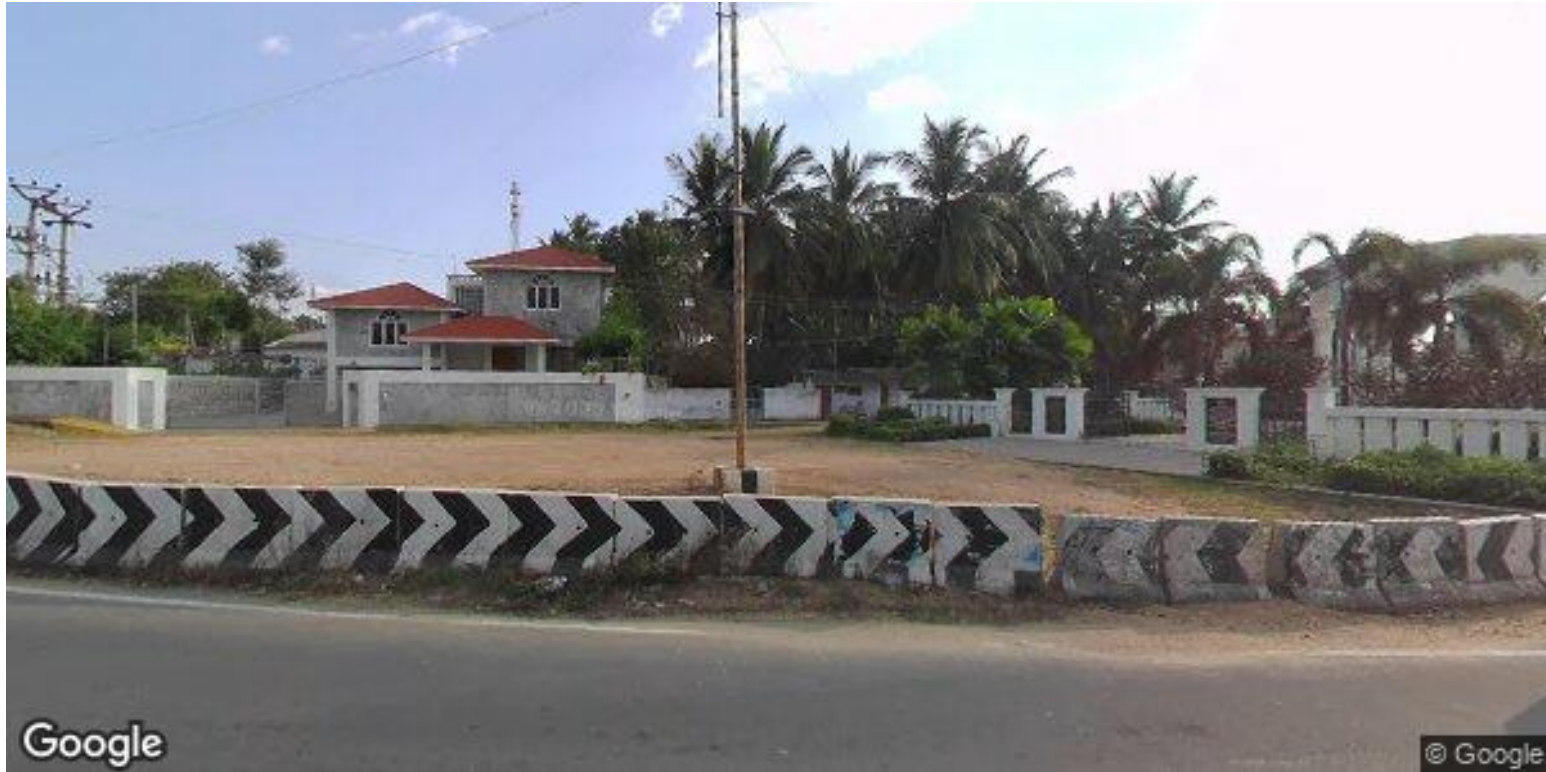
**Coordinates: 11.46316, 77.84921**

**Risk Type: Turn**

**Risk Level: Medium**

**Speed Limit: 30 KM/Hr**

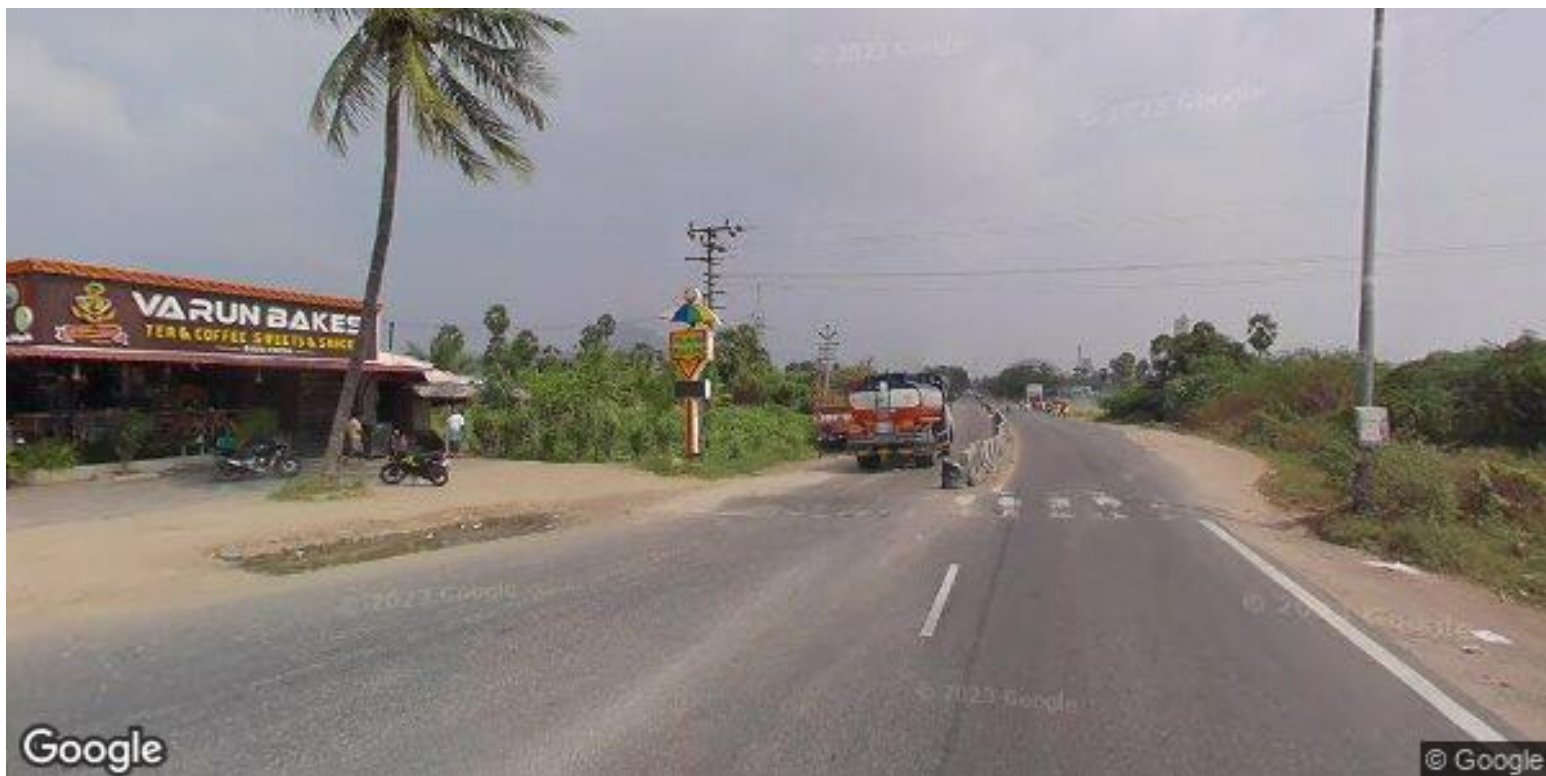
**Risk Type:** Blind Spot  
**Risk Level:** Blind Spot  
**Speed Limit:** 10 KM/Hr  
**Coordinates:** 11.45543, 77.81740

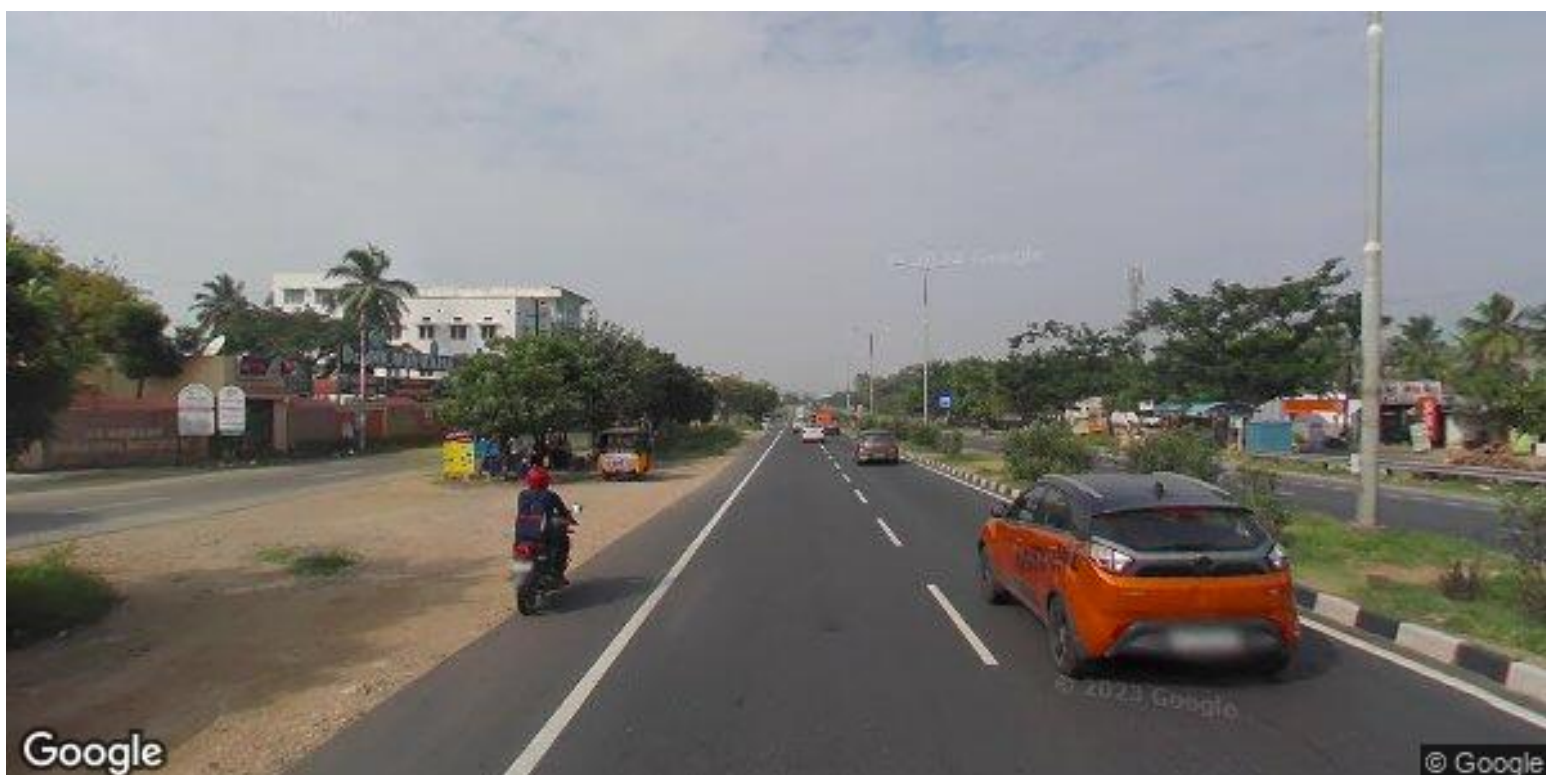
**Risk Type:** Blind Spot  
**Risk Level:** Blind Spot  
**Speed Limit:** 10 KM/Hr  
**Coordinates:** 11.44530, 77.72783

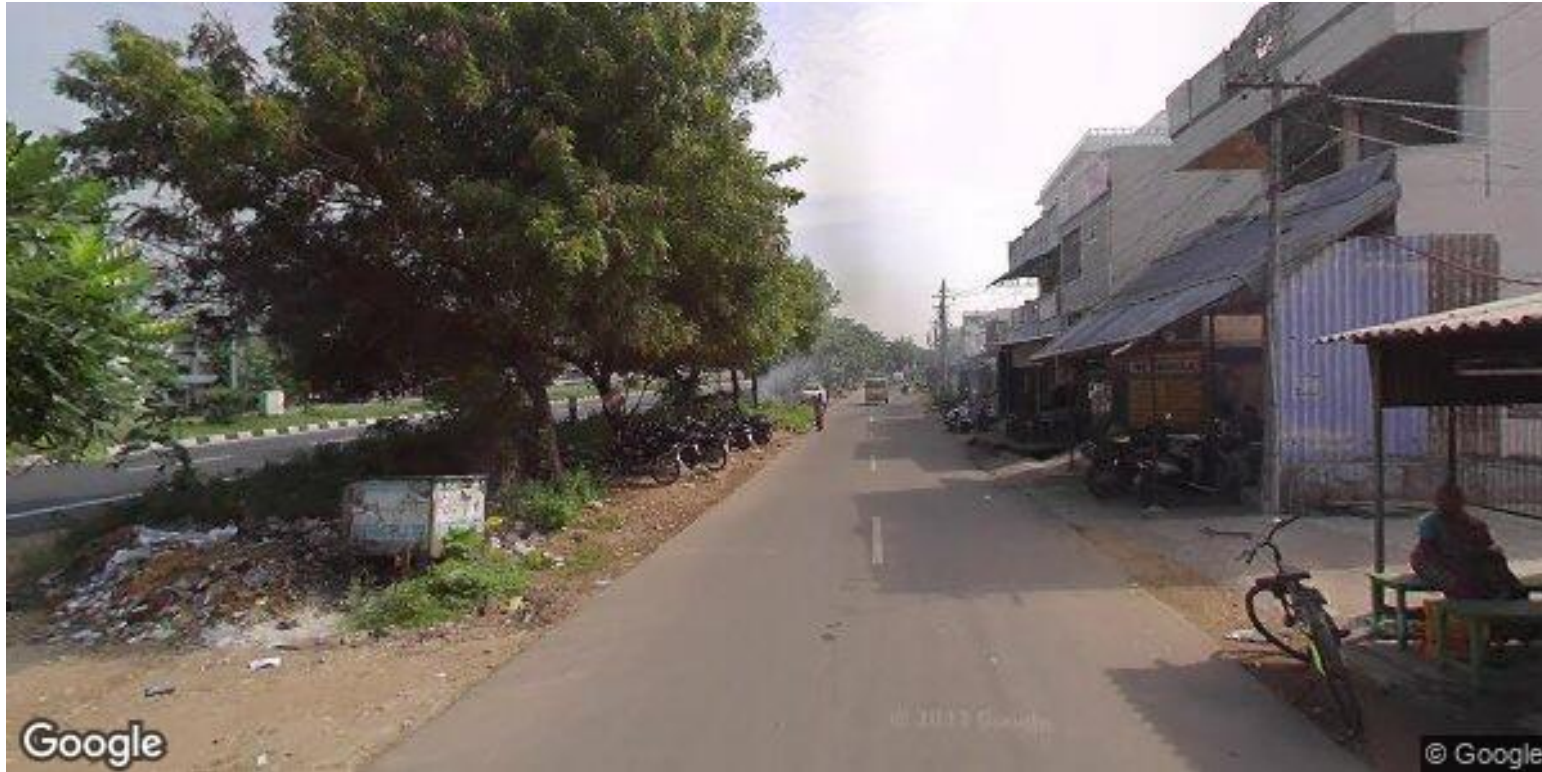
**Risk Type:** Blind Spot  
**Risk Level:** Blind Spot  
**Speed Limit:** 10 KM/Hr  
**Coordinates:** 11.44513, 77.72786

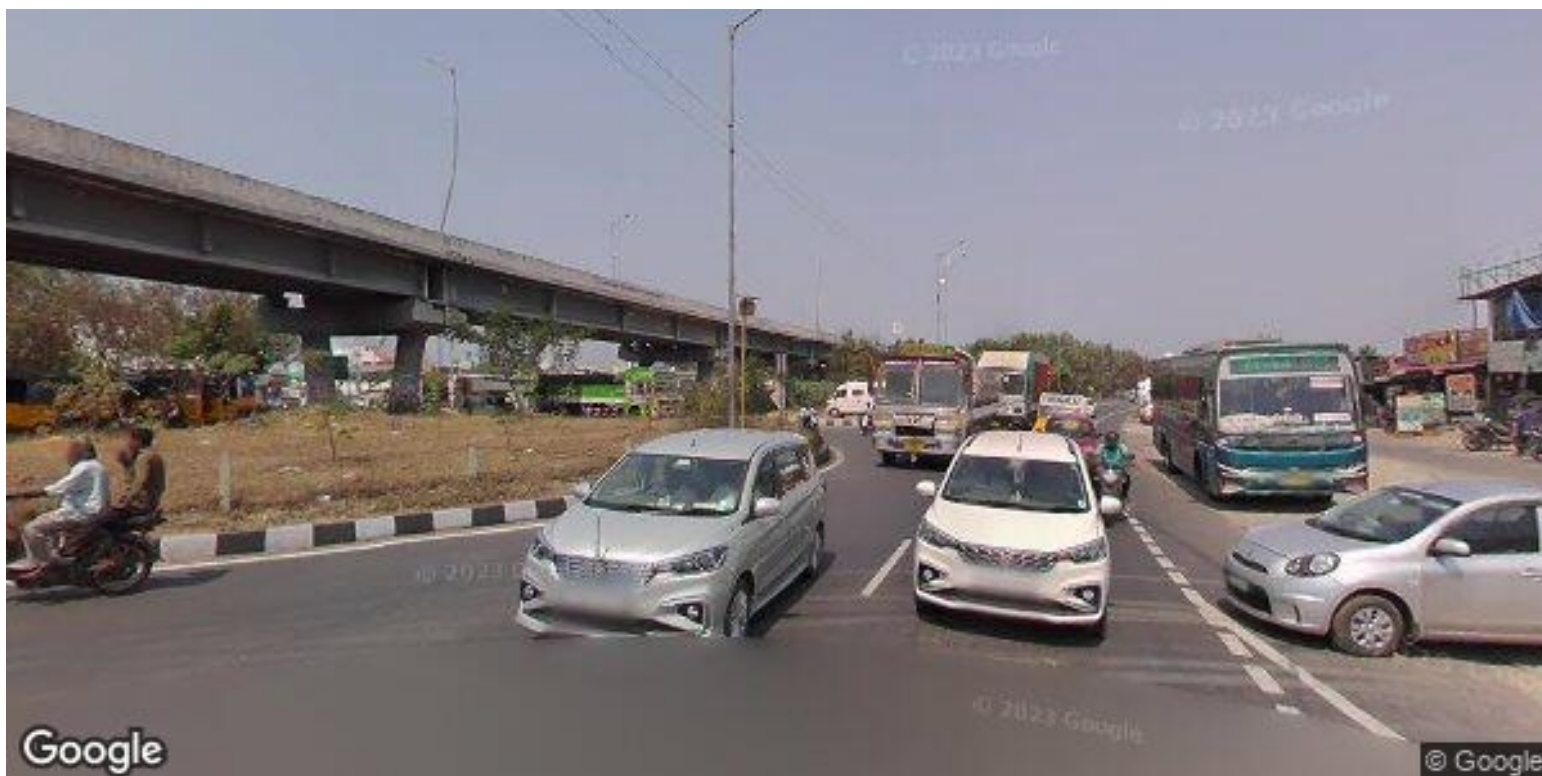
**Risk Type:** Turn  
**Risk Level:** High  
**Speed Limit:** 15 KM/Hr  
**Coordinates:** 11.43001, 77.67575

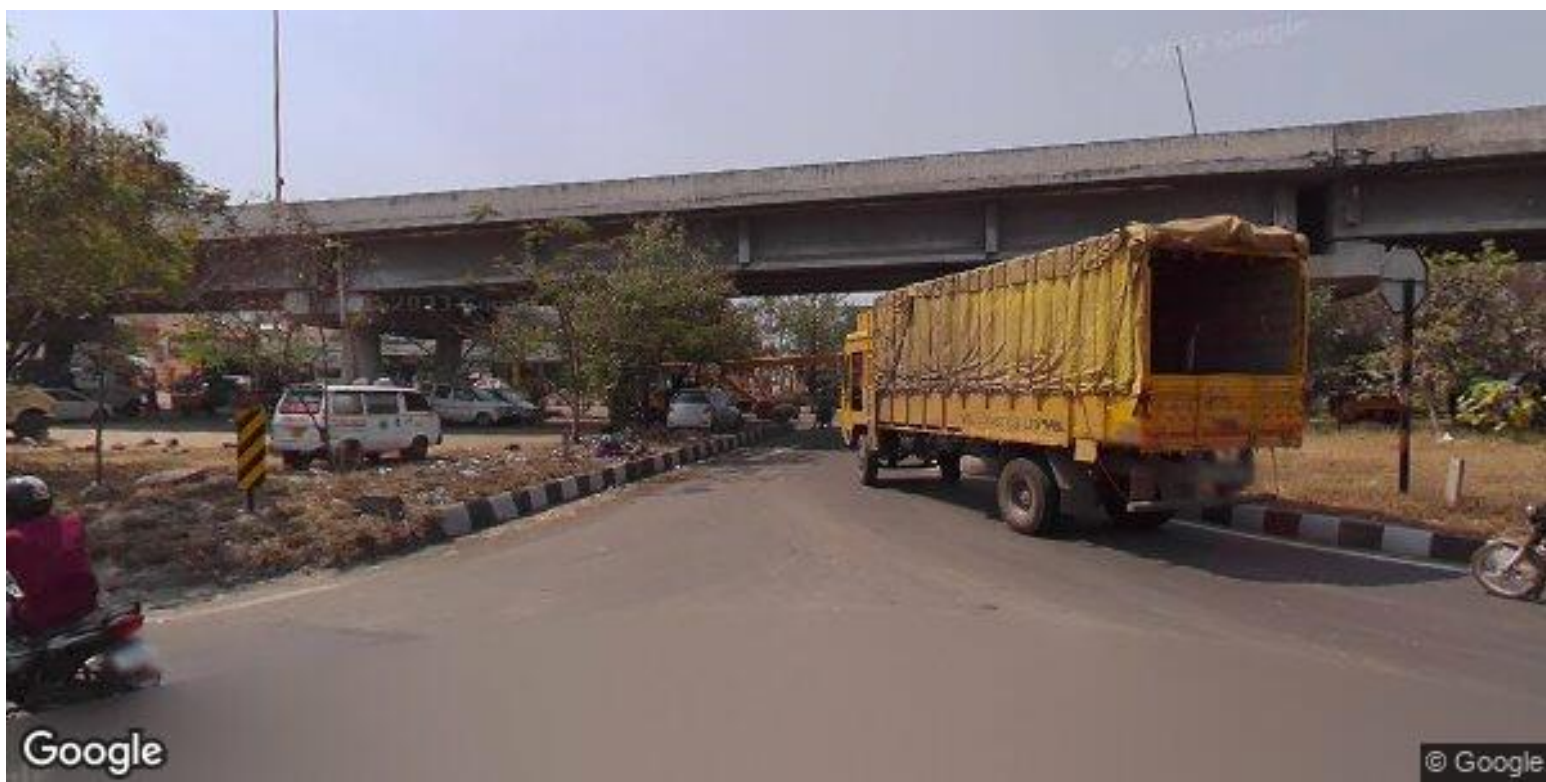
**Coordinates:** 11.43000, 77.67564

**Risk Type:** Turn

**Risk Level:** Medium

**Speed Limit:** 30 KM/Hr

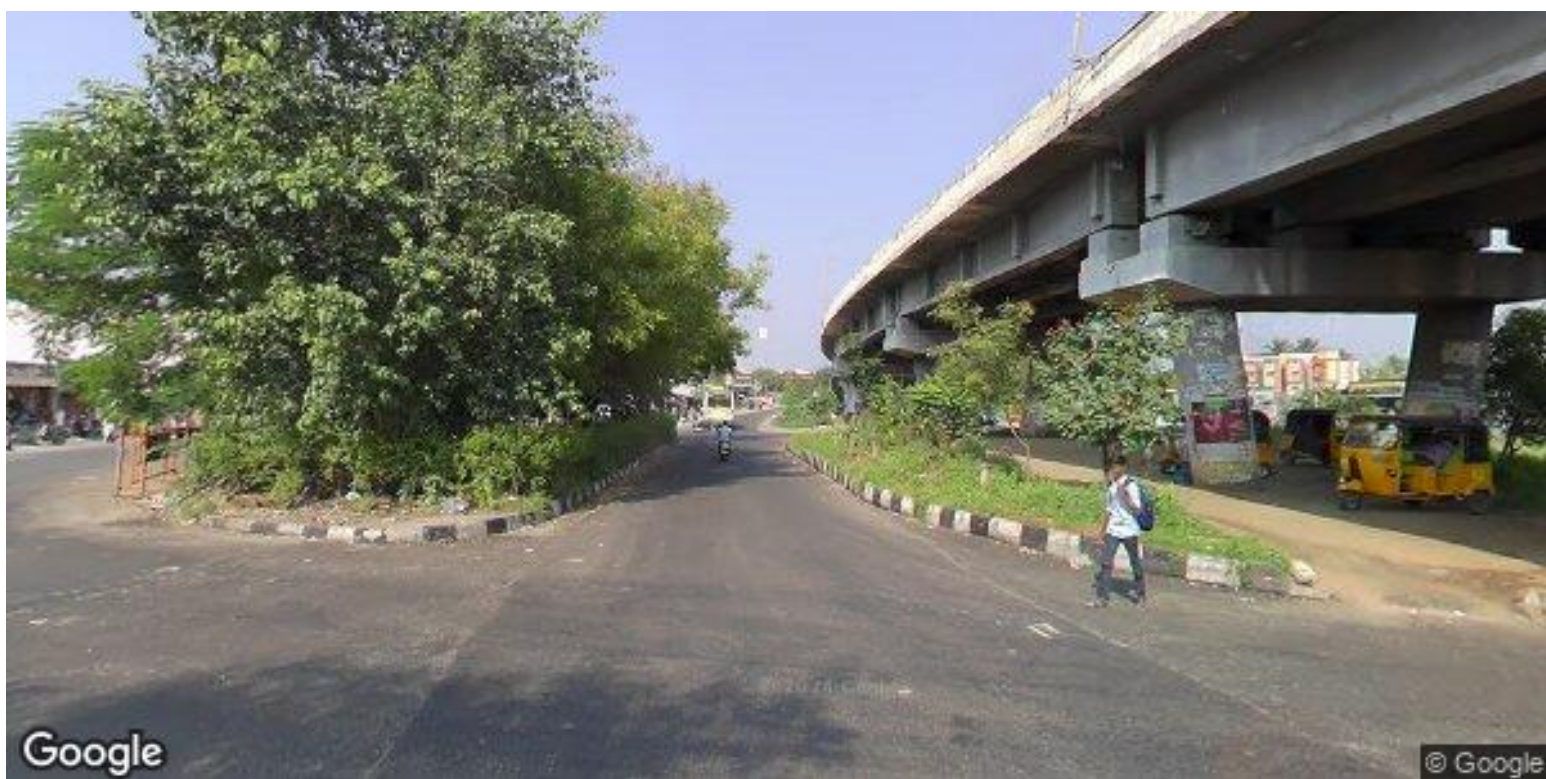
**Coordinates:** 11.43009, 77.67540

**Risk Type:** Turn

**Risk Level:** Medium

**Speed Limit:** 30 KM/Hr

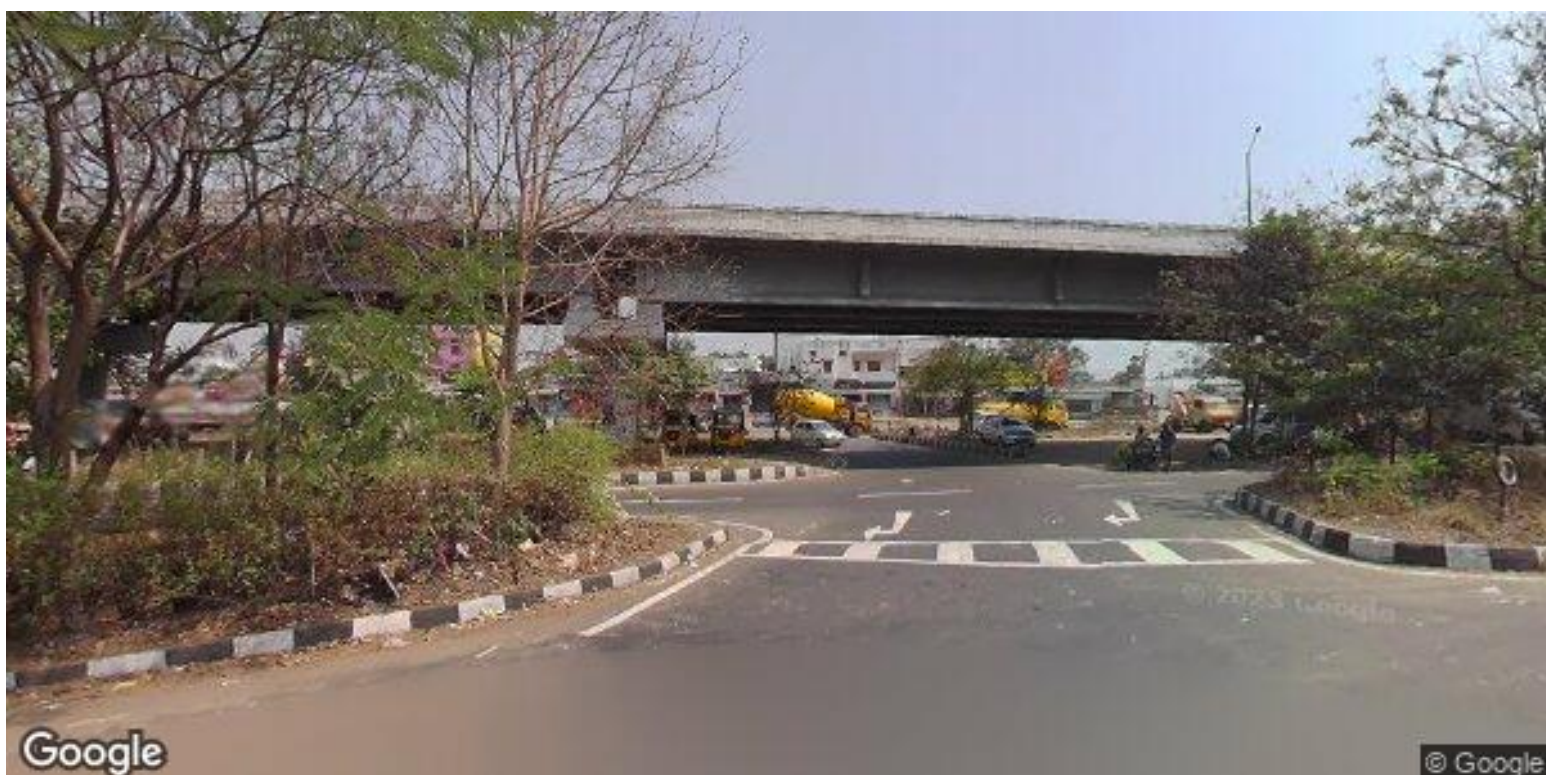
**Risk Type:** Turn  
**Risk Level:** High  
**Speed Limit:** 15 KM/Hr  
**Coordinates:** 11.43026, 77.67525

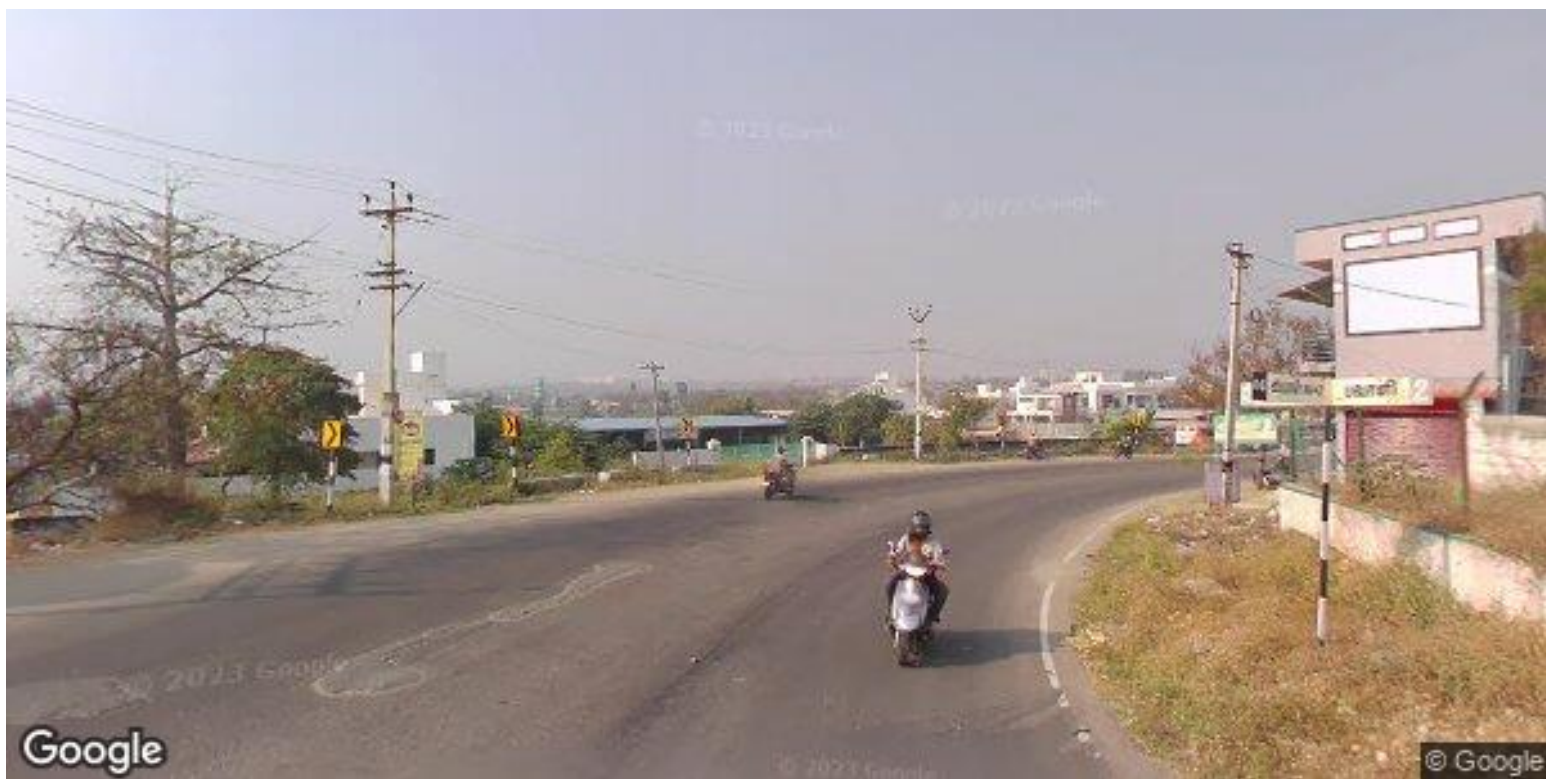
**Risk Type:** Turn  
**Risk Level:** High  
**Speed Limit:** 15 KM/Hr  
**Coordinates:** 11.43278, 77.67024

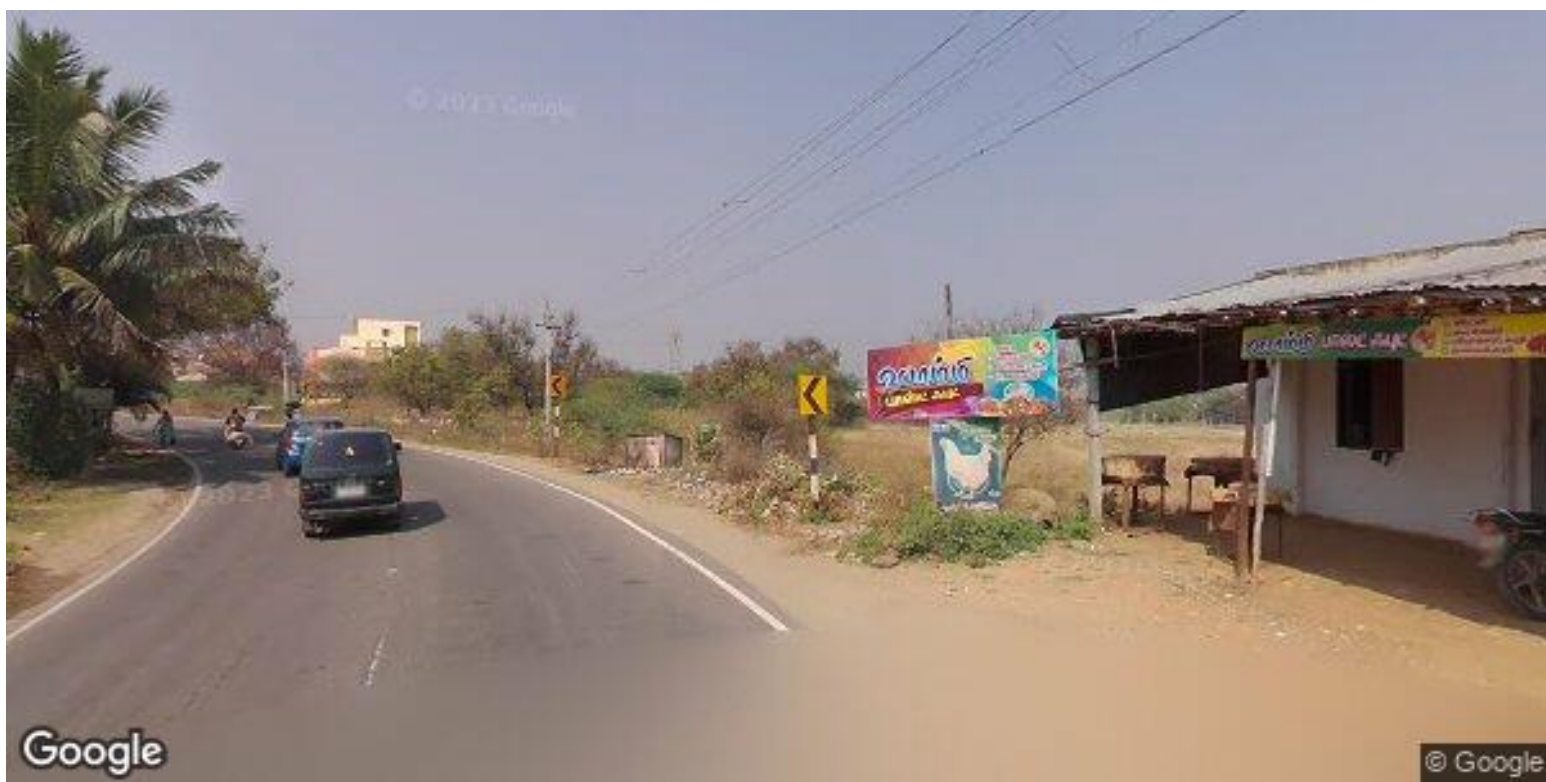
**Coordinates:** 11.43346, 77.66700

**Risk Type:** Turn

**Risk Level:** Medium

**Speed Limit:** 30 KM/Hr

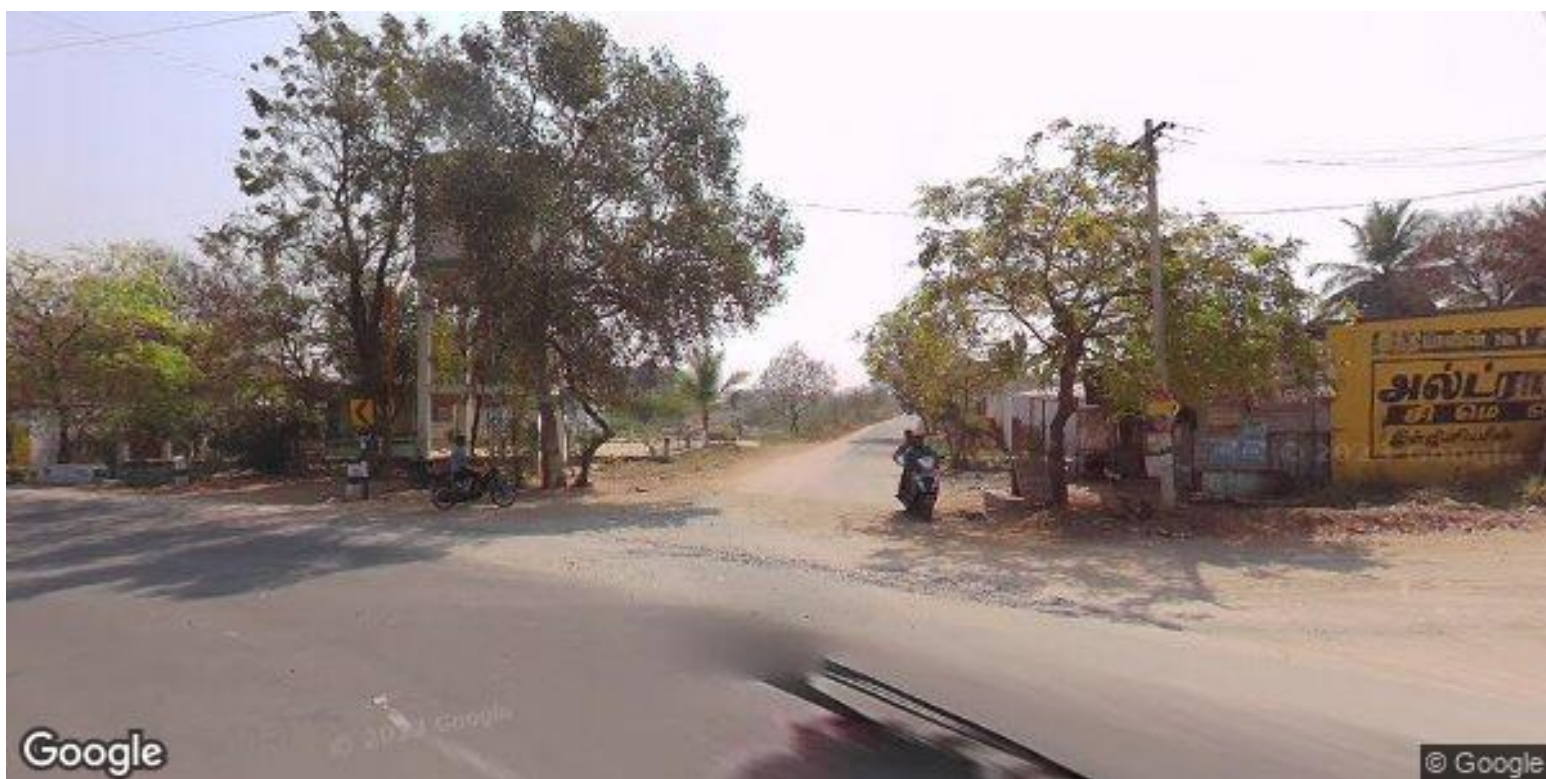
**Coordinates:** 11.43225, 77.66561

**Risk Type:** Turn

**Risk Level:** Medium

**Speed Limit:** 30 KM/Hr

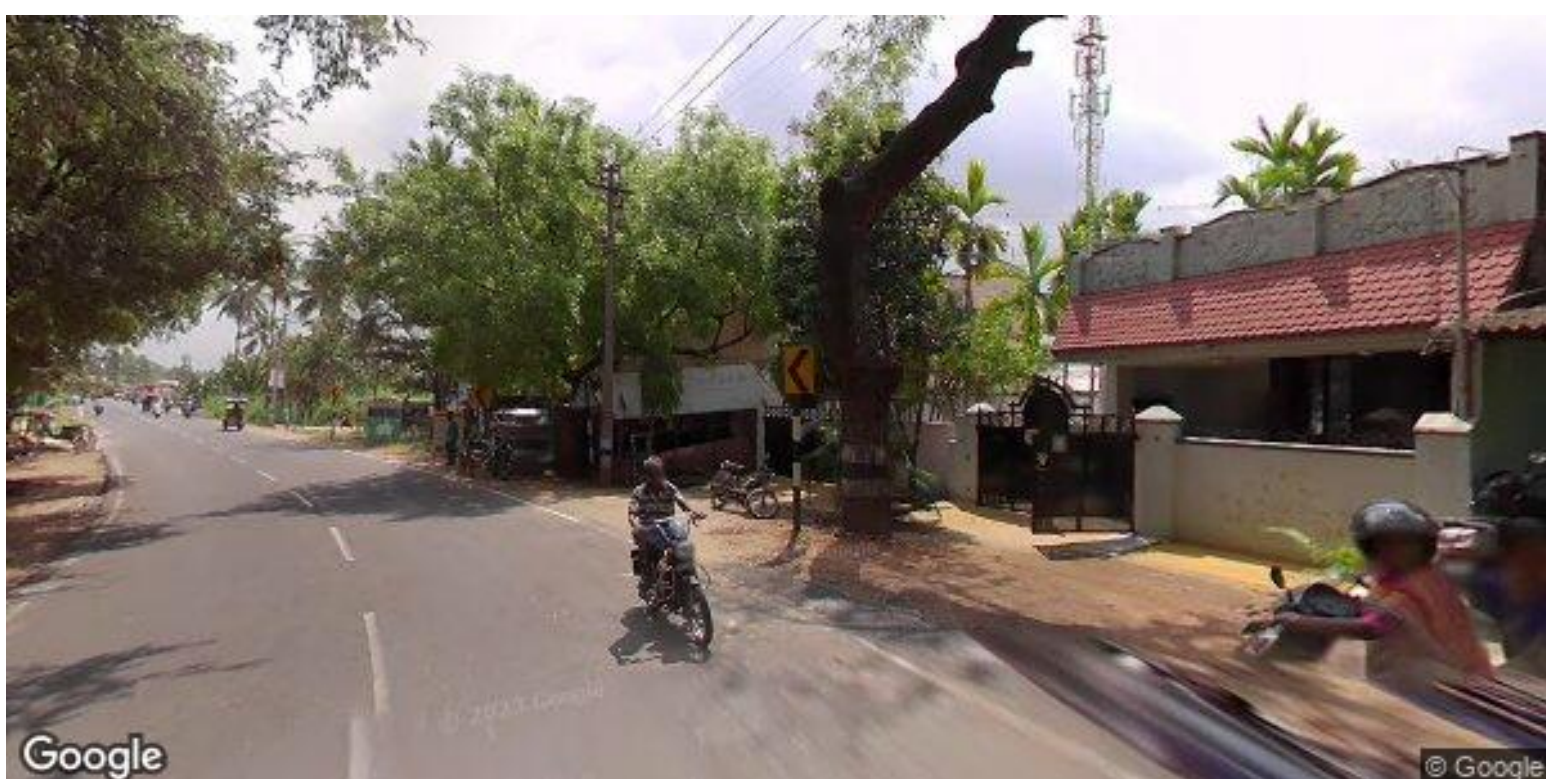
**Coordinates:** 11.42837, 77.56935

**Risk Type:** Turn

**Risk Level:** Medium

**Speed Limit:** 30 KM/Hr

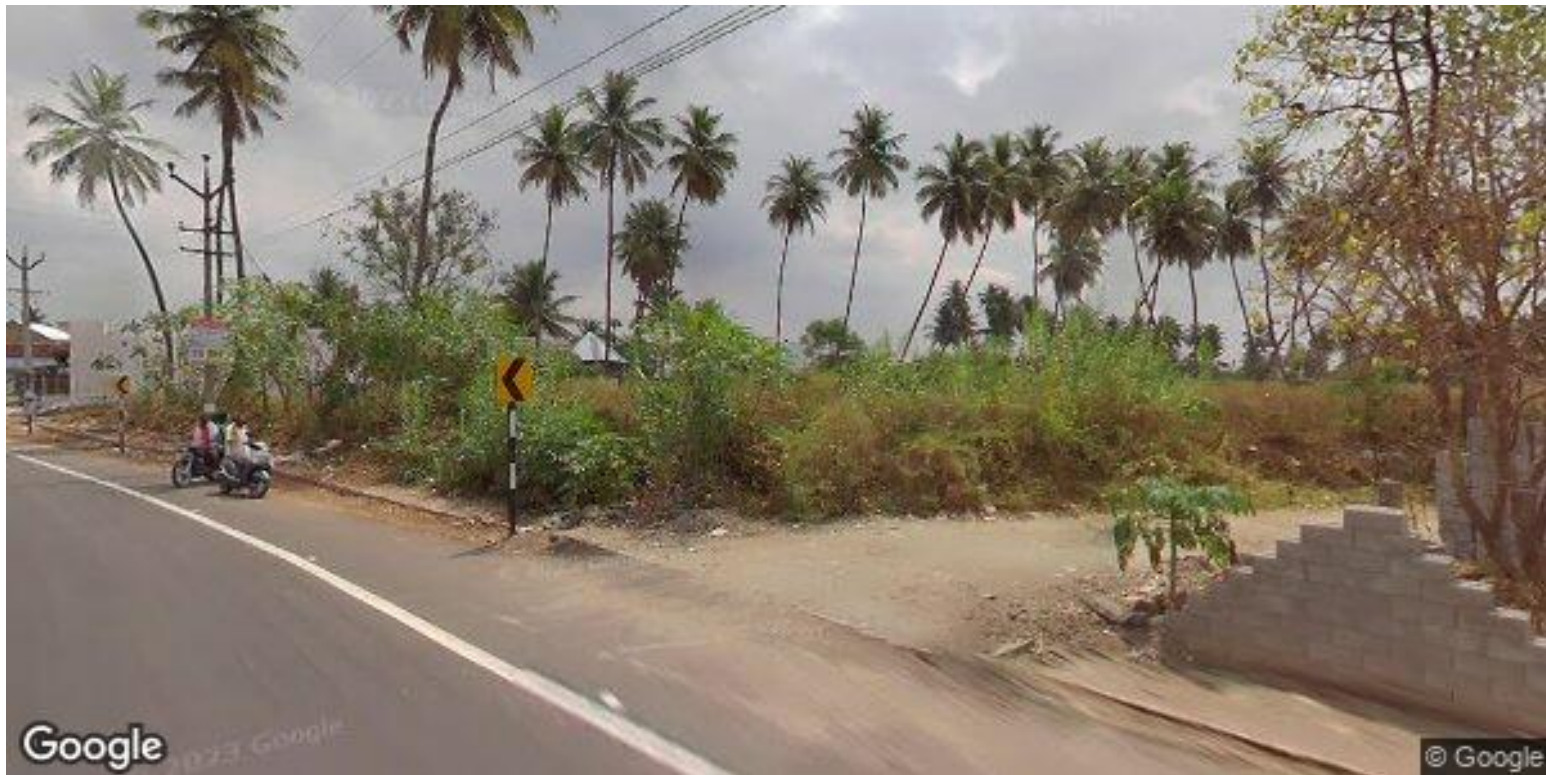
**Coordinates:** 11.42707, 77.56407

**Risk Type:** Turn

**Risk Level:** Medium

**Speed Limit:** 30 KM/Hr

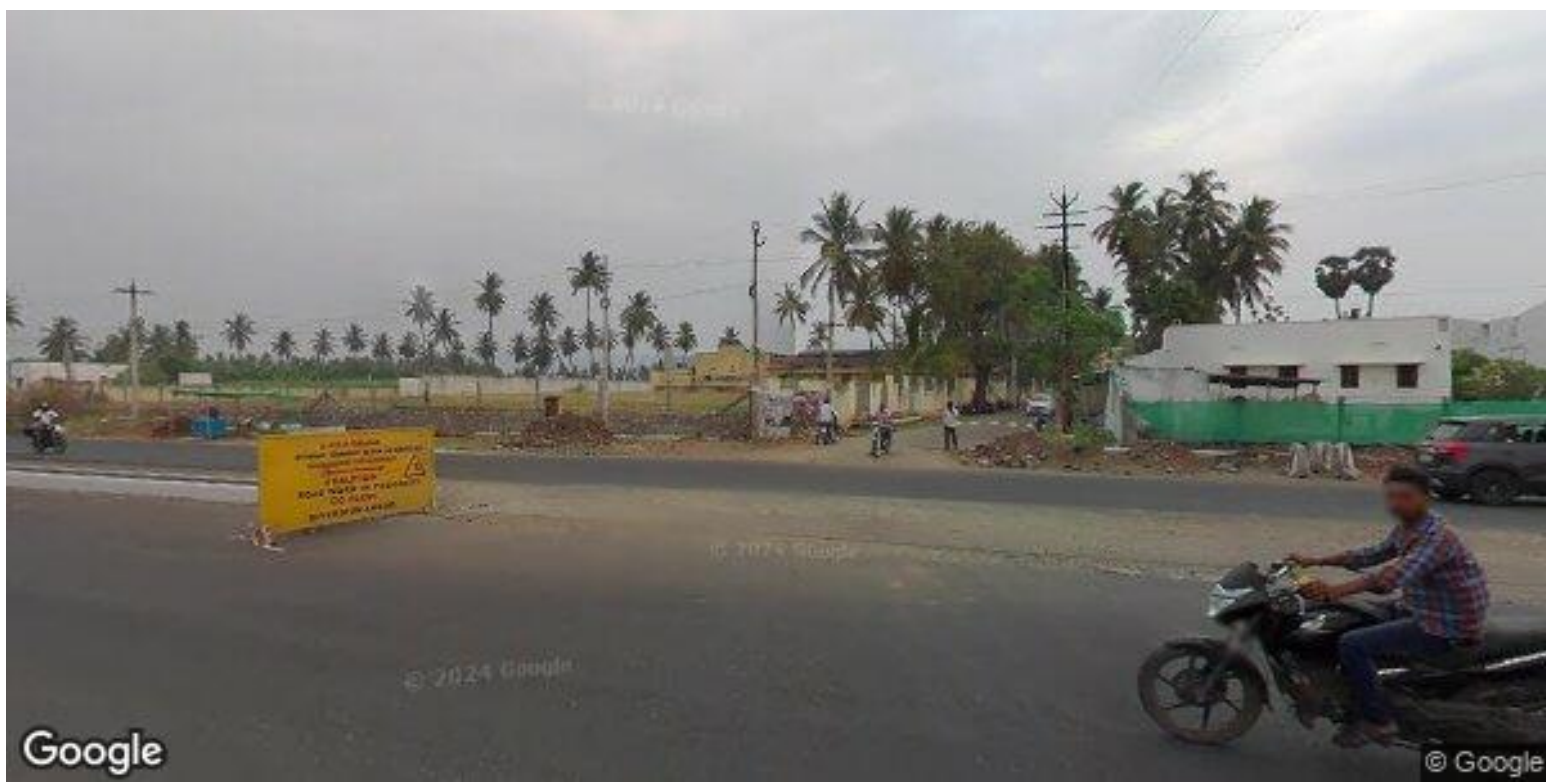
**Coordinates:** 11.45183, 77.46896

**Risk Type:** Turn

**Risk Level:** High

**Speed Limit:** 15 KM/Hr

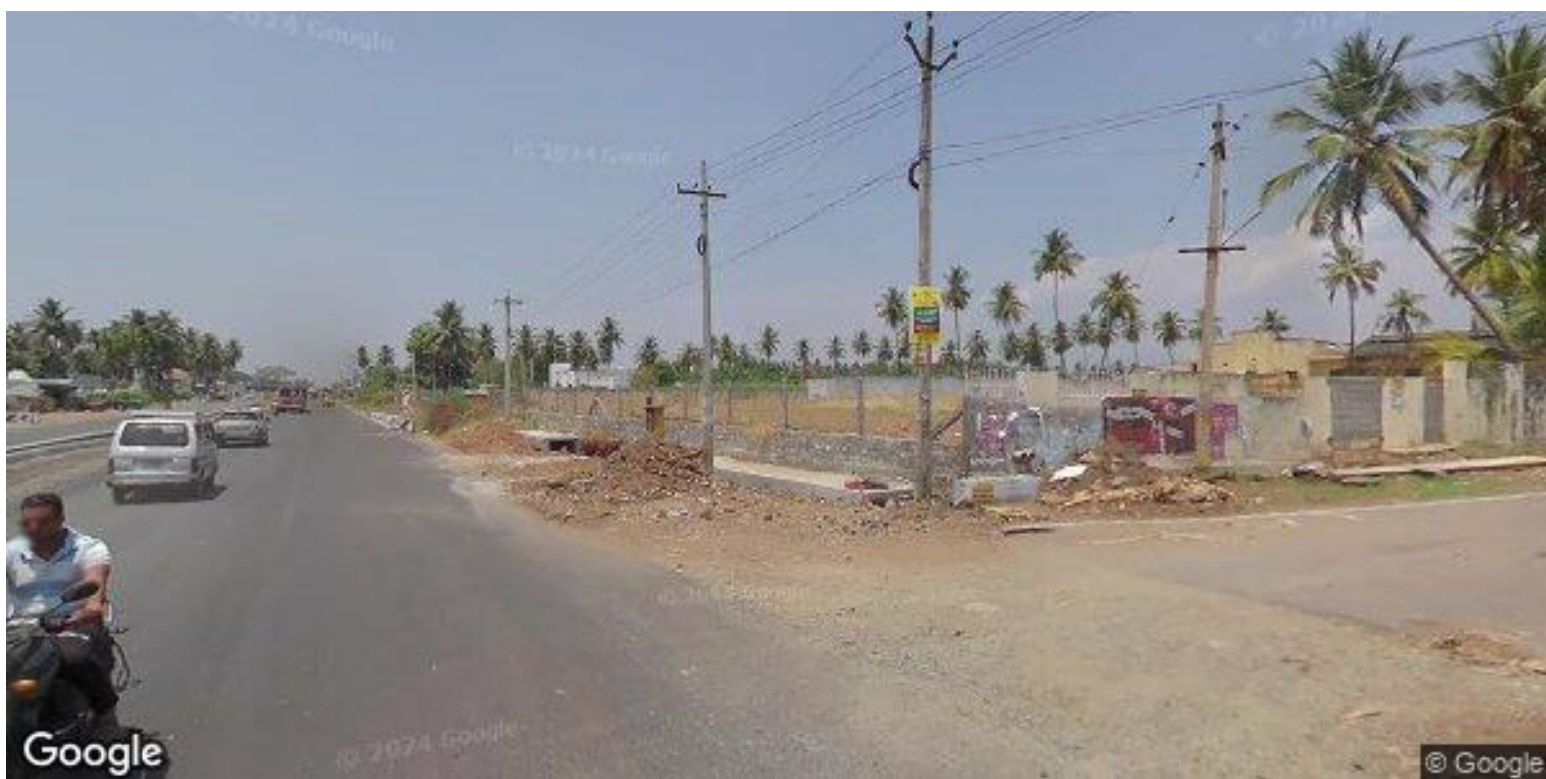
**Coordinates:** 11.45196, 77.46891

**Risk Type:** Blind Spot

**Risk Level:** Blind Spot

**Speed Limit:** 10 KM/Hr
