# IndianOil

## **JOURNEY RISK MANAGEMENT (JRM) STUDY**

### **Salem Terminal to ACMS COOPERATIVE PETROL BUNK**

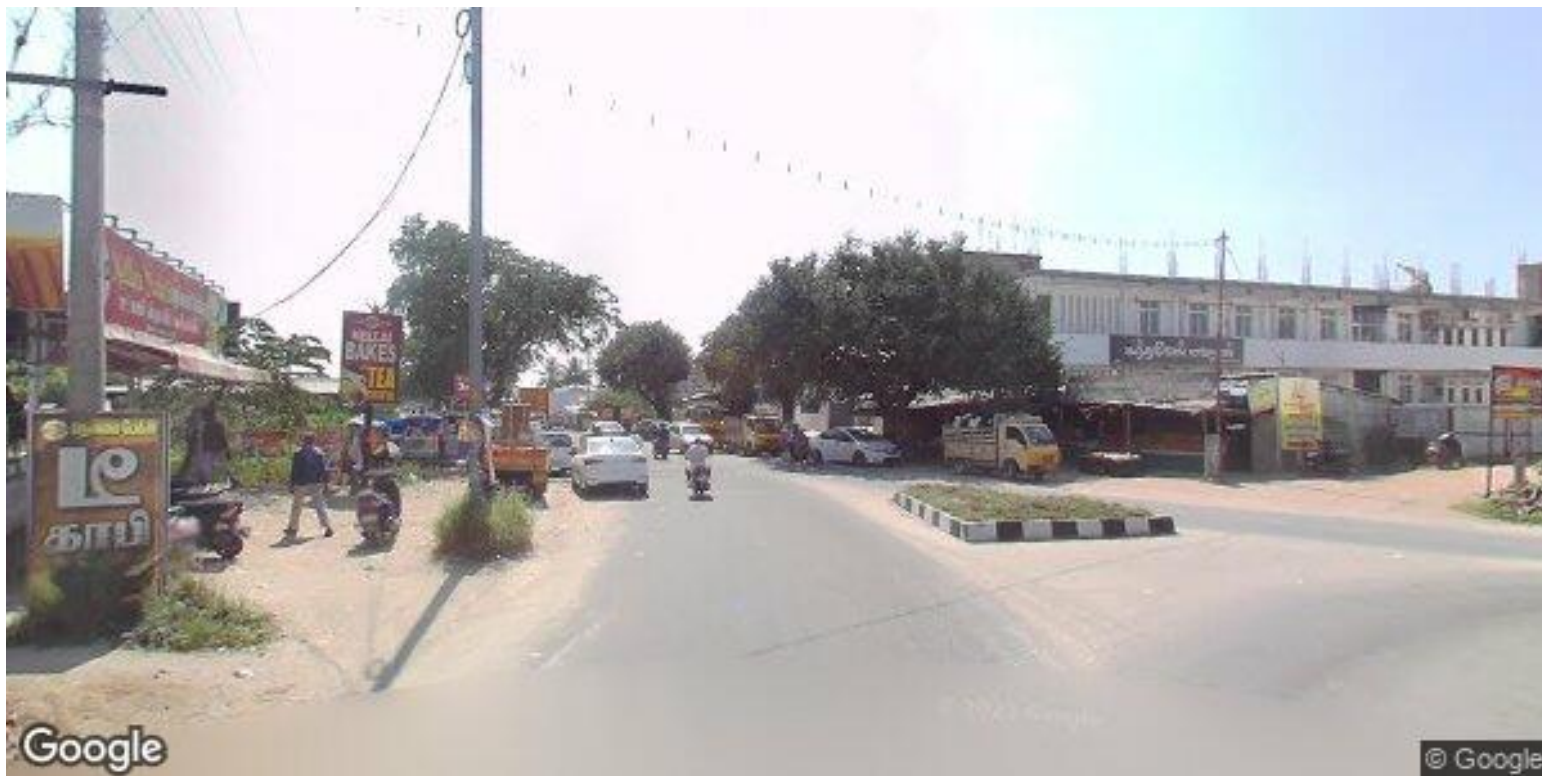
**Coordinates:** 11.17250, 77.26863

**Risk Type:** Roundabout

**Risk Level:** High

**Speed Limit:** 15 KM/Hr

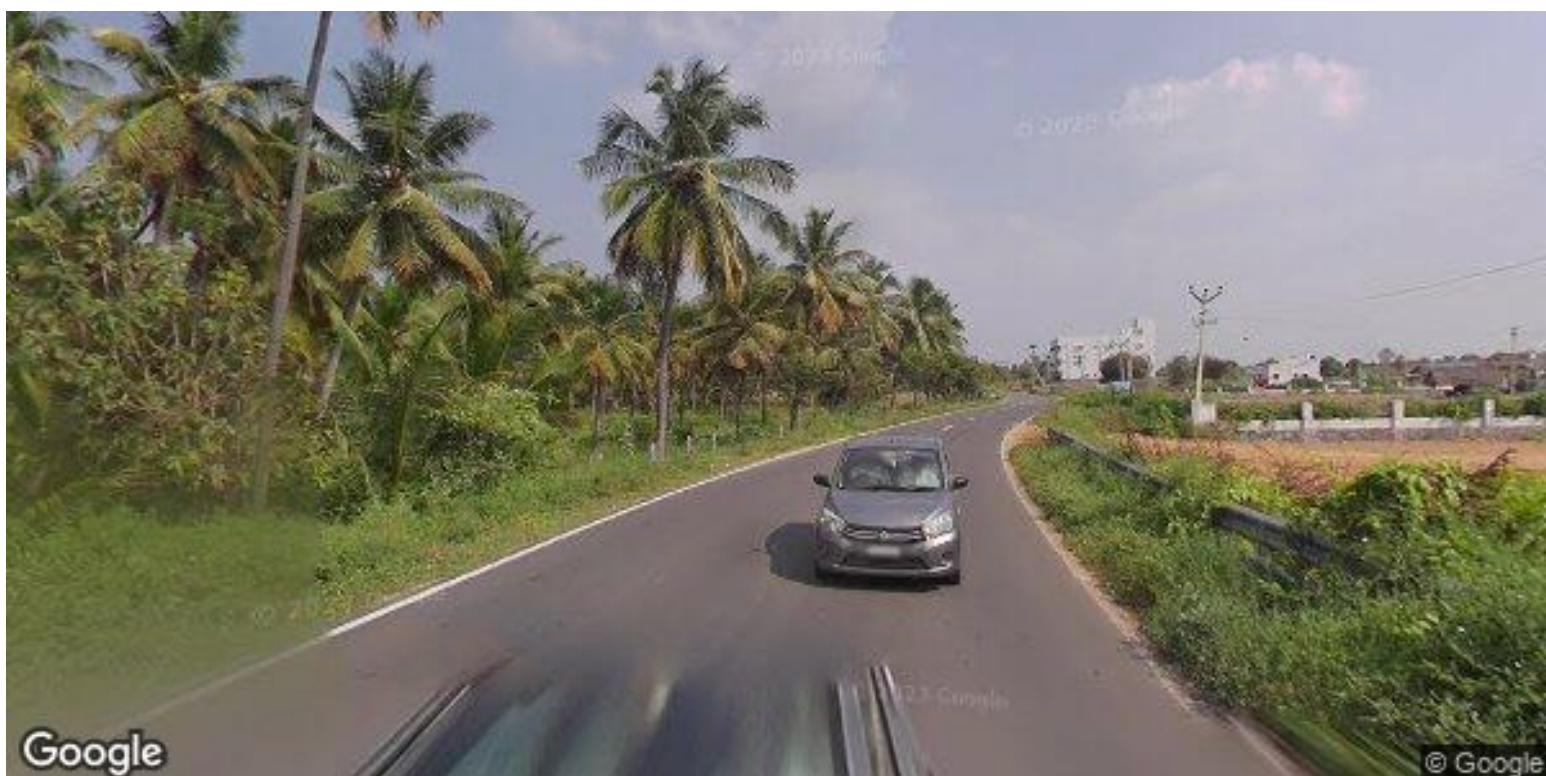
**Coordinates:** 11.45357, 77.85789

**Risk Type:** Turn

**Risk Level:** Medium

**Speed Limit:** 30 KM/Hr

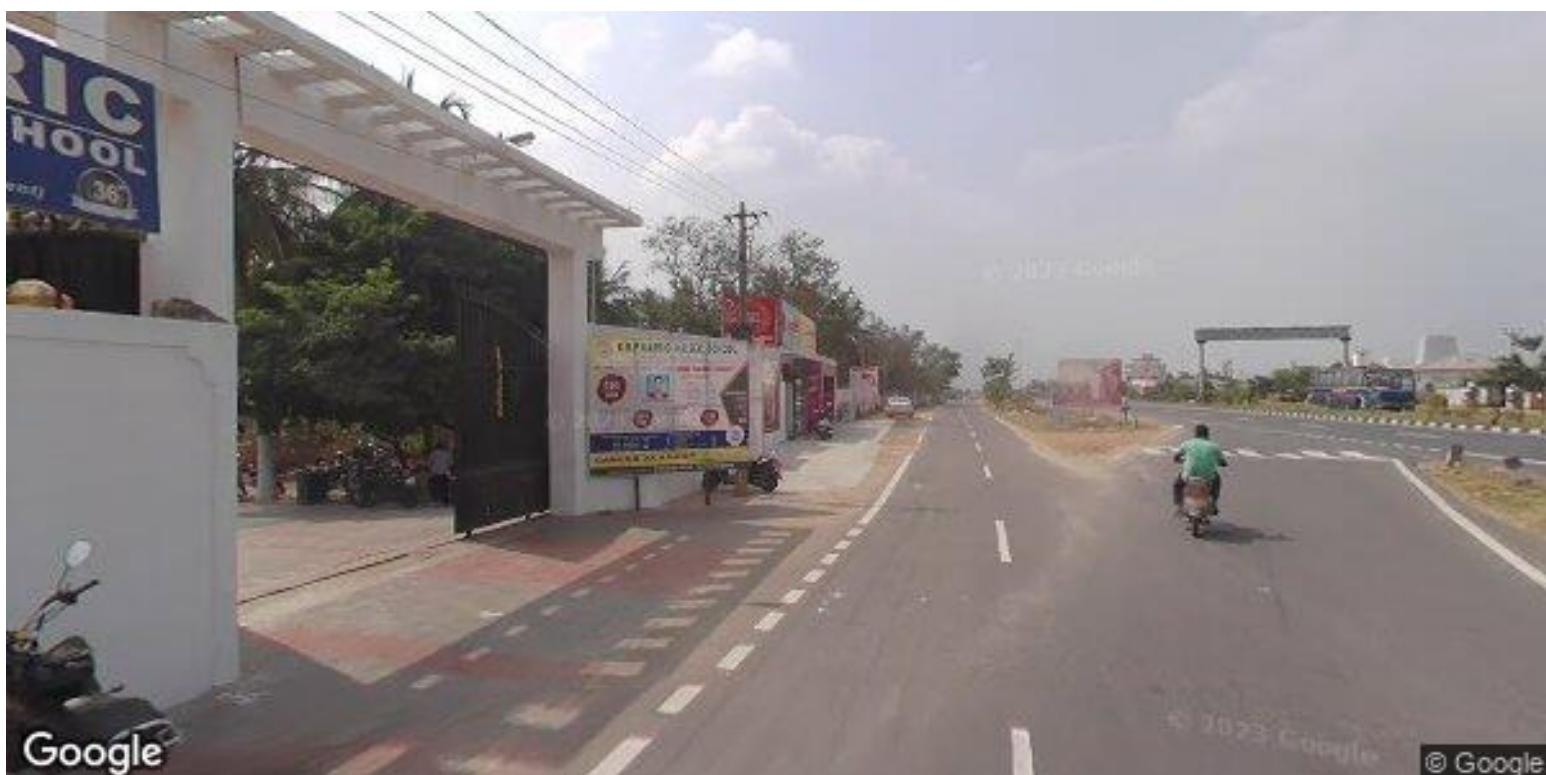
**Coordinates:** 11.45509, 77.81383

**Risk Type:** Turn

**Risk Level:** Medium

**Speed Limit:** 30 KM/Hr
