# IndianOil

## JOURNEY RISK MANAGEMENT (JRM) STUDY

### Salem Terminal TO PGS PETROL BUNK

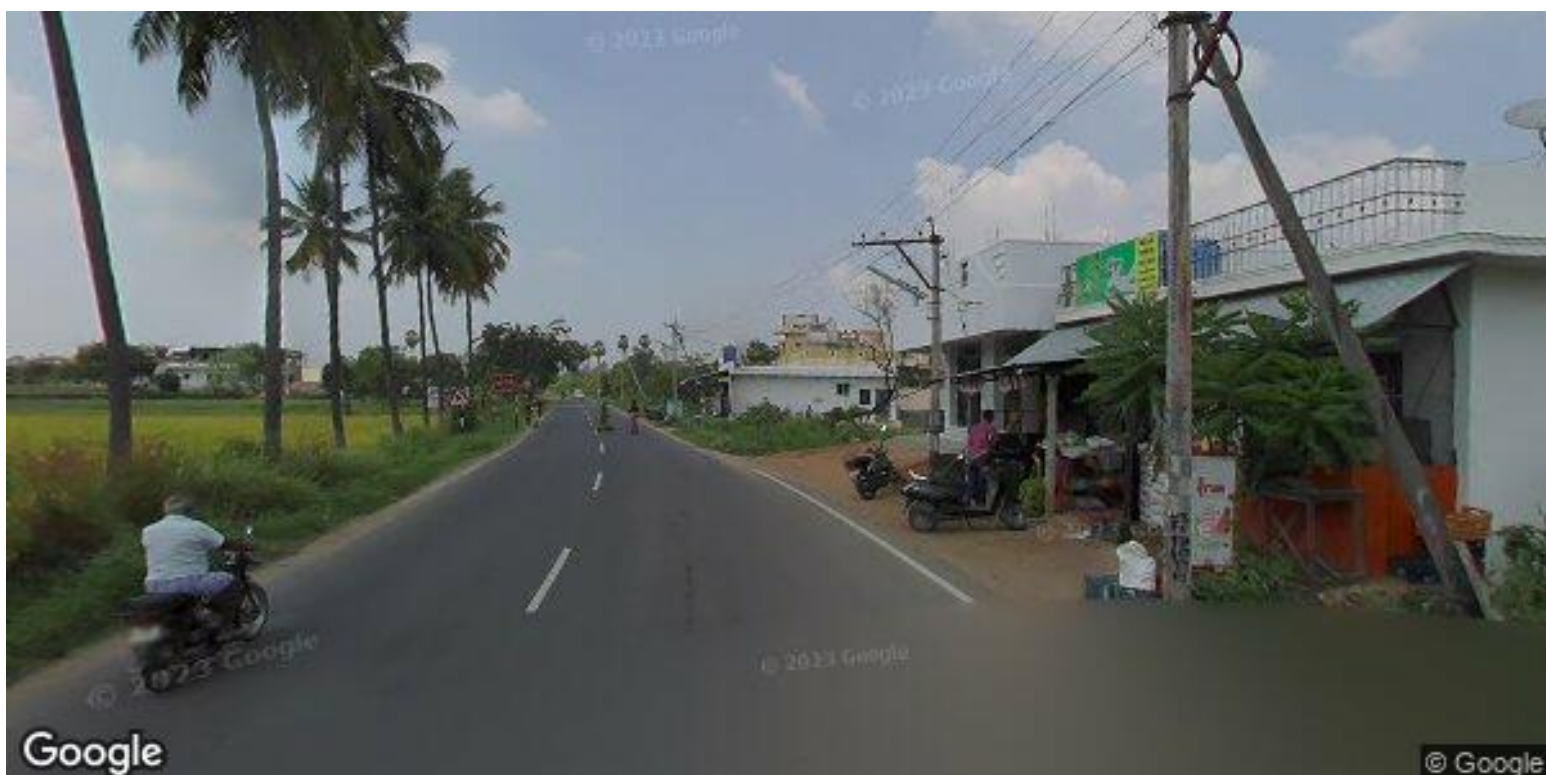
**Coordinates: 11.45127, 77.86734**

**Risk Type: Turn**

**Speed Limit: 15 KM/Hr**

**Distance from Start: 2.15 km**

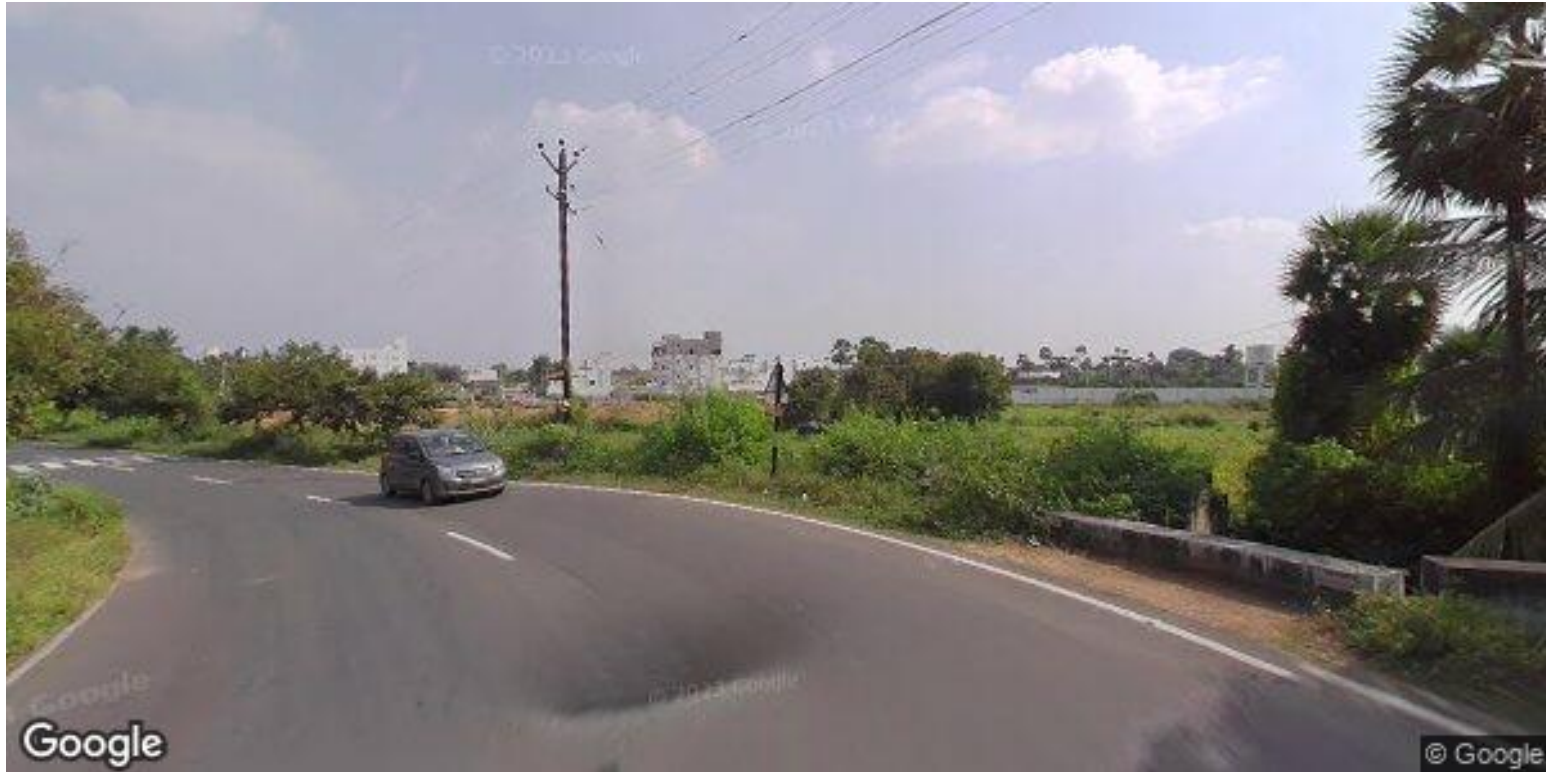
**Coordinates: 11.45350, 77.85700**

**Risk Type: Turn**

**Speed Limit: 15 KM/Hr**

**Distance from Start: 3.29 km**

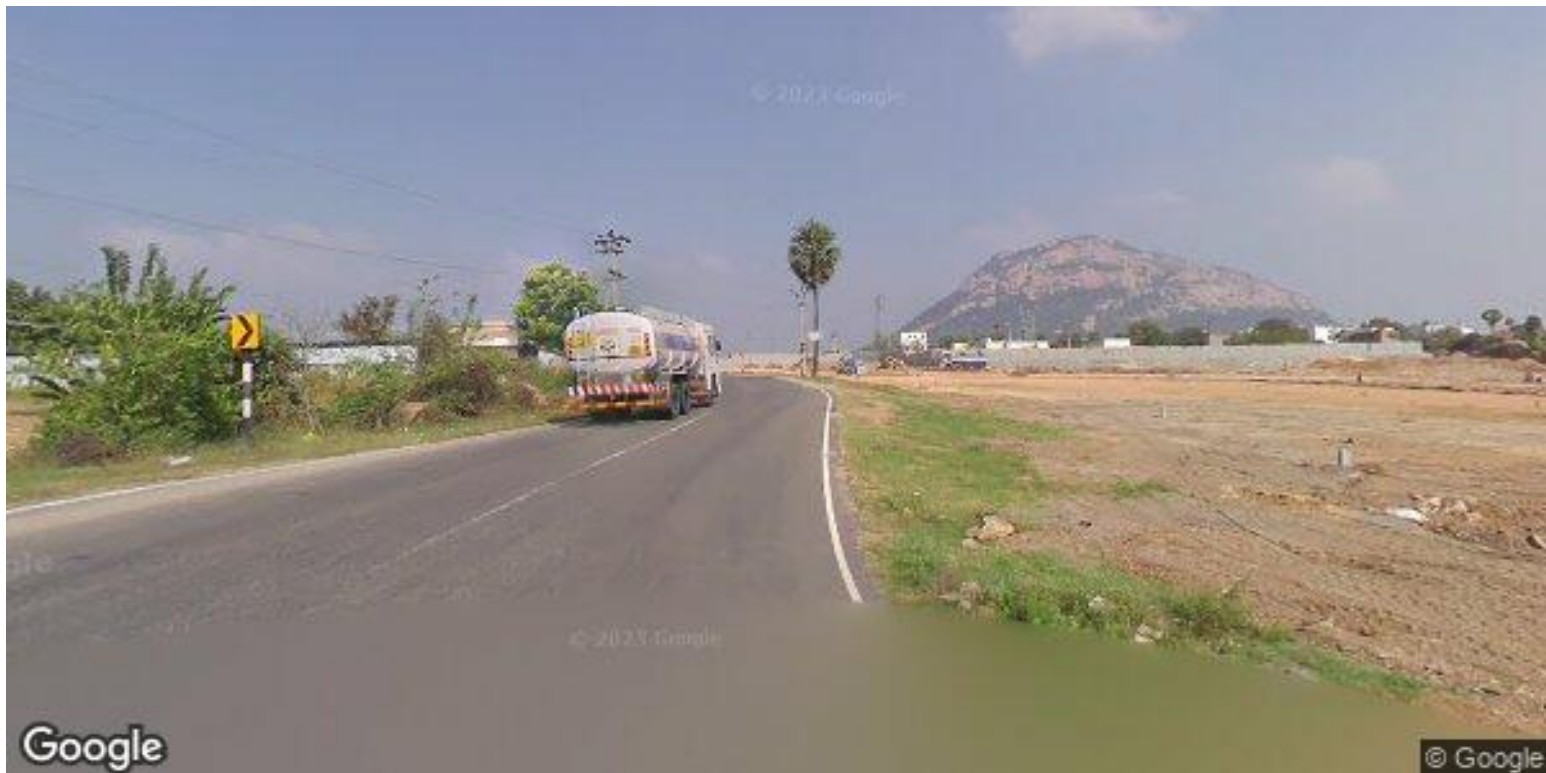
**Coordinates: 11.45845, 77.85141**

**Risk Type: Turn**

**Speed Limit: 15 KM/Hr**

**Distance from Start: 4.11 km**

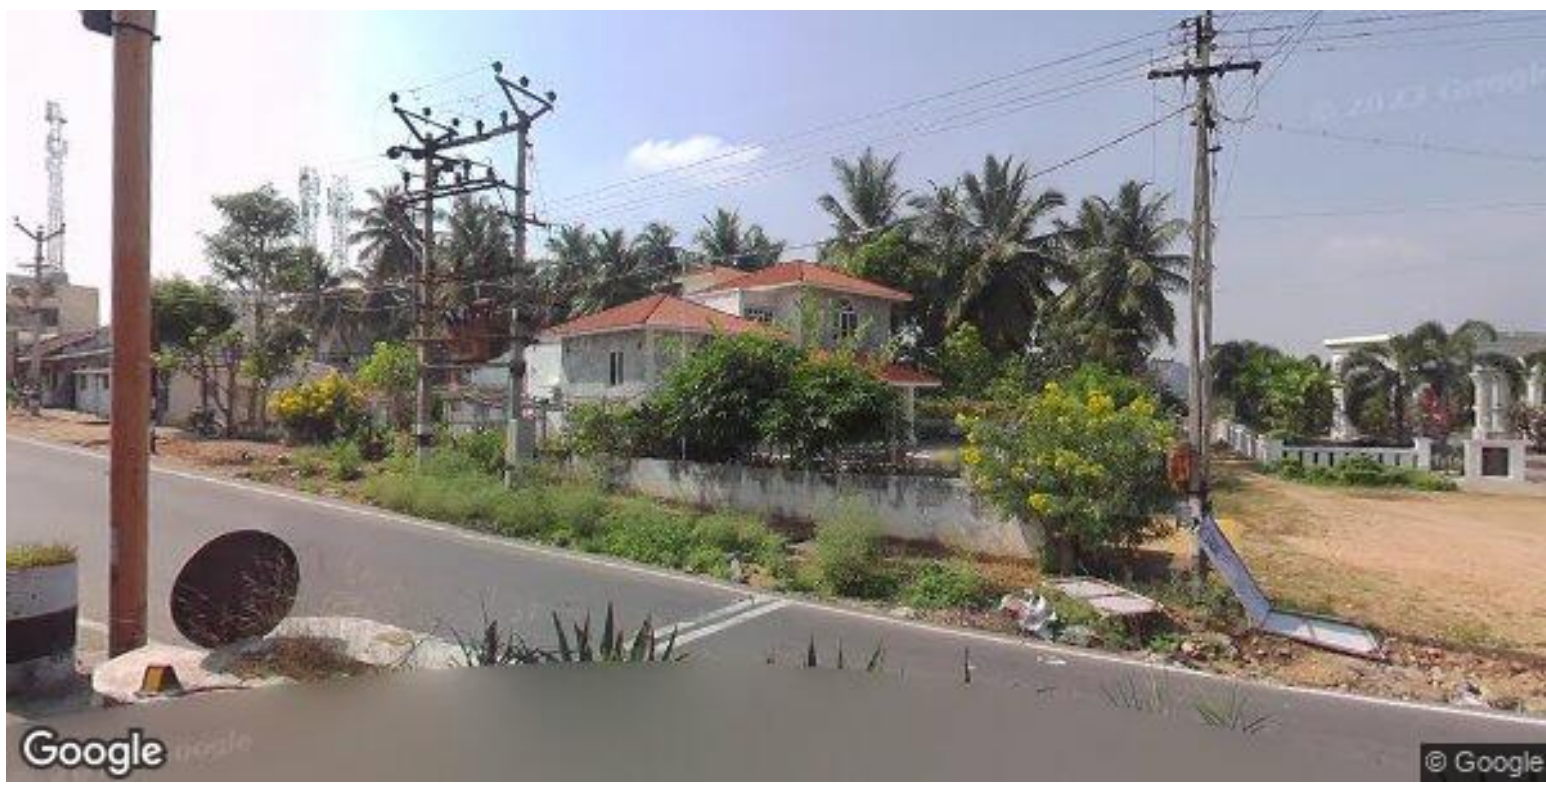
**Coordinates: 11.46303, 77.84945**

**Risk Type: Turn**

**Speed Limit: 15 KM/Hr**

**Distance from Start: 4.65 km**

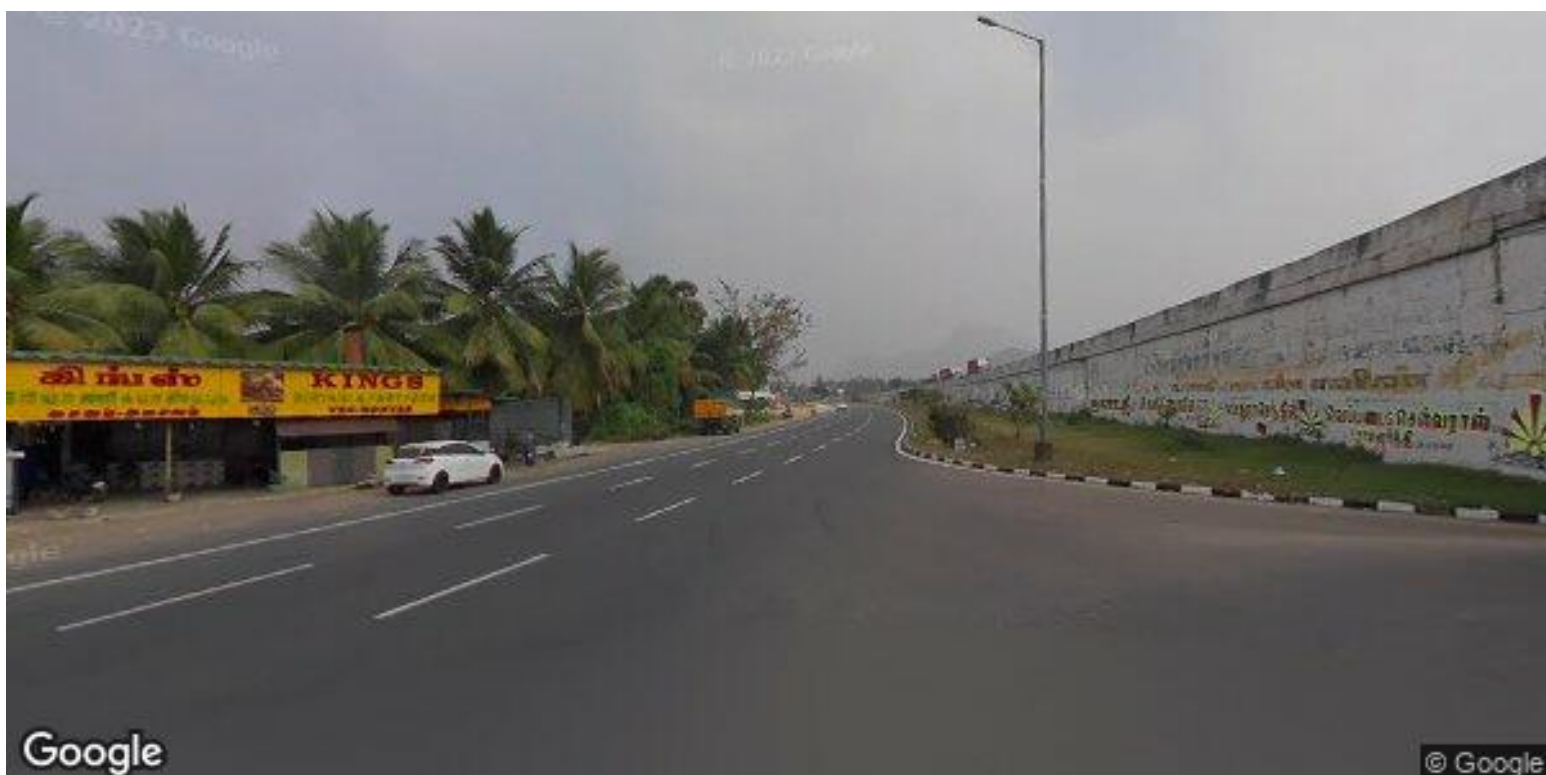
**Risk Type:** Blind Spot  
**Speed Limit:** 10 KM/Hr  
**Distance from Start:** 8.50 km  
**Coordinates:** 11.45634, 77.81673

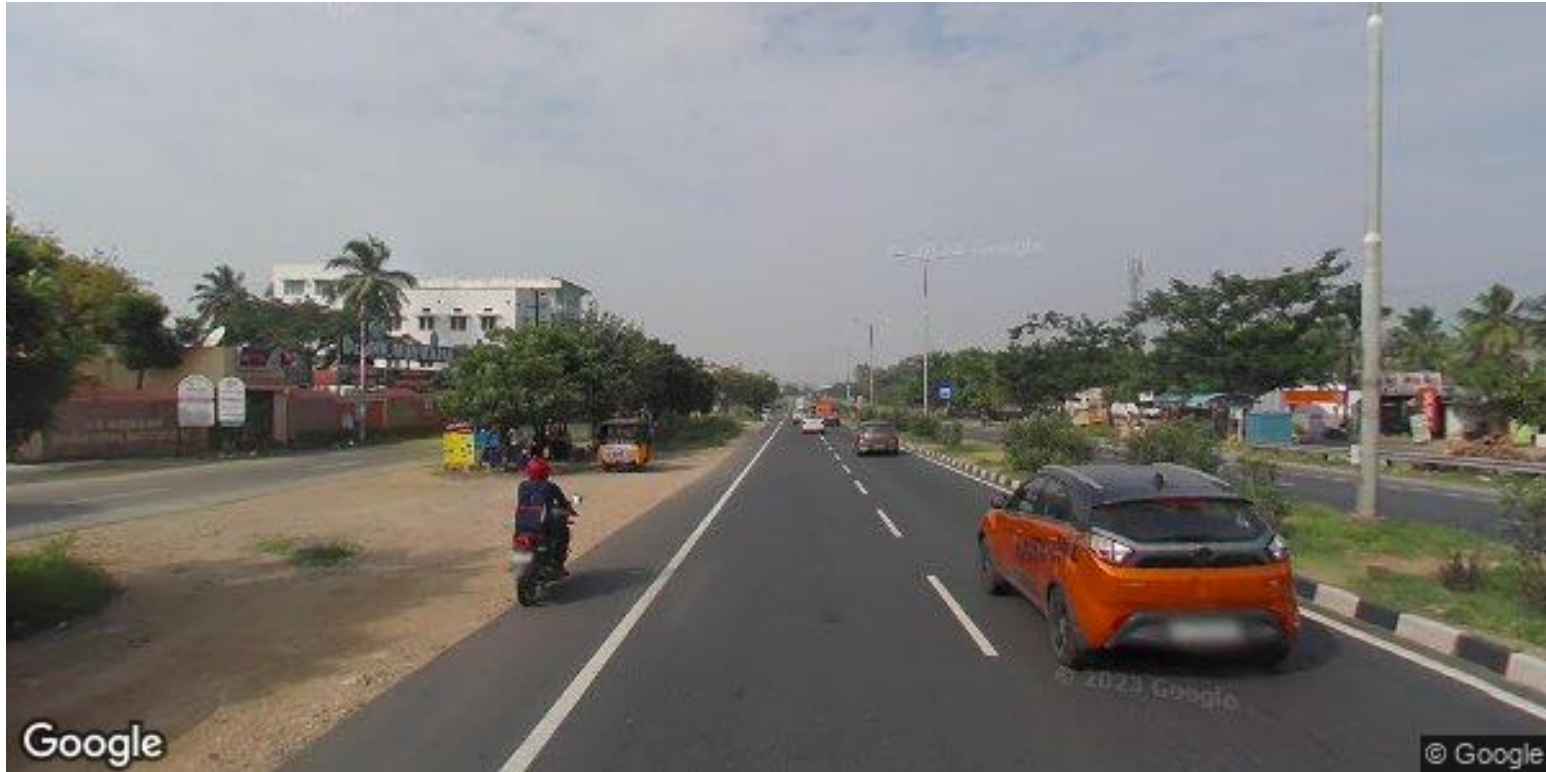
**Risk Type:** Blind Spot  
**Speed Limit:** 10 KM/Hr  
**Distance from Start:** 18.65 km  
**Coordinates:** 11.44530, 77.72783

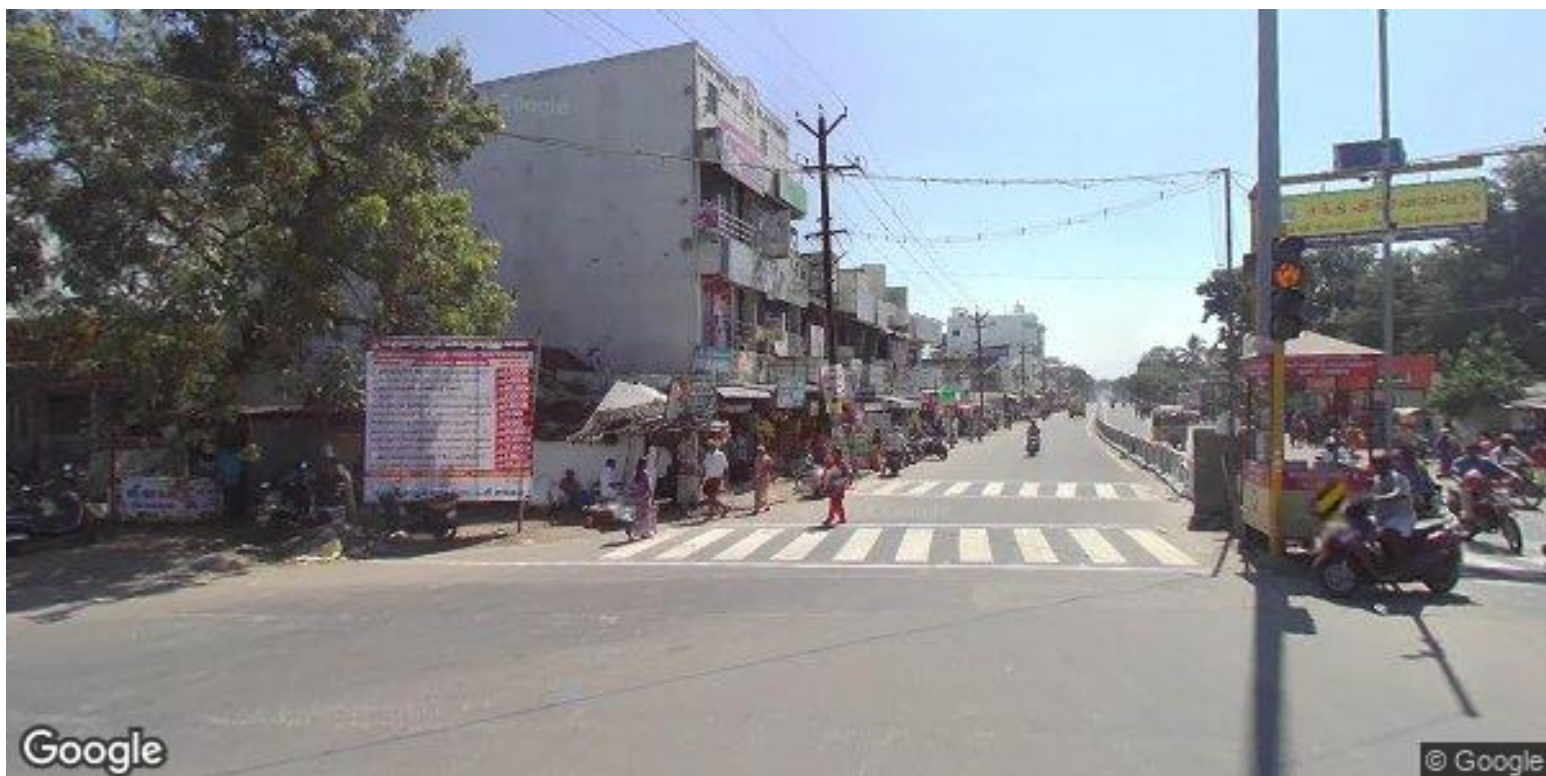
**Risk Type:** Turn  
**Speed Limit:** 15 KM/Hr  
**Distance from Start:** 74.23 km  
**Coordinates:** 11.20728, 77.35914

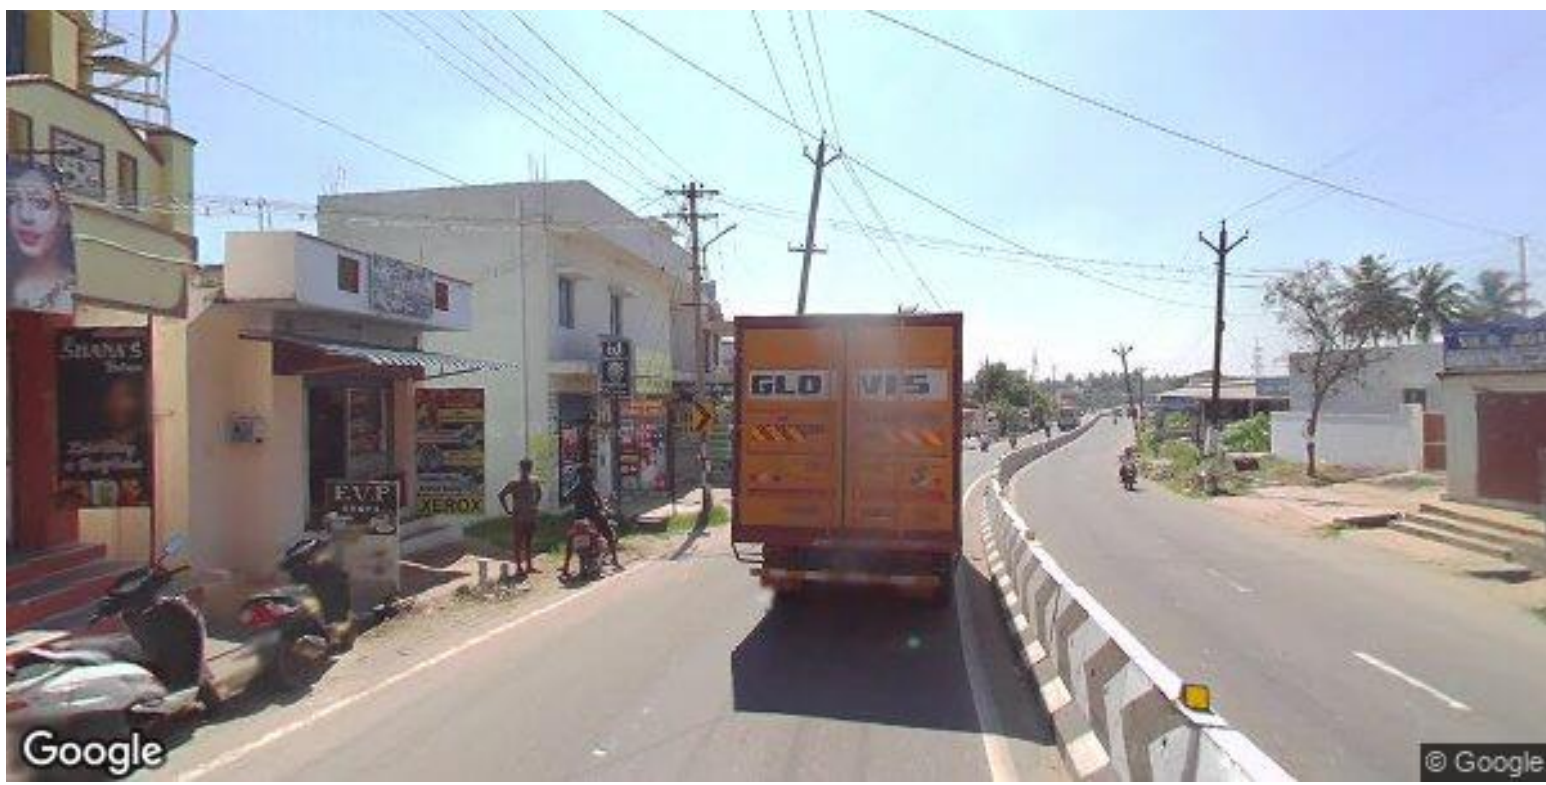
**Coordinates:** 11.20246, 77.35895

**Risk Type:** Turn

**Speed Limit:** 15 KM/Hr

**Distance from Start:** 74.85 km

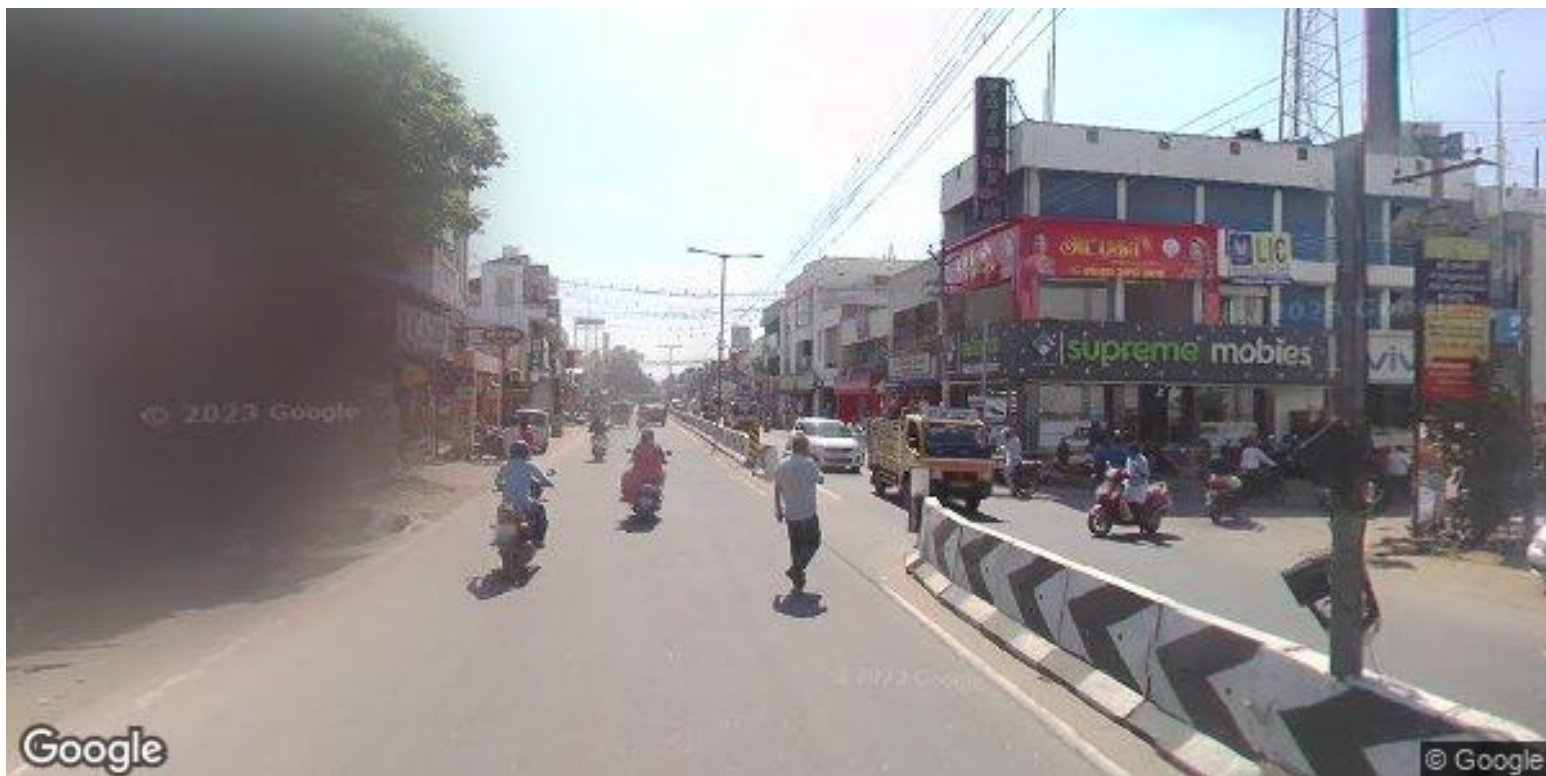
**Coordinates:** 11.13132, 77.34190

**Risk Type:** Turn

**Speed Limit:** 15 KM/Hr

**Distance from Start:** 83.09 km

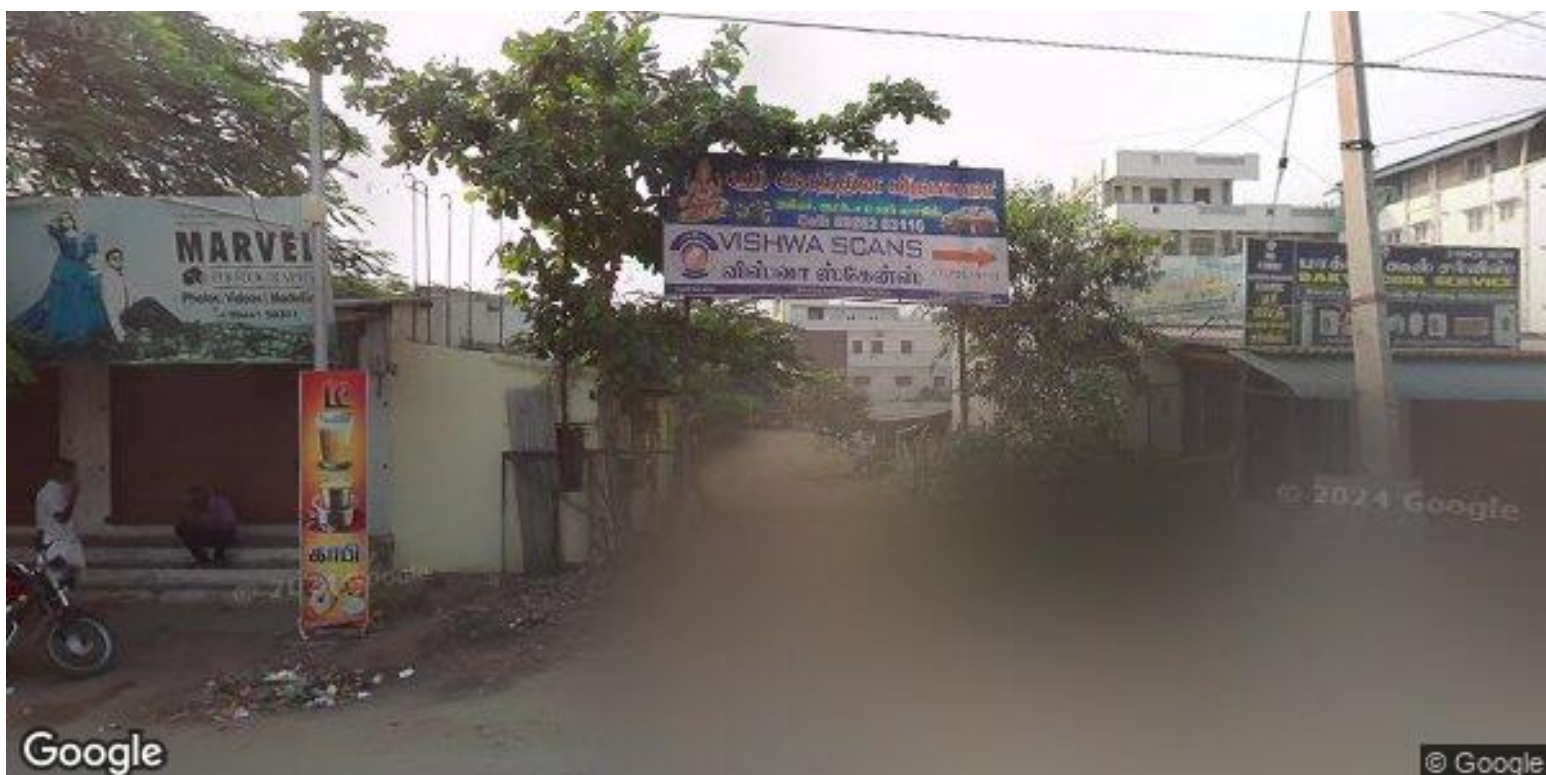
**Coordinates: 11.13131, 77.34033**

**Risk Type: Turn**

**Speed Limit: 15 KM/Hr**

**Distance from Start: 83.24 km**

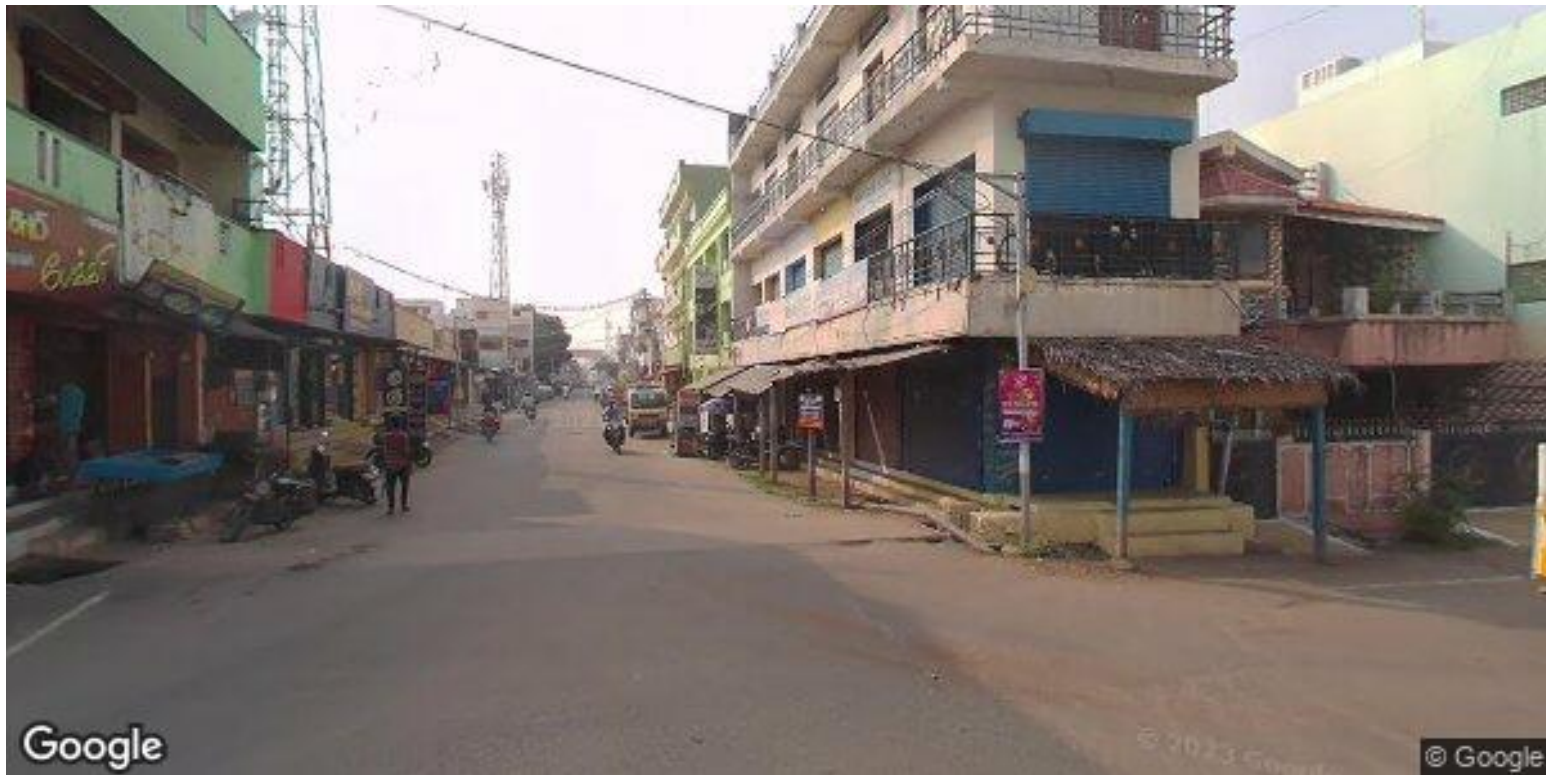
**Coordinates: 11.12933, 77.34007**

**Risk Type: Blind Spot**

**Speed Limit: 10 KM/Hr**

**Distance from Start: 83.52 km**

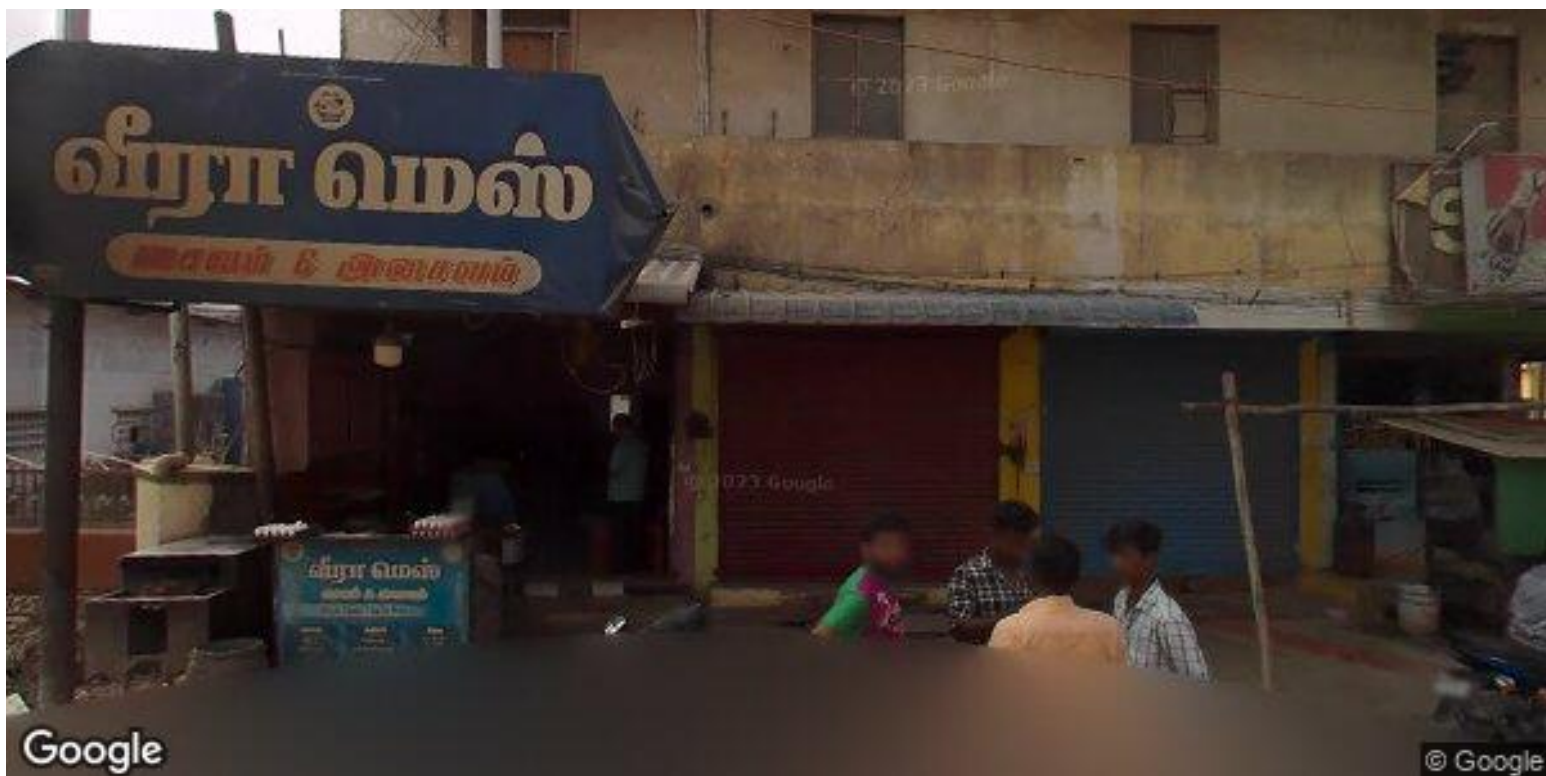
**Coordinates: 11.12918, 77.33333**

**Risk Type: Blind Spot**

**Speed Limit: 10 KM/Hr**

**Distance from Start: 84.21 km**

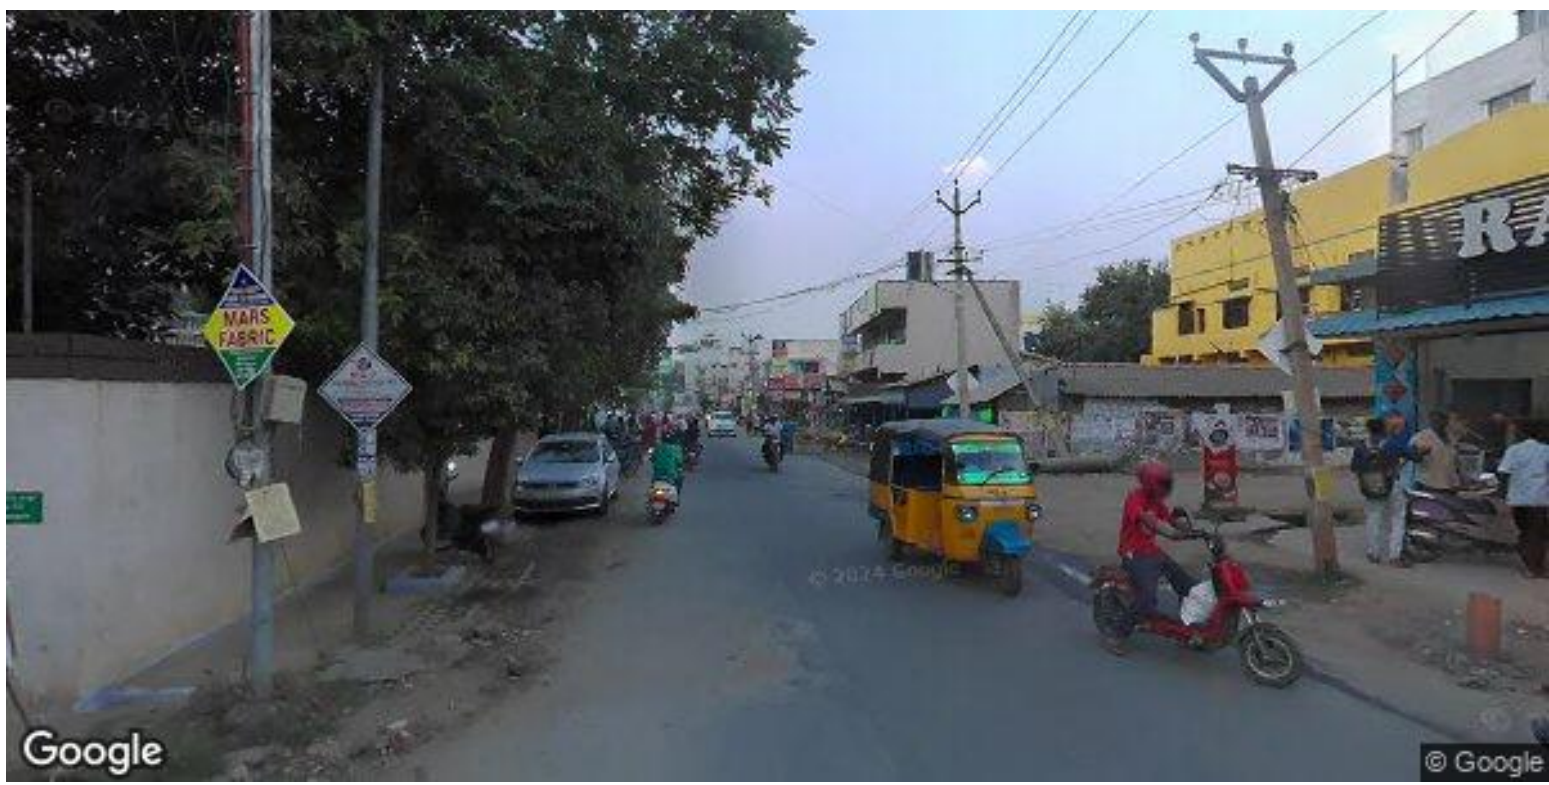
**Coordinates:** 11.13433, 77.33289

**Risk Type:** Blind Spot

**Speed Limit:** 10 KM/Hr

**Distance from Start:** 84.78 km
