## JOURNEY RISK MANAGEMENT (JRM) STUDY

### Salem Terminal to CHENDUR FUEL SERVICE

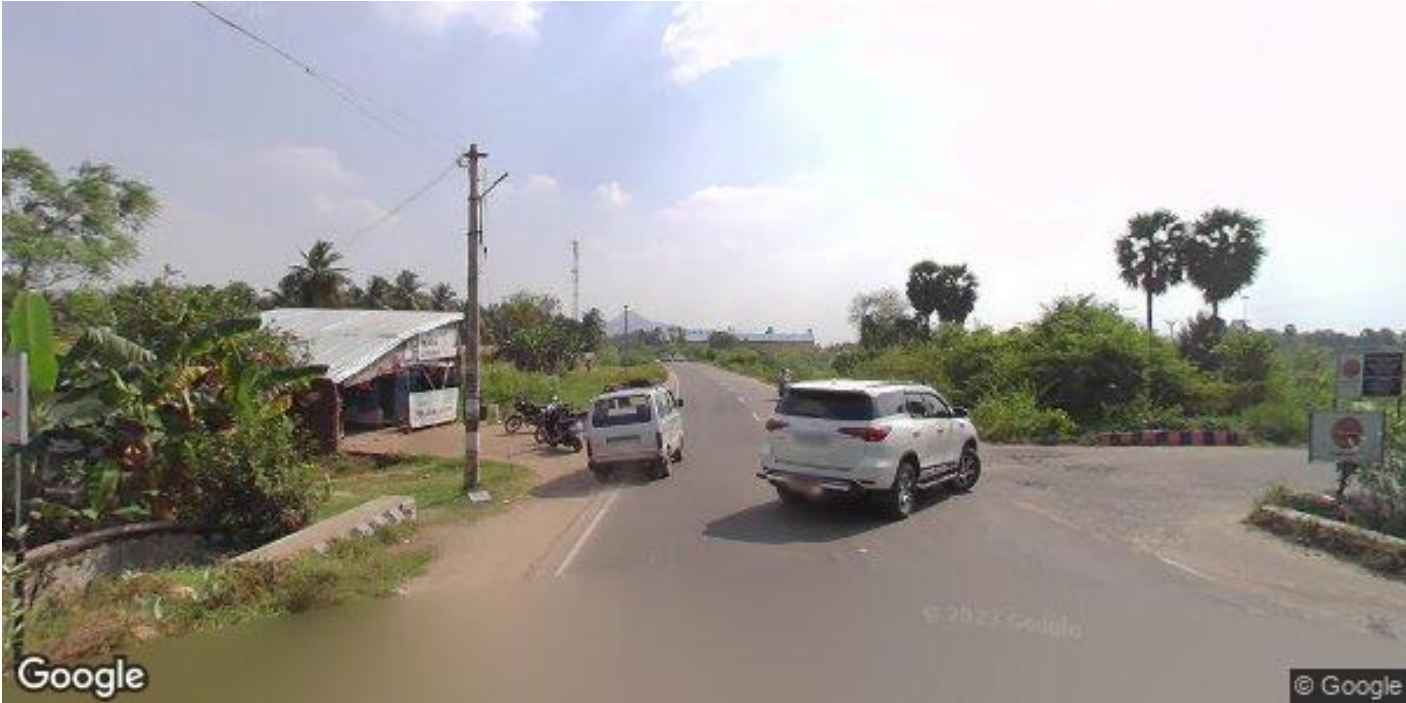
**Risk Type:** Turn  
**Risk Level:** High  
**Speed Limit:** 15 KM/Hr  
**Coordinates:** 11.44029, 77.87544

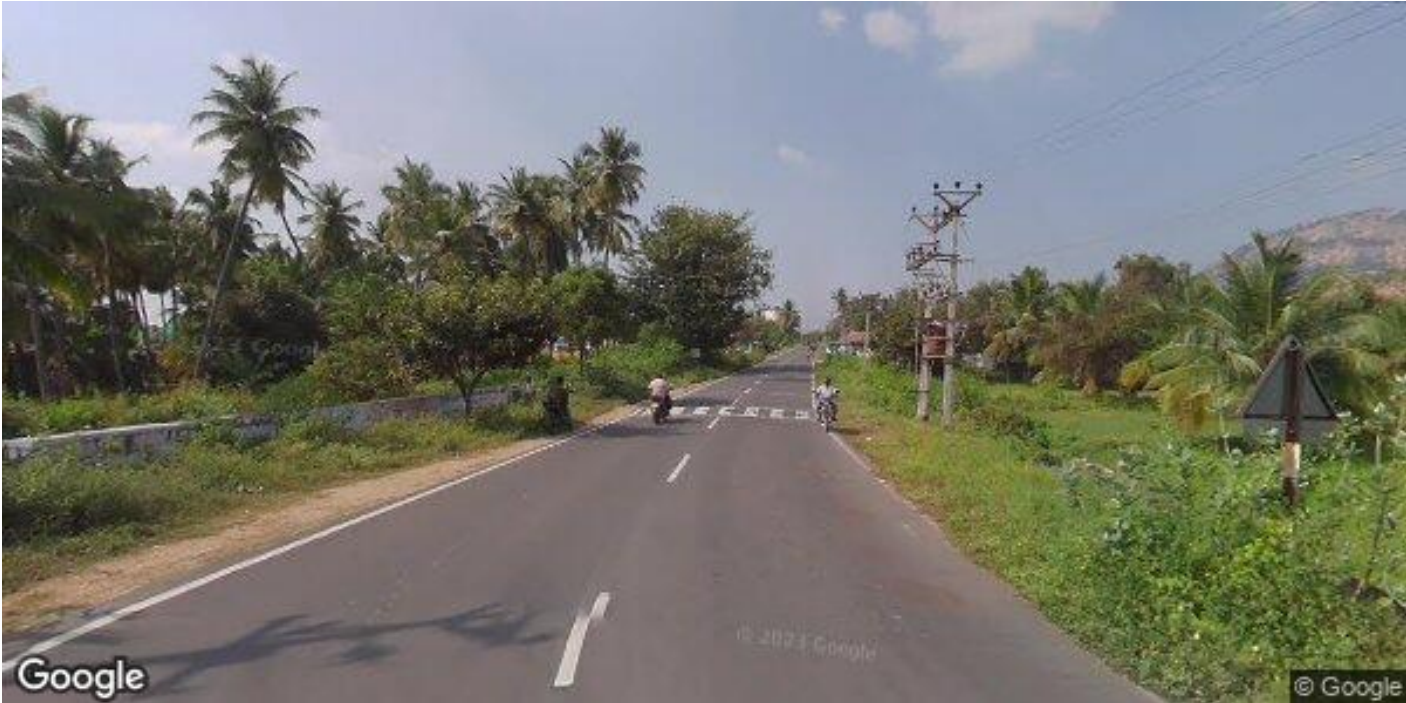
**Risk Type:** Turn  
**Risk Level:** Medium  
**Speed Limit:** 30 KM/Hr  
**Coordinates:** 11.45353, 77.85697

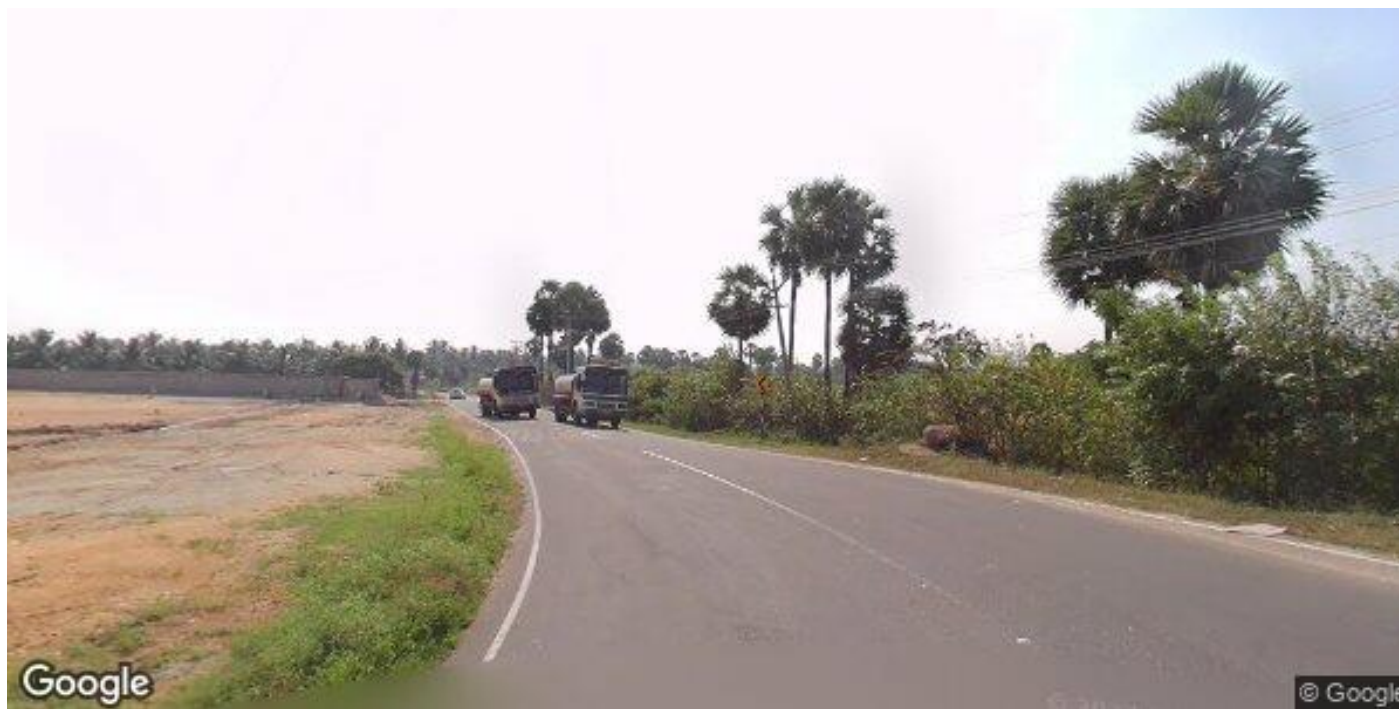
**Risk Type:** Turn  
**Risk Level:** Medium  
**Speed Limit:** 30 KM/Hr  
**Coordinates:** 11.45839, 77.85143

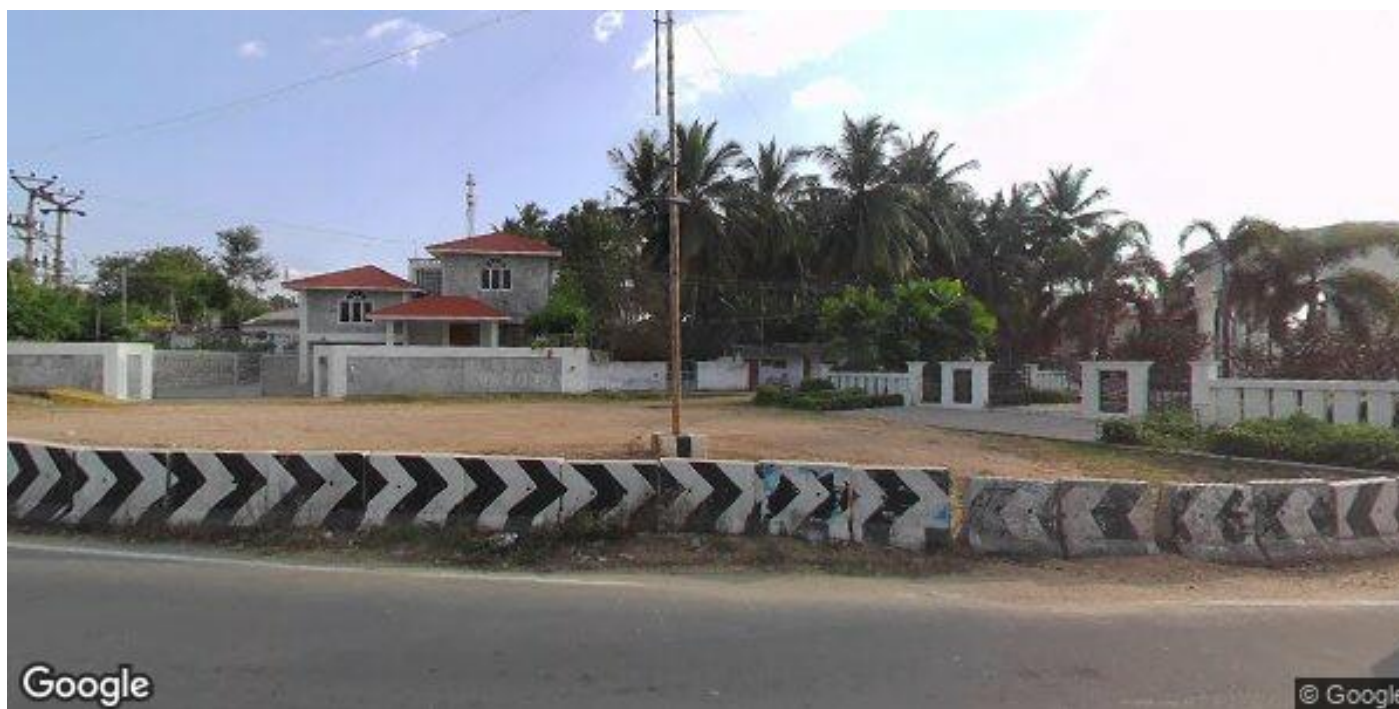
**Risk Type:** Turn  
**Risk Level:** Medium  
**Speed Limit:** 30 KM/Hr  
**Coordinates:** 11.46316, 77.84921

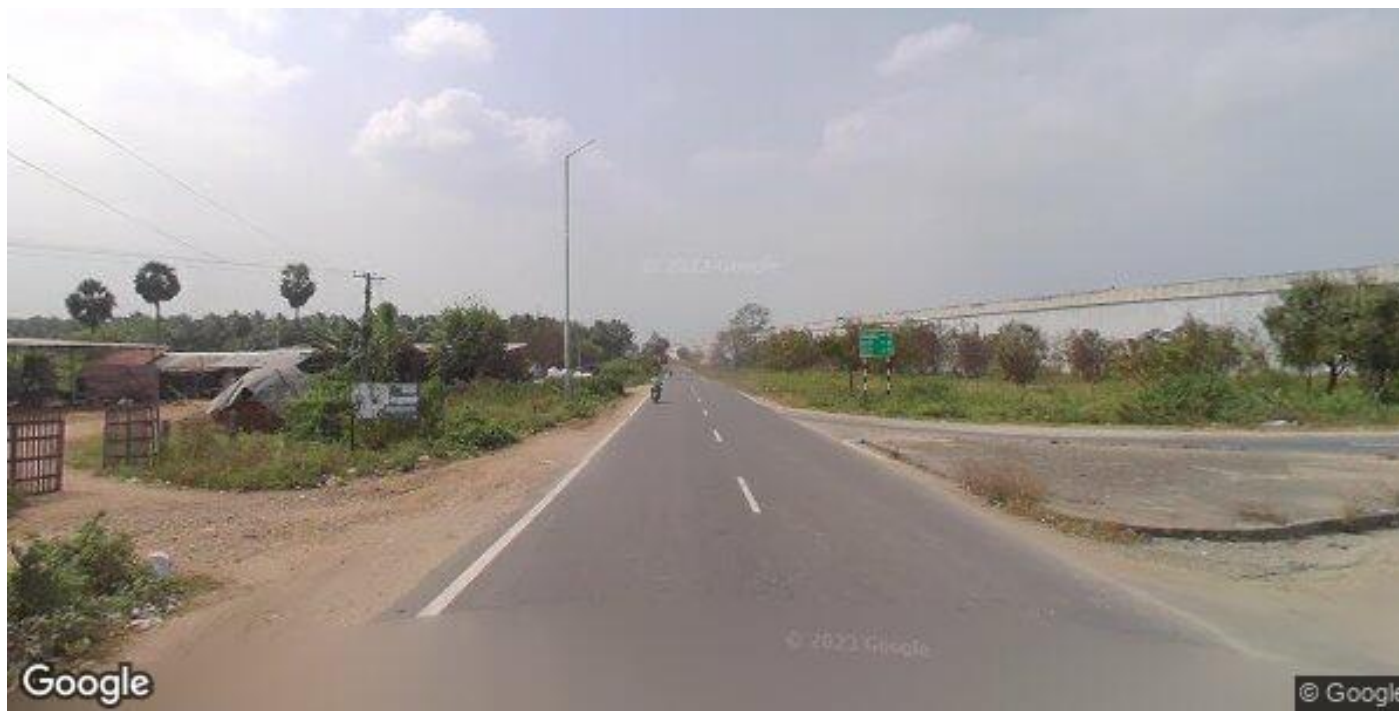
**Risk Type:** Turn  
**Risk Level:** High  
**Speed Limit:** 15 KM/Hr  
**Coordinates:** 11.45542, 77.81725

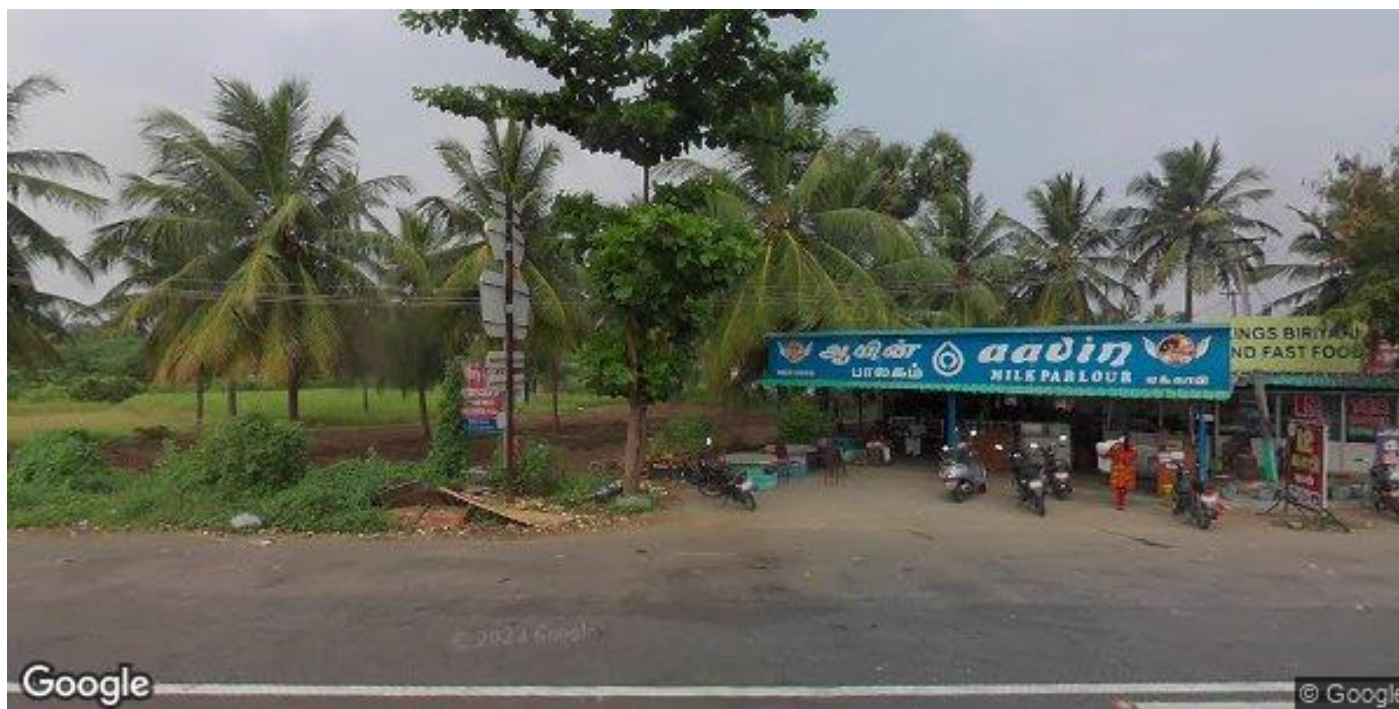
**Risk Type:** Blind Spot  
**Risk Level:** Blind Spot  
**Speed Limit:** 10 KM/Hr  
**Coordinates:** 11.45631, 77.81668

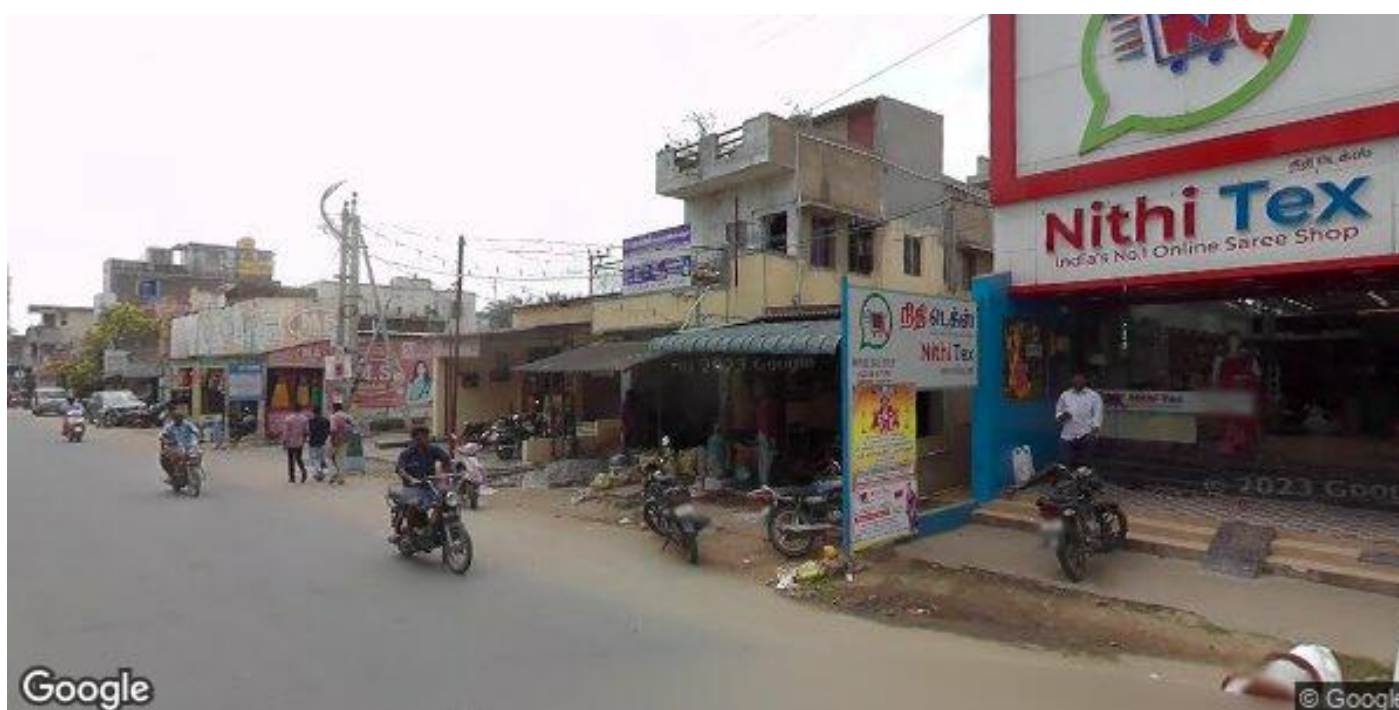
**Risk Type:** Turn  
**Risk Level:** Medium  
**Speed Limit:** 30 KM/Hr  
**Coordinates:** 11.60526, 78.00451

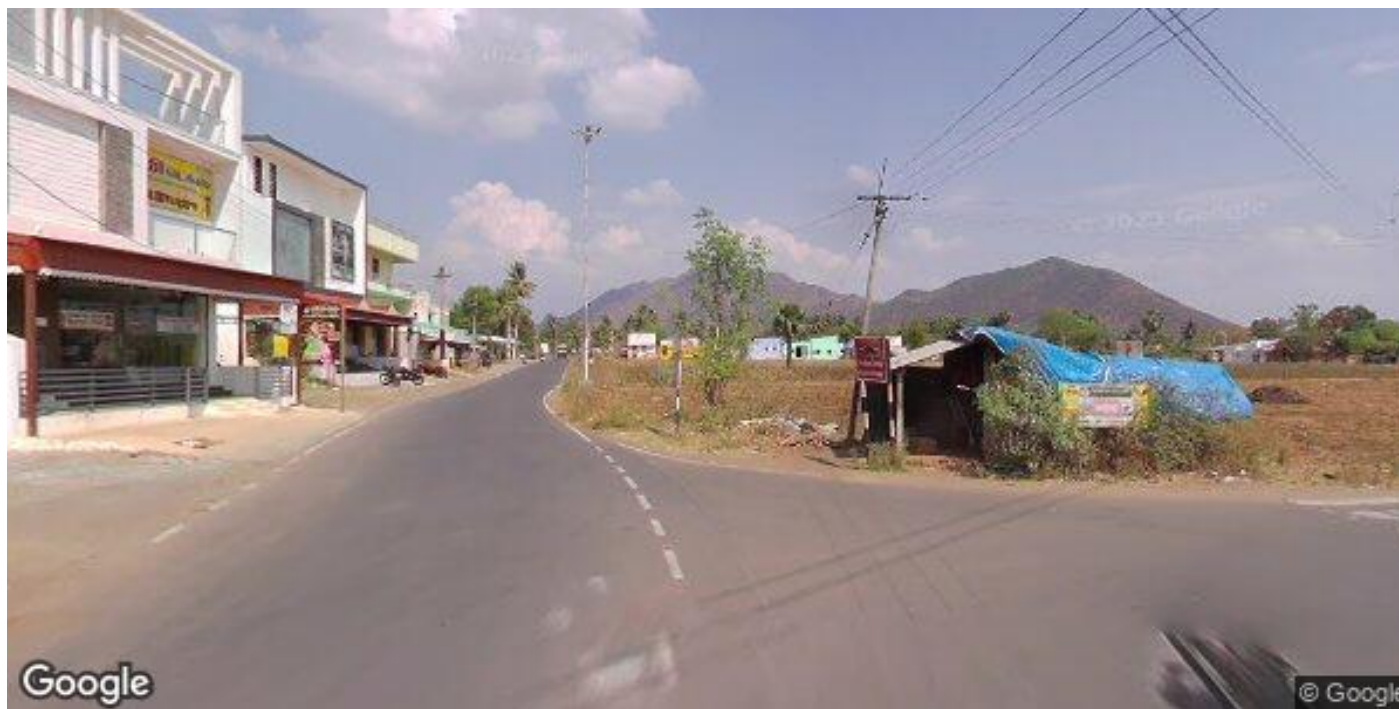
**Risk Type:** Turn  
**Risk Level:** High  
**Speed Limit:** 15 KM/Hr  
**Coordinates:** 11.62660, 78.00986

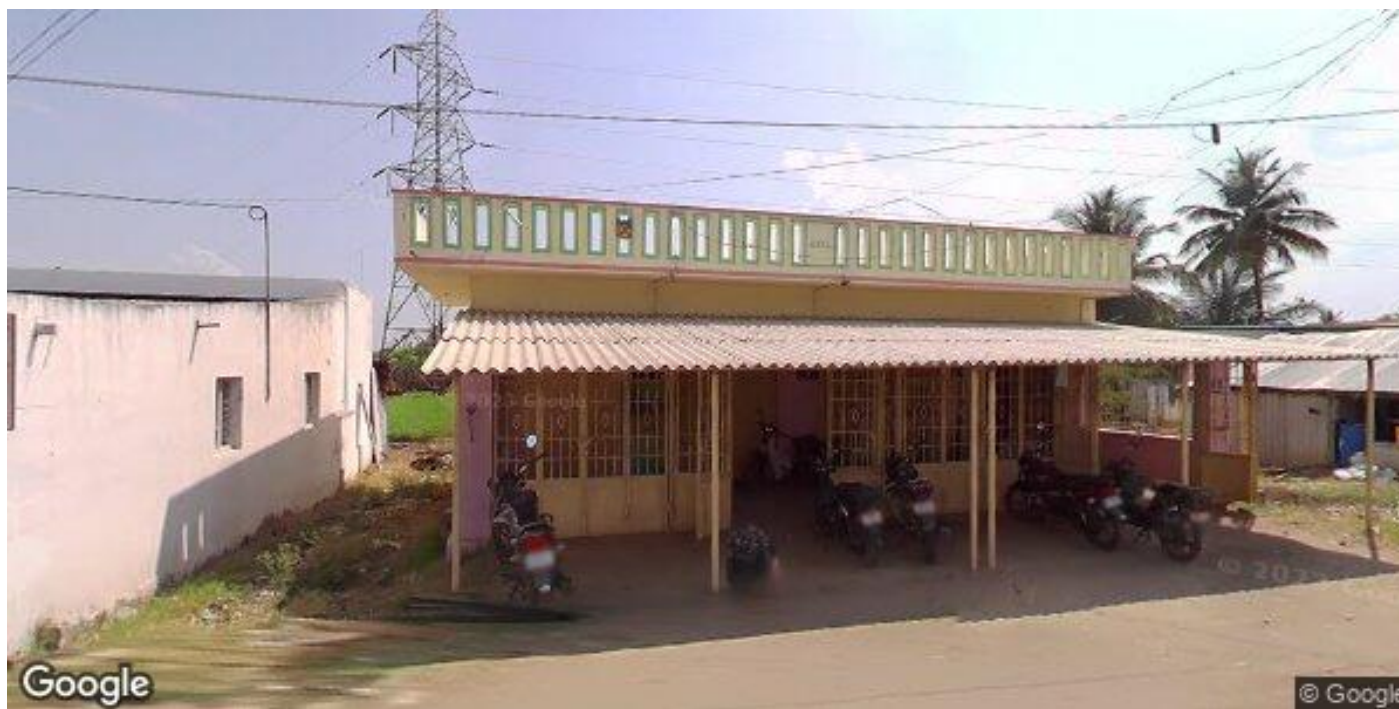
**Risk Type:** Turn  
**Risk Level:** High  
**Speed Limit:** 15 KM/Hr  
**Coordinates:** 11.62692, 78.00883

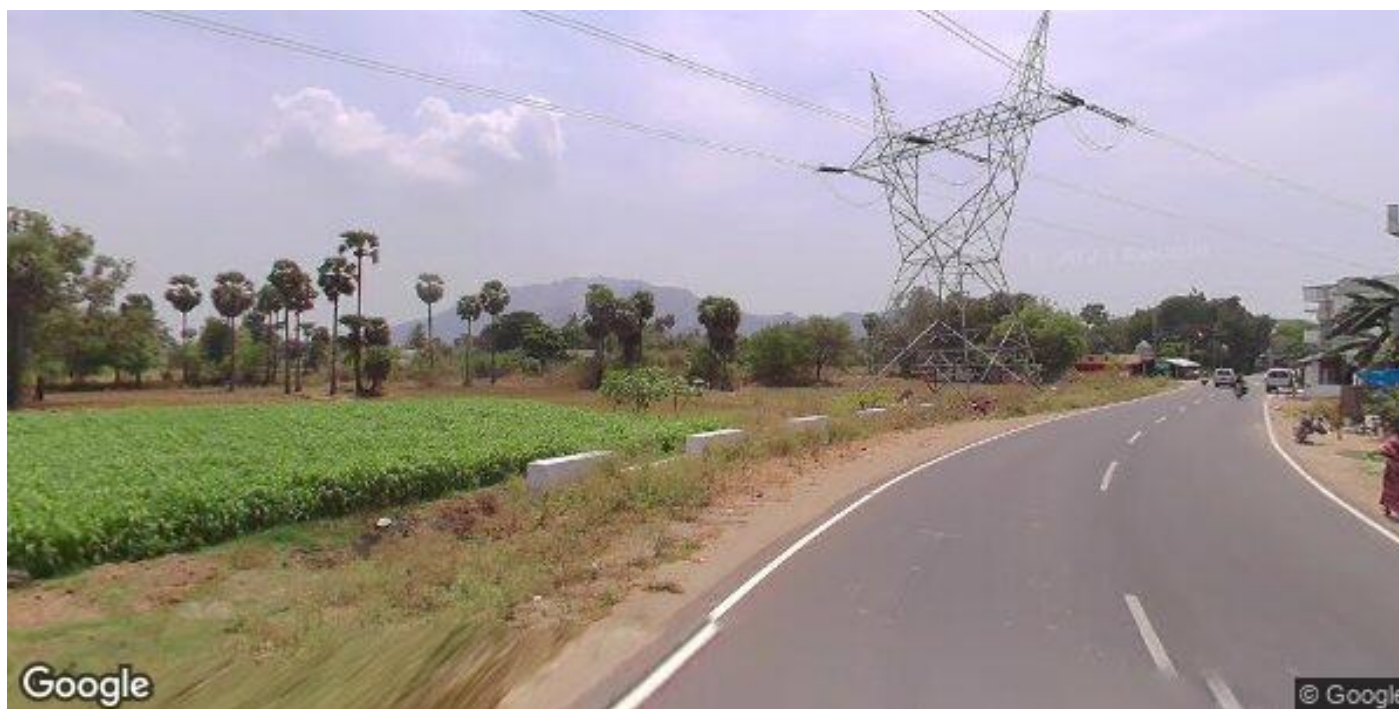
**Risk Type:** Turn  
**Risk Level:** Medium  
**Speed Limit:** 30 KM/Hr  
**Coordinates:** 11.64031, 78.00923

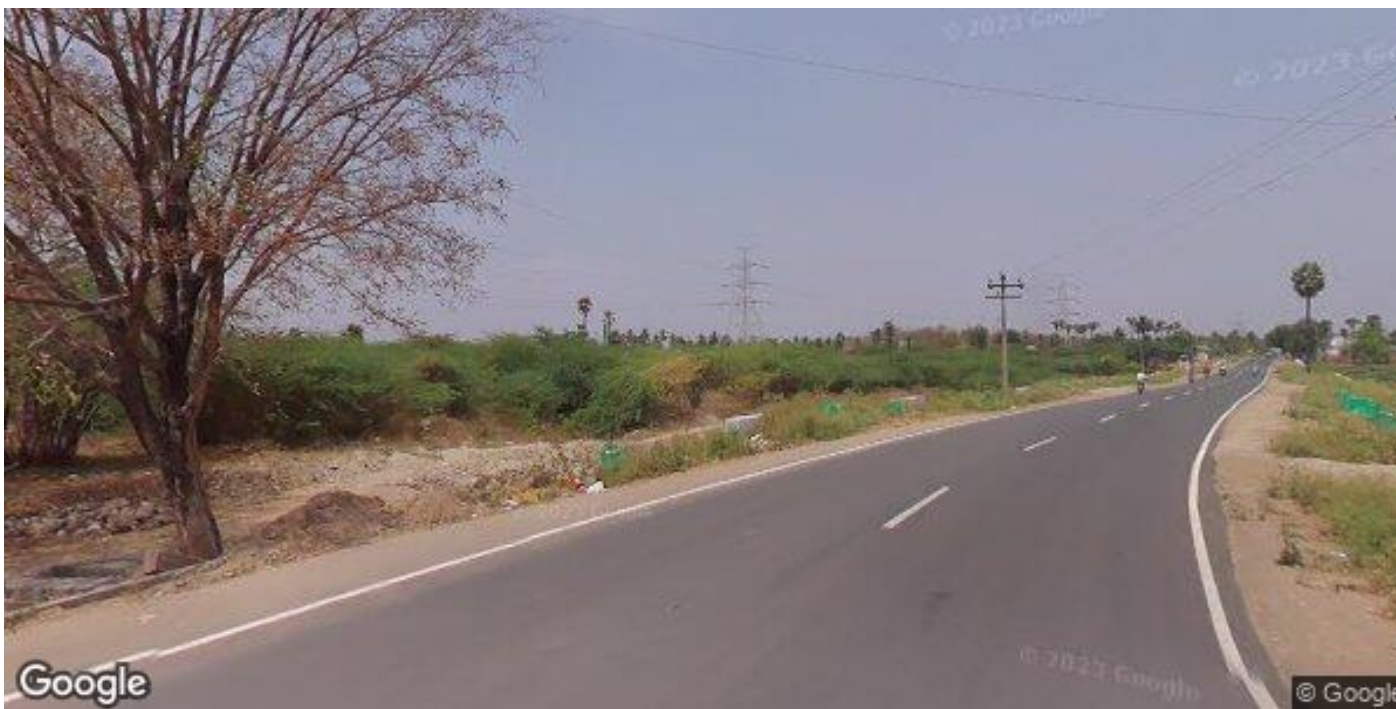
**Risk Type:** Turn  
**Risk Level:** Medium  
**Speed Limit:** 30 KM/Hr  
**Coordinates:** 11.64874, 78.00717

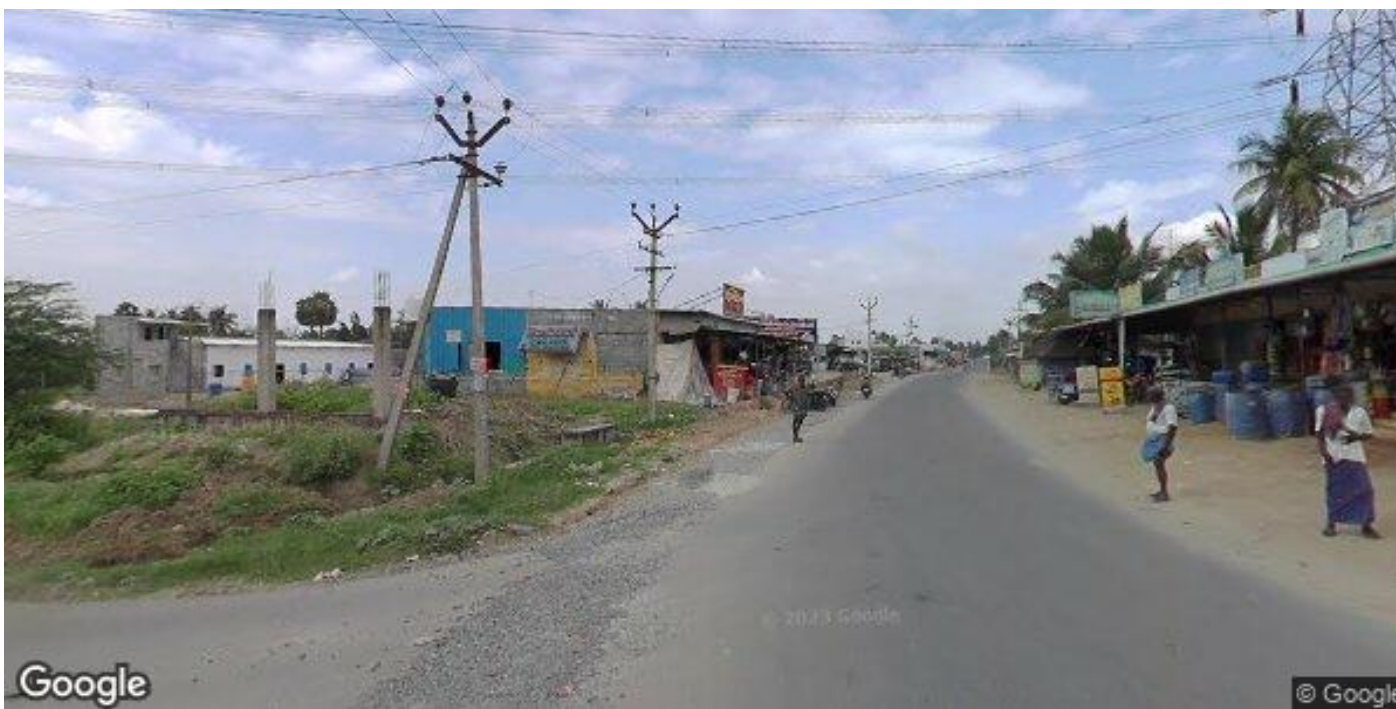
**Risk Type:** Blind Spot  
**Risk Level:** Blind Spot  
**Speed Limit:** 10 KM/Hr  
**Coordinates:** 11.66821, 78.00077

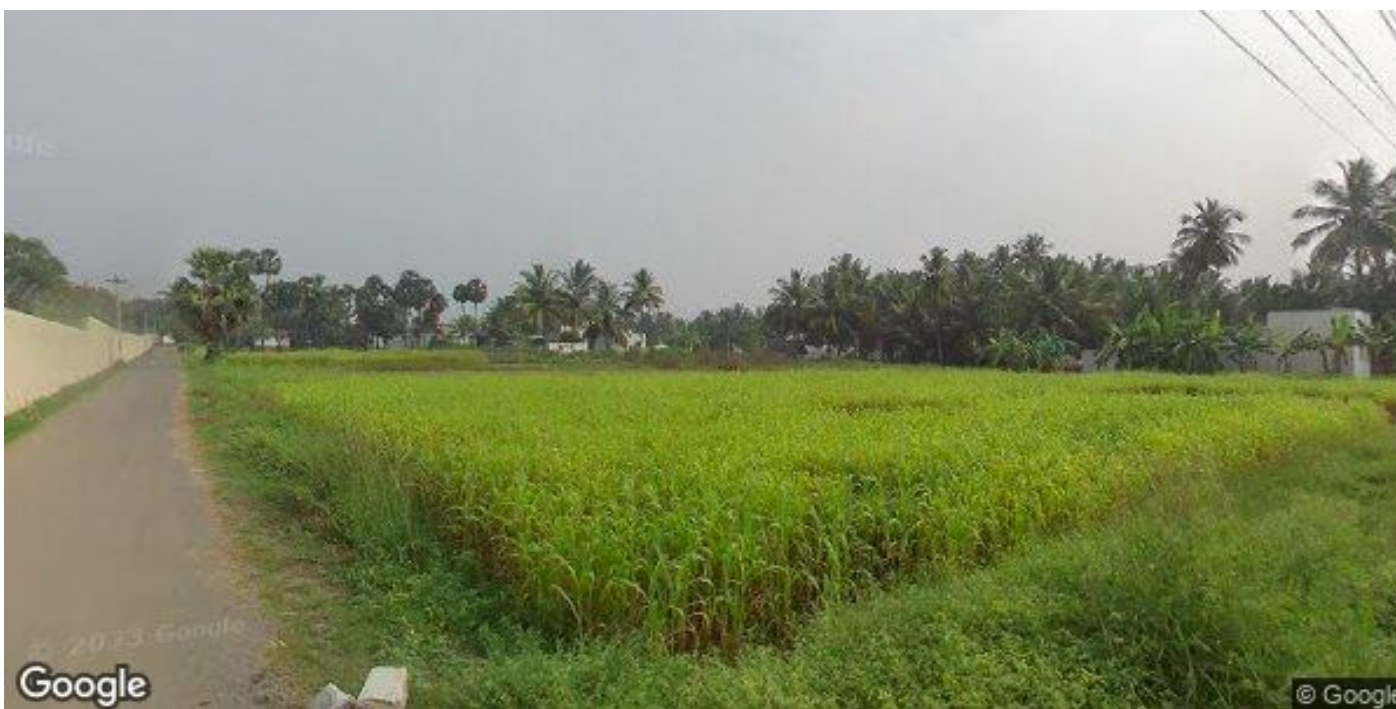
**Risk Type:** Turn  
**Risk Level:** High  
**Speed Limit:** 15 KM/Hr  
**Coordinates:** 11.66762, 78.00863

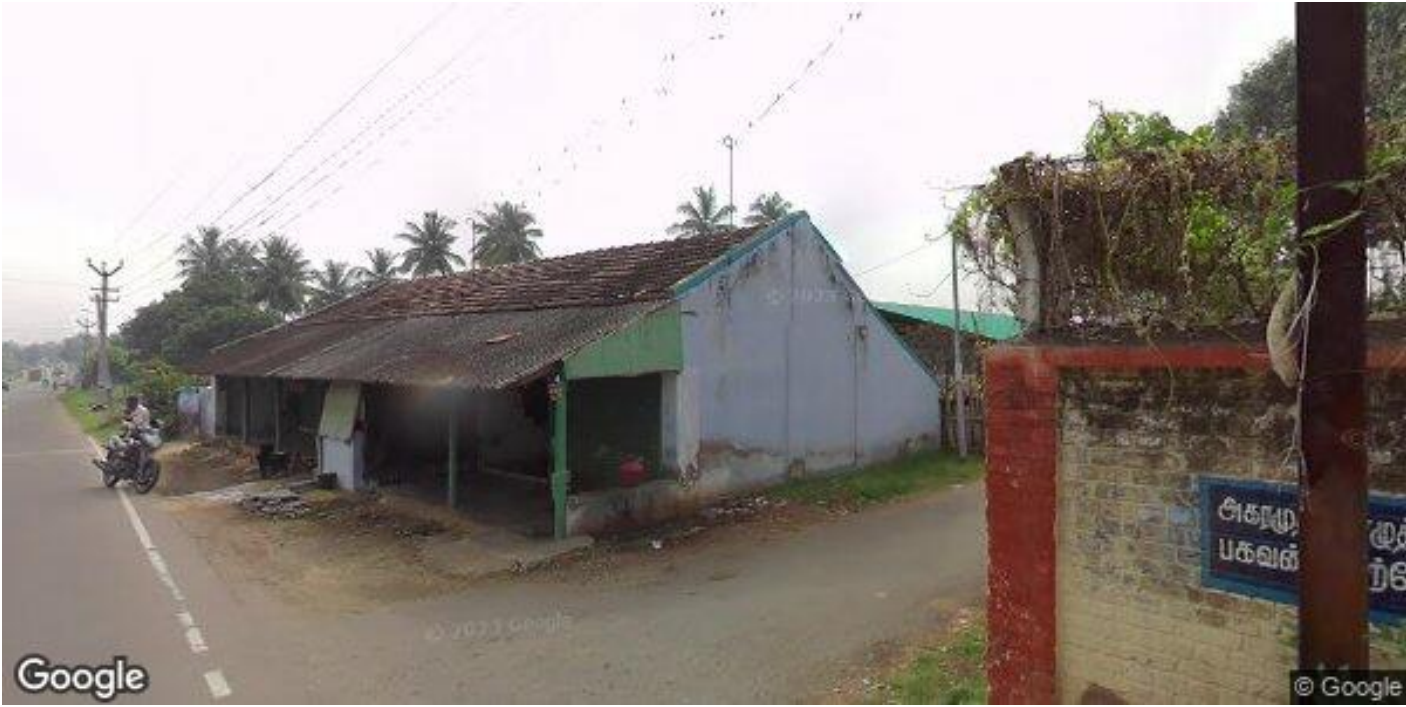
**Risk Type:** Blind Spot  
**Risk Level:** Blind Spot  
**Speed Limit:** 10 KM/Hr  
**Coordinates:** 11.67168, 78.00922

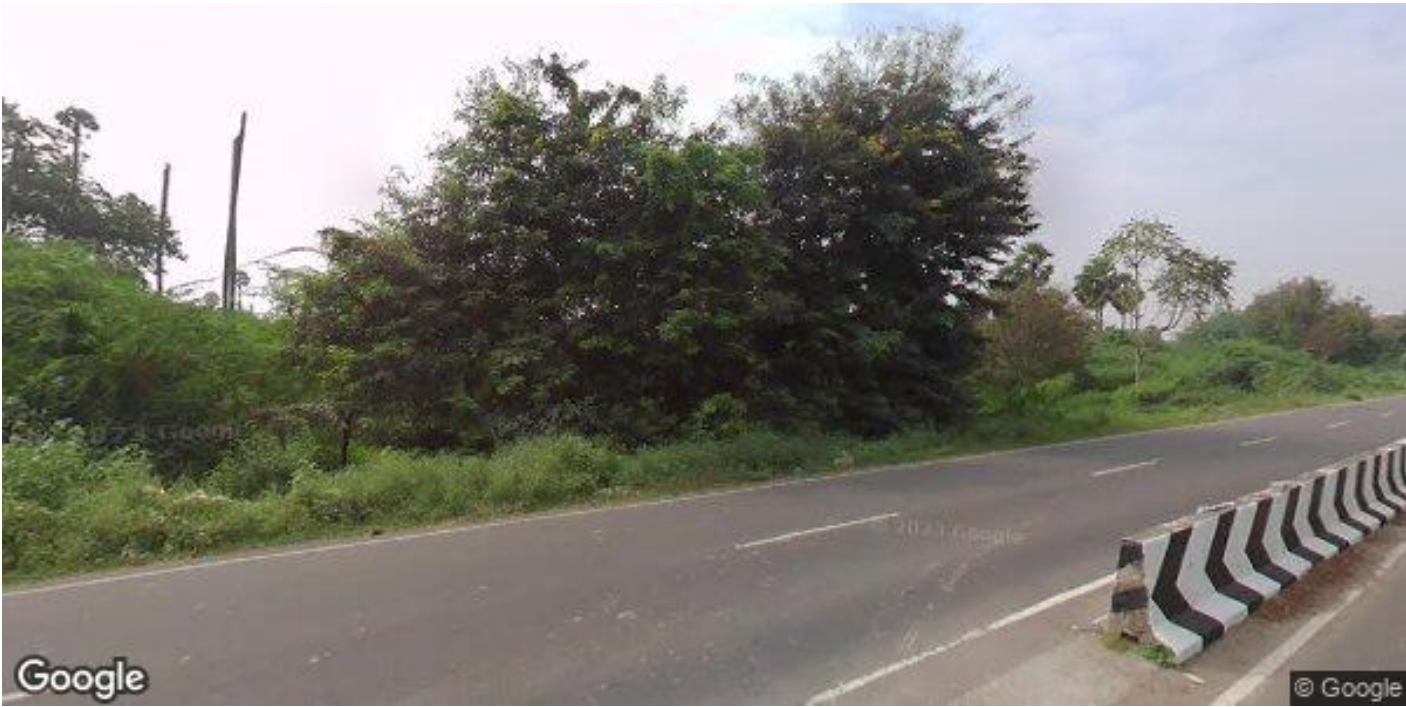
**Risk Type:** Blind Spot  
**Risk Level:** Blind Spot  
**Speed Limit:** 10 KM/Hr  
**Coordinates:** 11.66830, 78.04357

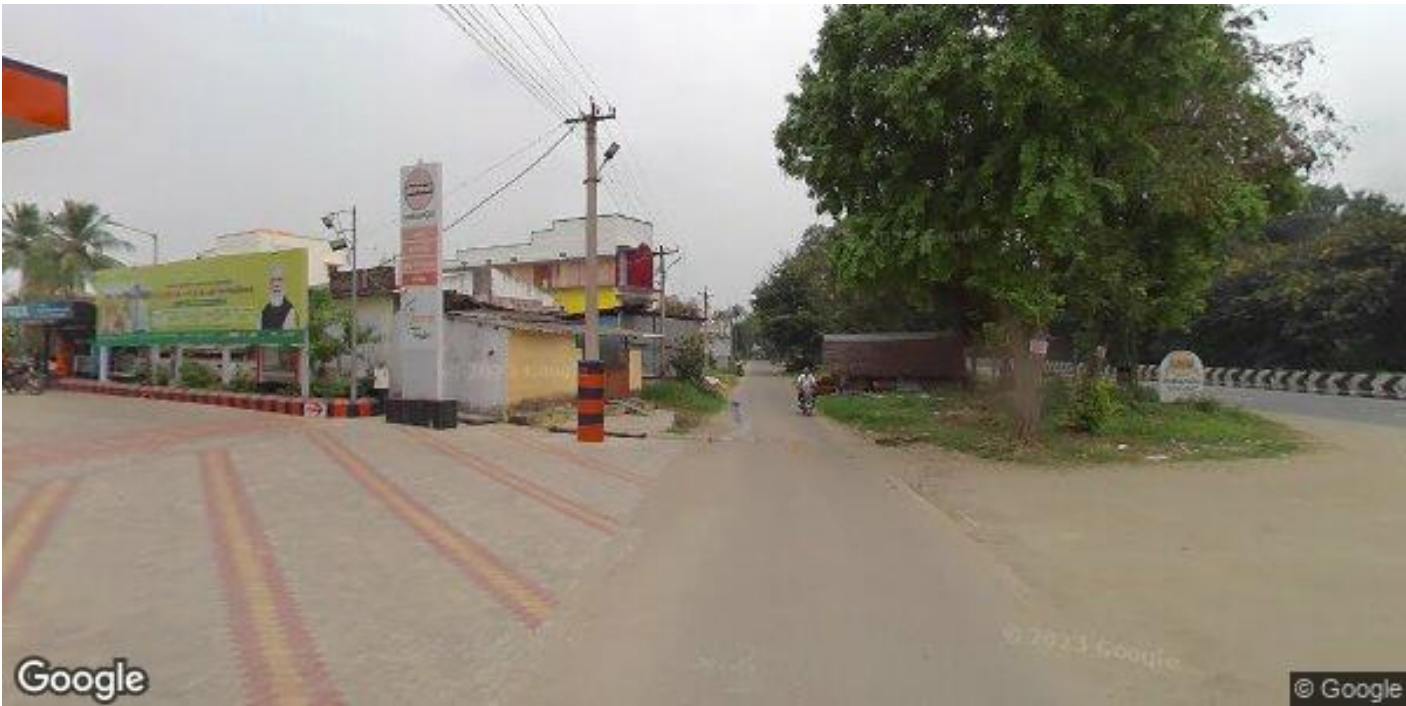
**Risk Type:** Blind Spot  
**Risk Level:** Blind Spot  
**Speed Limit:** 10 KM/Hr  
**Coordinates:** 11.66847, 78.04352
