# IndianOil

## JOURNEY RISK MANAGEMENT (JRM) STUDY

### Salem Terminal TO CPS AGENCIES

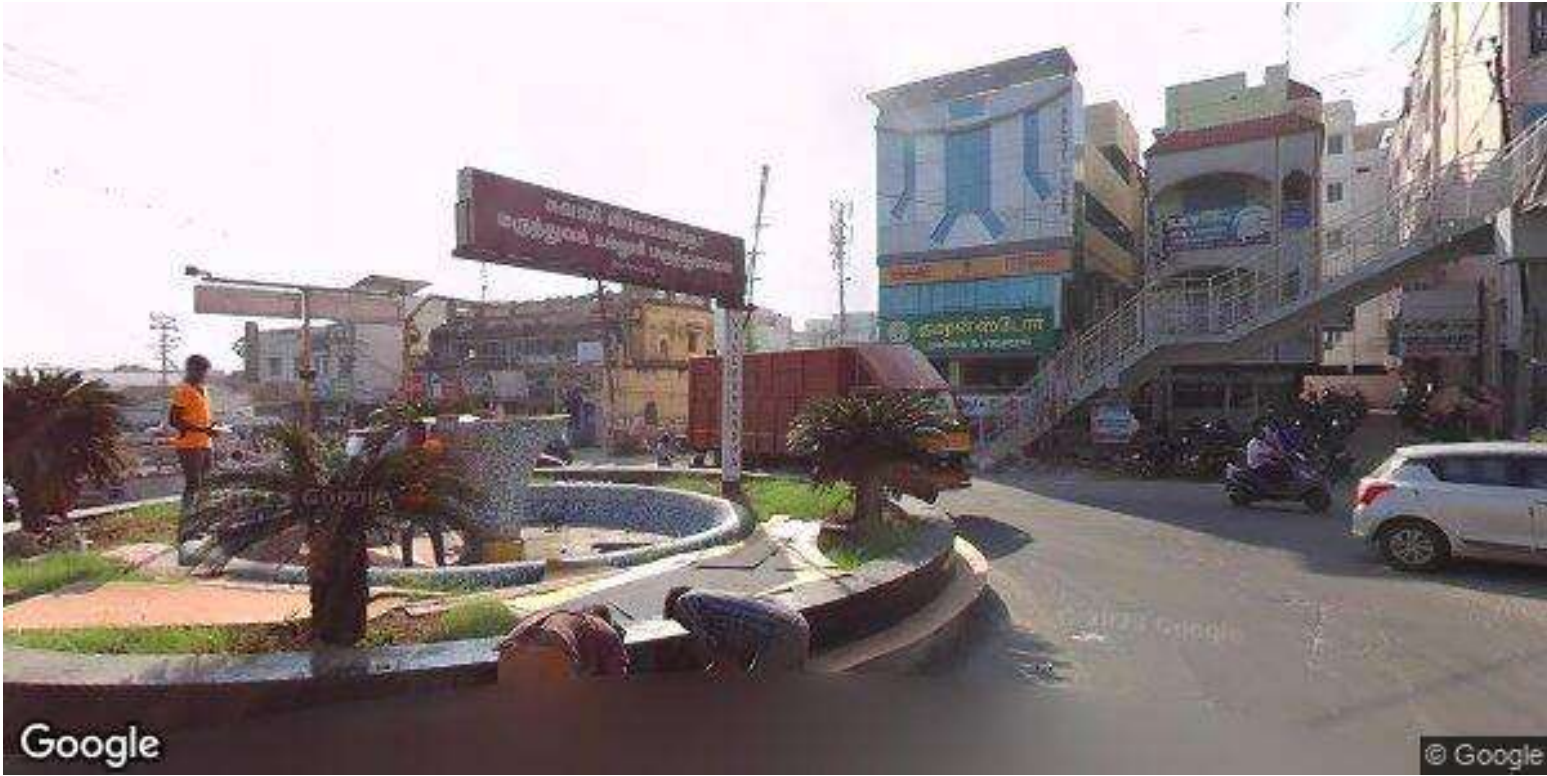
Coordinates: 11.38395, 77.89480

| | Risk Type | Risk Level | Coordinates | Speed Limit |
|---|---|---|---|---|
| 0 | Roundabout | High | 11.38395, 77.89480 | 15 KM/Hr |

Risk Type: Roundabout

Risk Level: High

Speed Limit: 15 KM/Hr

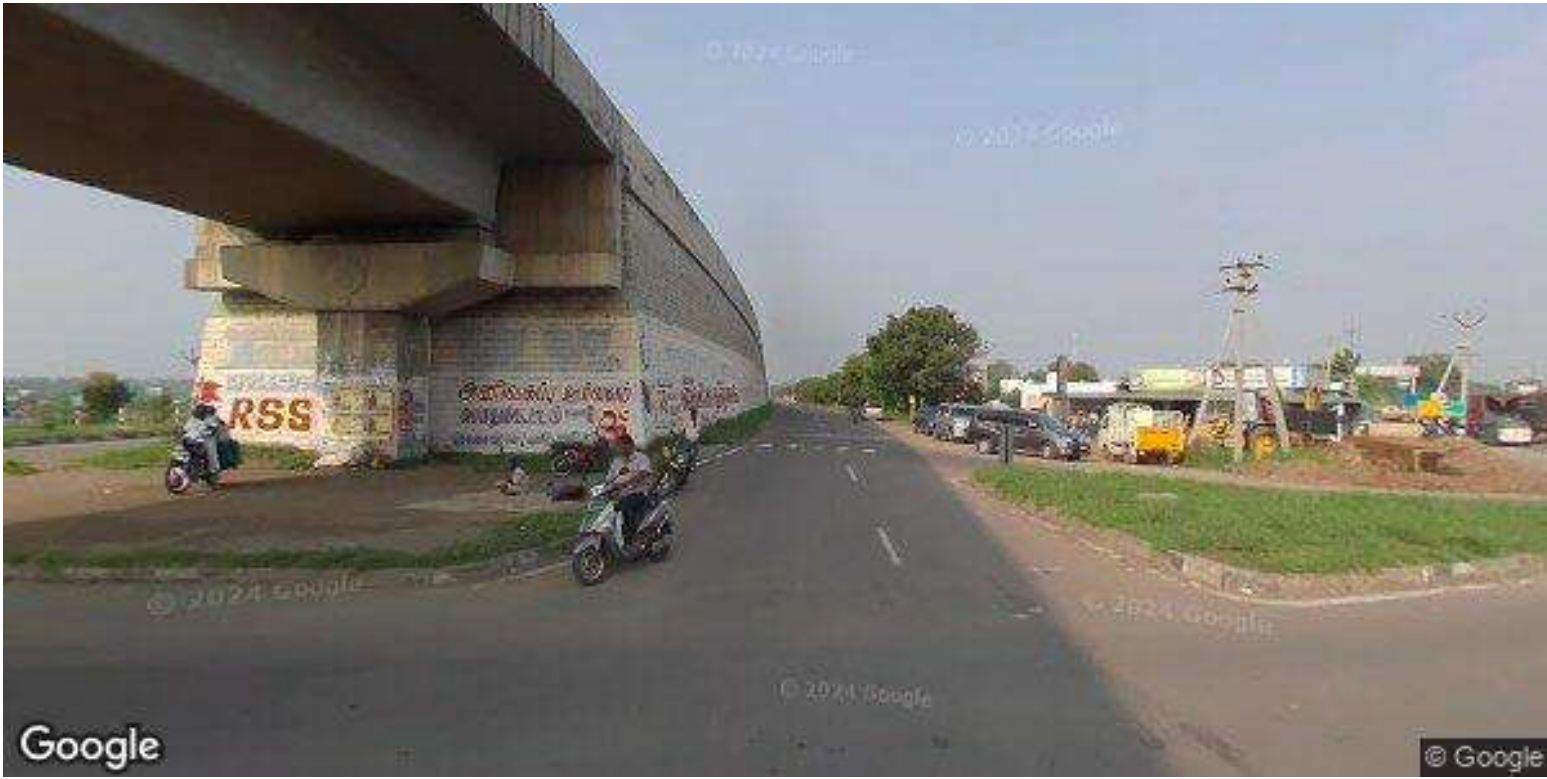
| | Risk Type | Risk Level | Coordinates | Speed Limit |
|---|---|---|---|---|
| 1 | Roundabout | High | 11.20387, 78.12203 | 15 KM/Hr |

**Risk Type:** Roundabout  
**Risk Level:** High  
**Speed Limit:** 15 KM/Hr  
**Coordinates:** 11.20387, 78.12203

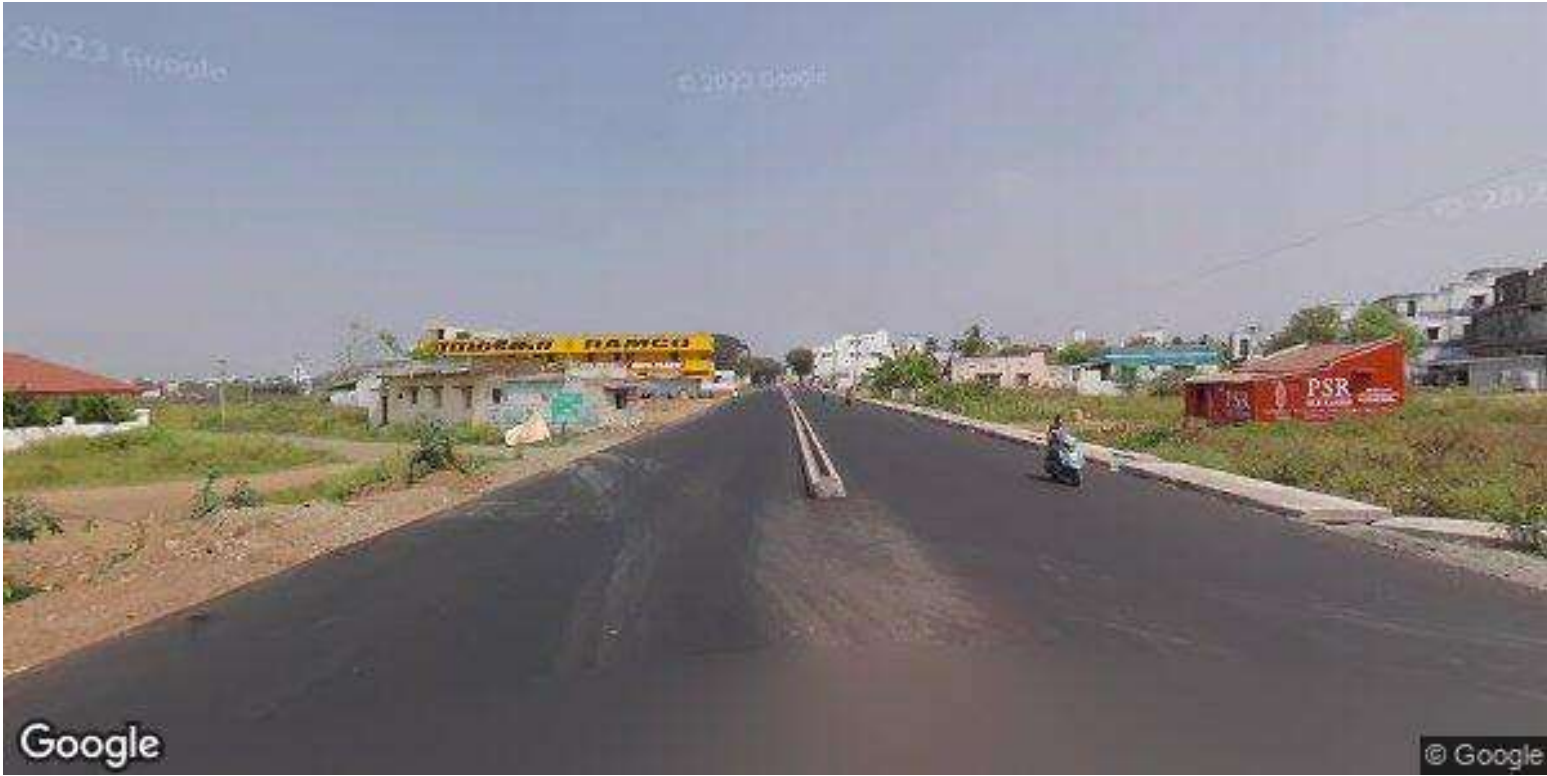
| | Risk Type | Risk Level | Coordinates | Speed Limit |
|---|---|---|---|---|
| 2 | U-Turn | High | 11.2089758, 78.1355753 | 10 KM/Hr |

**Risk Type:** U-Turn  
**Risk Level:** High  
**Speed Limit:** 10 KM/Hr  
**Coordinates:** 11.2089758, 78.1355753

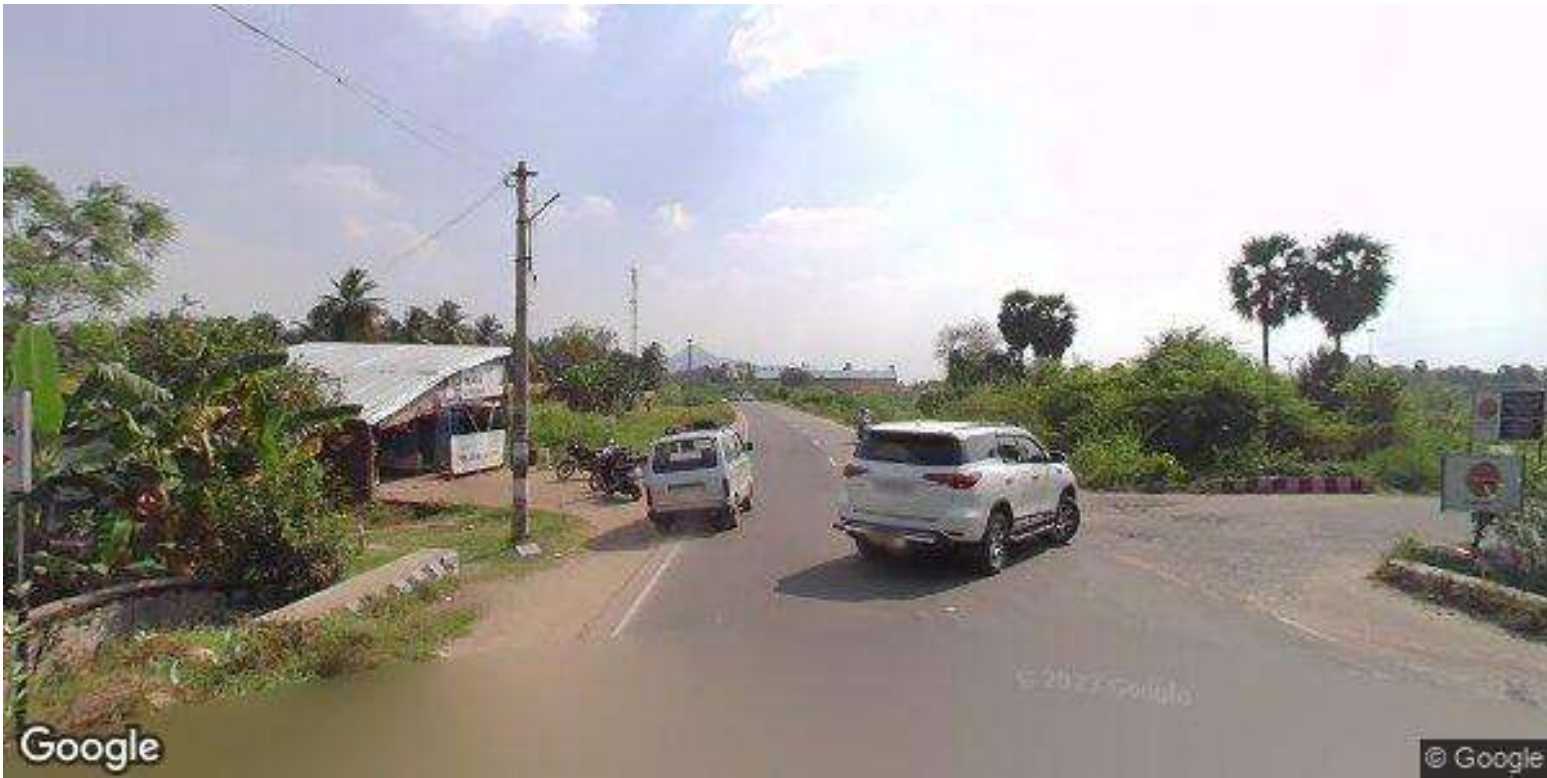
| | Risk Type | Risk Level | Coordinates | Speed Limit |
|---|---|---|---|---|
| 6 | Blind Spot | Blind Spot | 11.44029, 77.87544 | 10 KM/Hr |

**Risk Type:** Blind Spot  
**Risk Level:** Blind Spot  
**Speed Limit:** 10 KM/Hr  
**Coordinates:** 11.44029, 77.87544

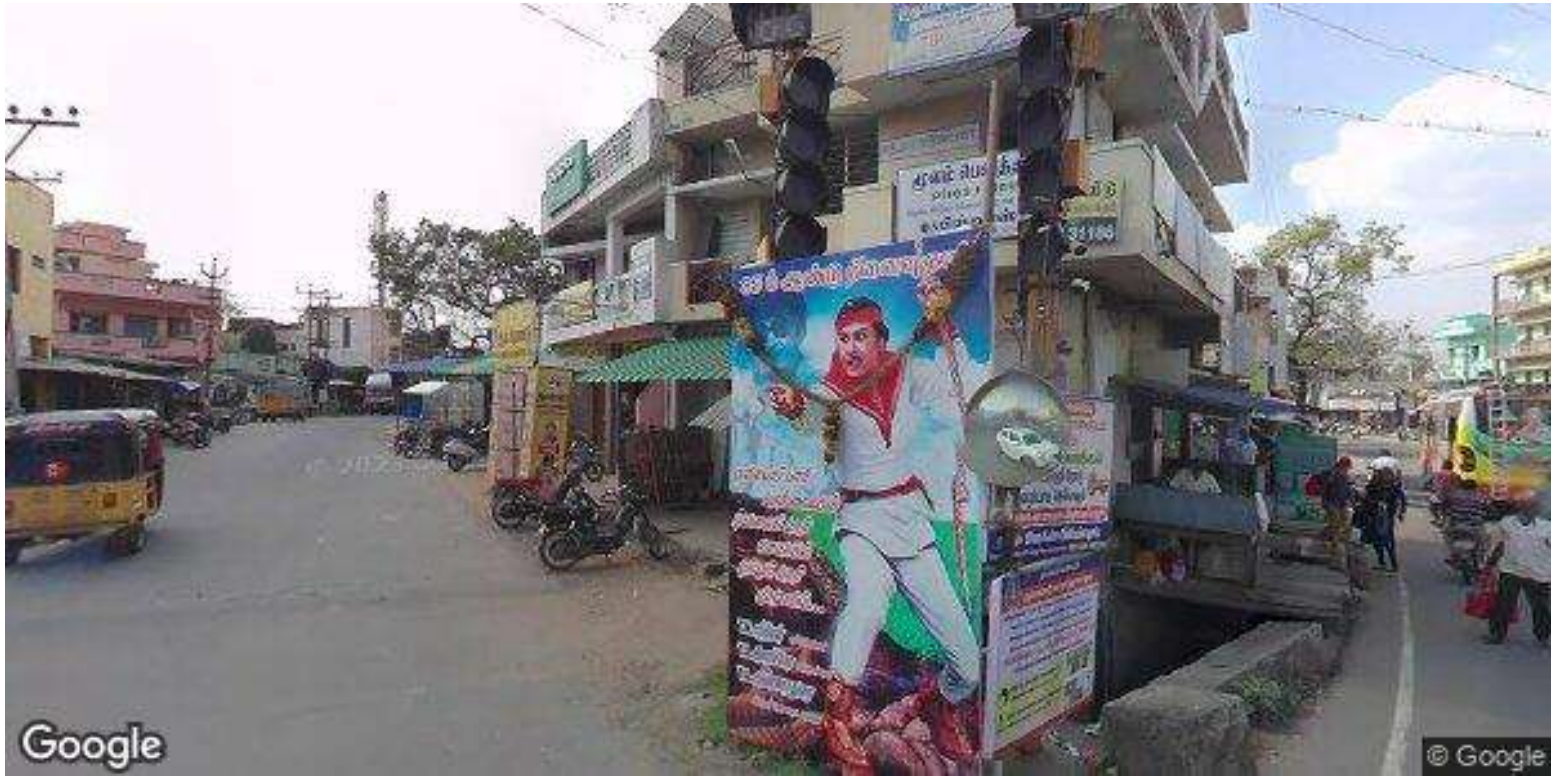
| | Risk Type | Risk Level | Coordinates | Speed Limit |
|---|---|---|---|---|
| 7 | Turn | Medium | 11.38342, 77.89975 | 30 KM/Hr |

**Risk Type:** Turn  
**Risk Level:** Medium  
**Speed Limit:** 30 KM/Hr  
**Coordinates:** 11.38342, 77.89975

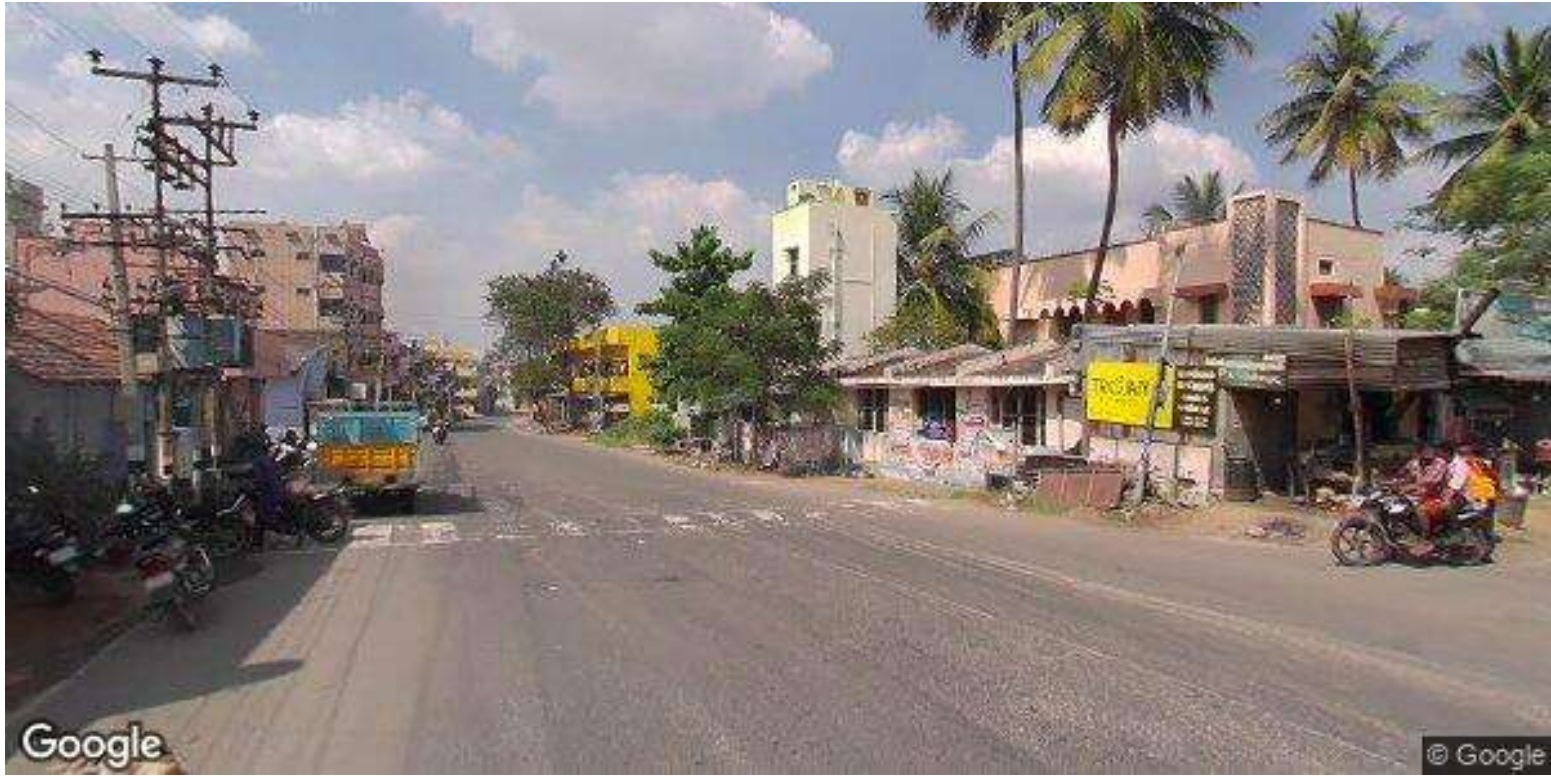
| | Risk Type | Risk Level | Coordinates | Speed Limit |
|---|---|---|---|---|
| 8 | Turn | Medium | 11.38190, 77.90254 | 30 KM/Hr |

**Risk Type:** Turn  
**Risk Level:** Medium  
**Speed Limit:** 30 KM/Hr  
**Coordinates:** 11.38190, 77.90254

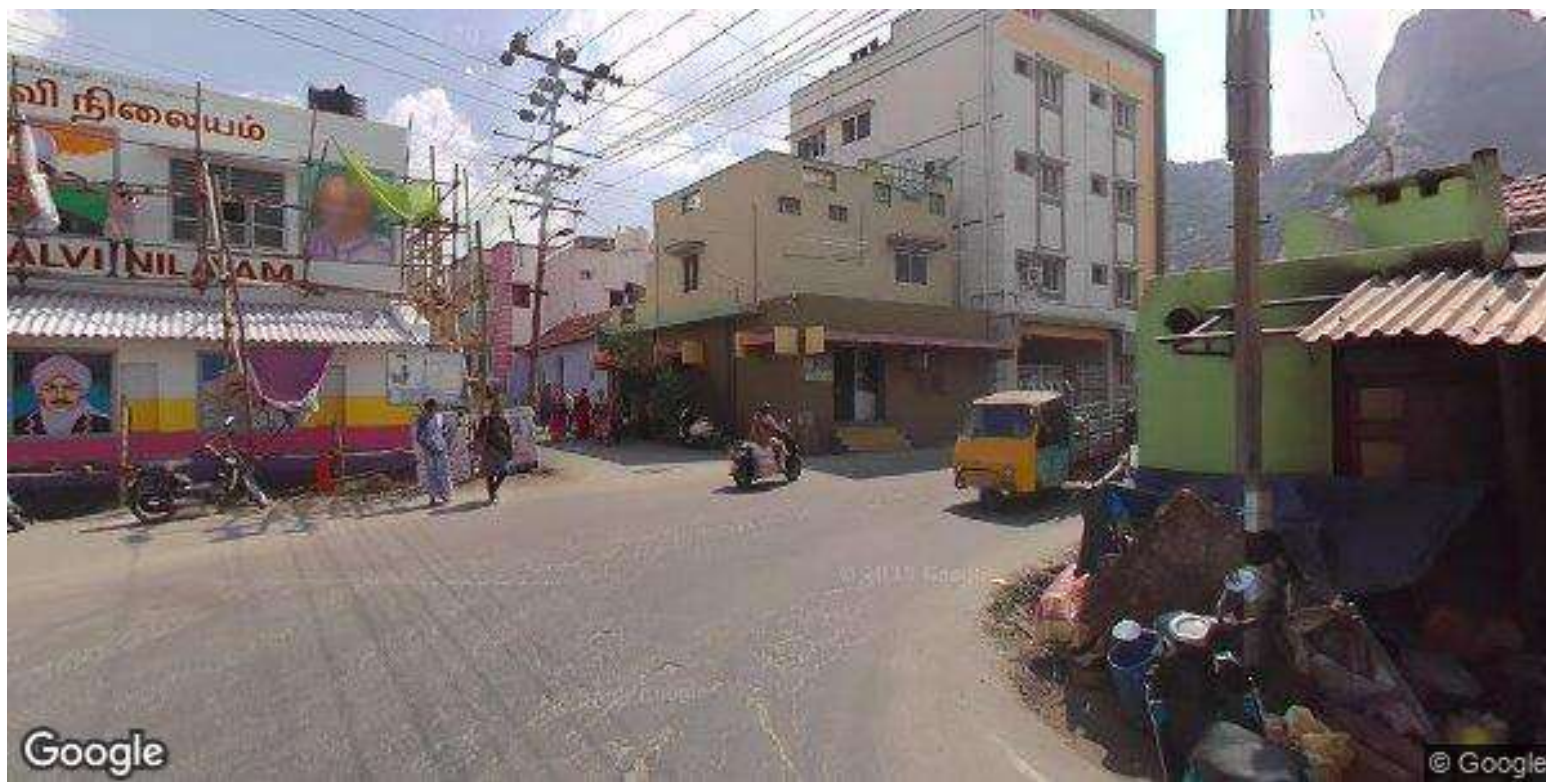
**Coordinates:** 11.38186, 77.90258

| | Risk Type | Risk Level | Coordinates | Speed Limit |
|---|---|---|---|---|
| 9 | Turn | High | 11.38186, 77.90258 | 15 KM/Hr |

**Risk Type:** Turn

**Risk Level:** High

**Speed Limit:** 15 KM/Hr

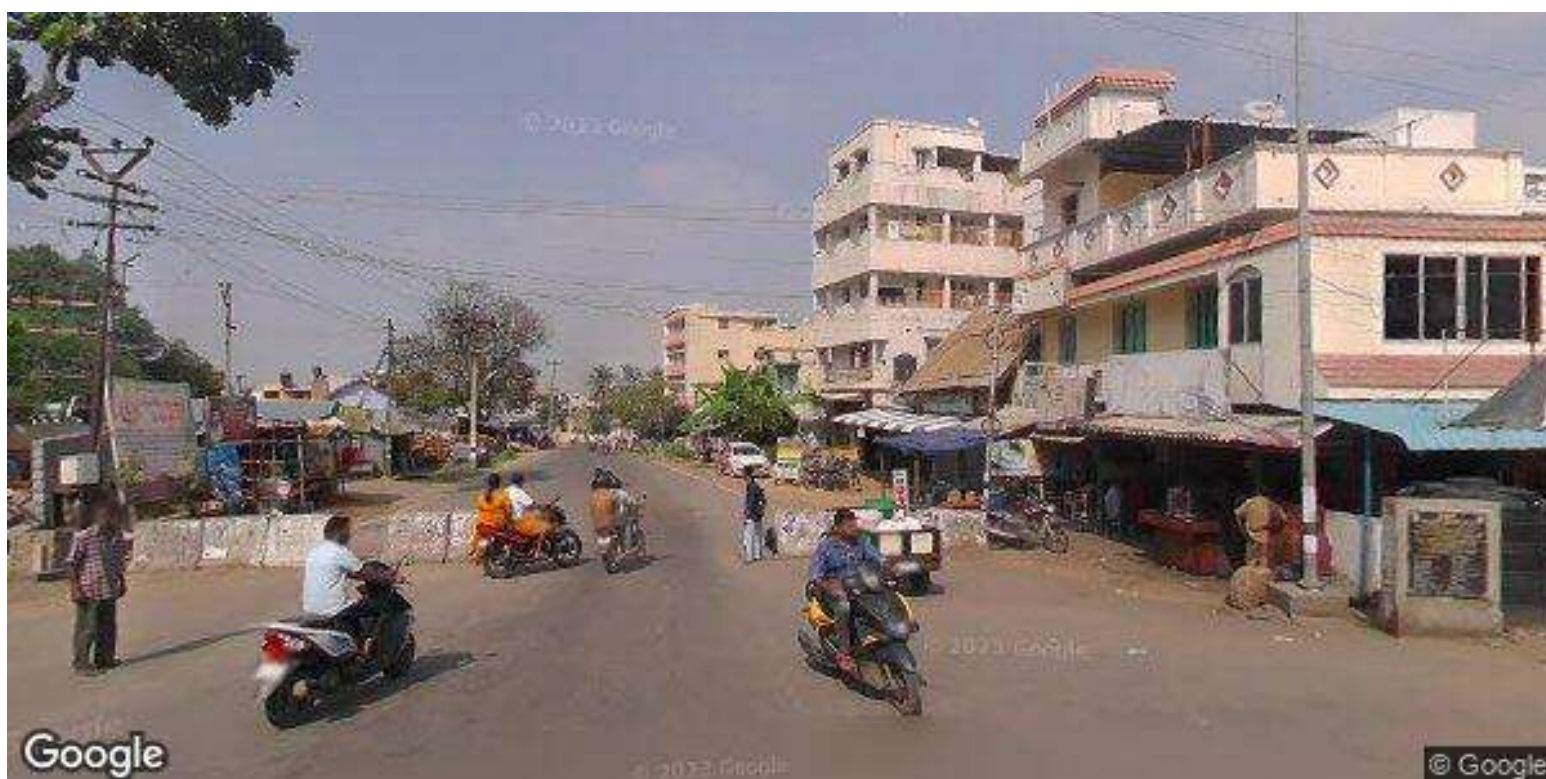
**Coordinates:** 11.37841, 77.90140

| | Risk Type | Risk Level | Coordinates | Speed Limit |
|---|---|---|---|---|
| 10 | Blind Spot | Blind Spot | 11.37841, 77.90140 | 10 KM/Hr |

**Risk Type:** Blind Spot

**Risk Level:** Blind Spot

**Speed Limit:** 10 KM/Hr

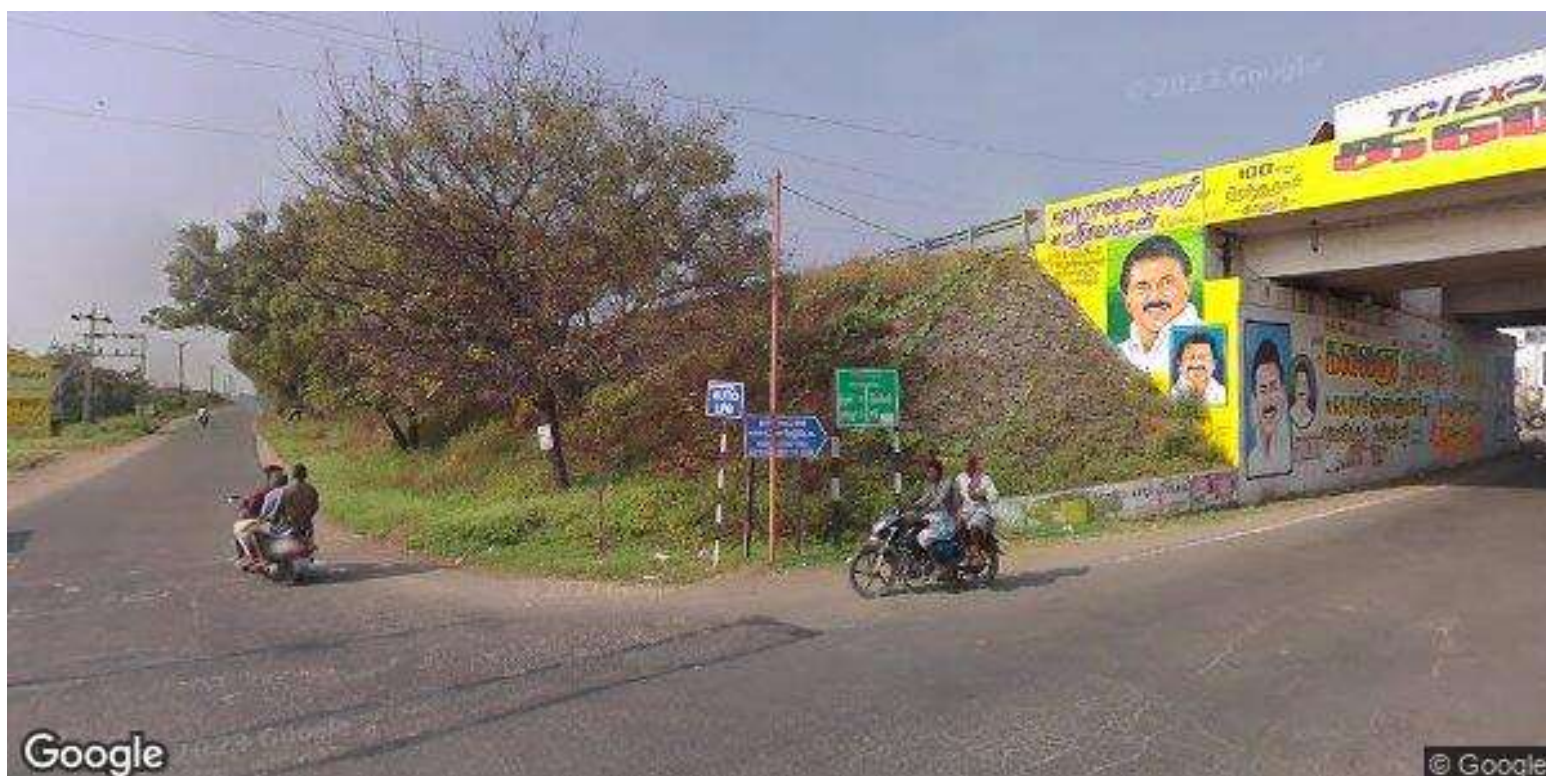
| | Risk Type | Risk Level | Coordinates | Speed Limit |
|---|---|---|---|---|
| 11 | Blind Spot | Blind Spot | 11.23936, 78.14267 | 10 KM/Hr |

**Risk Type:** Blind Spot  
**Risk Level:** Blind Spot  
**Speed Limit:** 10 KM/Hr  
**Coordinates:** 11.23936, 78.14267

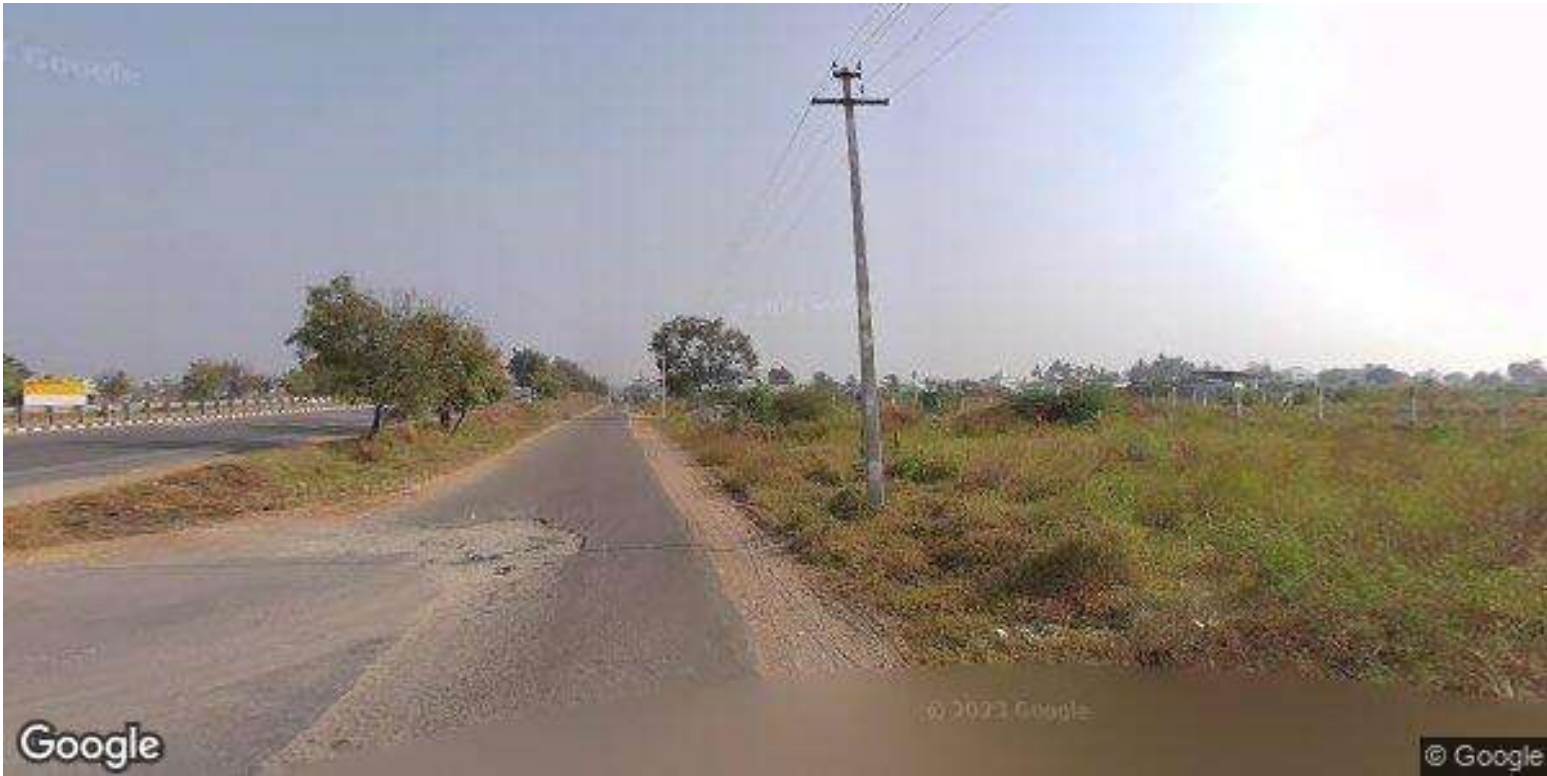
| | Risk Type | Risk Level | Coordinates | Speed Limit |
|---|---|---|---|---|
| 12 | Turn | High | 11.22817, 78.13576 | 15 KM/Hr |

**Risk Type:** Turn  
**Risk Level:** High  
**Speed Limit:** 15 KM/Hr  
**Coordinates:** 11.22817, 78.13576

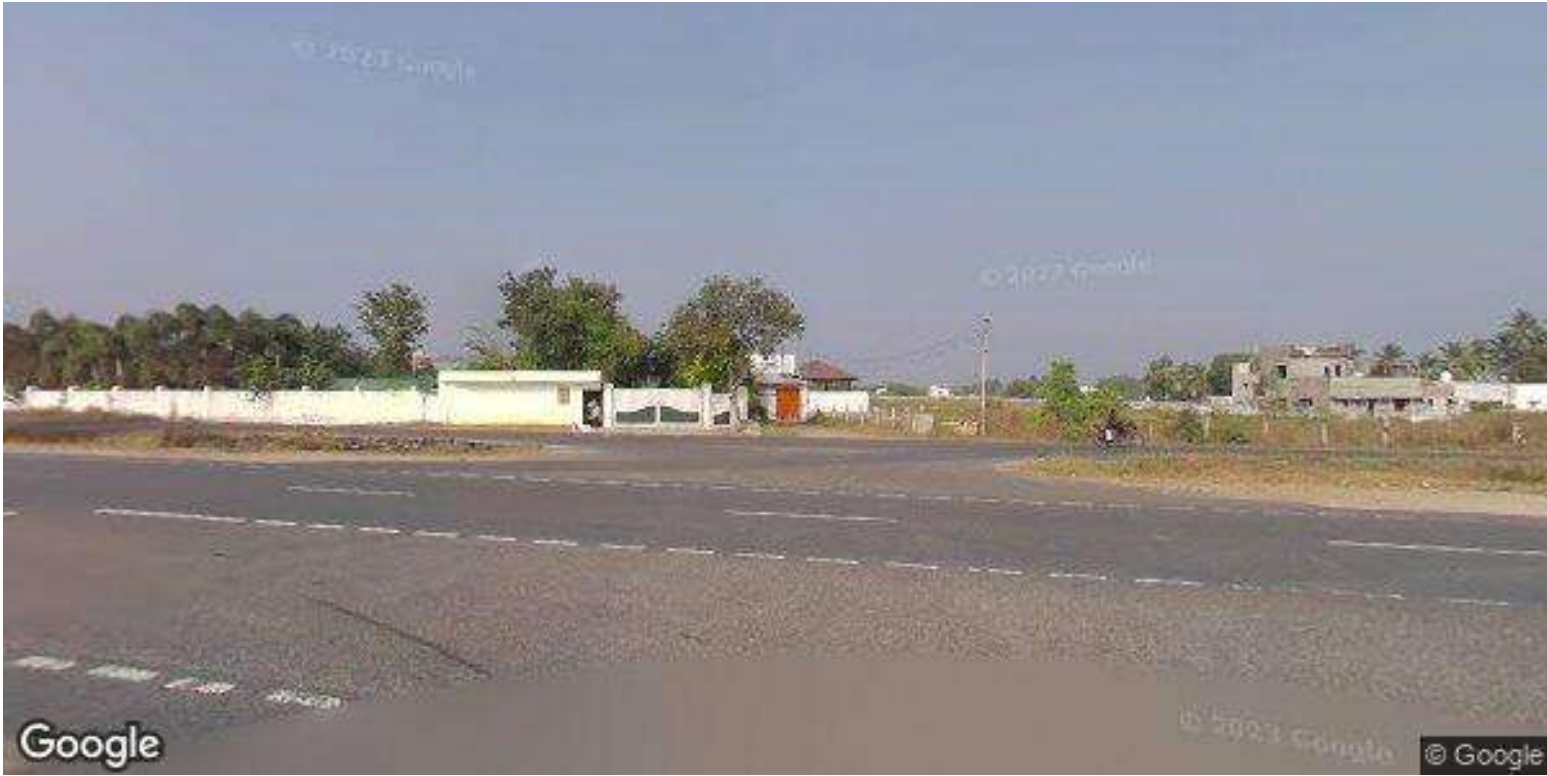
| | Risk Type | Risk Level | Coordinates | Speed Limit |
|---|---|---|---|---|
| 13 | Turn | High | 11.22822, 78.13561 | 15 KM/Hr |

**Risk Type:** Turn  
**Risk Level:** High  
**Speed Limit:** 15 KM/Hr  
**Coordinates:** 11.22822, 78.13561

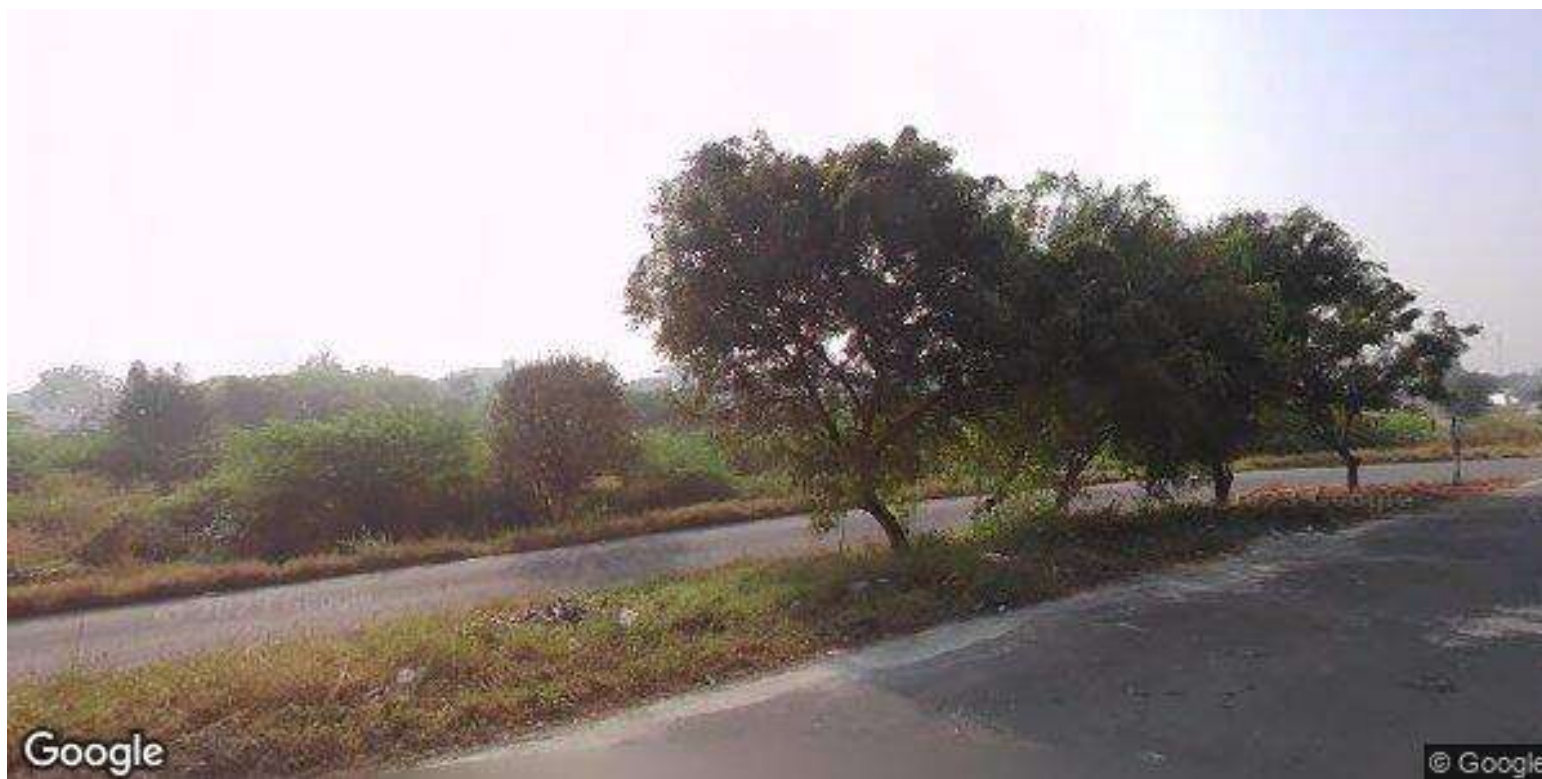
**Coordinates:** 11.20882, 78.12464

| | Risk Type | Risk Level | Coordinates | Speed Limit |
|---|---|---|---|---|
| 14 | Turn | Medium | 11.20882, 78.12464 | 30 KM/Hr |

**Risk Type:** Turn

**Risk Level:** Medium

**Speed Limit:** 30 KM/Hr

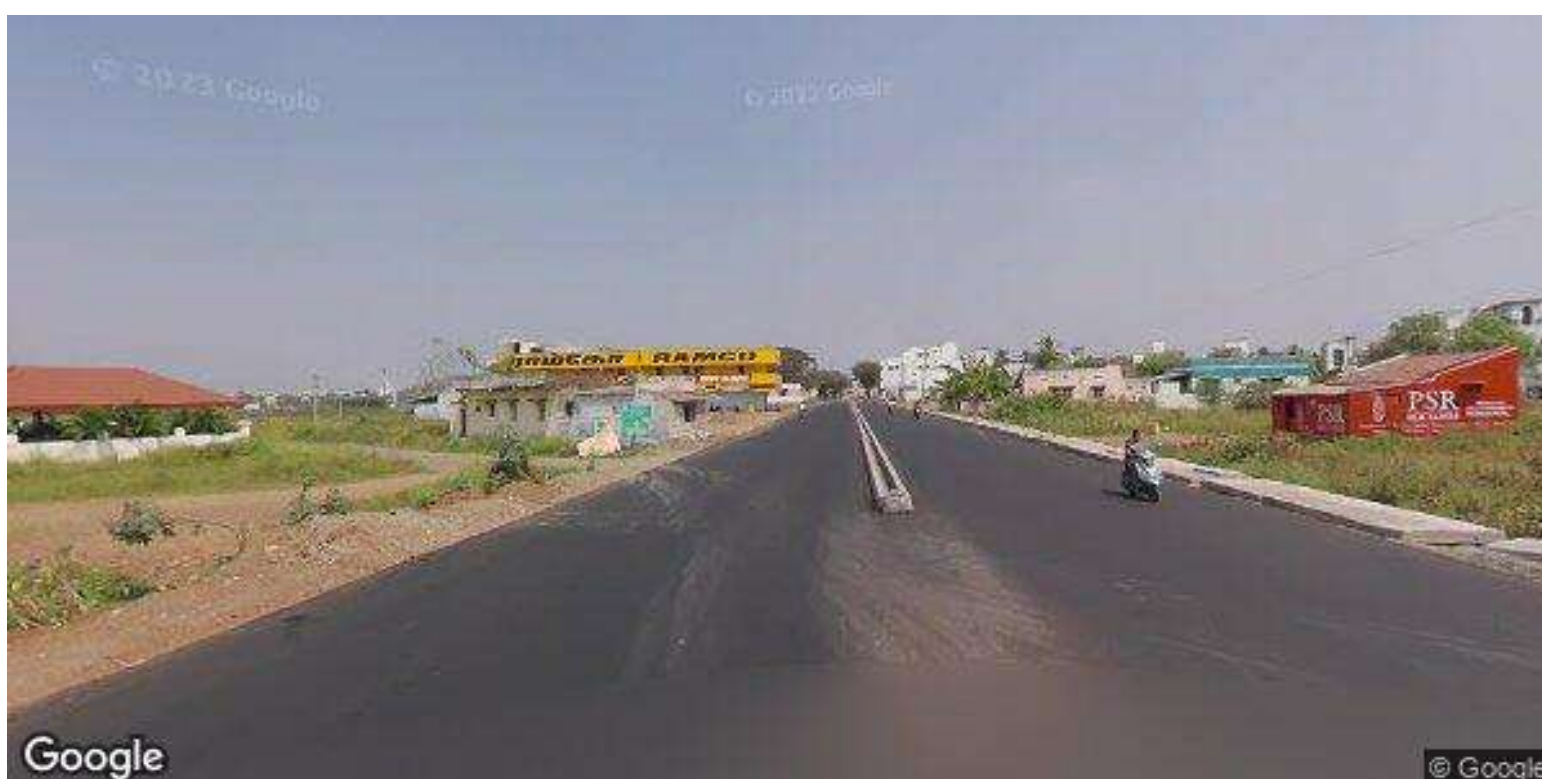
**Coordinates:** 11.20898, 78.13558

| | Risk Type | Risk Level | Coordinates | Speed Limit |
|---|---|---|---|---|
| 15 | Blind Spot | Blind Spot | 11.20898, 78.13558 | 10 KM/Hr |

**Risk Type:** Blind Spot

**Risk Level:** Blind Spot

**Speed Limit:** 10 KM/Hr

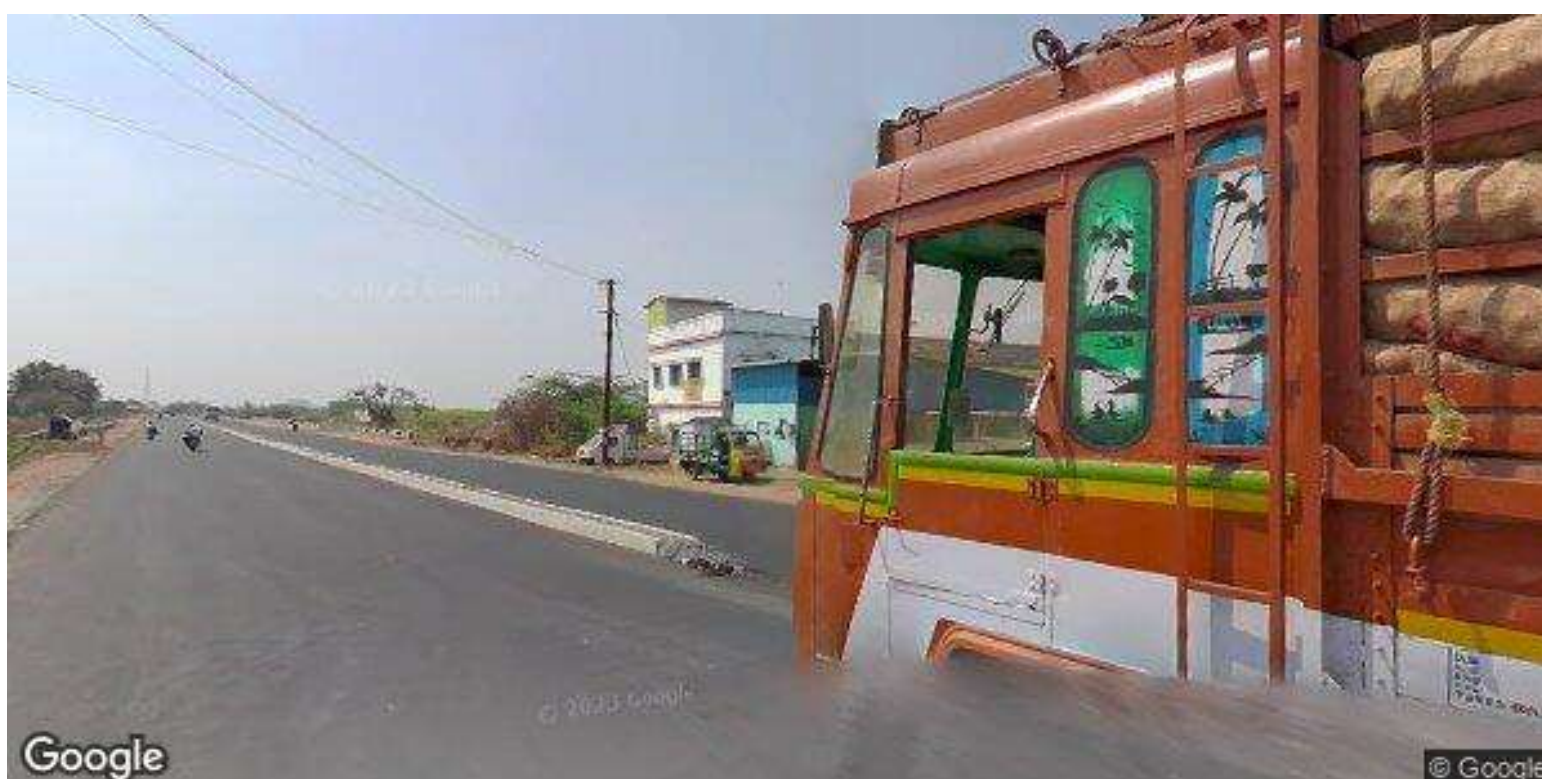
| | Risk Type | Risk Level | Coordinates | Speed Limit |
|---|---|---|---|---|
| 16 | Turn | High | 11.20890, 78.13558 | 15 KM/Hr |

**Risk Type:** Turn  
**Risk Level:** High  
**Speed Limit:** 15 KM/Hr  
**Coordinates:** 11.20890, 78.13558

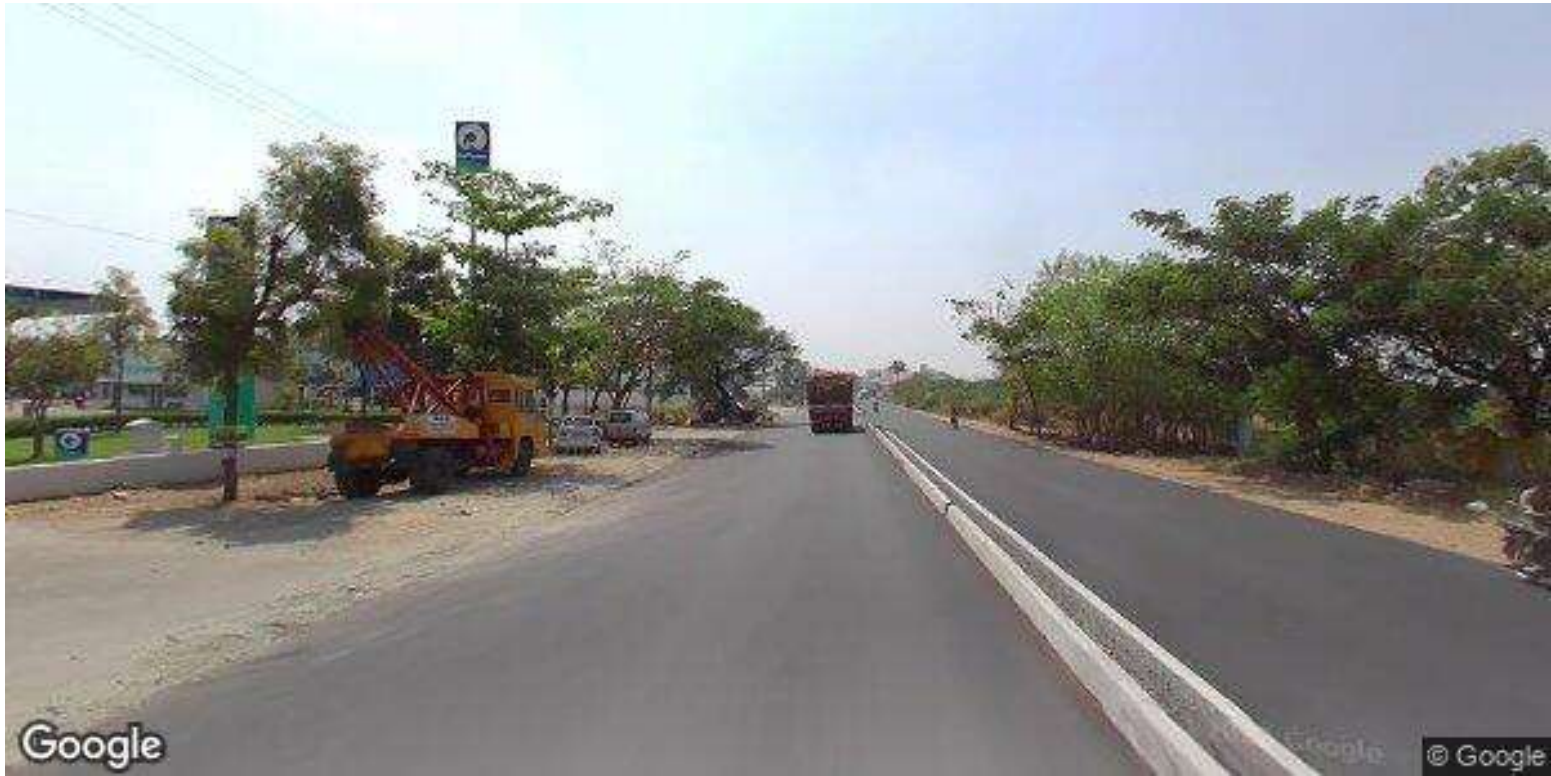
| | Risk Type | Risk Level | Coordinates | Speed Limit |
|---|---|---|---|---|
| 17 | Turn | High | 11.20761, 78.13016 | 15 KM/Hr |

**Risk Type:** Turn  
**Risk Level:** High  
**Speed Limit:** 15 KM/Hr  
**Coordinates:** 11.20761, 78.13016

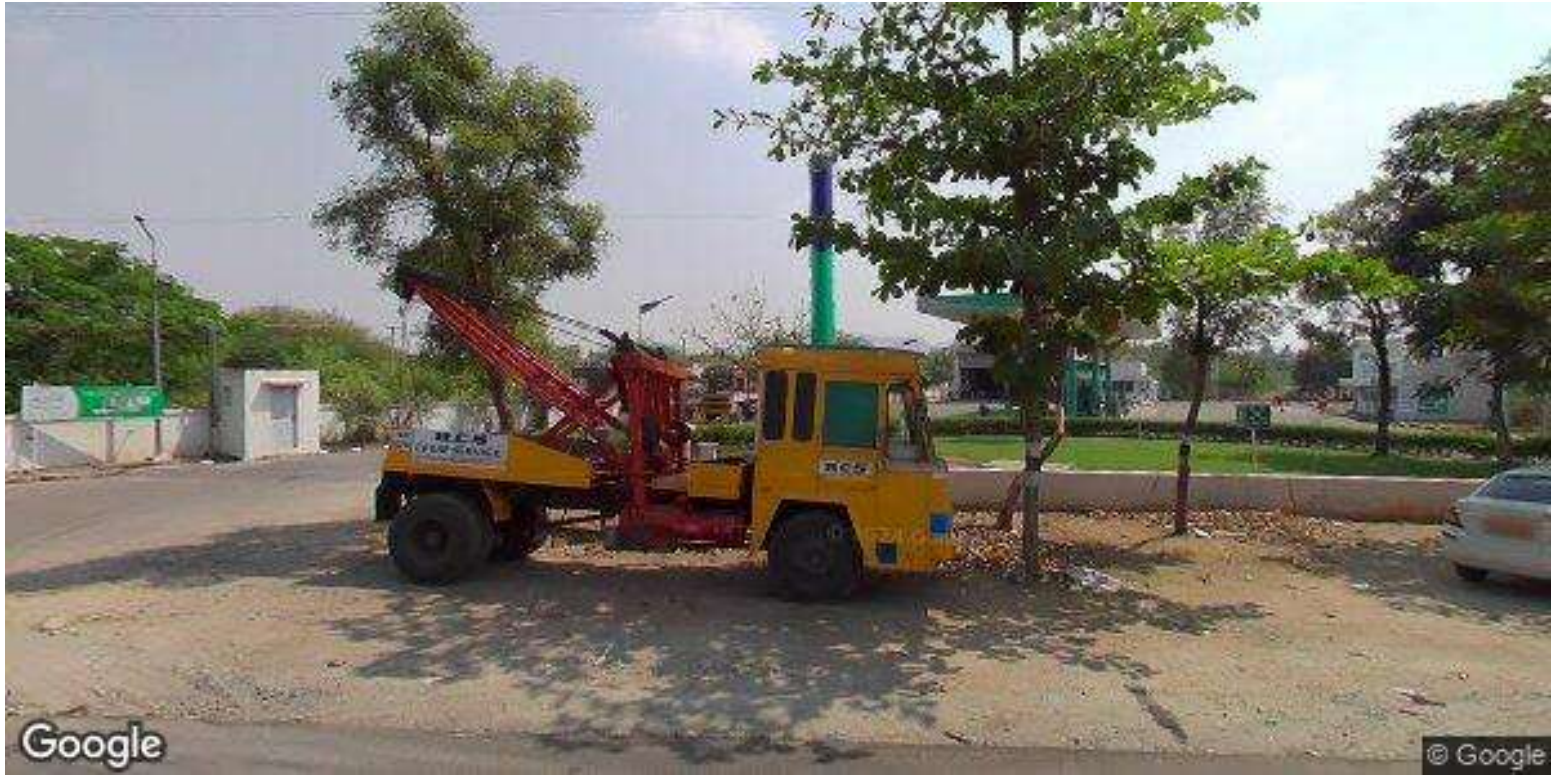
| | Risk Type | Risk Level | Coordinates | Speed Limit |
|---|---|---|---|---|
| 18 | Turn | High | 11.20730, 78.13013 | 15 KM/Hr |

**Risk Type:** Turn  
**Risk Level:** High  
**Speed Limit:** 15 KM/Hr  
**Coordinates:** 11.20730, 78.13013

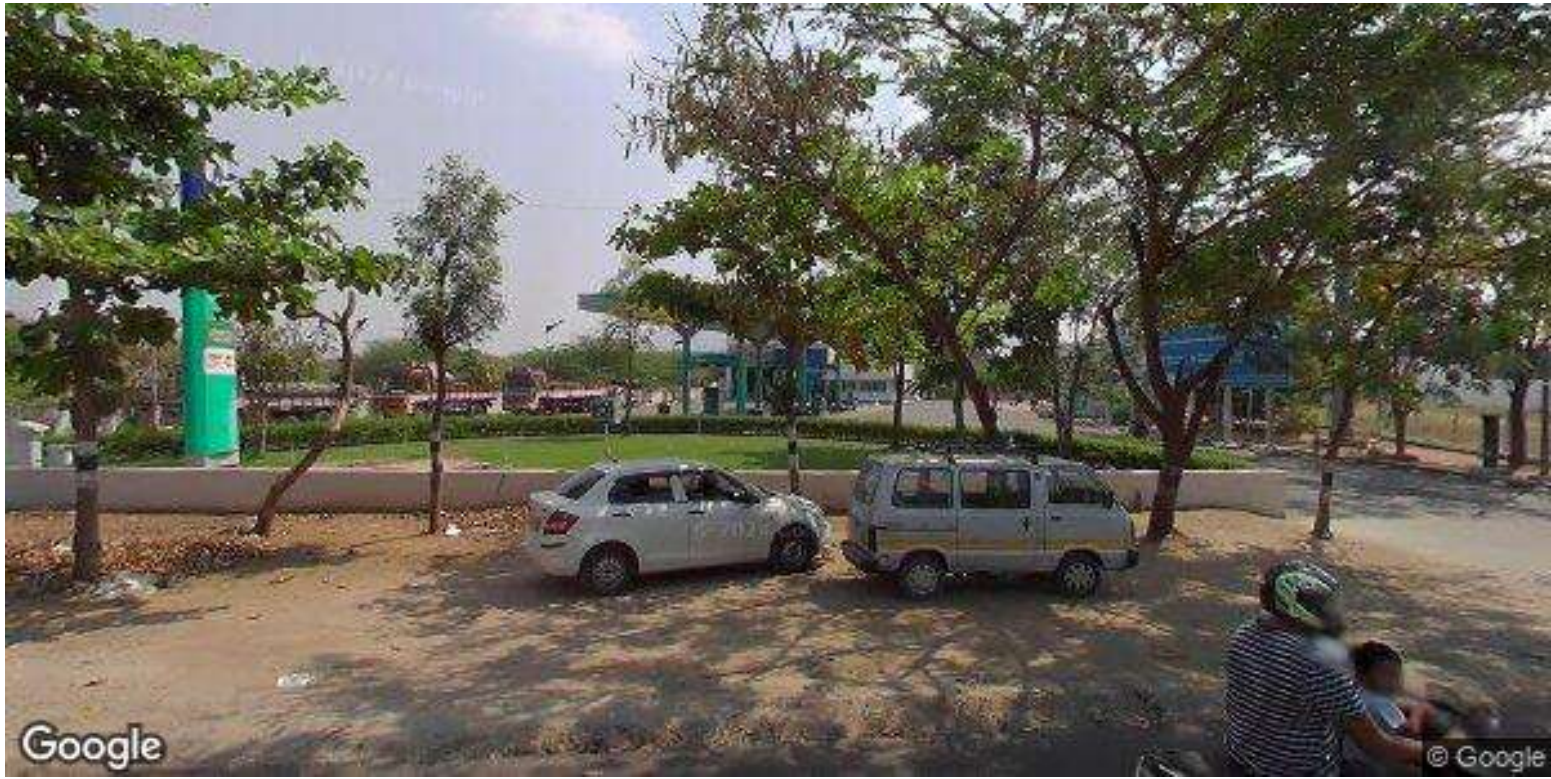
**Coordinates:** 11.20721, 78.13001

| | Risk Type | Risk Level | Coordinates | Speed Limit |
|---|---|---|---|---|
| 19 | Turn | High | 11.20721, 78.13001 | 15 KM/Hr |

**Risk Type:** Turn

**Risk Level:** High

**Speed Limit:** 15 KM/Hr
