# IndianOil

## JOURNEY RISK MANAGEMENT (JRM) STUDY

### Salem Terminal TO S S N AGENCIES

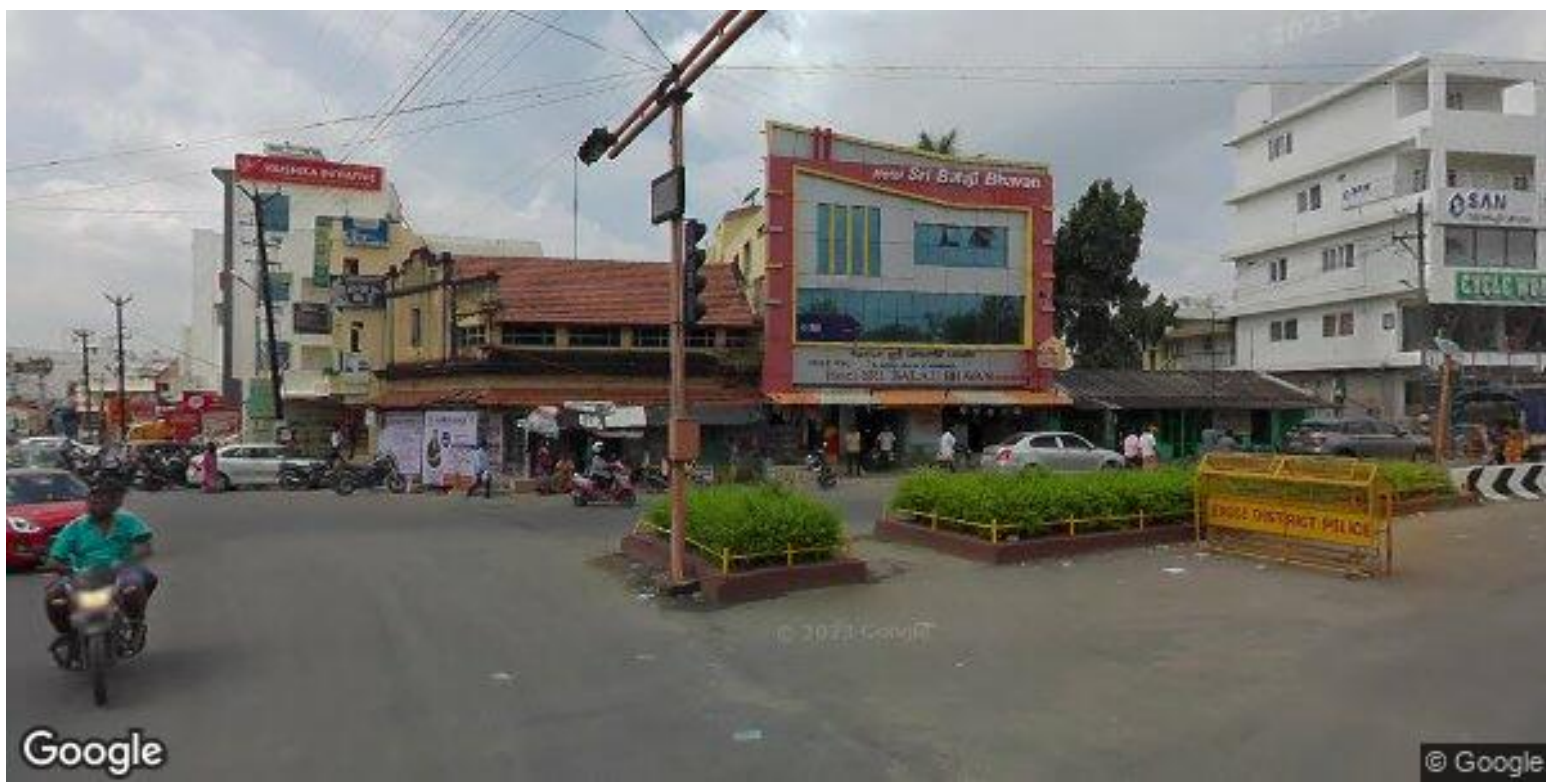
**Coordinates:** 11.27925, 77.58494

**Risk Type:** Roundabout

**Risk Level:** High

**Speed Limit:** 15 KM/Hr

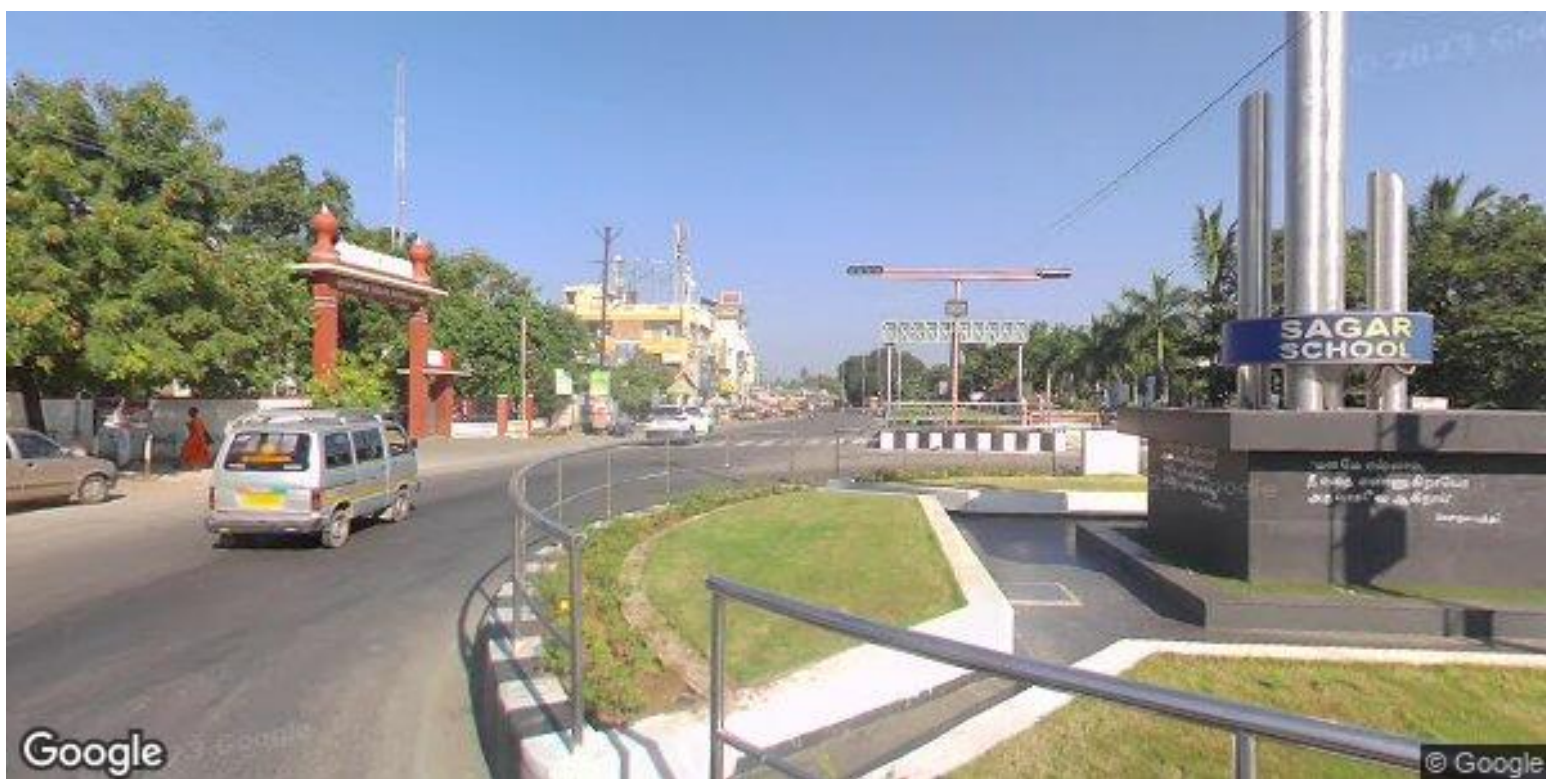
**Coordinates:** 11.27732, 77.58658

**Risk Type:** Roundabout

**Risk Level:** High

**Speed Limit:** 15 KM/Hr

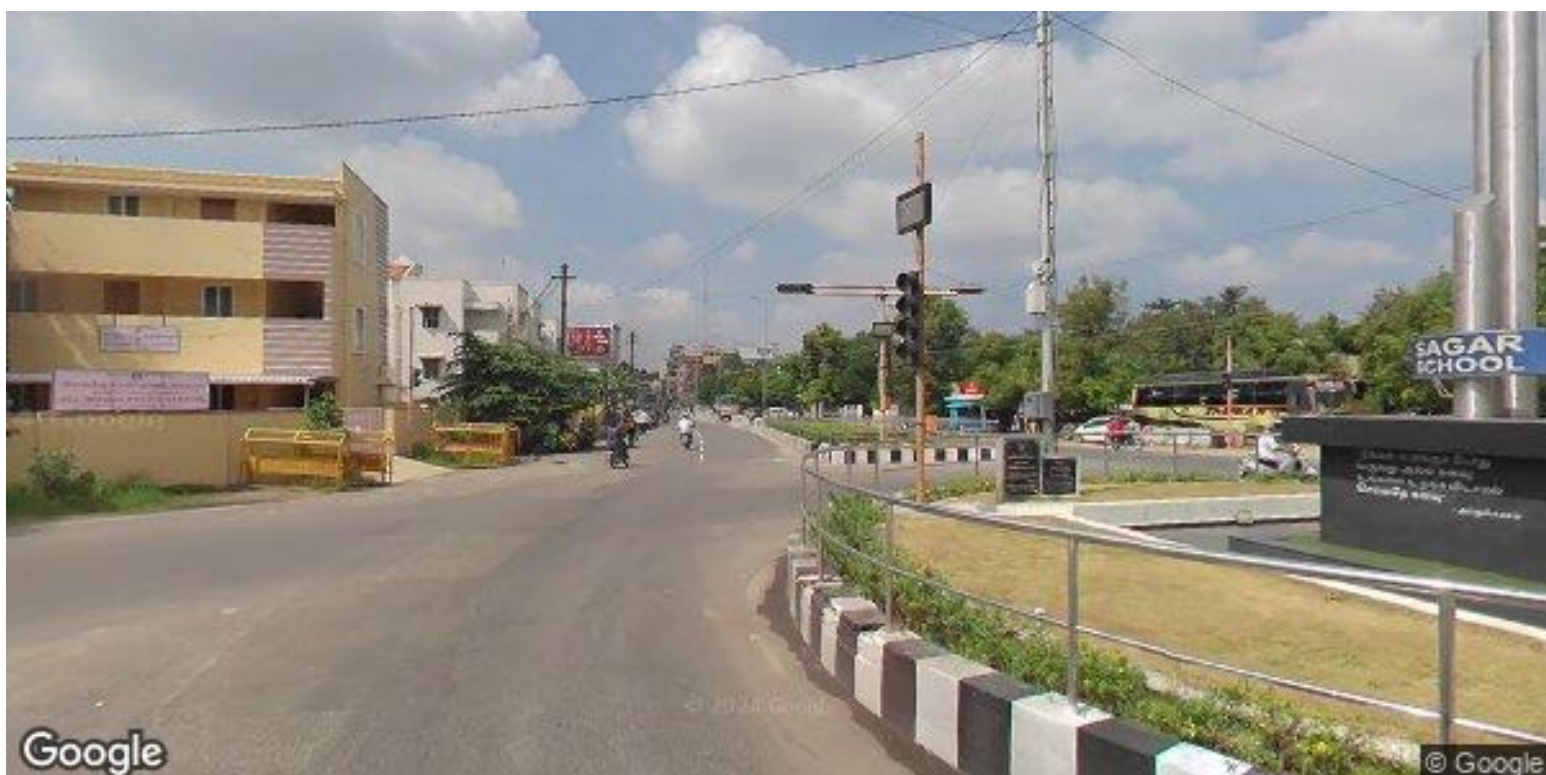
**Risk Type:** Roundabout  
**Risk Level:** High  
**Speed Limit:** 15 KM/Hr  
**Coordinates:** 11.27718, 77.58674

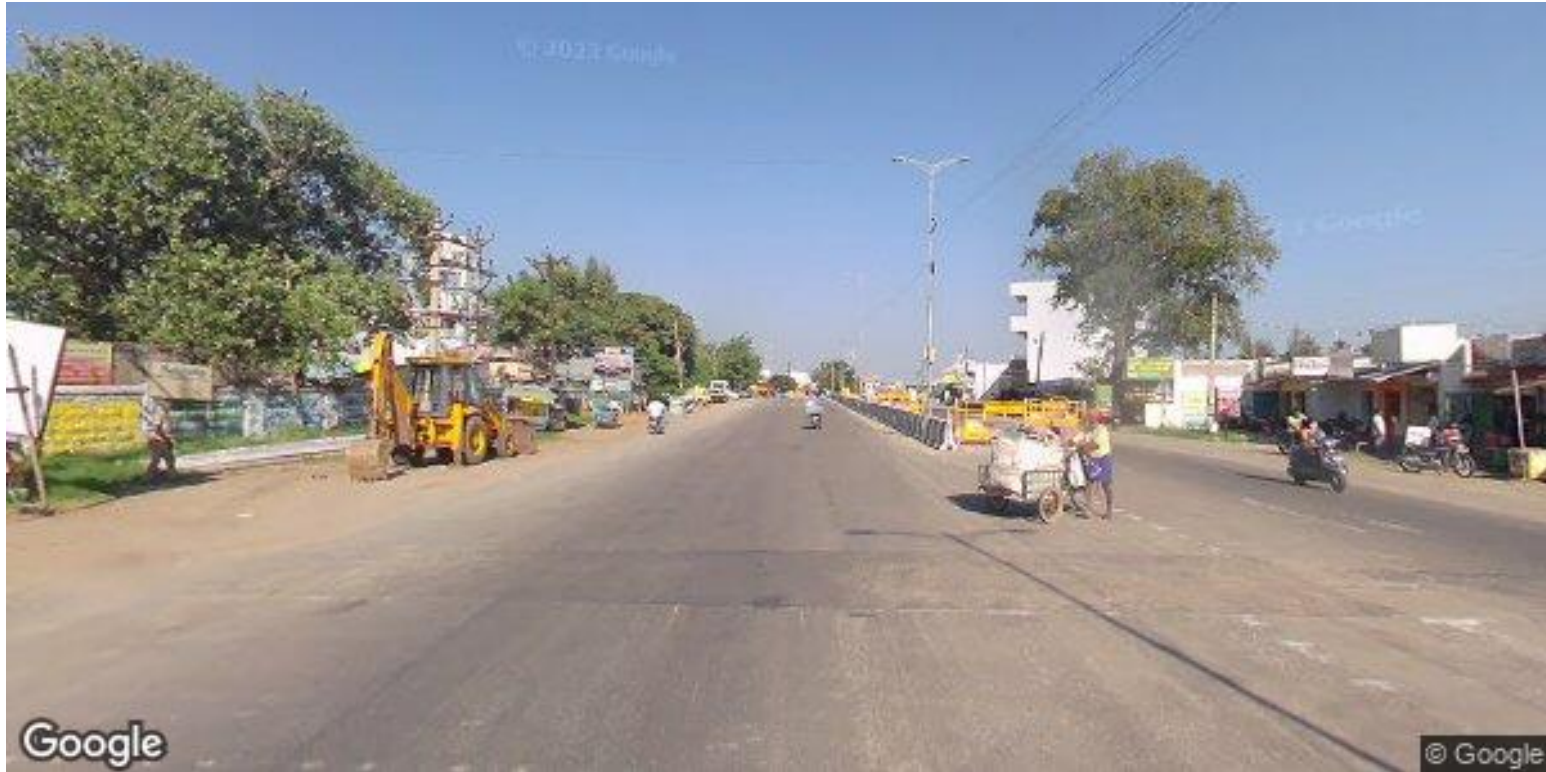
**Risk Type:** U-Turn  
**Risk Level:** High  
**Speed Limit:** 10 KM/Hr  
**Coordinates:** 11.278222, 77.5896496

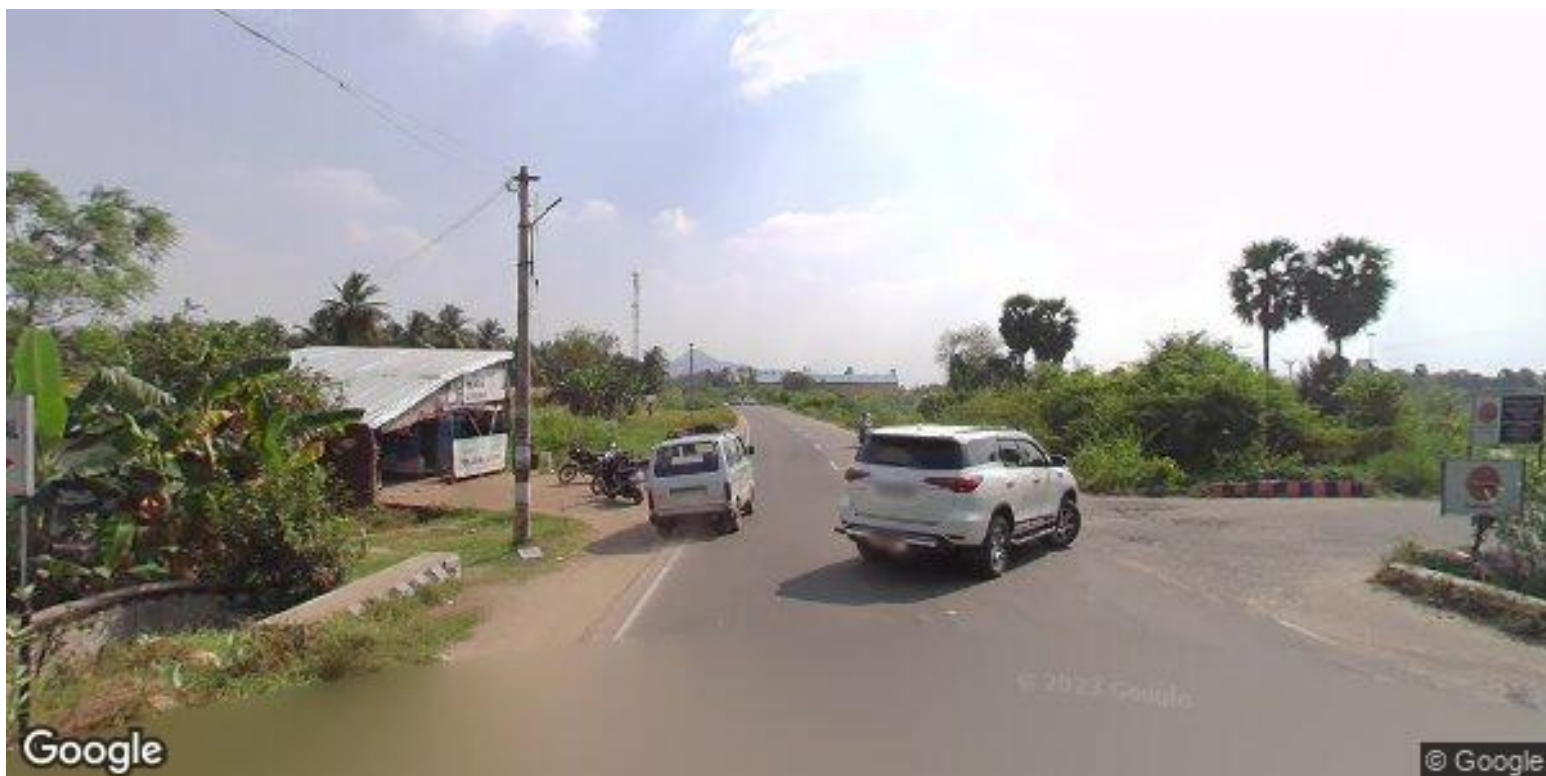
**Risk Type:** Turn  
**Risk Level:** High  
**Speed Limit:** 15 KM/Hr  
**Coordinates:** 11.44029, 77.87544

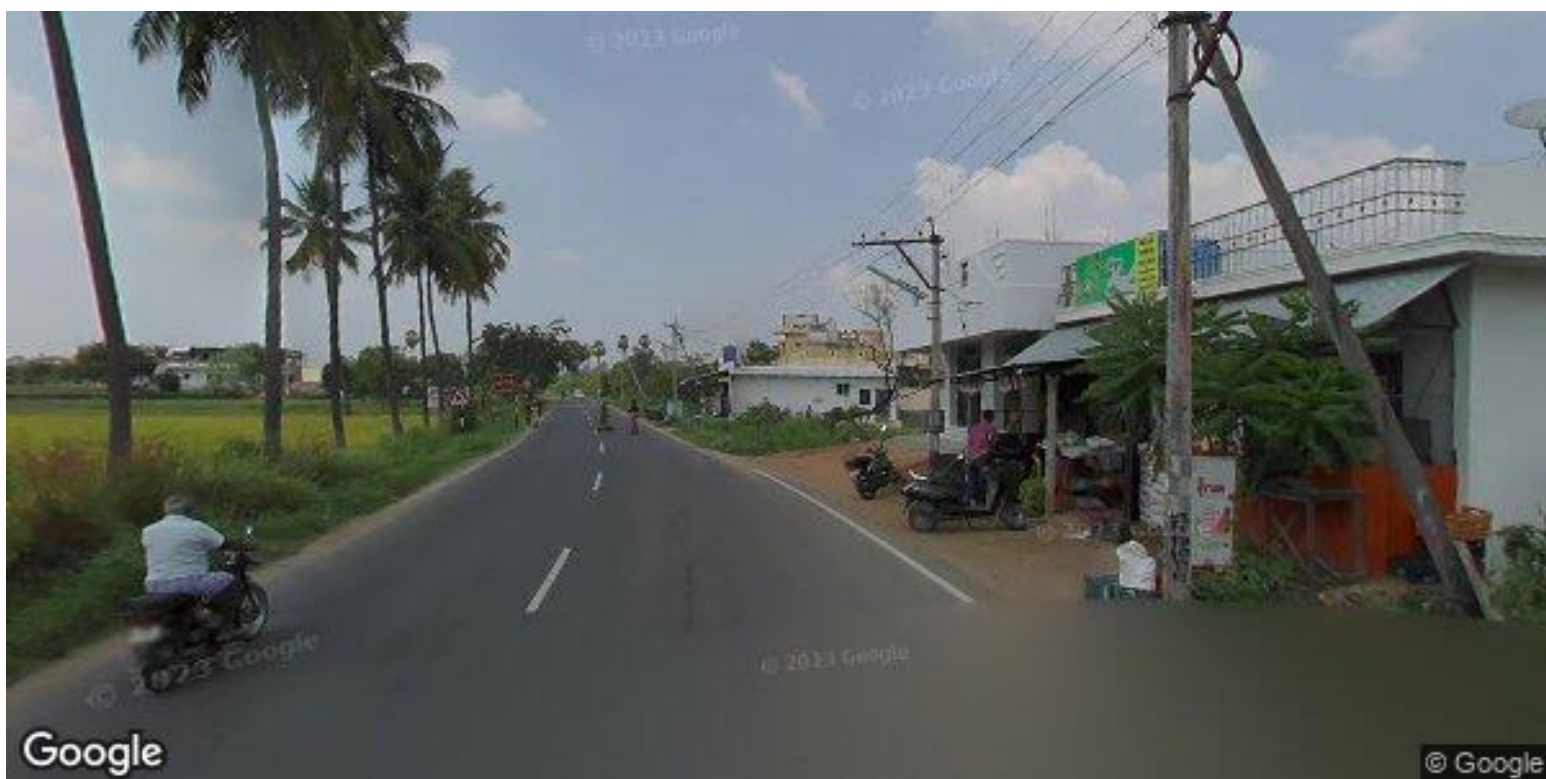
**Coordinates:** 11.45127, 77.86734

**Risk Type:** Turn

**Risk Level:** Medium

**Speed Limit:** 30 KM/Hr

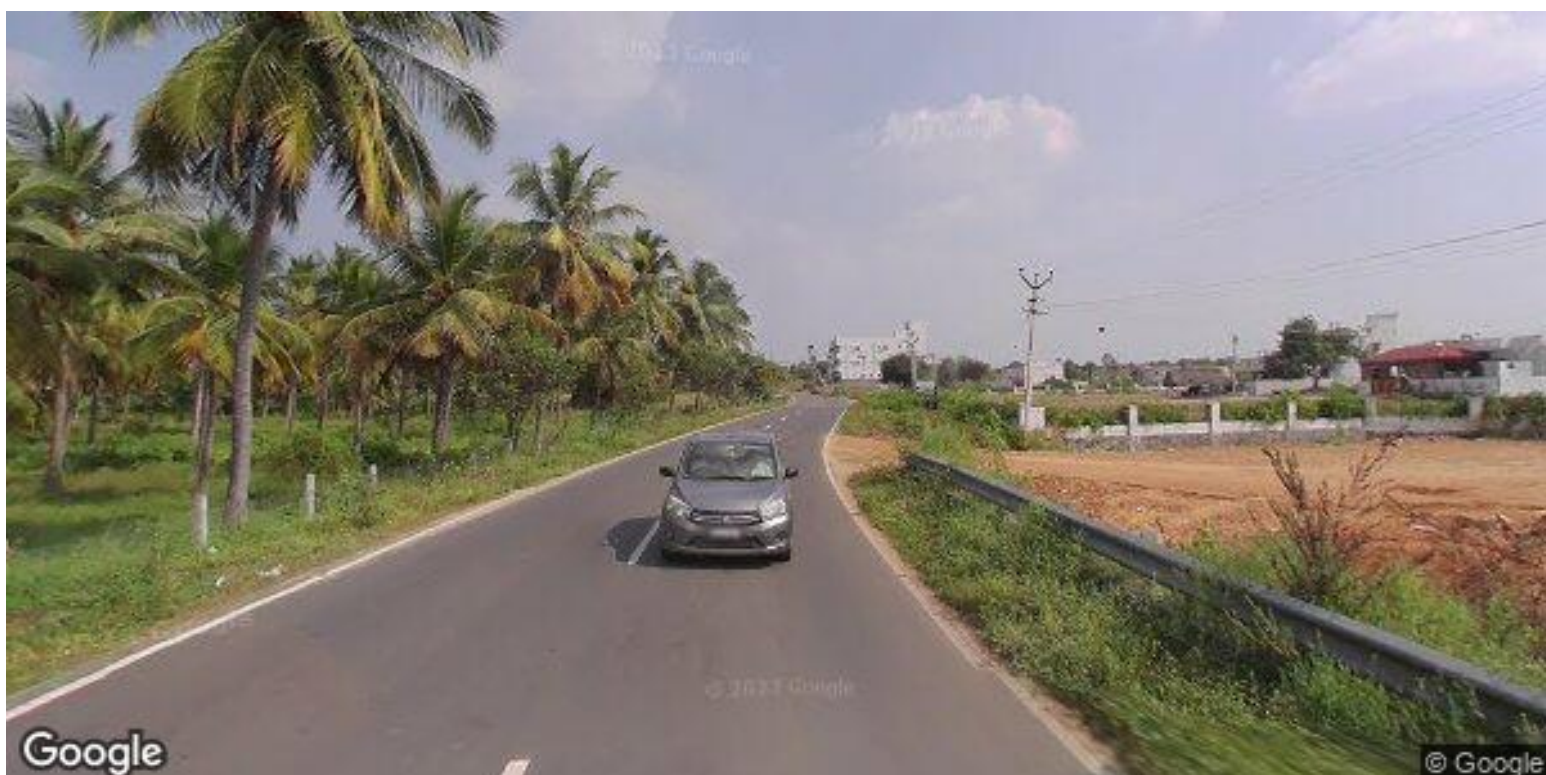
**Coordinates:** 11.45354, 77.85798

**Risk Type:** Turn

**Risk Level:** Medium

**Speed Limit:** 30 KM/Hr

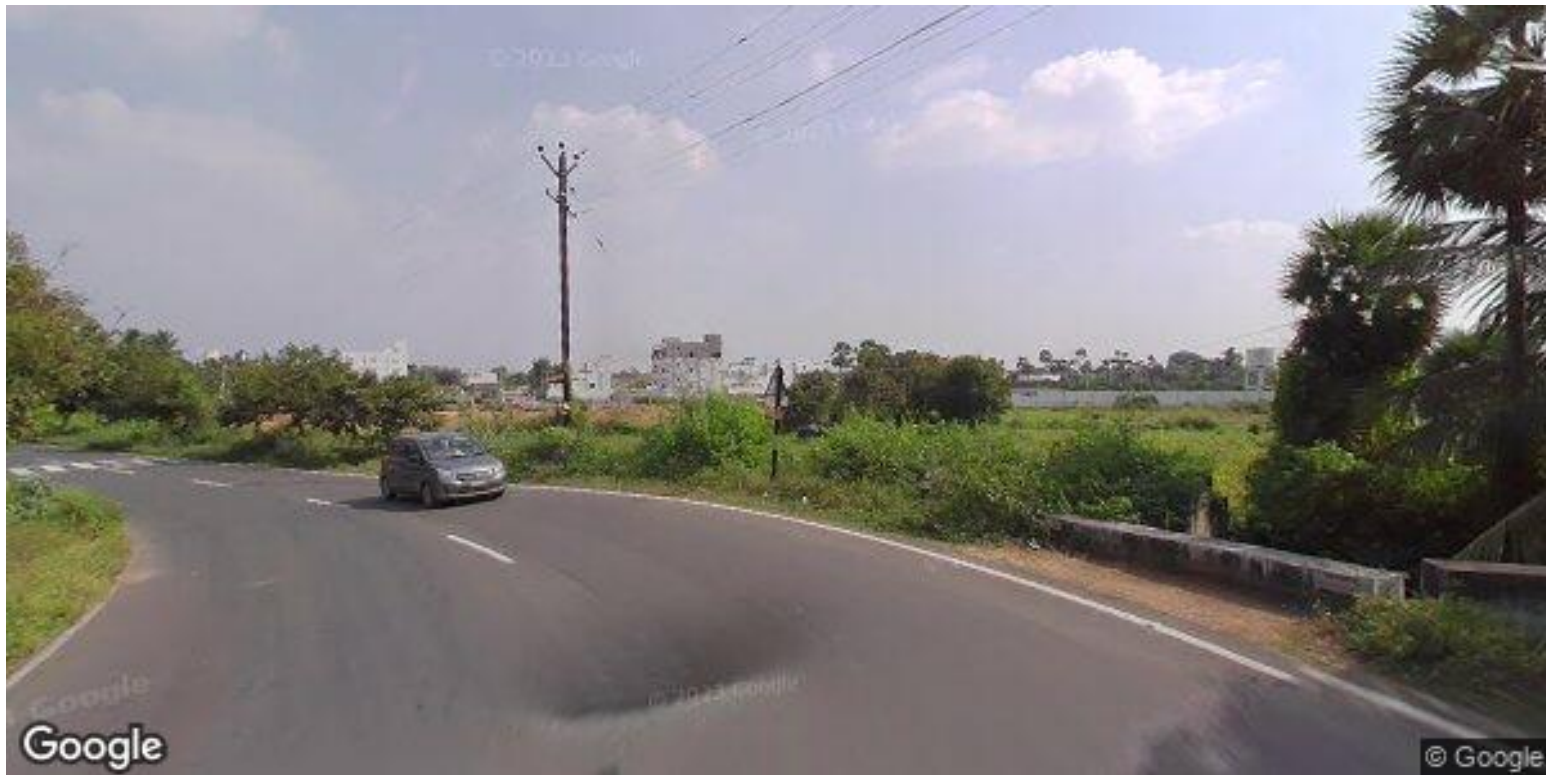
**Coordinates:** 11.45350, 77.85700

**Risk Type:** Turn

**Risk Level:** High

**Speed Limit:** 15 KM/Hr

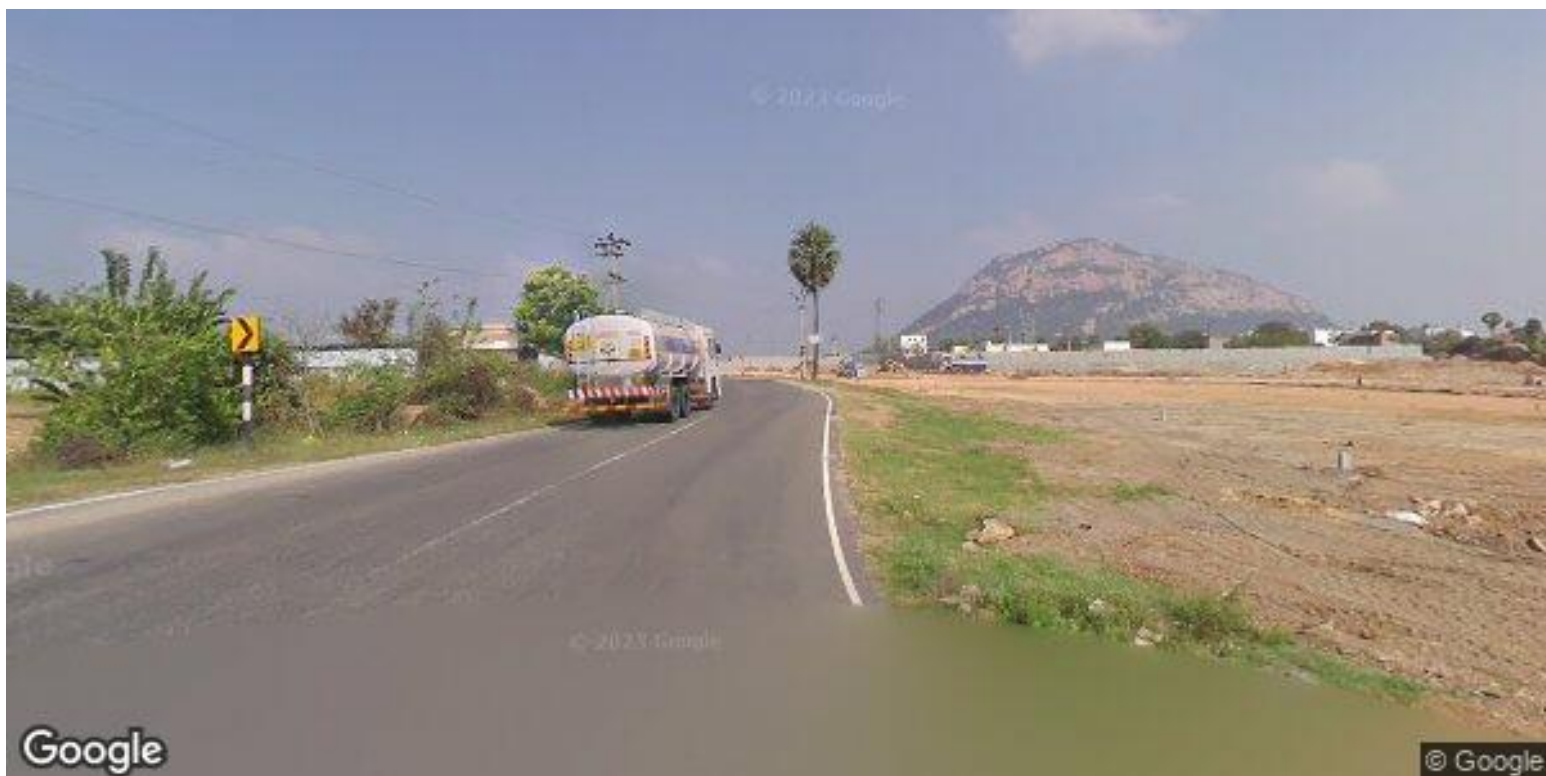
**Coordinates:** 11.45845, 77.85141

**Risk Type:** Turn

**Risk Level:** Medium

**Speed Limit:** 30 KM/Hr

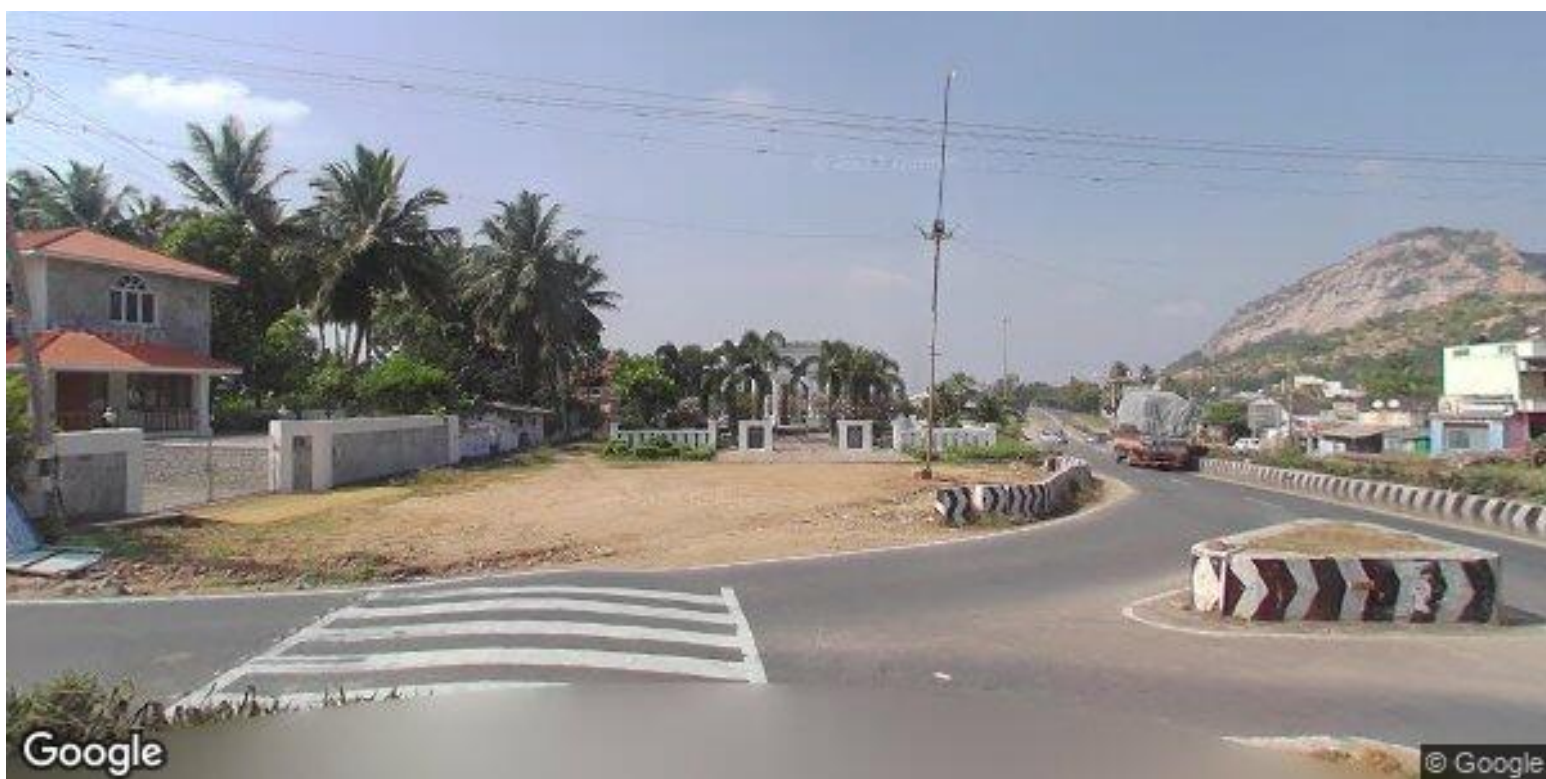
**Coordinates:** 11.46311, 77.84934

**Risk Type:** Turn

**Risk Level:** Medium

**Speed Limit:** 30 KM/Hr

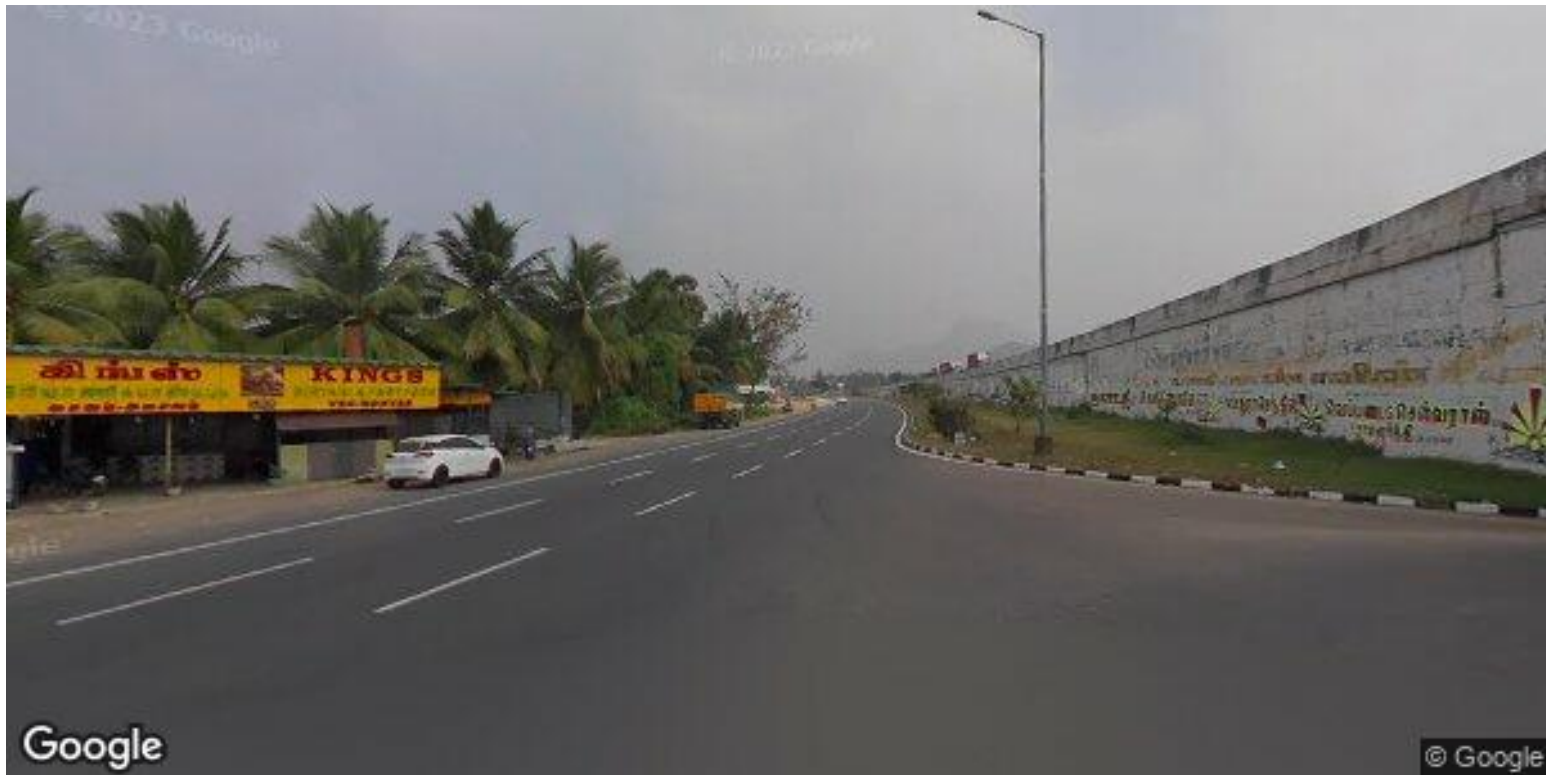
**Coordinates:** 11.45634, 77.81673

**Risk Type:** Blind Spot

**Risk Level:** Blind Spot

**Speed Limit:** 10 KM/Hr

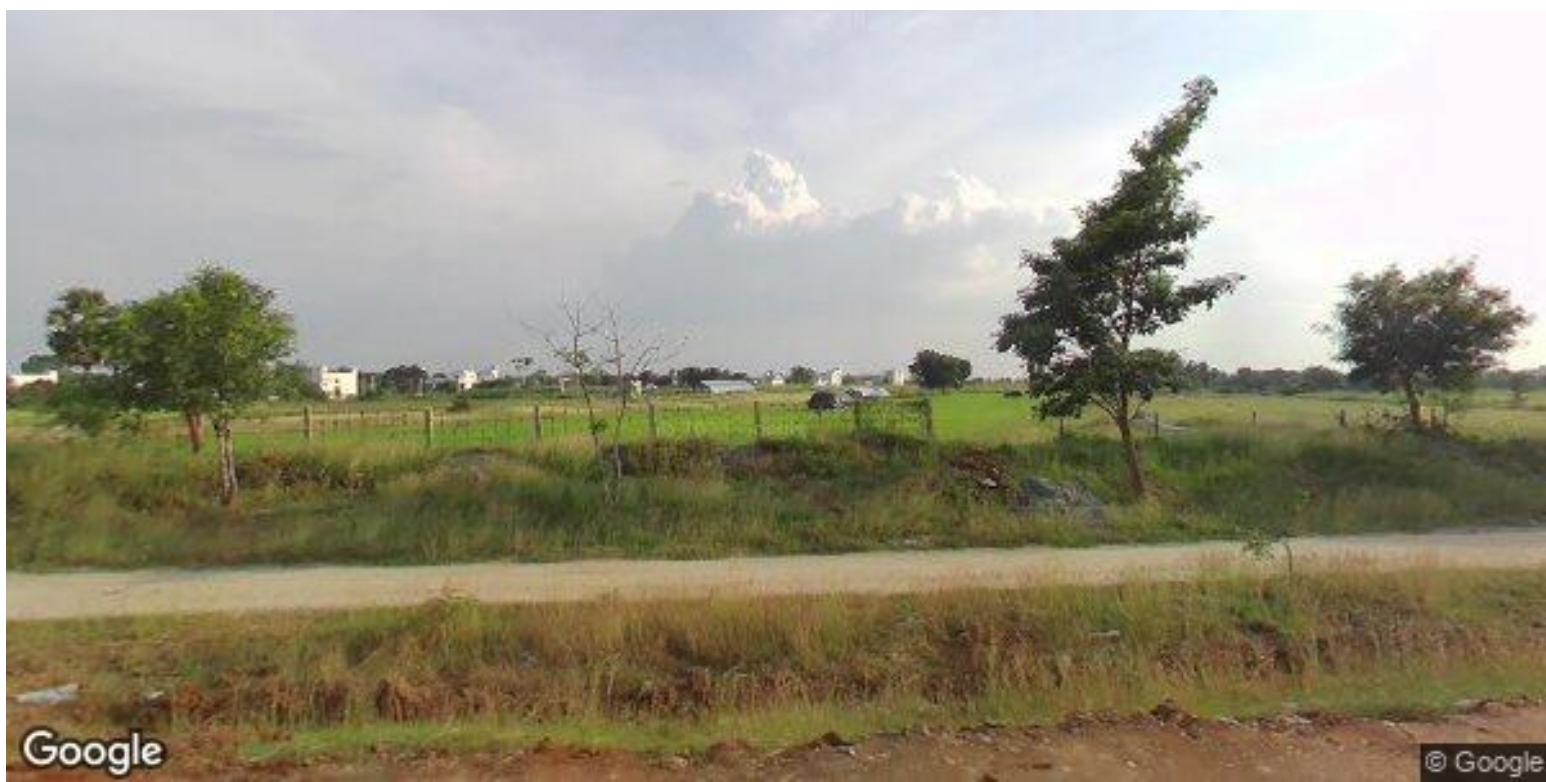
**Coordinates:** 11.29288, 77.59030

**Risk Type:** Turn

**Risk Level:** Medium

**Speed Limit:** 30 KM/Hr

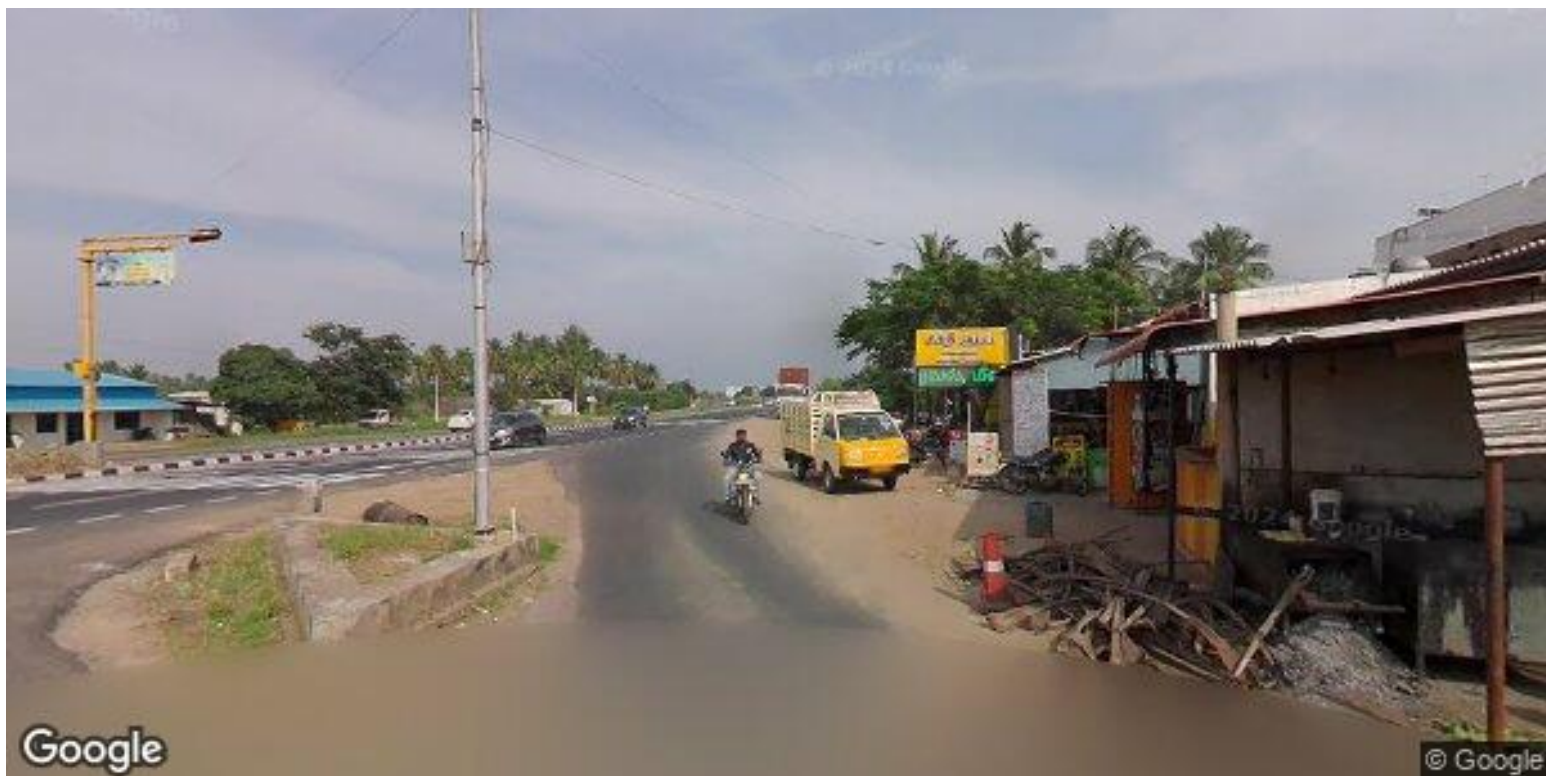
**Coordinates:** 11.29164, 77.58609

**Risk Type:** Turn

**Risk Level:** High

**Speed Limit:** 15 KM/Hr

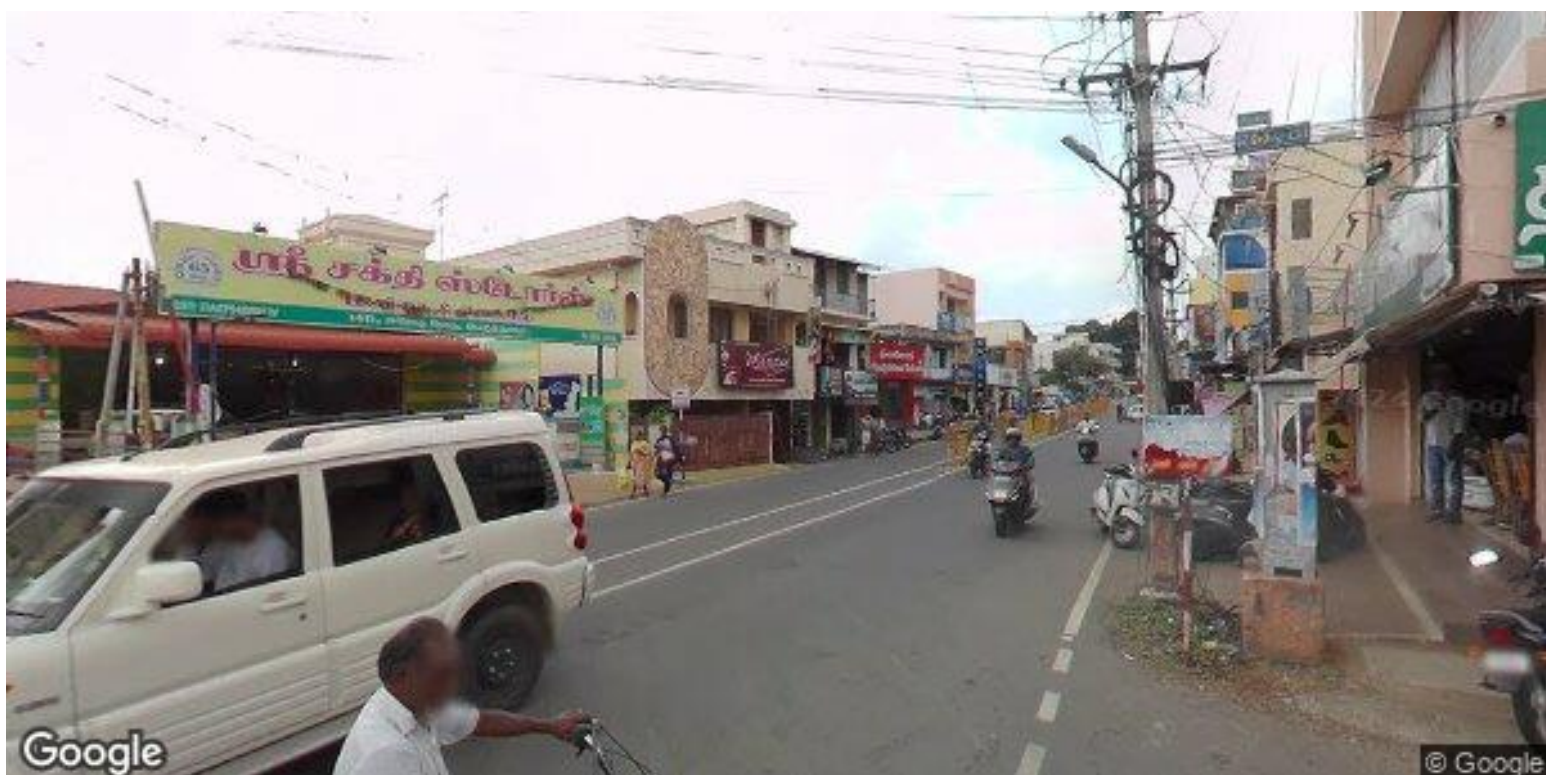
**Risk Type:** Blind Spot  
**Risk Level:** Blind Spot  
**Speed Limit:** 10 KM/Hr  
**Coordinates:** 11.27735, 77.58485

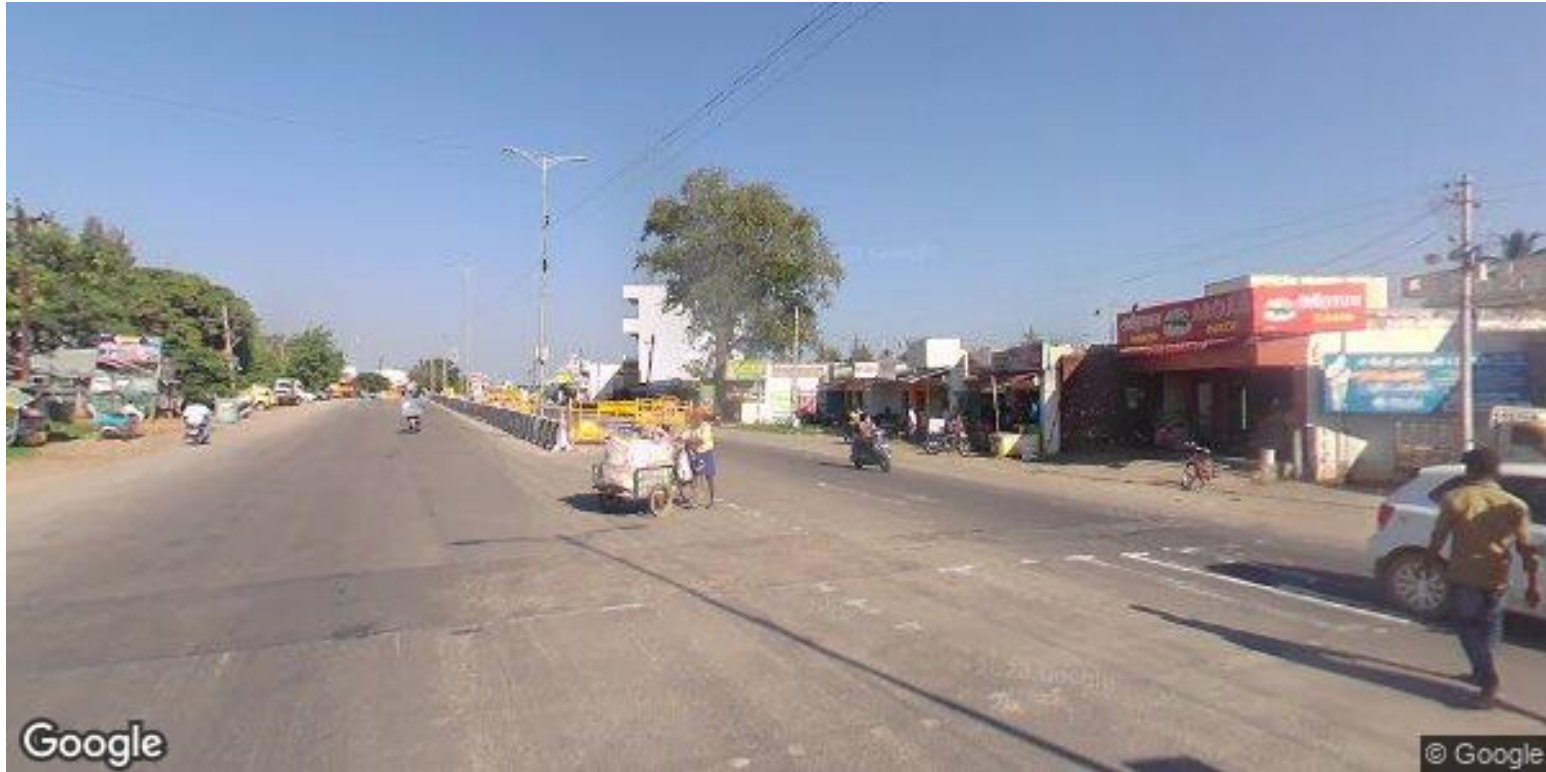
**Risk Type:** Blind Spot  
**Risk Level:** Blind Spot  
**Speed Limit:** 10 KM/Hr  
**Coordinates:** 11.27822, 77.58965

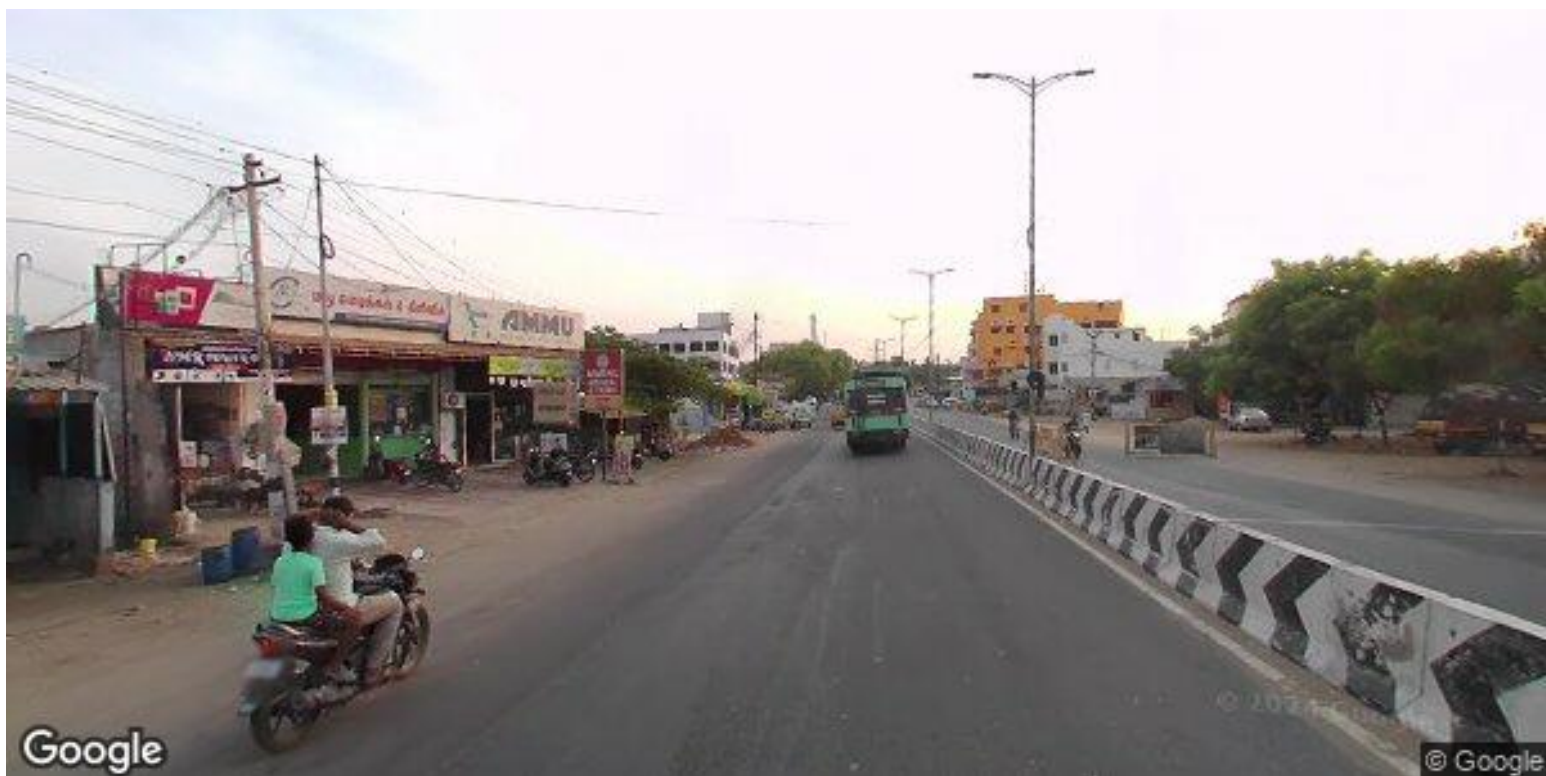
**Risk Type:** Turn  
**Risk Level:** Medium  
**Speed Limit:** 30 KM/Hr  
**Coordinates:** 11.27811, 77.58960

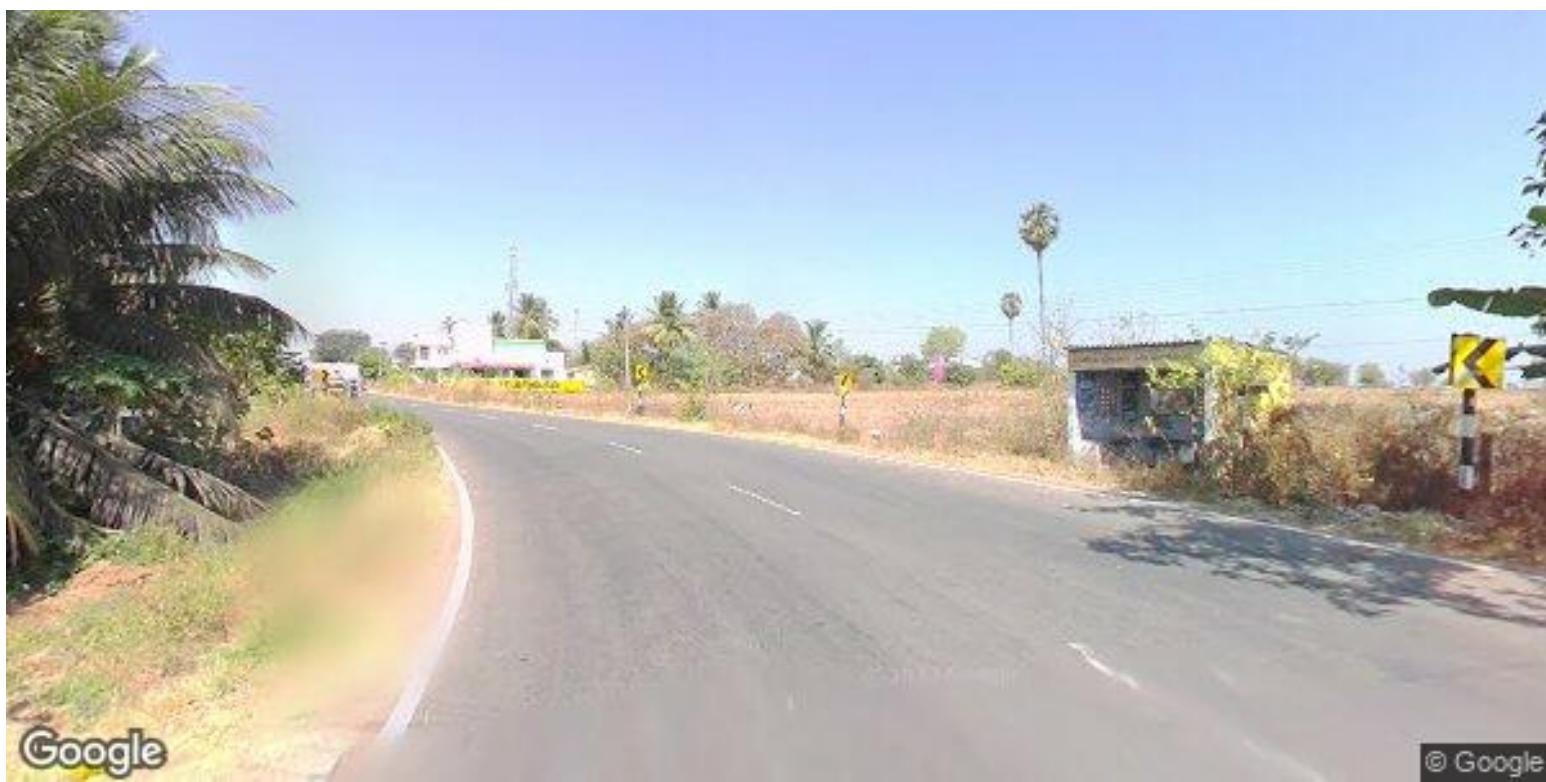
**Coordinates:** 11.29283, 77.53812

**Risk Type:** Turn

**Risk Level:** Medium

**Speed Limit:** 30 KM/Hr

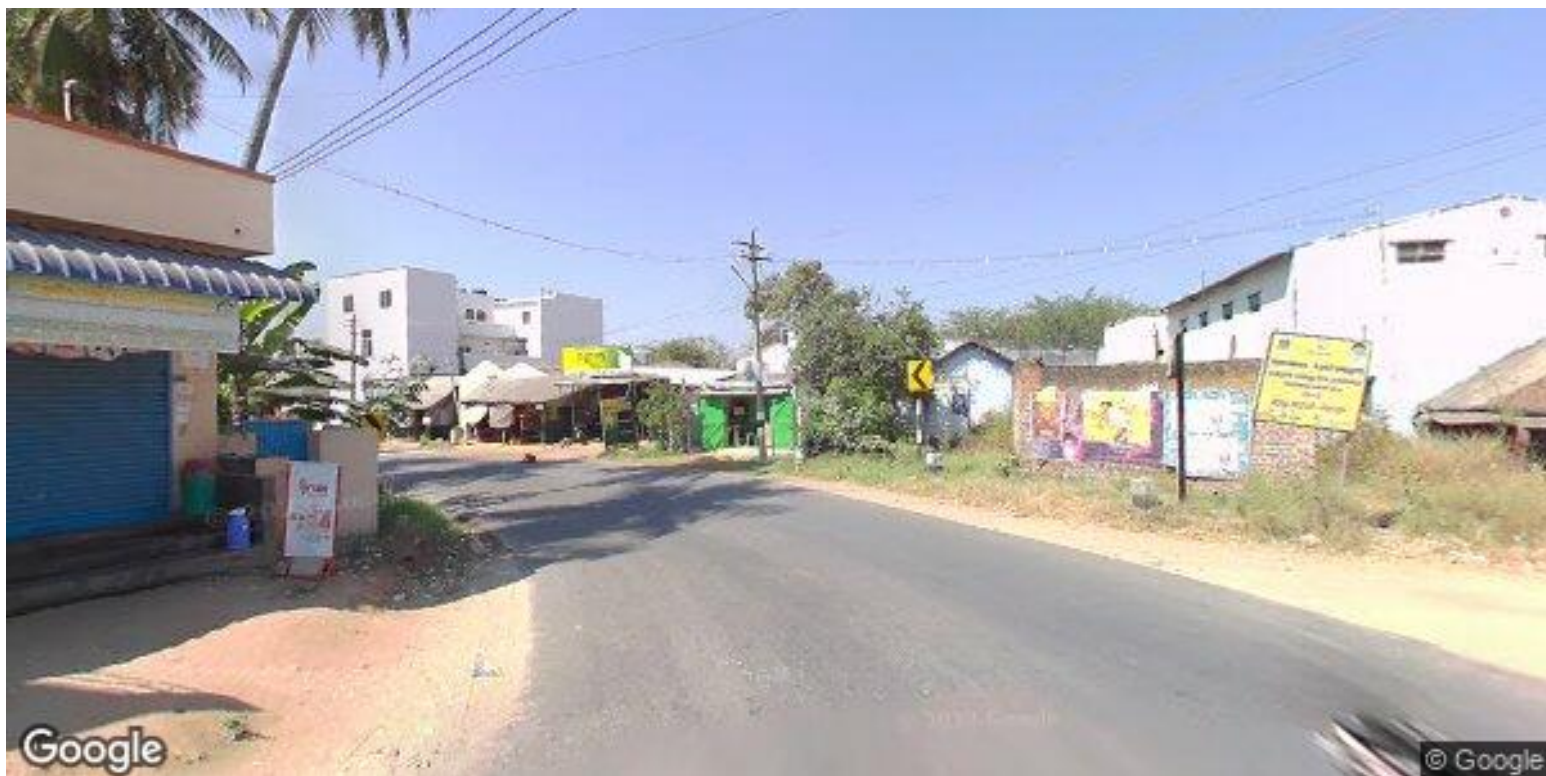
**Coordinates:** 11.29250, 77.53034

**Risk Type:** Turn

**Risk Level:** Medium

**Speed Limit:** 30 KM/Hr

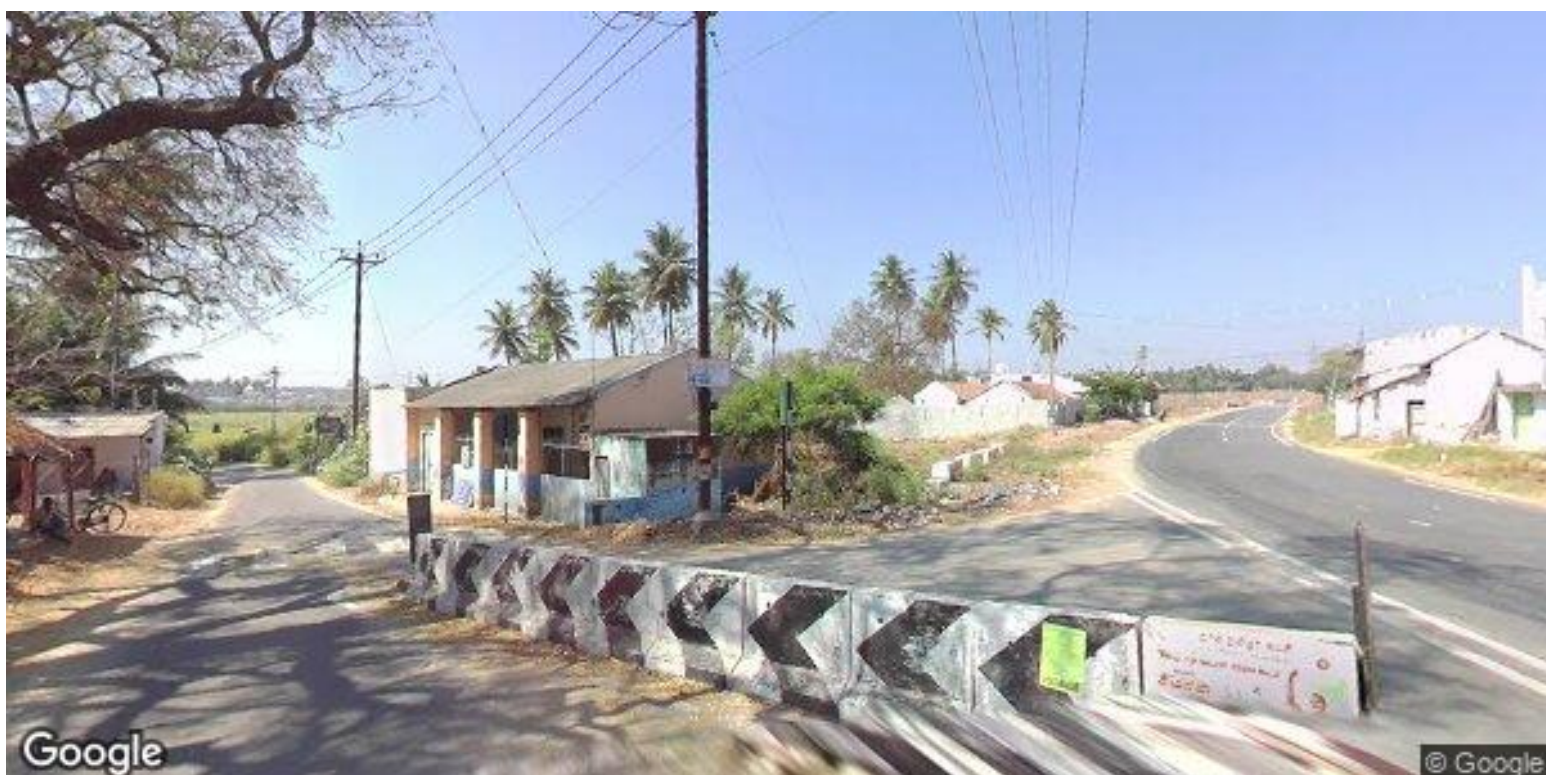
**Coordinates:** 11.29190, 77.52987

**Risk Type:** Turn

**Risk Level:** Medium

**Speed Limit:** 30 KM/Hr
