# IndianOil

## JOURNEY RISK MANAGEMENT (JRM) STUDY

### Salem Terminal TO S S N AGENCIES

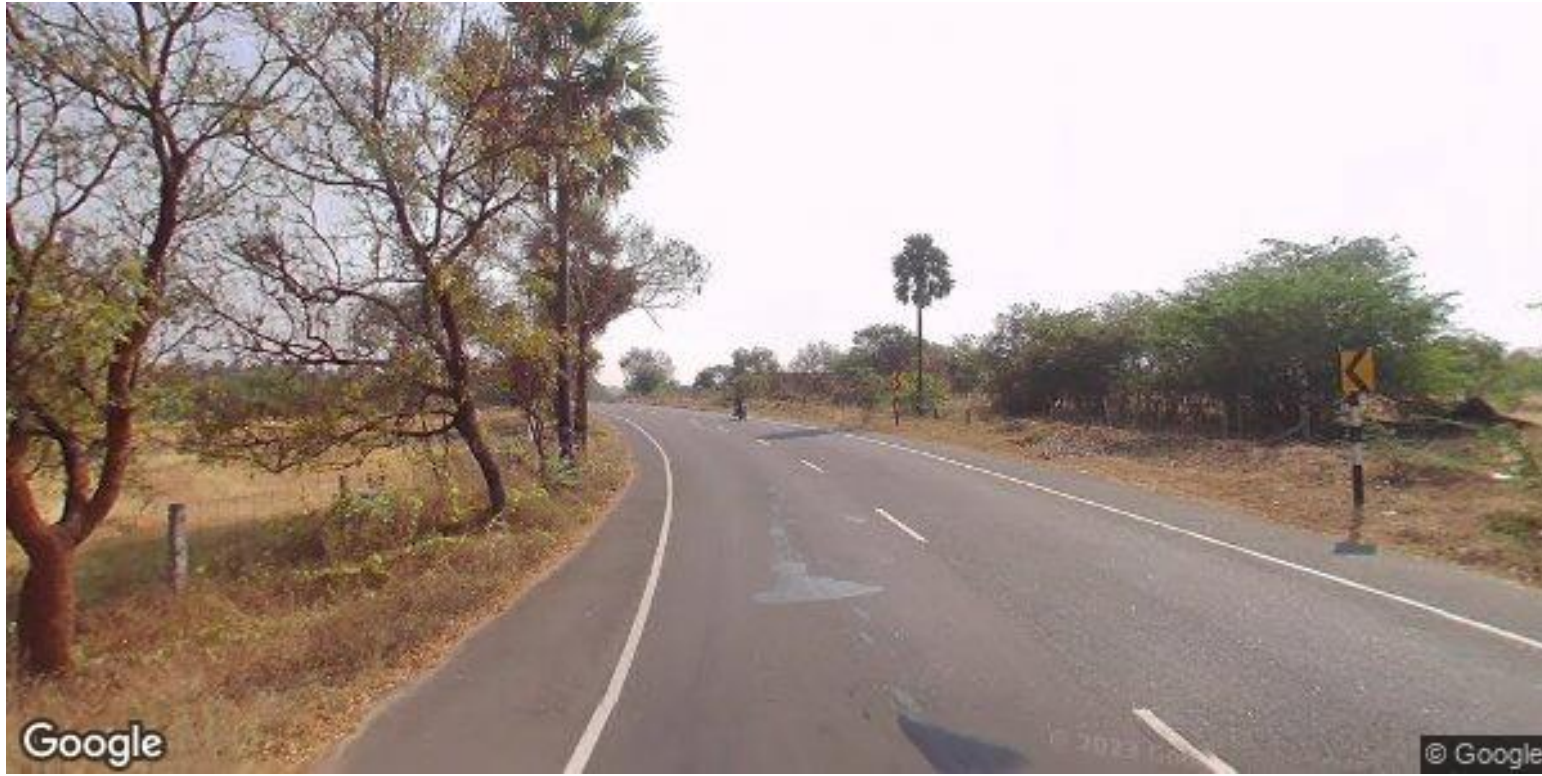
**Coordinates:** 11.28315, 77.48041

**Risk Type:** Turn

**Risk Level:** Medium

**Speed Limit:** 30 KM/Hr
