# IndianOil

## JOURNEY RISK MANAGEMENT (JRM) STUDY

### Salem Terminal to SRI JAYALAKSHMI FUELS

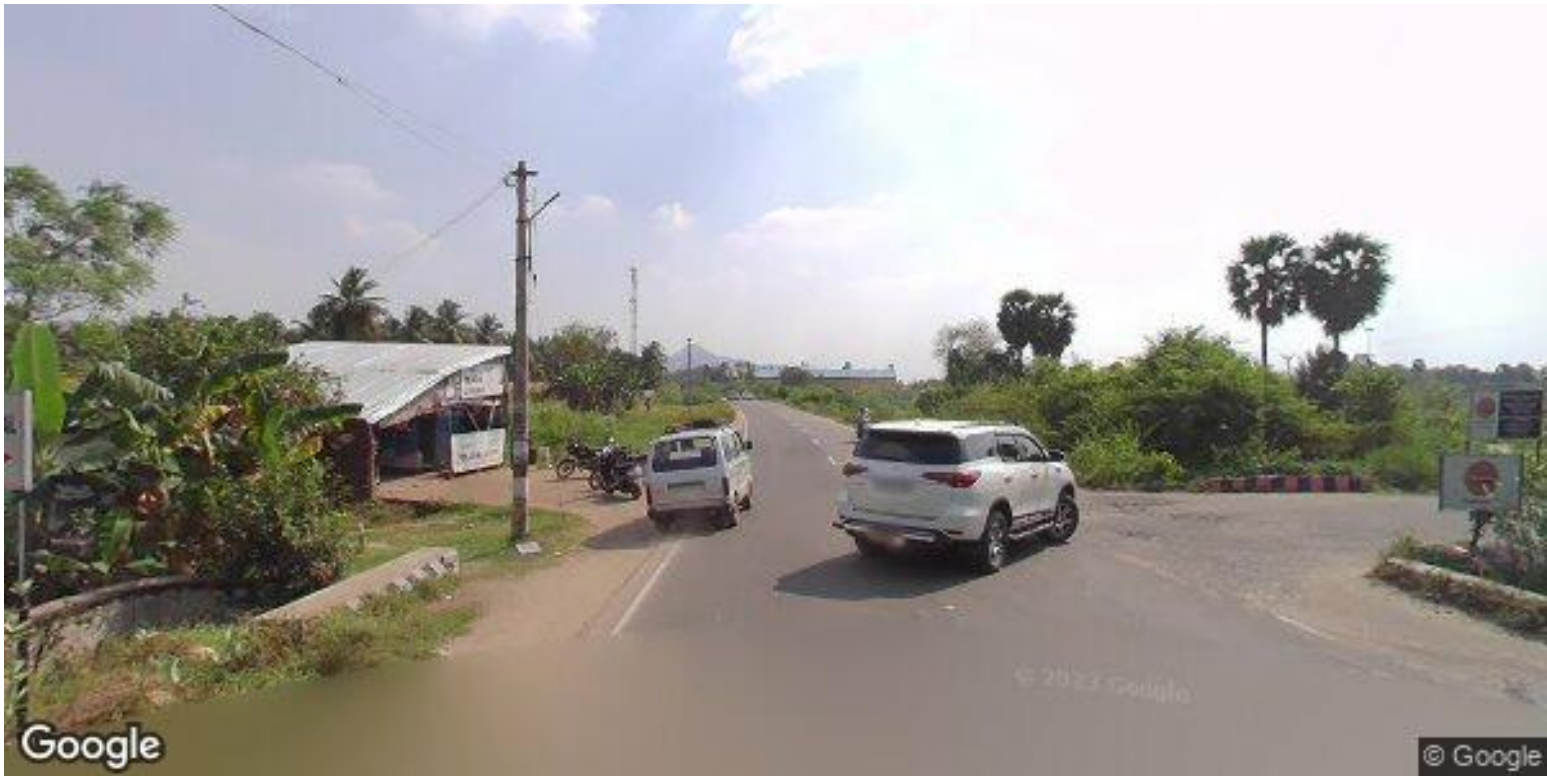
**Risk Type:** Turn  
**Risk Level:** High  
**Speed Limit:** 15 KM/Hr  
**Coordinates:** 11.44029, 77.87544

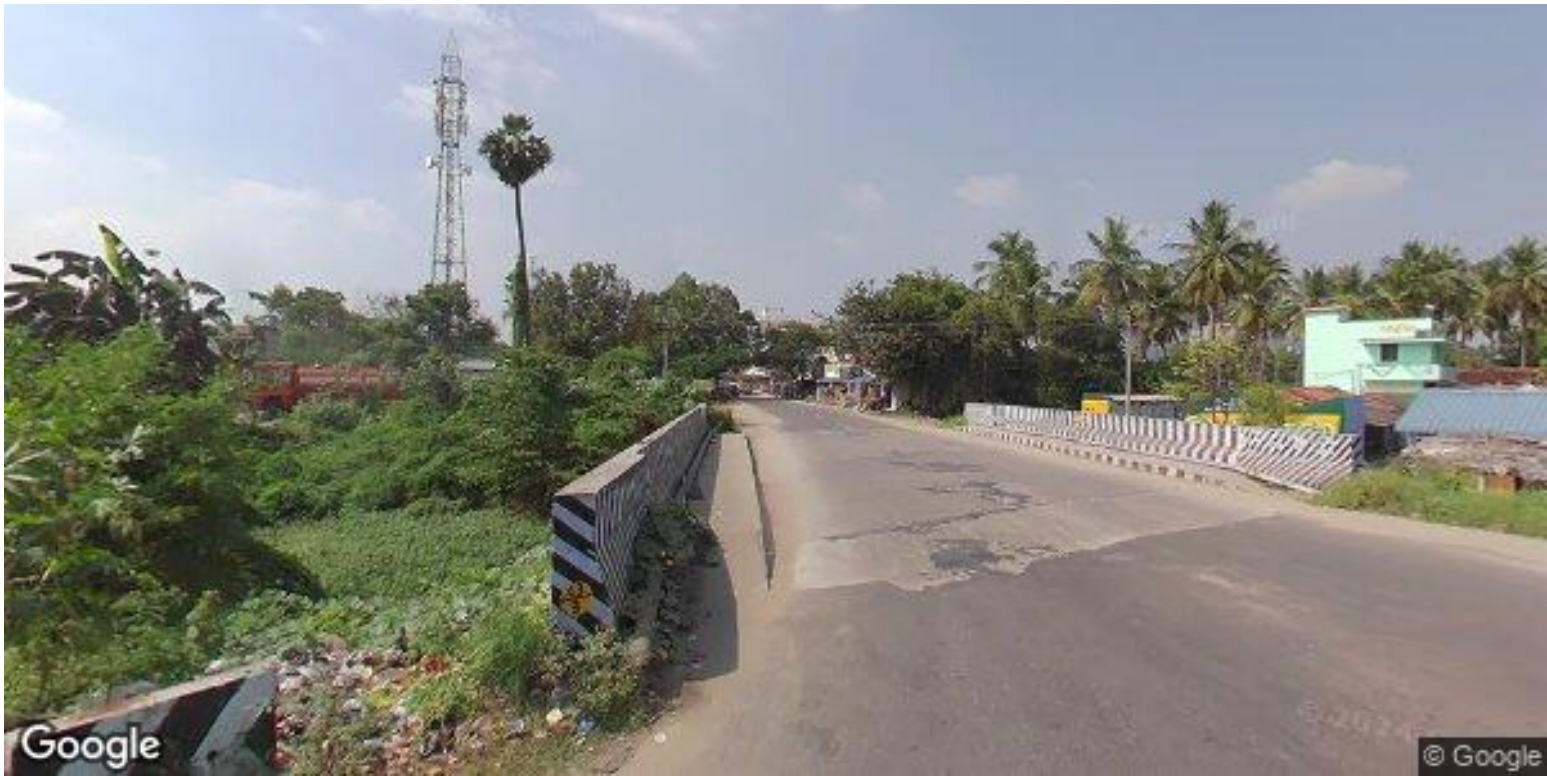
**Risk Type:** Turn  
**Risk Level:** Medium  
**Speed Limit:** 30 KM/Hr  
**Coordinates:** 11.44900, 77.87406

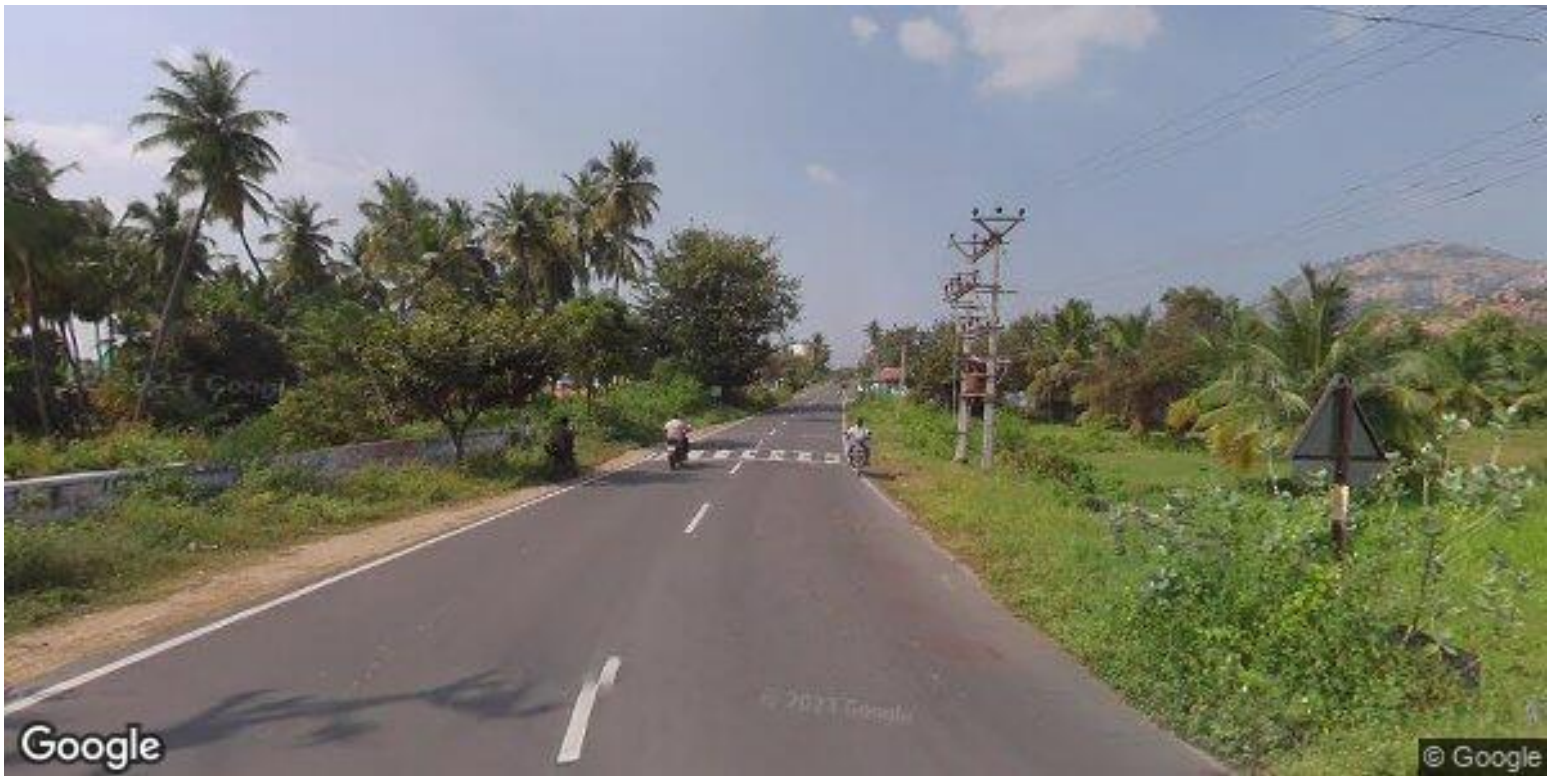
**Risk Type:** Turn  
**Risk Level:** High  
**Speed Limit:** 15 KM/Hr  
**Coordinates:** 11.45352, 77.85698

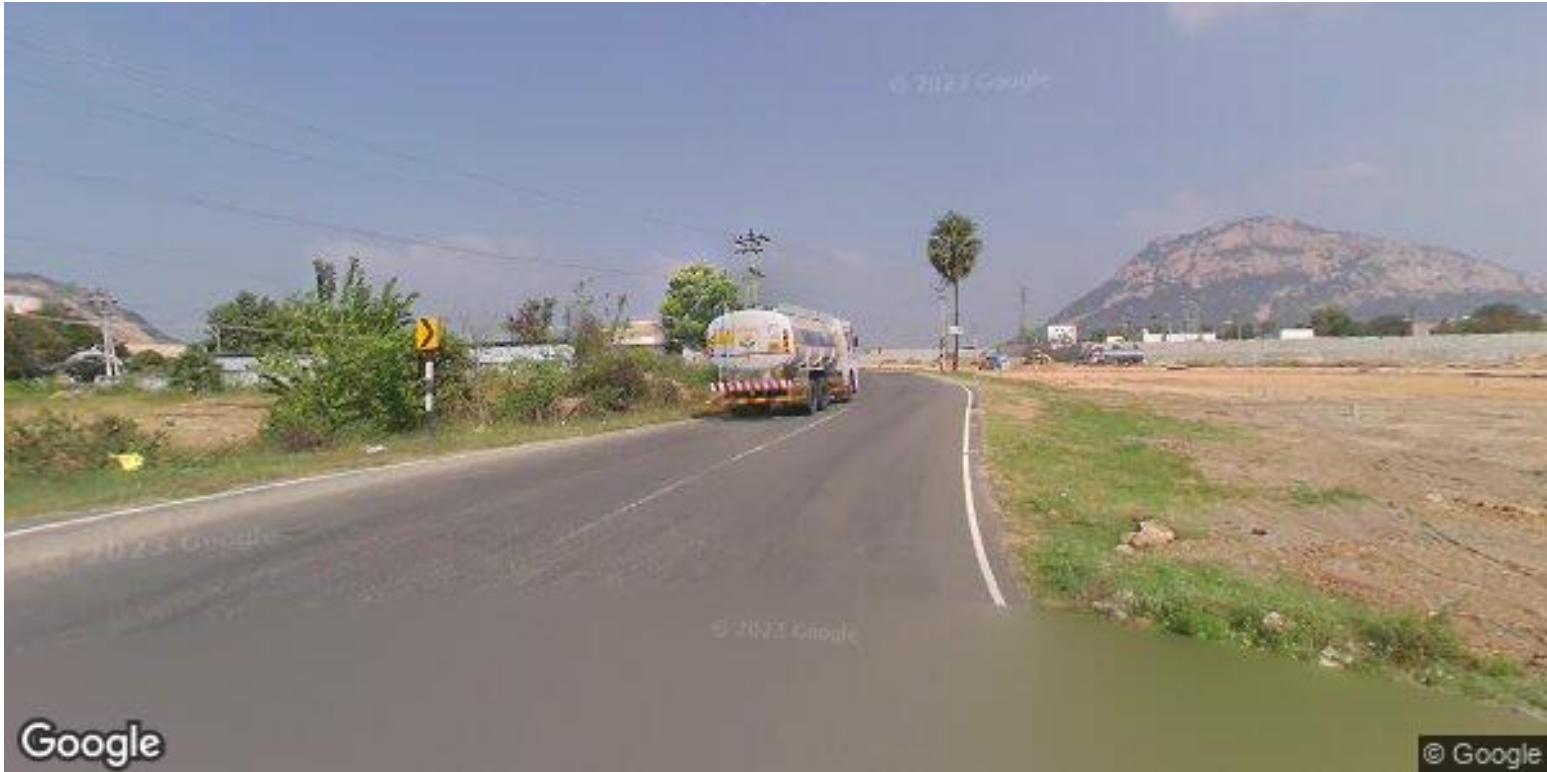
**Risk Type:** Turn  
**Risk Level:** Medium  
**Speed Limit:** 30 KM/Hr  
**Coordinates:** 11.45847, 77.85140

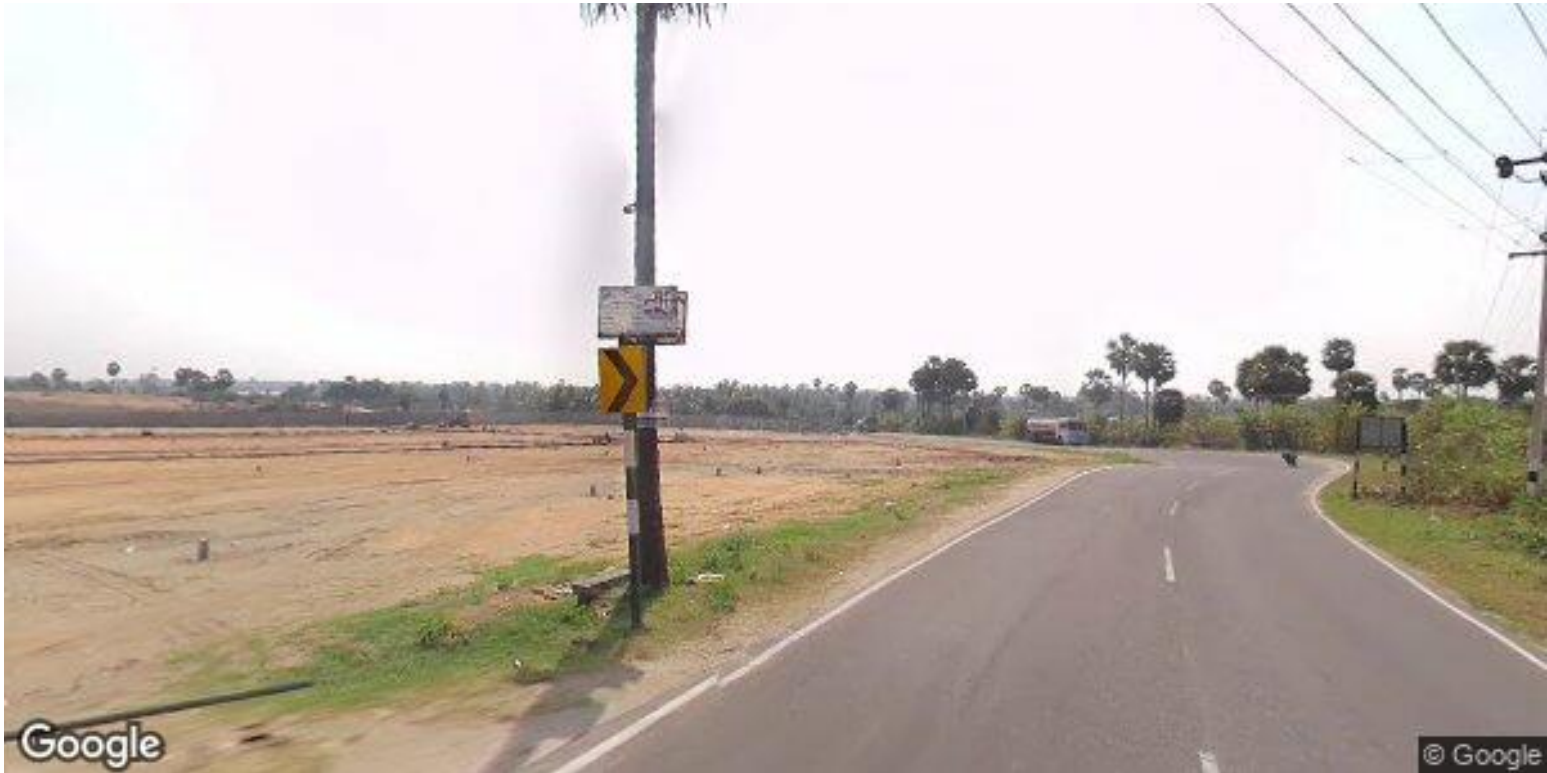
**Risk Type:** Turn  
**Risk Level:** Medium  
**Speed Limit:** 30 KM/Hr  
**Coordinates:** 11.45898, 77.85135

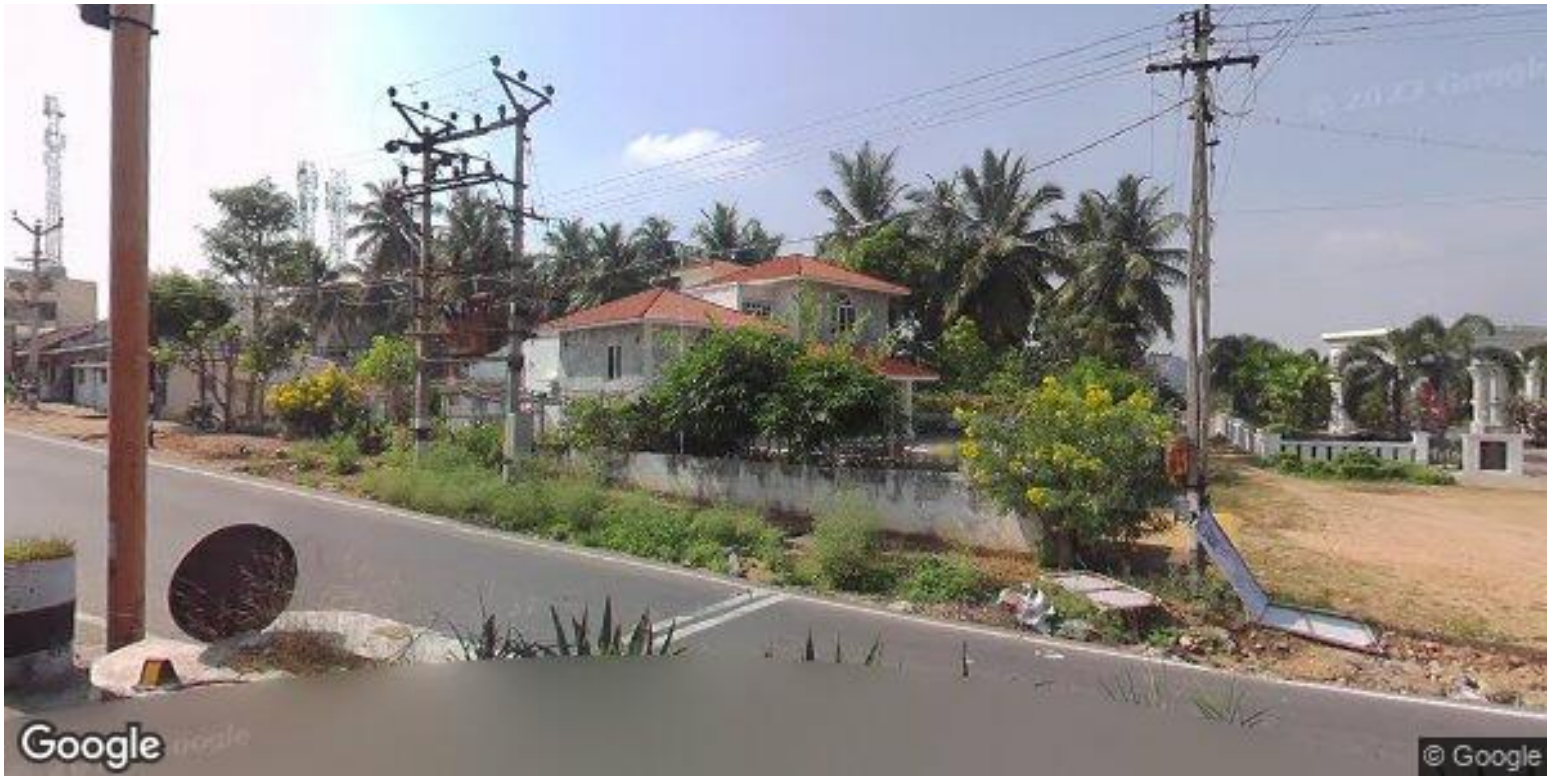
**Risk Type:** Turn  
**Risk Level:** High  
**Speed Limit:** 15 KM/Hr  
**Coordinates:** 11.46303, 77.84945

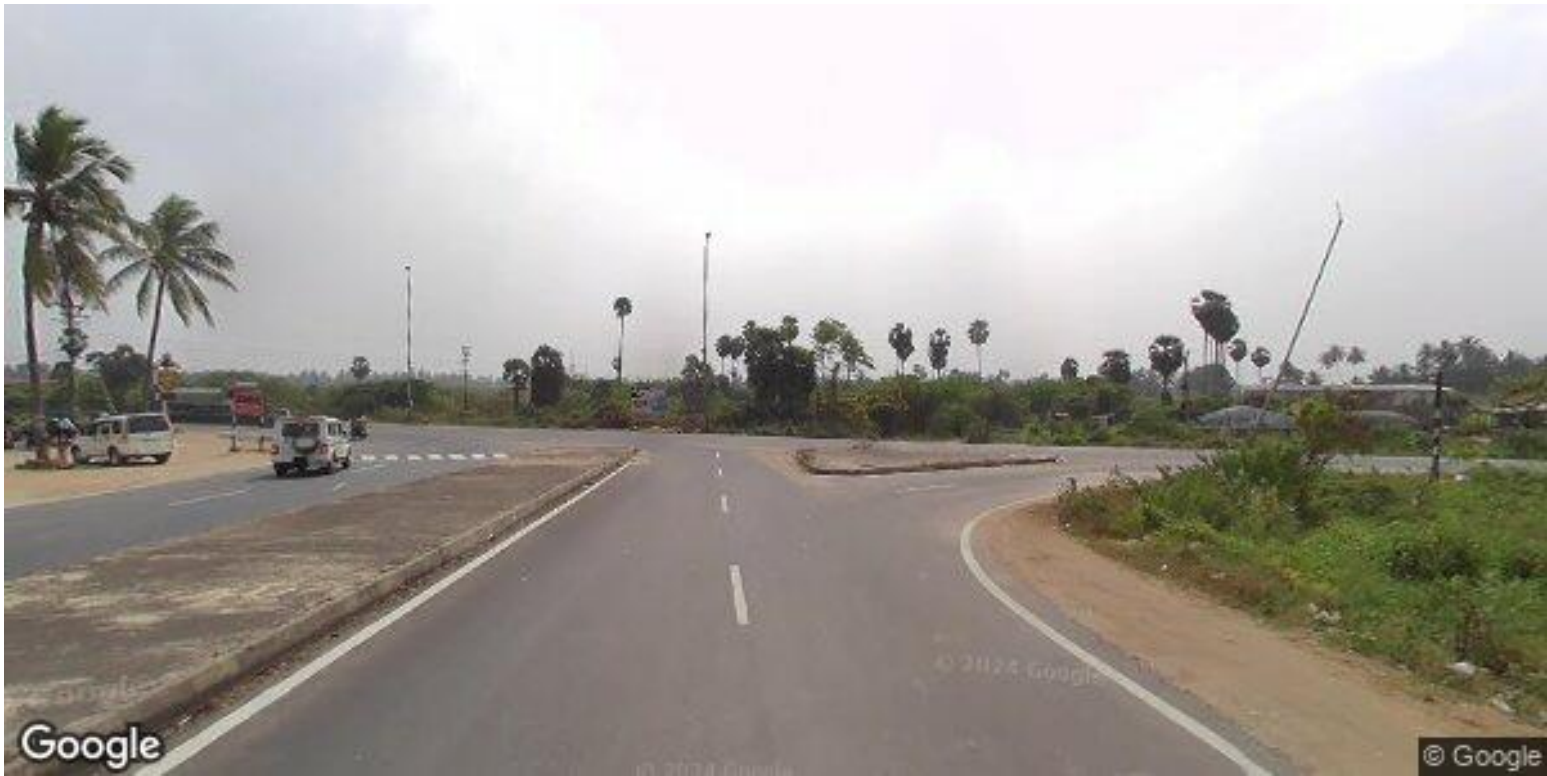
**Risk Type:** Turn  
**Risk Level:** Medium  
**Speed Limit:** 30 KM/Hr  
**Coordinates:** 11.45571, 77.81702

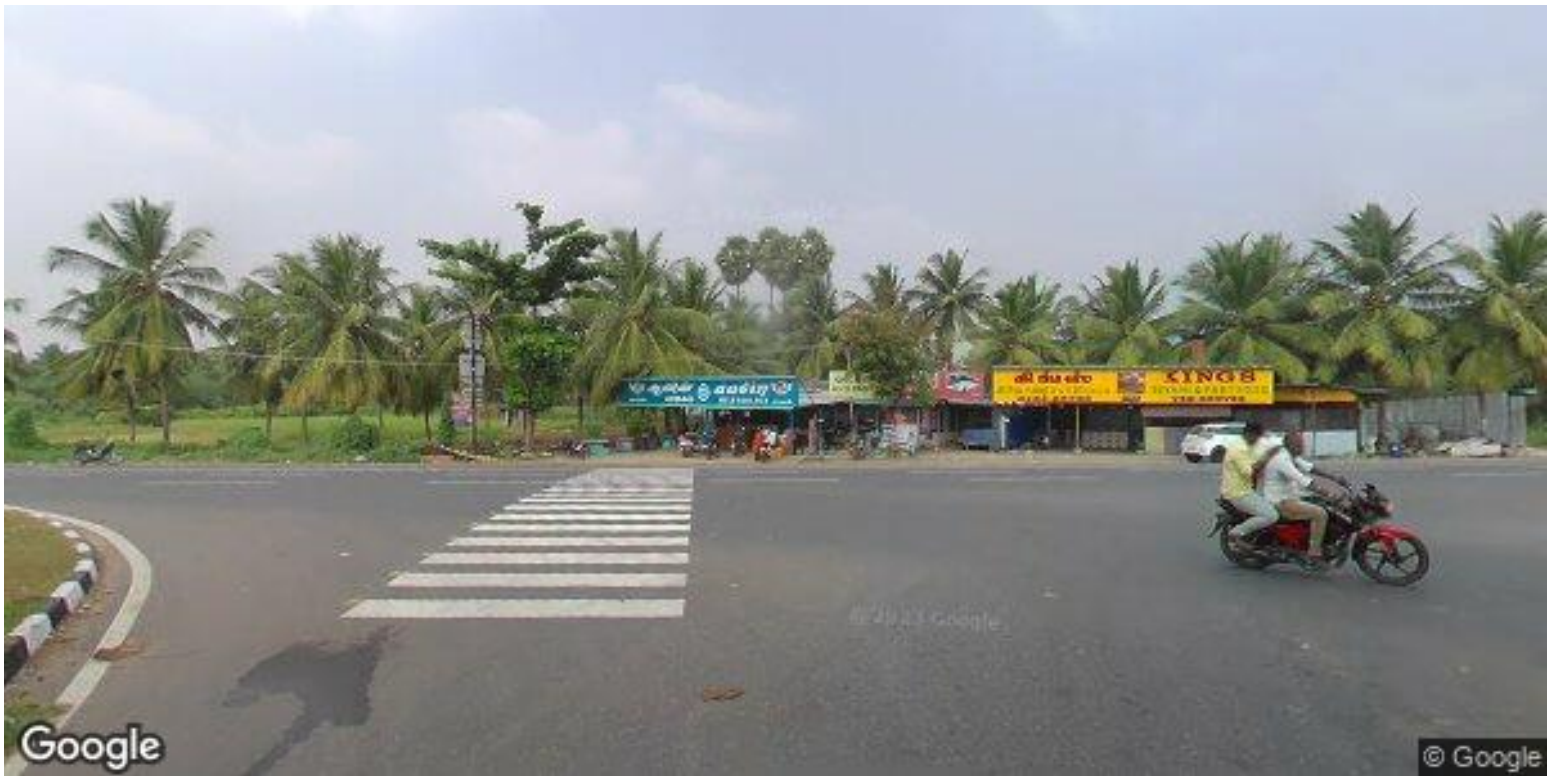
Risk Type: Turn

Risk Level: High

Speed Limit: 15 KM/Hr

Coordinates: 11.45615, 77.81677

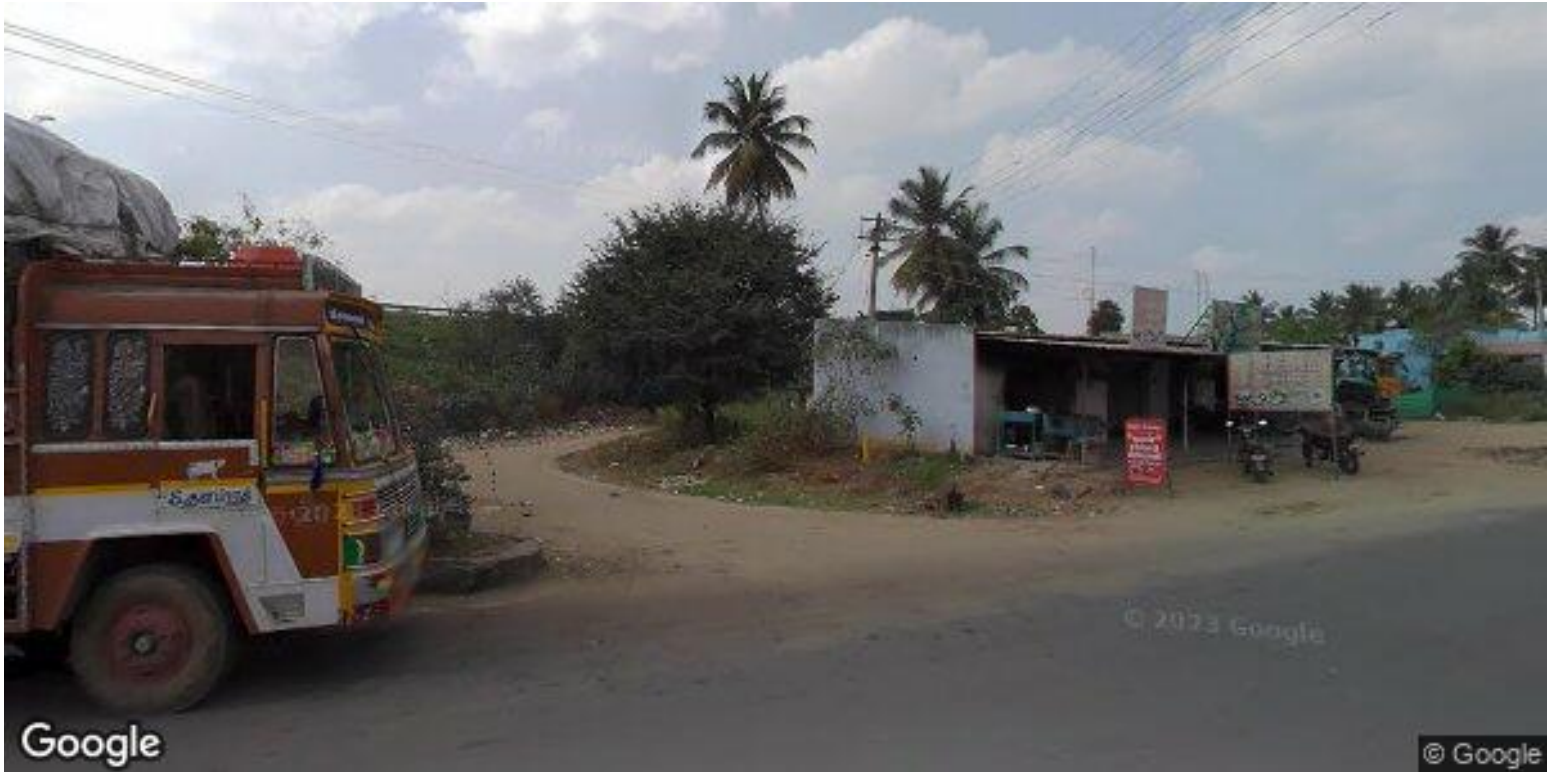
Risk Type: Blind Spot

Risk Level: Blind Spot

Speed Limit: 10 KM/Hr

Coordinates: 11.49395, 77.88537

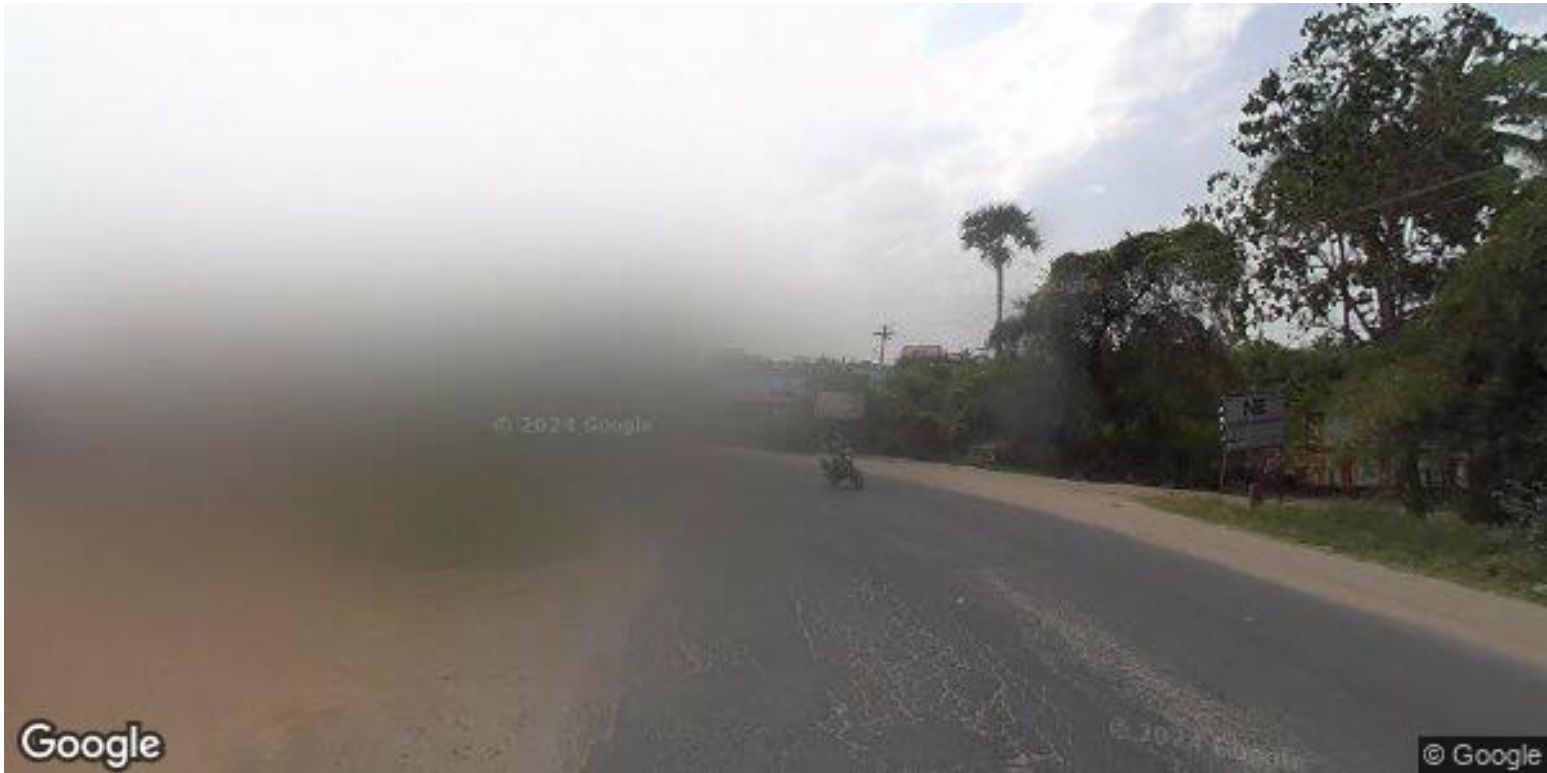
Risk Type: Turn

Risk Level: High

Speed Limit: 15 KM/Hr

Coordinates: 11.49465, 77.88488

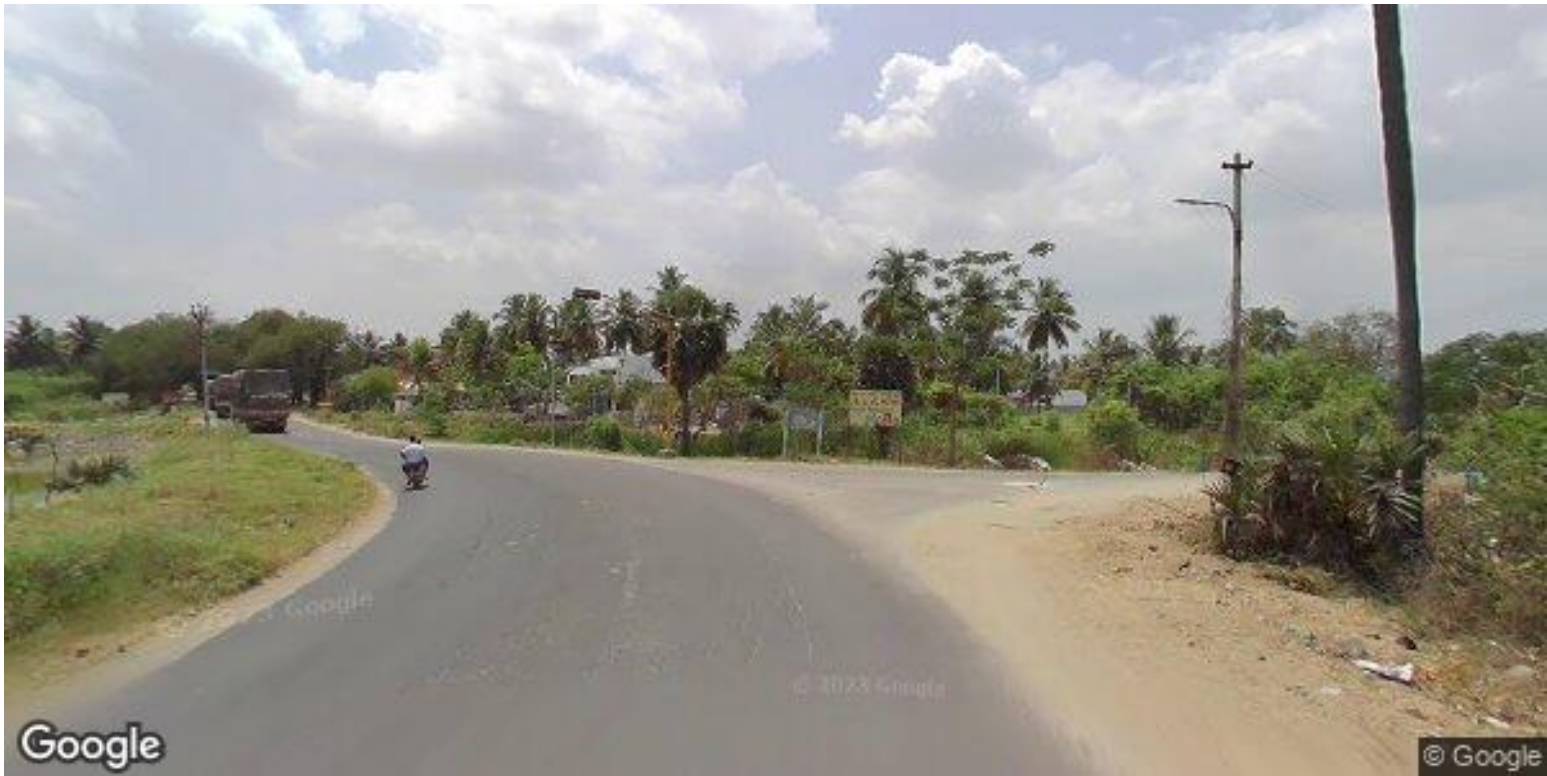
**Risk Type:** Turn  
**Risk Level:** Medium  
**Speed Limit:** 30 KM/Hr  
**Coordinates:** 11.56096, 77.89931

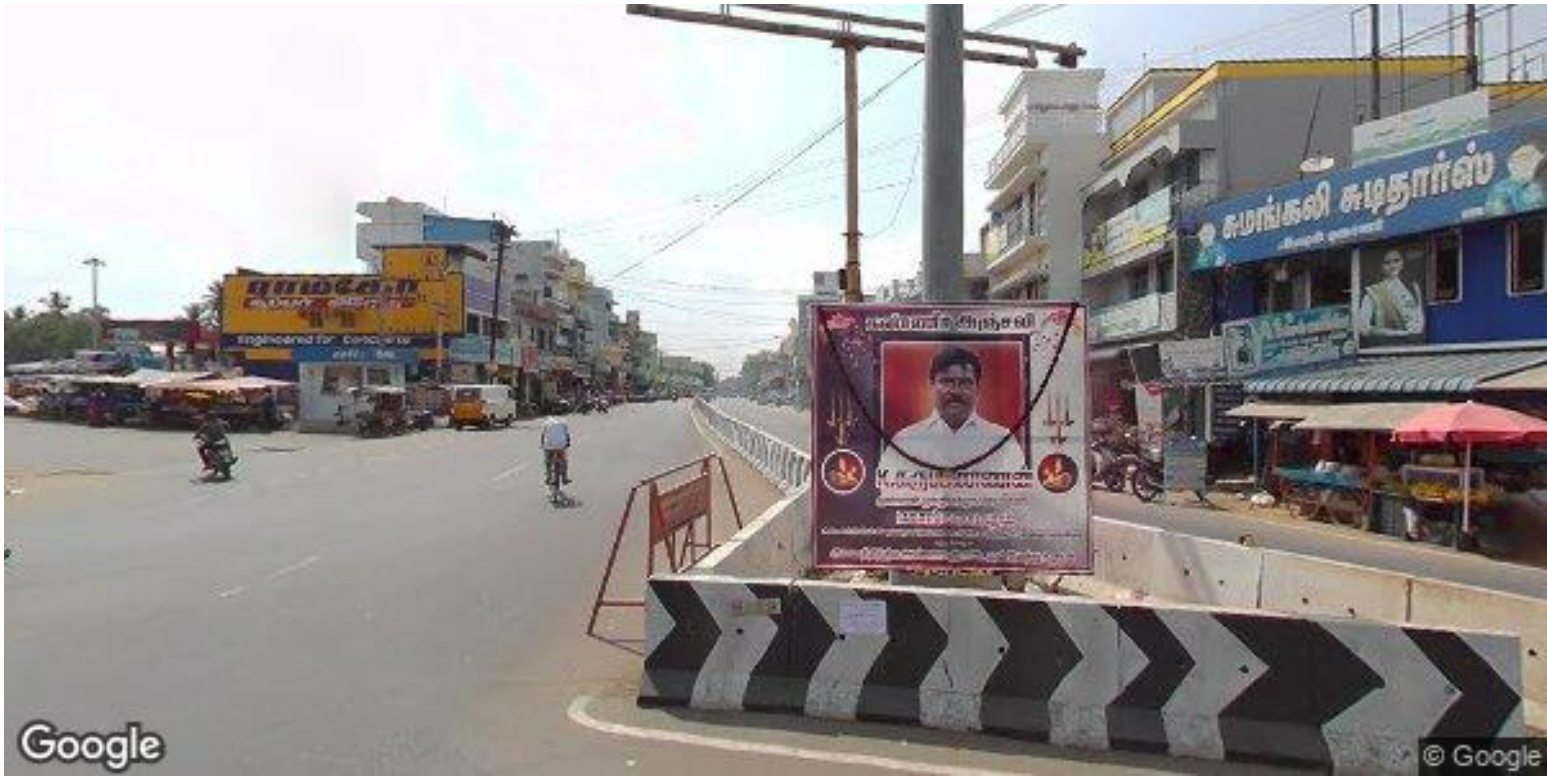
**Risk Type:** Turn  
**Risk Level:** Medium  
**Speed Limit:** 30 KM/Hr  
**Coordinates:** 11.57035, 77.90223

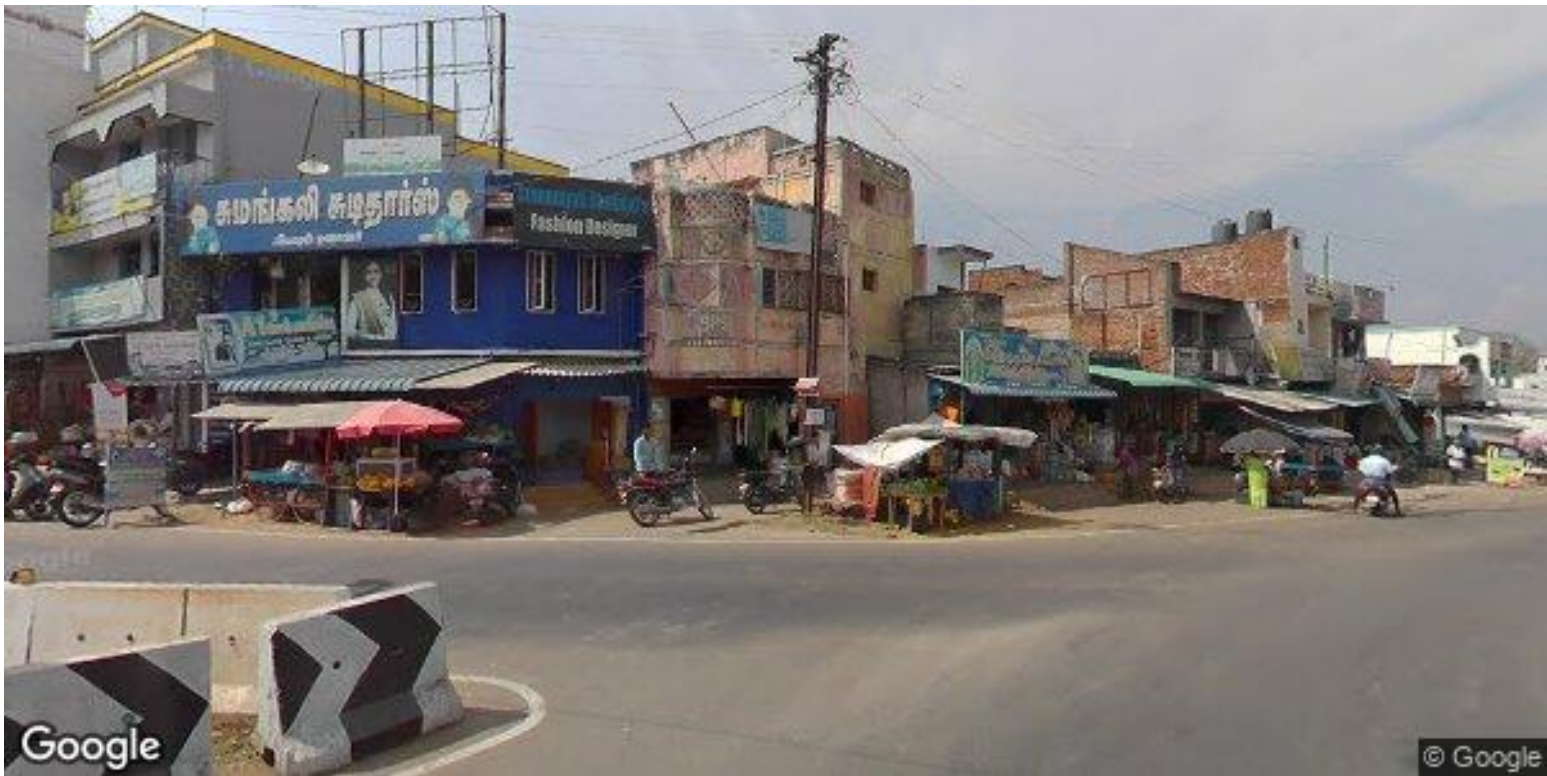
**Risk Type:** Turn  
**Risk Level:** High  
**Speed Limit:** 15 KM/Hr  
**Coordinates:** 11.57041, 77.90221

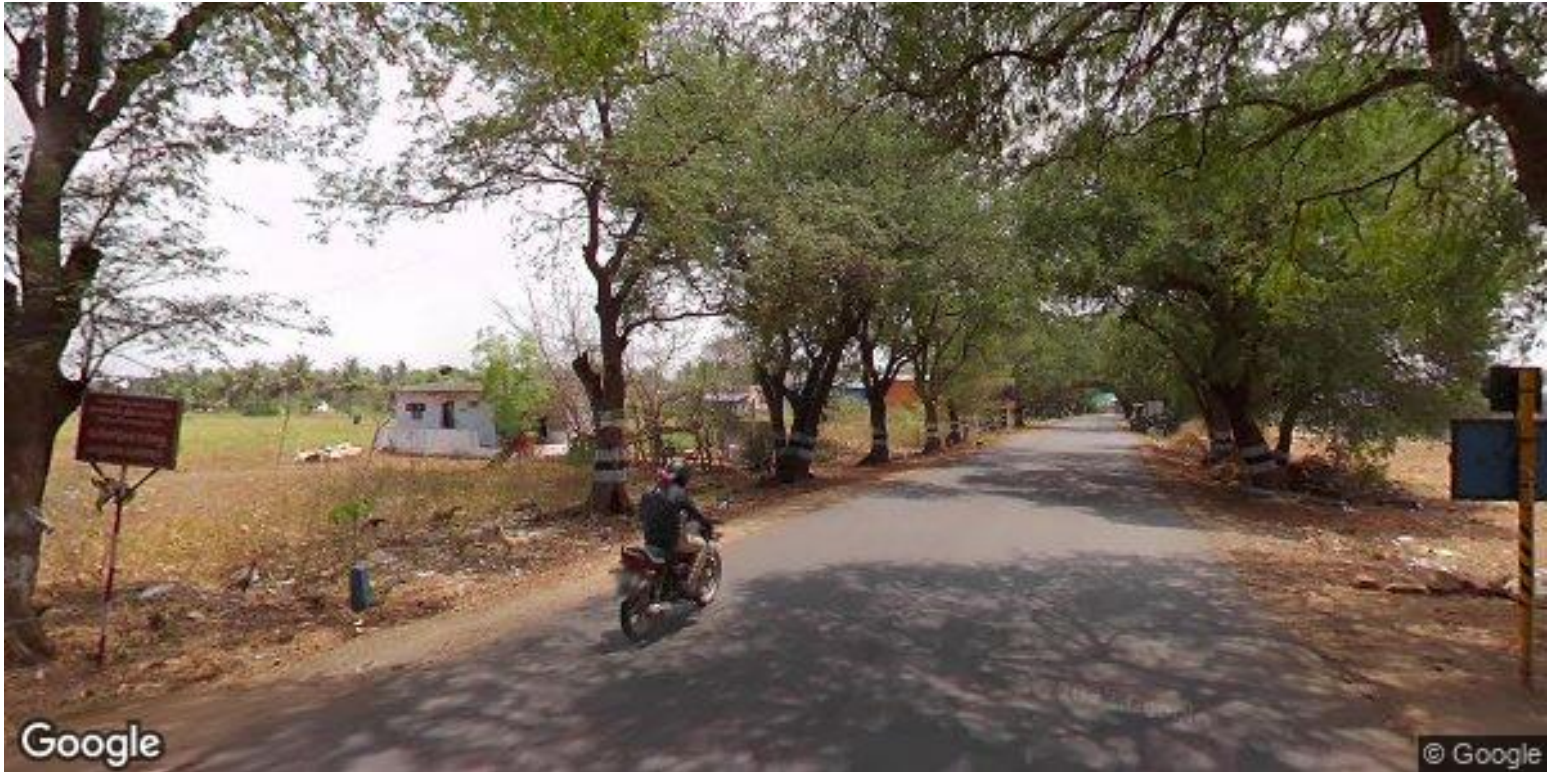
**Risk Type:** Turn  
**Risk Level:** Medium  
**Speed Limit:** 30 KM/Hr  
**Coordinates:** 11.57649, 77.90610

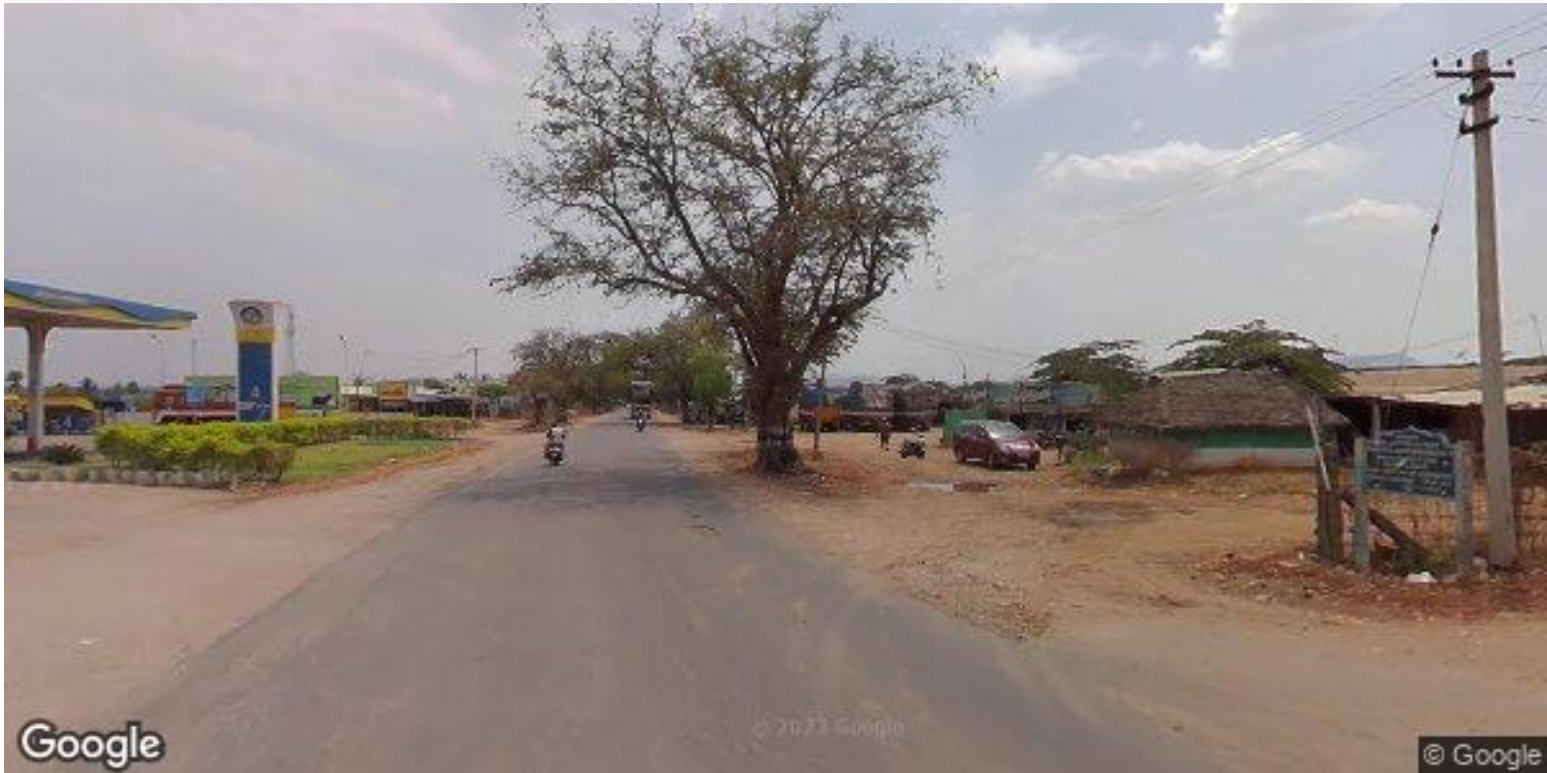
**Risk Type:** Turn  
**Risk Level:** Medium  
**Speed Limit:** 30 KM/Hr  
**Coordinates:** 11.58279, 77.90658

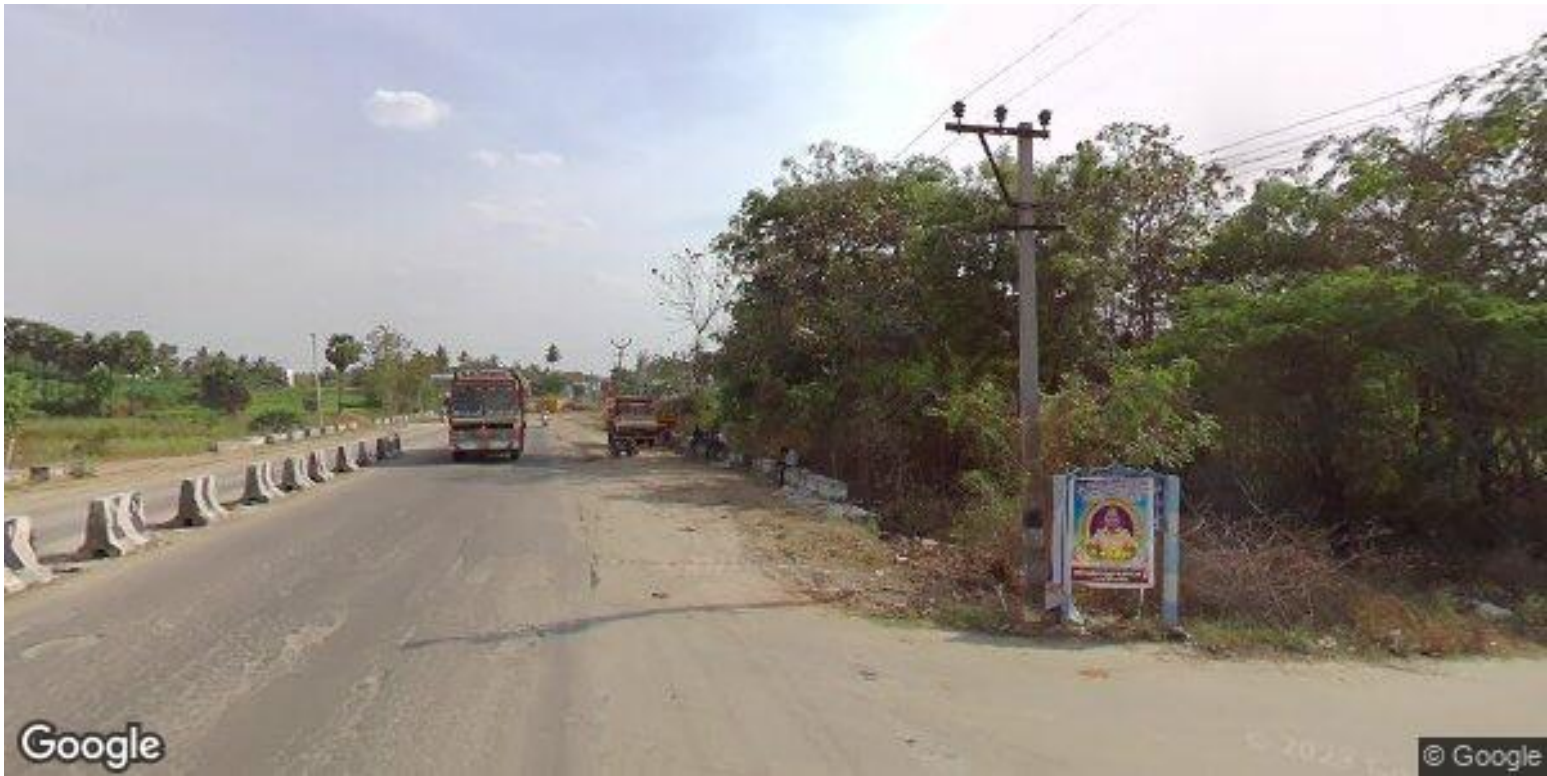
**Risk Type:** Turn  
**Risk Level:** Medium  
**Speed Limit:** 30 KM/Hr  
**Coordinates:** 11.63833, 77.94818

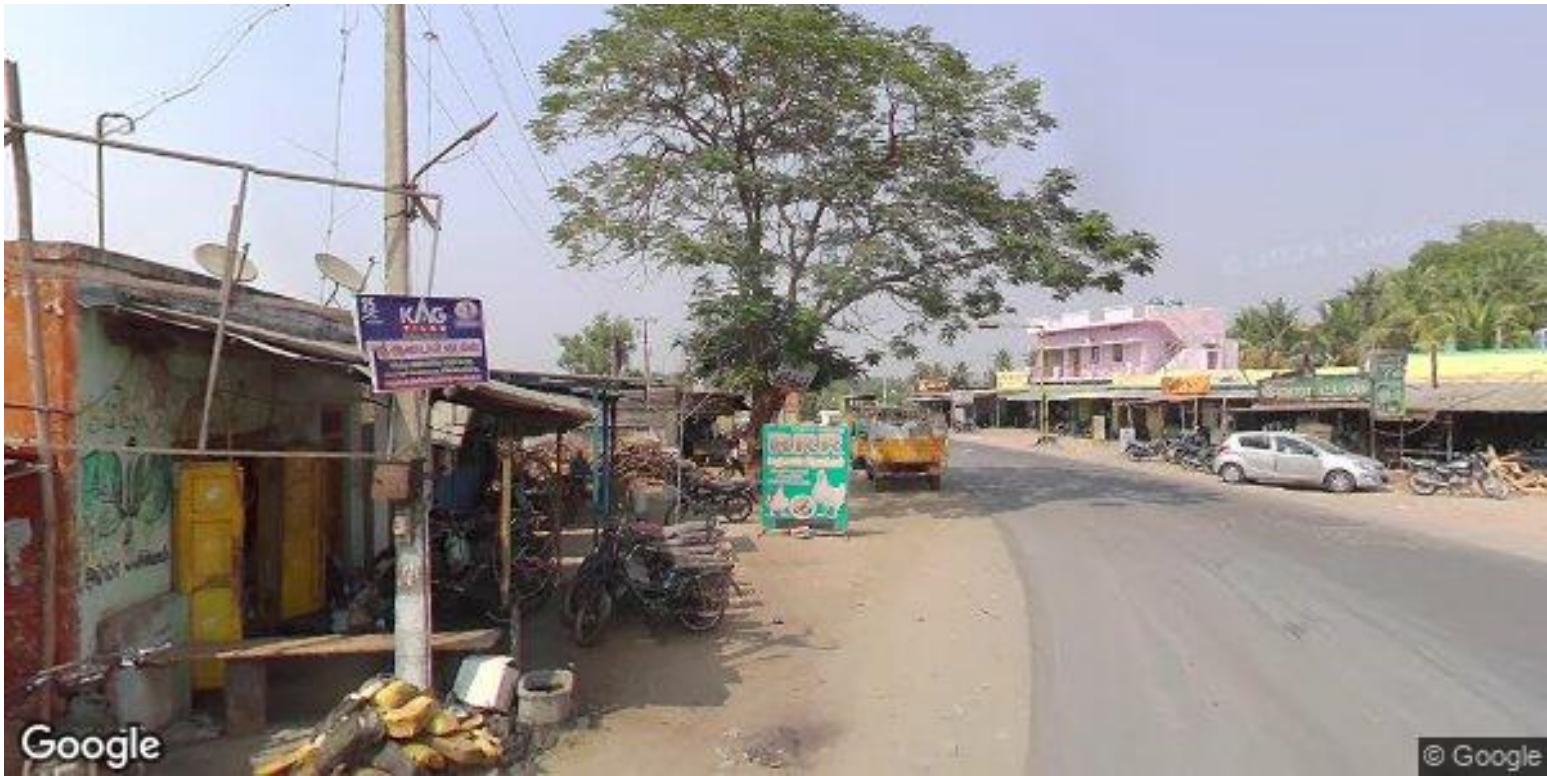
**Risk Type:** Turn  
**Risk Level:** Medium  
**Speed Limit:** 30 KM/Hr  
**Coordinates:** 11.64171, 77.95184

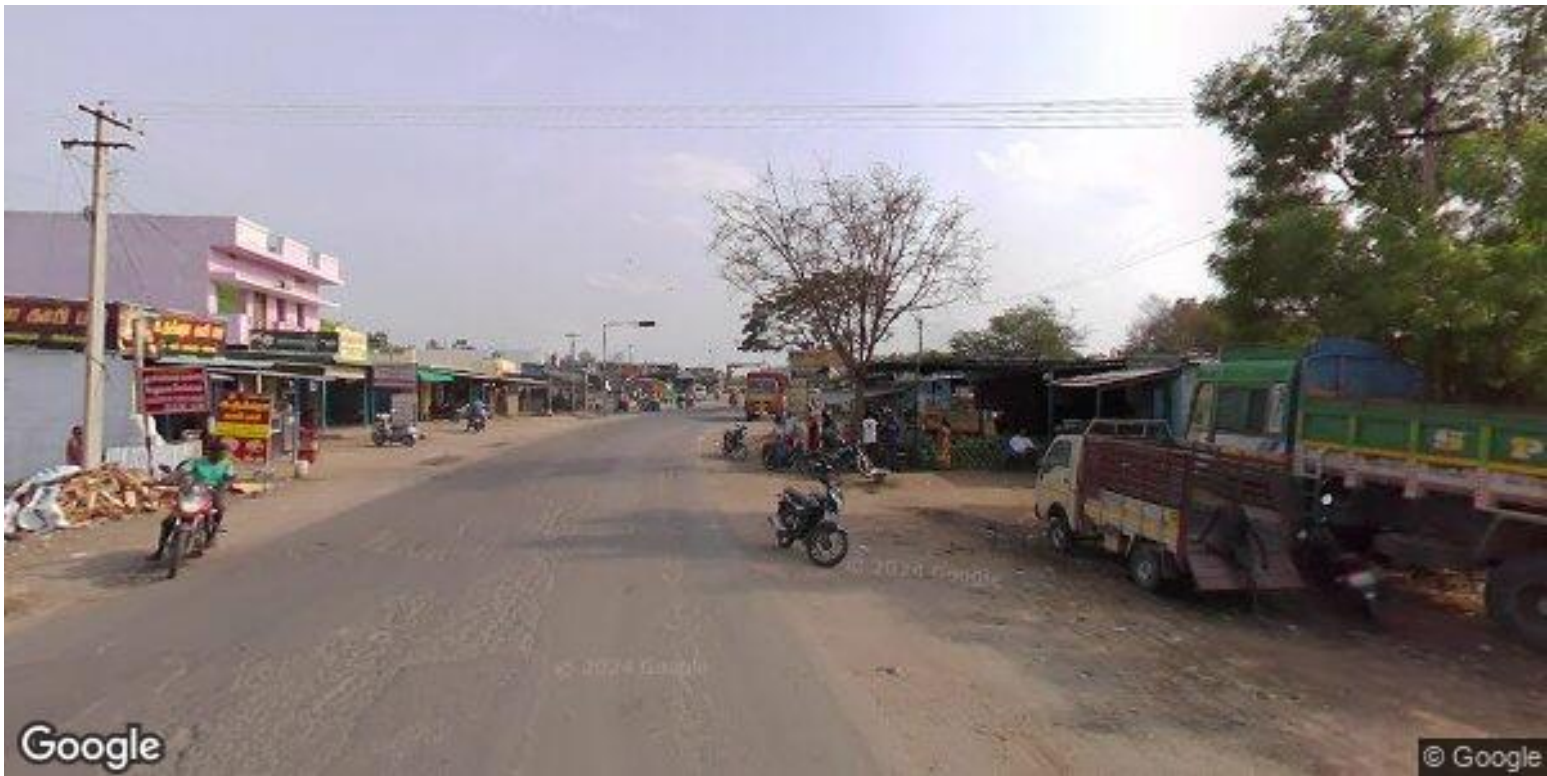
**Risk Type:** Turn  
**Risk Level:** Medium  
**Speed Limit:** 30 KM/Hr  
**Coordinates:** 11.64243, 77.95198

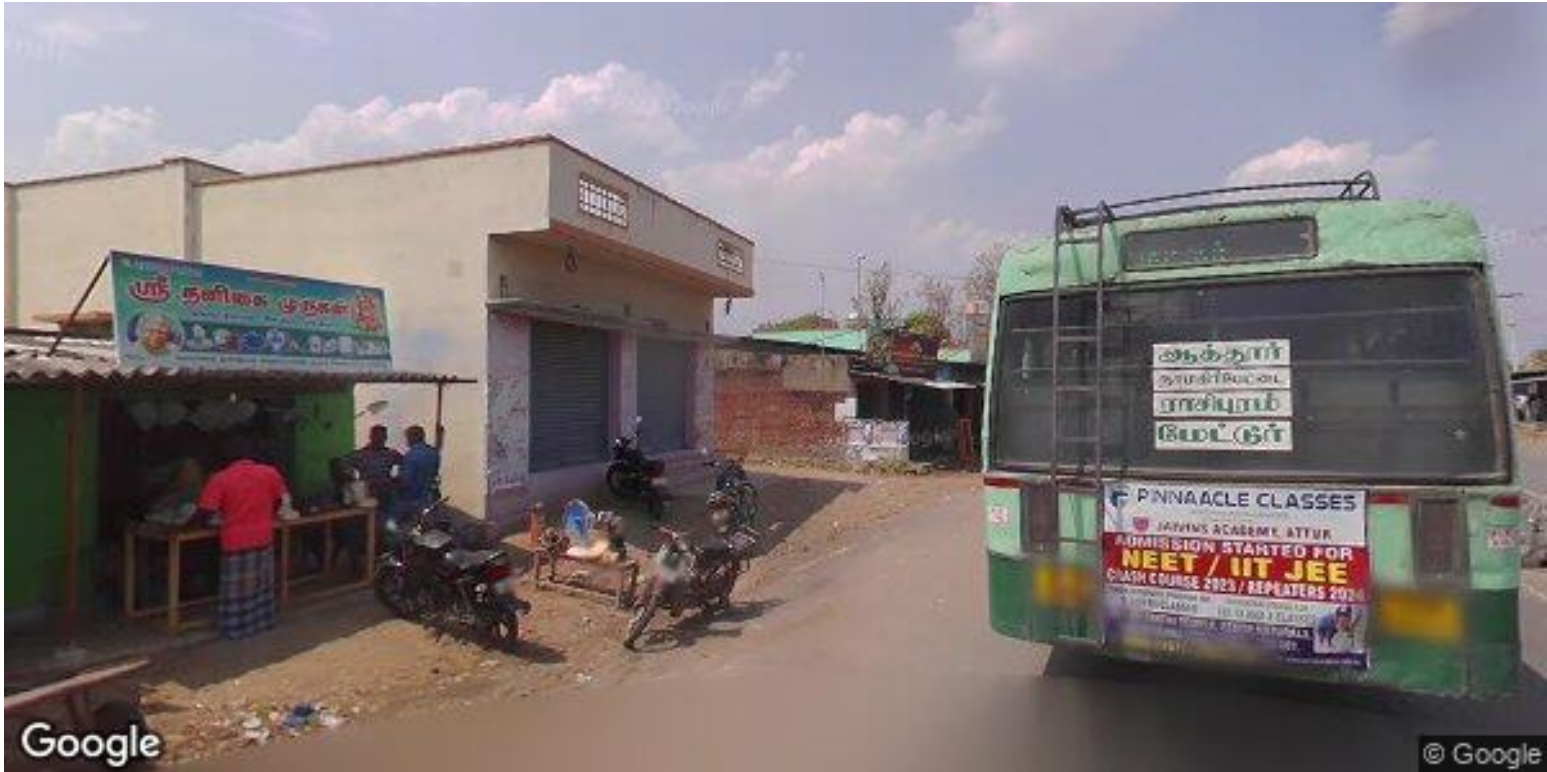
**Risk Type:** Turn  
**Risk Level:** Medium  
**Speed Limit:** 30 KM/Hr  
**Coordinates:** 11.64721, 77.95118
