# IndianOil

## JOURNEY RISK MANAGEMENT (JRM) STUDY

### Salem Terminal to SRI JAYALAKSHMI FUELS

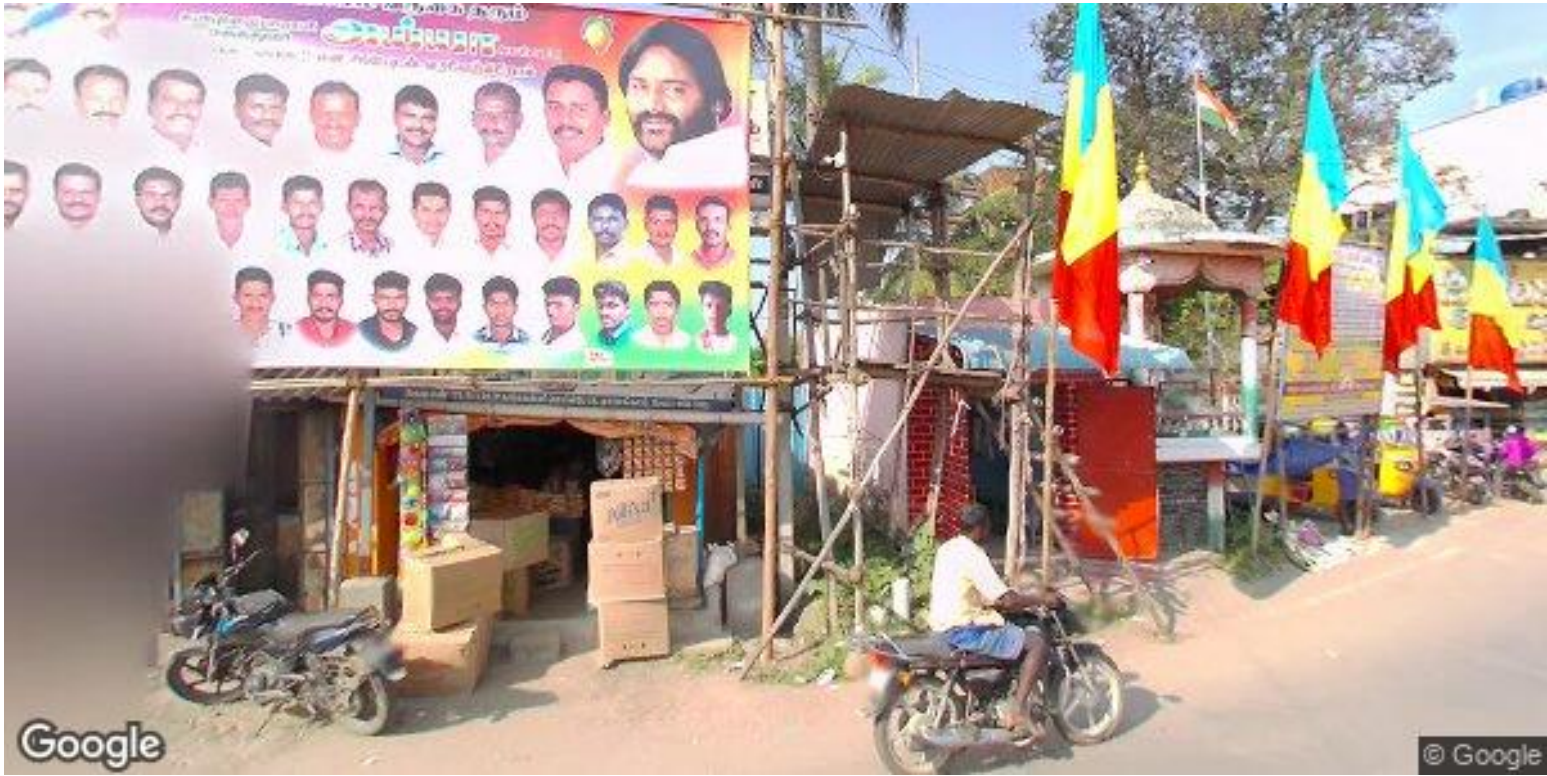
**Risk Type:** Turn  
**Risk Level:** High  
**Speed Limit:** 15 KM/Hr  
**Coordinates:** 11.69595, 77.97114

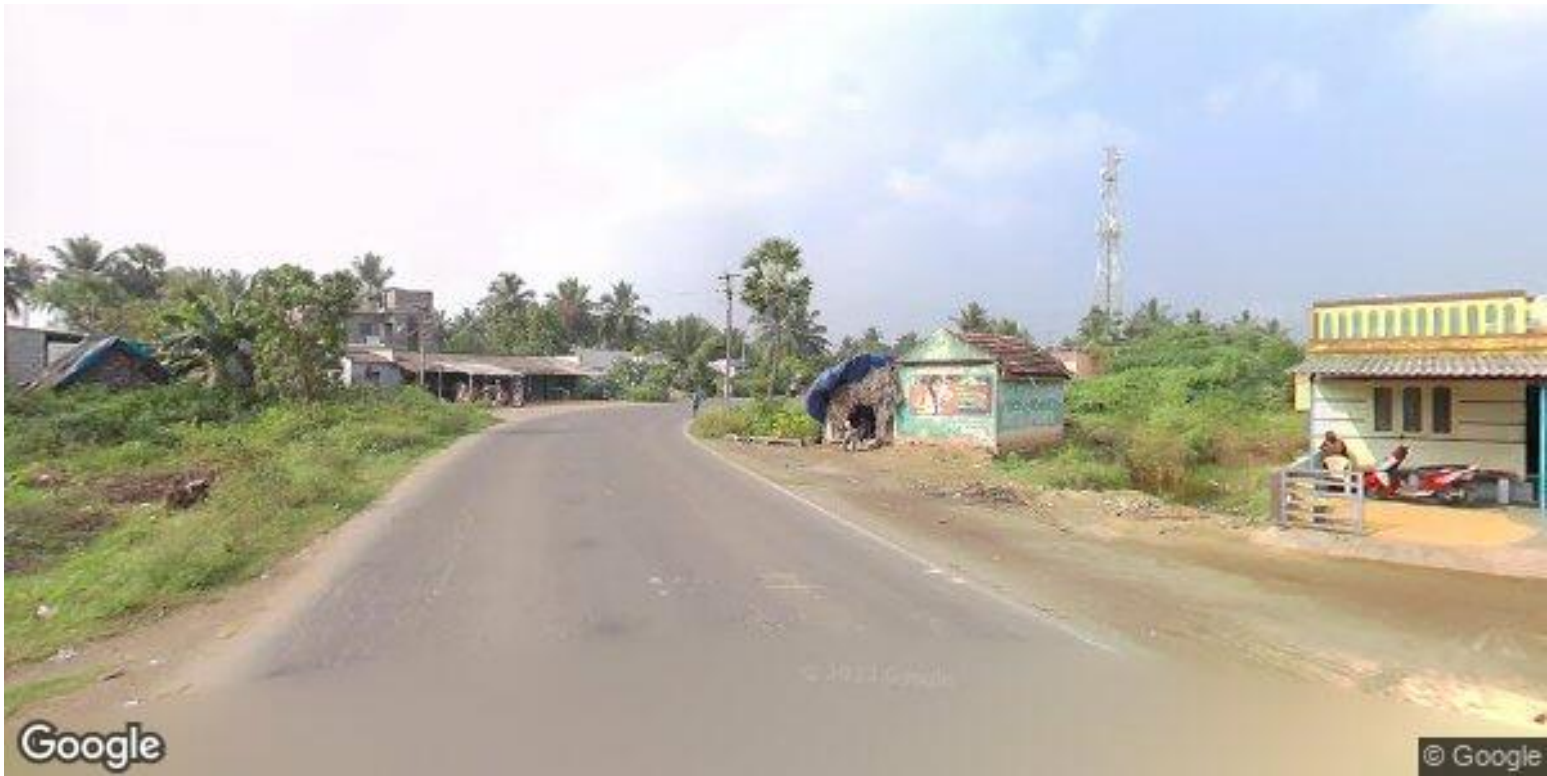
**Risk Type:** Turn  
**Risk Level:** Medium  
**Speed Limit:** 30 KM/Hr  
**Coordinates:** 11.71386, 77.99552

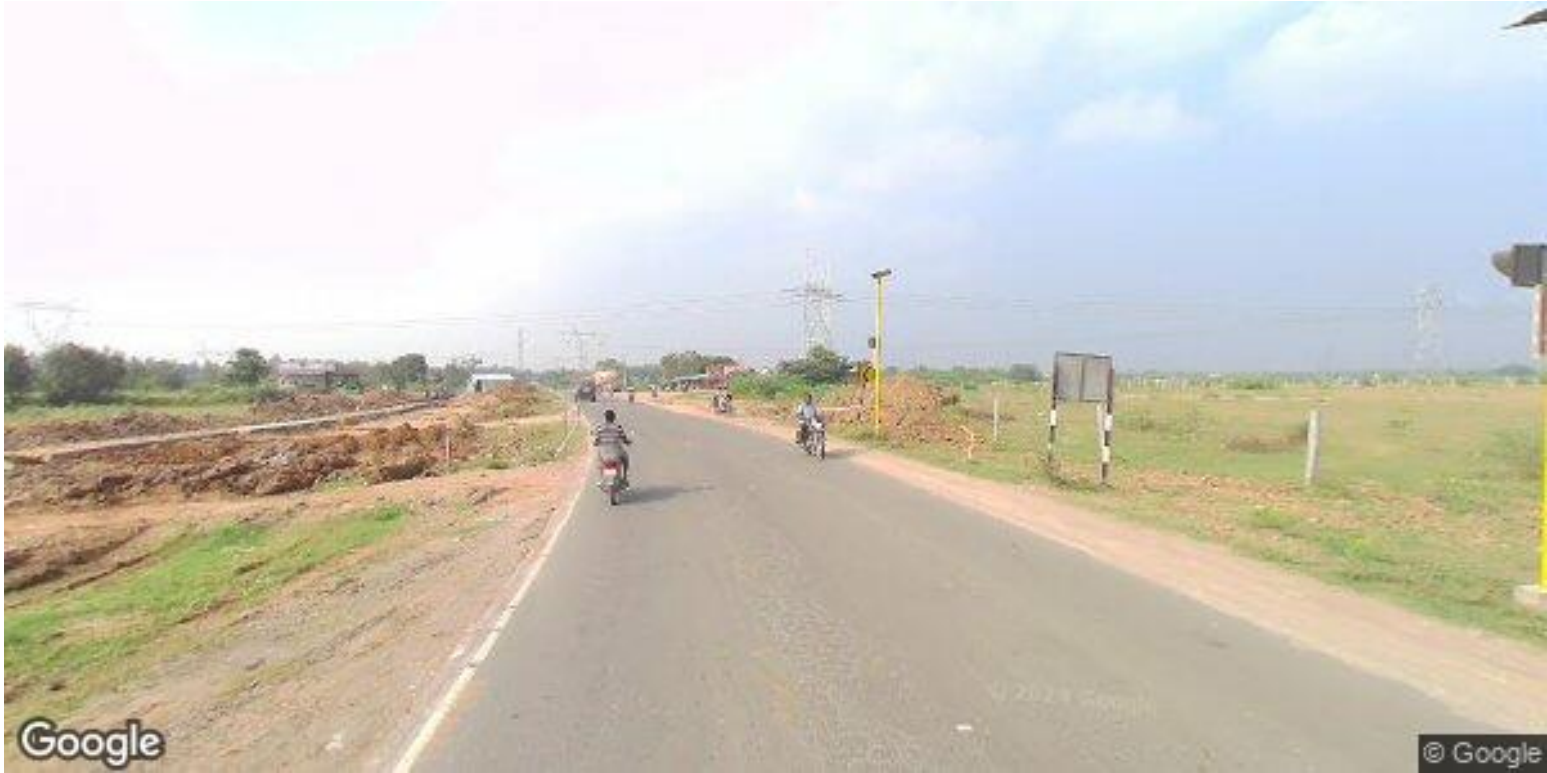
**Risk Type:** Turn  
**Risk Level:** Medium  
**Speed Limit:** 30 KM/Hr  
**Coordinates:** 11.71735, 78.00019

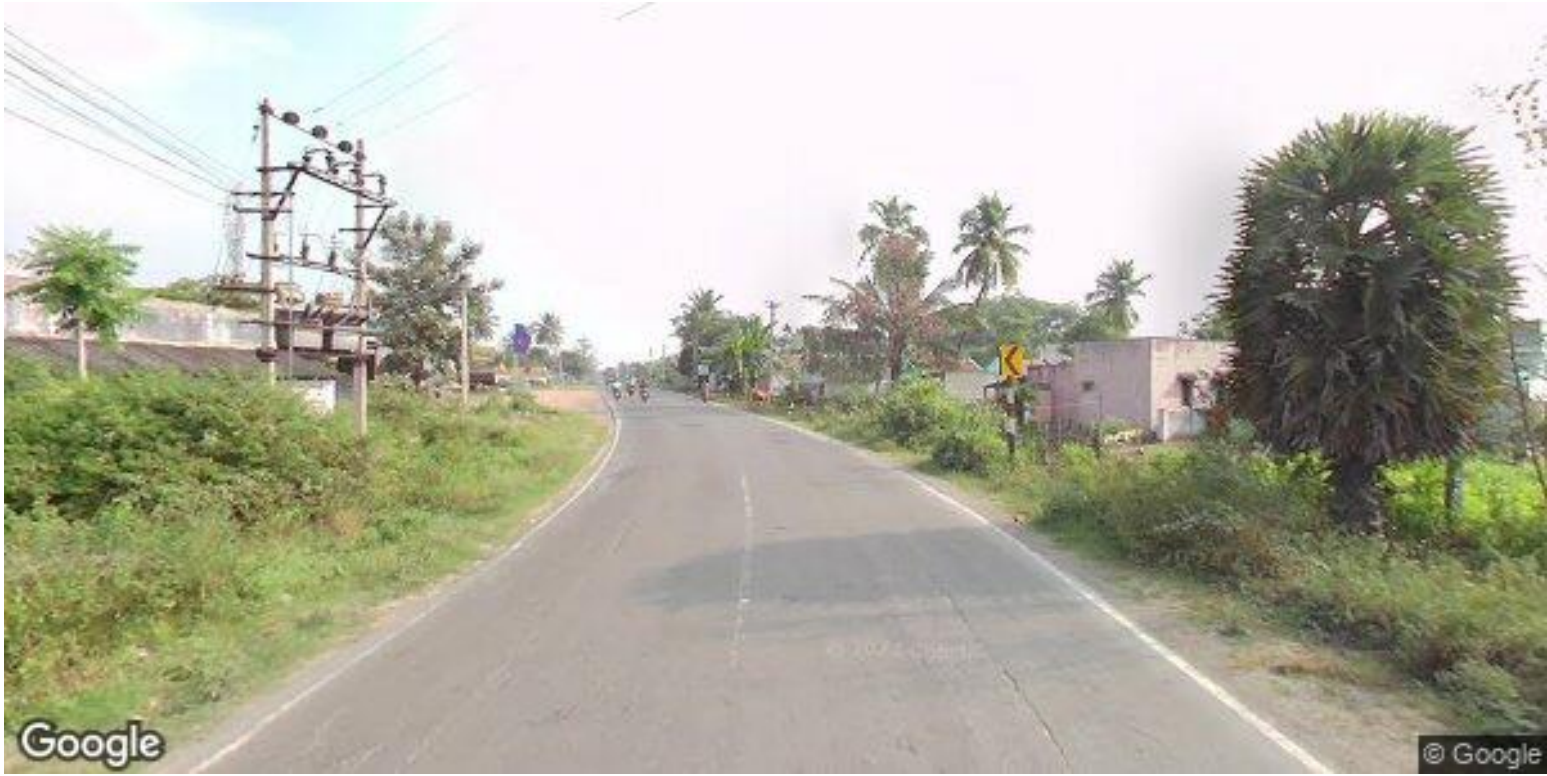
**Risk Type:** Turn  
**Risk Level:** Medium  
**Speed Limit:** 30 KM/Hr  
**Coordinates:** 11.72765, 78.02291

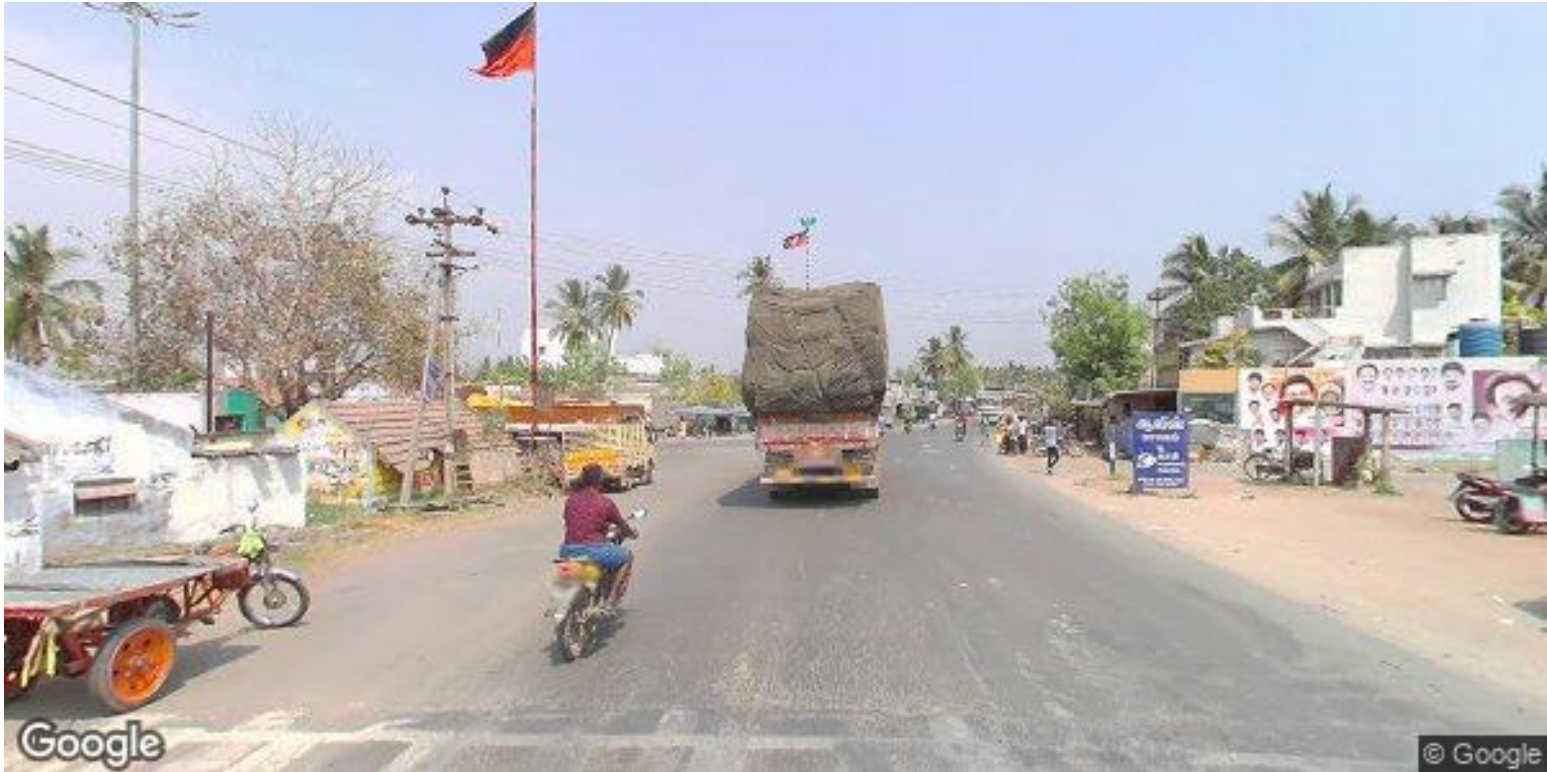
**Risk Type:** Turn  
**Risk Level:** Medium  
**Speed Limit:** 30 KM/Hr  
**Coordinates:** 11.73786, 78.03505

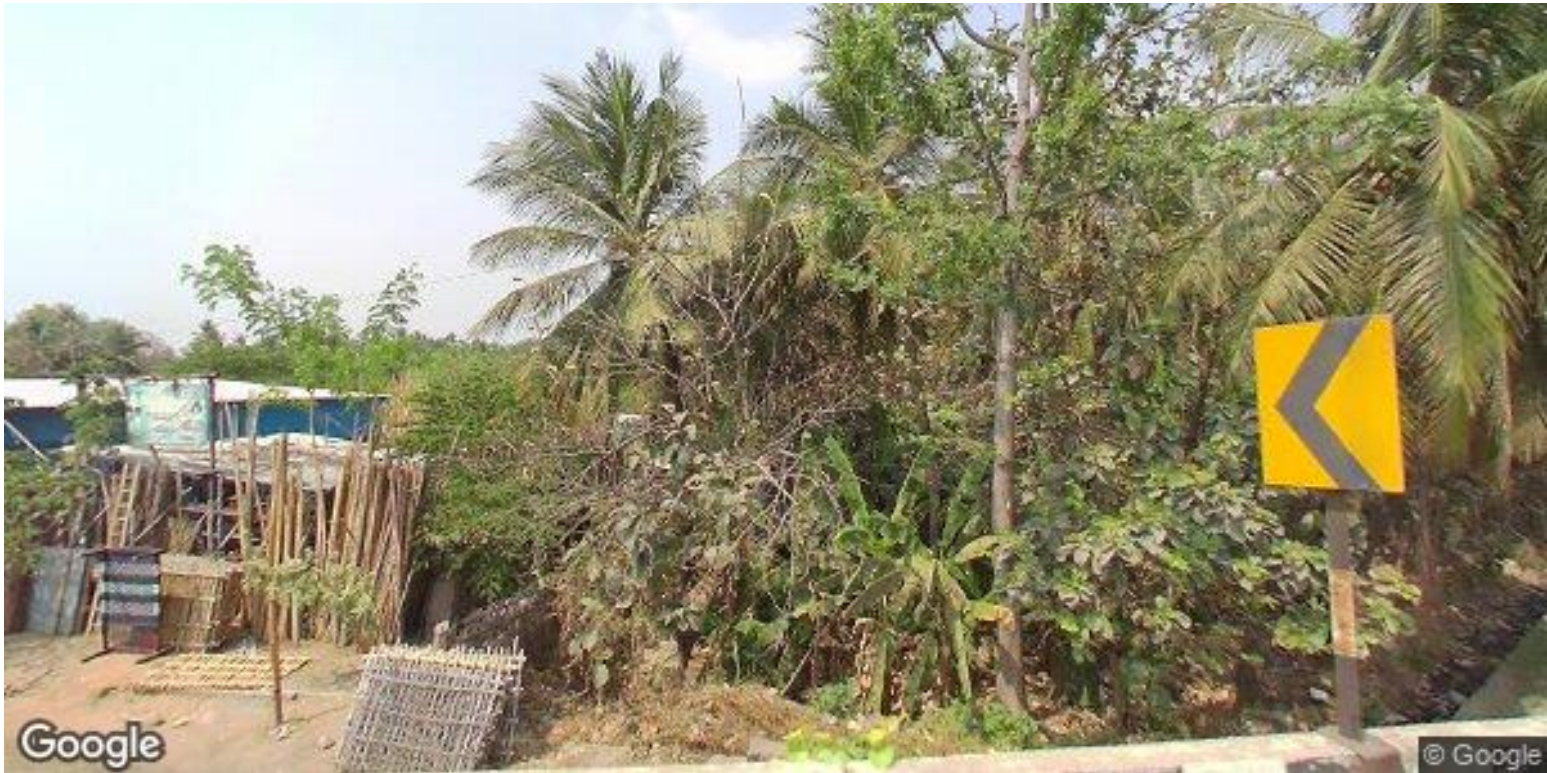
**Risk Type:** Turn  
**Risk Level:** High  
**Speed Limit:** 15 KM/Hr  
**Coordinates:** 11.73652, 78.03866

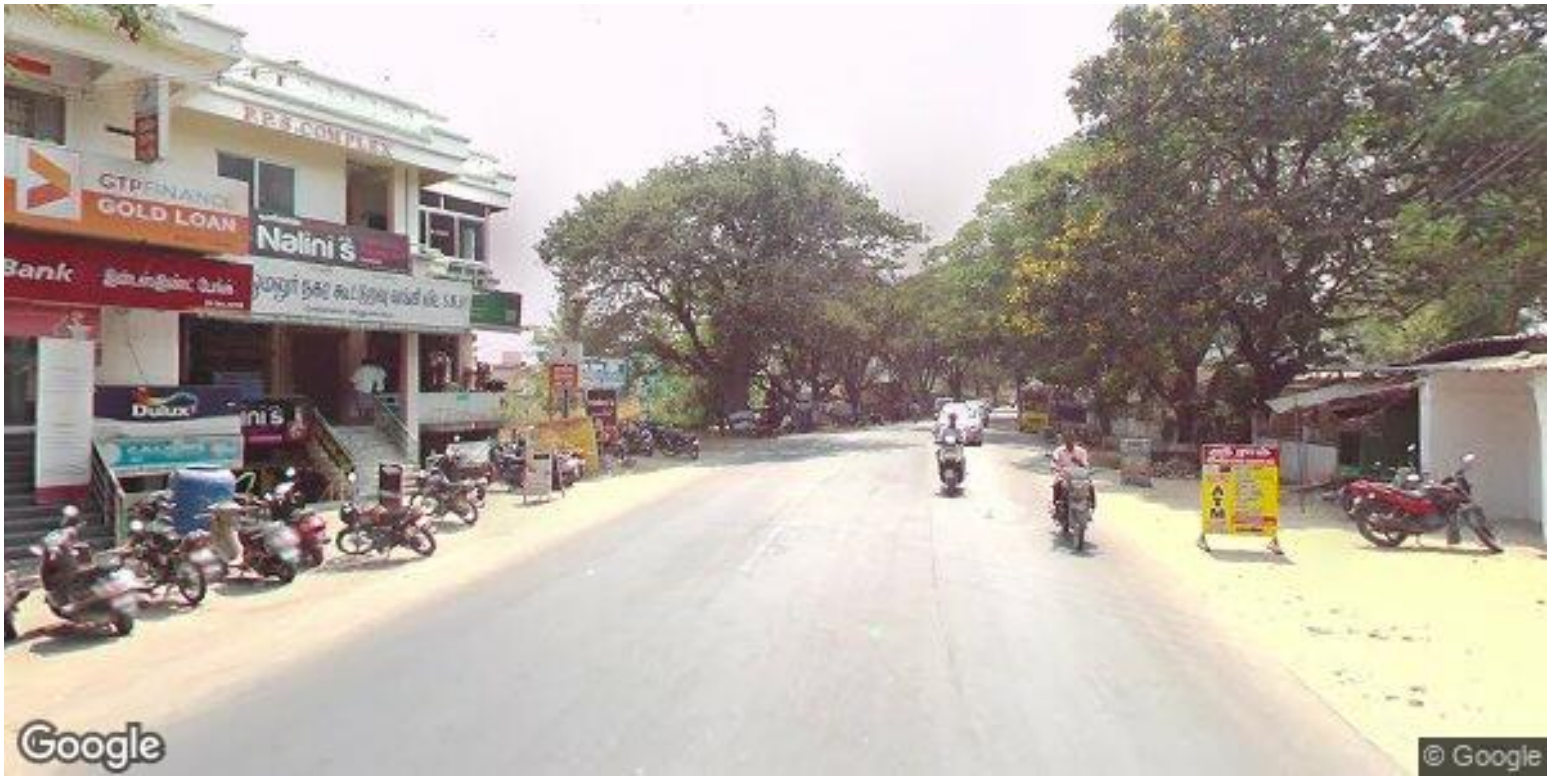
**Risk Type:** Turn  
**Risk Level:** Medium  
**Speed Limit:** 30 KM/Hr  
**Coordinates:** 11.74110, 78.04575

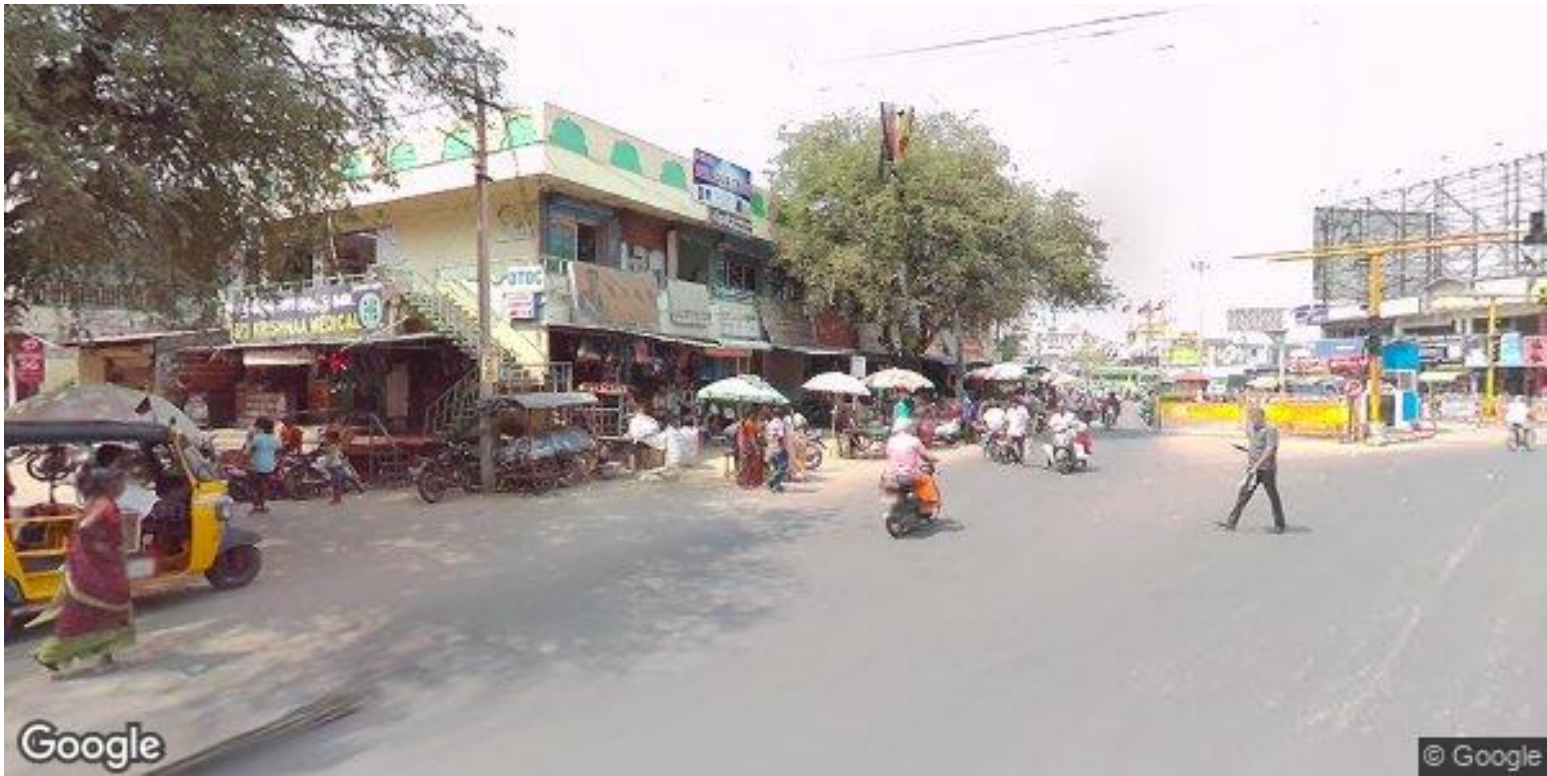
**Risk Type:** Turn  
**Risk Level:** Medium  
**Speed Limit:** 30 KM/Hr  
**Coordinates:** 11.74257, 78.04708

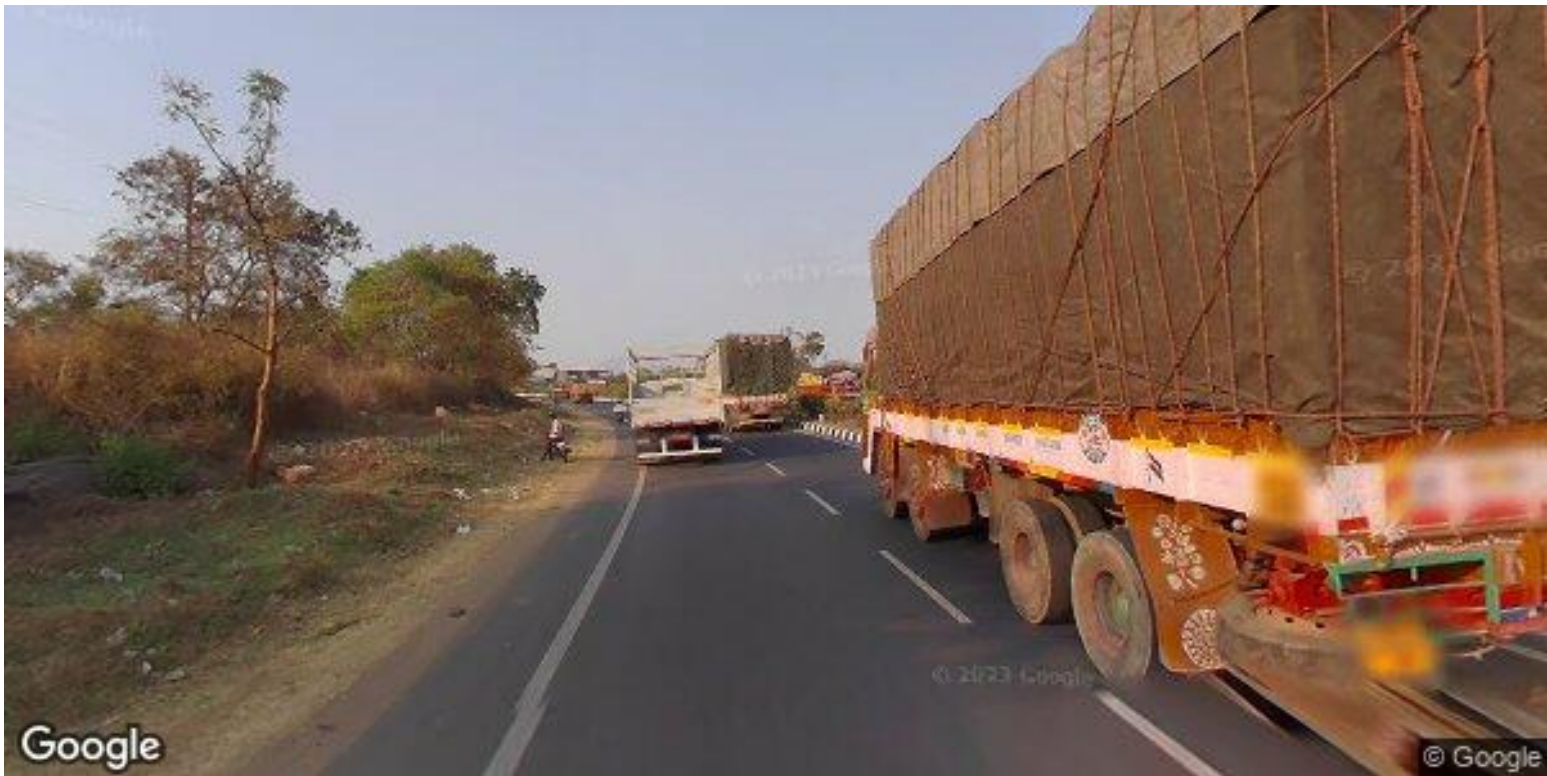
**Risk Type:** Turn  
**Risk Level:** Medium  
**Speed Limit:** 30 KM/Hr  
**Coordinates:** 11.77998, 78.05786

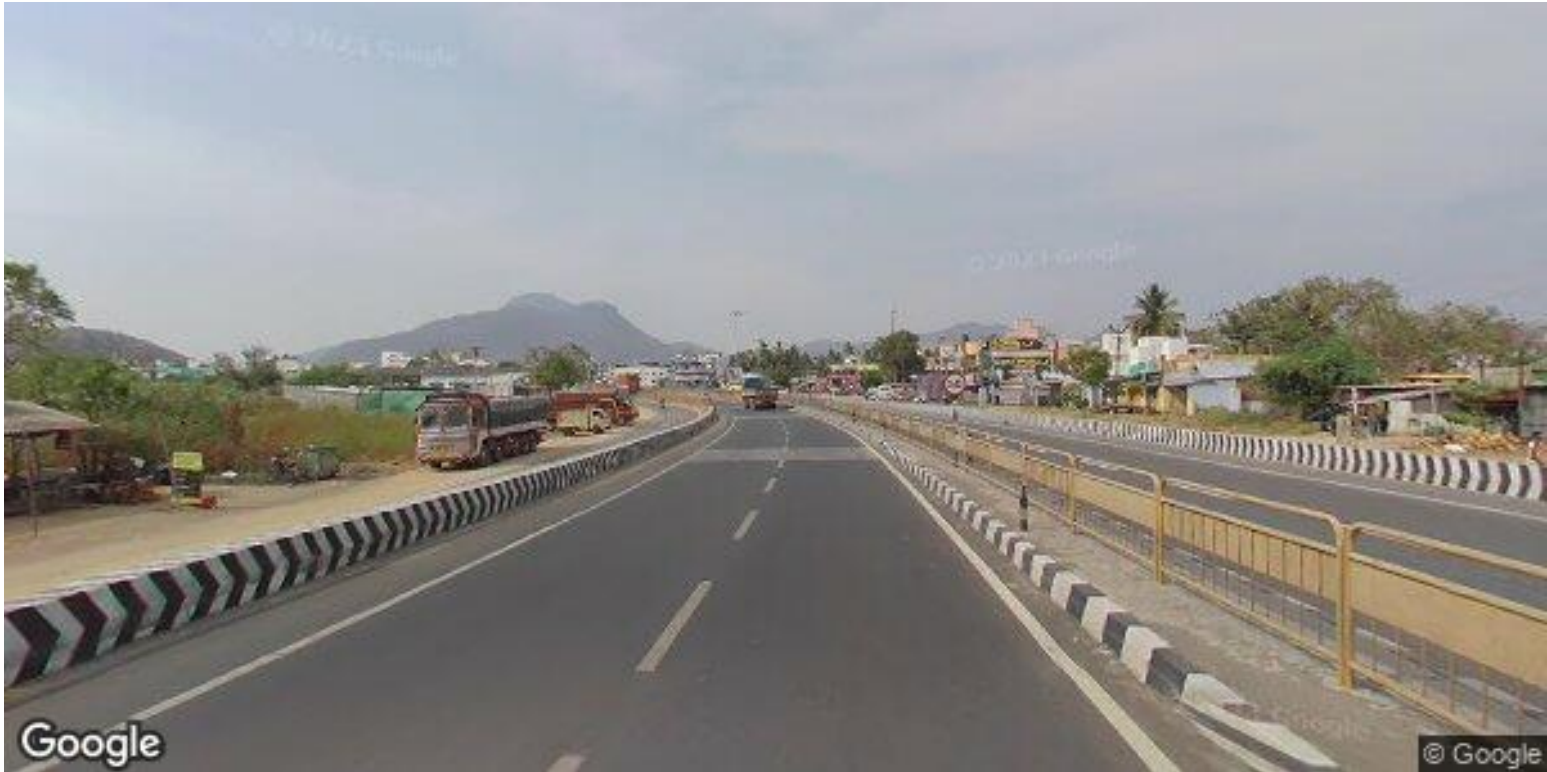
**Risk Type:** Turn  
**Risk Level:** Medium  
**Speed Limit:** 30 KM/Hr  
**Coordinates:** 11.86915, 78.08382

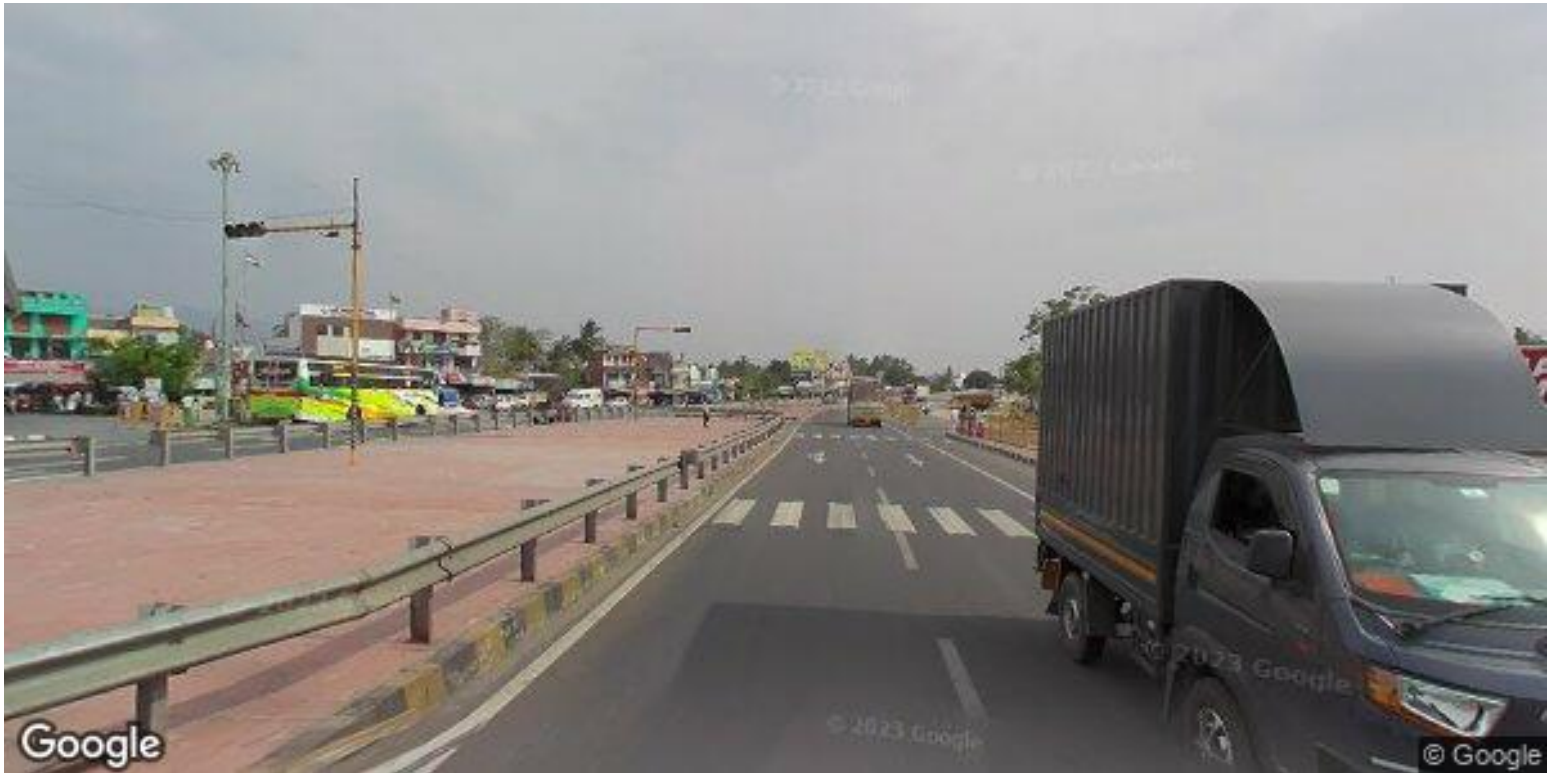
**Risk Type:** Turn  
**Risk Level:** High  
**Speed Limit:** 15 KM/Hr  
**Coordinates:** 11.87099, 78.08358

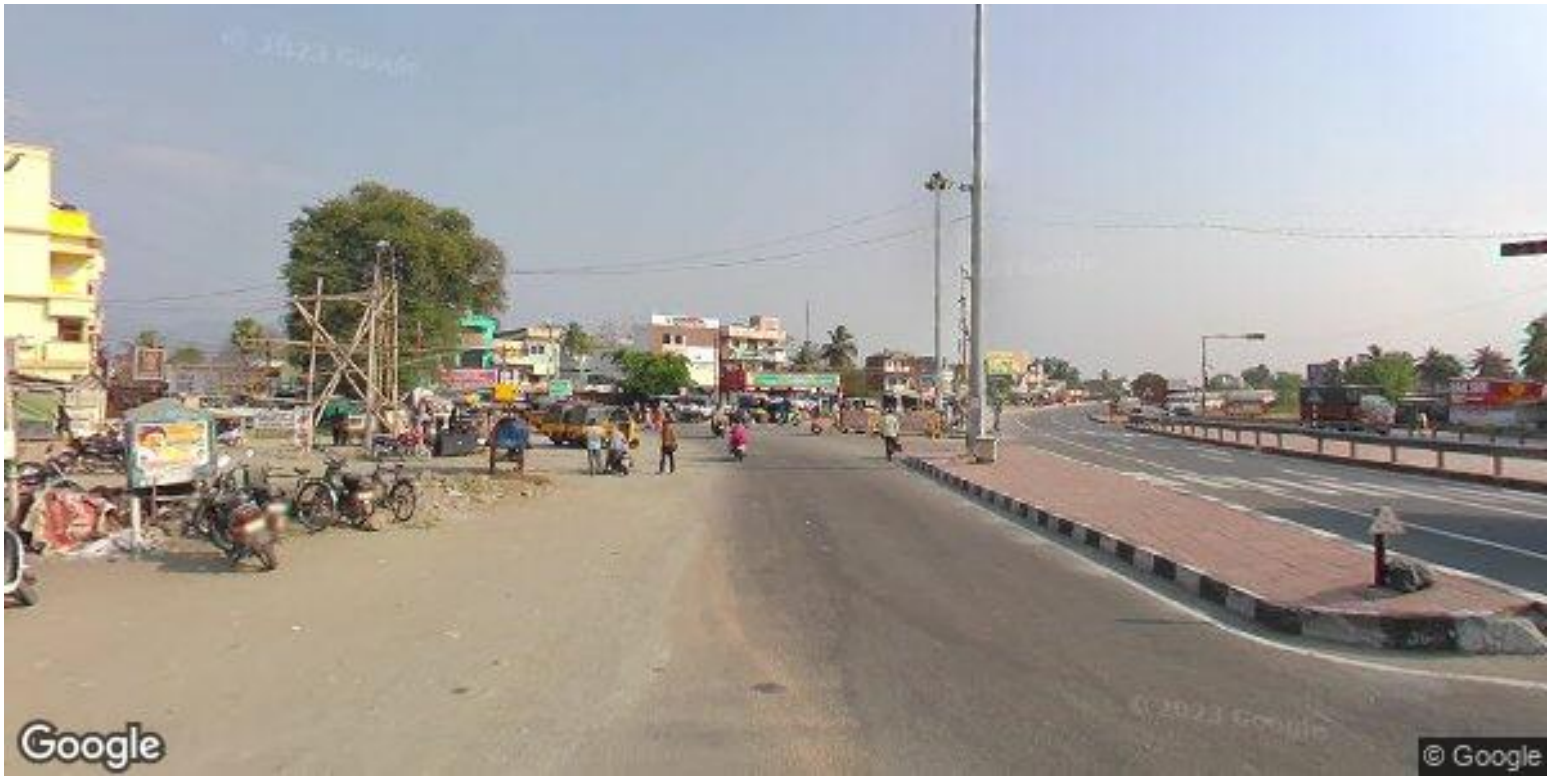
**Risk Type:** Turn  
**Risk Level:** High  
**Speed Limit:** 15 KM/Hr  
**Coordinates:** 11.87110, 78.08383

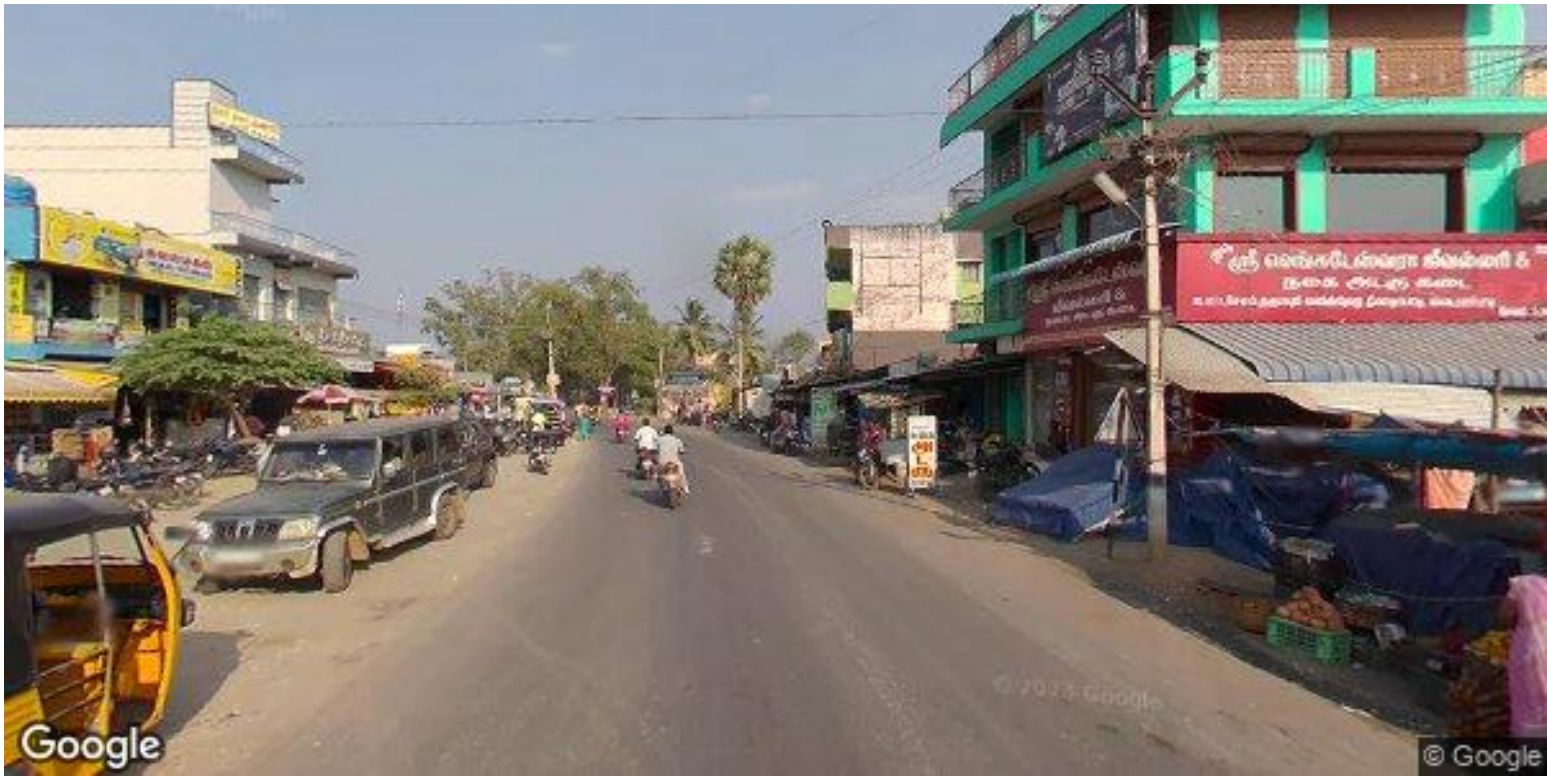
**Risk Type:** Turn  
**Risk Level:** Medium  
**Speed Limit:** 30 KM/Hr  
**Coordinates:** 11.87072, 78.08439

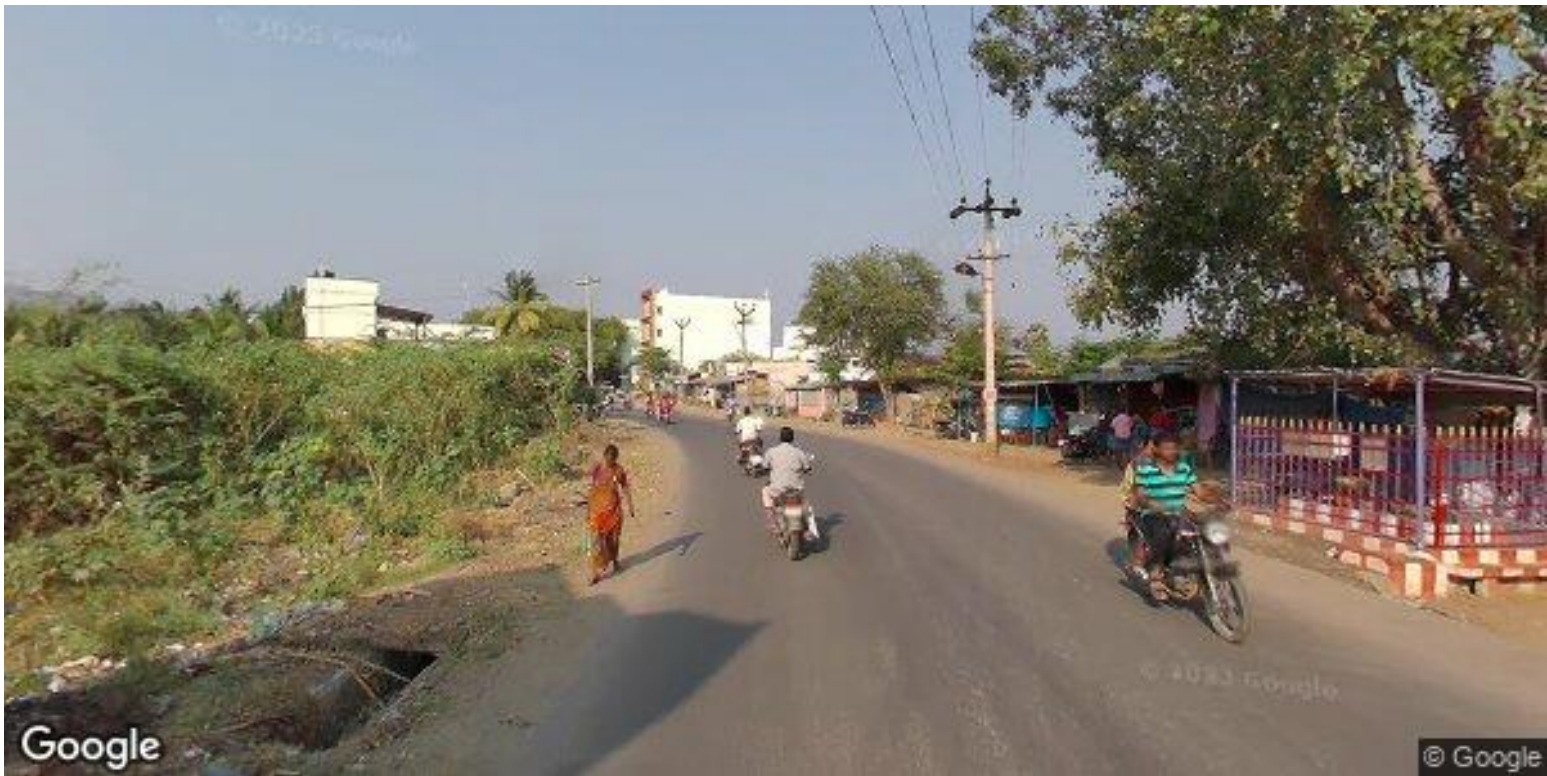
**Risk Type:** Turn  
**Risk Level:** Medium  
**Speed Limit:** 30 KM/Hr  
**Coordinates:** 11.87088, 78.08556

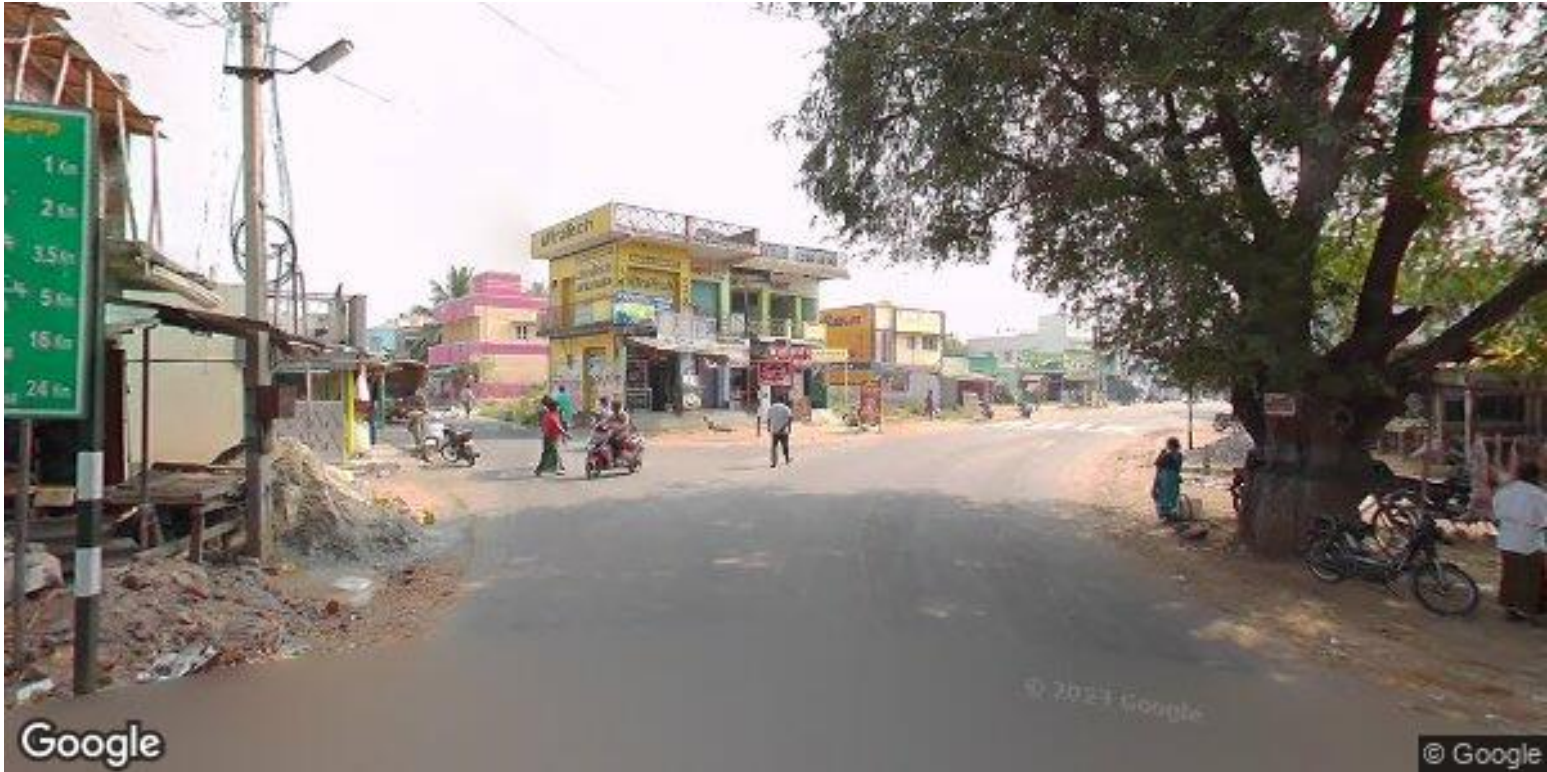
**Risk Type:** Turn  
**Risk Level:** High  
**Speed Limit:** 15 KM/Hr  
**Coordinates:** 11.87246, 78.08704

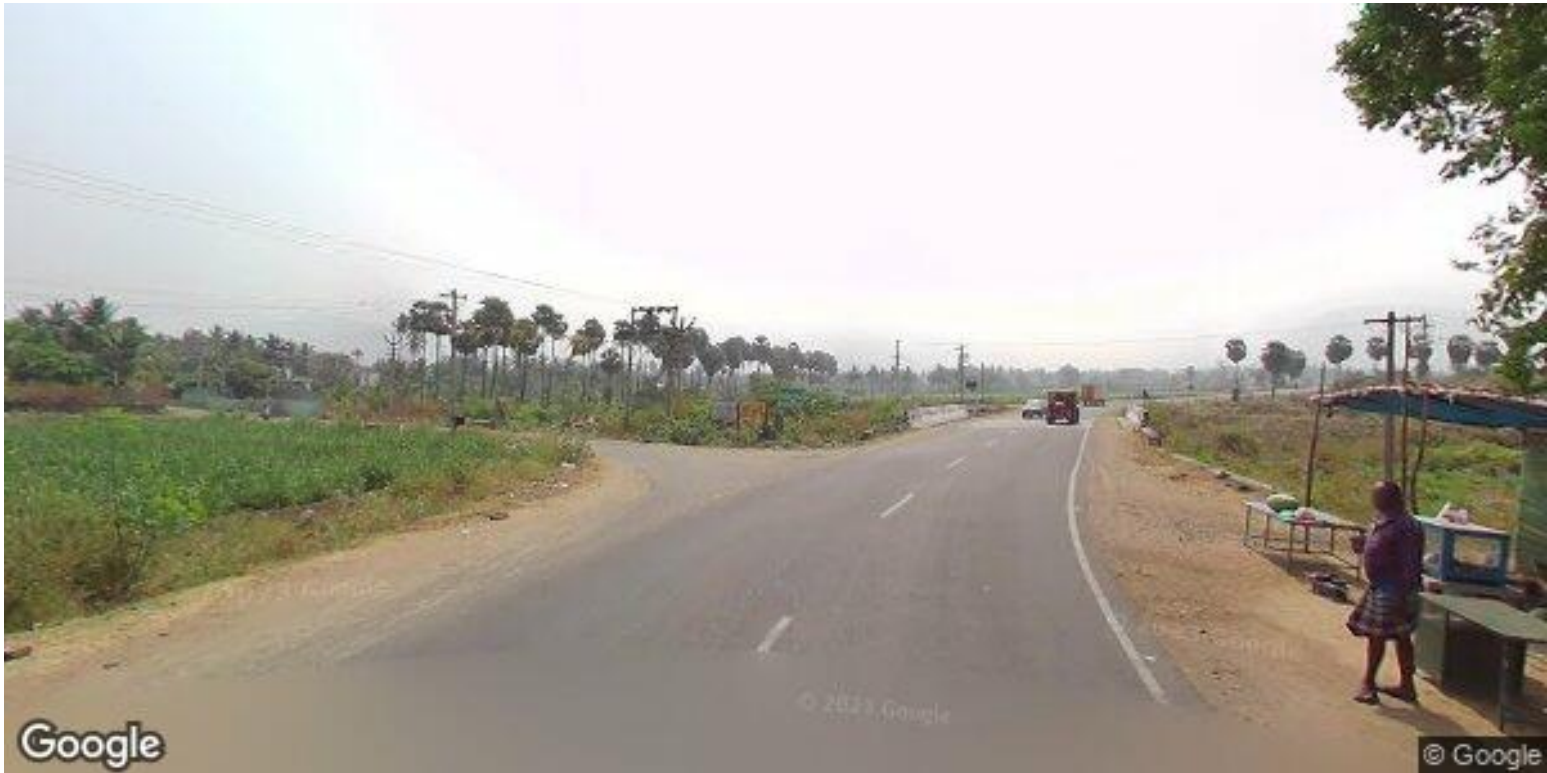
**Risk Type:** Turn  
**Risk Level:** Medium  
**Speed Limit:** 30 KM/Hr  
**Coordinates:** 11.86898, 78.12074

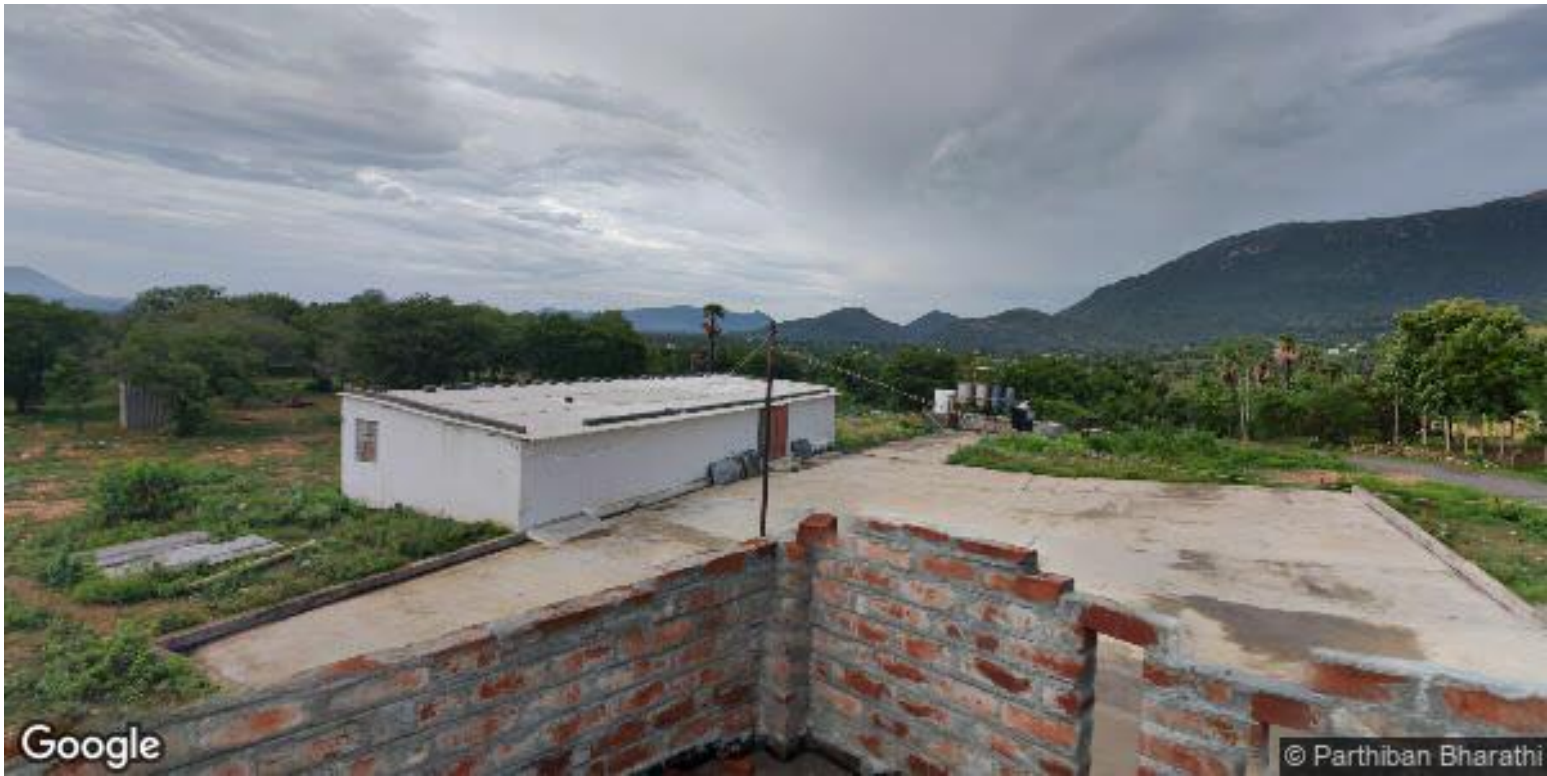
**Risk Type:** Turn  
**Risk Level:** Medium  
**Speed Limit:** 30 KM/Hr  
**Coordinates:** 11.95116, 78.20647

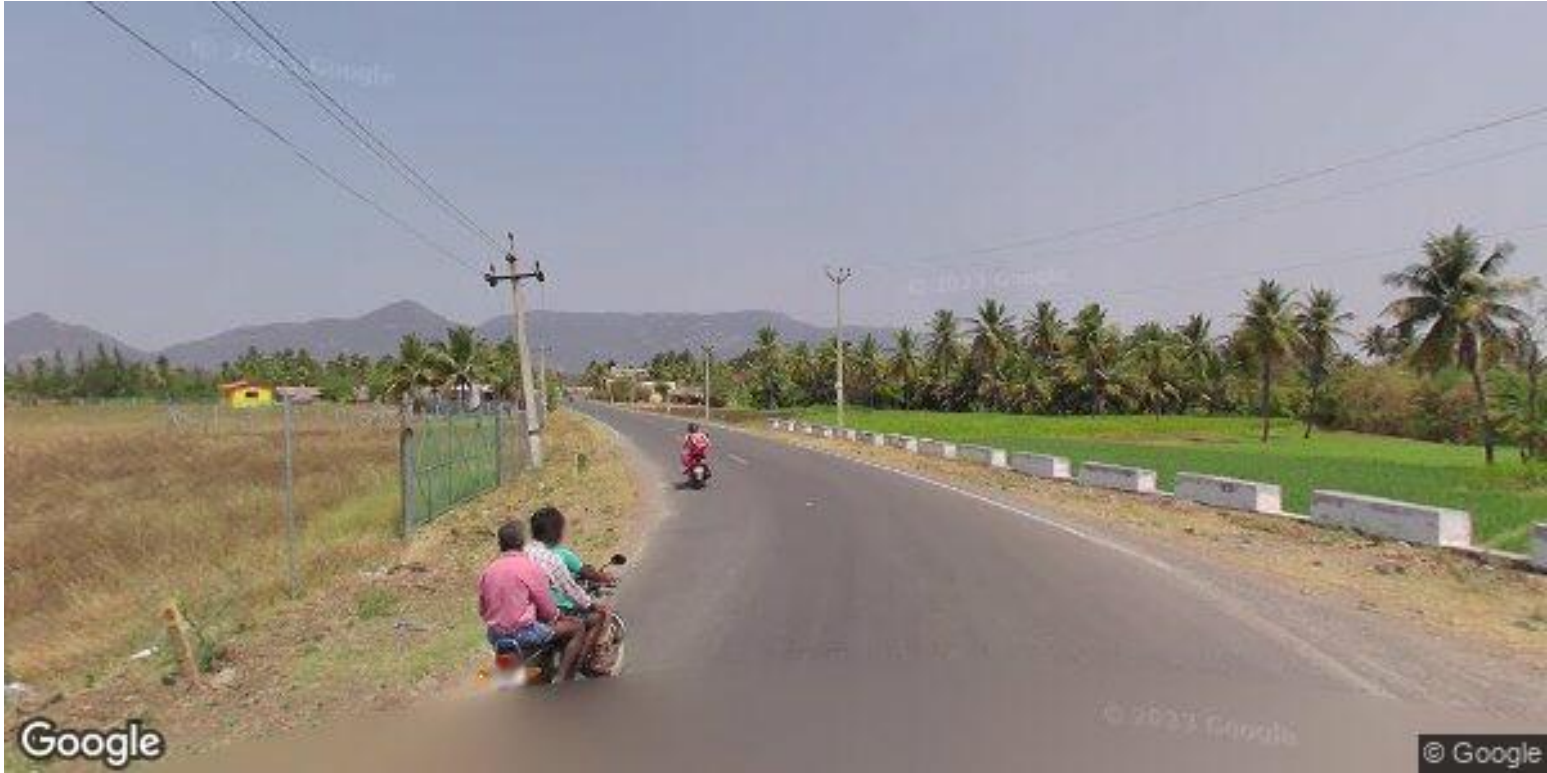
**Risk Type:** Turn  
**Risk Level:** High  
**Speed Limit:** 15 KM/Hr  
**Coordinates:** 11.97329, 78.23713

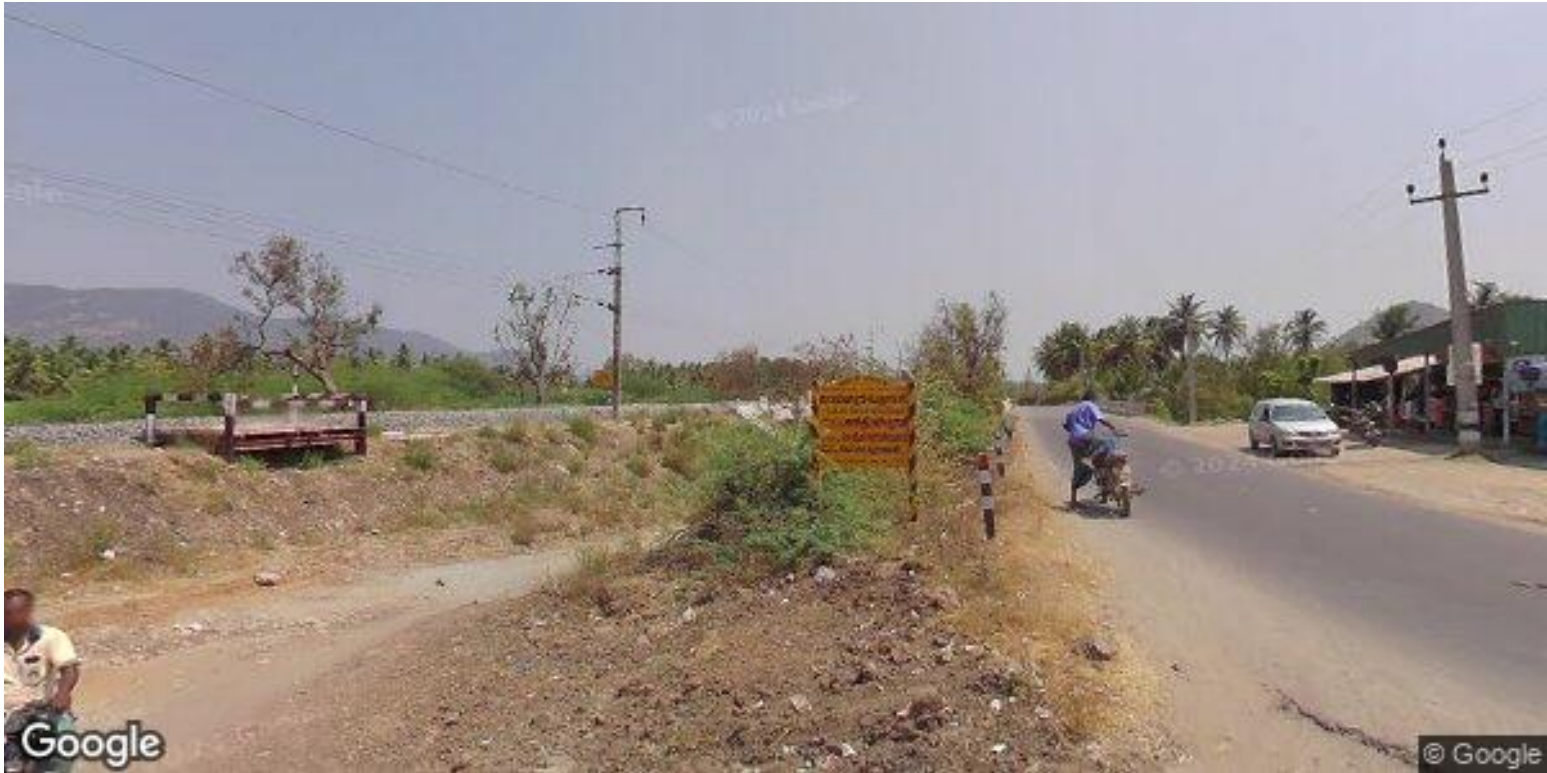
Risk Type: Turn

Risk Level: High

Speed Limit: 15 KM/Hr

Coordinates: 11.97765, 78.23556
