## JOURNEY RISK MANAGEMENT (JRM) STUDY

### Salem Terminal TO PRANAV AGENCY

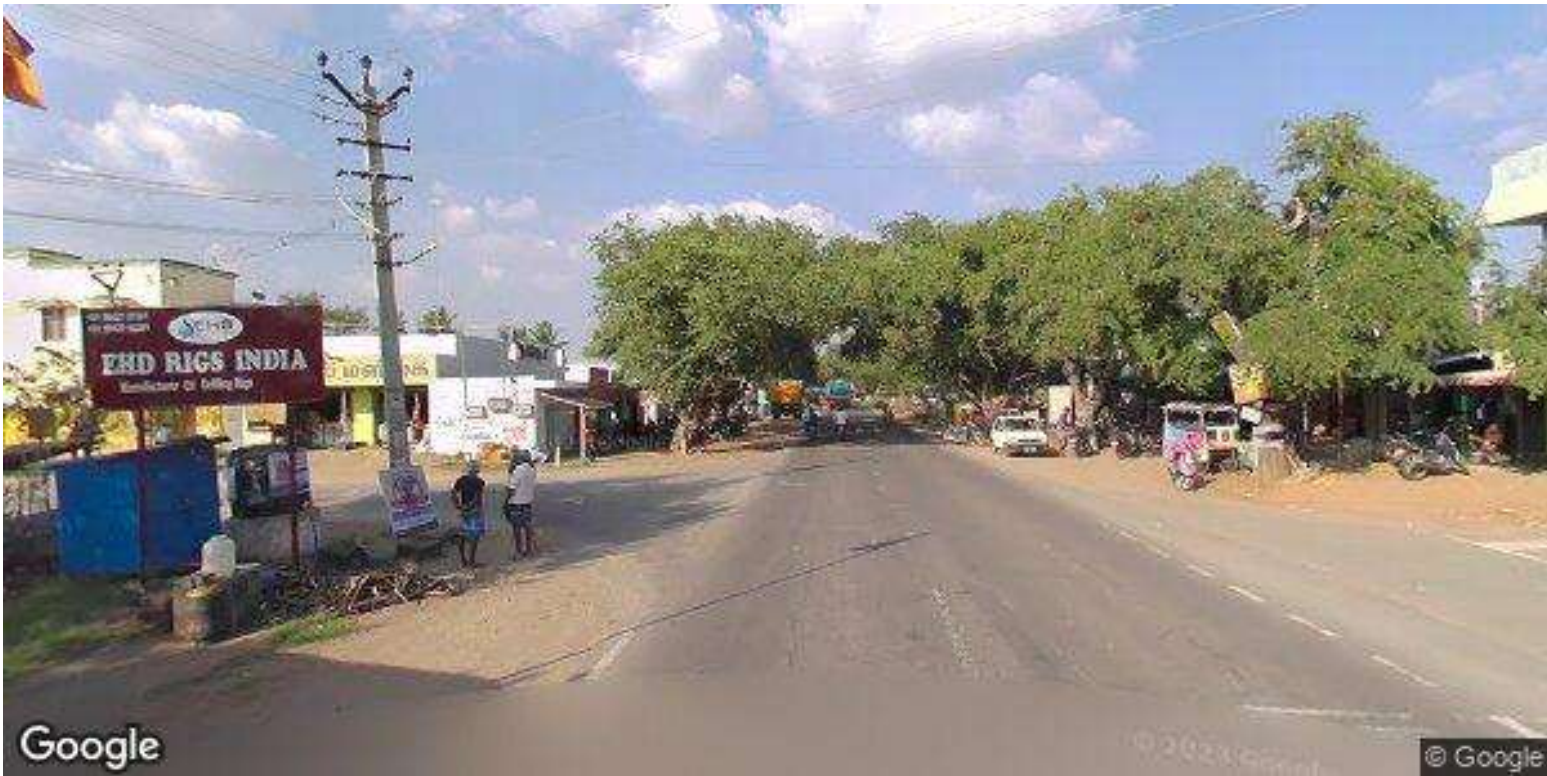
| | Risk Type | Risk Level | Coordinates | Speed Limit |
|---|---|---|---|---|
| 4 | Blind Spot | Blind Spot | 11.41975, 77.88075 | 10 KM/Hr |

Risk Type: Blind Spot  
Risk Level: Blind Spot  
Speed Limit: 10 KM/Hr  
Coordinates: 11.41975, 77.88075

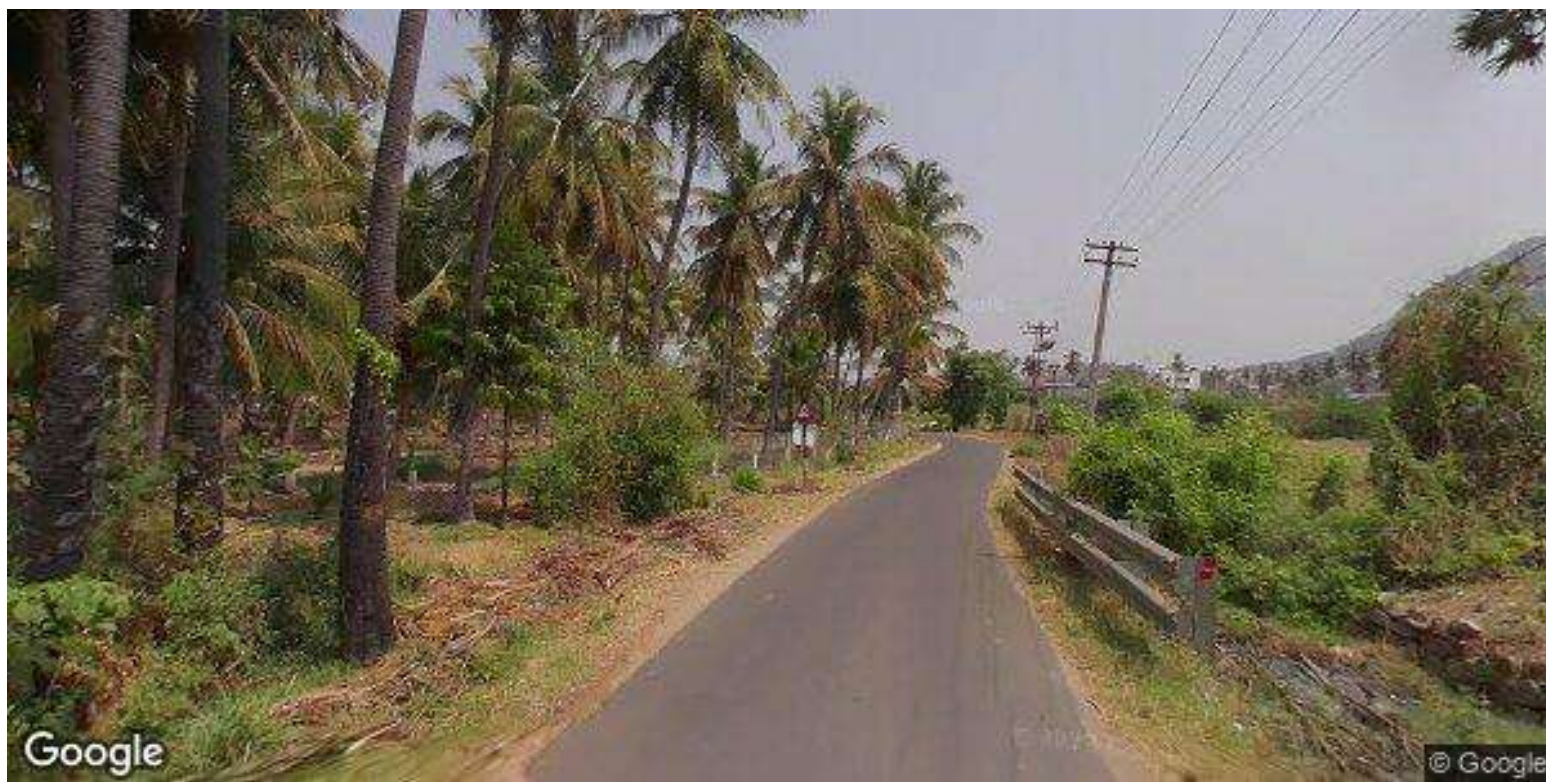
**Coordinates:** 11.41876, 77.88487

**Risk Type:** Turn

**Risk Level:** Medium

**Speed Limit:** 30 KM/Hr

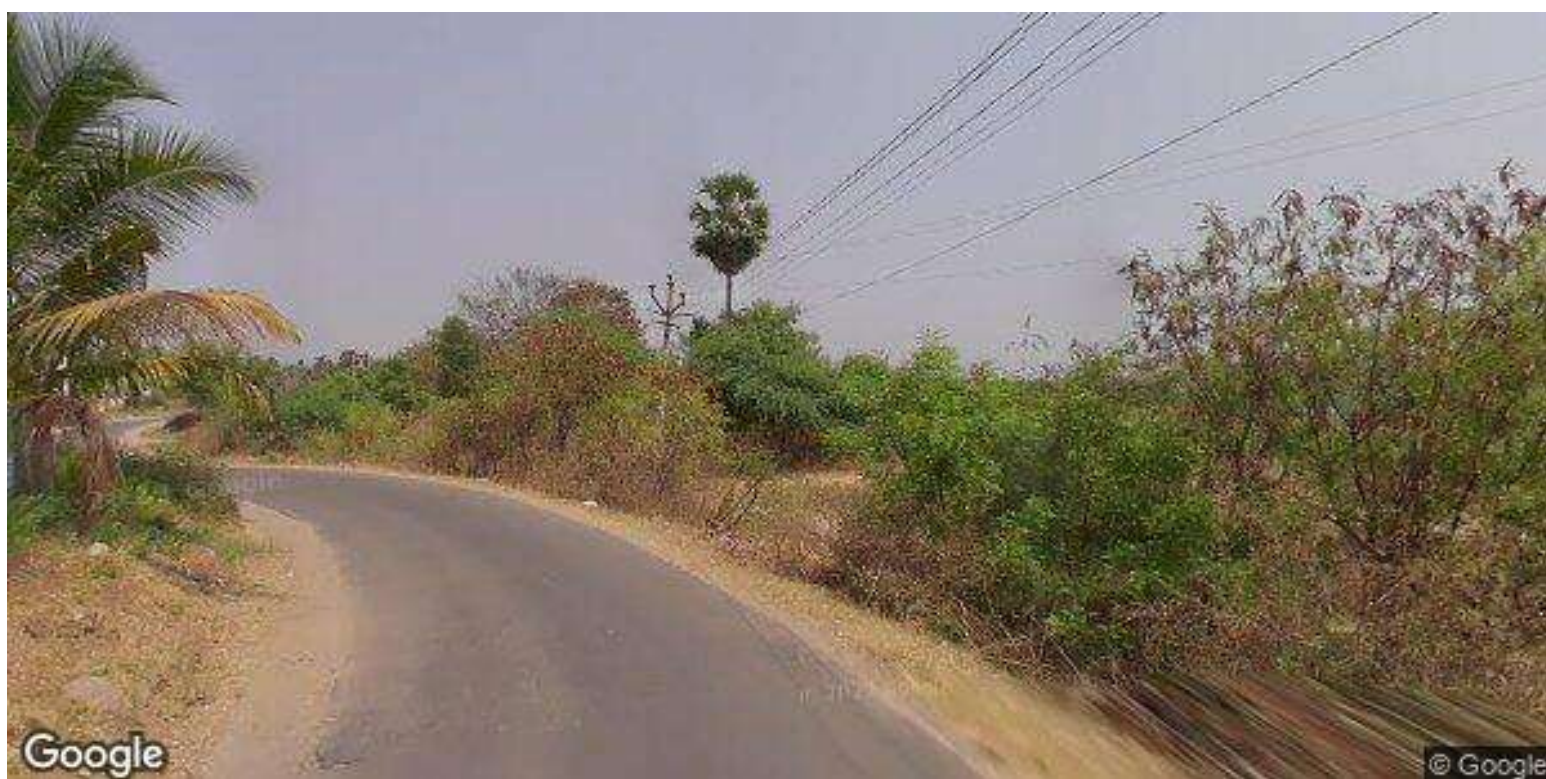
**Coordinates:** 11.41829, 77.88568

**Risk Type:** Turn

**Risk Level:** Medium

**Speed Limit:** 30 KM/Hr

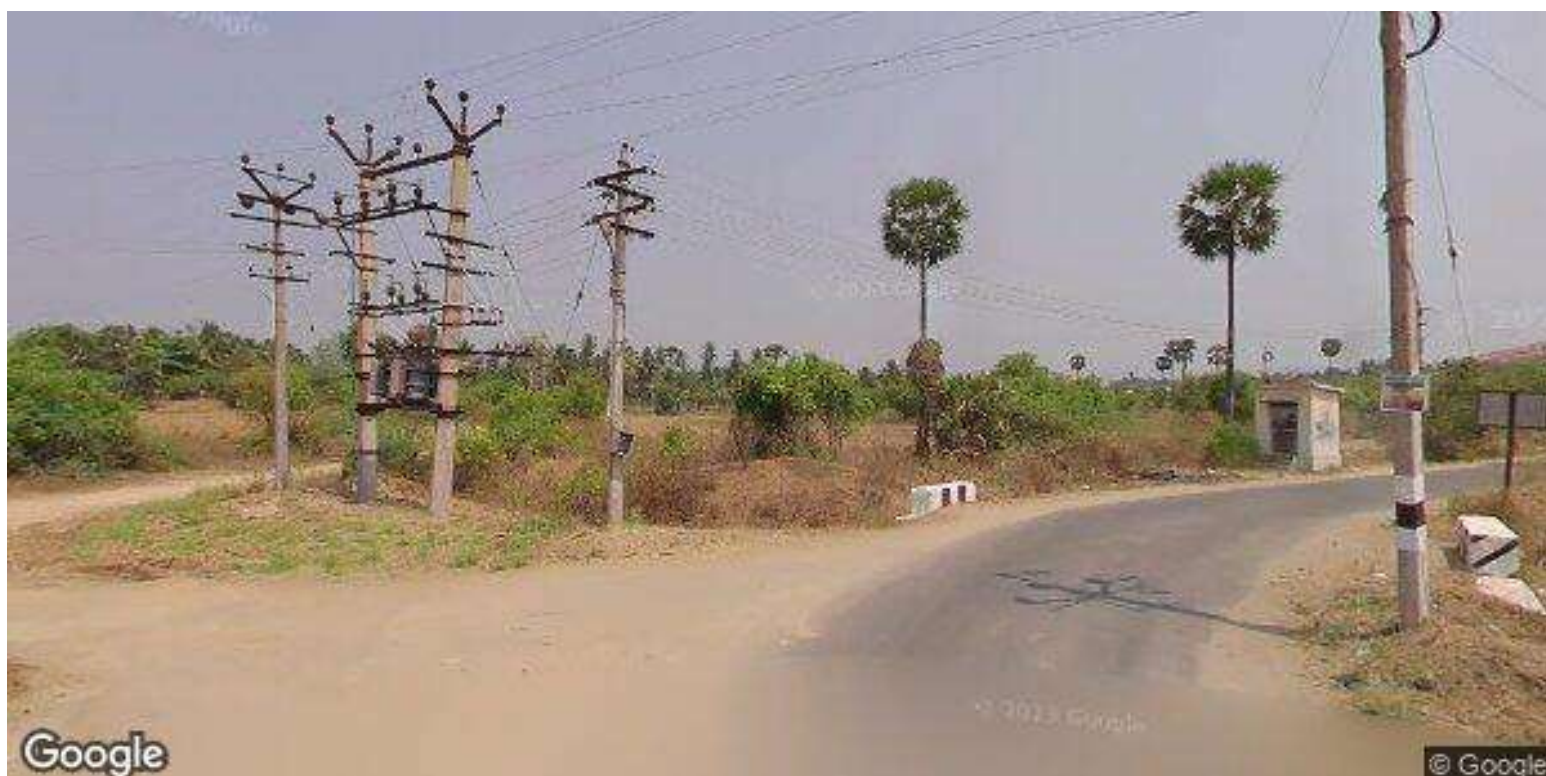
**Risk Type:** Turn  
**Risk Level:** High  
**Speed Limit:** 15 KM/Hr  
**Coordinates:** 11.41859, 77.88692

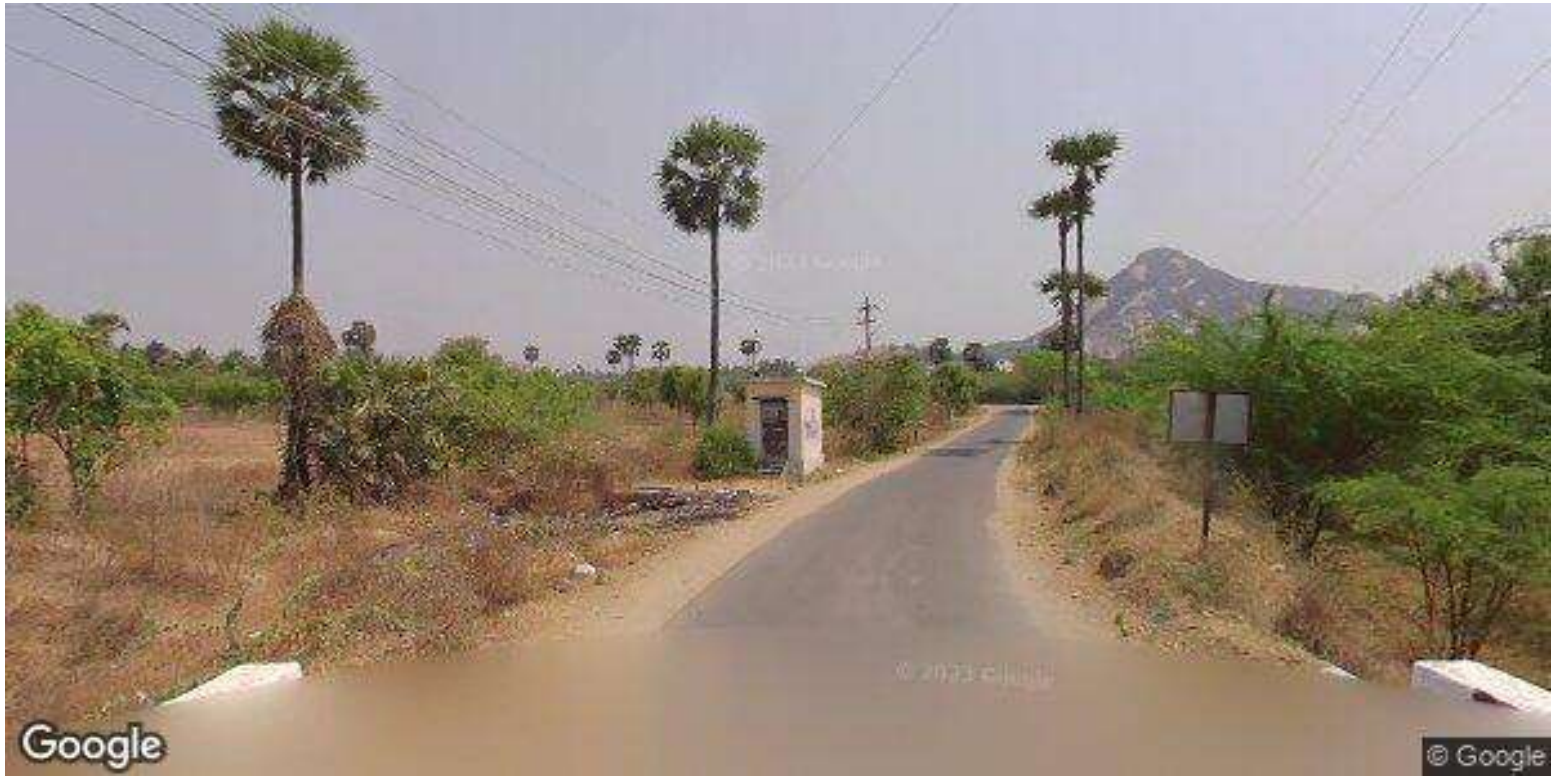
**Risk Type:** Turn  
**Risk Level:** Medium  
**Speed Limit:** 30 KM/Hr  
**Coordinates:** 11.41852, 77.88700

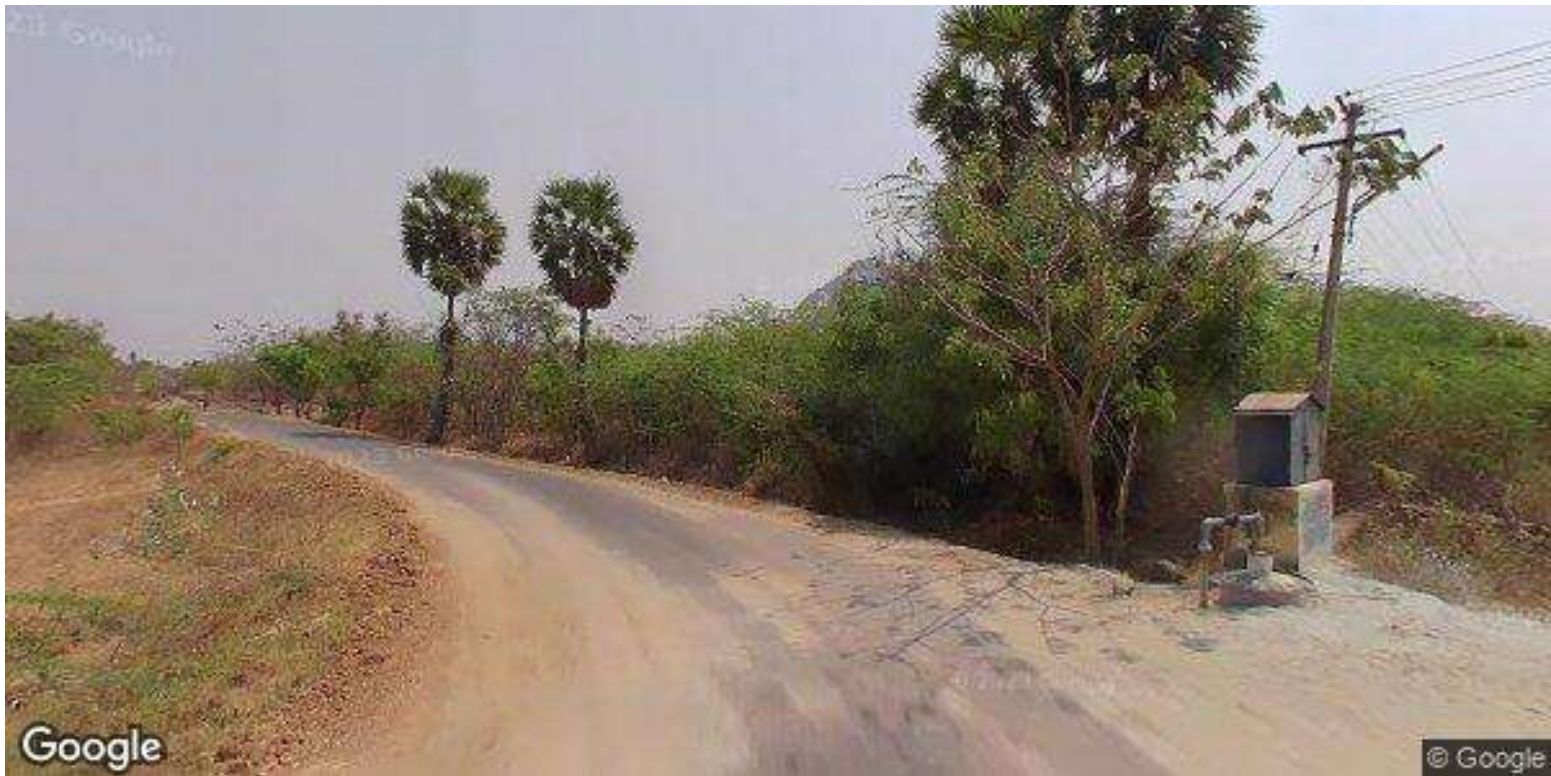
**Risk Type:** Turn  
**Risk Level:** Medium  
**Speed Limit:** 30 KM/Hr  
**Coordinates:** 11.41769, 77.88730

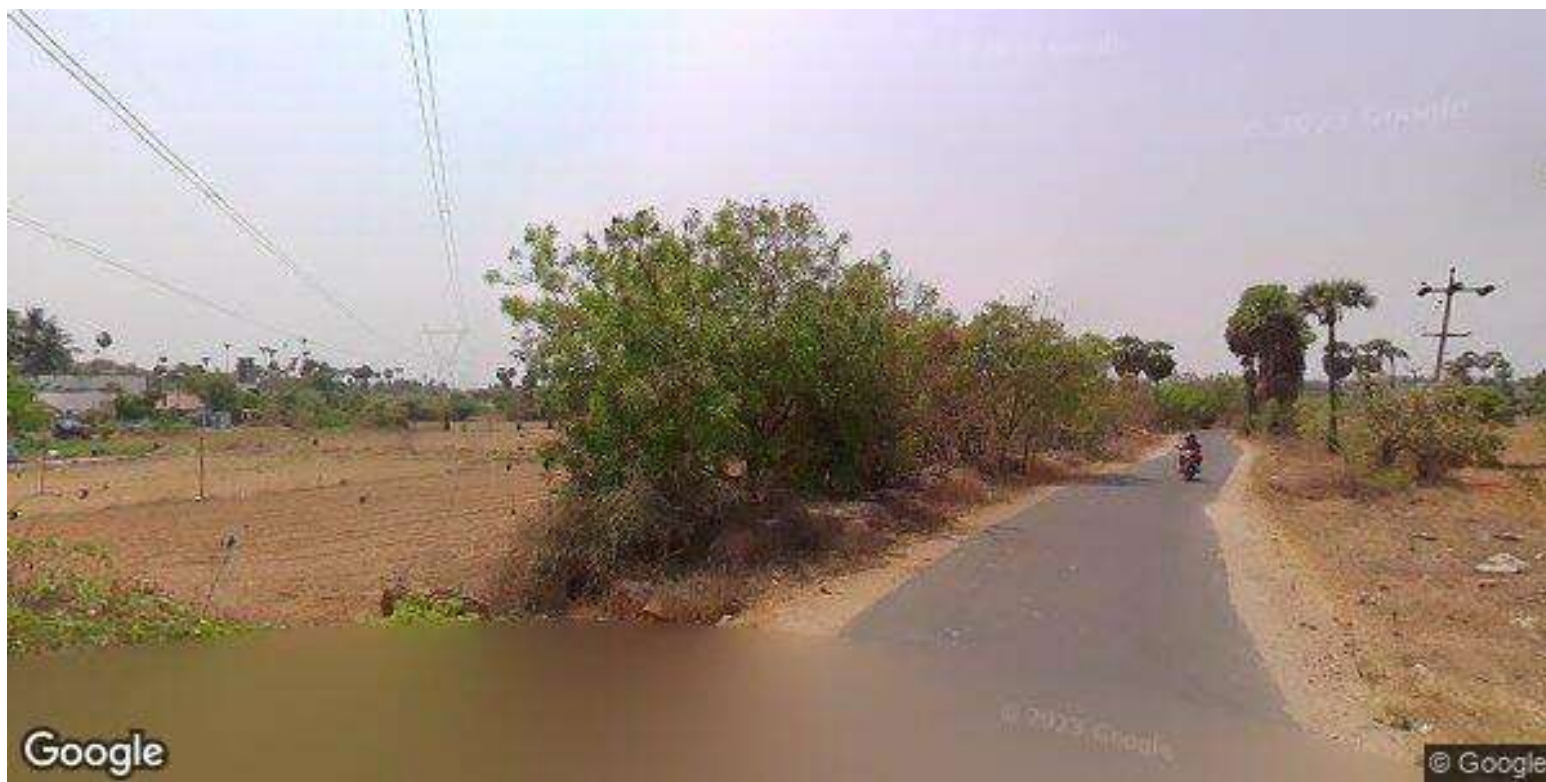
**Coordinates:** 11.41630, 77.89077

**Risk Type:** Turn

**Risk Level:** Medium

**Speed Limit:** 30 KM/Hr

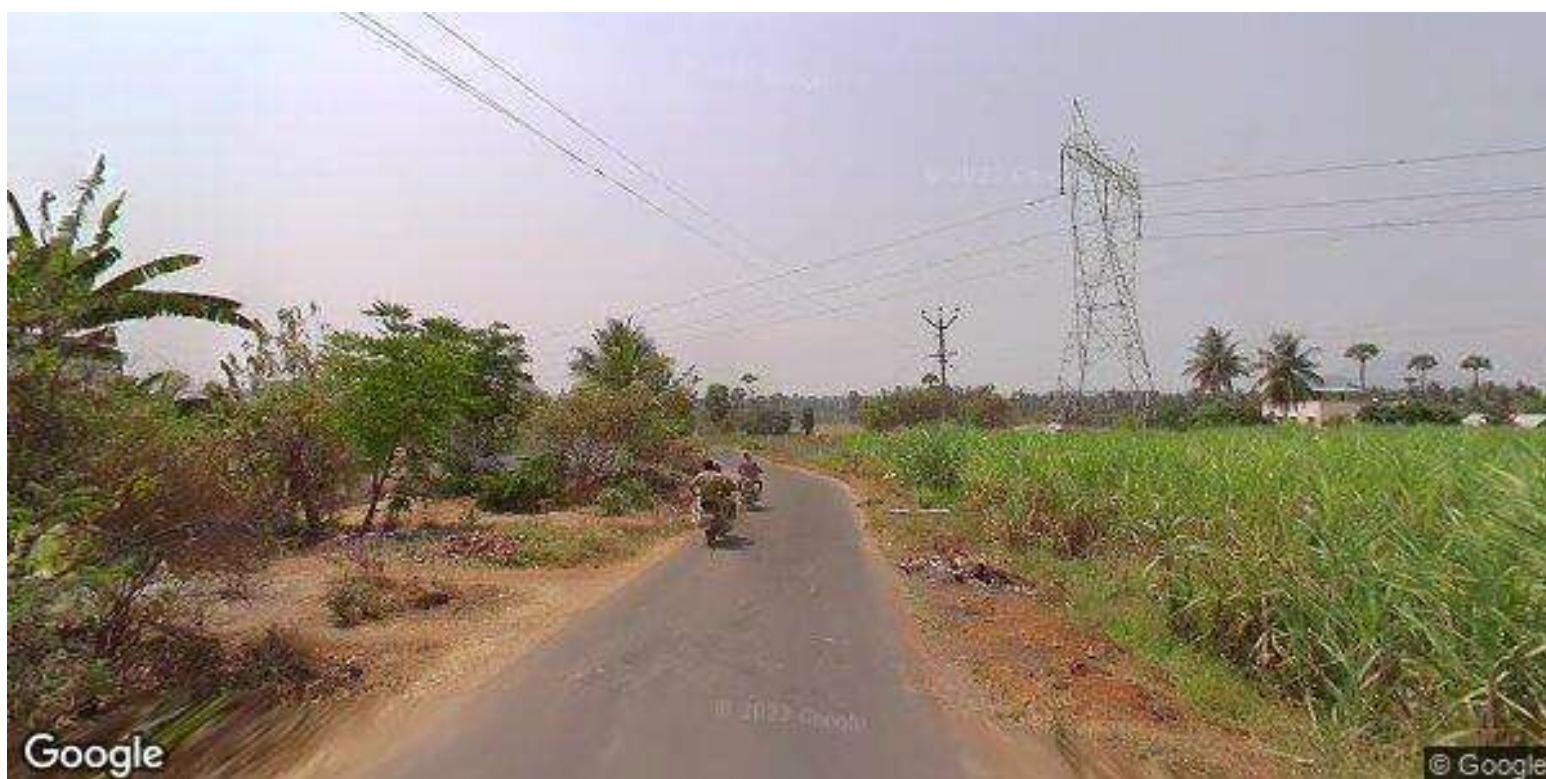
**Coordinates:** 11.41601, 77.89198

**Risk Type:** Turn

**Risk Level:** Medium

**Speed Limit:** 30 KM/Hr

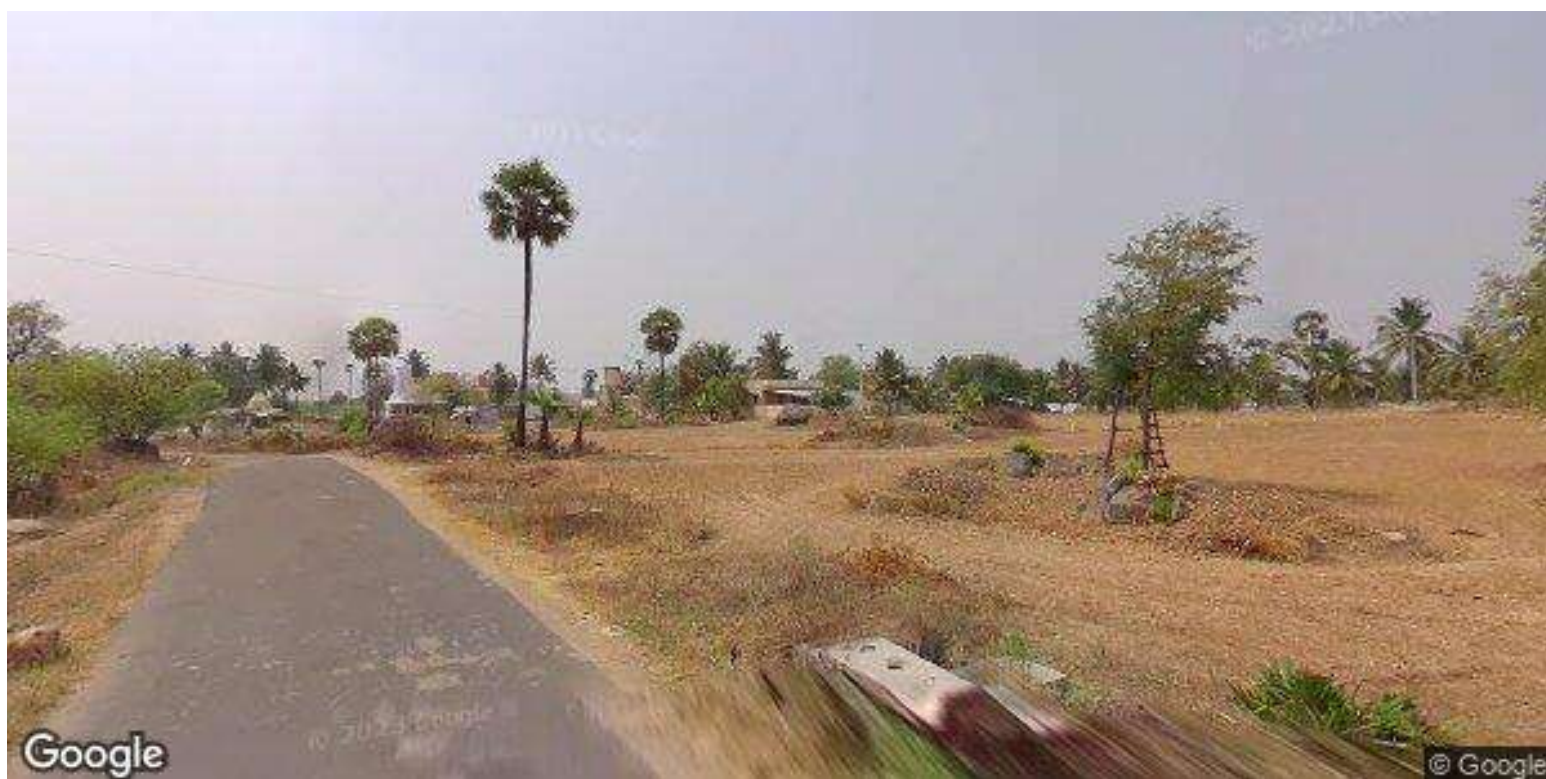
**Risk Type:** Turn  
**Risk Level:** Medium  
**Speed Limit:** 30 KM/Hr  
**Coordinates:** 11.41603, 77.89479

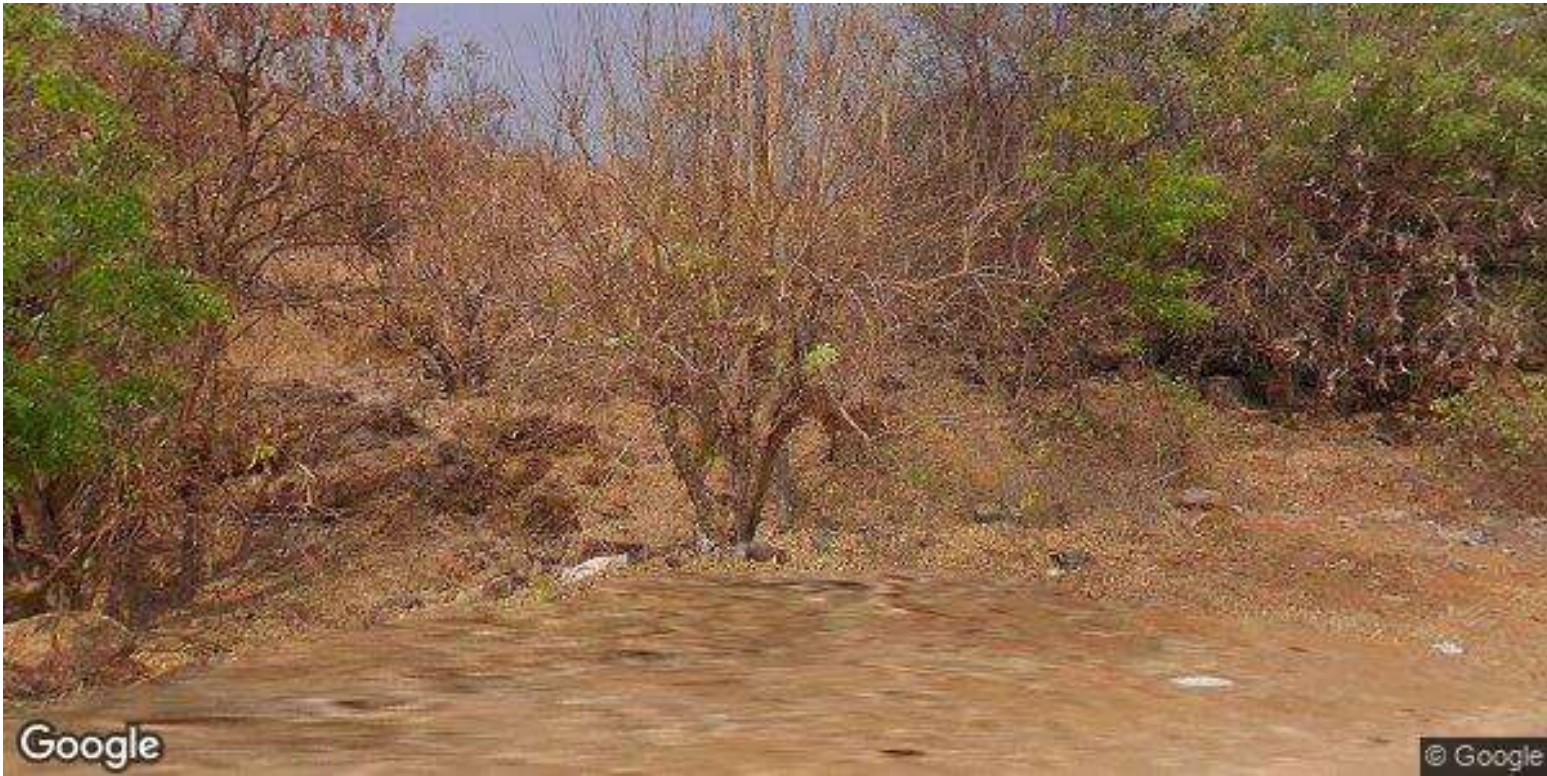
**Risk Type:** Turn  
**Risk Level:** Medium  
**Speed Limit:** 30 KM/Hr  
**Coordinates:** 11.41439, 77.90025

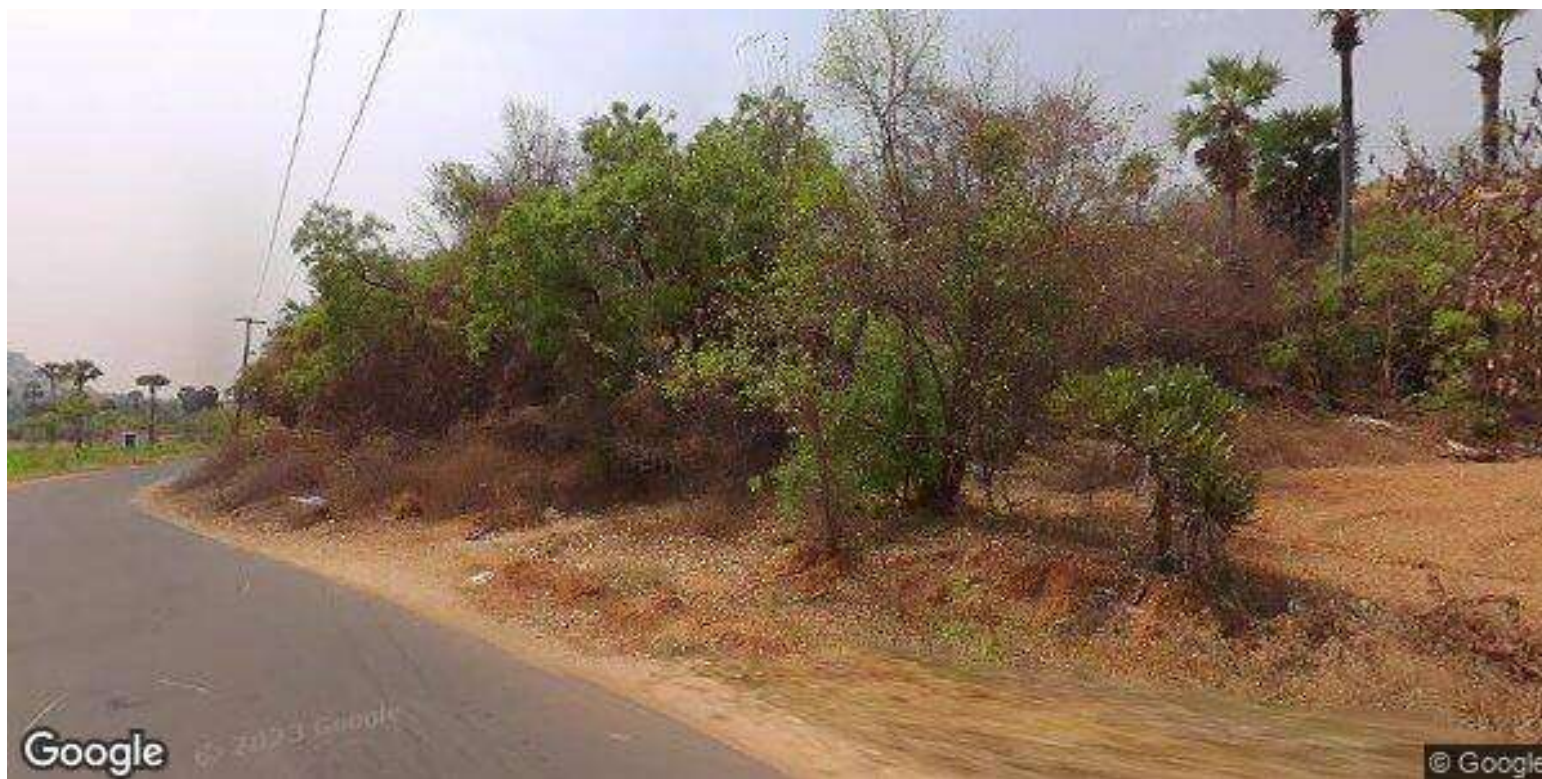
**Coordinates:** 11.41389, 77.90161

**Risk Type:** Turn

**Risk Level:** Medium

**Speed Limit:** 30 KM/Hr

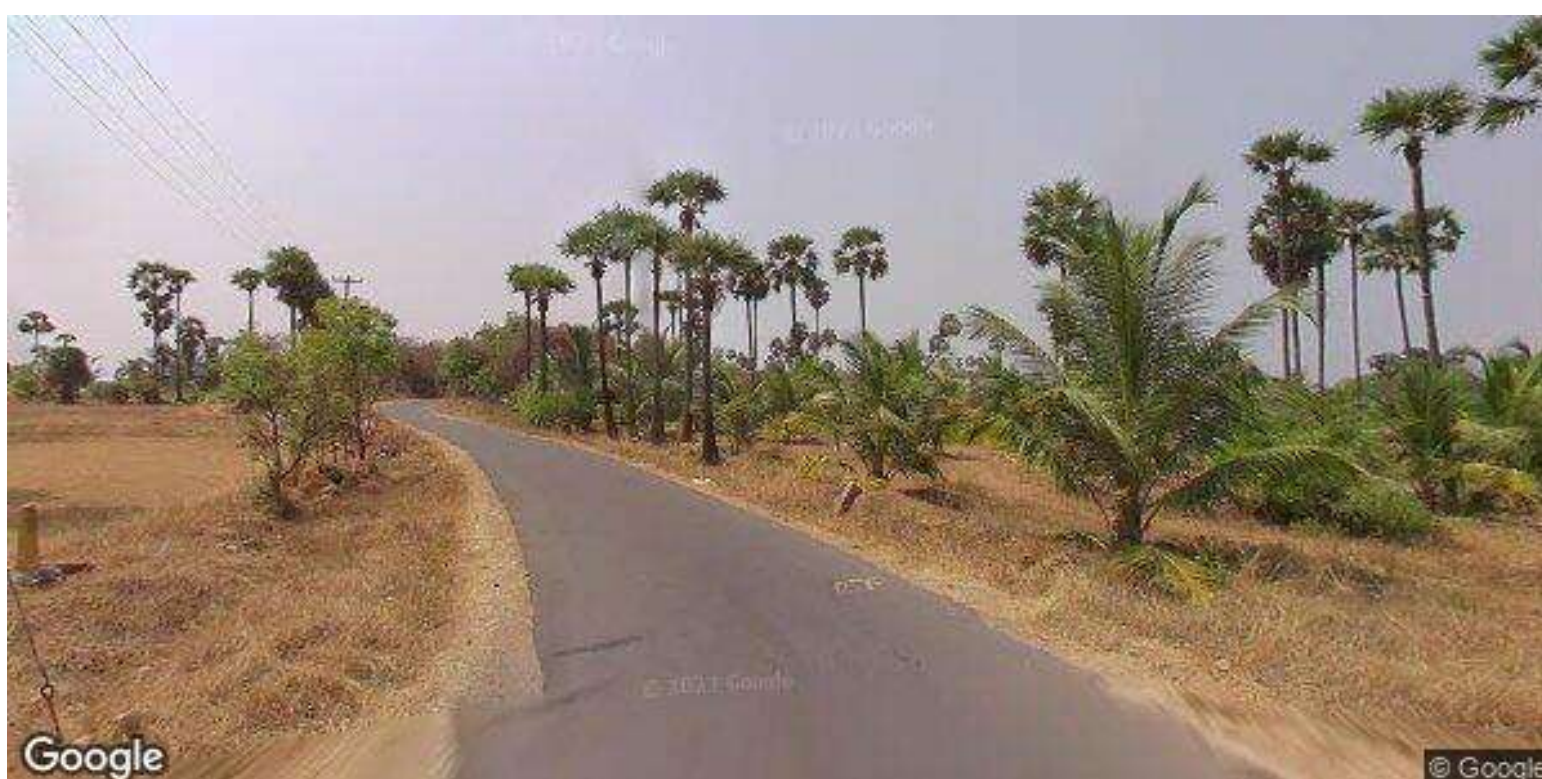
**Coordinates:** 11.41325, 77.90313

**Risk Type:** Turn

**Risk Level:** Medium

**Speed Limit:** 30 KM/Hr

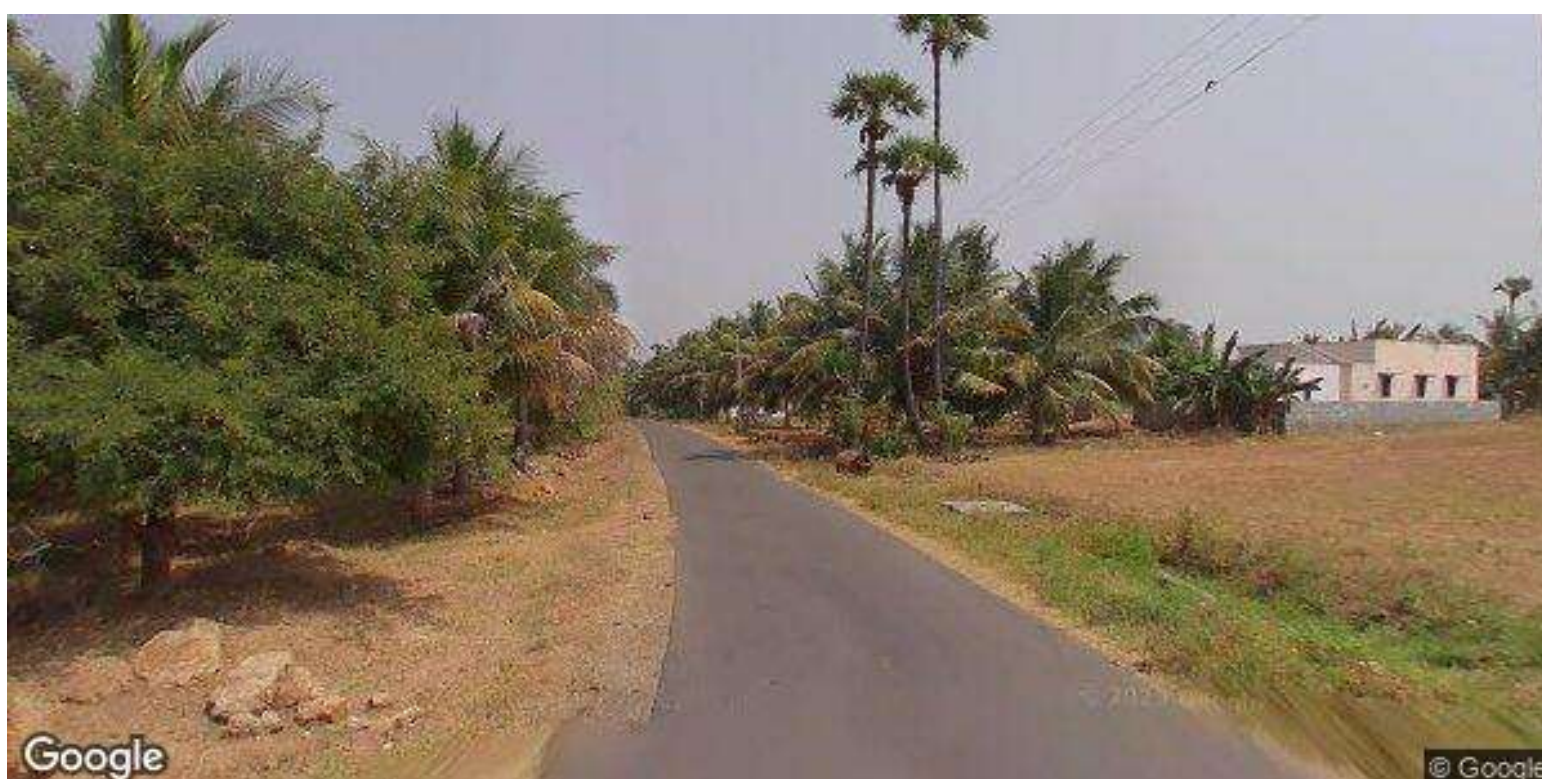
**Risk Type:** Turn  
**Risk Level:** Medium  
**Speed Limit:** 30 KM/Hr  
**Coordinates:** 11.41276, 77.90349

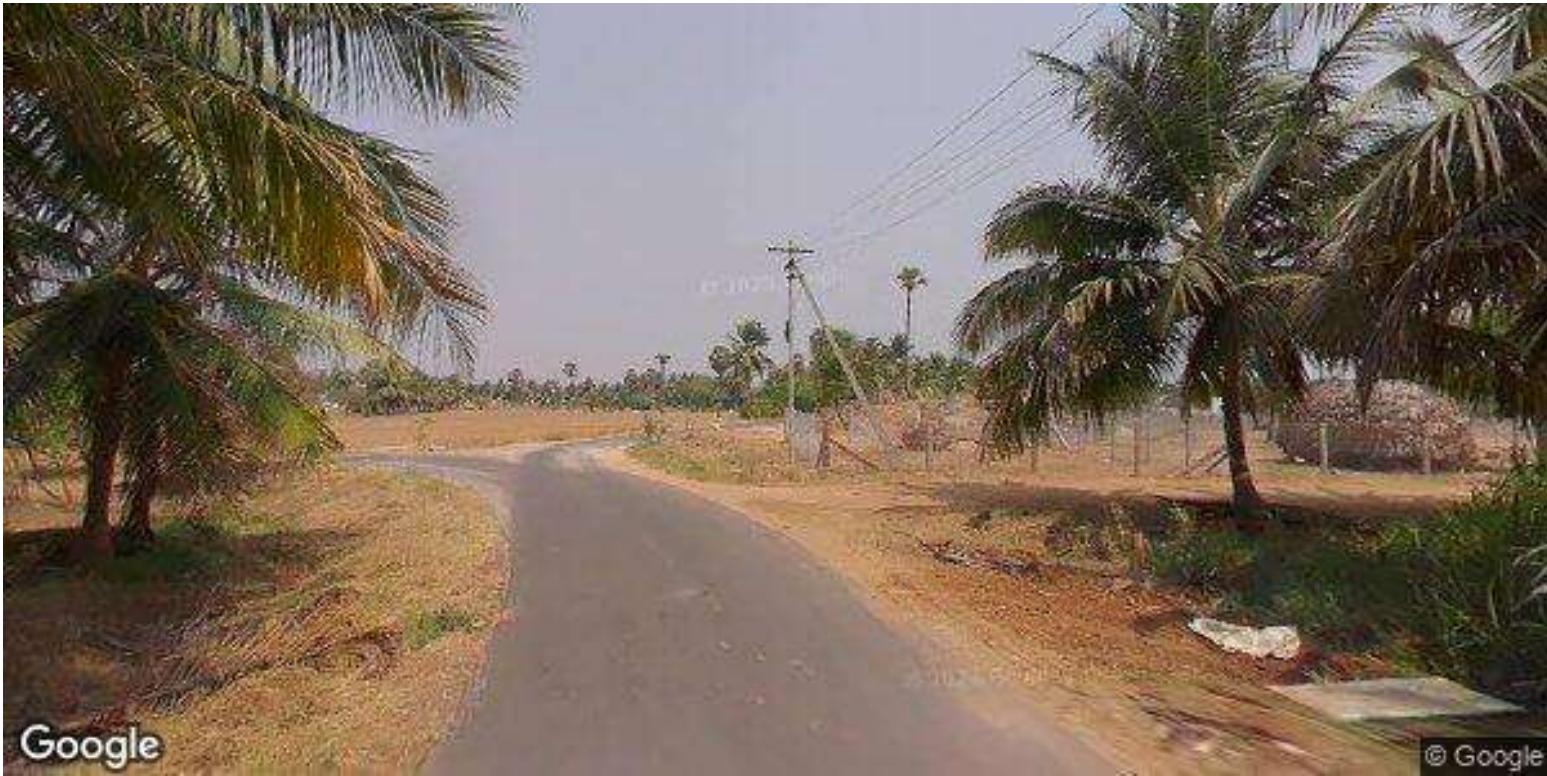
**Risk Type:** Turn  
**Risk Level:** Medium  
**Speed Limit:** 30 KM/Hr  
**Coordinates:** 11.41227, 77.90470

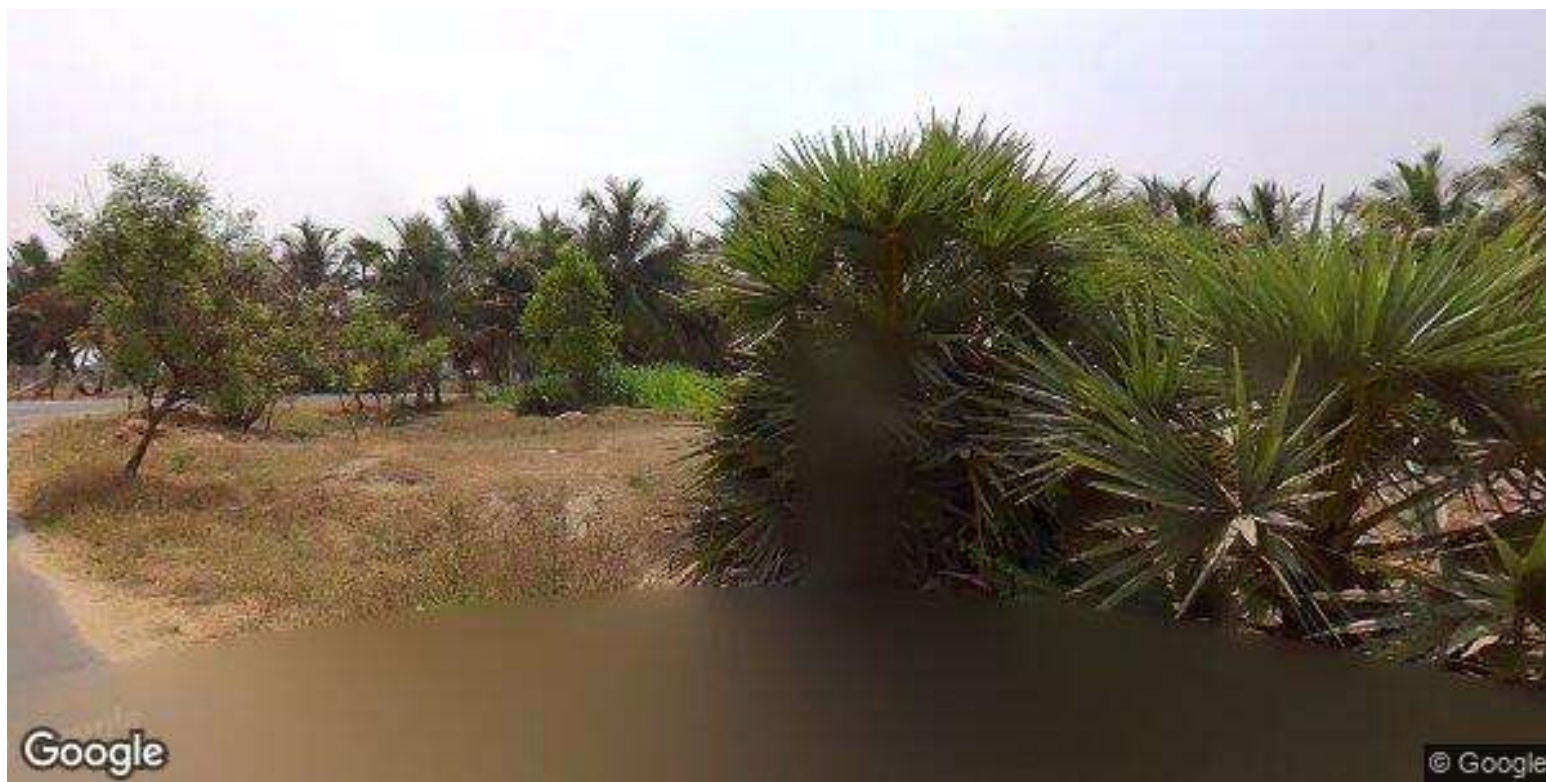
**Coordinates:** 11.41262, 77.90506

**Risk Type:** Turn

**Risk Level:** Medium

**Speed Limit:** 30 KM/Hr

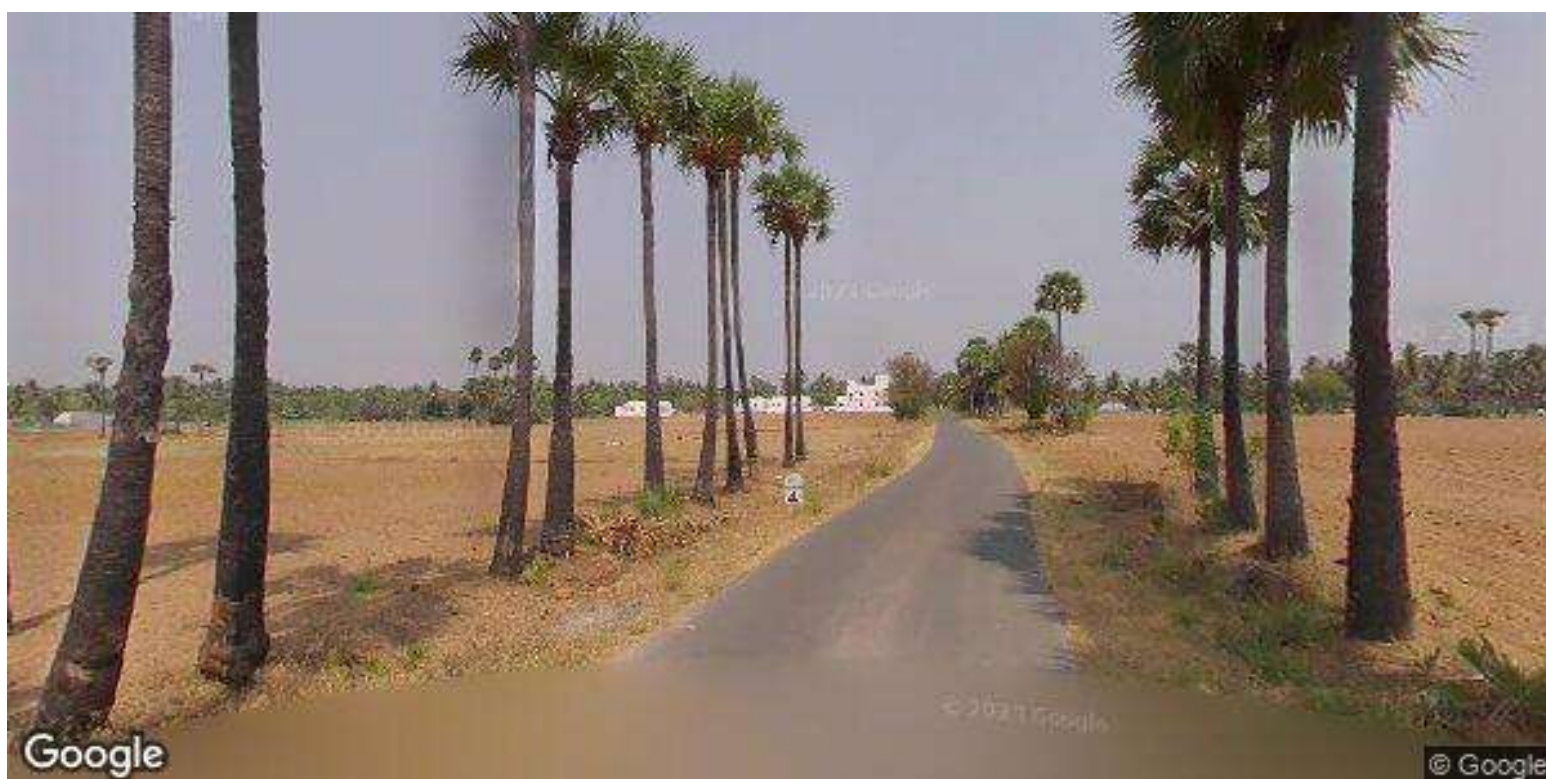
**Coordinates:** 11.41273, 77.90524

**Risk Type:** Turn

**Risk Level:** Medium

**Speed Limit:** 30 KM/Hr

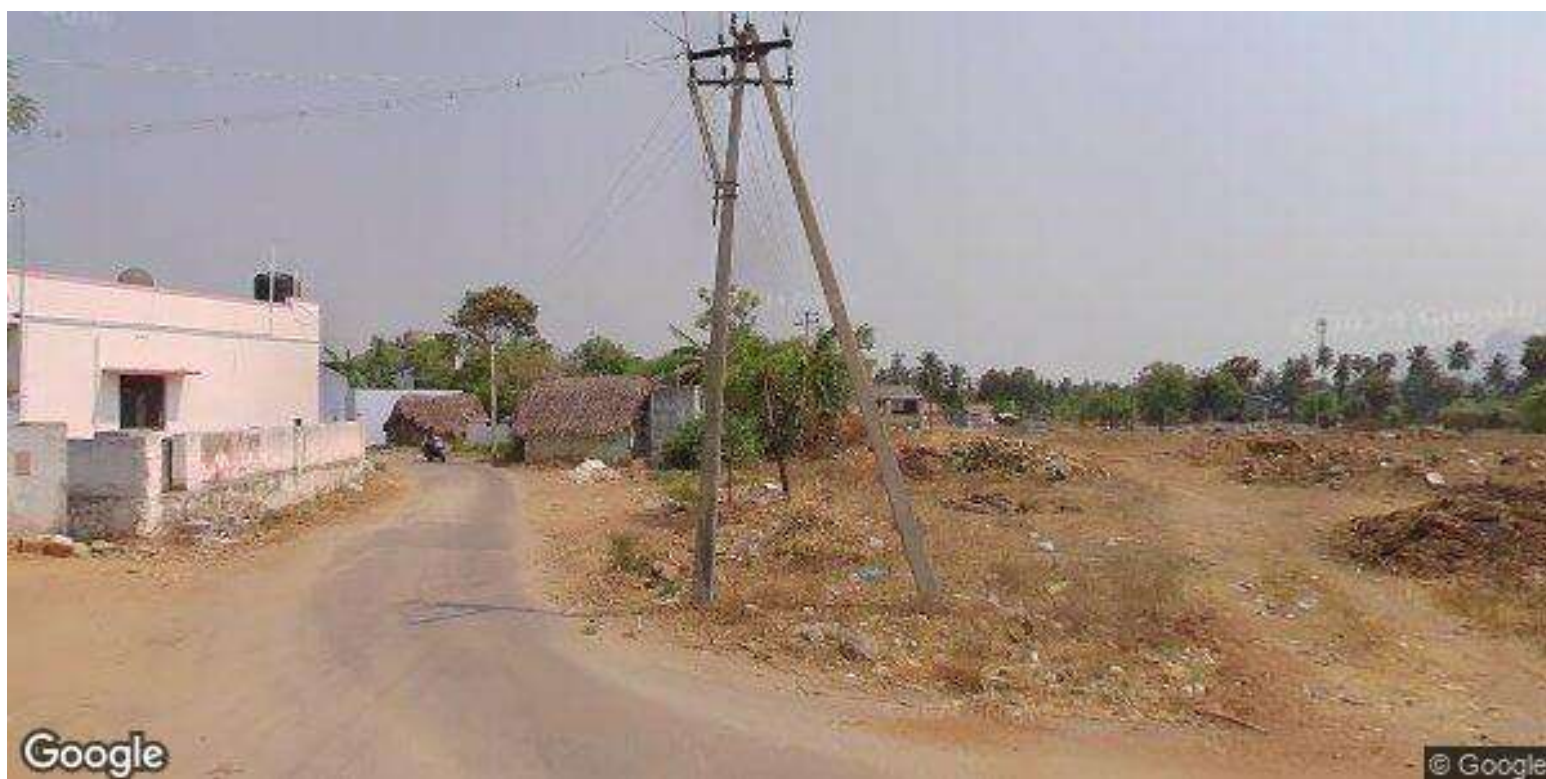
**Coordinates: 11.41329, 77.90978**

**Risk Type: Turn**

**Risk Level: High**

**Speed Limit: 15 KM/Hr**

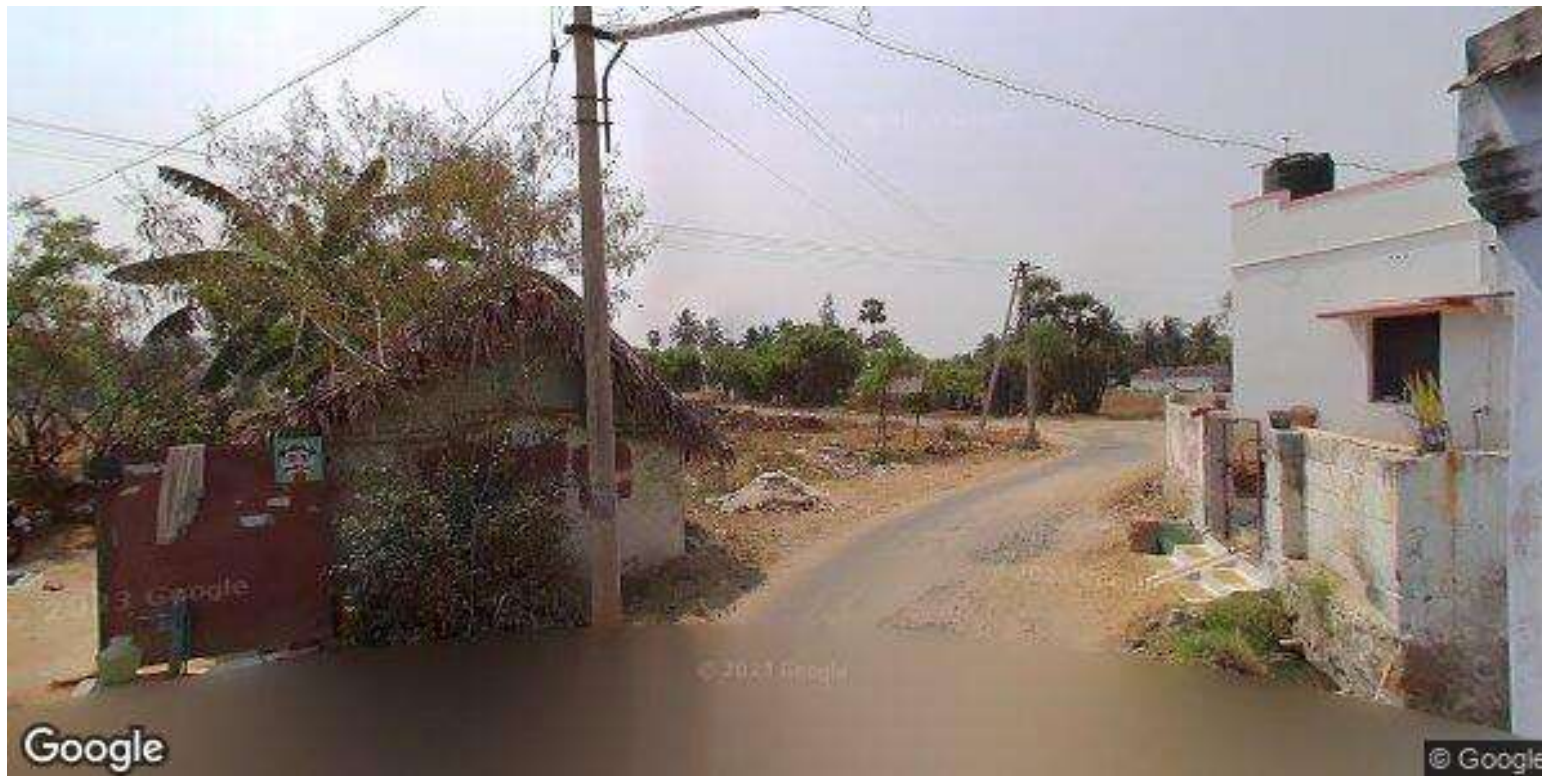
**Coordinates: 11.41314, 77.91006**

**Risk Type: Turn**

**Risk Level: Medium**

**Speed Limit: 30 KM/Hr**
