## JOURNEY RISK MANAGEMENT (JRM) STUDY

### Salem Terminal TO PRANAV AGENCY

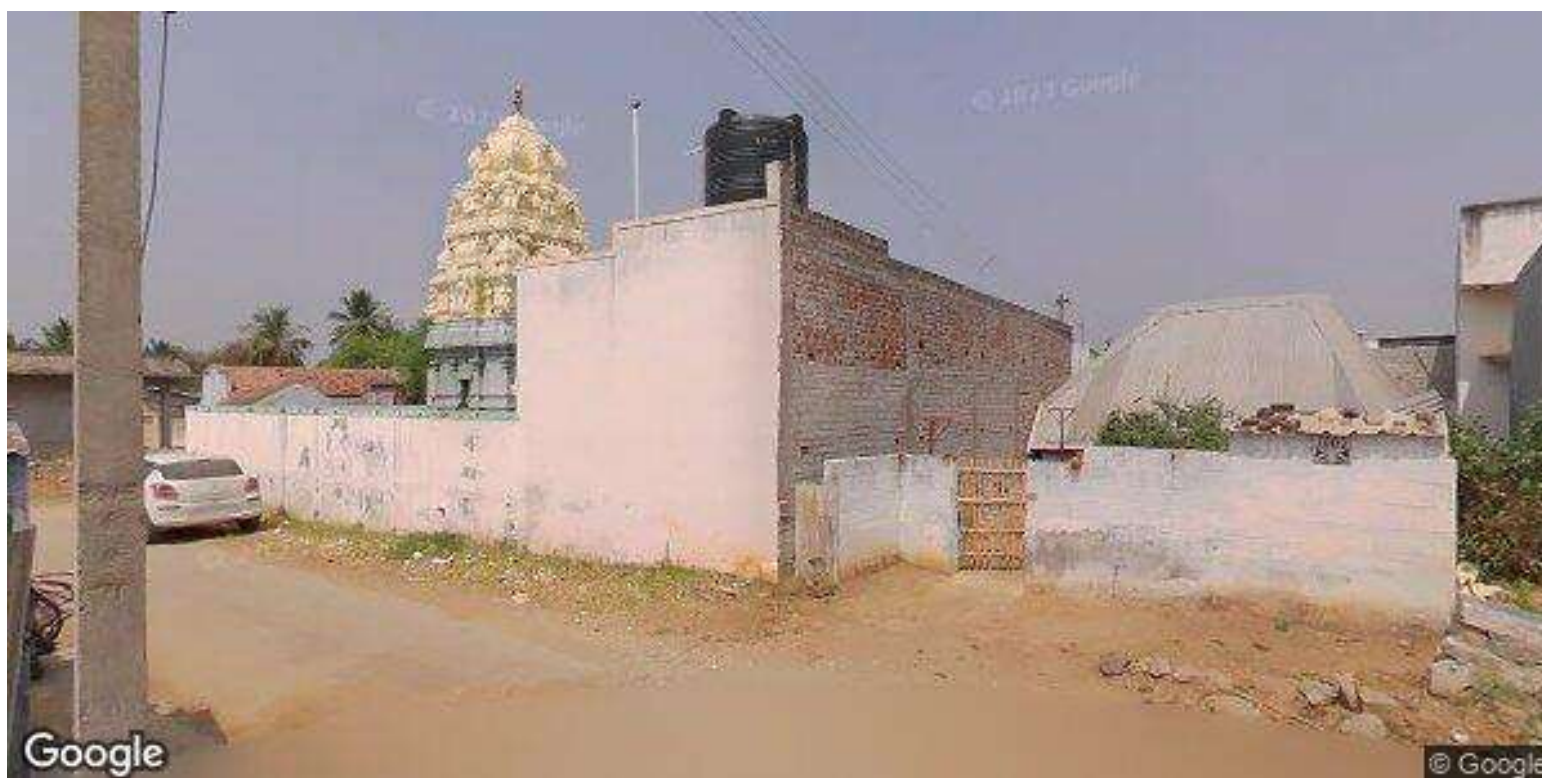
**Coordinates: 11.41313, 77.91057**

**Risk Type: Turn**

**Risk Level: High**

**Speed Limit: 15 KM/Hr**

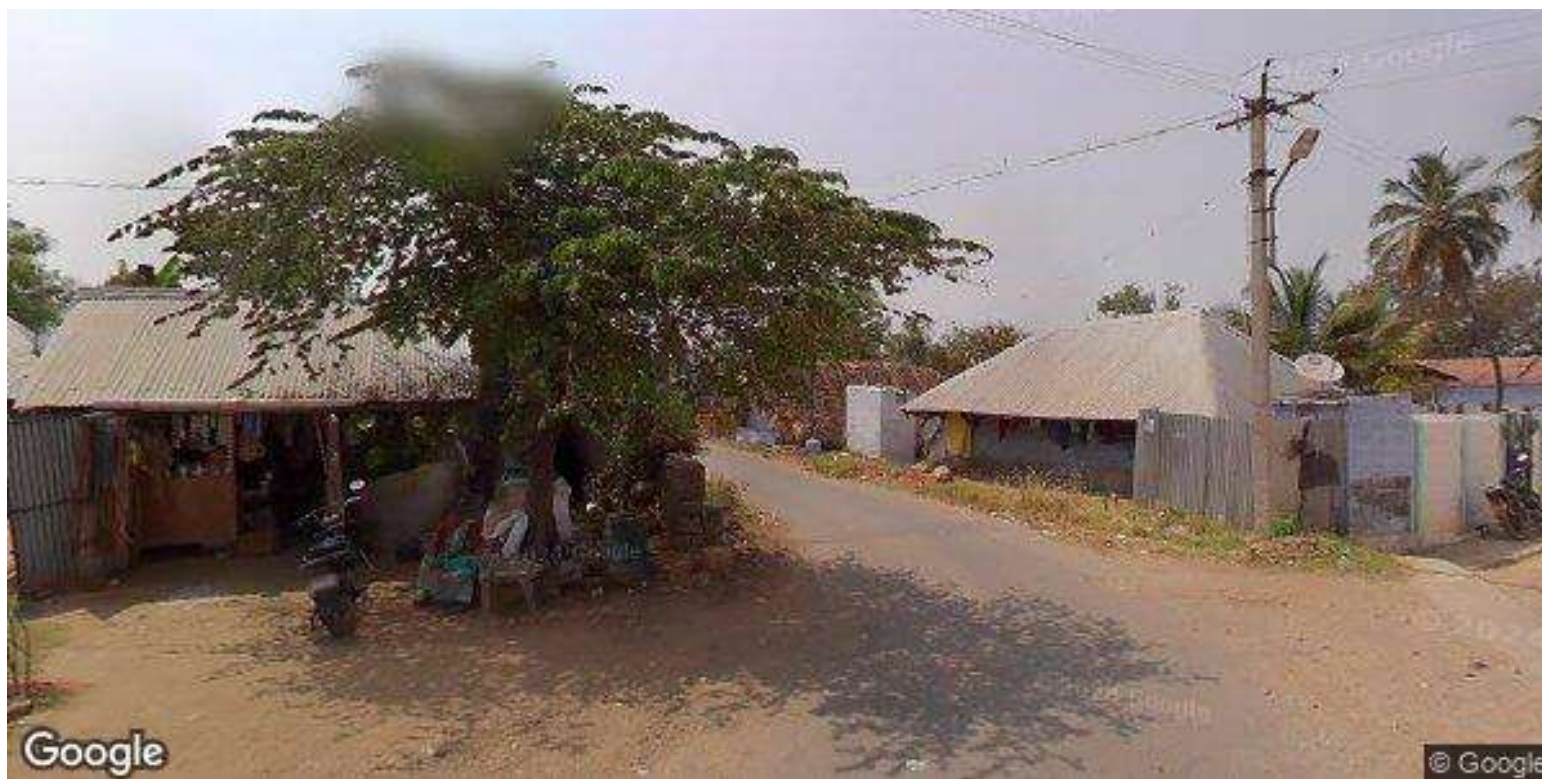
**Coordinates:** 11.41307, 77.91058

**Risk Type:** Turn

**Risk Level:** High

**Speed Limit:** 15 KM/Hr

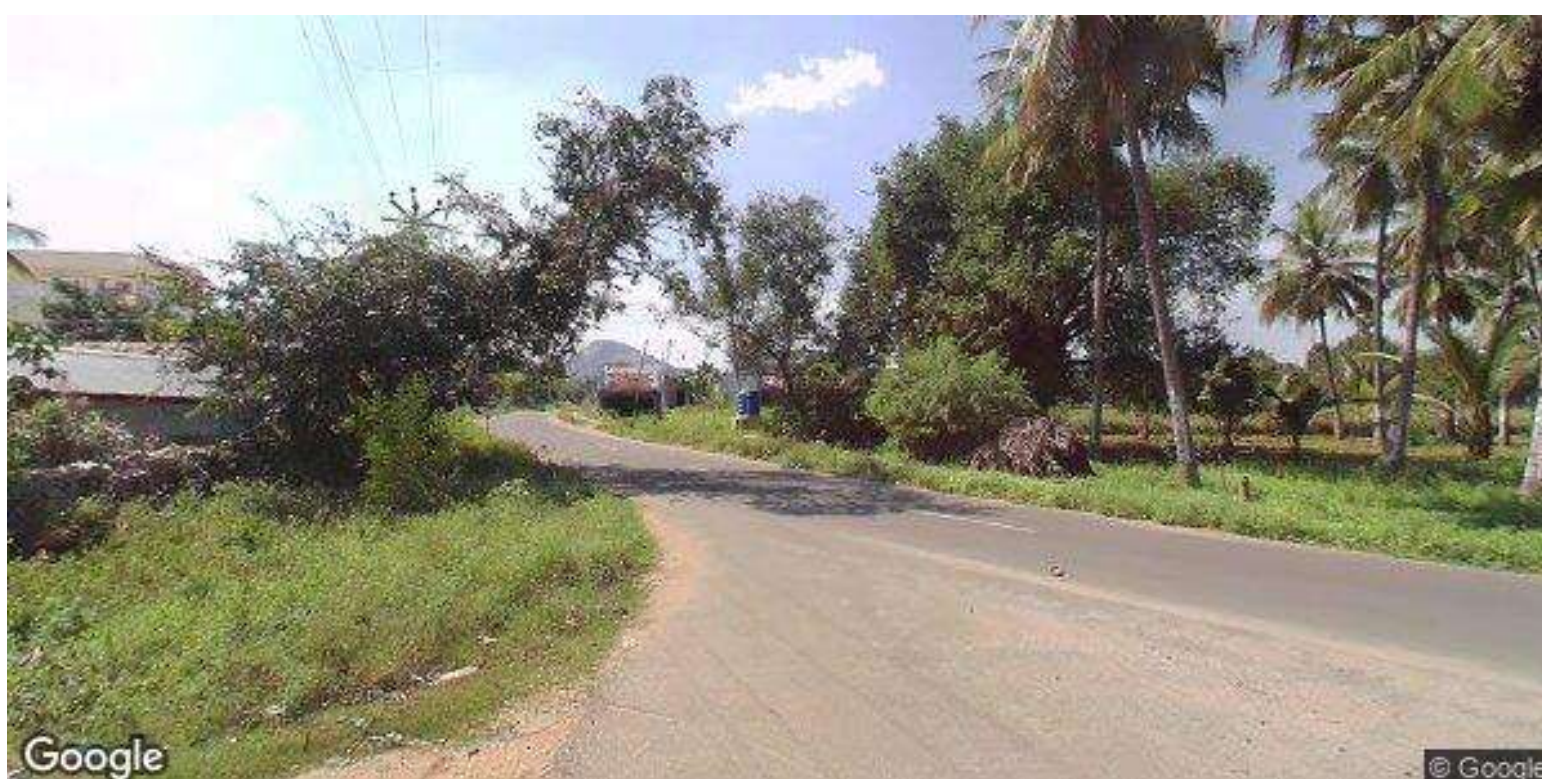
**Coordinates:** 11.41334, 77.91266

**Risk Type:** Turn

**Risk Level:** Medium

**Speed Limit:** 30 KM/Hr

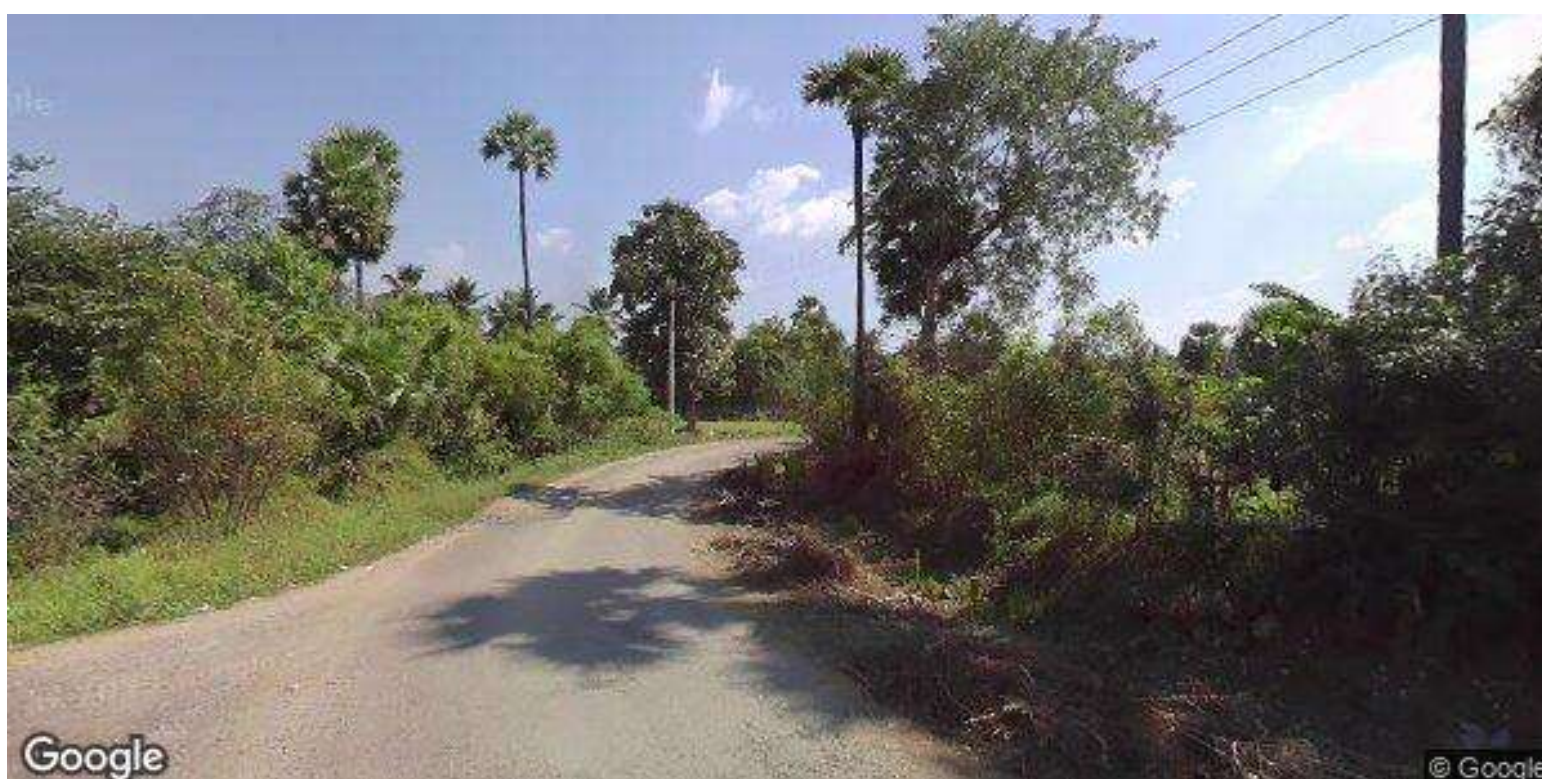
**Risk Type:** Turn  
**Risk Level:** High  
**Speed Limit:** 15 KM/Hr  
**Coordinates:** 11.41424, 77.91433

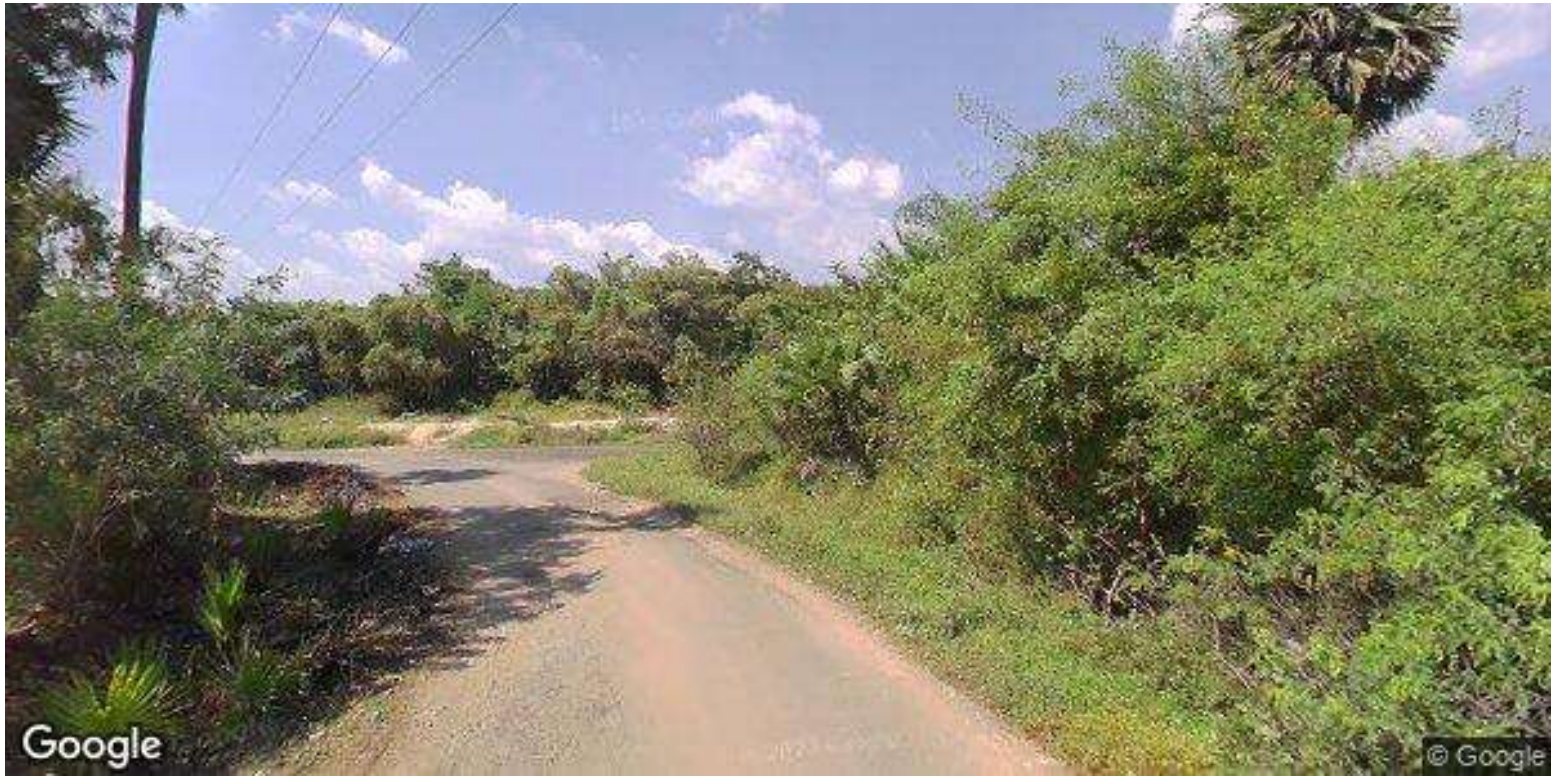
**Risk Type:** Turn  
**Risk Level:** Medium  
**Speed Limit:** 30 KM/Hr  
**Coordinates:** 11.41409, 77.91458

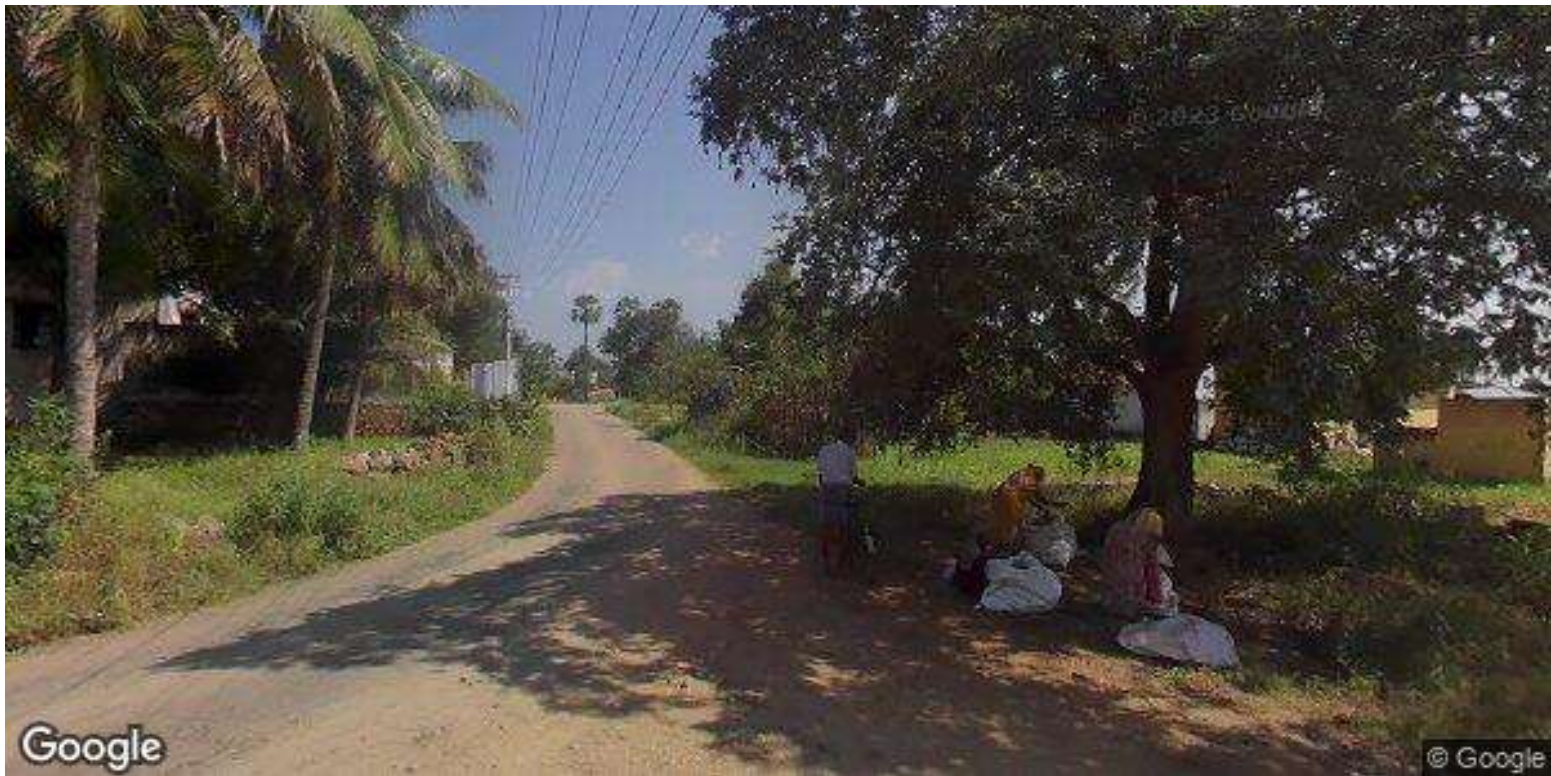
**Risk Type:** Turn  
**Risk Level:** High  
**Speed Limit:** 15 KM/Hr  
**Coordinates:** 11.41208, 77.91551

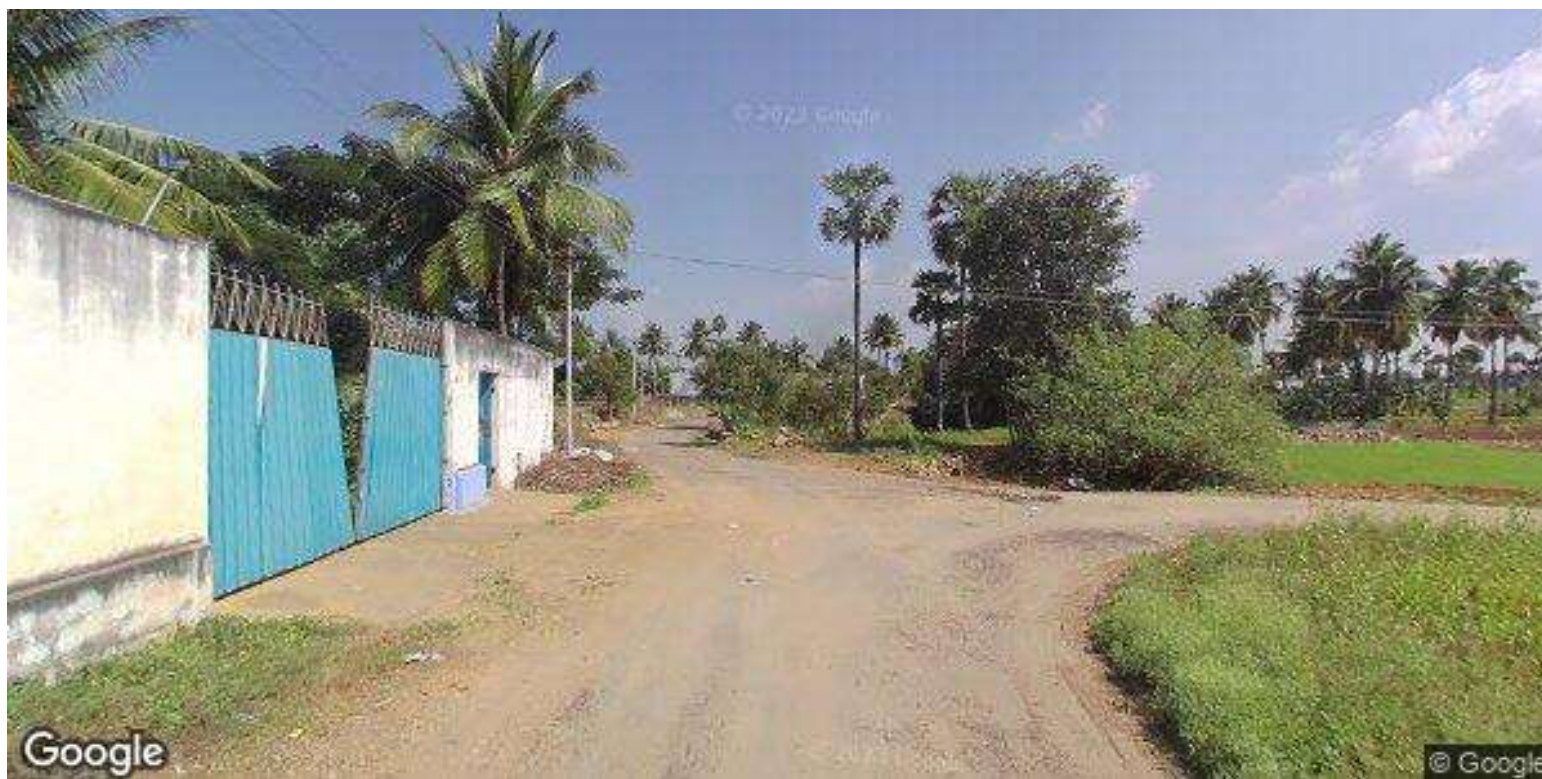
**Coordinates:** 11.41207, 77.91604

**Risk Type:** Turn

**Risk Level:** Medium

**Speed Limit:** 30 KM/Hr

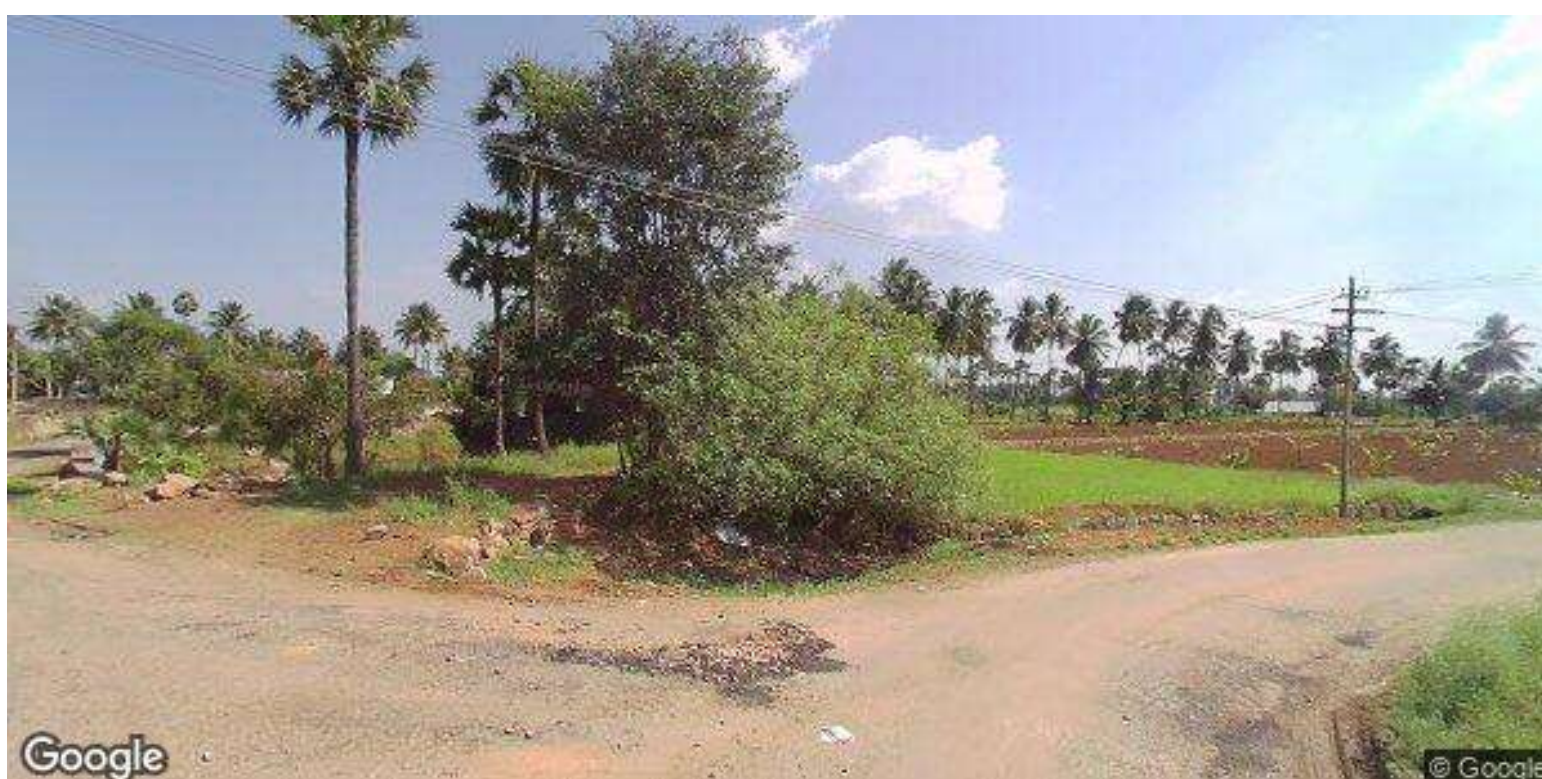
**Coordinates:** 11.41204, 77.91610

**Risk Type:** Turn

**Risk Level:** High

**Speed Limit:** 15 KM/Hr

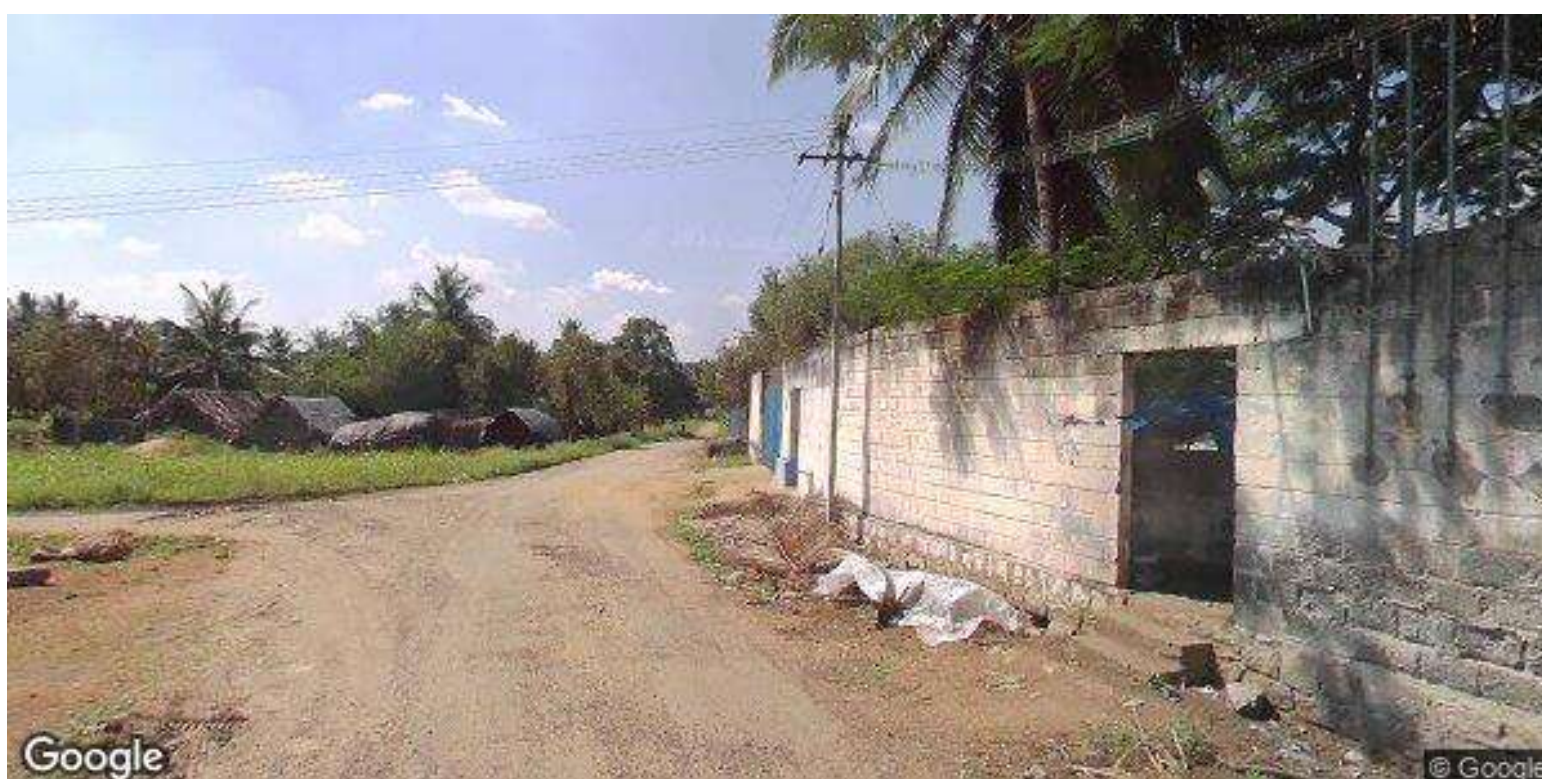
**Risk Type:** Turn  
**Risk Level:** Medium  
**Speed Limit:** 30 KM/Hr  
**Coordinates:** 11.41216, 77.91626

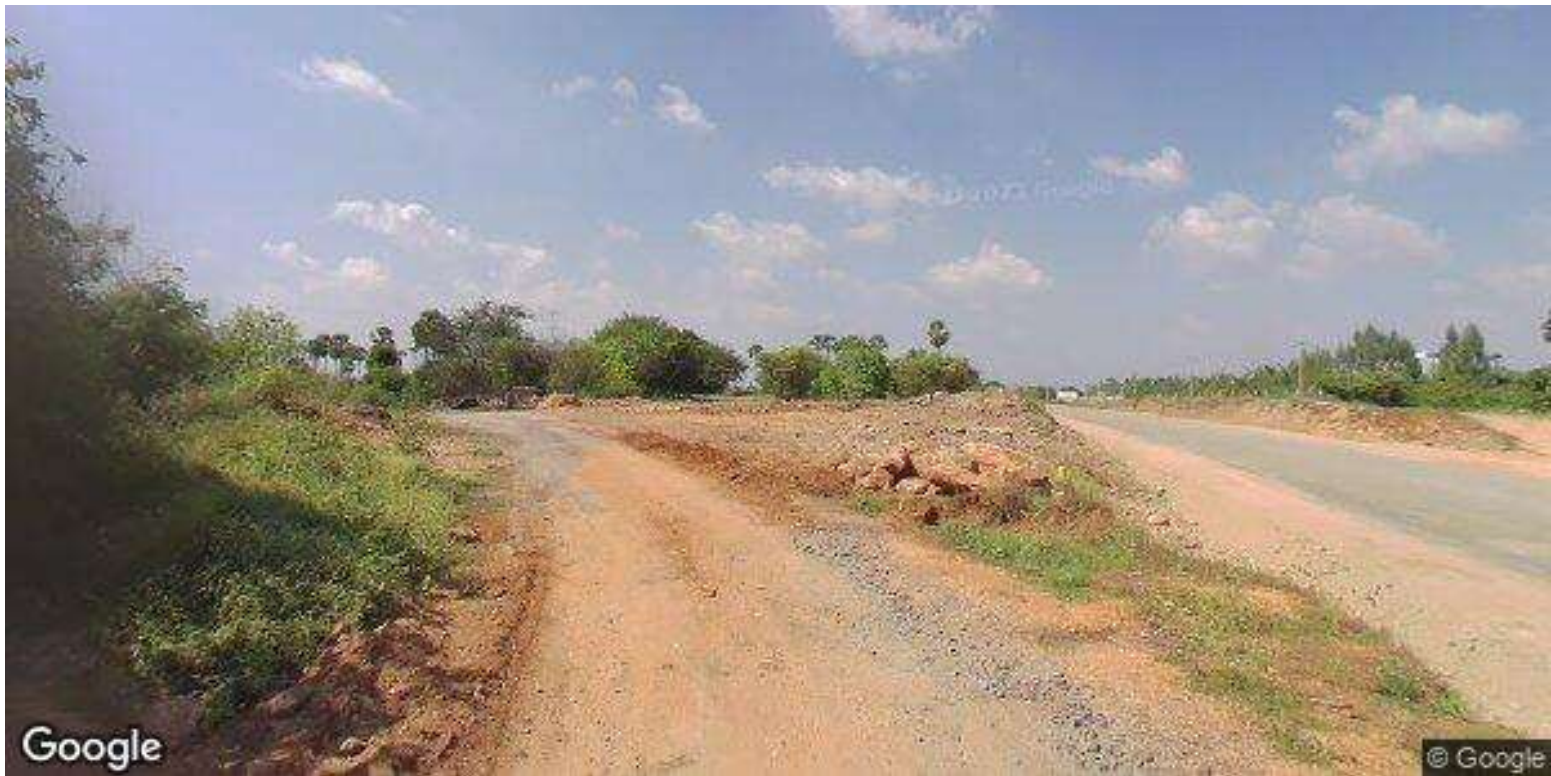
**Risk Type:** Turn  
**Risk Level:** Medium  
**Speed Limit:** 30 KM/Hr  
**Coordinates:** 11.41336, 77.92130

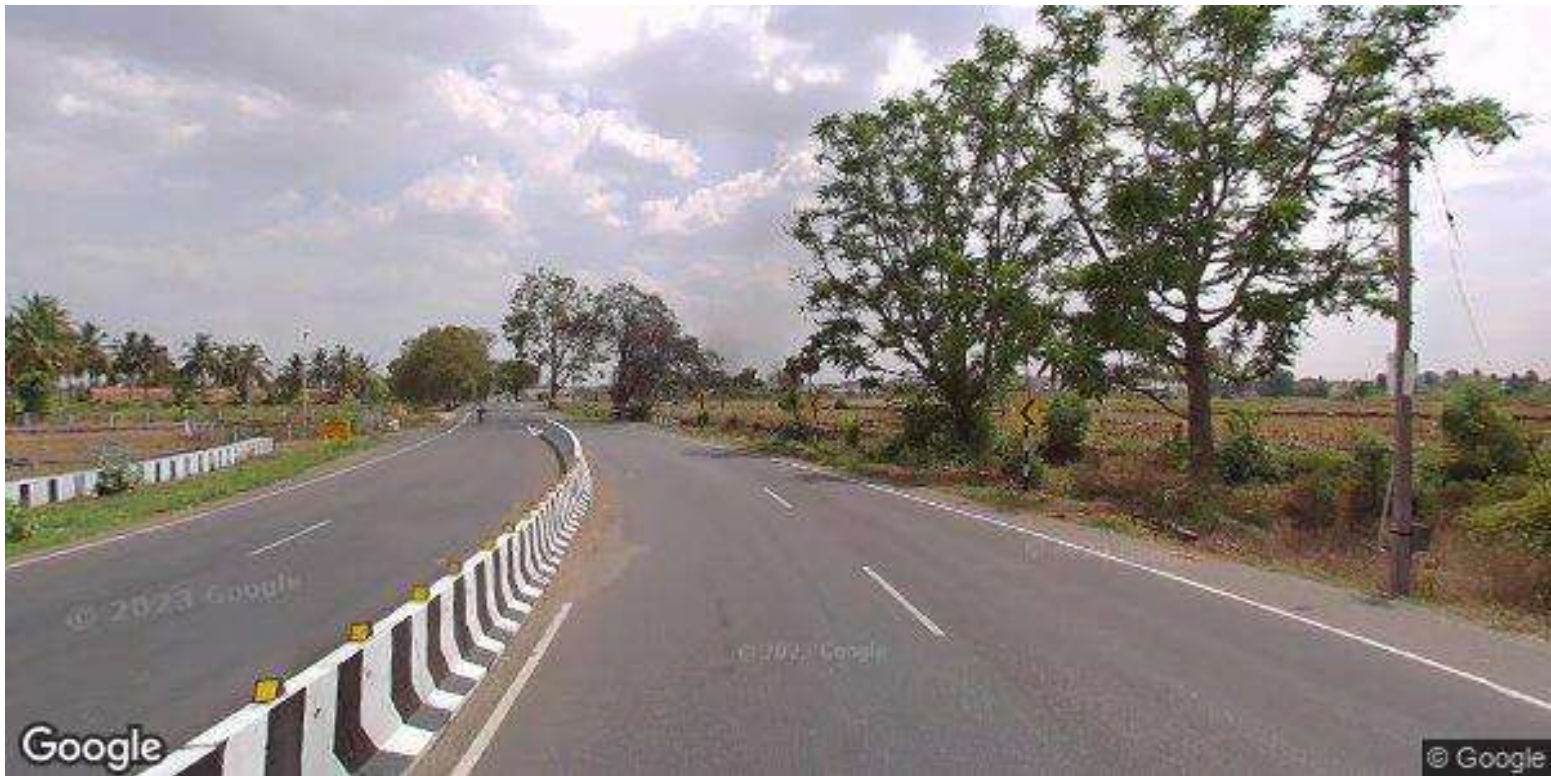
**Risk Type:** Turn  
**Risk Level:** Medium  
**Speed Limit:** 30 KM/Hr  
**Coordinates:** 11.43248, 78.12074

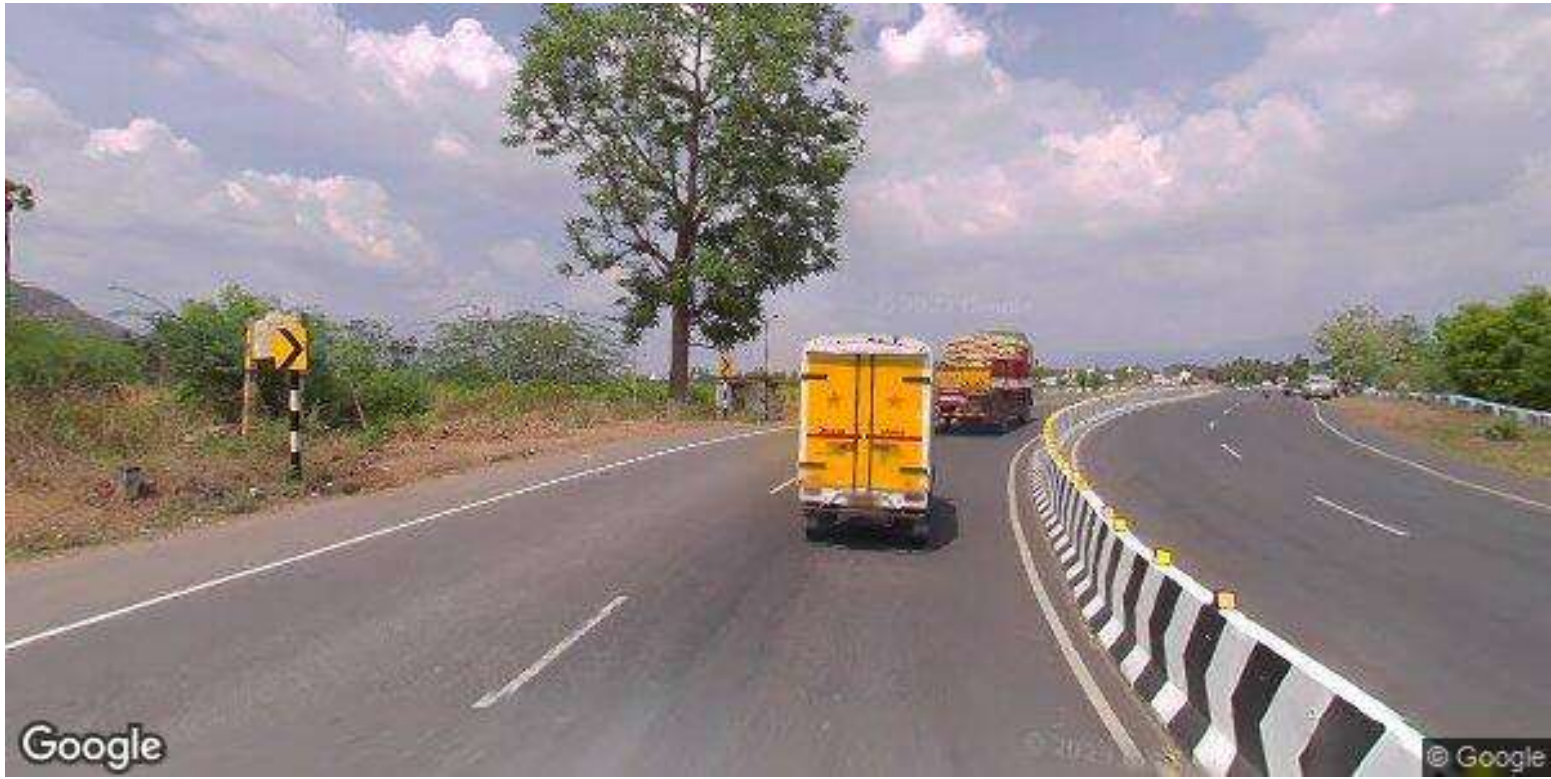
**Coordinates:** 11.43257, 78.12096

**Risk Type:** Turn

**Risk Level:** Medium

**Speed Limit:** 30 KM/Hr
