# IndianOil

## JOURNEY RISK MANAGEMENT (JRM) STUDY

### Salem Terminal to SRI MAHADHEV FUEL

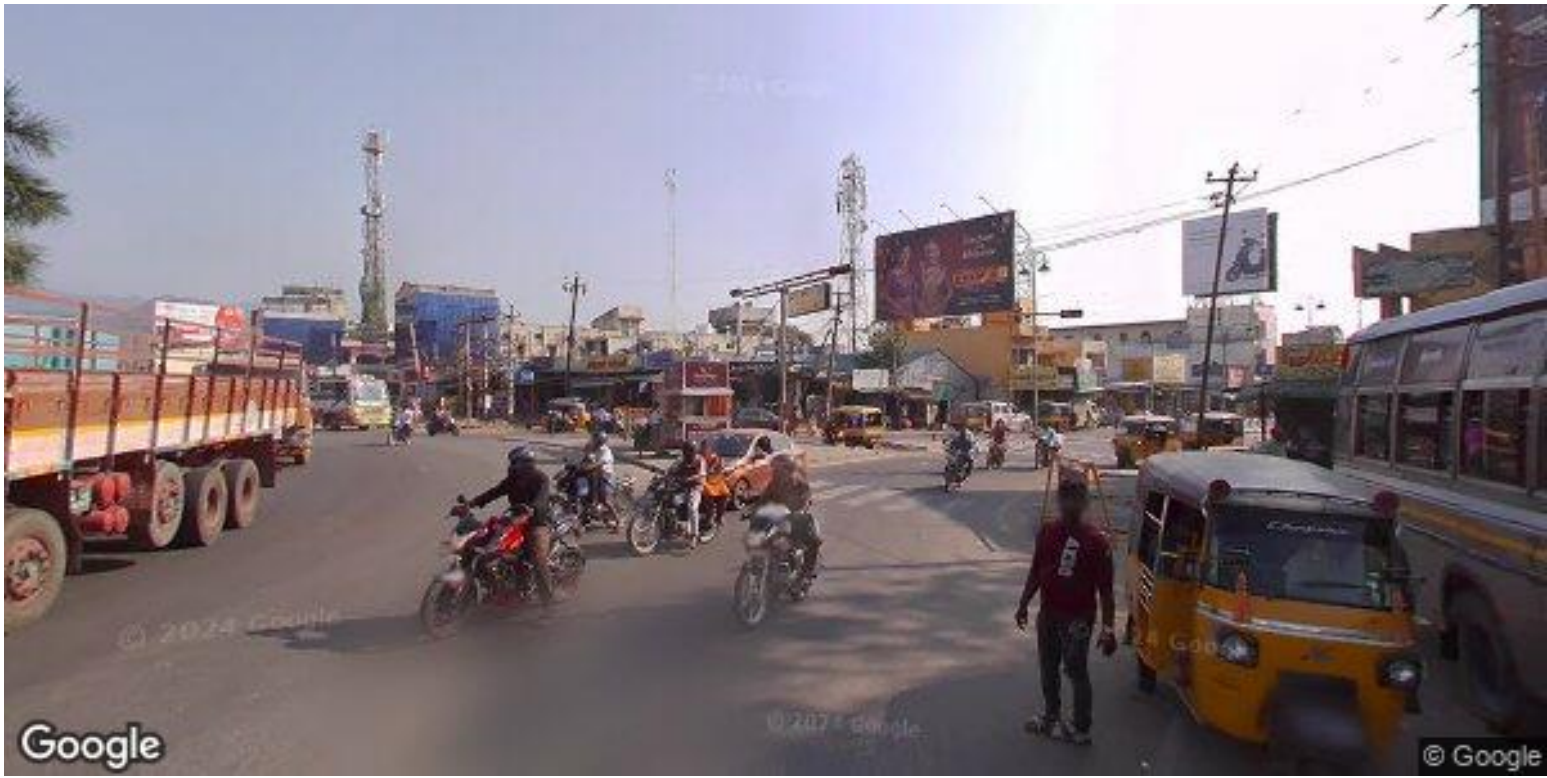
Coordinates: 11.63266, 78.12699

Risk Type: Roundabout

Risk Level: High

Speed Limit: 15 KM/Hr

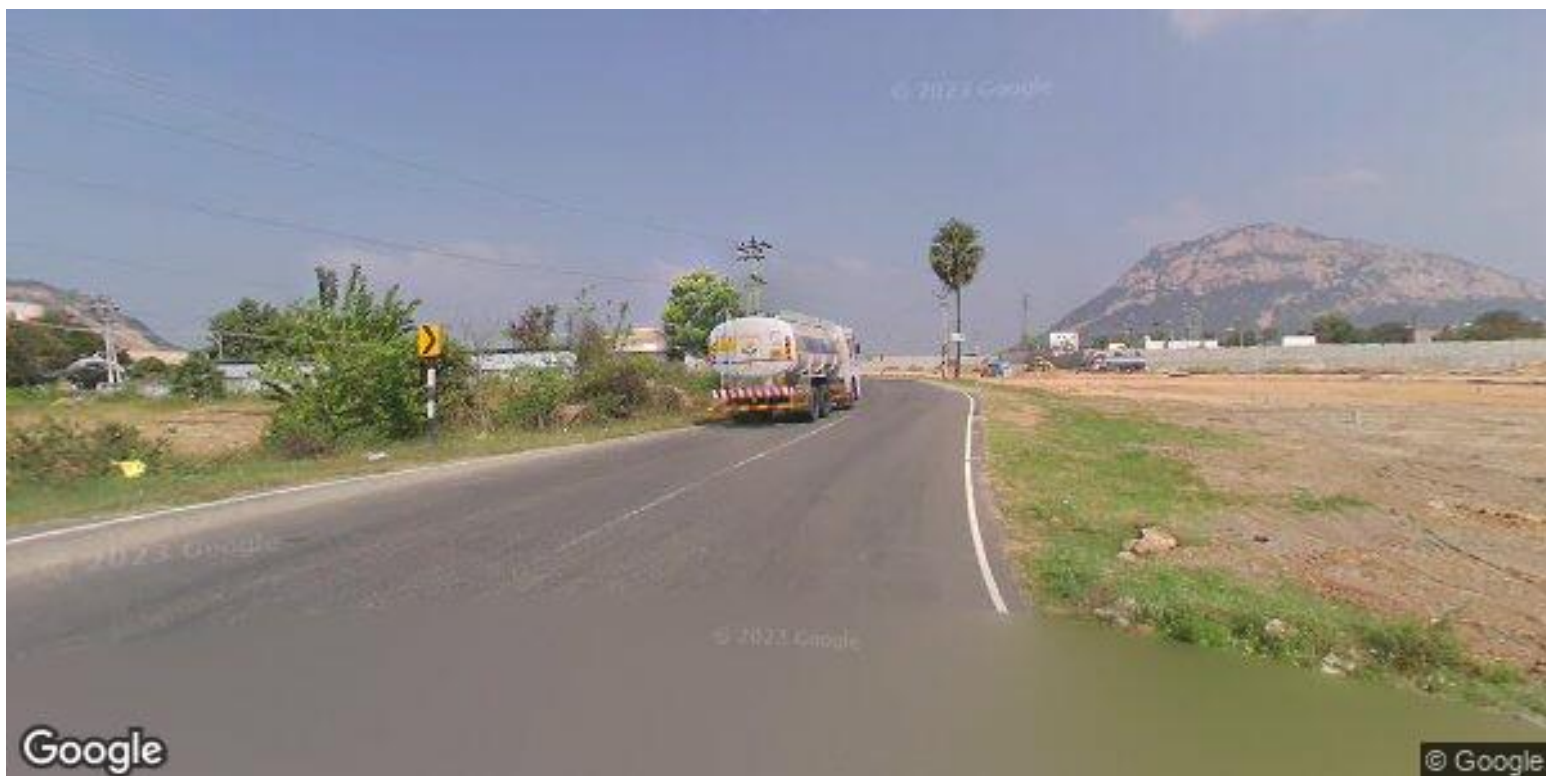
**Risk Type:** Turn  
**Risk Level:** Medium  
**Speed Limit:** 30 KM/Hr  
**Coordinates:** 11.45847, 77.85140

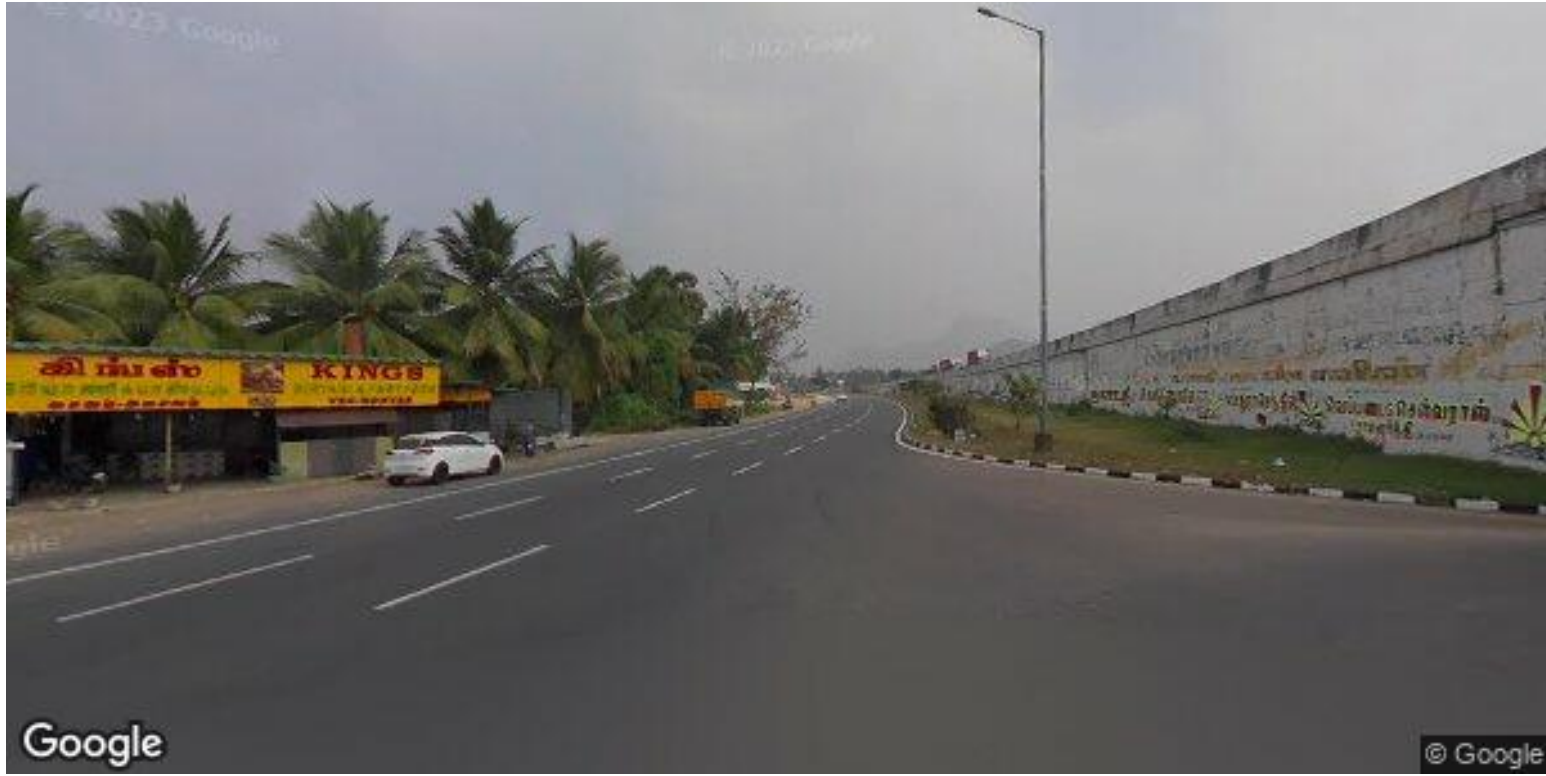
**Coordinates: 11.45634, 77.81673**

**Risk Type: Turn**

**Risk Level: High**

**Speed Limit: 15 KM/Hr**

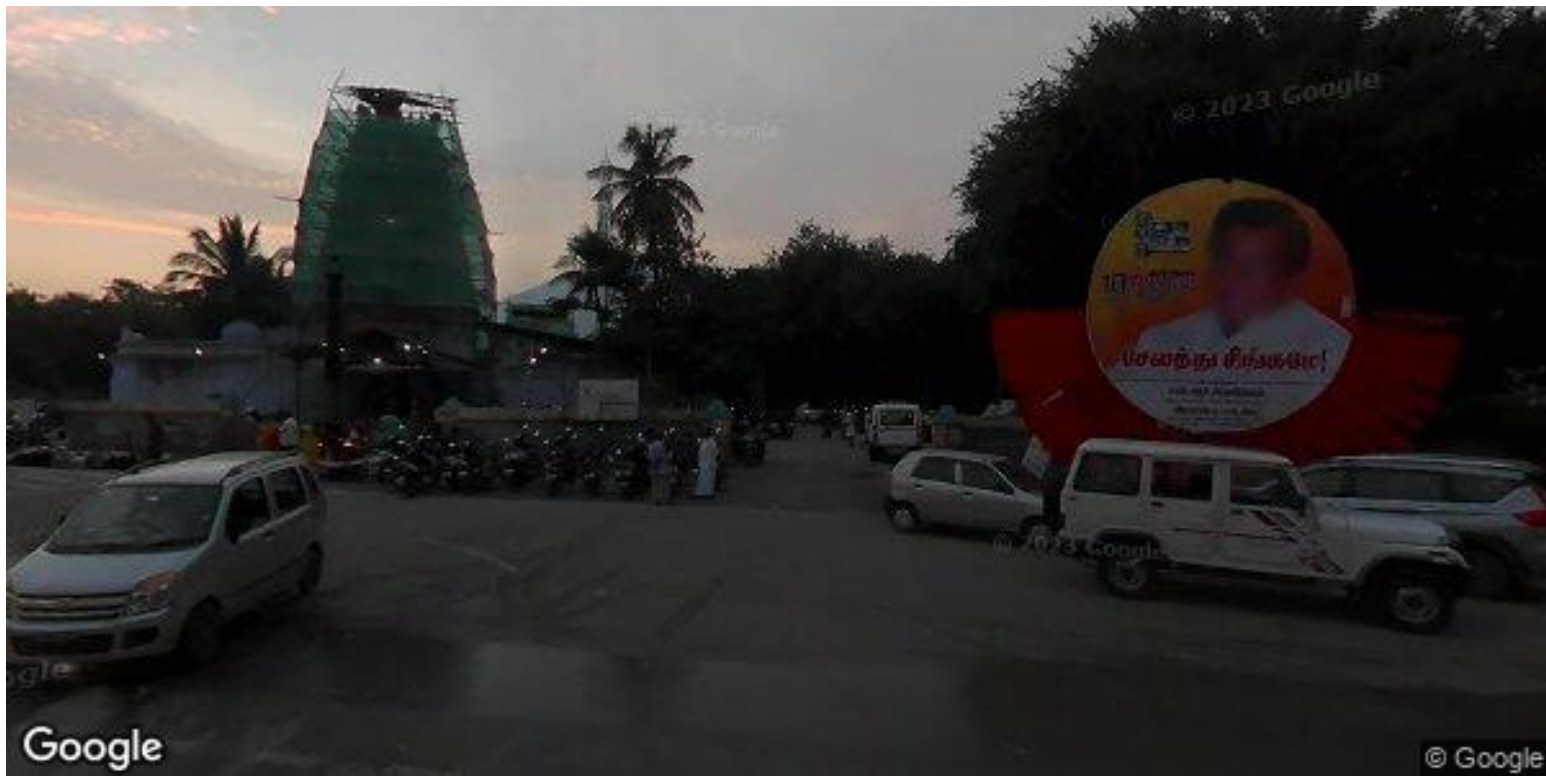
**Coordinates: 11.61233, 78.10397**

**Risk Type: Turn**

**Risk Level: High**

**Speed Limit: 15 KM/Hr**

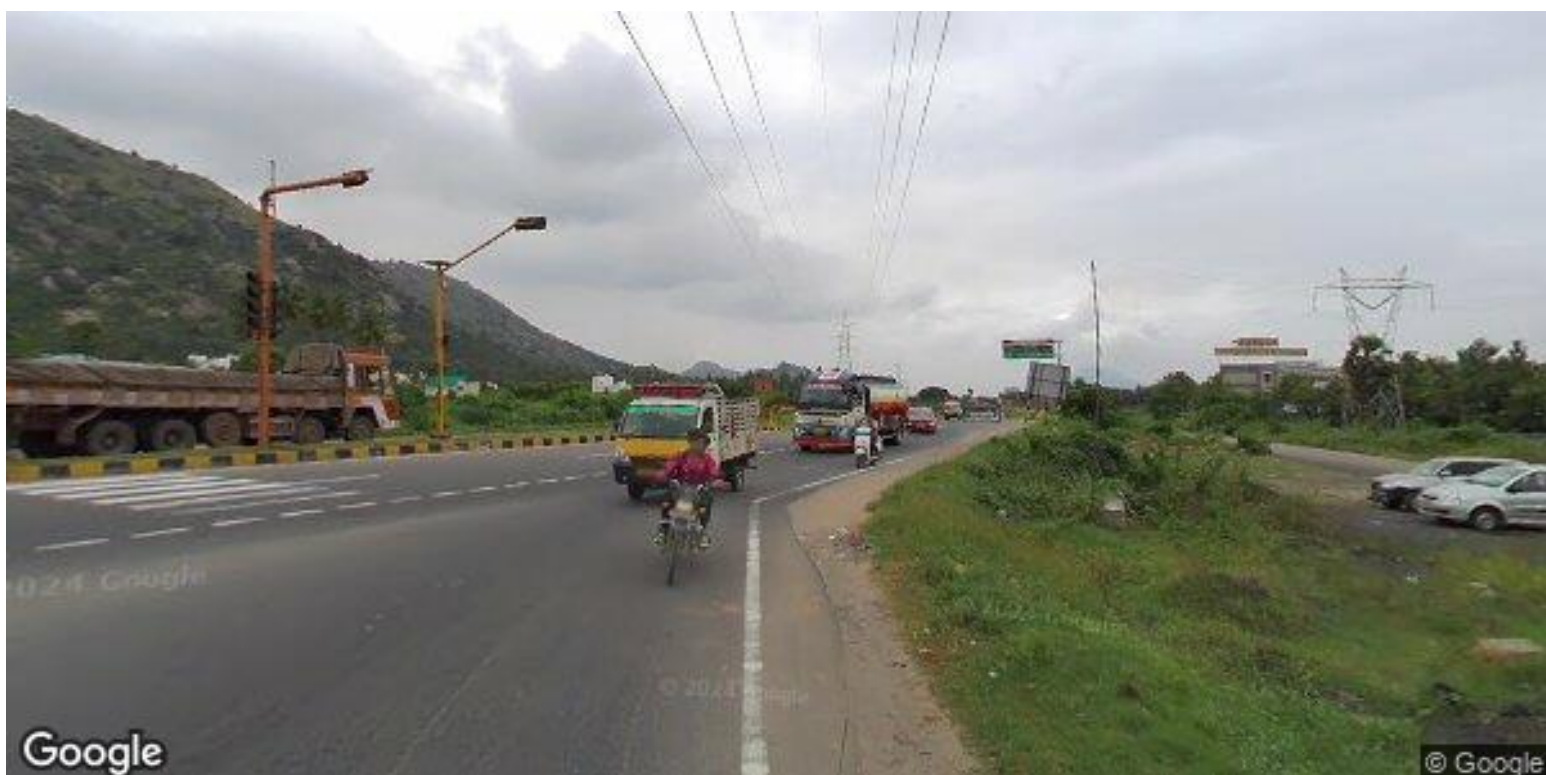
**Risk Type:** Turn  
**Risk Level:** Medium  
**Speed Limit:** 30 KM/Hr  
**Coordinates:** 11.65627, 78.20215

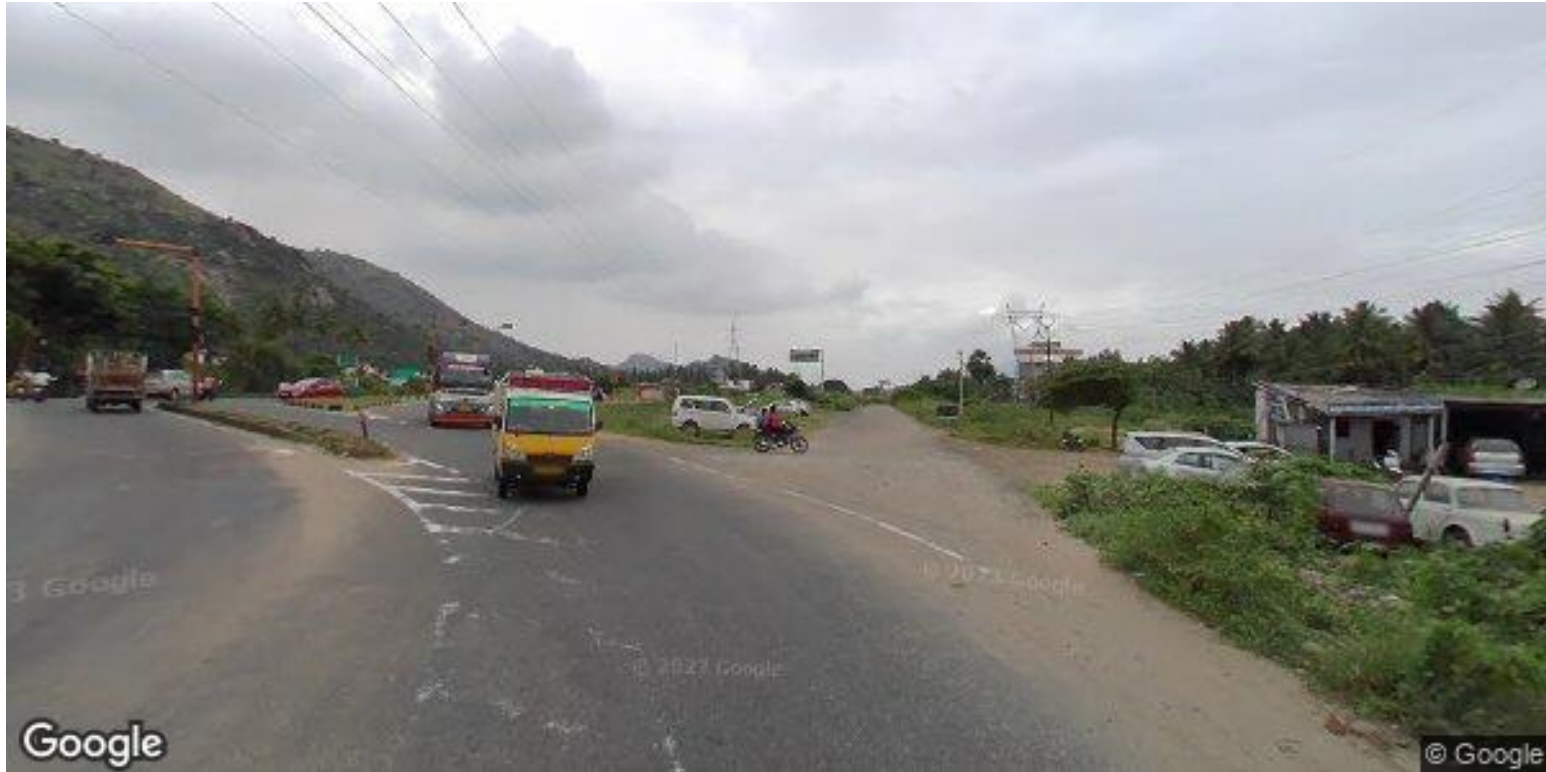
**Risk Type:** Turn  
**Risk Level:** Medium  
**Speed Limit:** 30 KM/Hr  
**Coordinates:** 11.65664, 78.20240

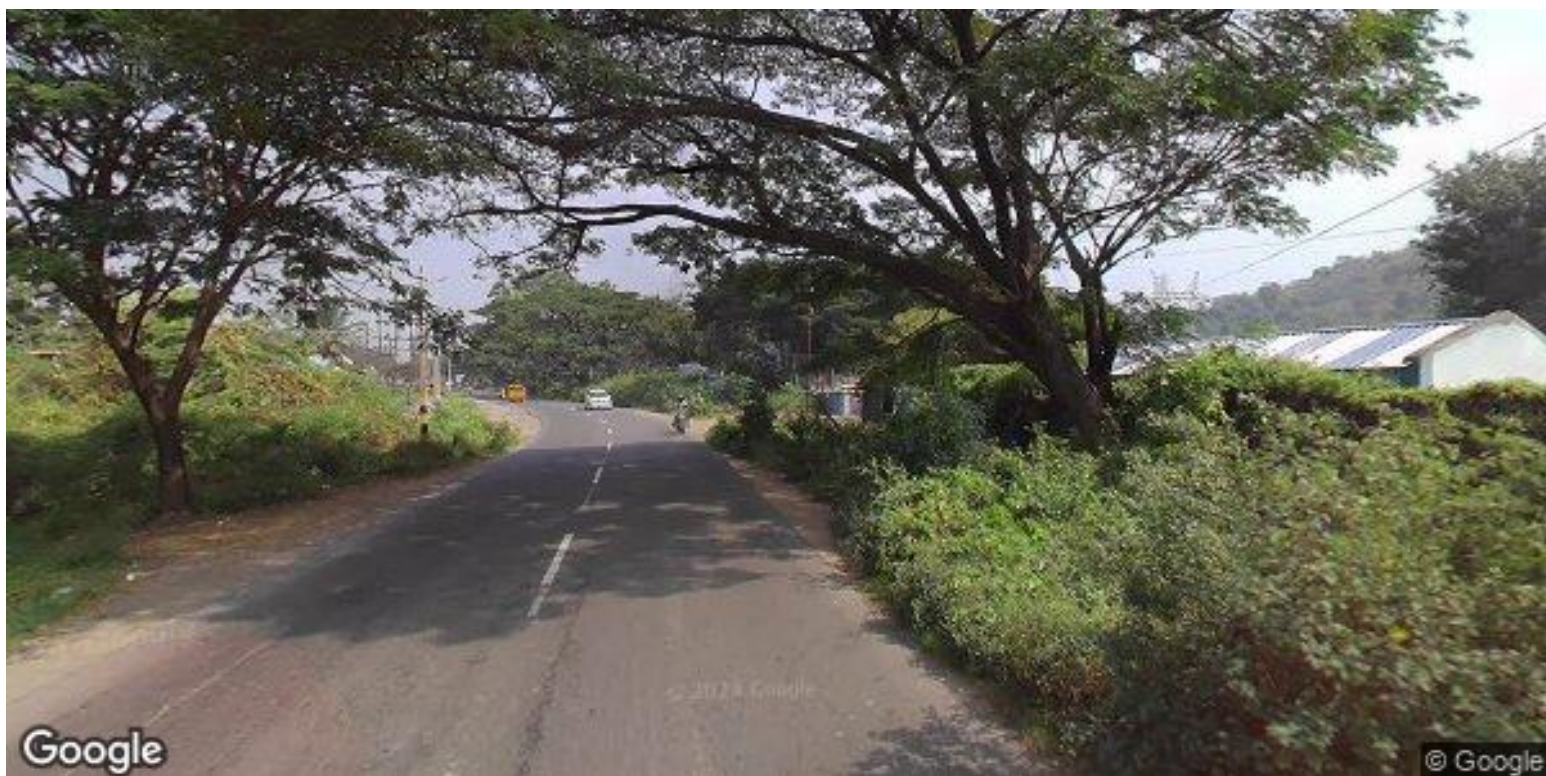
**Risk Type:** Turn  
**Risk Level:** Medium  
**Speed Limit:** 30 KM/Hr  
**Coordinates:** 11.65825, 78.20469

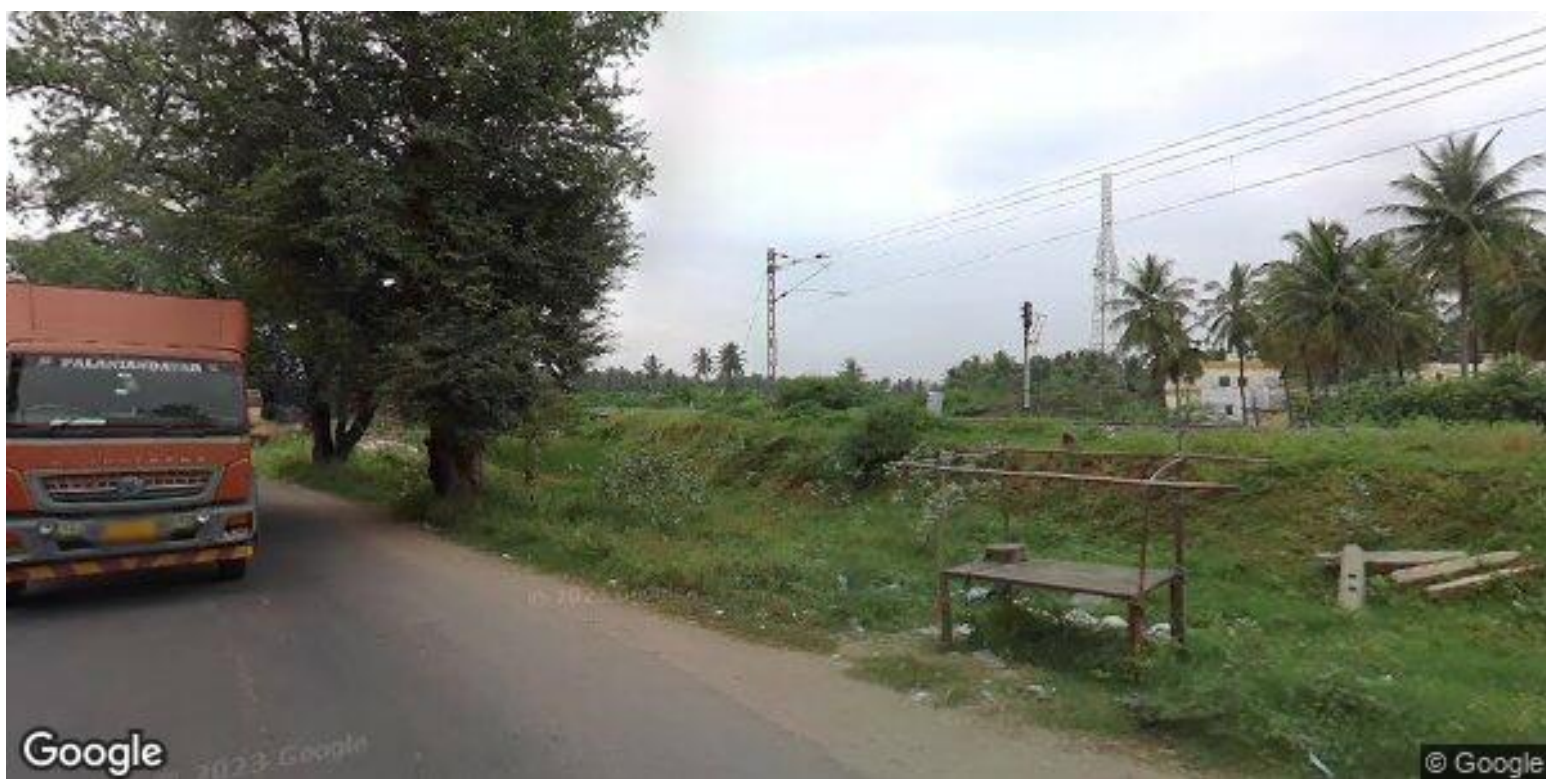
**Coordinates:** 11.67128, 78.22971

**Risk Type:** Turn

**Risk Level:** Medium

**Speed Limit:** 30 KM/Hr

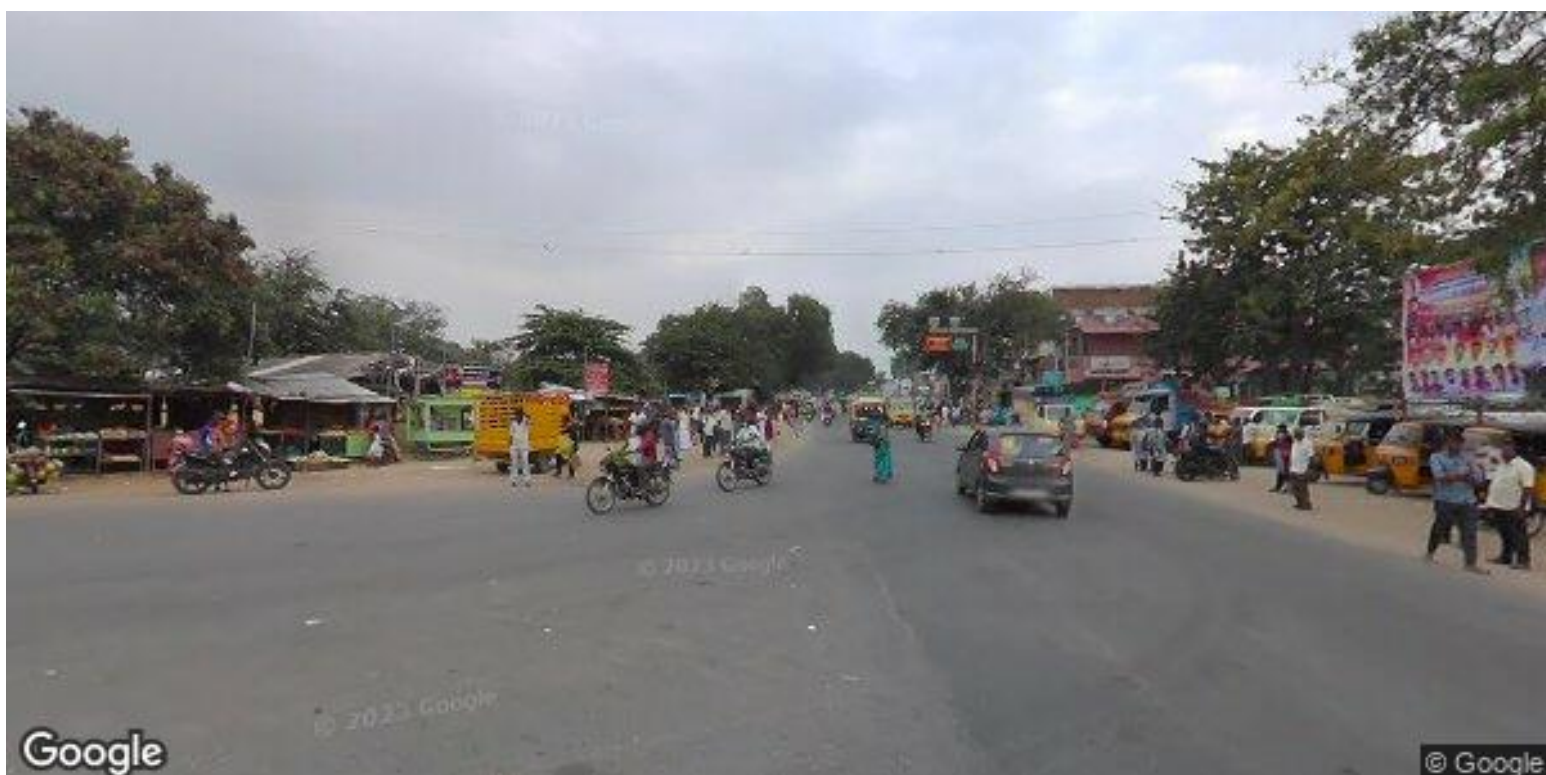
**Risk Type:** Turn  
**Risk Level:** High  
**Speed Limit:** 15 KM/Hr  
**Coordinates:** 11.67111, 78.23134

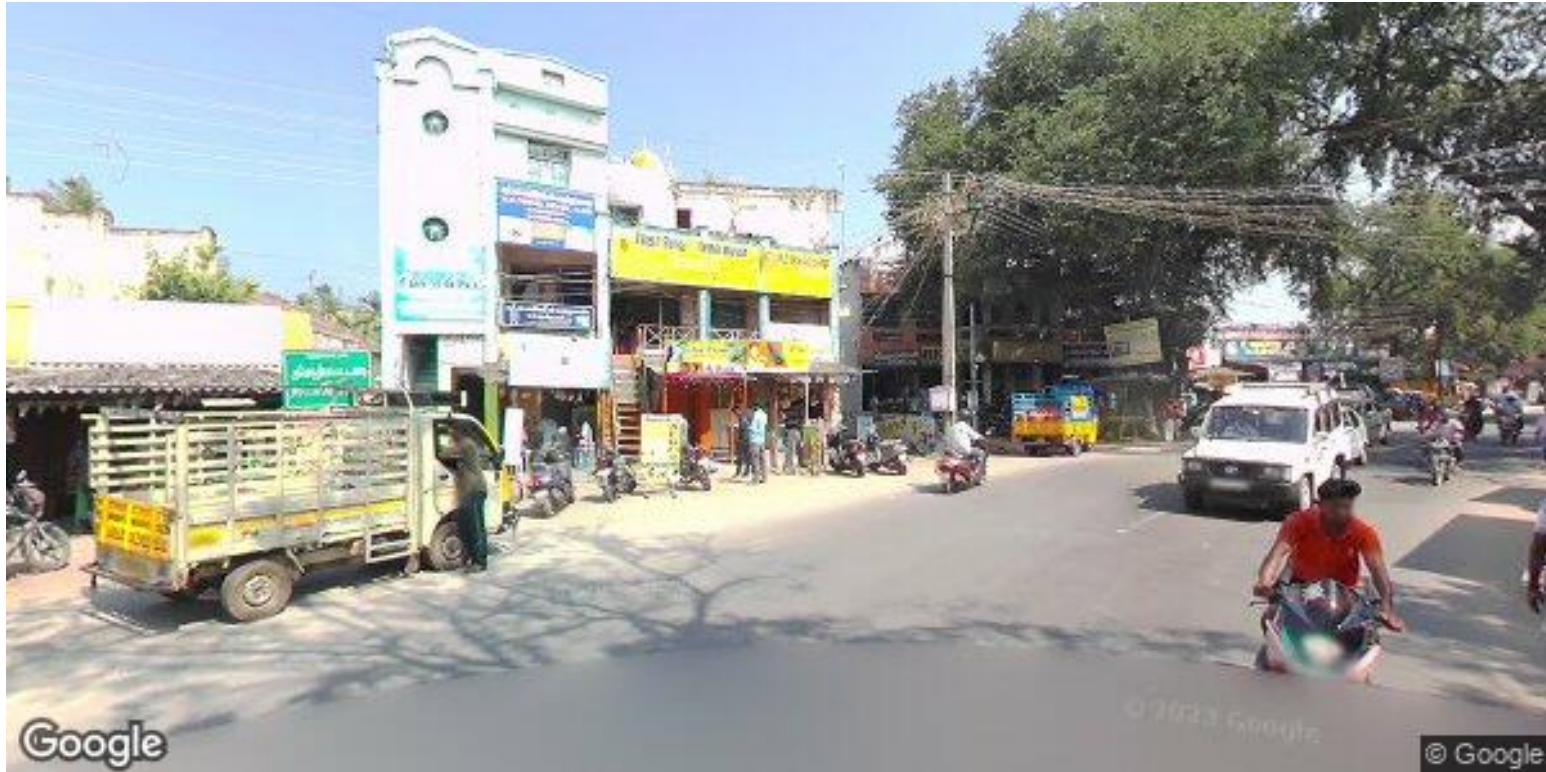
**Risk Type:** Turn  
**Risk Level:** Medium  
**Speed Limit:** 30 KM/Hr  
**Coordinates:** 11.67195, 78.23146

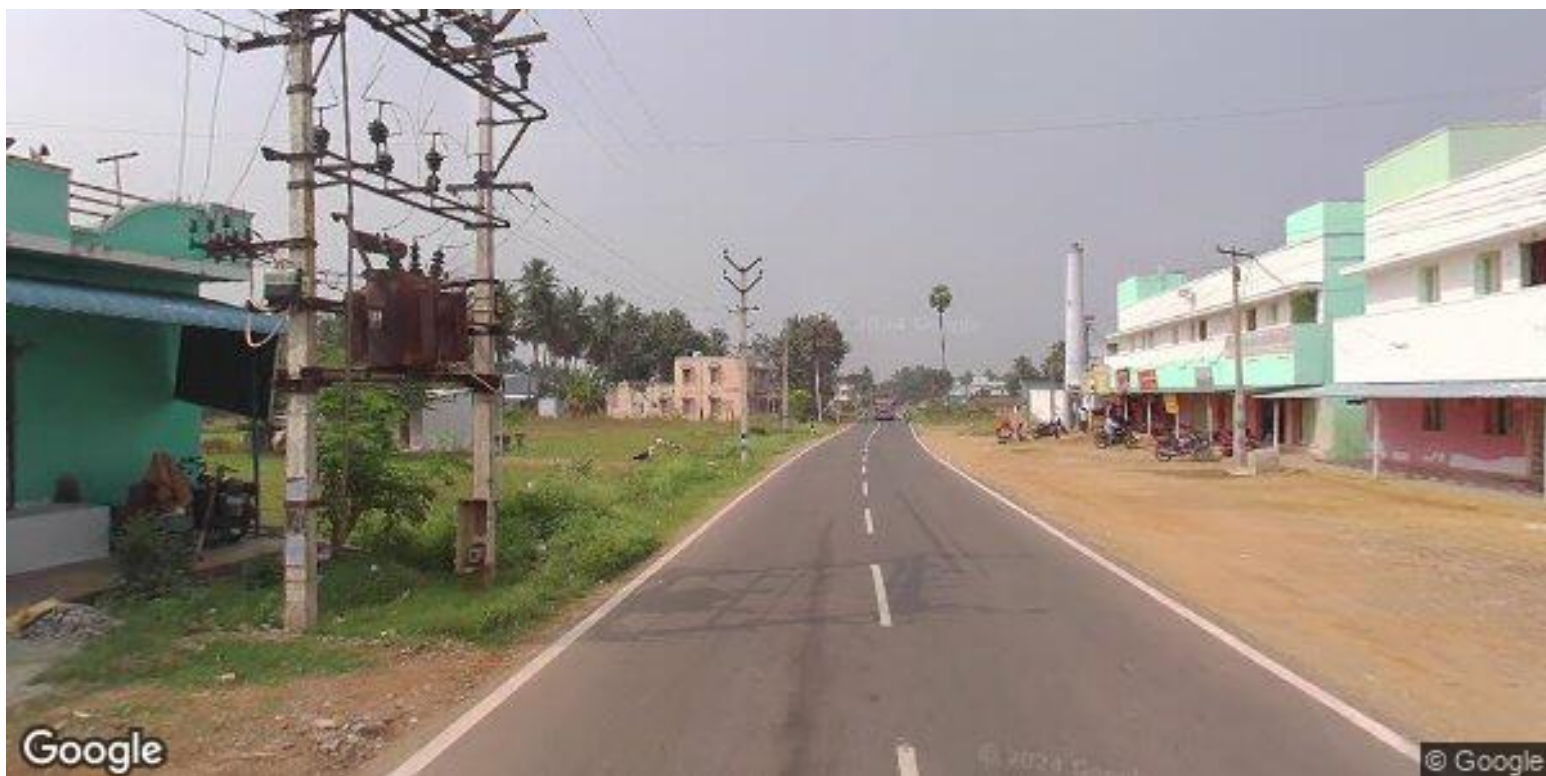
**Risk Type:** Turn  
**Risk Level:** Medium  
**Speed Limit:** 30 KM/Hr  
**Coordinates:** 11.67666, 78.24906

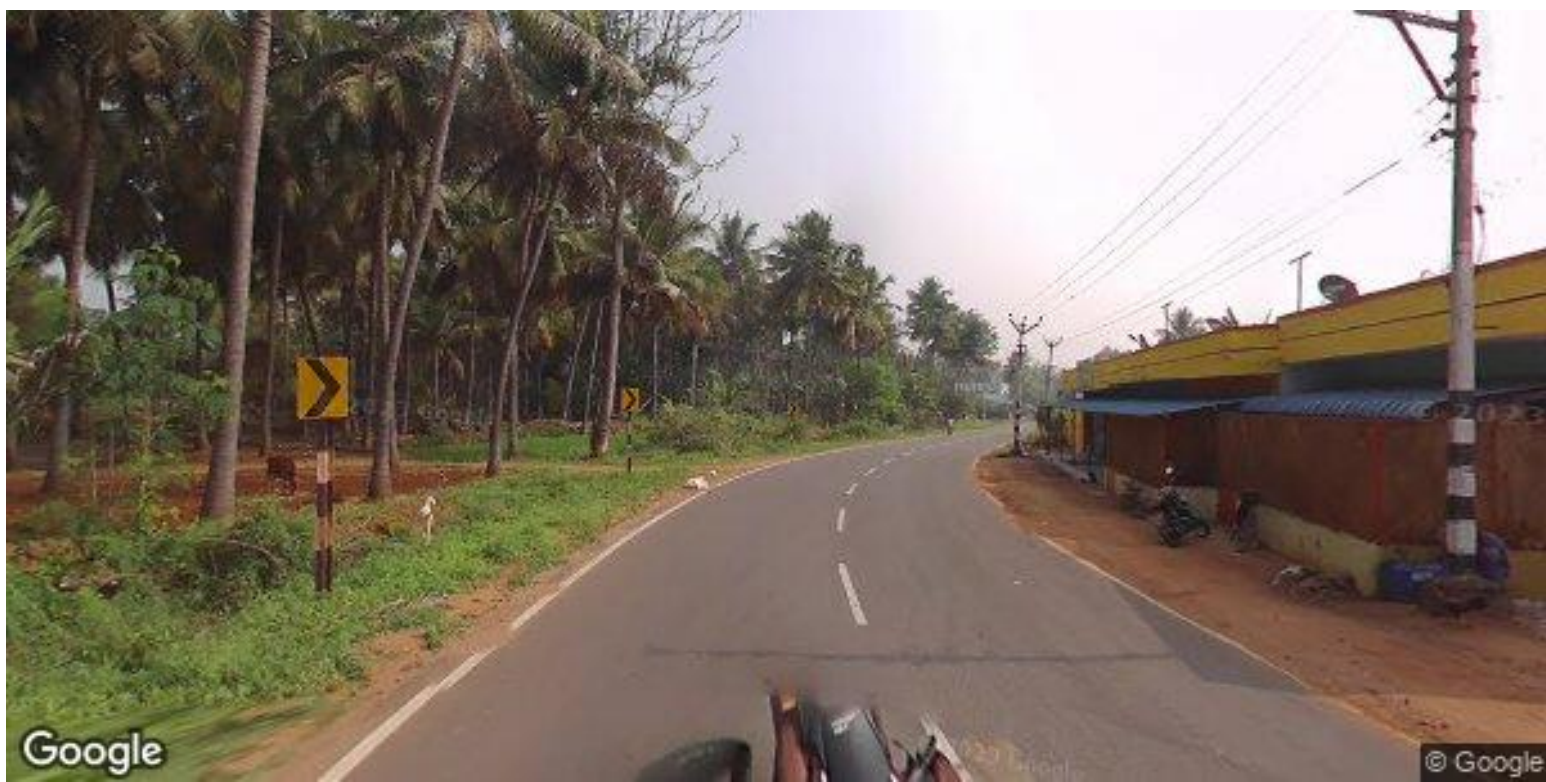
**Coordinates:** 11.68494, 78.26198

**Risk Type:** Turn

**Risk Level:** Medium

**Speed Limit:** 30 KM/Hr

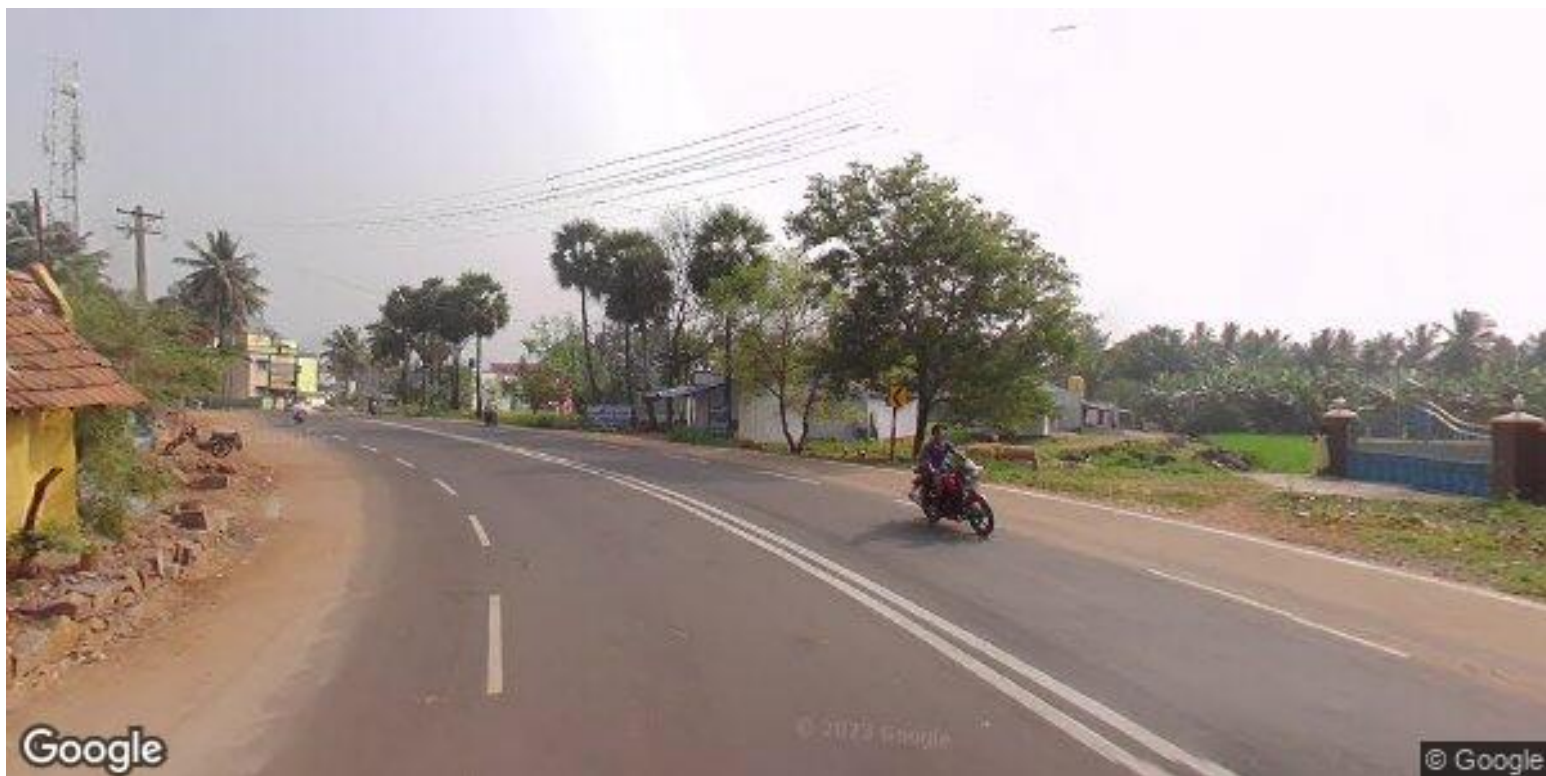
**Coordinates:** 11.68551, 78.26771

**Risk Type:** Turn

**Risk Level:** Medium

**Speed Limit:** 30 KM/Hr

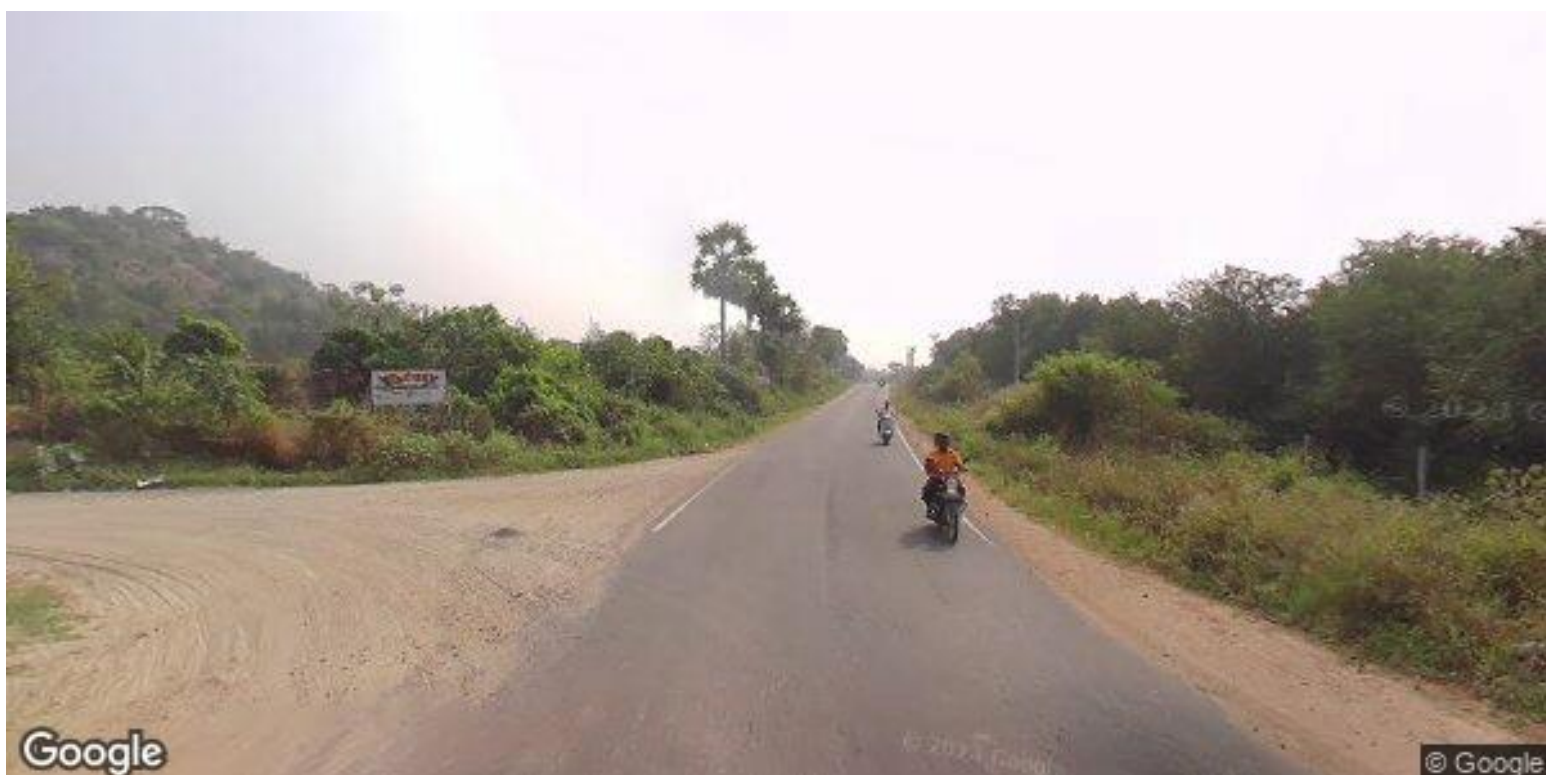
**Risk Type:** Turn  
**Risk Level:** Medium  
**Speed Limit:** 30 KM/Hr  
**Coordinates:** 11.68751, 78.27618

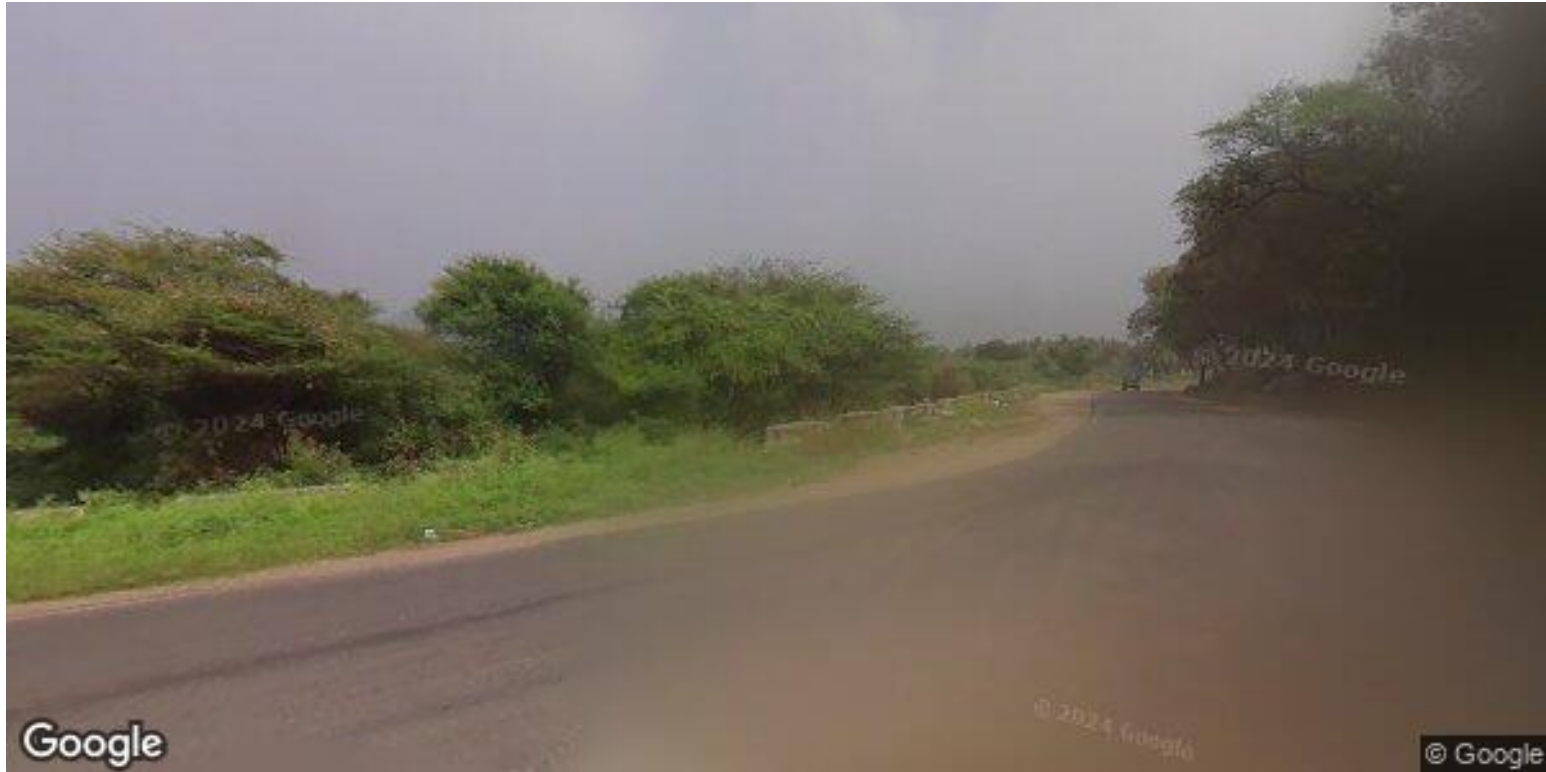
**Risk Type:** Turn  
**Risk Level:** Medium  
**Speed Limit:** 30 KM/Hr  
**Coordinates:** 11.68624, 78.28833

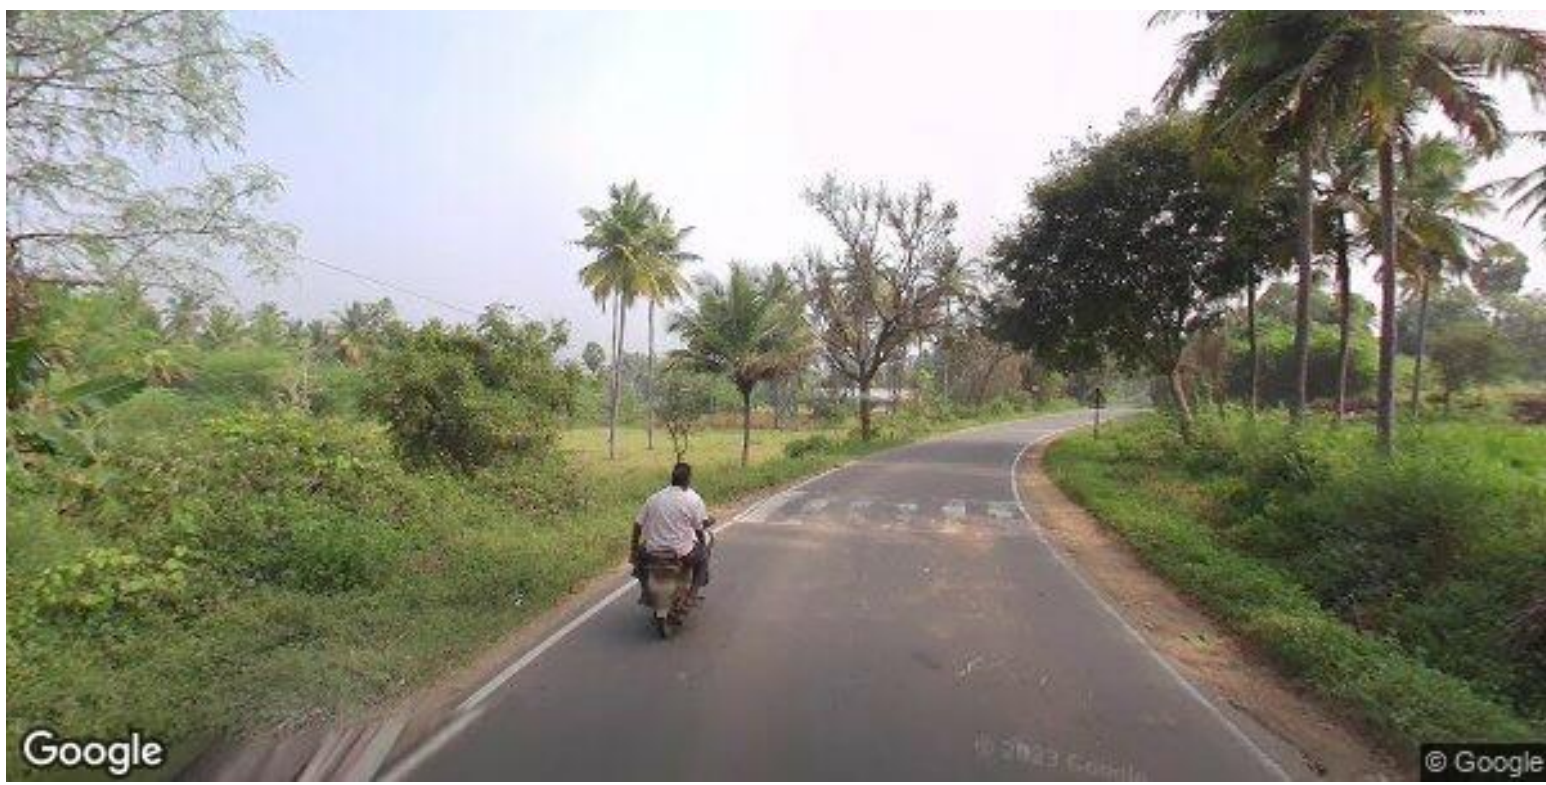
**Coordinates:** 11.70555, 78.31562

**Risk Type:** Turn

**Risk Level:** Medium

**Speed Limit:** 30 KM/Hr

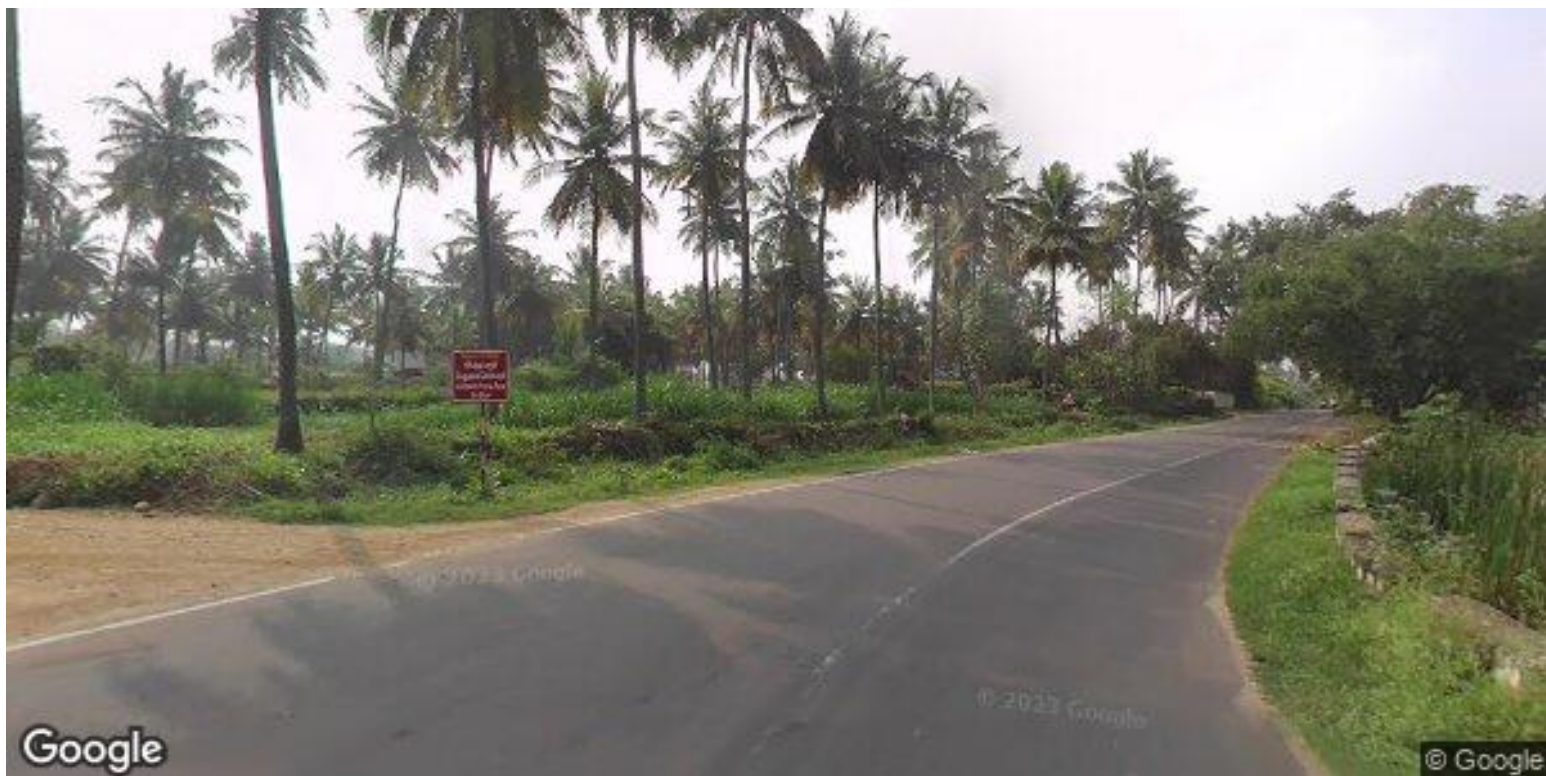
**Coordinates:** 11.70752, 78.31775

**Risk Type:** Turn

**Risk Level:** Medium

**Speed Limit:** 30 KM/Hr
