## JOURNEY RISK MANAGEMENT (JRM) STUDY

### Salem Terminal TO SABARMATHI FUELSS

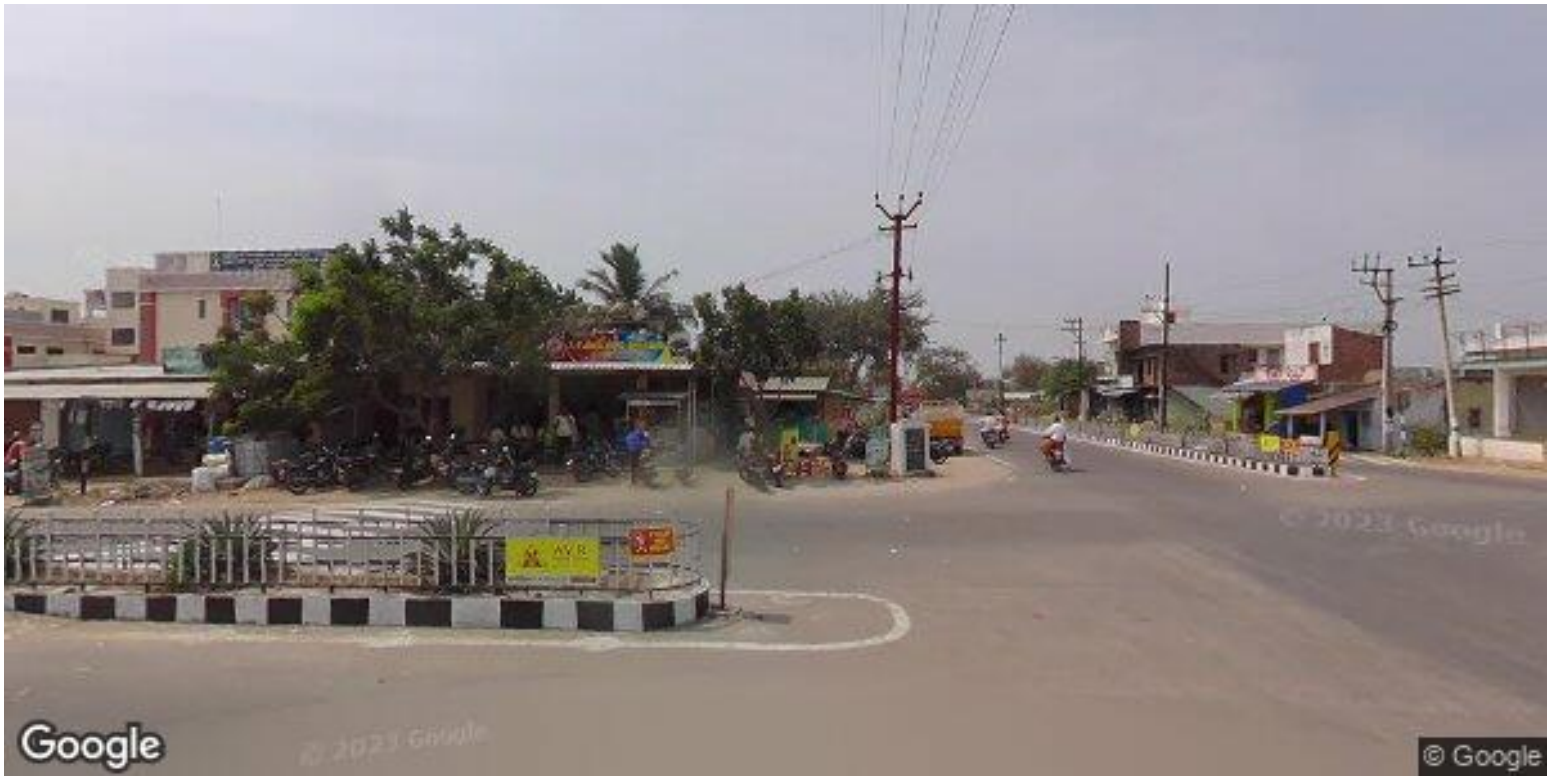
**Risk Type:** Roundabout  
**Risk Level:** High

**Speed Limit: 15 KM/Hr**  
**Coordinates: 11.58300, 77.85813**

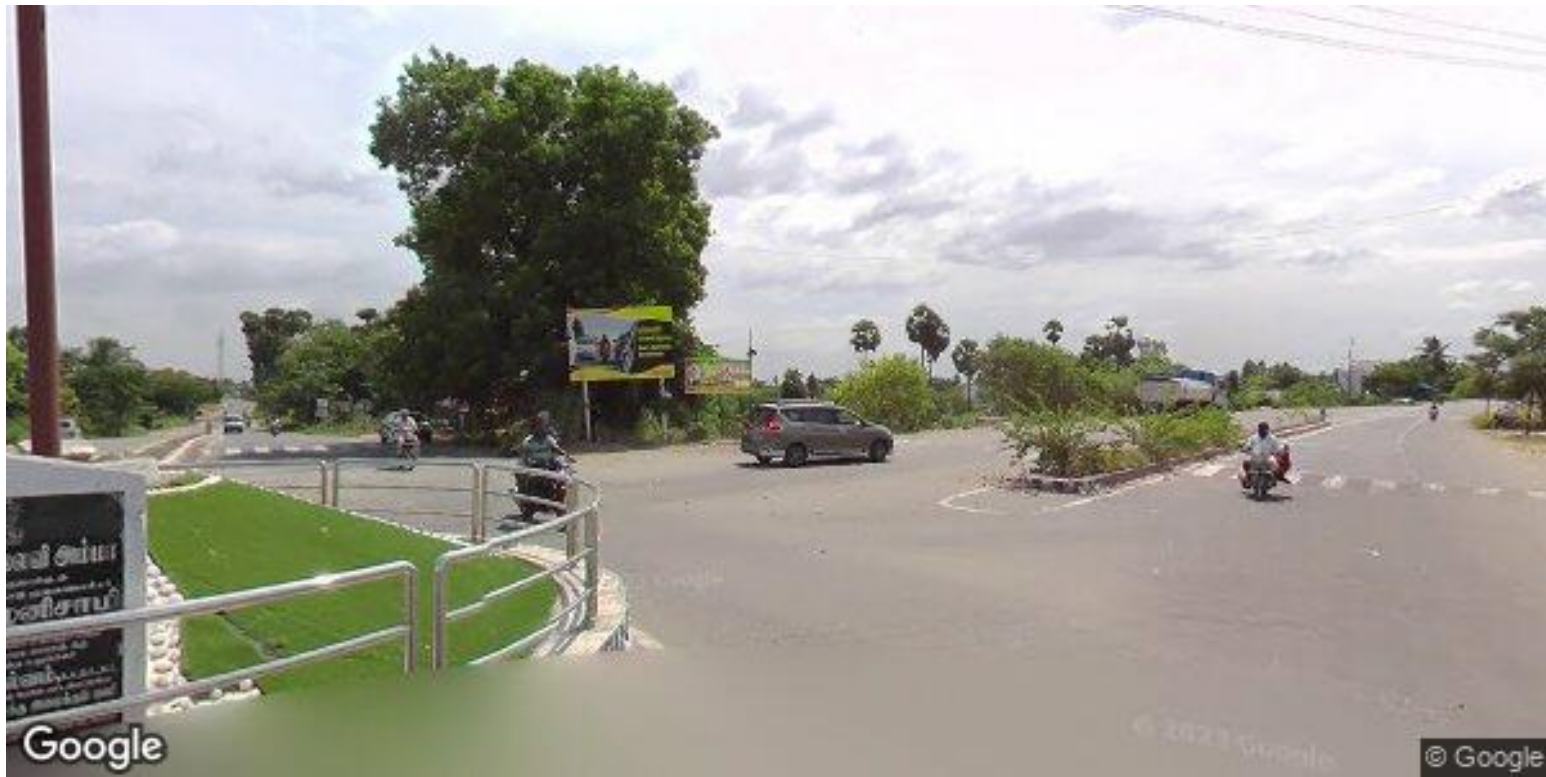
**Risk Type: Roundabout**  
**Risk Level: High**  
**Speed Limit: 15 KM/Hr**  
**Coordinates: 11.60348, 77.83967**

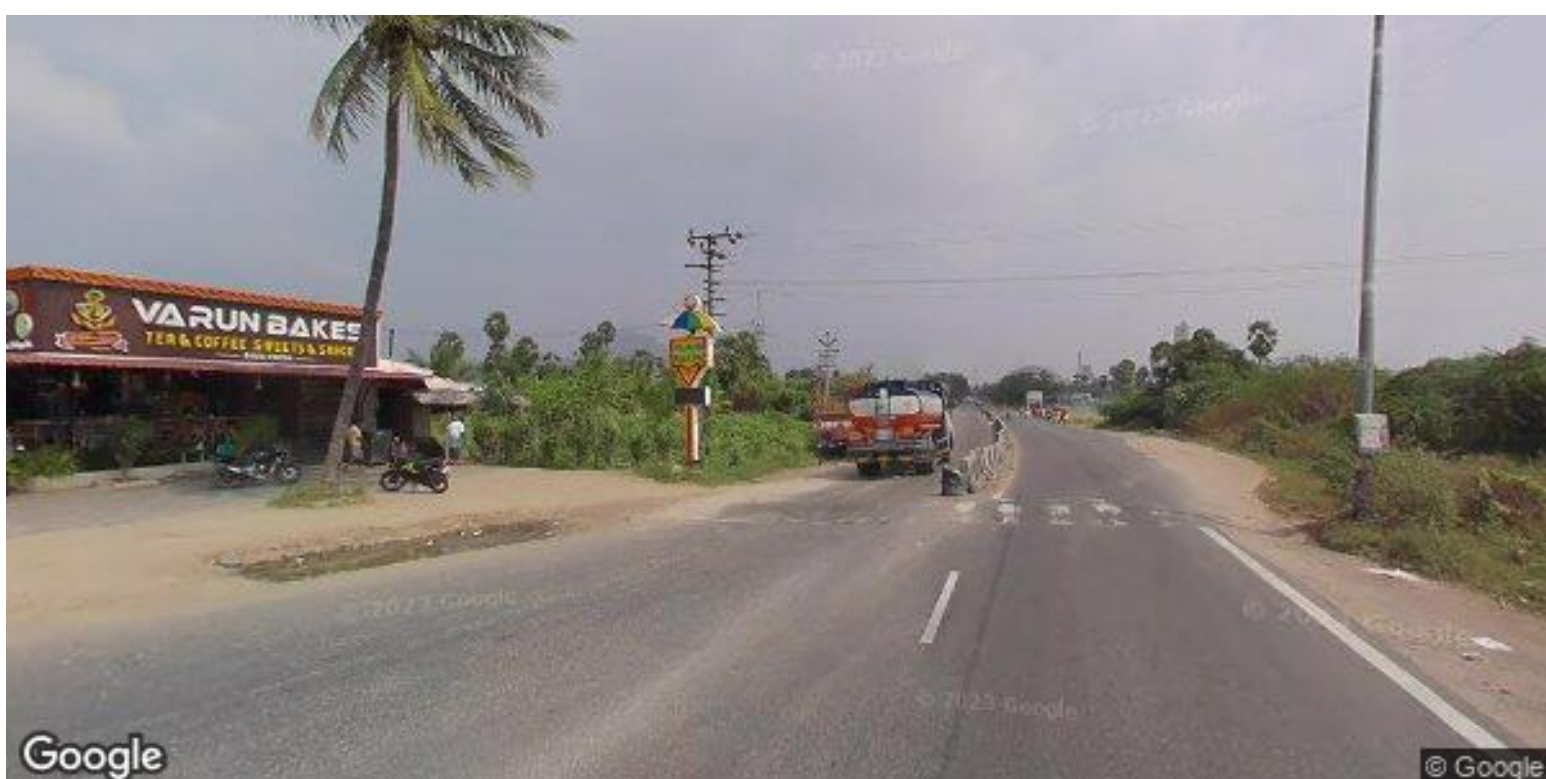
**Risk Type:** Turn  
**Risk Level:** Medium  
**Speed Limit:** 30 KM/Hr  
**Coordinates:** 11.45543, 77.81740

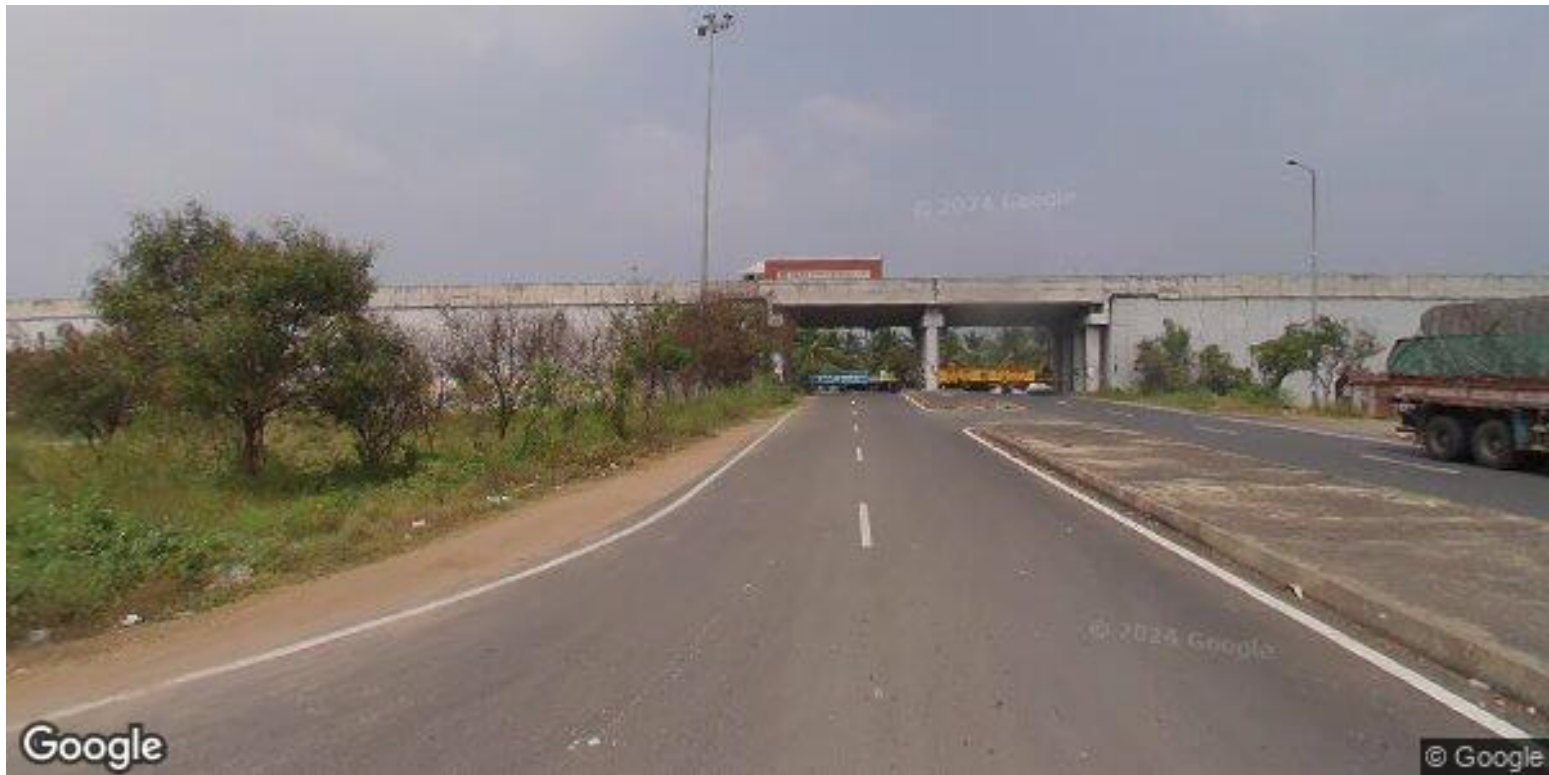
**Risk Type:** Turn  
**Risk Level:** Medium  
**Speed Limit:** 30 KM/Hr  
**Coordinates:** 11.45563, 77.81708

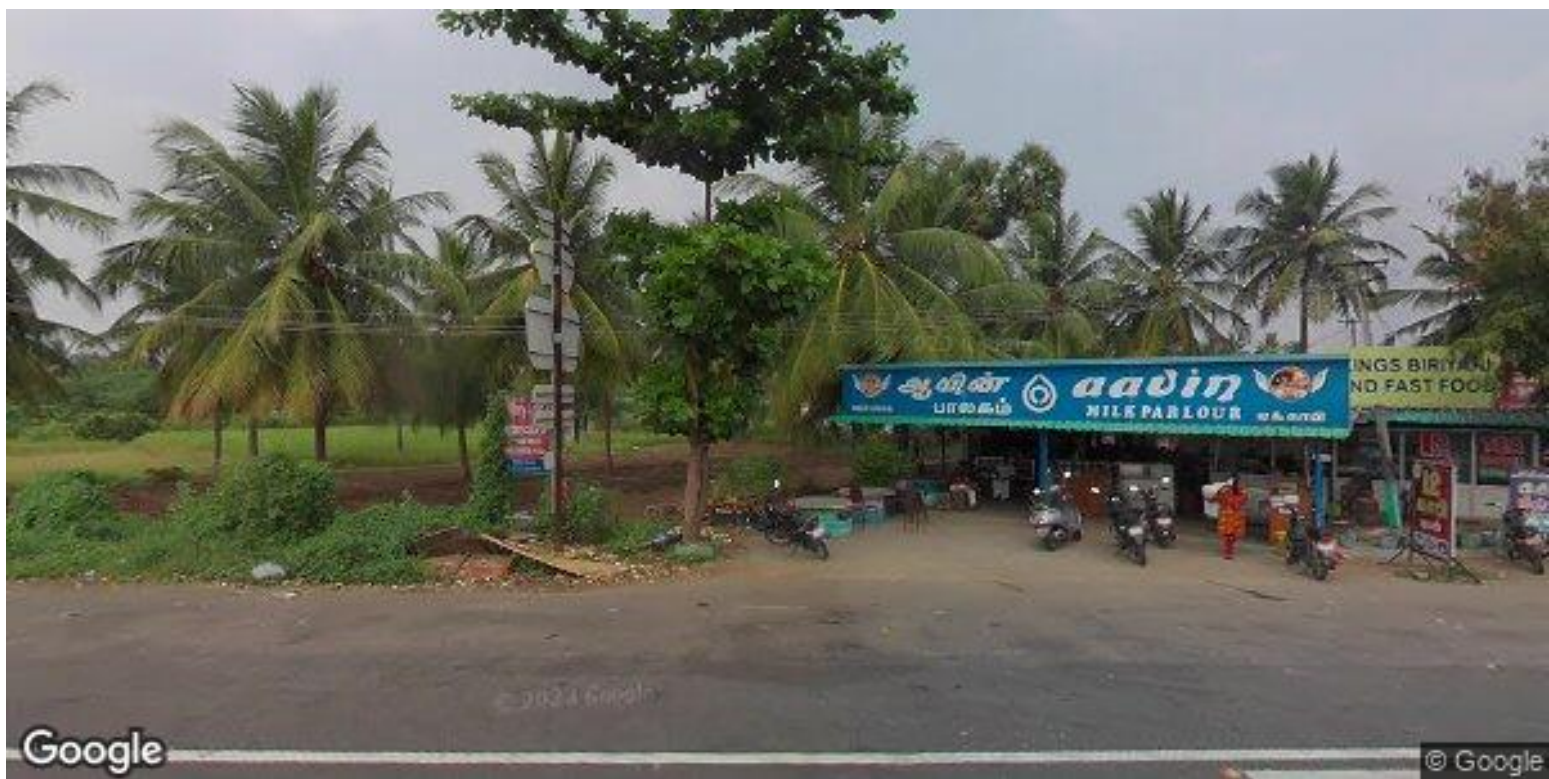
**Risk Type:** Turn  
**Risk Level:** High  
**Speed Limit:** 15 KM/Hr  
**Coordinates:** 11.45631, 77.81668

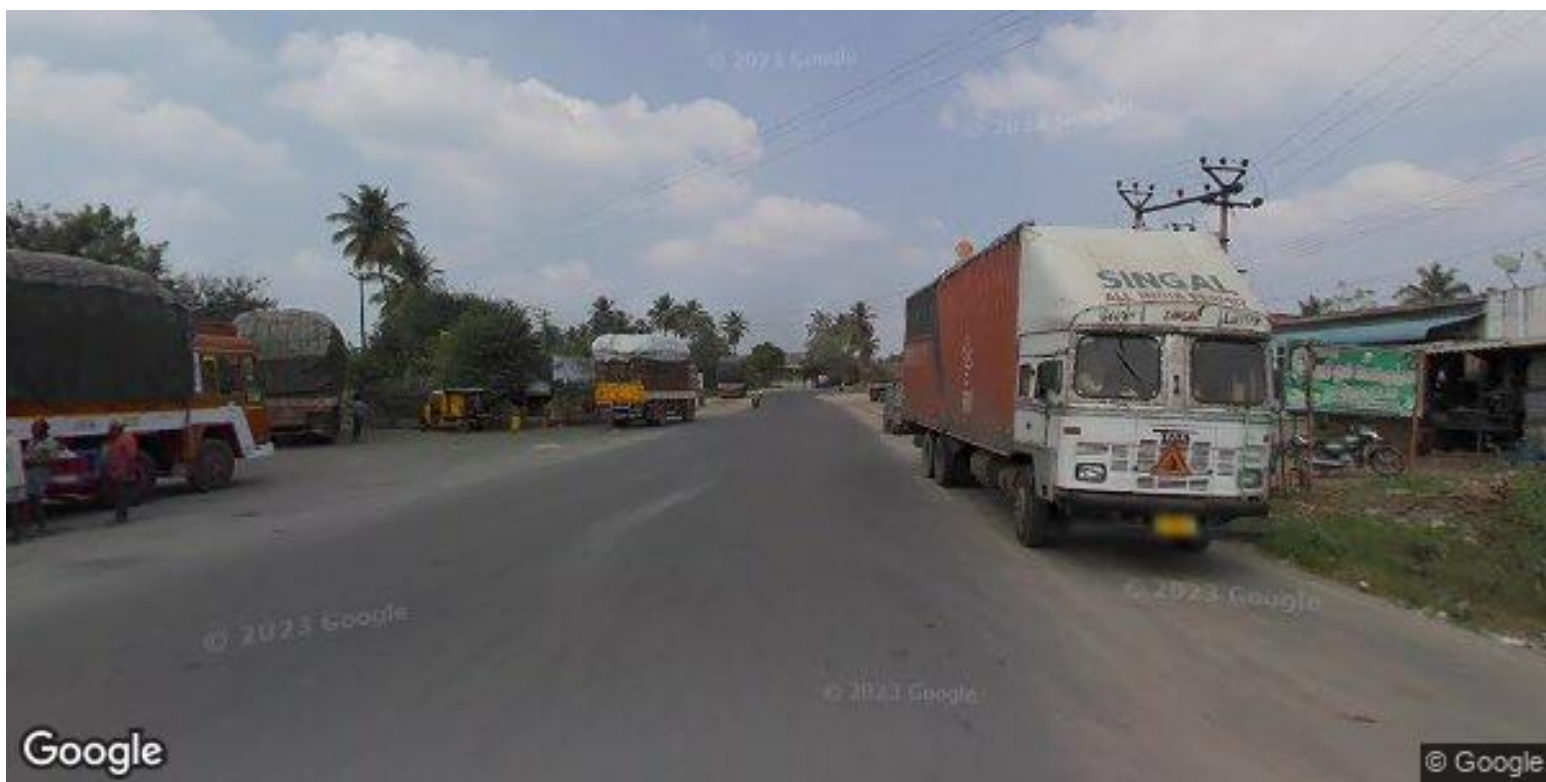
**Risk Type:** Turn

**Risk Level:** Medium

**Speed Limit:** 30 KM/Hr

**Coordinates:** 11.49377, 77.88573

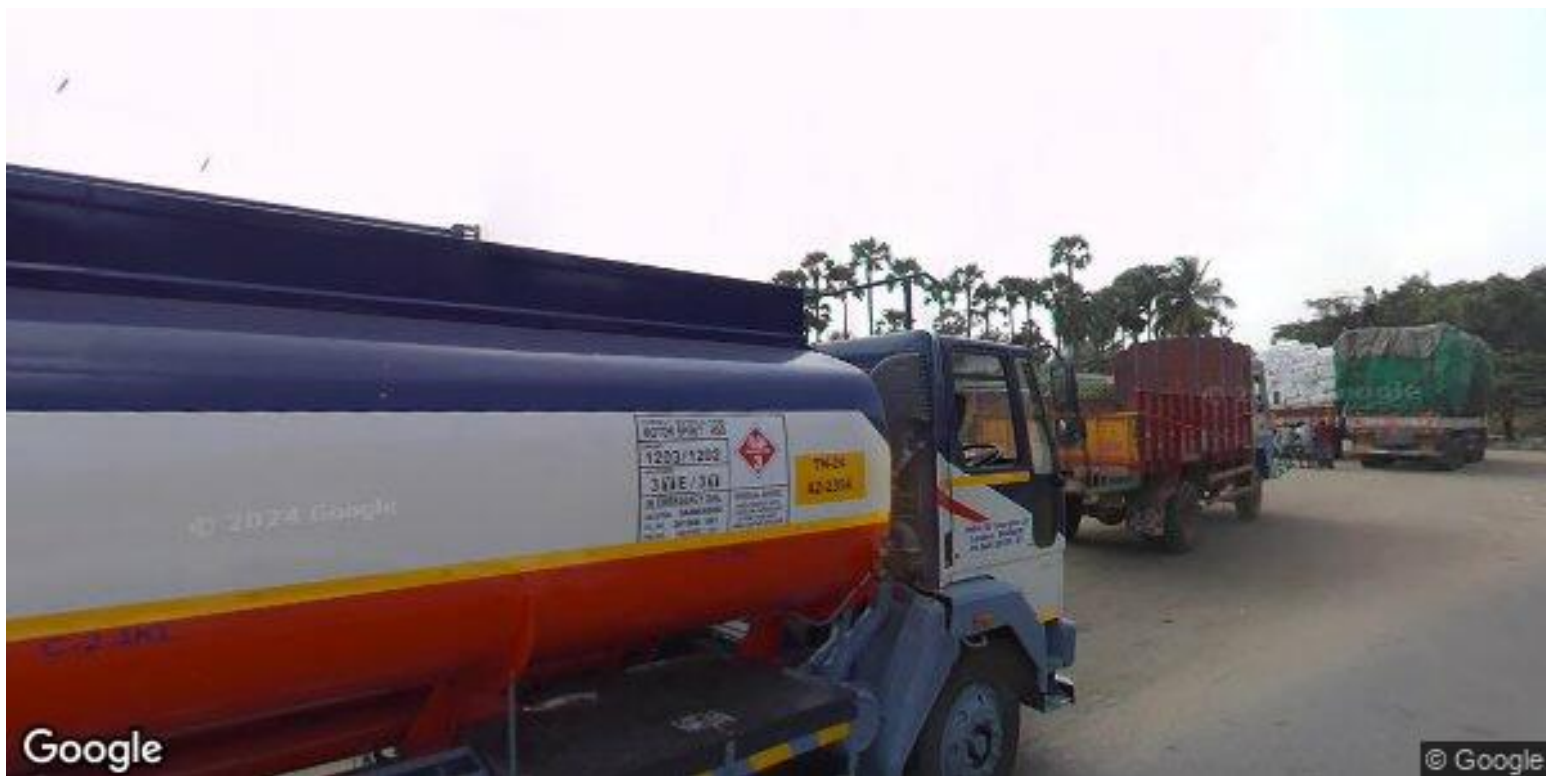
**Risk Type:** Turn

**Risk Level:** High

**Speed Limit:** 15 KM/Hr

**Coordinates:** 11.49274, 77.88688

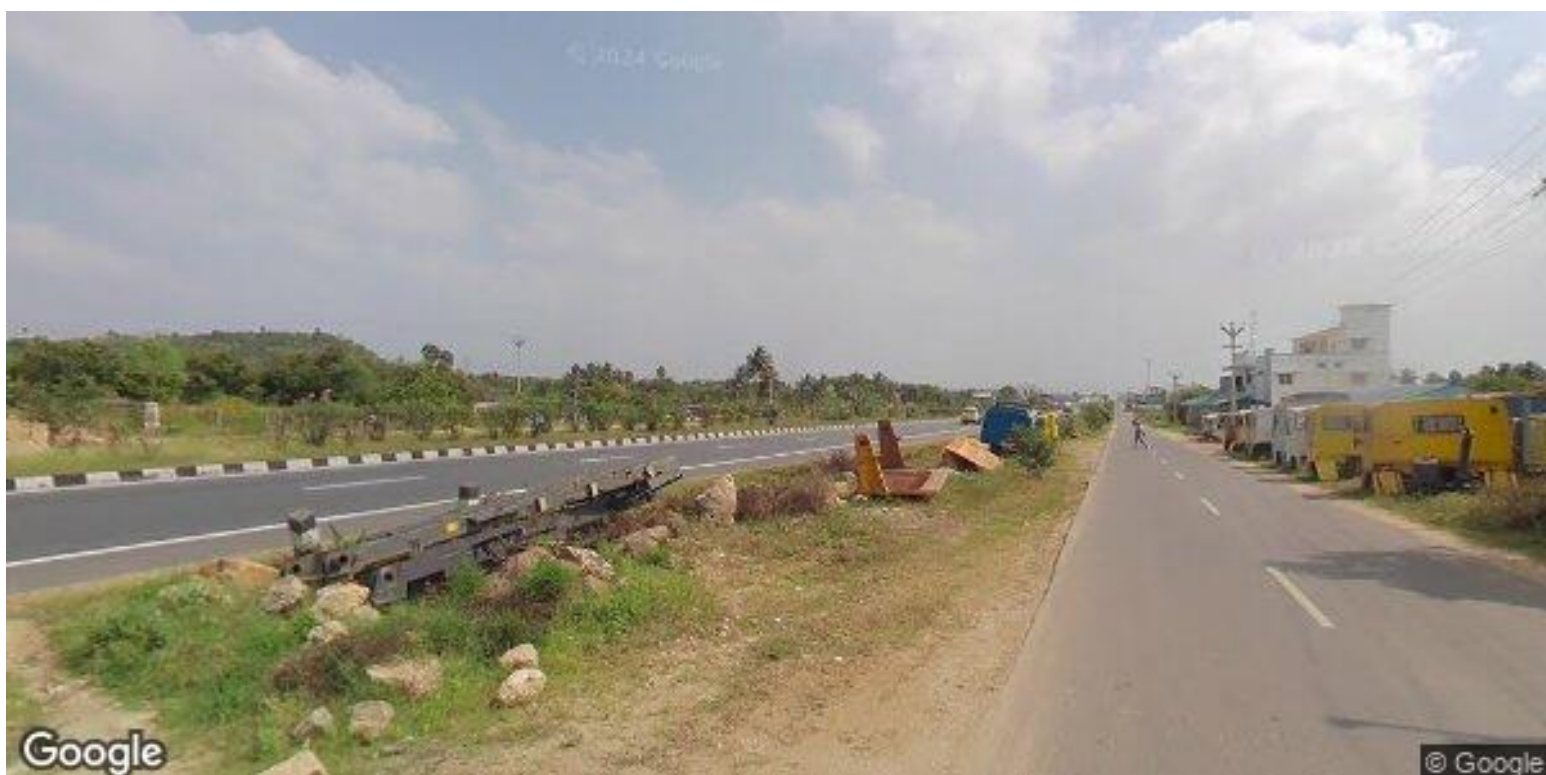
**Risk Type:** Blind Spot  
**Risk Level:** Blind Spot  
**Speed Limit:** 10 KM/Hr  
**Coordinates:** 11.49267, 77.88934

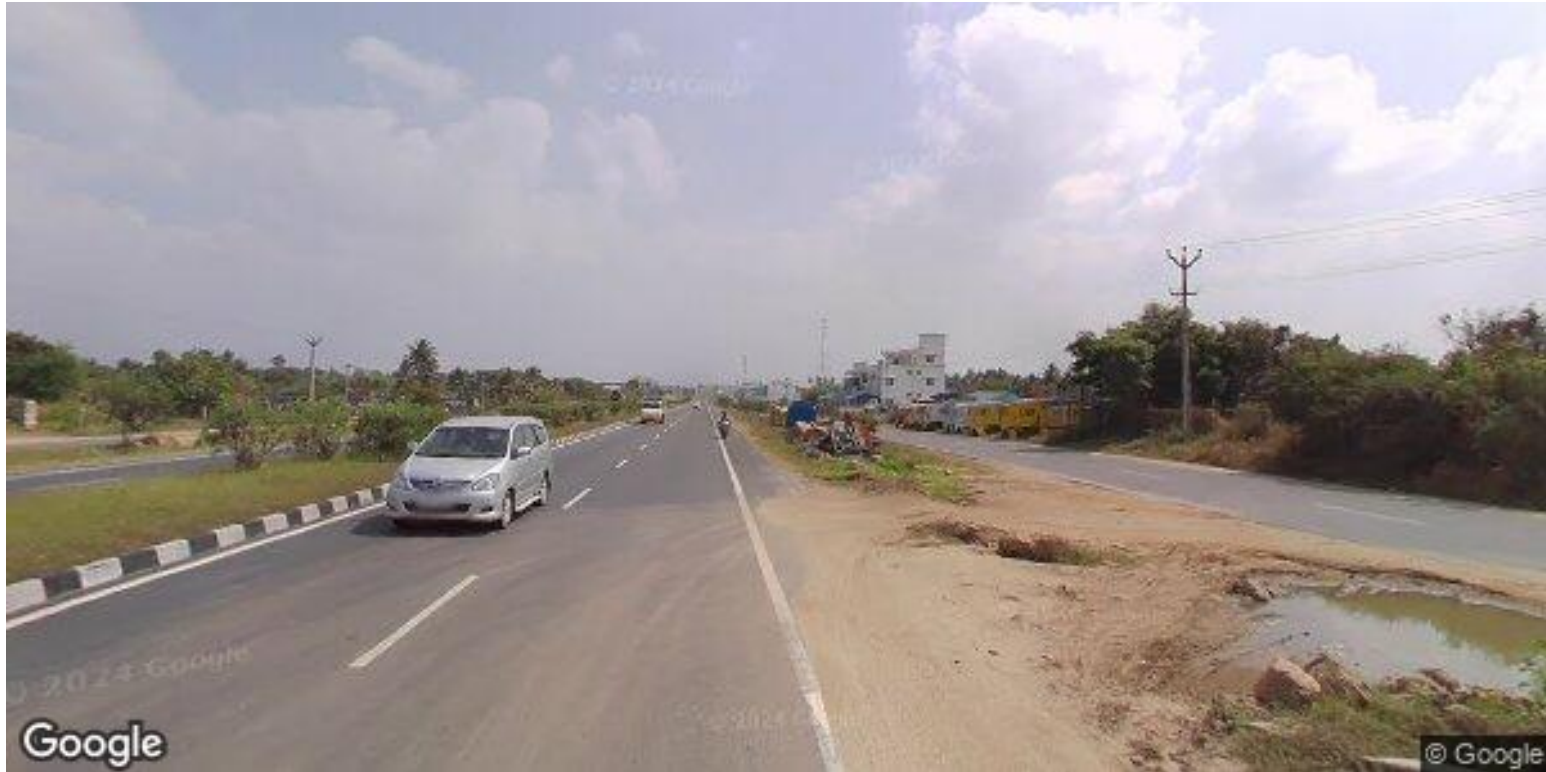
**Risk Type:** Turn  
**Risk Level:** Medium  
**Speed Limit:** 30 KM/Hr  
**Coordinates:** 11.49284, 77.88915

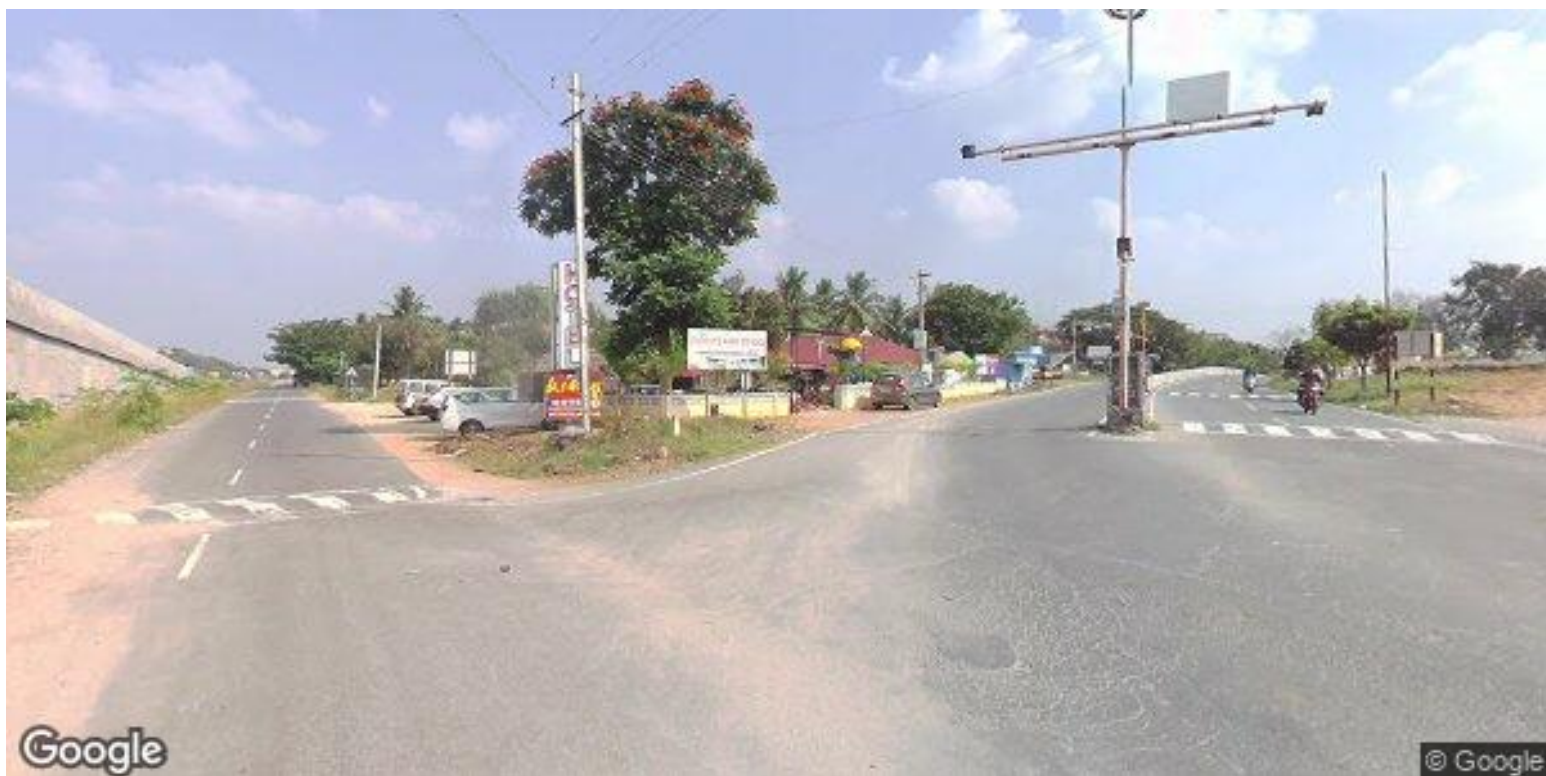
**Risk Type:** Turn  
**Risk Level:** High  
**Speed Limit:** 15 KM/Hr  
**Coordinates:** 11.49353, 77.86769

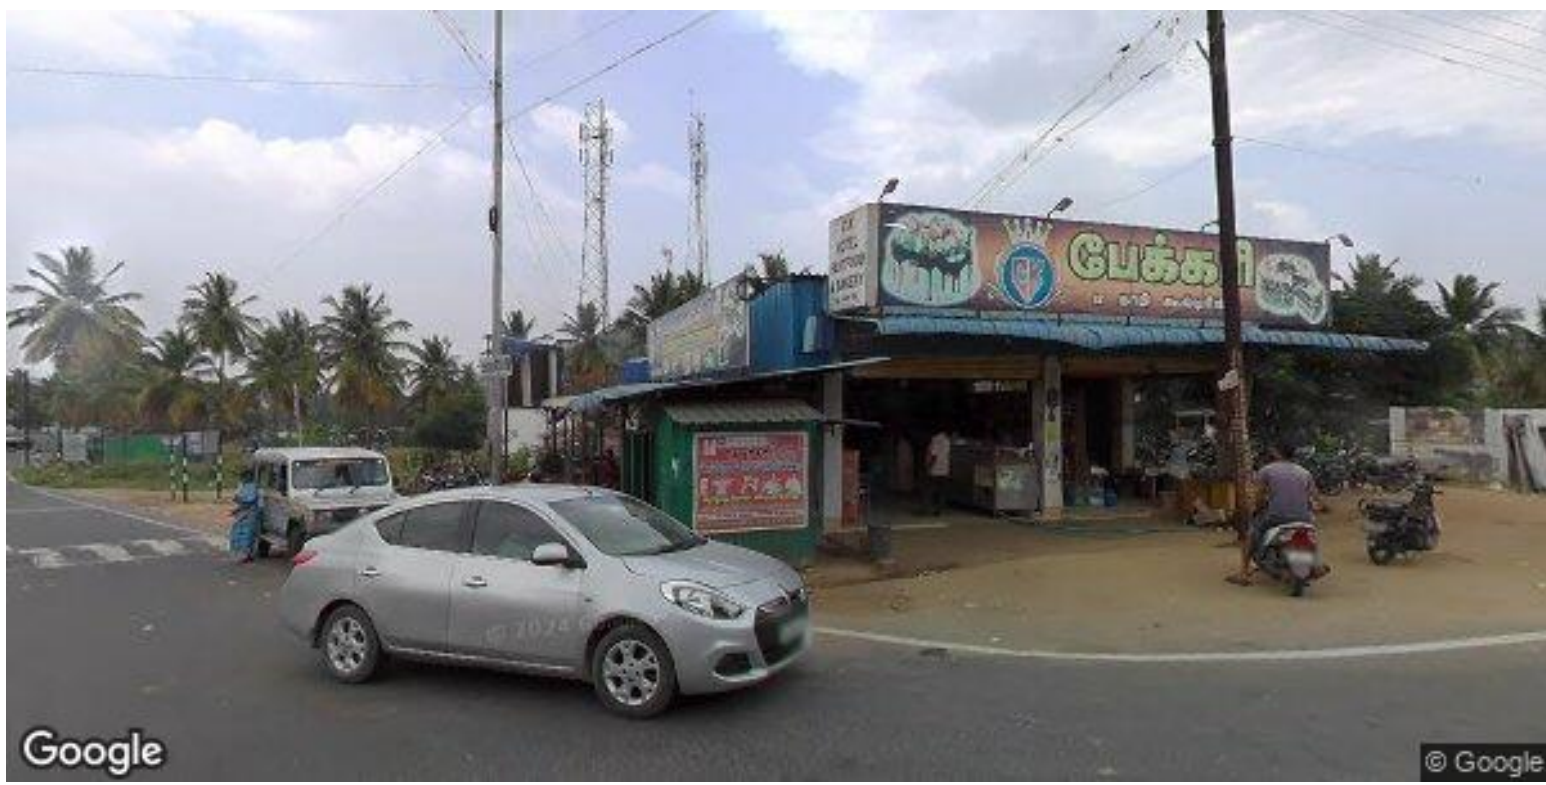
**Risk Type:** Turn

**Risk Level:** Medium

**Speed Limit:** 30 KM/Hr

**Coordinates:** 11.49390, 77.86748

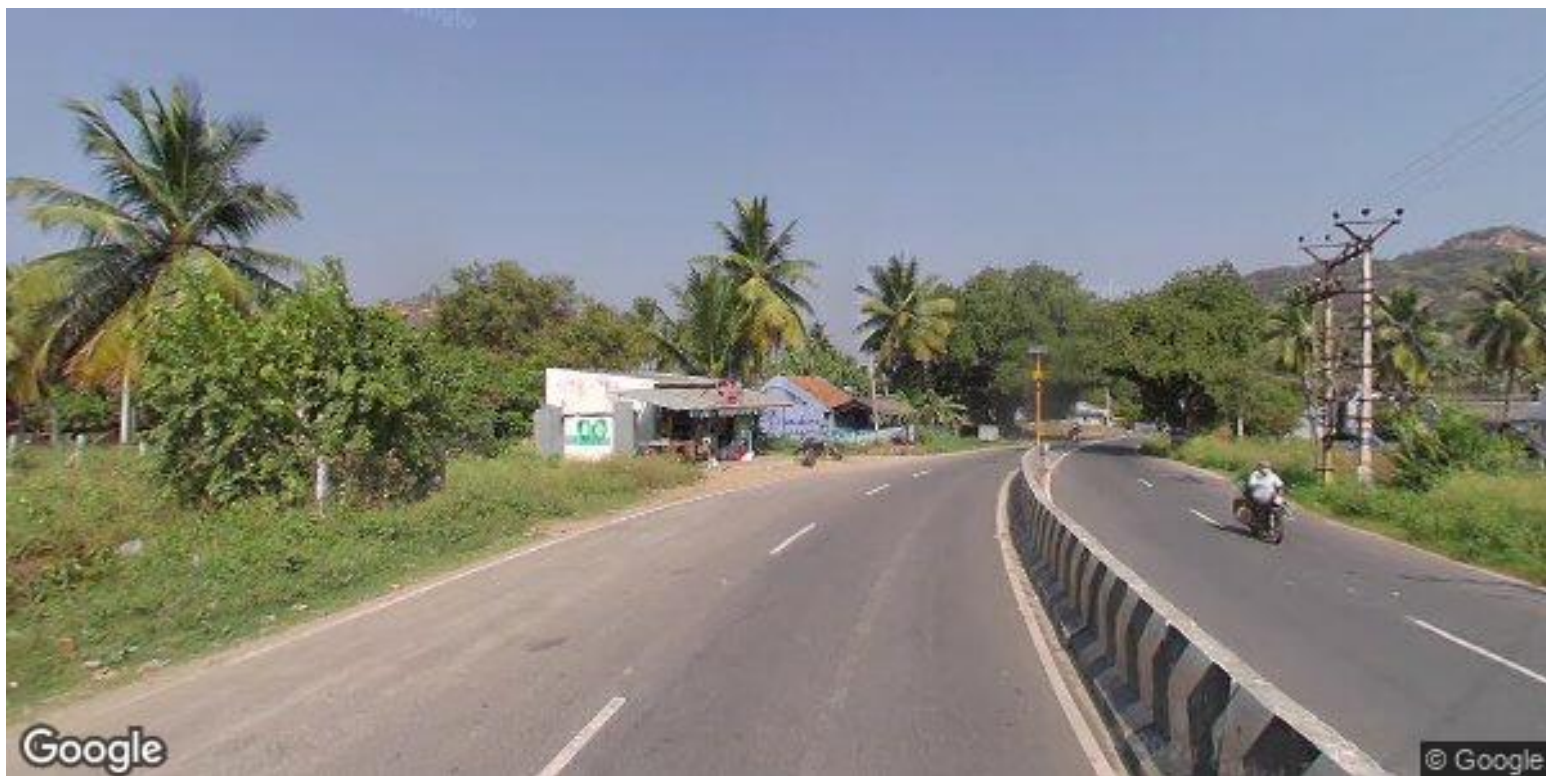
**Risk Type:** Turn

**Risk Level:** Medium

**Speed Limit:** 30 KM/Hr

**Coordinates:** 11.49490, 77.86661

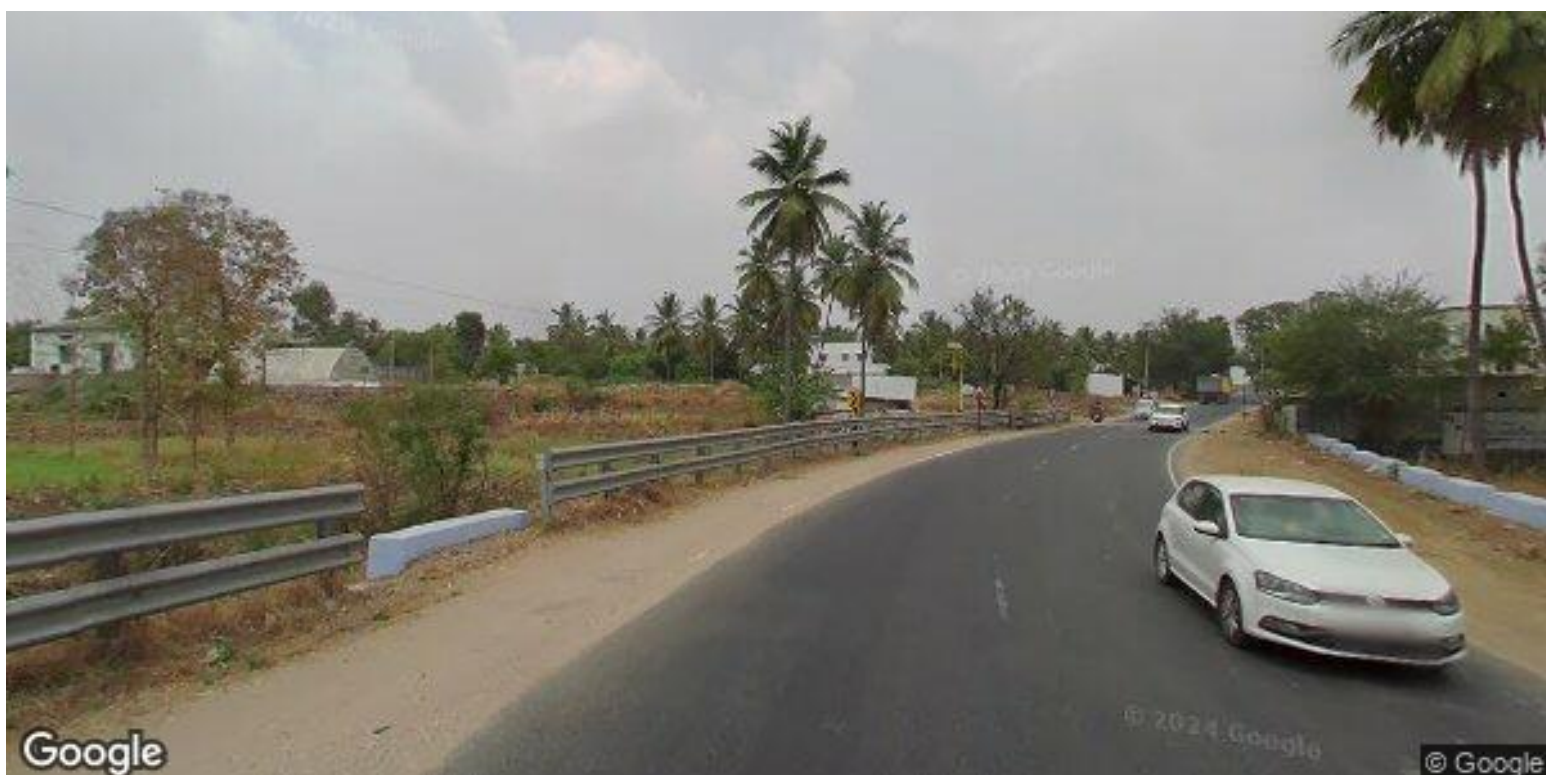
**Risk Type:** Turn  
**Risk Level:** Medium  
**Speed Limit:** 30 KM/Hr  
**Coordinates:** 11.52561, 77.85522

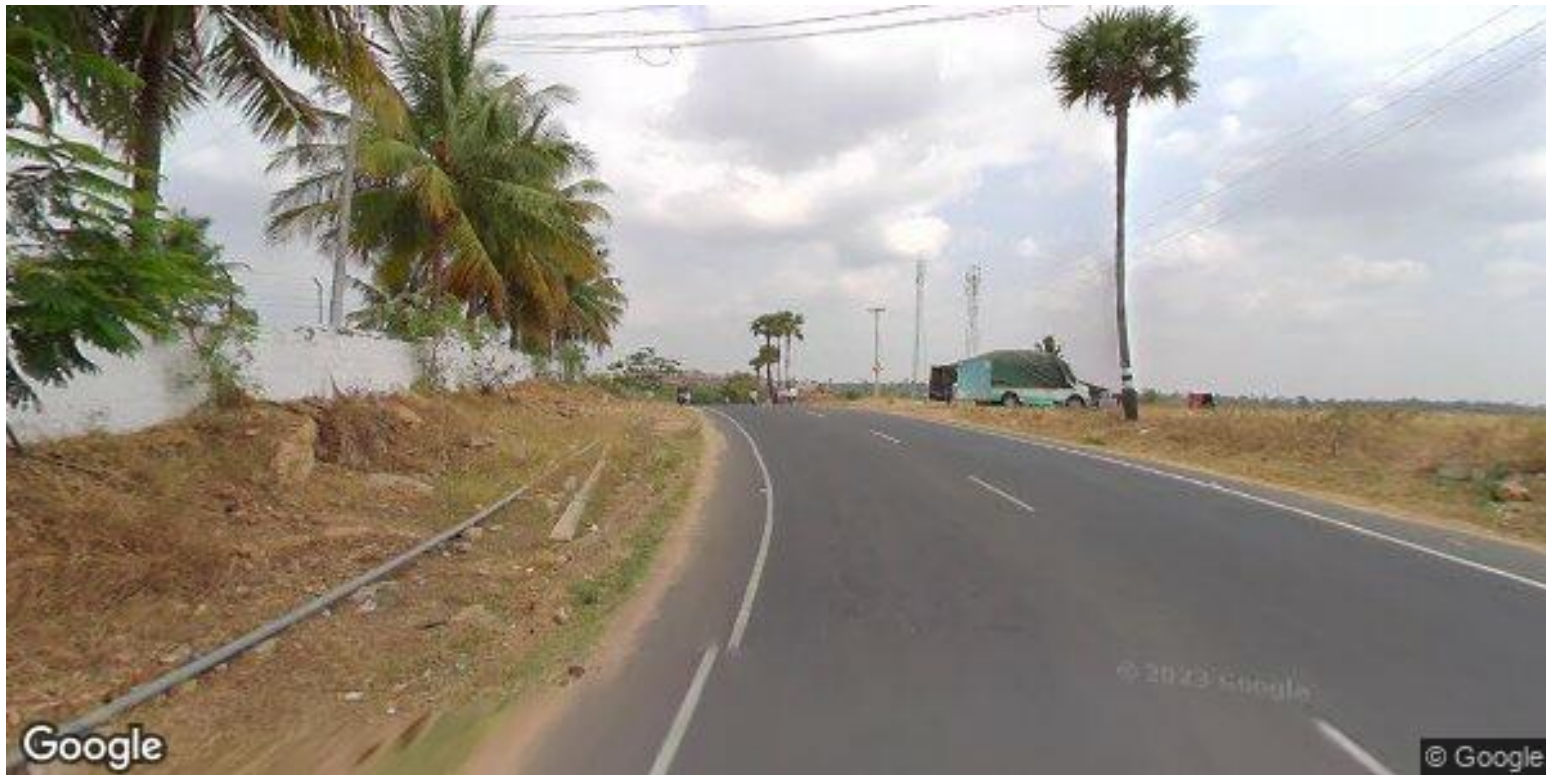
**Risk Type:** Turn  
**Risk Level:** Medium  
**Speed Limit:** 30 KM/Hr  
**Coordinates:** 11.52766, 77.85585

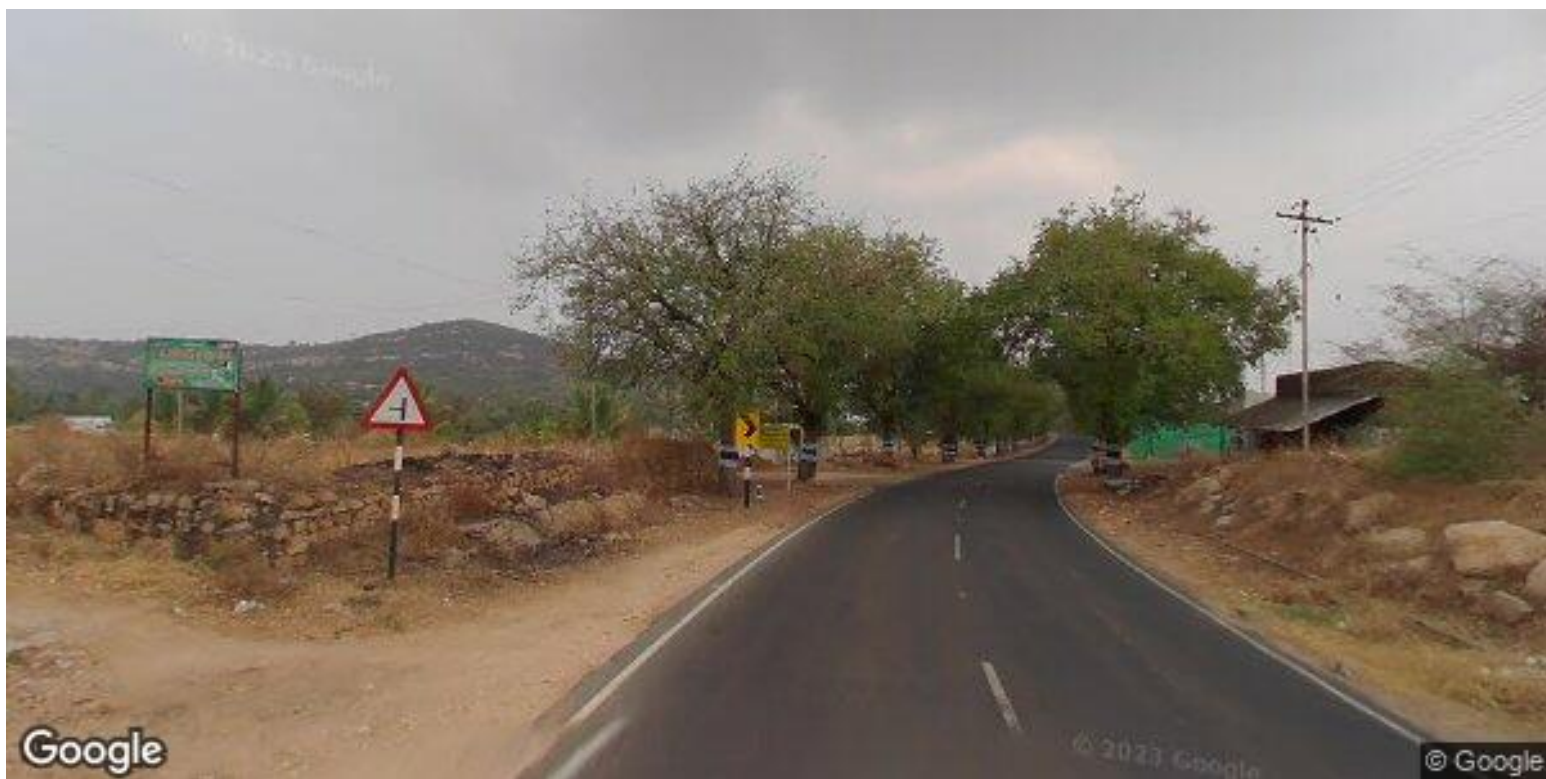
**Risk Type:** Turn  
**Risk Level:** Medium  
**Speed Limit:** 30 KM/Hr  
**Coordinates:** 11.53849, 77.85088

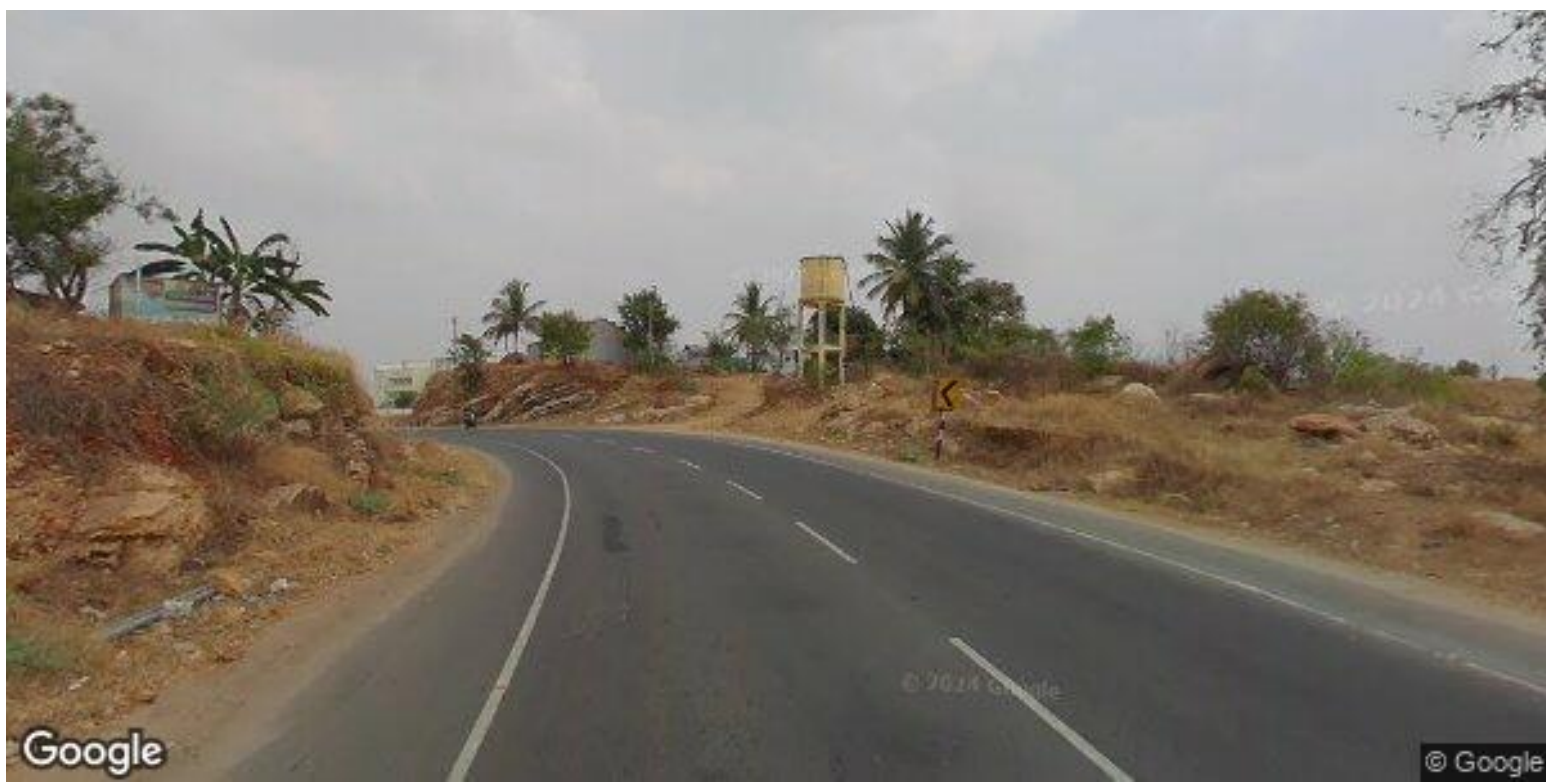
**Risk Type:** Turn

**Risk Level:** Medium

**Speed Limit:** 30 KM/Hr

**Coordinates:** 11.55013, 77.85498

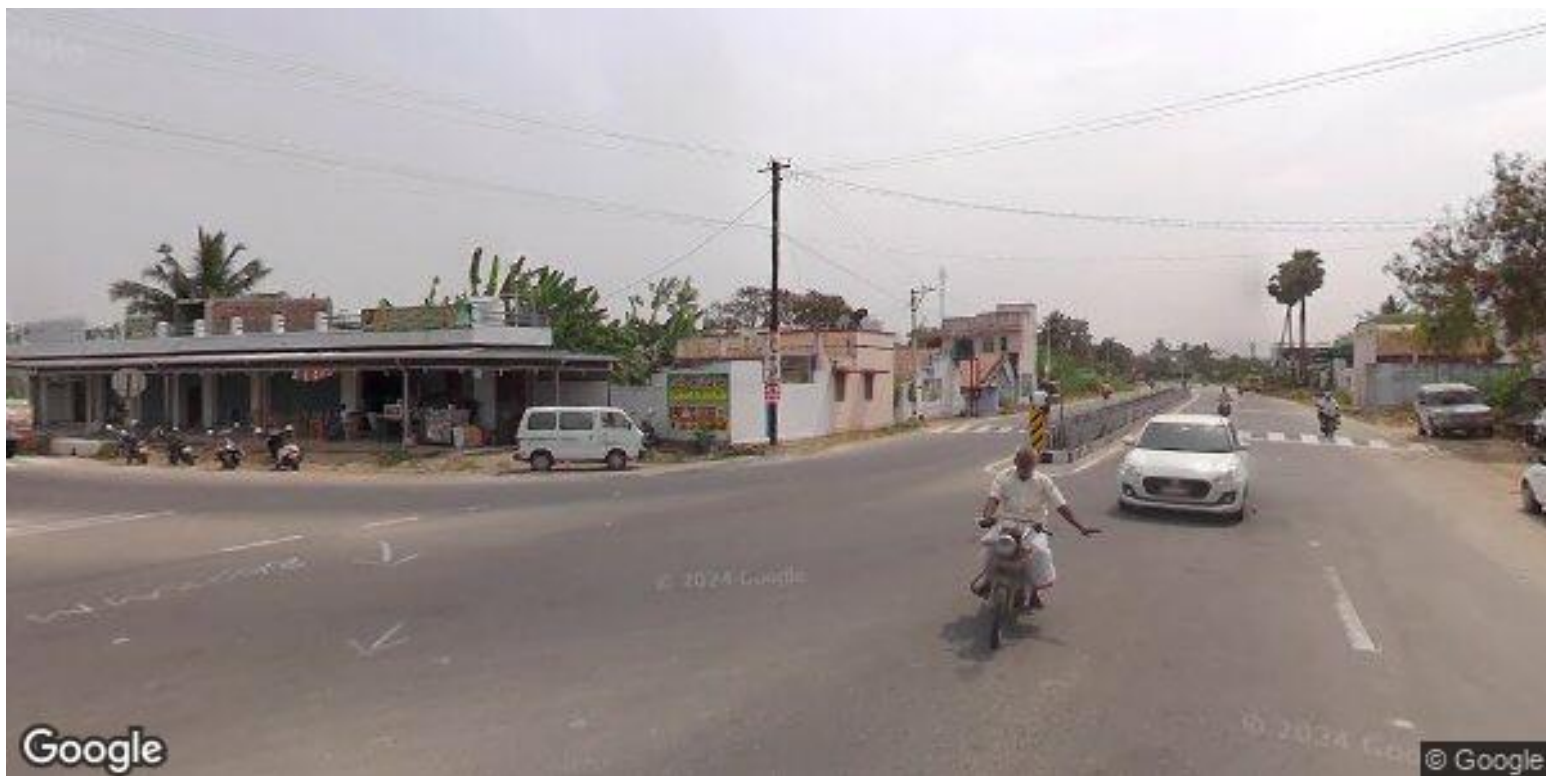
**Risk Type:** Turn

**Risk Level:** High

**Speed Limit:** 15 KM/Hr

**Coordinates:** 11.57903, 77.85432

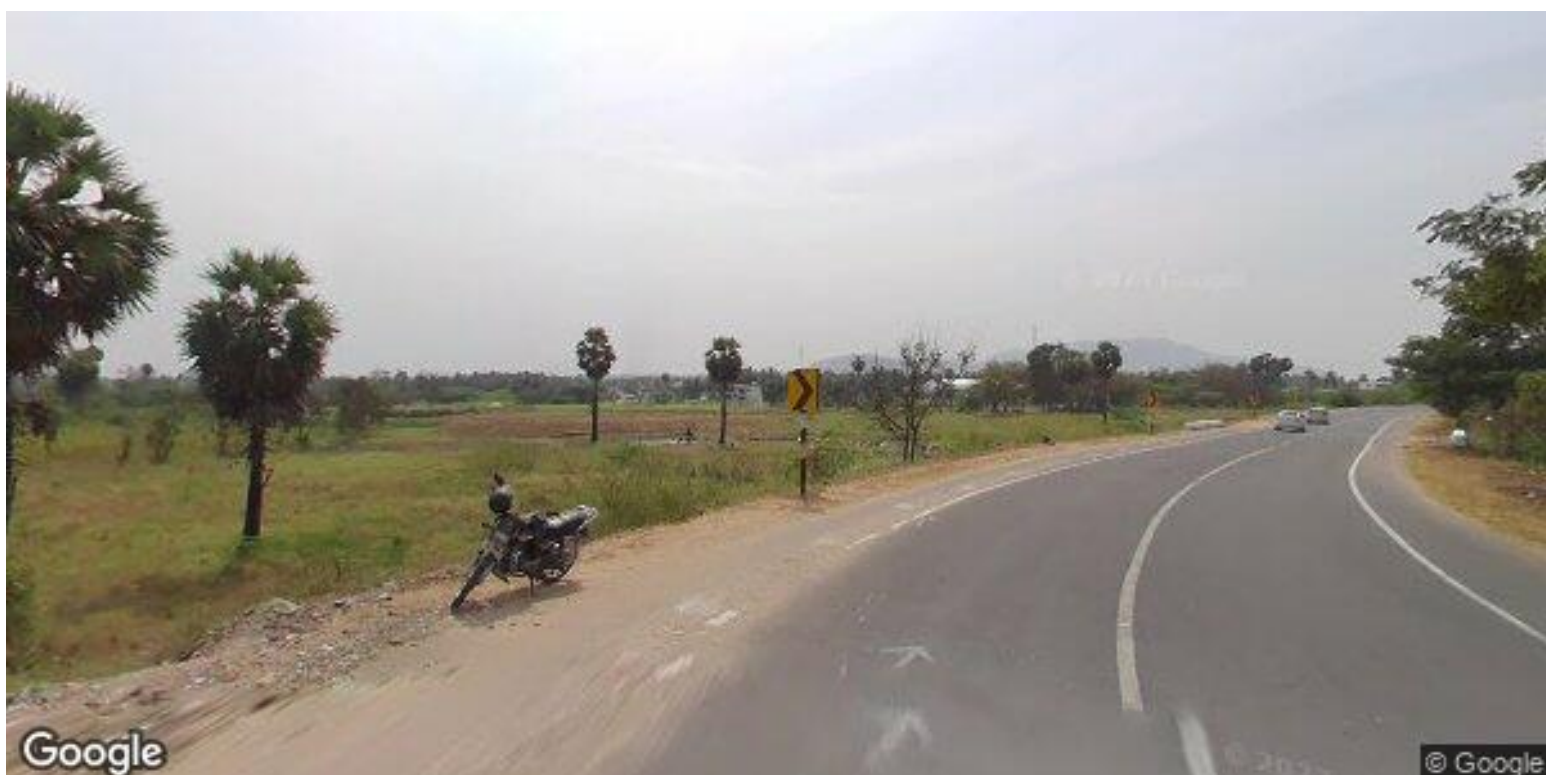
**Risk Type:** Turn

**Risk Level:** Medium

**Speed Limit:** 30 KM/Hr

**Coordinates:** 11.58022, 77.85744
