## JOURNEY RISK MANAGEMENT (JRM) STUDY

### Salem Terminal TO SABARMATHI FUELSS

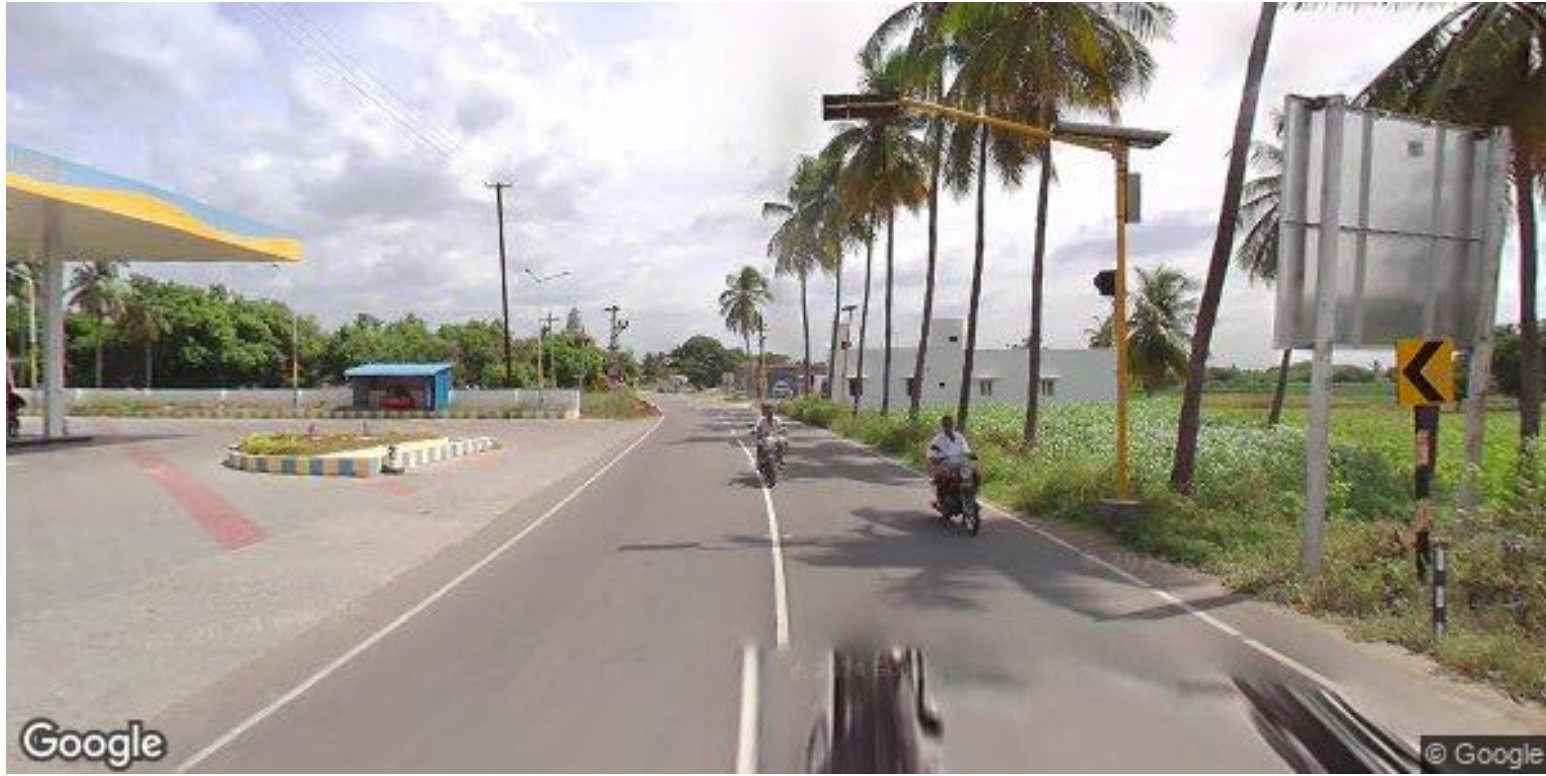
**Risk Type:** Turn

**Risk Level:** Medium

**Speed Limit:** 30 KM/Hr

**Coordinates:** 11.60992, 77.84165

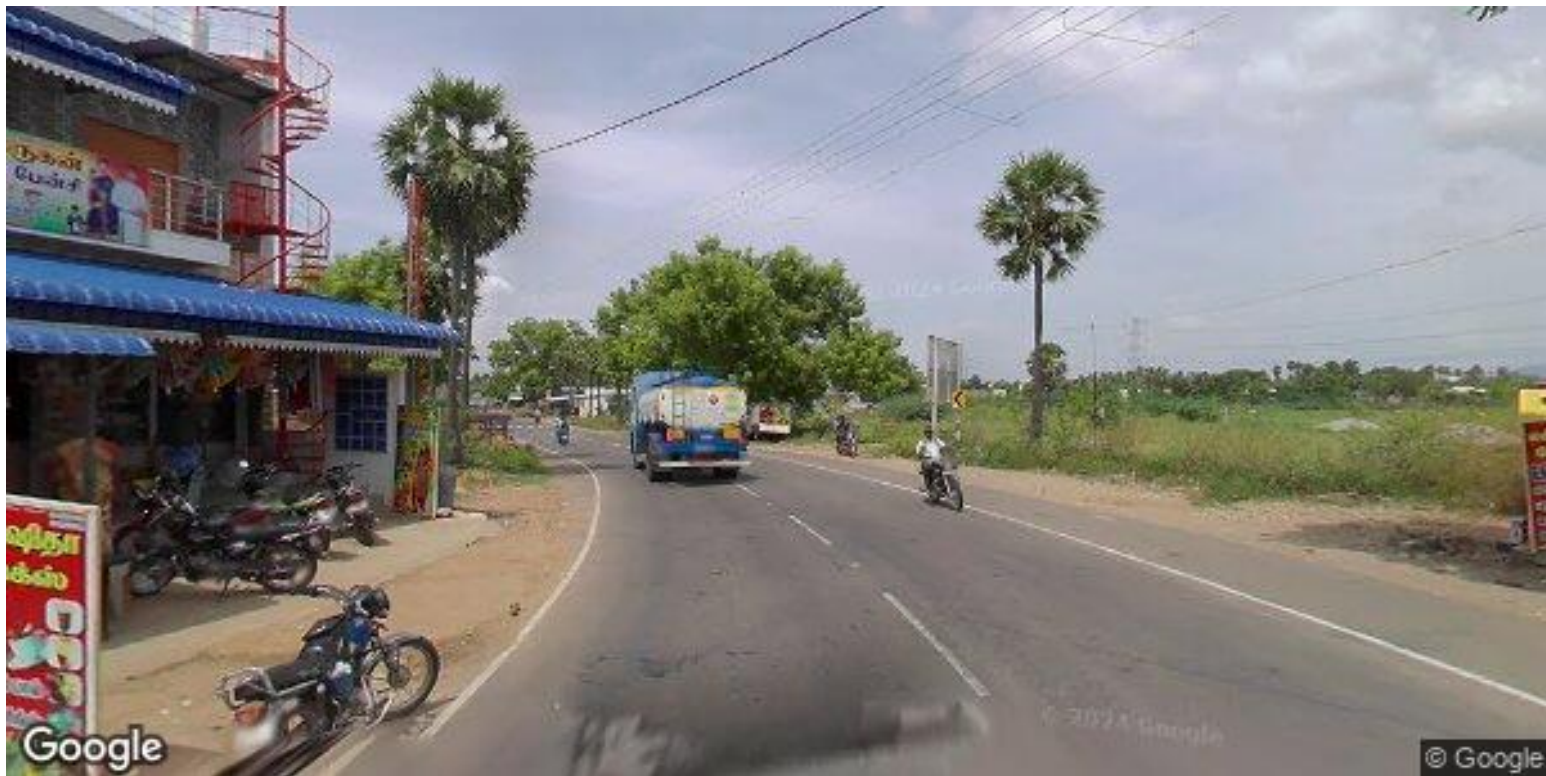
**Risk Type:** Turn

**Risk Level:** Medium

**Speed Limit:** 30 KM/Hr

**Coordinates:** 11.64064, 77.84611

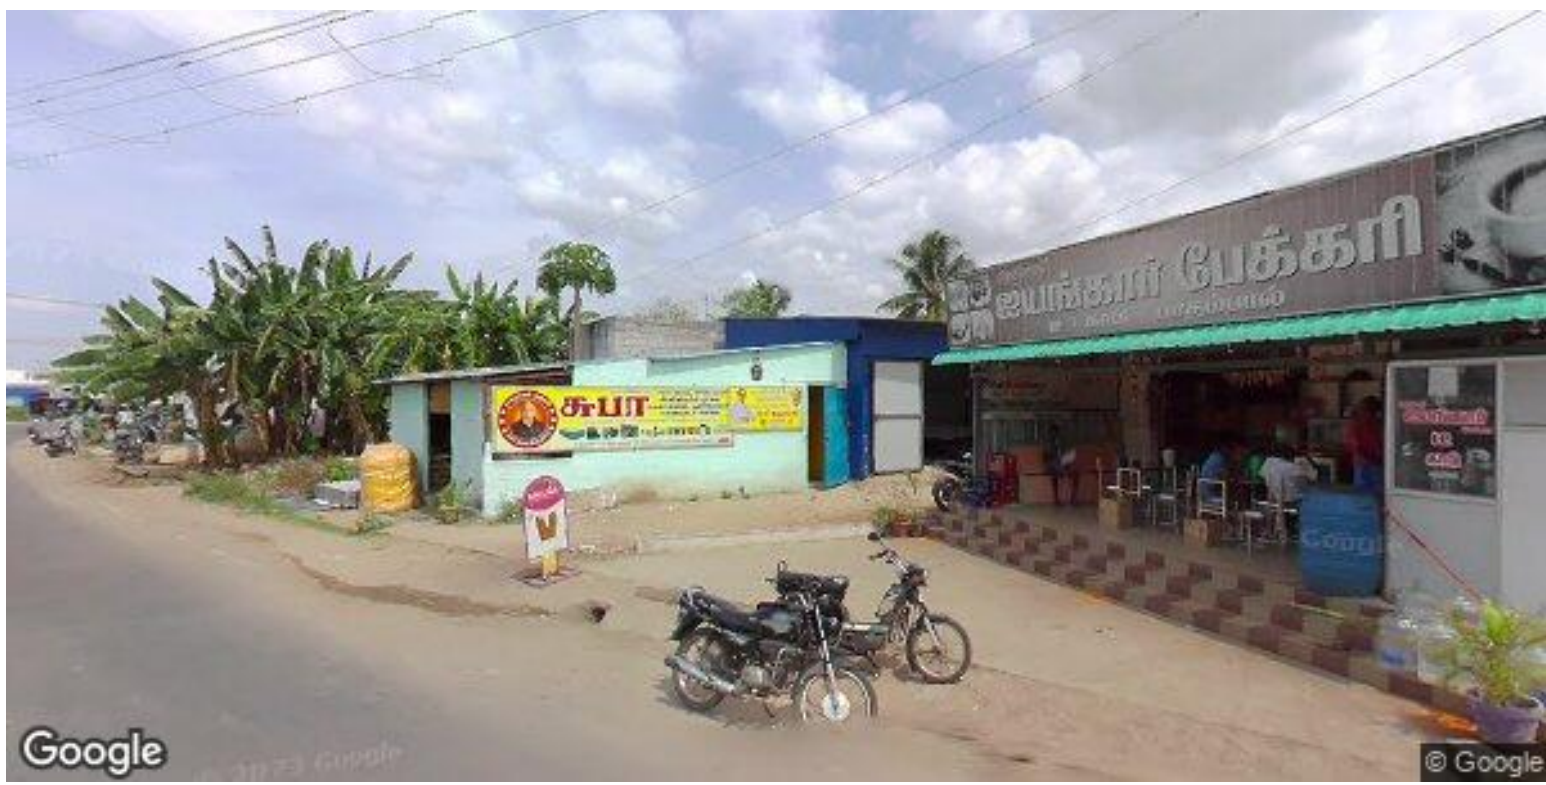
**Risk Type:** Turn

**Risk Level:** Medium

**Speed Limit:** 30 KM/Hr

**Coordinates:** 11.64155, 77.84858

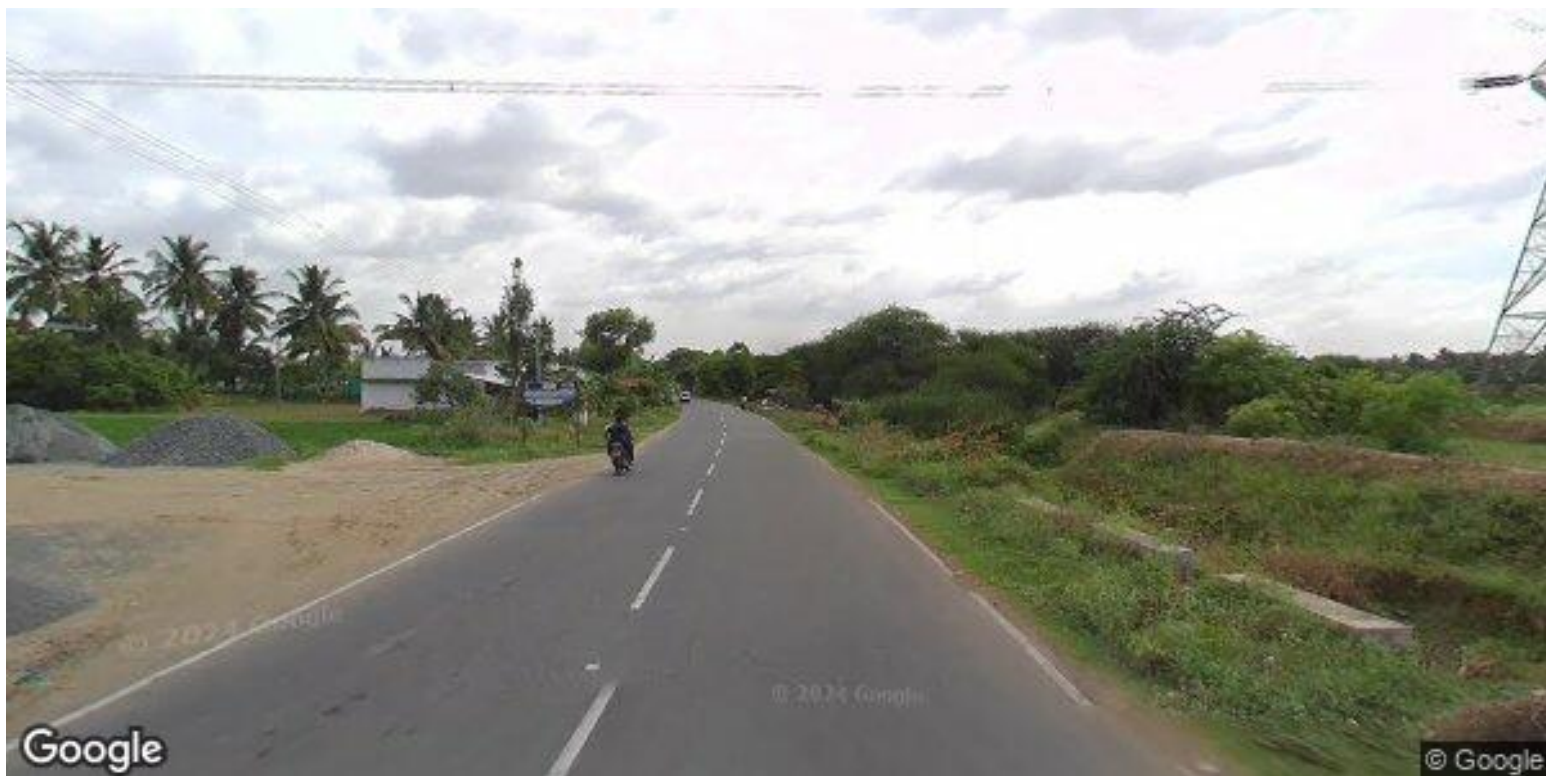
**Risk Type:** Turn

**Risk Level:** Medium

**Speed Limit:** 30 KM/Hr

**Coordinates:** 11.64570, 77.85137

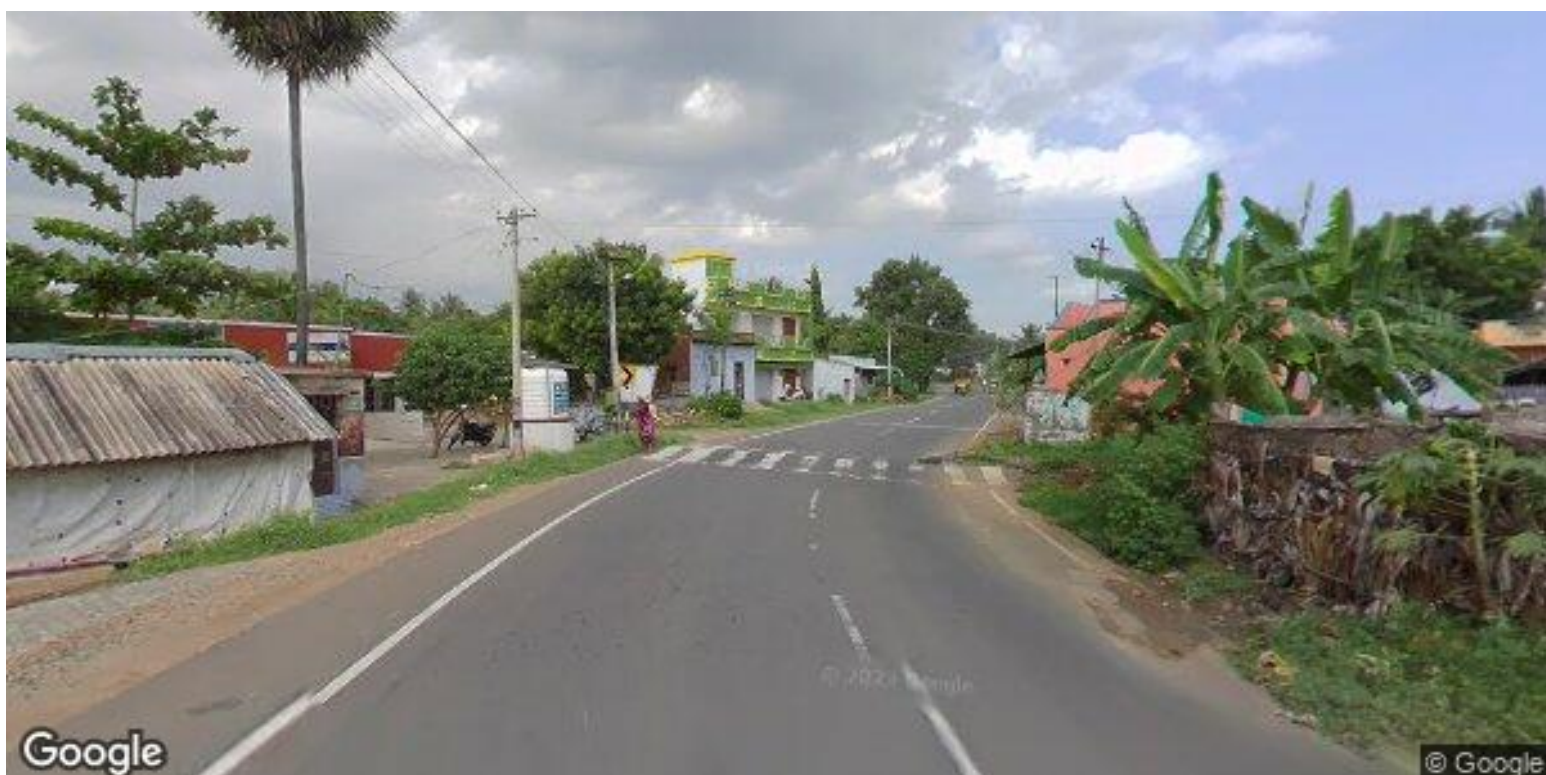
**Risk Type:** Turn  
**Risk Level:** Medium  
**Speed Limit:** 30 KM/Hr  
**Coordinates:** 11.67316, 77.86038

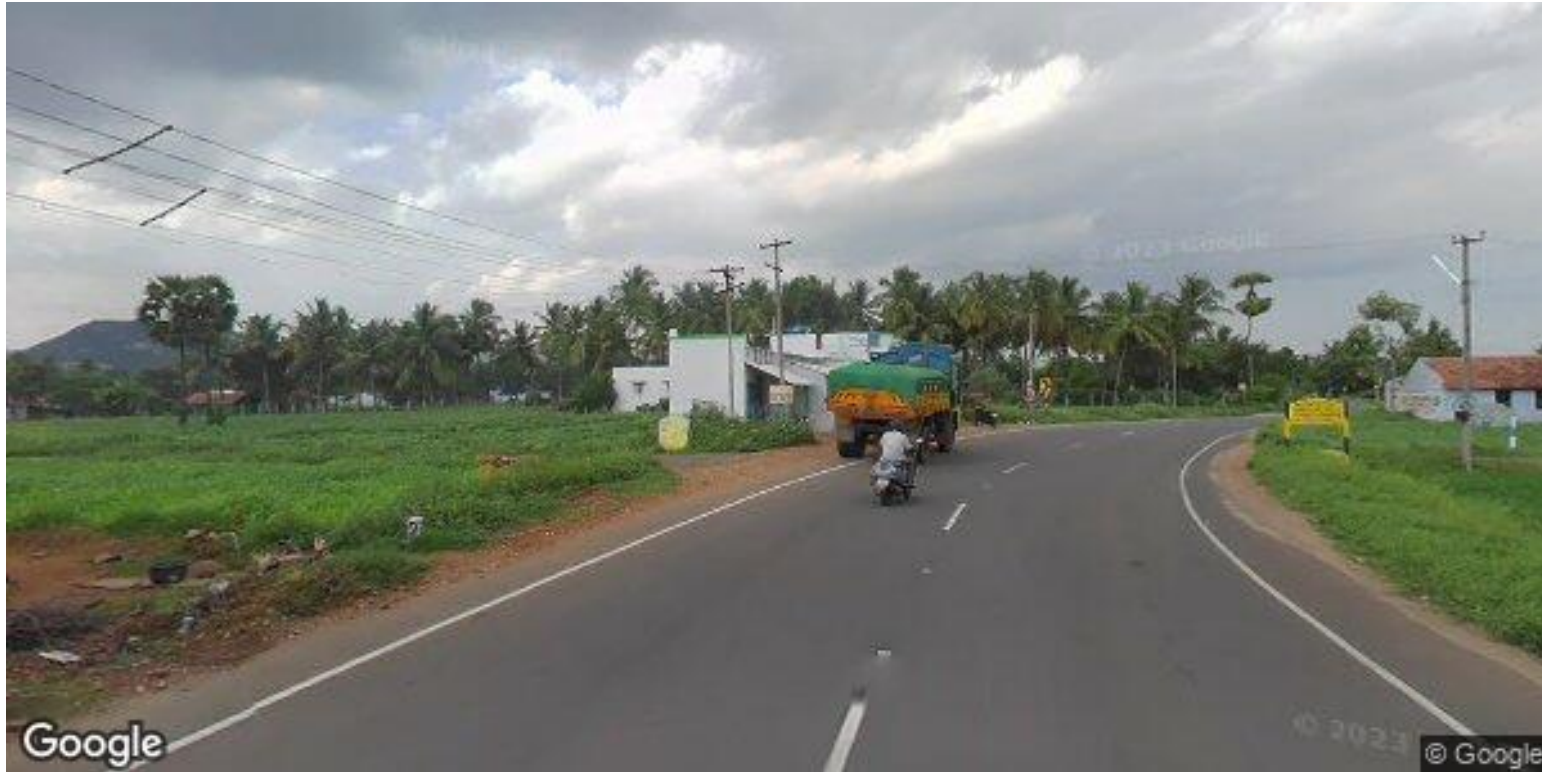
**Risk Type:** Turn  
**Risk Level:** Medium  
**Speed Limit:** 30 KM/Hr  
**Coordinates:** 11.68171, 77.86676

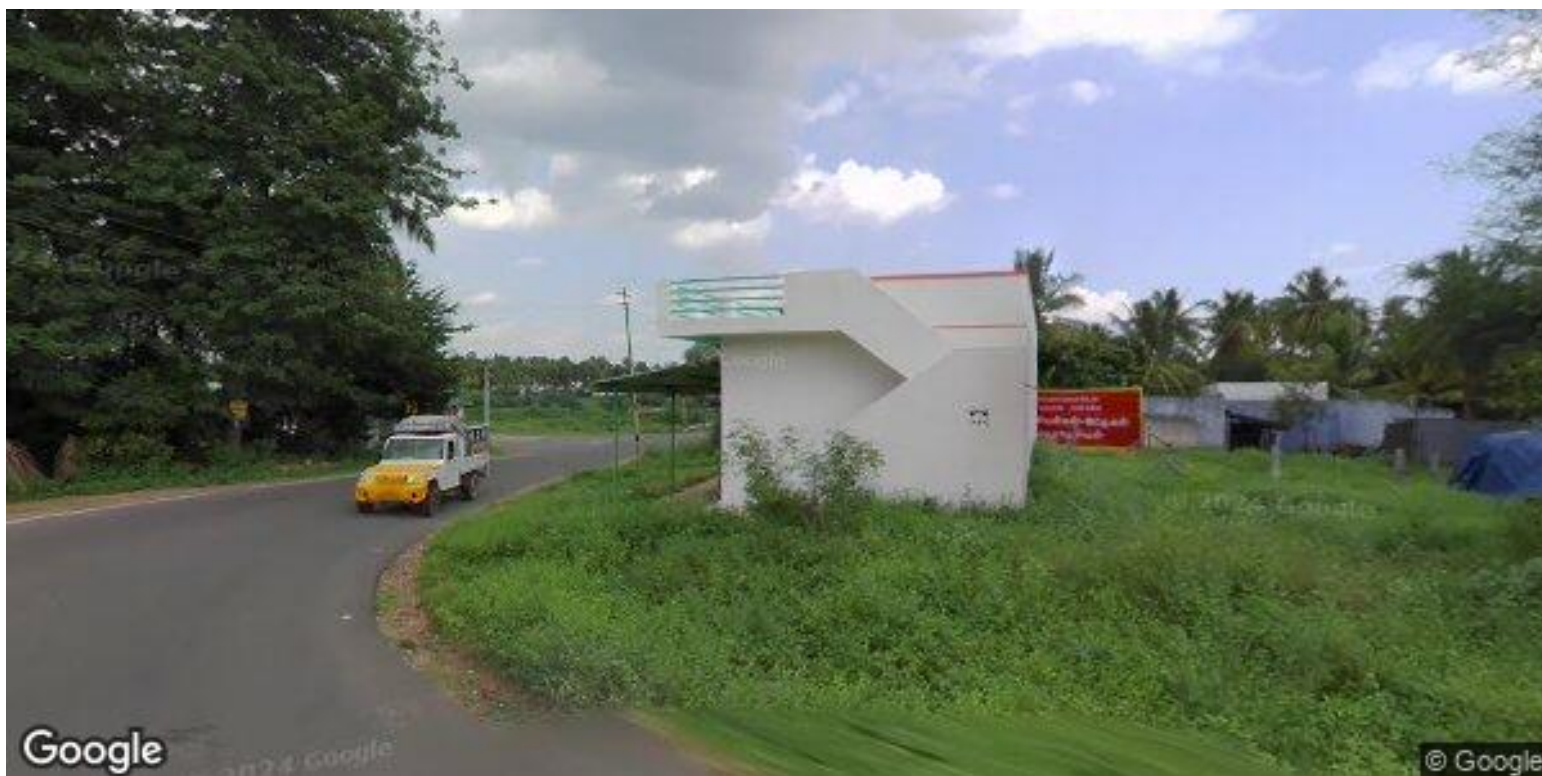
**Risk Type:** Turn  
**Risk Level:** Medium  
**Speed Limit:** 30 KM/Hr  
**Coordinates:** 11.68484, 77.86886

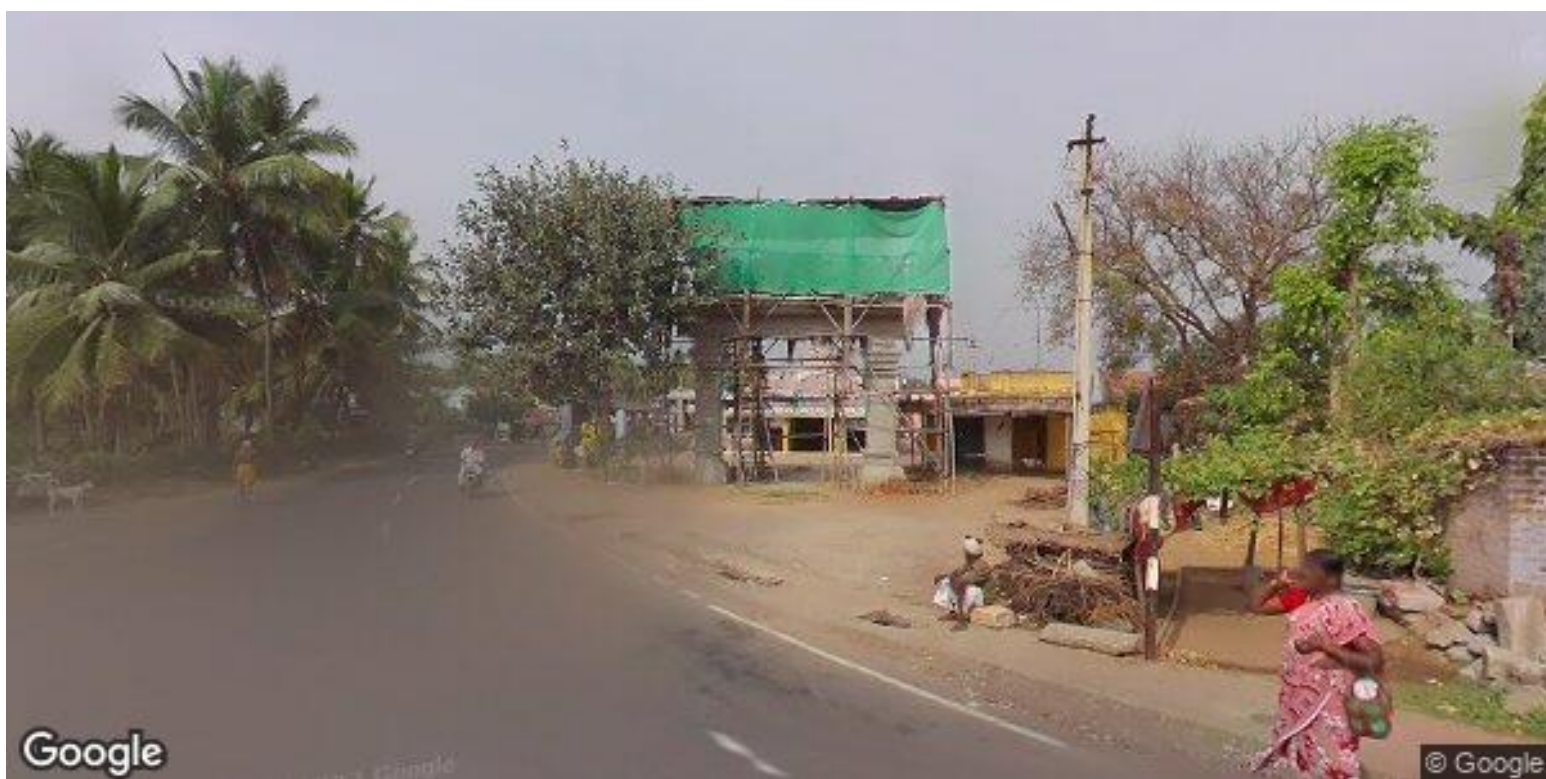
**Risk Type:** Turn

**Risk Level:** High

**Speed Limit:** 15 KM/Hr

**Coordinates:** 11.68472, 77.87281

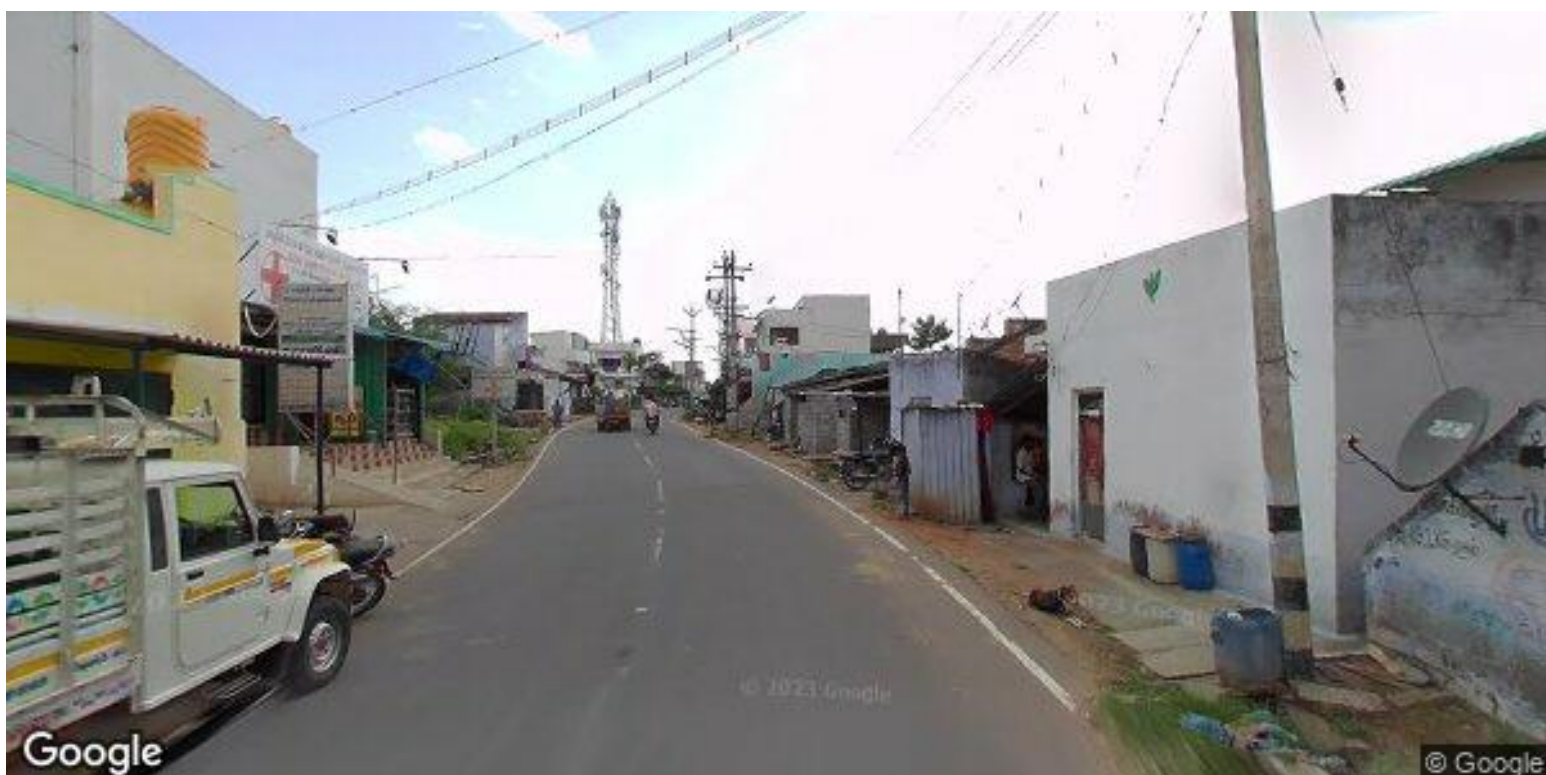
**Risk Type:** Turn

**Risk Level:** Medium

**Speed Limit:** 30 KM/Hr

**Coordinates:** 11.69280, 77.87439

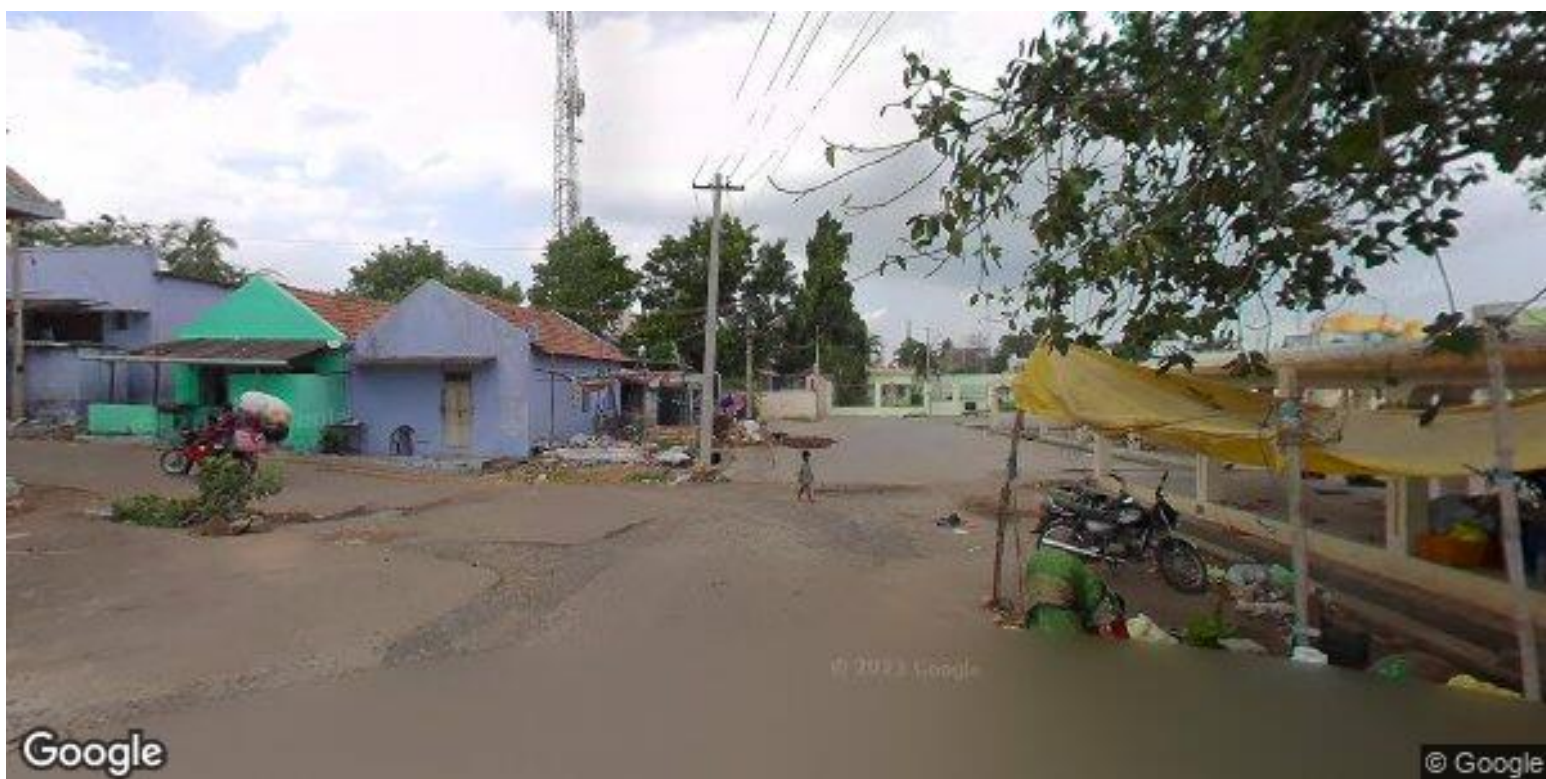
**Risk Type:** Turn  
**Risk Level:** High  
**Speed Limit:** 15 KM/Hr  
**Coordinates:** 11.69501, 77.87546

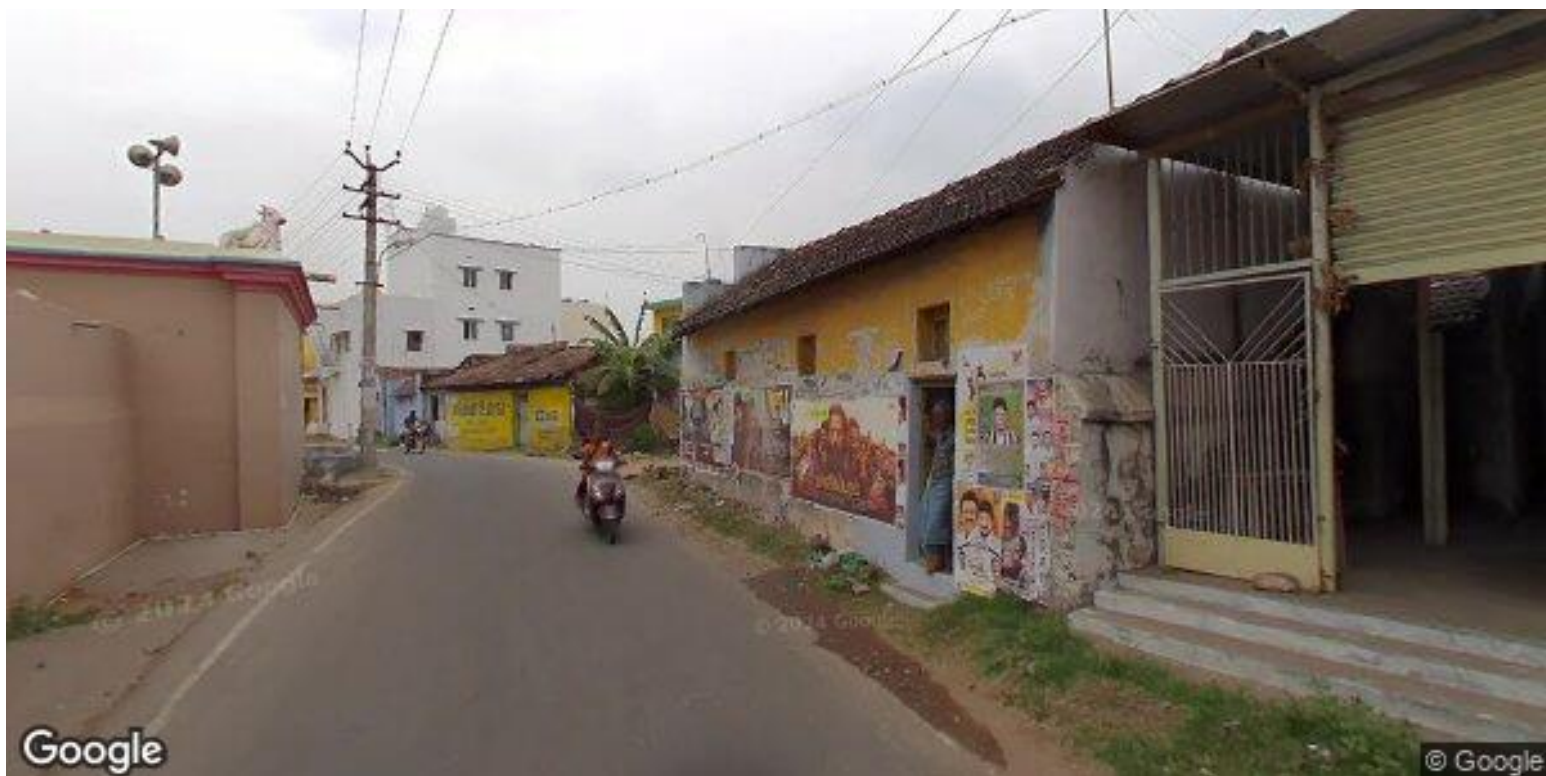
**Risk Type: Turn**

**Risk Level: High**

**Speed Limit: 15 KM/Hr**

**Coordinates: 11.69922, 77.87494**

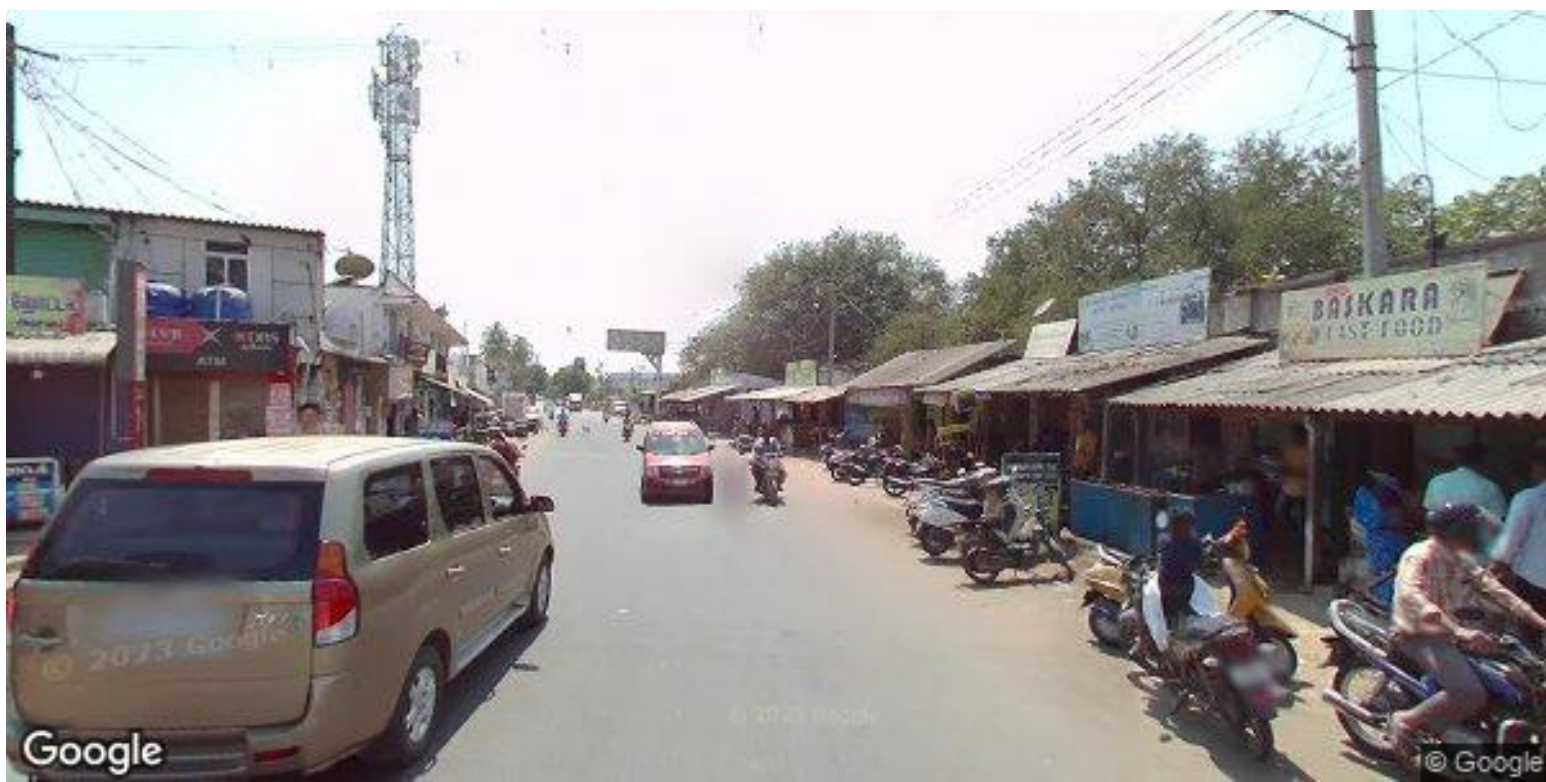
**Risk Type:** Turn

**Risk Level:** Medium

**Speed Limit:** 30 KM/Hr

**Coordinates:** 11.76005, 77.89017

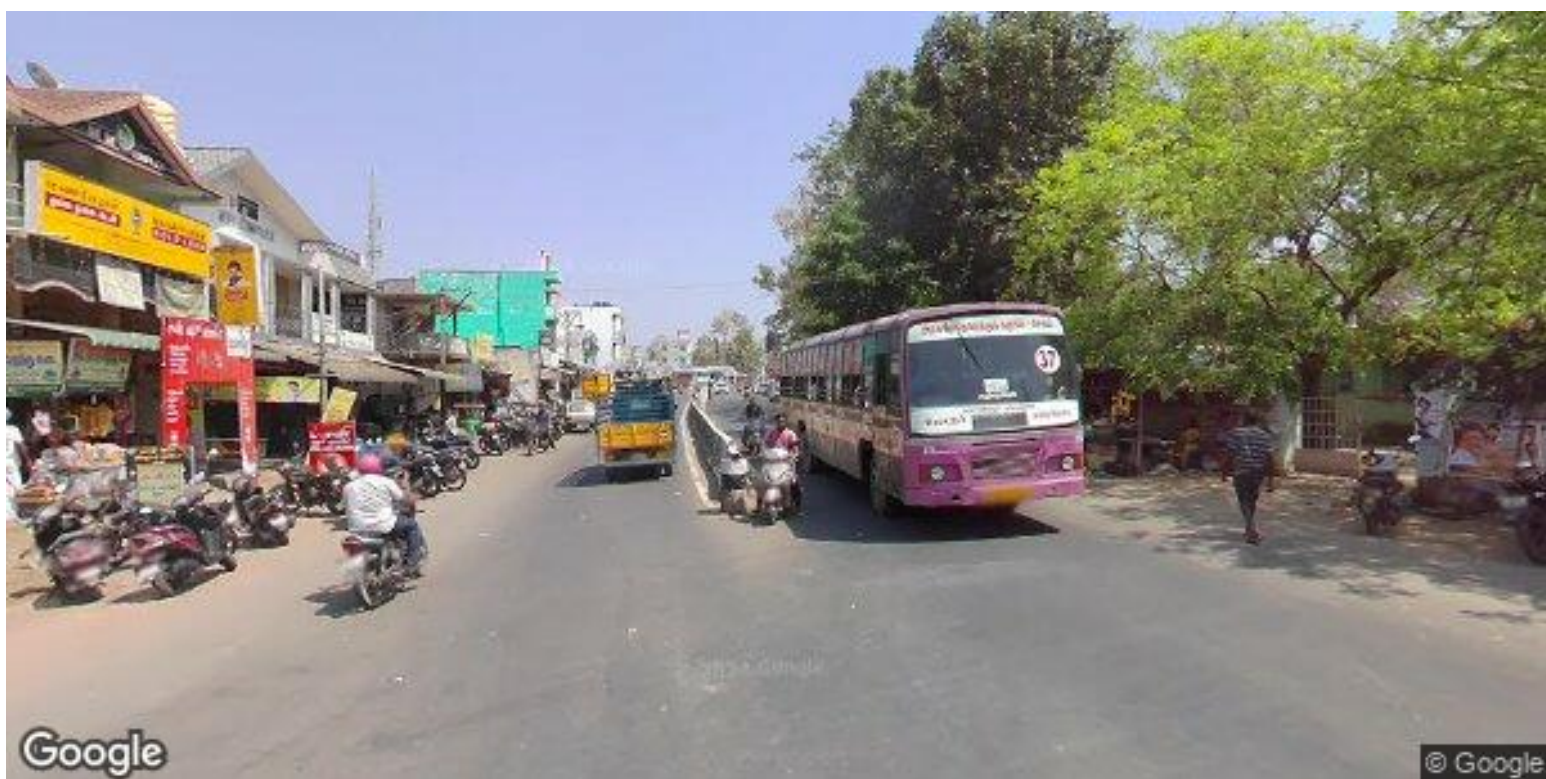
**Risk Type:** Turn

**Risk Level:** Medium

**Speed Limit:** 30 KM/Hr

**Coordinates:** 11.76020, 77.89061

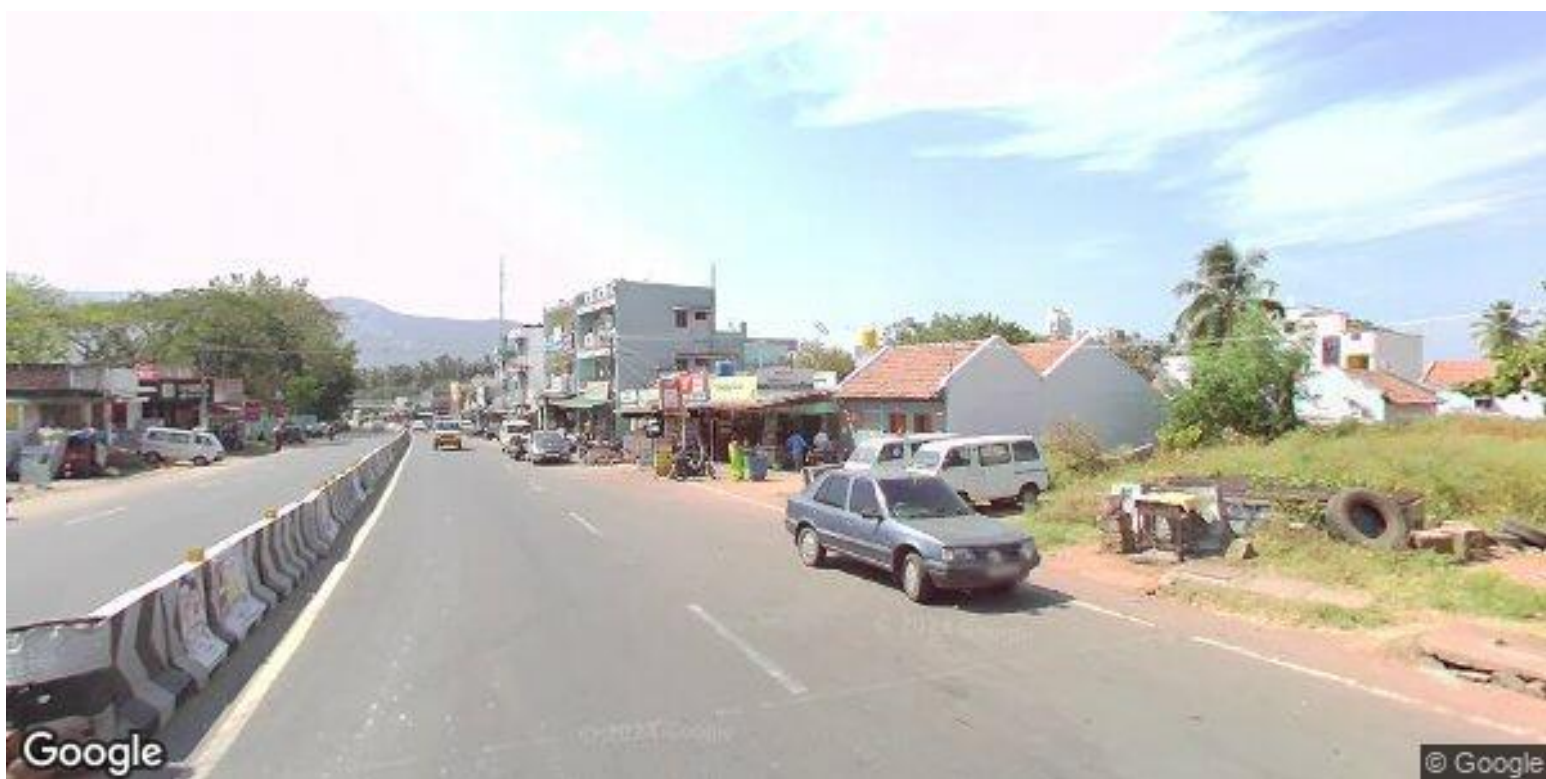
**Risk Type:** Turn

**Risk Level:** Medium

**Speed Limit:** 30 KM/Hr

**Coordinates:** 11.75957, 77.89205

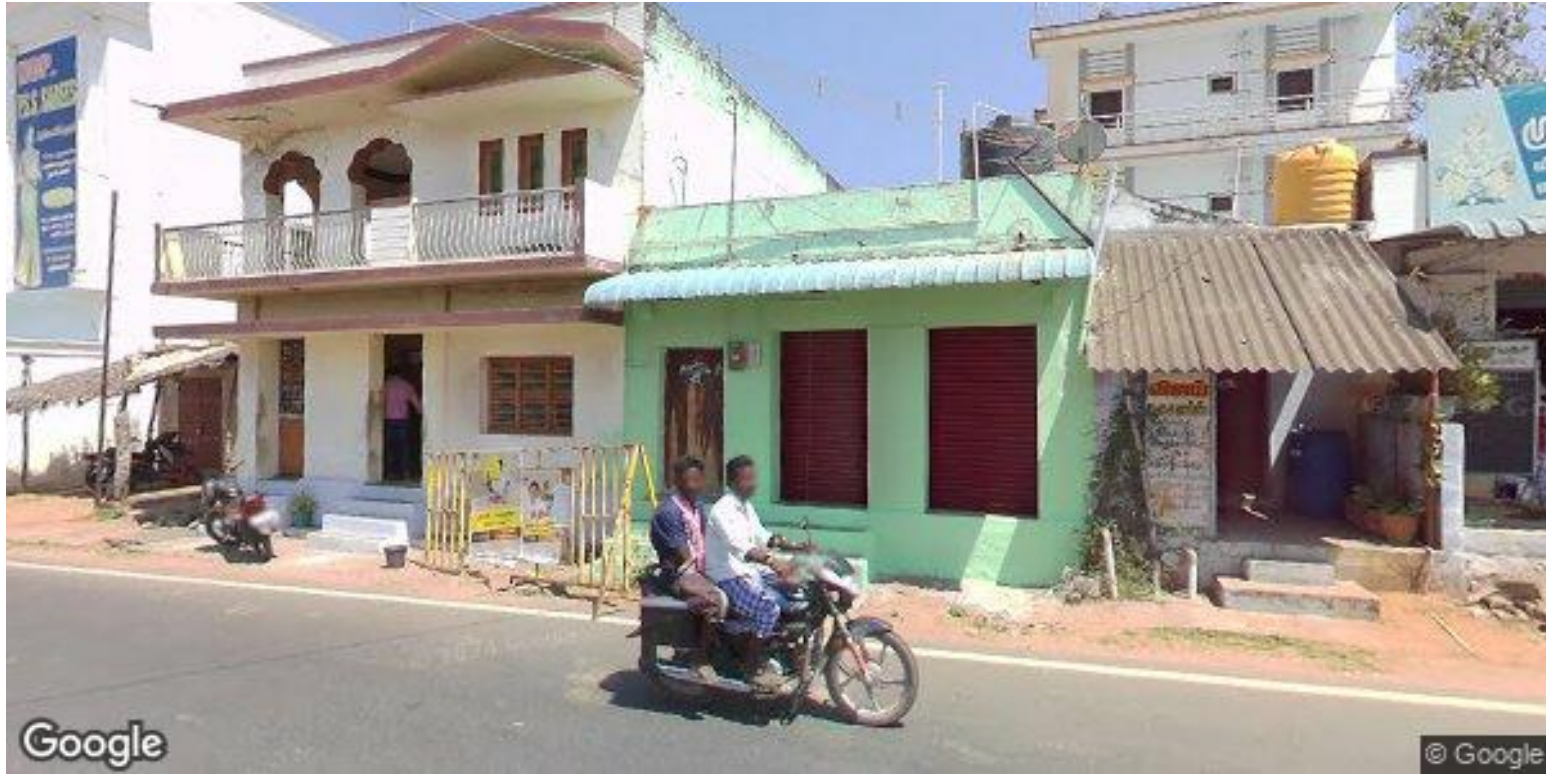
**Risk Type:** Turn

**Risk Level:** High

**Speed Limit:** 15 KM/Hr

**Coordinates:** 11.75960, 77.89221

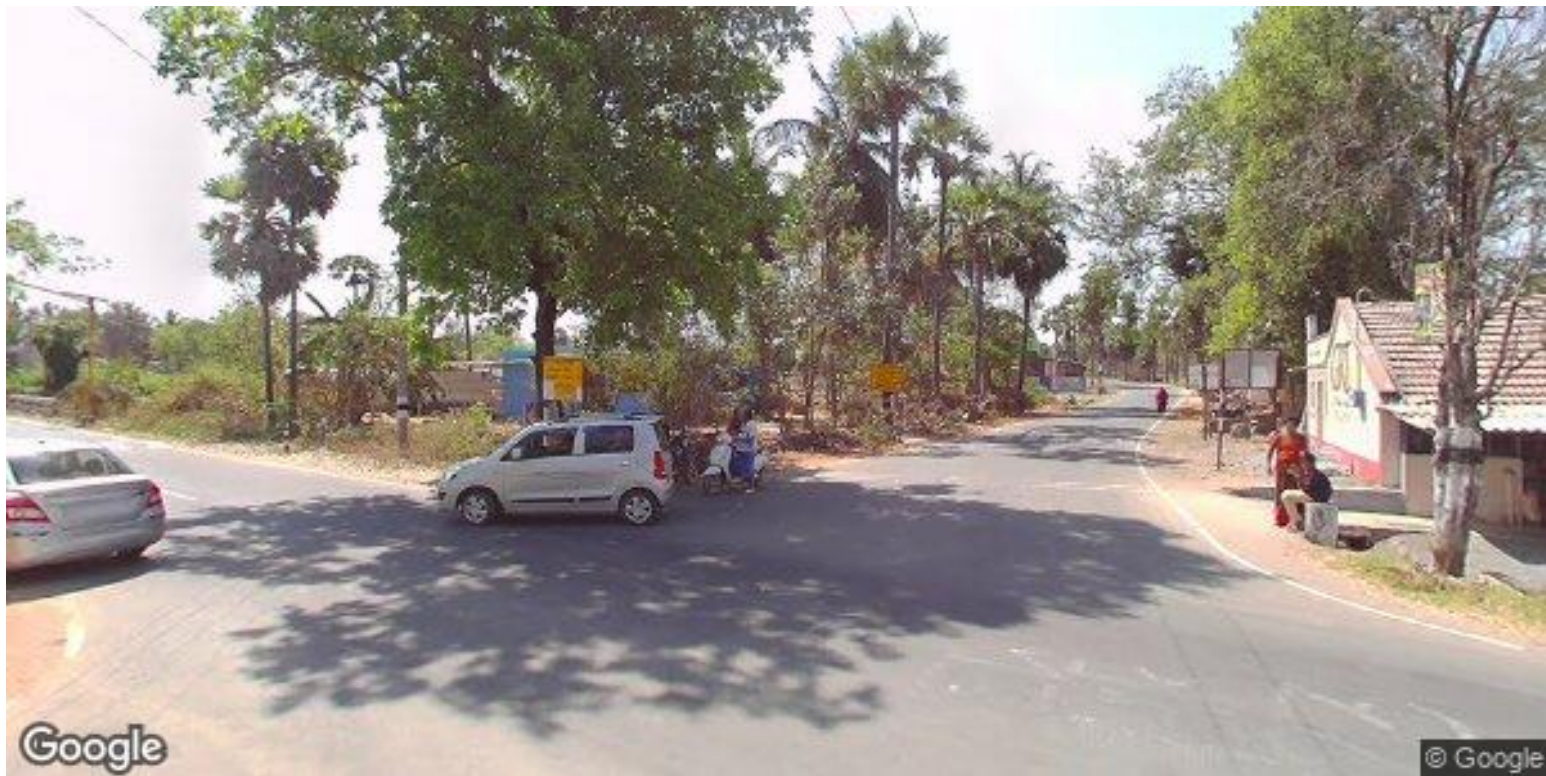
**Risk Type:** Turn

**Risk Level:** High

**Speed Limit:** 15 KM/Hr

**Coordinates:** 11.79280, 77.91433

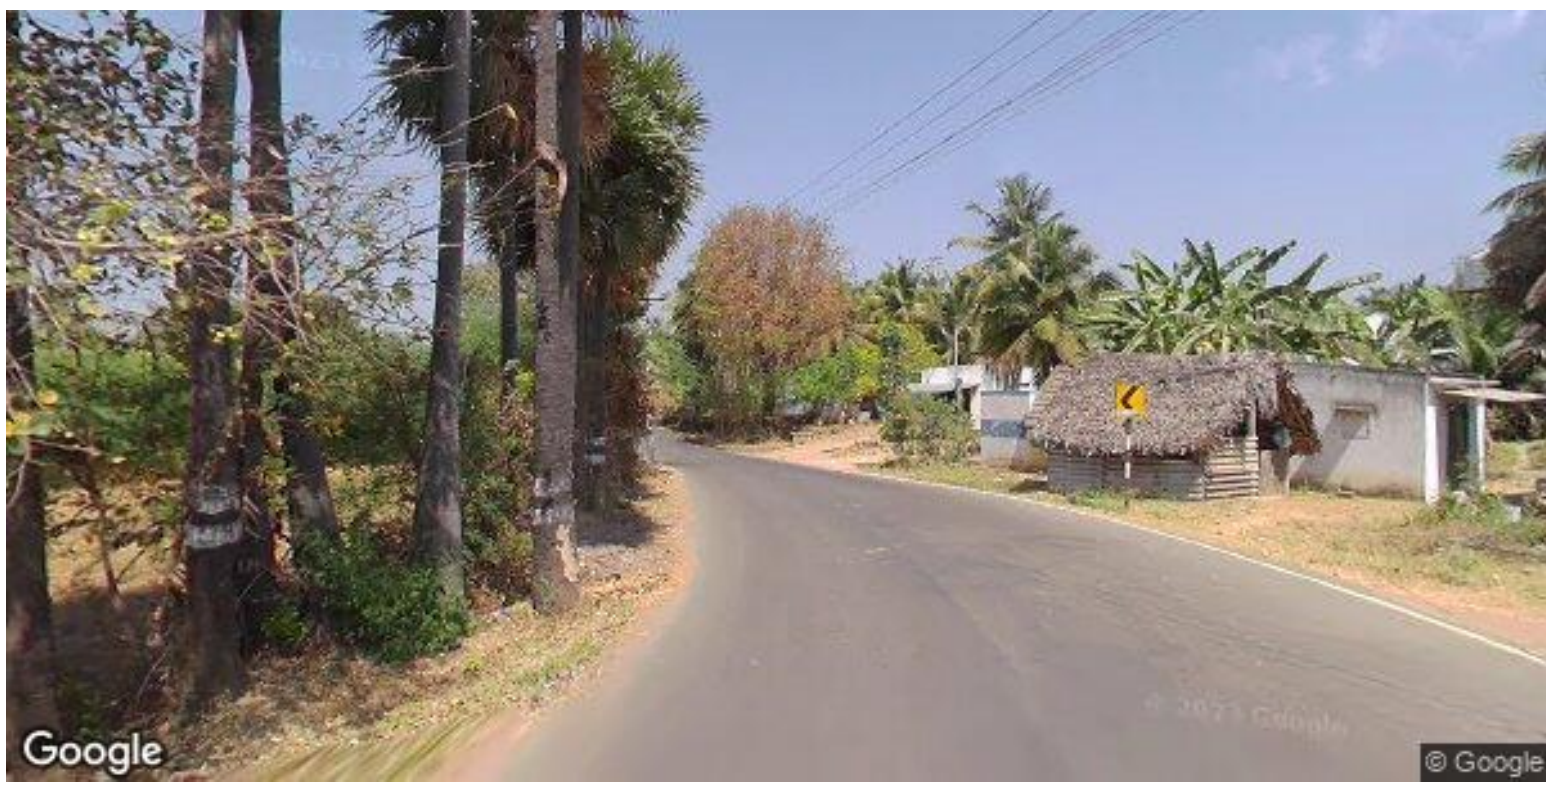
**Risk Type:** Turn

**Risk Level:** Medium

**Speed Limit:** 30 KM/Hr

**Coordinates:** 11.79281, 77.91501
