# IndianOil

## JOURNEY RISK MANAGEMENT (JRM) STUDY

### Salem Terminal to BAKYA LAKSHMI FUELS

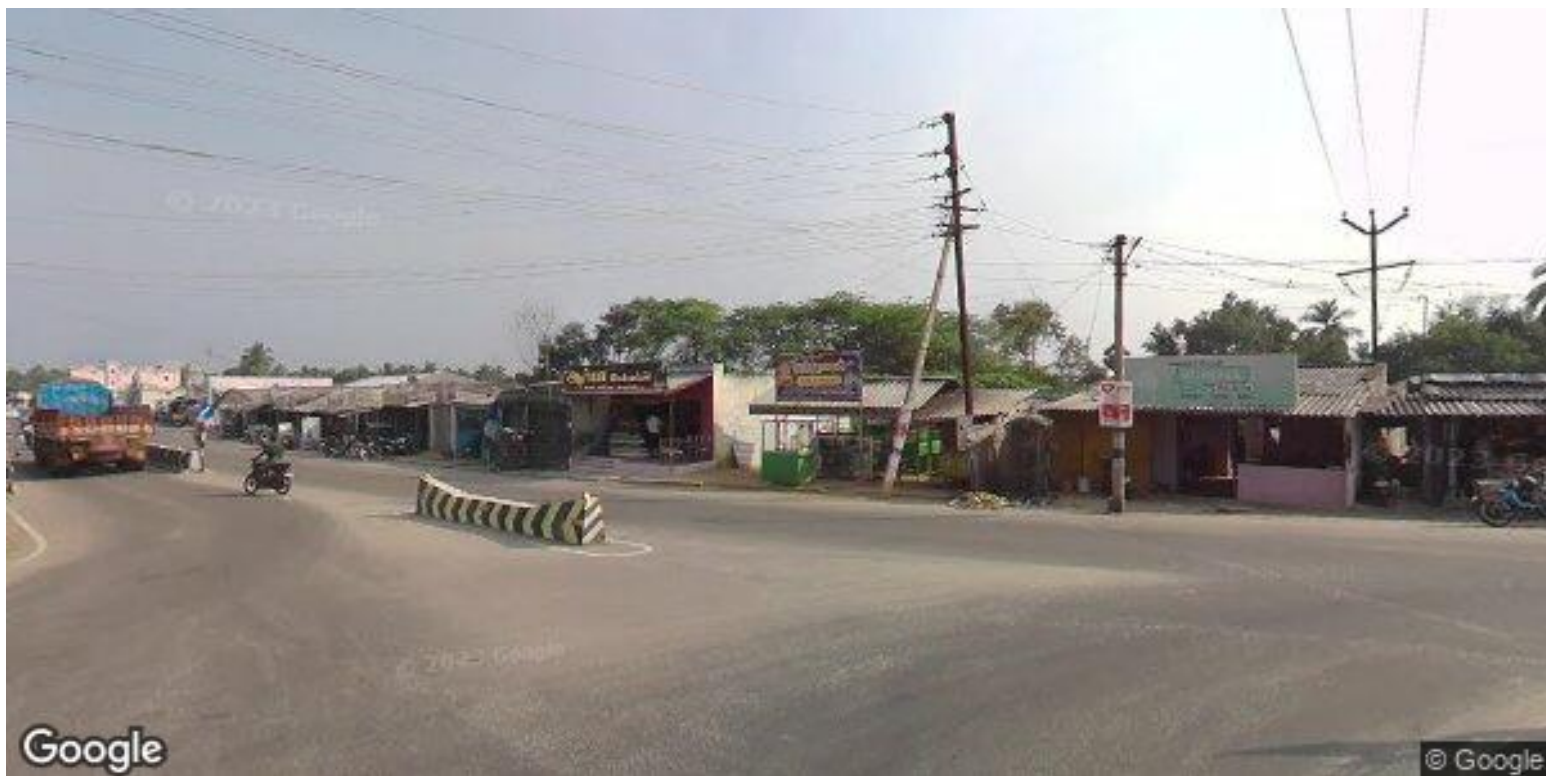
**Coordinates:** 11.04637, 77.73761

**Risk Type:** Roundabout

**Risk Level:** High

**Speed Limit:** 15 KM/Hr

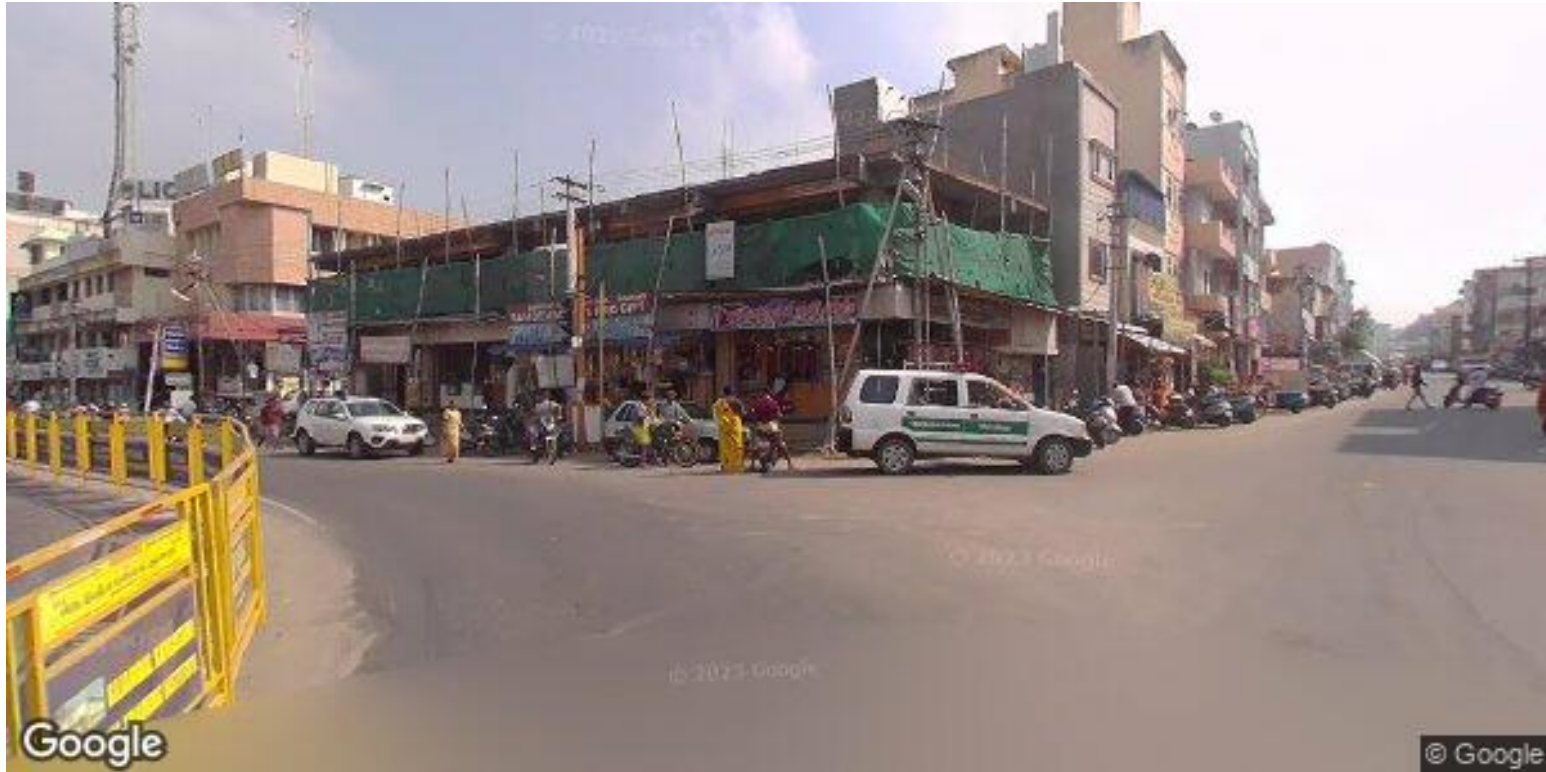
**Risk Type:** Turn  
**Risk Level:** High  
**Speed Limit:** 15 KM/Hr  
**Coordinates:** 11.37868, 77.89498

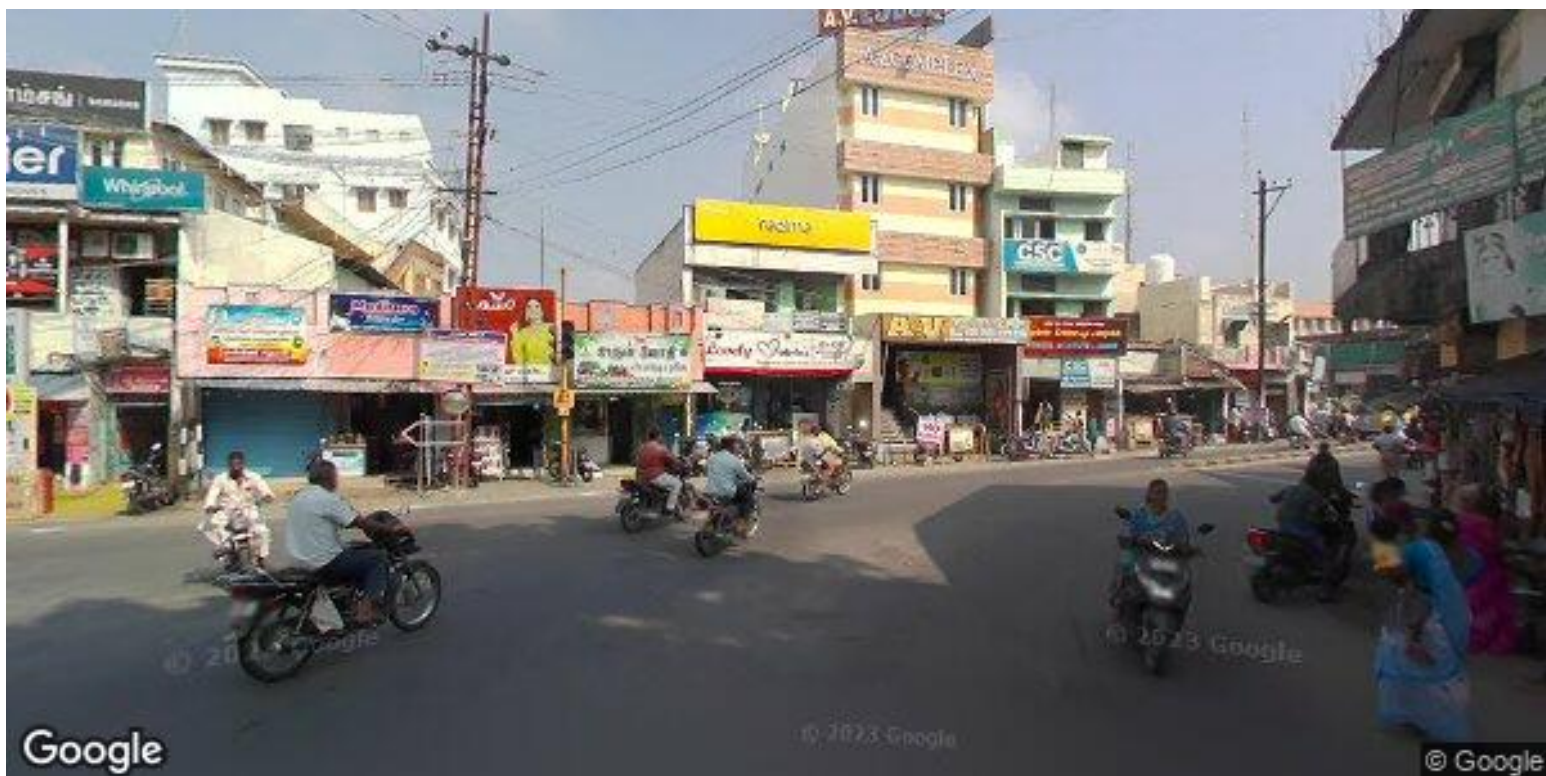
**Risk Type:** Turn  
**Risk Level:** Medium  
**Speed Limit:** 30 KM/Hr  
**Coordinates:** 11.37842, 77.89452

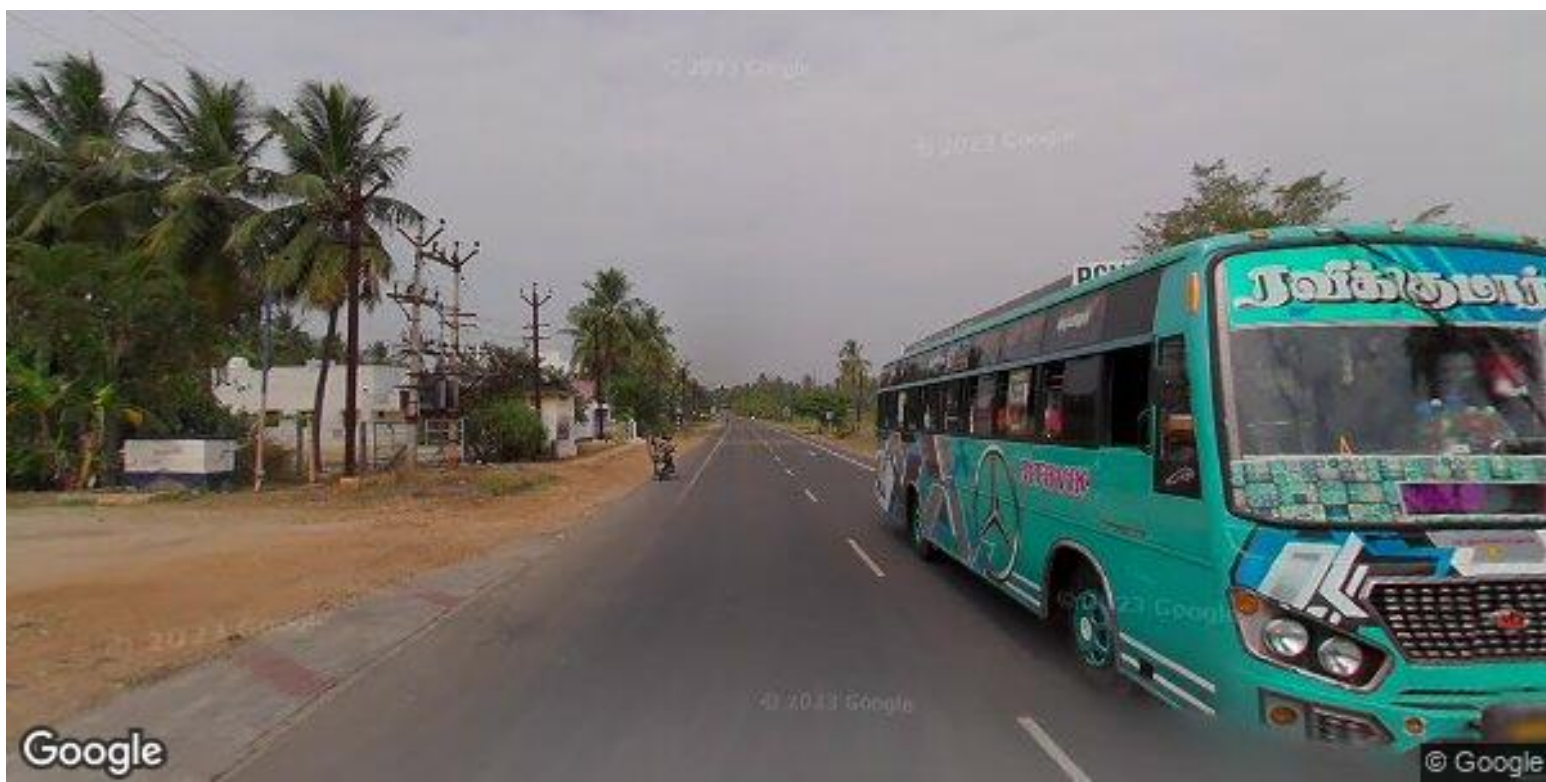
**Coordinates:** 11.30869, 77.92911

**Risk Type:** Turn

**Risk Level:** Medium

**Speed Limit:** 30 KM/Hr

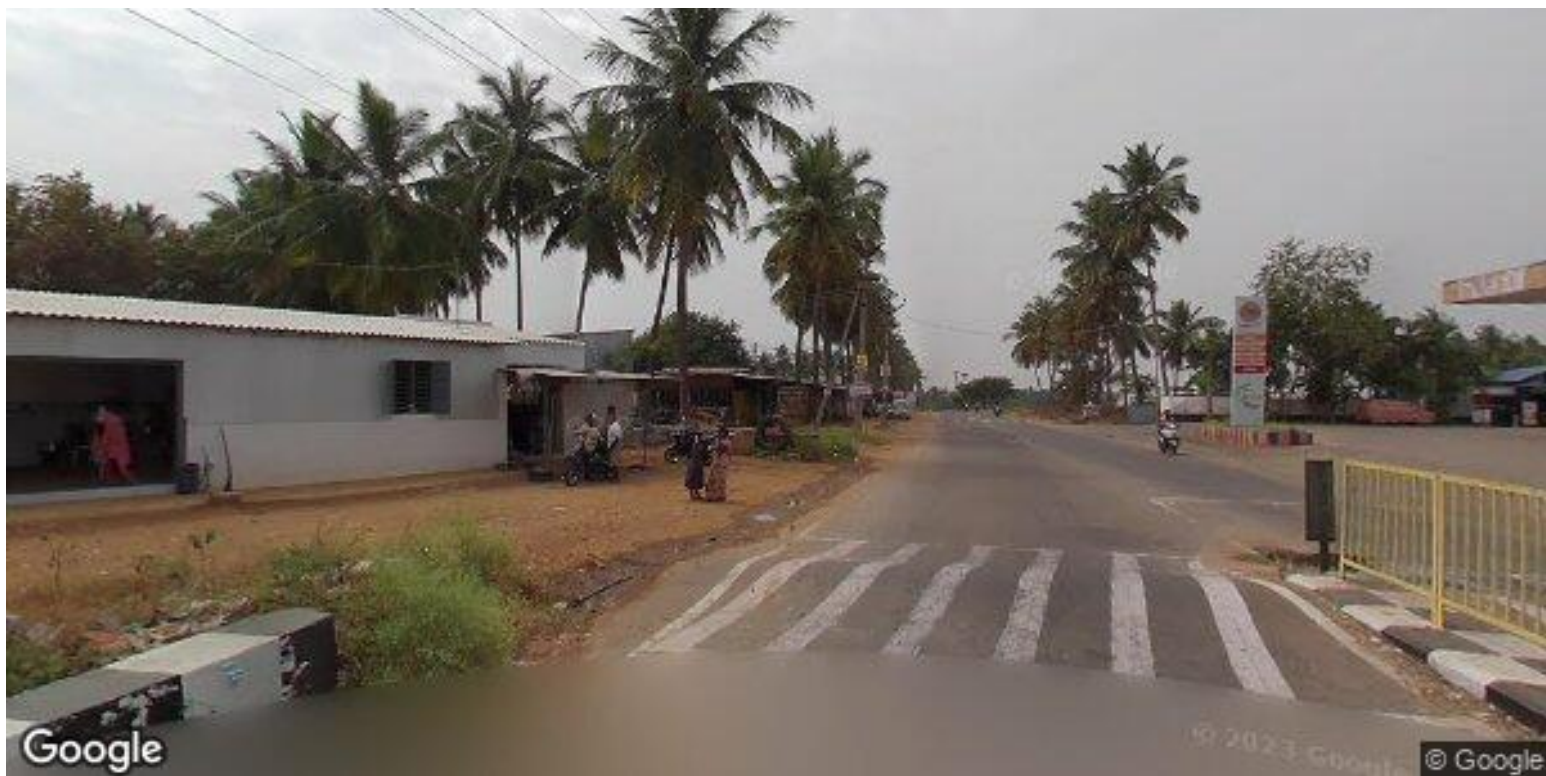
**Coordinates:** 11.30849, 77.92910

**Risk Type:** Turn

**Risk Level:** Medium

**Speed Limit:** 30 KM/Hr

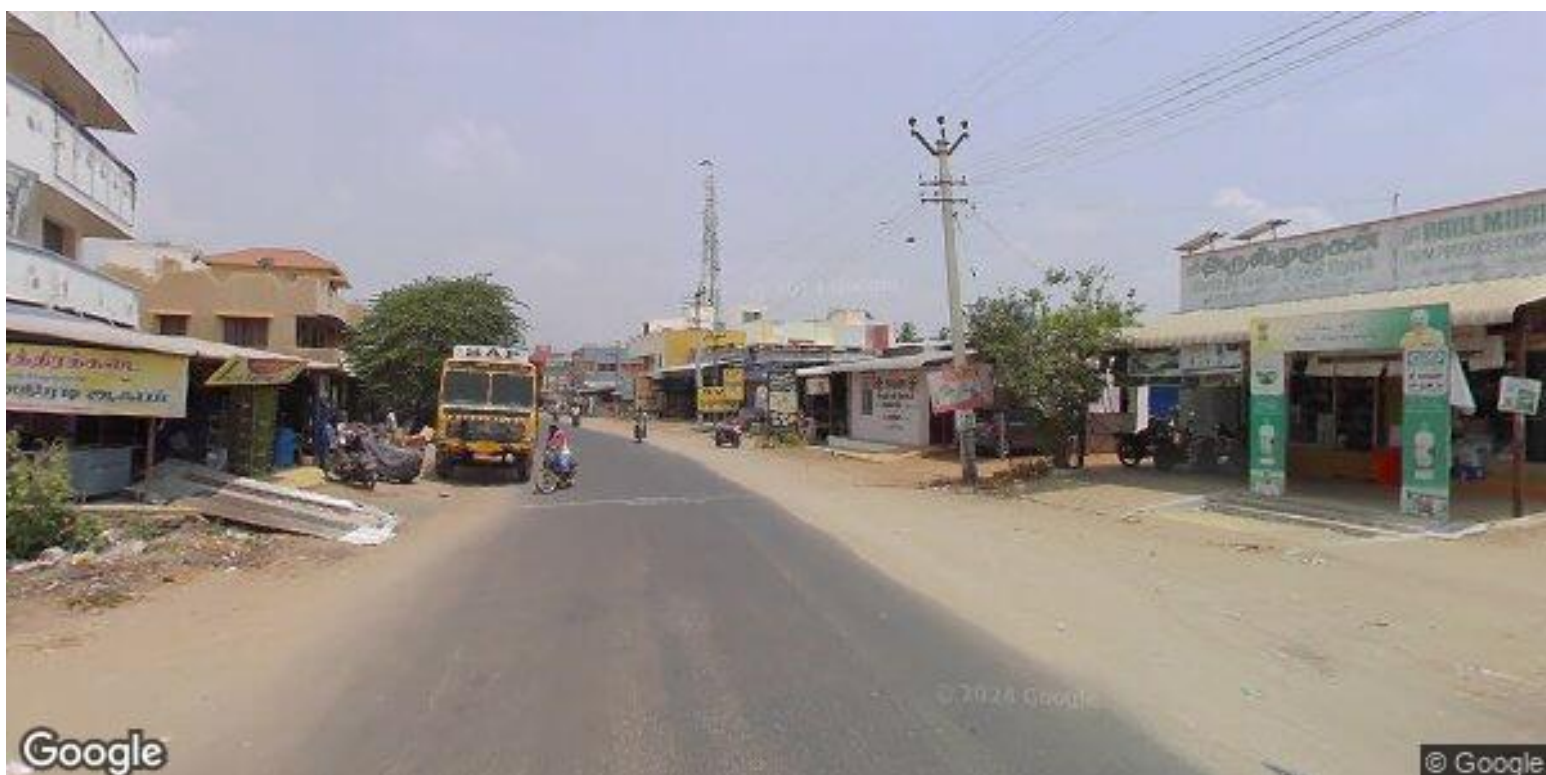
**Risk Type:** Turn  
**Risk Level:** Medium  
**Speed Limit:** 30 KM/Hr  
**Coordinates:** 11.24172, 77.87357

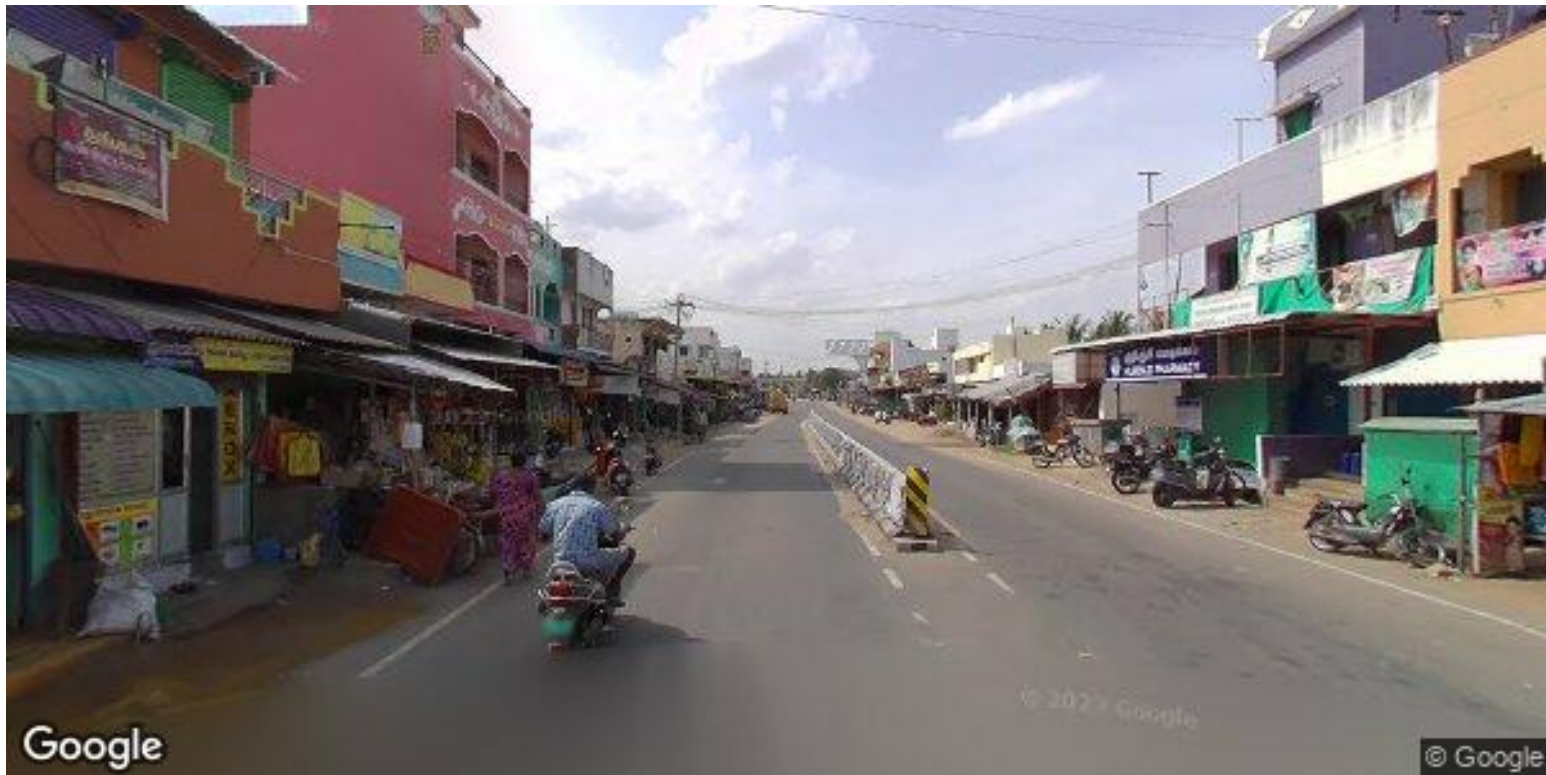
**Risk Type:** Turn  
**Risk Level:** High  
**Speed Limit:** 15 KM/Hr  
**Coordinates:** 11.24000, 77.87363

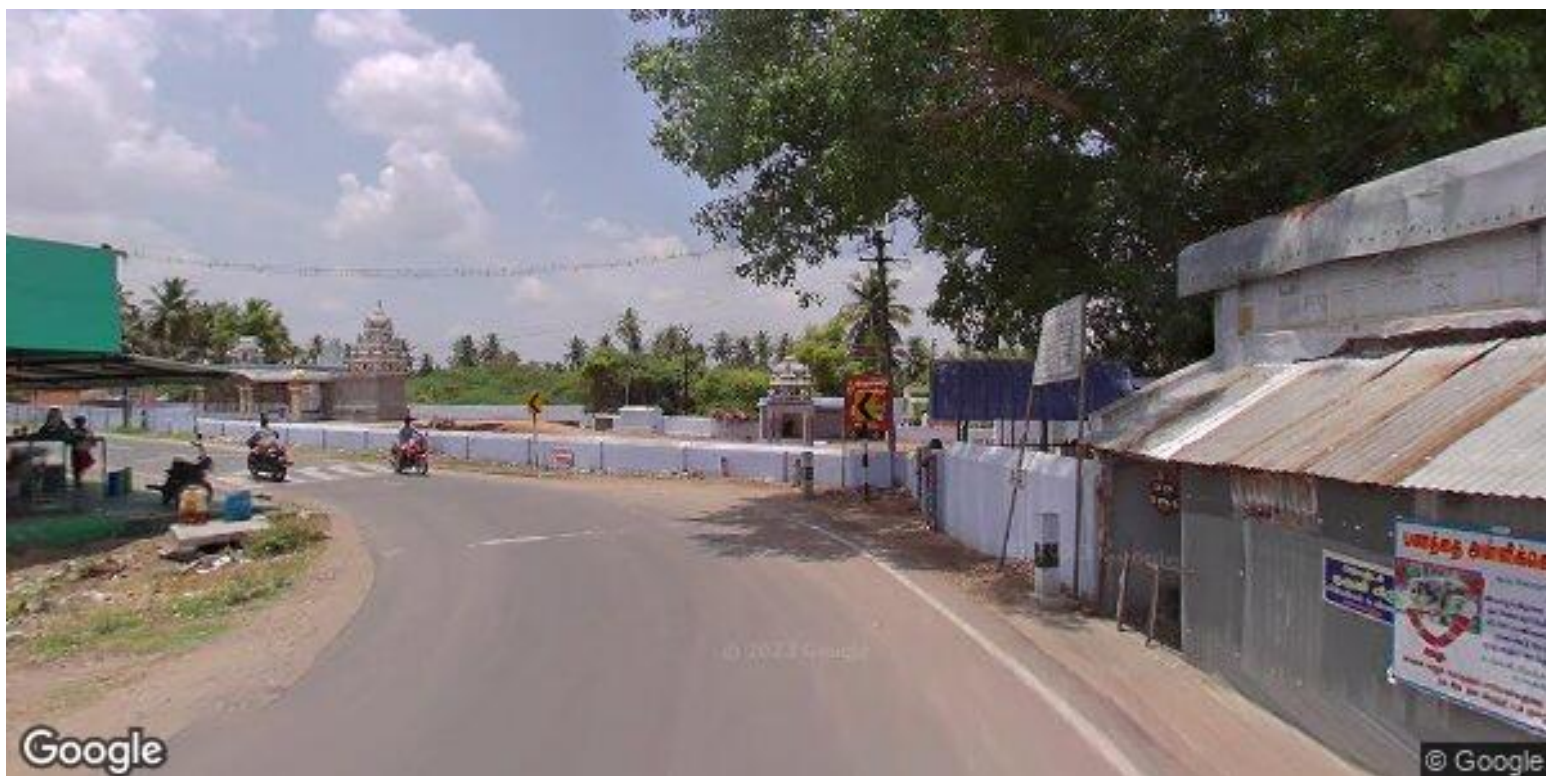
**Risk Type:** Turn  
**Risk Level:** Medium  
**Speed Limit:** 30 KM/Hr  
**Coordinates:** 11.24053, 77.86902

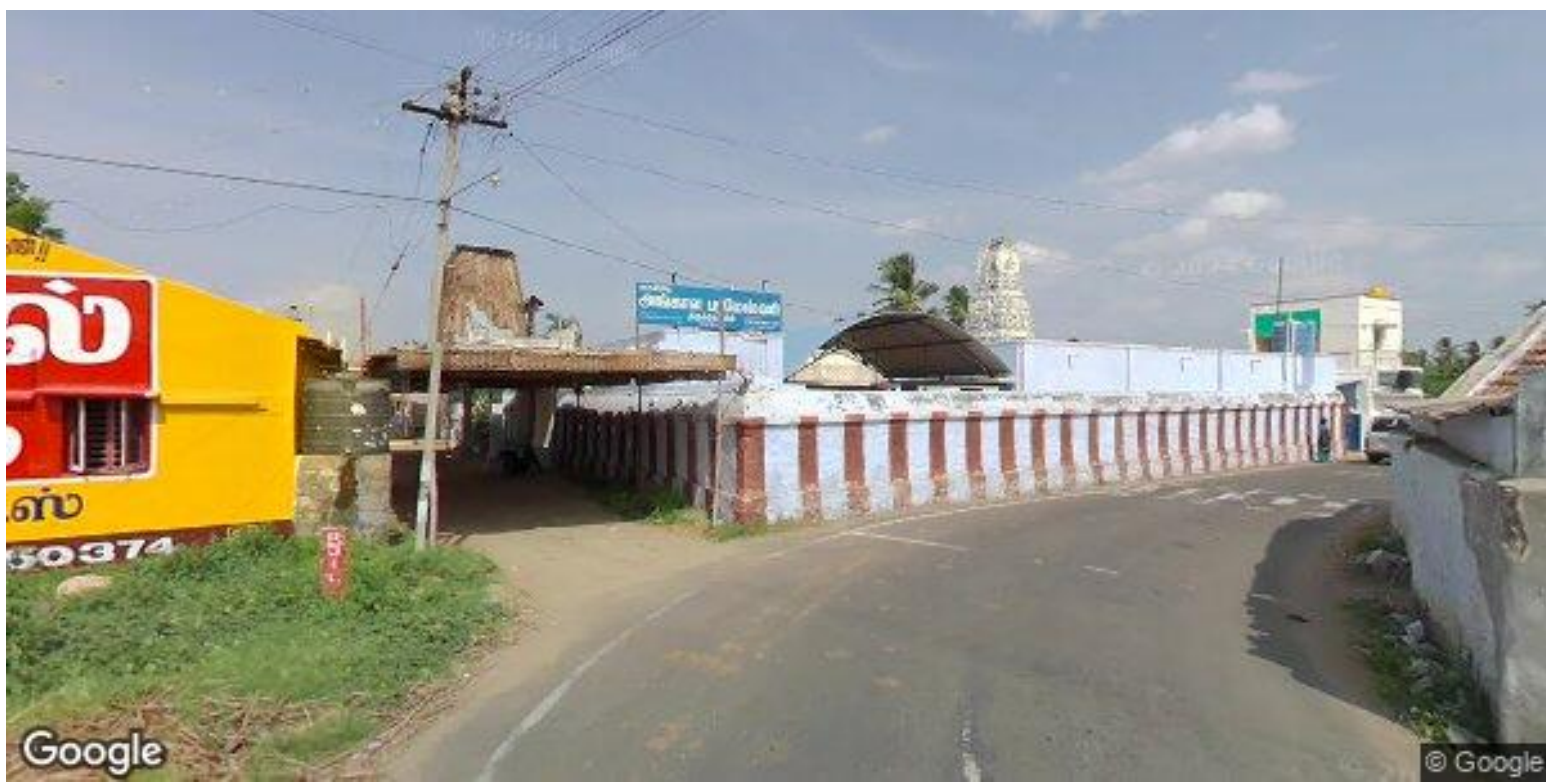
**Coordinates:** 11.24115, 77.86891

**Risk Type:** Turn

**Risk Level:** Medium

**Speed Limit:** 30 KM/Hr

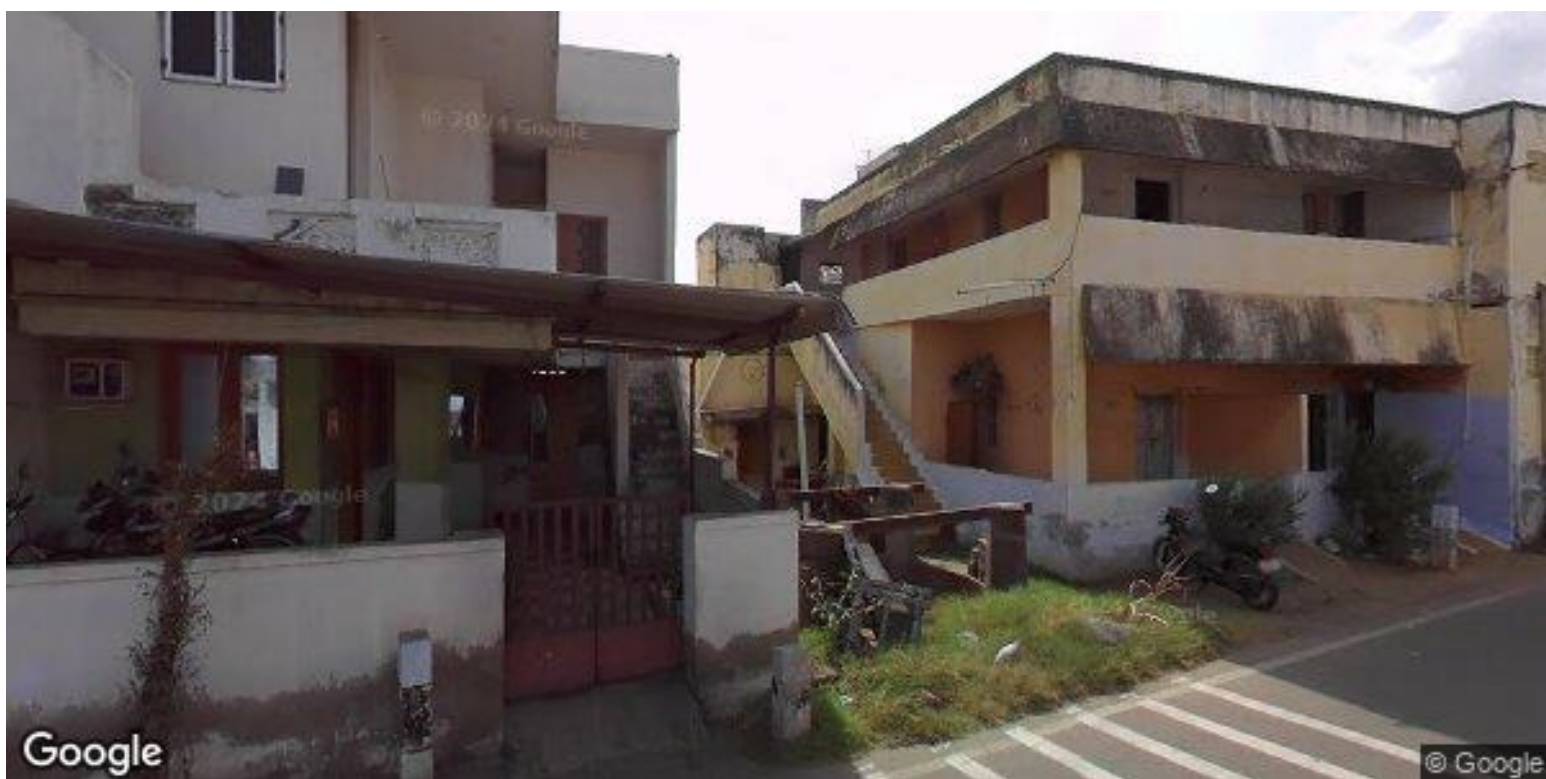
**Coordinates:** 11.24122, 77.86883

**Risk Type:** Turn

**Risk Level:** Medium

**Speed Limit:** 30 KM/Hr

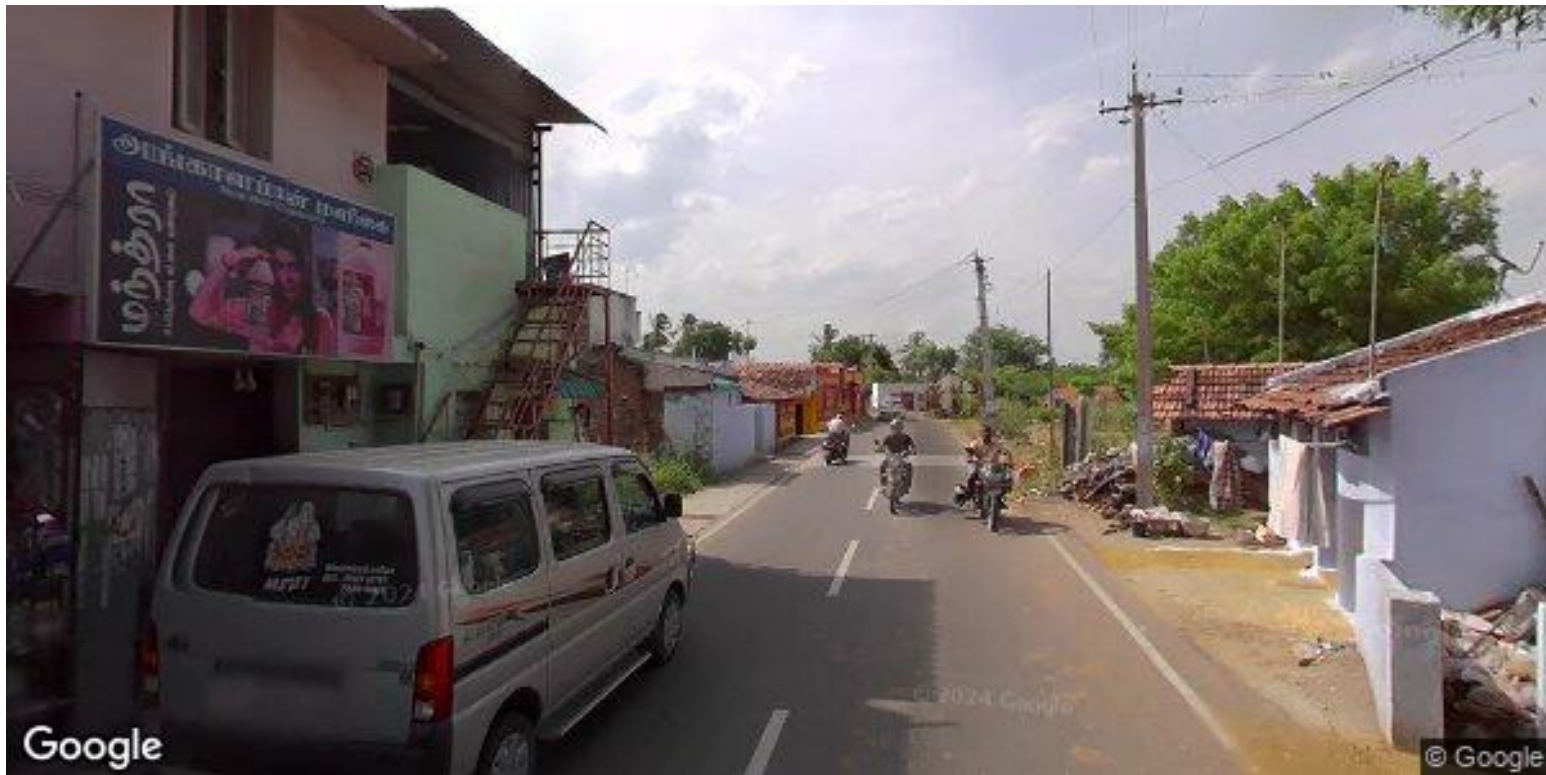
**Coordinates:** 11.24170, 77.86842

**Risk Type:** Turn

**Risk Level:** High

**Speed Limit:** 15 KM/Hr

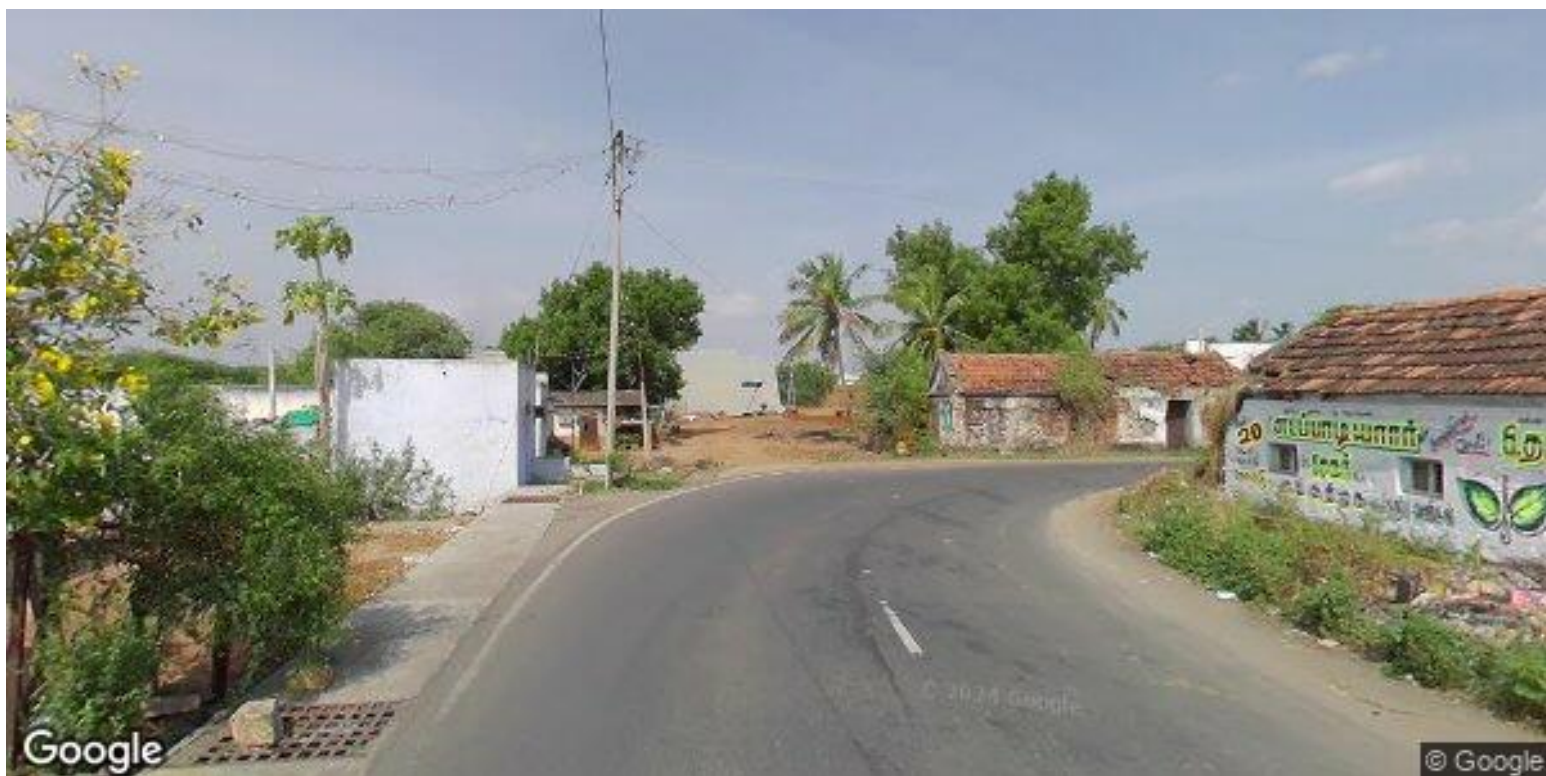
**Coordinates:** 11.24248, 77.86829

**Risk Type:** Turn

**Risk Level:** High

**Speed Limit:** 15 KM/Hr

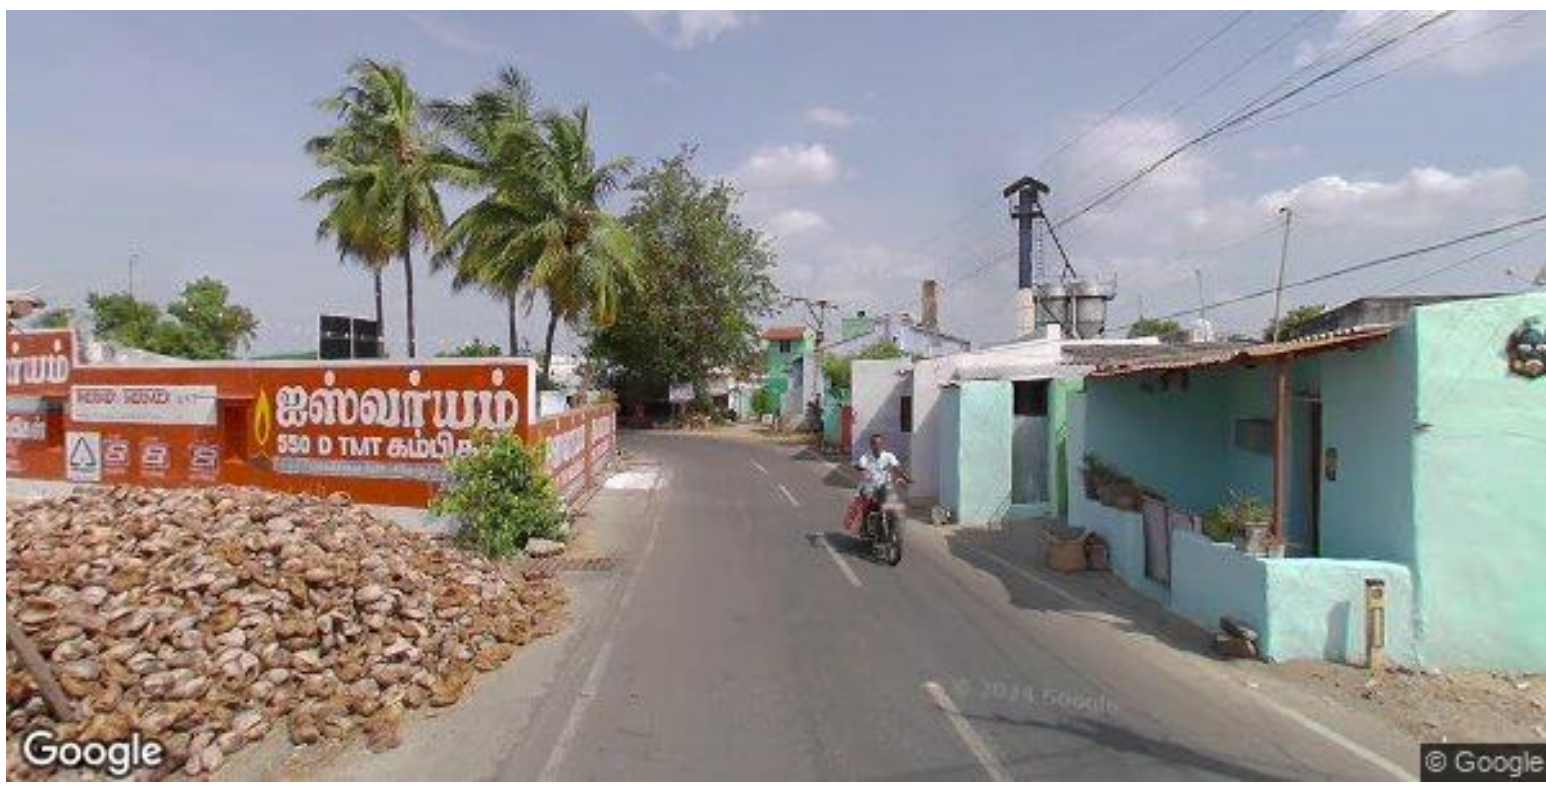
**Coordinates:** 11.24257, 77.86776

**Risk Type:** Turn

**Risk Level:** High

**Speed Limit:** 15 KM/Hr

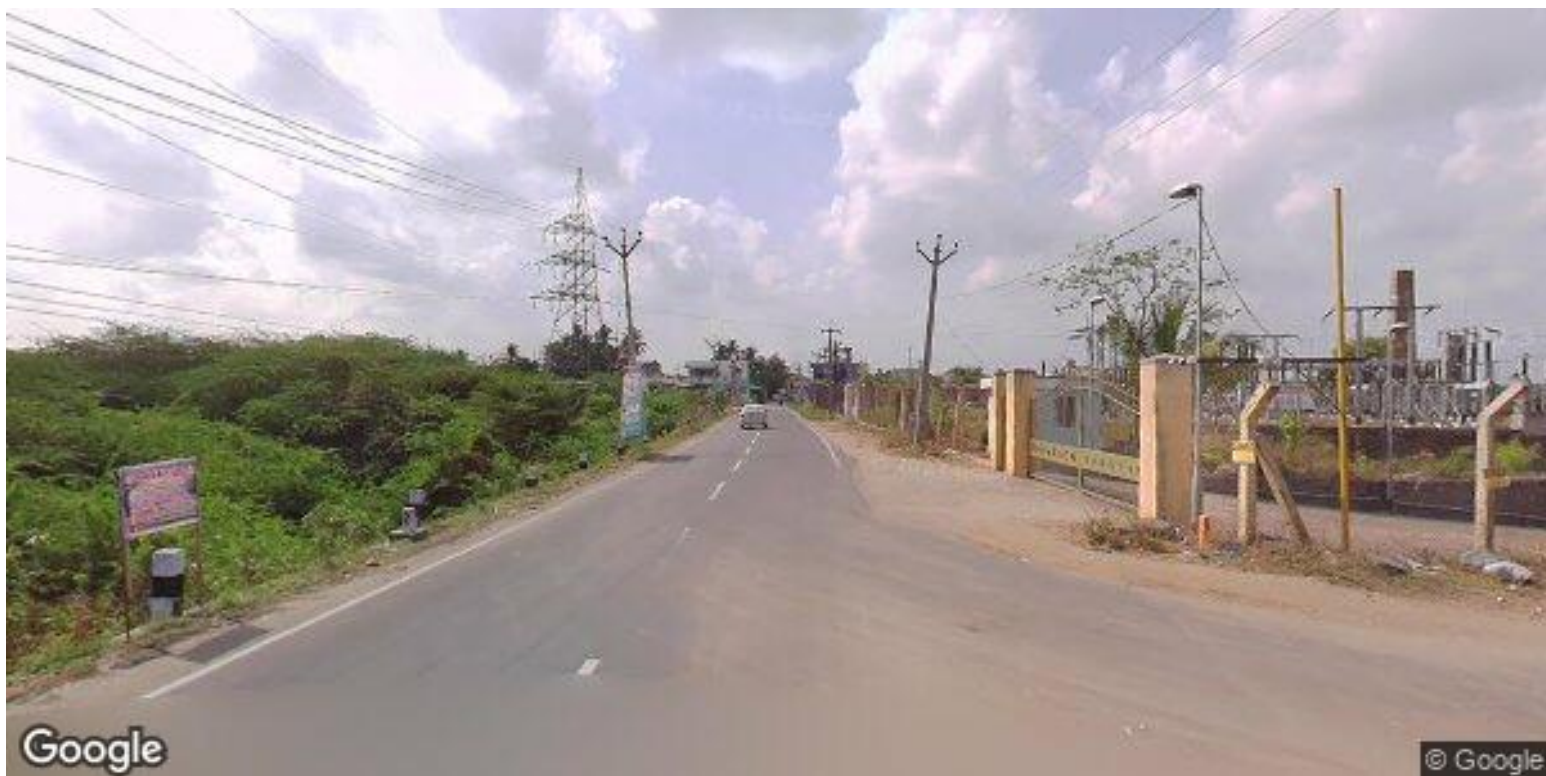
**Coordinates:** 11.24384, 77.86689

**Risk Type:** Blind Spot

**Risk Level:** Blind Spot

**Speed Limit:** 10 KM/Hr

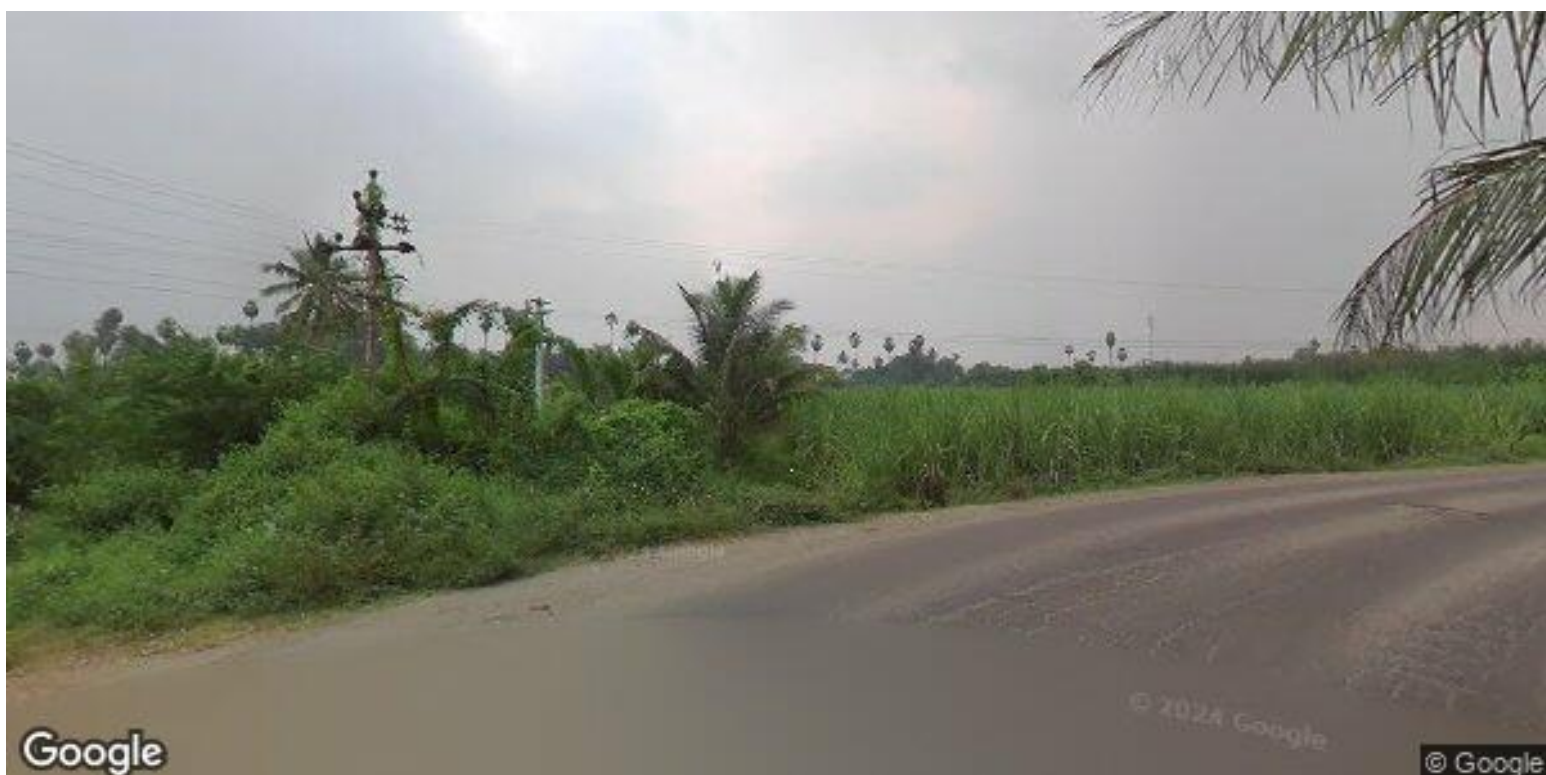
**Risk Type:** Turn  
**Risk Level:** Medium  
**Speed Limit:** 30 KM/Hr  
**Coordinates:** 11.24101, 77.86034

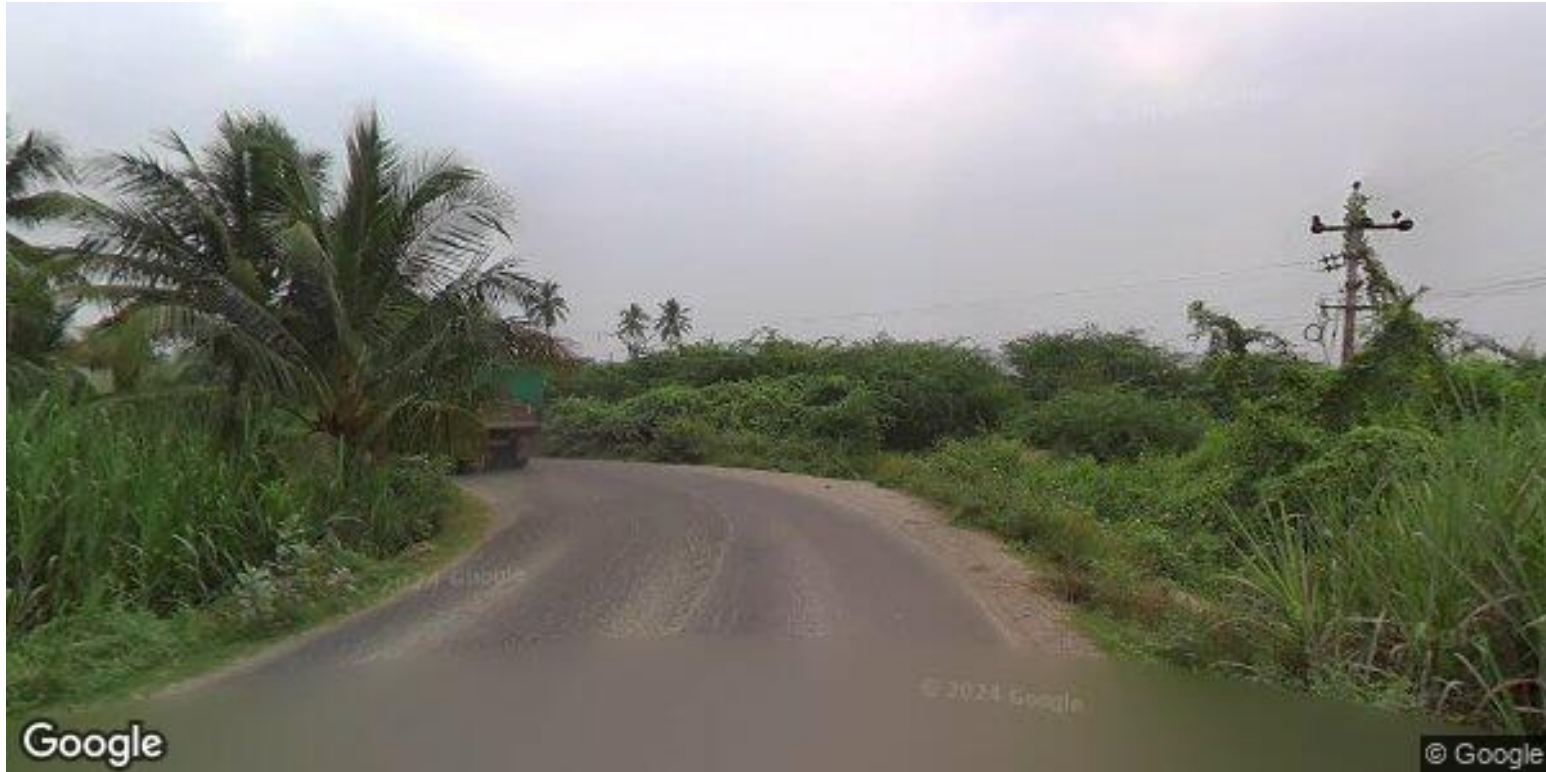
**Risk Type:** Turn  
**Risk Level:** Medium  
**Speed Limit:** 30 KM/Hr  
**Coordinates:** 11.24103, 77.86020

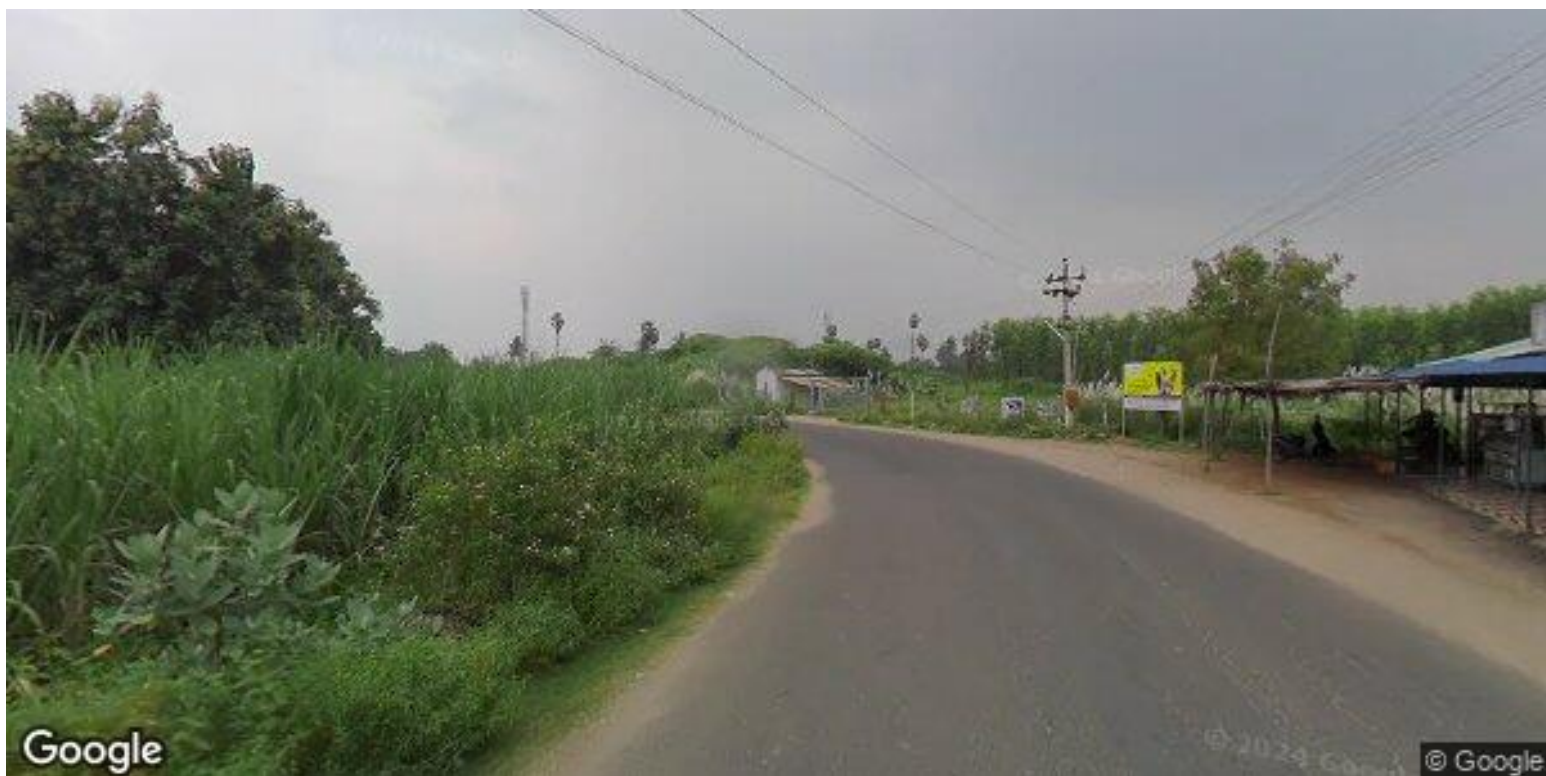
**Risk Type:** Turn  
**Risk Level:** Medium  
**Speed Limit:** 30 KM/Hr  
**Coordinates:** 11.24200, 77.85882

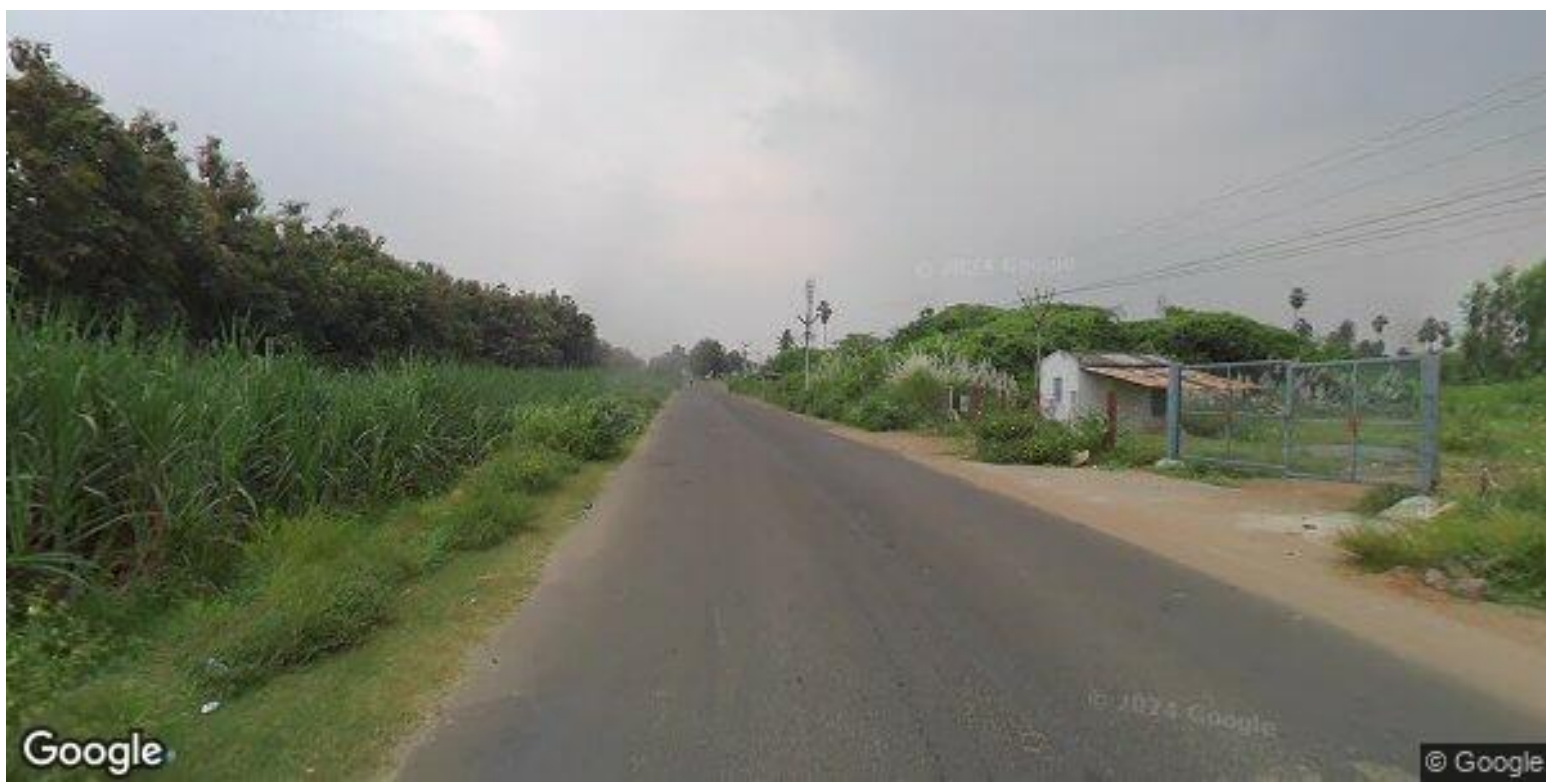
**Coordinates:** 11.24196, 77.85856

**Risk Type:** Turn

**Risk Level:** Medium

**Speed Limit:** 30 KM/Hr

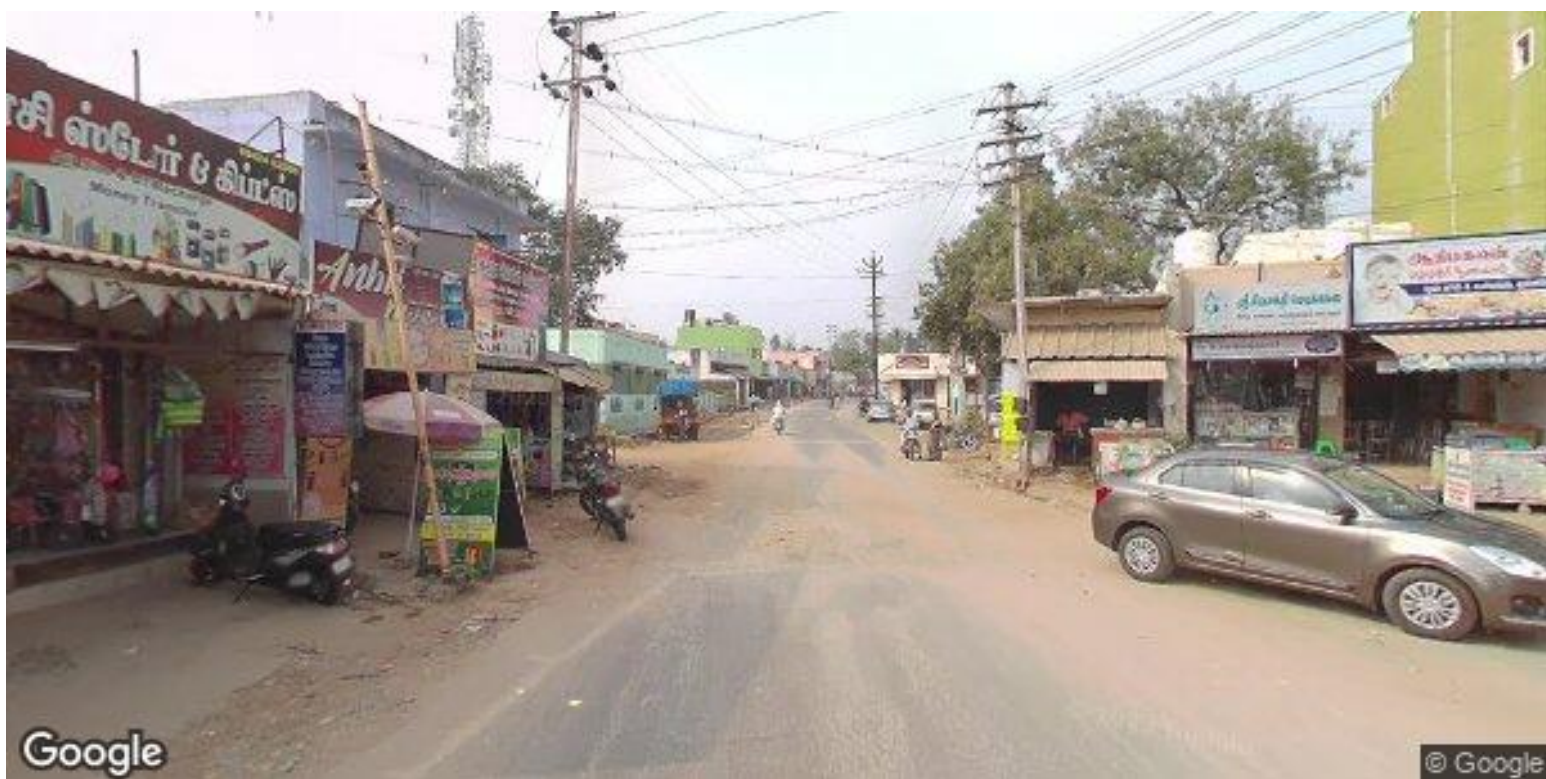
**Coordinates:** 11.18856, 77.77110

**Risk Type:** Turn

**Risk Level:** High

**Speed Limit:** 15 KM/Hr
