# IndianOil

## JOURNEY RISK MANAGEMENT (JRM) STUDY

### Salem Terminal to BAKYA LAKSHMI FUELS

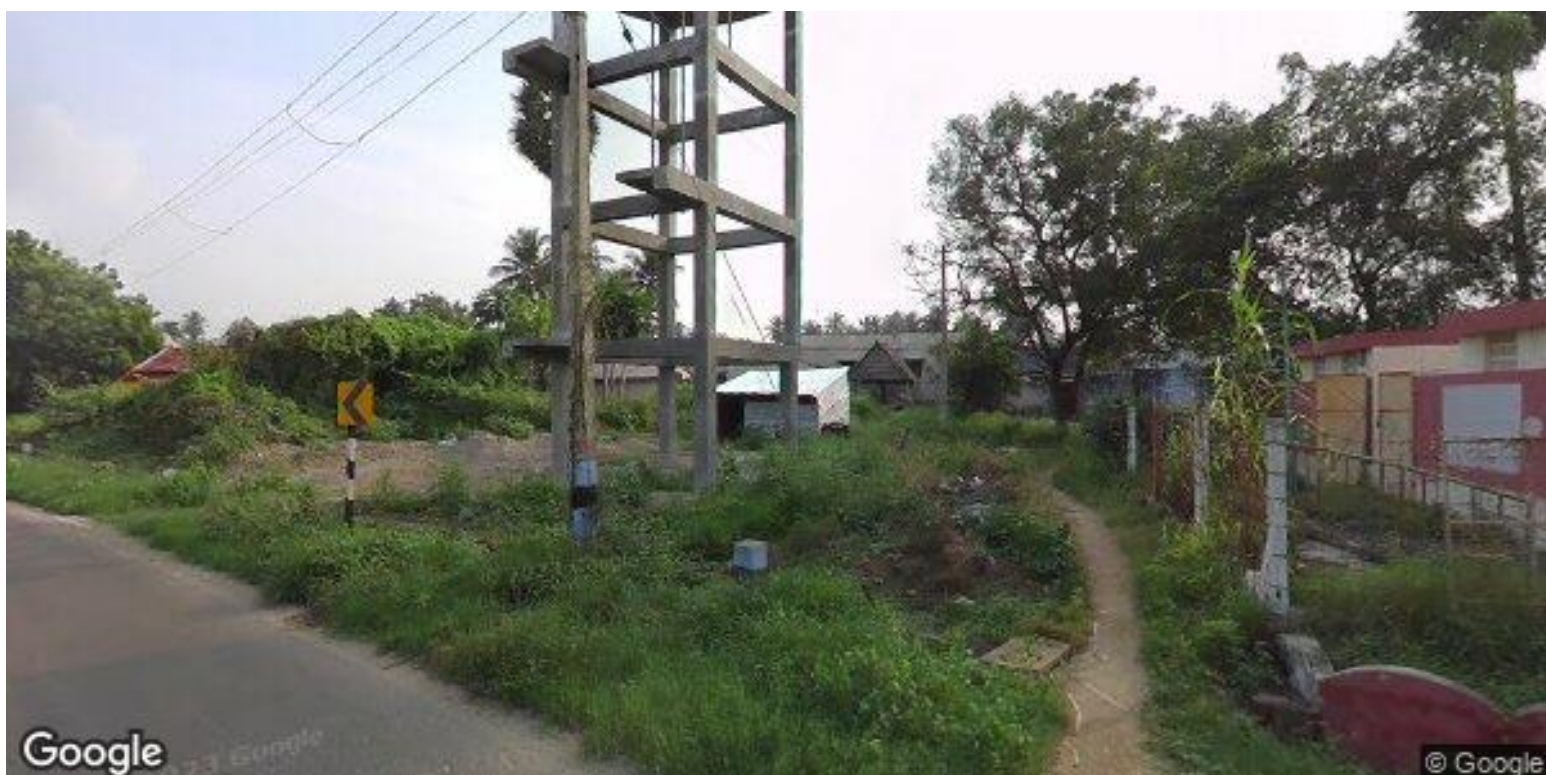
**Risk Type:** Turn  
**Risk Level:** Medium  
**Speed Limit:** 30 KM/Hr  
**Coordinates:** 11.16404, 77.77379

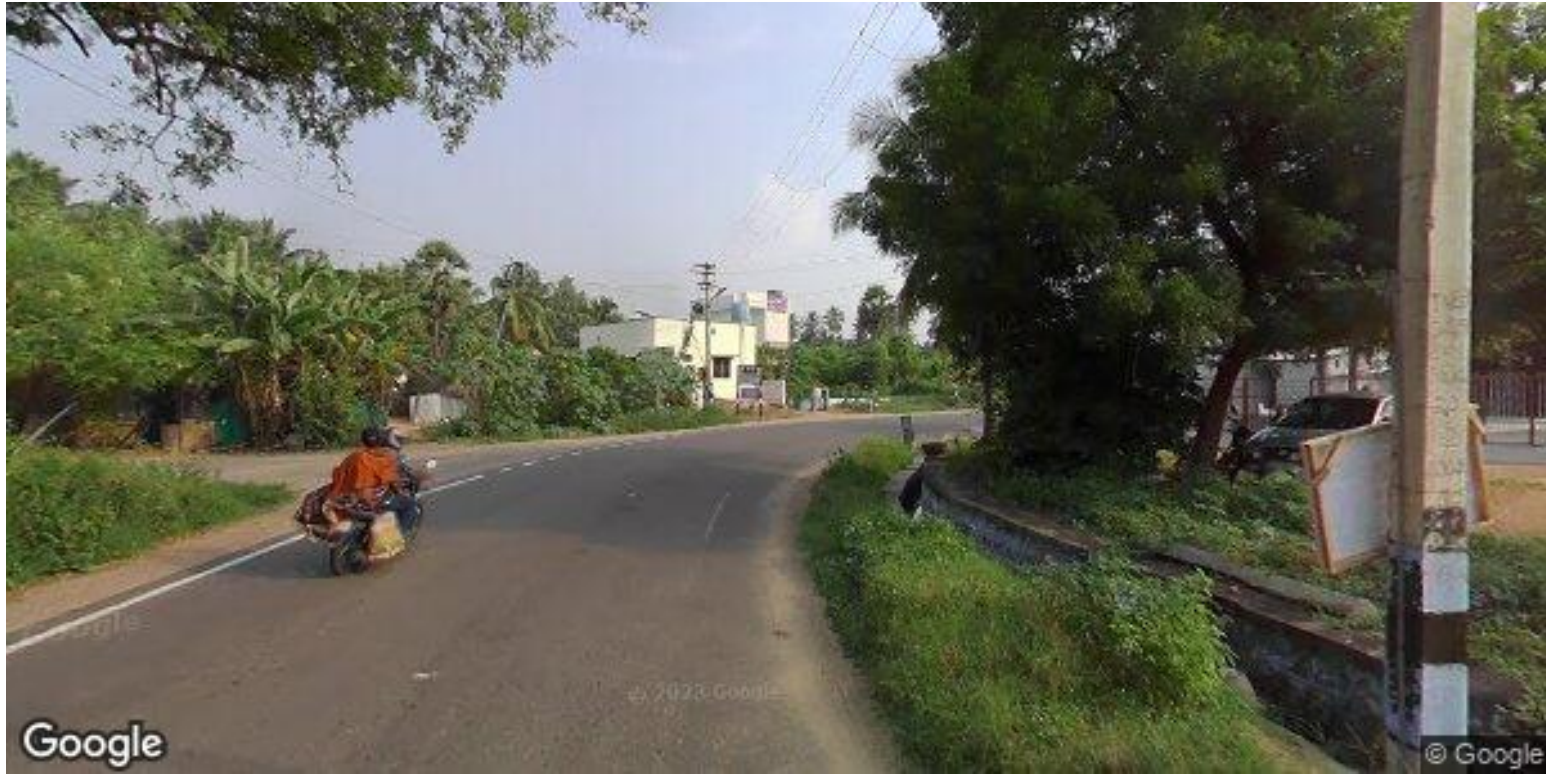
**Risk Type:** Turn  
**Risk Level:** Medium  
**Speed Limit:** 30 KM/Hr  
**Coordinates:** 11.16377, 77.77421

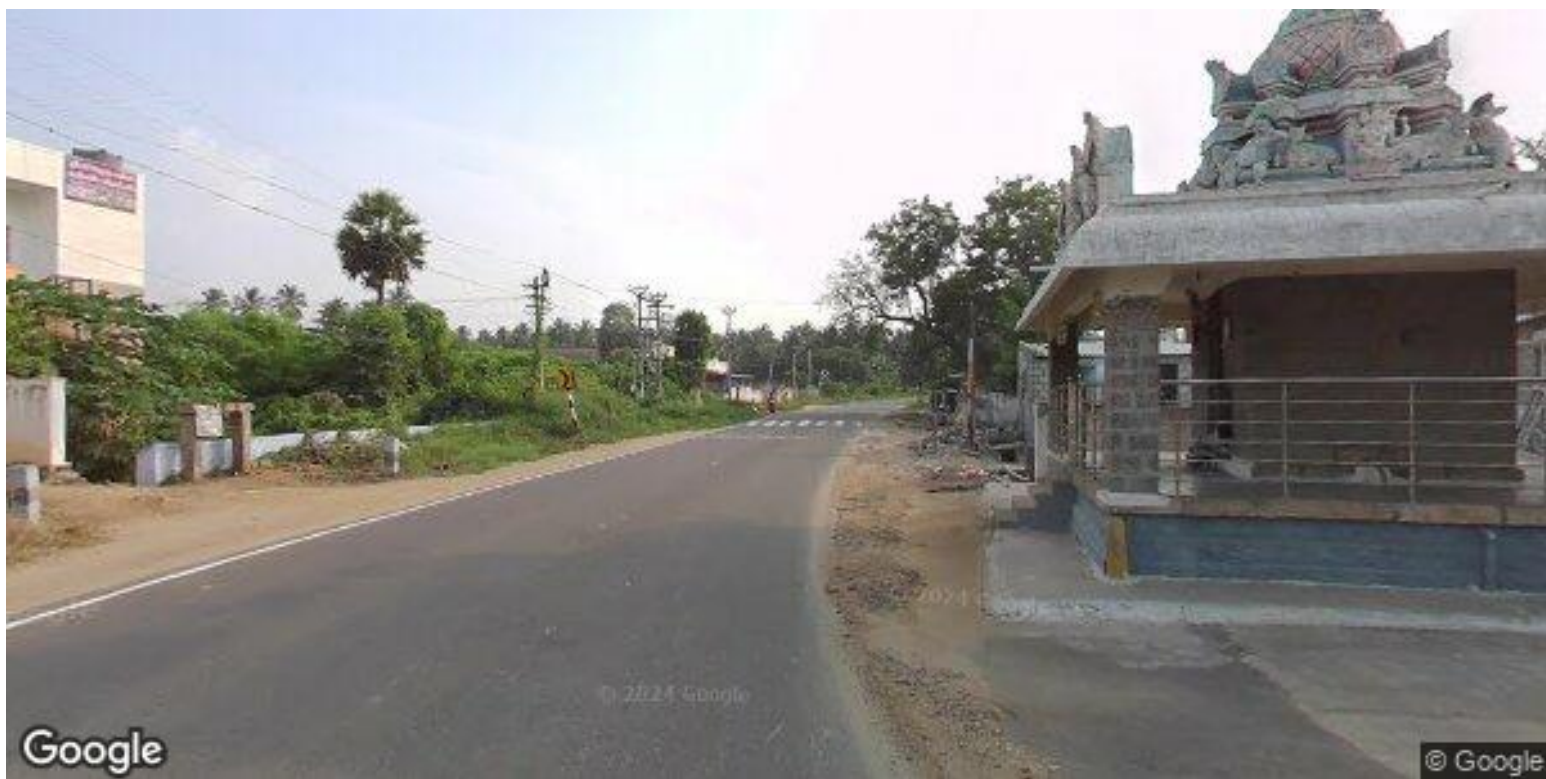
**Risk Type:** Turn  
**Risk Level:** Medium  
**Speed Limit:** 30 KM/Hr  
**Coordinates:** 11.16354, 77.77435

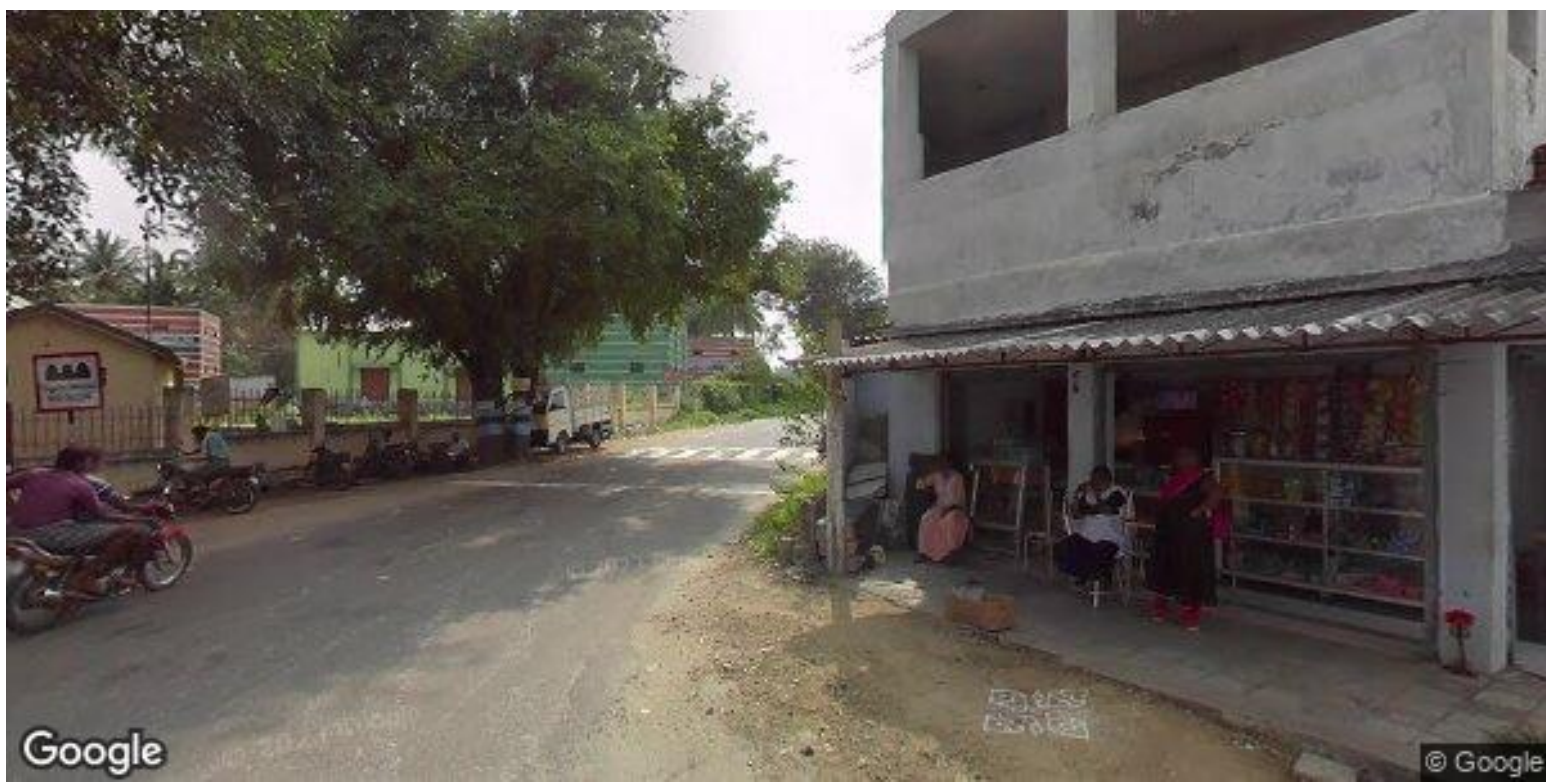
**Coordinates:** 11.13664, 77.76524

**Risk Type:** Turn

**Risk Level:** Medium

**Speed Limit:** 30 KM/Hr

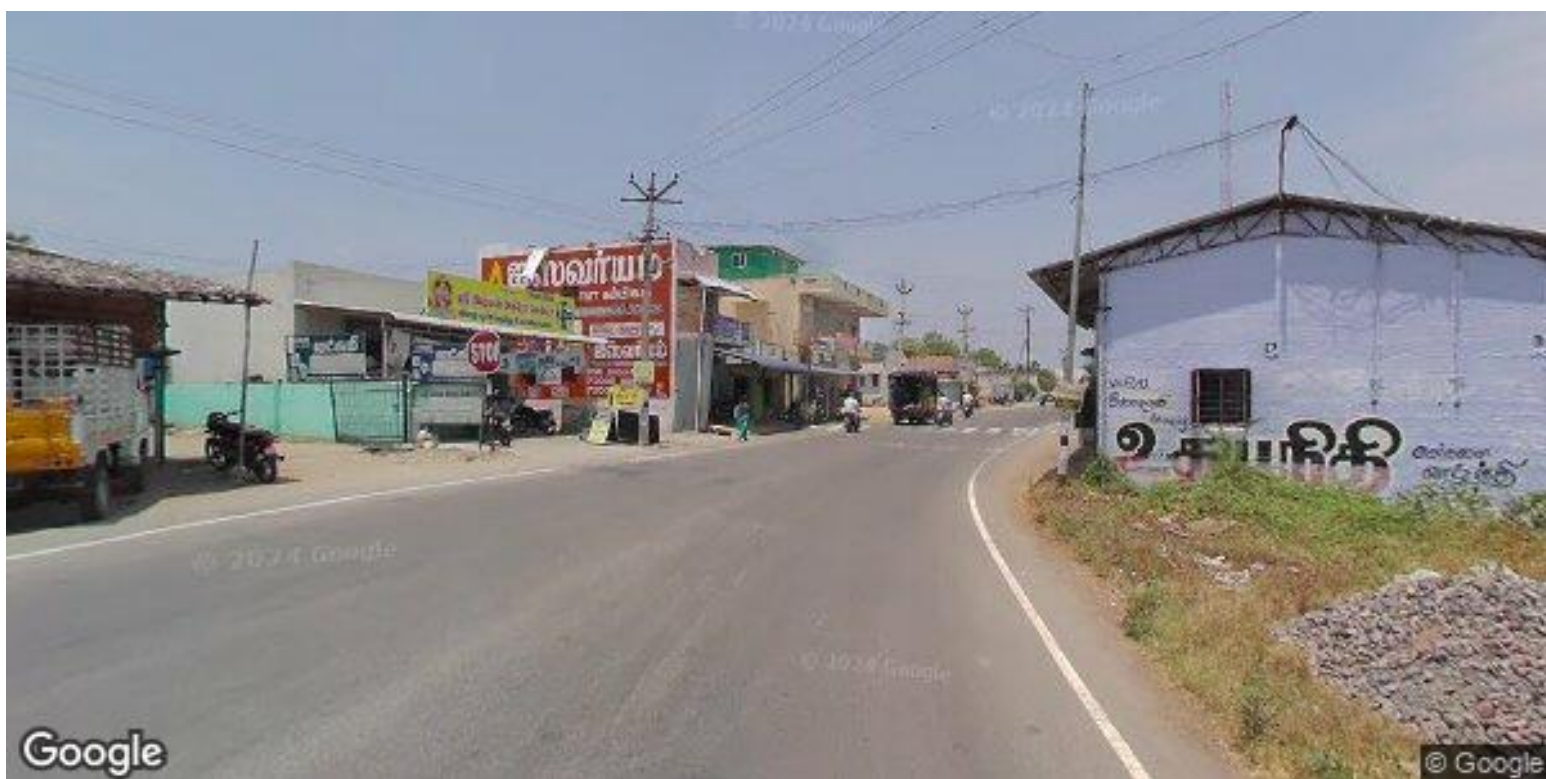
**Coordinates:** 11.04718, 77.73742

**Risk Type:** Turn

**Risk Level:** Medium

**Speed Limit:** 30 KM/Hr

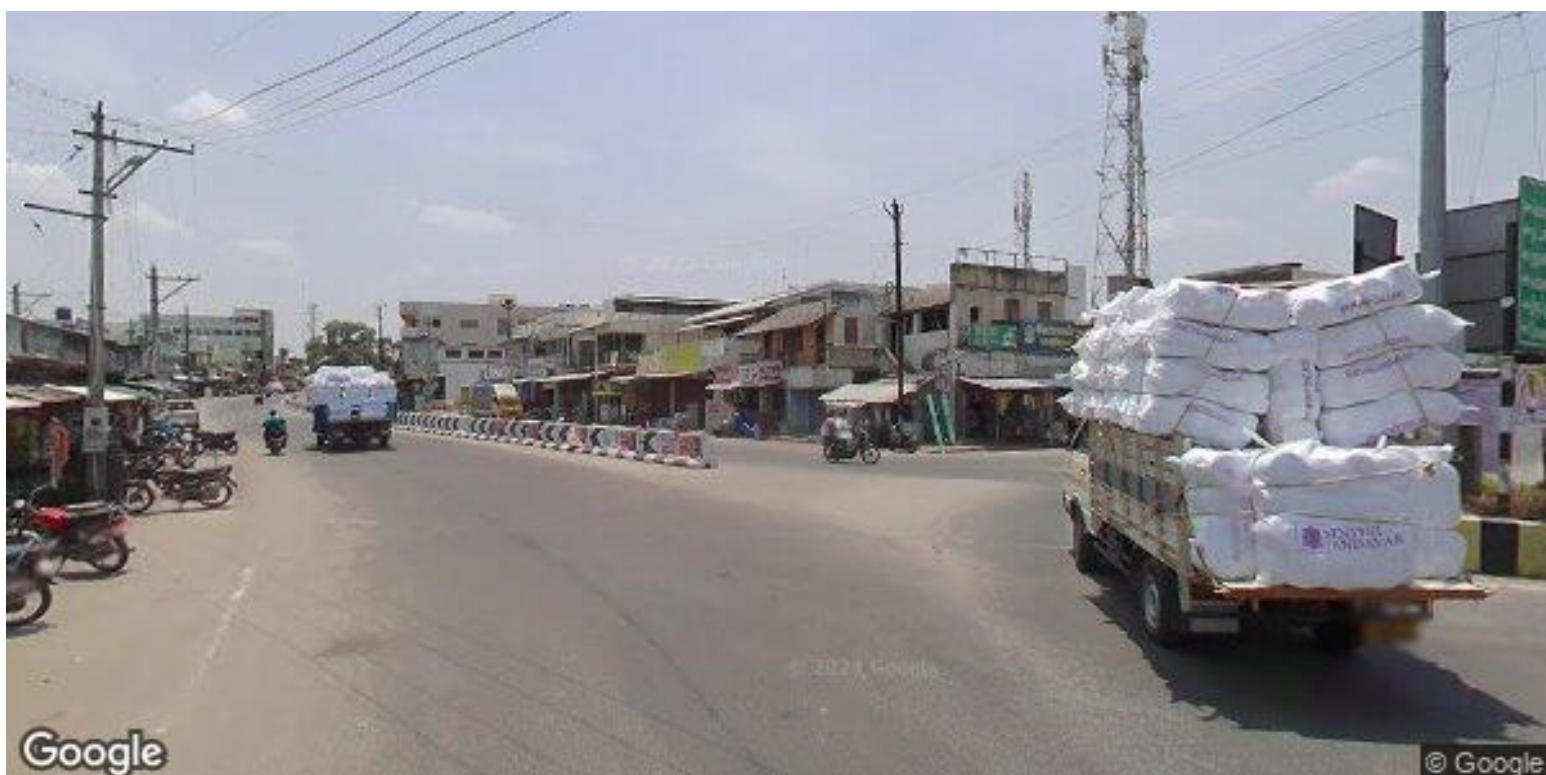
**Risk Type:** Turn  
**Risk Level:** High  
**Speed Limit:** 15 KM/Hr  
**Coordinates:** 11.04515, 77.73621

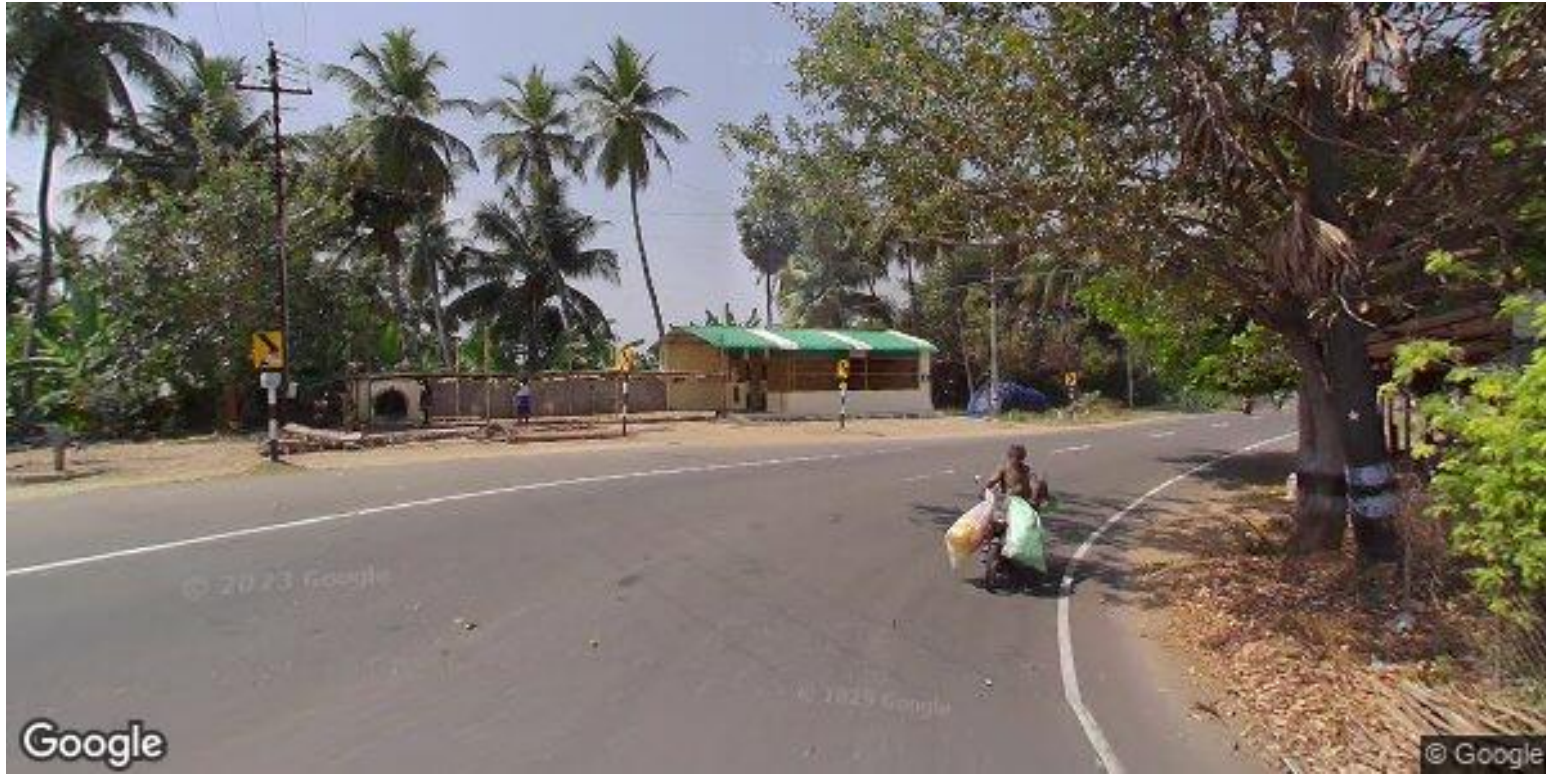
**Risk Type:** Turn  
**Risk Level:** High  
**Speed Limit:** 15 KM/Hr  
**Coordinates:** 10.99026, 77.72511

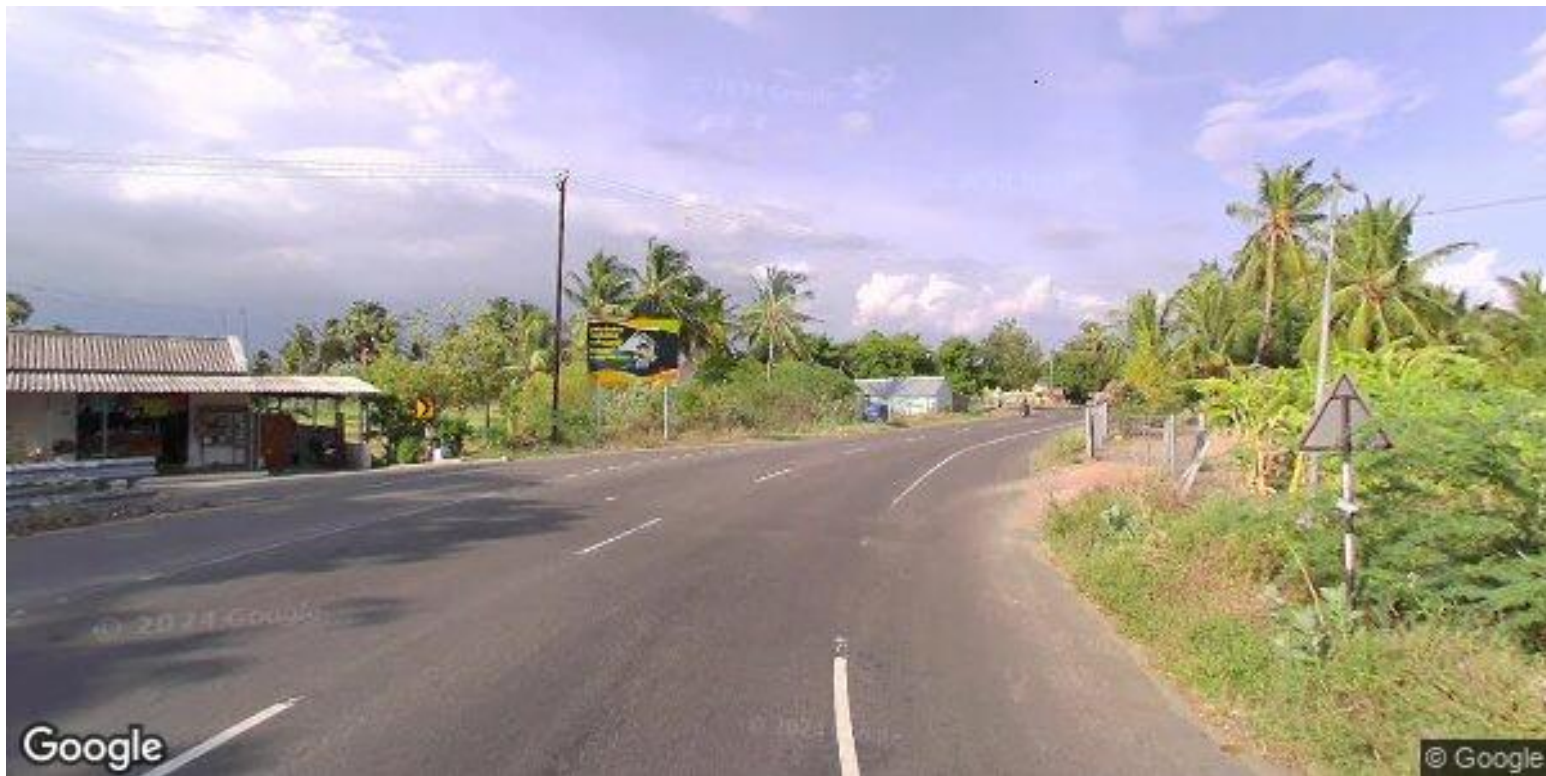
**Risk Type:** Turn  
**Risk Level:** High  
**Speed Limit:** 15 KM/Hr  
**Coordinates:** 10.98974, 77.72388

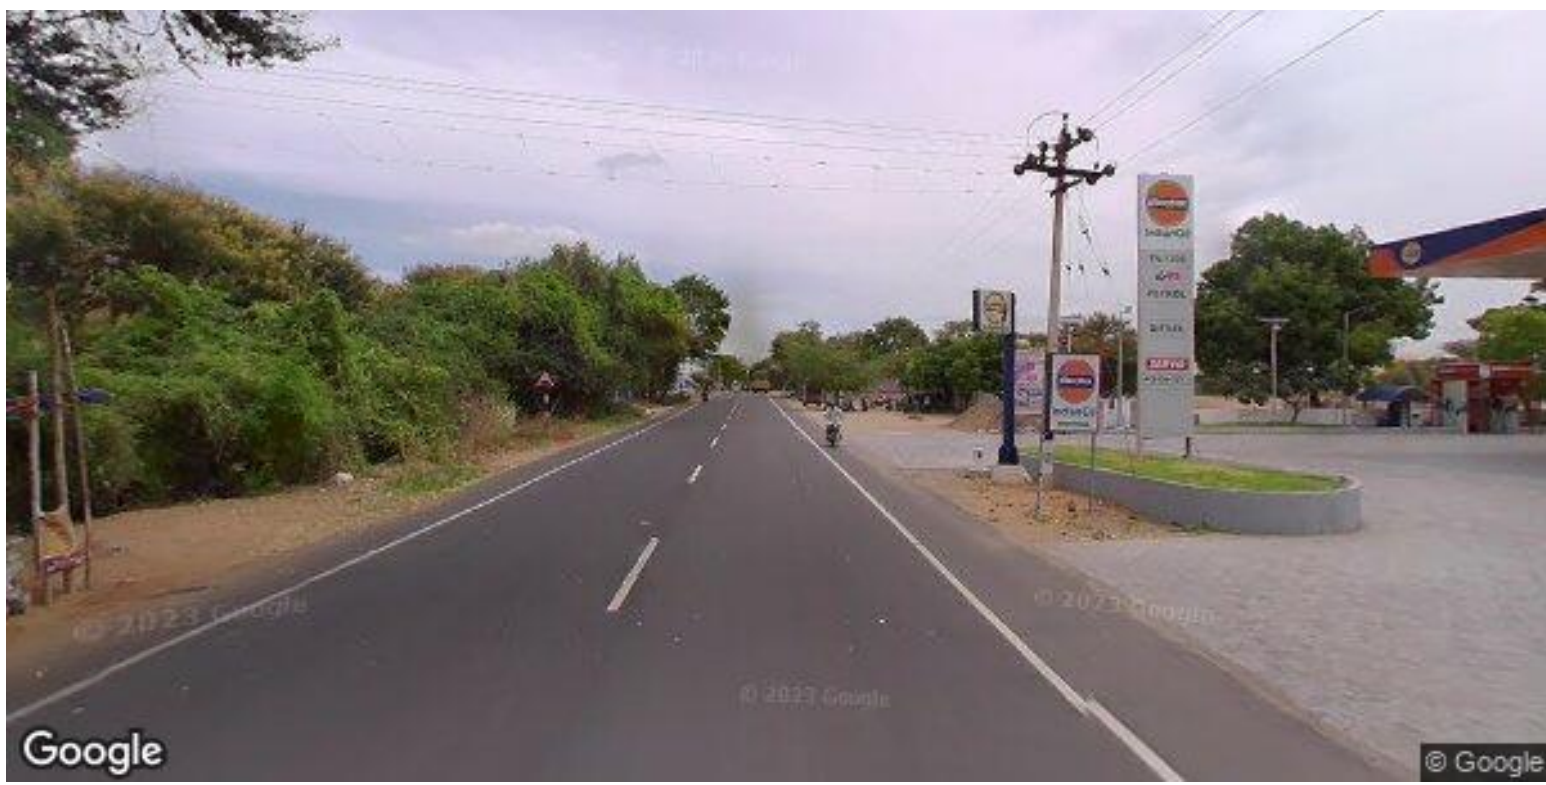
**Coordinates:** 10.96959, 77.71867

**Risk Type:** Blind Spot

**Risk Level:** Blind Spot

**Speed Limit:** 10 KM/Hr
