# IndianOil

## JOURNEY RISK MANAGEMENT (JRM) STUDY

### Salem Terminal to AMMAN ENTERPRISE

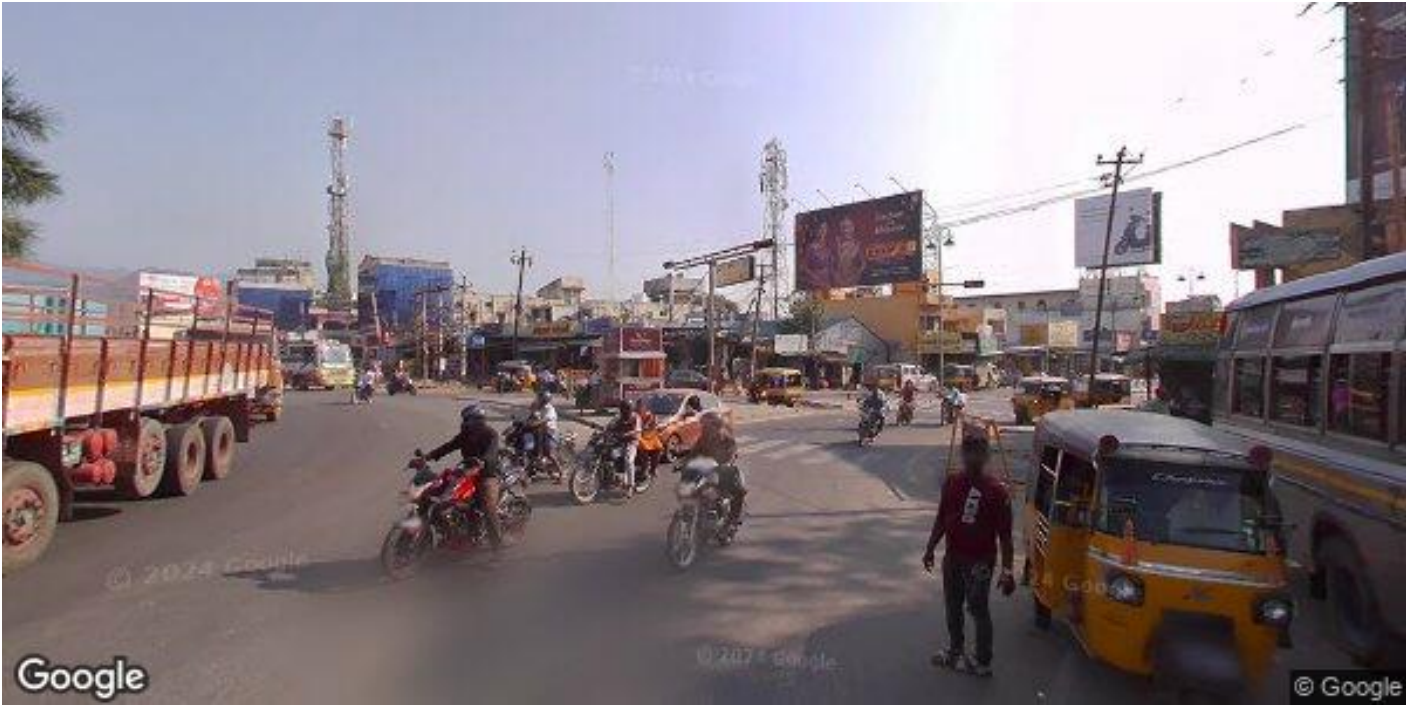
Risk Type: Roundabout

Risk Level: High

Speed Limit: 15 KM/Hr

Coordinates: 11.63266, 78.12699

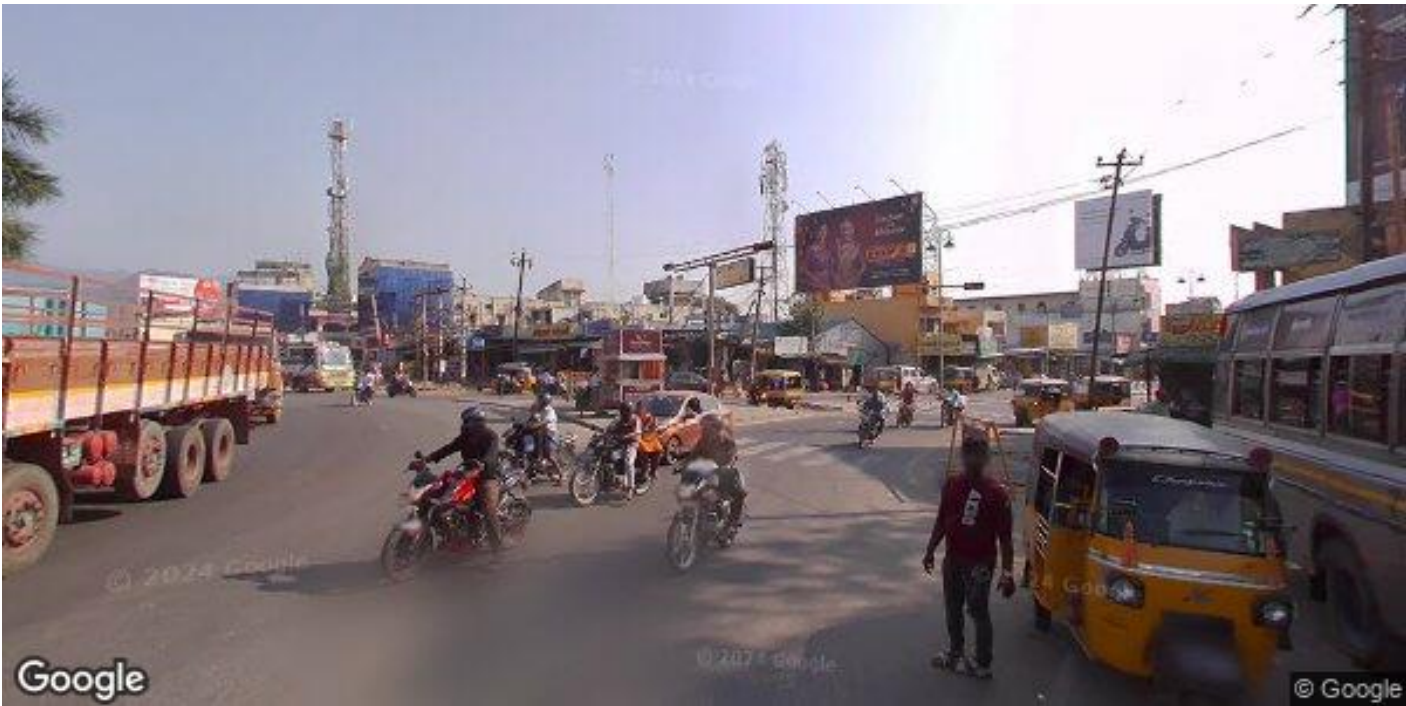
Risk Type: Roundabout

Risk Level: High

Speed Limit: 15 KM/Hr

Coordinates: 11.63266, 78.12699

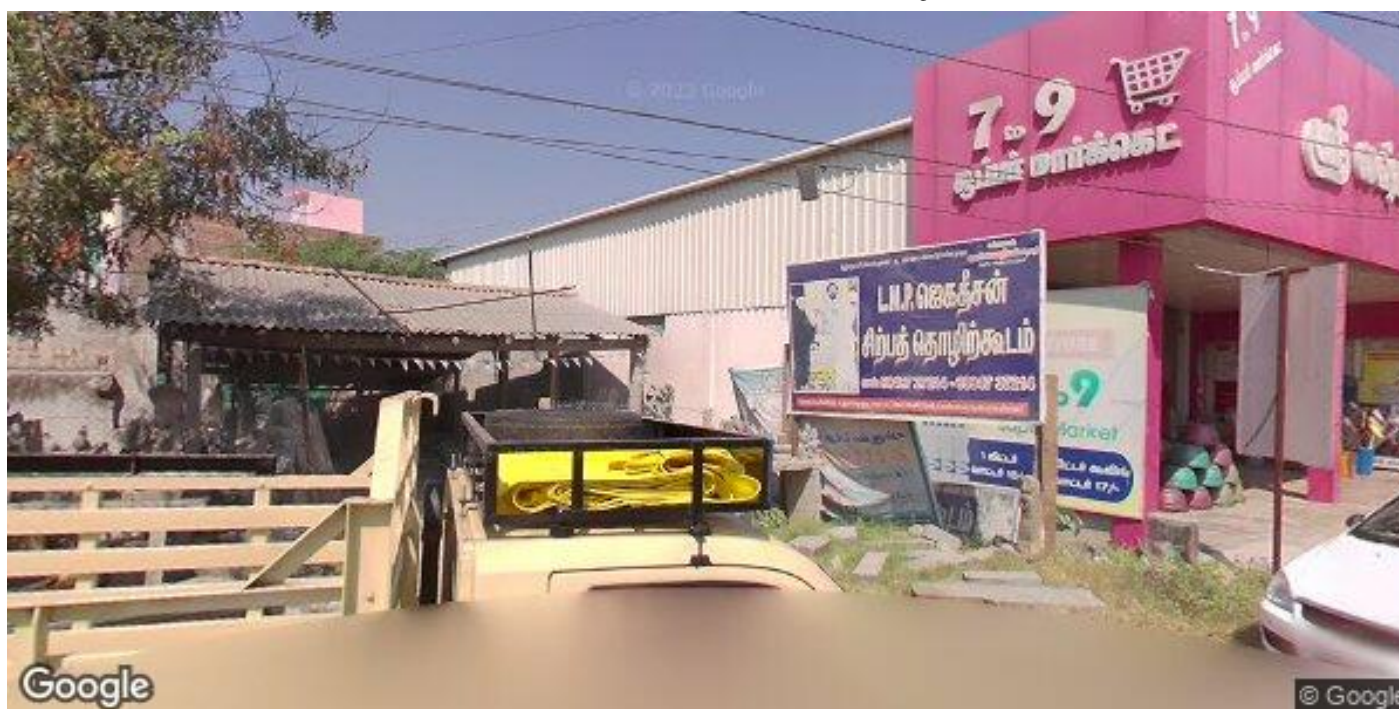
**Risk Type:** U-Turn

**Risk Level:** High

**Speed Limit:** 10 KM/Hr

**Coordinates:** 11.6302987, 78.12452429999999

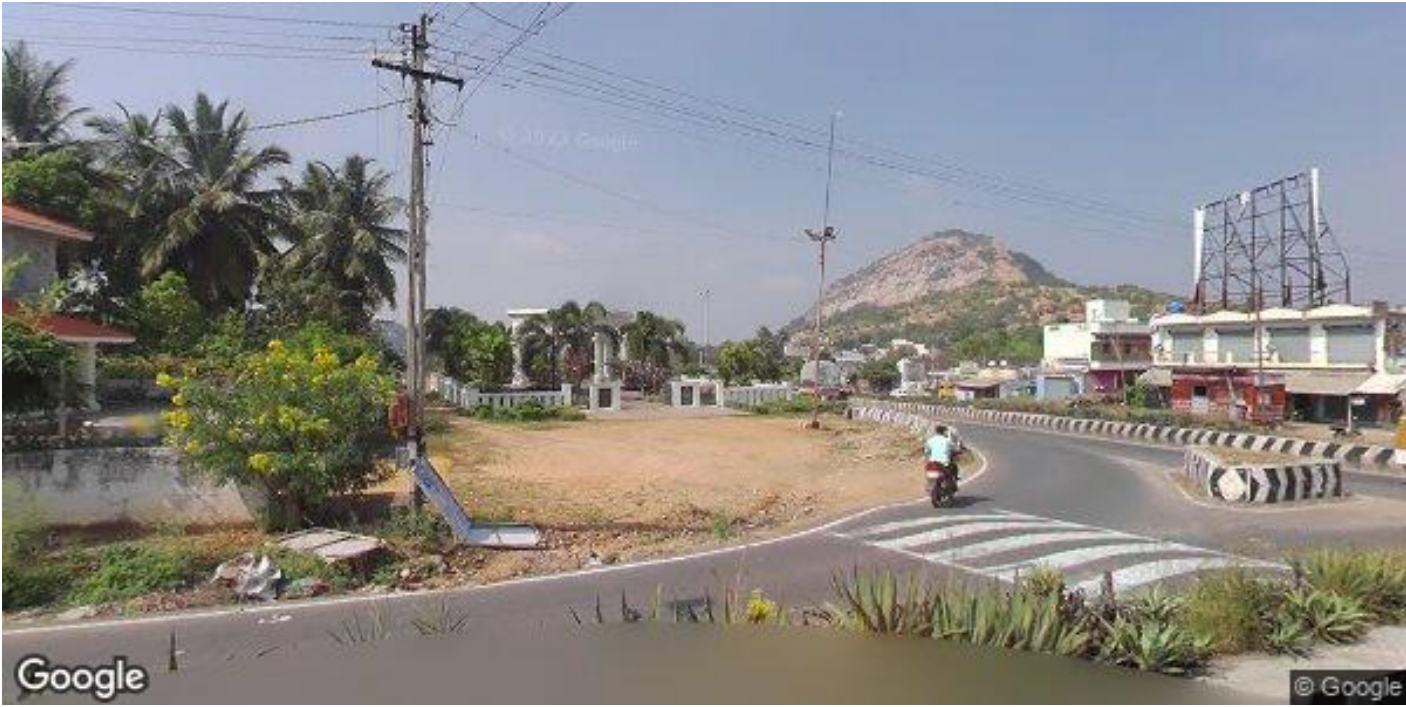
**Risk Type:** Turn  
**Risk Level:** Medium  
**Speed Limit:** 30 KM/Hr  
**Coordinates:** 11.46307, 77.84941

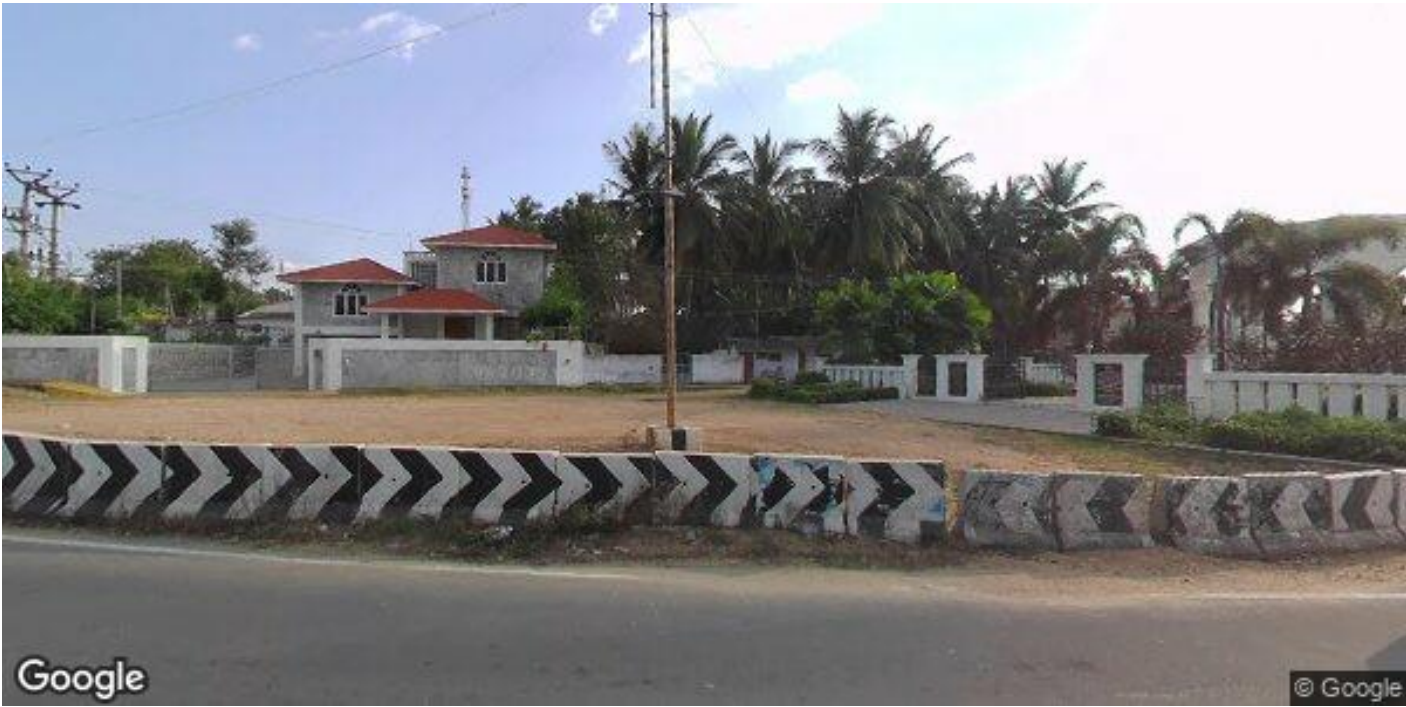
**Risk Type:** Turn  
**Risk Level:** Medium  
**Speed Limit:** 30 KM/Hr  
**Coordinates:** 11.46316, 77.84921

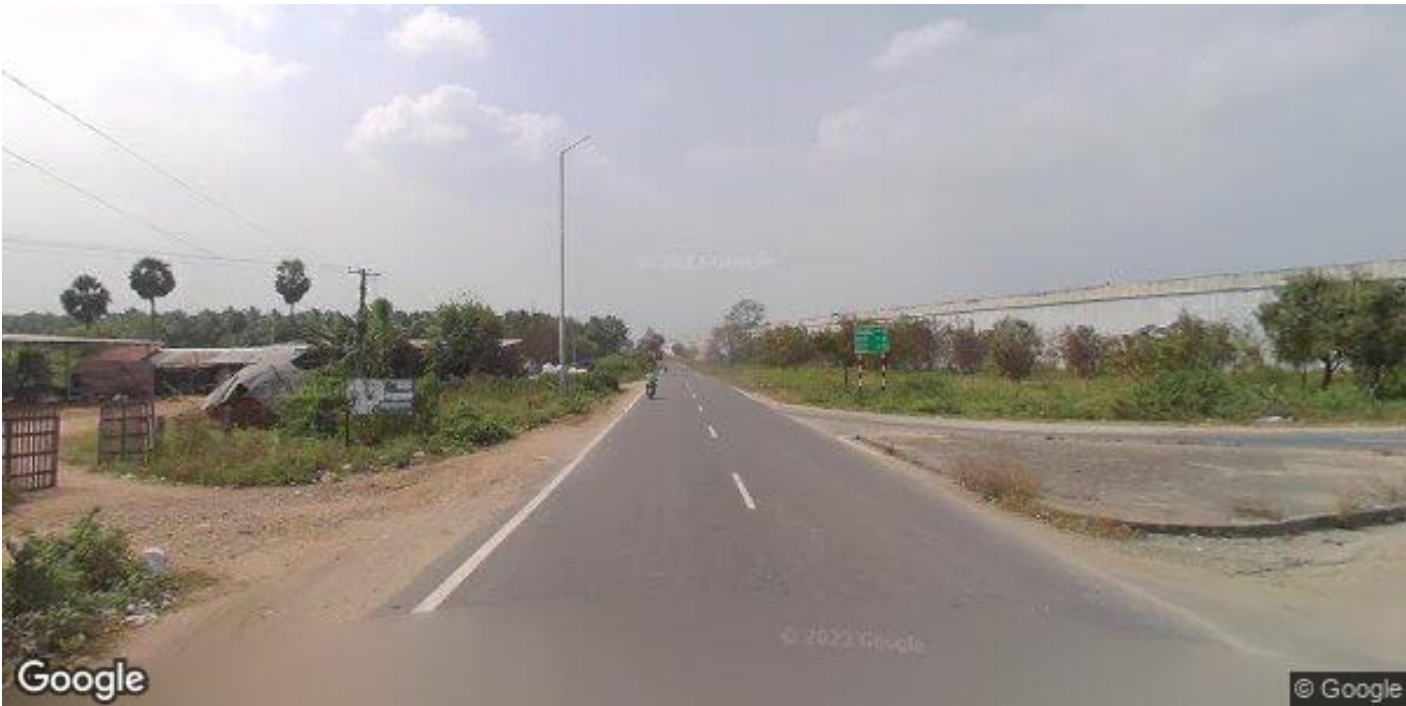
**Risk Type:** Turn  
**Risk Level:** High  
**Speed Limit:** 15 KM/Hr  
**Coordinates:** 11.45542, 77.81725

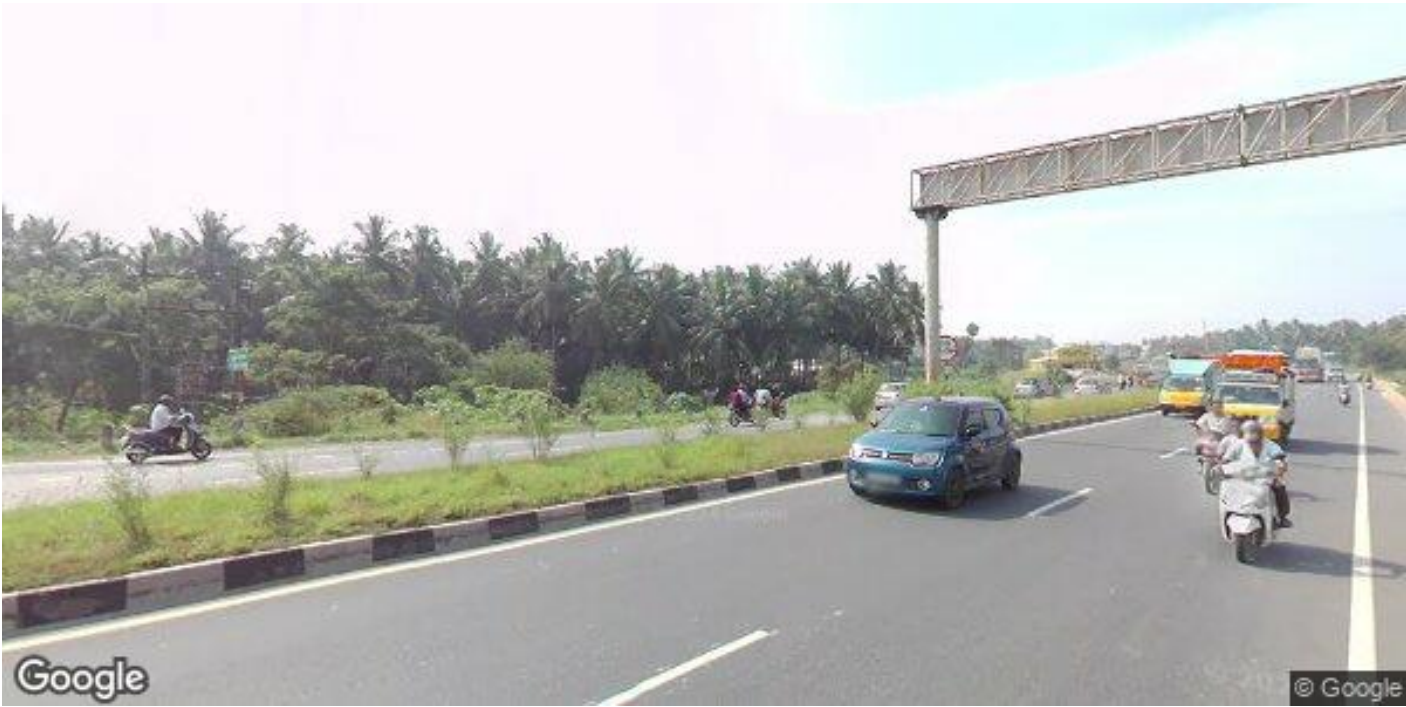
**Risk Type:** Turn  
**Risk Level:** Medium  
**Speed Limit:** 30 KM/Hr  
**Coordinates:** 11.60942, 78.10056

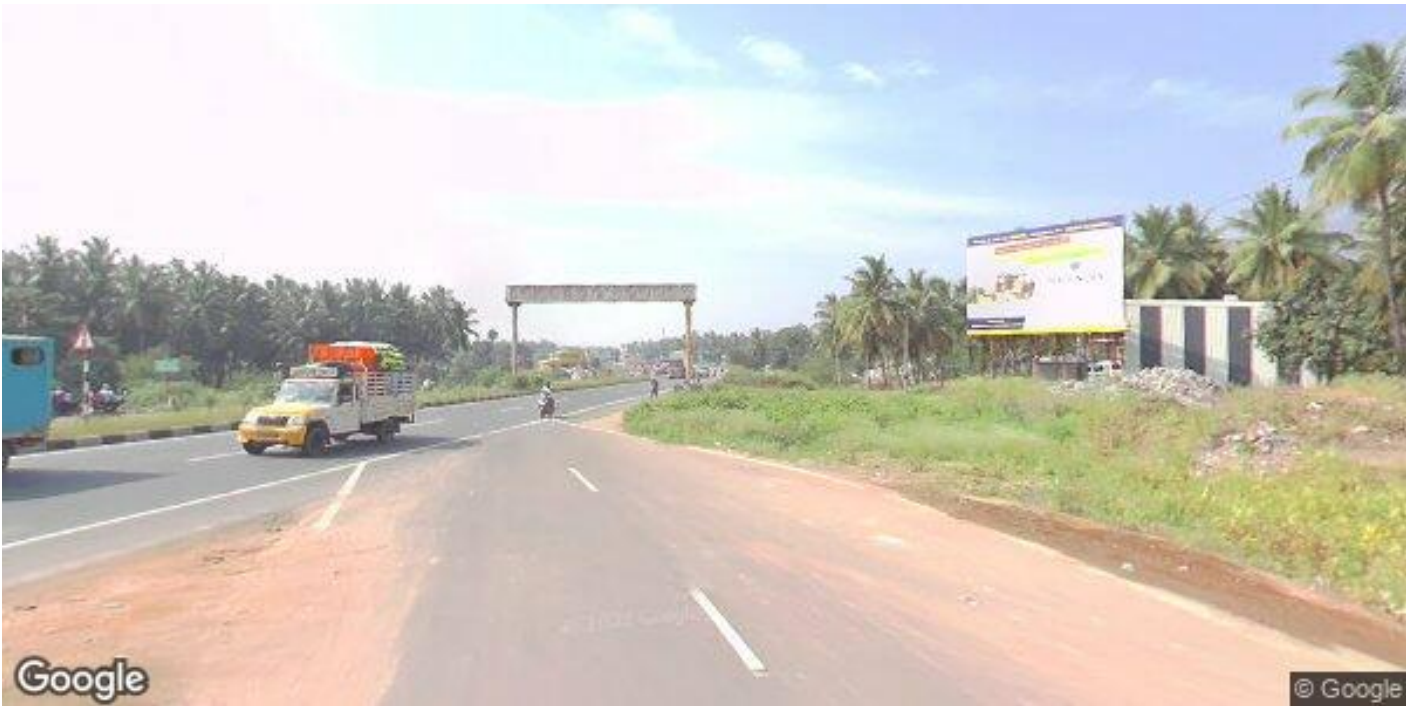
**Risk Type:** Turn  
**Risk Level:** Medium  
**Speed Limit:** 30 KM/Hr  
**Coordinates:** 11.60965, 78.10070

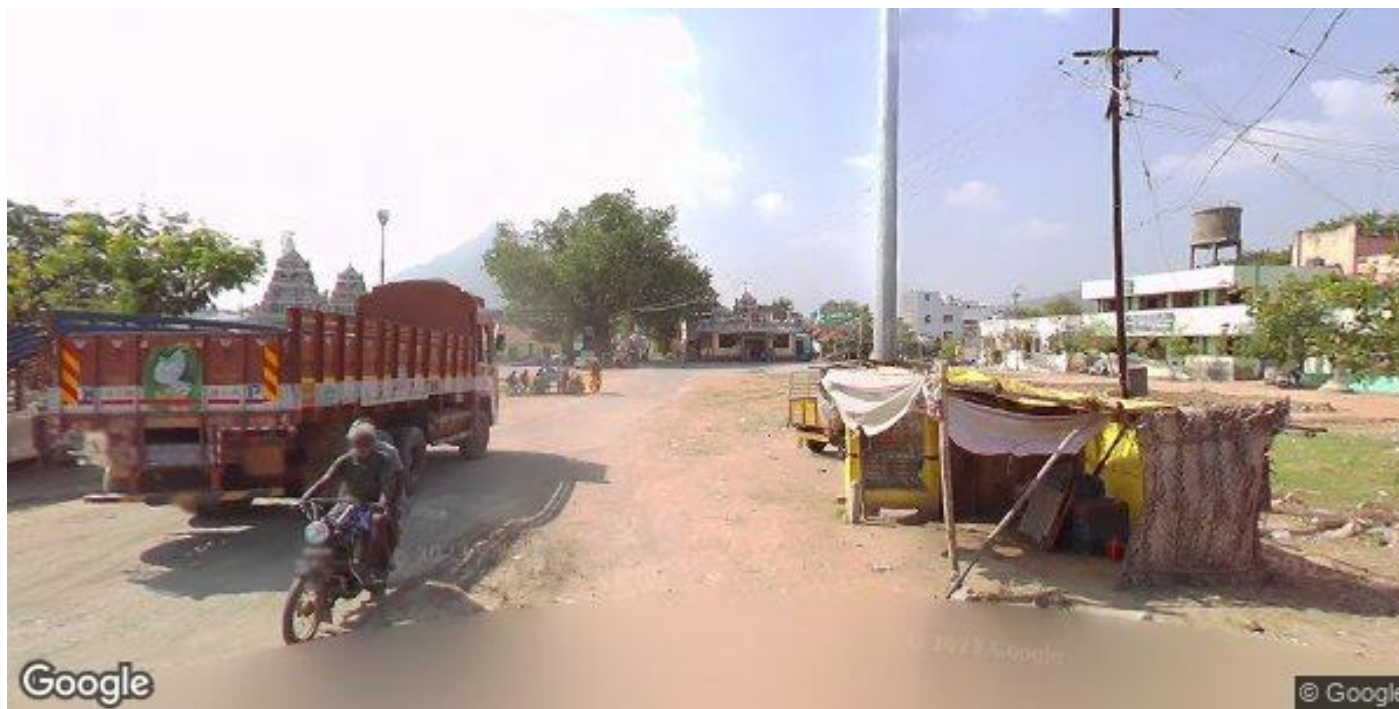
**Risk Type:** Blind Spot  
**Risk Level:** Blind Spot  
**Speed Limit:** 10 KM/Hr  
**Coordinates:** 11.62145, 78.10740

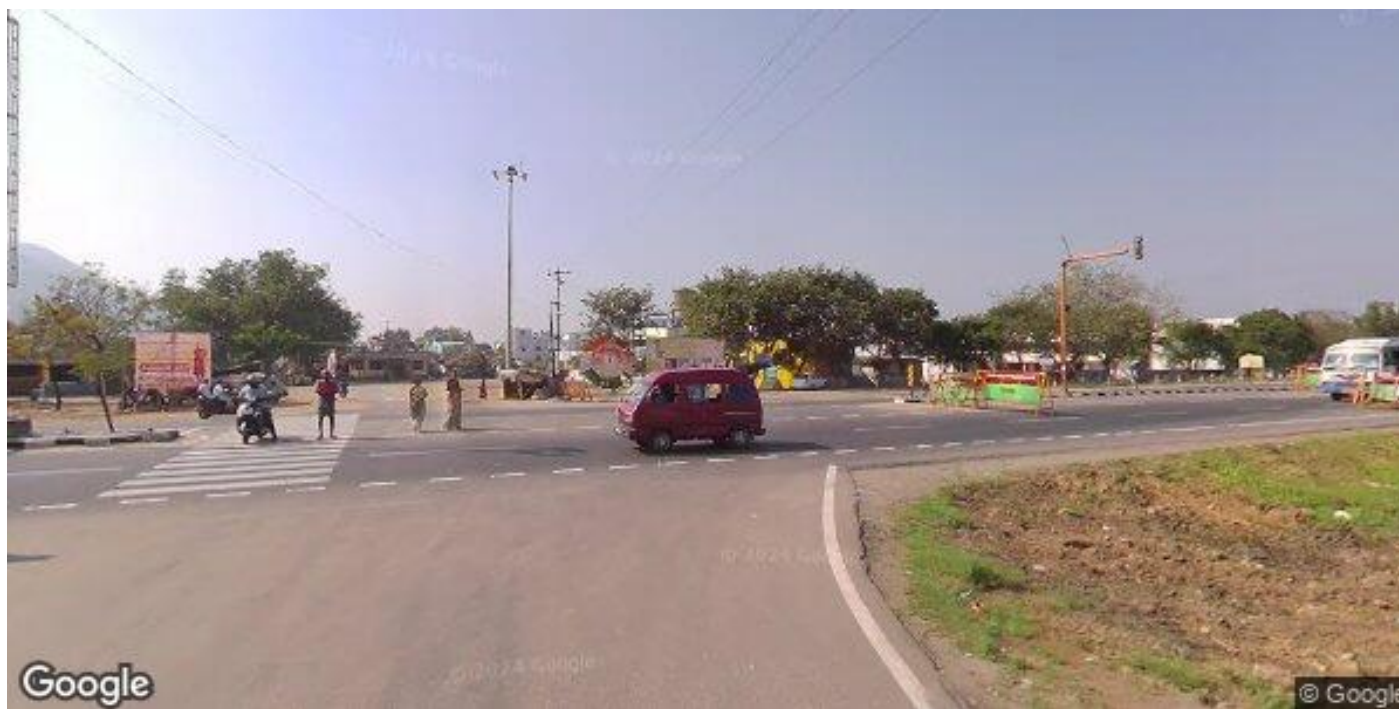
**Risk Type:** Turn  
**Risk Level:** High  
**Speed Limit:** 15 KM/Hr  
**Coordinates:** 11.62130, 78.10776

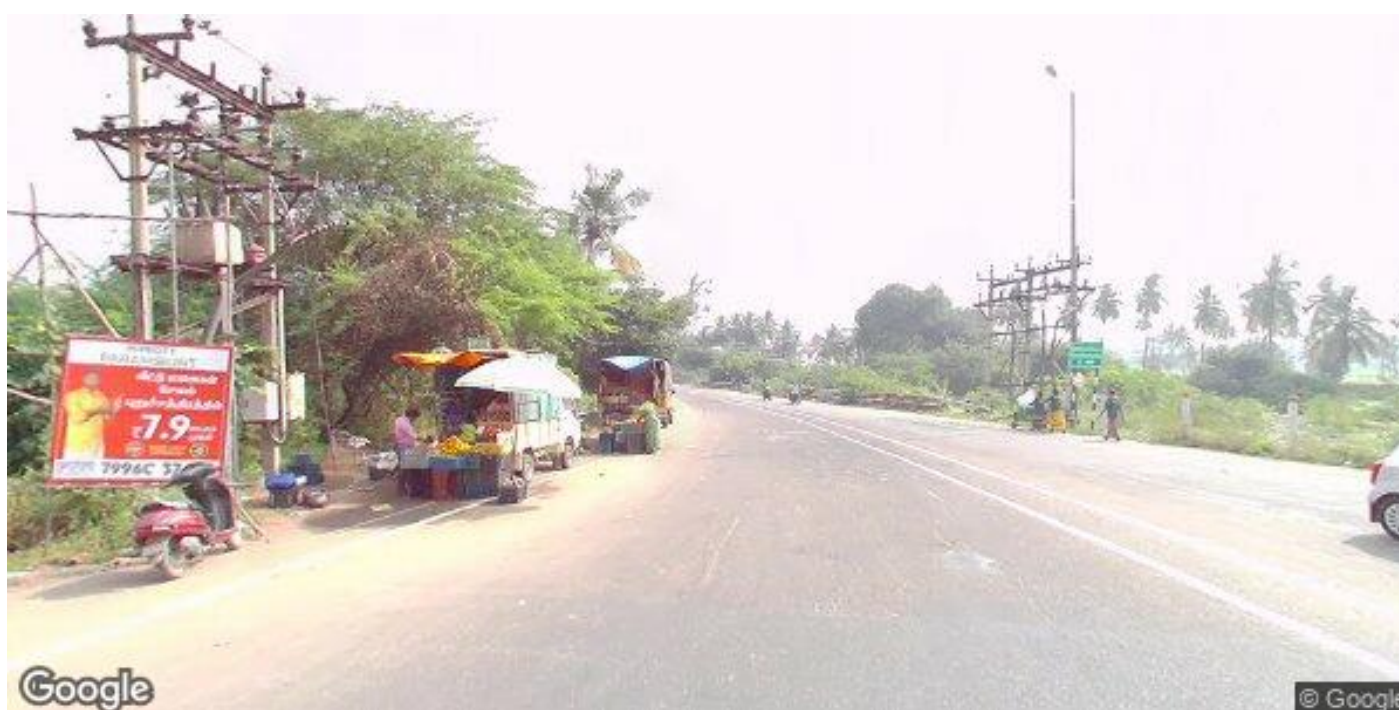
**Risk Type:** Blind Spot  
**Risk Level:** Blind Spot  
**Speed Limit:** 10 KM/Hr  
**Coordinates:** 11.61217, 78.10439

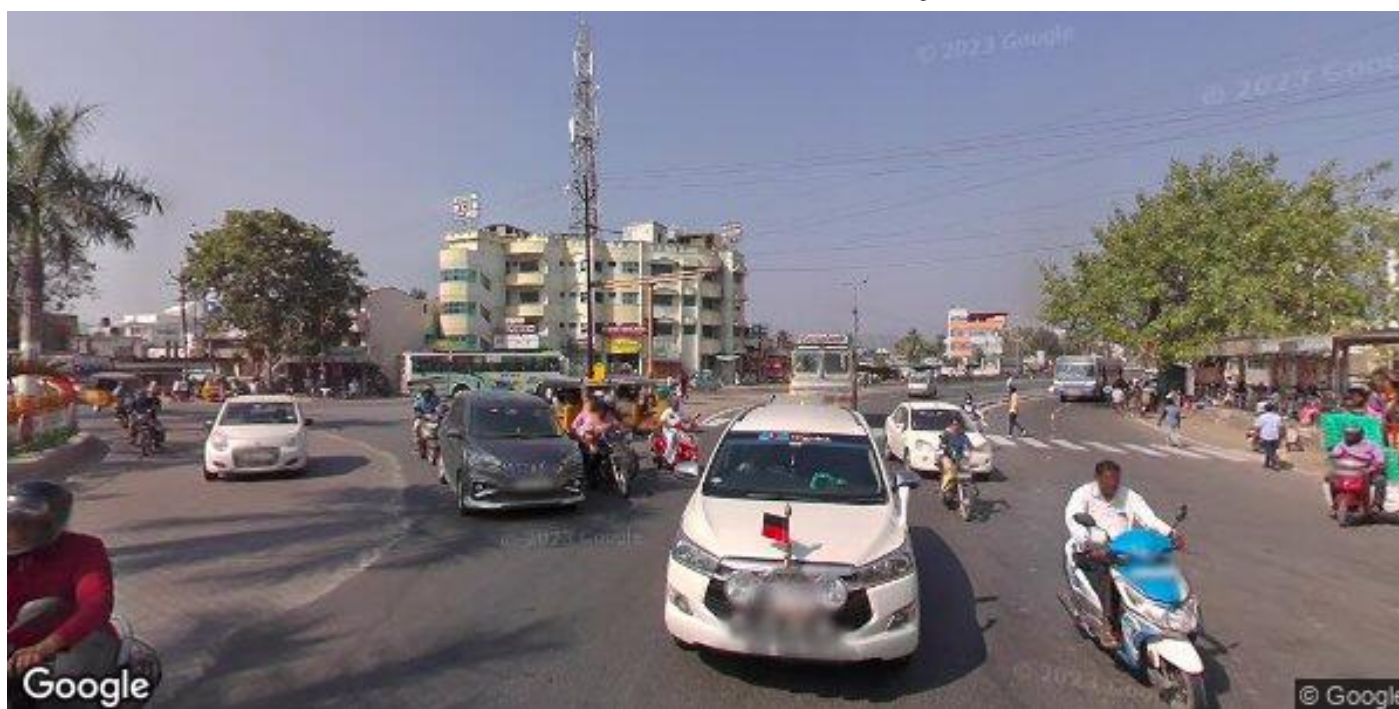
**Risk Type:** Turn  
**Risk Level:** High  
**Speed Limit:** 15 KM/Hr  
**Coordinates:** 11.63306, 78.12722

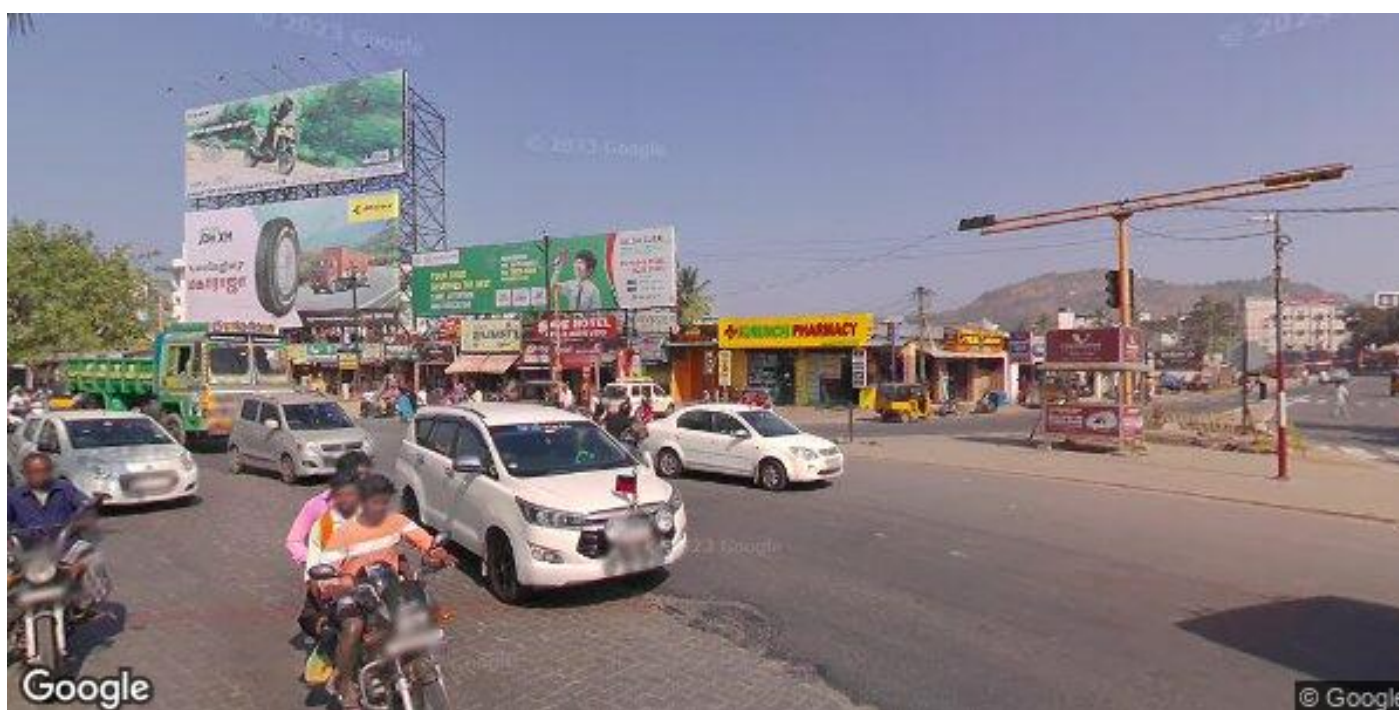
**Risk Type:** Turn  
**Risk Level:** Medium  
**Speed Limit:** 30 KM/Hr  
**Coordinates:** 11.63294, 78.12752

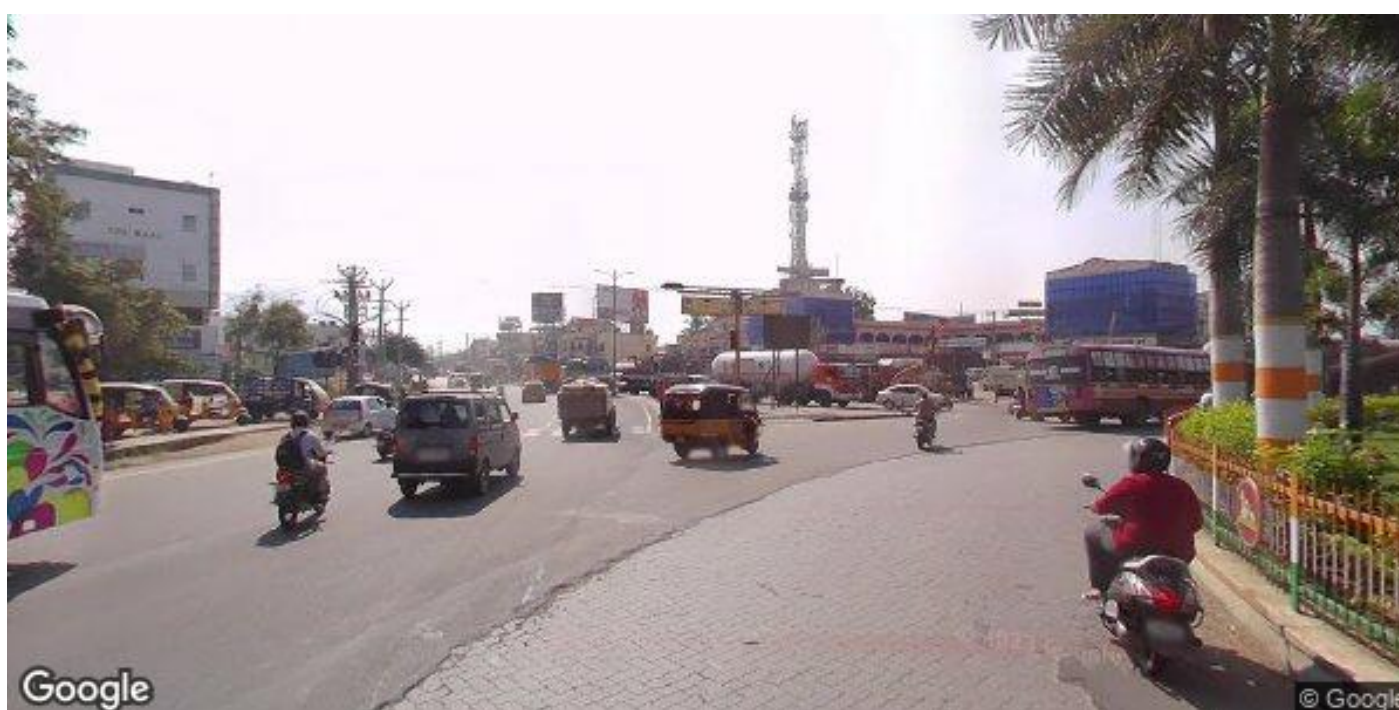
**Risk Type:** Turn  
**Risk Level:** Medium  
**Speed Limit:** 30 KM/Hr  
**Coordinates:** 11.63283, 78.12757

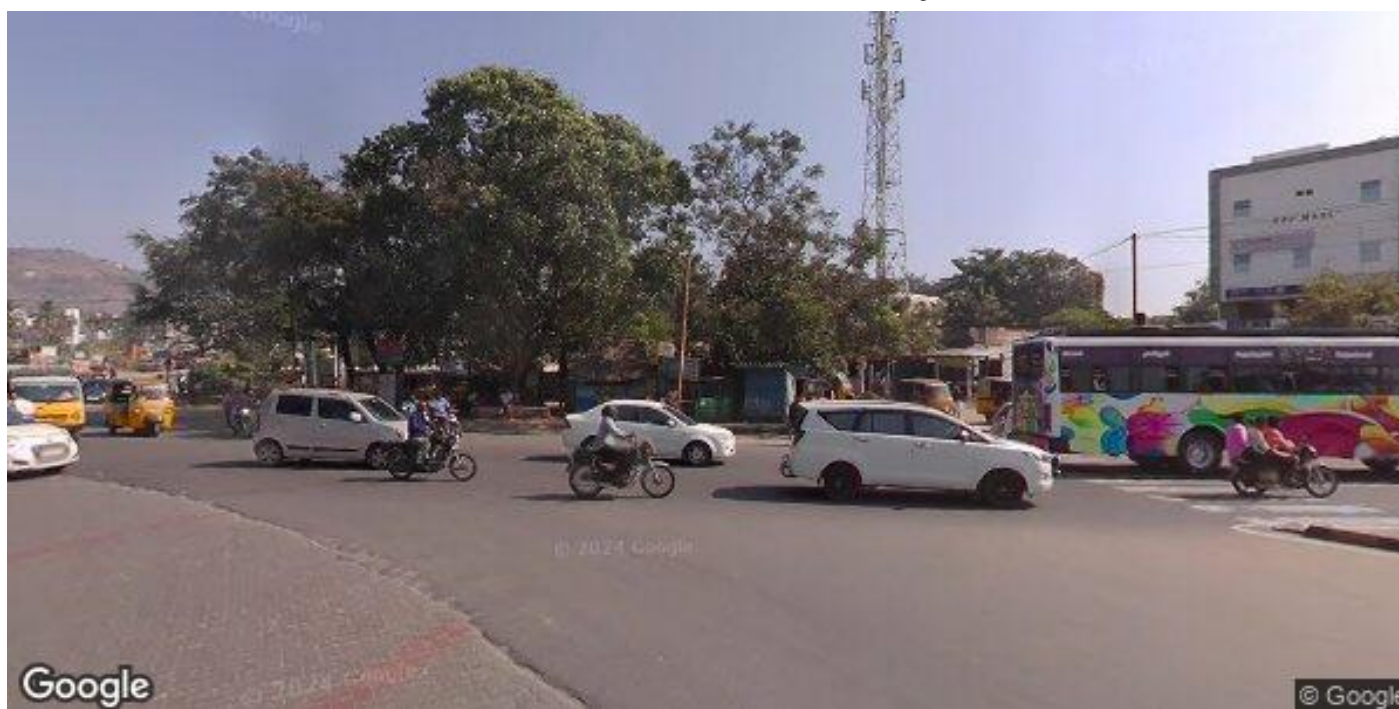
**Risk Type:** Turn  
**Risk Level:** High  
**Speed Limit:** 15 KM/Hr  
**Coordinates:** 11.63262, 78.12754

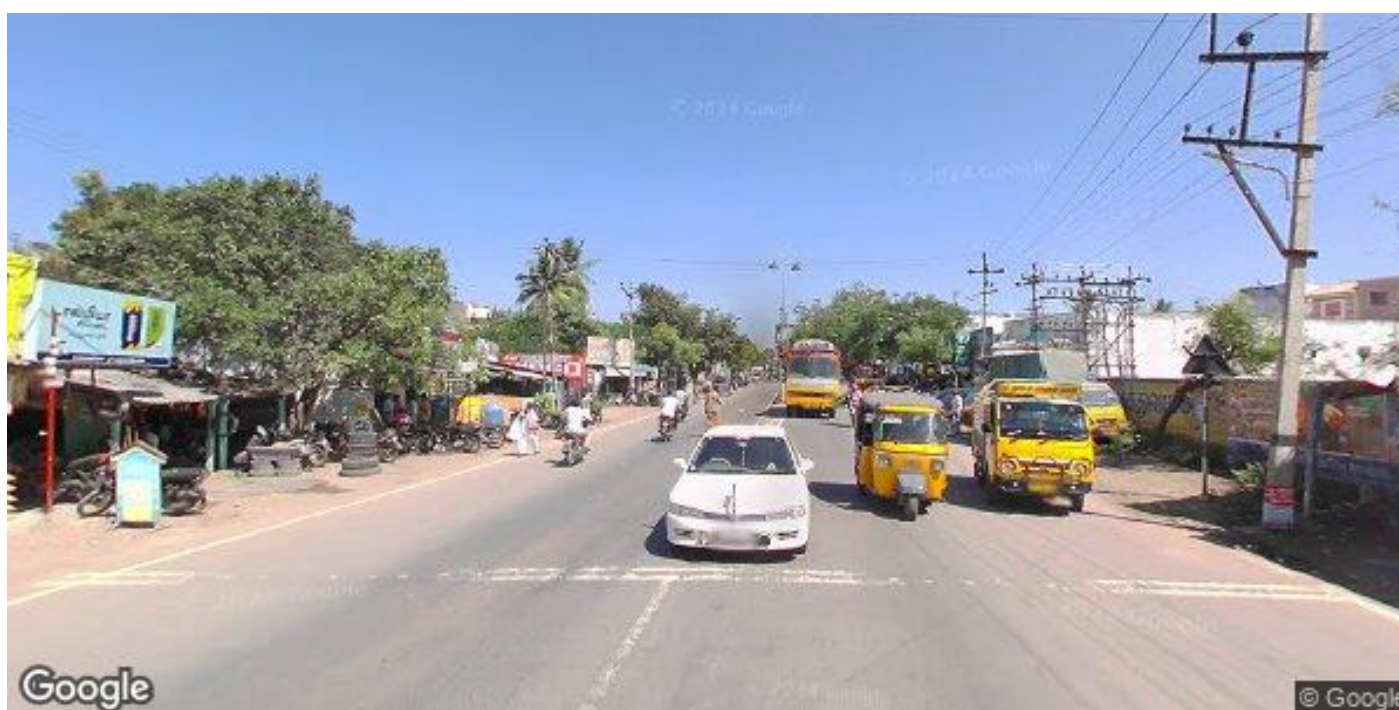
**Risk Type:** Turn  
**Risk Level:** Medium  
**Speed Limit:** 30 KM/Hr  
**Coordinates:** 11.63026, 78.12481

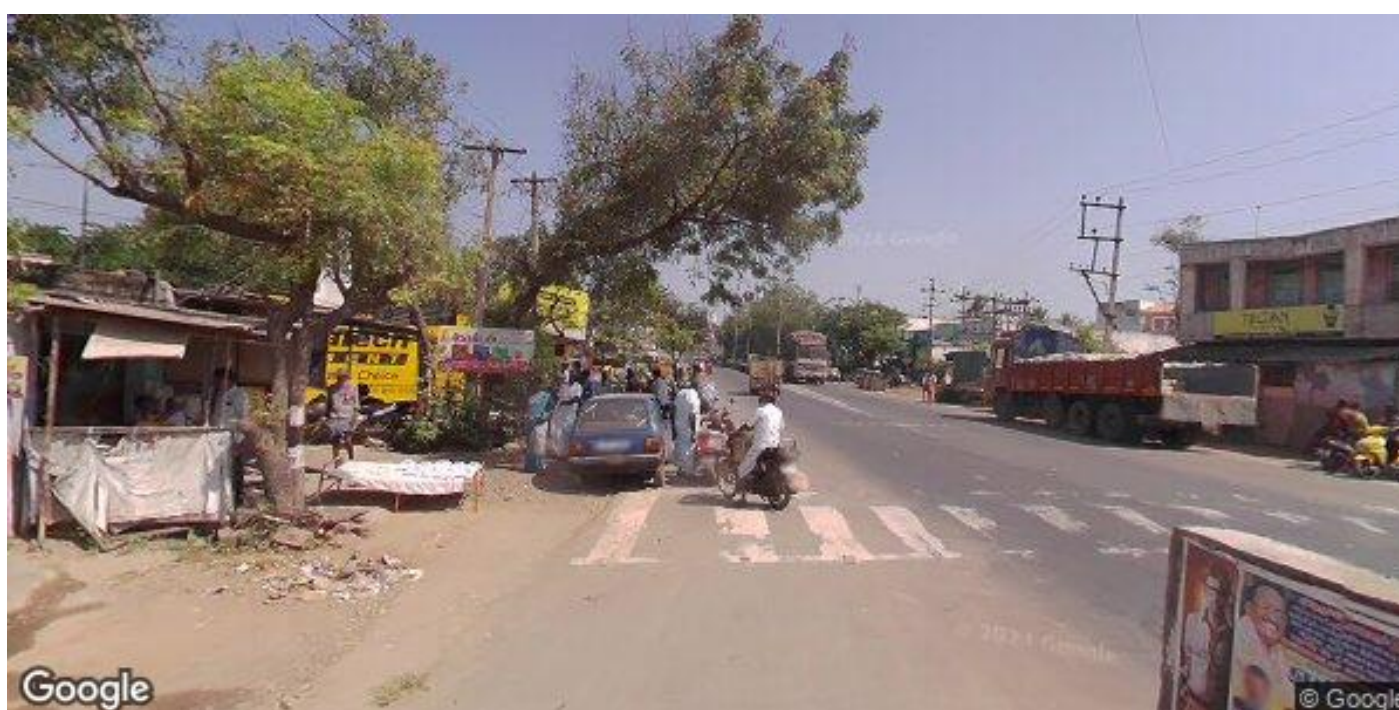
**Risk Type:** Turn  
**Risk Level:** Medium  
**Speed Limit:** 30 KM/Hr  
**Coordinates:** 11.63025, 78.12470

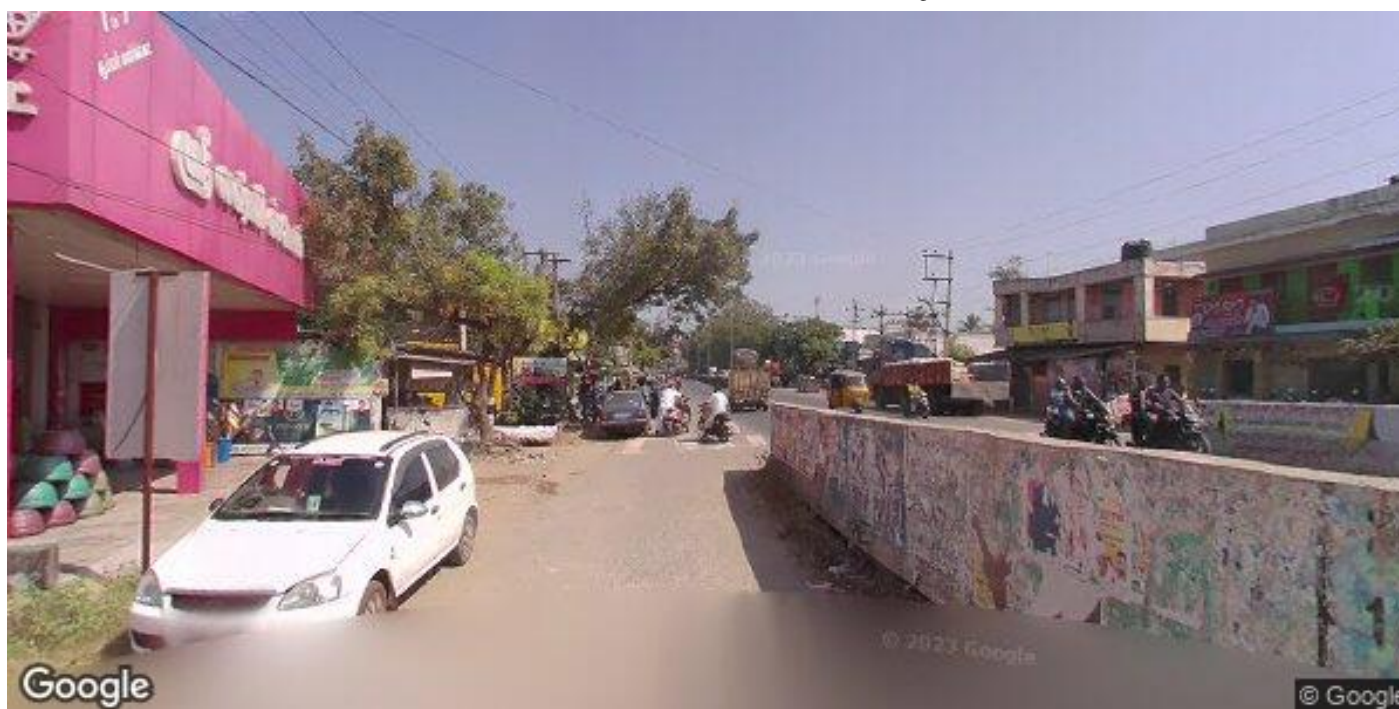
**Risk Type:** Blind Spot  
**Risk Level:** Blind Spot  
**Speed Limit:** 10 KM/Hr  
**Coordinates:** 11.63018, 78.12462

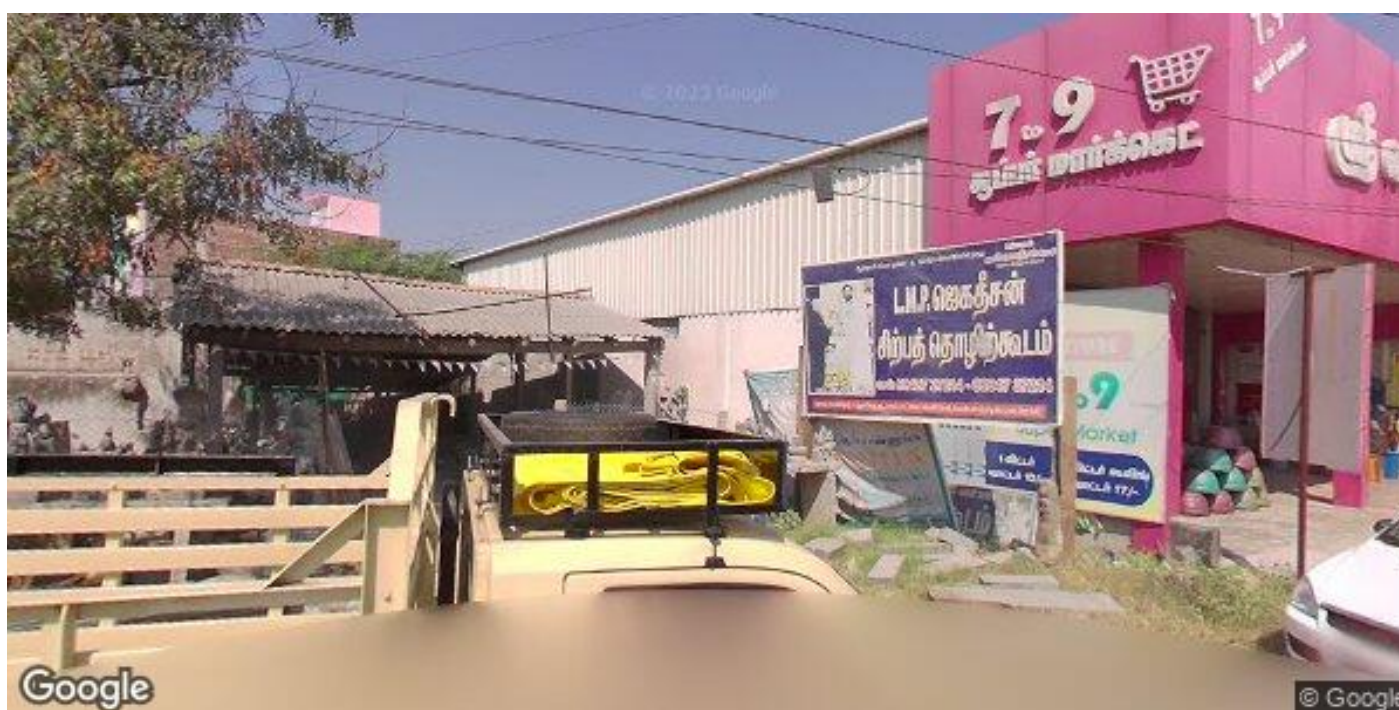
**Risk Type:** Blind Spot  
**Risk Level:** Blind Spot  
**Speed Limit:** 10 KM/Hr  
**Coordinates:** 11.63030, 78.12452

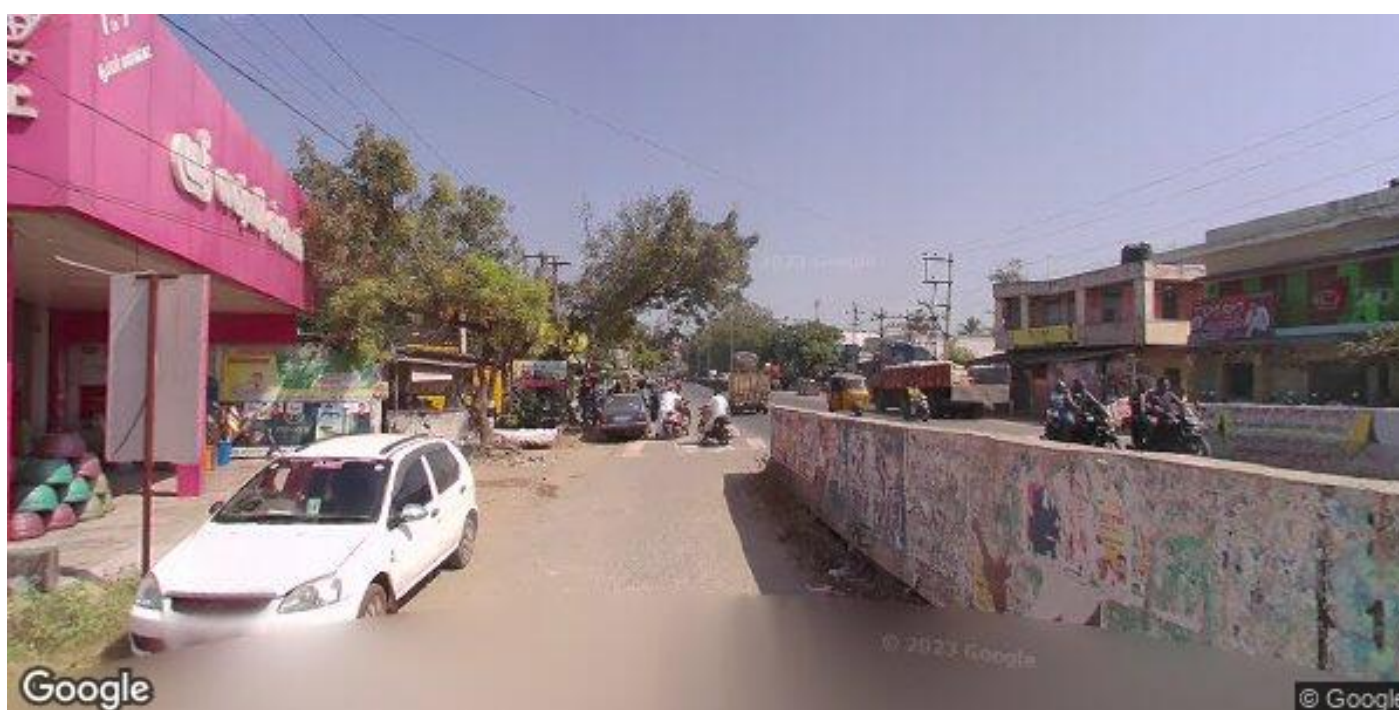
**Risk Type:** Blind Spot  
**Risk Level:** Blind Spot  
**Speed Limit:** 10 KM/Hr  
**Coordinates:** 11.63018, 78.12462

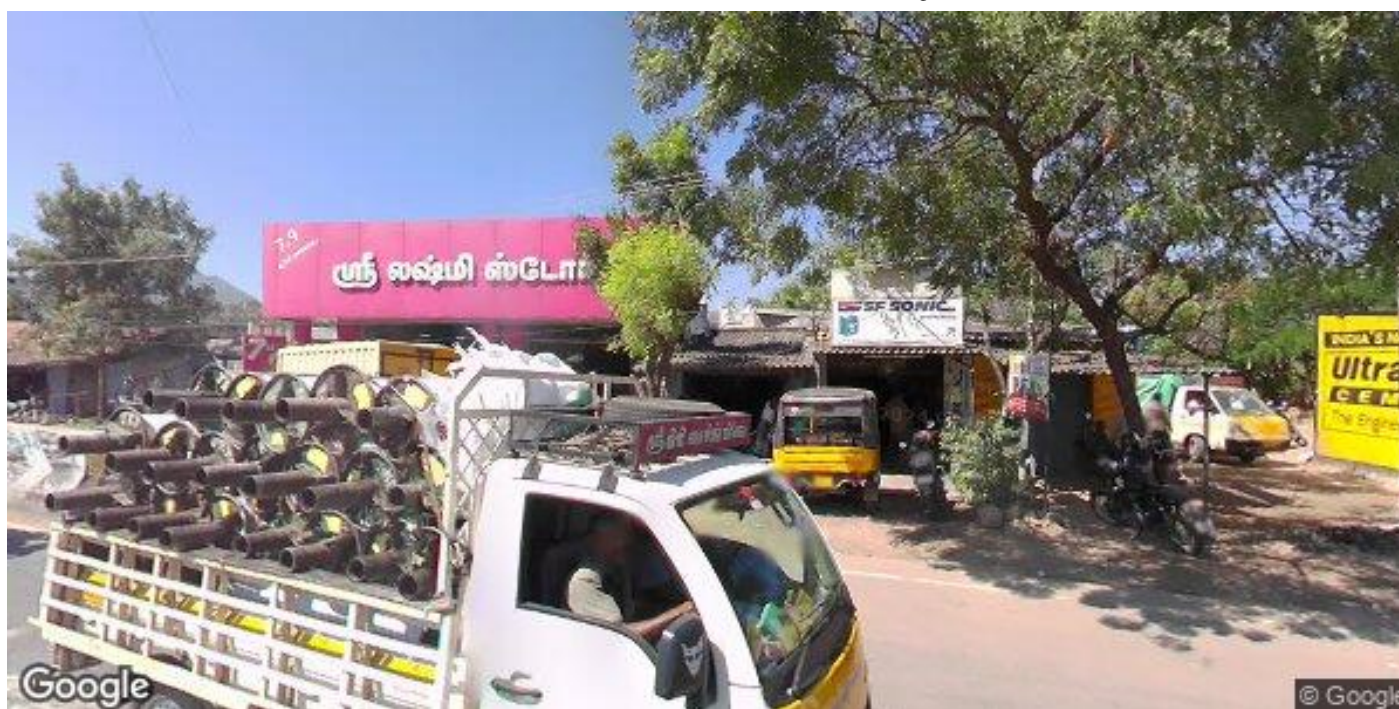
**Risk Type:** Turn  
**Risk Level:** High  
**Speed Limit:** 15 KM/Hr  
**Coordinates:** 11.63028, 78.12474

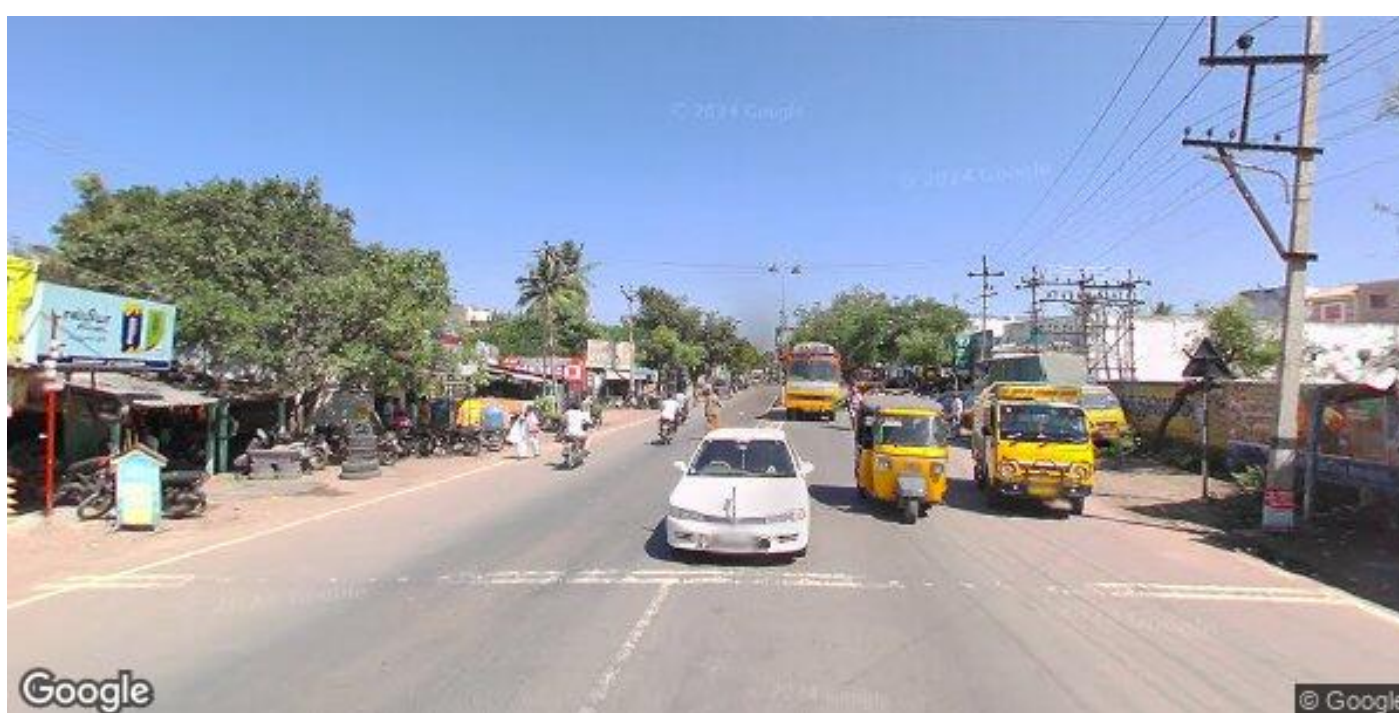
**Risk Type:** Turn  
**Risk Level:** High  
**Speed Limit:** 15 KM/Hr  
**Coordinates:** 11.63026, 78.12481
