# IndianOil

## JOURNEY RISK MANAGEMENT (JRM) STUDY

### Salem Terminal to AMMAN ENTERPRISE

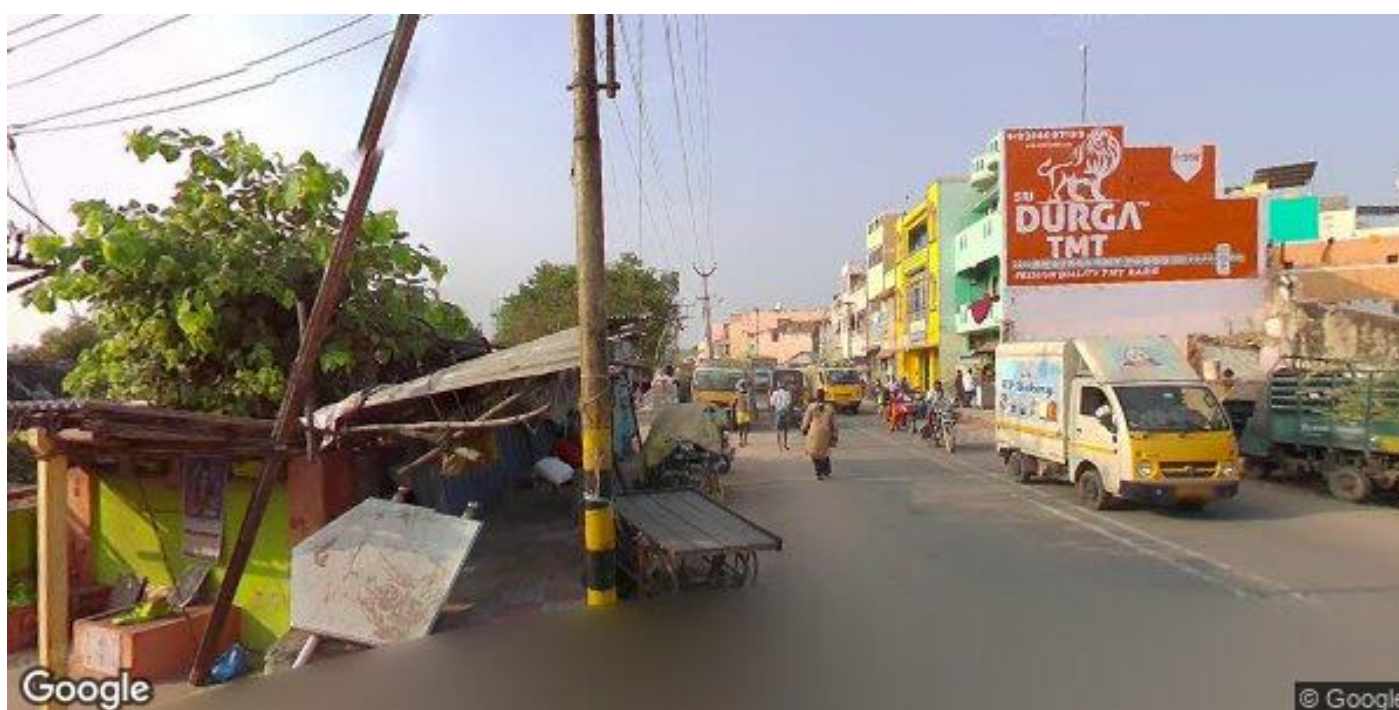
**Risk Type:** Turn  
**Risk Level:** Medium  
**Speed Limit:** 30 KM/Hr  
**Coordinates:** 11.64854, 78.14335

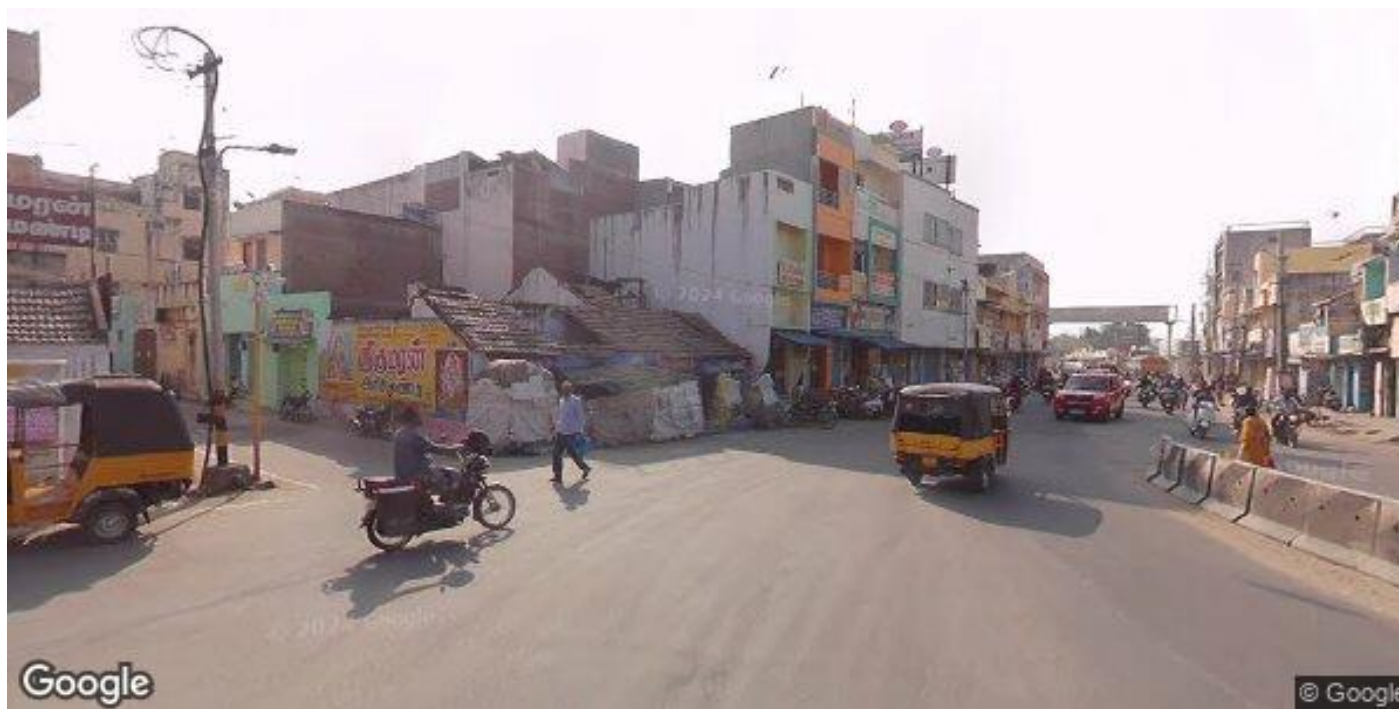
**Risk Type:** Turn  
**Risk Level:** Medium  
**Speed Limit:** 30 KM/Hr  
**Coordinates:** 11.65152, 78.14229

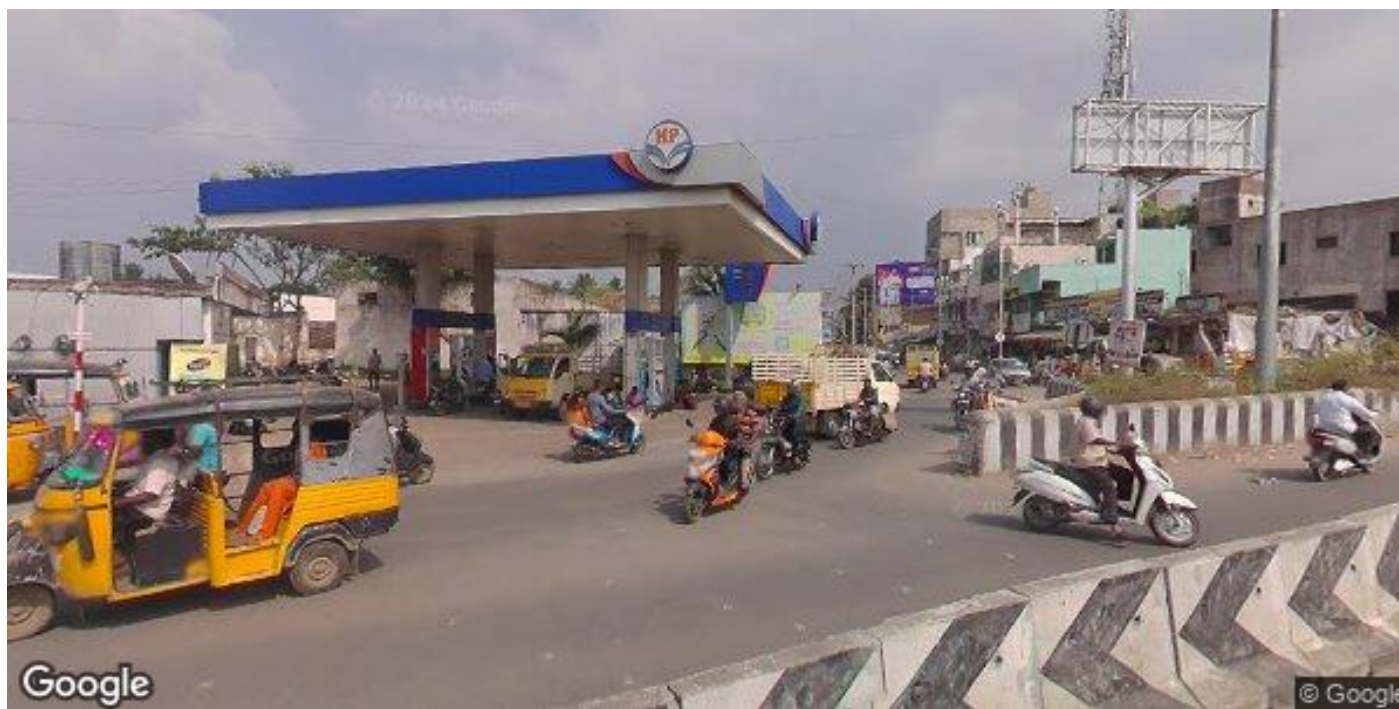
**Risk Type:** Blind Spot  
**Risk Level:** Blind Spot  
**Speed Limit:** 10 KM/Hr  
**Coordinates:** 11.65573, 78.13972

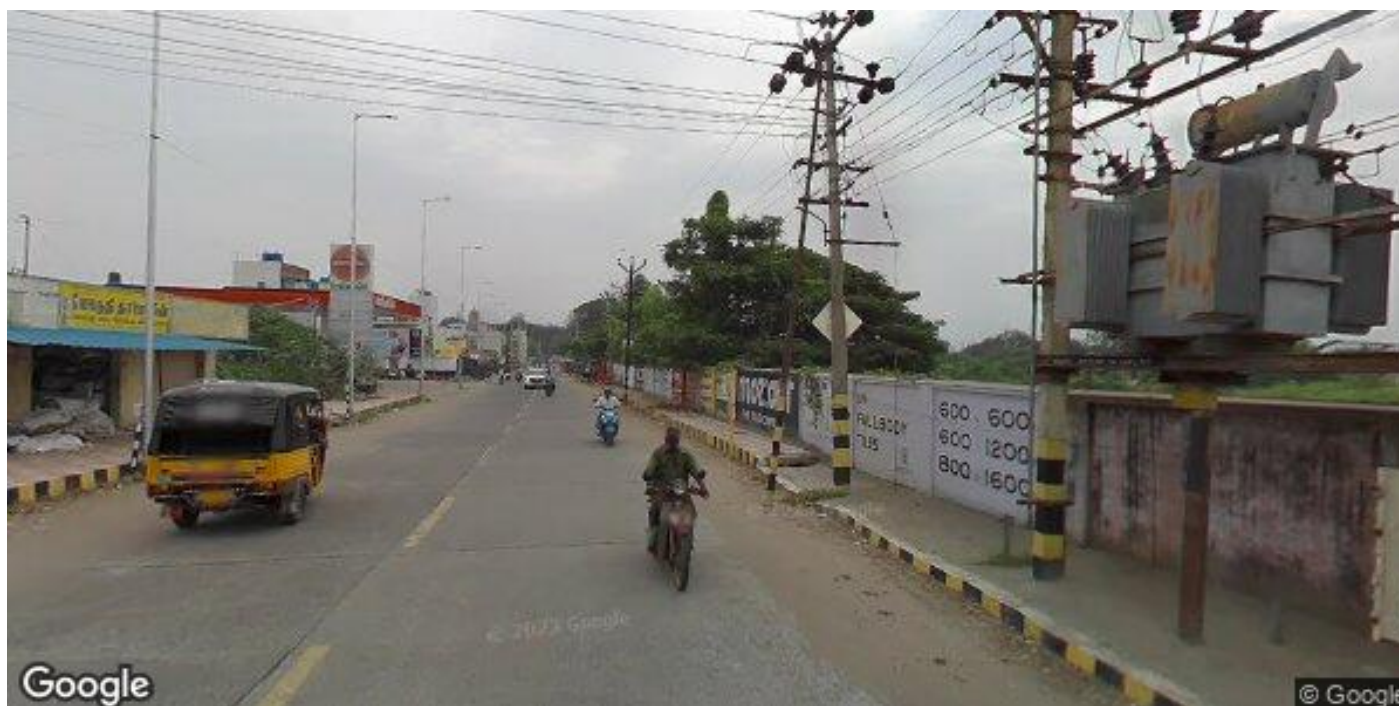
**Risk Type:** Turn  
**Risk Level:** High  
**Speed Limit:** 15 KM/Hr  
**Coordinates:** 11.65623, 78.14218

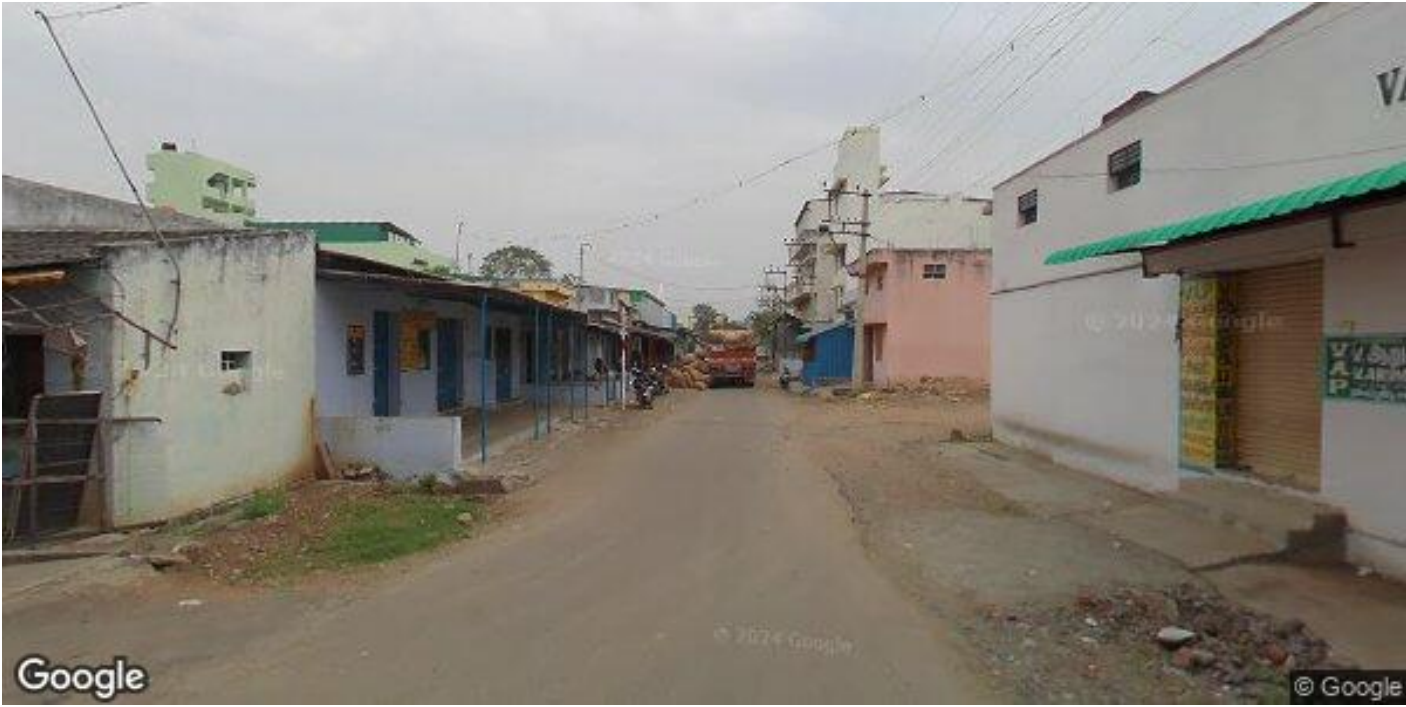
**Risk Type:** Turn  
**Risk Level:** High  
**Speed Limit:** 15 KM/Hr  
**Coordinates:** 11.65658, 78.14217
