# IndianOil

## JOURNEY RISK MANAGEMENT (JRM) STUDY

### Salem Terminal to SRI THAYARS AGENCY

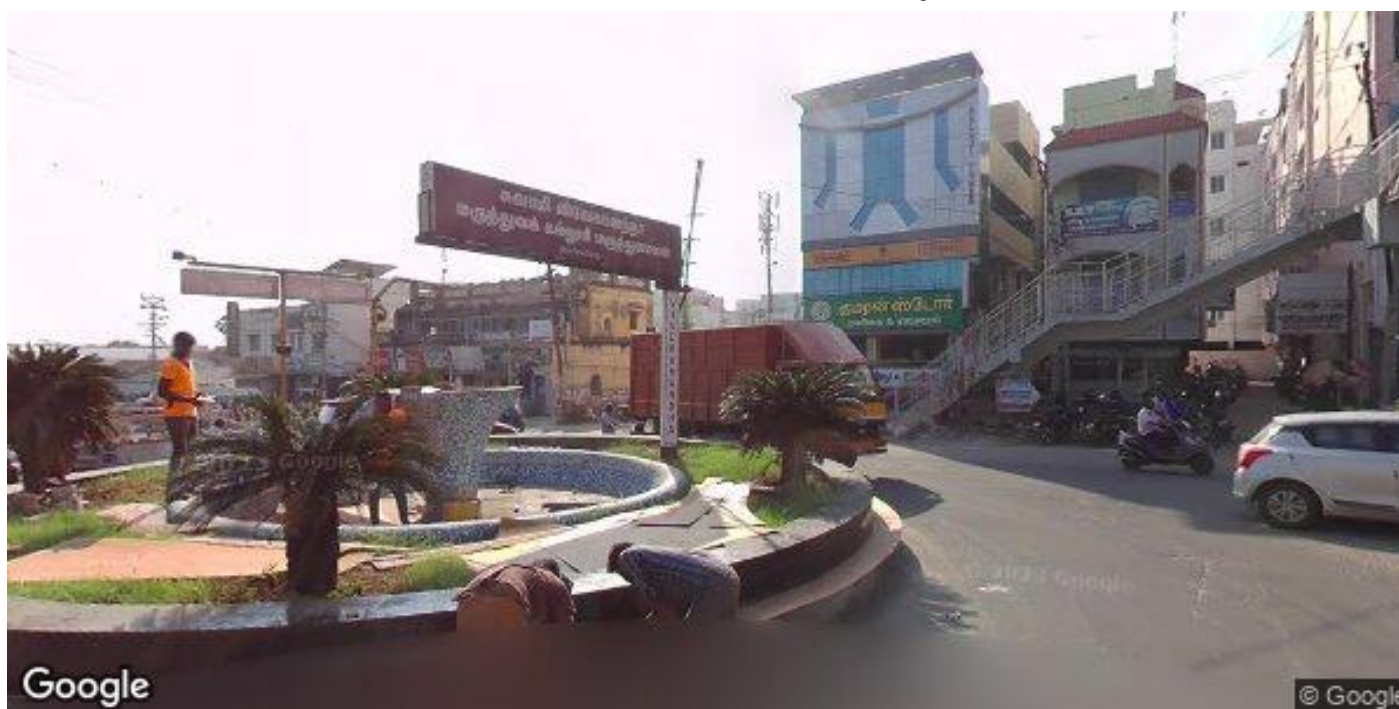
**Risk Type:** Roundabout  
**Risk Level:** High  
**Speed Limit:** 15 KM/Hr  
**Coordinates:** 11.38395, 77.89480

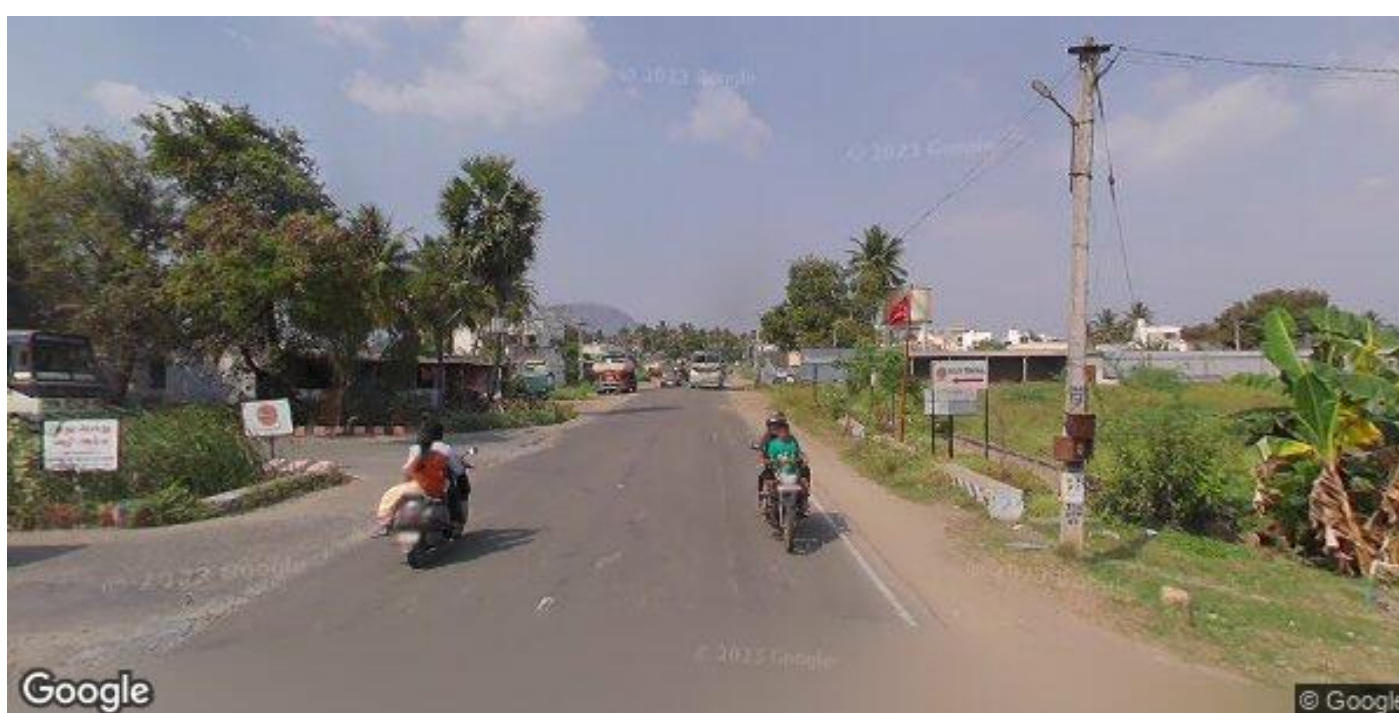
**Risk Type:** Turn  
**Risk Level:** High  
**Speed Limit:** 15 KM/Hr  
**Coordinates:** 11.44019, 77.87547

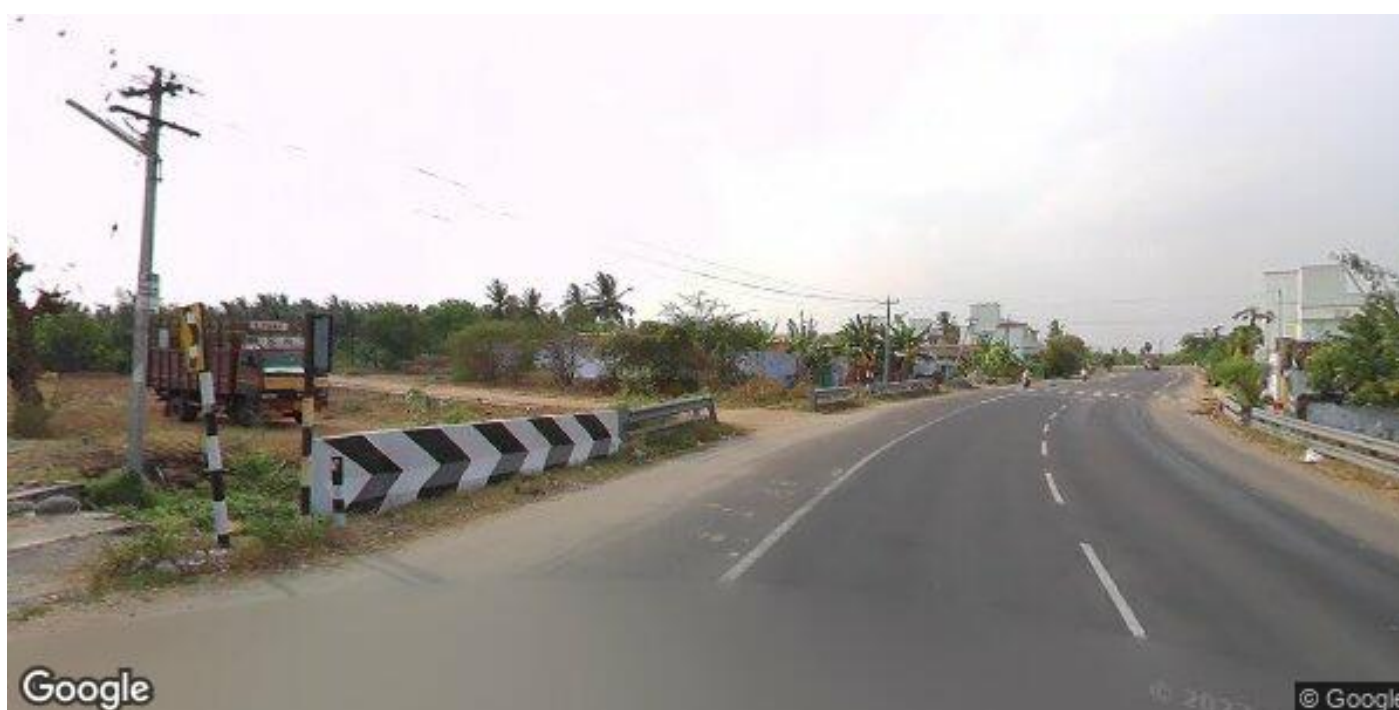
**Risk Type:** Turn  
**Risk Level:** Medium  
**Speed Limit:** 30 KM/Hr  
**Coordinates:** 11.16755, 78.01568

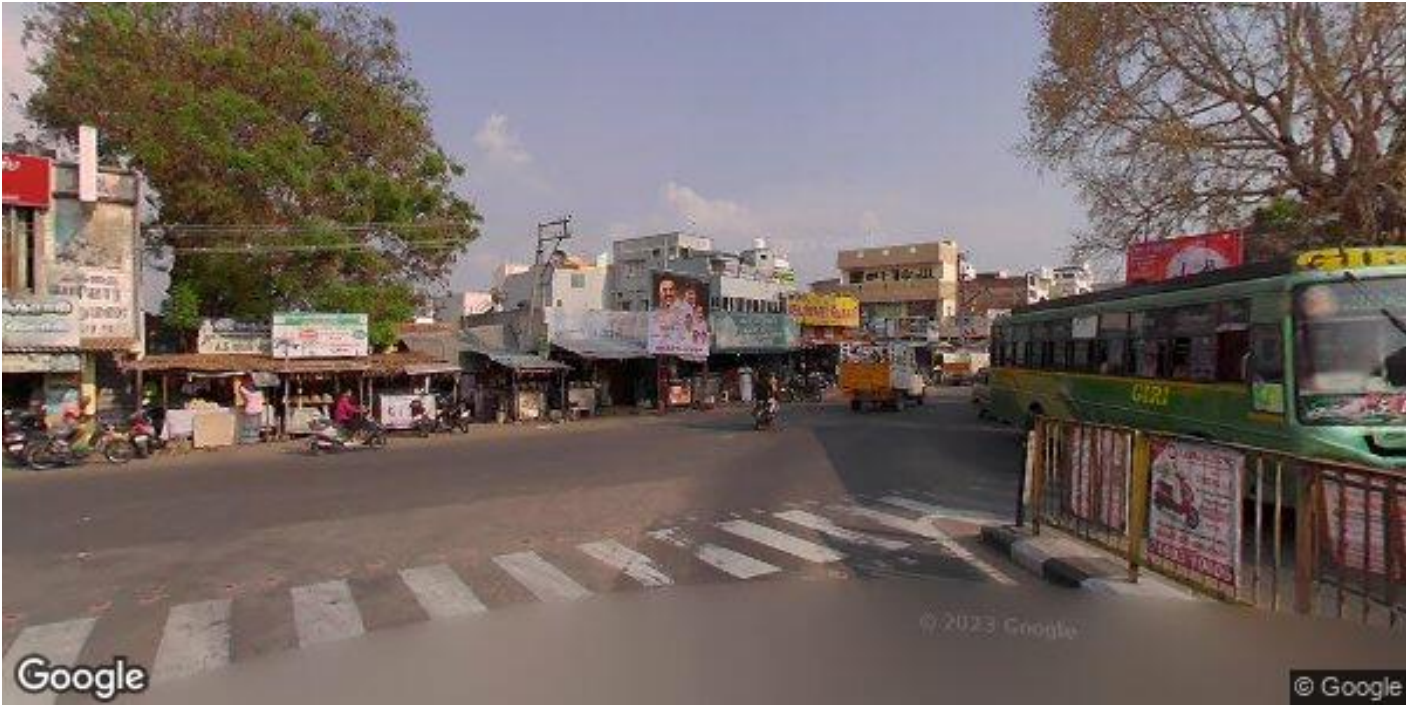
**Risk Type:** Turn  
**Risk Level:** Medium  
**Speed Limit:** 30 KM/Hr  
**Coordinates:** 11.15579, 78.02169

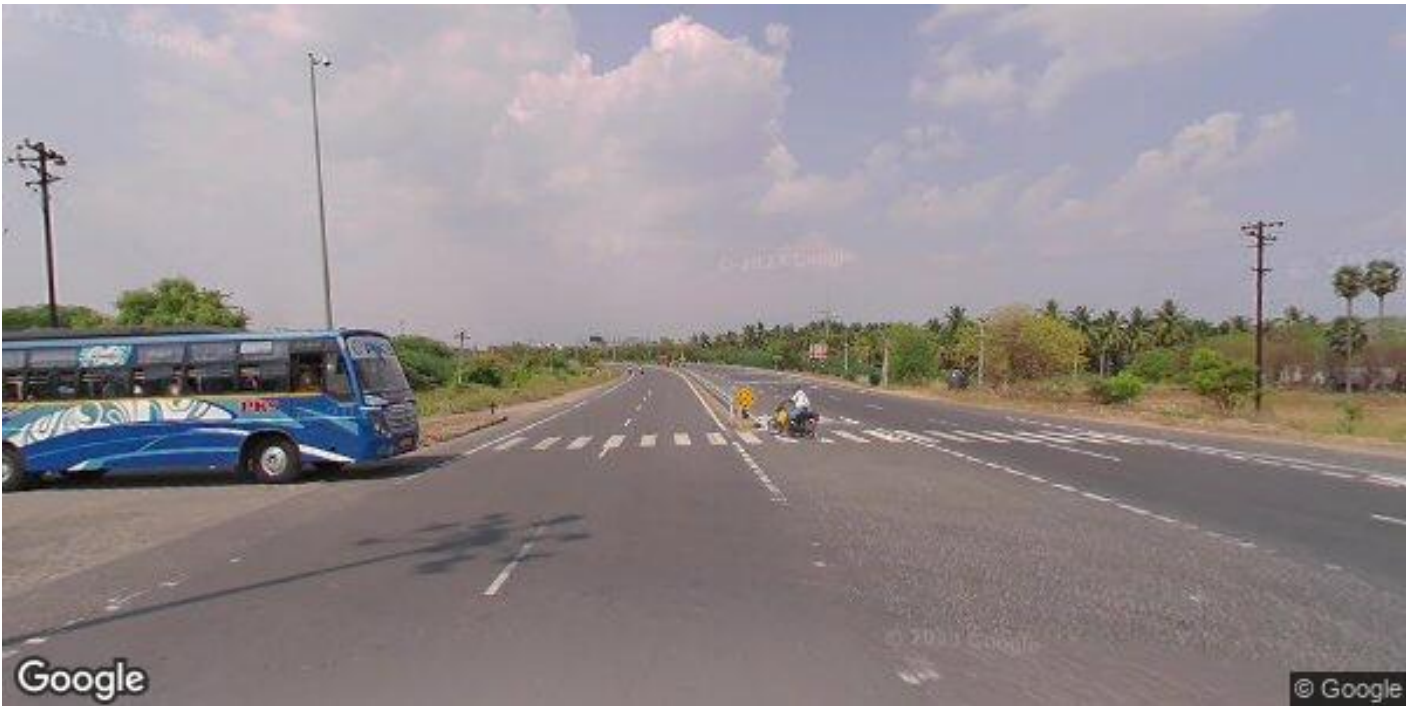
**Risk Type:** Turn  
**Risk Level:** High  
**Speed Limit:** 15 KM/Hr  
**Coordinates:** 11.14485, 78.02282

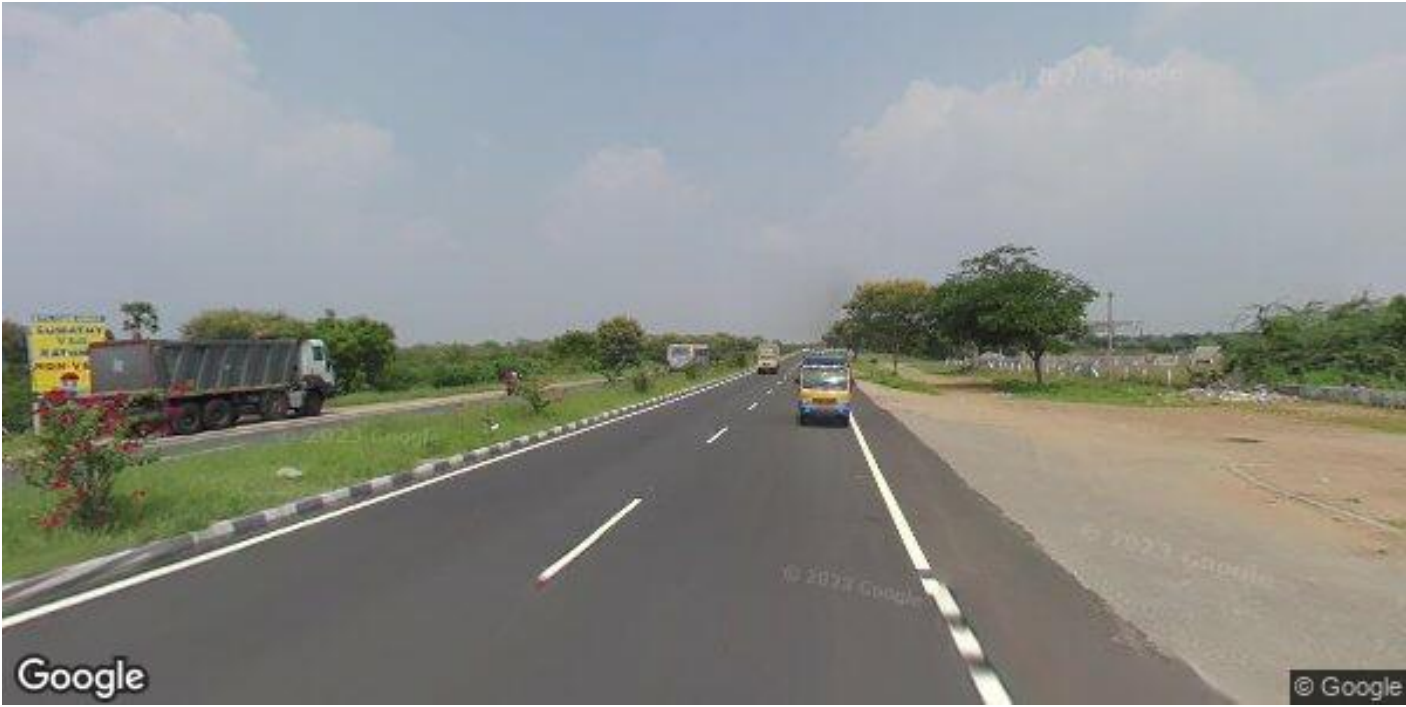
**Risk Type:** Turn  
**Risk Level:** High  
**Speed Limit:** 15 KM/Hr  
**Coordinates:** 10.80699, 77.93429

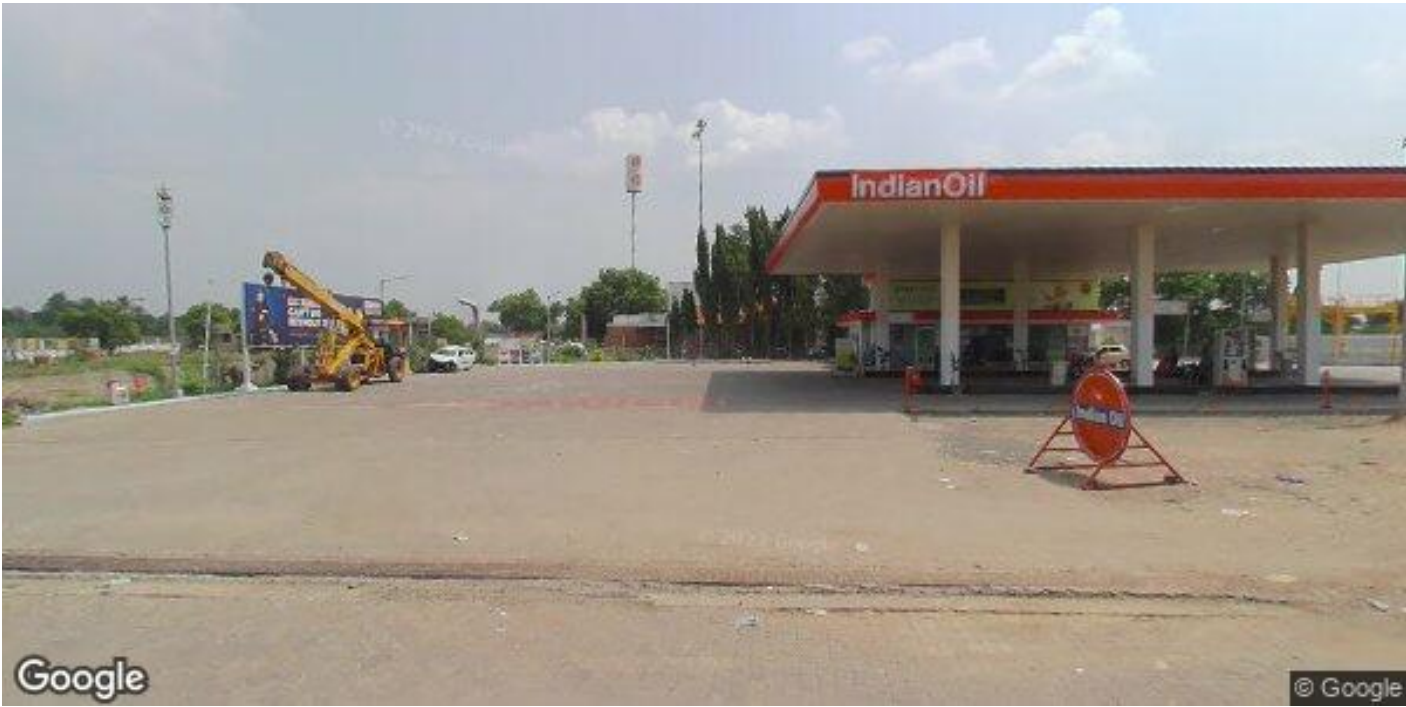
**Risk Type:** Turn  
**Risk Level:** High  
**Speed Limit:** 15 KM/Hr  
**Coordinates:** 10.80676, 77.93437
