## JOURNEY RISK MANAGEMENT (JRM) STUDY

### Salem Terminal to PRASANNA CORPORATION

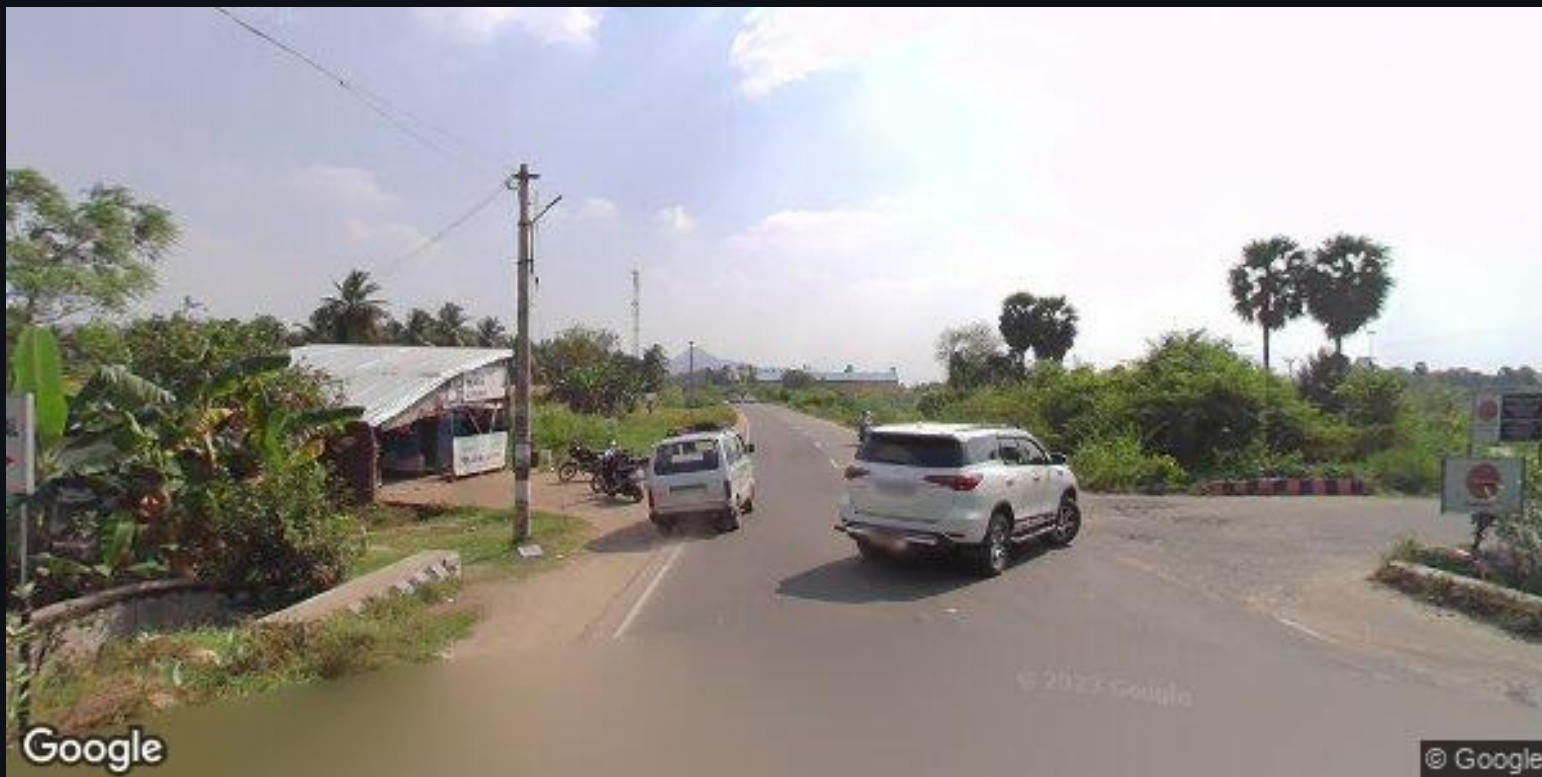
**Coordinates:** 11.44029, 77.87544

**Risk Type:** Turn

**Risk Level:** High

**Speed Limit:** 15 KM/Hr

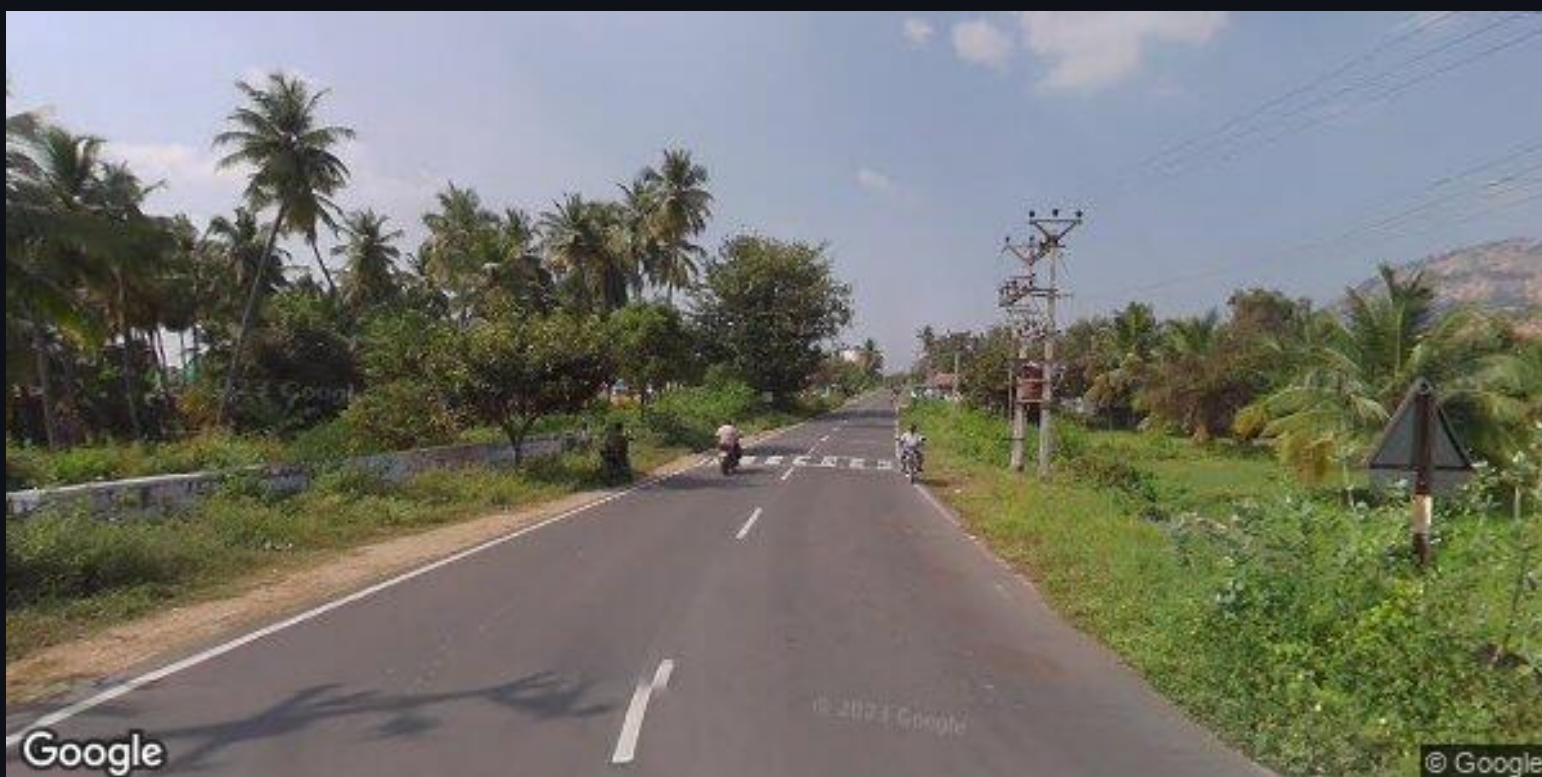
**Coordinates:** 11.45353, 77.85697

**Risk Type:** Turn

**Risk Level:** Medium

**Speed Limit:** 30 KM/Hr

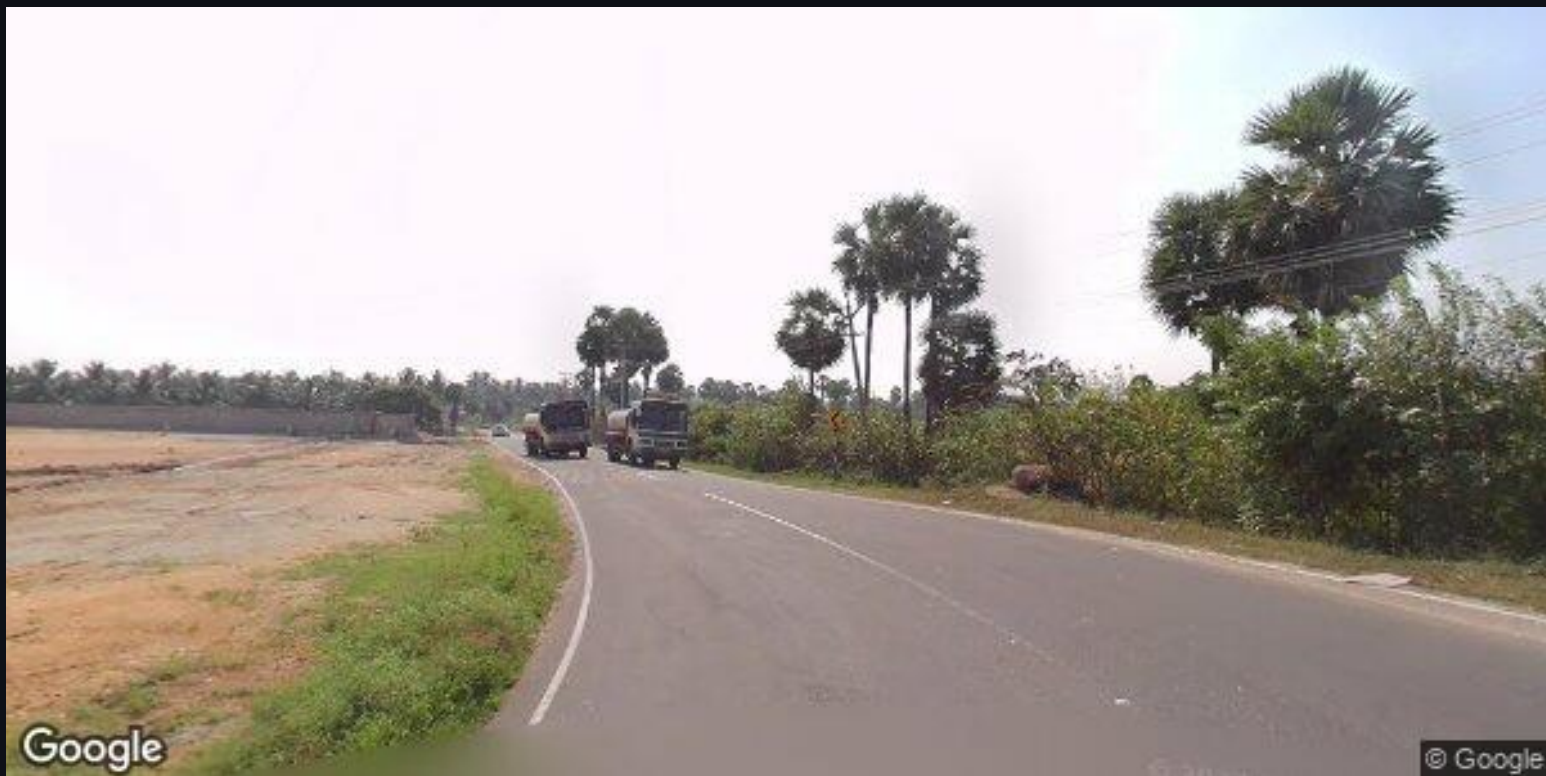
**Coordinates:** 11.45839, 77.85143

**Risk Type:** Turn

**Risk Level:** Medium

**Speed Limit:** 30 KM/Hr

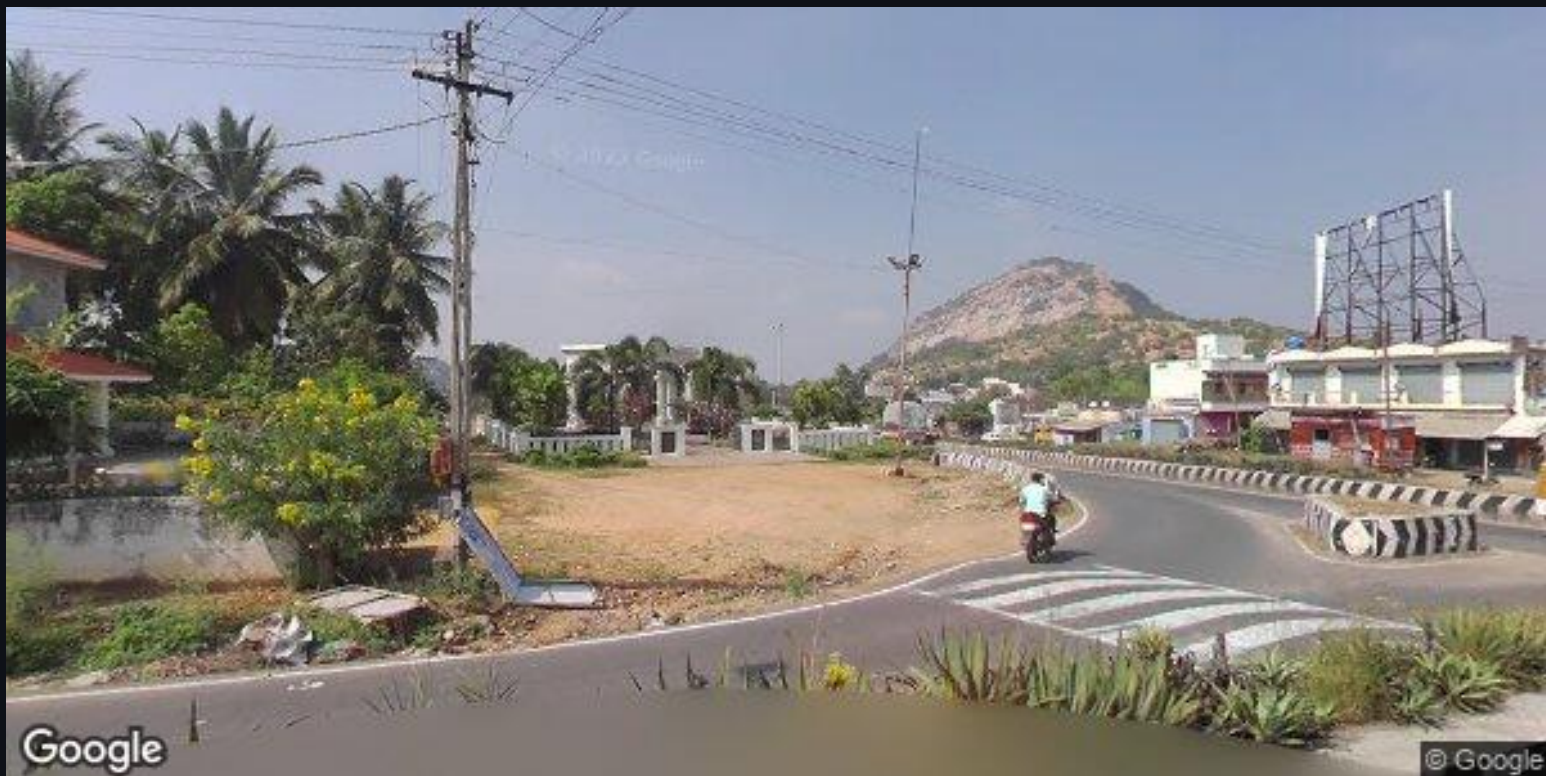
**Coordinates:** 11.46307, 77.84941

**Risk Type:** Turn

**Risk Level:** Medium

**Speed Limit:** 30 KM/Hr

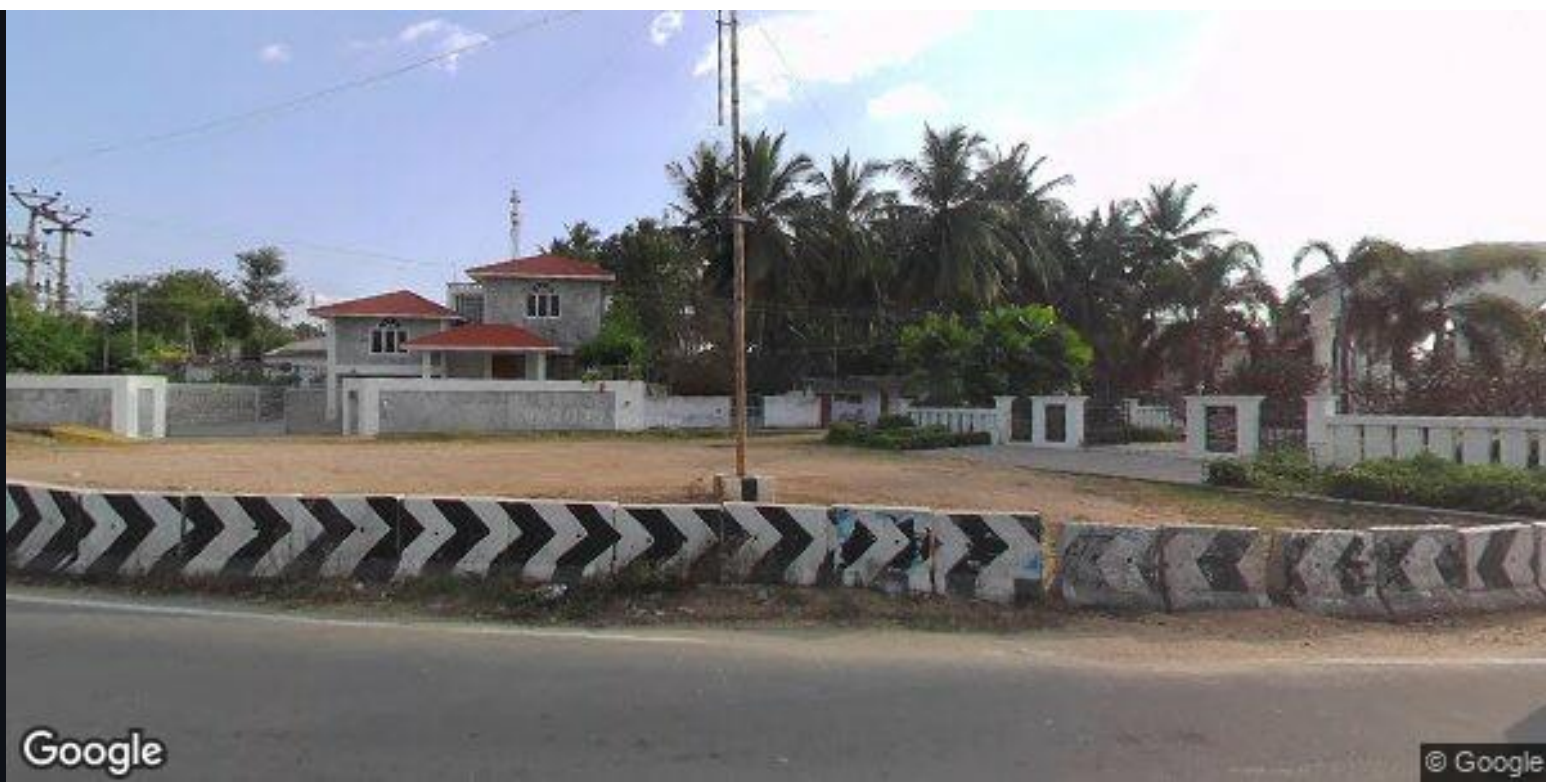
**Coordinates:** 11.46316, 77.84921

**Risk Type:** Turn

**Risk Level:** Medium

**Speed Limit:** 30 KM/Hr

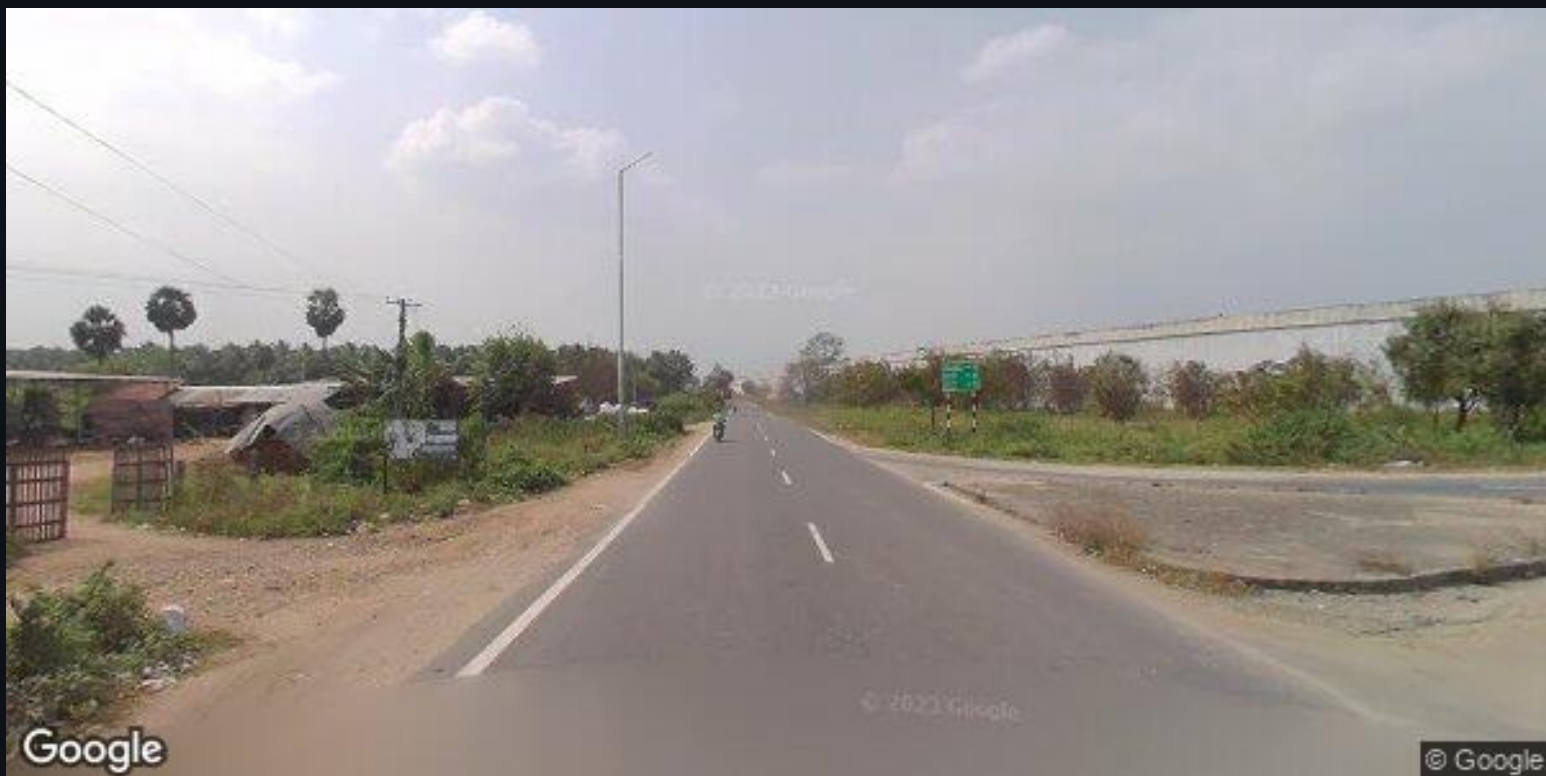
**Coordinates:** 11.45542, 77.81725

**Risk Type:** Turn

**Risk Level:** High

**Speed Limit:** 15 KM/Hr

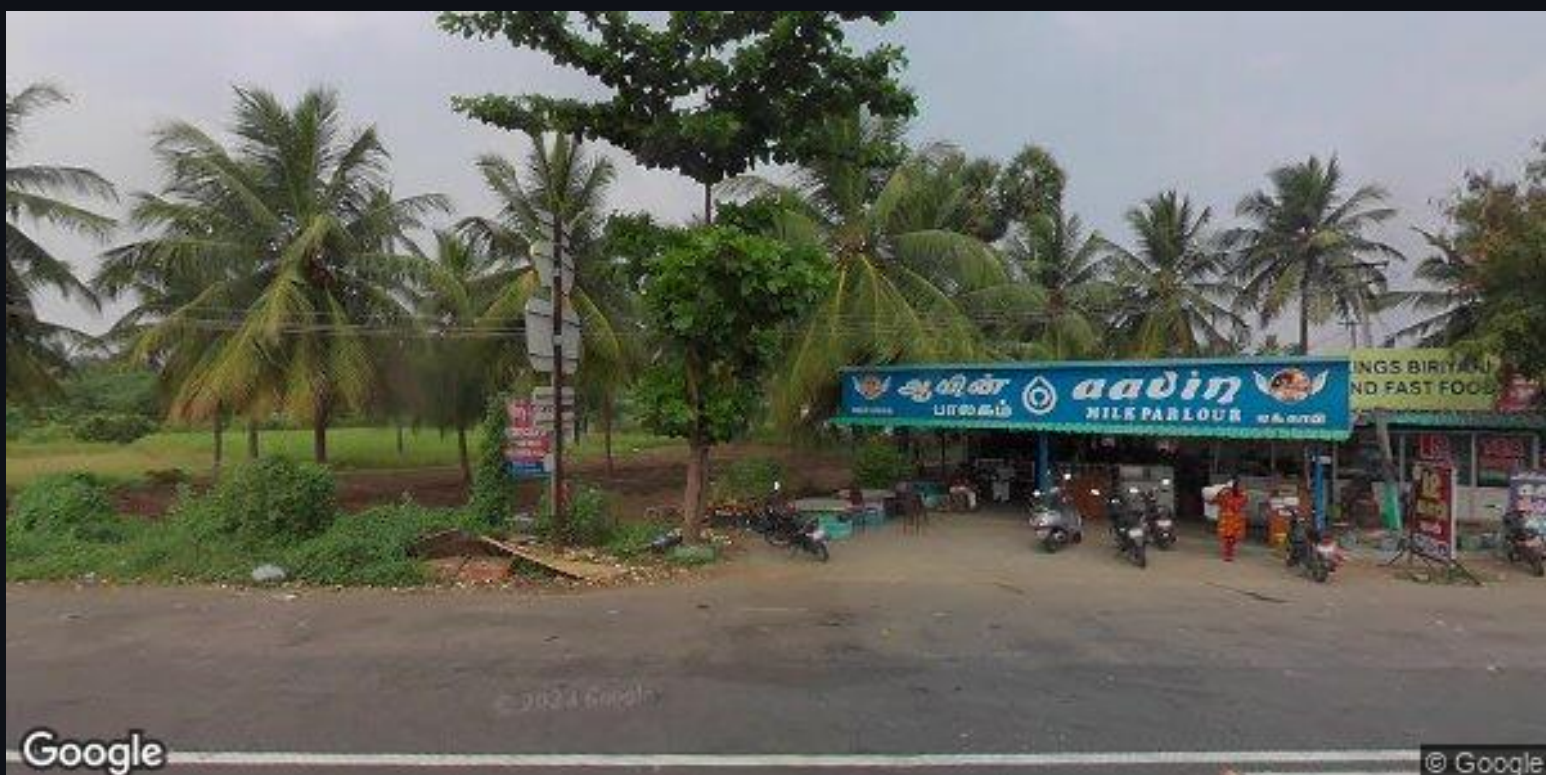
**Risk Type:** Blind Spot  
**Risk Level:** Blind Spot  
**Speed Limit:** 10 KM/Hr  
**Coordinates:** 11.45631, 77.81668

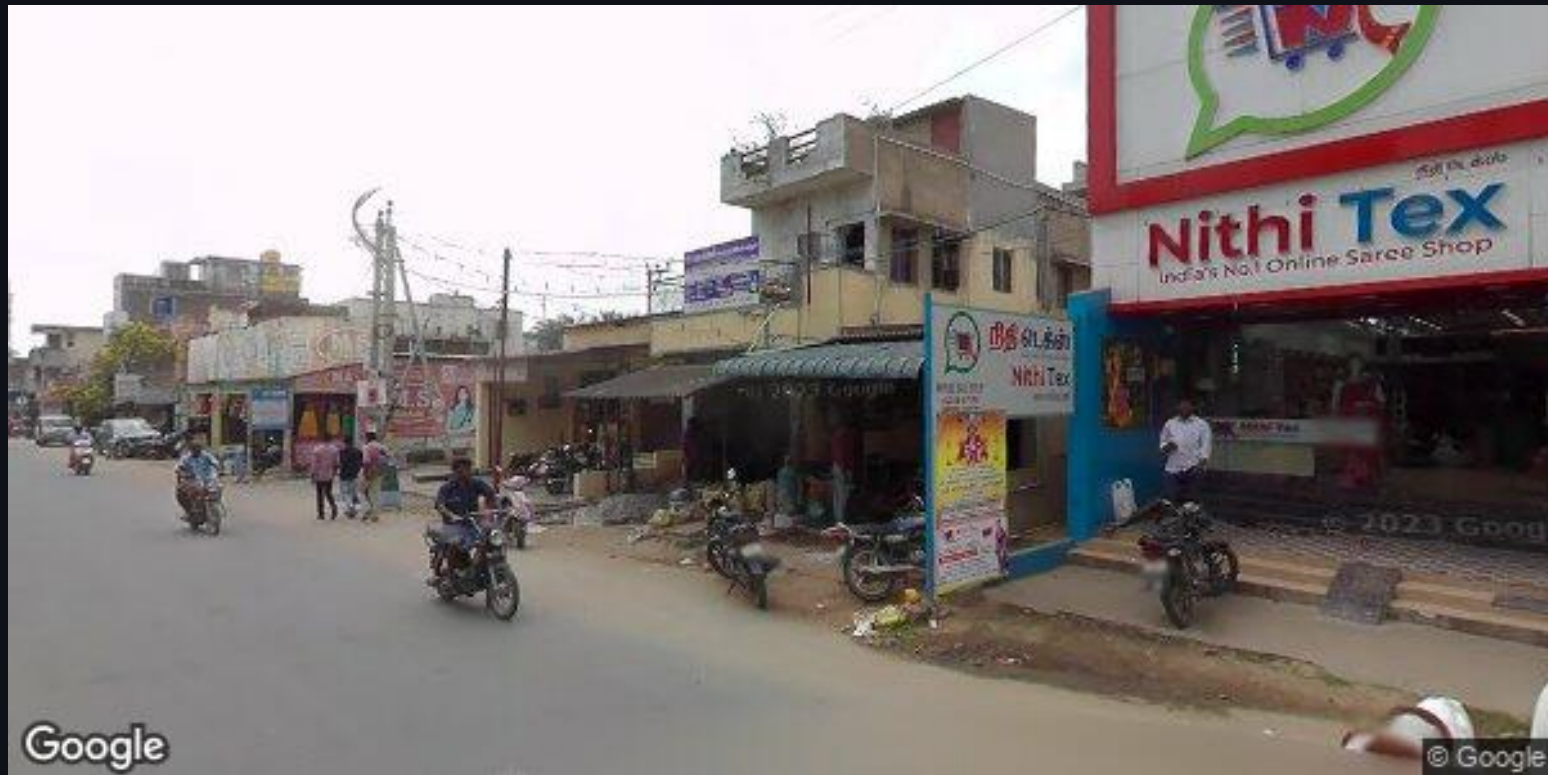
**Risk Type:** Turn  
**Risk Level:** Medium  
**Speed Limit:** 30 KM/Hr  
**Coordinates:** 11.60526, 78.00451

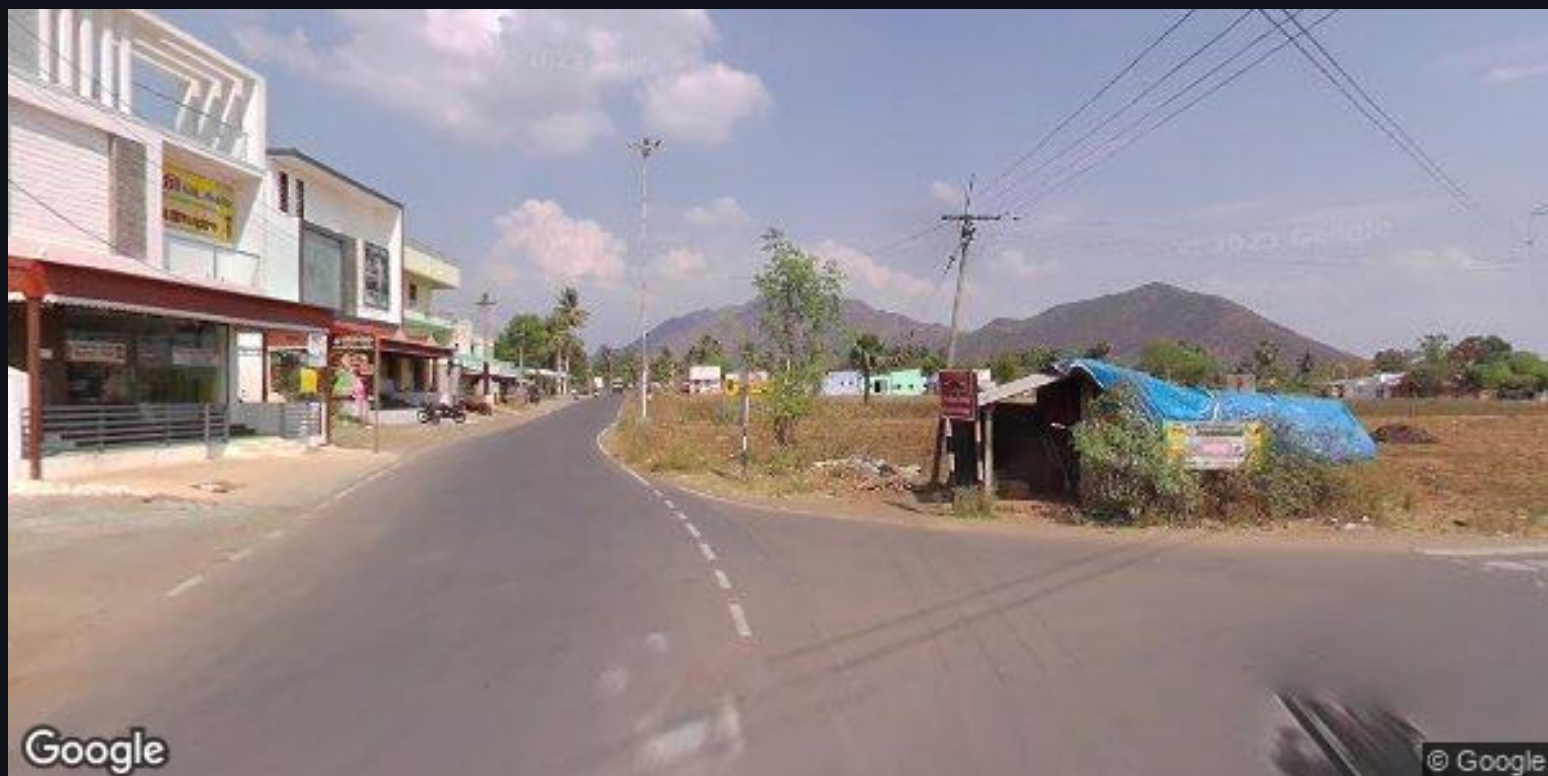
**Risk Type:** Turn  
**Risk Level:** High  
**Speed Limit:** 15 KM/Hr  
**Coordinates:** 11.62660, 78.00986

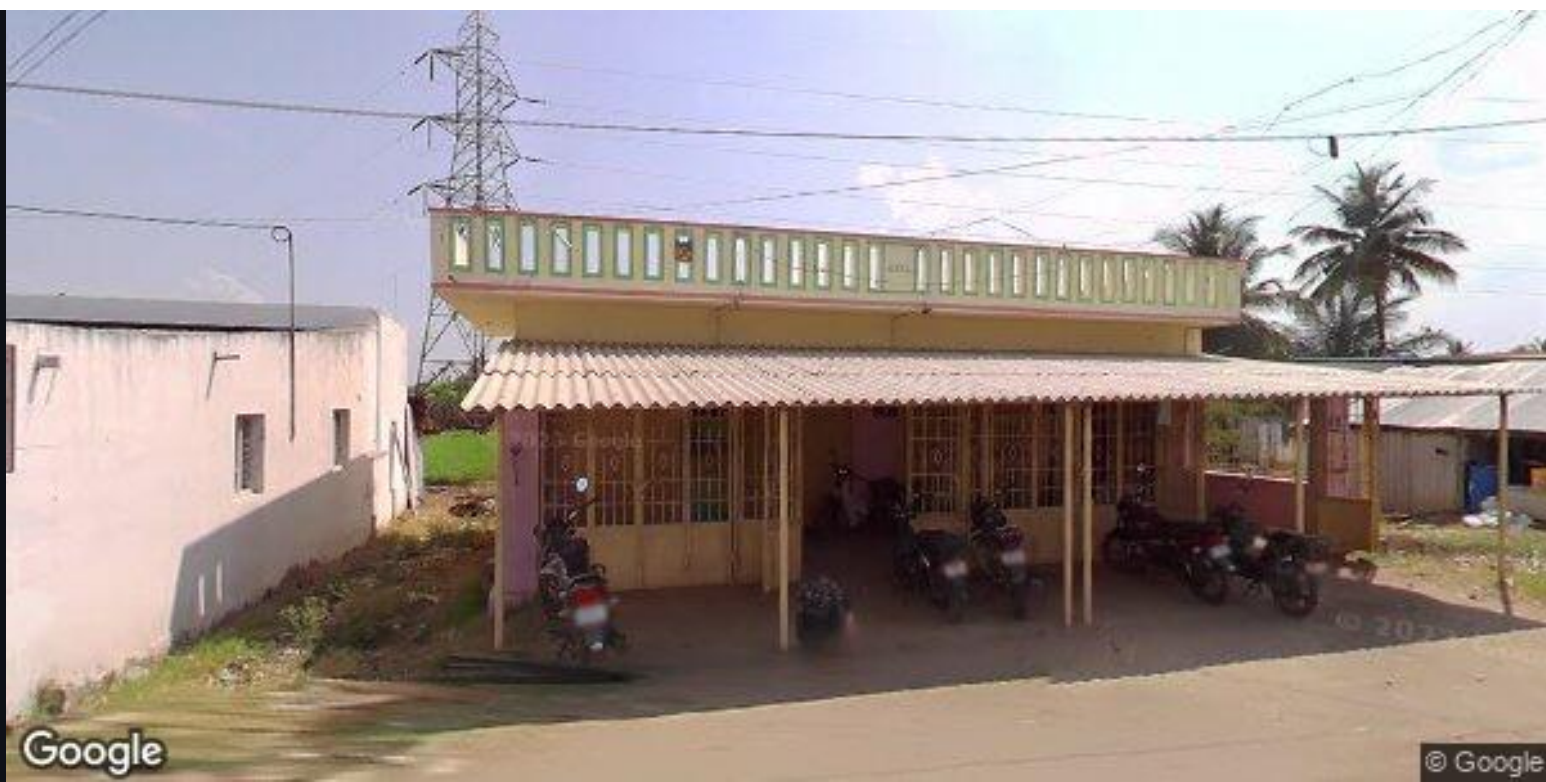
**Coordinates:** 11.62692, 78.00883

**Risk Type:** Turn

**Risk Level:** High

**Speed Limit:** 15 KM/Hr

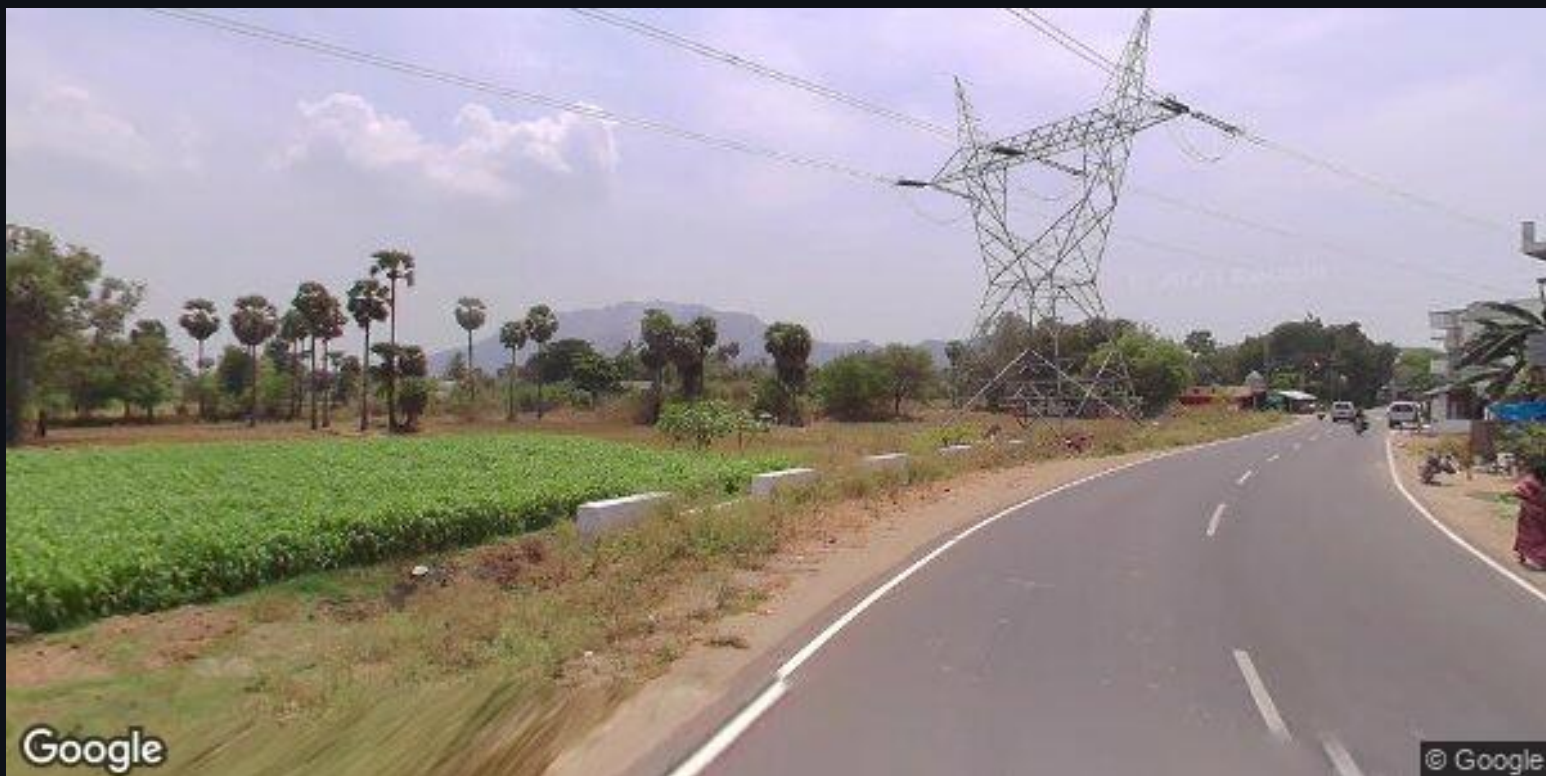
**Coordinates:** 11.64031, 78.00923

**Risk Type:** Turn

**Risk Level:** Medium

**Speed Limit:** 30 KM/Hr

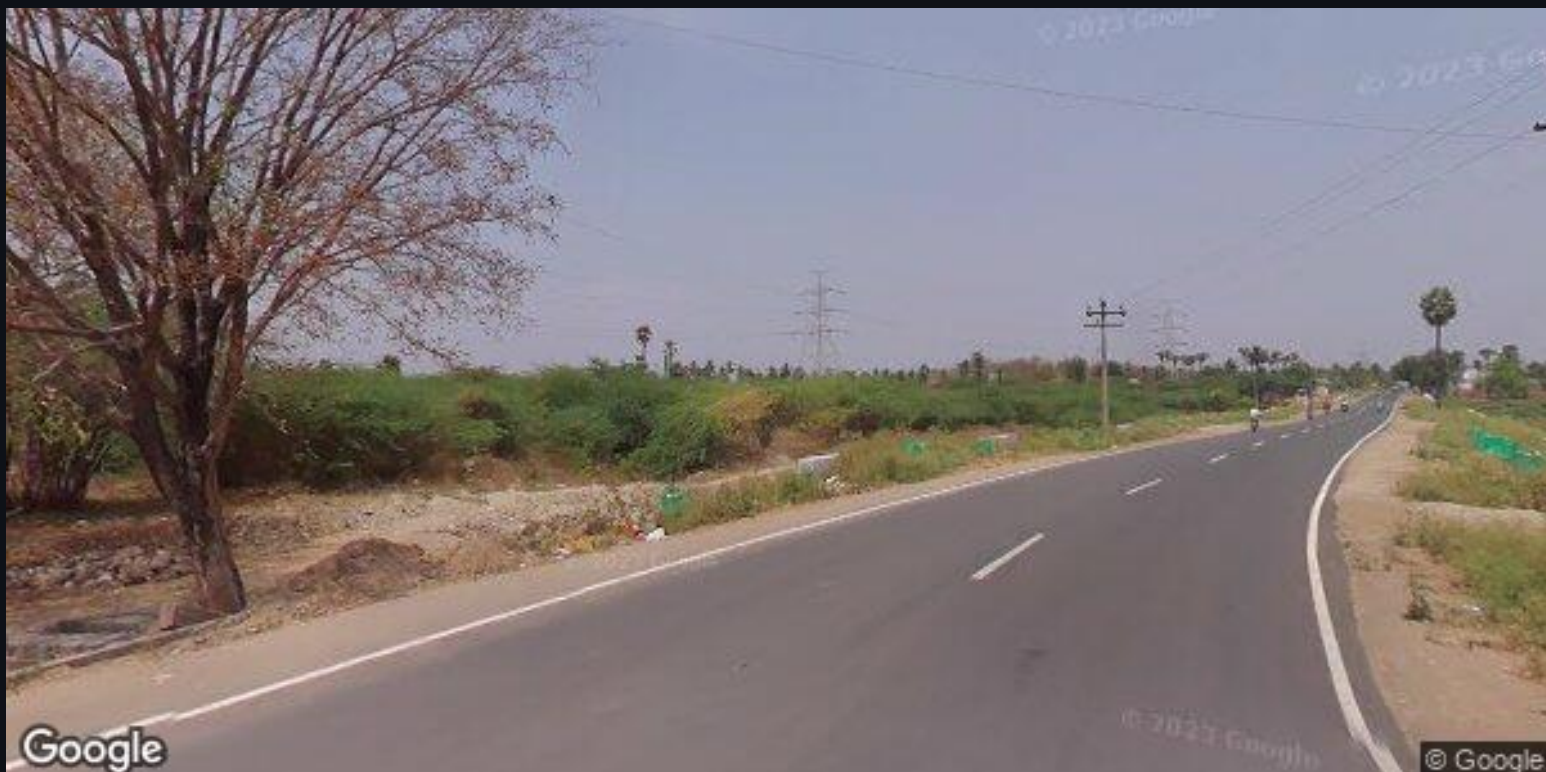
**Risk Type:** Turn  
**Risk Level:** Medium  
**Speed Limit:** 30 KM/Hr  
**Coordinates:** 11.64874, 78.00717

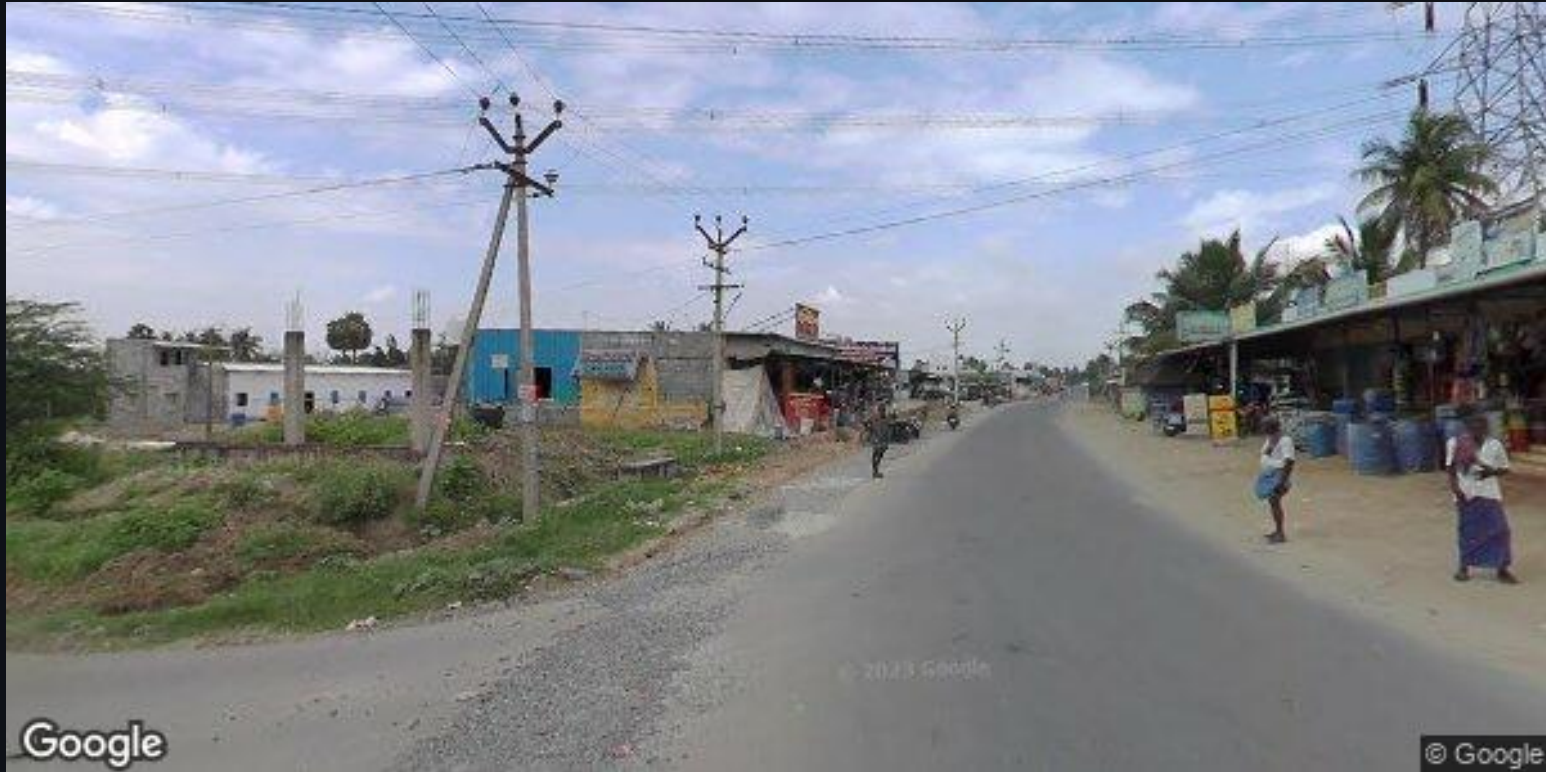
**Risk Type:** Blind Spot  
**Risk Level:** Blind Spot  
**Speed Limit:** 10 KM/Hr  
**Coordinates:** 11.66821, 78.00077

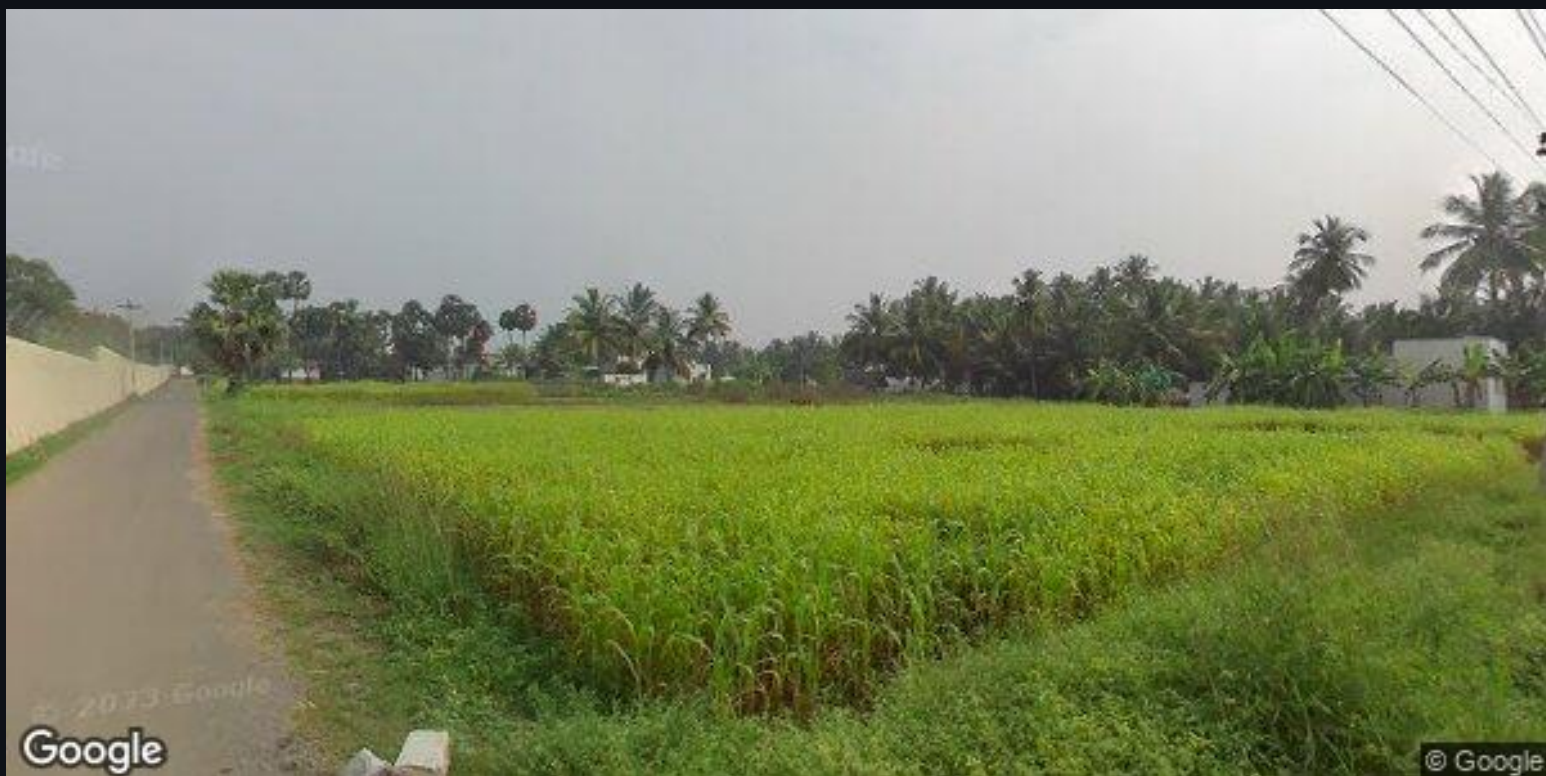
**Risk Type:** Turn  
**Risk Level:** High  
**Speed Limit:** 15 KM/Hr  
**Coordinates:** 11.66762, 78.00863

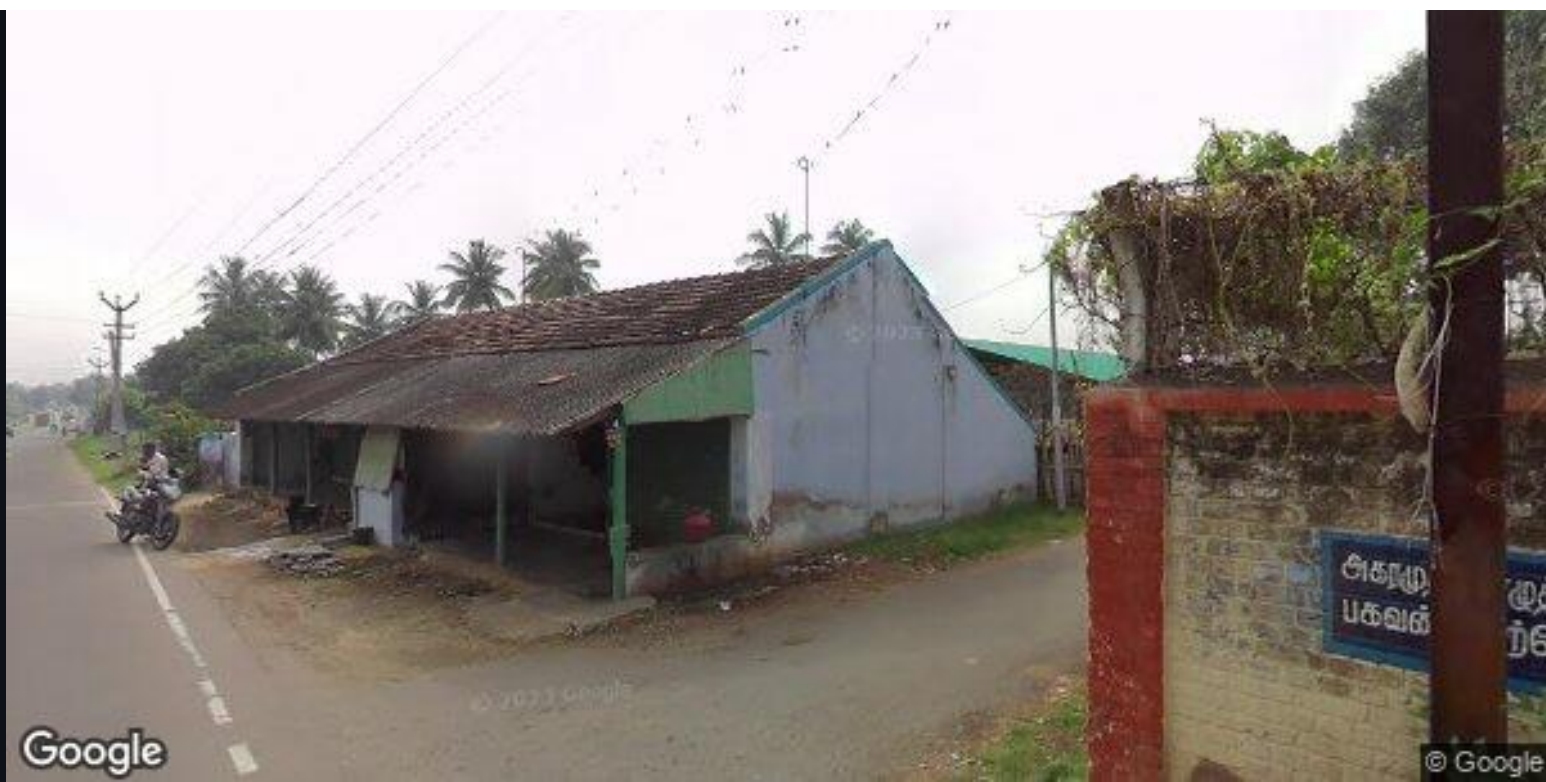
**Risk Type:** Blind Spot  
**Risk Level:** Blind Spot  
**Speed Limit:** 10 KM/Hr  
**Coordinates:** 11.67168, 78.00922

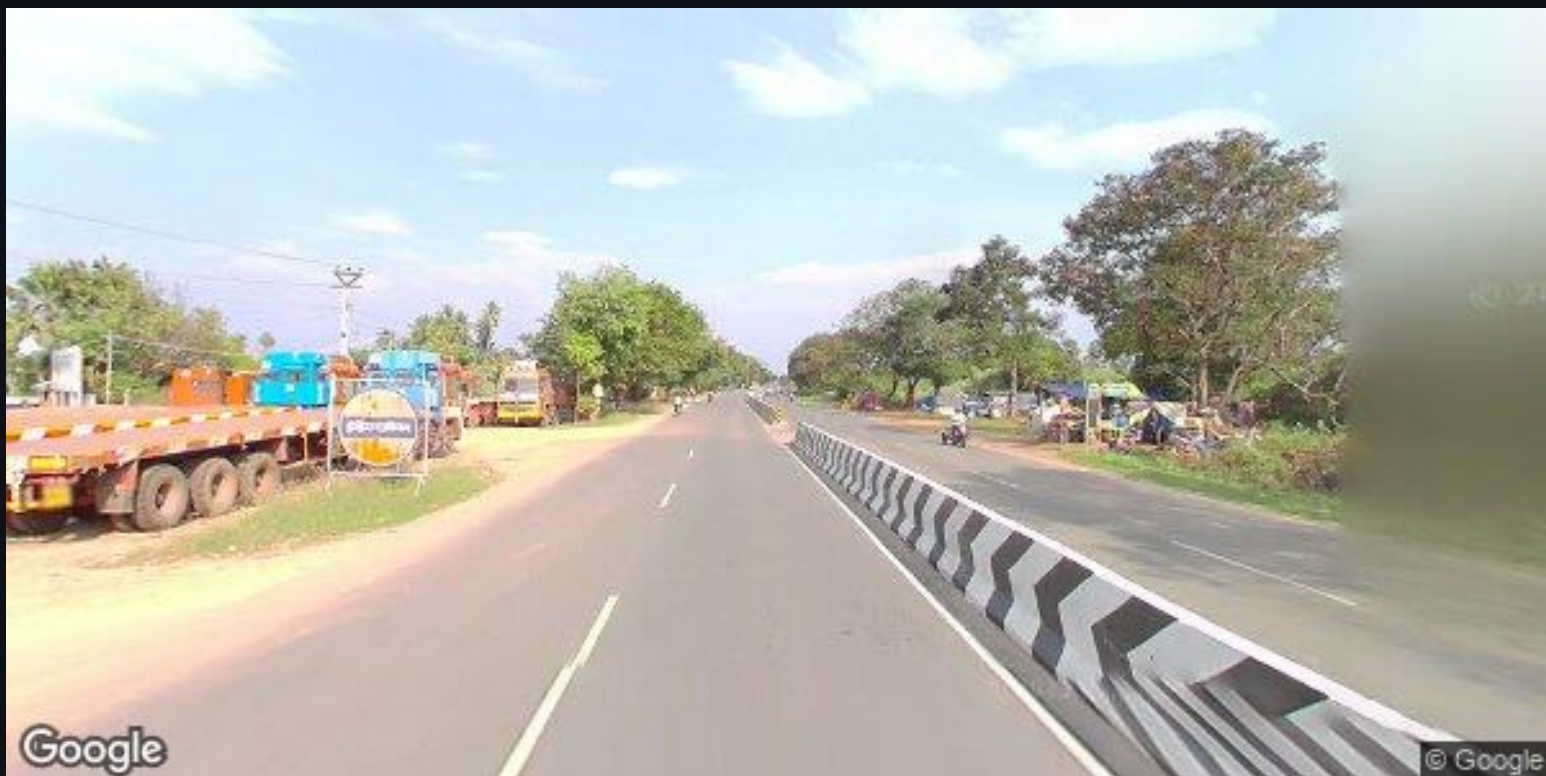
**Risk Type:** Turn  
**Risk Level:** High  
**Speed Limit:** 15 KM/Hr  
**Coordinates:** 11.67094, 78.05691

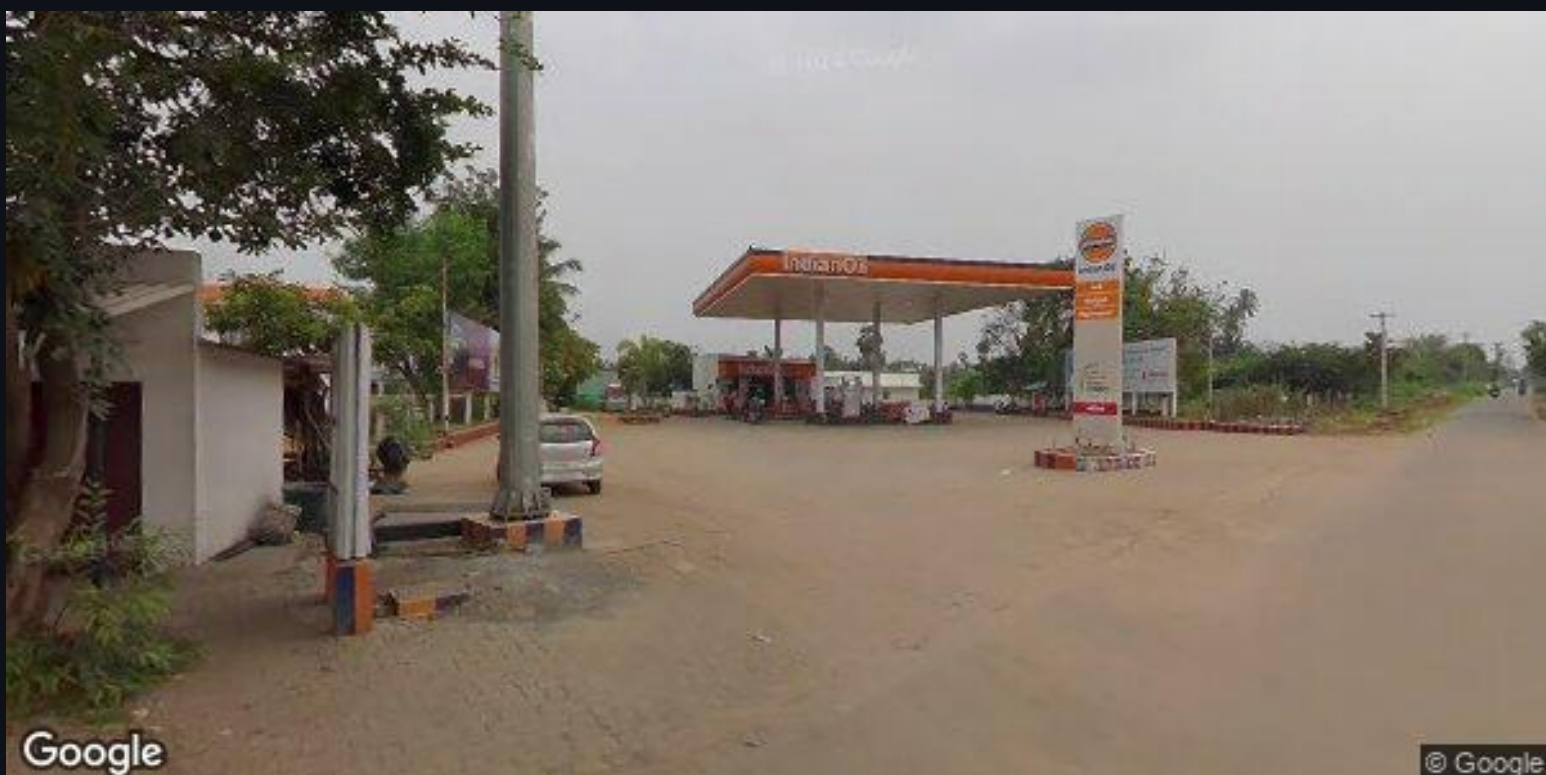
**Coordinates: 11.67120, 78.05691**

**Risk Type: Turn**

**Risk Level: Medium**

**Speed Limit: 30 KM/Hr**

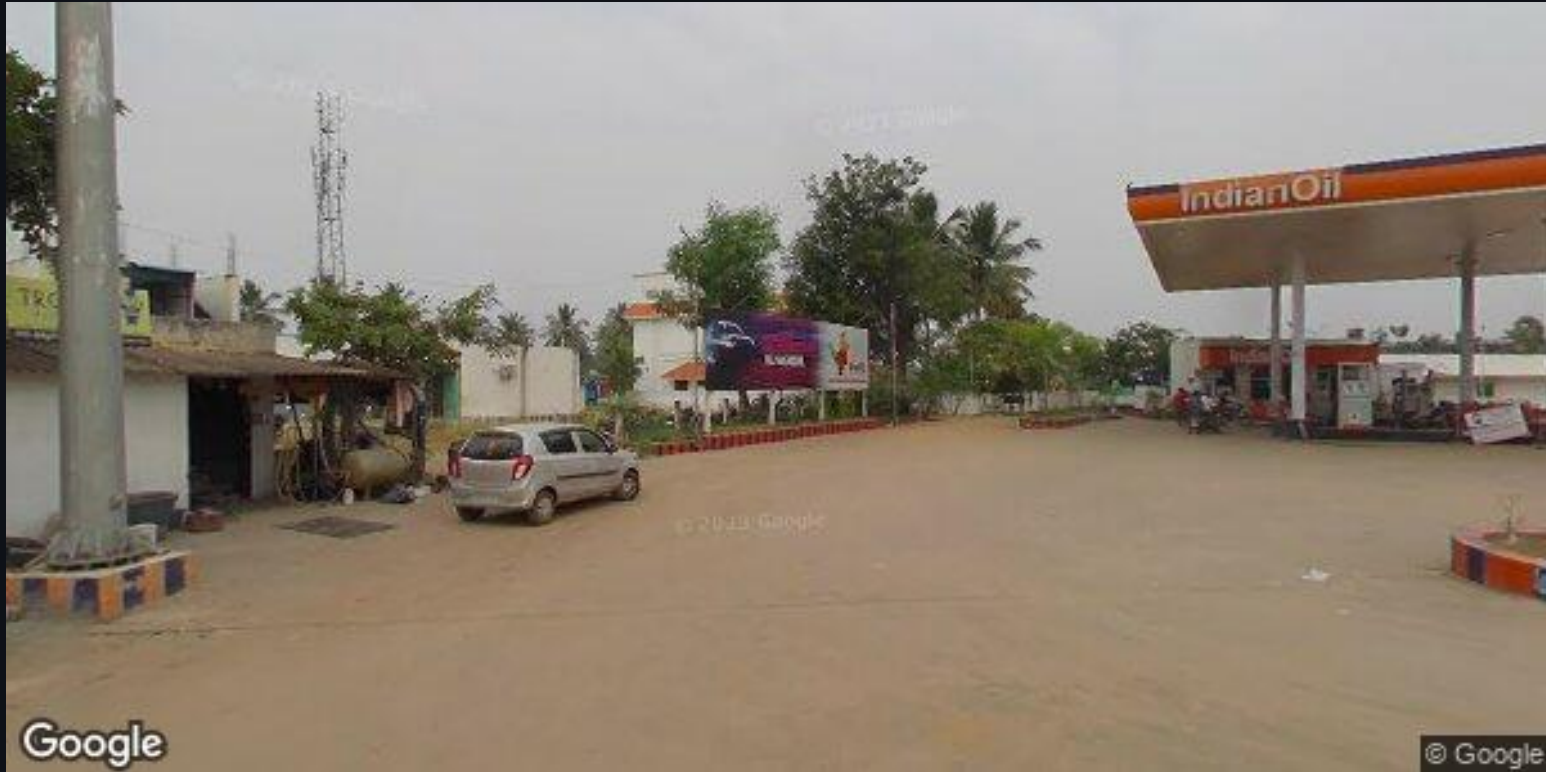
**Coordinates: 11.67126, 78.05696**

**Risk Type: Turn**

**Risk Level: Medium**

**Speed Limit: 30 KM/Hr**
