# IndianOil

## **JOURNEY RISK MANAGEMENT (JRM) STUDY**

### **Salem Terminal to SRI ROYAL PETROLEUM**

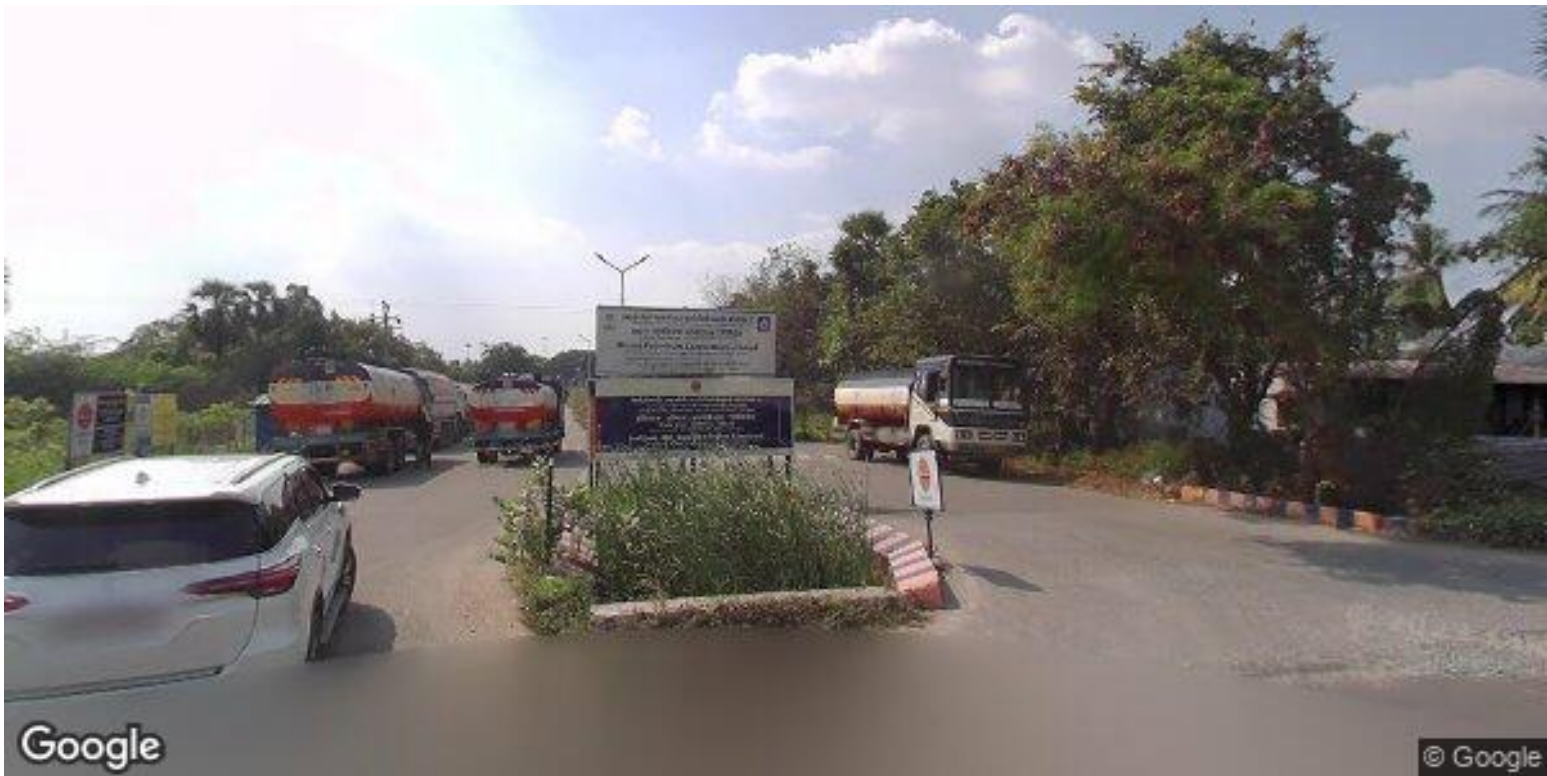
Risk Type: Turn  
Risk Level: High  
Speed Limit: 15 KM/Hr  
Coordinates: 11.44024, 77.87528

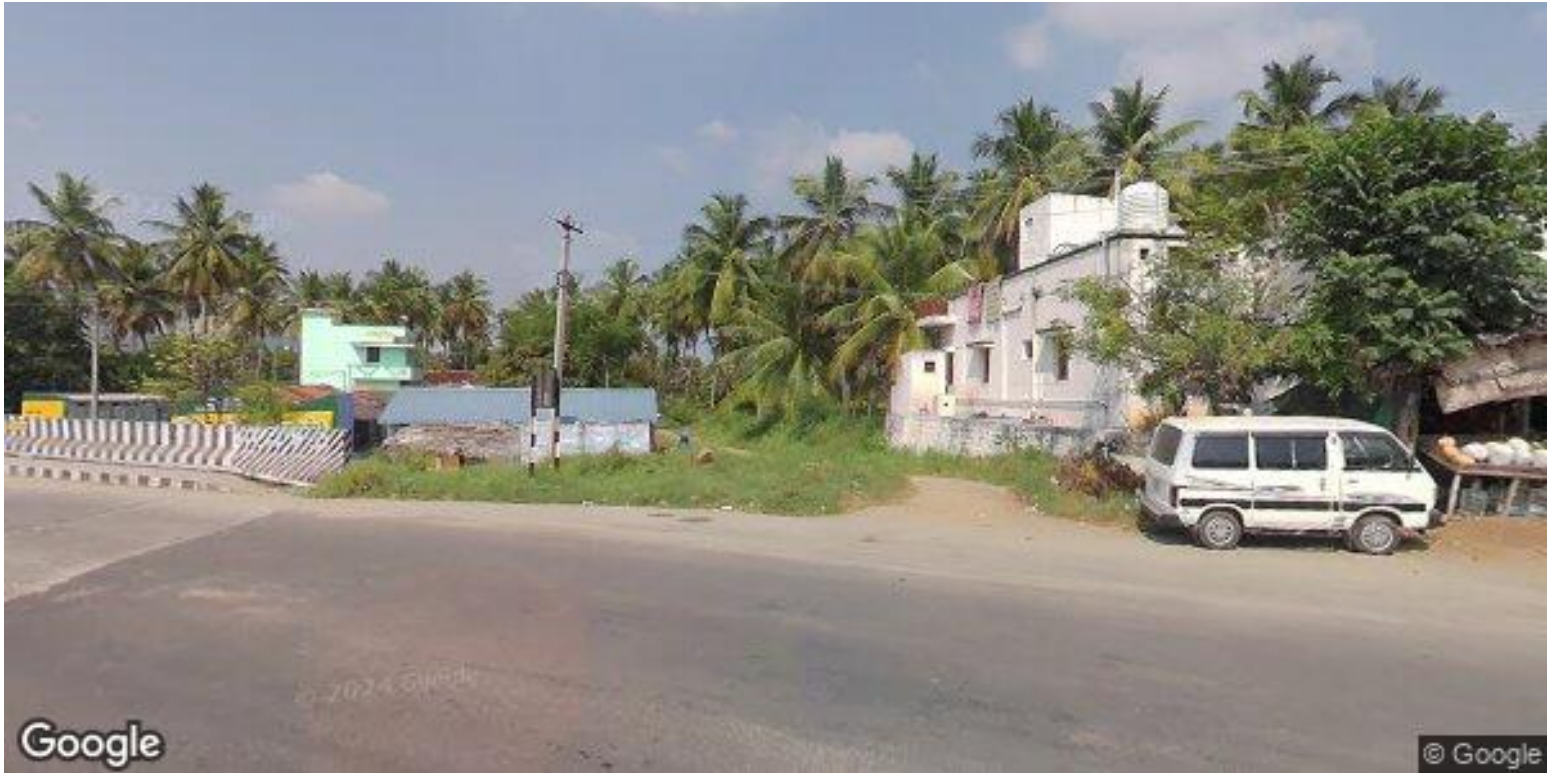
Risk Type: Turn  
Risk Level: High

**Speed Limit: 15 KM/Hr**  
**Coordinates: 11.44898, 77.87410**

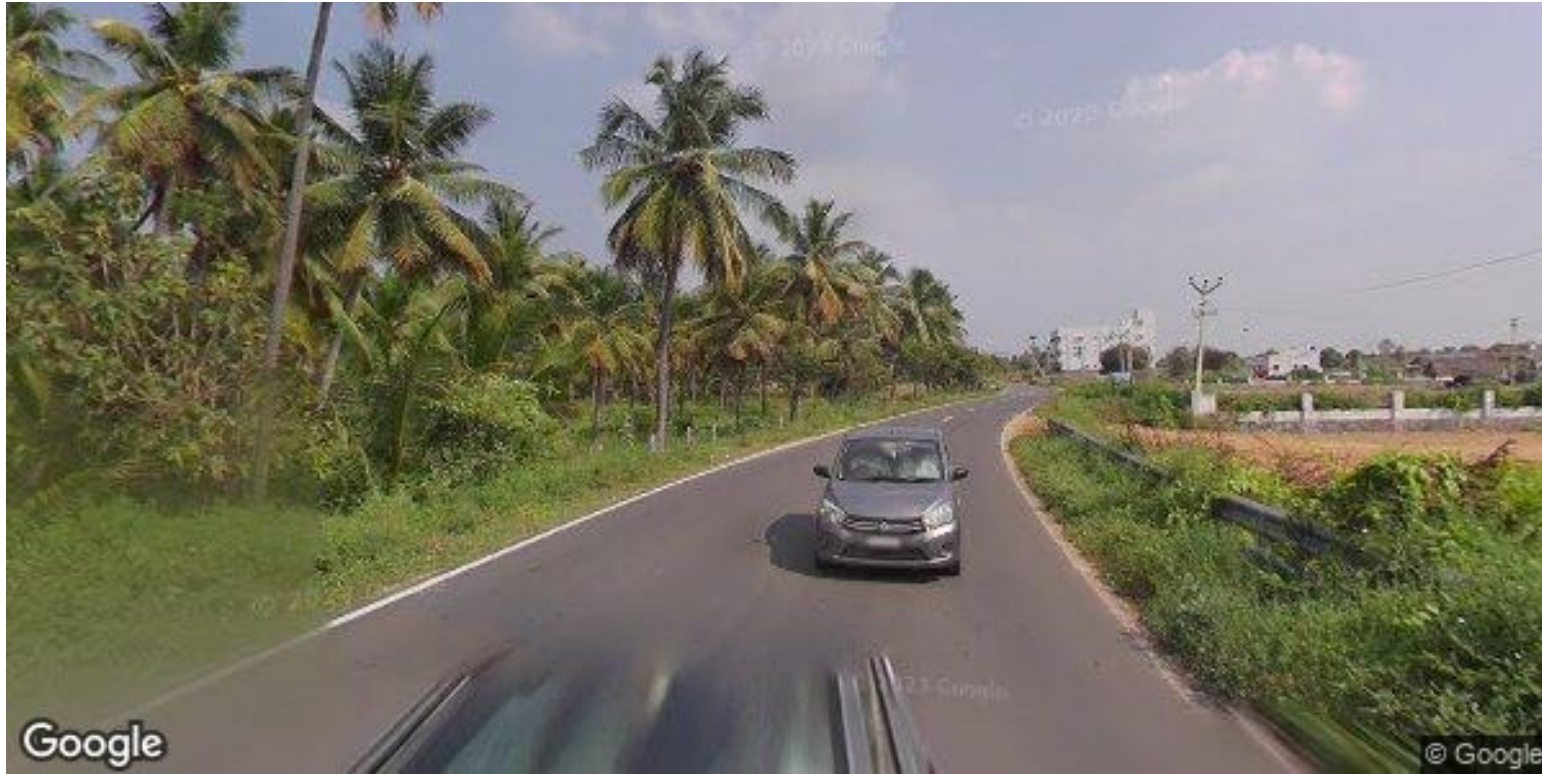
**Risk Type: Turn**  
**Risk Level: Medium**  
**Speed Limit: 30 KM/Hr**  
**Coordinates: 11.45357, 77.85789**

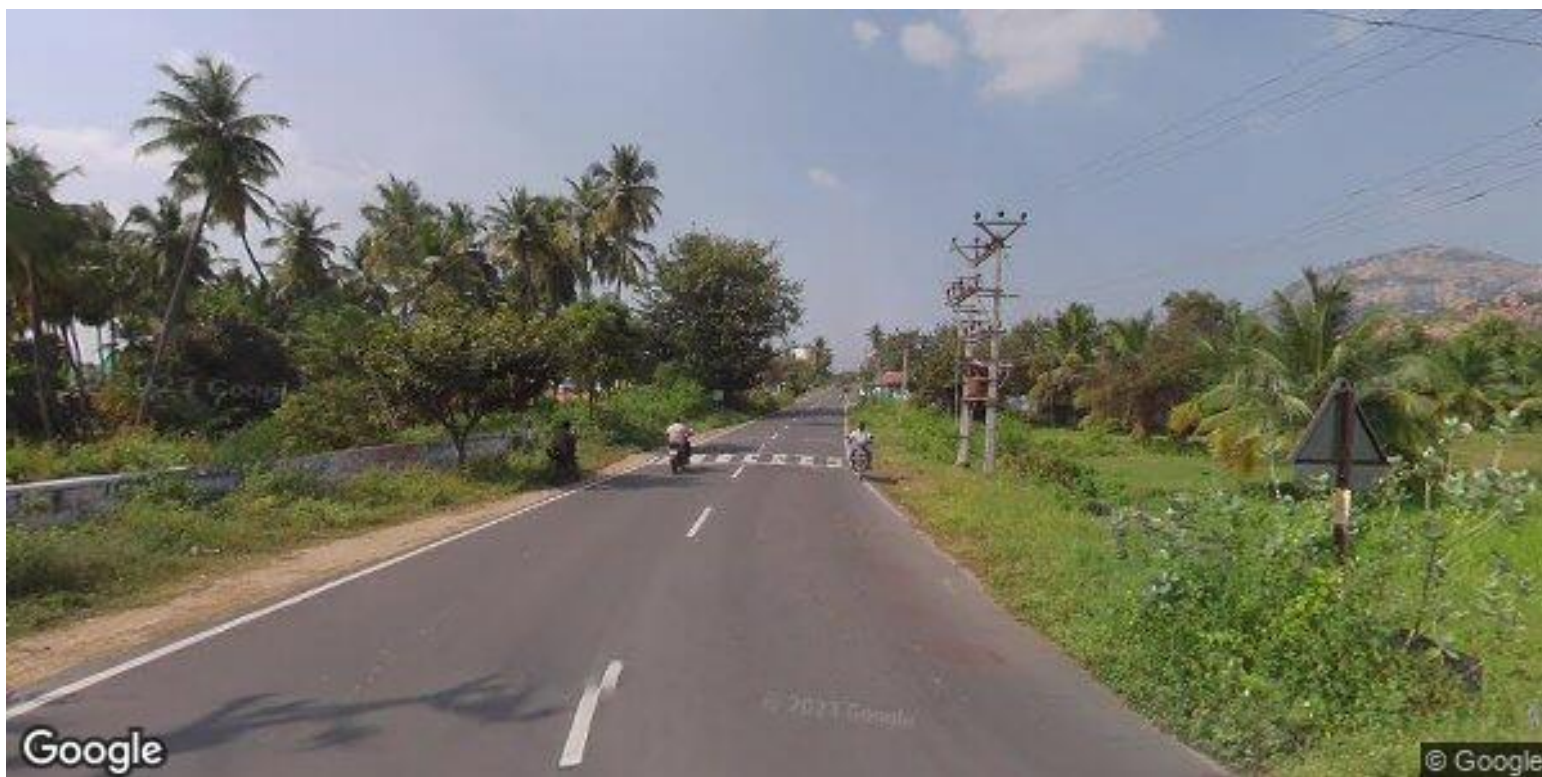
**Risk Type: Turn**  
**Risk Level: High**  
**Speed Limit: 15 KM/Hr**  
**Coordinates: 11.45352, 77.85698**

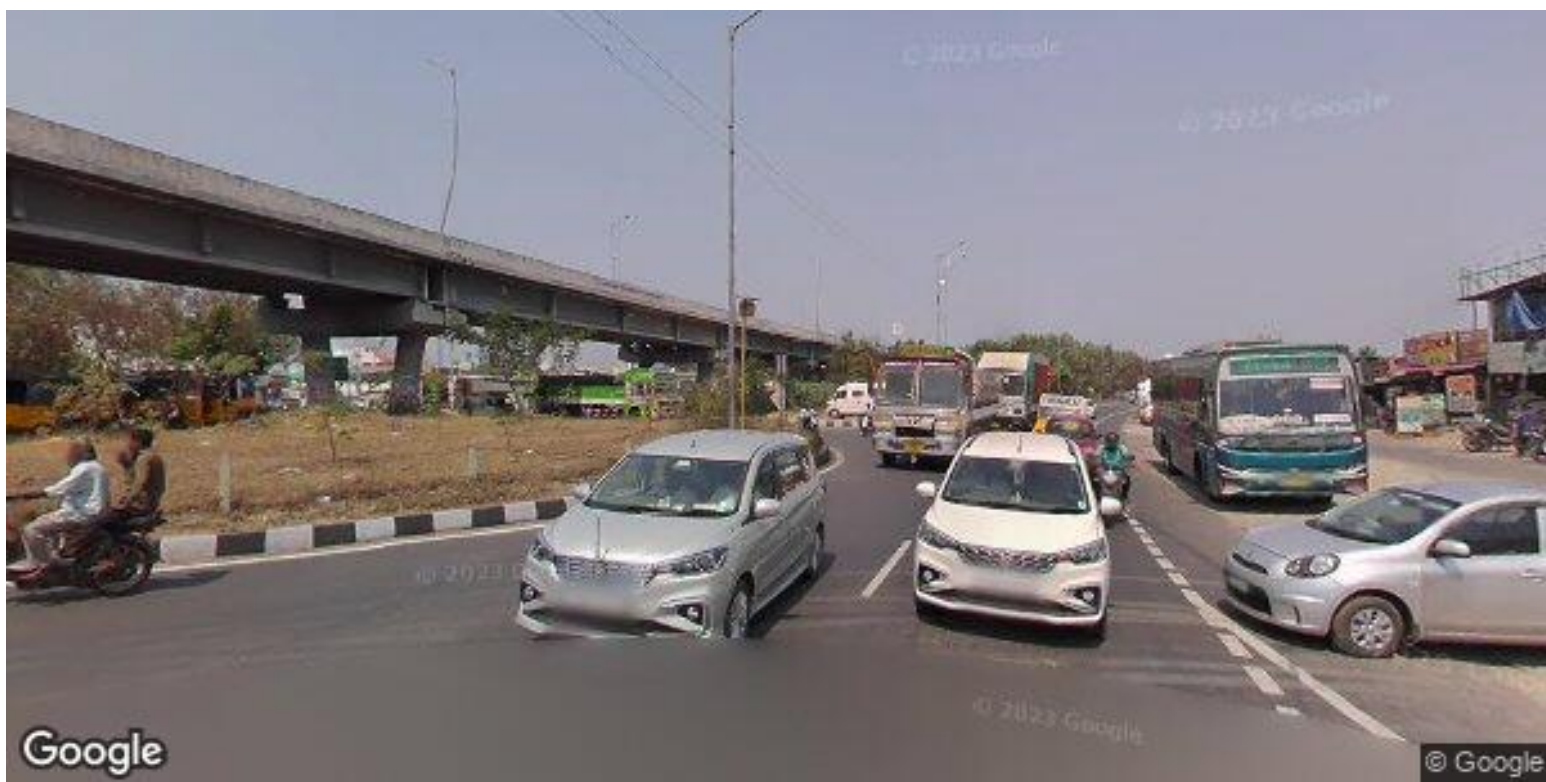
**Risk Type:** Turn

**Risk Level:** High

**Speed Limit:** 15 KM/Hr

**Coordinates:** 11.43001, 77.67575

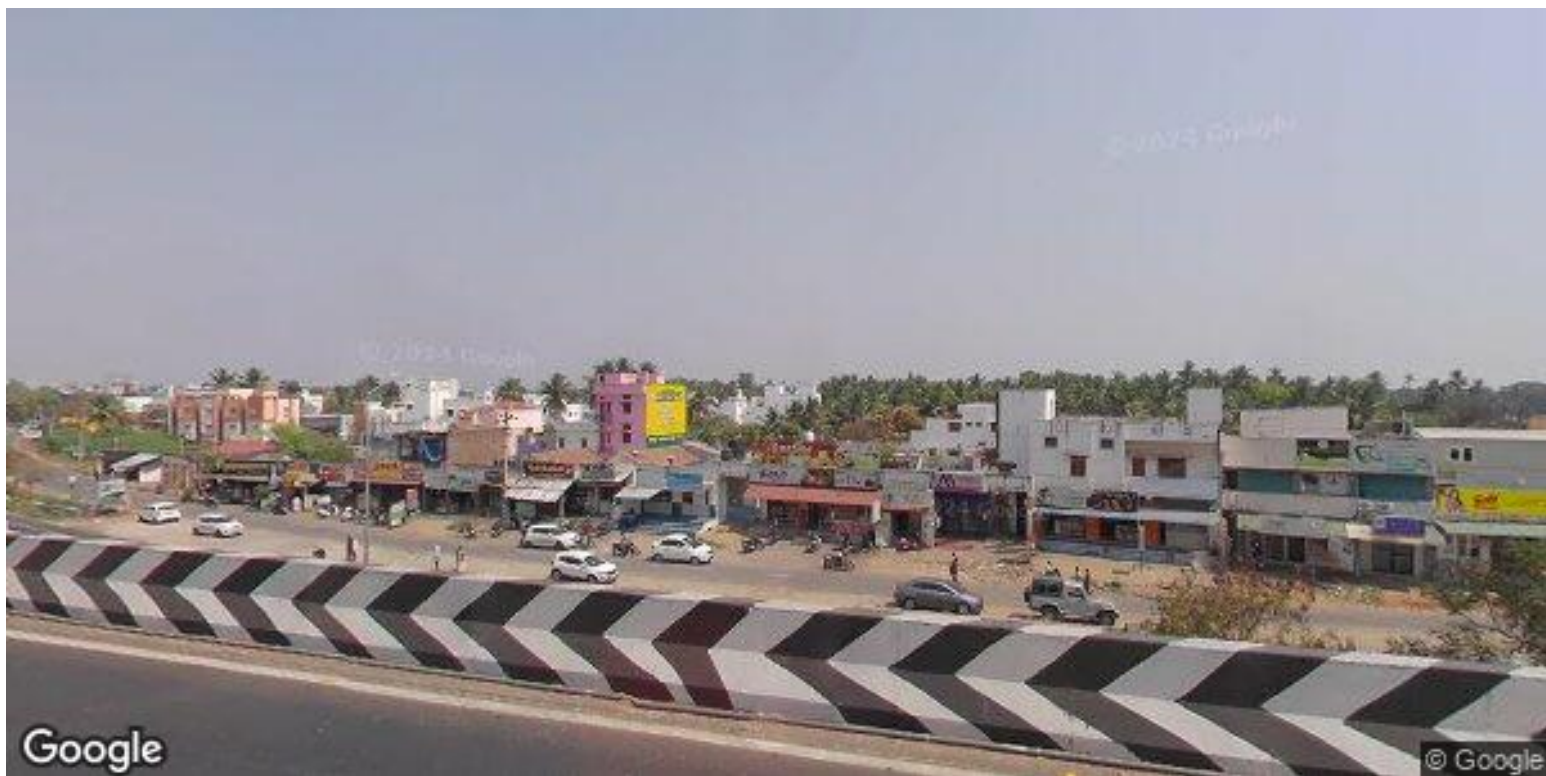
**Risk Type:** Turn

**Risk Level:** Medium

**Speed Limit:** 30 KM/Hr

**Coordinates:** 11.43003, 77.67551

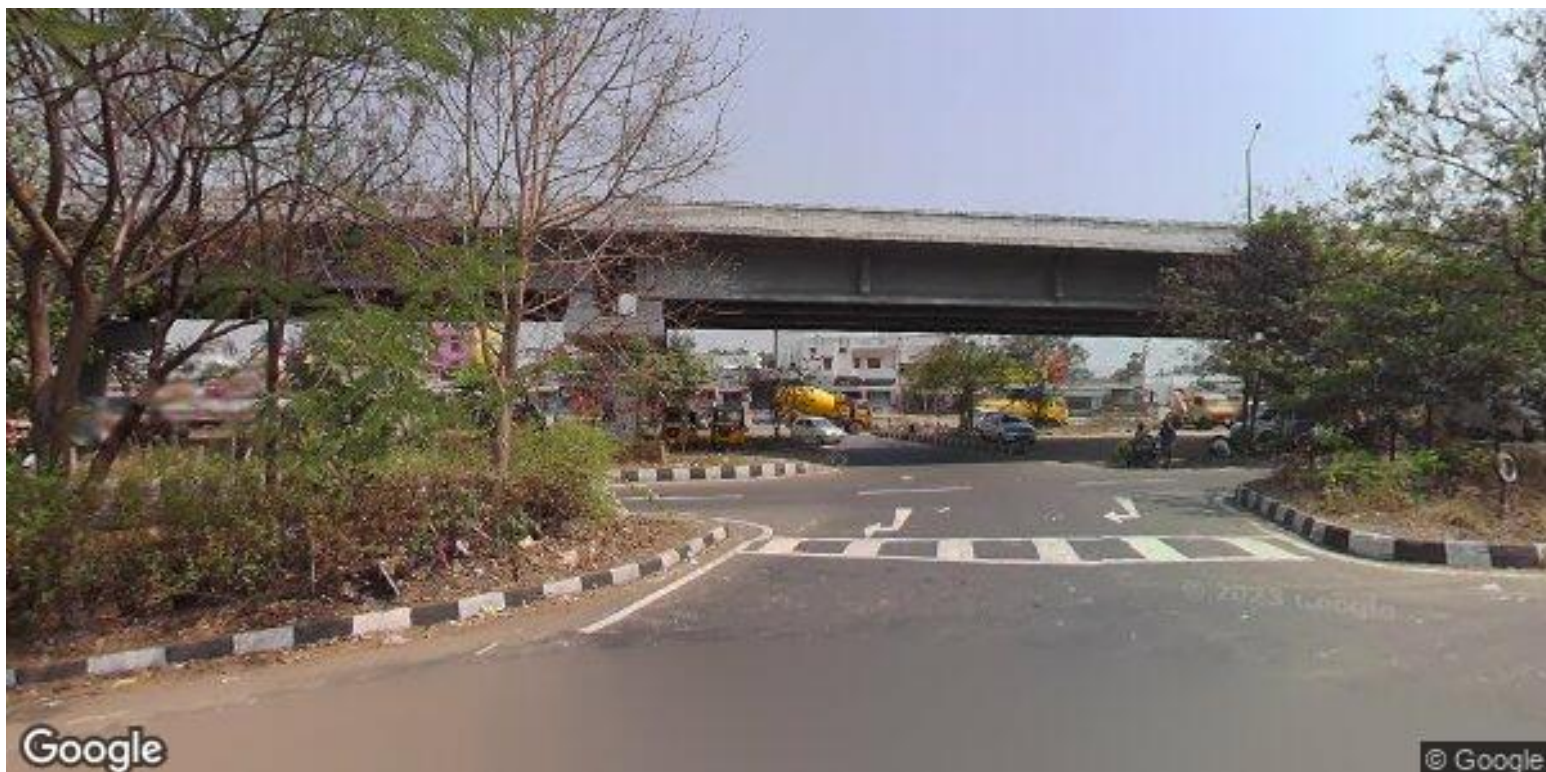
**Risk Type:** Turn  
**Risk Level:** High  
**Speed Limit:** 15 KM/Hr  
**Coordinates:** 11.43026, 77.67525

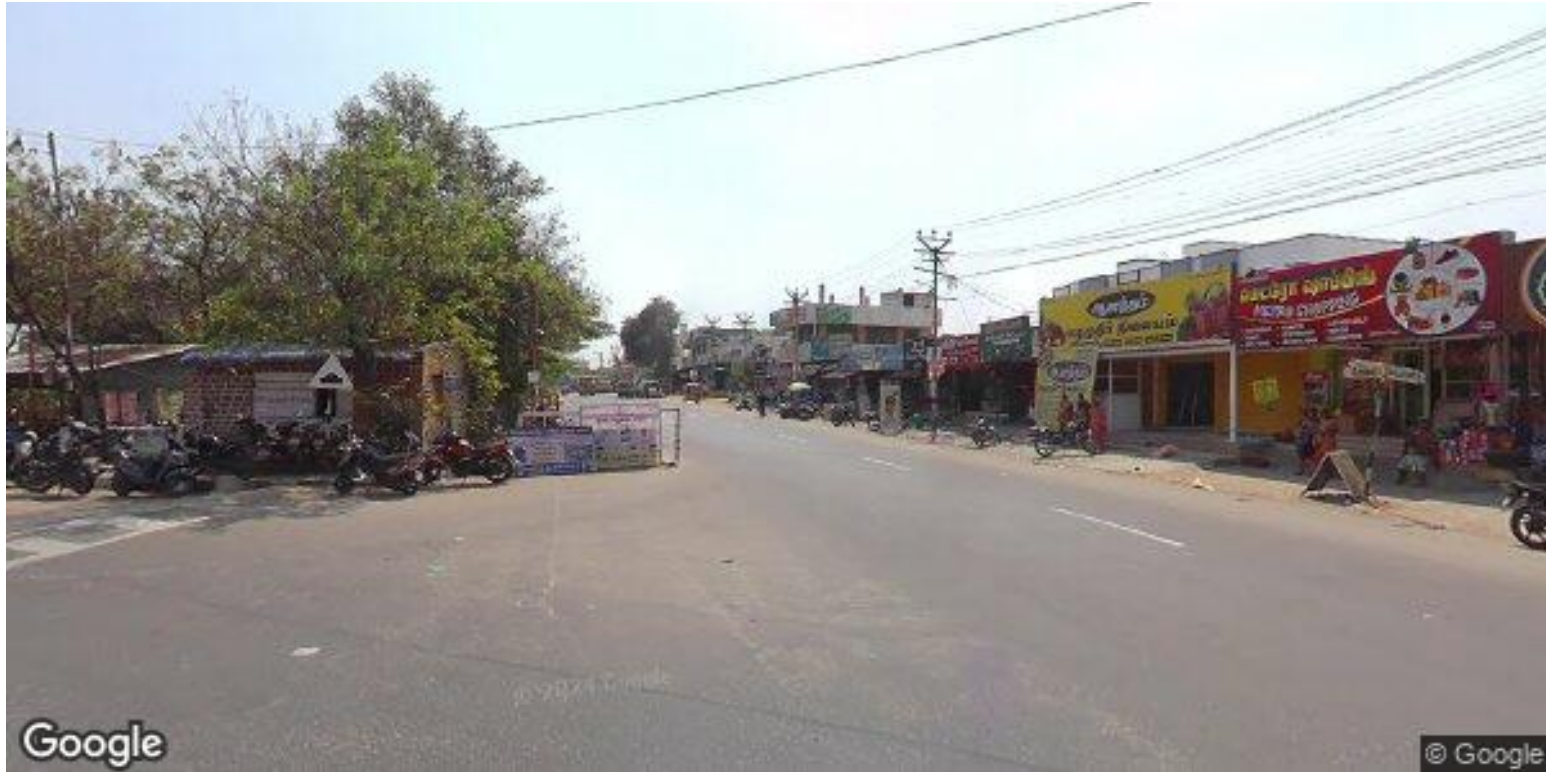
**Risk Type:** Blind Spot  
**Risk Level:** Blind Spot  
**Speed Limit:** 10 KM/Hr  
**Coordinates:** 11.43073, 77.67536

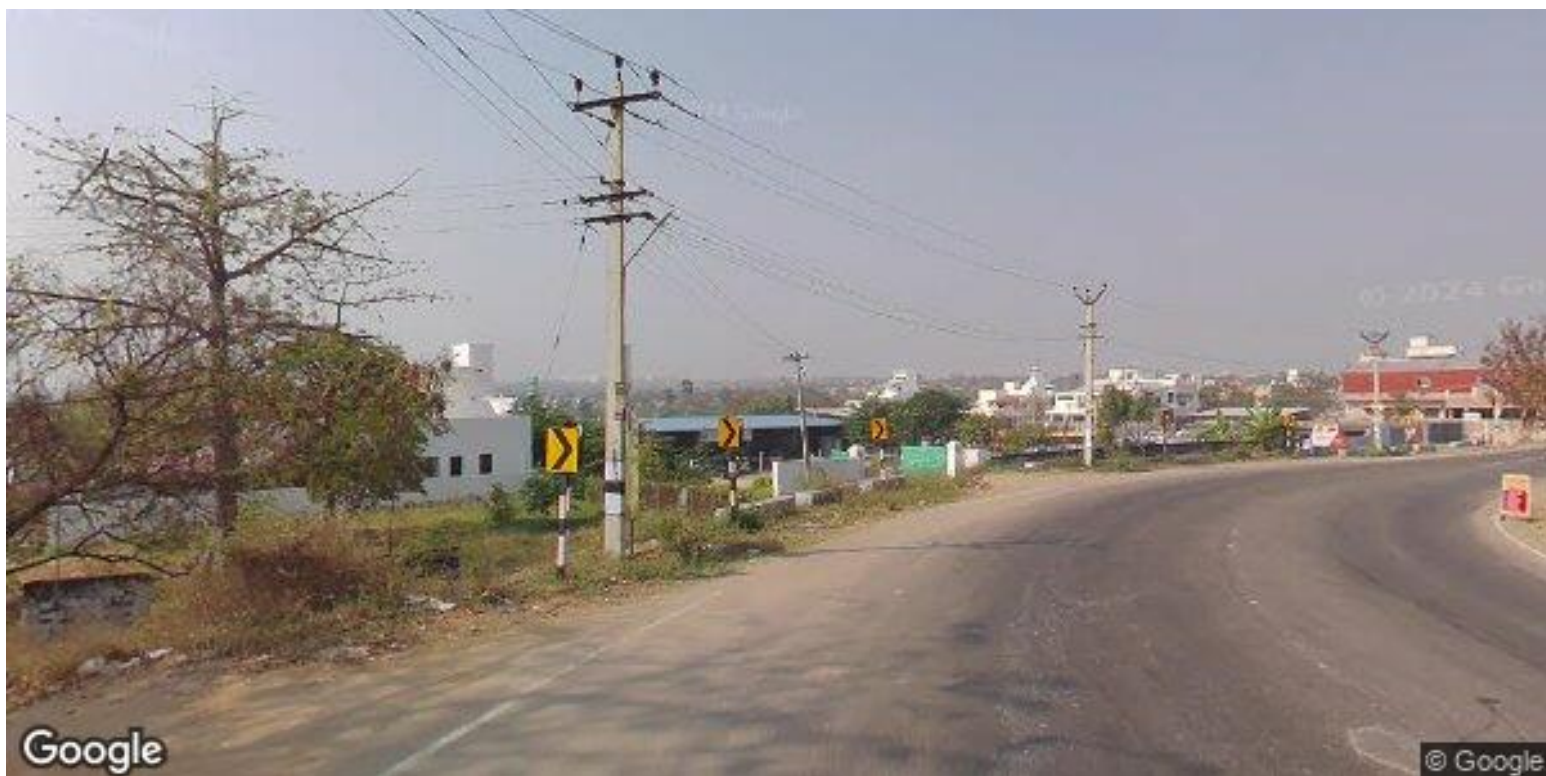
**Risk Type:** Turn  
**Risk Level:** Medium  
**Speed Limit:** 30 KM/Hr  
**Coordinates:** 11.43273, 77.67018

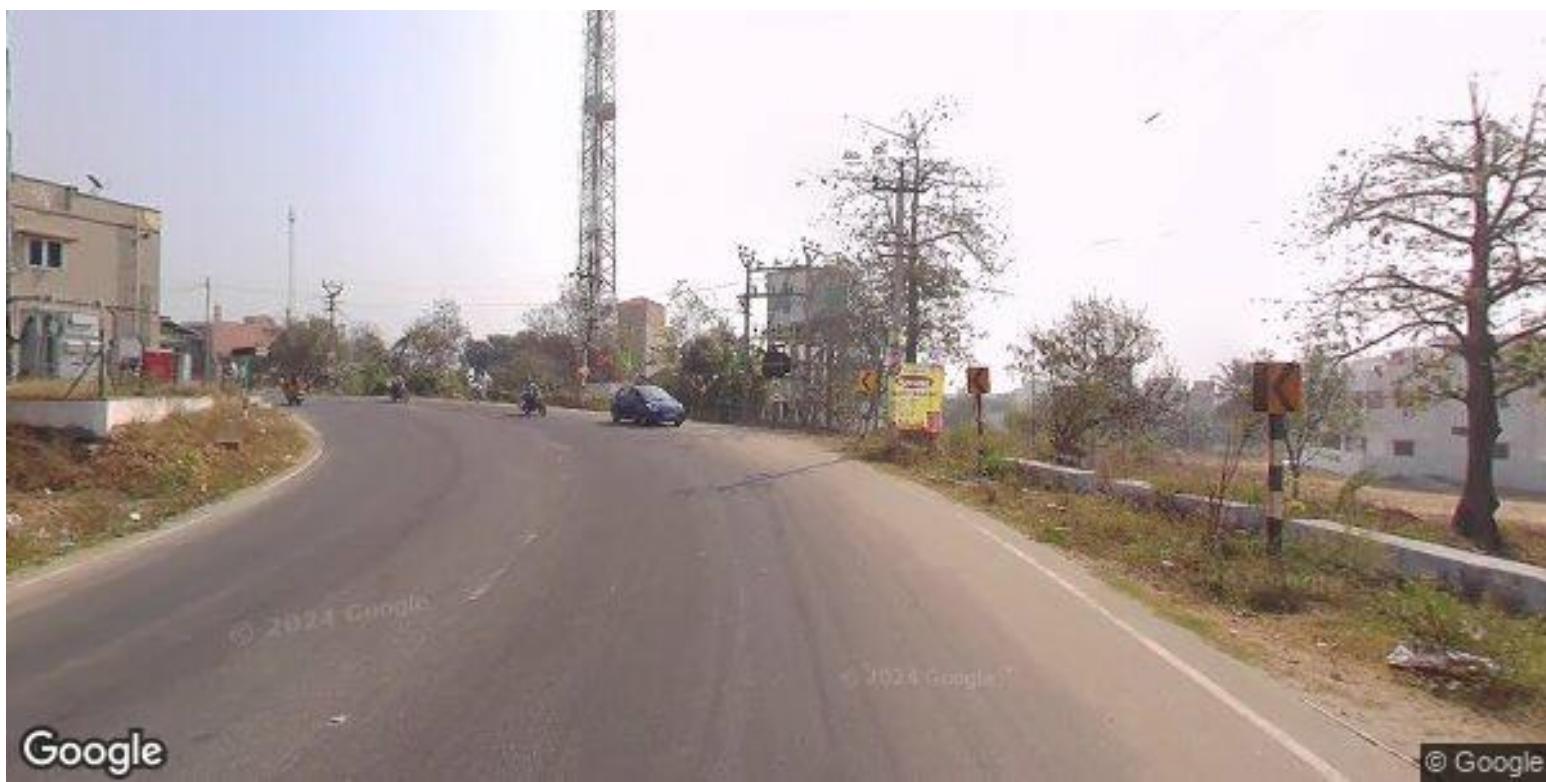
**Risk Type:** Turn

**Risk Level:** Medium

**Speed Limit:** 30 KM/Hr

**Coordinates:** 11.43268, 77.66999

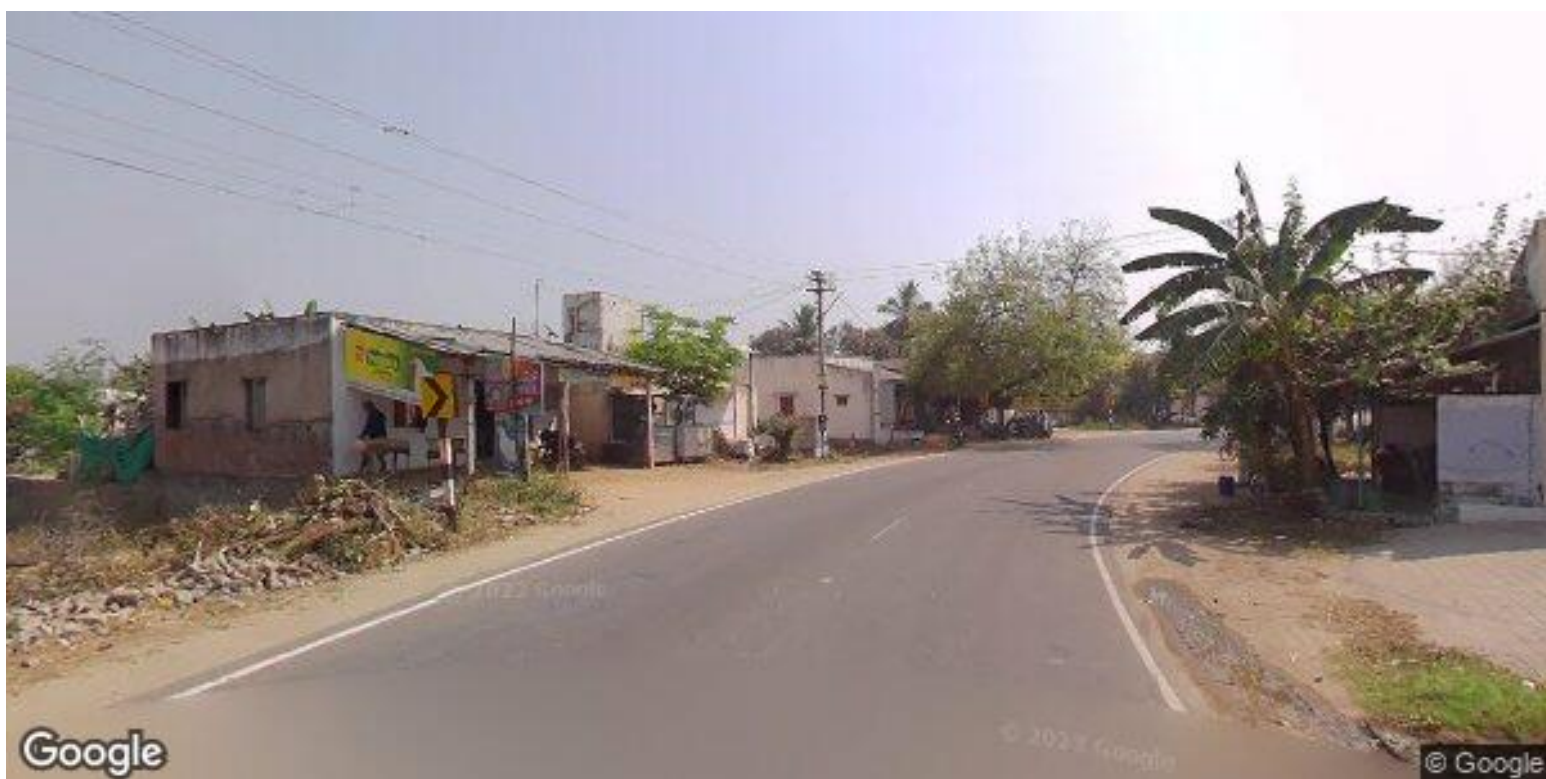
**Risk Type:** Turn

**Risk Level:** High

**Speed Limit:** 15 KM/Hr

**Coordinates:** 11.43342, 77.66685

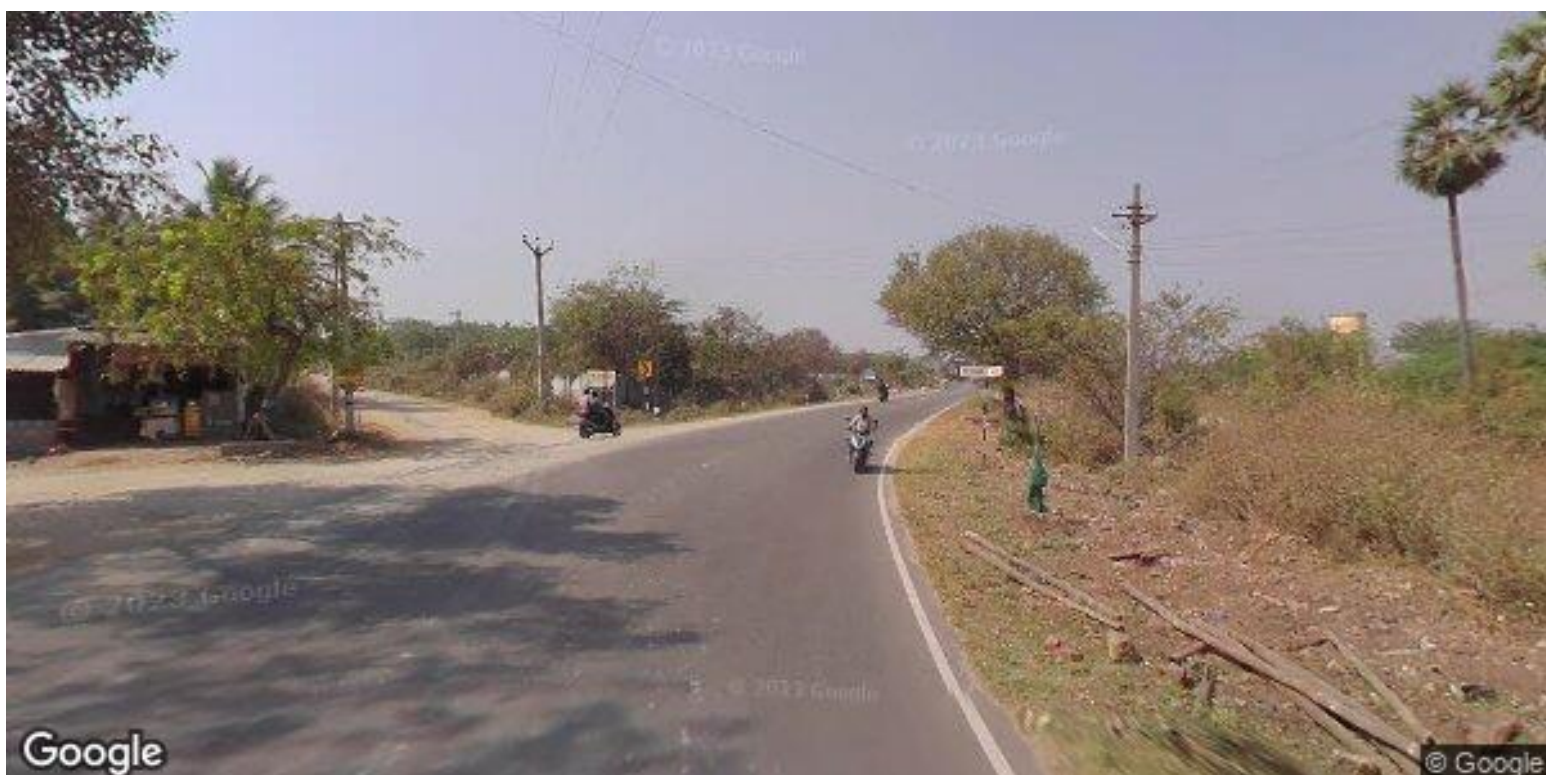
**Risk Type:** Turn  
**Risk Level:** Medium  
**Speed Limit:** 30 KM/Hr  
**Coordinates:** 11.43239, 77.66578

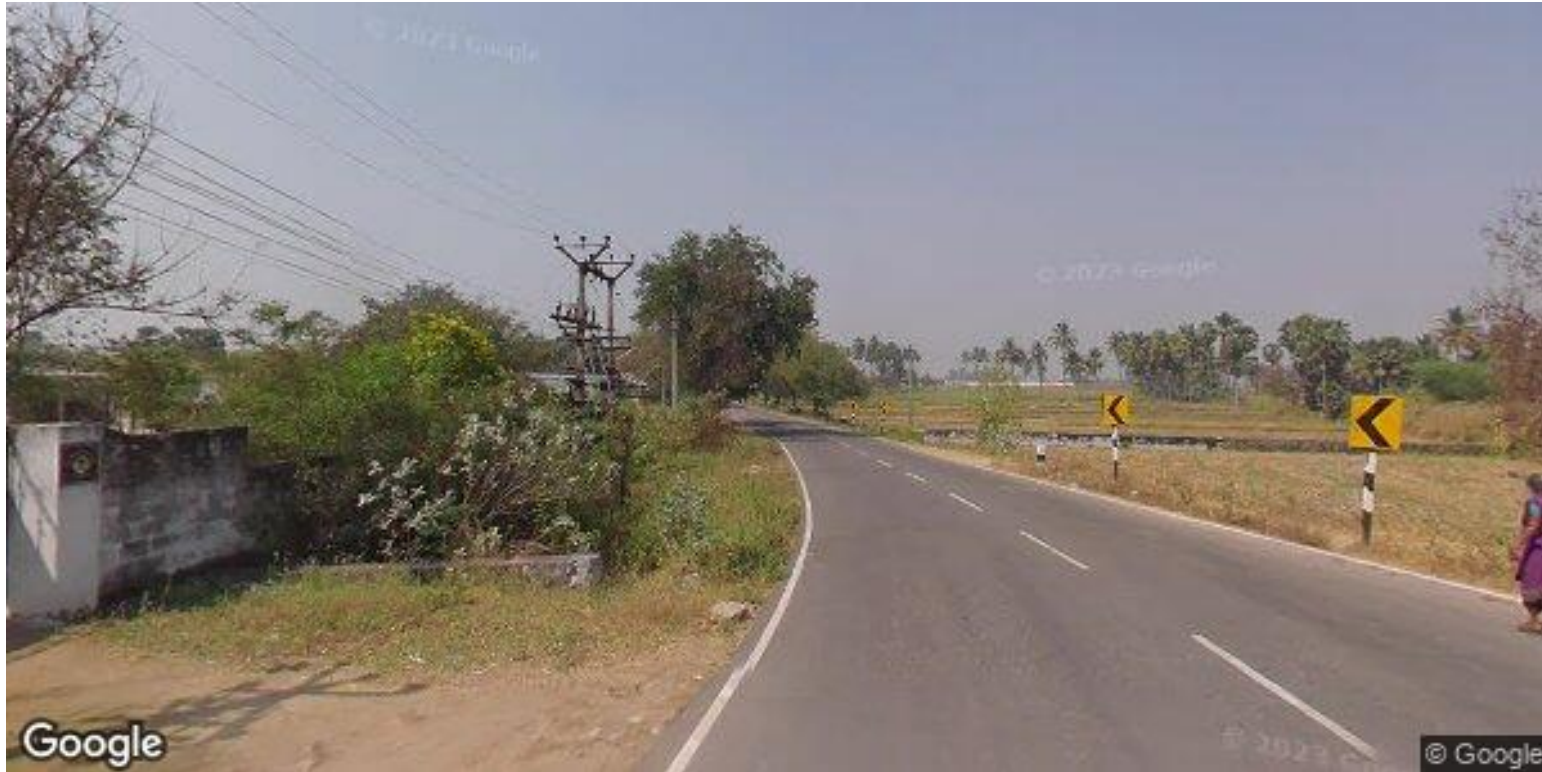
**Risk Type:** Turn  
**Risk Level:** Medium  
**Speed Limit:** 30 KM/Hr  
**Coordinates:** 11.43222, 77.65329

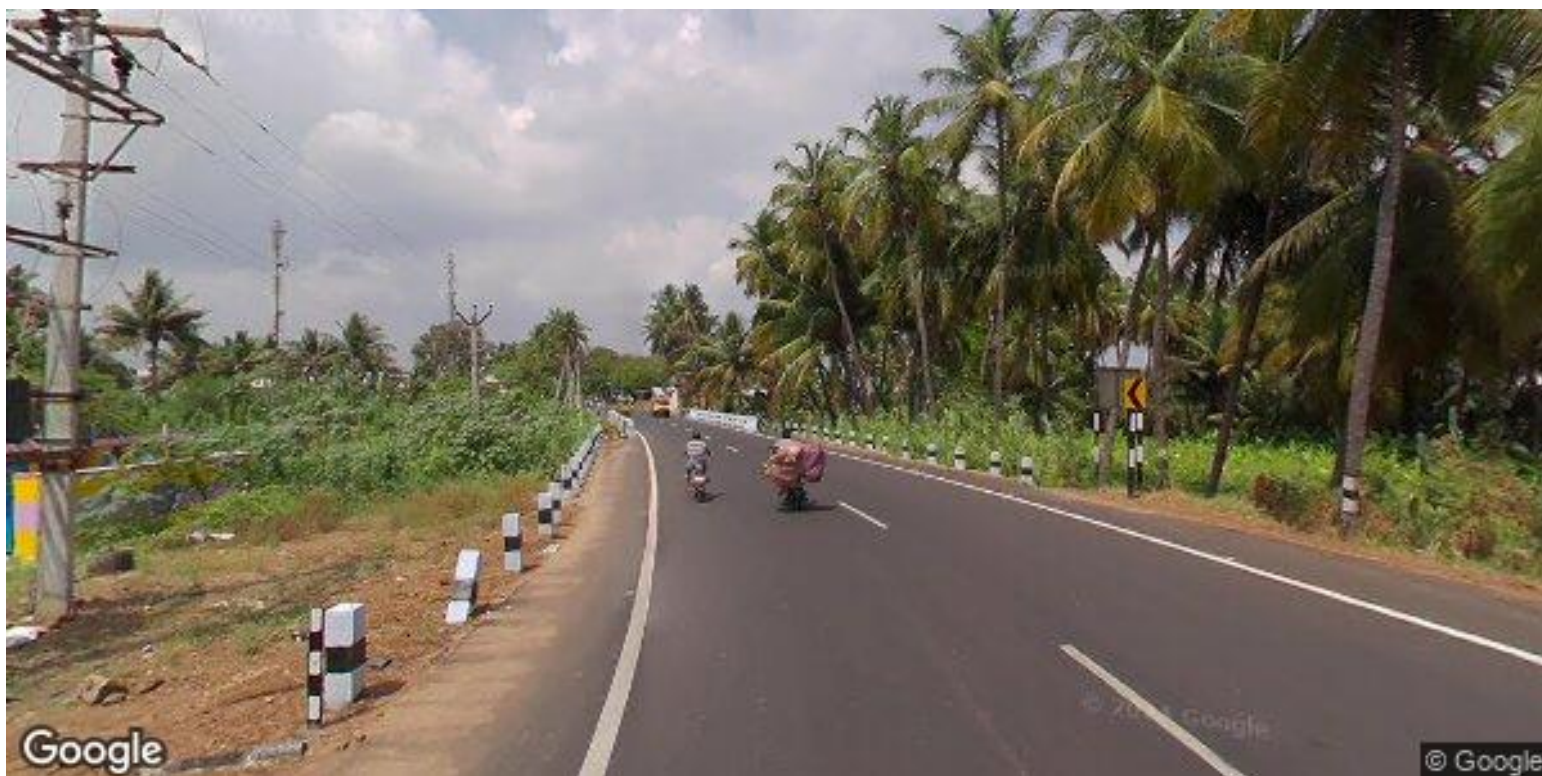
**Risk Type:** Turn  
**Risk Level:** Medium  
**Speed Limit:** 30 KM/Hr  
**Coordinates:** 11.42904, 77.57122

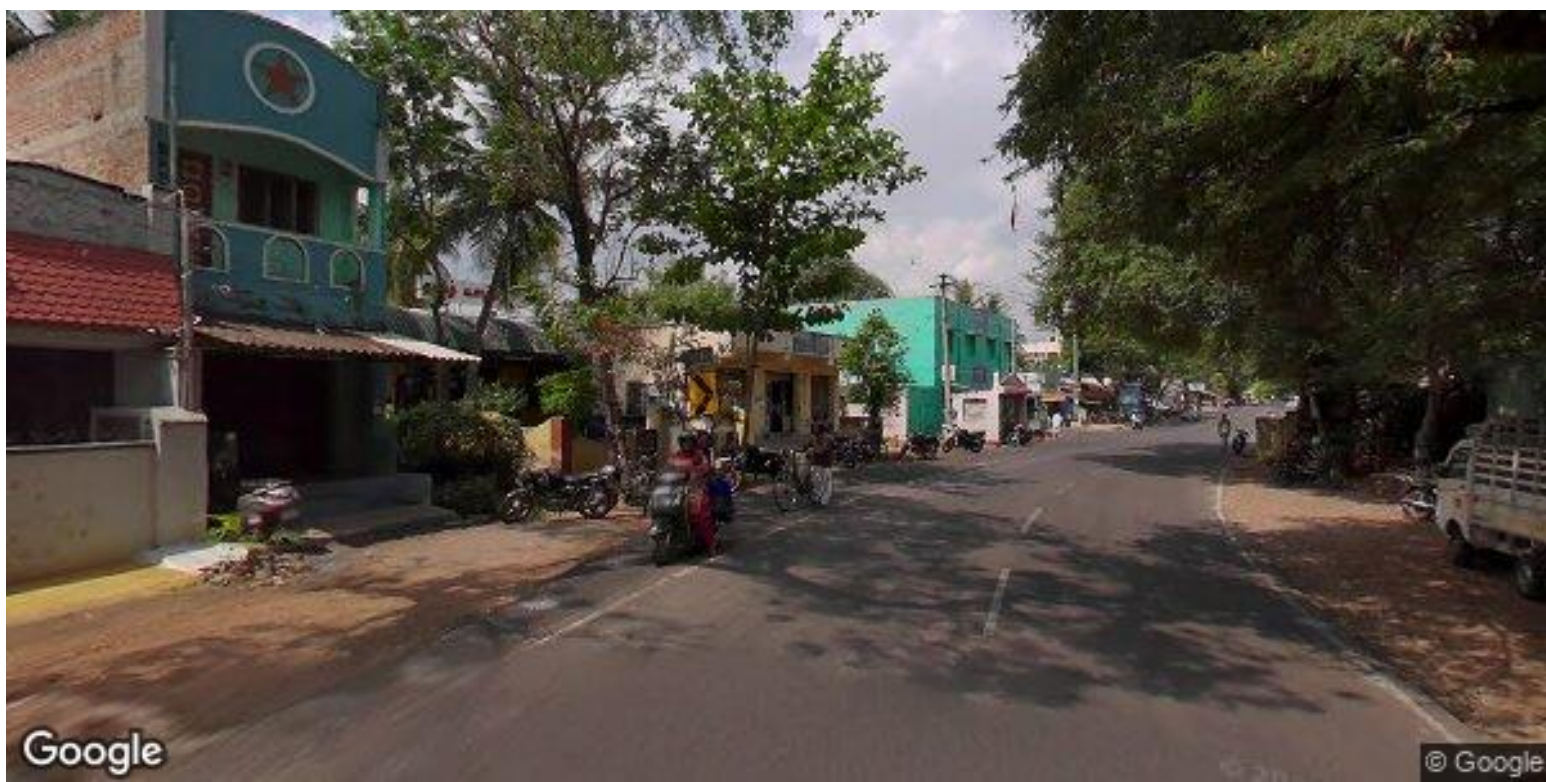
**Risk Type:** Turn

**Risk Level:** Medium

**Speed Limit:** 30 KM/Hr

**Coordinates:** 11.42838, 77.56943

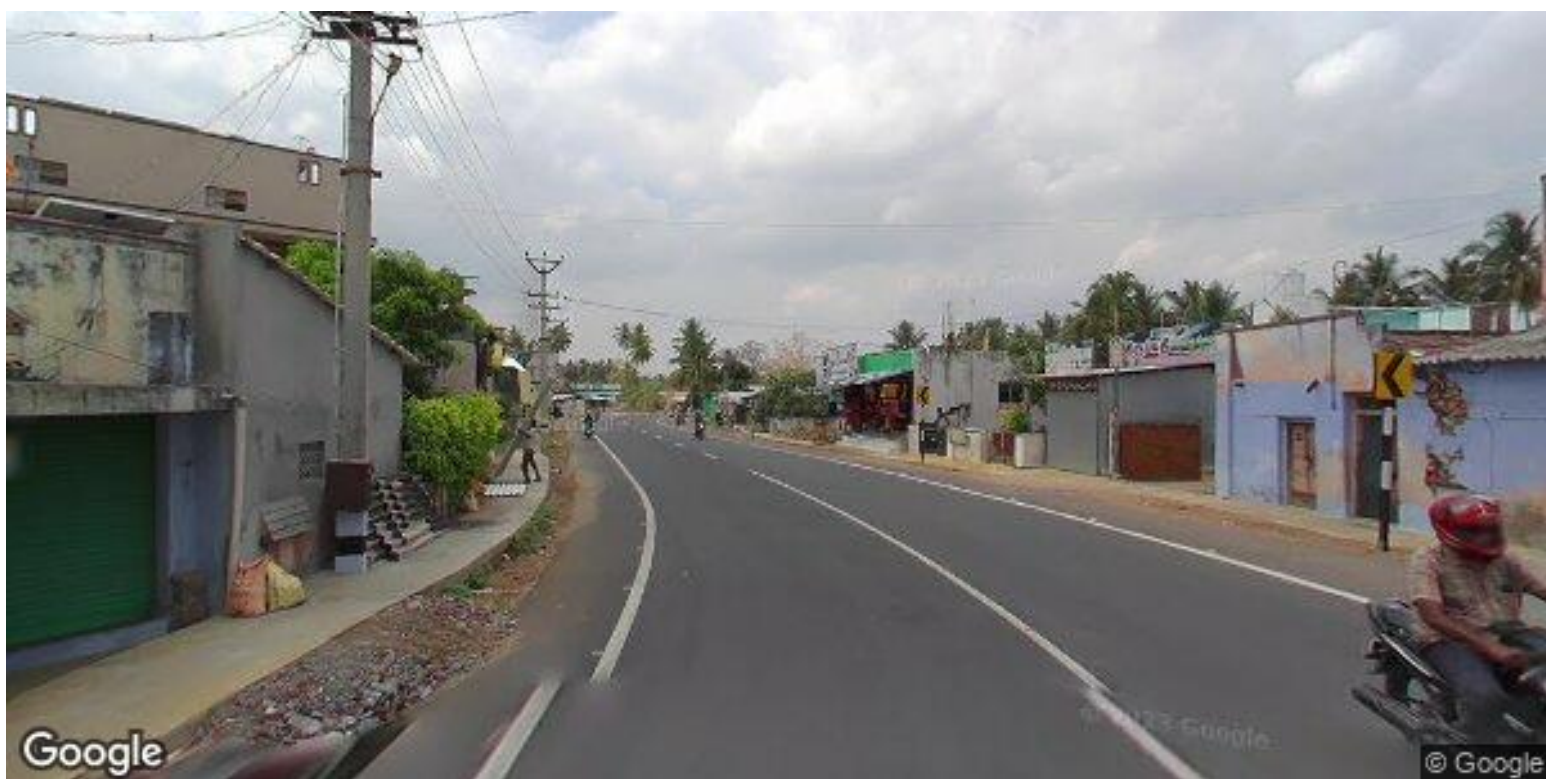
**Risk Type:** Turn

**Risk Level:** Medium

**Speed Limit:** 30 KM/Hr

**Coordinates:** 11.42828, 77.56554

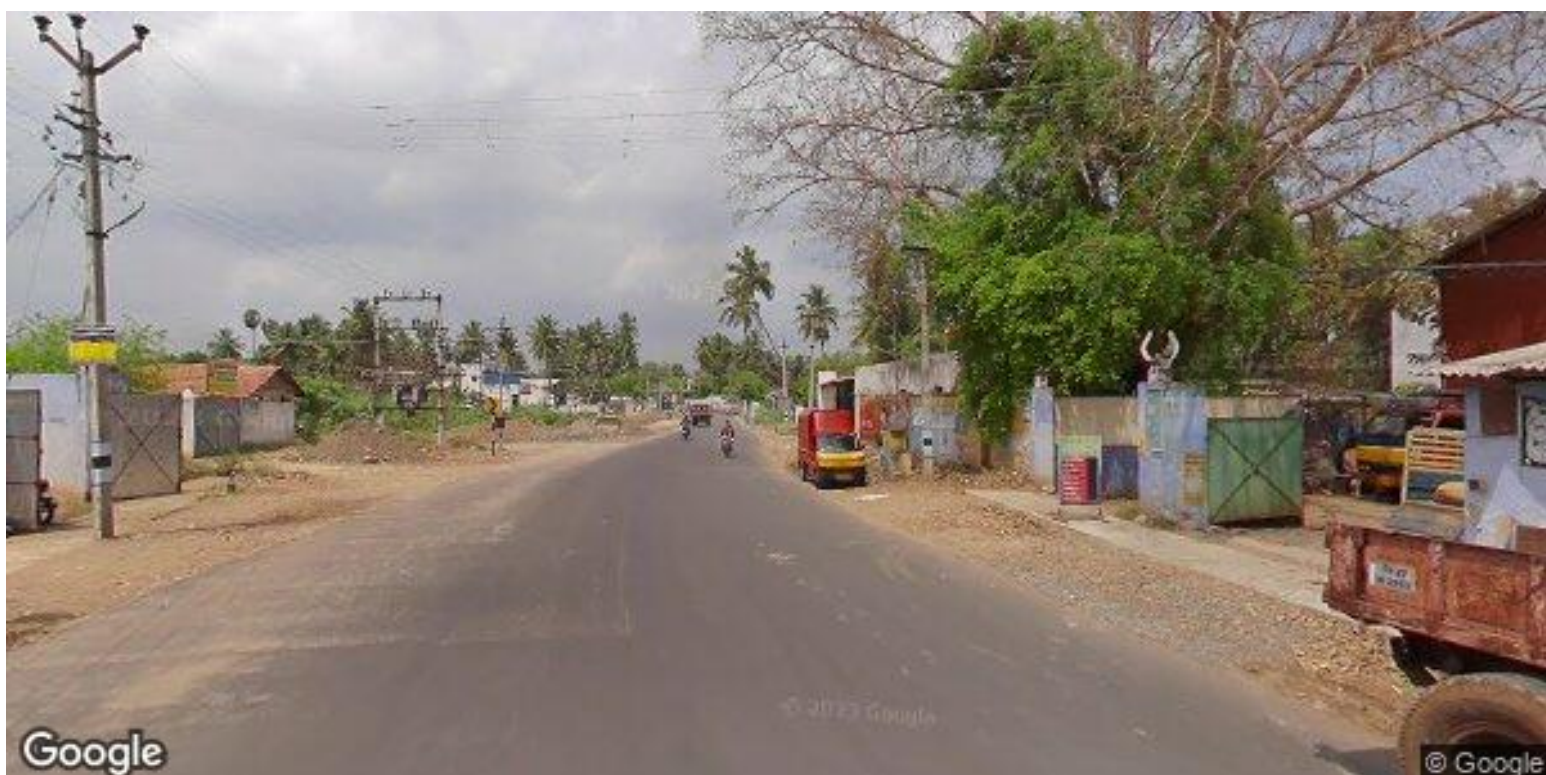
**Risk Type: Turn**

**Risk Level: Medium**

**Speed Limit: 30 KM/Hr**

**Coordinates: 11.42704, 77.56397**

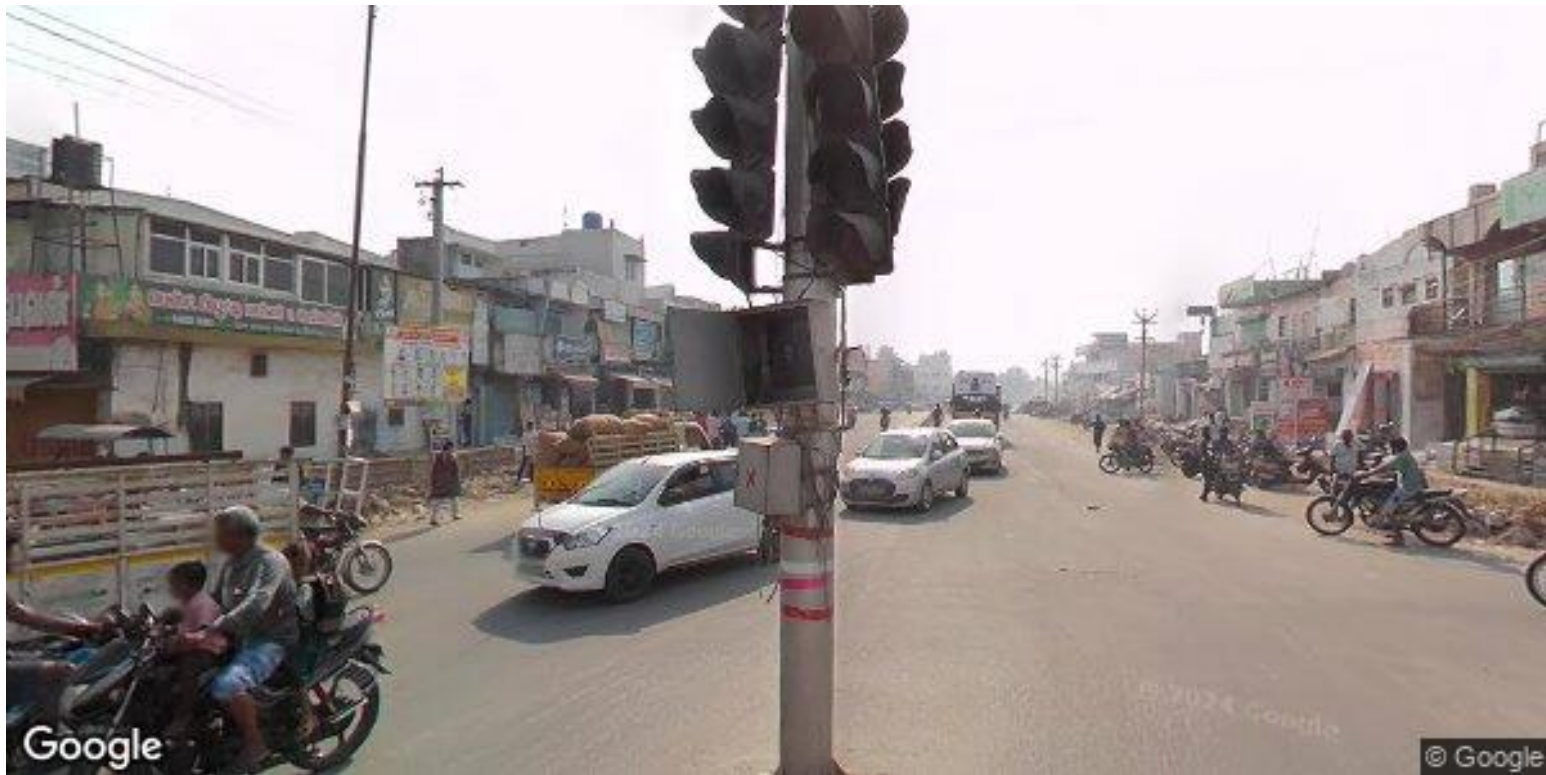
**Risk Type: Turn**

**Risk Level: High**

**Speed Limit: 15 KM/Hr**

**Coordinates: 11.42337, 77.55804**

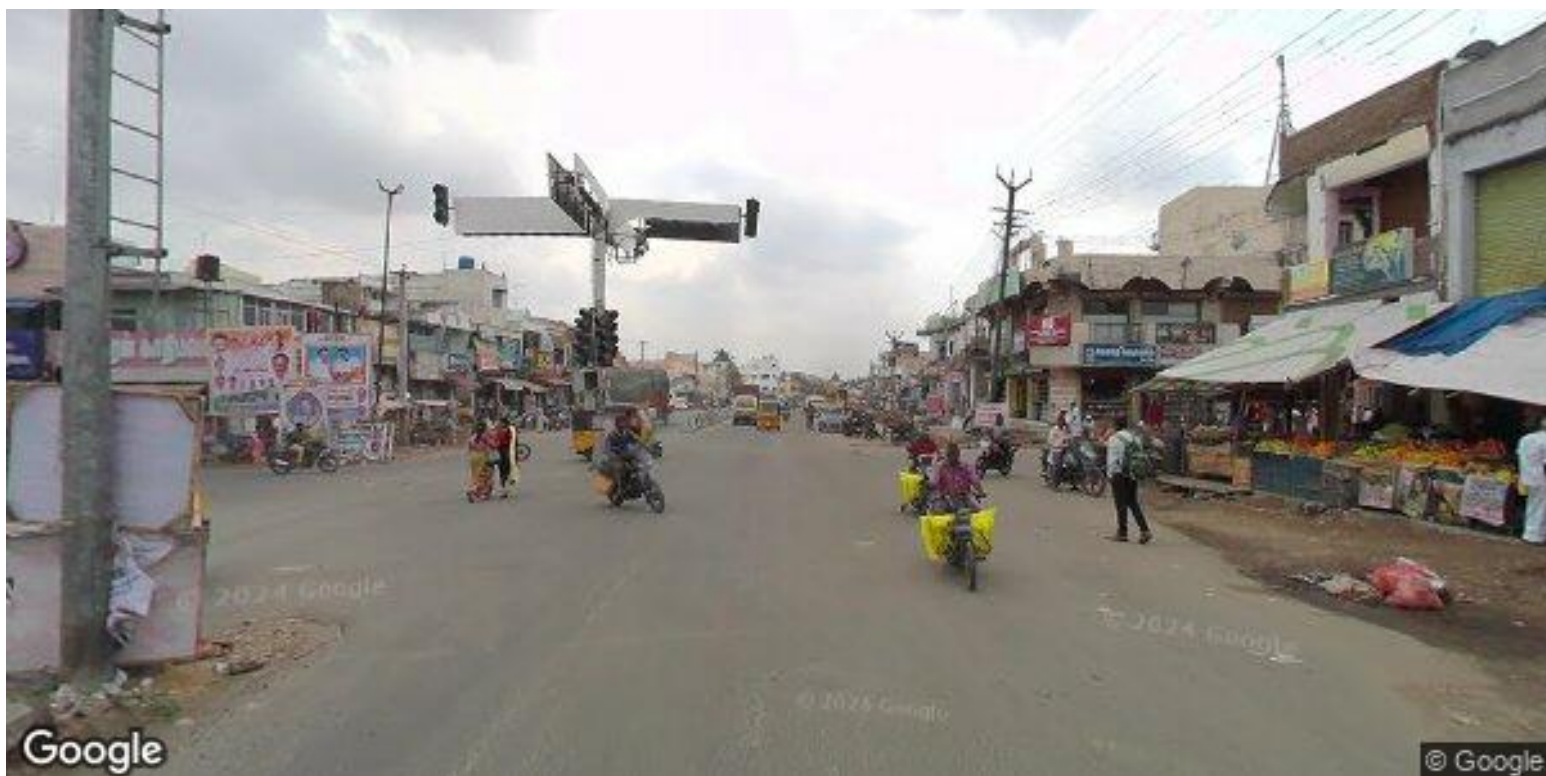
**Risk Type: Turn**

**Risk Level: Medium**

**Speed Limit: 30 KM/Hr**

**Coordinates: 11.42335, 77.55788**
