# IndianOil

## **JOURNEY RISK MANAGEMENT (JRM) STUDY**

### **Salem Terminal to SRI ROYAL PETROLEUM**

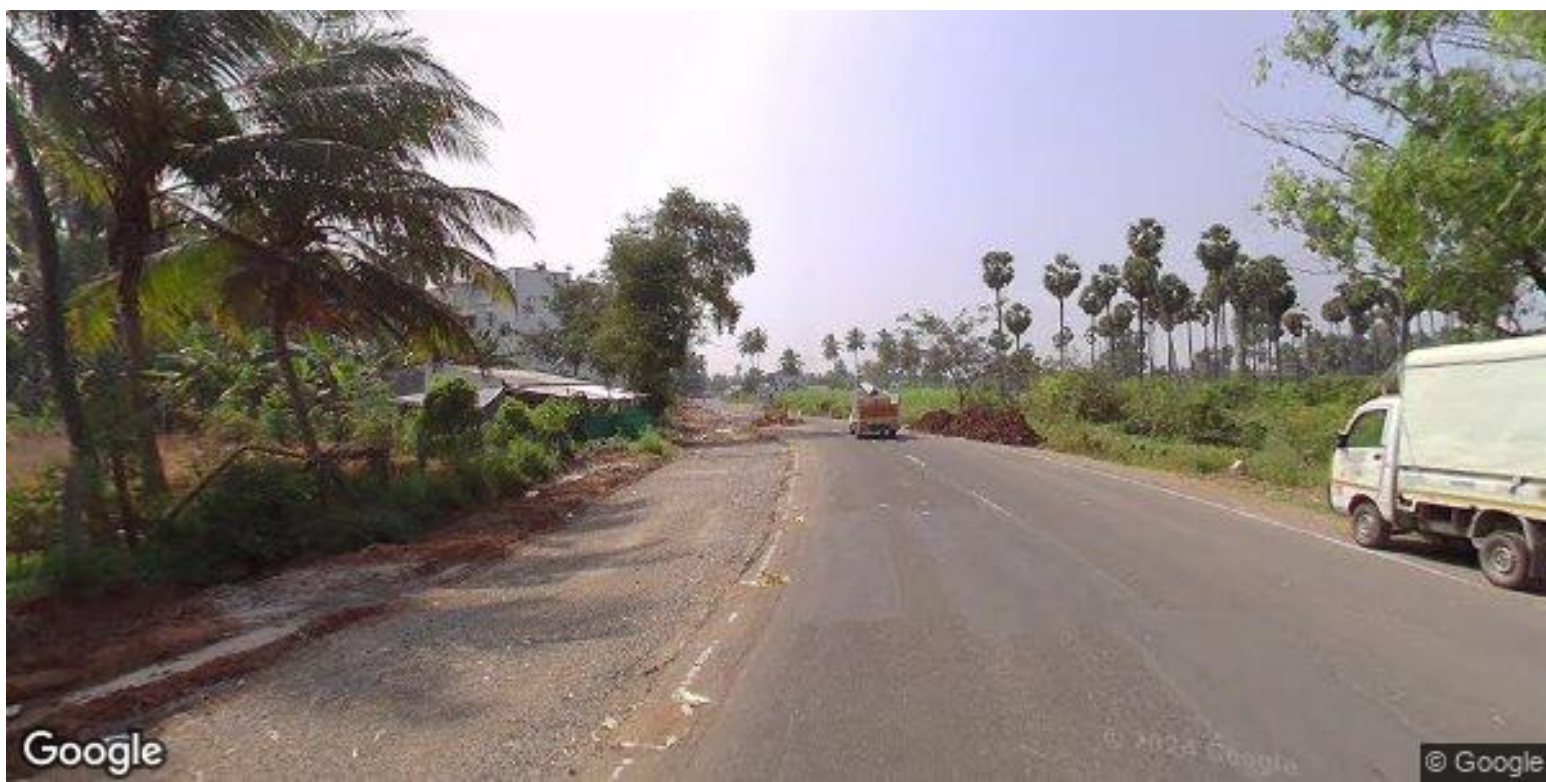
**Risk Type:** Turn

**Risk Level:** Medium

**Speed Limit:** 30 KM/Hr

**Coordinates:** 11.45761, 77.36302

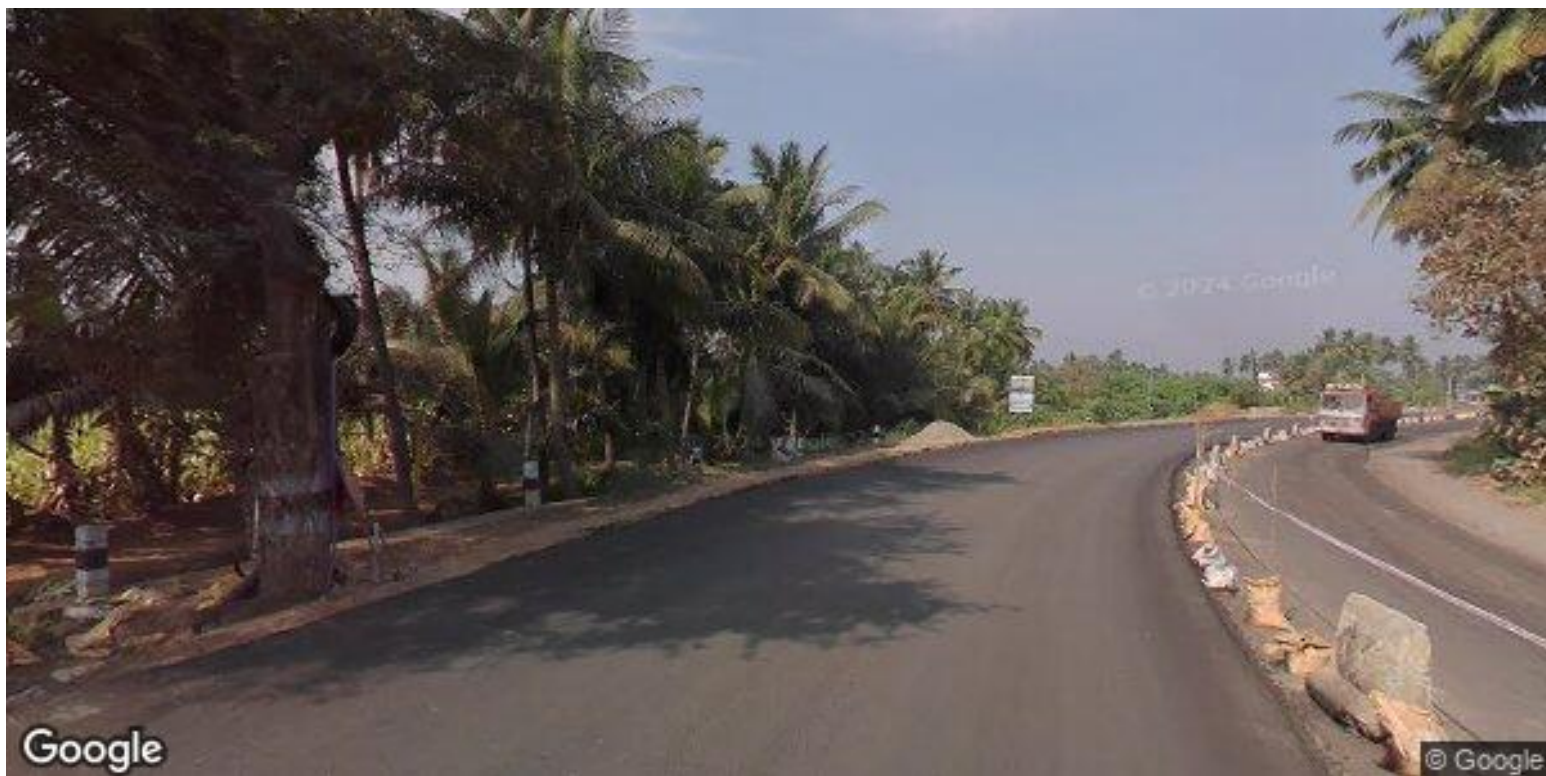
**Risk Type:** Turn

**Risk Level:** Medium

**Speed Limit:** 30 KM/Hr

**Coordinates:** 11.45634, 77.35808

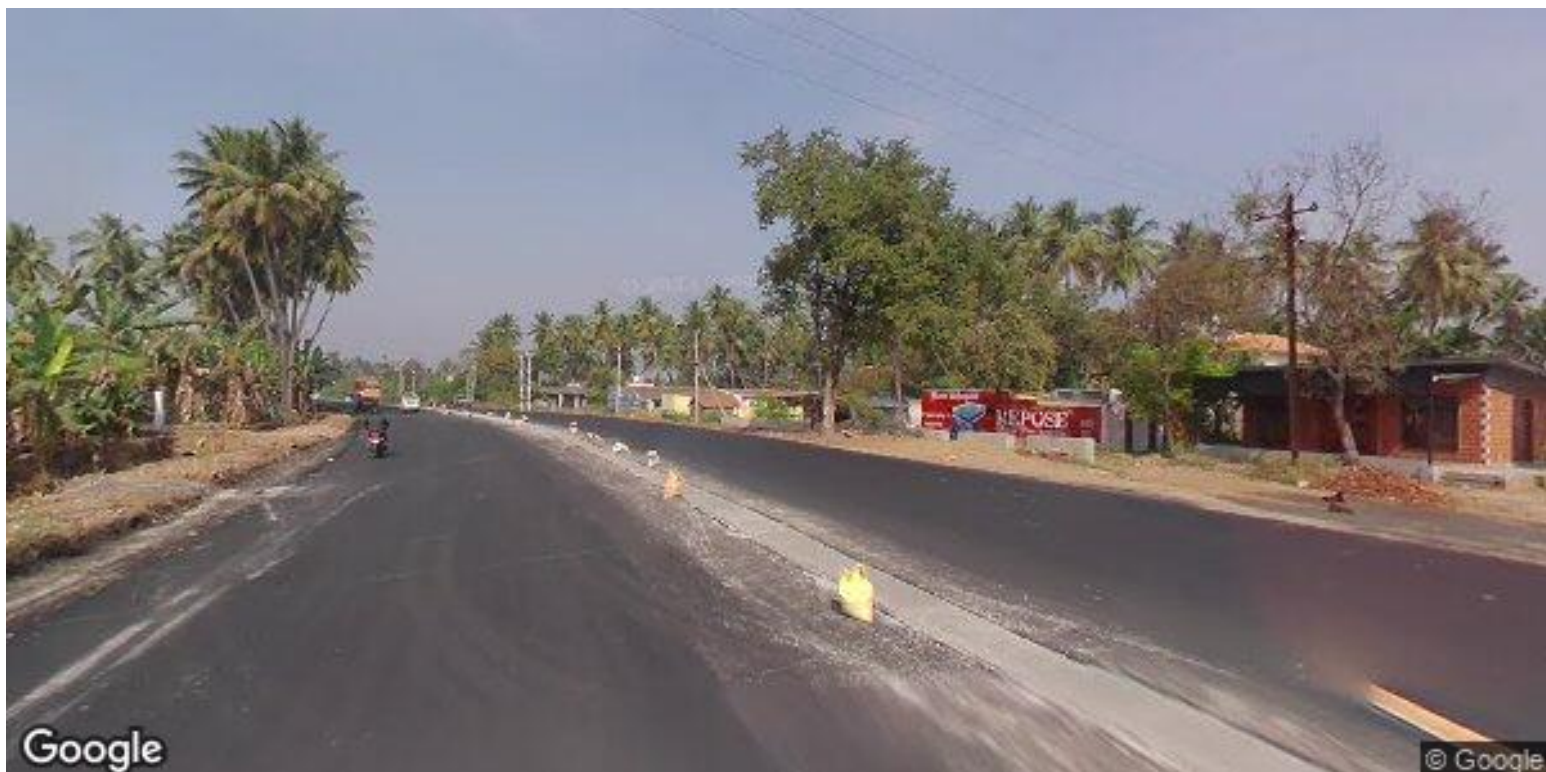
**Risk Type:** Turn  
**Risk Level:** Medium  
**Speed Limit:** 30 KM/Hr  
**Coordinates:** 11.45755, 77.35606

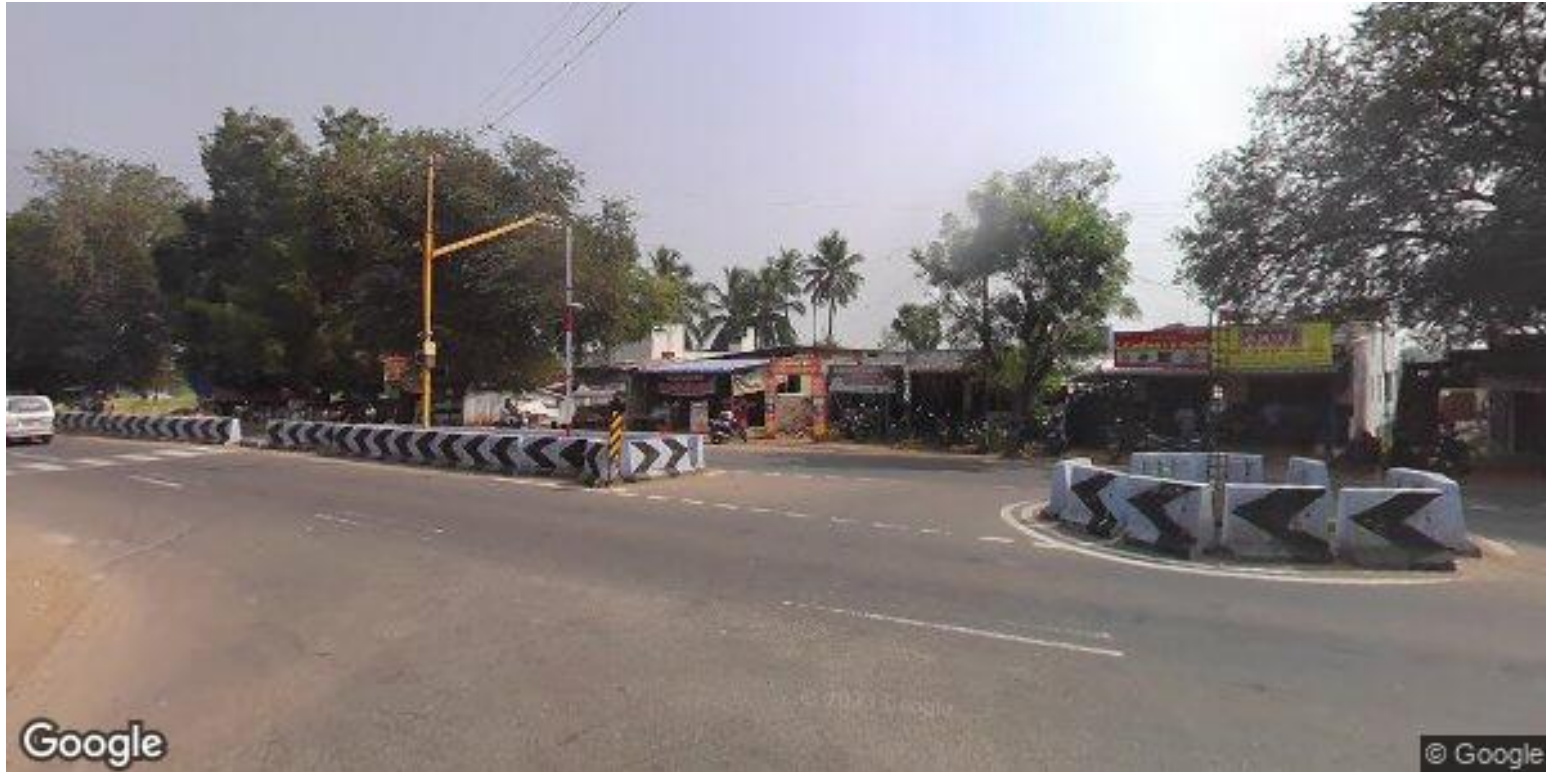
**Risk Type:** Turn  
**Risk Level:** High  
**Speed Limit:** 15 KM/Hr  
**Coordinates:** 11.45964, 77.30748

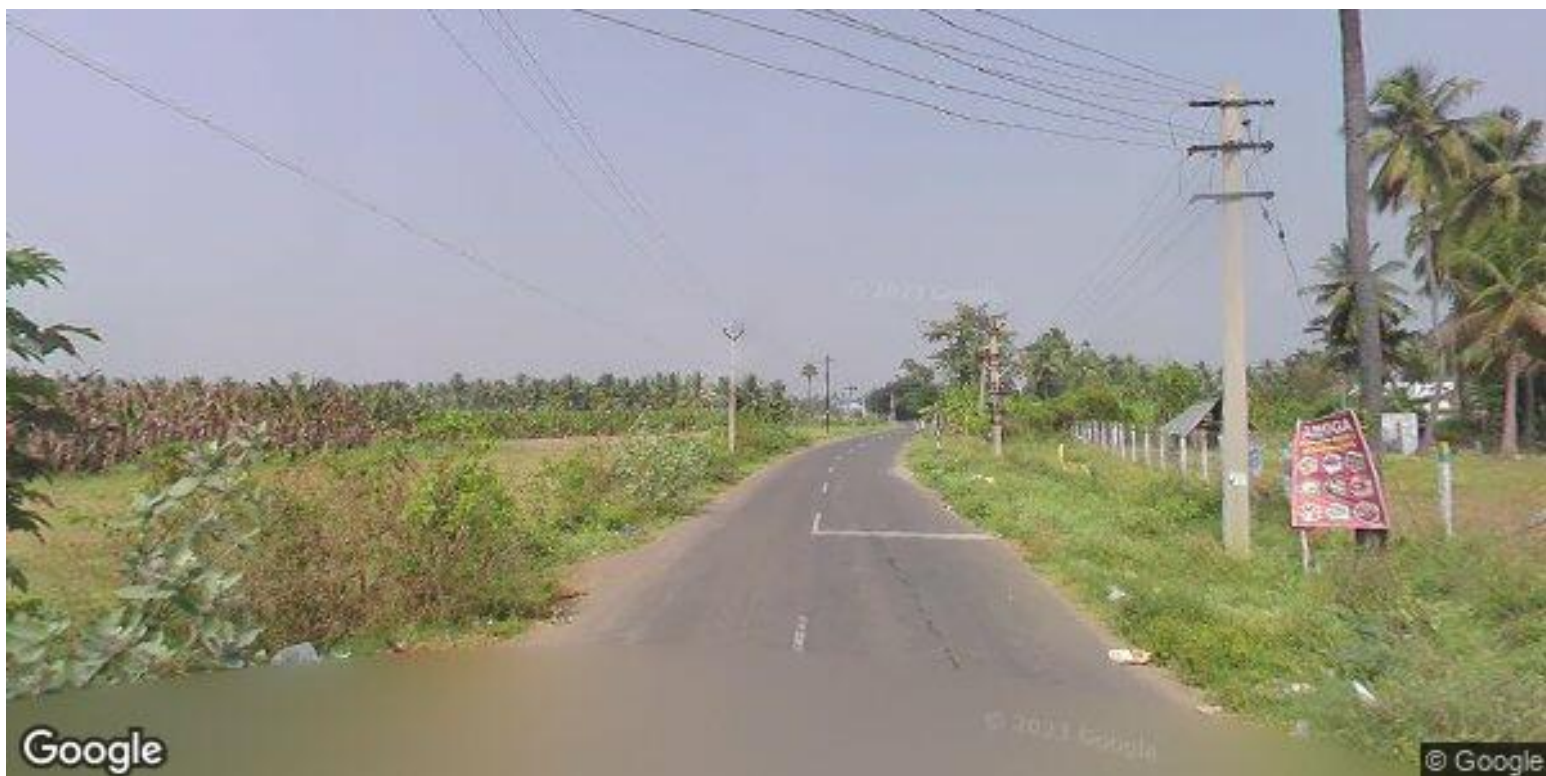
**Risk Type:** Turn  
**Risk Level:** Medium  
**Speed Limit:** 30 KM/Hr  
**Coordinates:** 11.46616, 77.30075

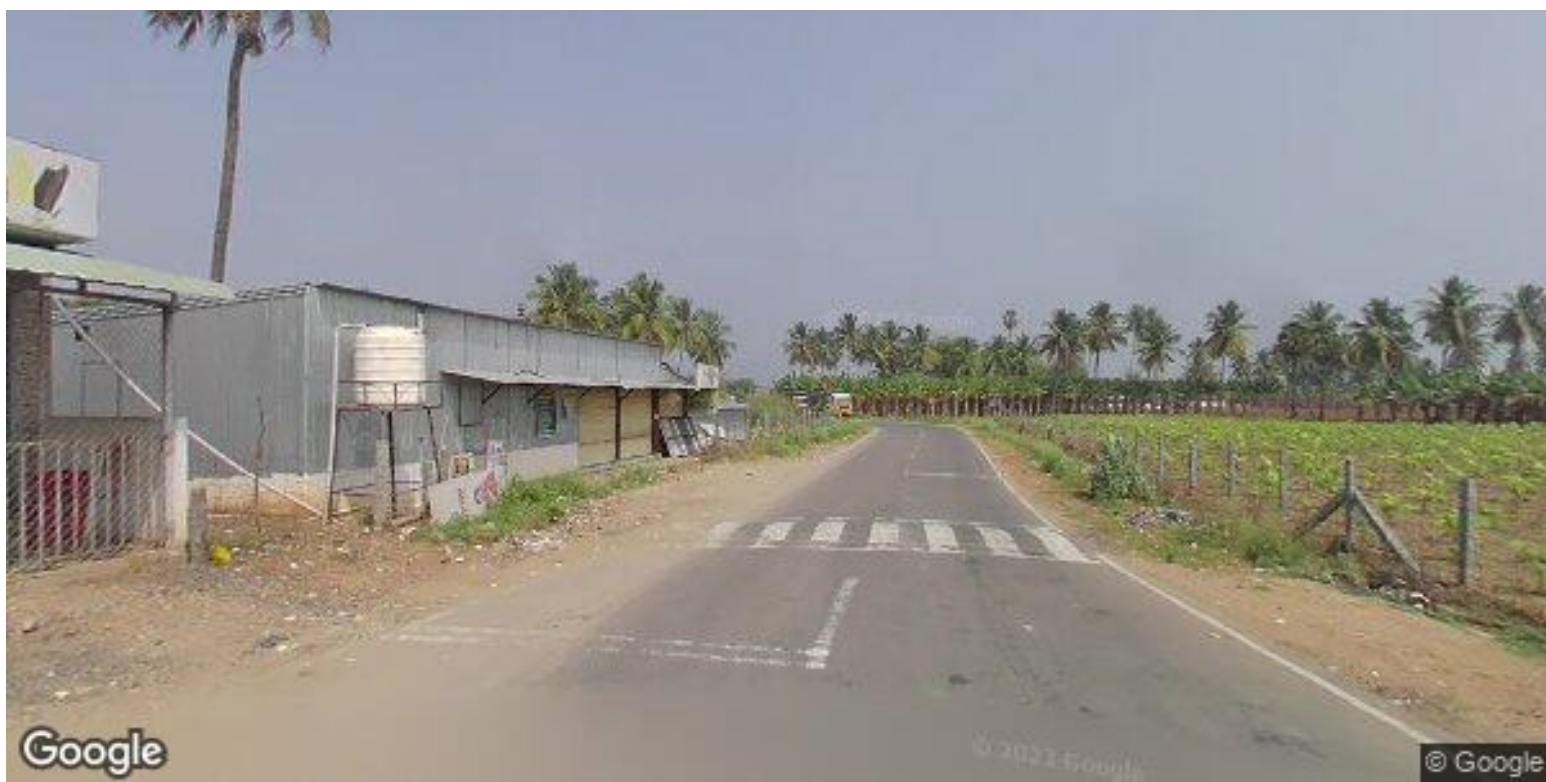
**Risk Type:** Turn

**Risk Level:** High

**Speed Limit:** 15 KM/Hr

**Coordinates:** 11.47157, 77.29804

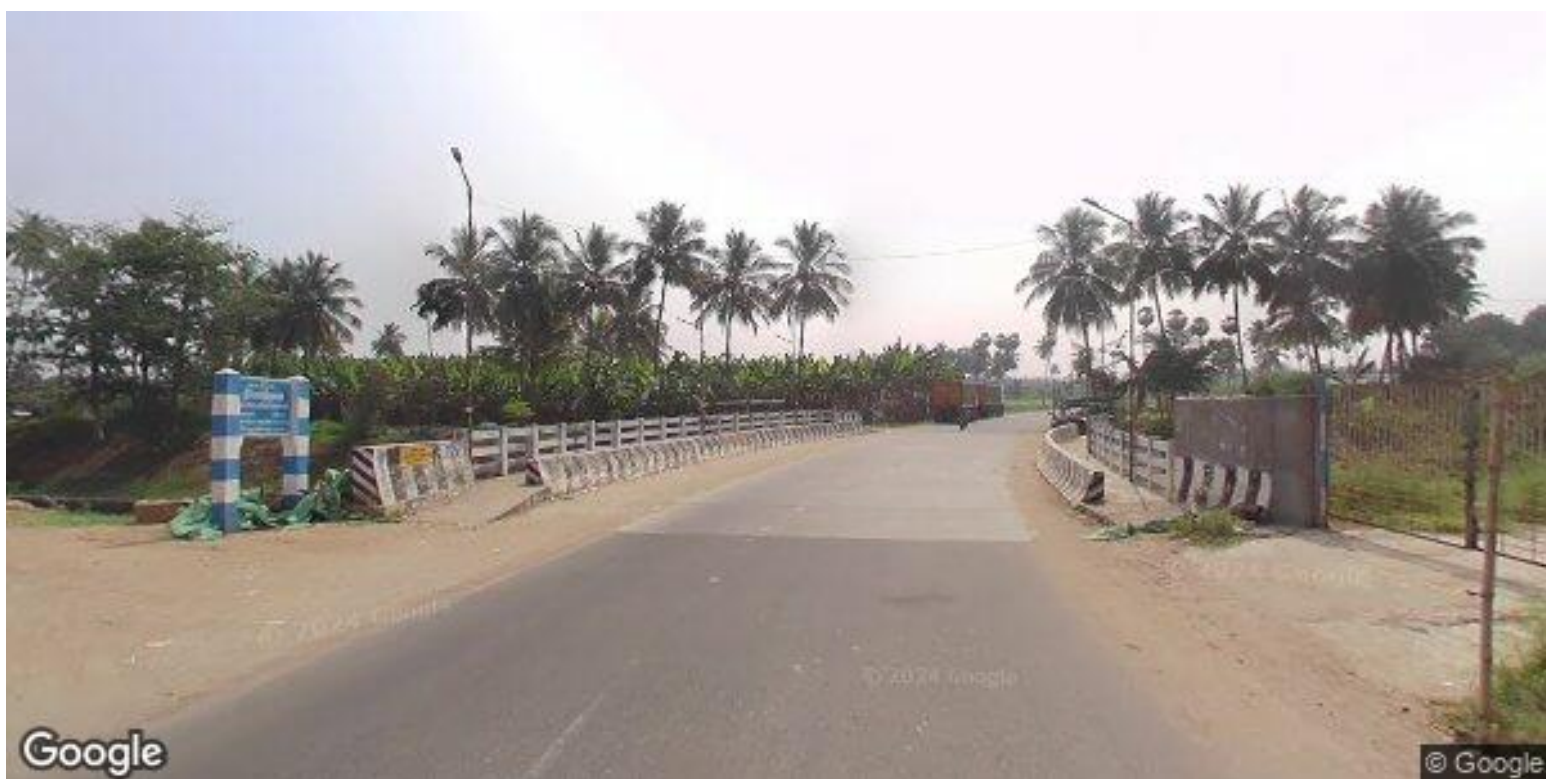
**Risk Type:** Turn

**Risk Level:** Medium

**Speed Limit:** 30 KM/Hr

**Coordinates:** 11.47294, 77.29866

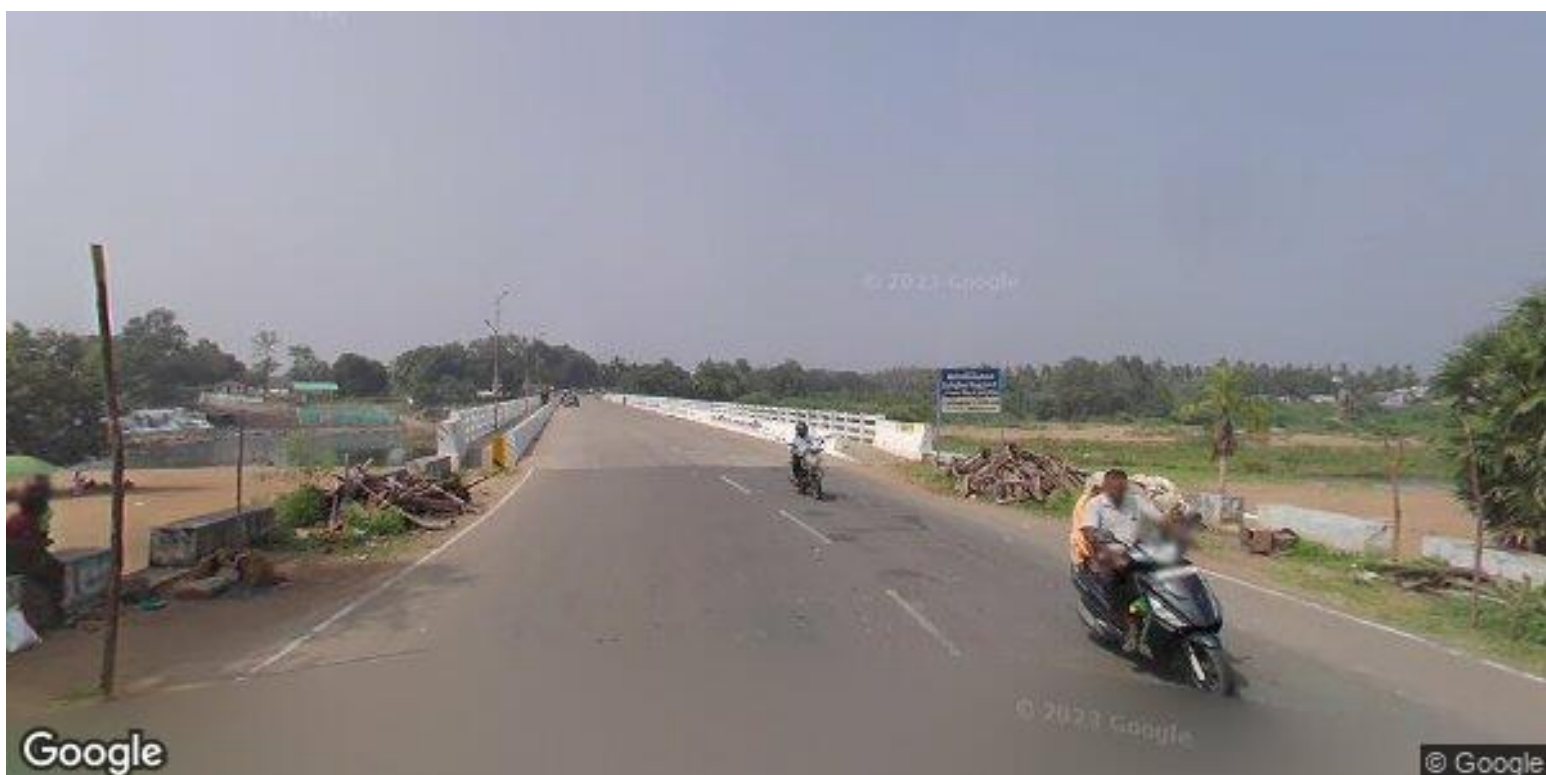
**Risk Type:** Turn  
**Risk Level:** Medium  
**Speed Limit:** 30 KM/Hr  
**Coordinates:** 11.47333, 77.29847

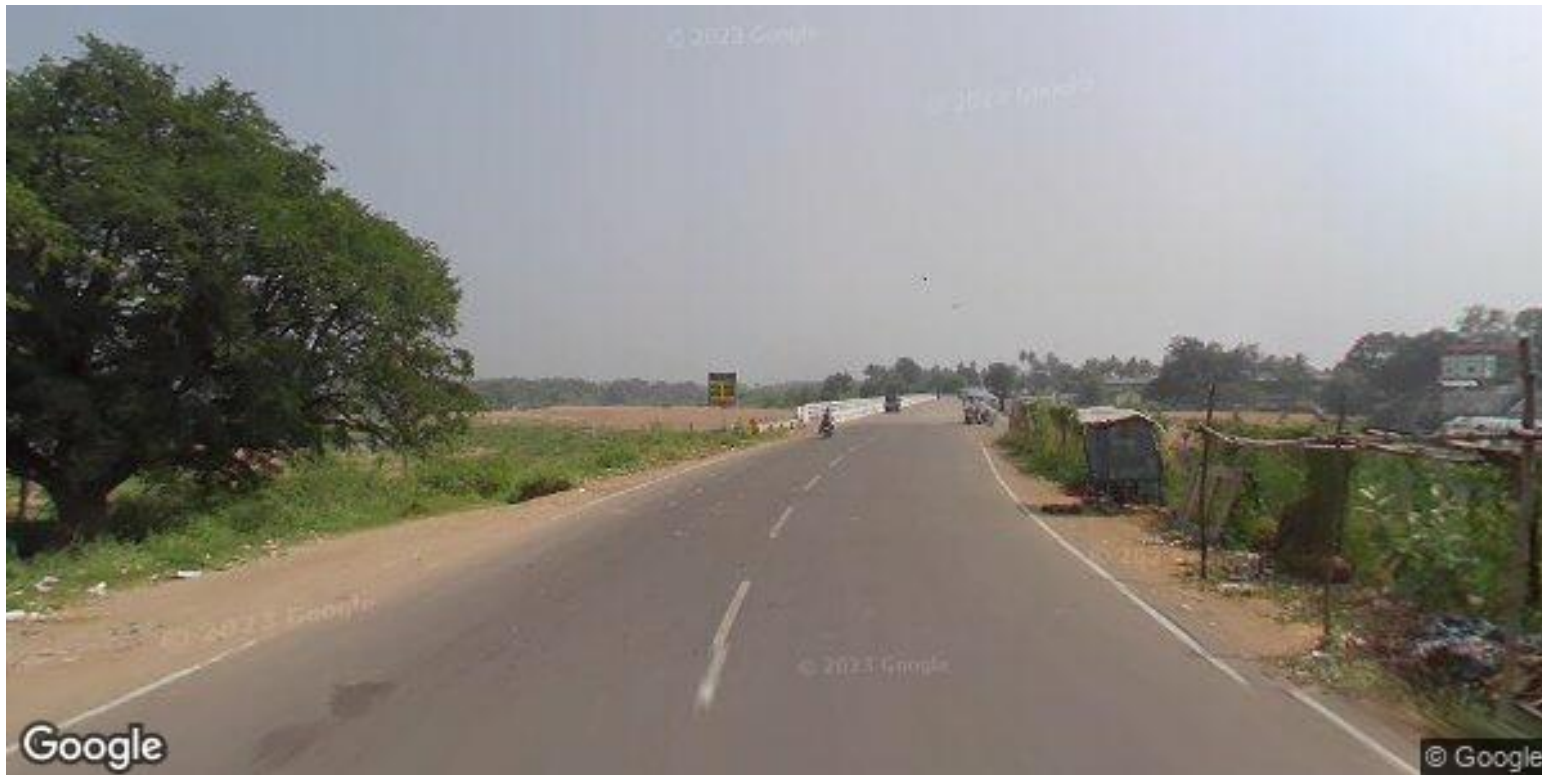
**Risk Type:** Turn  
**Risk Level:** Medium  
**Speed Limit:** 30 KM/Hr  
**Coordinates:** 11.47449, 77.29614

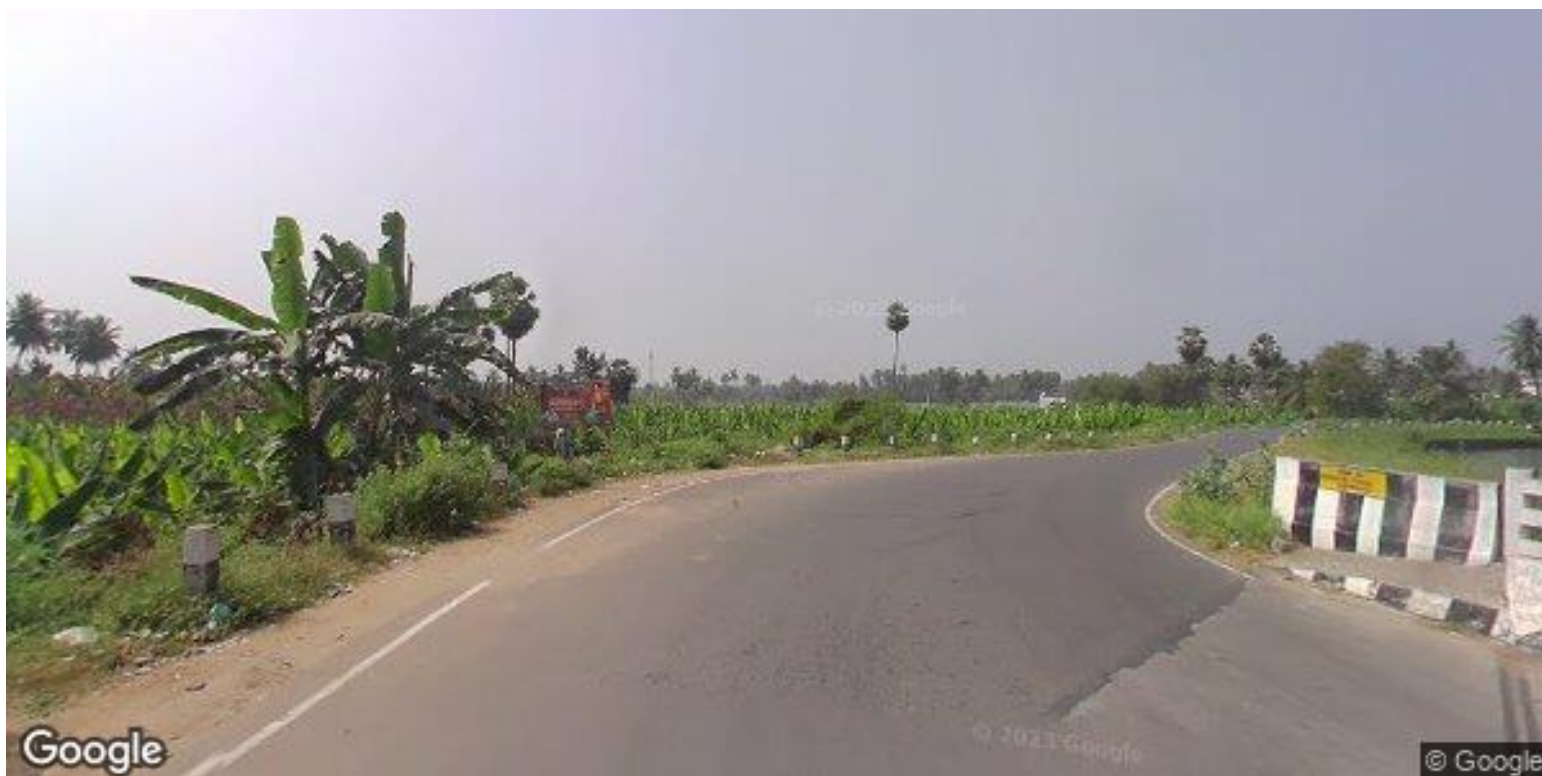
**Risk Type:** Turn  
**Risk Level:** Medium  
**Speed Limit:** 30 KM/Hr  
**Coordinates:** 11.47449, 77.29541

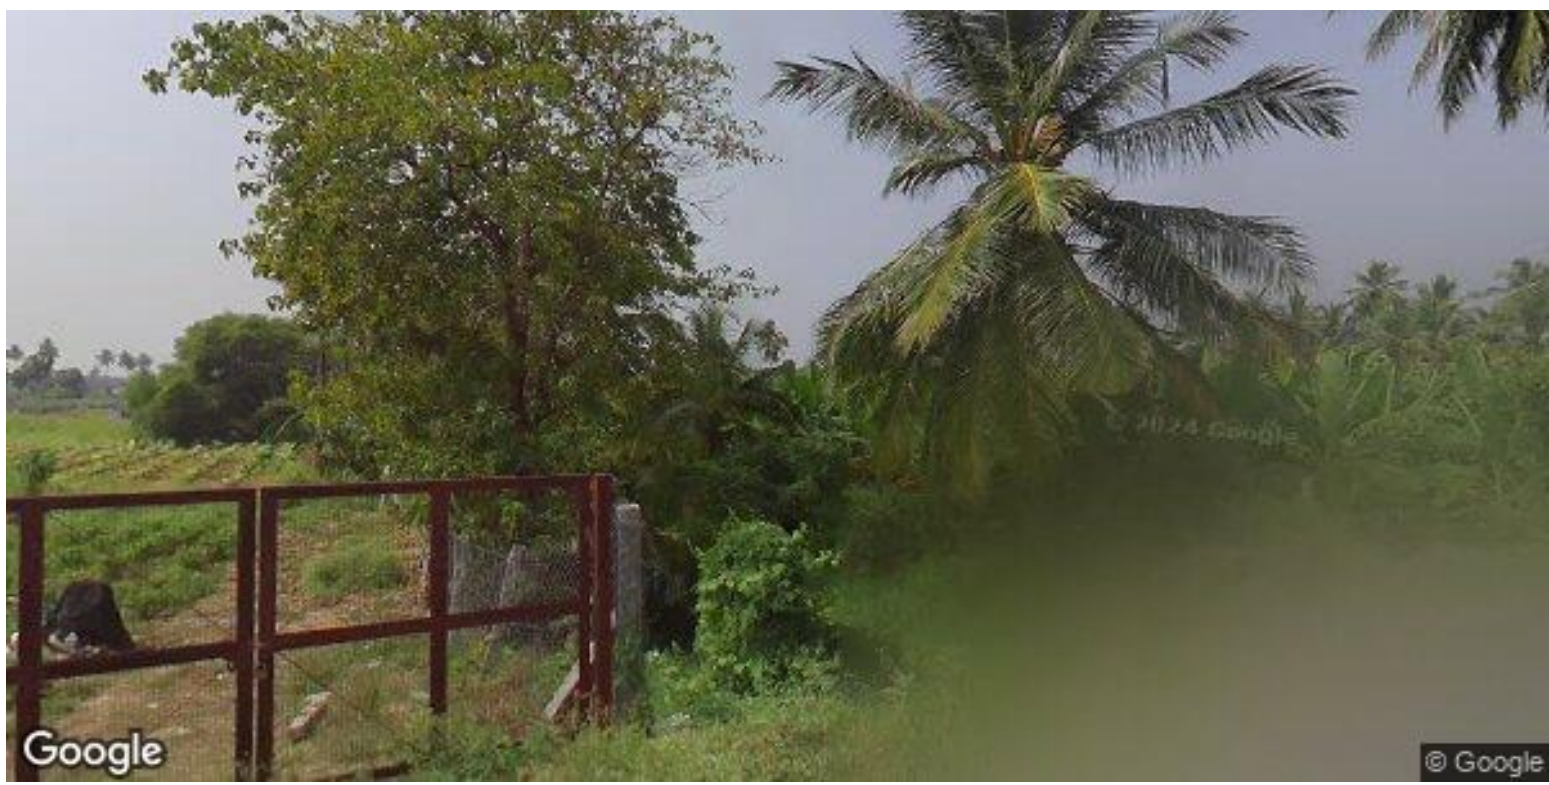
**Risk Type:** Turn

**Risk Level:** Medium

**Speed Limit:** 30 KM/Hr

**Coordinates:** 11.47525, 77.29446

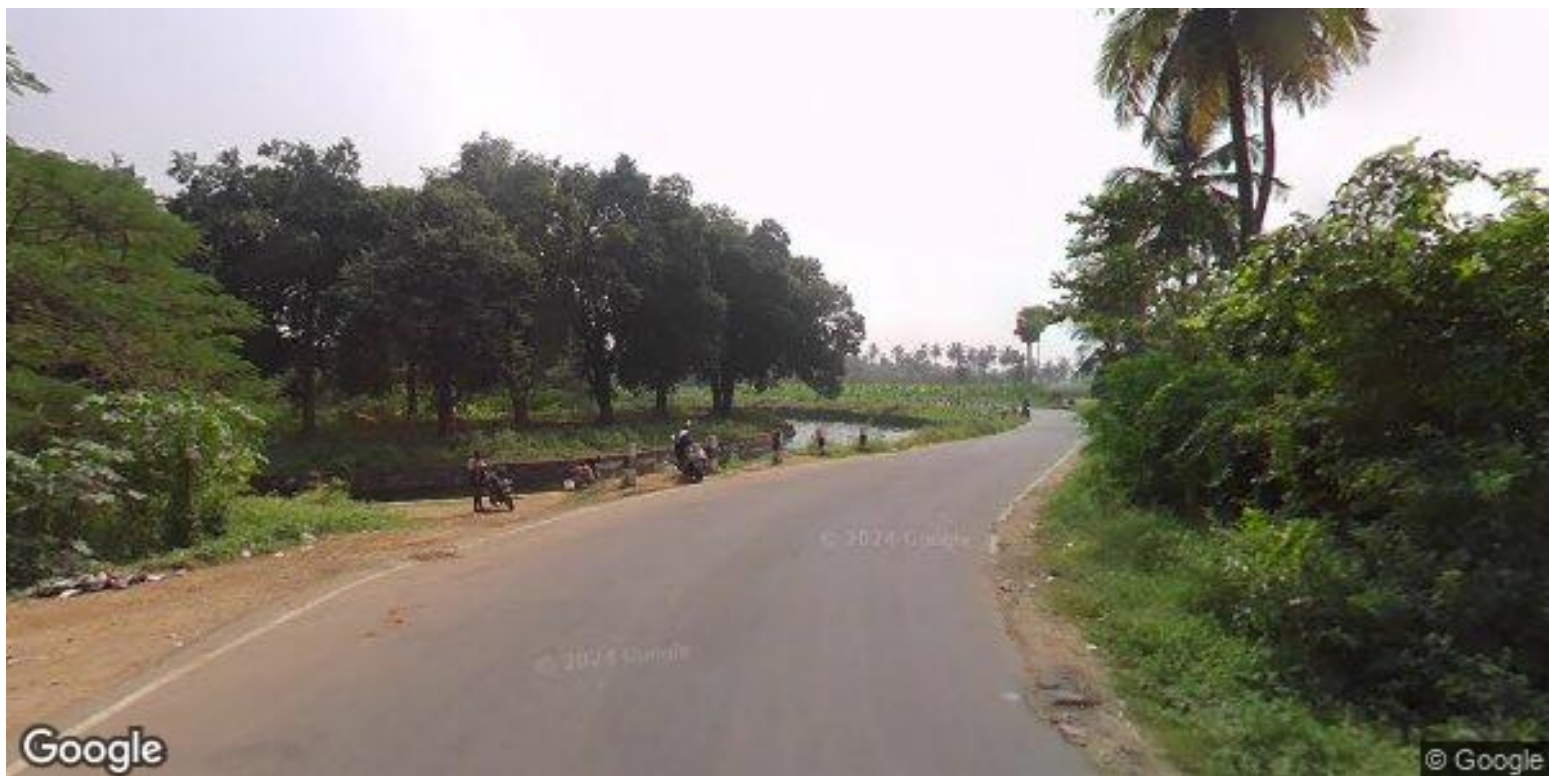
**Risk Type:** Turn

**Risk Level:** High

**Speed Limit:** 15 KM/Hr

**Coordinates:** 11.47602, 77.29451

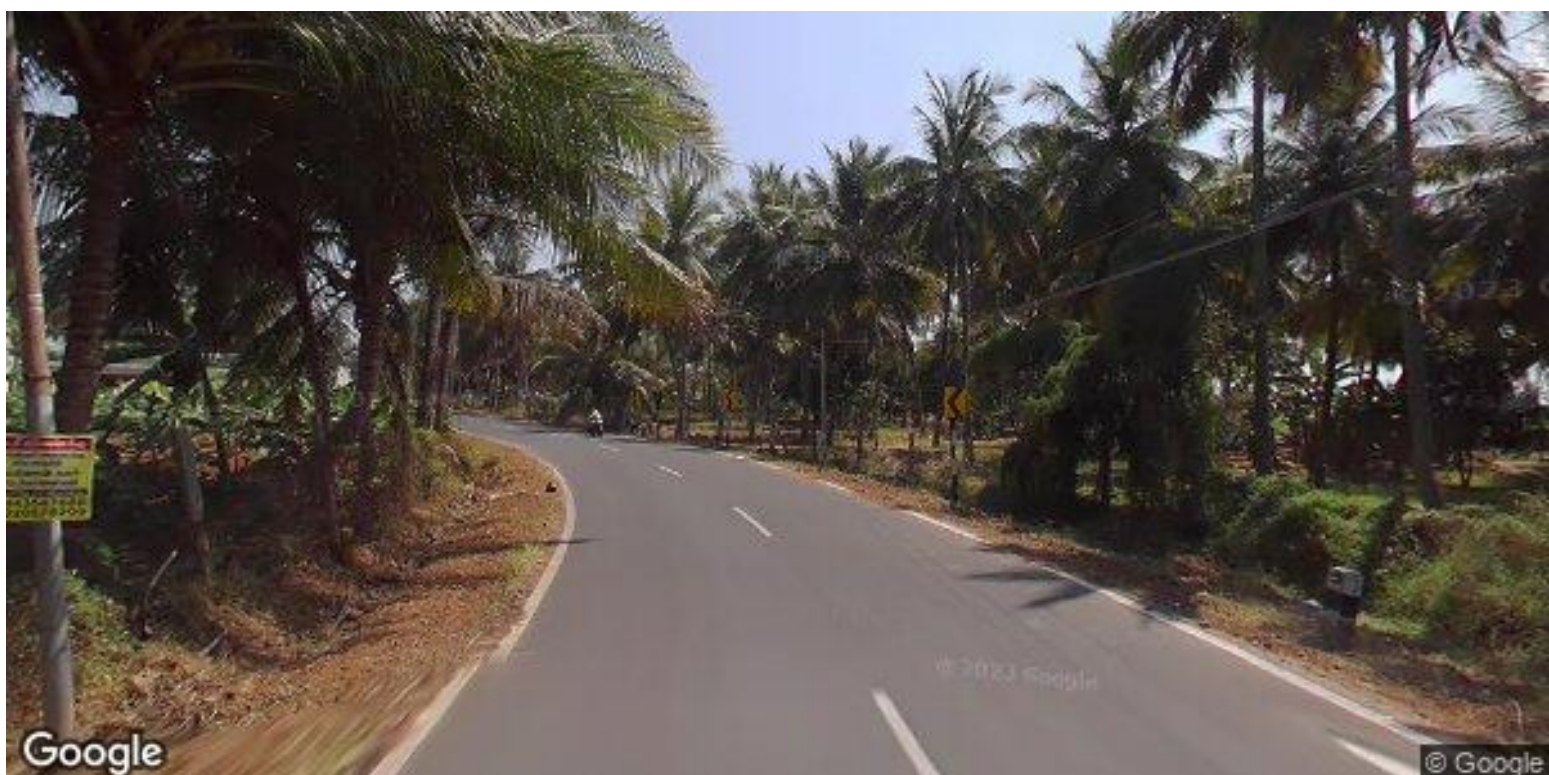
**Risk Type:** Turn  
**Risk Level:** Medium  
**Speed Limit:** 30 KM/Hr  
**Coordinates:** 11.47746, 77.28972

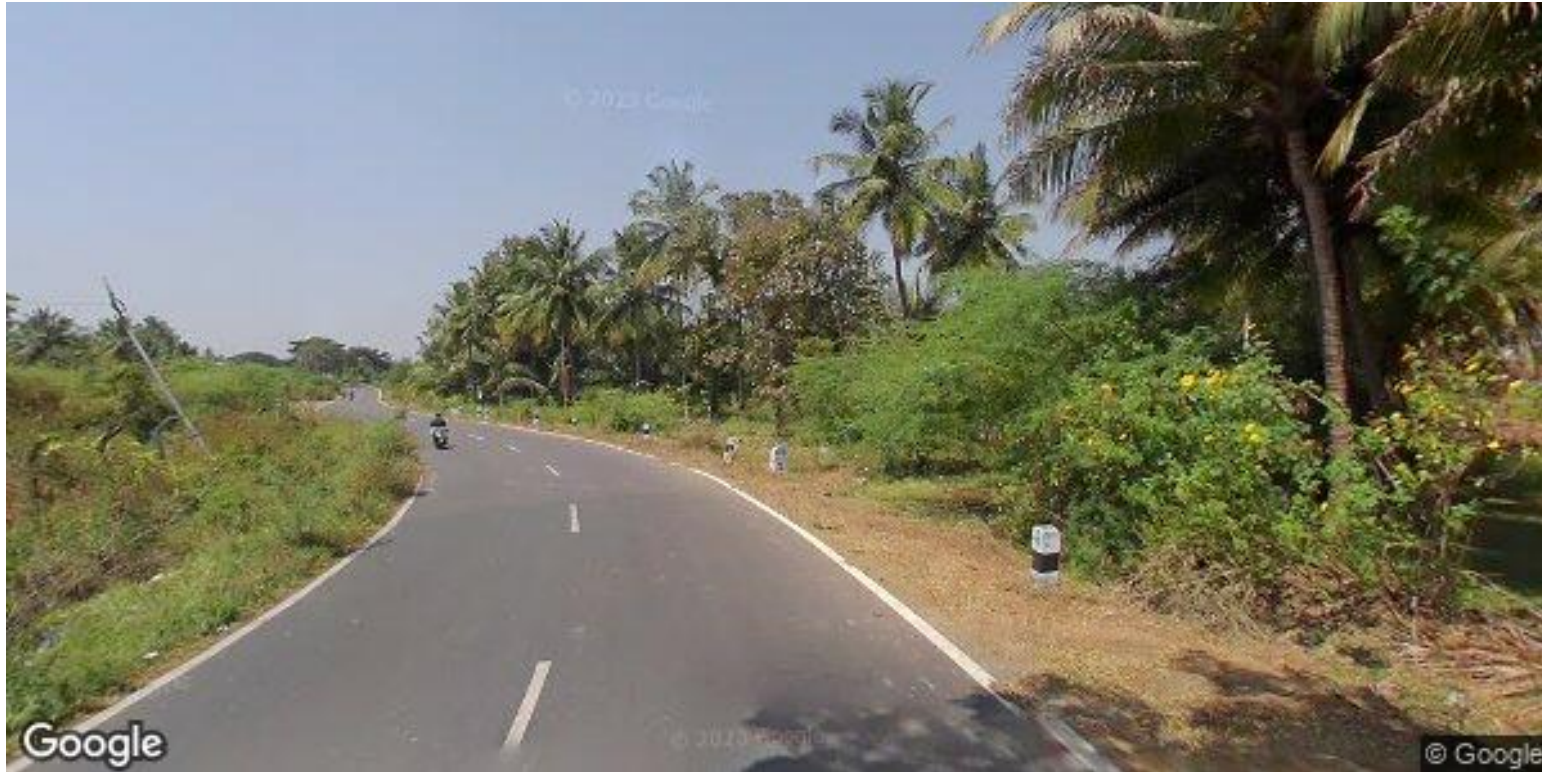
**Risk Type:** Turn  
**Risk Level:** Medium  
**Speed Limit:** 30 KM/Hr  
**Coordinates:** 11.48272, 77.28581

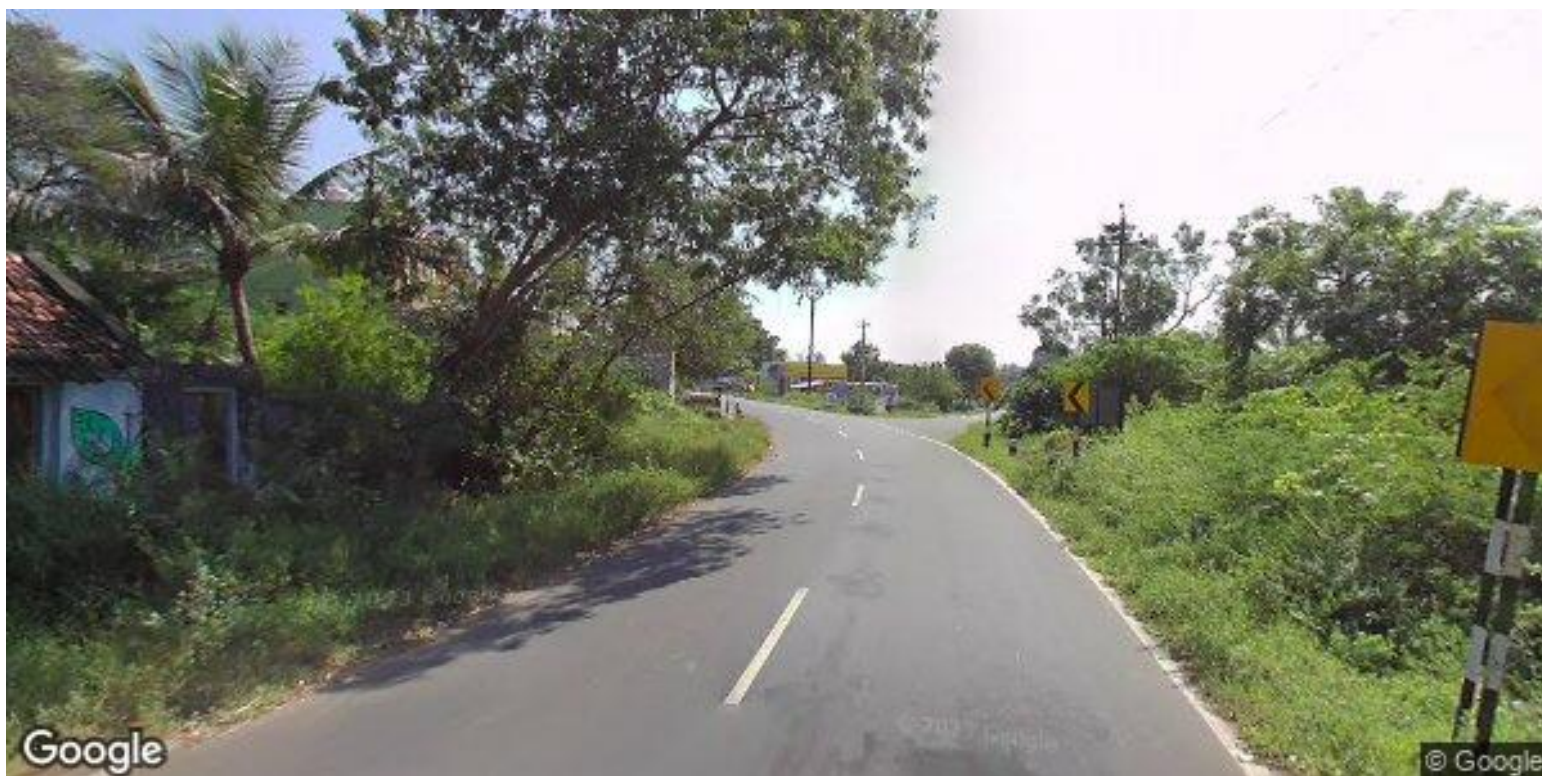
**Risk Type:** Turn  
**Risk Level:** Medium  
**Speed Limit:** 30 KM/Hr  
**Coordinates:** 11.49558, 77.25638

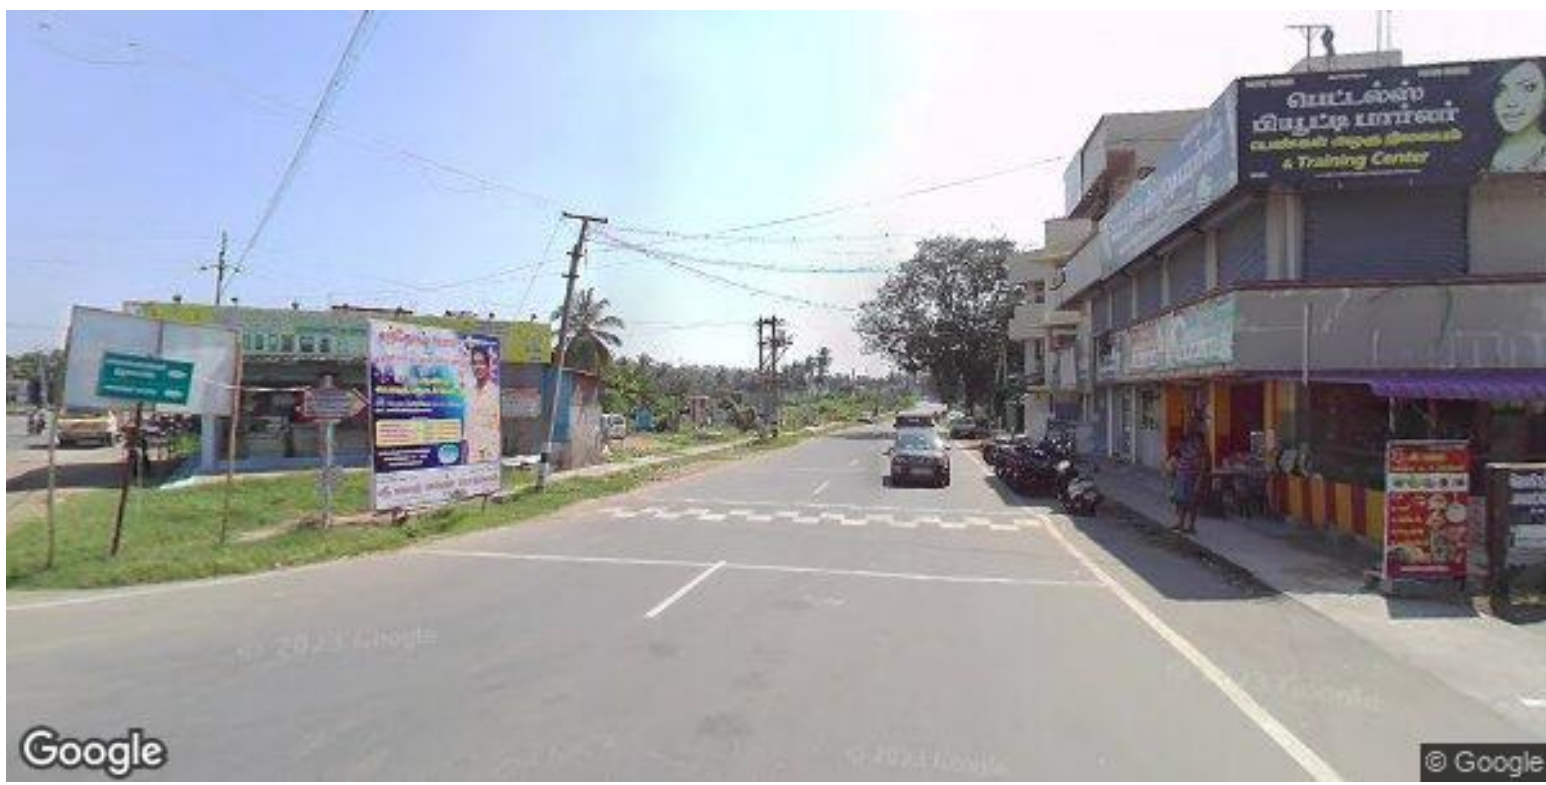
**Risk Type:** Turn

**Risk Level:** Medium

**Speed Limit:** 30 KM/Hr

**Coordinates:** 11.50737, 77.25025

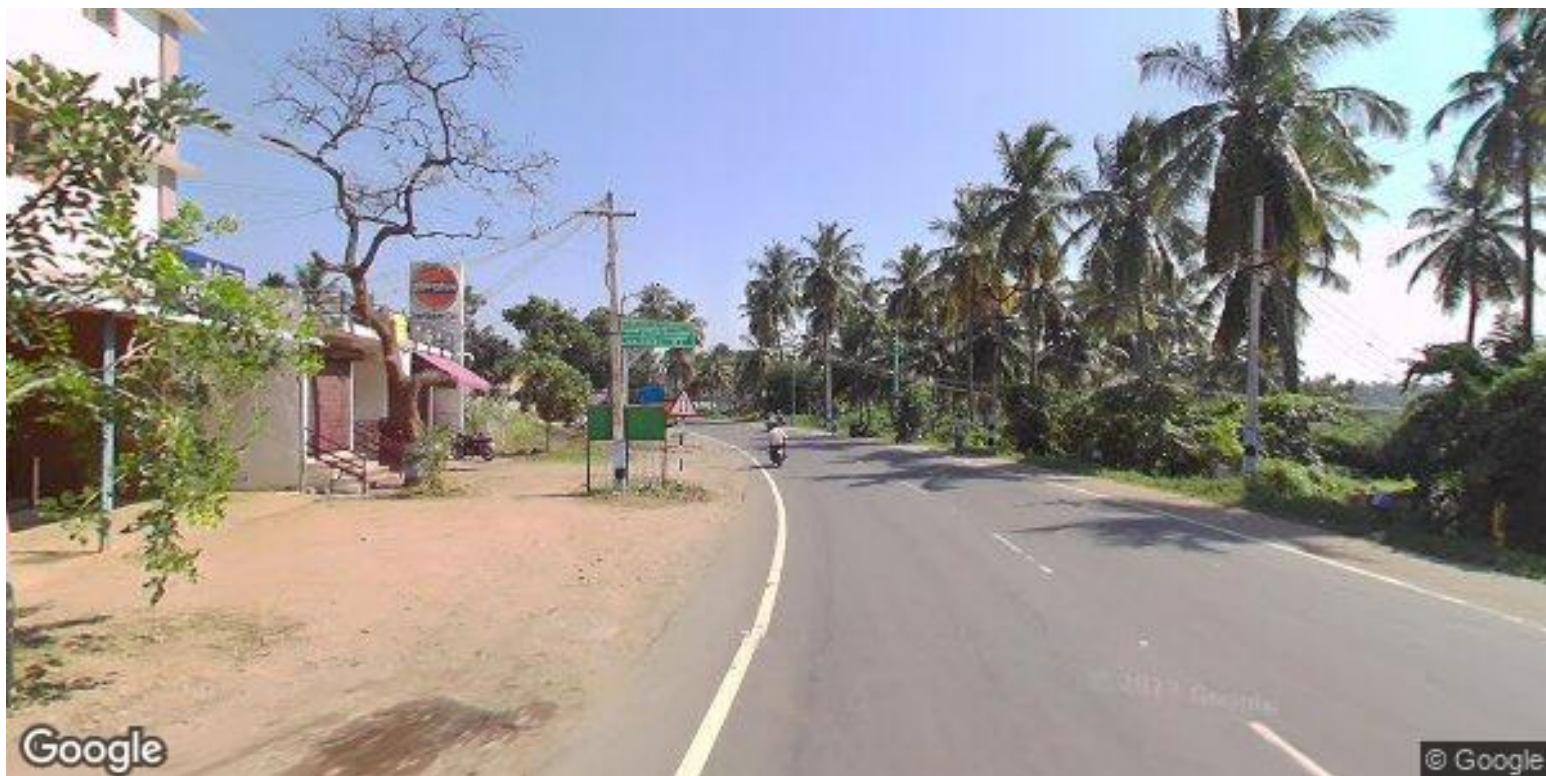
**Risk Type:** Turn

**Risk Level:** Medium

**Speed Limit:** 30 KM/Hr

**Coordinates:** 11.50939, 77.22974

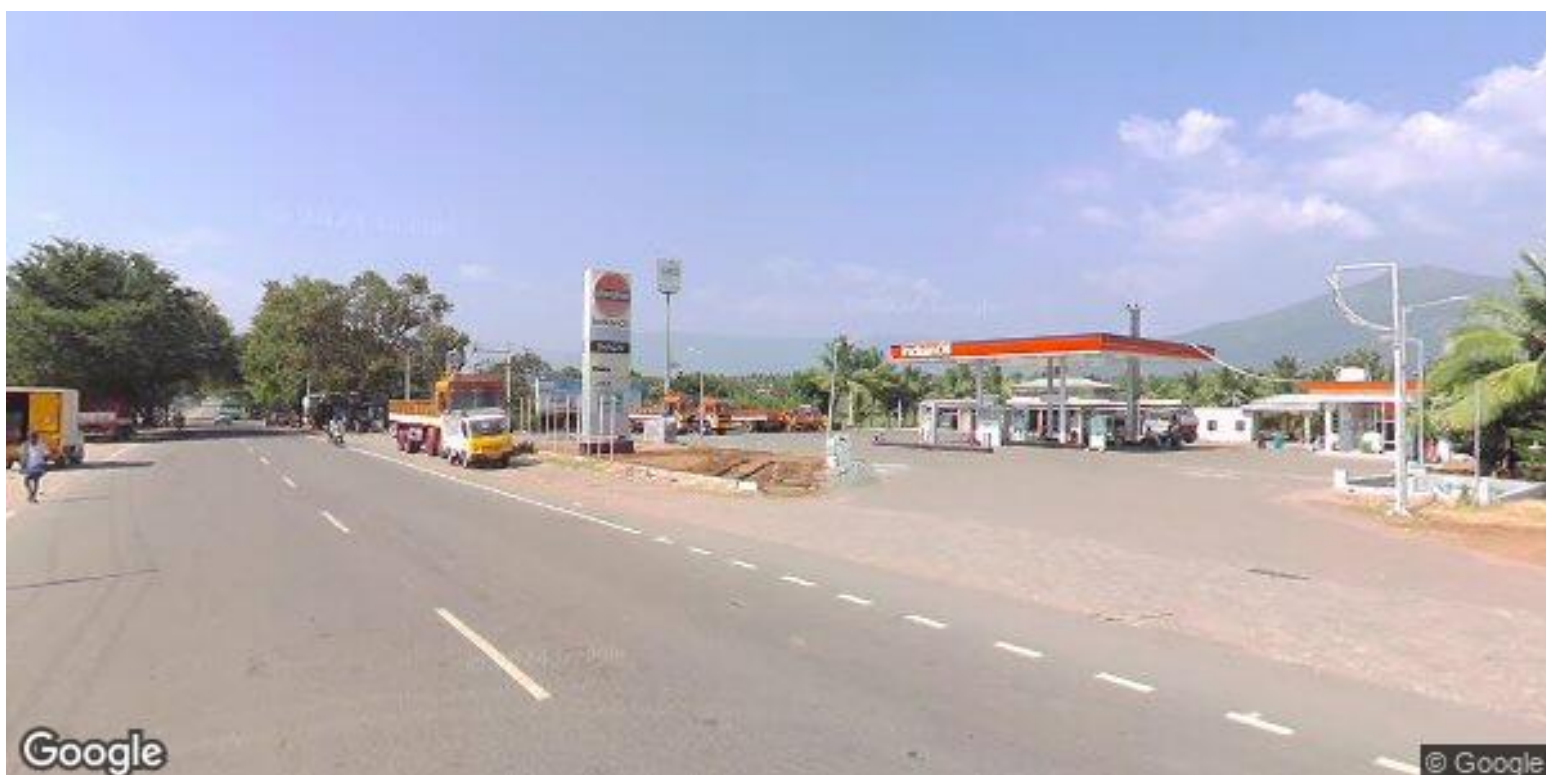
**Risk Type:** Turn

**Risk Level:** High

**Speed Limit:** 15 KM/Hr

**Coordinates:** 11.51961, 77.21565

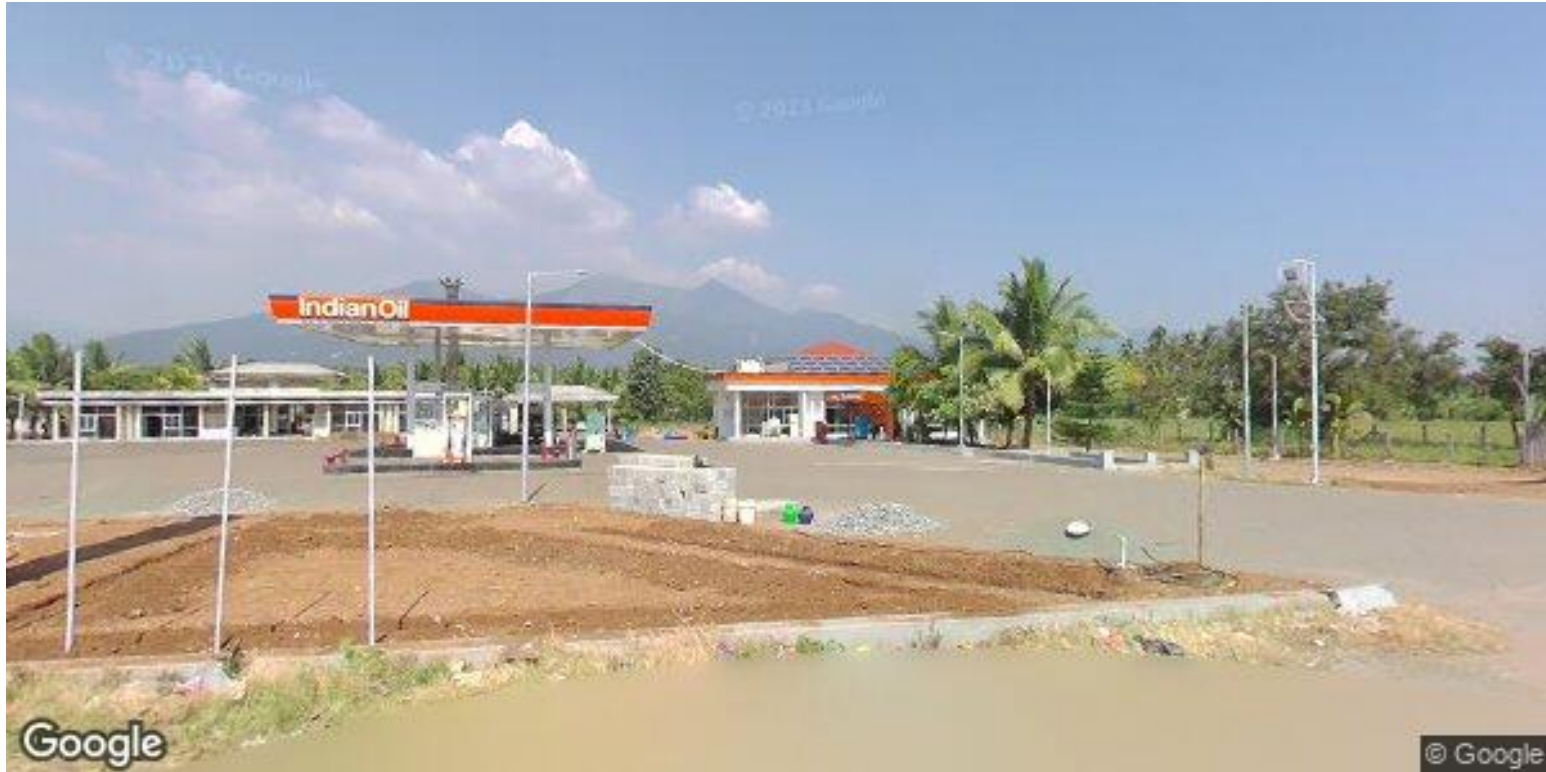
**Risk Type:** Turn

**Risk Level:** Medium

**Speed Limit:** 30 KM/Hr

**Coordinates:** 11.51990, 77.21564
