# IndianOil

## JOURNEY RISK MANAGEMENT (JRM) STUDY

### Salem Terminal to Sri Valli Agencies

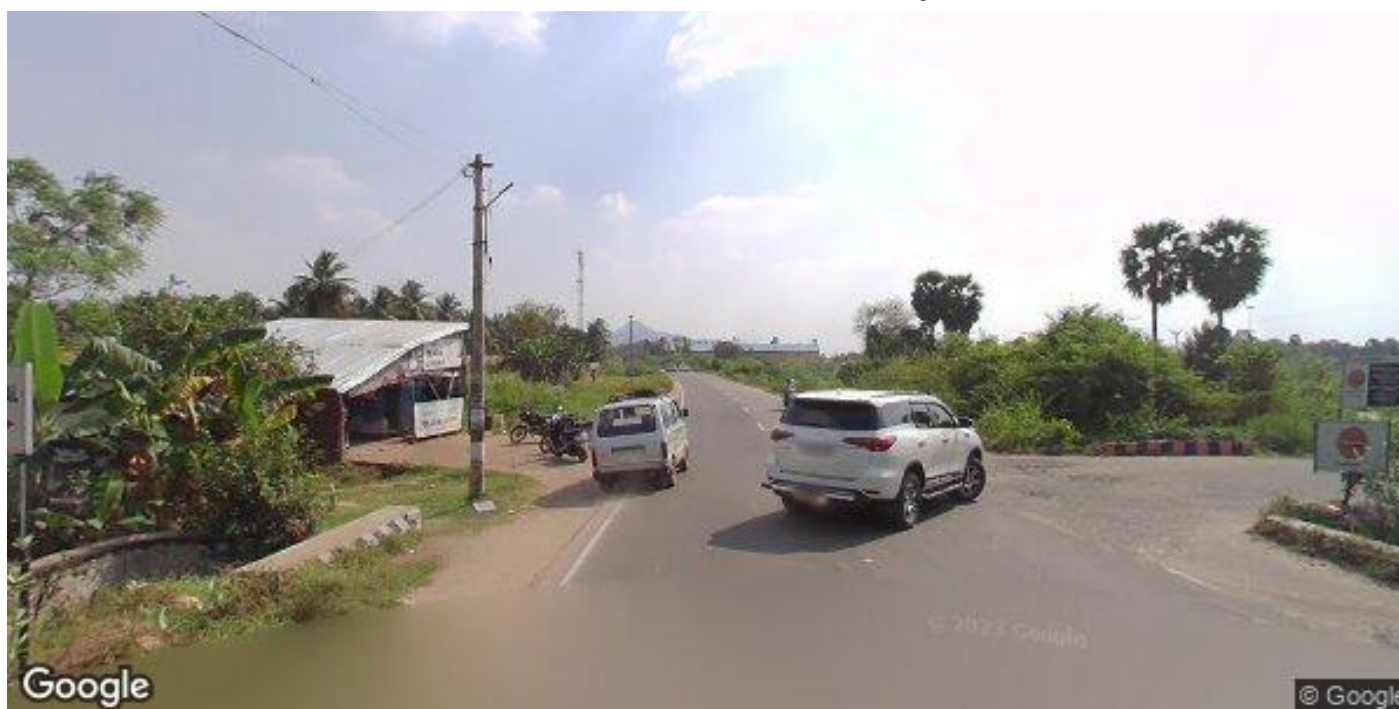
**Risk Type:** Turn  
**Risk Level:** High  
**Speed Limit:** 15 KM/Hr  
**Coordinates:** 11.44029, 77.87544

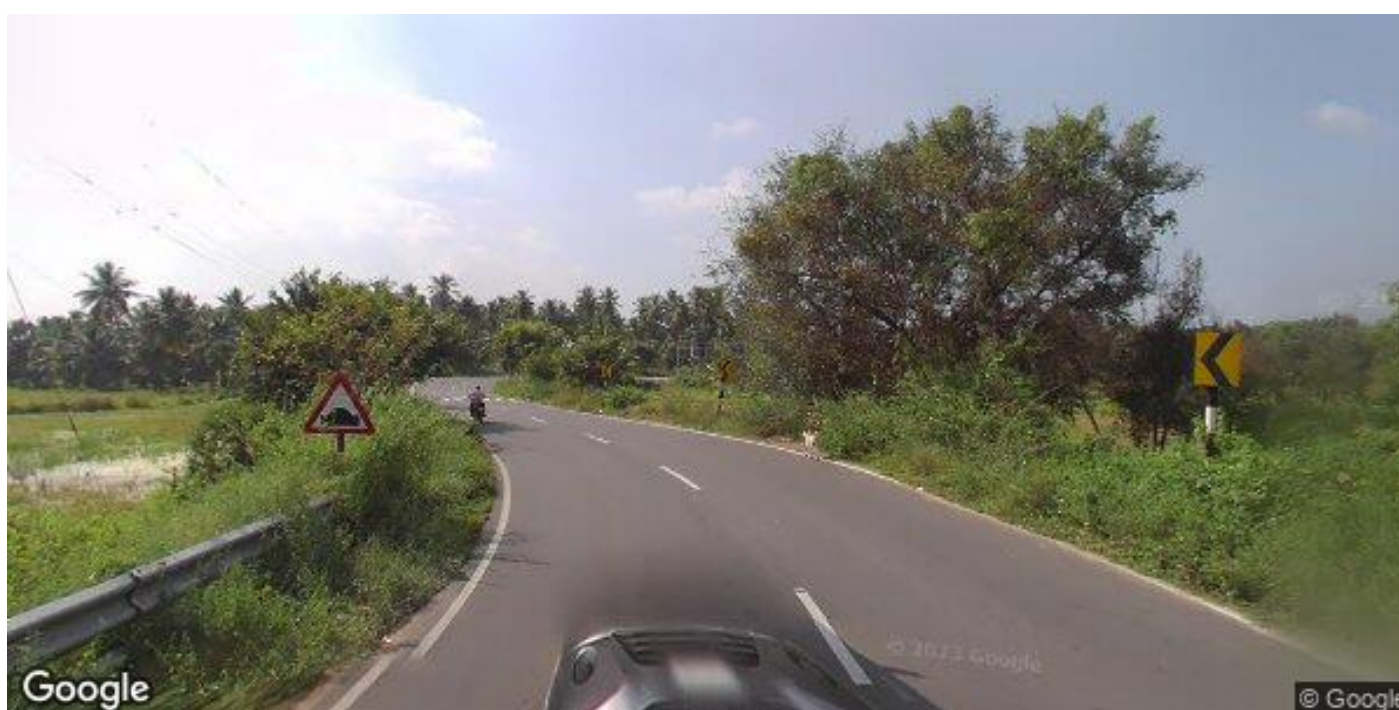
**Risk Type:** Turn  
**Risk Level:** Medium  
**Speed Limit:** 30 KM/Hr  
**Coordinates:** 11.45358, 77.85781

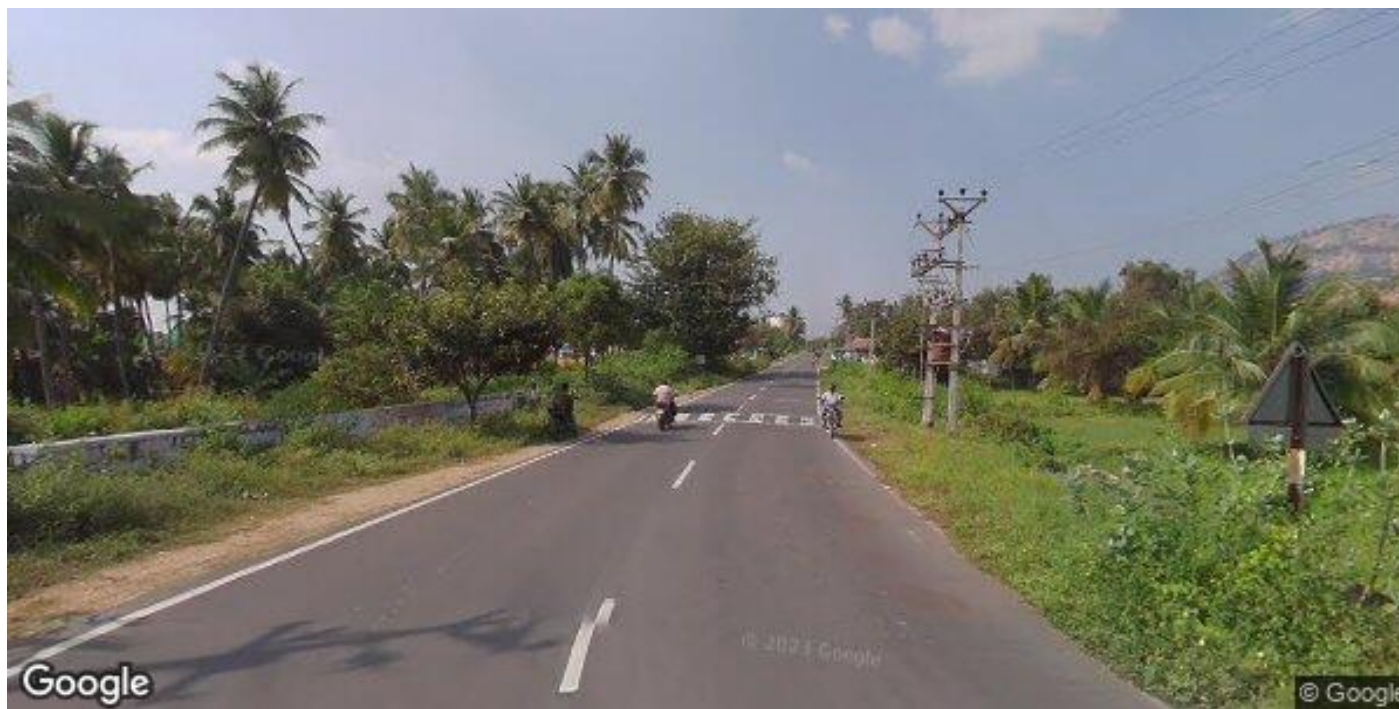
**Risk Type:** Turn  
**Risk Level:** High  
**Speed Limit:** 15 KM/Hr  
**Coordinates:** 11.45353, 77.85697

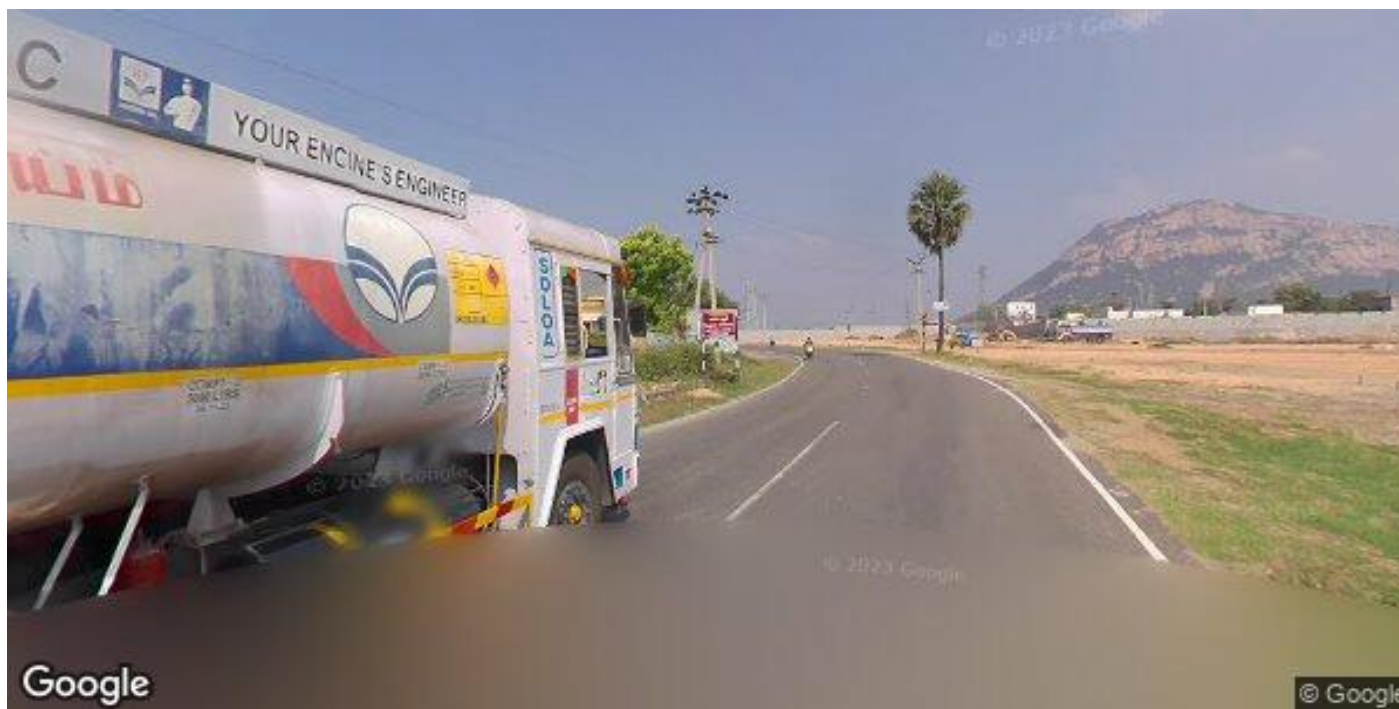
**Risk Type:** Turn  
**Risk Level:** Medium  
**Speed Limit:** 30 KM/Hr  
**Coordinates:** 11.45853, 77.85139

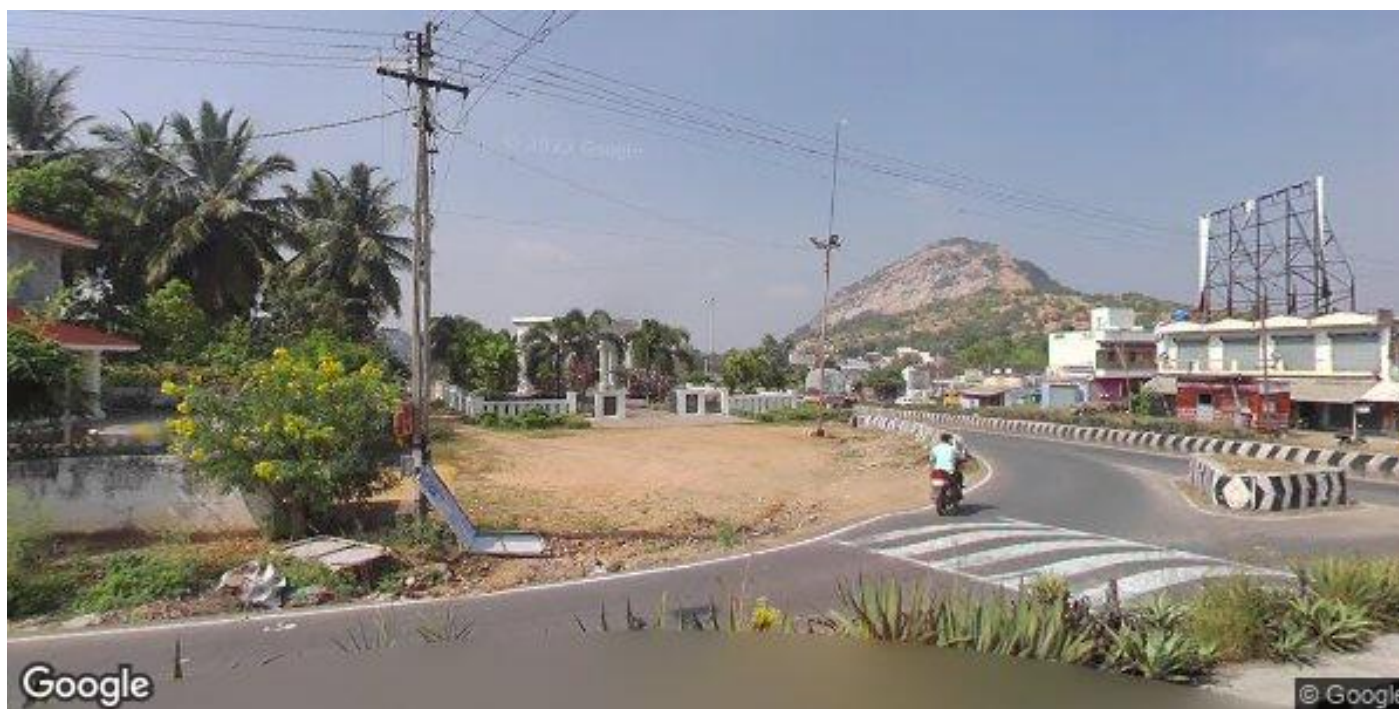
**Risk Type:** Turn  
**Risk Level:** Medium  
**Speed Limit:** 30 KM/Hr  
**Coordinates:** 11.46307, 77.84941

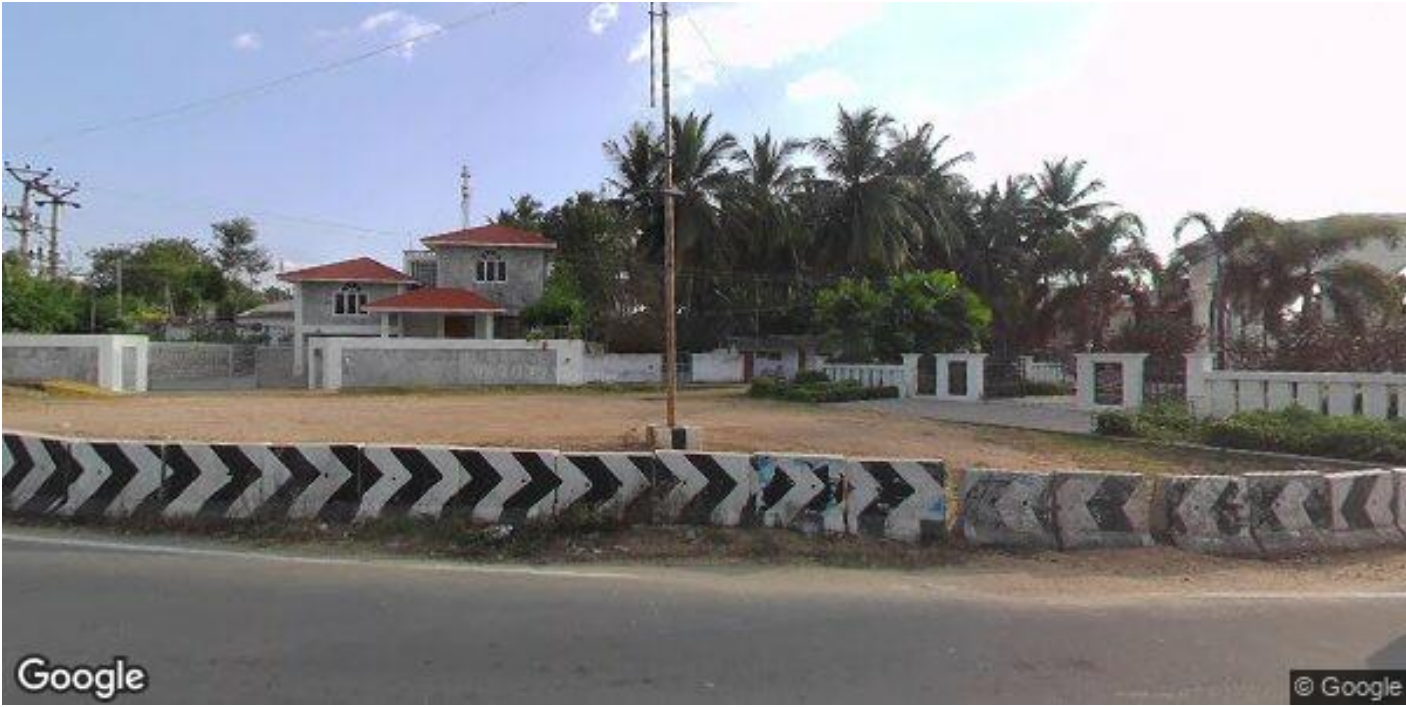
**Risk Type:** Turn  
**Risk Level:** Medium  
**Speed Limit:** 30 KM/Hr  
**Coordinates:** 11.46316, 77.84921

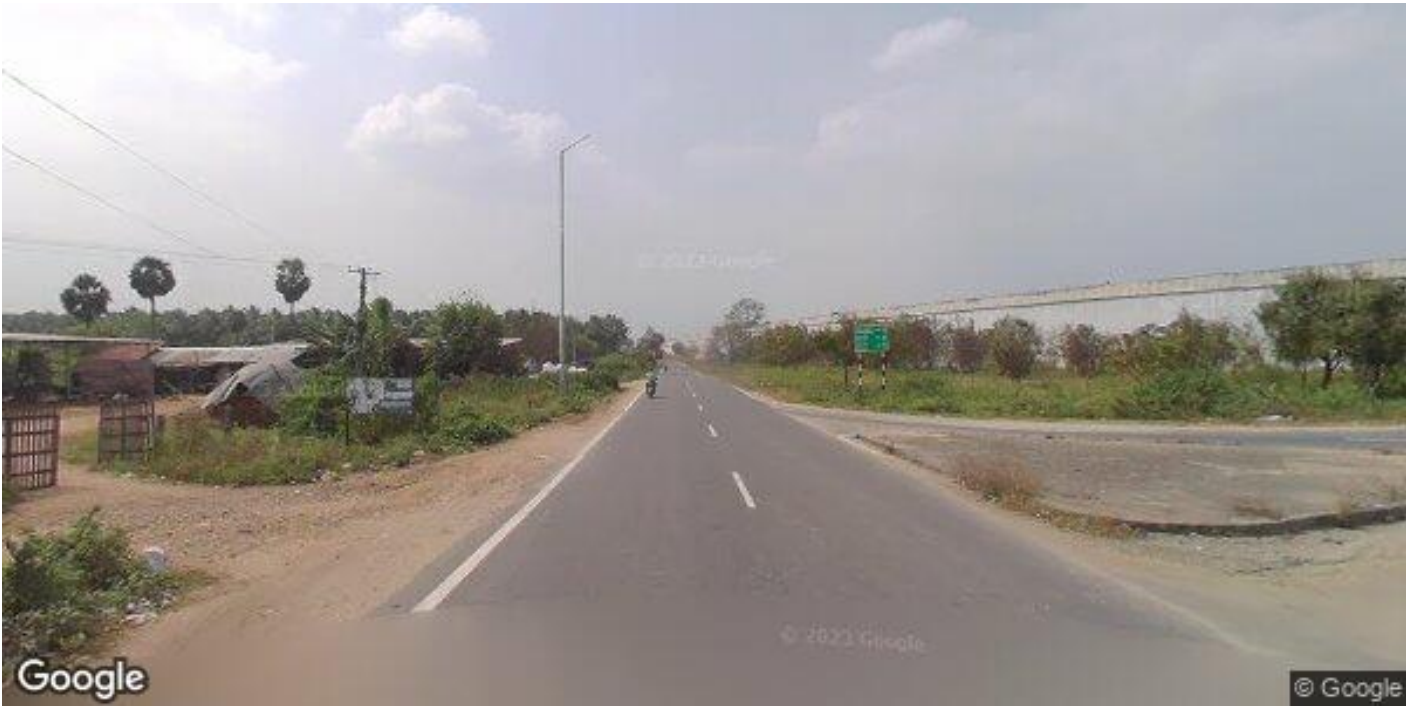
**Risk Type:** Turn  
**Risk Level:** High  
**Speed Limit:** 15 KM/Hr  
**Coordinates:** 11.45542, 77.81725

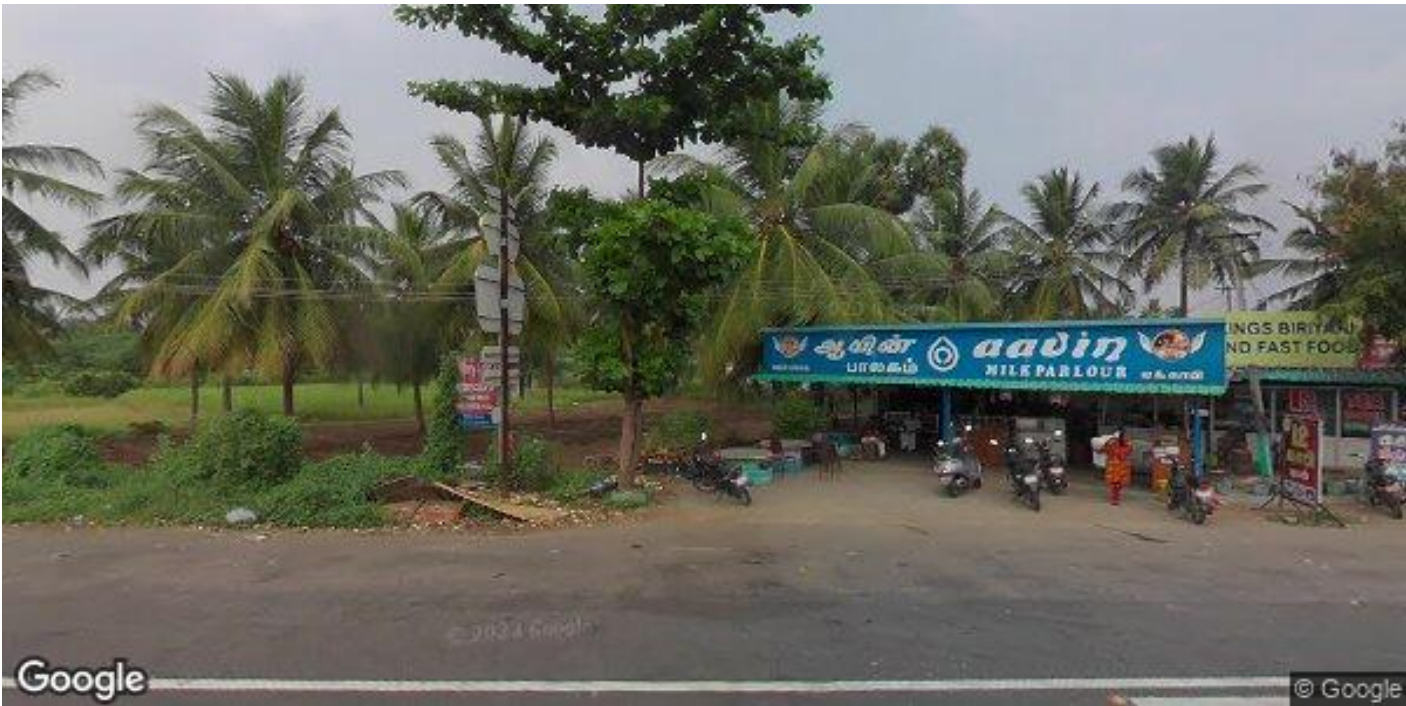
**Risk Type:** Blind Spot  
**Risk Level:** Blind Spot  
**Speed Limit:** 10 KM/Hr  
**Coordinates:** 11.45631, 77.81668

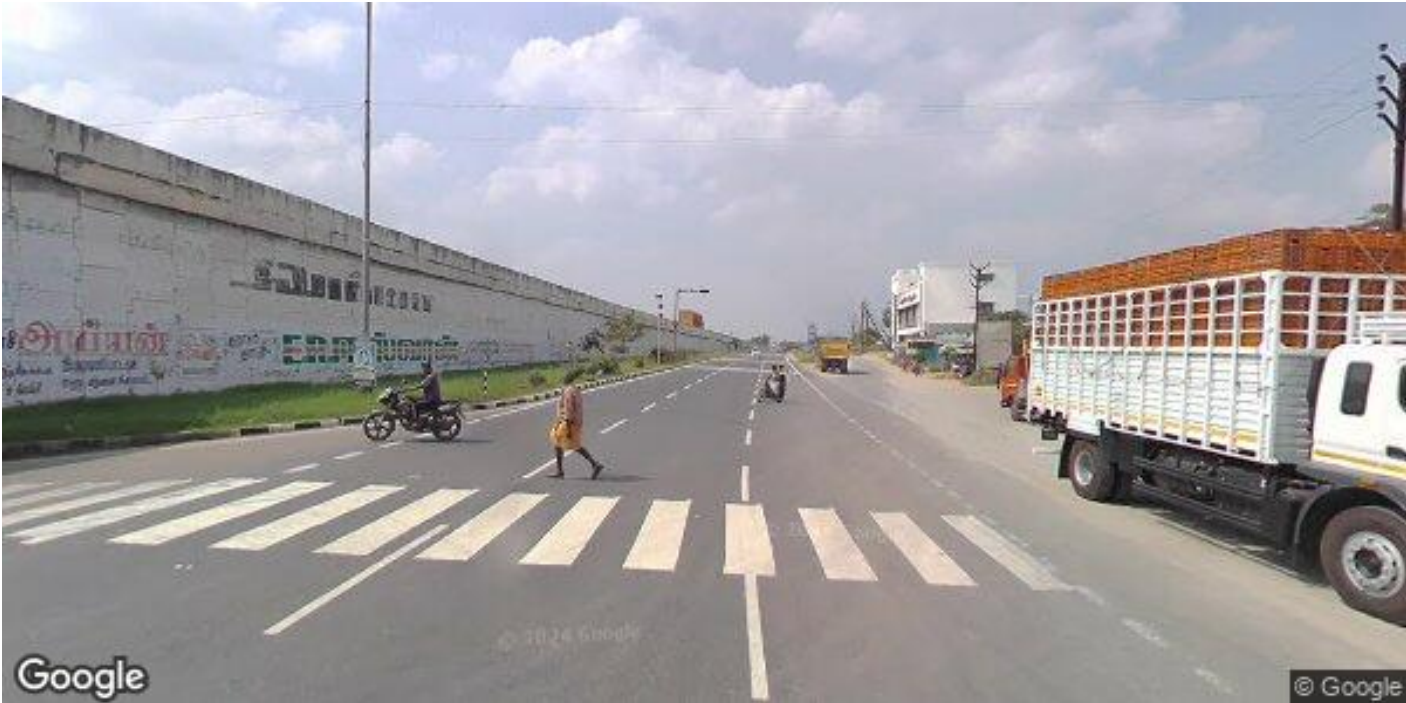
**Risk Type:** Turn  
**Risk Level:** High  
**Speed Limit:** 15 KM/Hr  
**Coordinates:** 11.49224, 77.89606

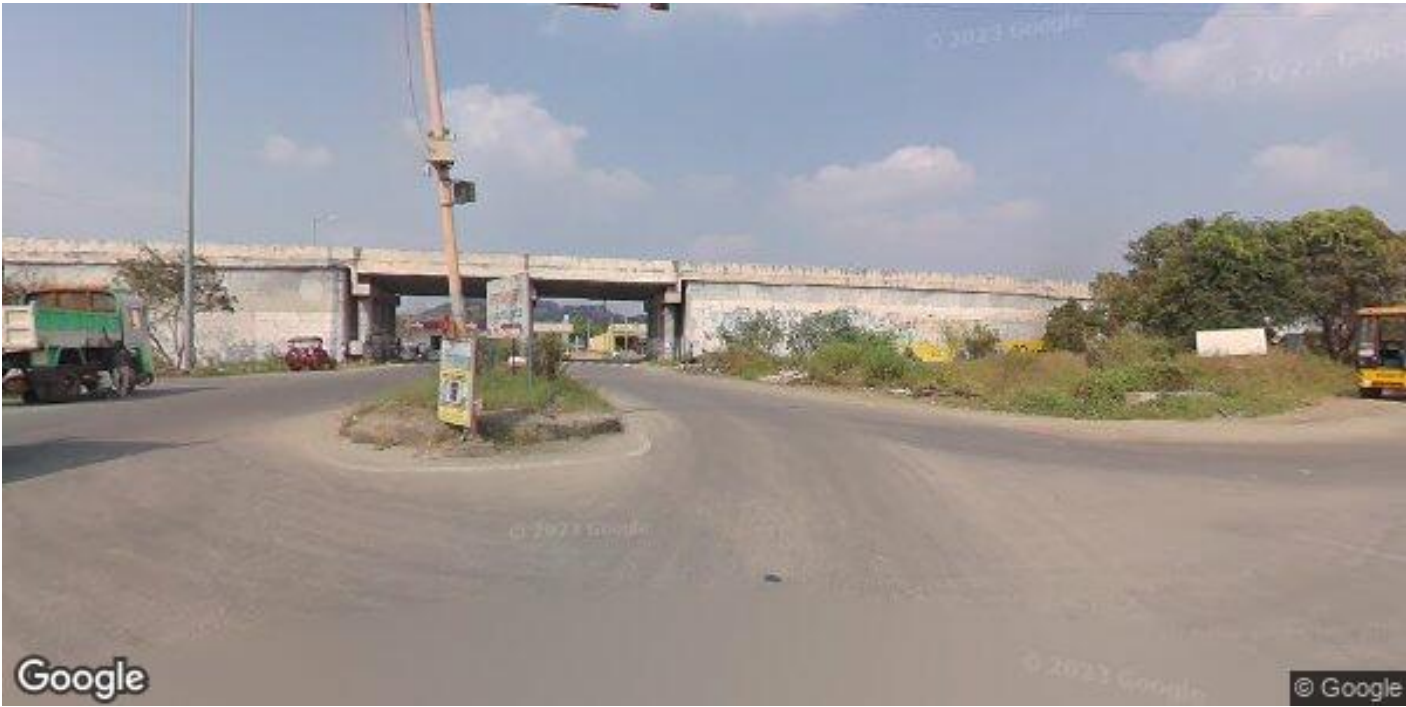
**Risk Type:** Turn  
**Risk Level:** High  
**Speed Limit:** 15 KM/Hr  
**Coordinates:** 11.49153, 77.89615

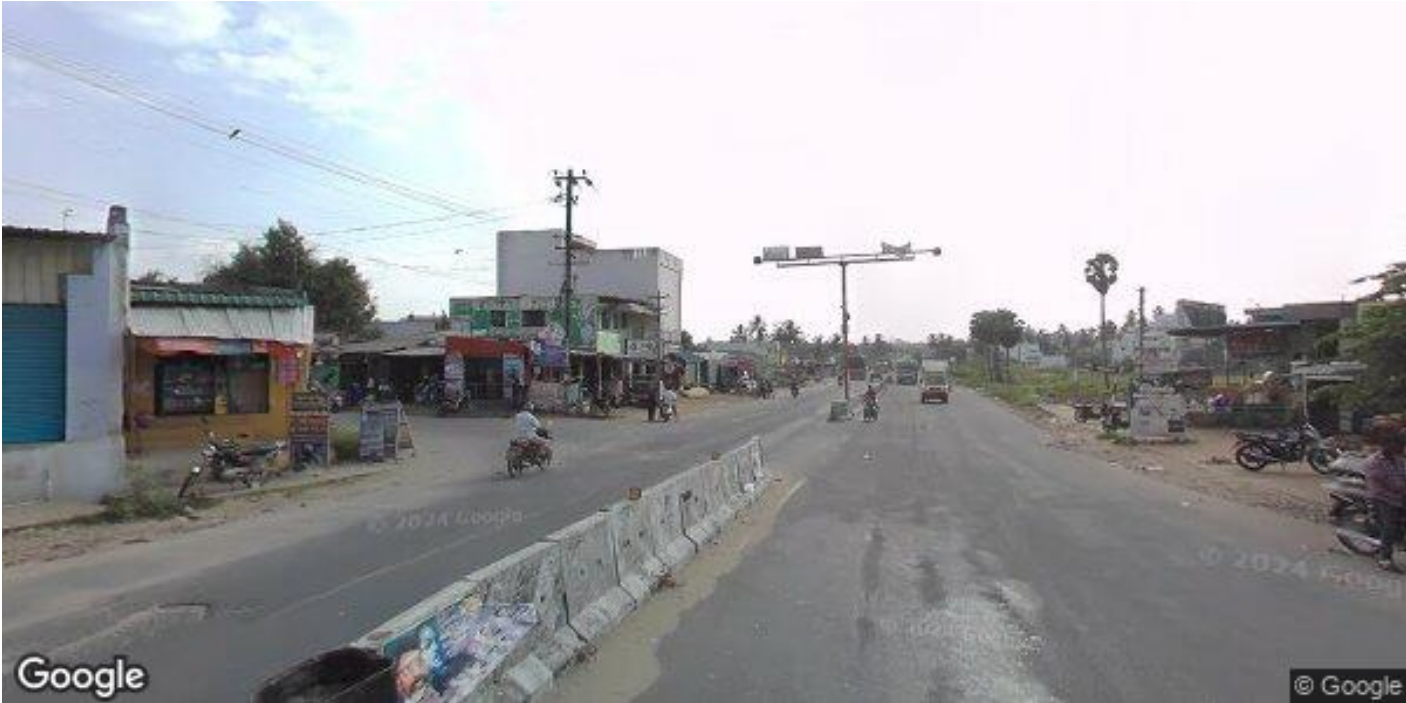
**Risk Type:** Blind Spot  
**Risk Level:** Blind Spot  
**Speed Limit:** 10 KM/Hr  
**Coordinates:** 11.48364, 77.88780

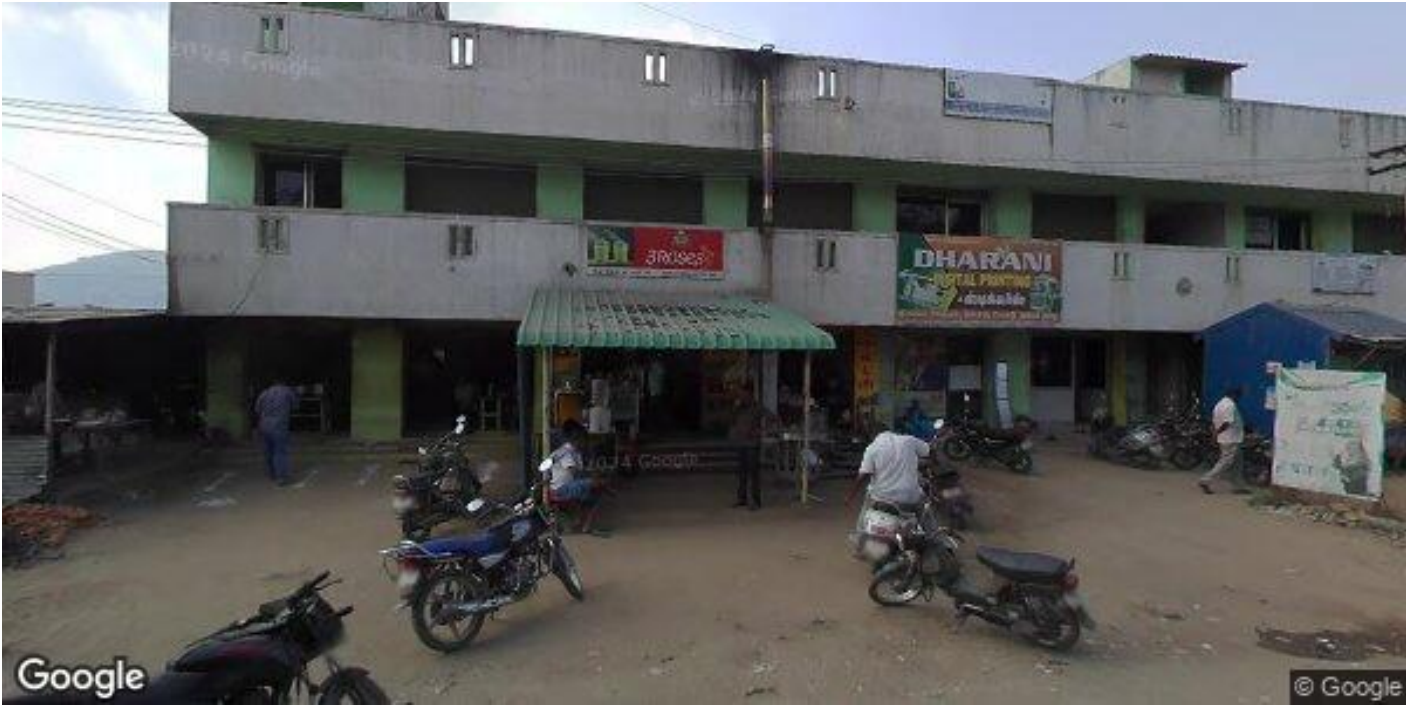
**Risk Type:** Turn  
**Risk Level:** Medium  
**Speed Limit:** 30 KM/Hr  
**Coordinates:** 11.49155, 77.88776

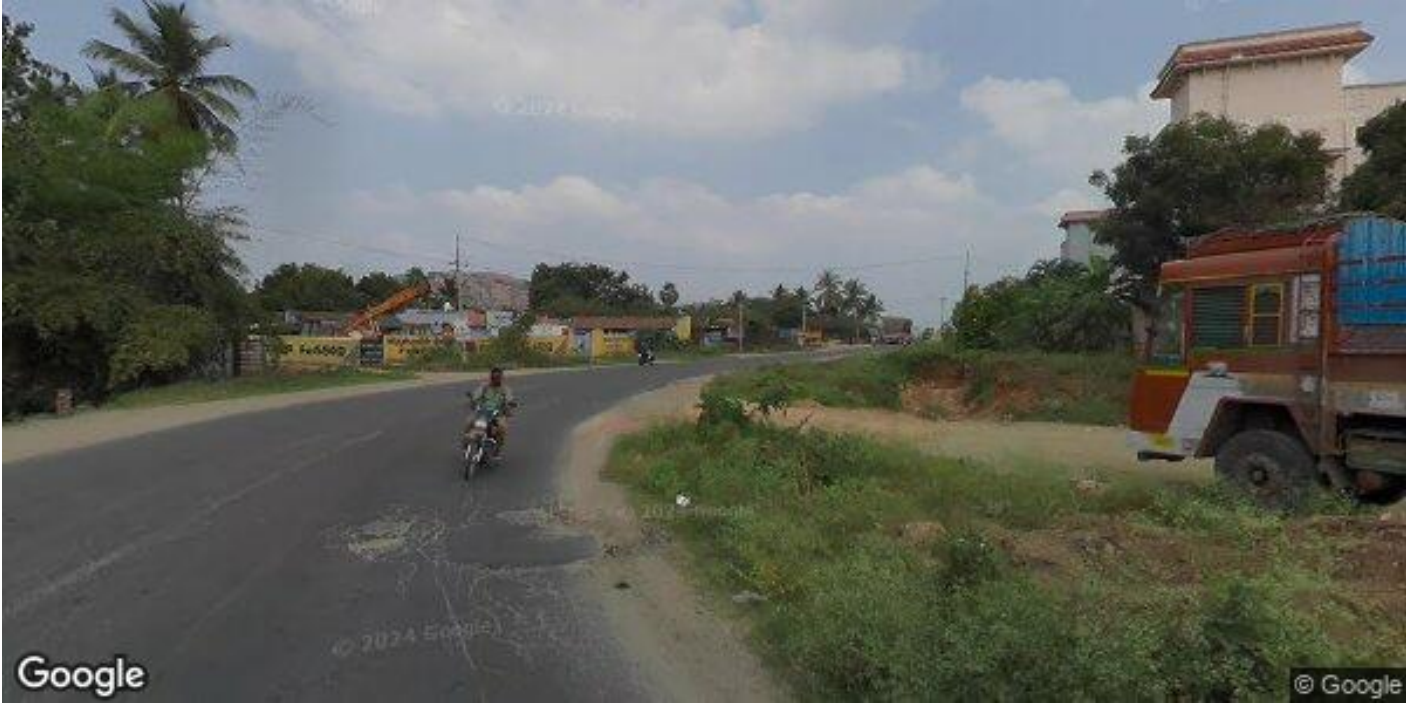
**Risk Type:** Turn  
**Risk Level:** Medium  
**Speed Limit:** 30 KM/Hr  
**Coordinates:** 11.49441, 77.88495

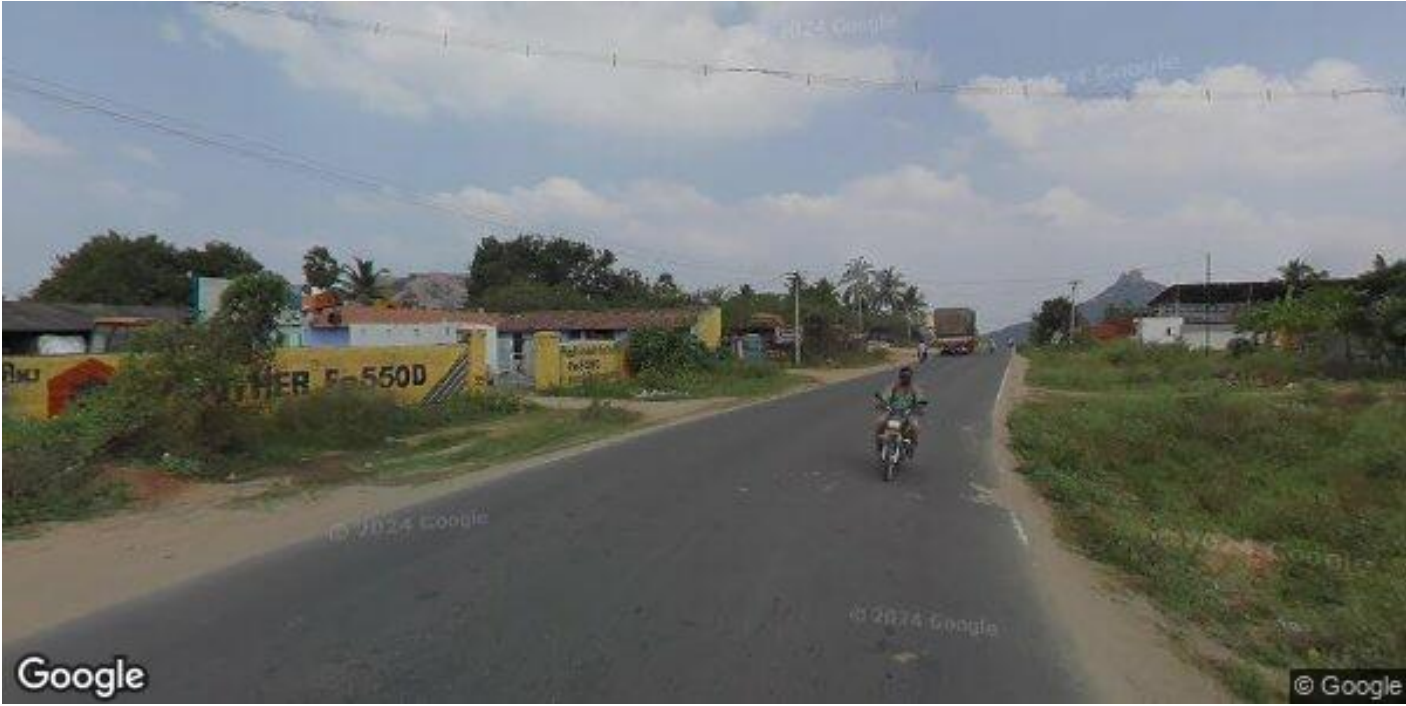
**Risk Type:** Turn  
**Risk Level:** Medium  
**Speed Limit:** 30 KM/Hr  
**Coordinates:** 11.49469, 77.88488

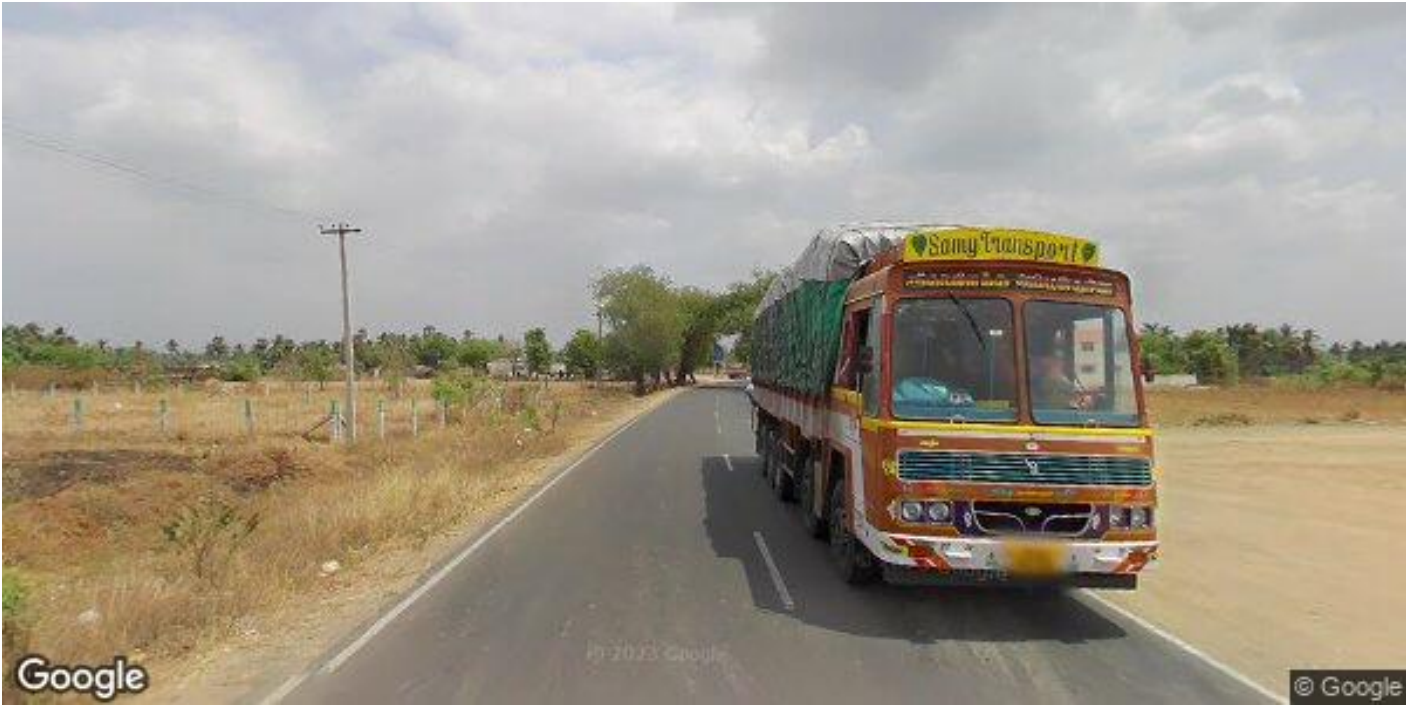
**Risk Type:** Turn  
**Risk Level:** High  
**Speed Limit:** 15 KM/Hr  
**Coordinates:** 11.55614, 77.89764

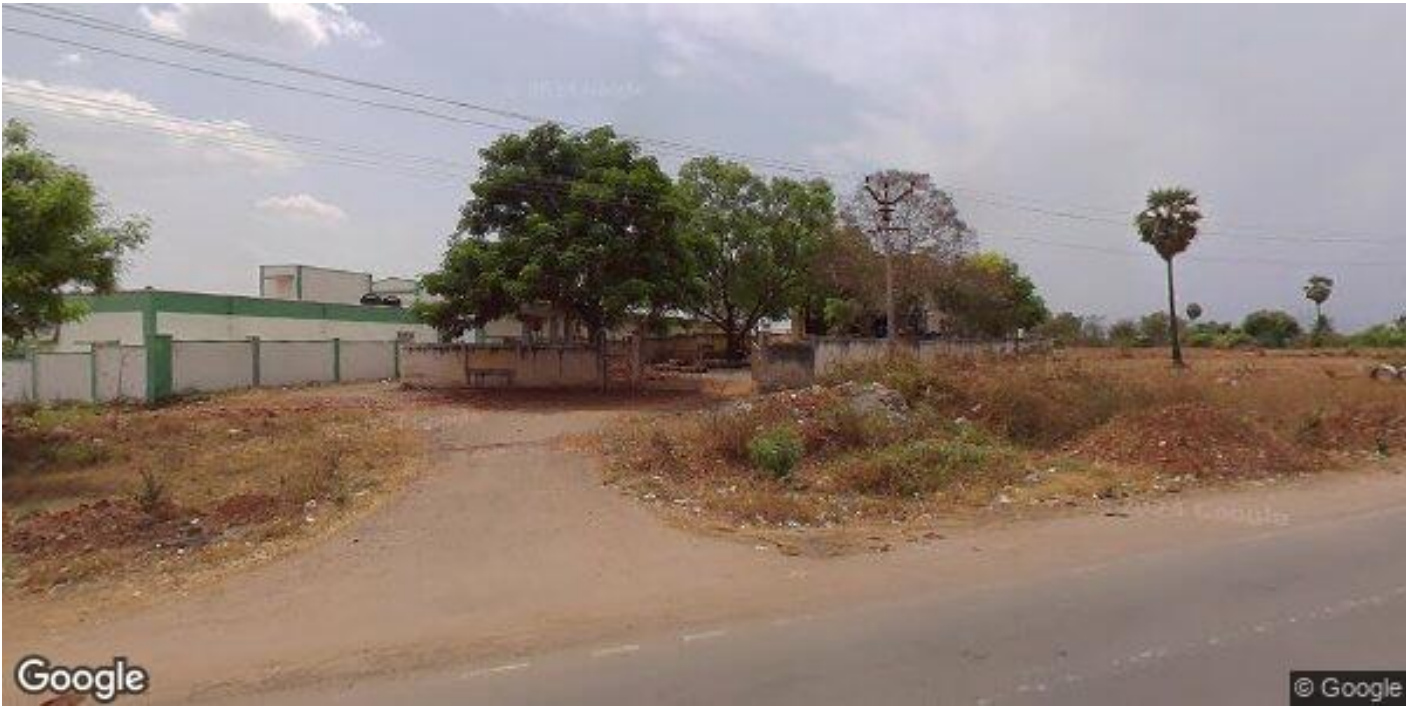
**Risk Type:** Turn  
**Risk Level:** High  
**Speed Limit:** 15 KM/Hr  
**Coordinates:** 11.58317, 77.90647

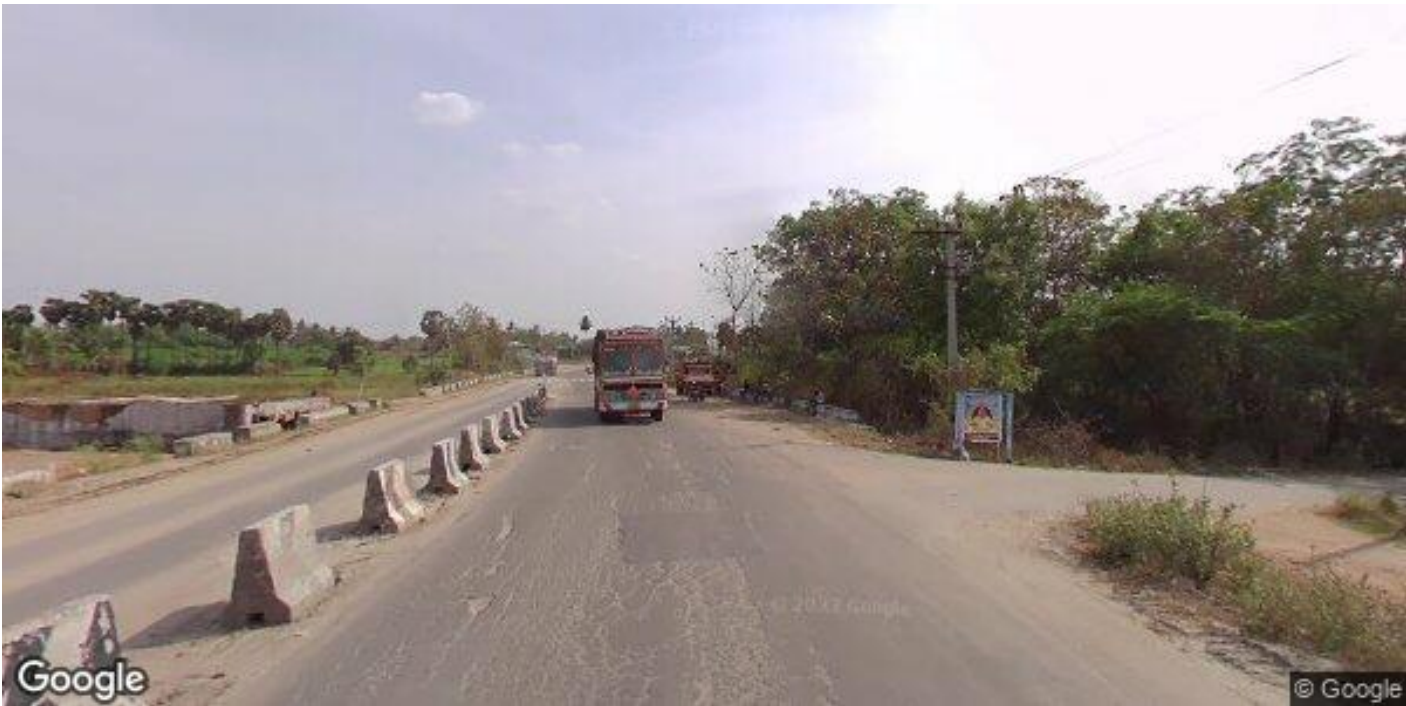
**Risk Type:** Turn  
**Risk Level:** Medium  
**Speed Limit:** 30 KM/Hr  
**Coordinates:** 11.63840, 77.94820

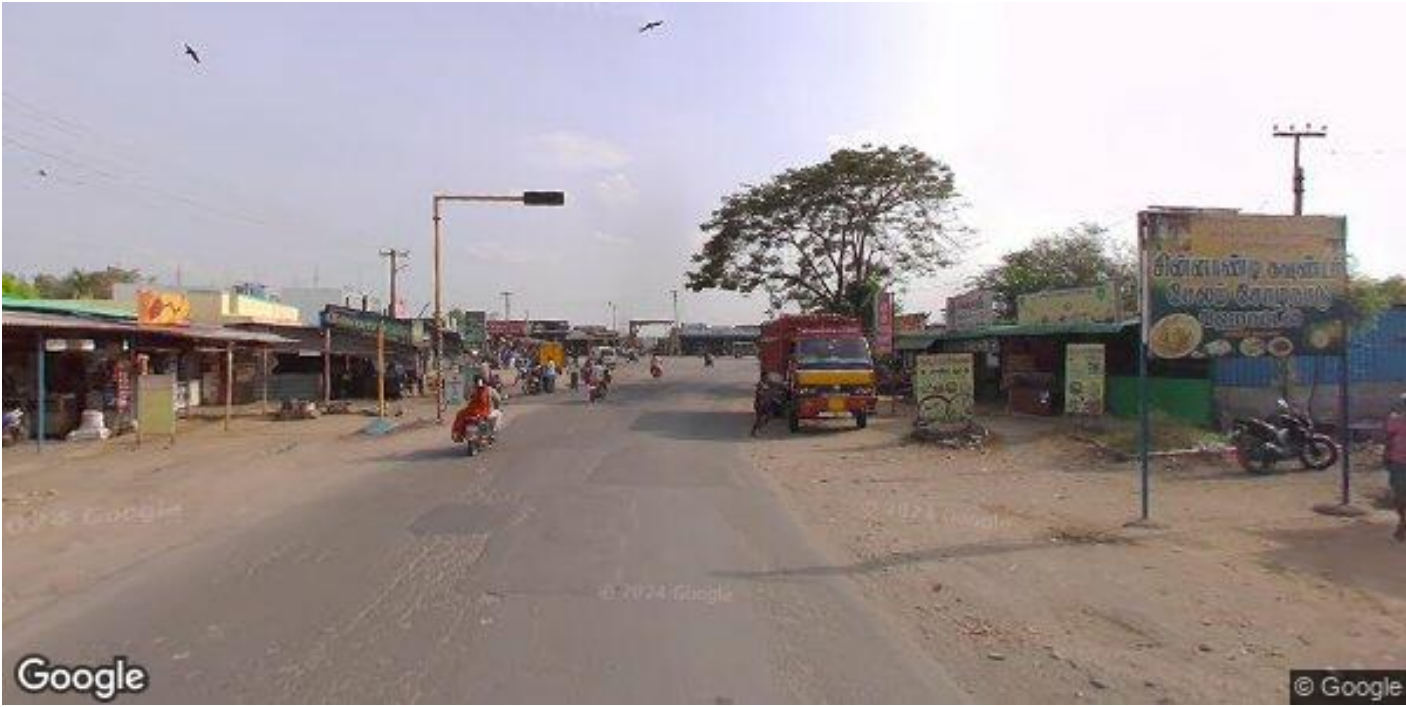
**Risk Type:** Turn  
**Risk Level:** Medium  
**Speed Limit:** 30 KM/Hr  
**Coordinates:** 11.64217, 77.95200

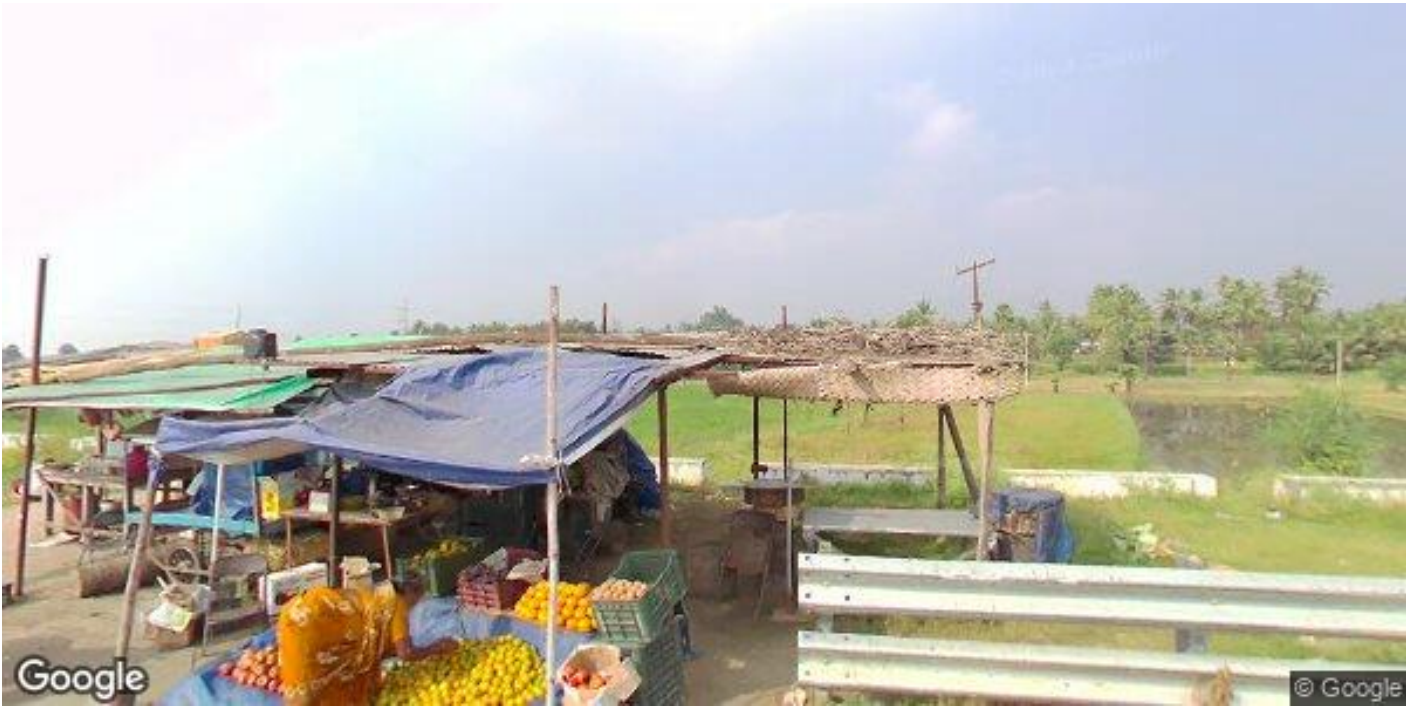
**Risk Type:** Turn  
**Risk Level:** Medium  
**Speed Limit:** 30 KM/Hr  
**Coordinates:** 11.67858, 77.96834

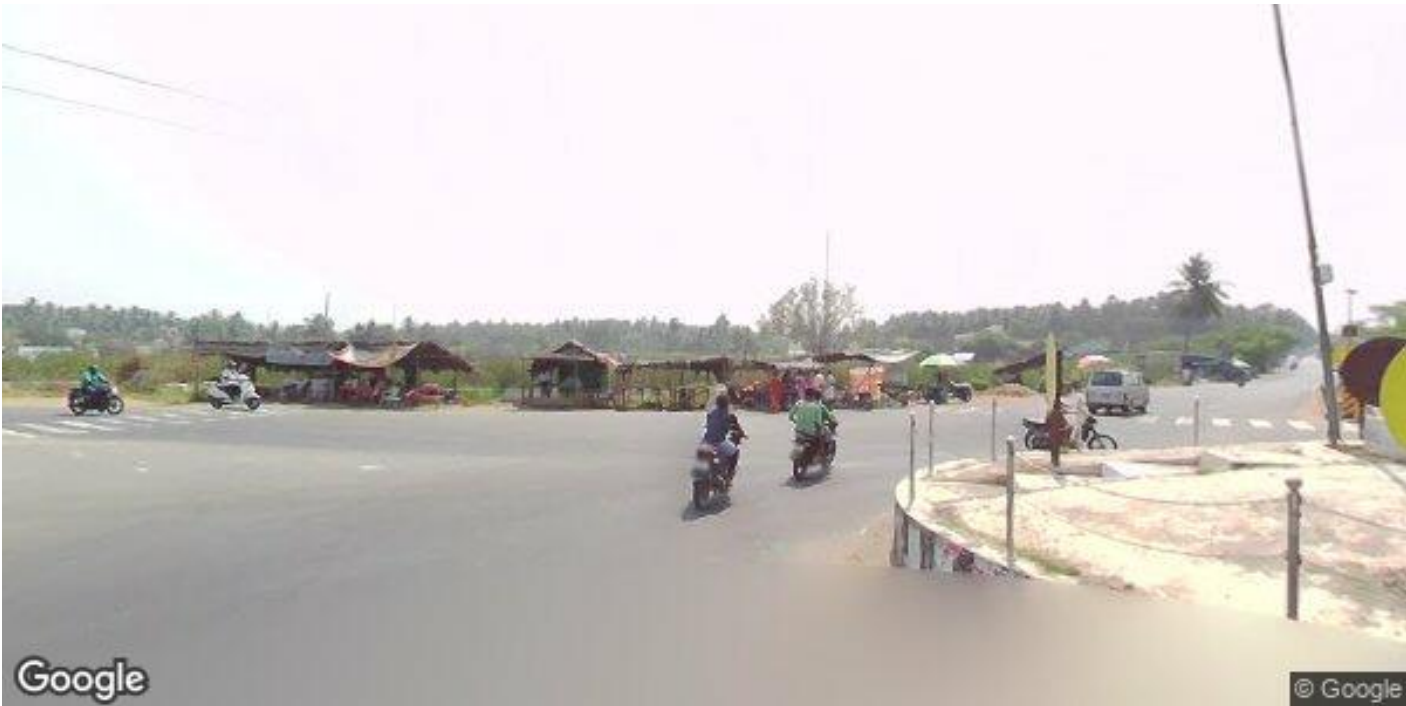
**Risk Type:** Turn  
**Risk Level:** Medium  
**Speed Limit:** 30 KM/Hr  
**Coordinates:** 11.68925, 77.97742

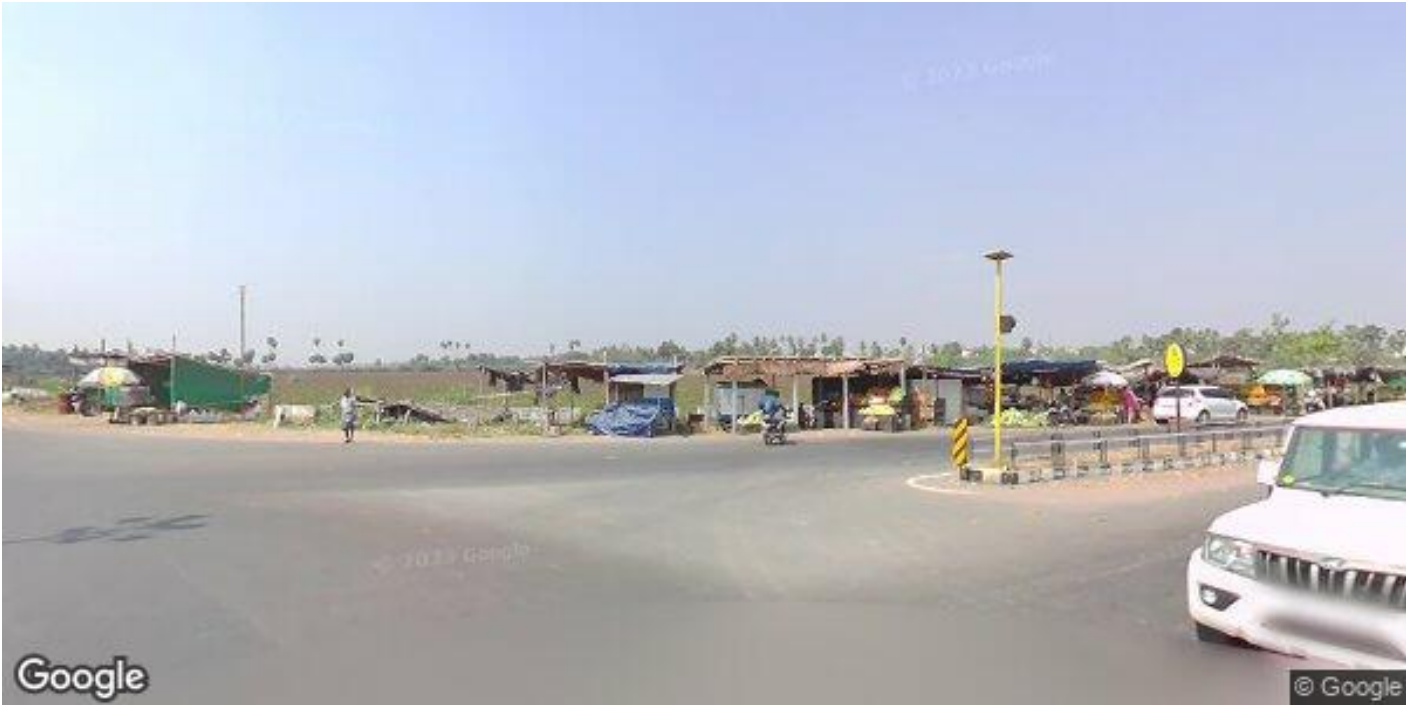
**Risk Type:** Turn  
**Risk Level:** High  
**Speed Limit:** 15 KM/Hr  
**Coordinates:** 11.68927, 77.97748

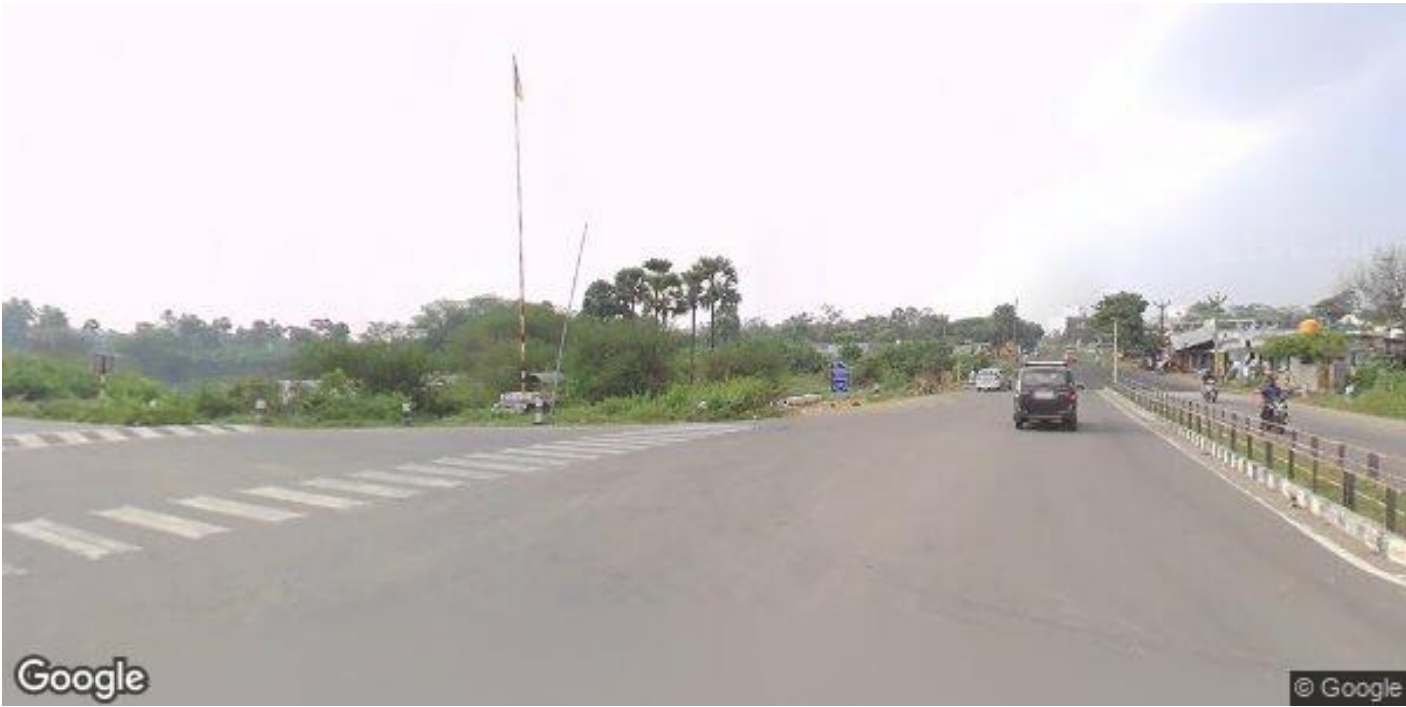
**Risk Type:** Turn  
**Risk Level:** Medium  
**Speed Limit:** 30 KM/Hr  
**Coordinates:** 11.70218, 77.97866
