# IndianOil

## JOURNEY RISK MANAGEMENT (JRM) STUDY

### Salem Terminal to Sri Valli Agencies

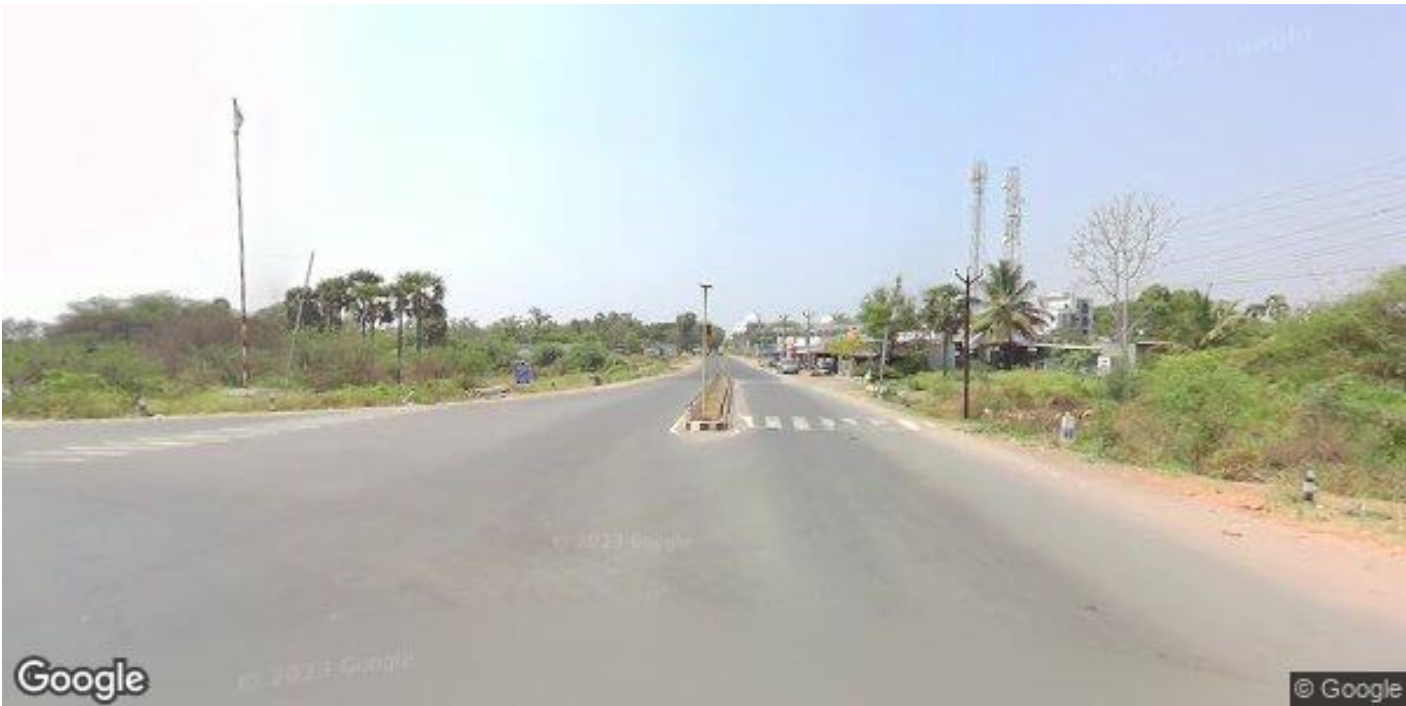
**Risk Type:** Turn  
**Risk Level:** High  
**Speed Limit:** 15 KM/Hr  
**Coordinates:** 11.70227, 77.97864

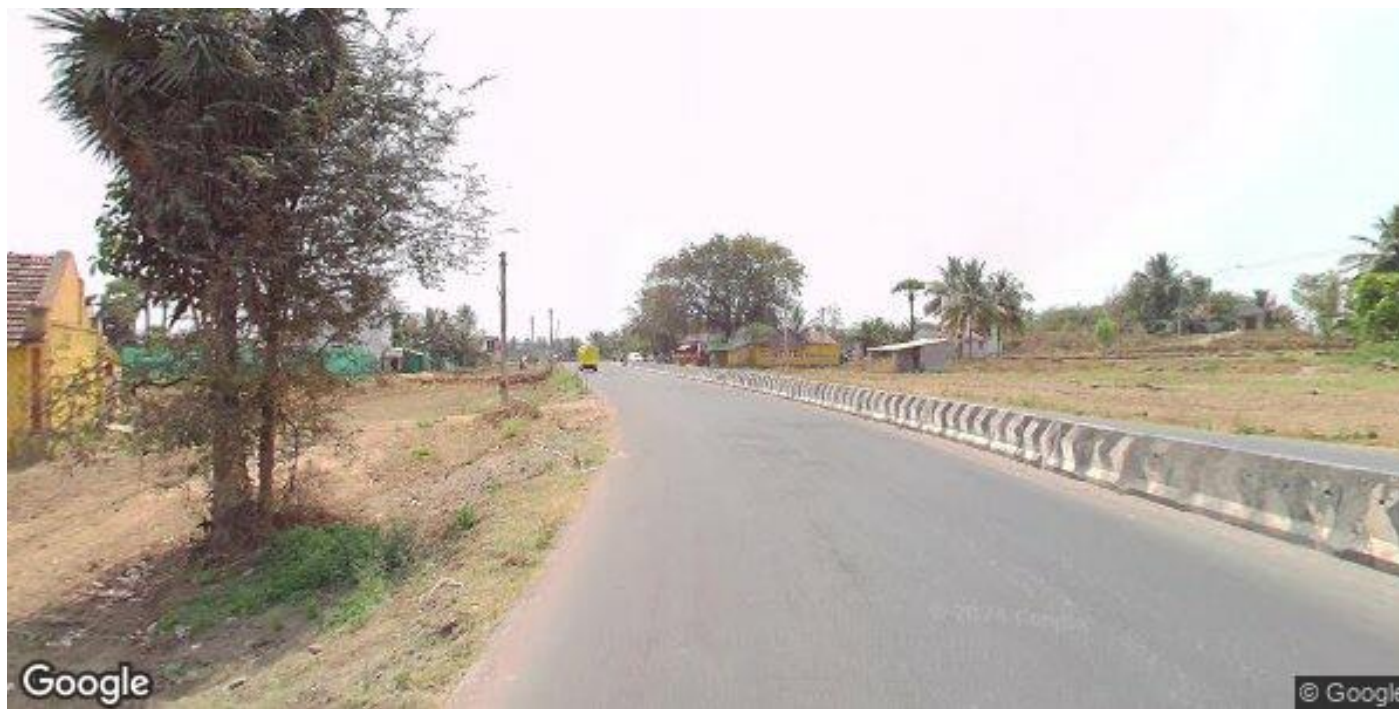
**Risk Type:** Turn  
**Risk Level:** Medium  
**Speed Limit:** 30 KM/Hr  
**Coordinates:** 11.72565, 78.01770

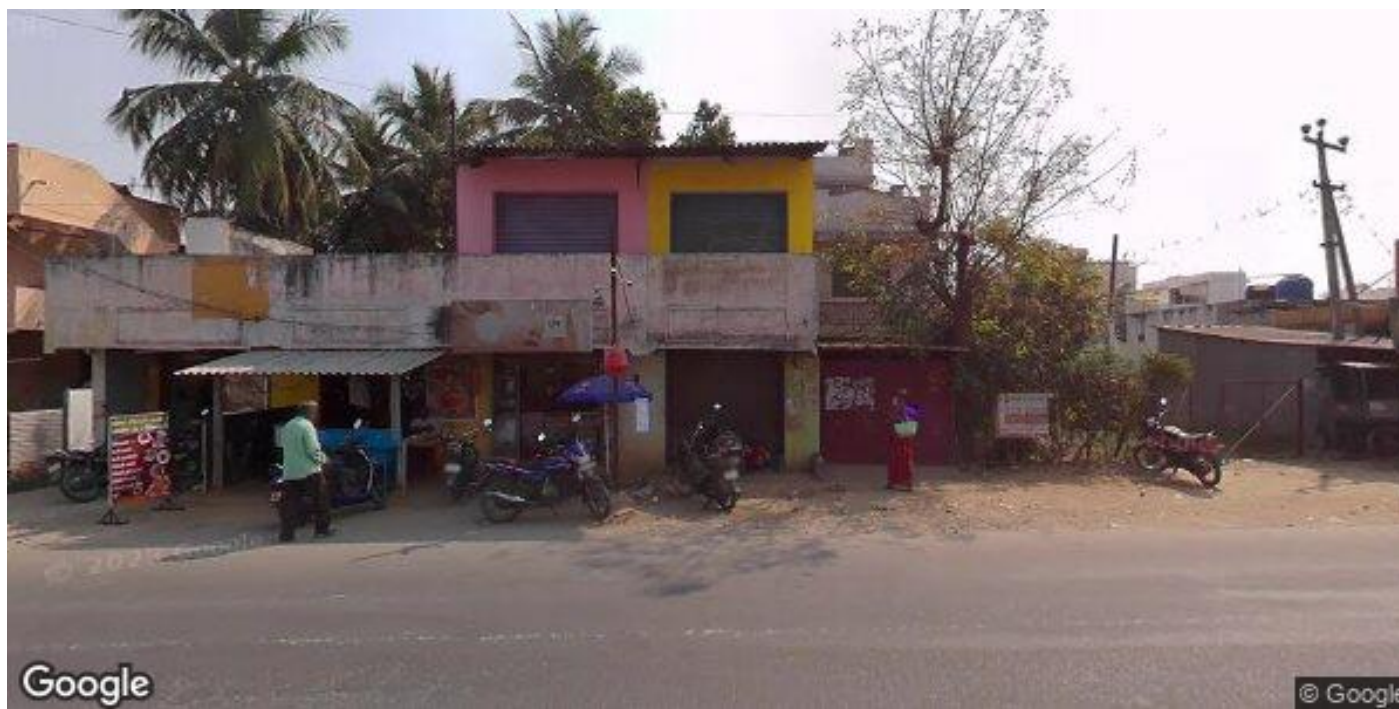
**Risk Type:** Blind Spot  
**Risk Level:** Blind Spot  
**Speed Limit:** 10 KM/Hr  
**Coordinates:** 11.73785, 78.03551

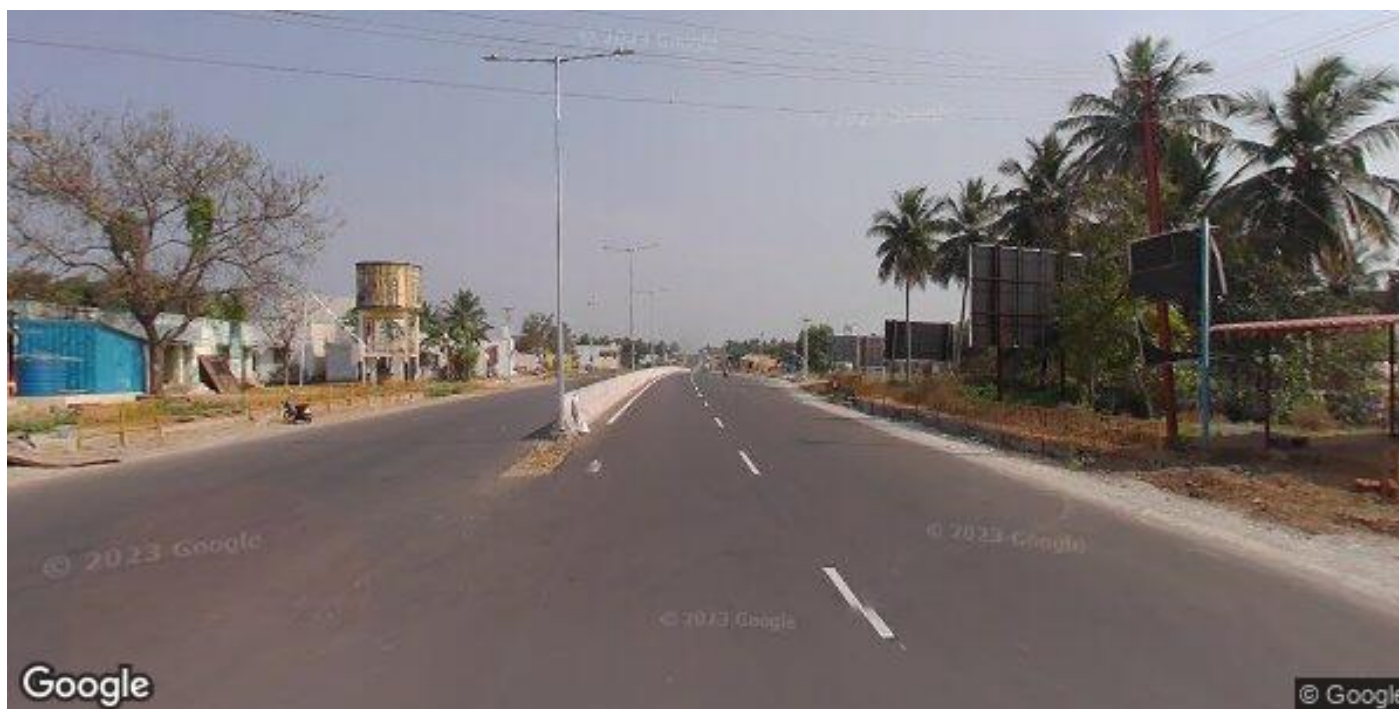
**Risk Type:** Turn  
**Risk Level:** High  
**Speed Limit:** 15 KM/Hr  
**Coordinates:** 11.76193, 78.01473

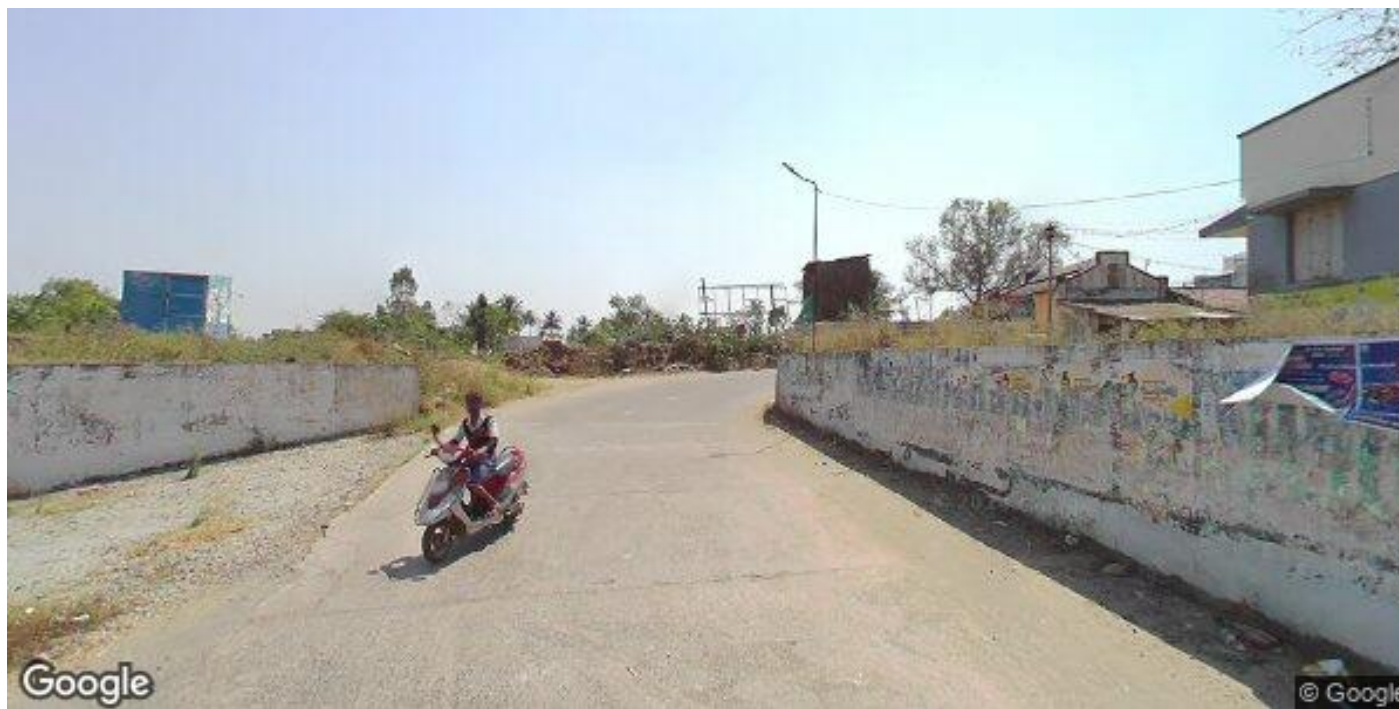
**Risk Type:** Turn  
**Risk Level:** High  
**Speed Limit:** 15 KM/Hr  
**Coordinates:** 11.78957, 78.02669

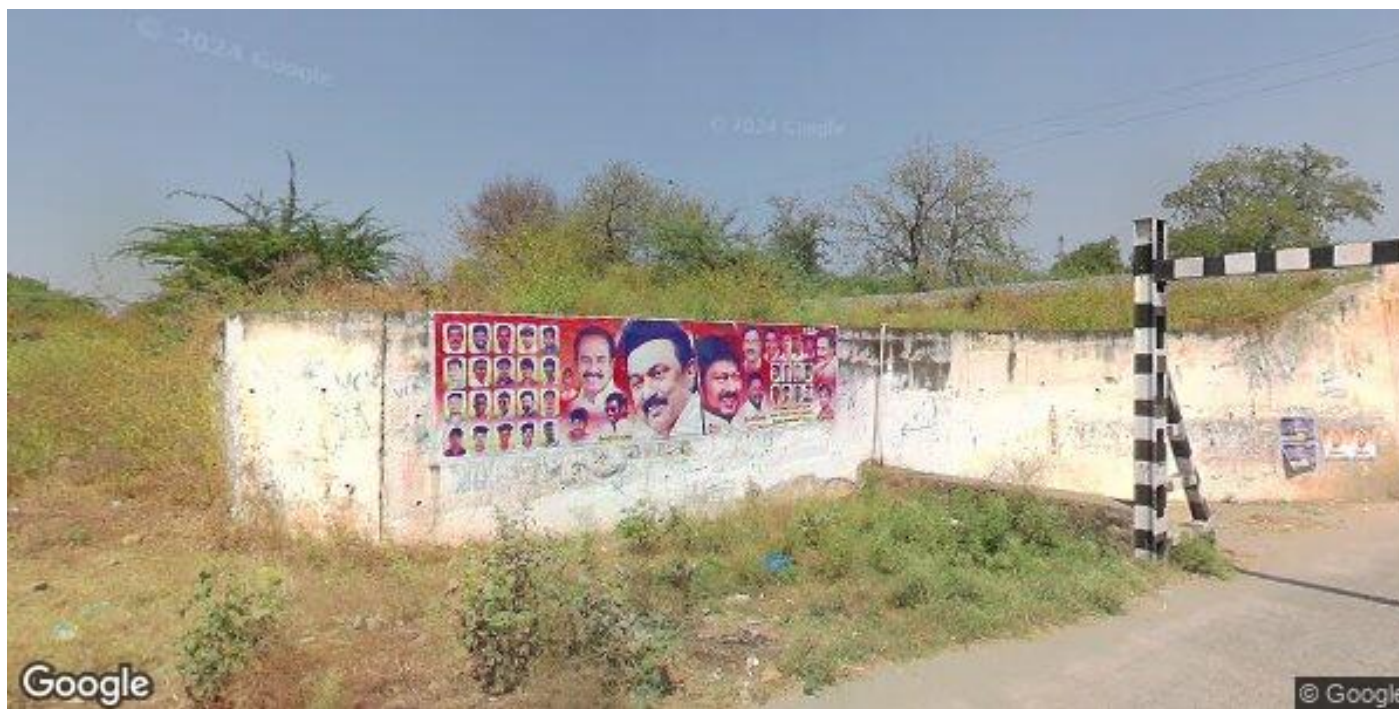
**Risk Type:** Turn  
**Risk Level:** High  
**Speed Limit:** 15 KM/Hr  
**Coordinates:** 11.78987, 78.02684

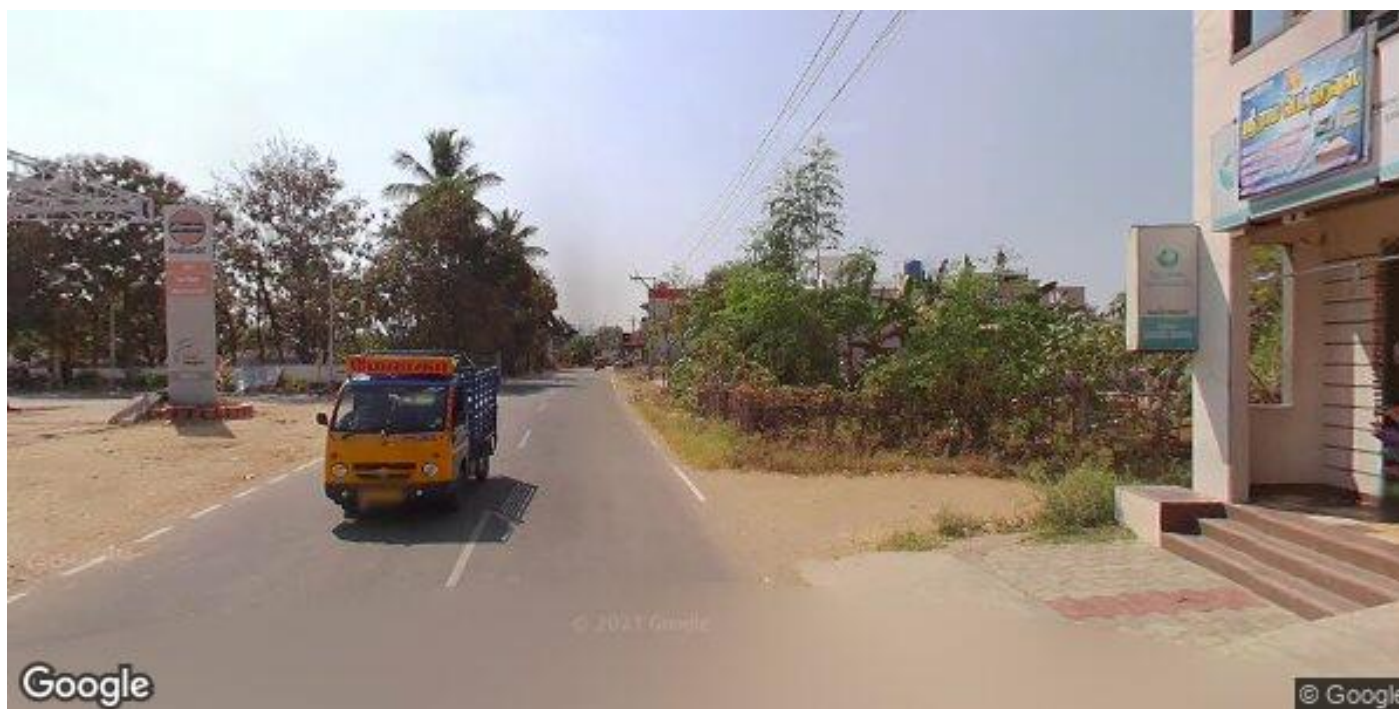
**Risk Type:** Blind Spot  
**Risk Level:** Blind Spot  
**Speed Limit:** 10 KM/Hr  
**Coordinates:** 11.79002, 78.03301
