# IndianOil

## JOURNEY RISK MANAGEMENT (JRM) STUDY

### Salem Terminal TO GPM AGENCY

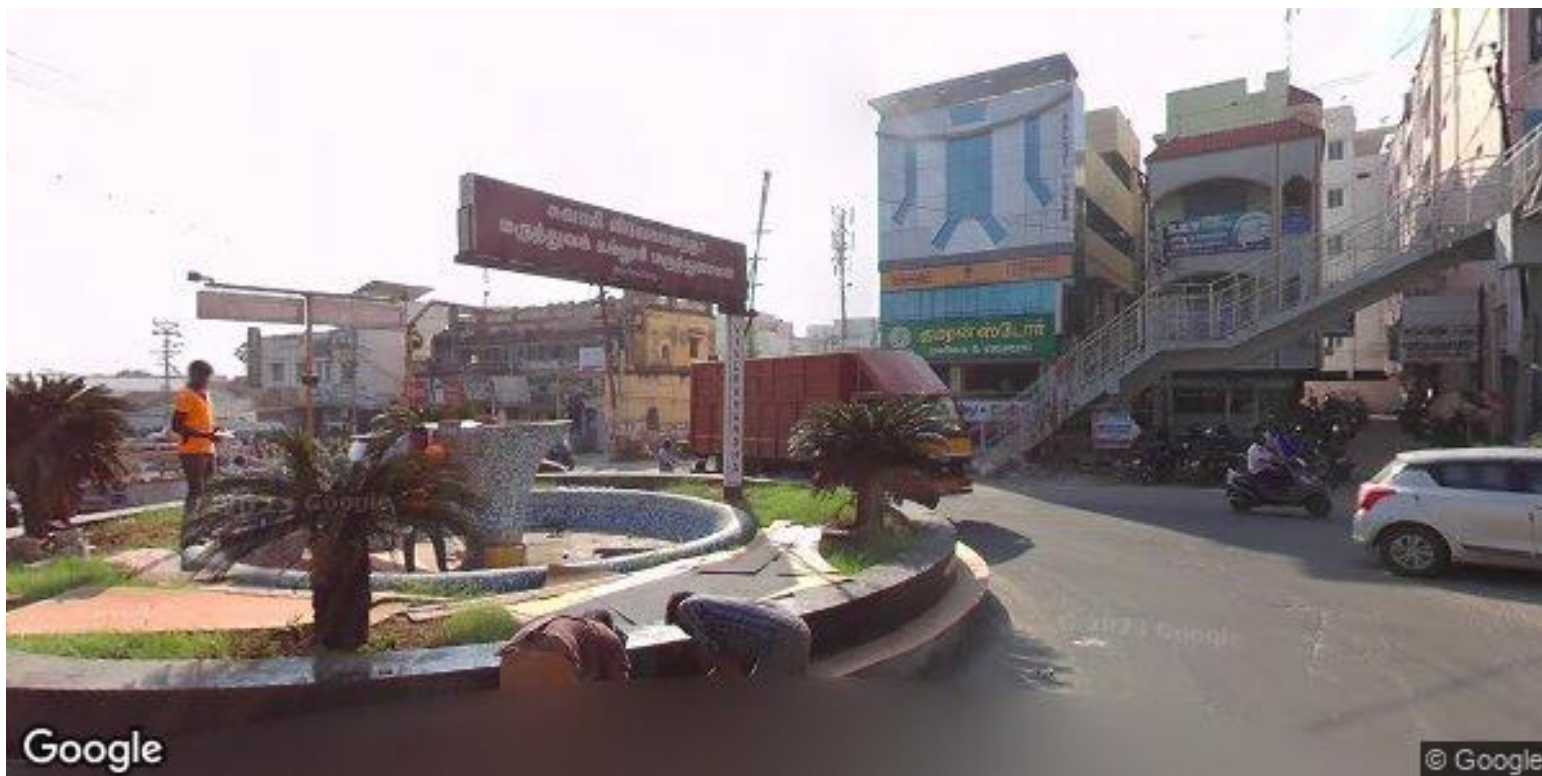
**Coordinates:** 11.38395, 77.89480

**Risk Type:** Roundabout

**Risk Level:** High

**Speed Limit:** 15 KM/Hr

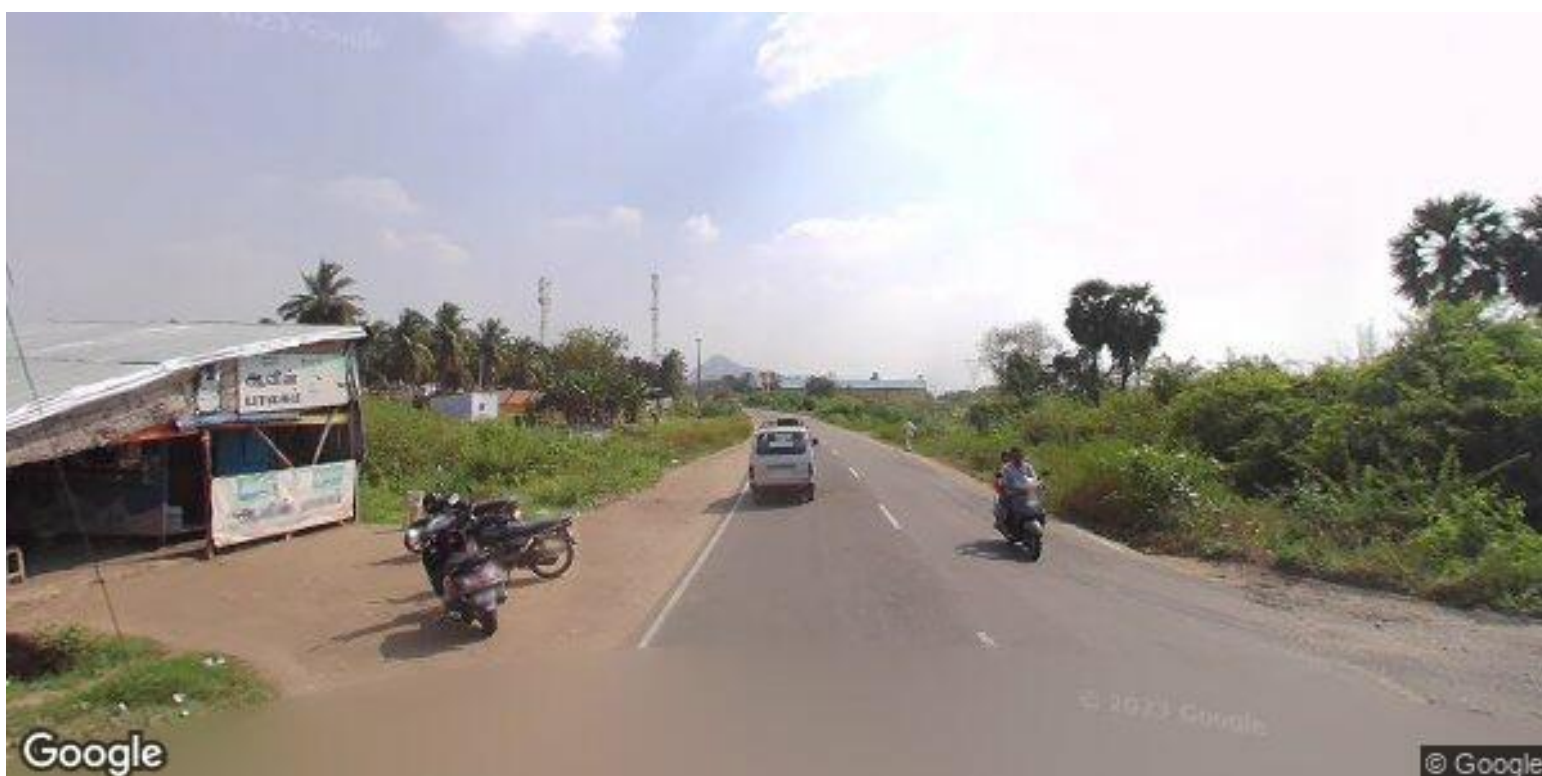
**Coordinates:** 11.44022, 77.87546

**Risk Type:** Turn

**Risk Level:** High

**Speed Limit:** 15 KM/Hr

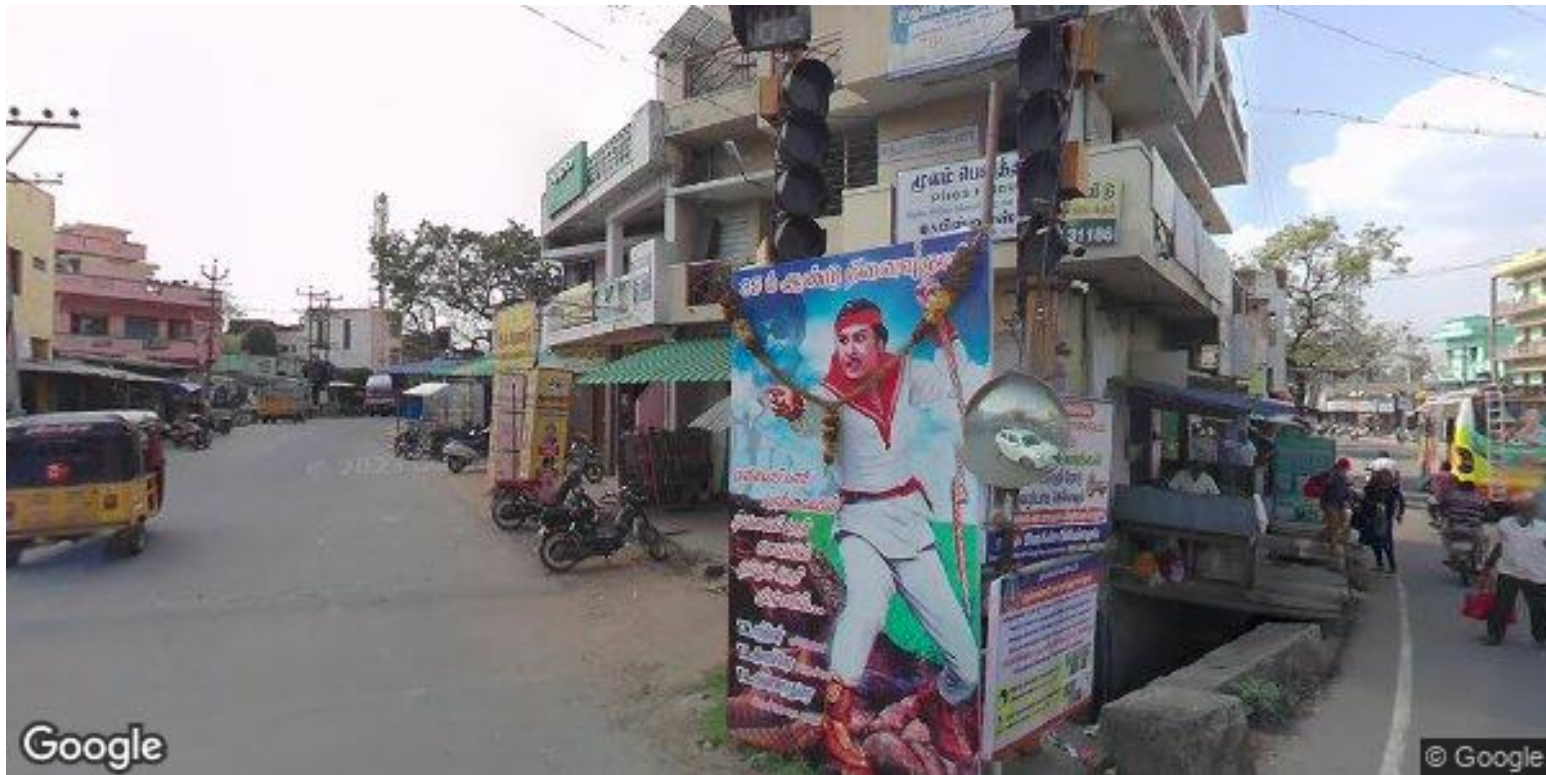
**Coordinates:** 11.38342, 77.89975

**Risk Type:** Turn

**Risk Level:** Medium

**Speed Limit:** 30 KM/Hr

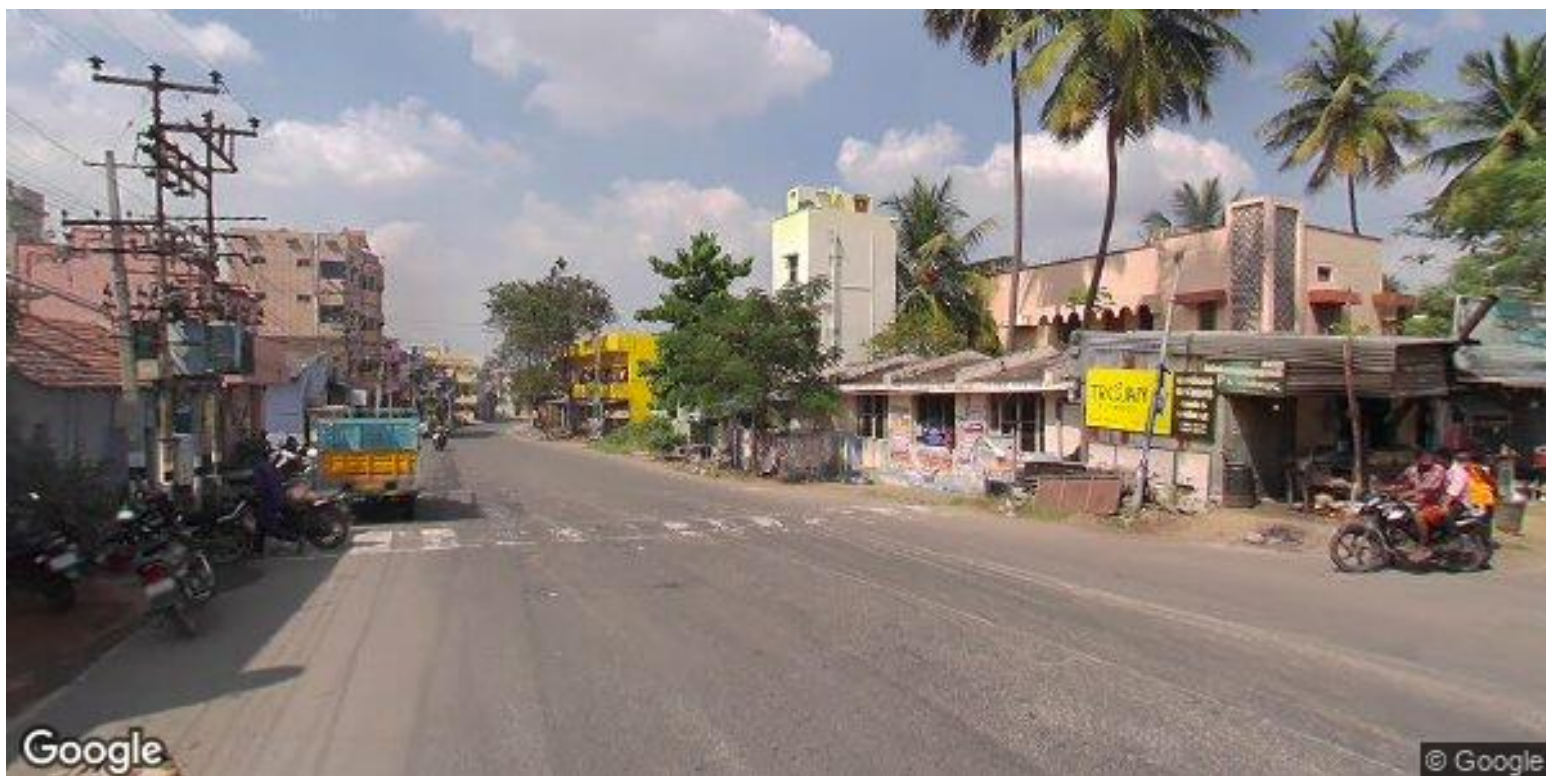
**Coordinates:** 11.38190, 77.90254

**Risk Type:** Turn

**Risk Level:** High

**Speed Limit:** 15 KM/Hr

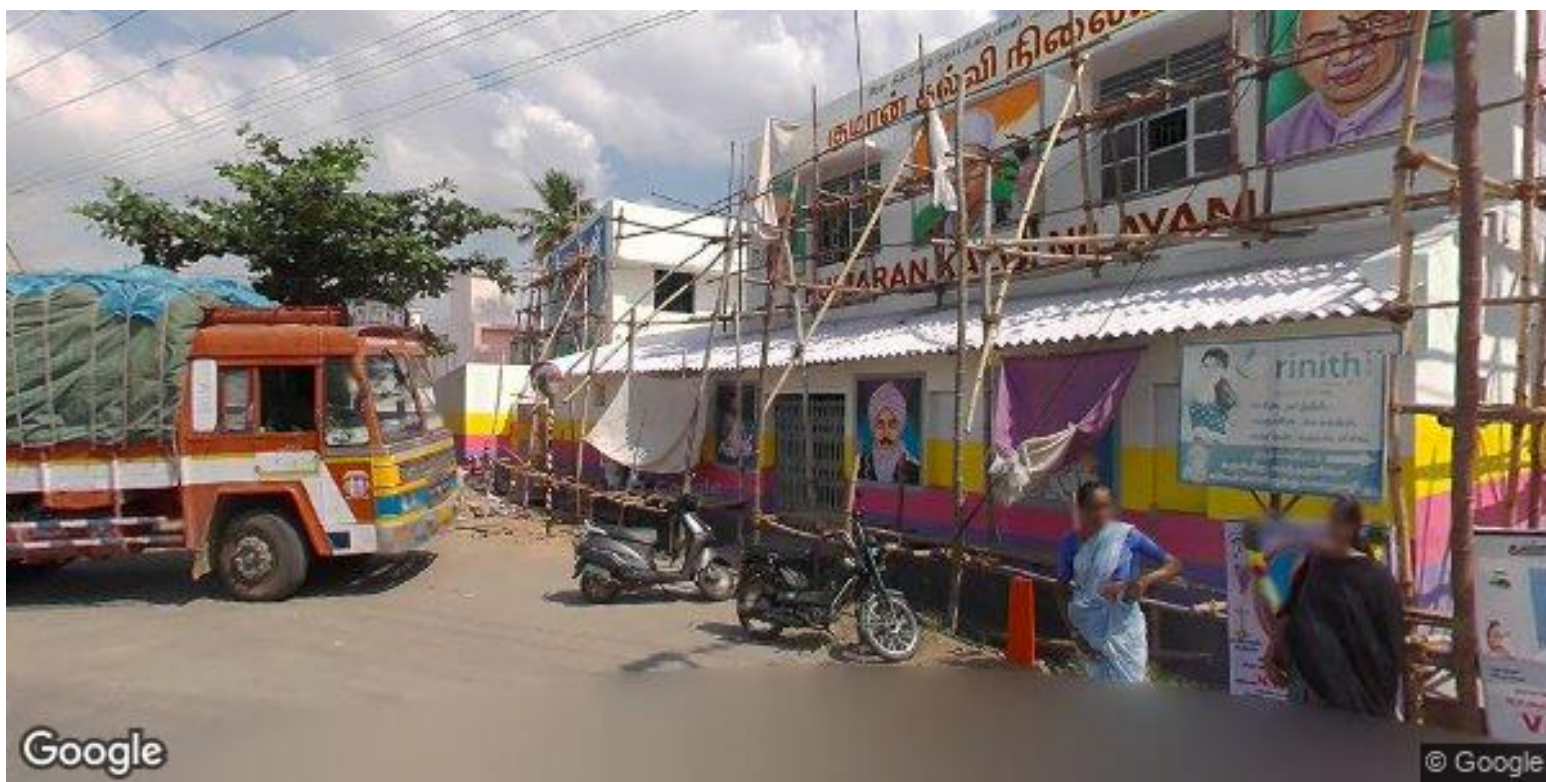
**Coordinates:** 11.38182, 77.90259

**Risk Type:** Turn

**Risk Level:** Medium

**Speed Limit:** 30 KM/Hr

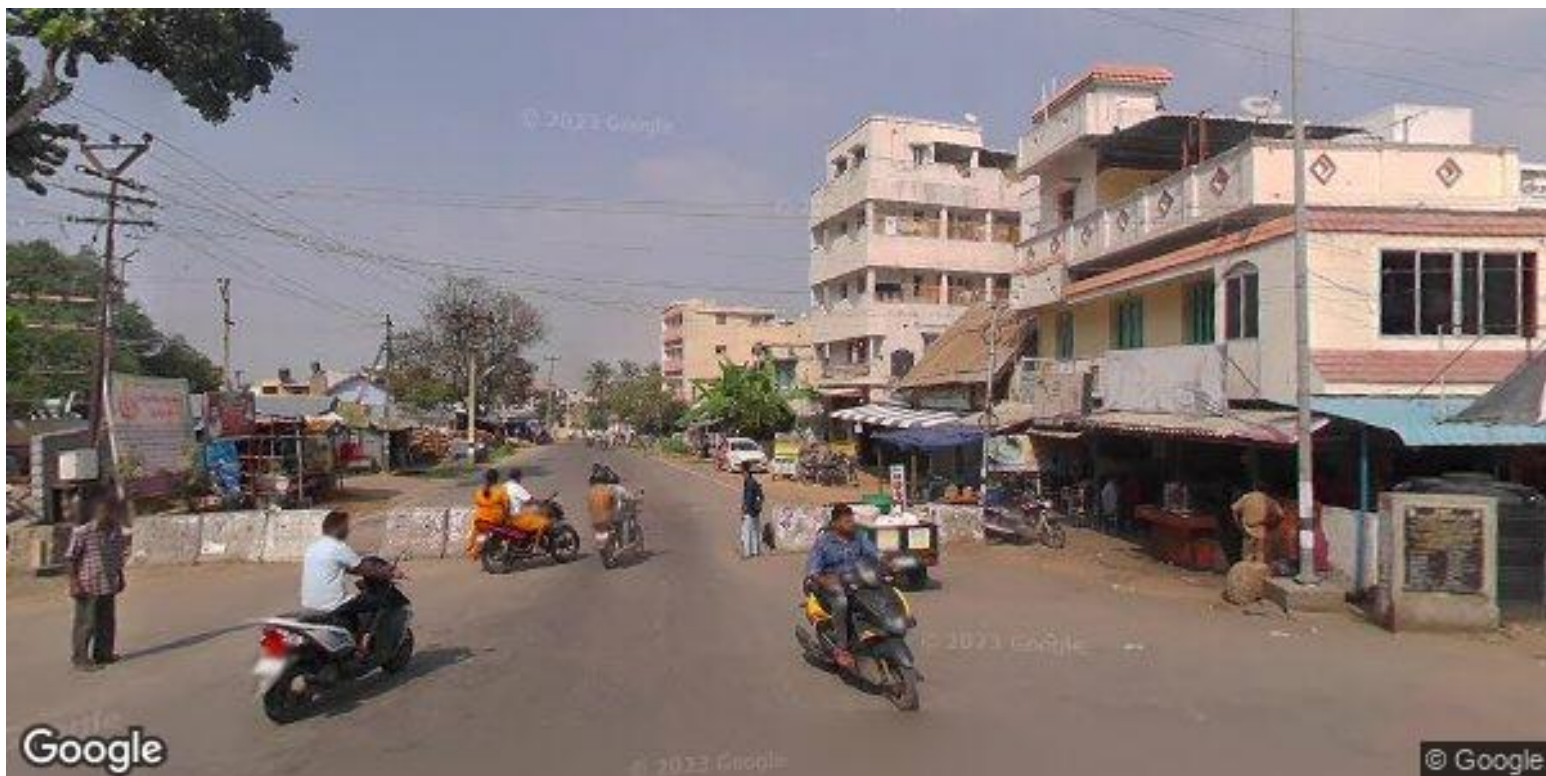
**Coordinates:** 11.37841, 77.90140

**Risk Type:** Blind Spot

**Risk Level:** Blind Spot

**Speed Limit:** 10 KM/Hr

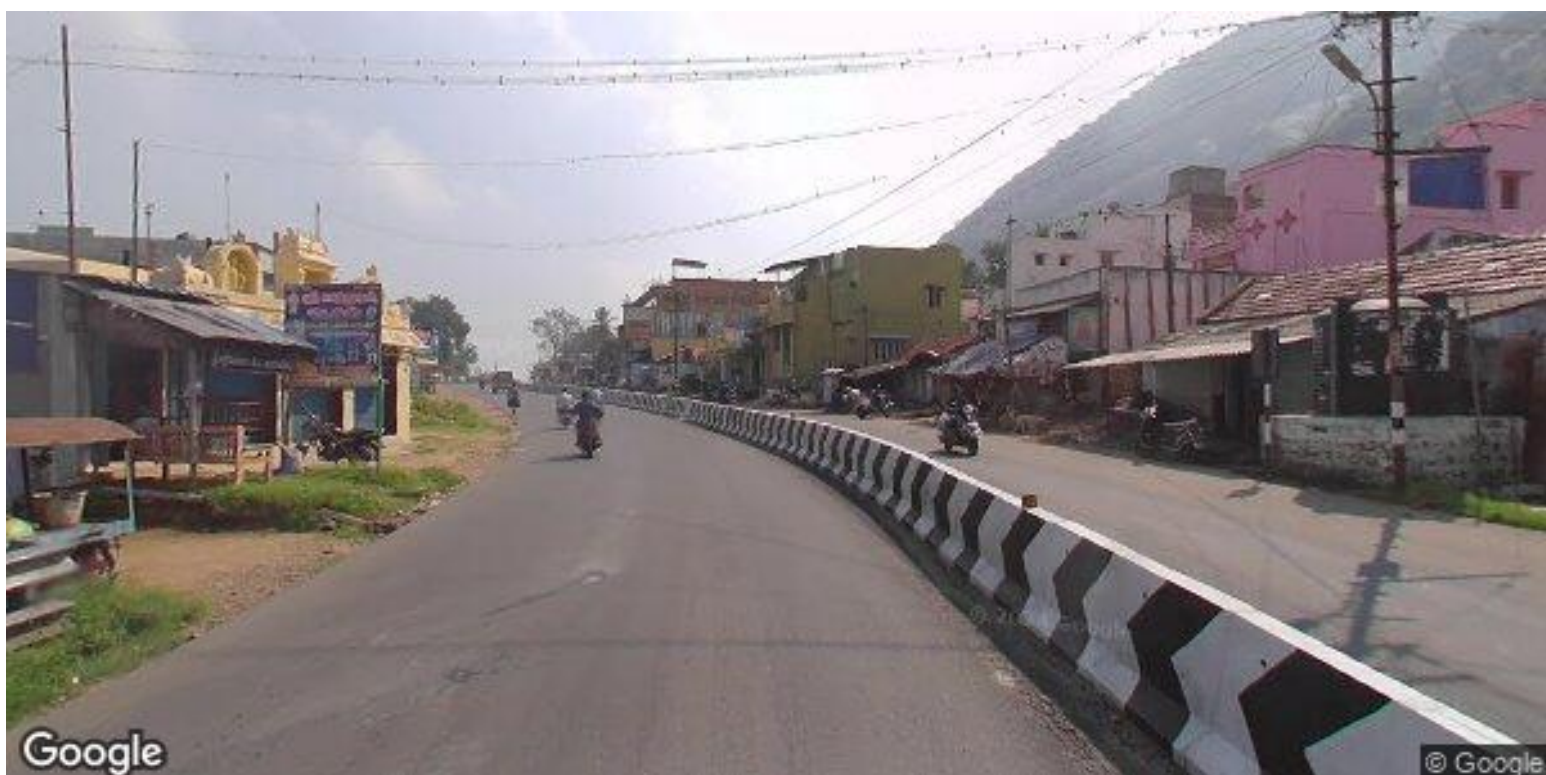
**Risk Type:** Turn  
**Risk Level:** Medium  
**Speed Limit:** 30 KM/Hr  
**Coordinates:** 11.37820, 77.90198

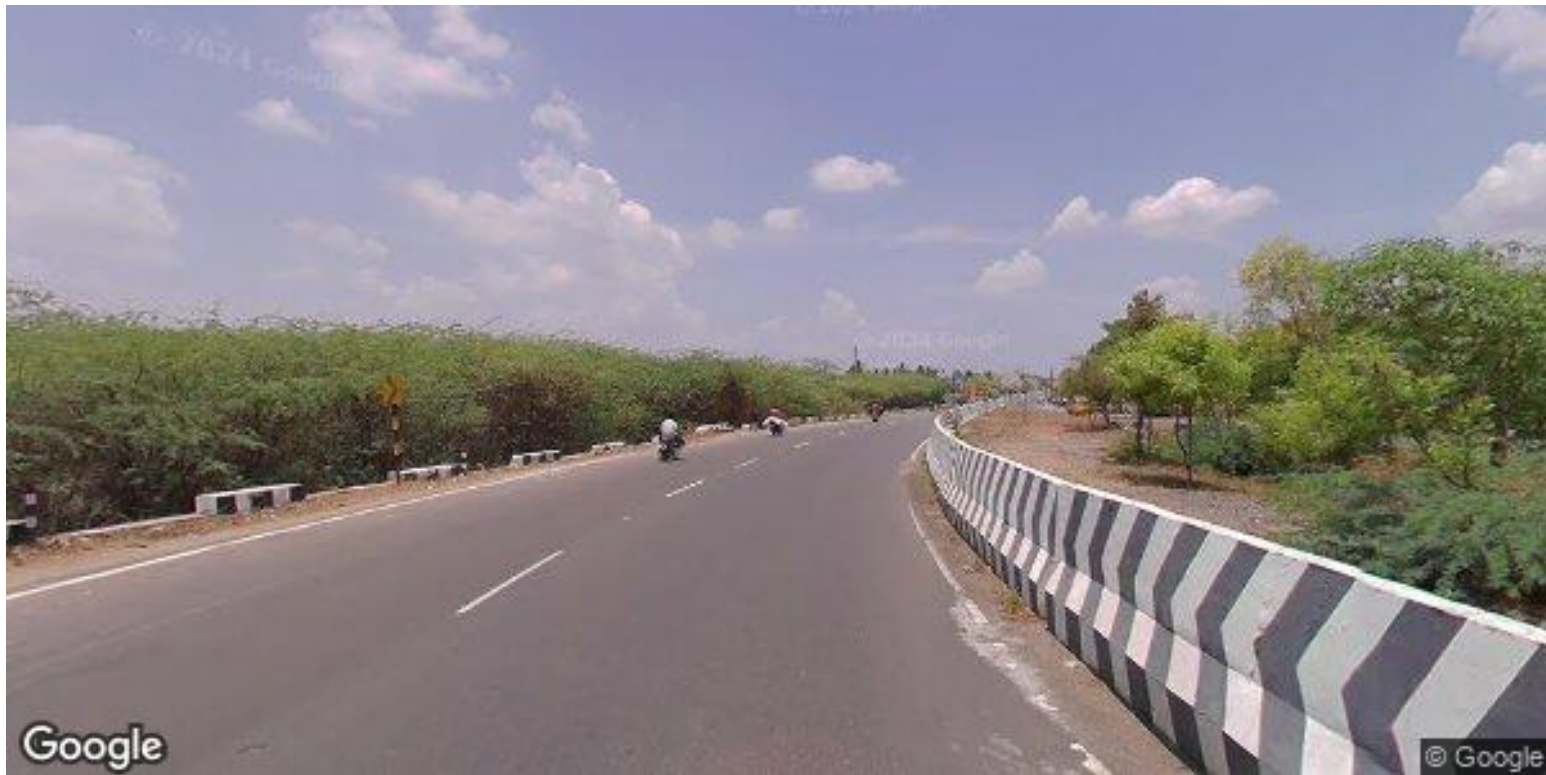
**Risk Type:** Turn  
**Risk Level:** Medium  
**Speed Limit:** 30 KM/Hr  
**Coordinates:** 11.33432, 78.00825

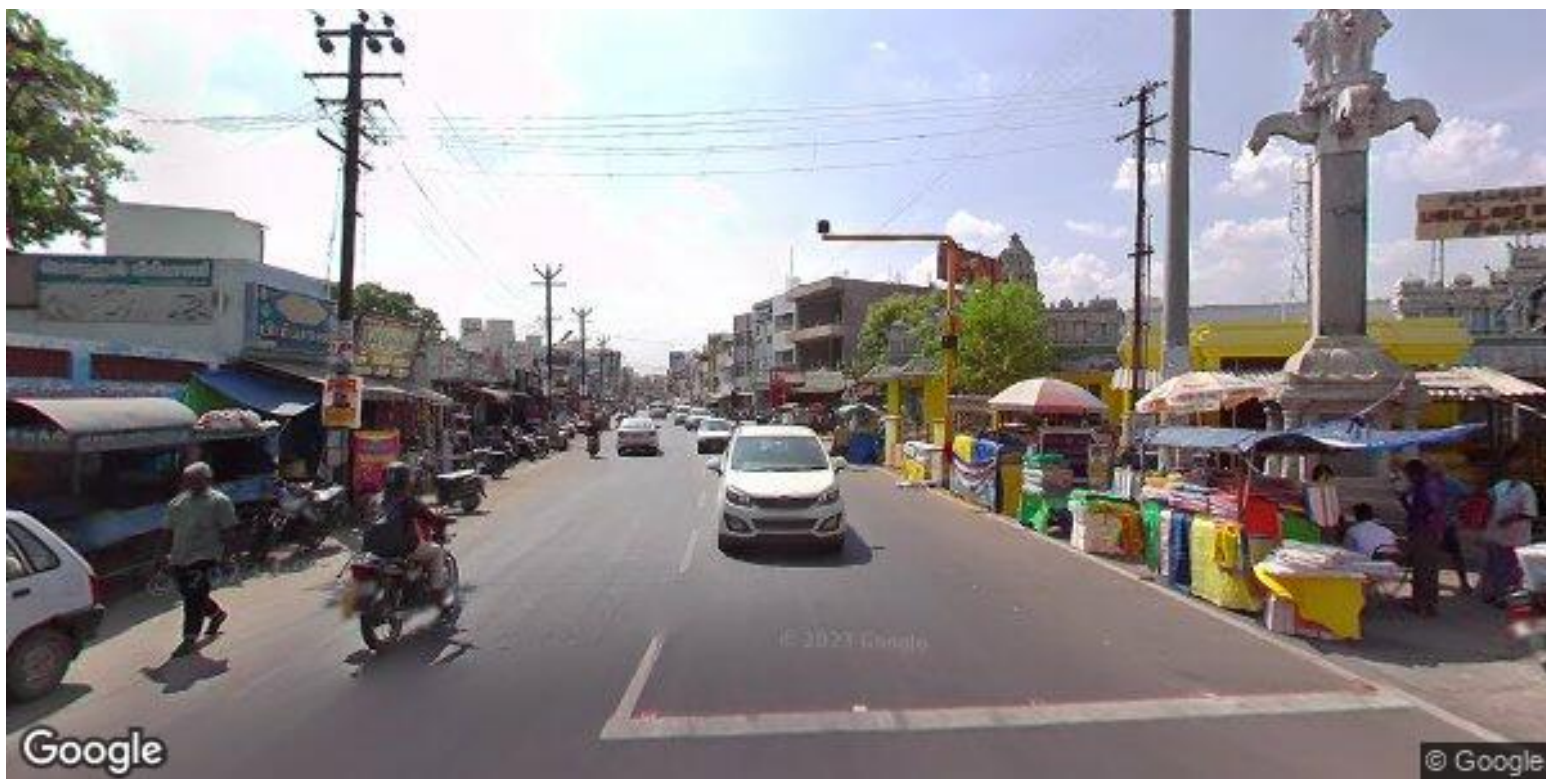
**Risk Type:** Turn  
**Risk Level:** Medium  
**Speed Limit:** 30 KM/Hr  
**Coordinates:** 11.22417, 78.16632

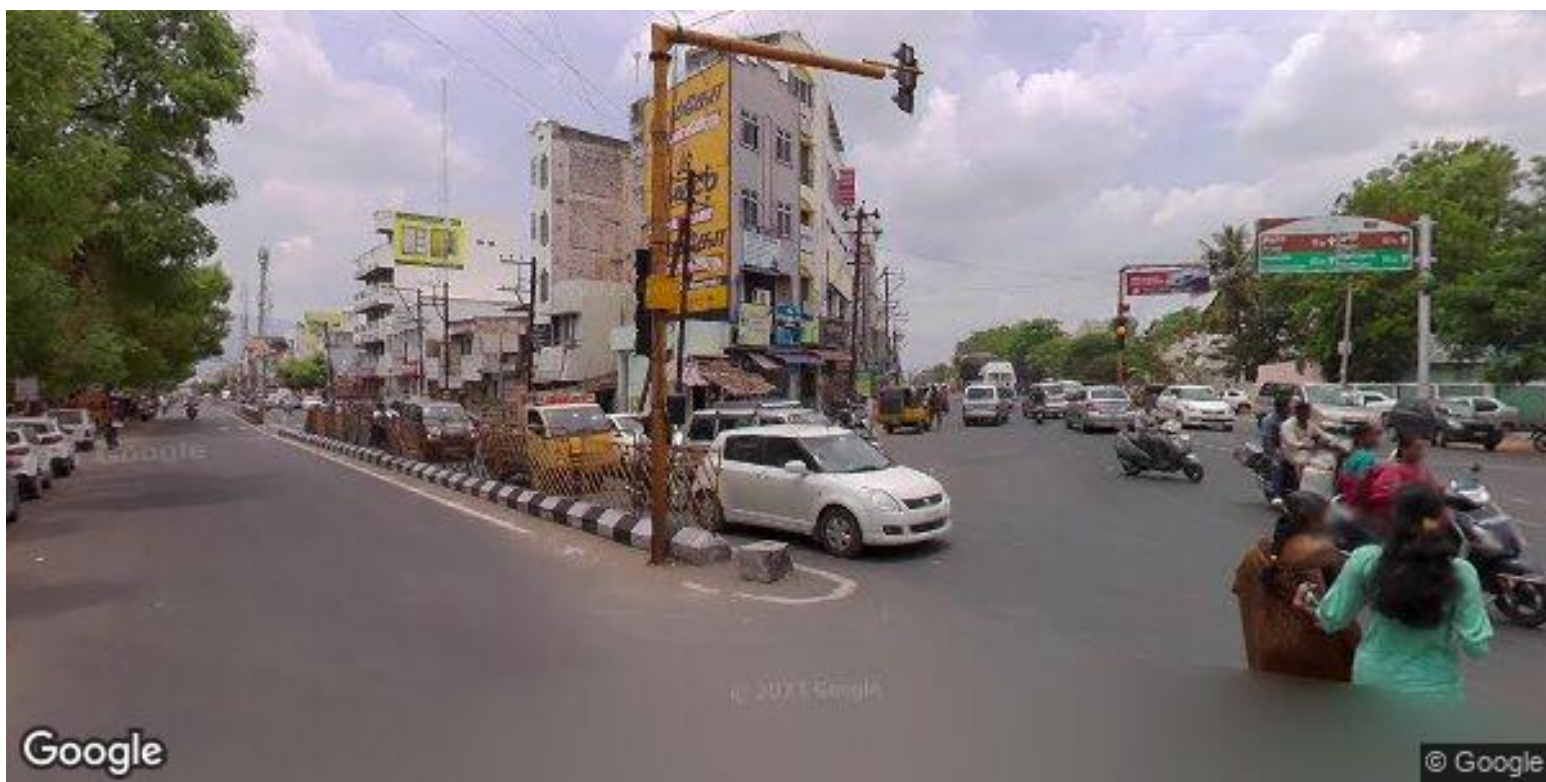
**Coordinates:** 11.21816, 78.16934

**Risk Type:** Turn

**Risk Level:** High

**Speed Limit:** 15 KM/Hr

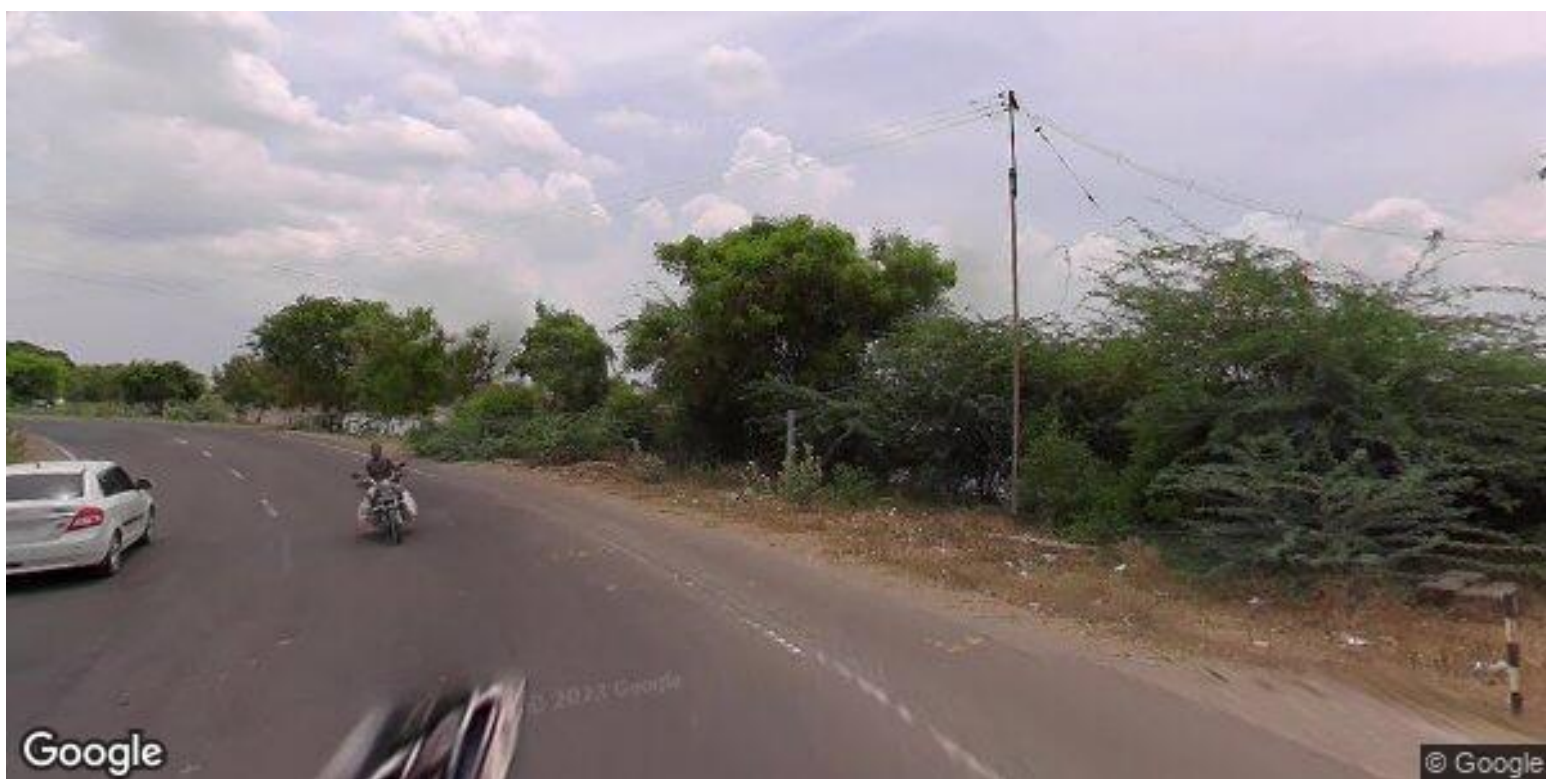
**Coordinates:** 11.20105, 78.23198

**Risk Type:** Turn

**Risk Level:** Medium

**Speed Limit:** 30 KM/Hr

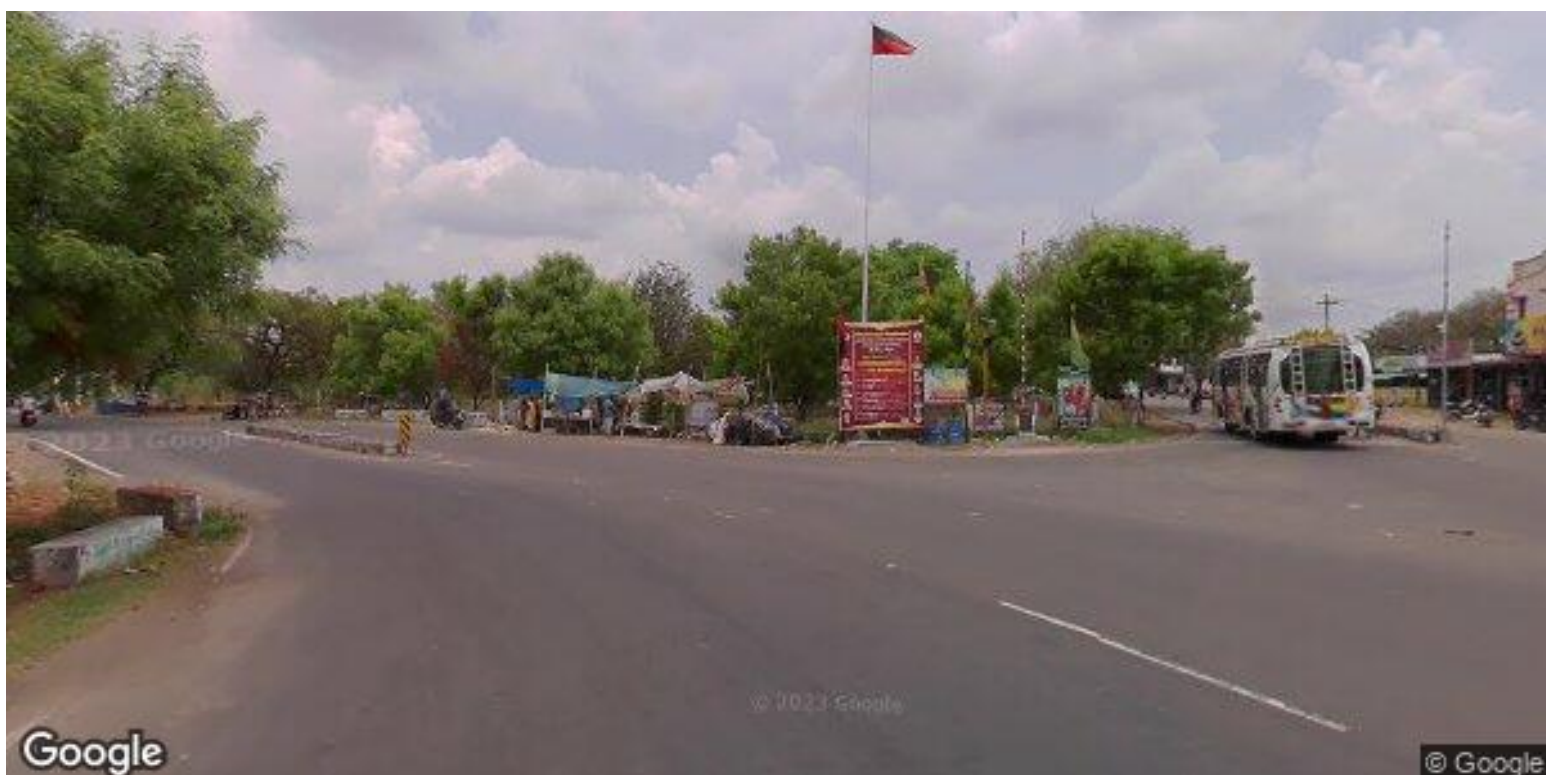
**Risk Type:** Turn  
**Risk Level:** High  
**Speed Limit:** 15 KM/Hr  
**Coordinates:** 11.16126, 78.28092

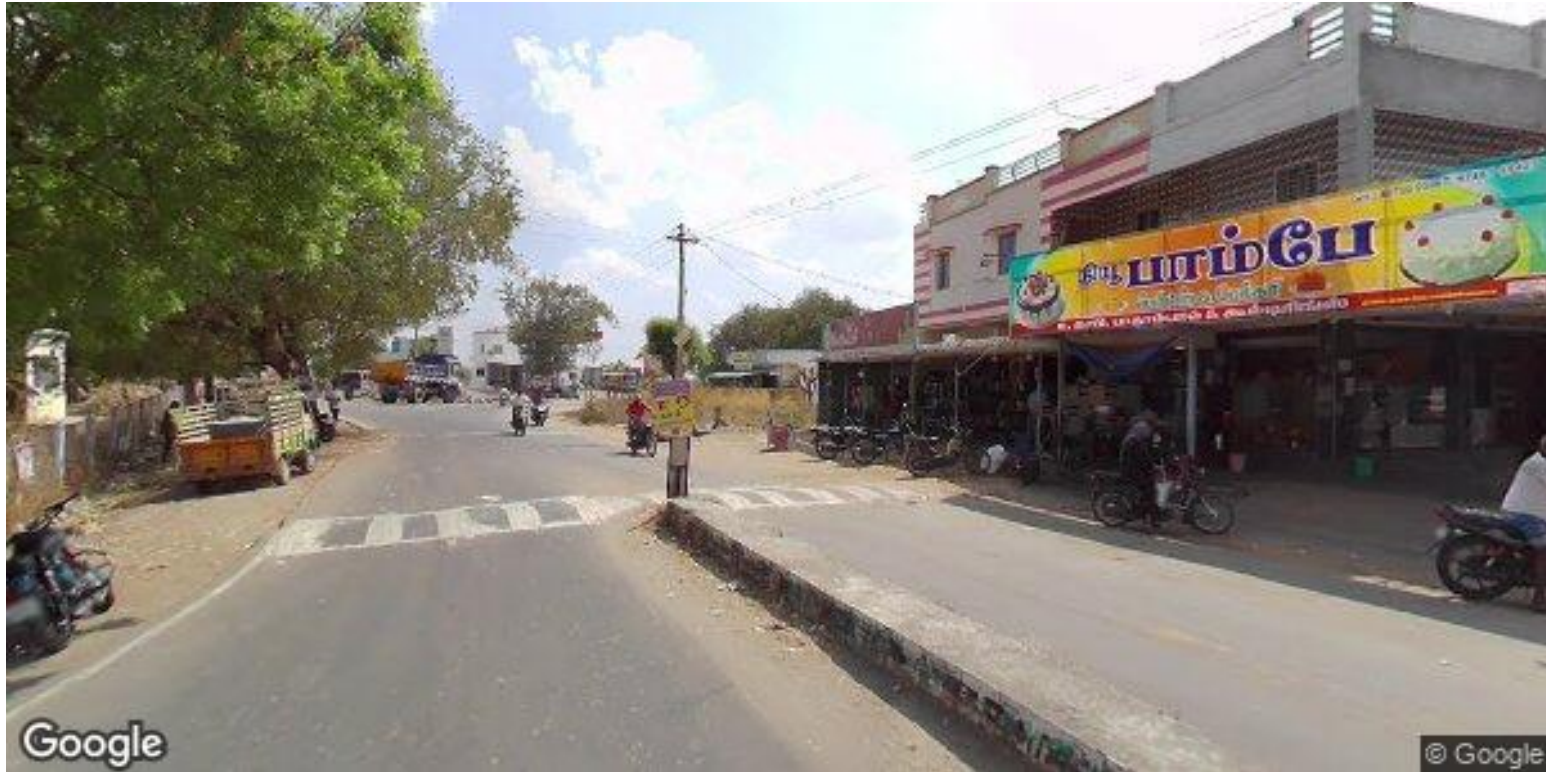
**Risk Type:** Turn  
**Risk Level:** Medium  
**Speed Limit:** 30 KM/Hr  
**Coordinates:** 11.16105, 78.28081

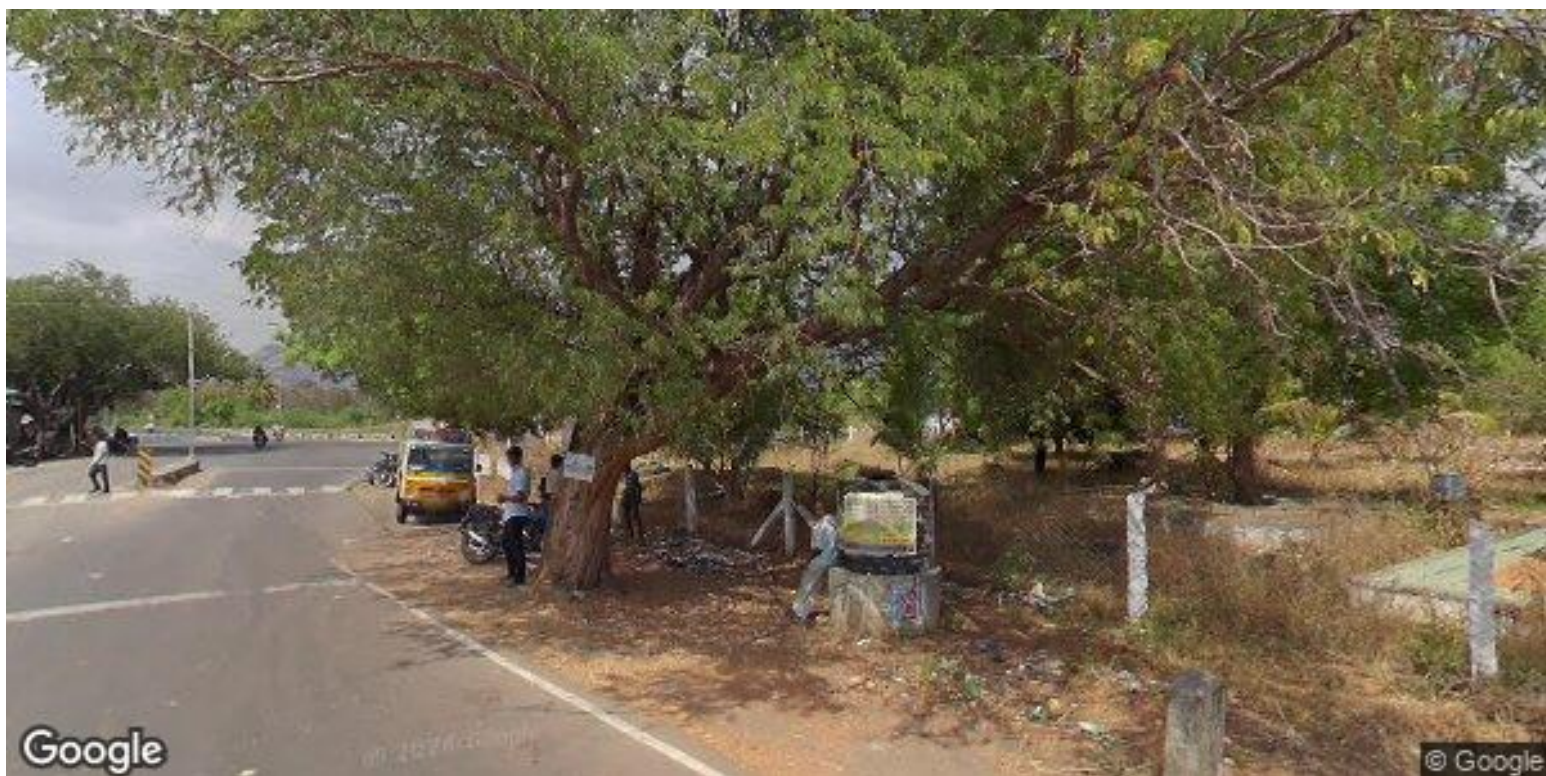
**Risk Type:** Turn  
**Risk Level:** Medium  
**Speed Limit:** 30 KM/Hr  
**Coordinates:** 11.16071, 78.28080
