# IndianOil

## **JOURNEY RISK MANAGEMENT (JRM) STUDY**

### **Salem Terminal TO SREE SAPTHAGIRI AGENCIES**

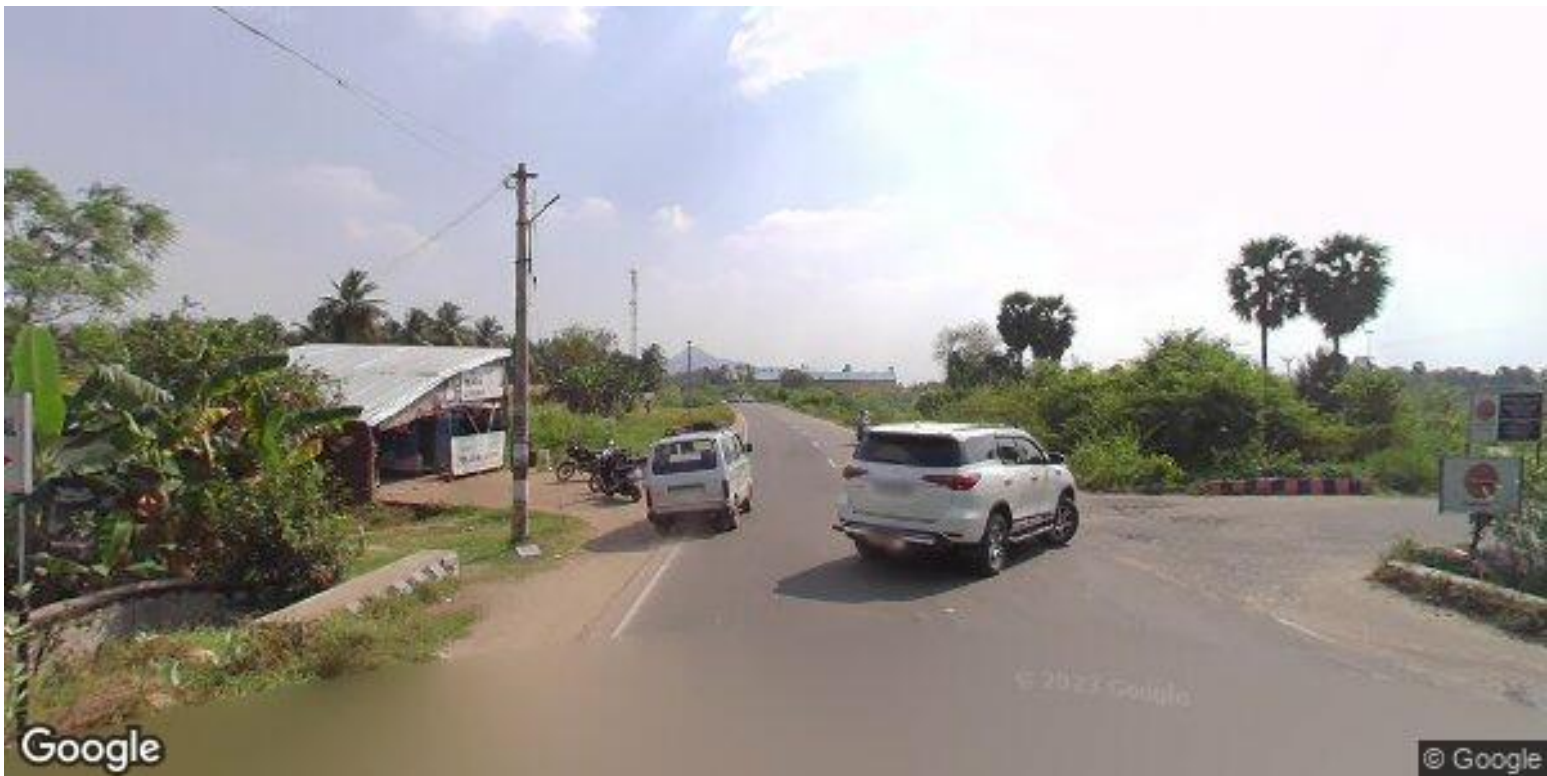
Coordinates: 11.44029, 77.87544

Risk Type: Turn

Risk Level: High

Speed Limit: 15 KM/Hr

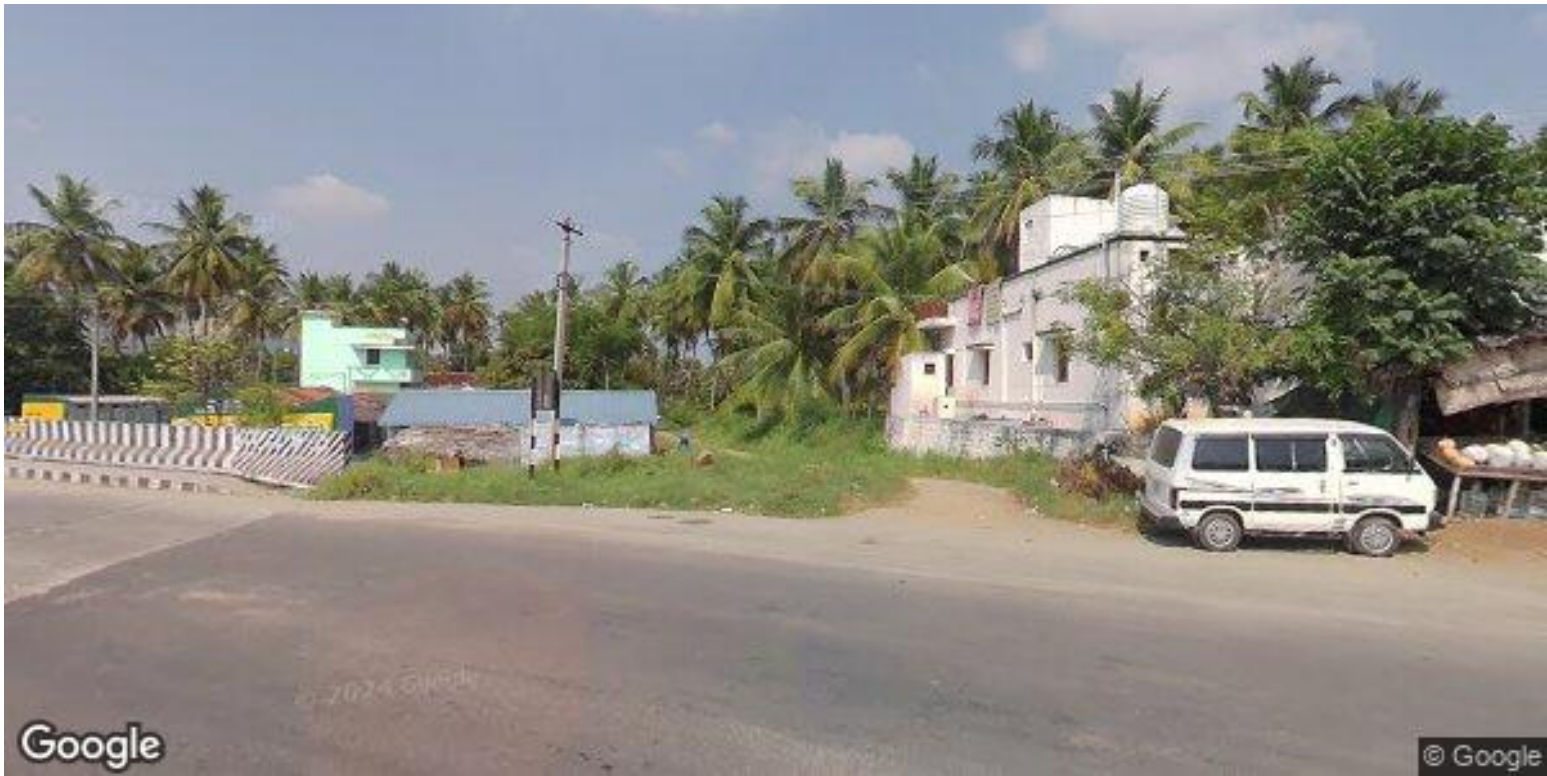
Risk Type: Turn

Risk Level: Medium

**Speed Limit: 30 KM/Hr**  
**Coordinates: 11.44898, 77.87410**

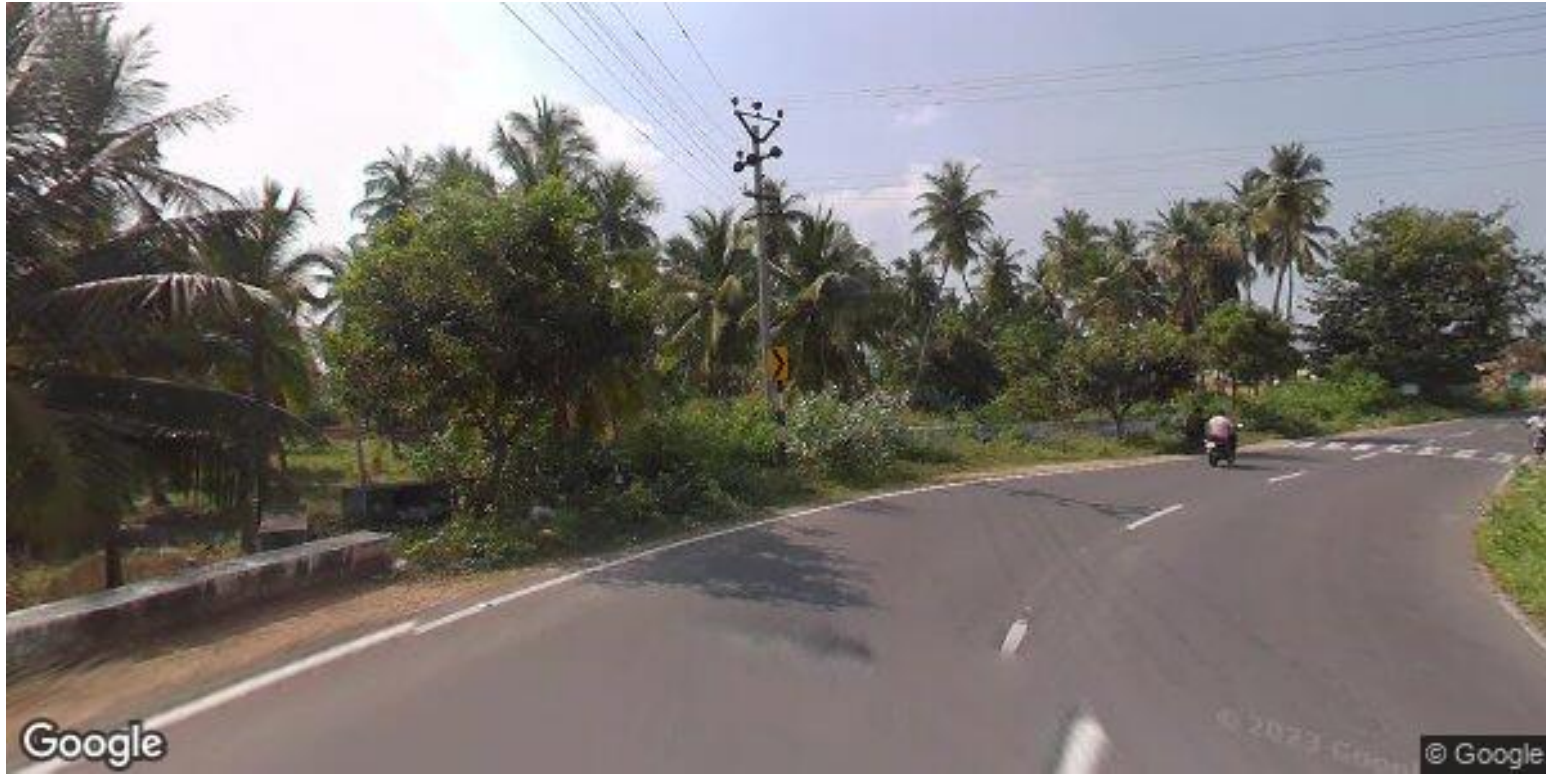
**Risk Type: Turn**  
**Risk Level: Medium**  
**Speed Limit: 30 KM/Hr**  
**Coordinates: 11.45348, 77.85706**

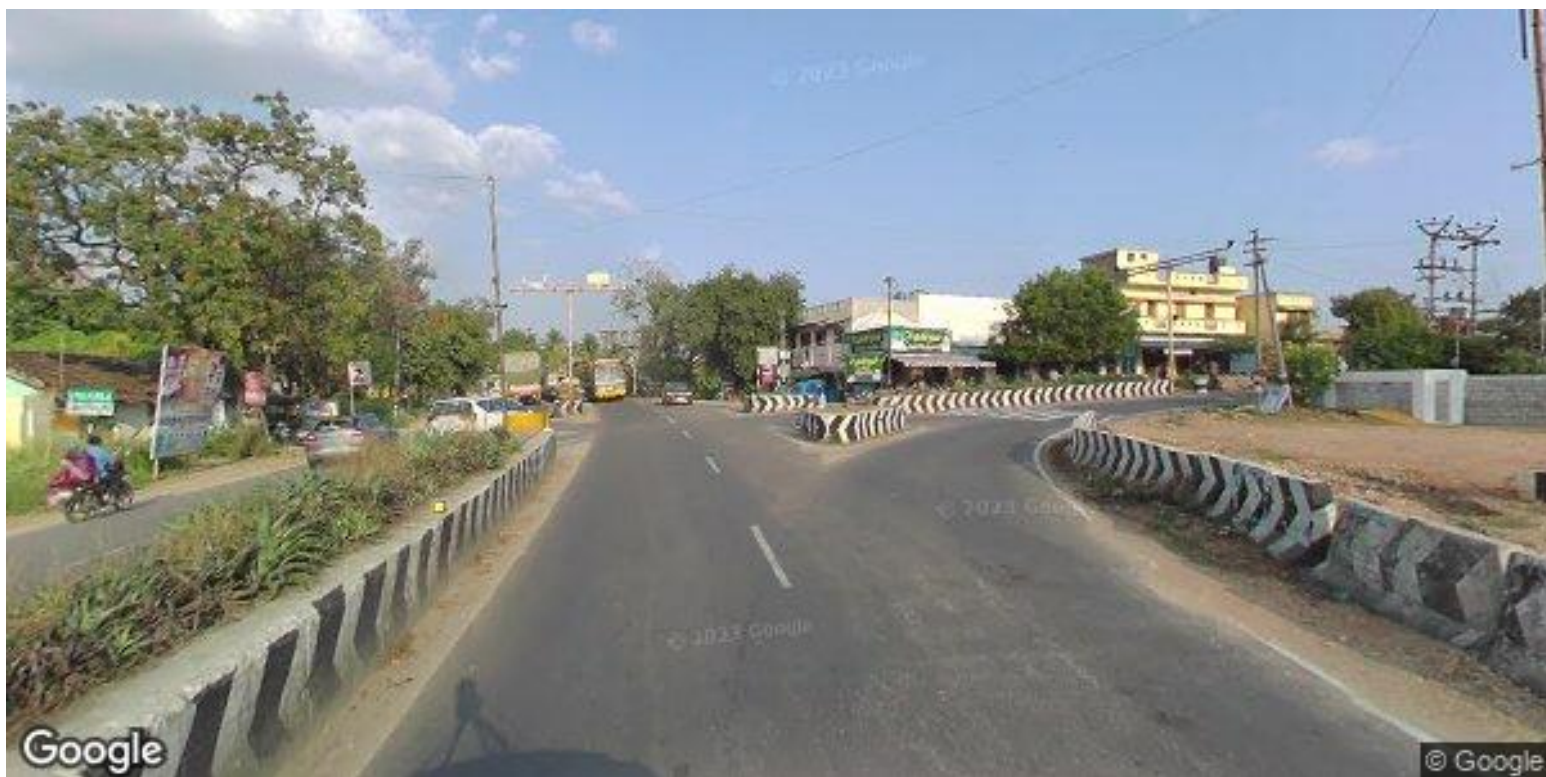
**Risk Type: Turn**  
**Risk Level: Medium**  
**Speed Limit: 30 KM/Hr**  
**Coordinates: 11.46318, 77.84913**

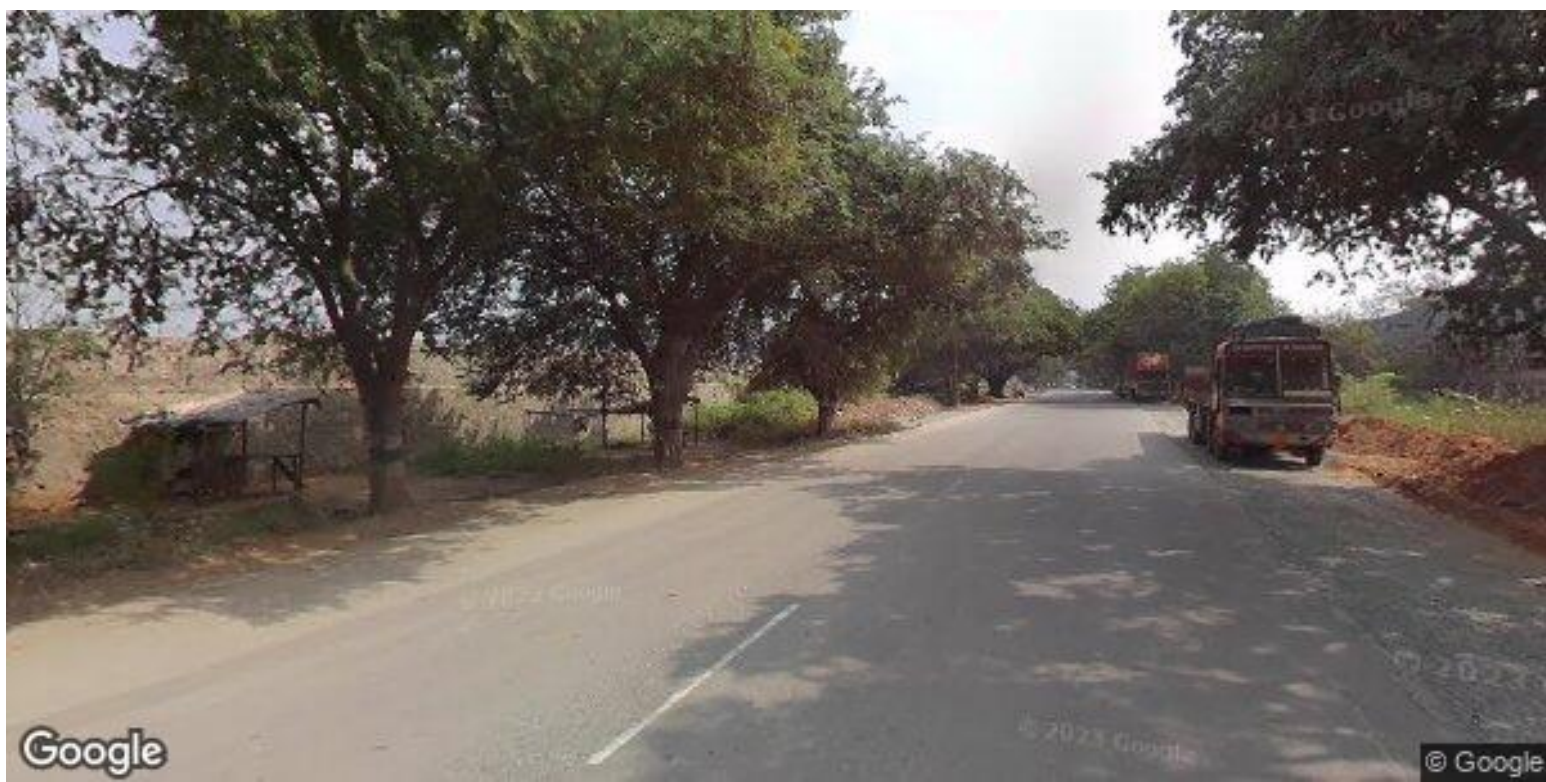
**Coordinates:** 11.45697, 77.82719

**Risk Type:** Turn

**Risk Level:** Medium

**Speed Limit:** 30 KM/Hr

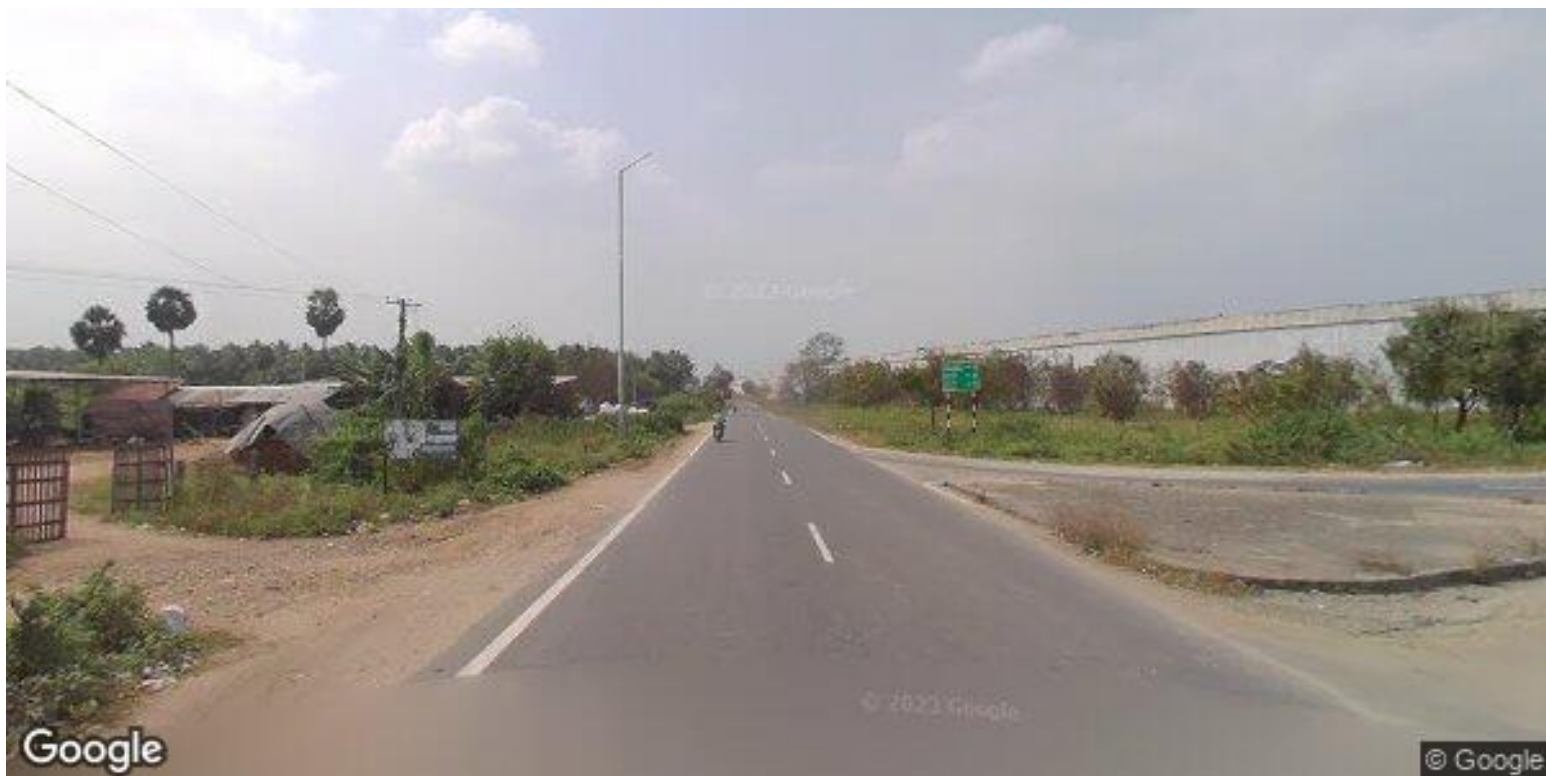
**Coordinates:** 11.45542, 77.81725

**Risk Type:** Turn

**Risk Level:** High

**Speed Limit:** 15 KM/Hr

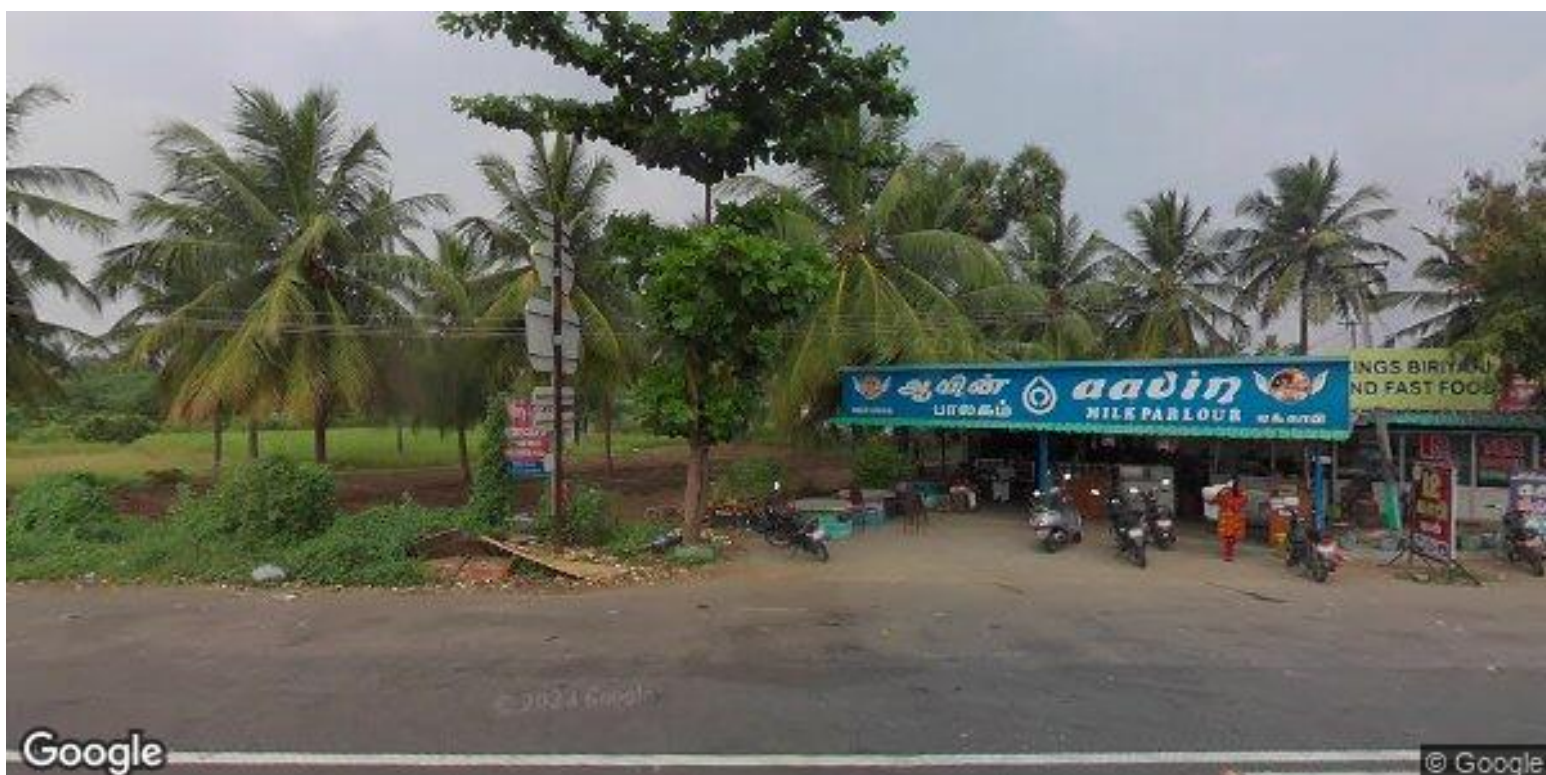
**Risk Type:** Turn  
**Risk Level:** High  
**Speed Limit:** 15 KM/Hr  
**Coordinates:** 11.45631, 77.81668

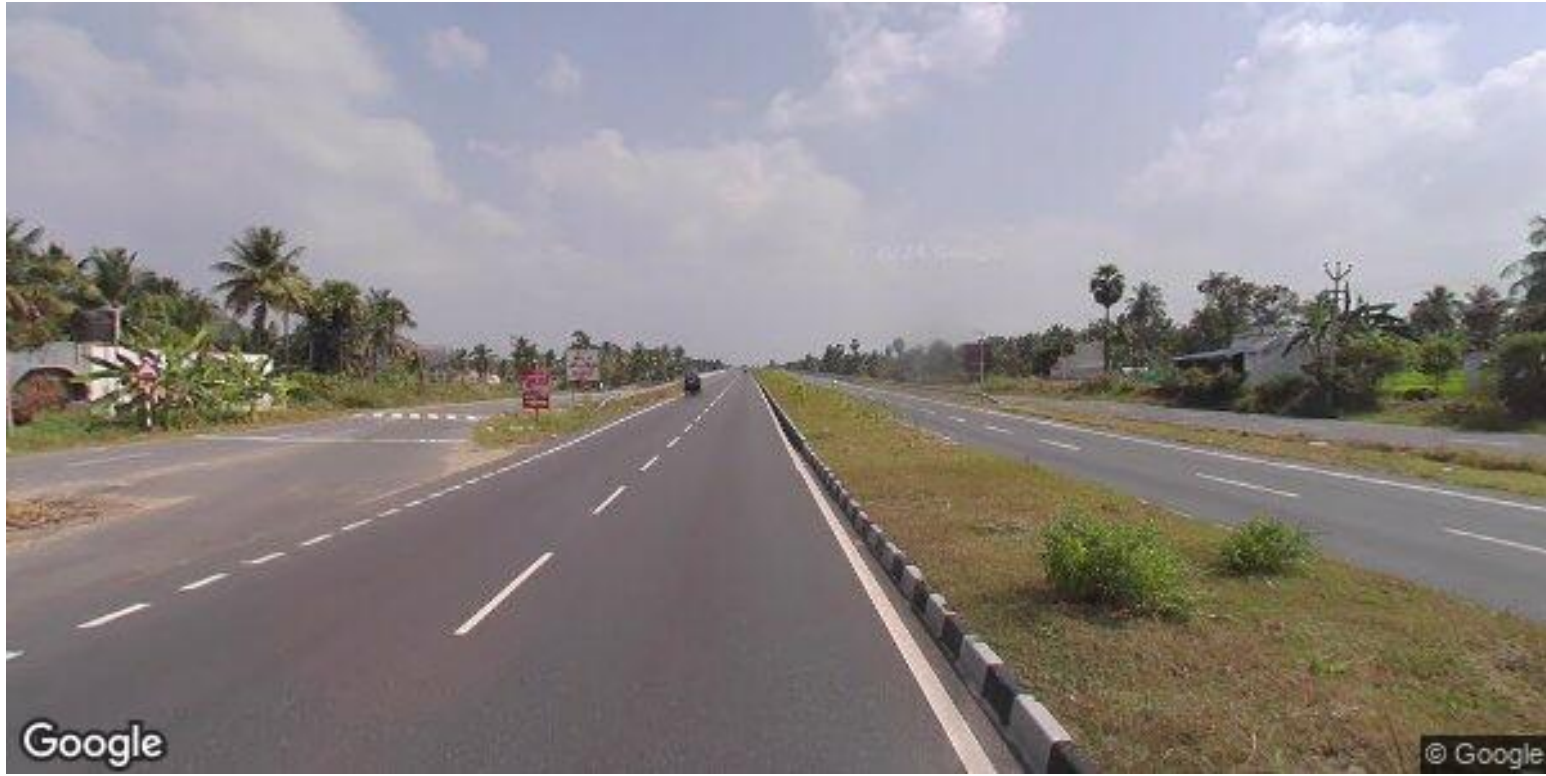
**Risk Type:** Turn  
**Risk Level:** Medium  
**Speed Limit:** 30 KM/Hr  
**Coordinates:** 11.49249, 77.85821

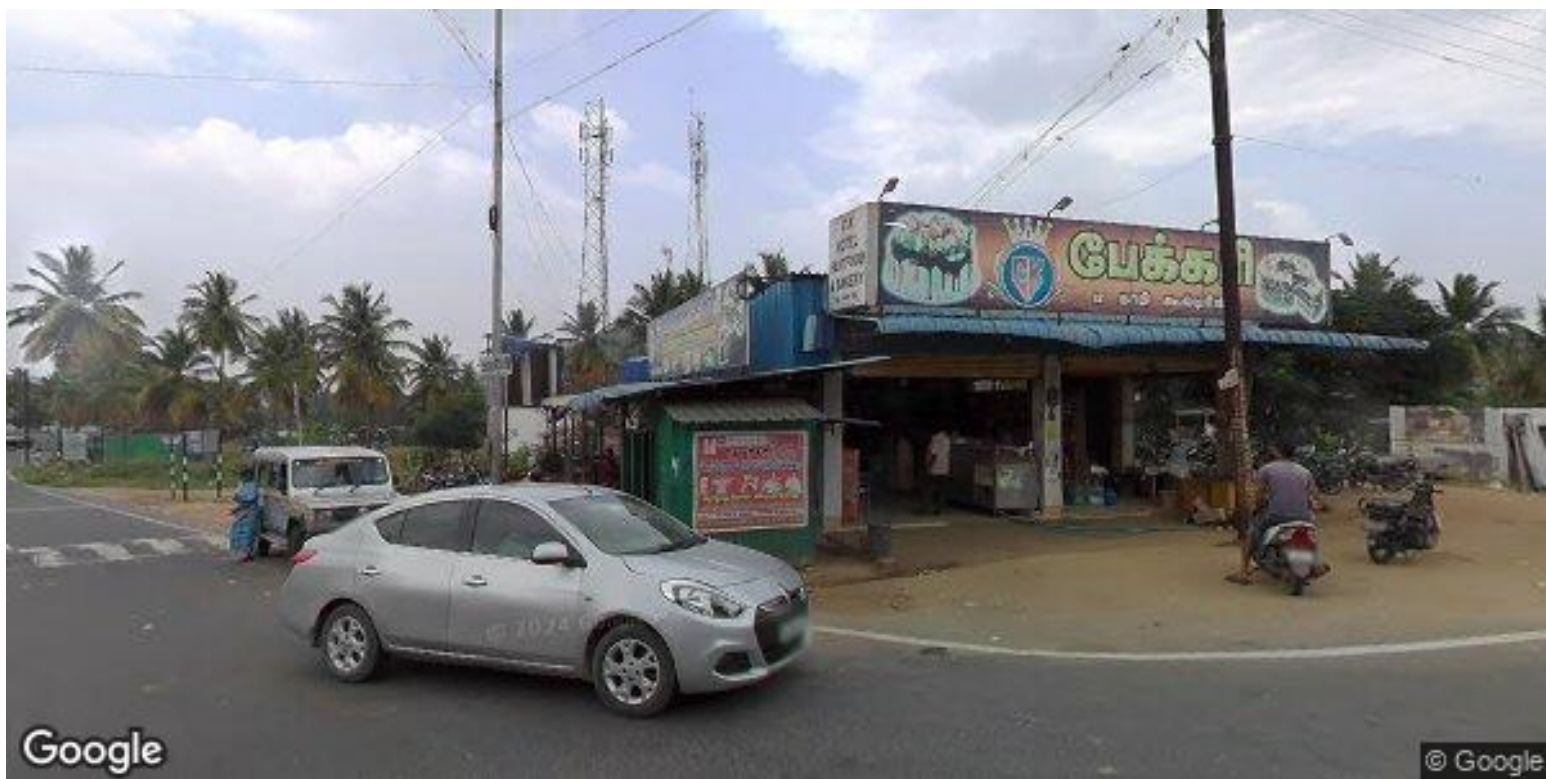
**Risk Type:** Blind Spot  
**Risk Level:** Blind Spot  
**Speed Limit:** 10 KM/Hr  
**Coordinates:** 11.49390, 77.86748

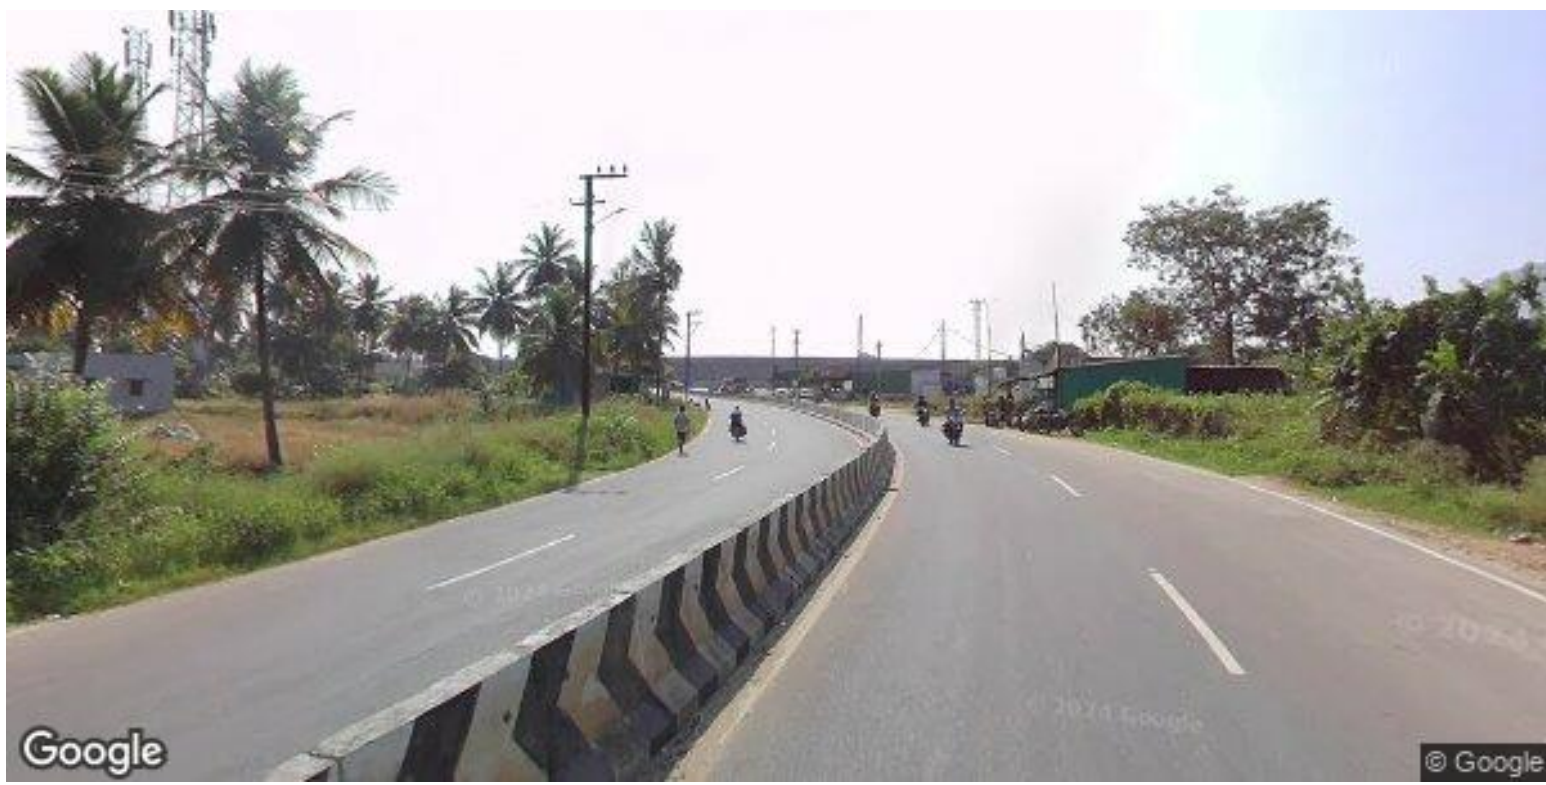
**Coordinates:** 11.49513, 77.86656

**Risk Type:** Turn

**Risk Level:** Medium

**Speed Limit:** 30 KM/Hr

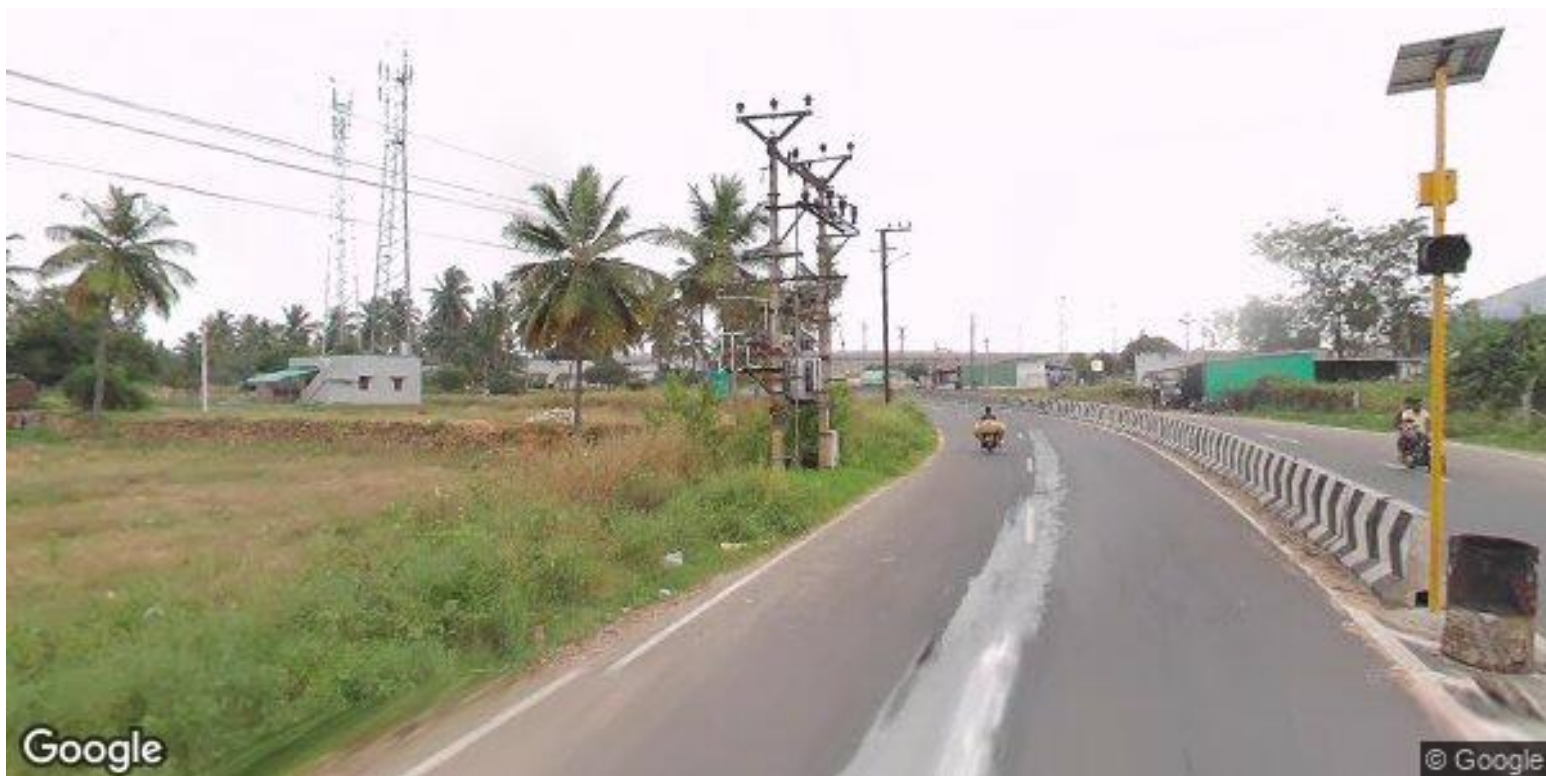
**Coordinates:** 11.49525, 77.86659

**Risk Type:** Turn

**Risk Level:** Medium

**Speed Limit:** 30 KM/Hr
