## JOURNEY RISK MANAGEMENT (JRM) STUDY

### Salem Terminal to BAAGA FUELS

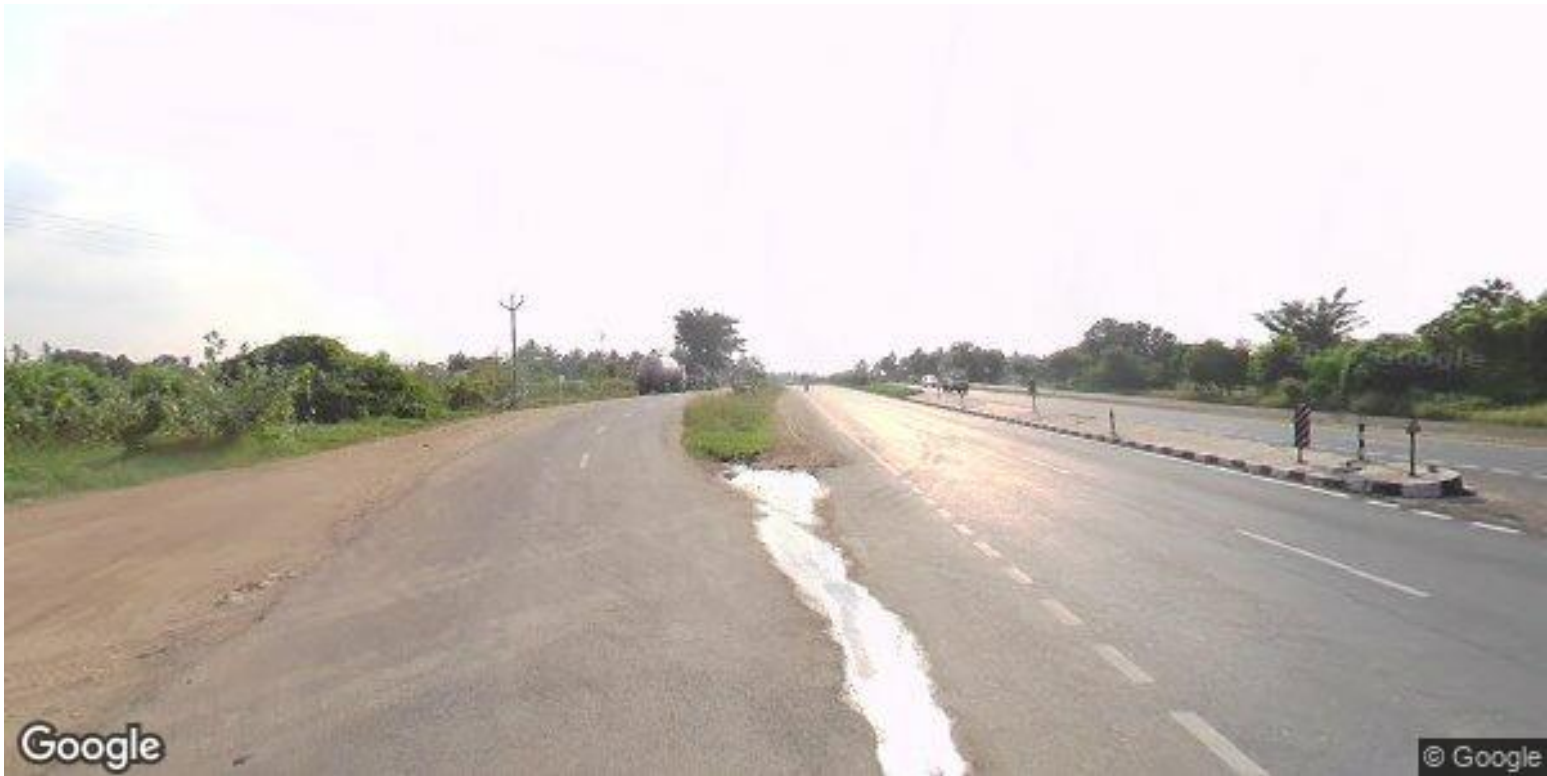
**Coordinates:** 11.3141552, 77.6131059

**Risk Type:** U-Turn

**Risk Level:** High

**Speed Limit:** 10 KM/Hr

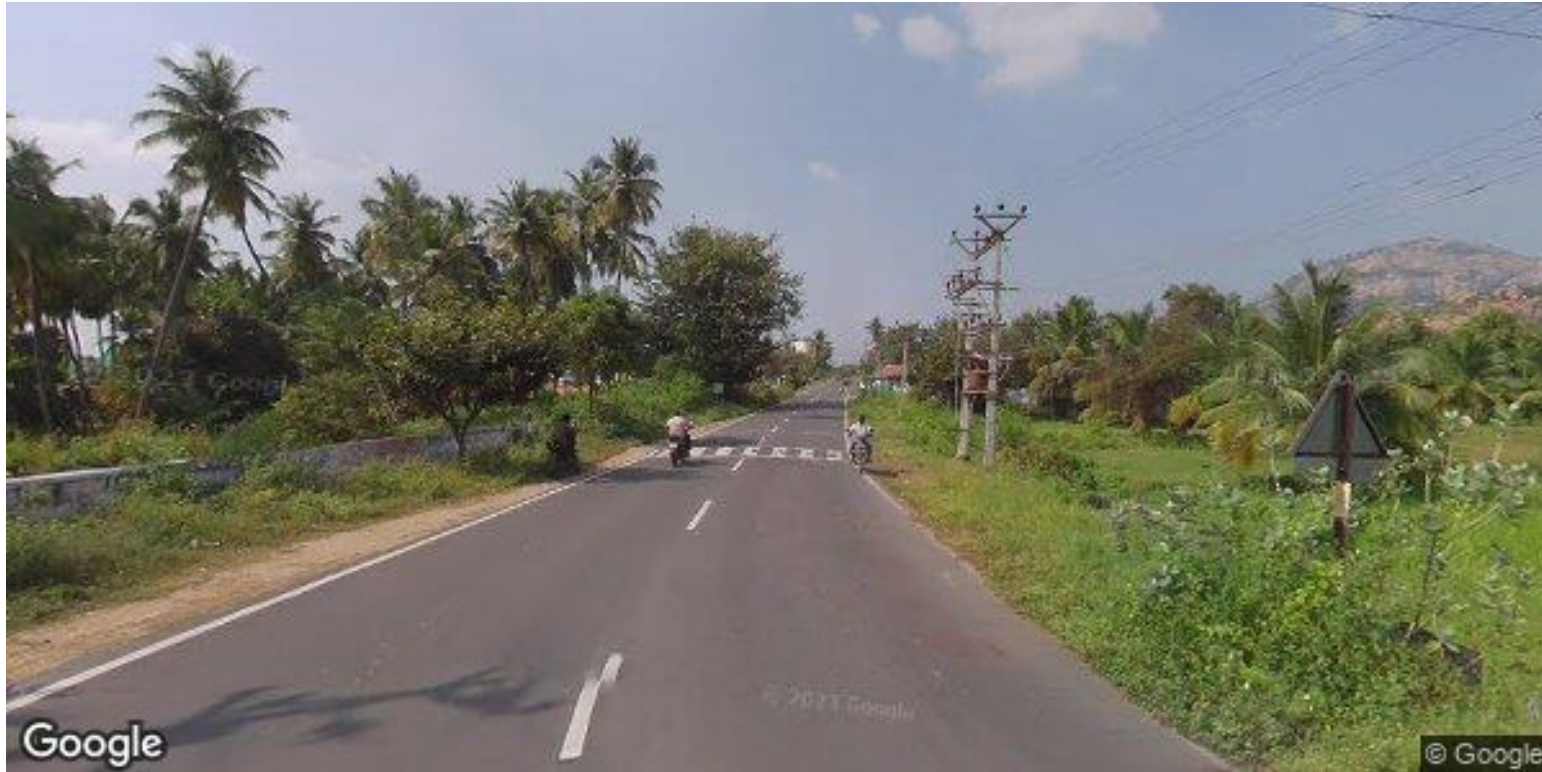
**Risk Type:** Turn  
**Risk Level:** Medium  
**Speed Limit:** 30 KM/Hr  
**Coordinates:** 11.45352, 77.85698

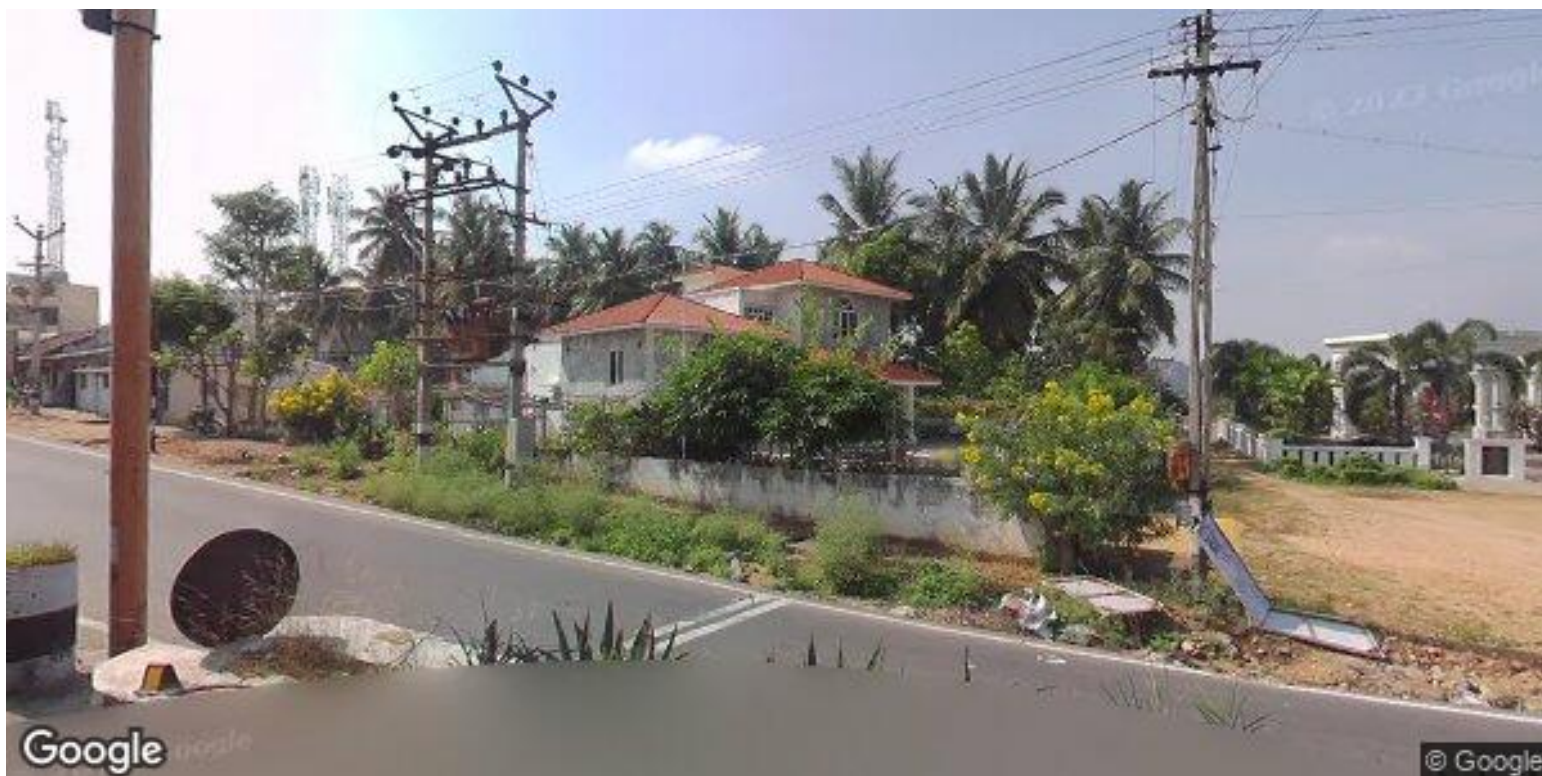
**Risk Type:** Turn  
**Risk Level:** Medium  
**Speed Limit:** 30 KM/Hr  
**Coordinates:** 11.46303, 77.84945

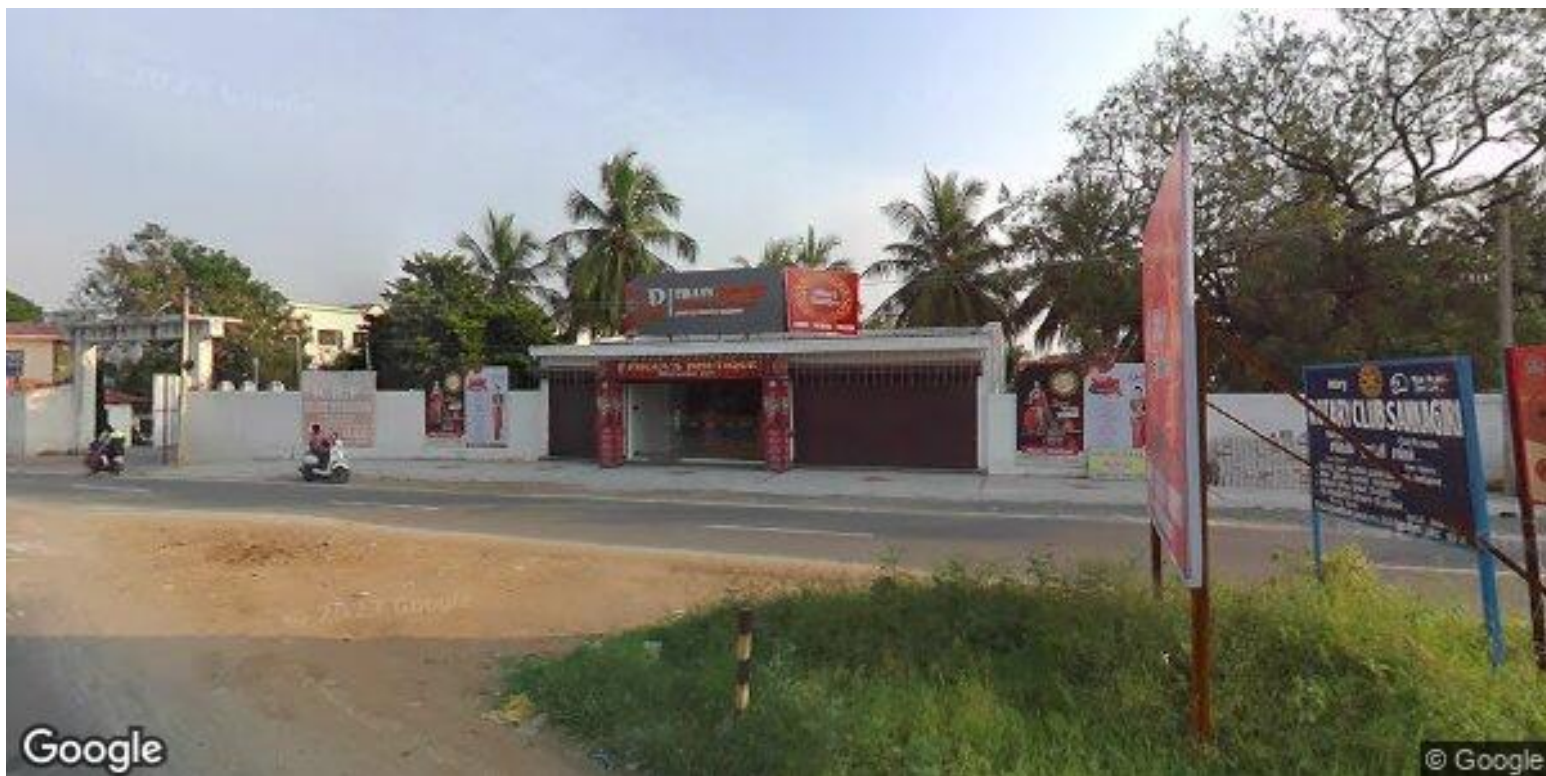
**Coordinates:** 11.45516, 77.81346

**Risk Type:** Turn

**Risk Level:** High

**Speed Limit:** 15 KM/Hr

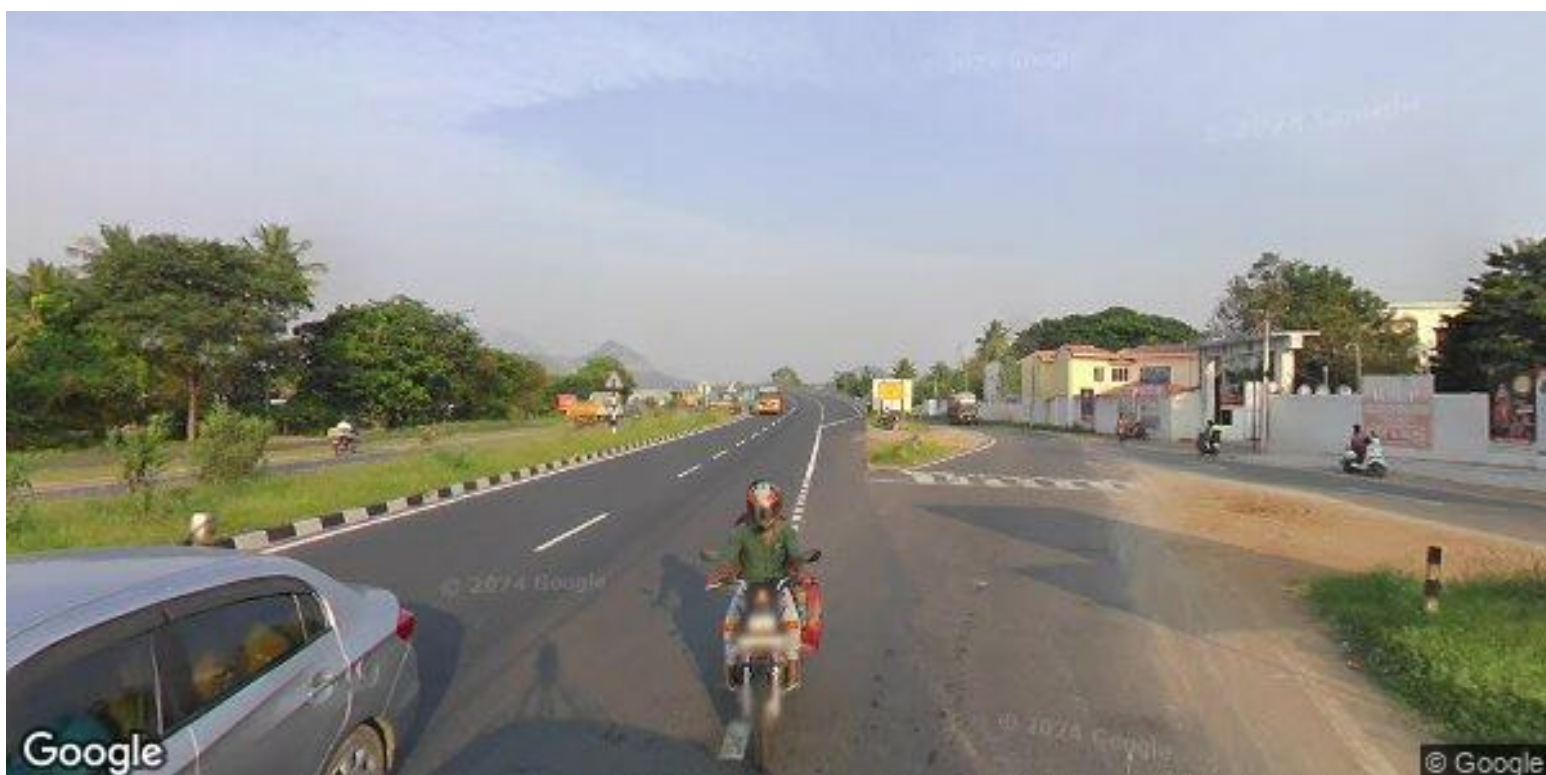
**Risk Type:** Turn  
**Risk Level:** High  
**Speed Limit:** 15 KM/Hr  
**Coordinates:** 11.45521, 77.81343

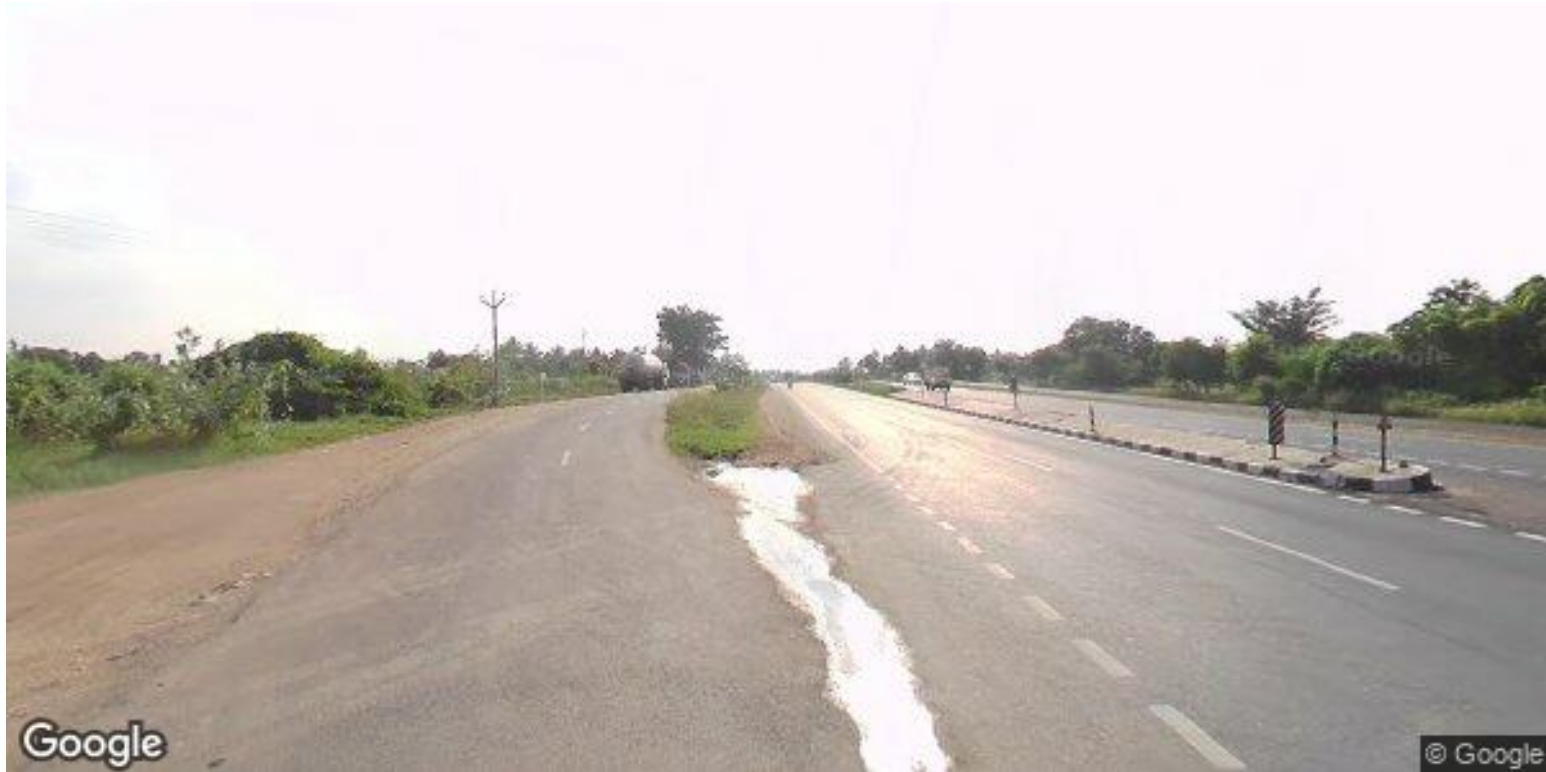
**Risk Type:** Blind Spot  
**Risk Level:** Blind Spot  
**Speed Limit:** 10 KM/Hr  
**Coordinates:** 11.31416, 77.61311

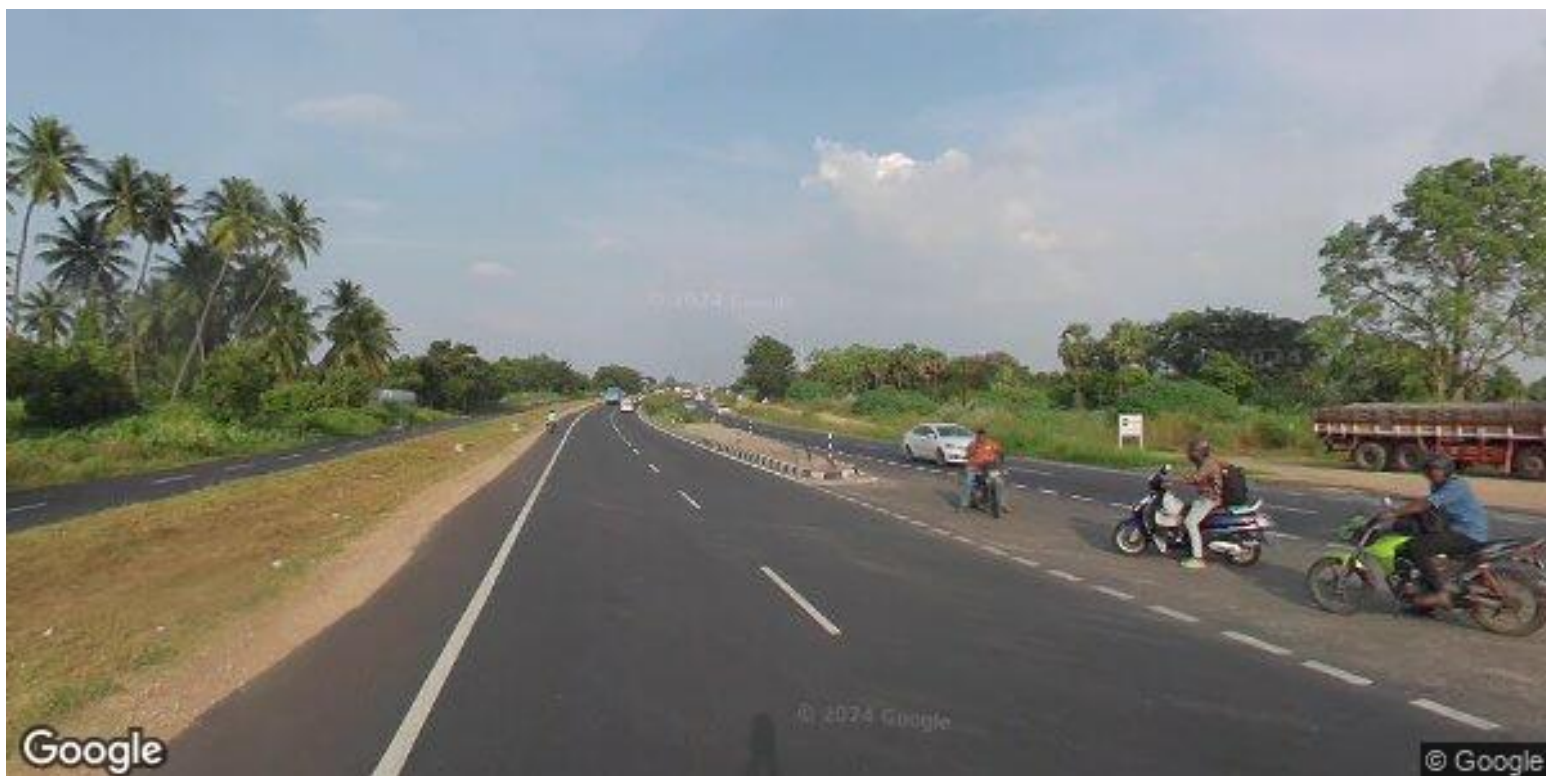
**Risk Type:** Turn  
**Risk Level:** High  
**Speed Limit:** 15 KM/Hr  
**Coordinates:** 11.31425, 77.61303

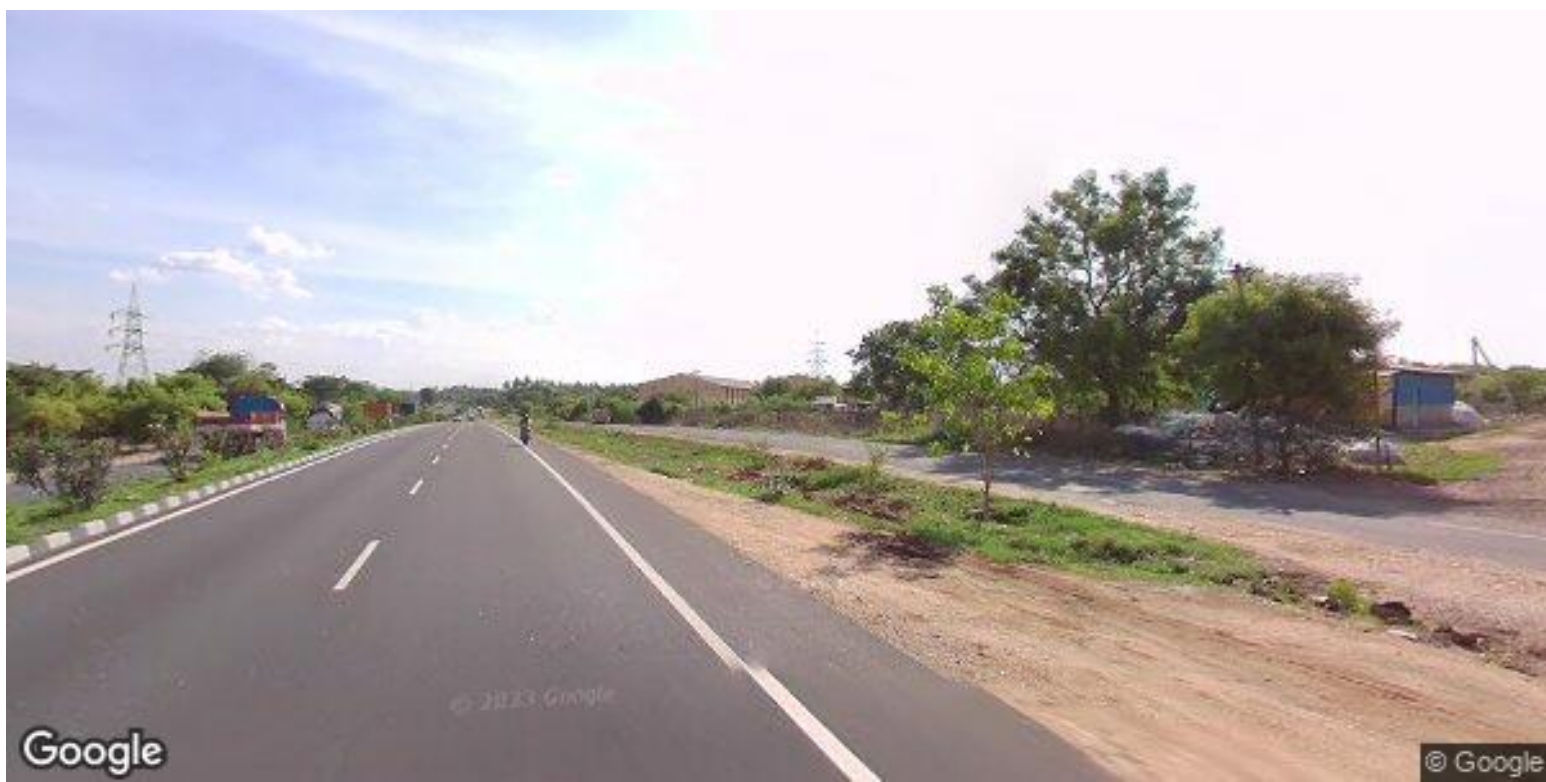
**Risk Type:** Blind Spot  
**Risk Level:** Blind Spot  
**Speed Limit:** 10 KM/Hr  
**Coordinates:** 11.31812, 77.61873

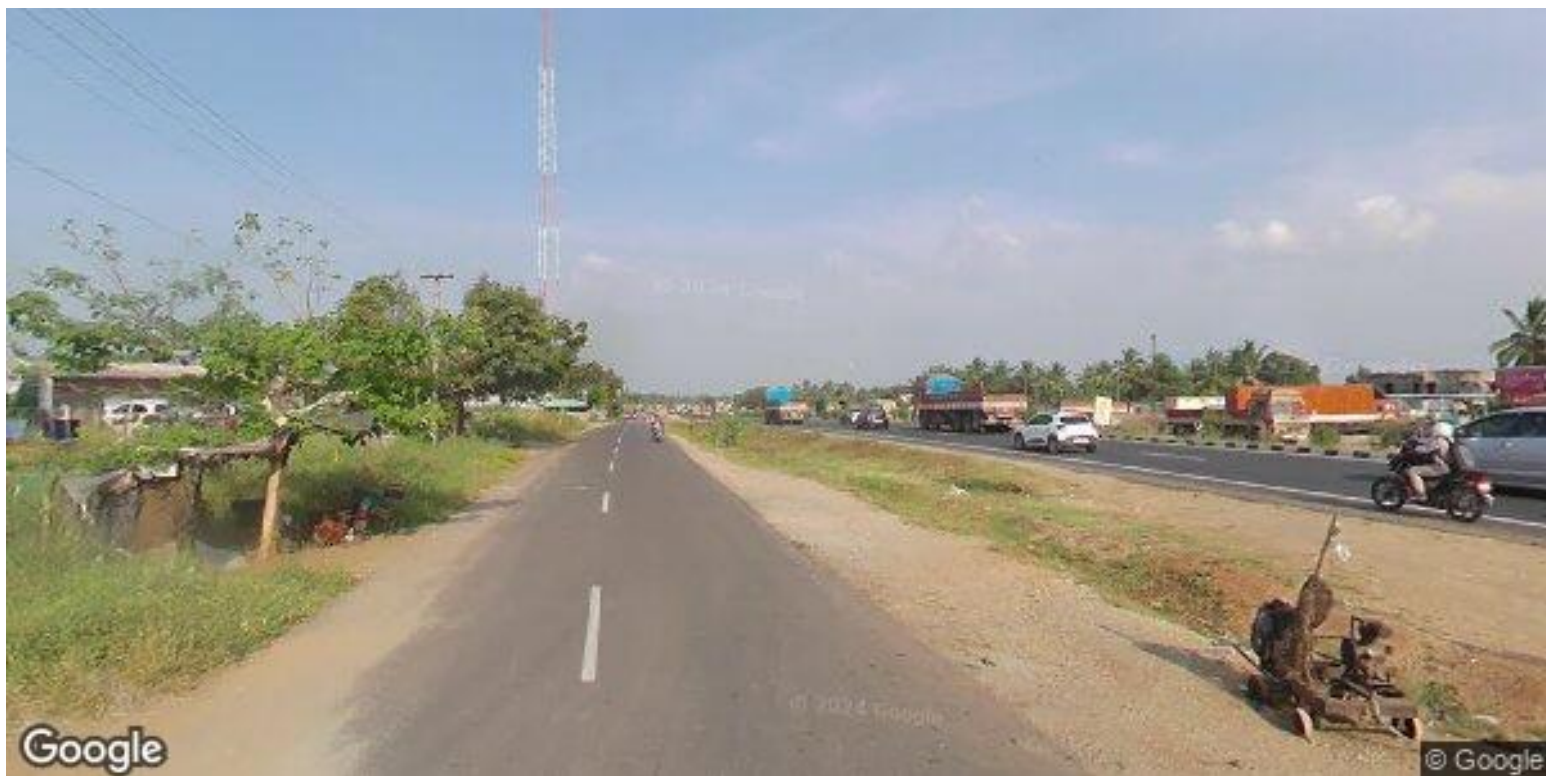
**Risk Type:** Blind Spot  
**Risk Level:** Blind Spot  
**Speed Limit:** 10 KM/Hr  
**Coordinates:** 11.31824, 77.61861

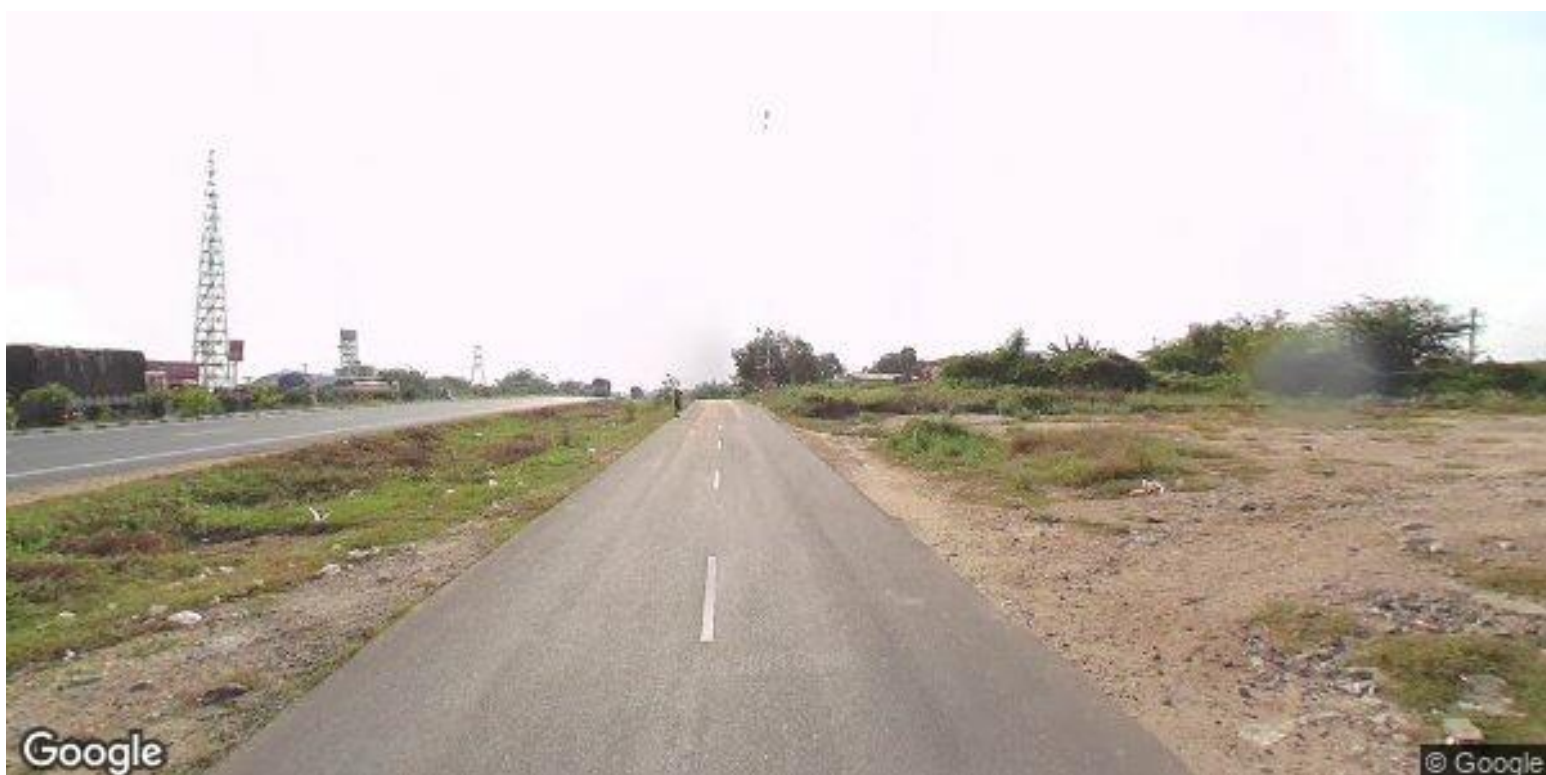
**Risk Type:** Blind Spot  
**Risk Level:** Blind Spot  
**Speed Limit:** 10 KM/Hr  
**Coordinates:** 11.31869, 77.61950

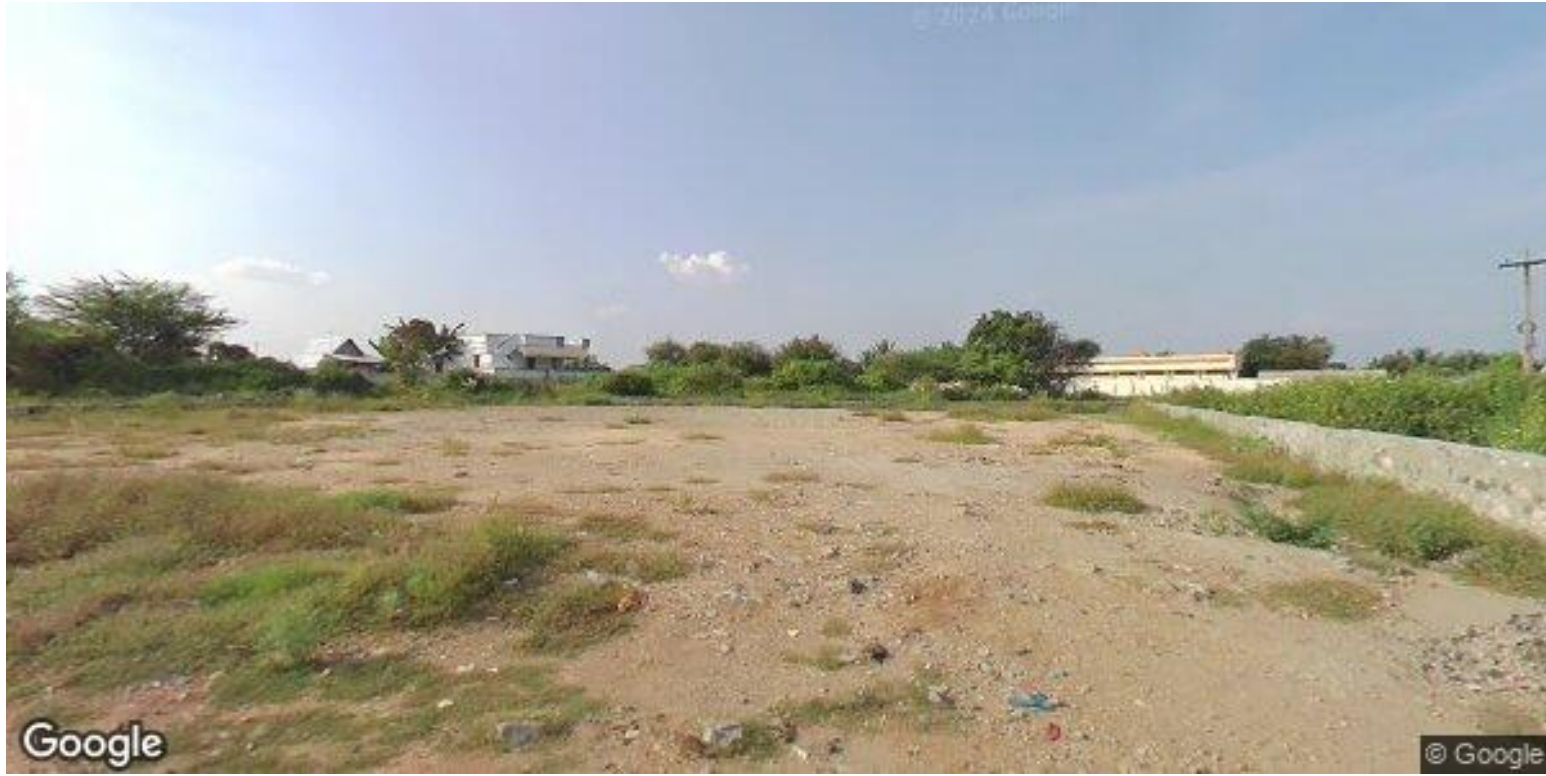
**Risk Type:** Turn  
**Risk Level:** High  
**Speed Limit:** 15 KM/Hr  
**Coordinates:** 11.31889, 77.61931
