# IndianOil

## JOURNEY RISK MANAGEMENT (JRM) STUDY

### Salem Terminal to THULASIMANI AGENCIES

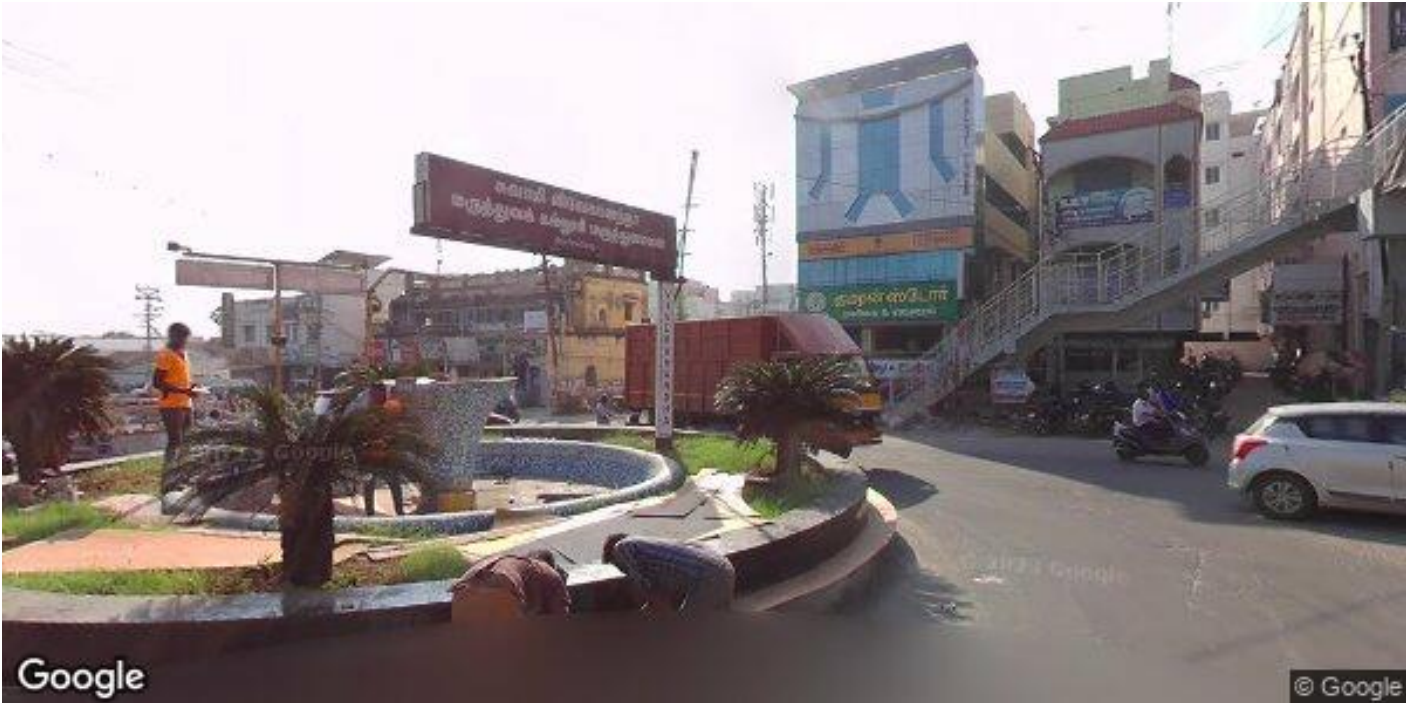
Risk Type: Roundabout

Risk Level: High

Speed Limit: 15 KM/Hr

Coordinates: 11.38395, 77.89480

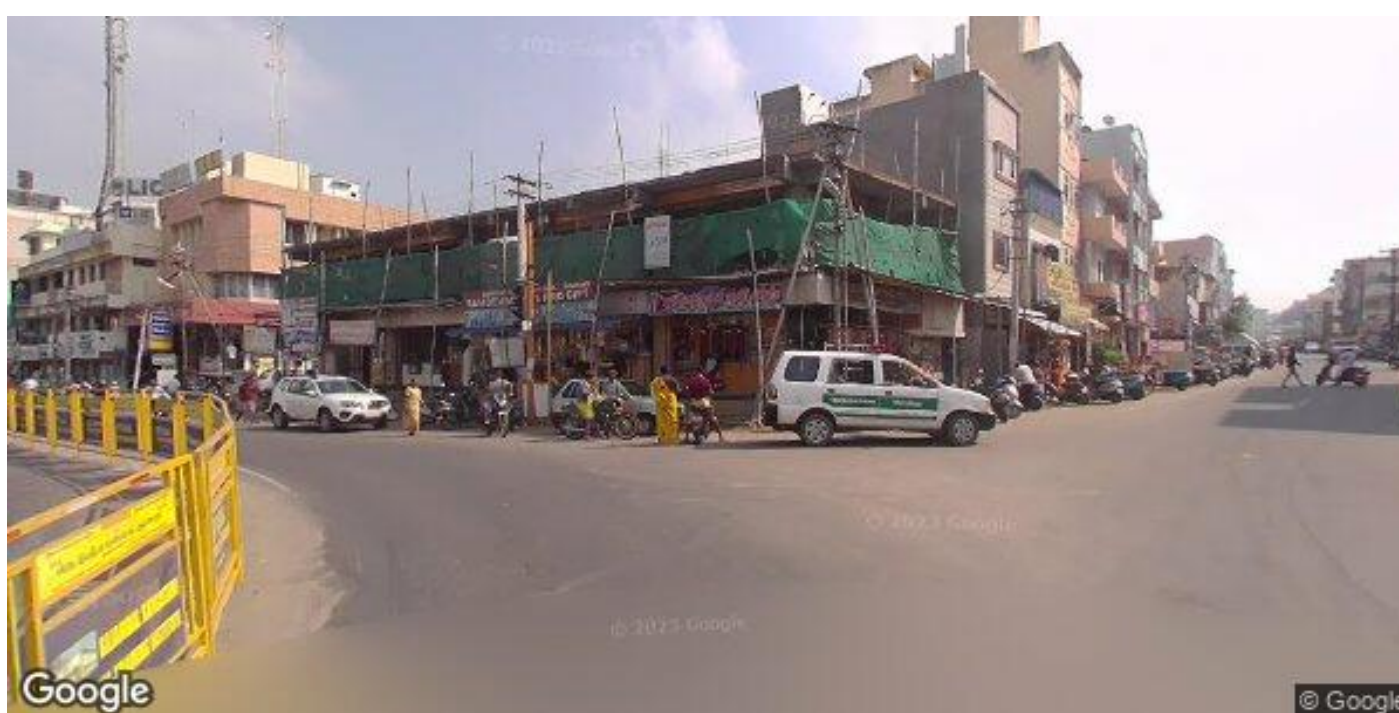
**Risk Type:** Turn  
**Risk Level:** High  
**Speed Limit:** 15 KM/Hr  
**Coordinates:** 11.37868, 77.89498

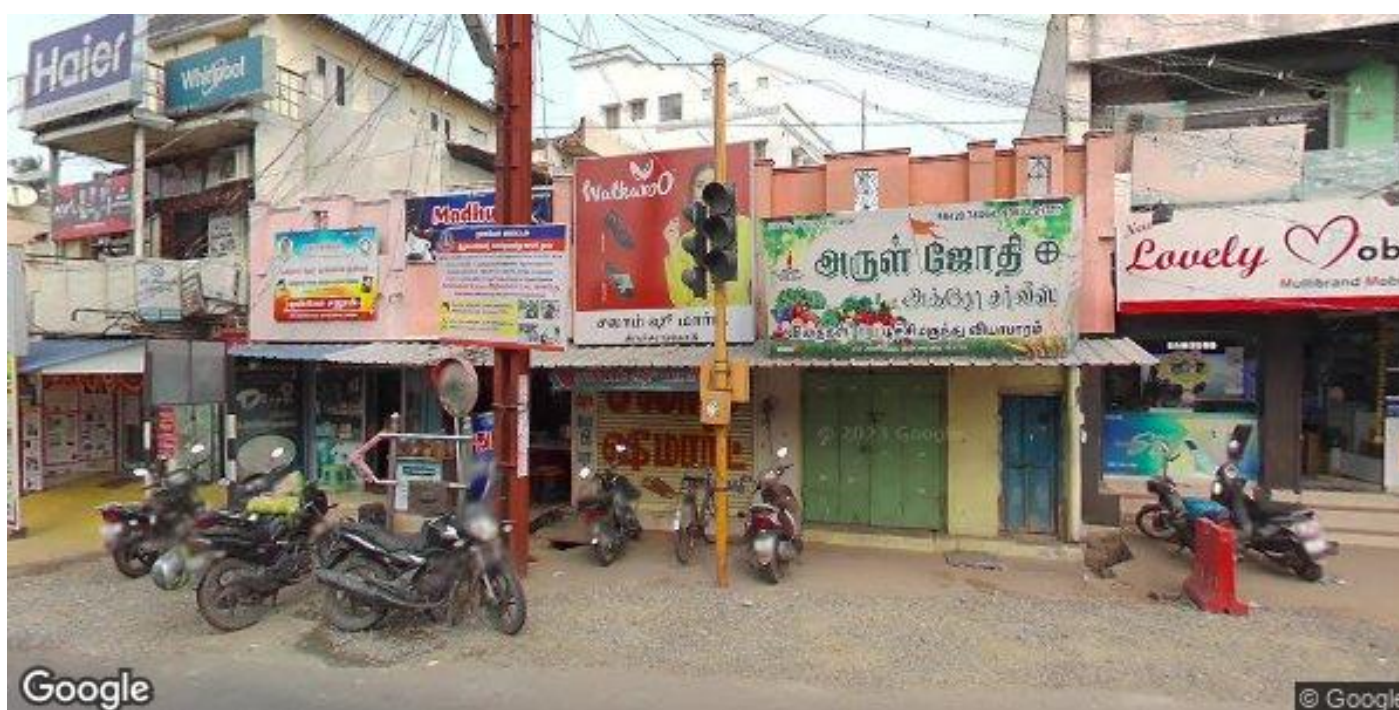
**Risk Type:** Turn  
**Risk Level:** High  
**Speed Limit:** 15 KM/Hr  
**Coordinates:** 11.37850, 77.89453

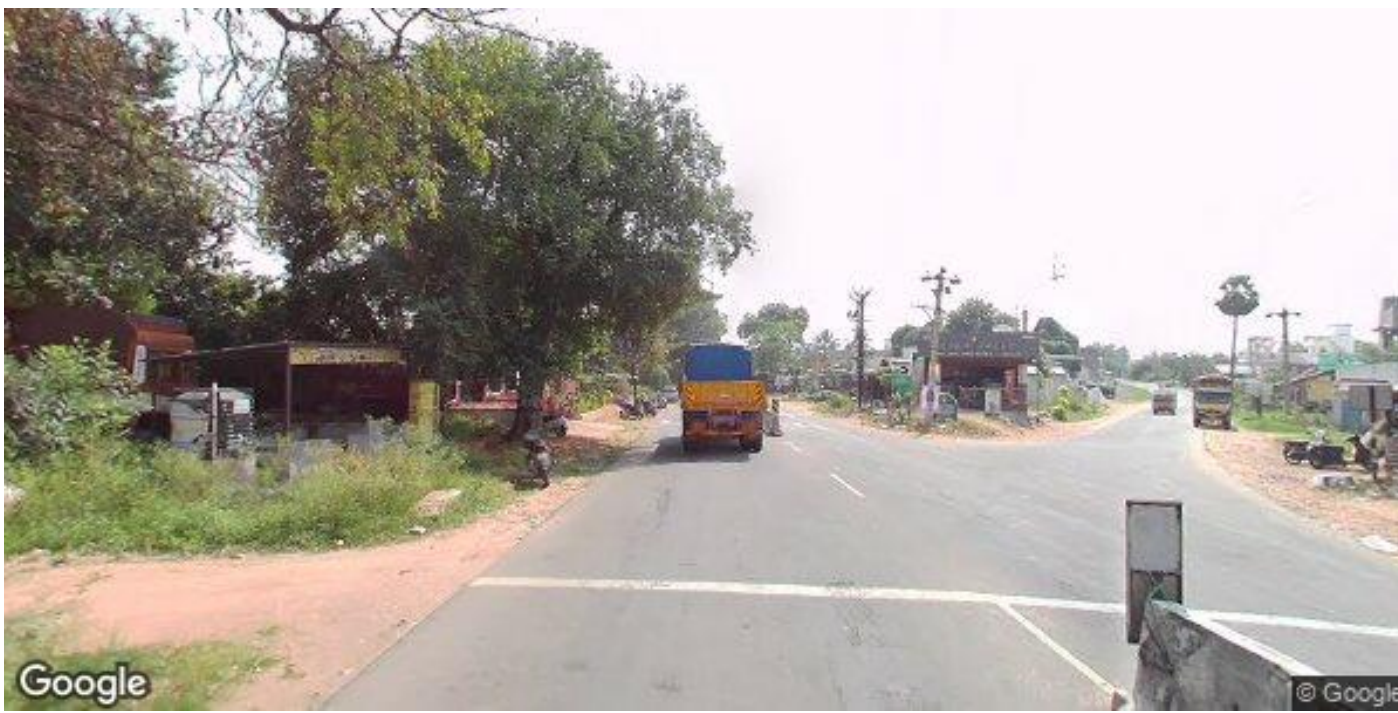
**Risk Type:** Turn  
**Risk Level:** Medium  
**Speed Limit:** 30 KM/Hr  
**Coordinates:** 11.35759, 77.89191

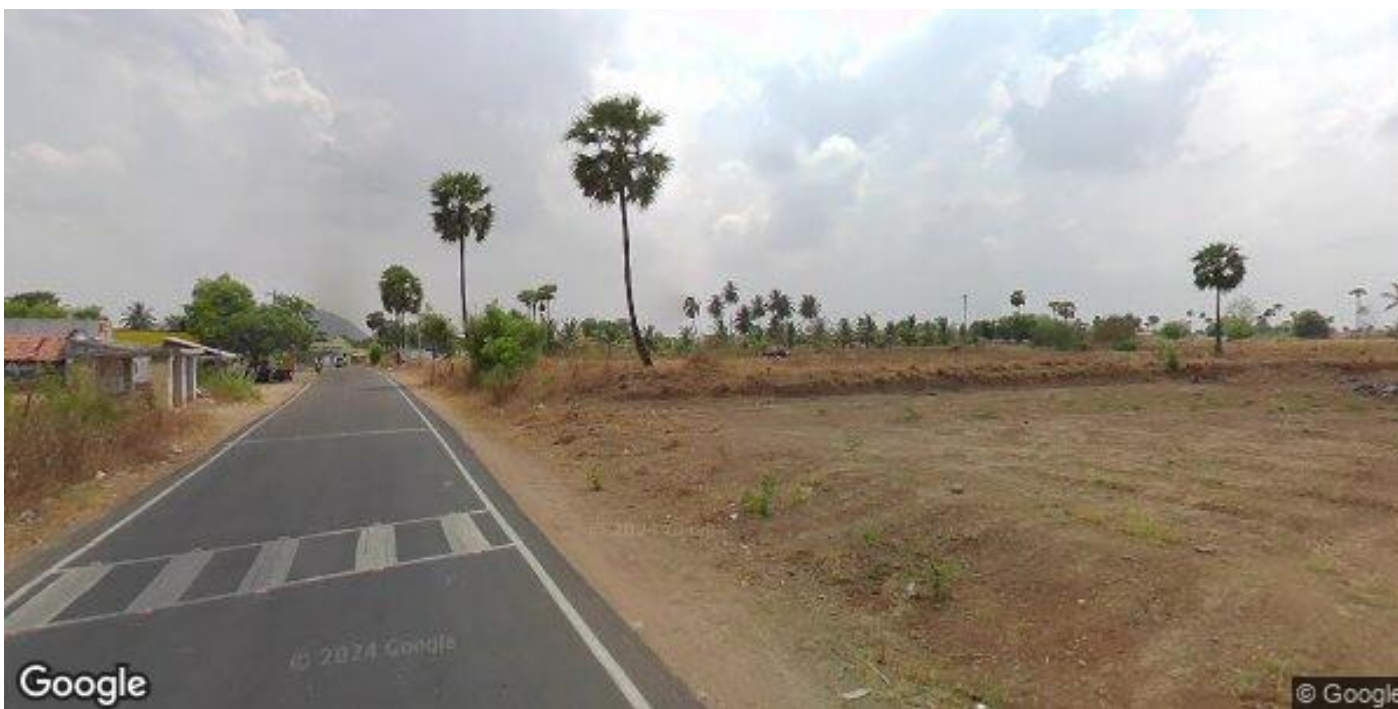
**Risk Type:** Turn  
**Risk Level:** Medium  
**Speed Limit:** 30 KM/Hr  
**Coordinates:** 11.33071, 77.88660

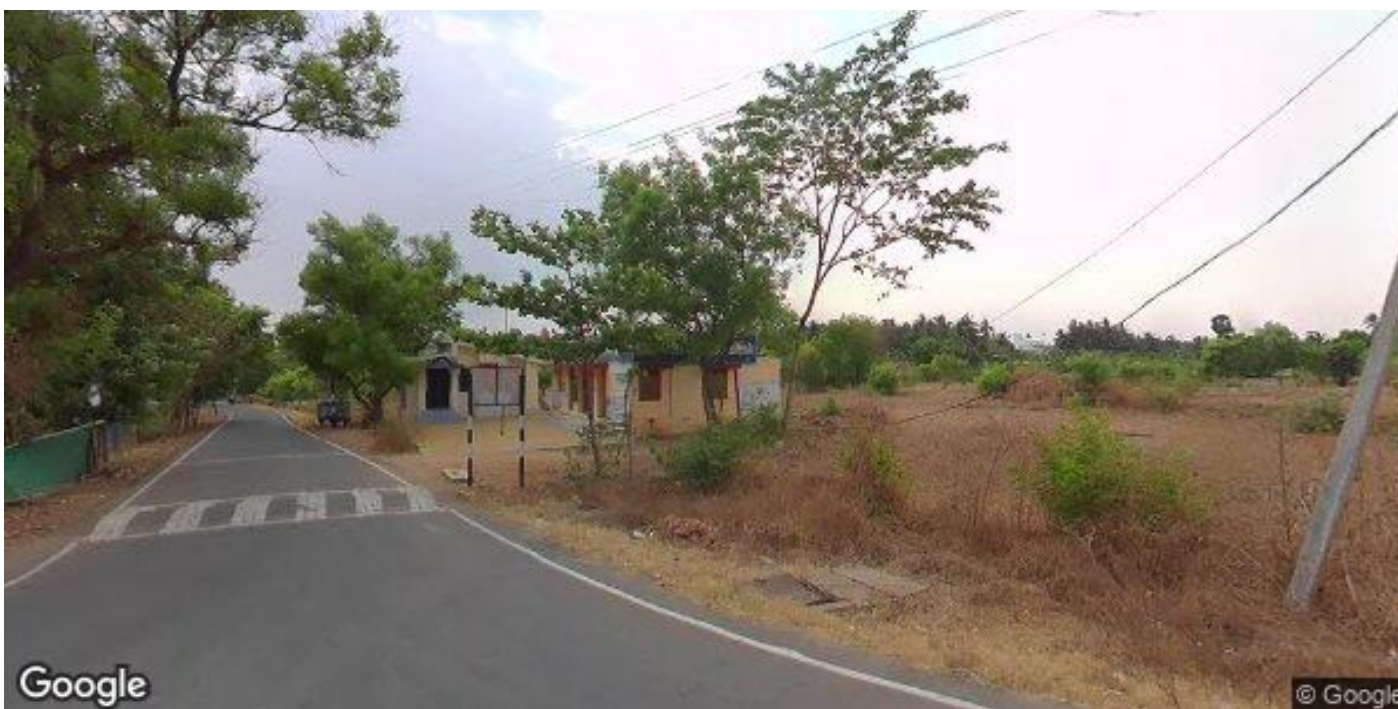
**Risk Type:** Turn  
**Risk Level:** High  
**Speed Limit:** 15 KM/Hr  
**Coordinates:** 11.33065, 77.88650

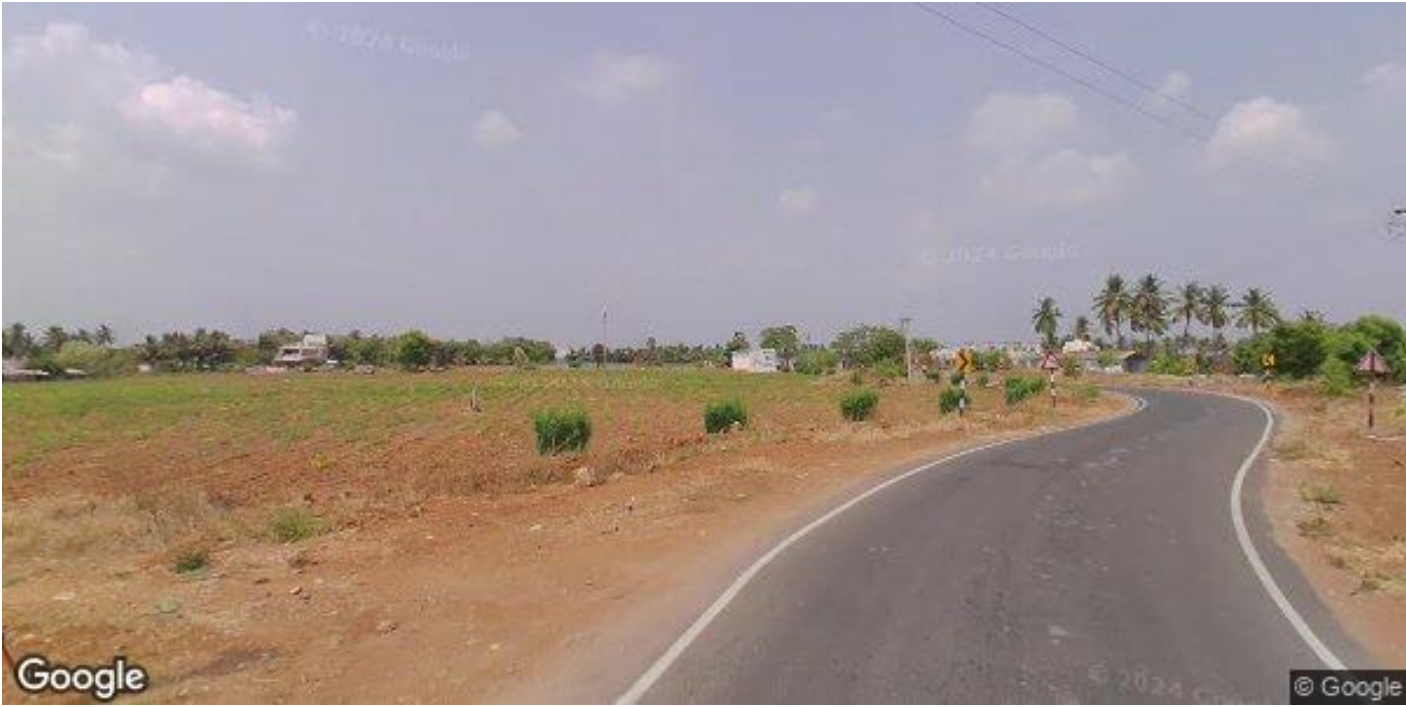
**Risk Type:** Turn  
**Risk Level:** Medium  
**Speed Limit:** 30 KM/Hr  
**Coordinates:** 11.32134, 77.88489

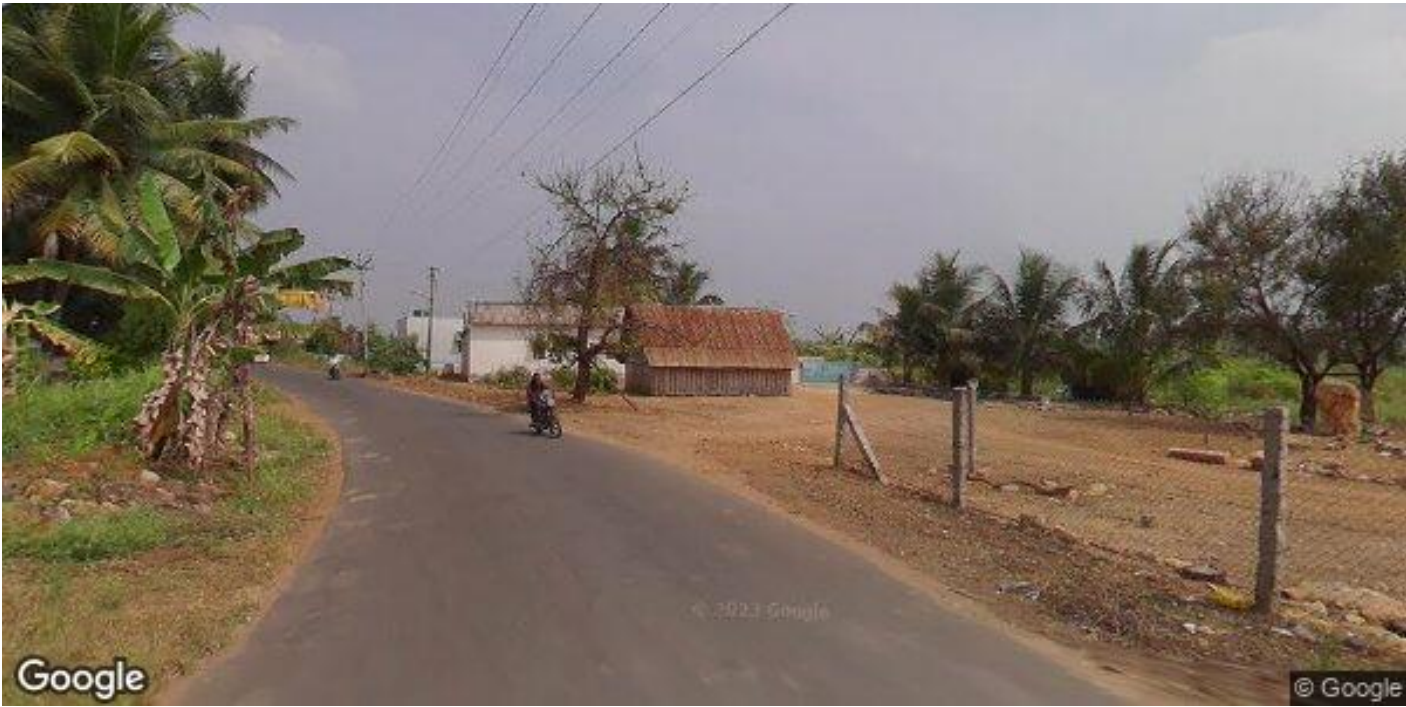
**Risk Type:** Turn  
**Risk Level:** Medium  
**Speed Limit:** 30 KM/Hr  
**Coordinates:** 11.31205, 77.88131

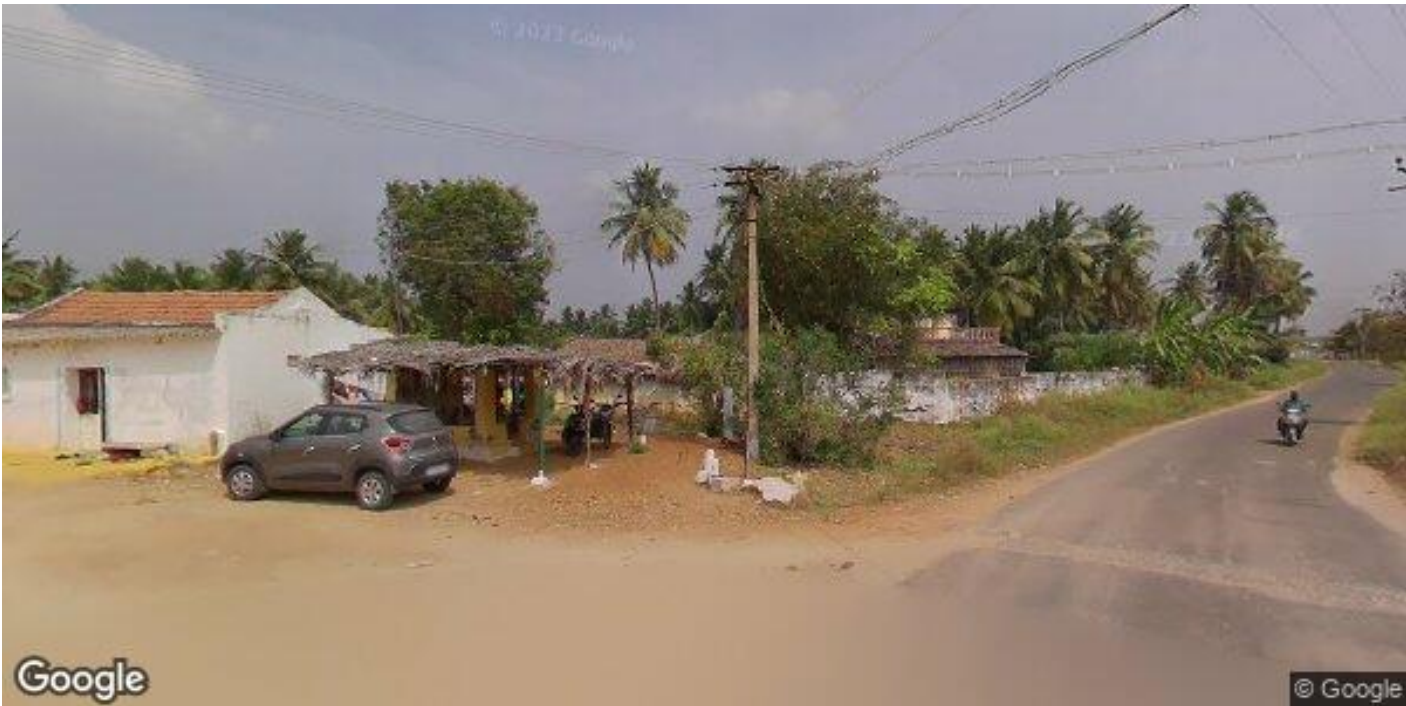
**Risk Type:** Turn  
**Risk Level:** Medium  
**Speed Limit:** 30 KM/Hr  
**Coordinates:** 11.31151, 77.88008

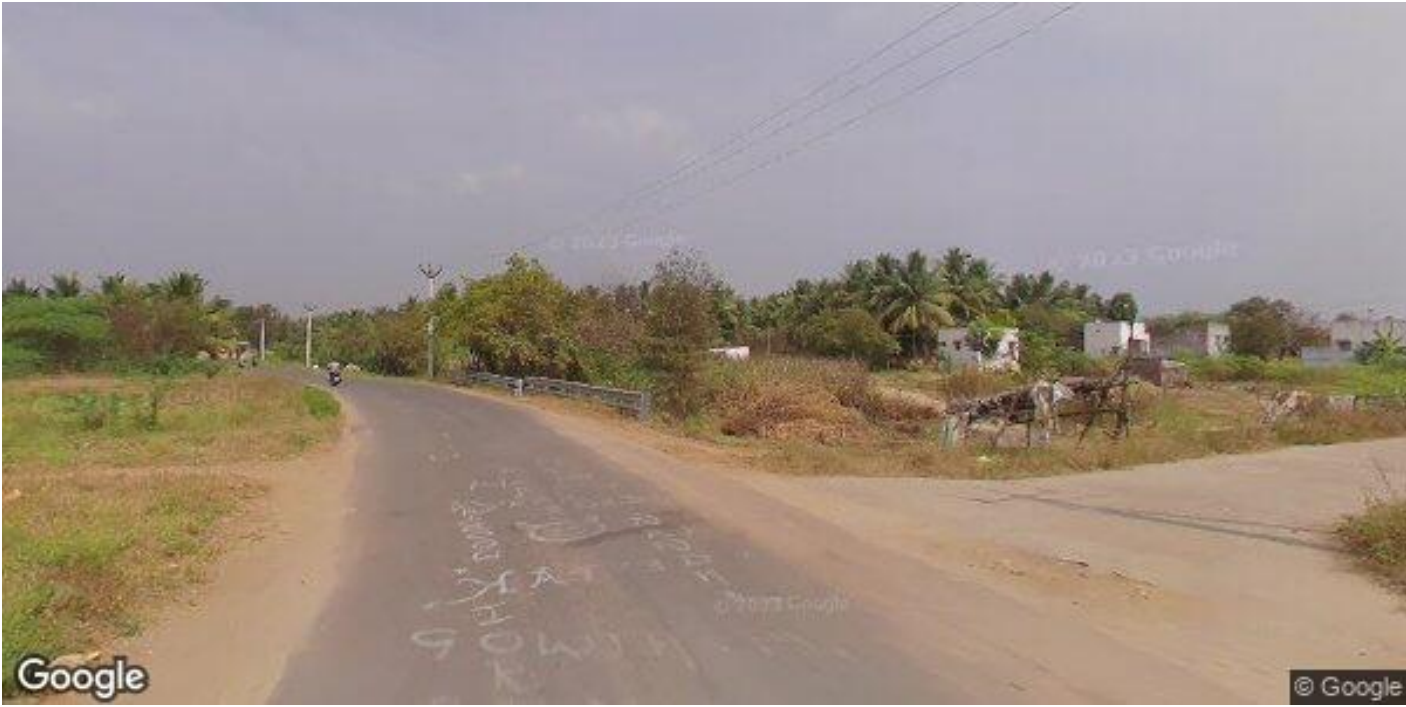
**Risk Type:** Turn  
**Risk Level:** Medium  
**Speed Limit:** 30 KM/Hr  
**Coordinates:** 11.30805, 77.87934

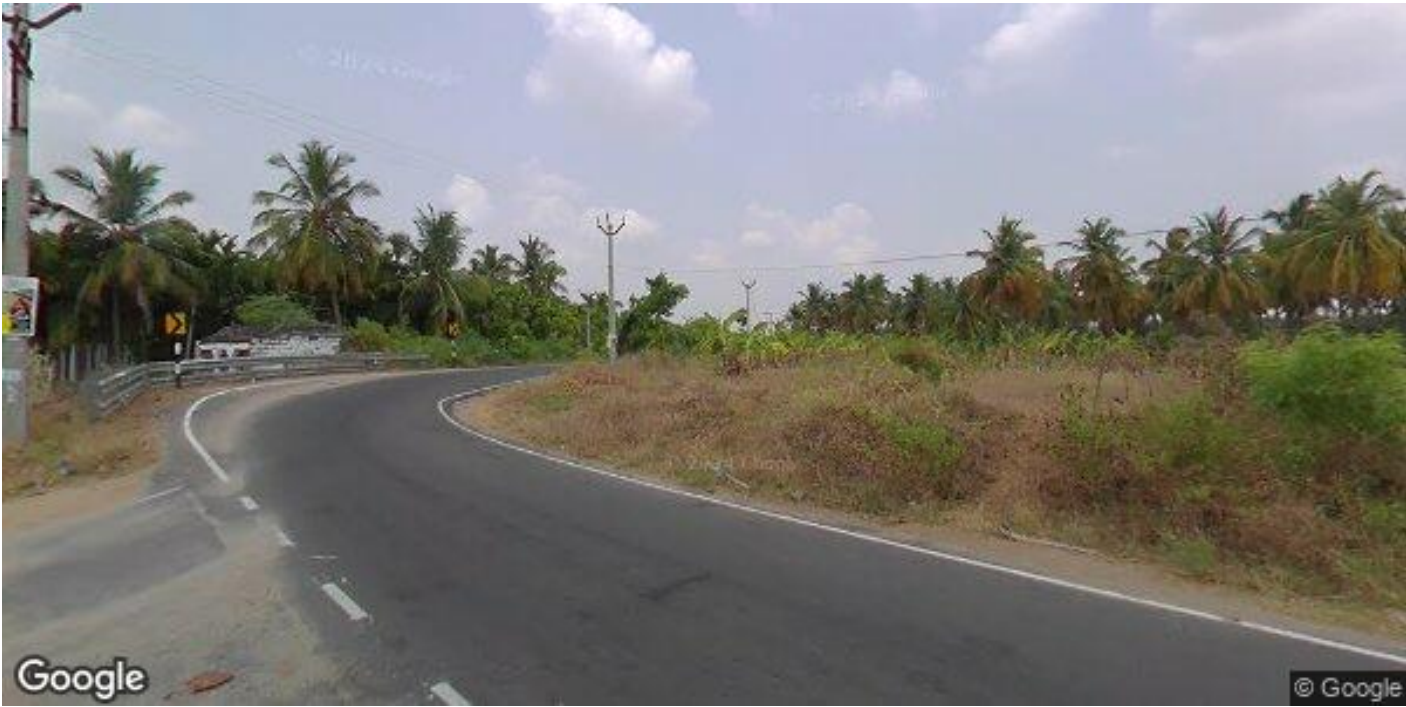
**Risk Type:** Turn  
**Risk Level:** High  
**Speed Limit:** 15 KM/Hr  
**Coordinates:** 11.29763, 77.87710

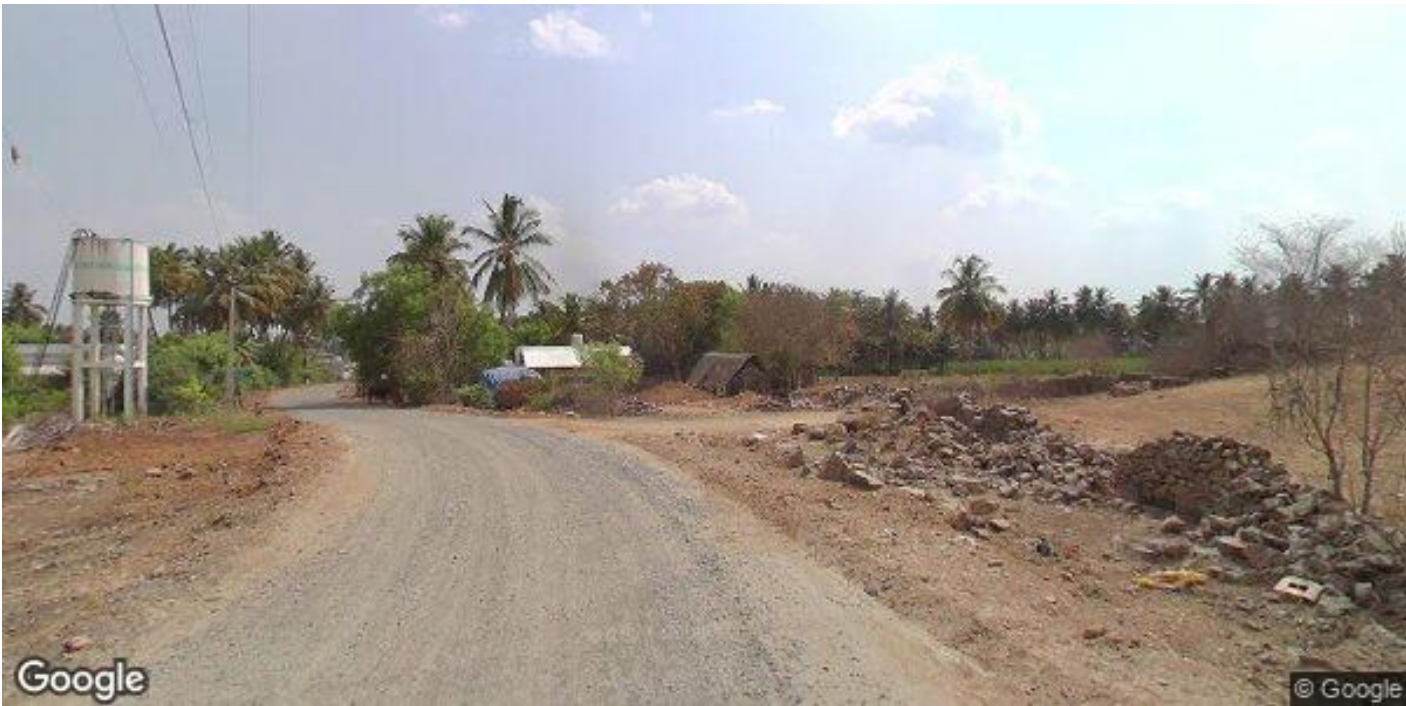
**Risk Type:** Turn  
**Risk Level:** Medium  
**Speed Limit:** 30 KM/Hr  
**Coordinates:** 11.27061, 77.86833

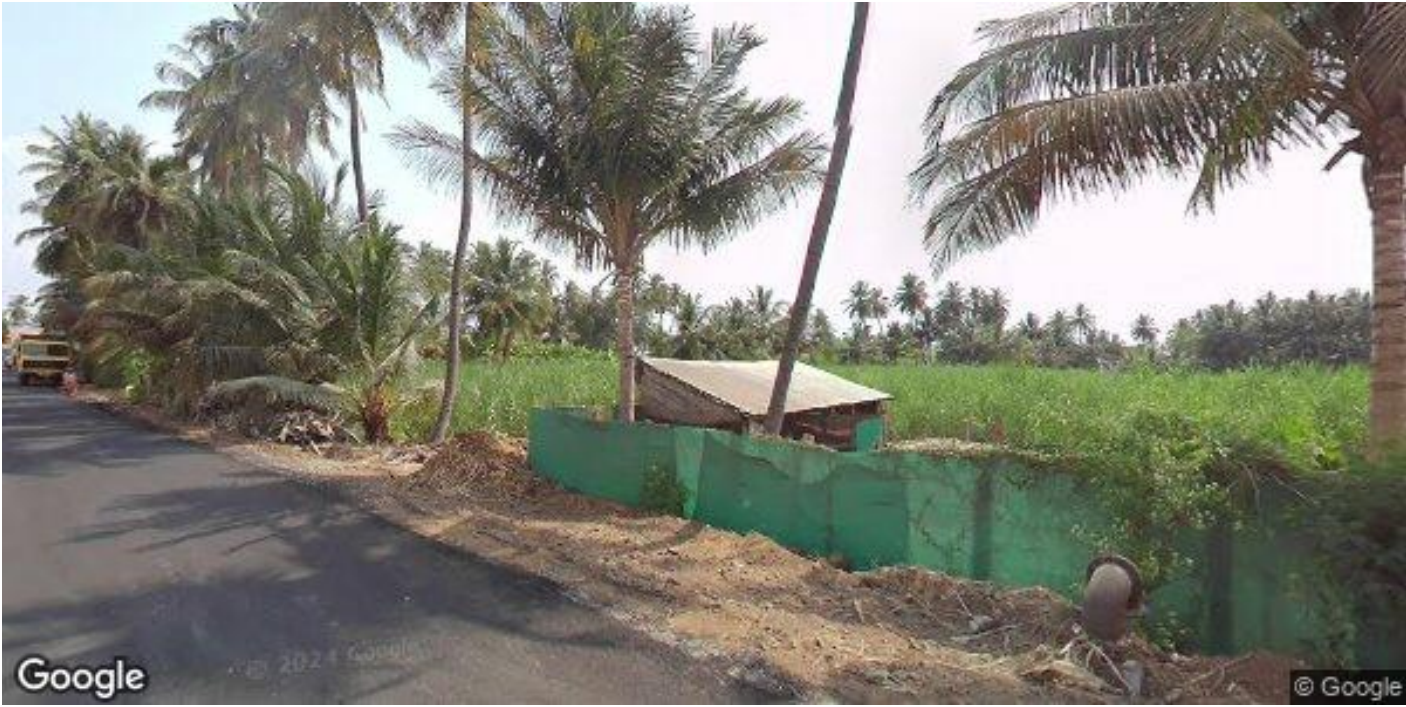
**Risk Type:** Turn  
**Risk Level:** High  
**Speed Limit:** 15 KM/Hr  
**Coordinates:** 11.26017, 77.85606

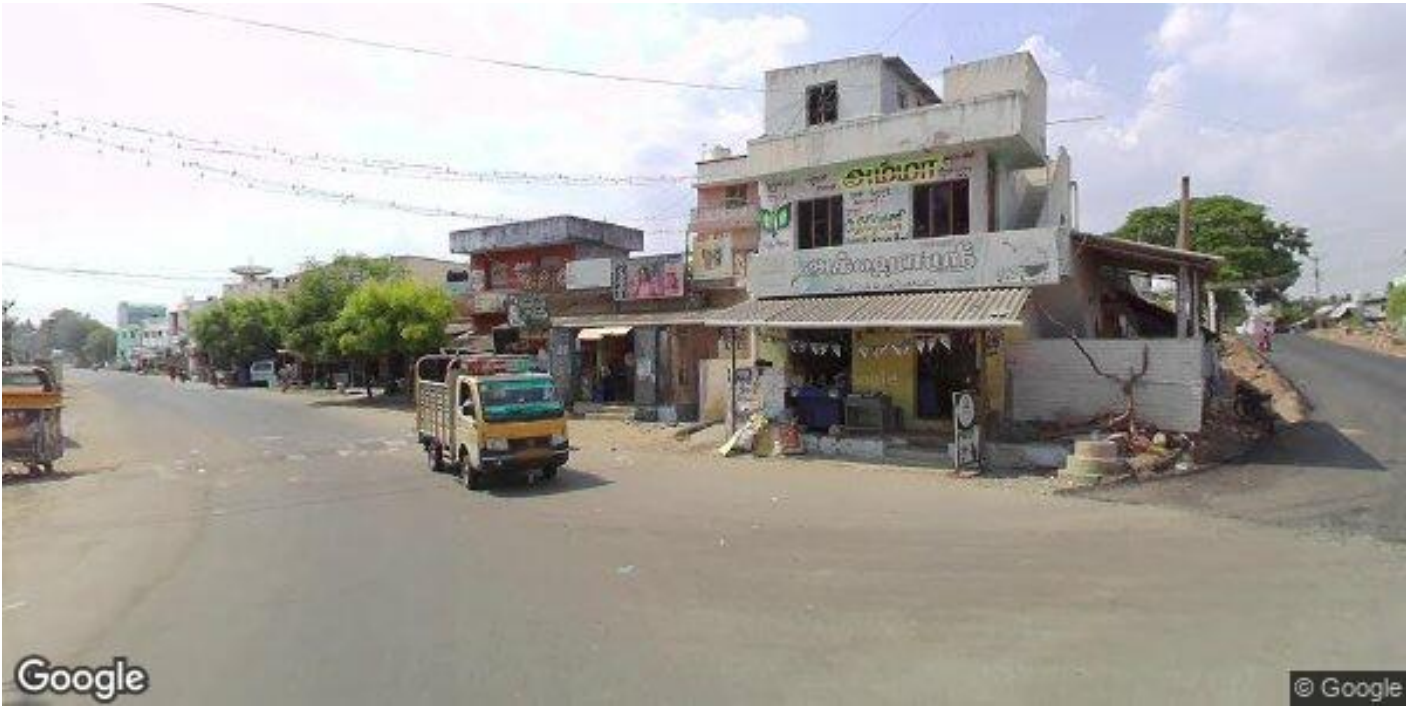
**Risk Type:** Blind Spot  
**Risk Level:** Blind Spot  
**Speed Limit:** 10 KM/Hr  
**Coordinates:** 11.25802, 77.85511
