## JOURNEY RISK MANAGEMENT (JRM) STUDY

### Salem Terminal to BRIGHT AGENCIES

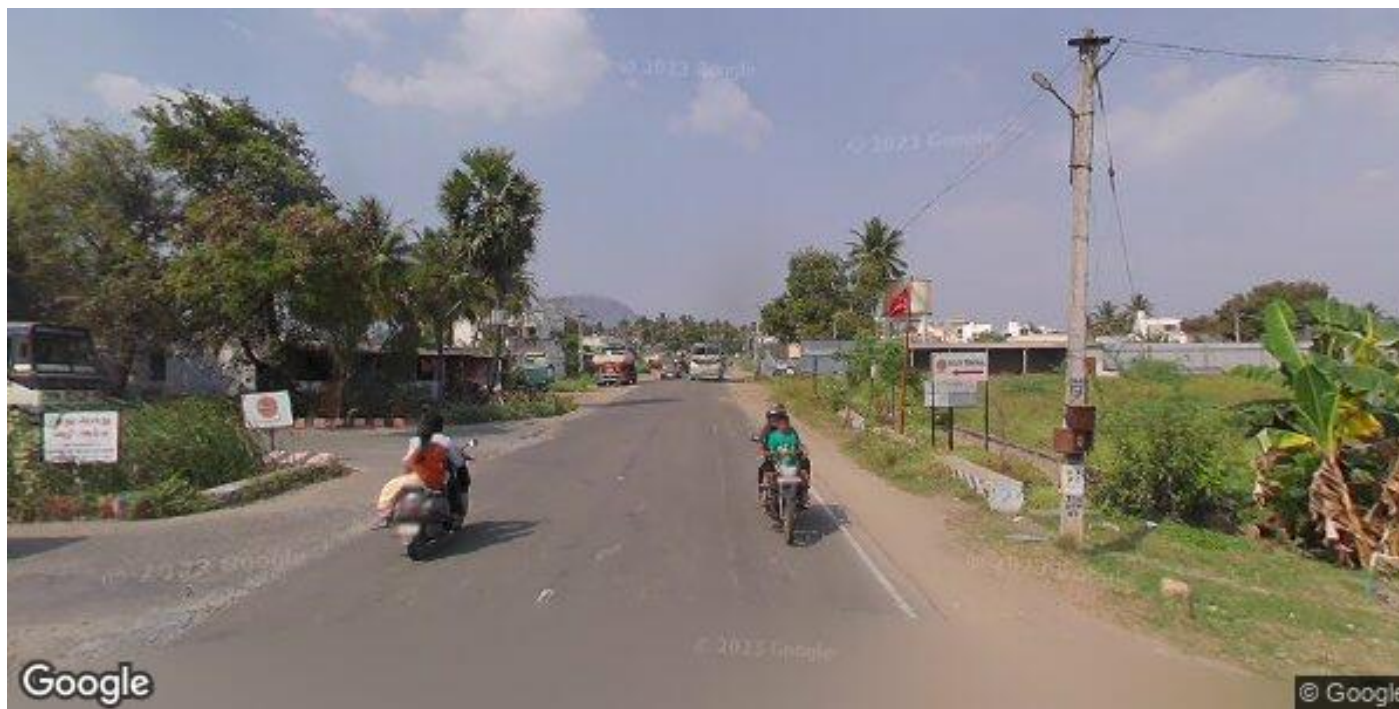
**Risk Type:** Turn  
**Risk Level:** High  
**Speed Limit:** 15 KM/Hr  
**Coordinates:** 11.44019, 77.87547

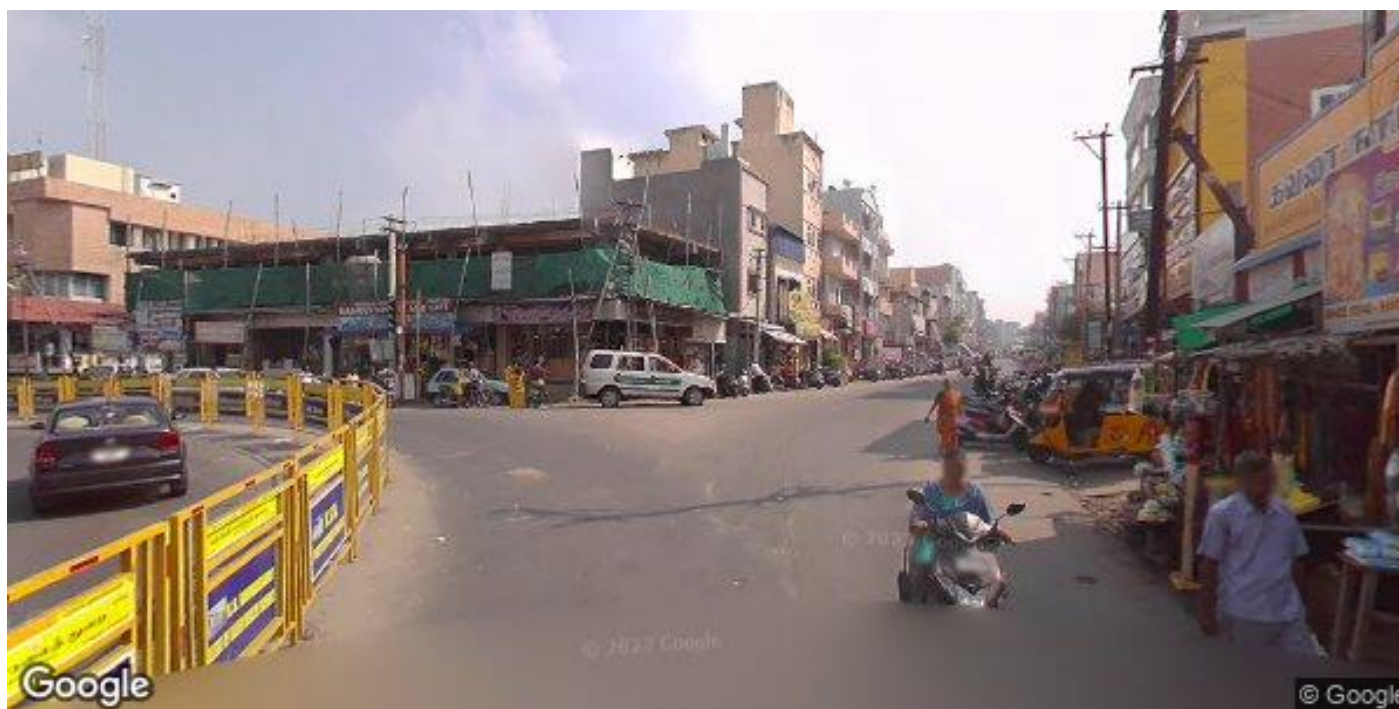
**Risk Type:** Turn  
**Risk Level:** High  
**Speed Limit:** 15 KM/Hr  
**Coordinates:** 11.37862, 77.89488

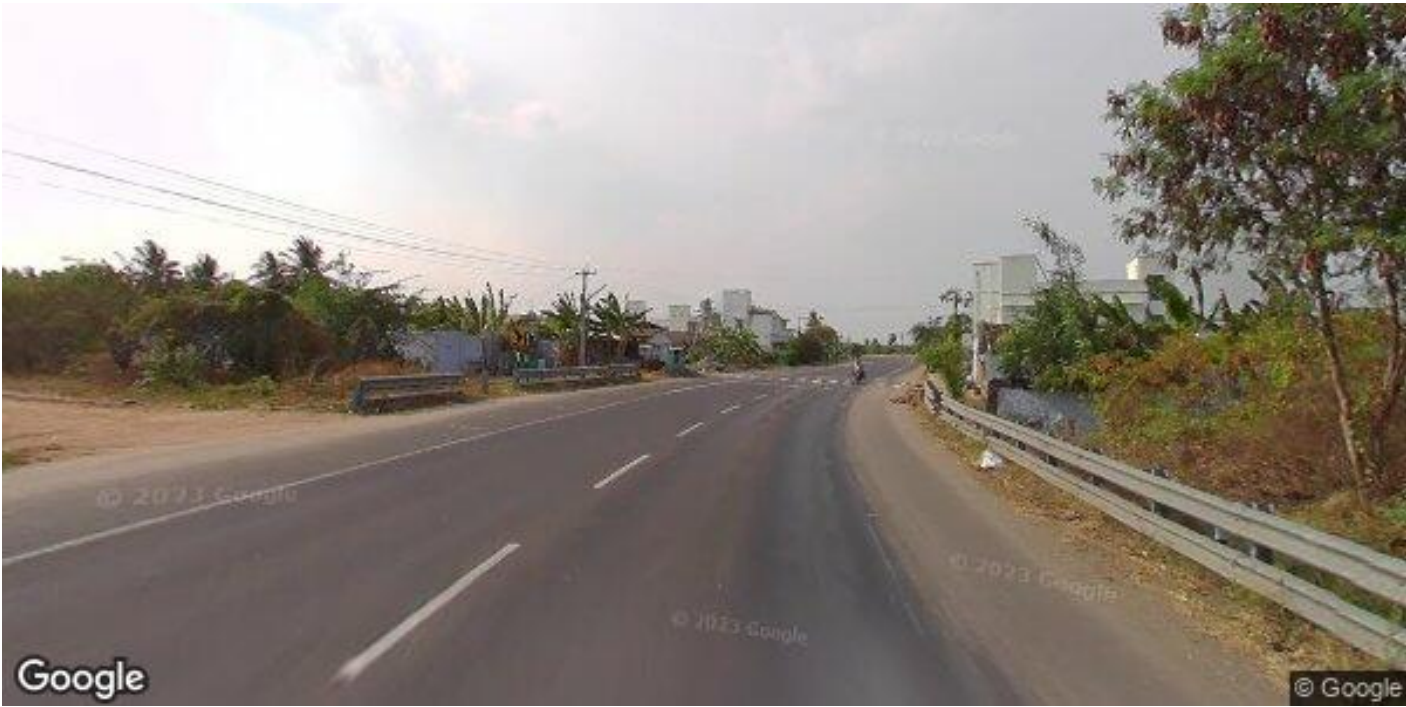
Risk Type: Turn  
Risk Level: Medium  
Speed Limit: 30 KM/Hr  
Coordinates: 11.16764, 78.01565

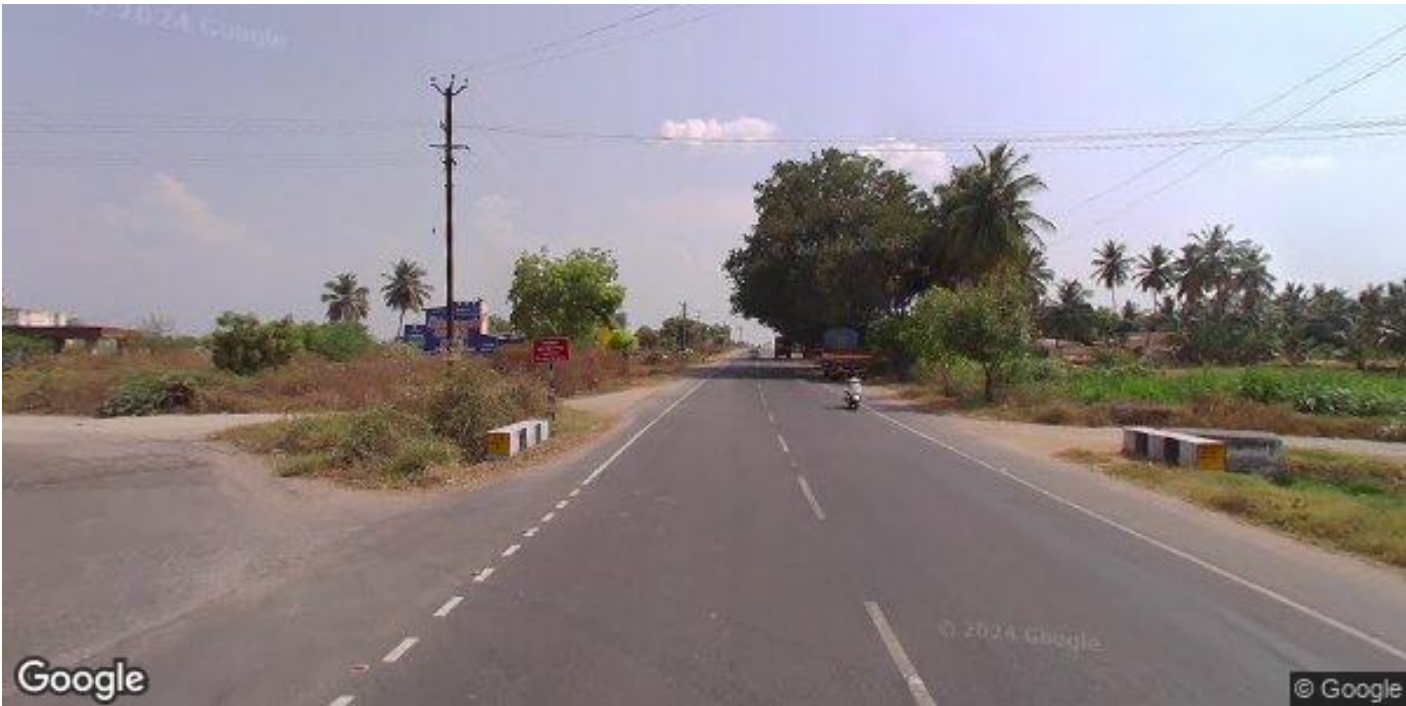
Risk Type: Turn  
Risk Level: High  
Speed Limit: 15 KM/Hr  
Coordinates: 11.14545, 78.02208

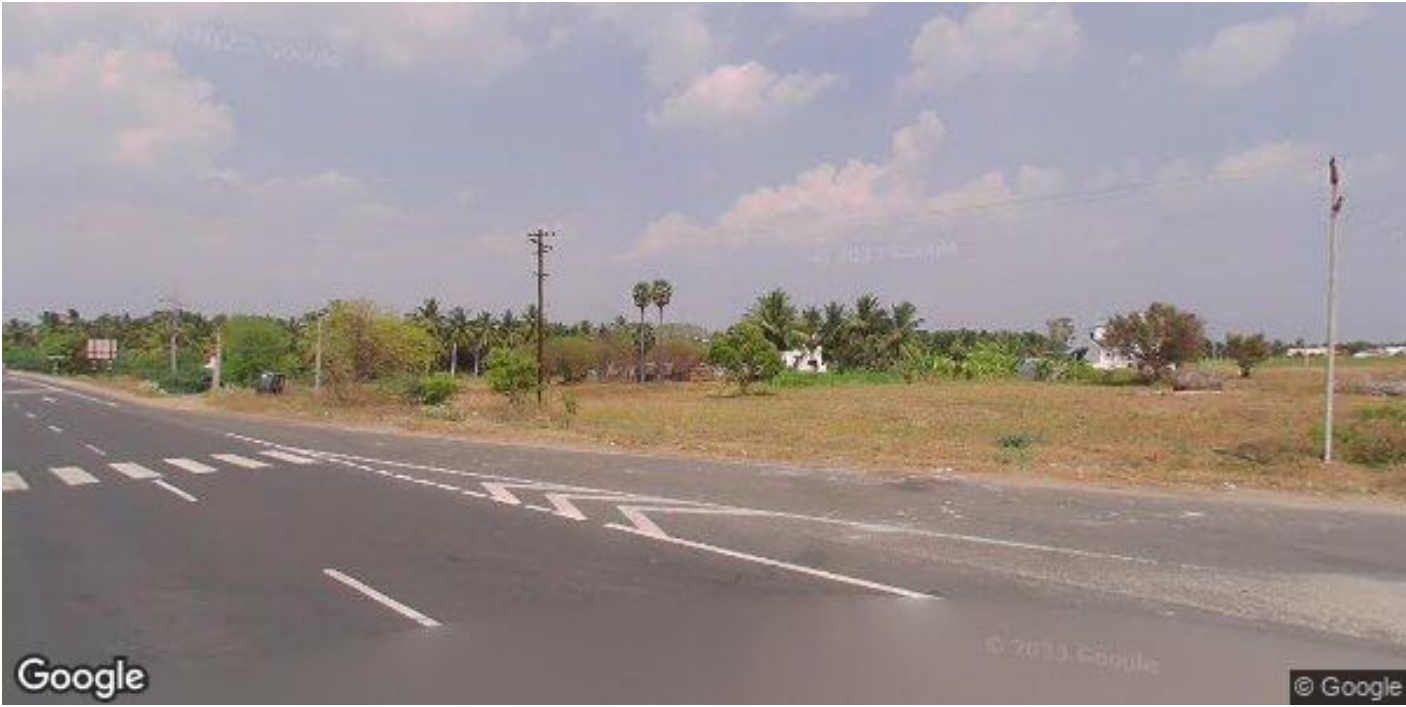
**Risk Type:** Turn  
**Risk Level:** High  
**Speed Limit:** 15 KM/Hr  
**Coordinates:** 11.14480, 78.02291

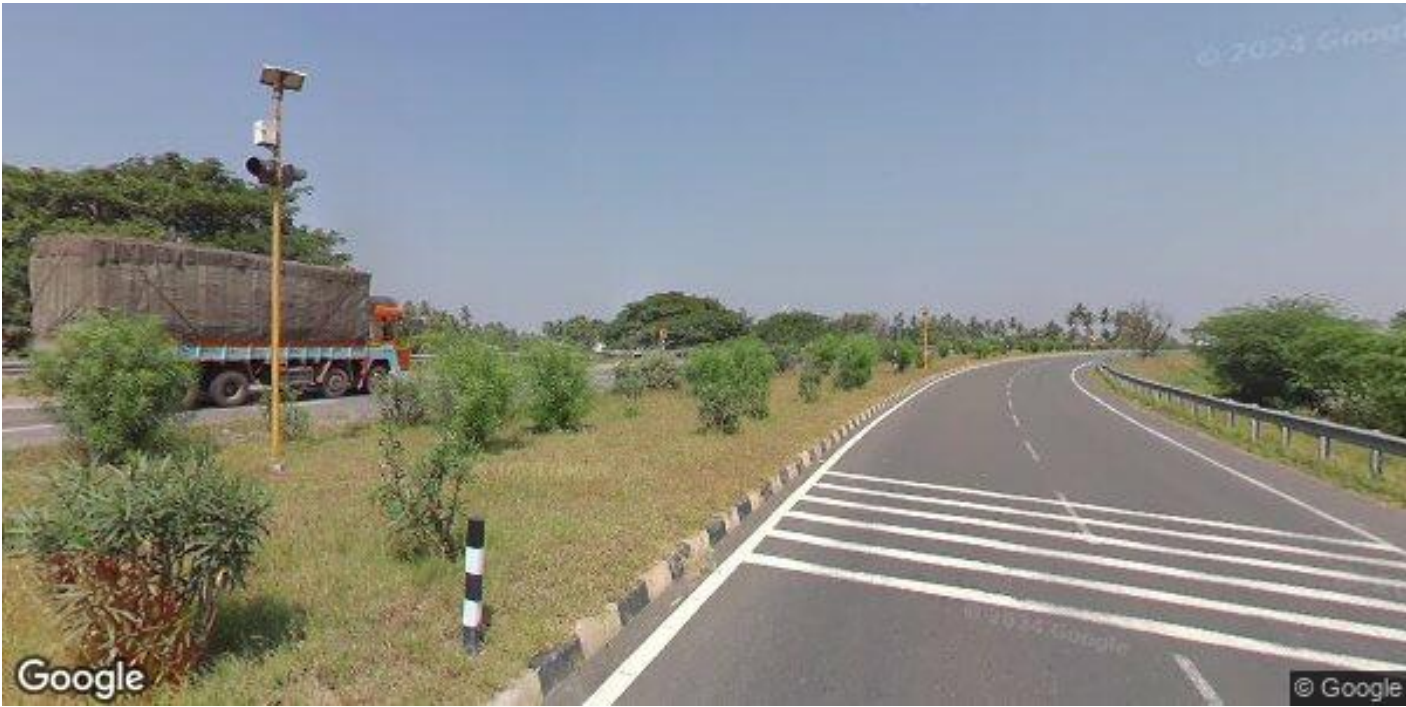
**Risk Type:** Turn  
**Risk Level:** Medium  
**Speed Limit:** 30 KM/Hr  
**Coordinates:** 11.10102, 78.00572

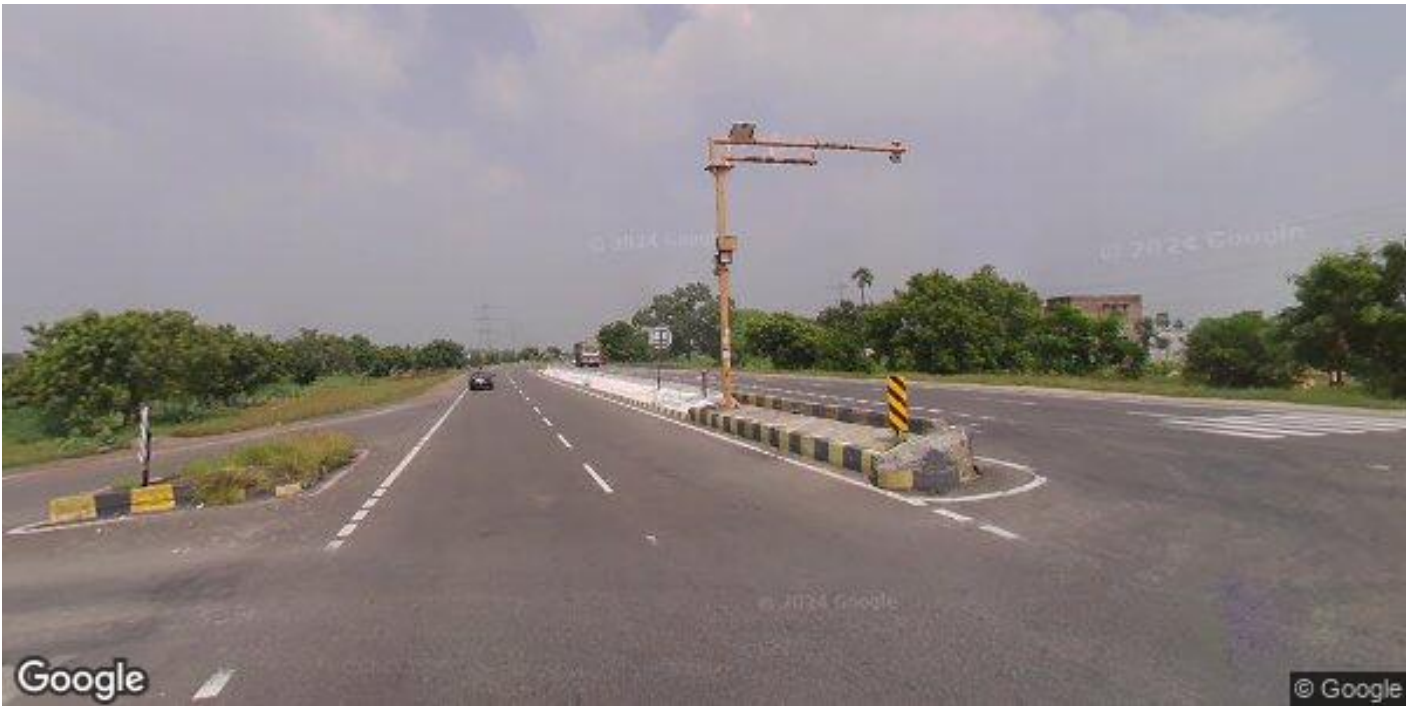
**Risk Type:** Turn  
**Risk Level:** High  
**Speed Limit:** 15 KM/Hr  
**Coordinates:** 10.79637, 77.92684
