# IndianOil

## JOURNEY RISK MANAGEMENT (JRM) STUDY

### Salem Terminal TO SWASAN FILLING STATION

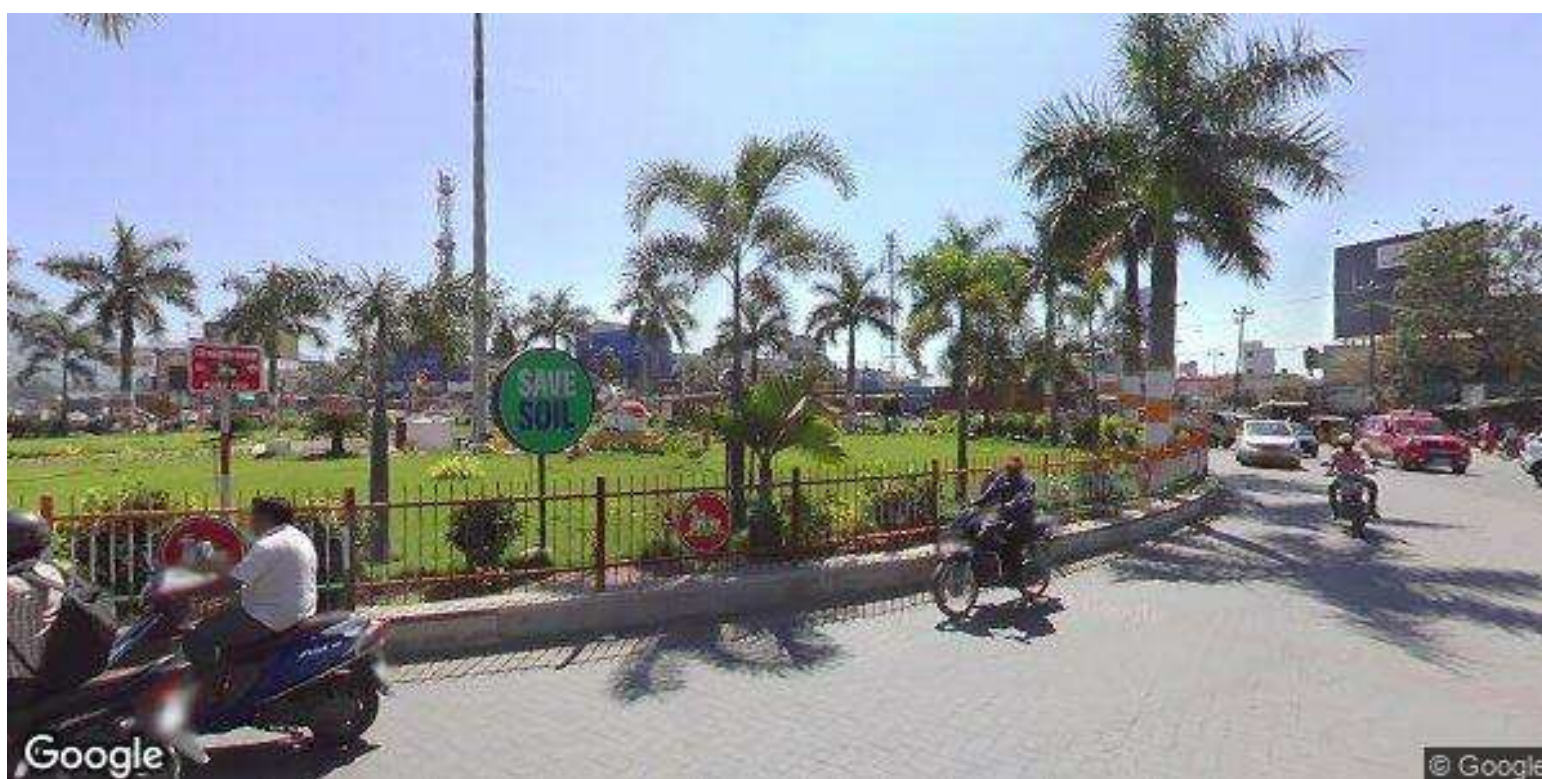
**Coordinates:** 11.63303, 78.12713

**Risk Type:** Roundabout

**Risk Level:** High

**Speed Limit:** 15 KM/Hr

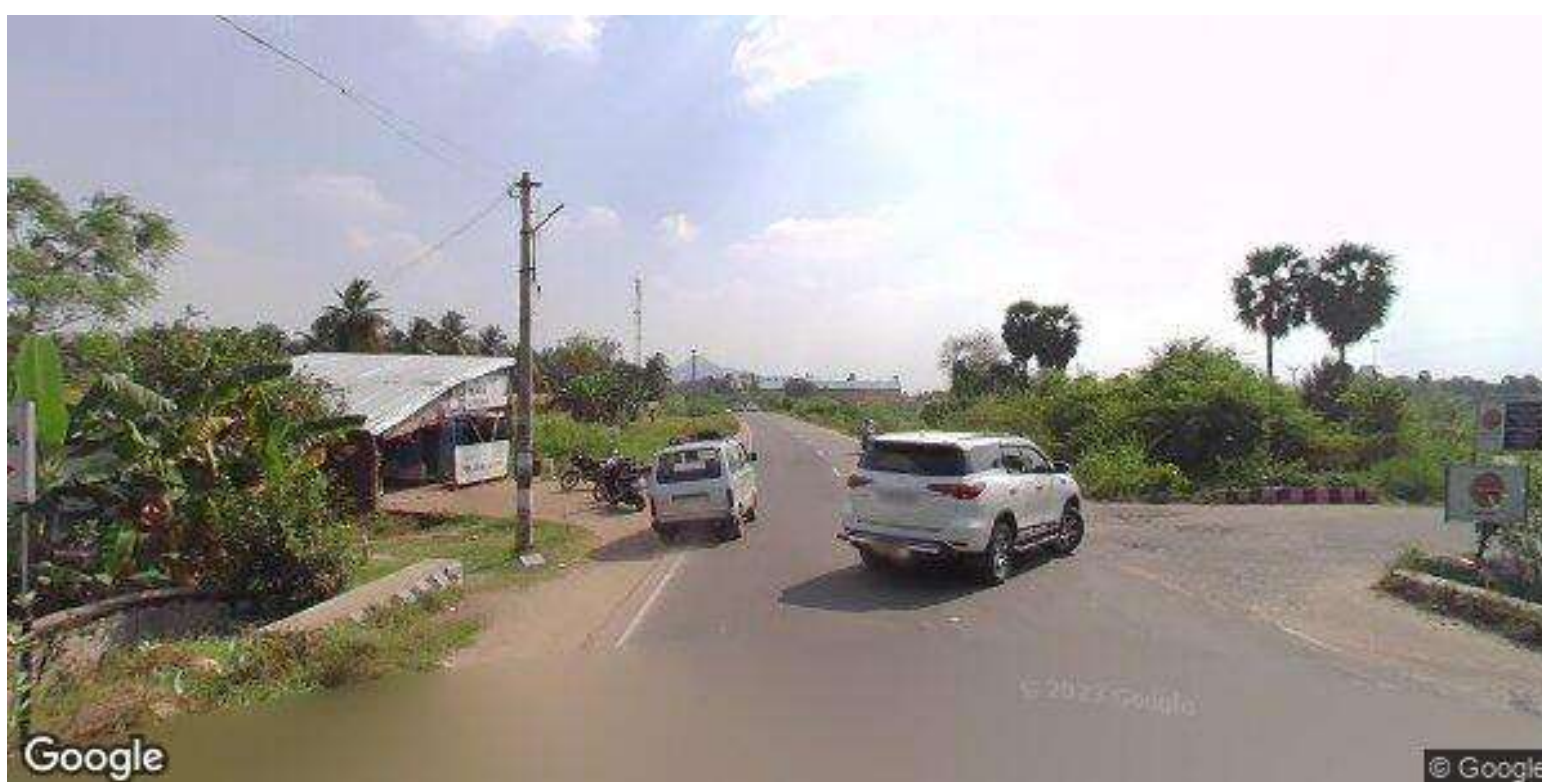
**Coordinates:** 11.44029, 77.87544

**Risk Type:** Turn

**Risk Level:** High

**Speed Limit:** 15 KM/Hr

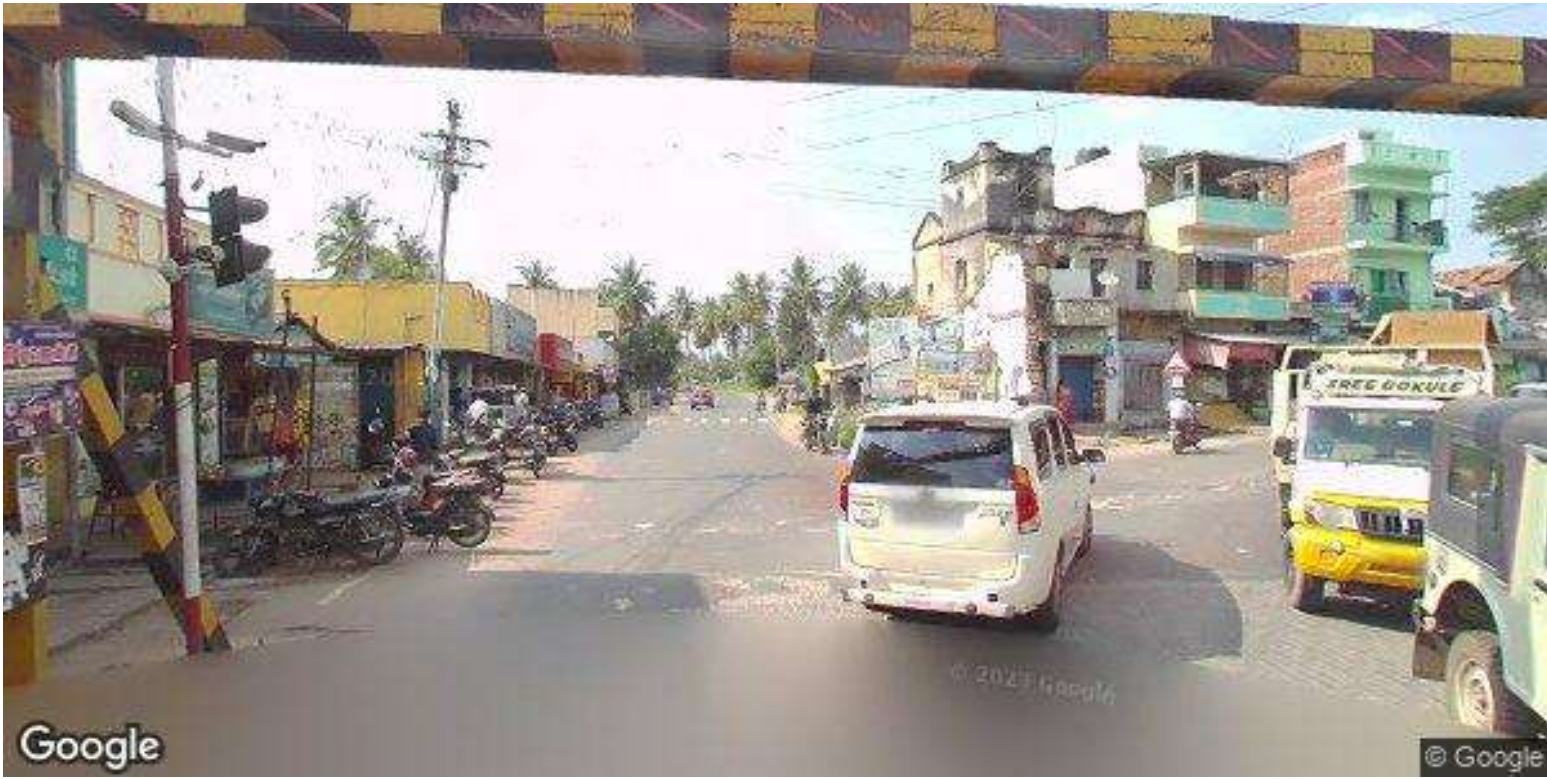
Risk Type: Turn  
Risk Level: High  
Speed Limit: 15 KM/Hr  
Coordinates: 11.45004, 77.87206

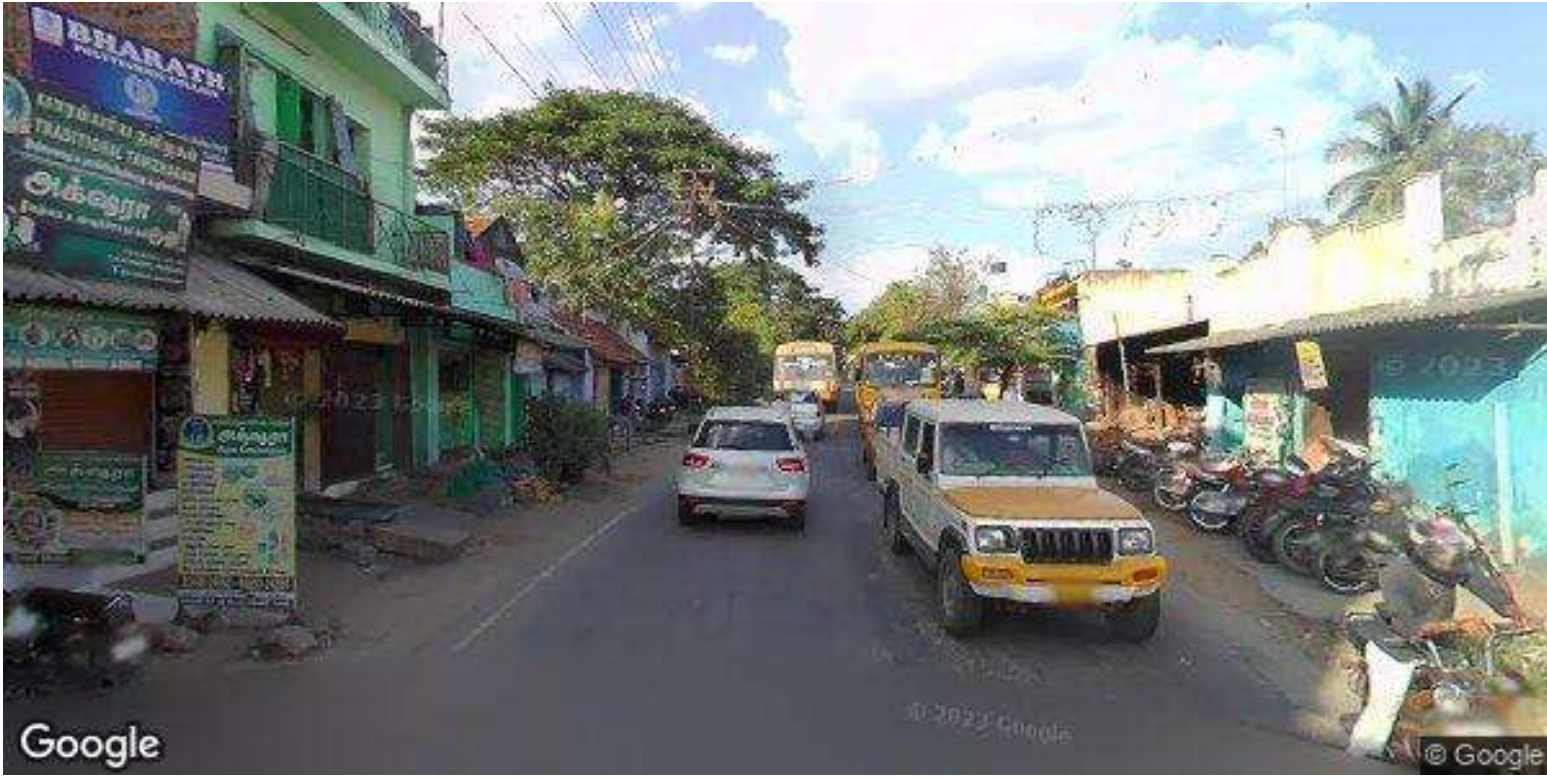
Risk Type: Turn  
Risk Level: Medium  
Speed Limit: 30 KM/Hr  
Coordinates: 11.45028, 77.87202

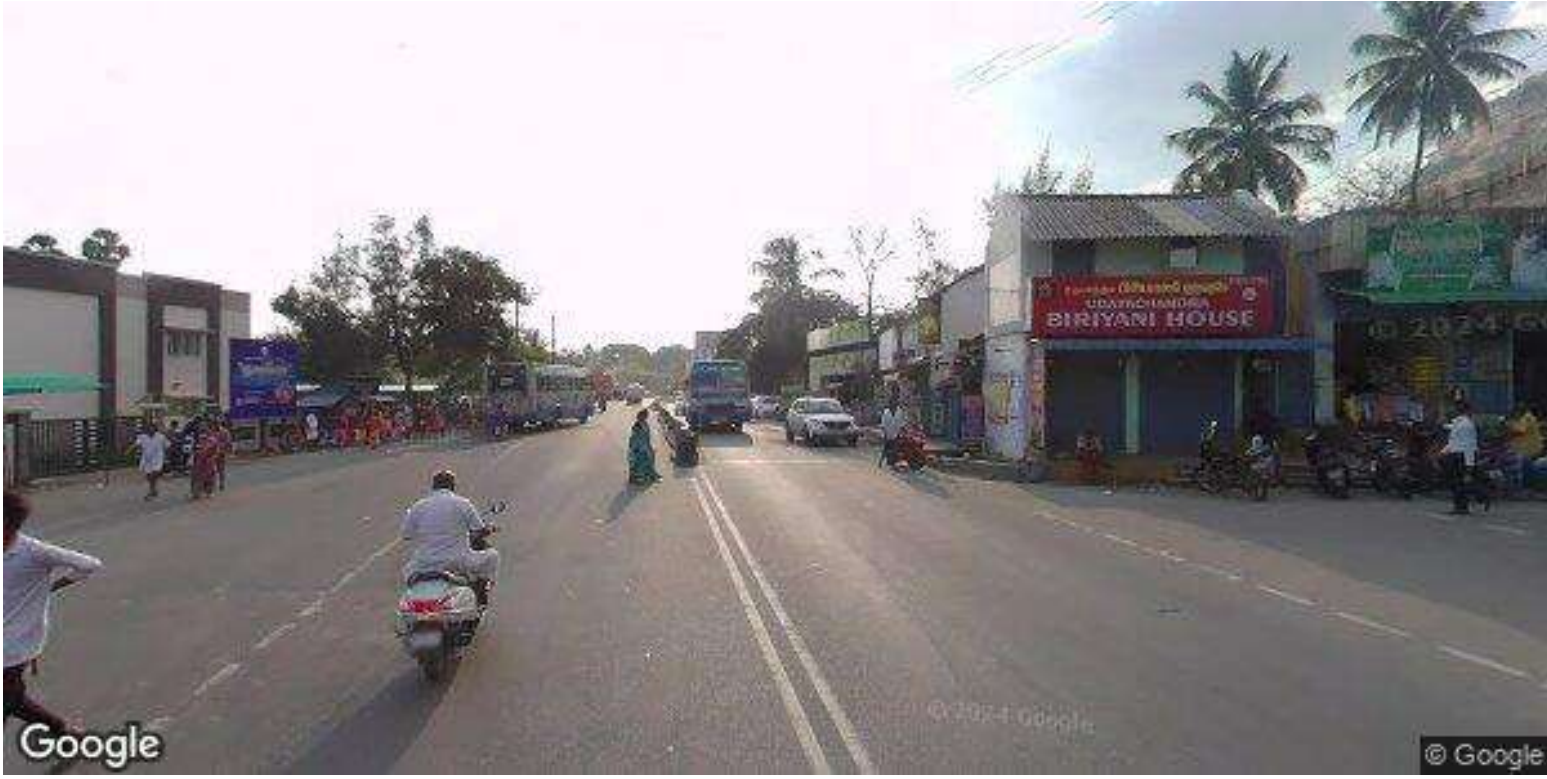
**Risk Type:** Turn  
**Risk Level:** High  
**Speed Limit:** 15 KM/Hr  
**Coordinates:** 11.47403, 77.86841

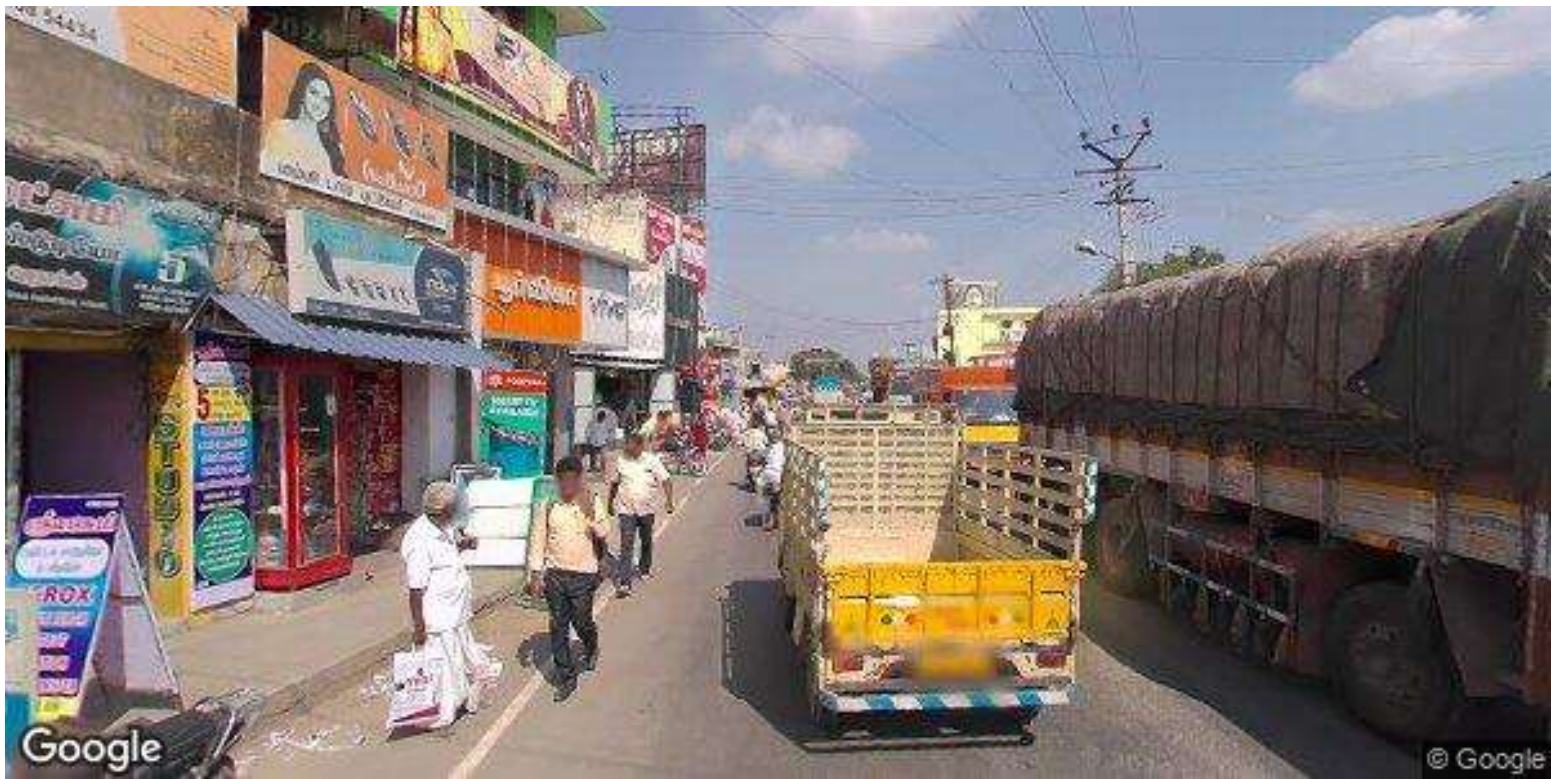
**Risk Type:** Turn  
**Risk Level:** Medium  
**Speed Limit:** 30 KM/Hr  
**Coordinates:** 11.47410, 77.86845

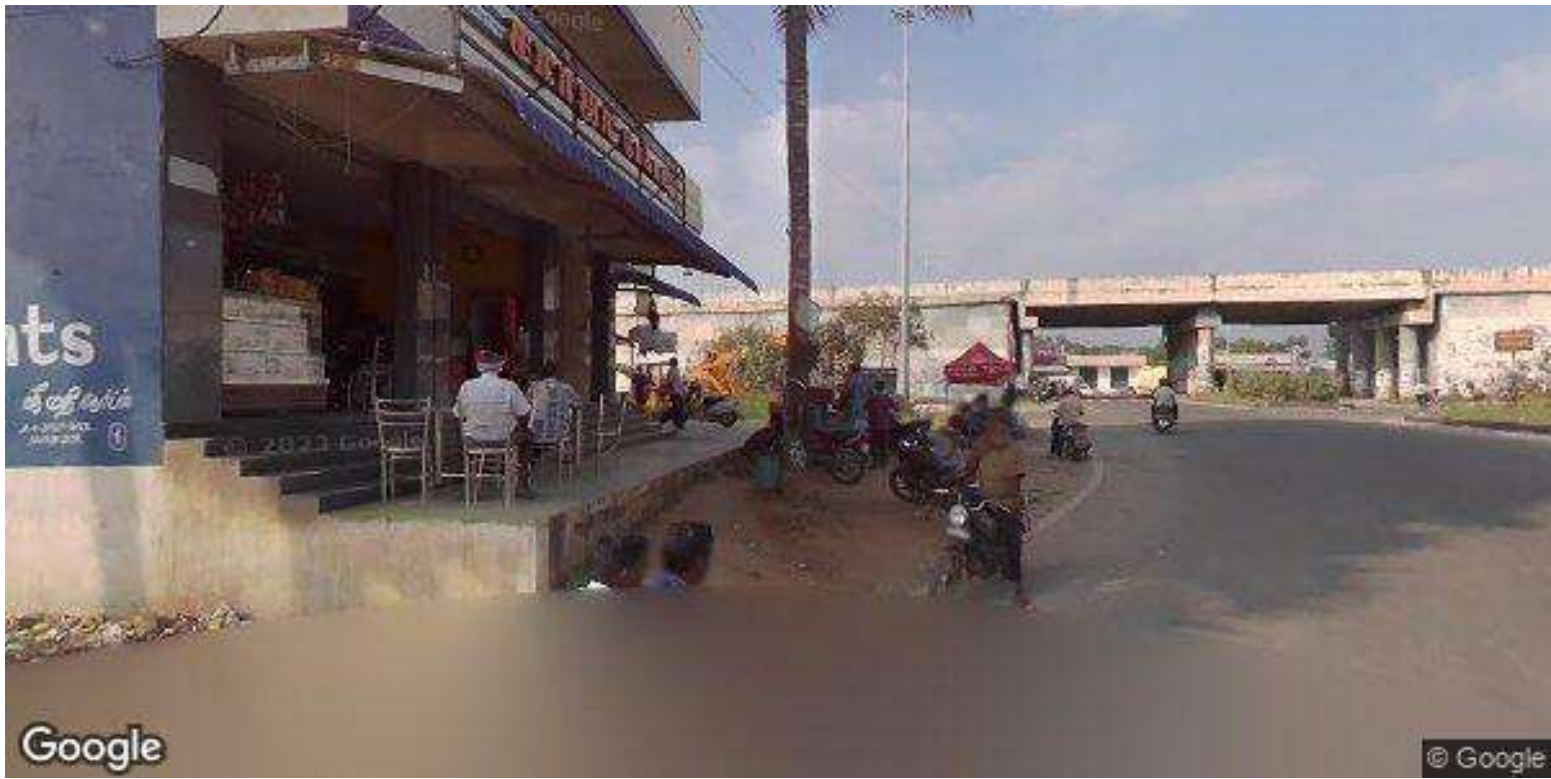
**Risk Type:** Turn  
**Risk Level:** High  
**Speed Limit:** 15 KM/Hr  
**Coordinates:** 11.49149, 77.89601

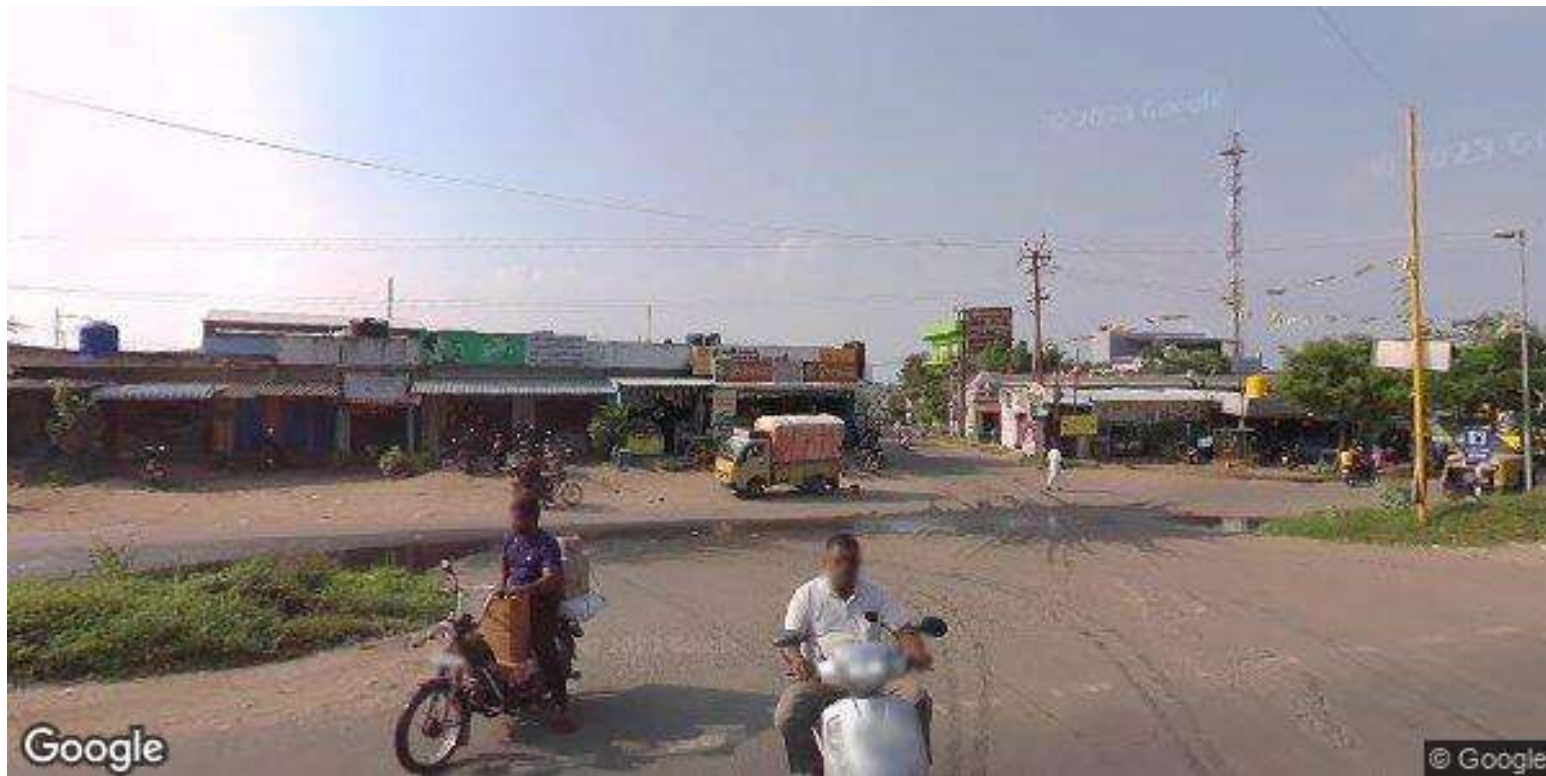
**Coordinates: 11.63219, 78.16753**

**Risk Type: Blind Spot**

**Risk Level: Blind Spot**

**Speed Limit: 10 KM/Hr**

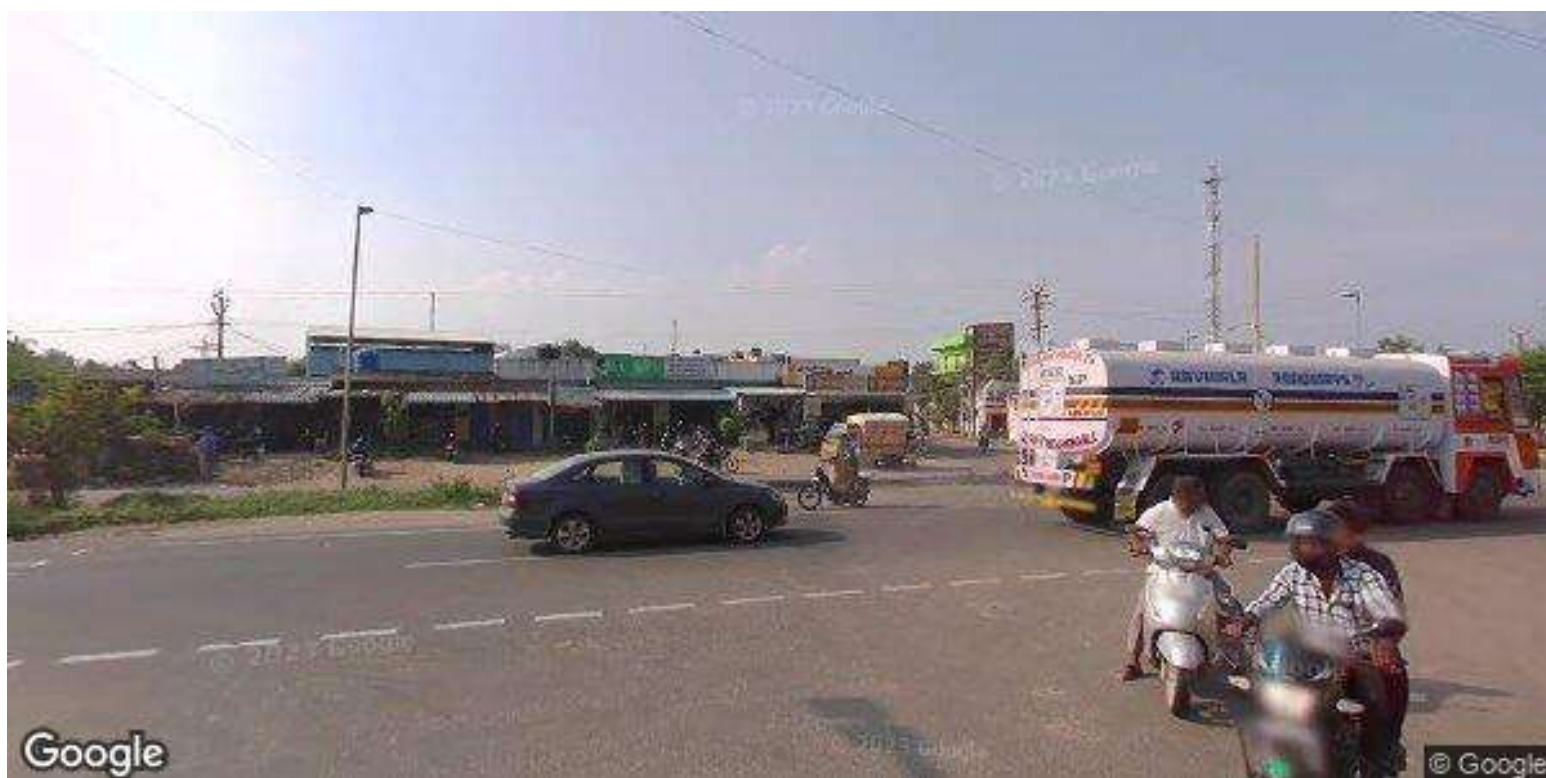
**Coordinates: 11.63211, 78.16762**

**Risk Type: Turn**

**Risk Level: High**

**Speed Limit: 15 KM/Hr**

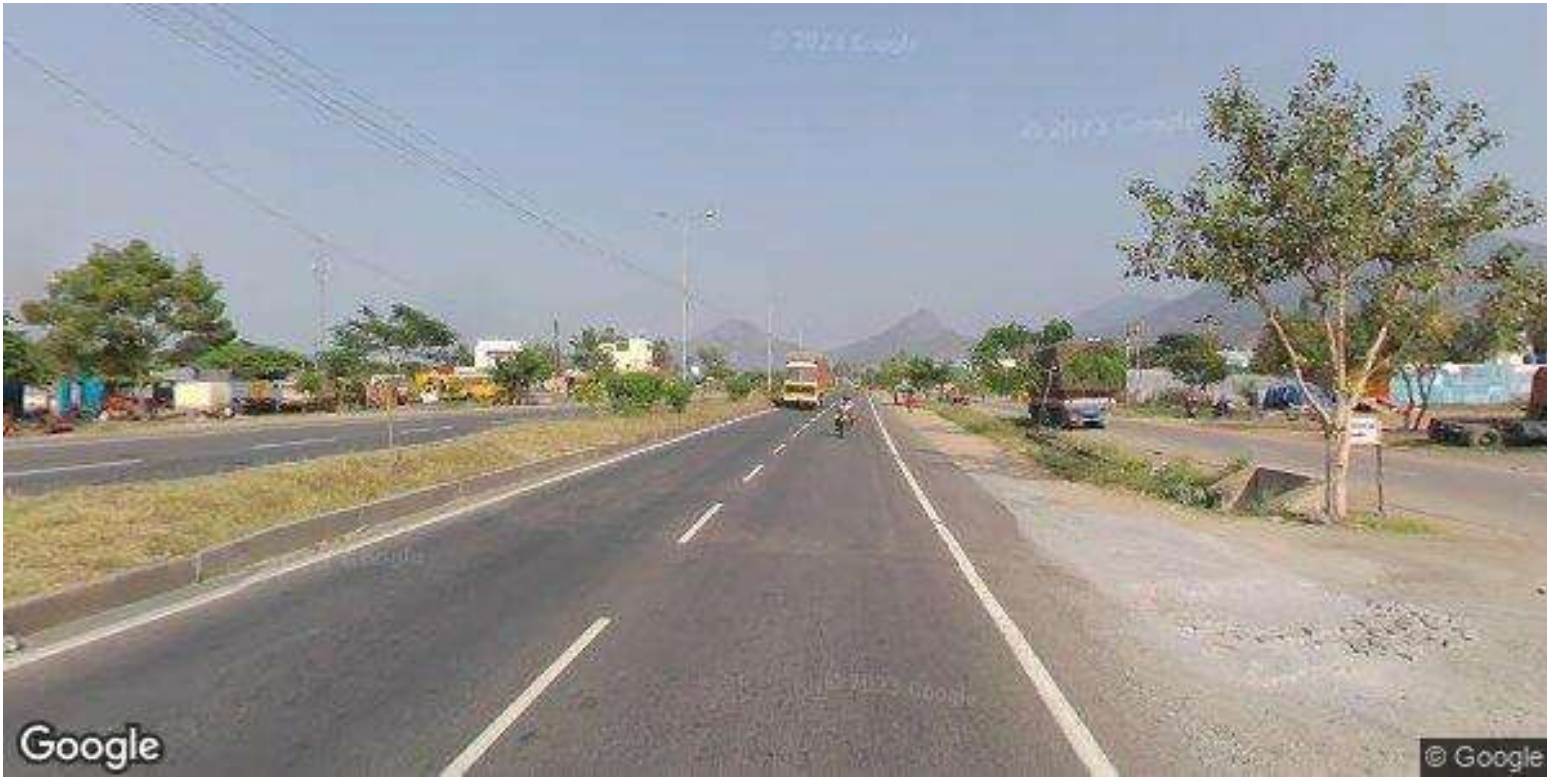
**Risk Type:** Blind Spot  
**Risk Level:** Blind Spot  
**Speed Limit:** 10 KM/Hr  
**Coordinates:** 11.62746, 78.16194

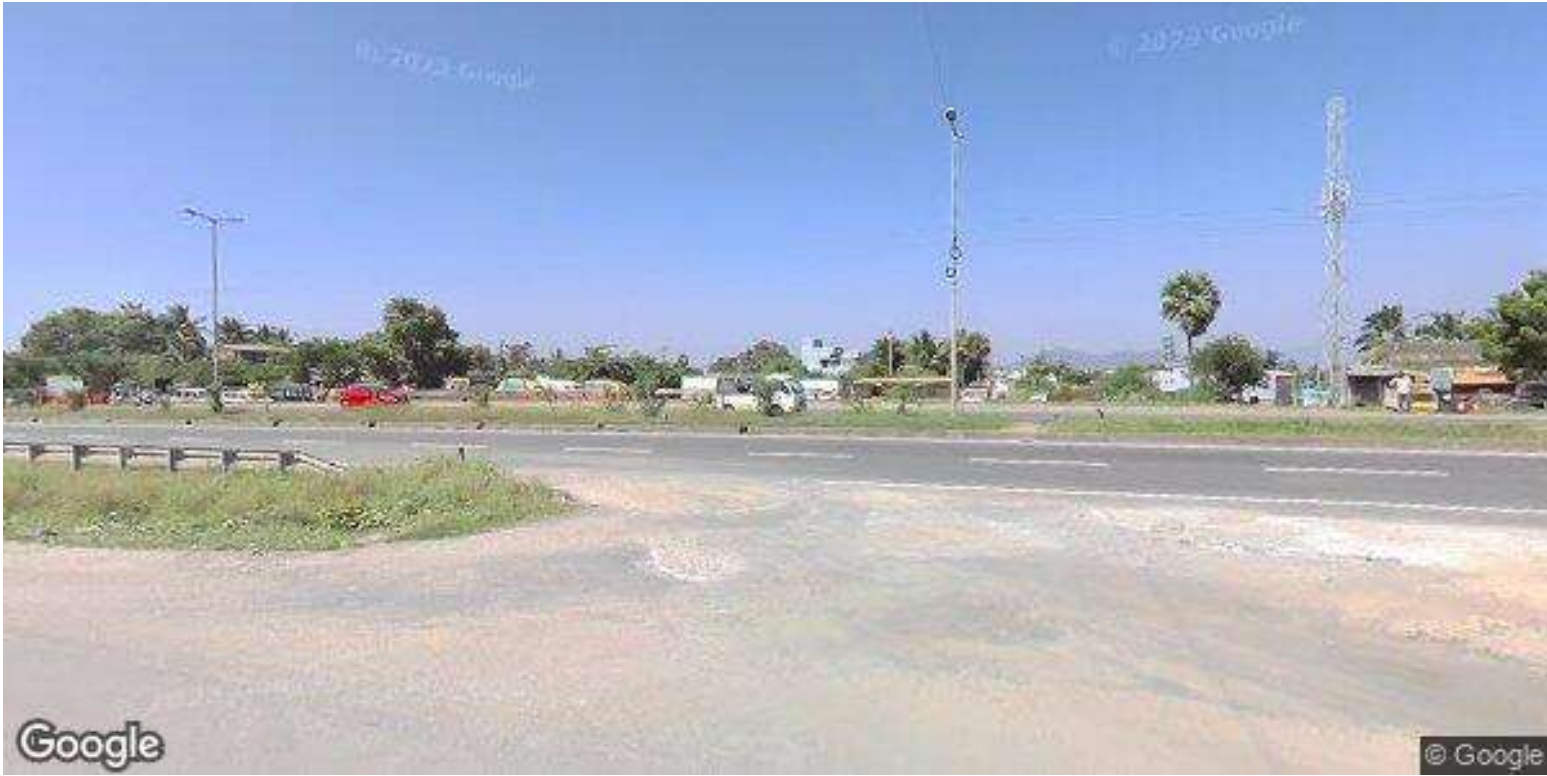
**Risk Type:** Blind Spot  
**Risk Level:** Blind Spot  
**Speed Limit:** 10 KM/Hr  
**Coordinates:** 11.62732, 78.16198

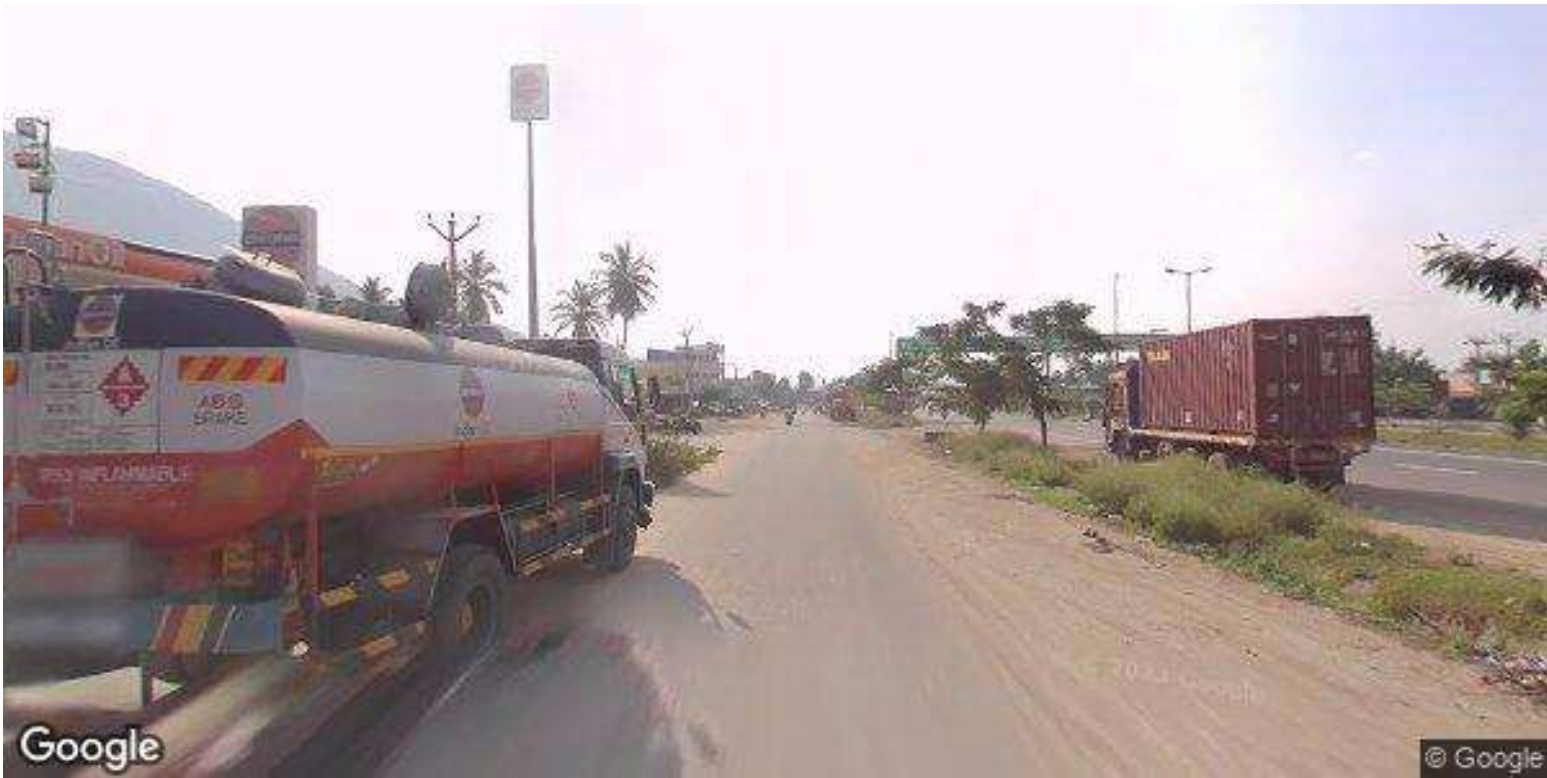
Coordinates: 11.62564, 78.15656

Risk Type: Turn

Risk Level: High

Speed Limit: 15 KM/Hr

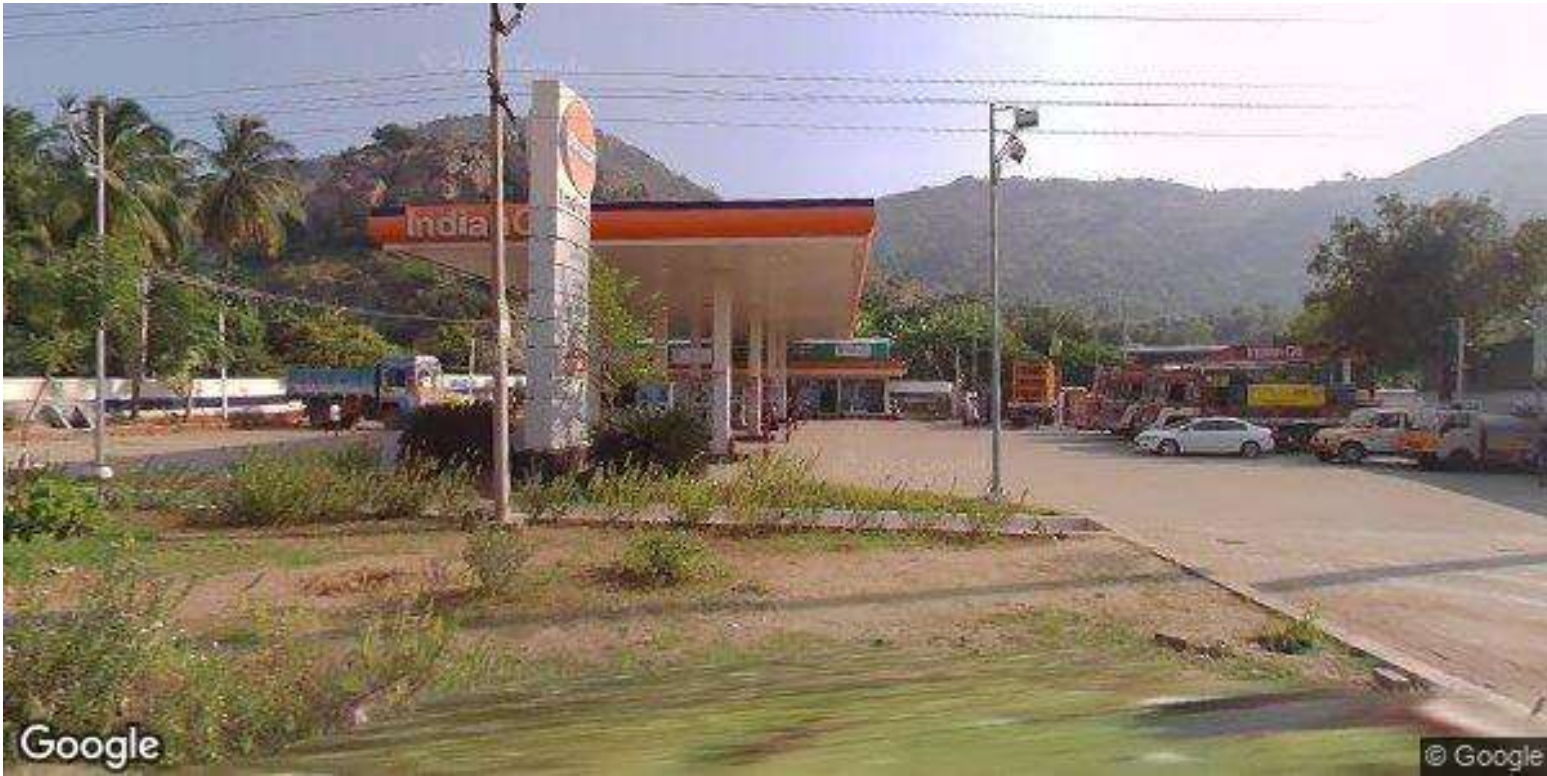
Coordinates: 11.62522, 78.15646

Risk Type: Turn

Risk Level: High

Speed Limit: 15 KM/Hr
