## JOURNEY RISK MANAGEMENT (JRM) STUDY

### Salem Terminal TO ARUNACHALAM FUELS

Route Safety Analysis Report

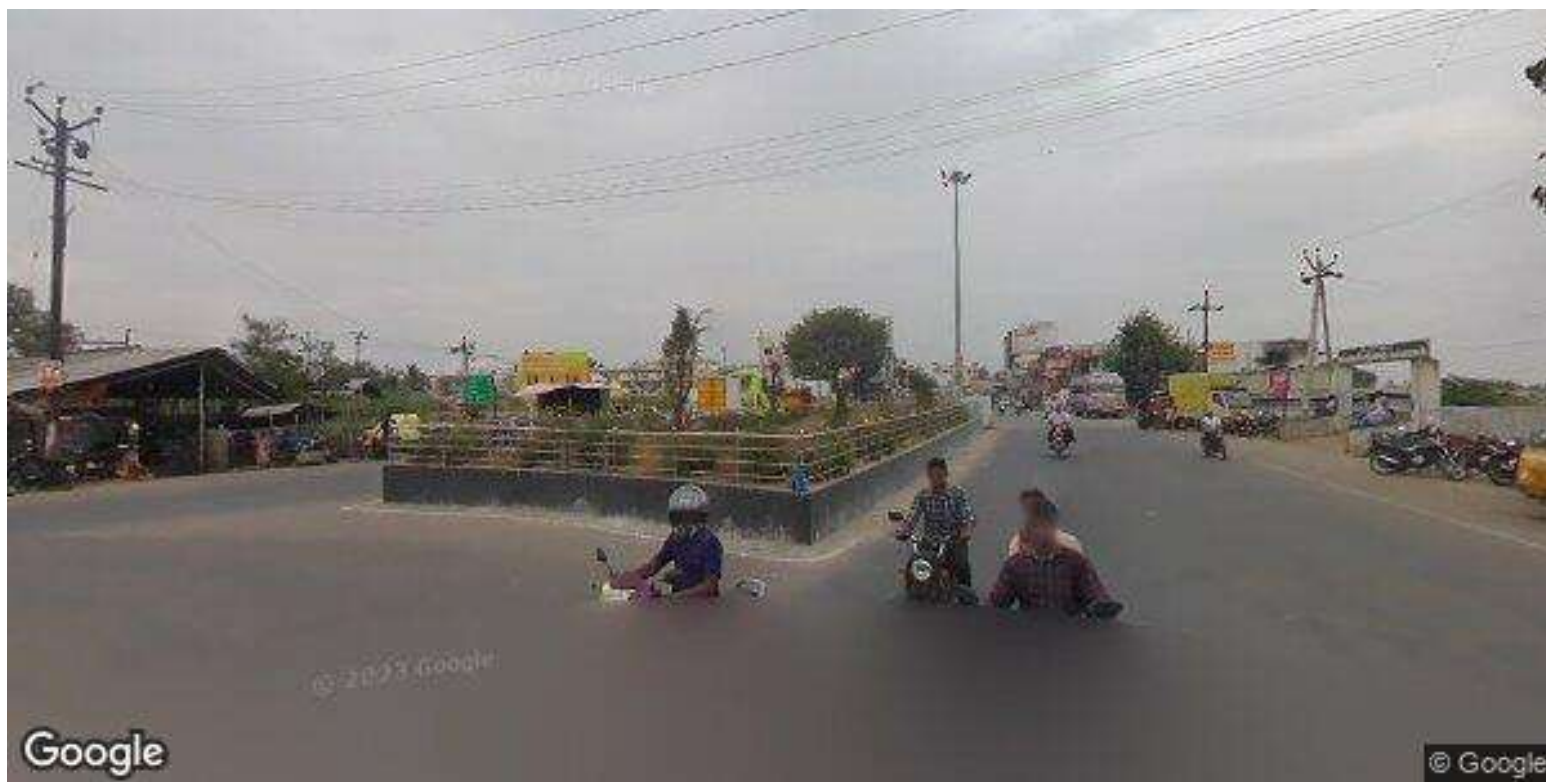
**Coordinates: 11.58435, 77.83651**

**Risk Type: Roundabout**

**Risk Level: High**

**Speed Limit: 15 KM/Hr**

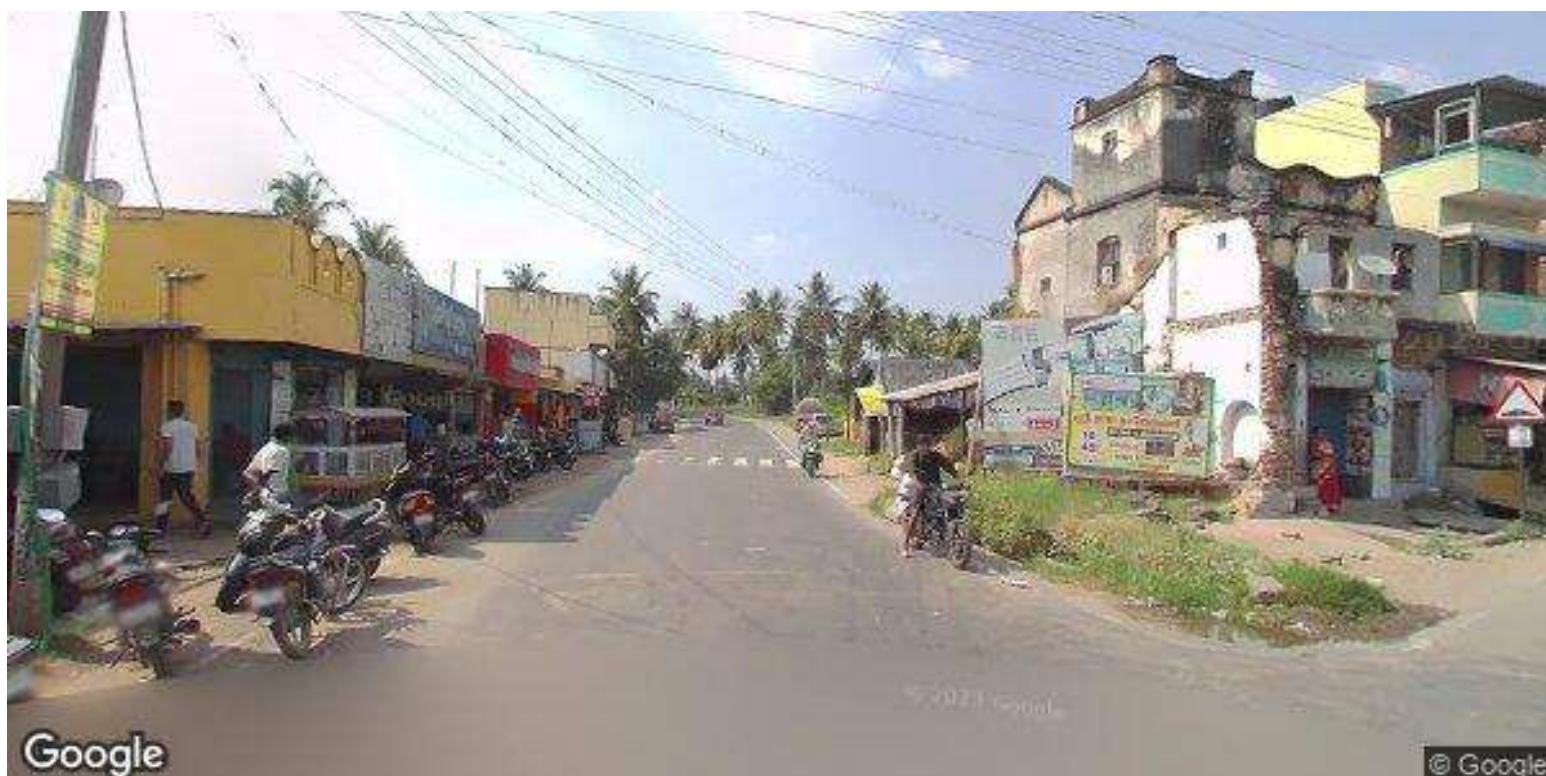
Coordinates: 11.45007, 77.87201

Risk Type: Turn

Risk Level: High

Speed Limit: 15 KM/Hr

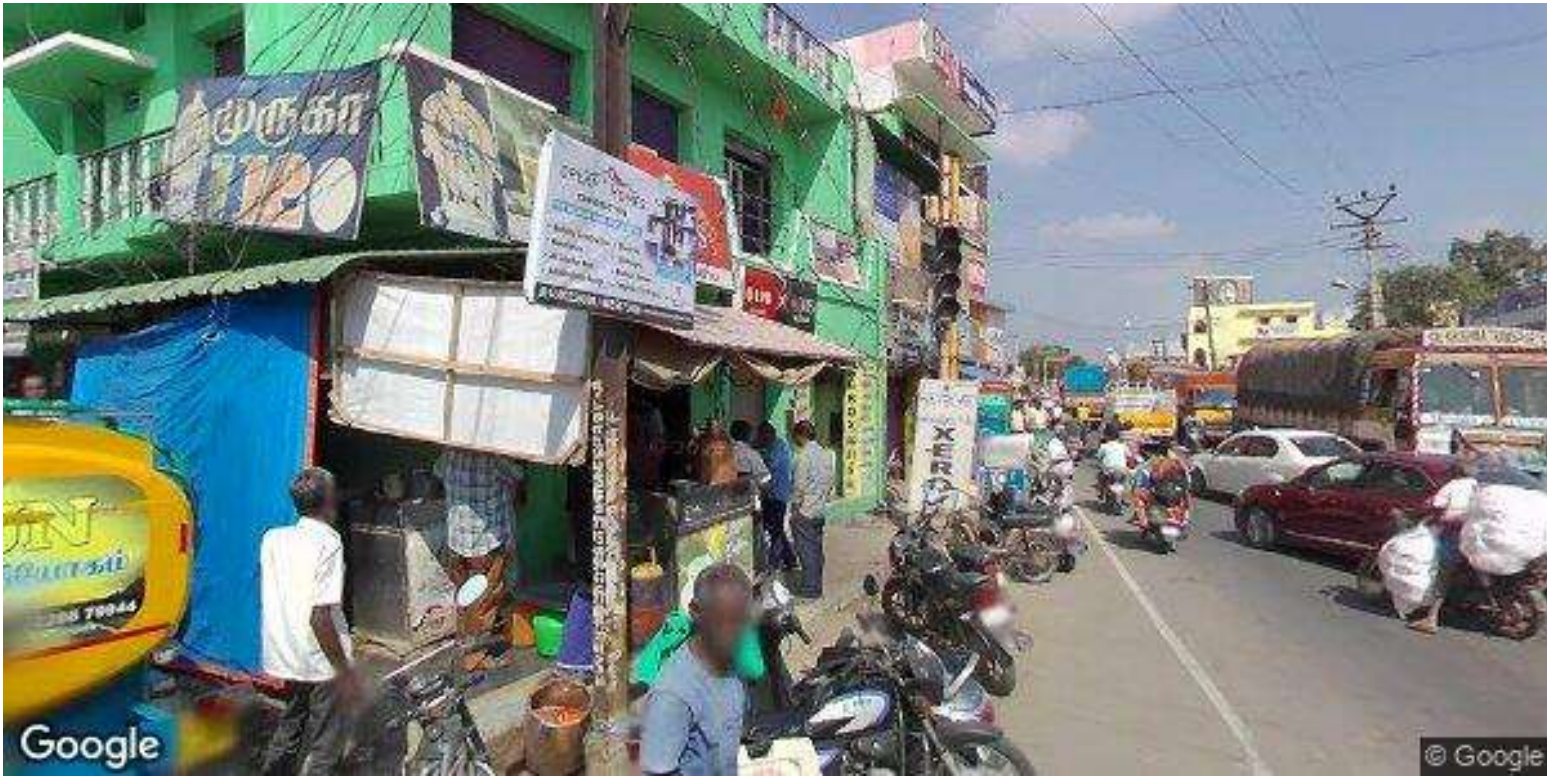
Coordinates: 11.47407, 77.86839

Risk Type: Turn

Risk Level: High

Speed Limit: 15 KM/Hr

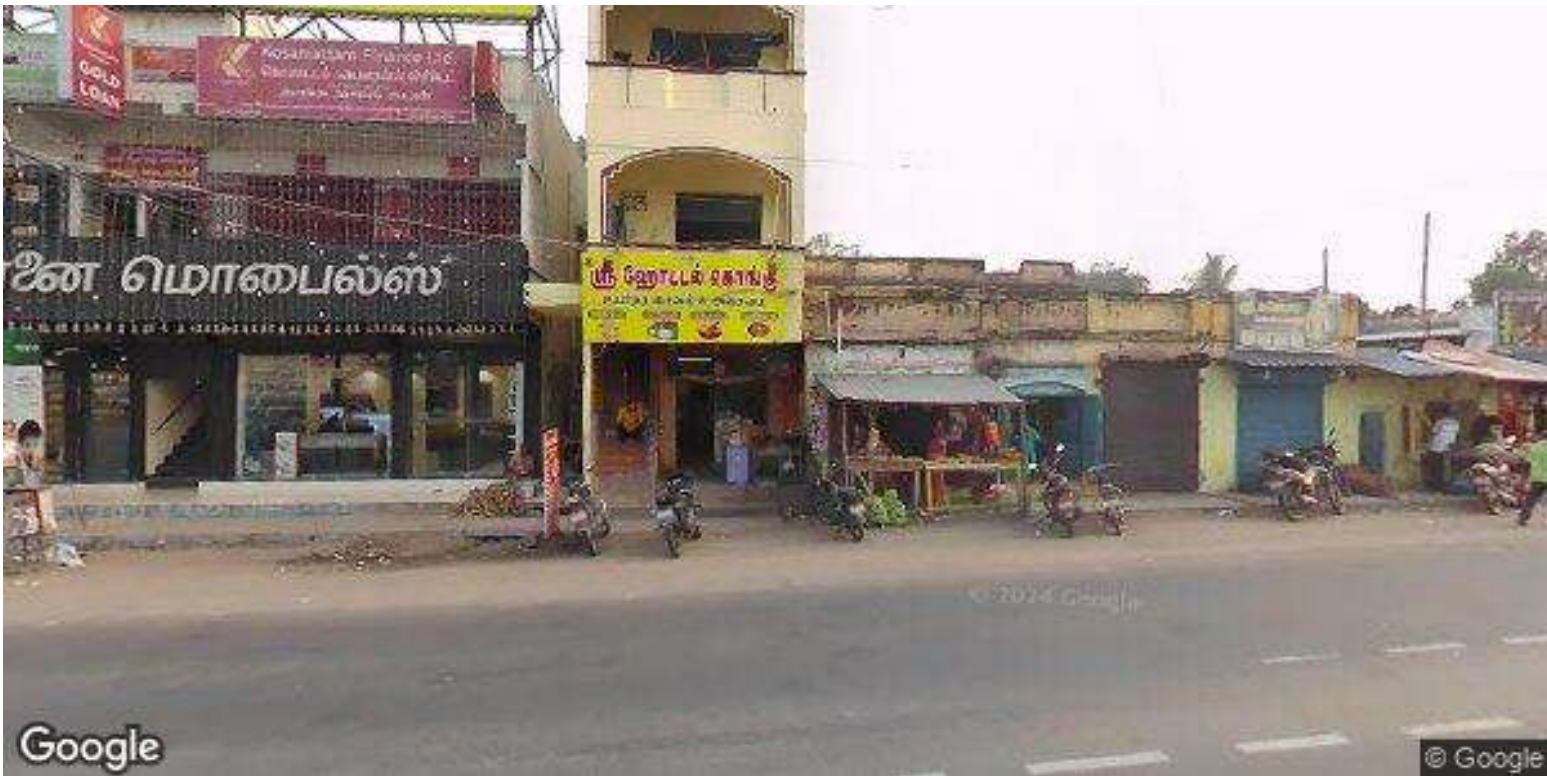
Coordinates: 11.47451, 77.86914

Risk Type: Turn

Risk Level: High

Speed Limit: 15 KM/Hr

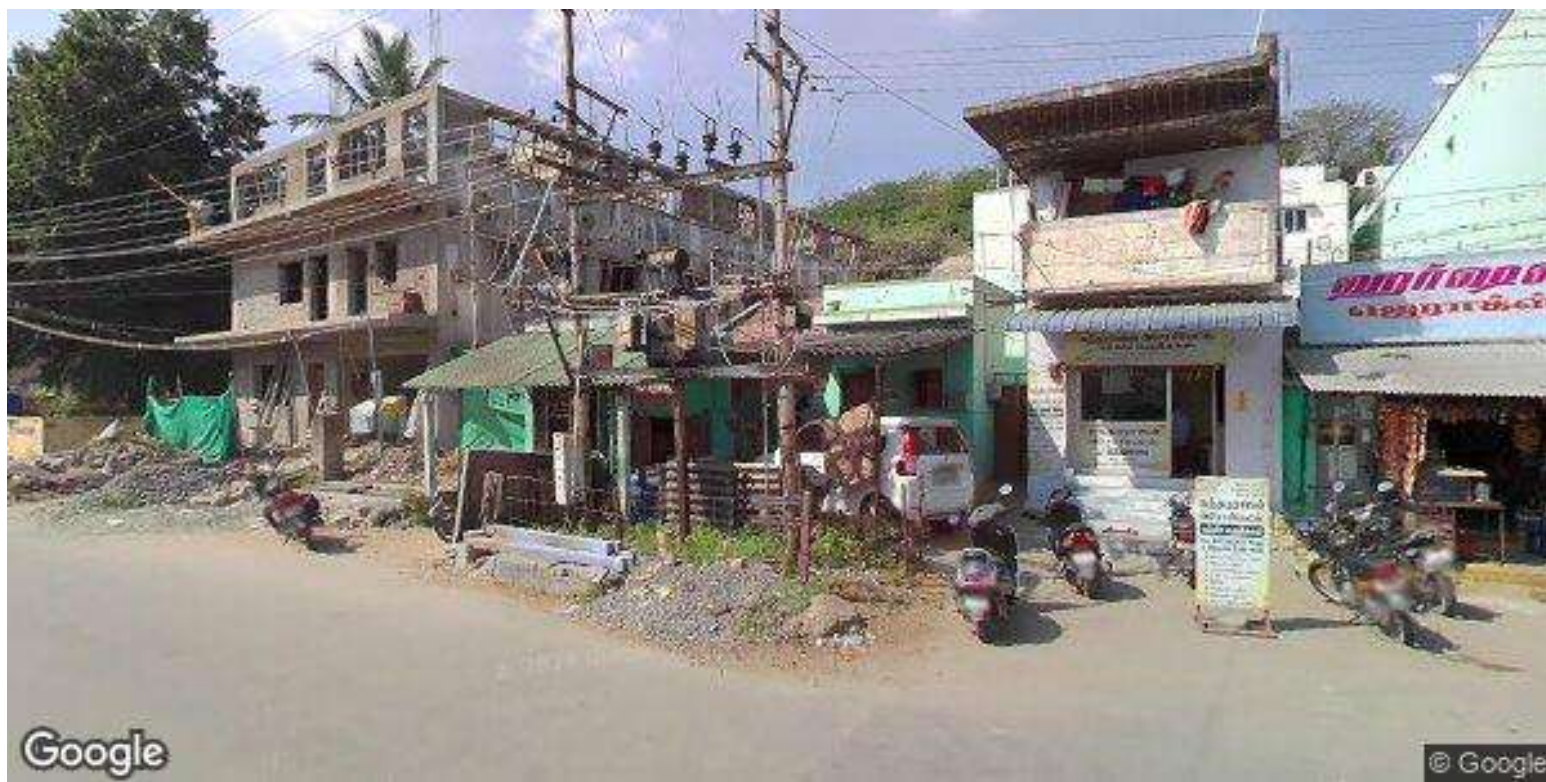
**Coordinates:** 11.47920, 77.86989

**Risk Type:** Turn

**Risk Level:** High

**Speed Limit:** 15 KM/Hr

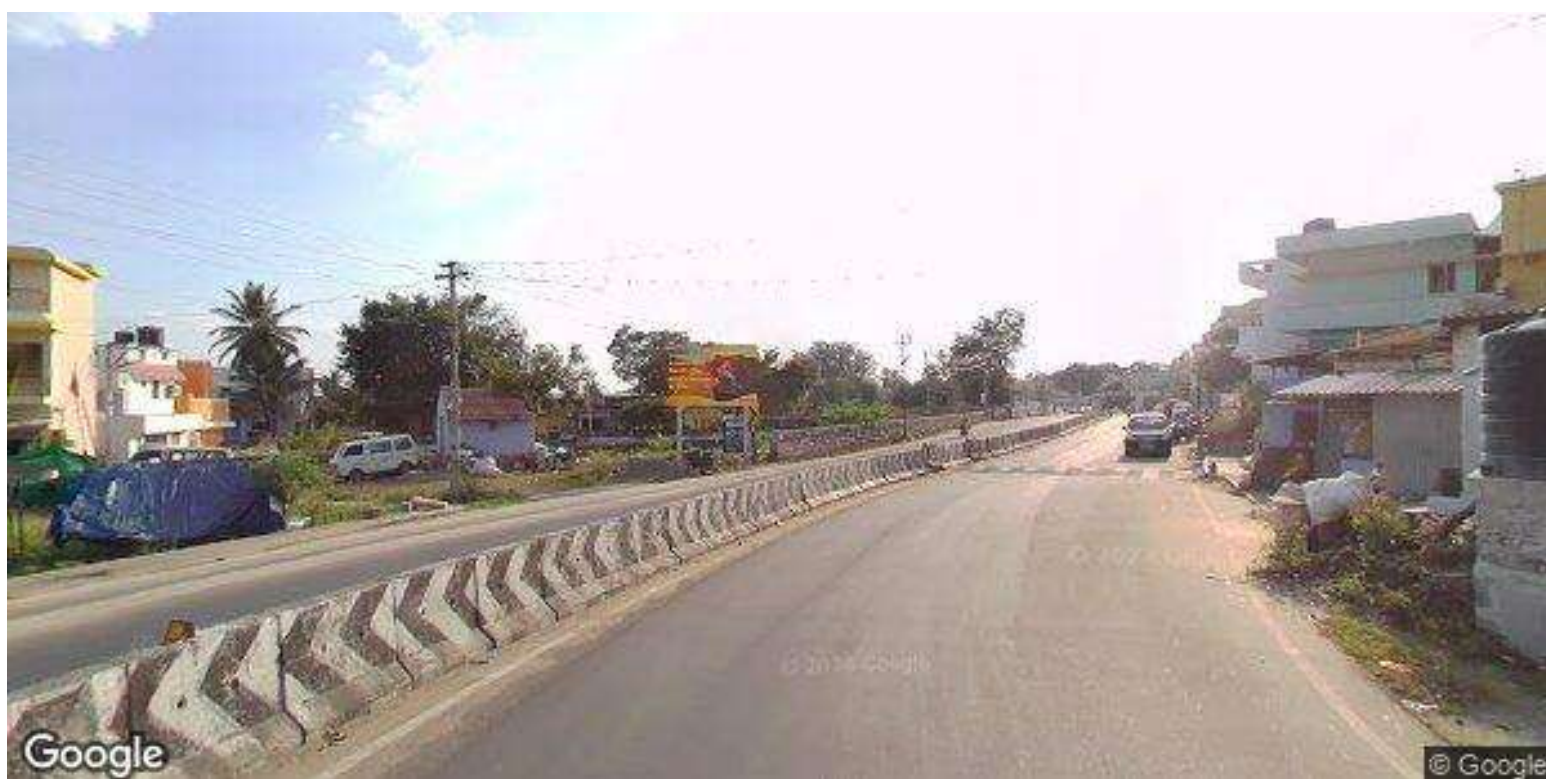
**Coordinates:** 11.48058, 77.87163

**Risk Type:** Turn

**Risk Level:** Medium

**Speed Limit:** 30 KM/Hr

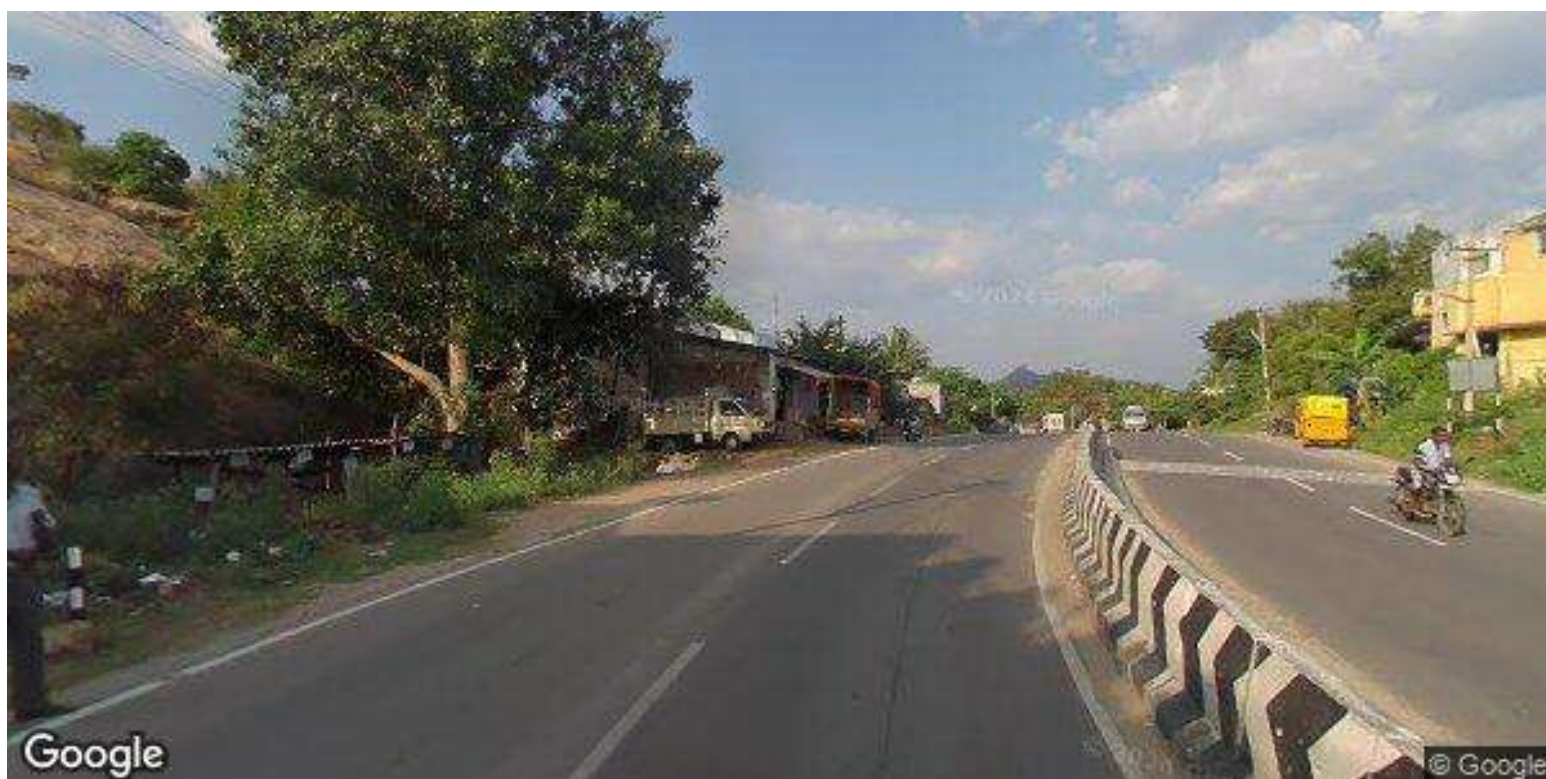
**Risk Type:** Turn  
**Risk Level:** Medium  
**Speed Limit:** 30 KM/Hr  
**Coordinates:** 11.48155, 77.87174

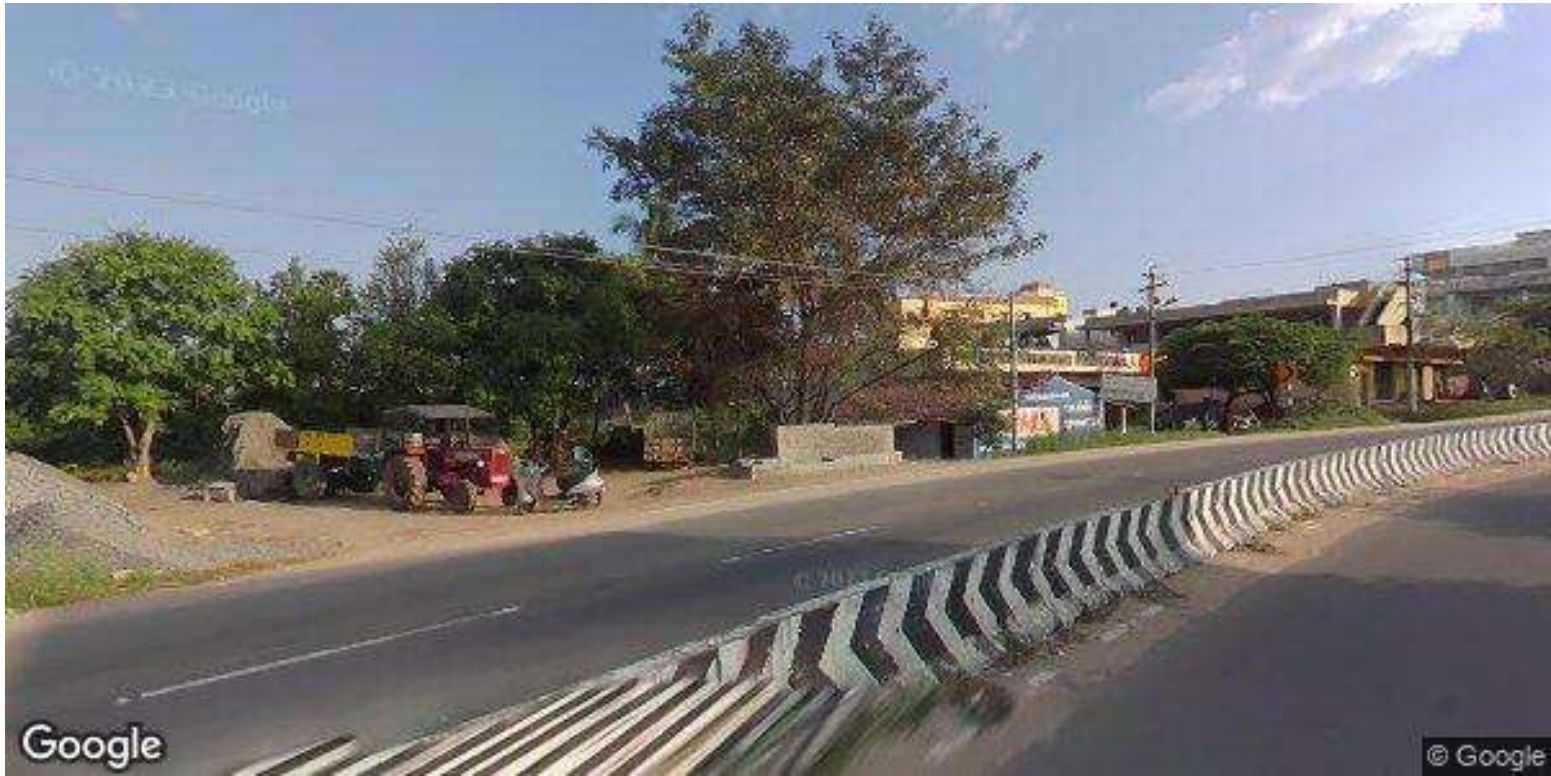
**Risk Type:** Turn  
**Risk Level:** Medium  
**Speed Limit:** 30 KM/Hr  
**Coordinates:** 11.48277, 77.87250

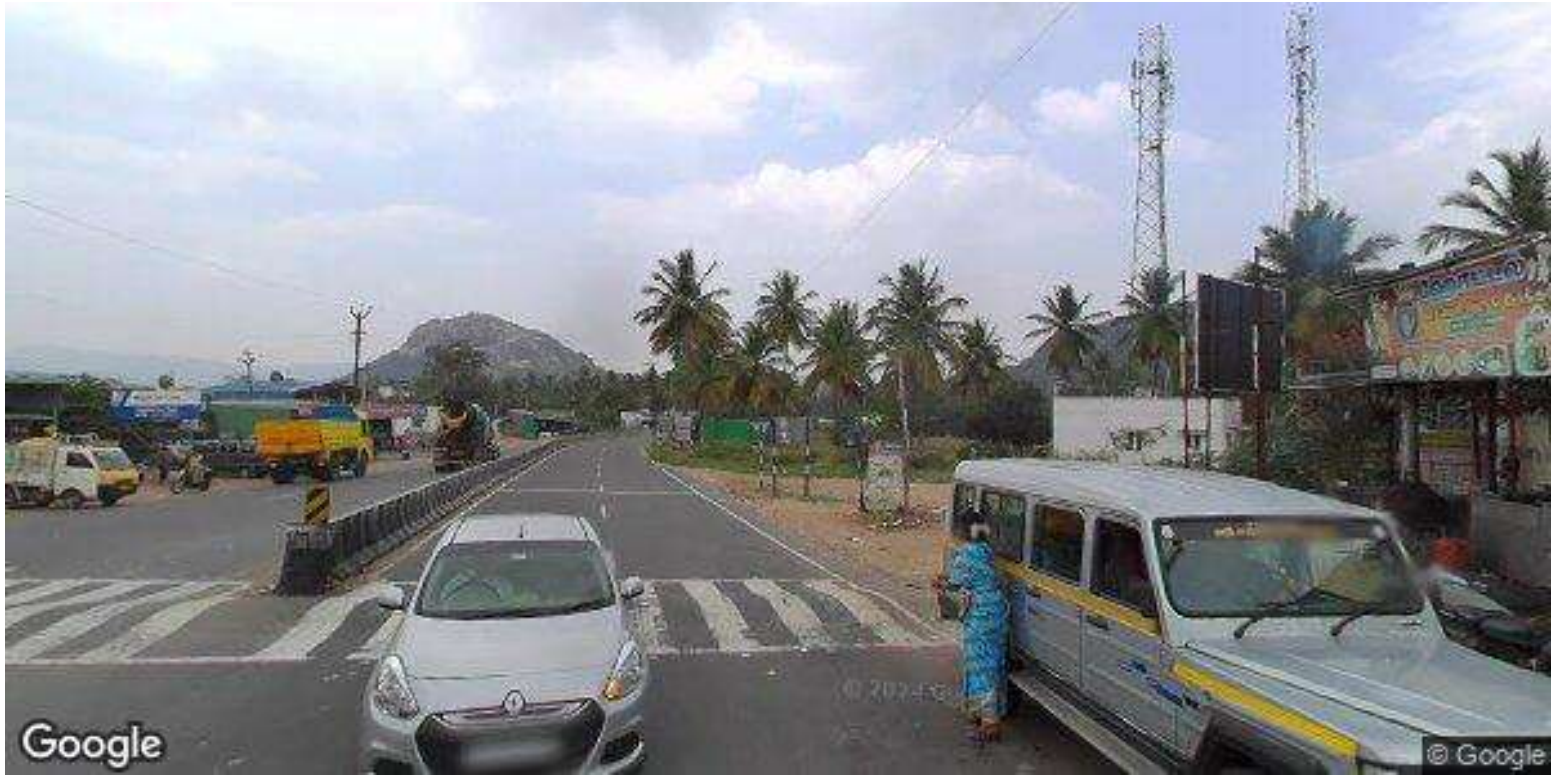
**Risk Type:** Turn  
**Risk Level:** Medium  
**Speed Limit:** 30 KM/Hr  
**Coordinates:** 11.49397, 77.86740

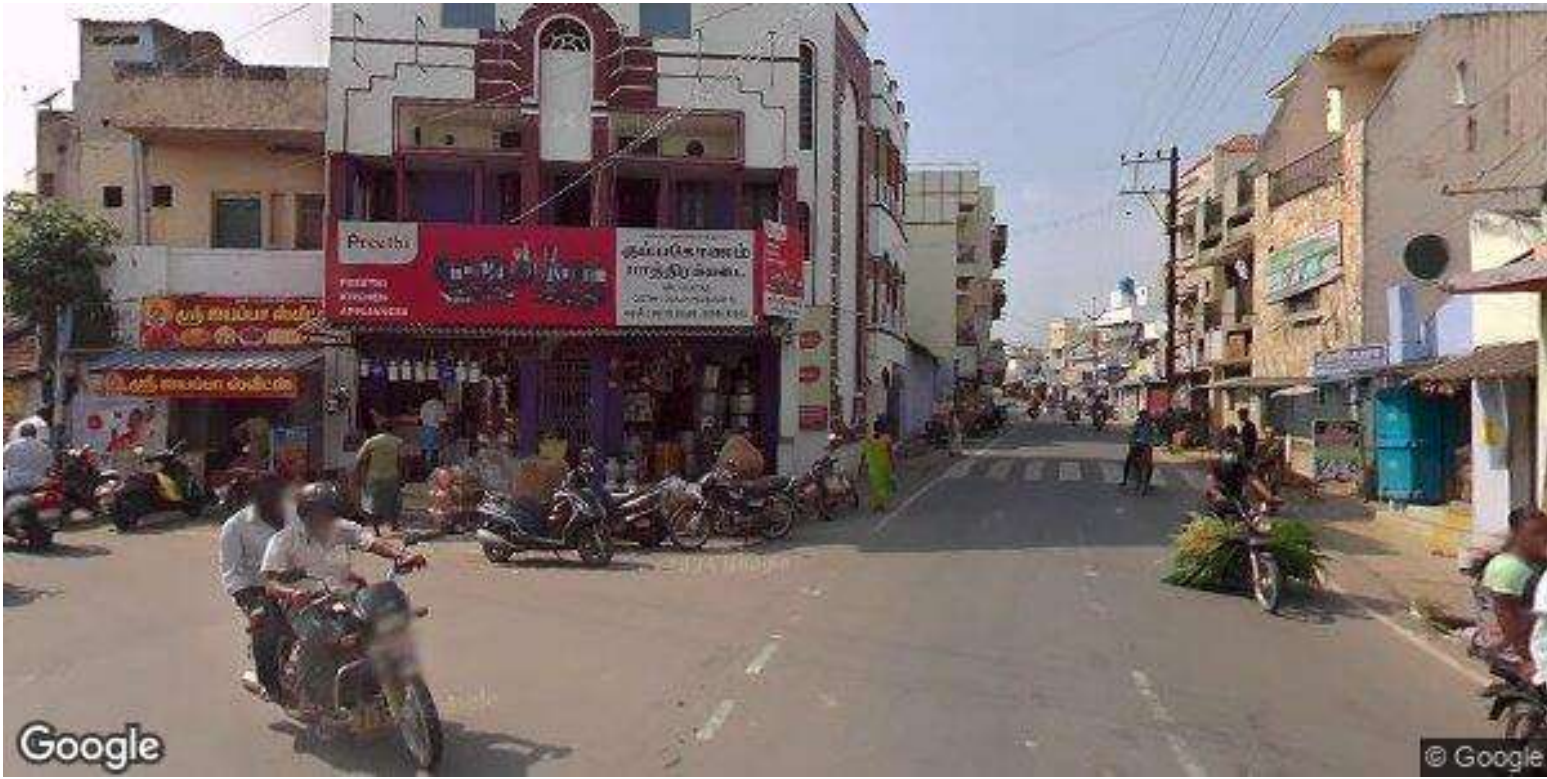
Coordinates: 11.58533, 77.83450

Risk Type: Turn

Risk Level: High

Speed Limit: 15 KM/Hr

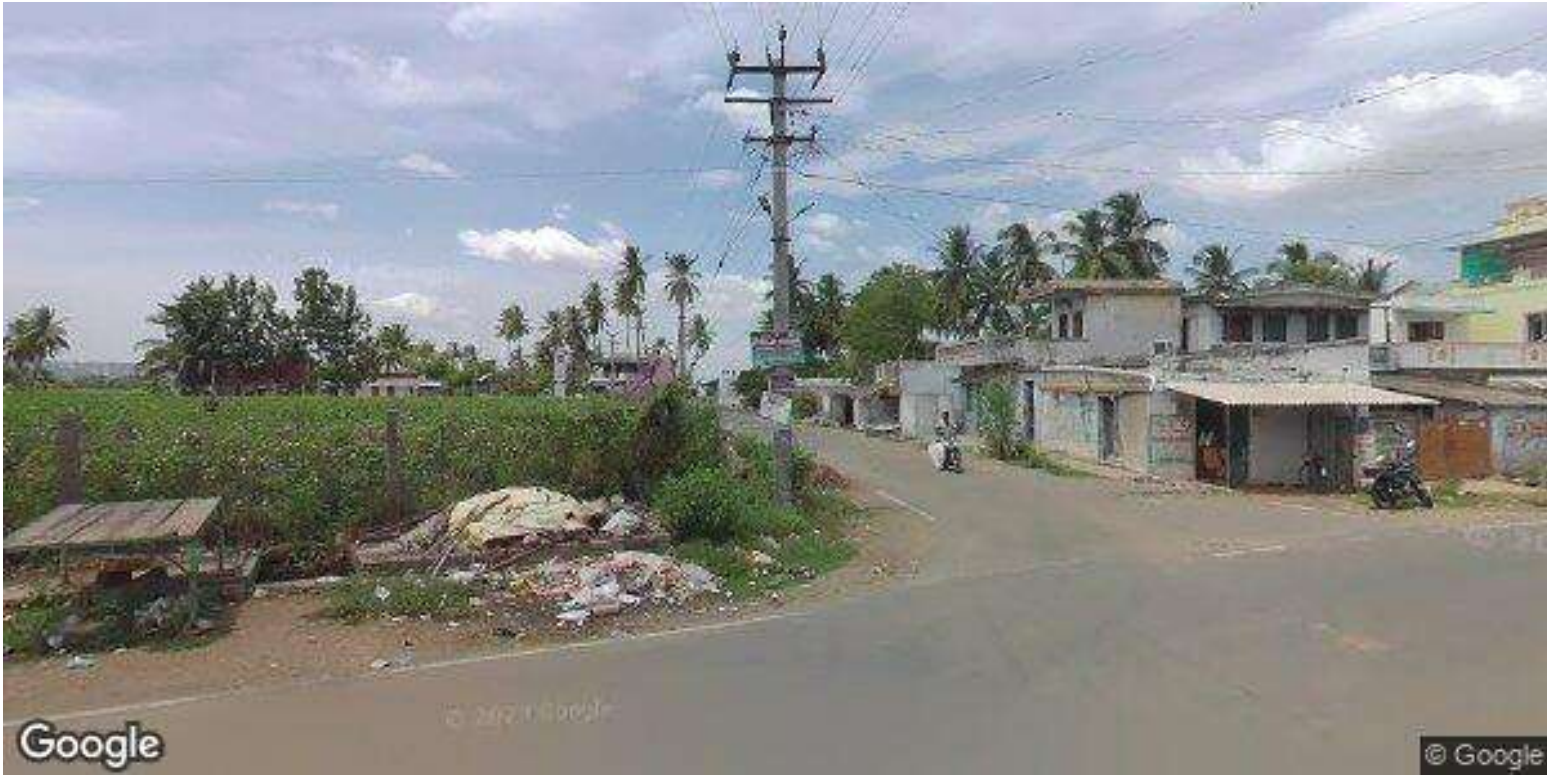
Coordinates: 11.56019, 77.74944

Risk Type: Turn

Risk Level: High

Speed Limit: 15 KM/Hr
