# IndianOil

## JOURNEY RISK MANAGEMENT (JRM) STUDY

### Salem Terminal TO SANKAGIRI LORRY OWENER'S ASSOCIAATI

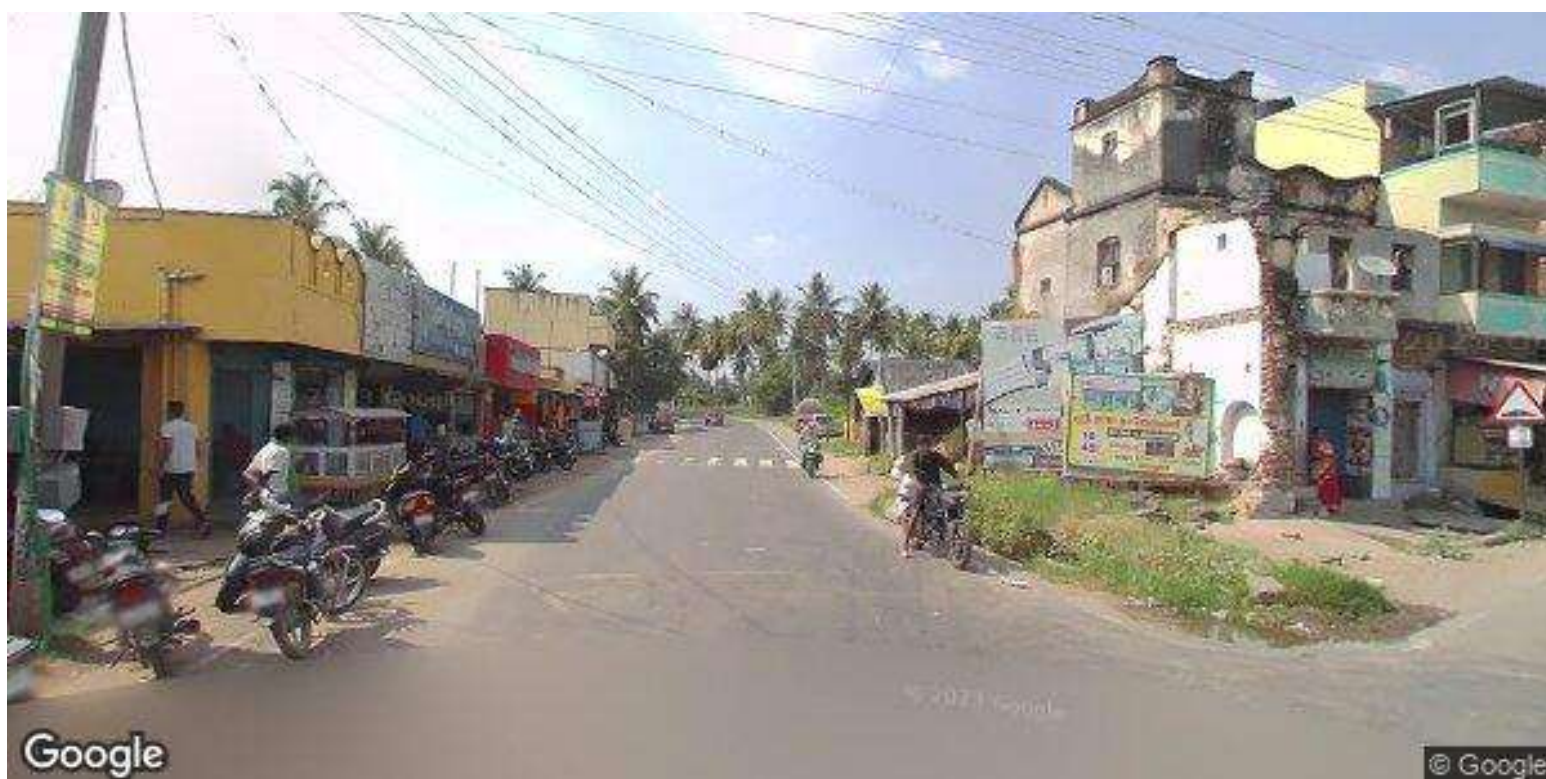
**Coordinates: 11.45007, 77.87201**

**Risk Type: Turn**

**Risk Level: High**

**Speed Limit: 15 KM/Hr**

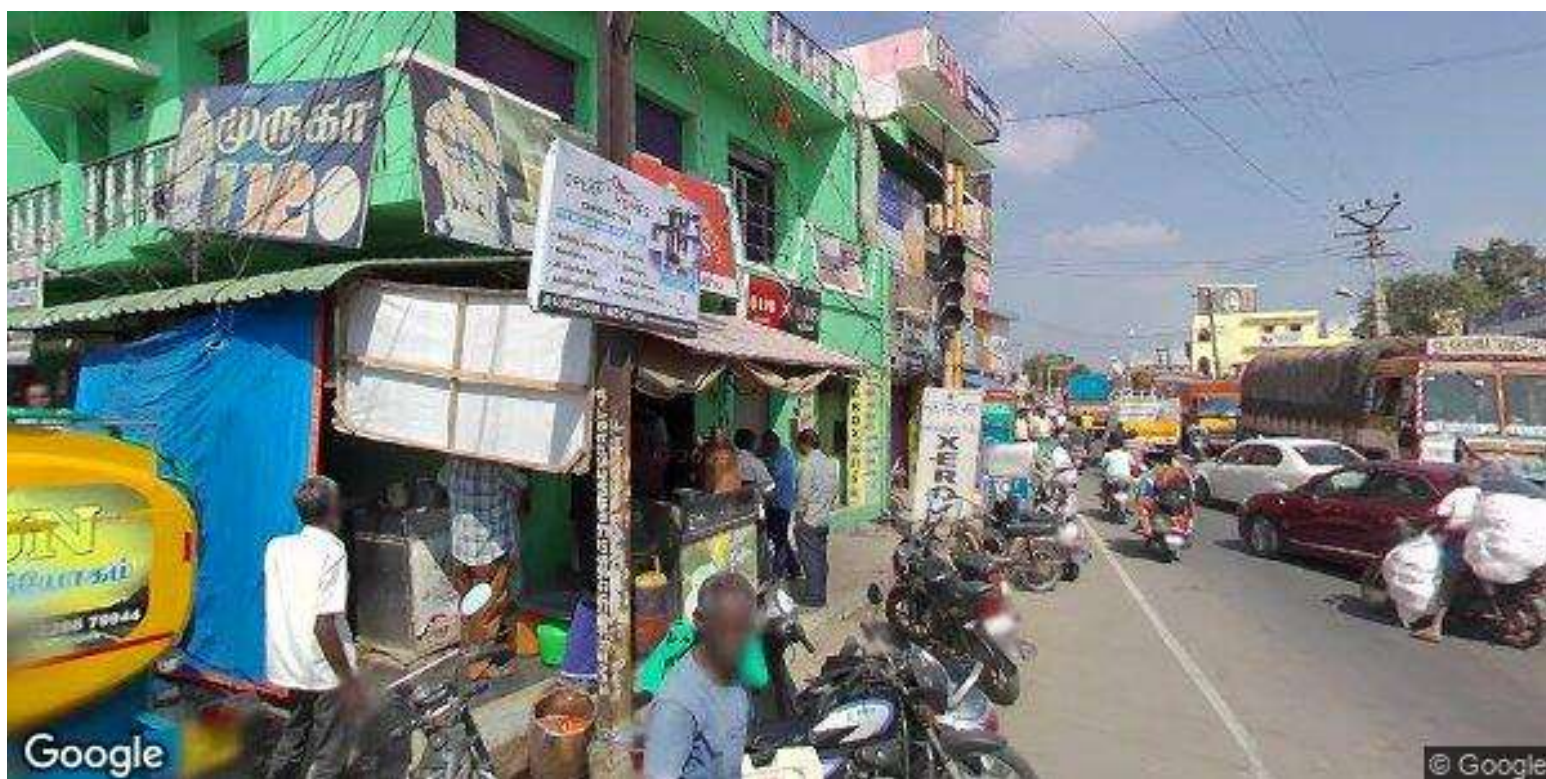
**Coordinates: 11.47407, 77.86839**

**Risk Type: Turn**

**Risk Level: High**

**Speed Limit: 15 KM/Hr**

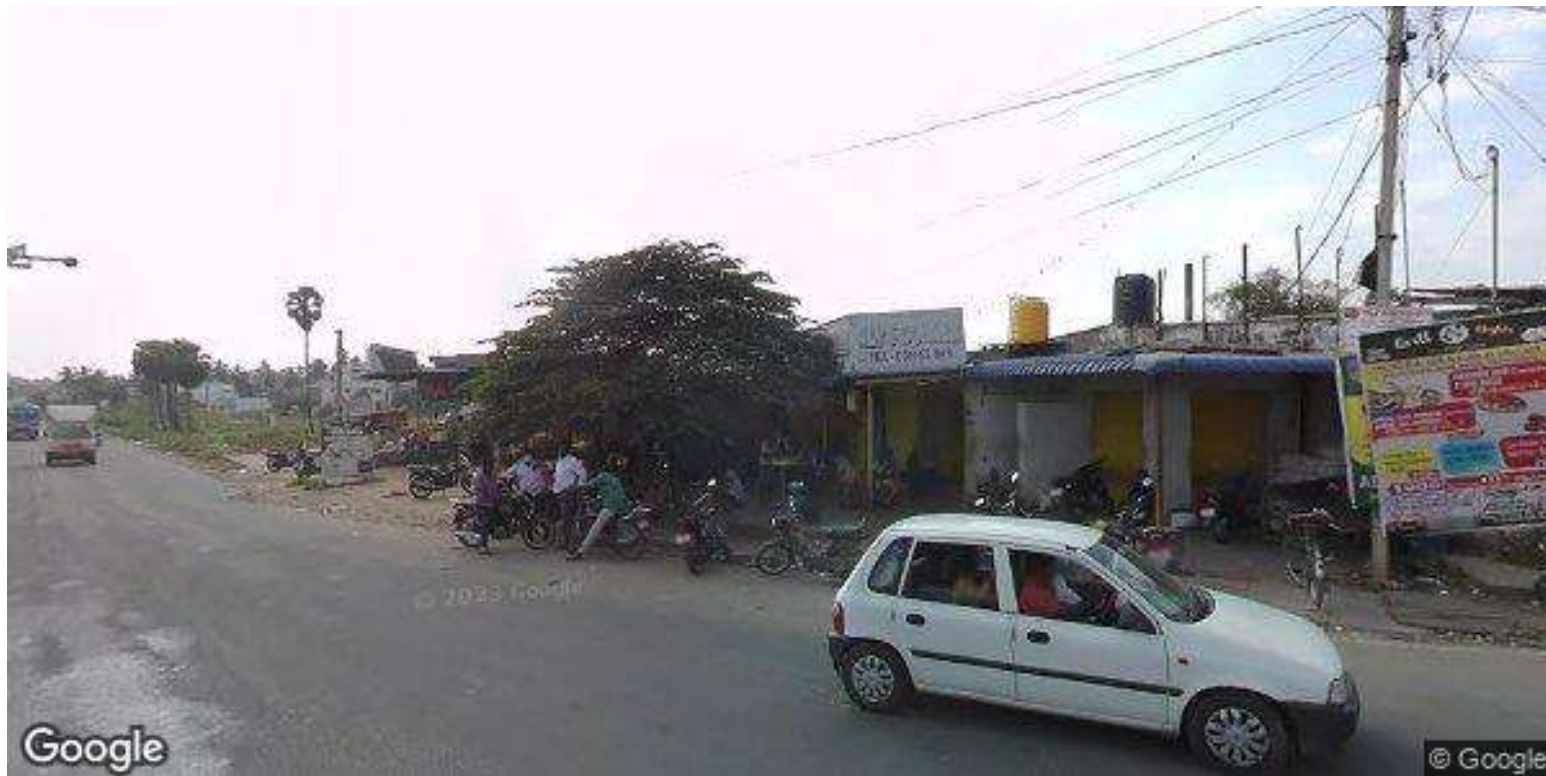
**Coordinates: 11.48369, 77.88781**

**Risk Type: Turn**

**Risk Level: High**

**Speed Limit: 15 KM/Hr**

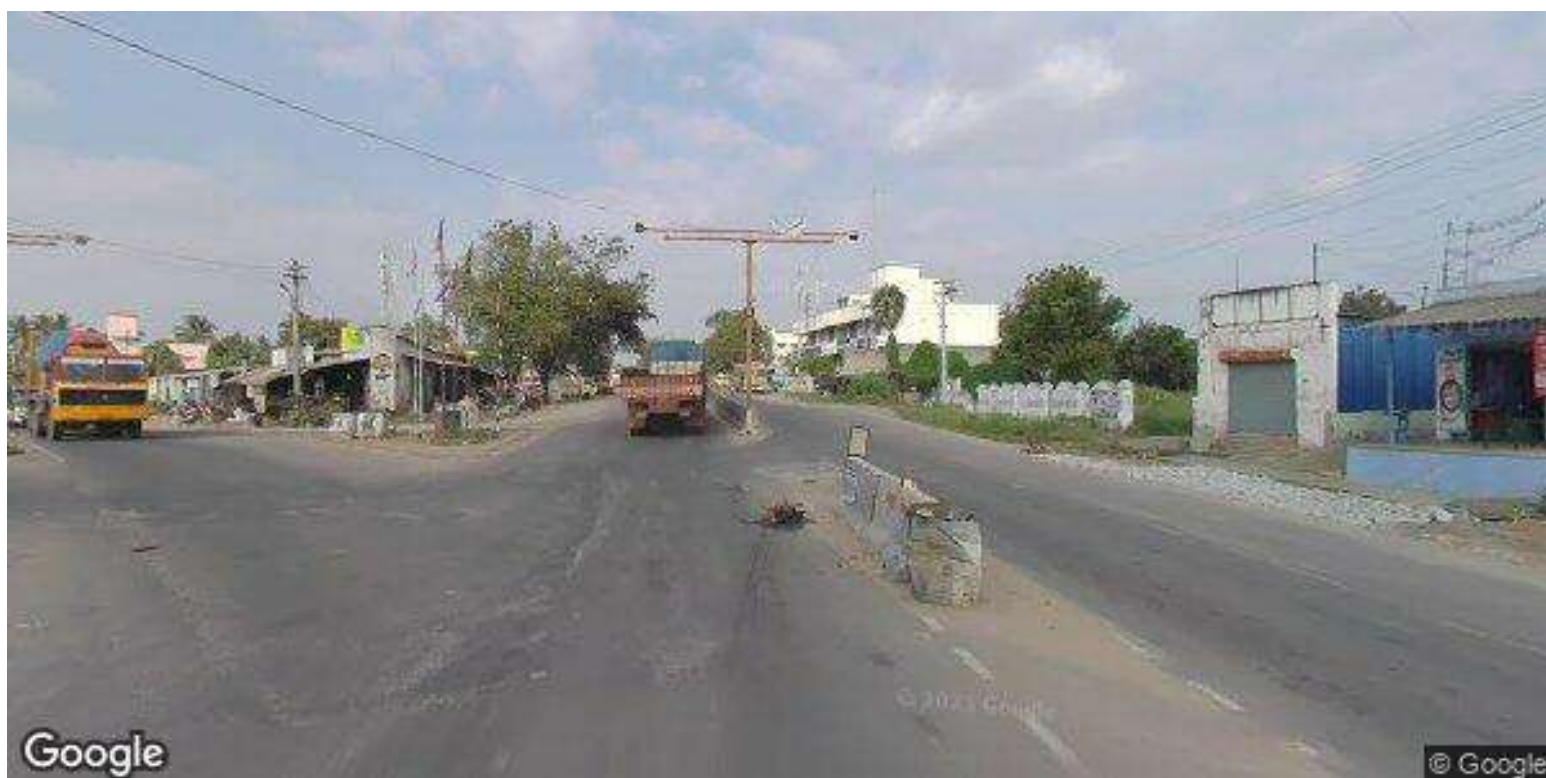
**Coordinates: 11.48370, 77.88787**

**Risk Type: Turn**

**Risk Level: Medium**

**Speed Limit: 30 KM/Hr**

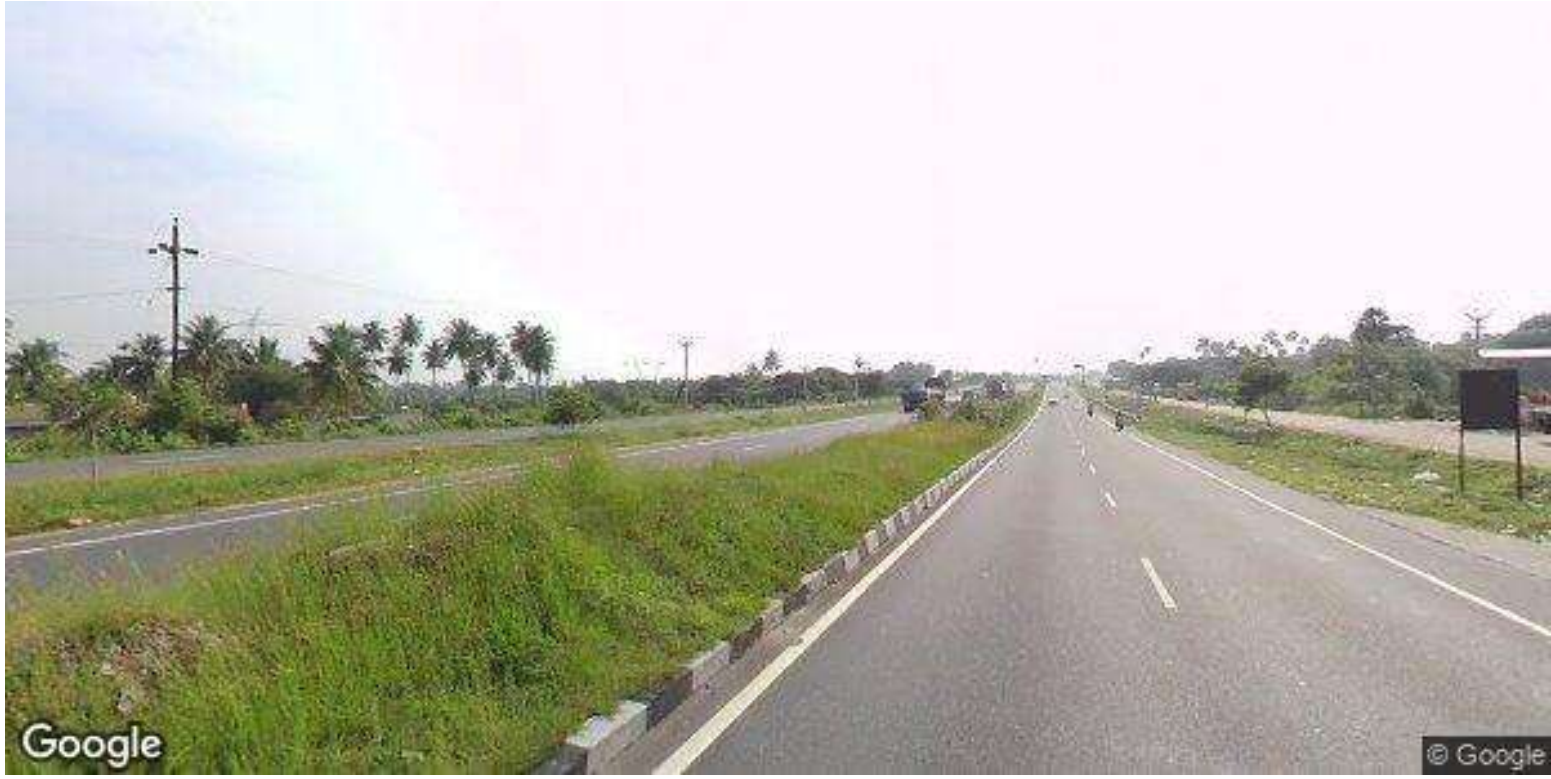
**Coordinates: 11.50108, 77.91039**

**Risk Type: Blind Spot**

**Risk Level: Blind Spot**

**Speed Limit: 10 KM/Hr**

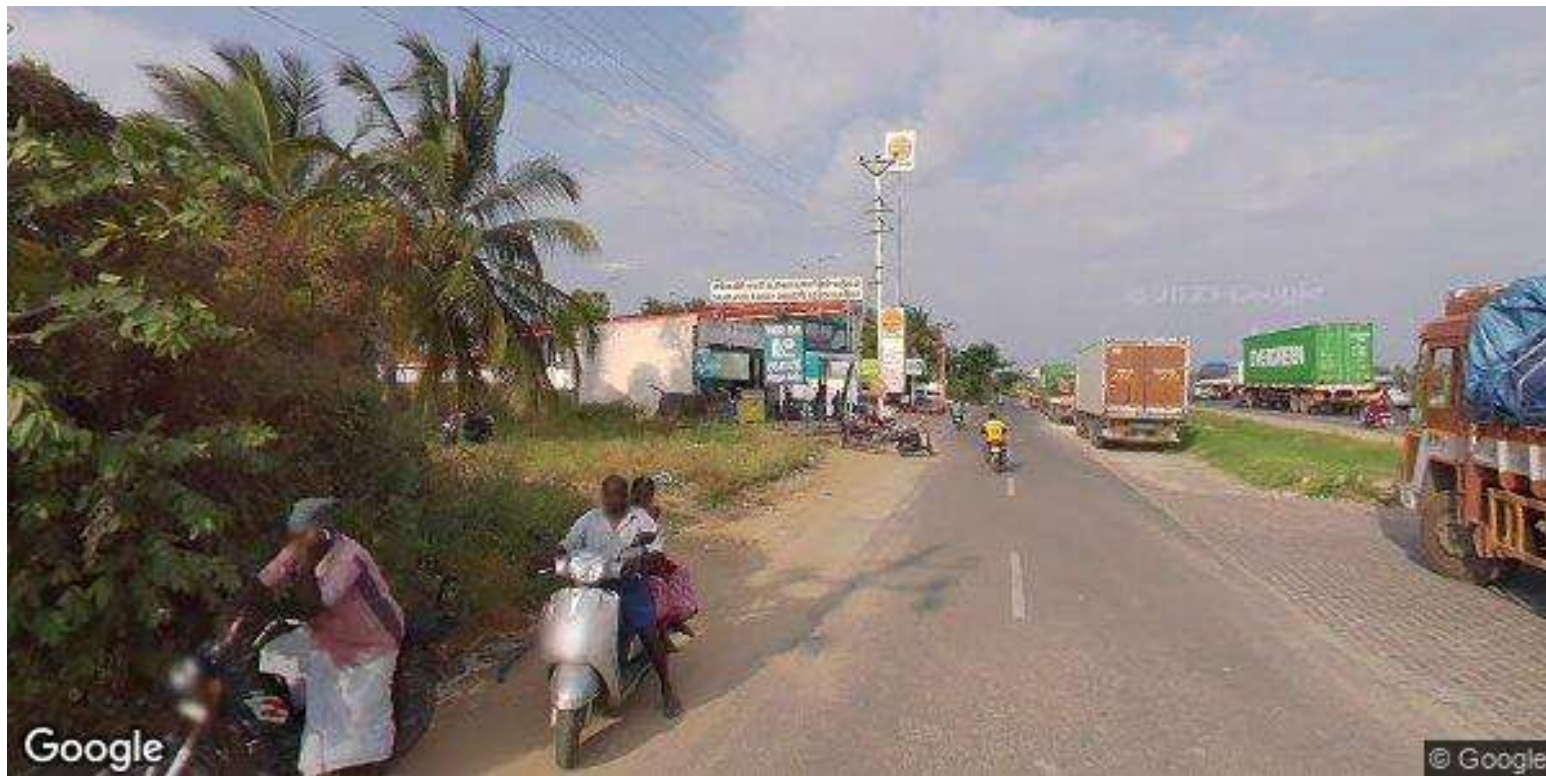
**Coordinates: 11.50119, 77.91025**

**Risk Type: Blind Spot**

**Risk Level: Blind Spot**

**Speed Limit: 10 KM/Hr**

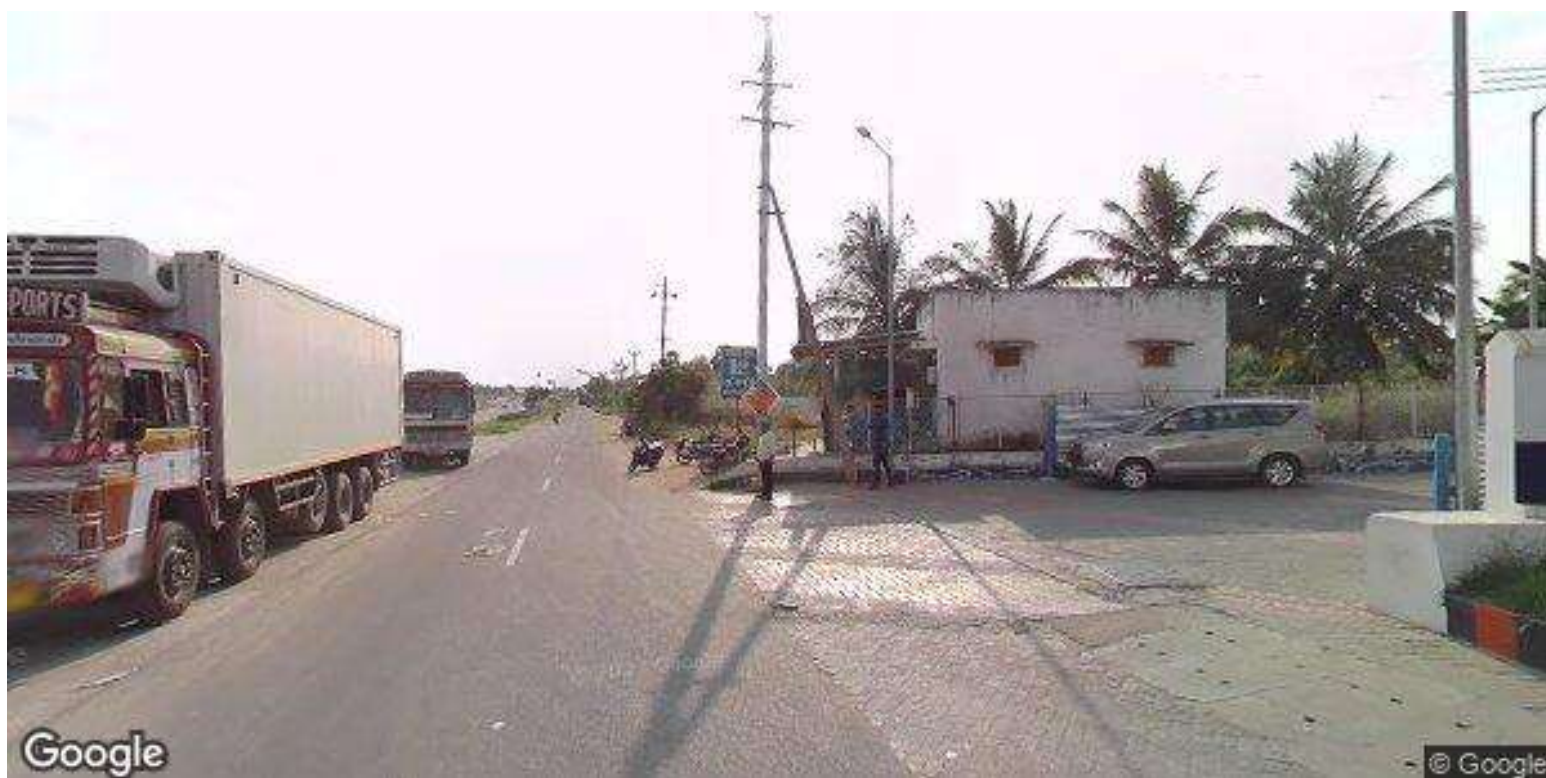
**Coordinates: 11.50150, 77.91052**

**Risk Type: Turn**

**Risk Level: High**

**Speed Limit: 15 KM/Hr**
