## **JOURNEY RISK MANAGEMENT (JRM) STUDY**

### **Salem Terminal to SRI M.R.S. PETROL BUNK**

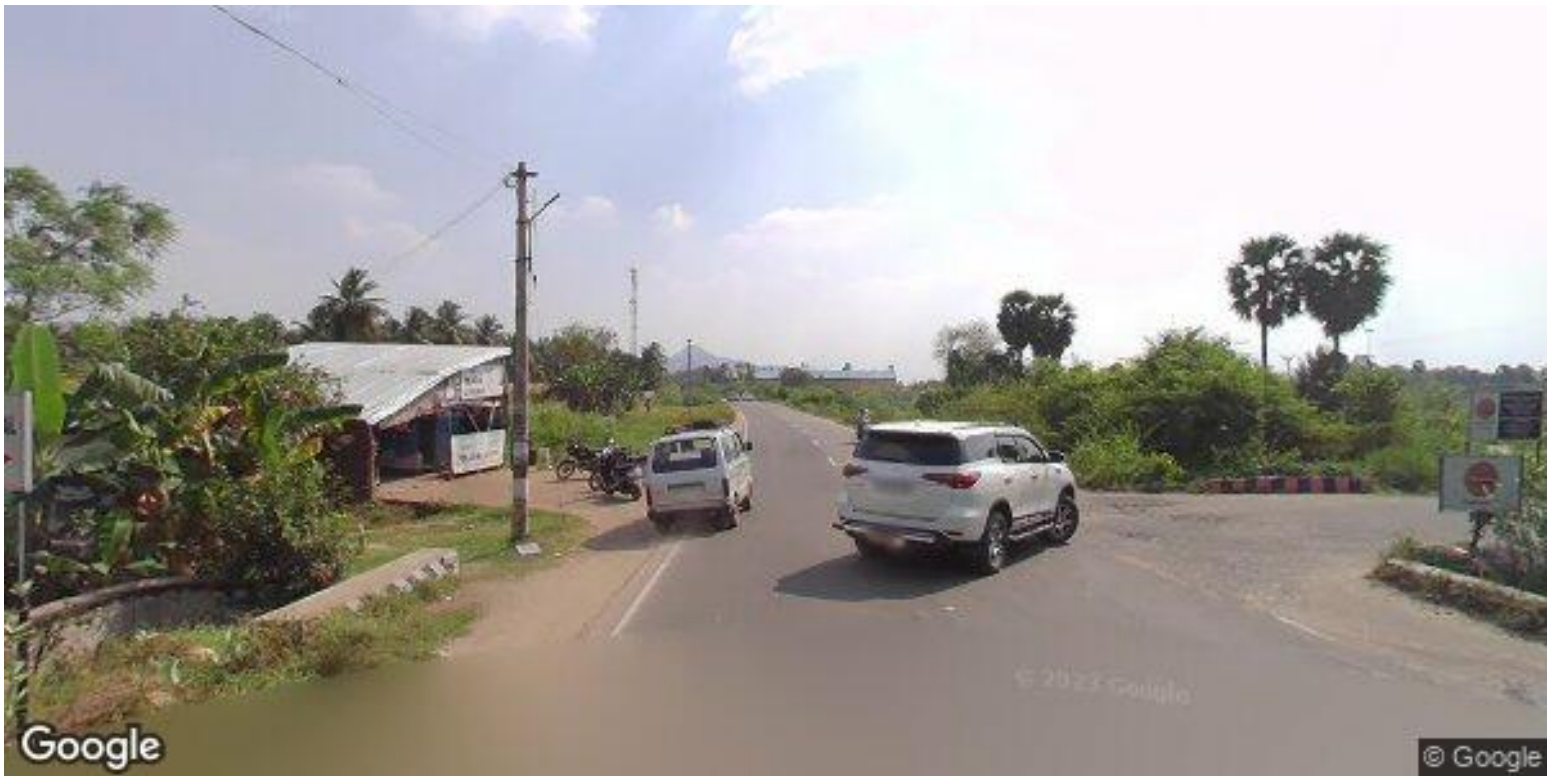
Coordinates: 11.44029, 77.87544

| | Risk Type | Risk Level | Coordinates | Speed Limit |
|---|---|---|---|---|
| 3 | Turn | High | 11.44029, 77.87544 | 15 KM/Hr |

Risk Type: Turn

Risk Level: High

Speed Limit: 15 KM/Hr

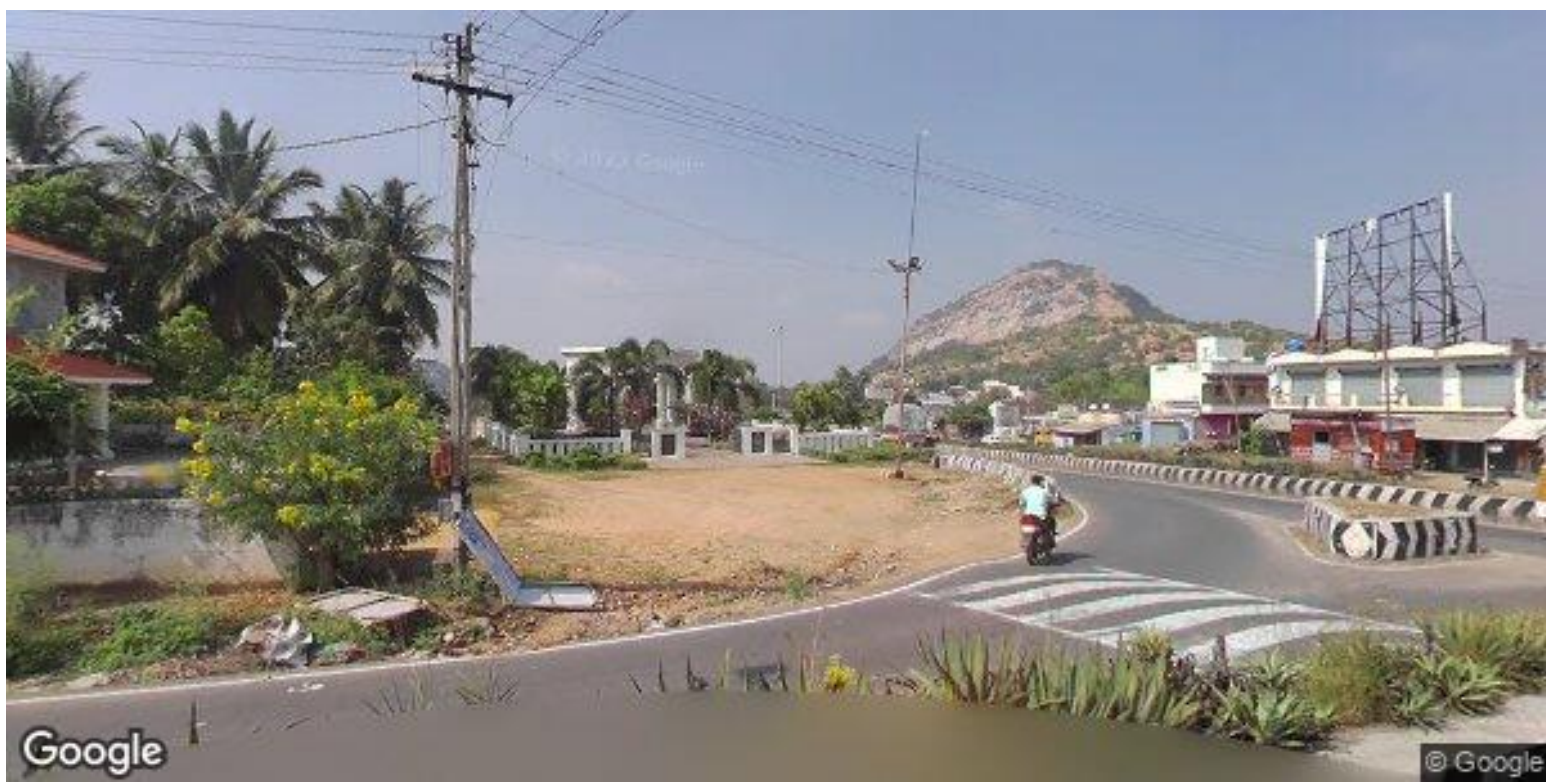
**Coordinates:** 11.46307, 77.84941

| | Risk Type | Risk Level | Coordinates | Speed Limit |
|---|---|---|---|---|
| 4 | Turn | Medium | 11.46307, 77.84941 | 30 KM/Hr |

**Risk Type:** Turn

**Risk Level:** Medium

**Speed Limit:** 30 KM/Hr

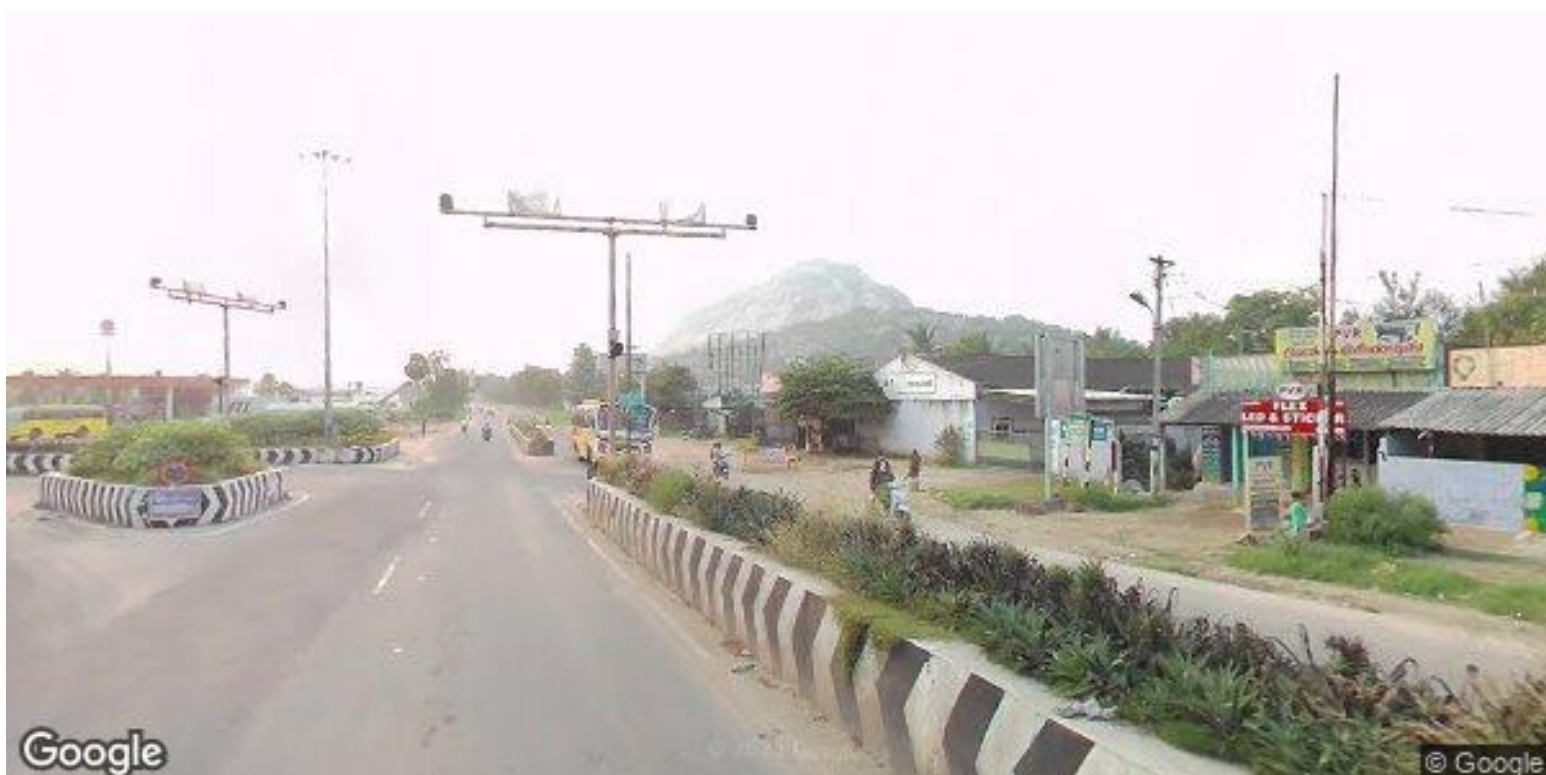
**Coordinates:** 11.46312, 77.84886

| | Risk Type | Risk Level | Coordinates | Speed Limit |
|---|---|---|---|---|
| 6 | Turn | Medium | 11.46312, 77.84886 | 30 KM/Hr |

**Risk Type:** Turn

**Risk Level:** Medium

**Speed Limit:** 30 KM/Hr

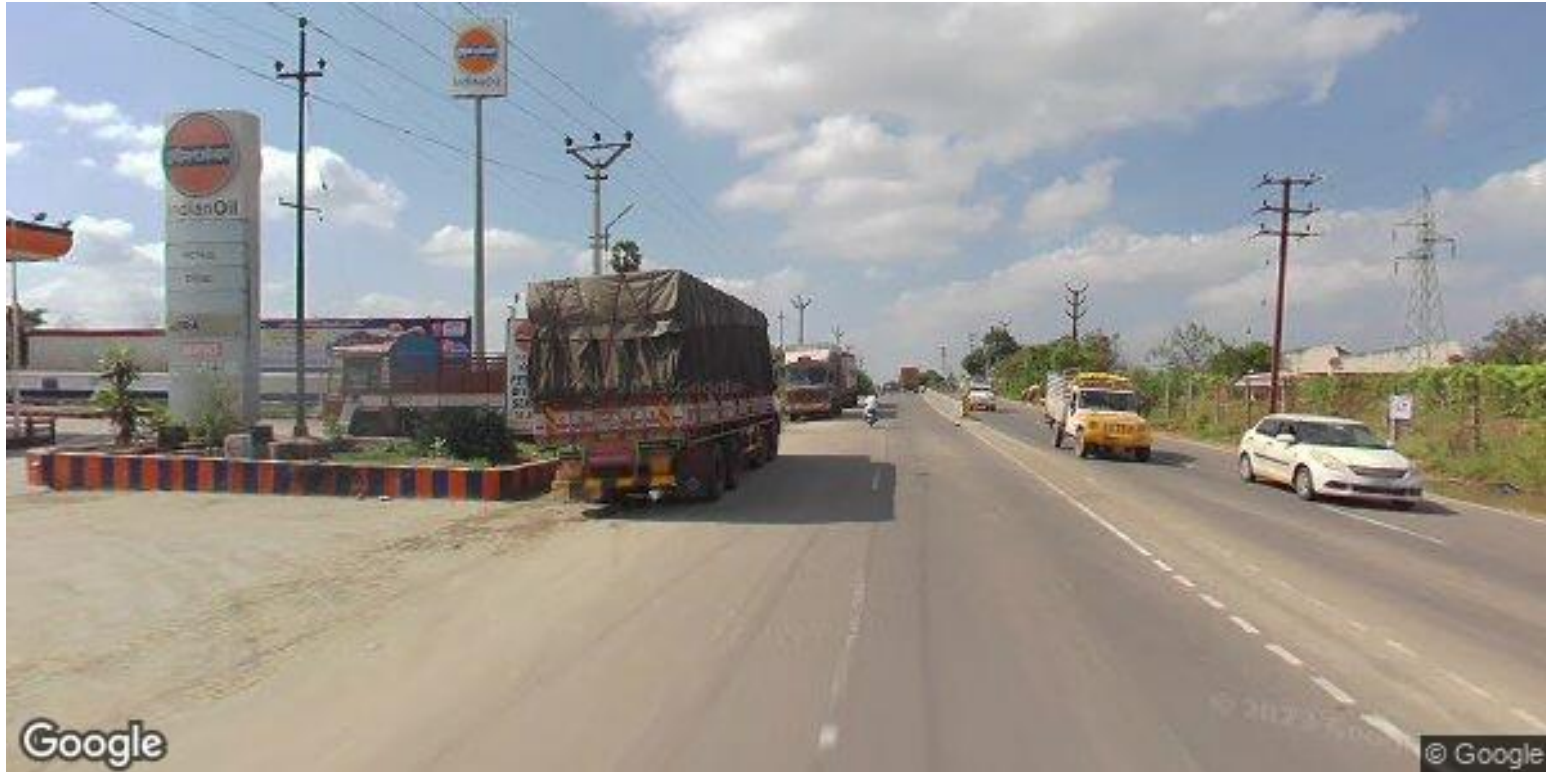
**Coordinates:** 11.40198, 77.78225

| | Risk Type | Risk Level | Coordinates | Speed Limit |
|---|---|---|---|---|
| 7 | Turn | High | 11.40198, 77.78225 | 15 KM/Hr |

**Risk Type:** Turn

**Risk Level:** High

**Speed Limit:** 15 KM/Hr

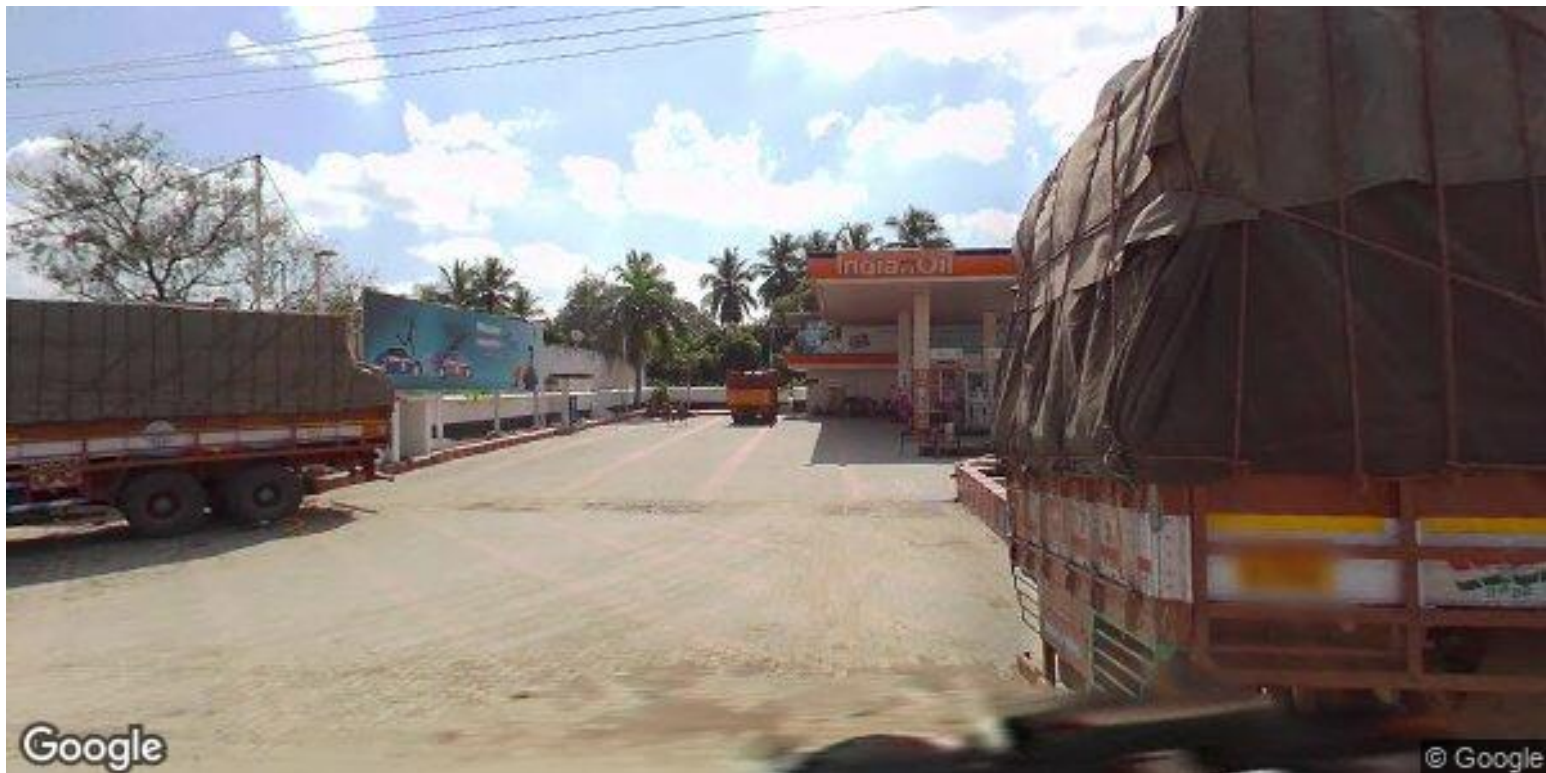
**Coordinates:** 11.40172, 77.78236

| | Risk Type | Risk Level | Coordinates | Speed Limit |
|---|---|---|---|---|
| 8 | Turn | High | 11.40172, 77.78236 | 15 KM/Hr |

**Risk Type:** Turn

**Risk Level:** High

**Speed Limit:** 15 KM/Hr
