## JOURNEY RISK MANAGEMENT (JRM) STUDY

### Salem Terminal to AMMAN PETROLEUM

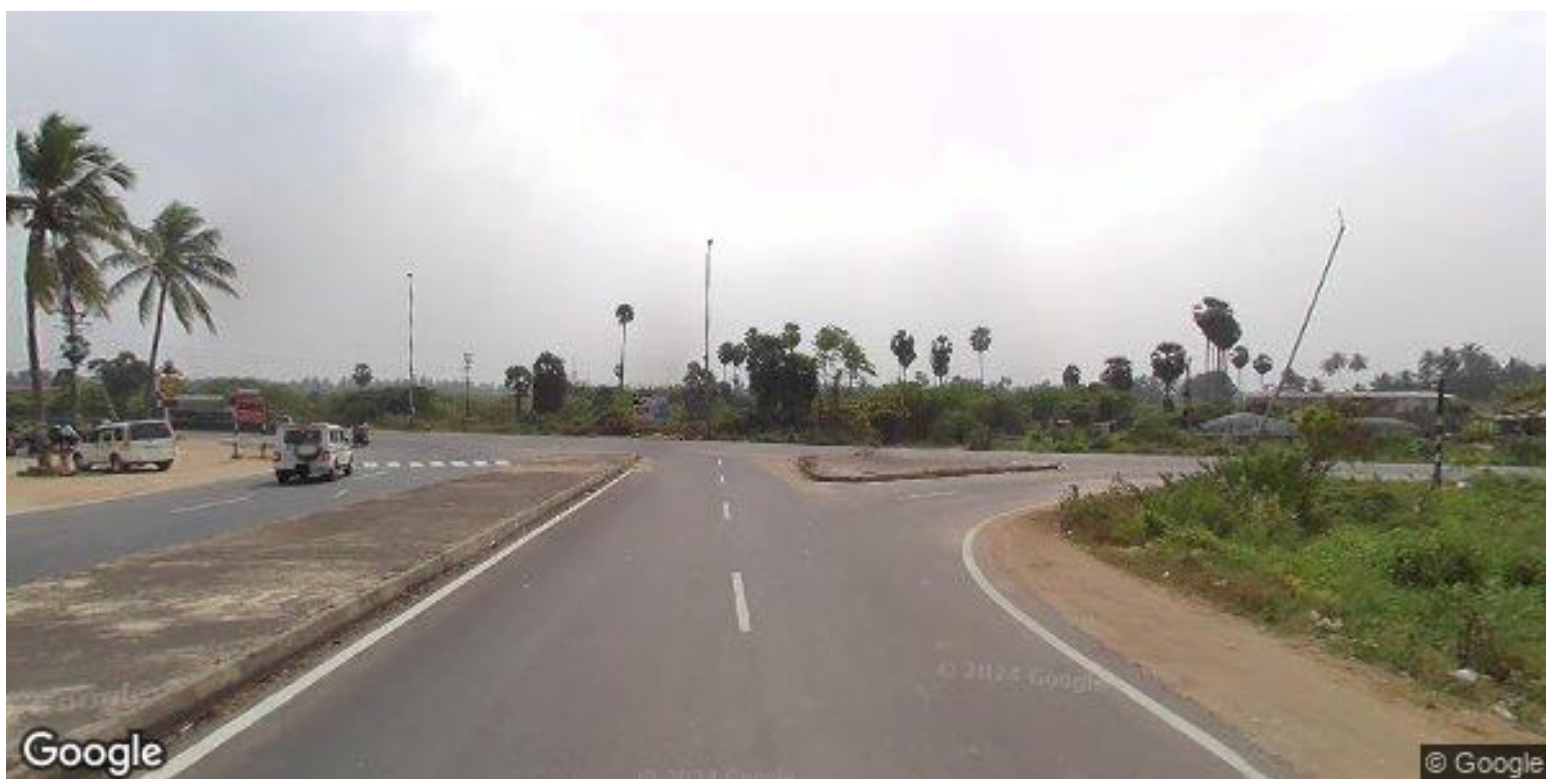
**Risk Type:** Turn

**Risk Level:** Medium

**Speed Limit:** 30 KM/Hr

**Coordinates:** 11.45571, 77.81702

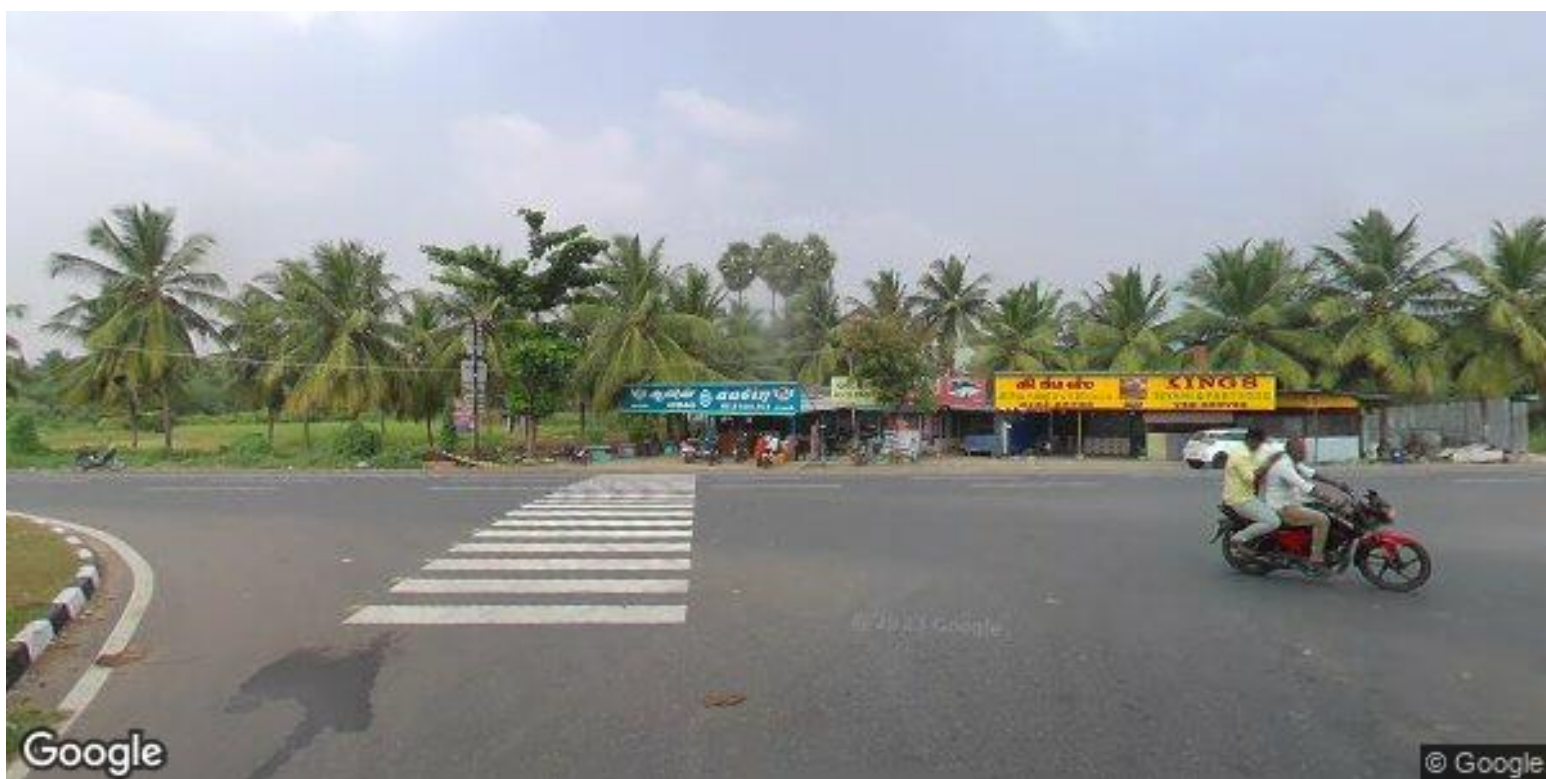
**Risk Type:** Turn  
**Risk Level:** High  
**Speed Limit:** 15 KM/Hr  
**Coordinates:** 11.45615, 77.81677

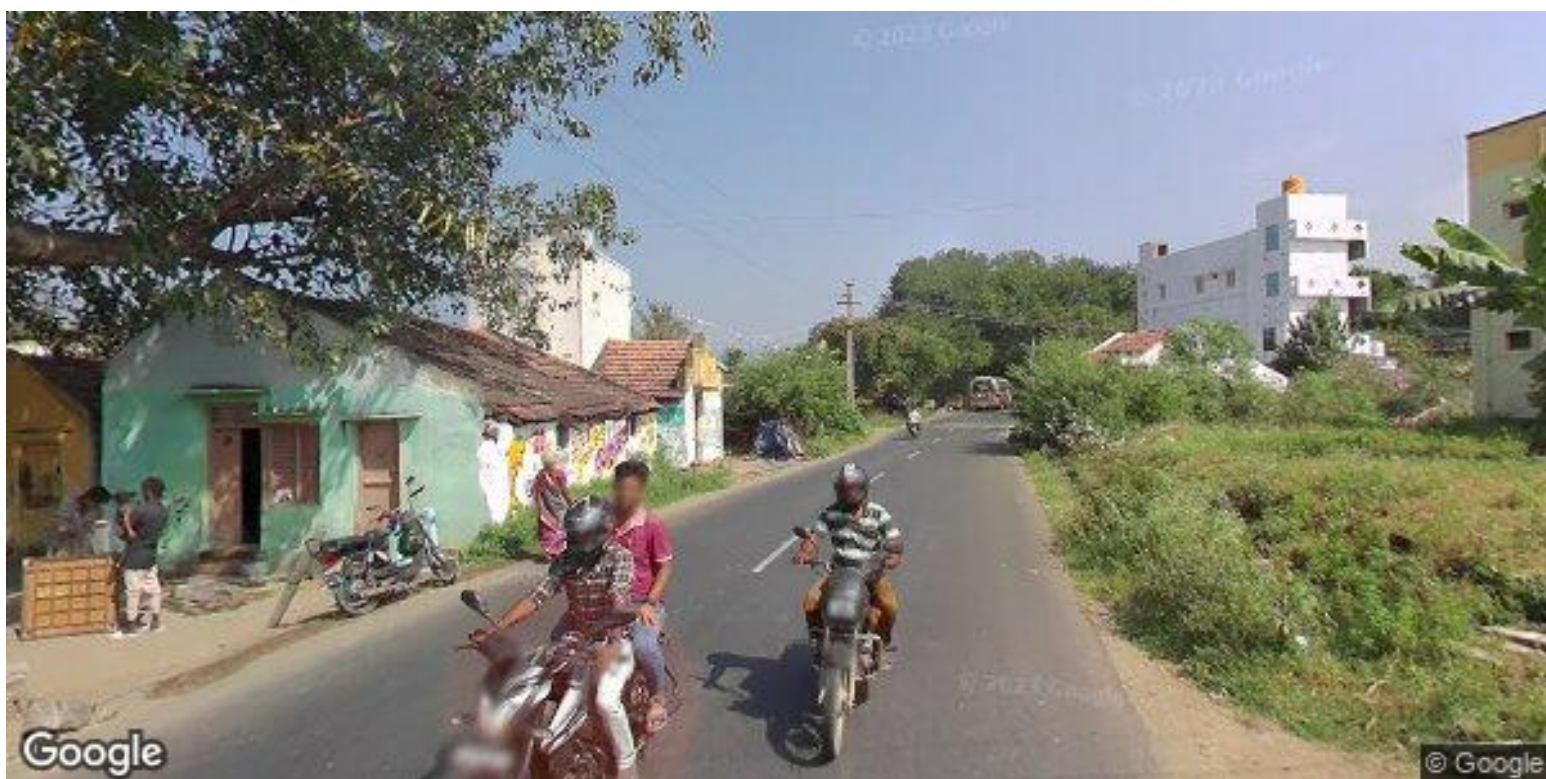
**Risk Type:** Turn  
**Risk Level:** Medium  
**Speed Limit:** 30 KM/Hr  
**Coordinates:** 11.68017, 78.24250

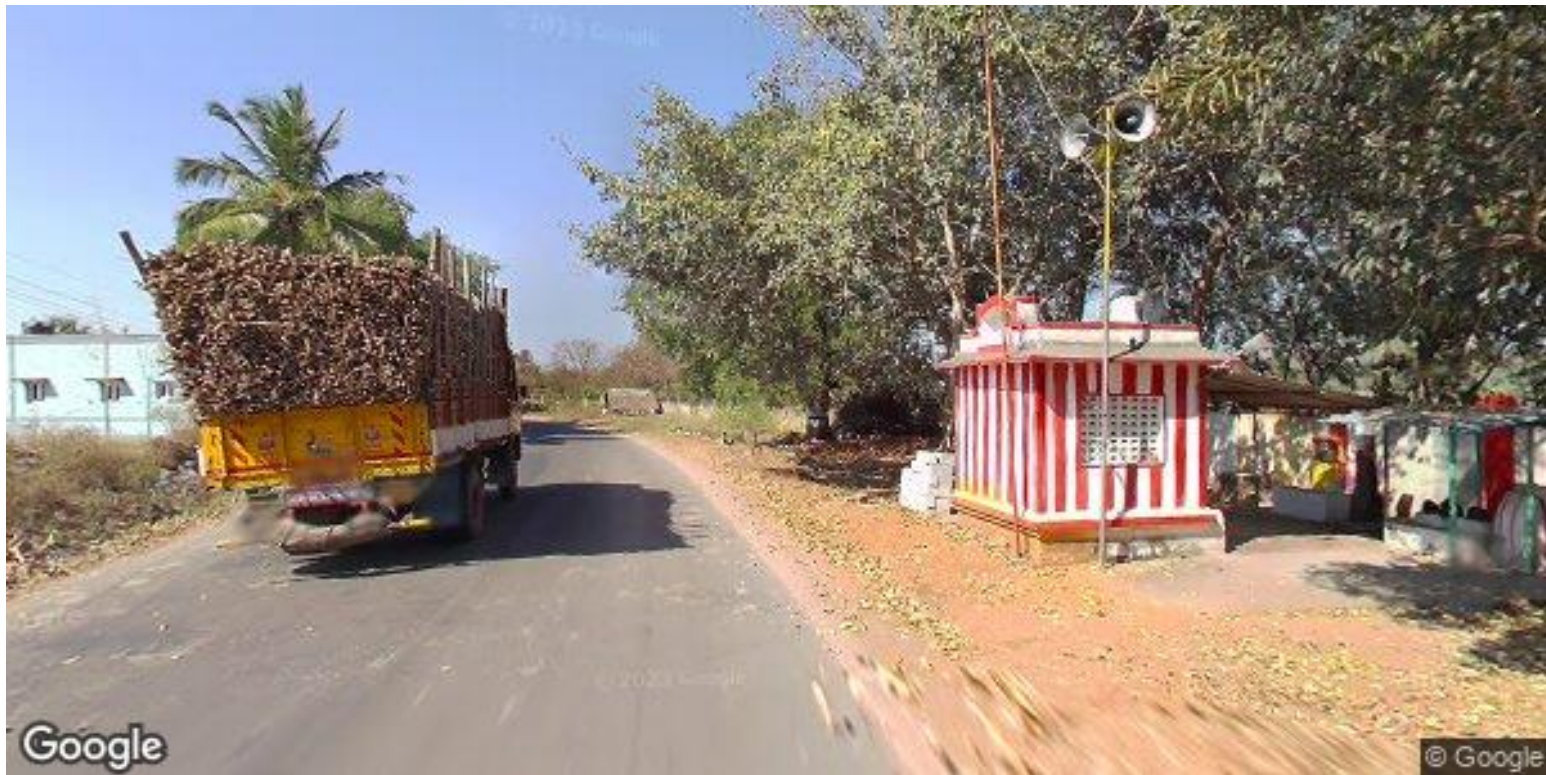
**Risk Type:** Turn

**Risk Level:** Medium

**Speed Limit:** 30 KM/Hr

**Coordinates:** 11.98751, 78.39991

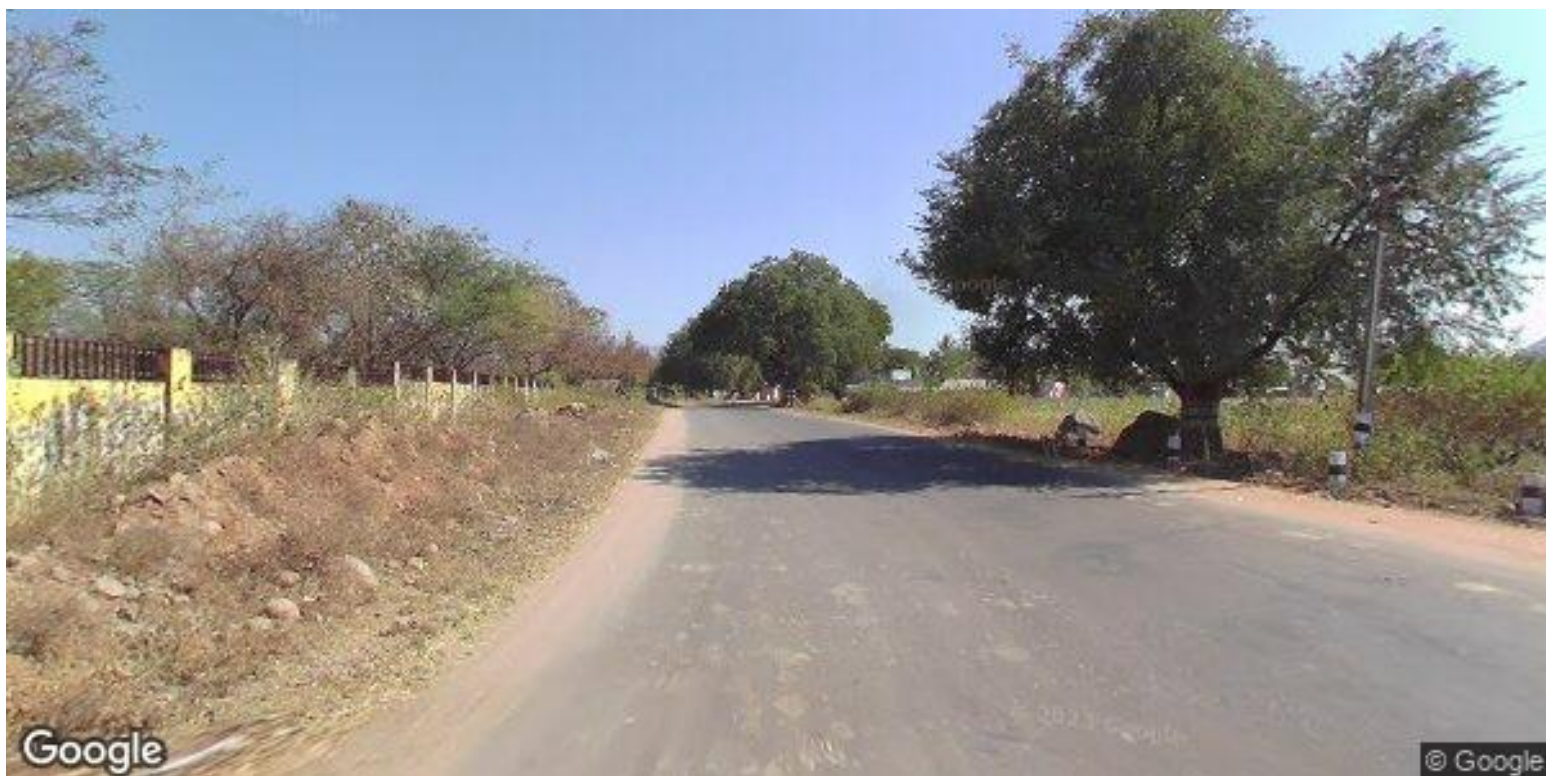
**Risk Type:** Turn

**Risk Level:** Medium

**Speed Limit:** 30 KM/Hr

**Coordinates:** 11.98876, 78.39941

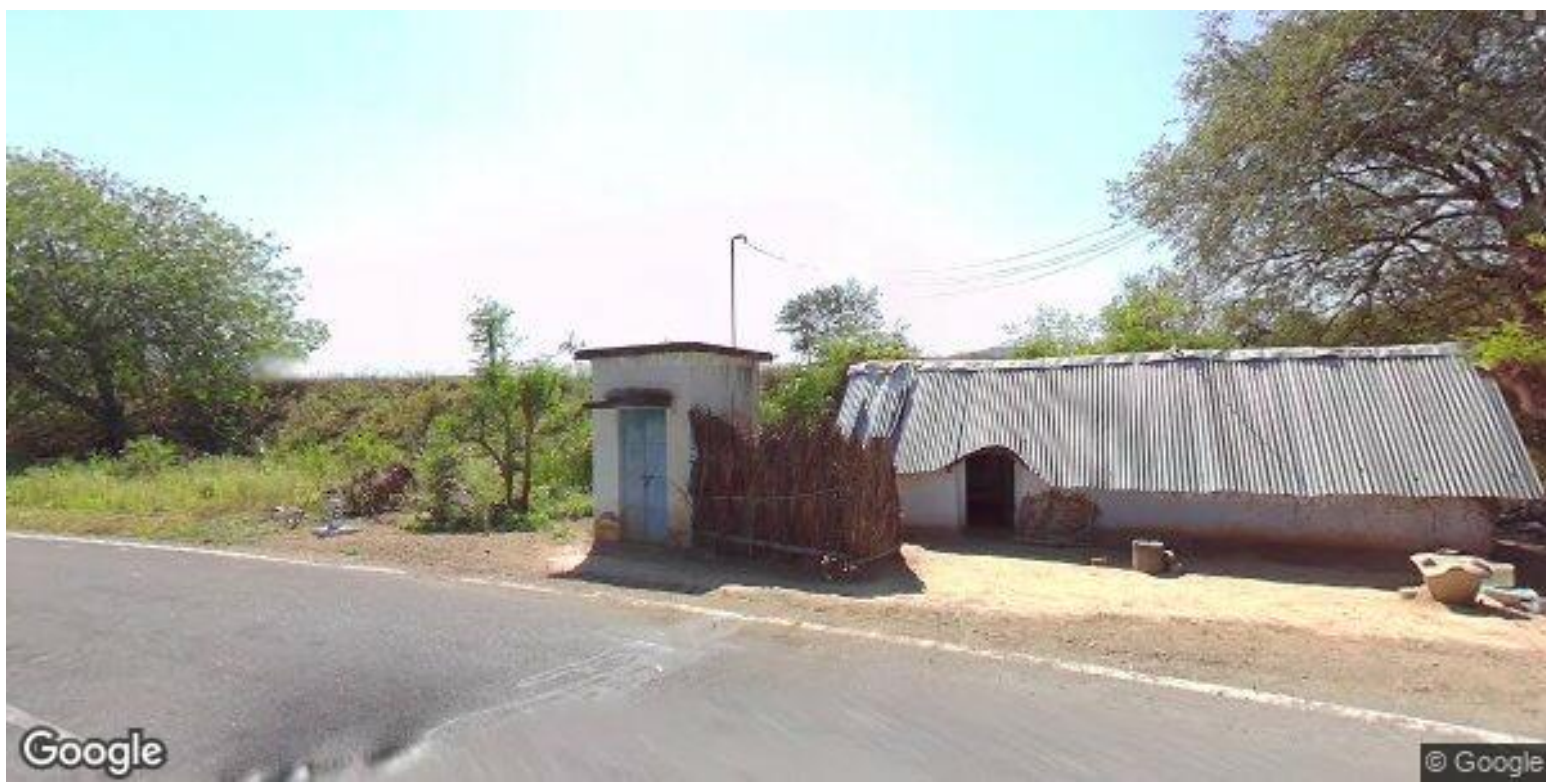
**Risk Type:** Turn  
**Risk Level:** High  
**Speed Limit:** 15 KM/Hr  
**Coordinates:** 12.01020, 78.39698

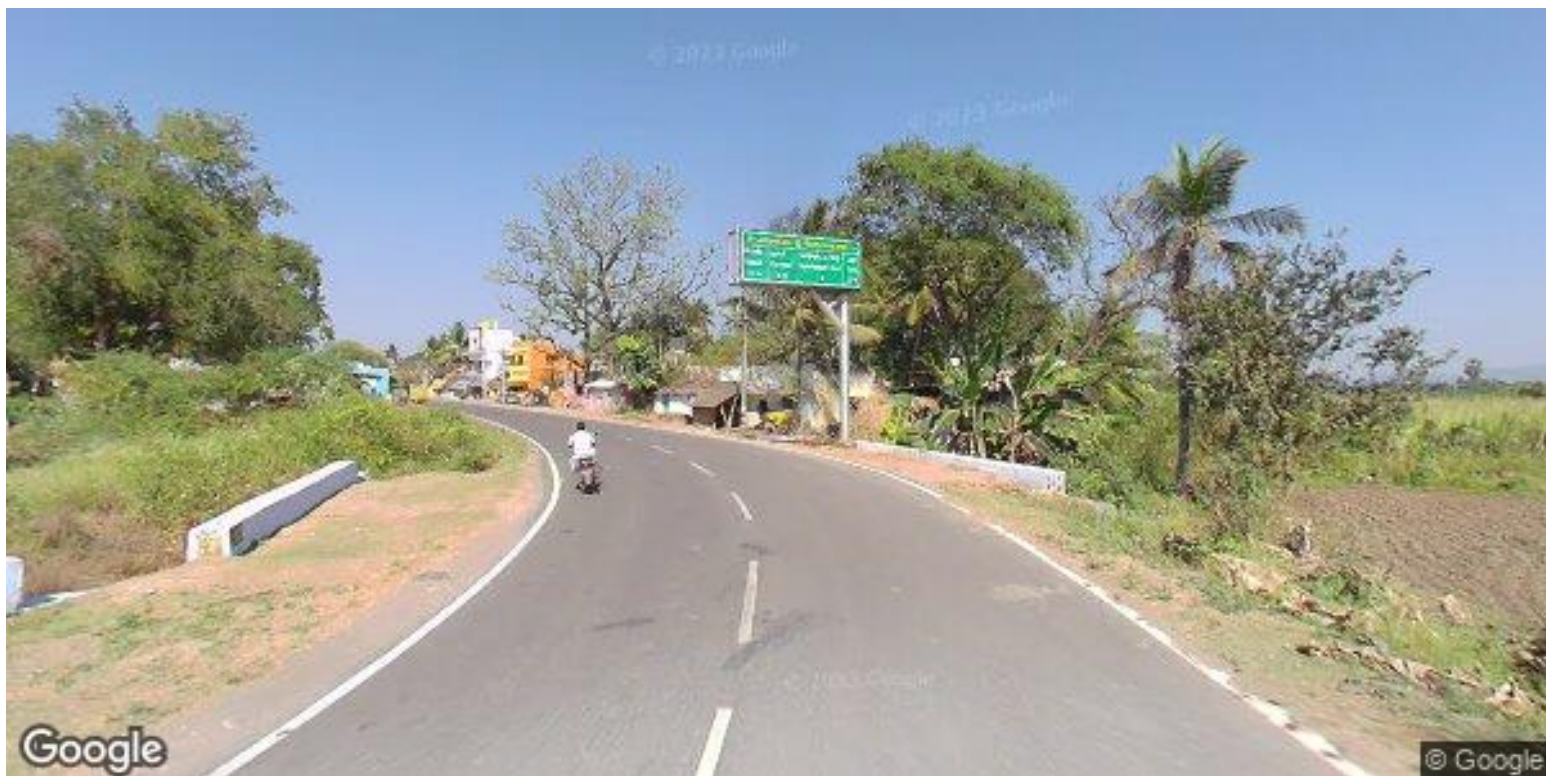
**Risk Type:** Turn  
**Risk Level:** Medium  
**Speed Limit:** 30 KM/Hr  
**Coordinates:** 12.01049, 78.39755

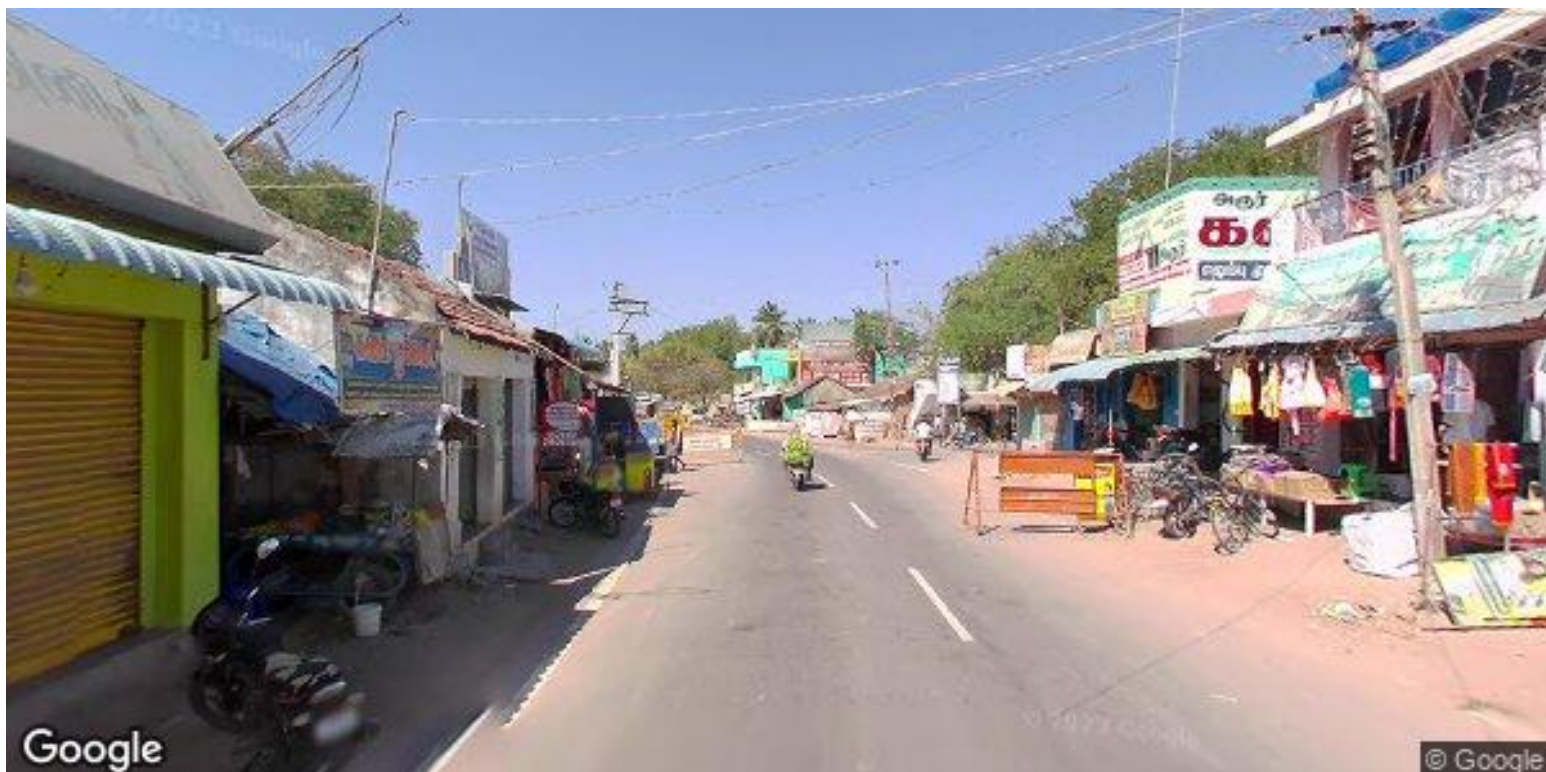
**Risk Type:** Turn  
**Risk Level:** Medium  
**Speed Limit:** 30 KM/Hr  
**Coordinates:** 12.01222, 78.39878

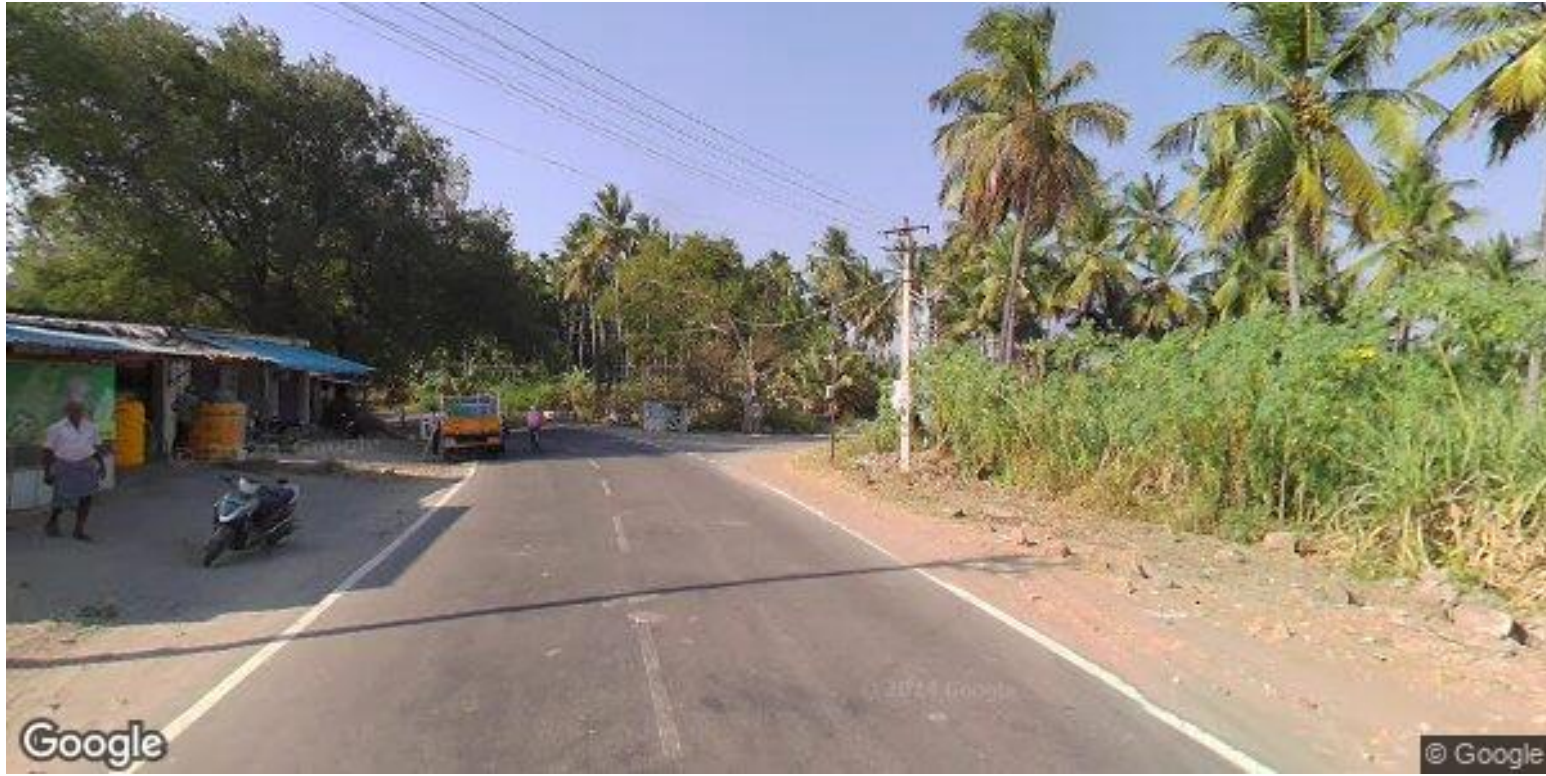
**Risk Type:** Turn  
**Risk Level:** Medium  
**Speed Limit:** 30 KM/Hr  
**Coordinates:** 12.01366, 78.39888

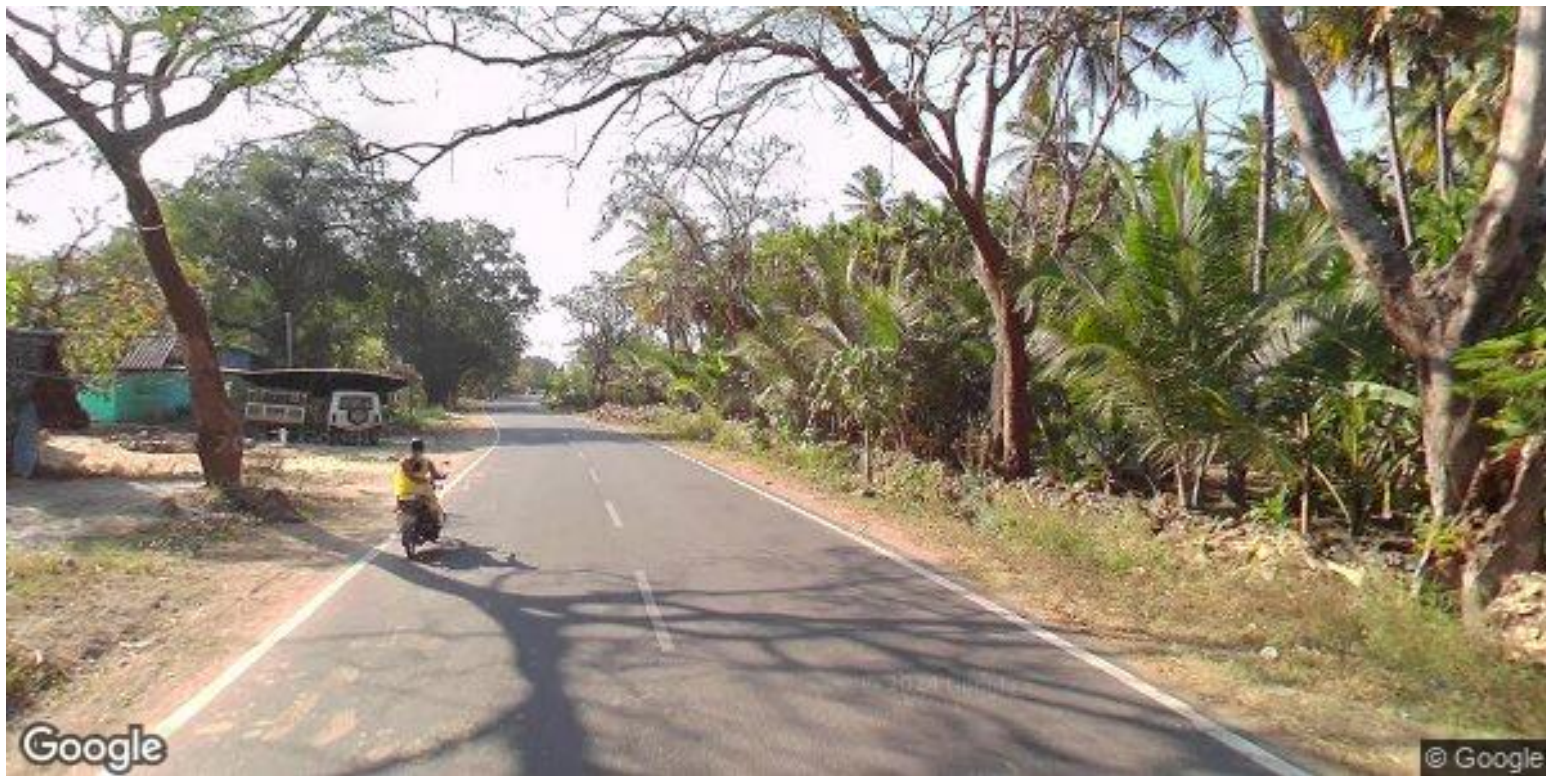
**Risk Type:** Turn  
**Risk Level:** Medium  
**Speed Limit:** 30 KM/Hr  
**Coordinates:** 12.01431, 78.39858
