## JOURNEY RISK MANAGEMENT (JRM) STUDY

### Salem Terminal to SRI SANKARA FUELS

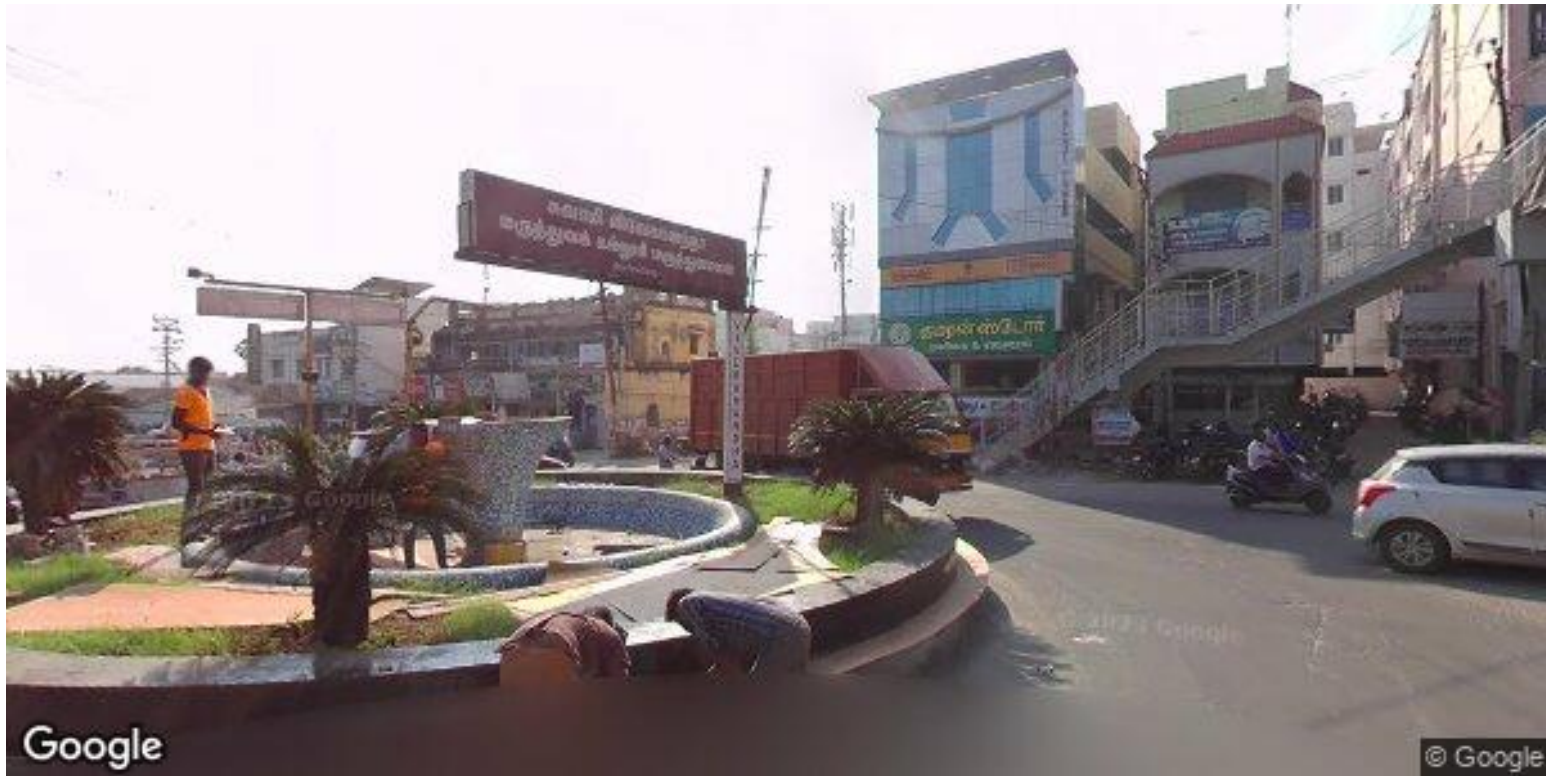
**Coordinates:** 11.38395, 77.89480

**Risk Type:** Roundabout

**Risk Level:** High

**Speed Limit:** 15 KM/Hr

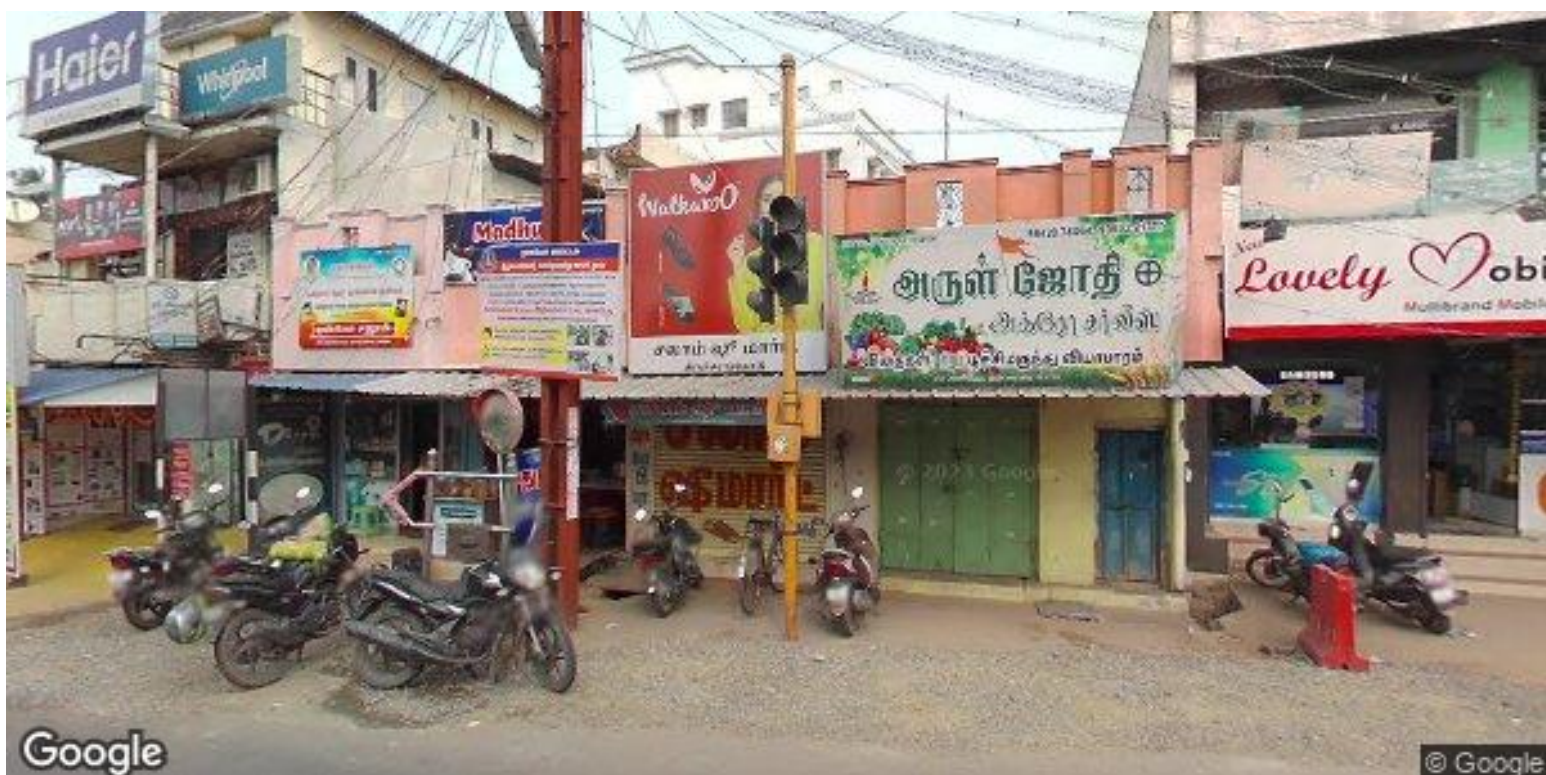
**Coordinates:** 11.37850, 77.89453

**Risk Type:** Turn

**Risk Level:** High

**Speed Limit:** 15 KM/Hr

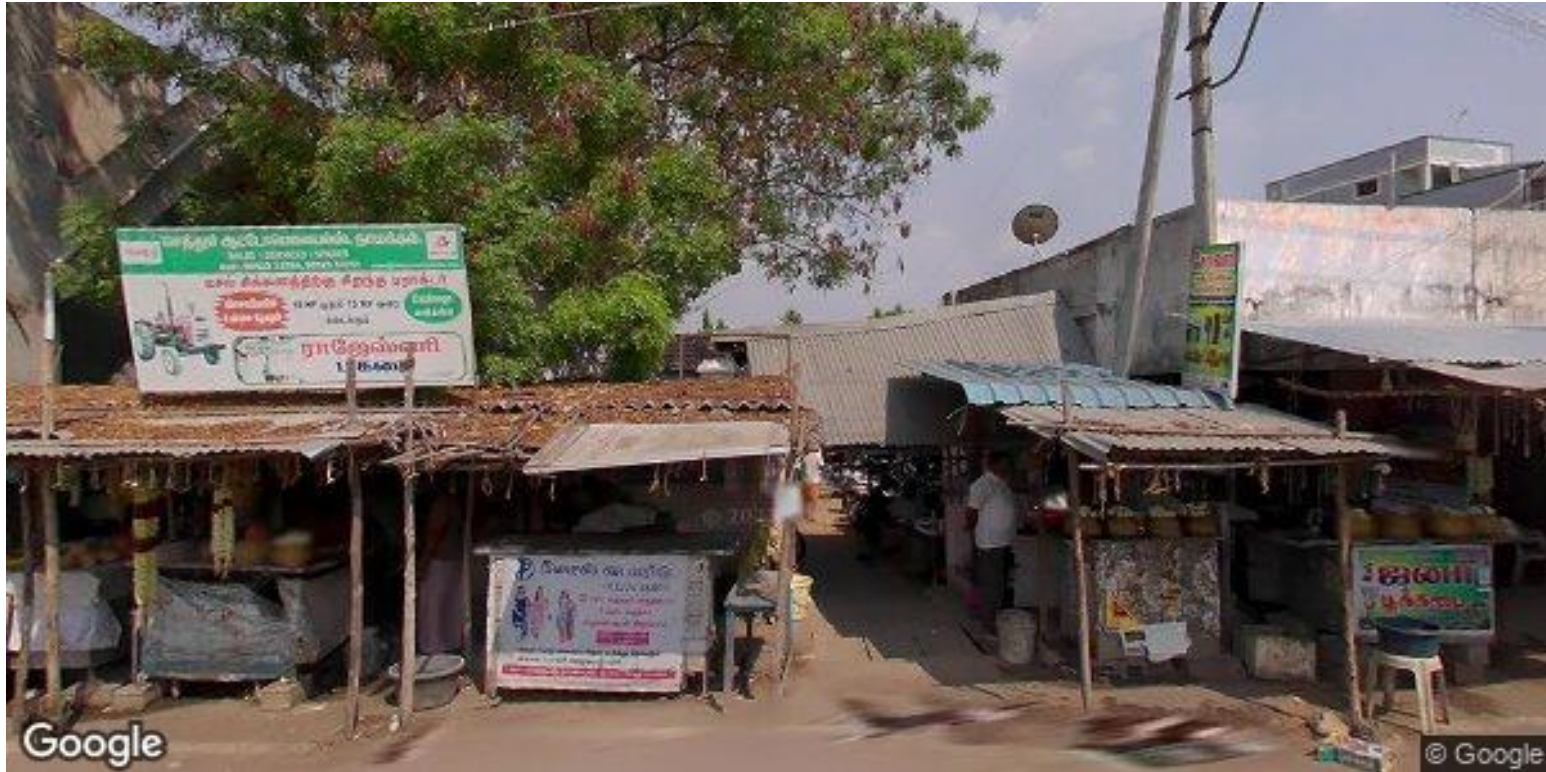
**Coordinates:** 11.15573, 78.02176

**Risk Type:** Turn

**Risk Level:** High

**Speed Limit:** 15 KM/Hr

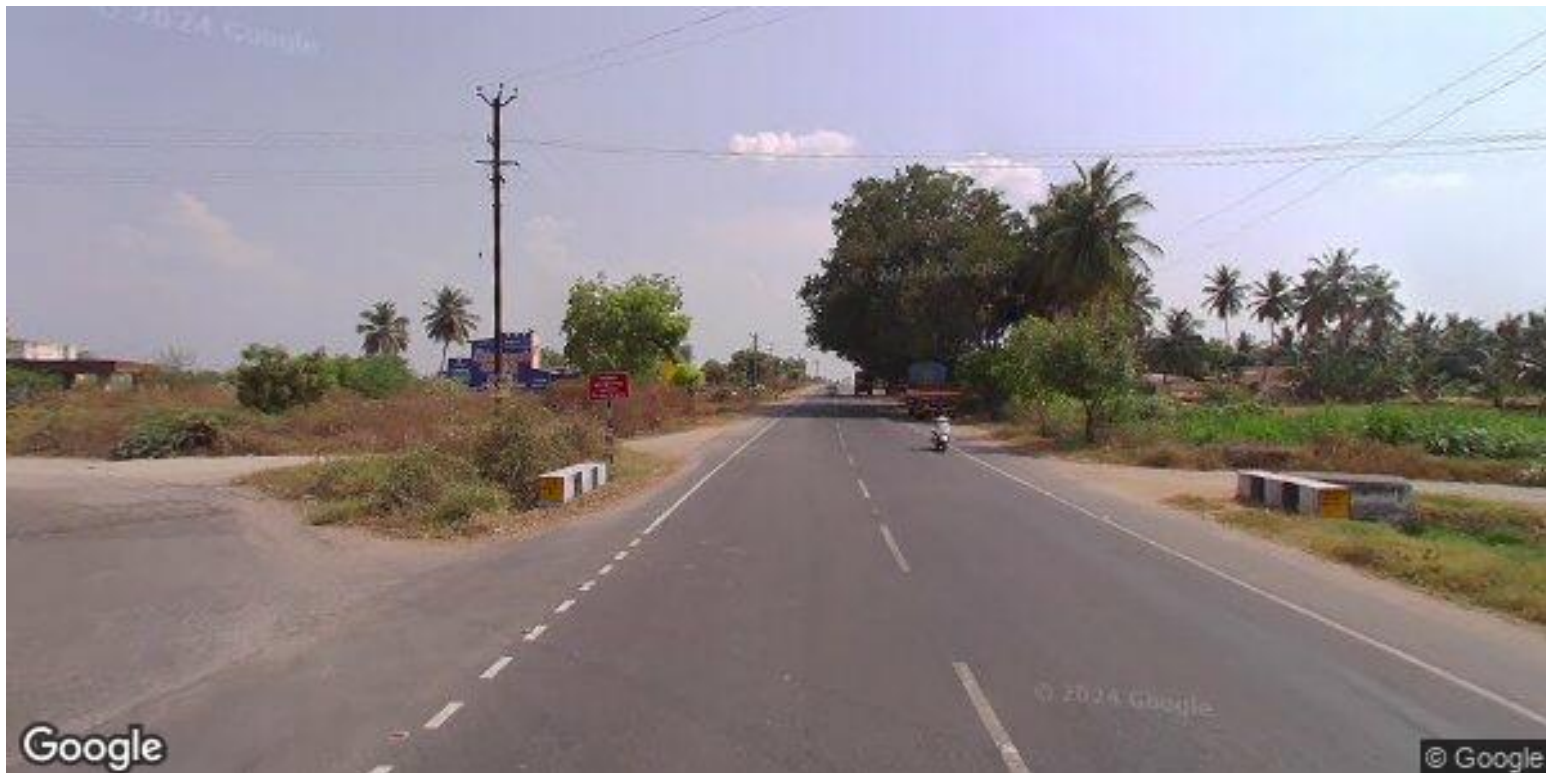
**Coordinates:** 11.14545, 78.02208

**Risk Type:** Turn

**Risk Level:** High

**Speed Limit:** 15 KM/Hr

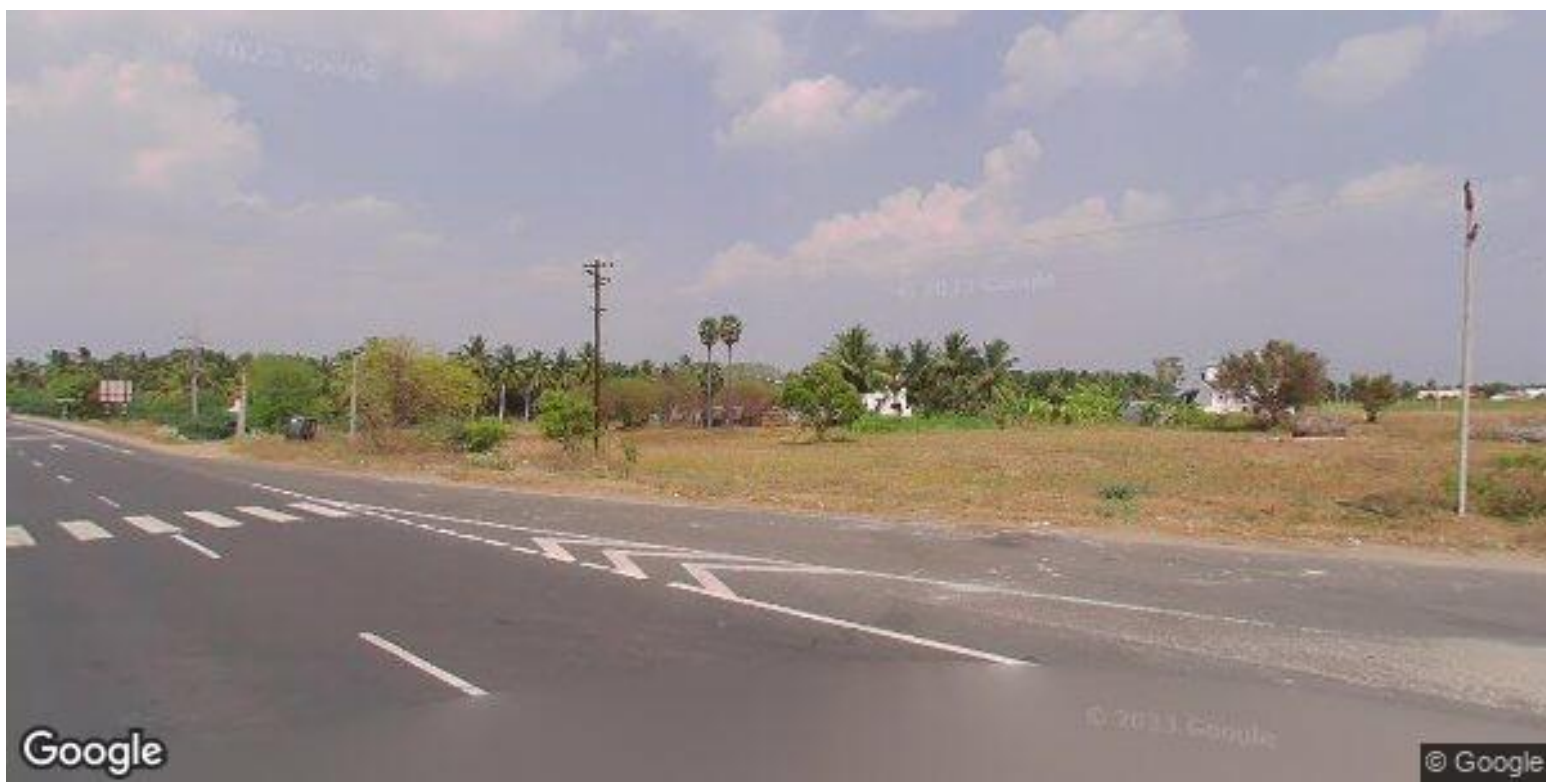
**Coordinates:** 11.14480, 78.02291

**Risk Type:** Turn

**Risk Level:** High

**Speed Limit:** 15 KM/Hr

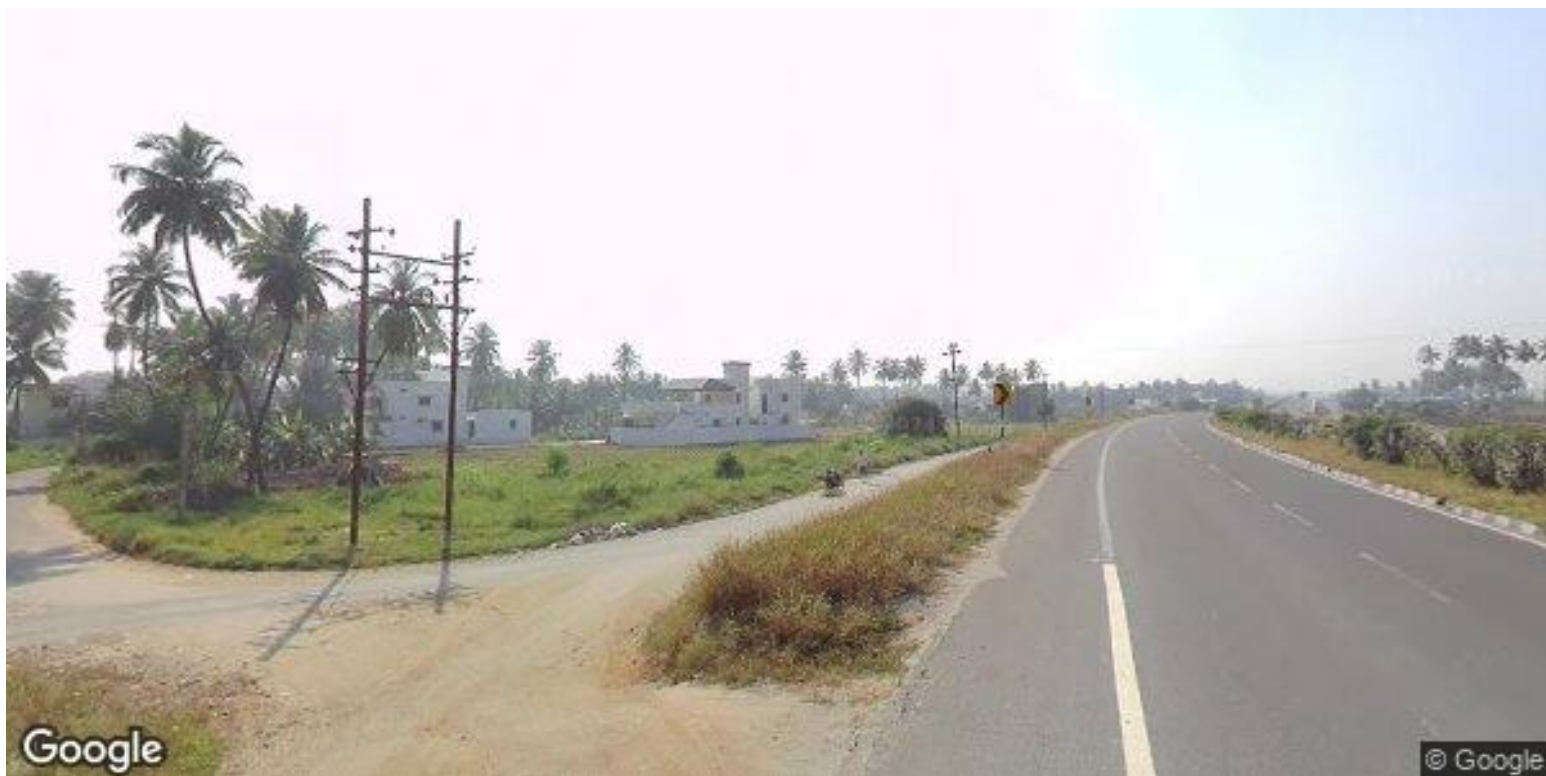
**Coordinates:** 11.11887, 78.01758

**Risk Type:** Turn

**Risk Level:** High

**Speed Limit:** 15 KM/Hr

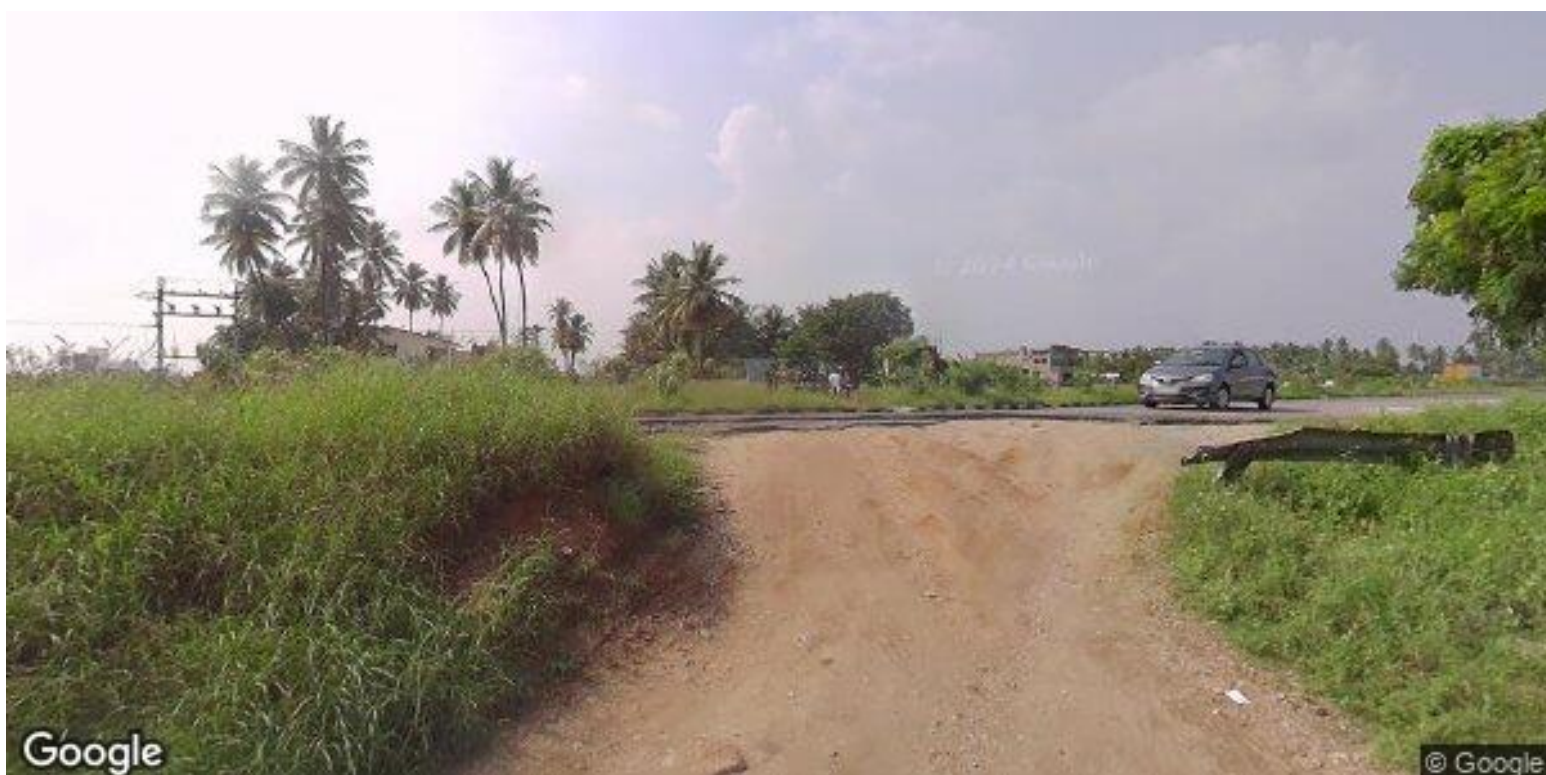
**Risk Type:** Turn  
**Risk Level:** High  
**Speed Limit:** 15 KM/Hr  
**Coordinates:** 11.11883, 78.01771

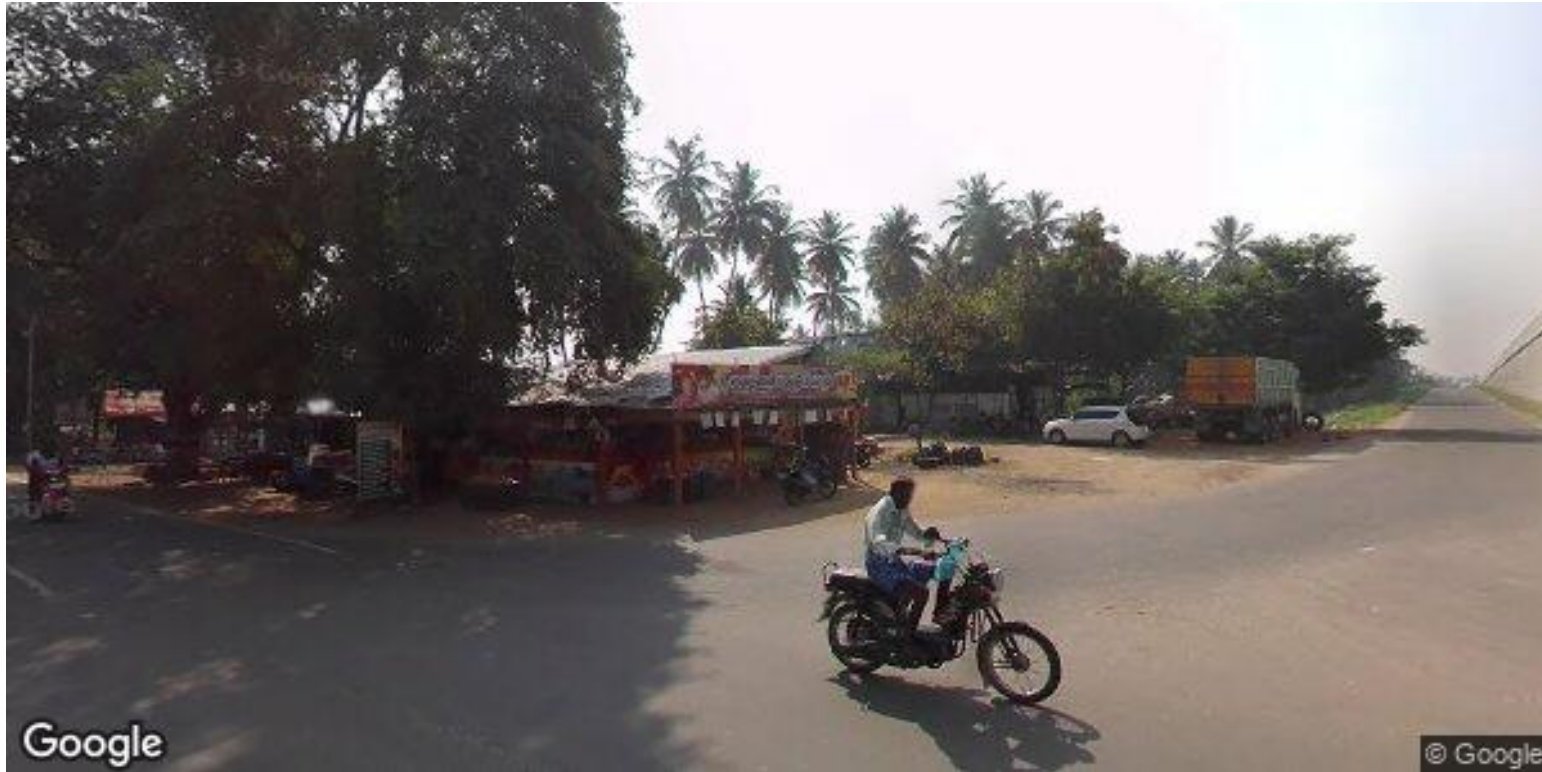
**Risk Type:** Blind Spot  
**Risk Level:** Blind Spot  
**Speed Limit:** 10 KM/Hr  
**Coordinates:** 11.11397, 78.01722

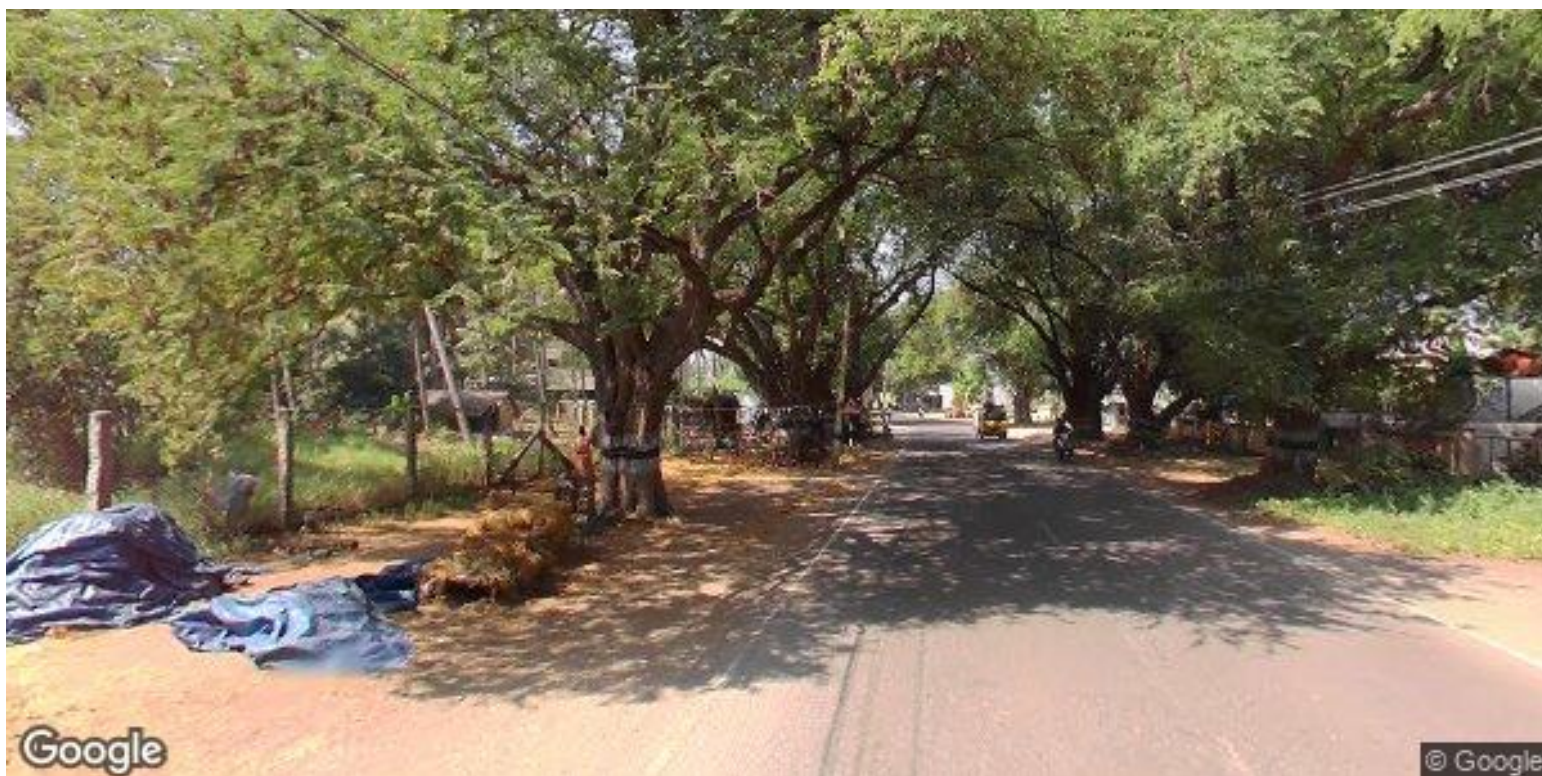
**Risk Type:** Blind Spot  
**Risk Level:** Blind Spot  
**Speed Limit:** 10 KM/Hr  
**Coordinates:** 11.11362, 78.02131

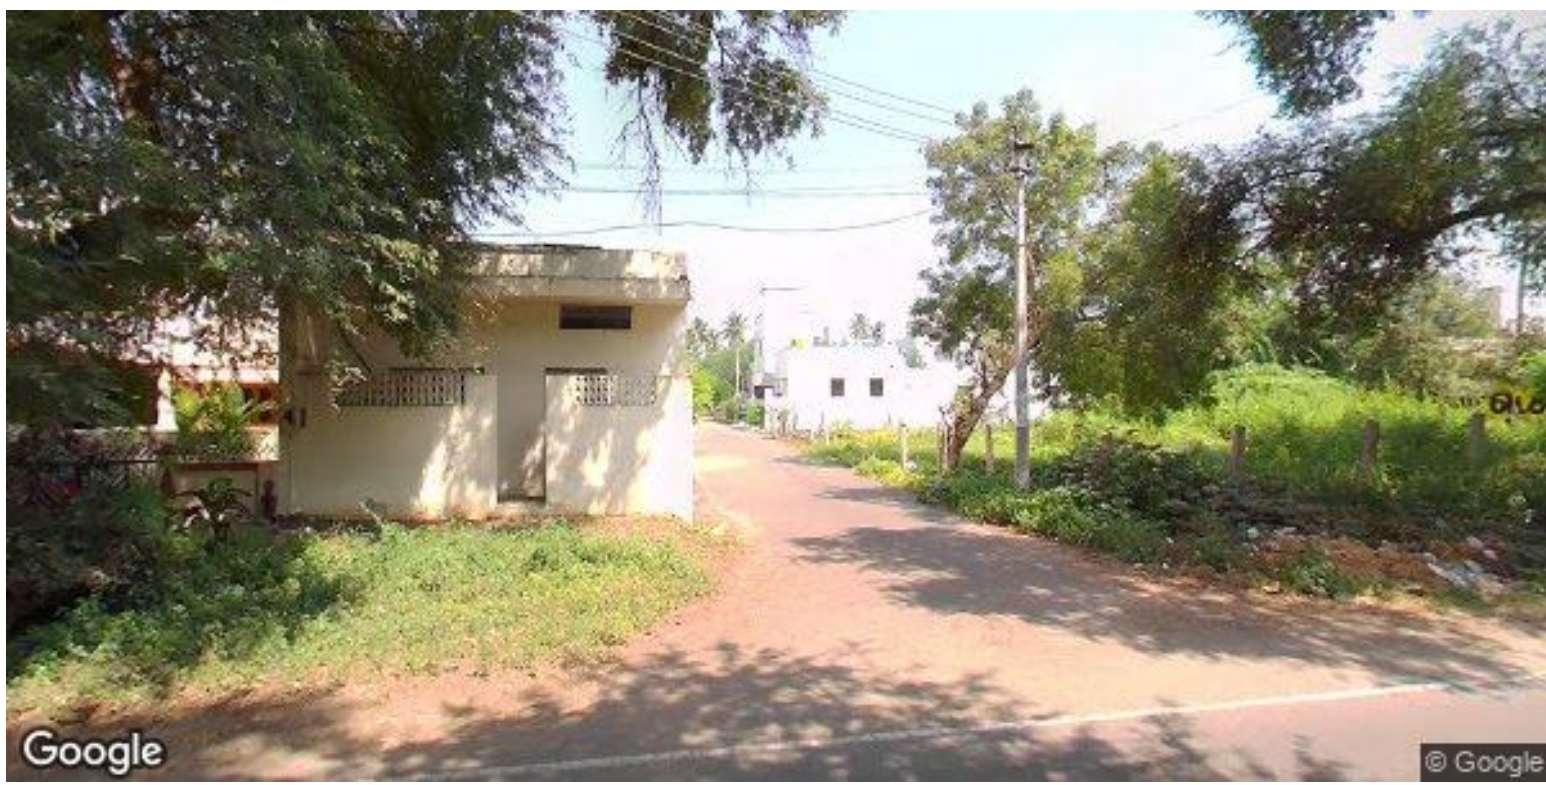
**Coordinates:** 11.11405, 78.02142

**Risk Type:** Blind Spot

**Risk Level:** Blind Spot

**Speed Limit:** 10 KM/Hr
