# IndianOil

## JOURNEY RISK MANAGEMENT (JRM) STUDY

### Salem Terminal TO KULUMAI AGENCIES

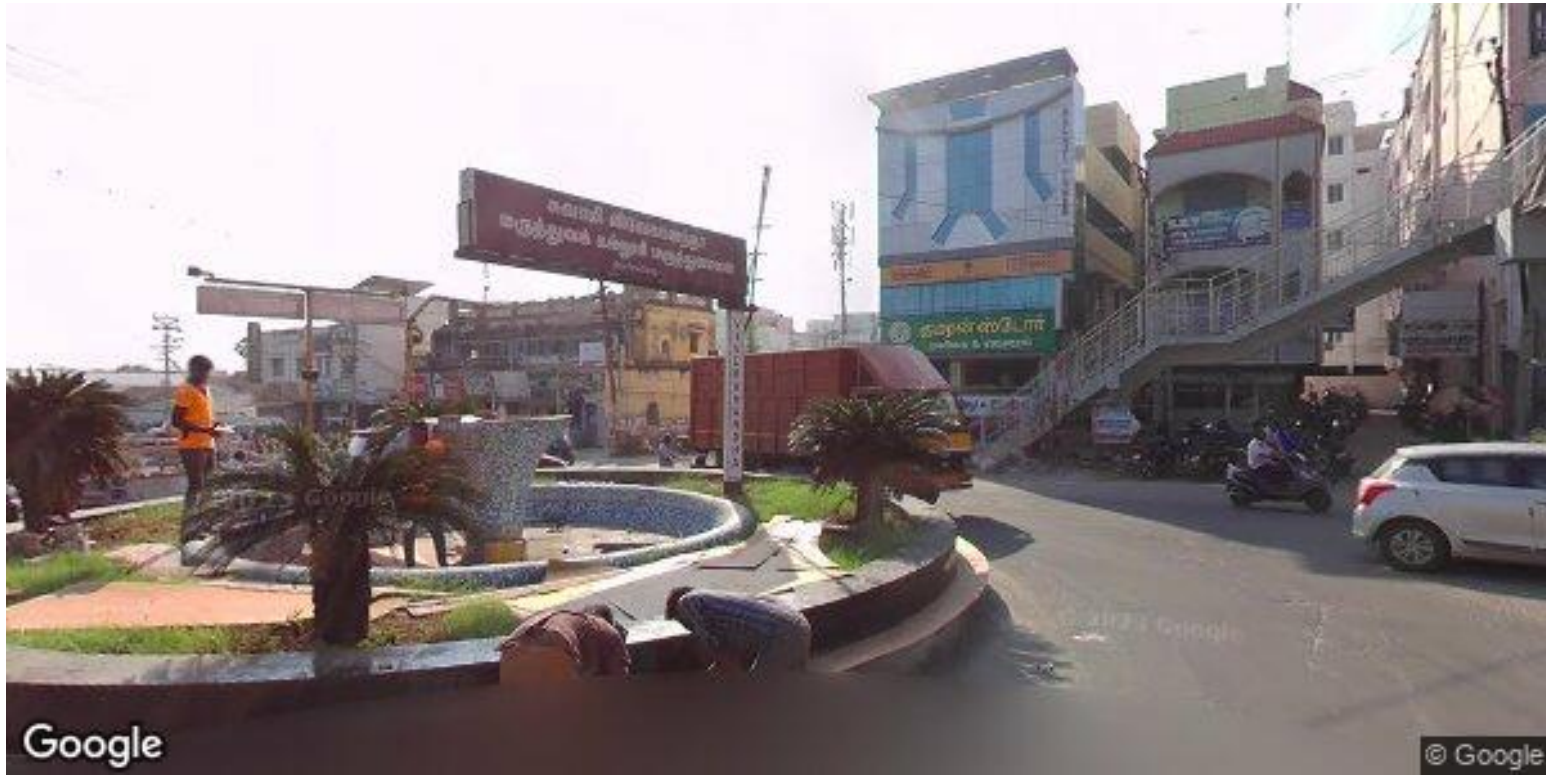
**Coordinates:** 11.38395, 77.89480

**Risk Type:** Roundabout

**Risk Level:** High

**Speed Limit:** 15 KM/Hr

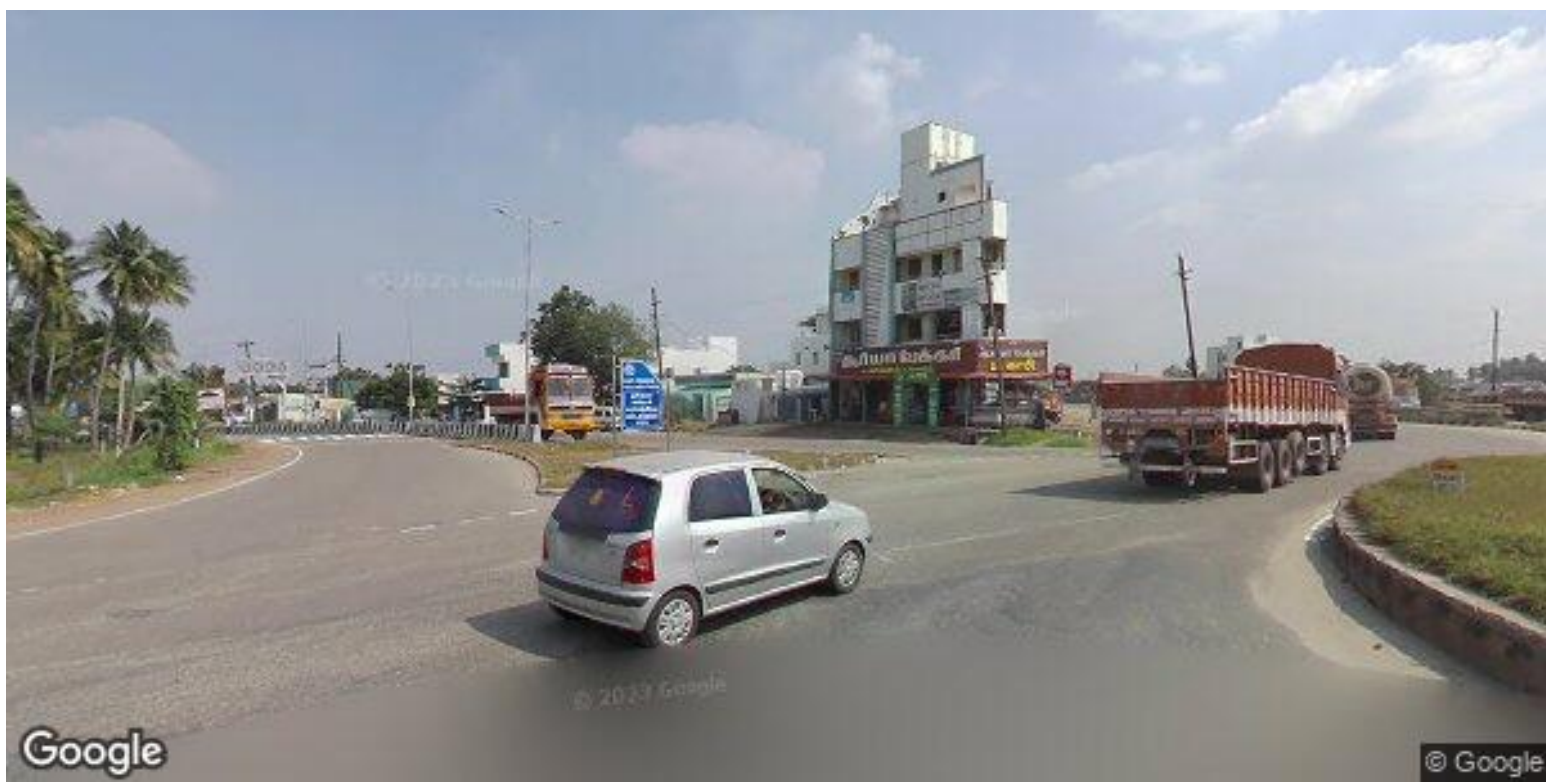
**Coordinates:** 10.92958, 78.05452

**Risk Type:** Roundabout

**Risk Level:** High

**Speed Limit:** 15 KM/Hr

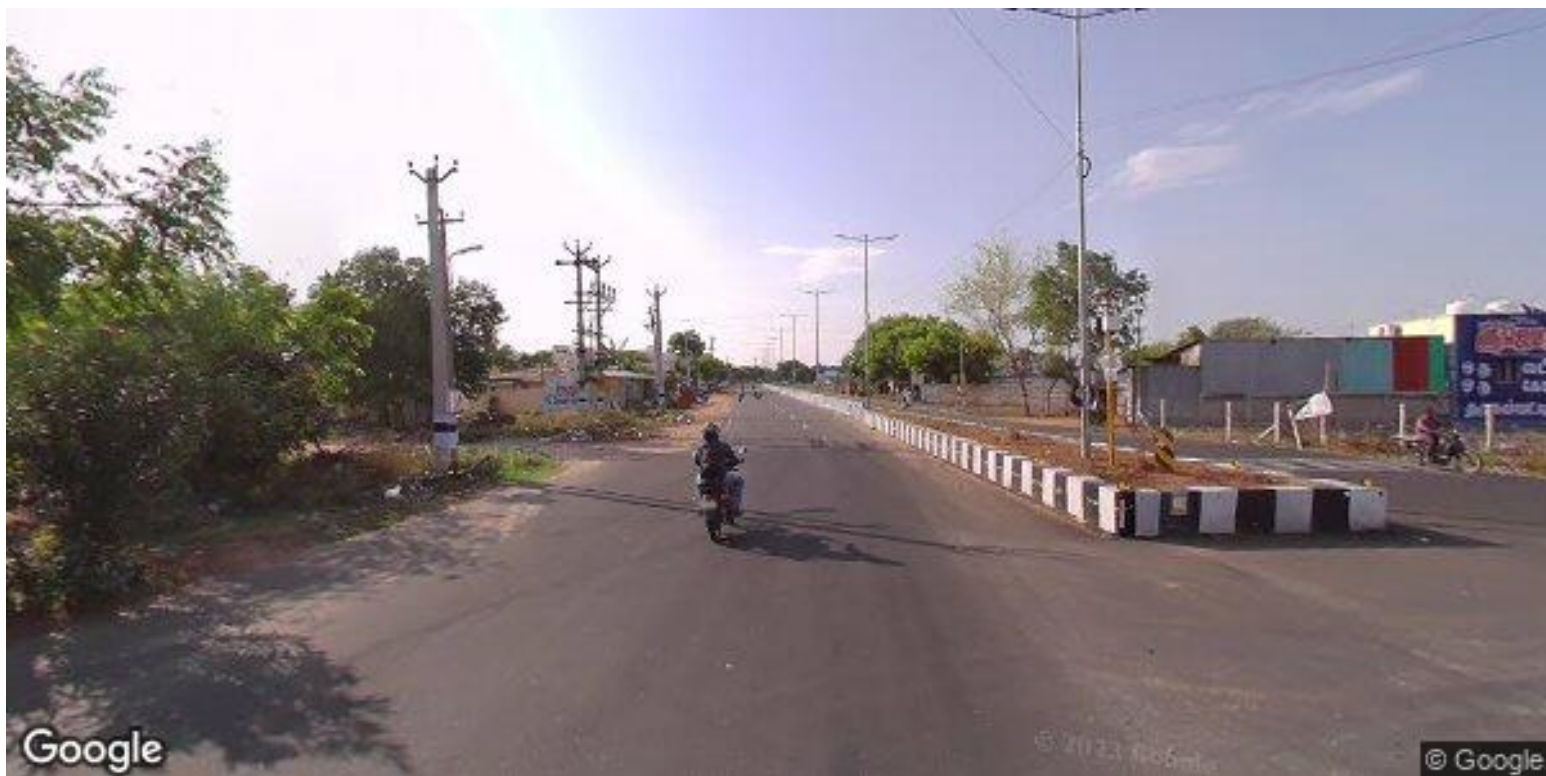
**Coordinates:** 10.9110477, 78.09713769999999

**Risk Type:** U-Turn

**Risk Level:** High

**Speed Limit:** 10 KM/Hr

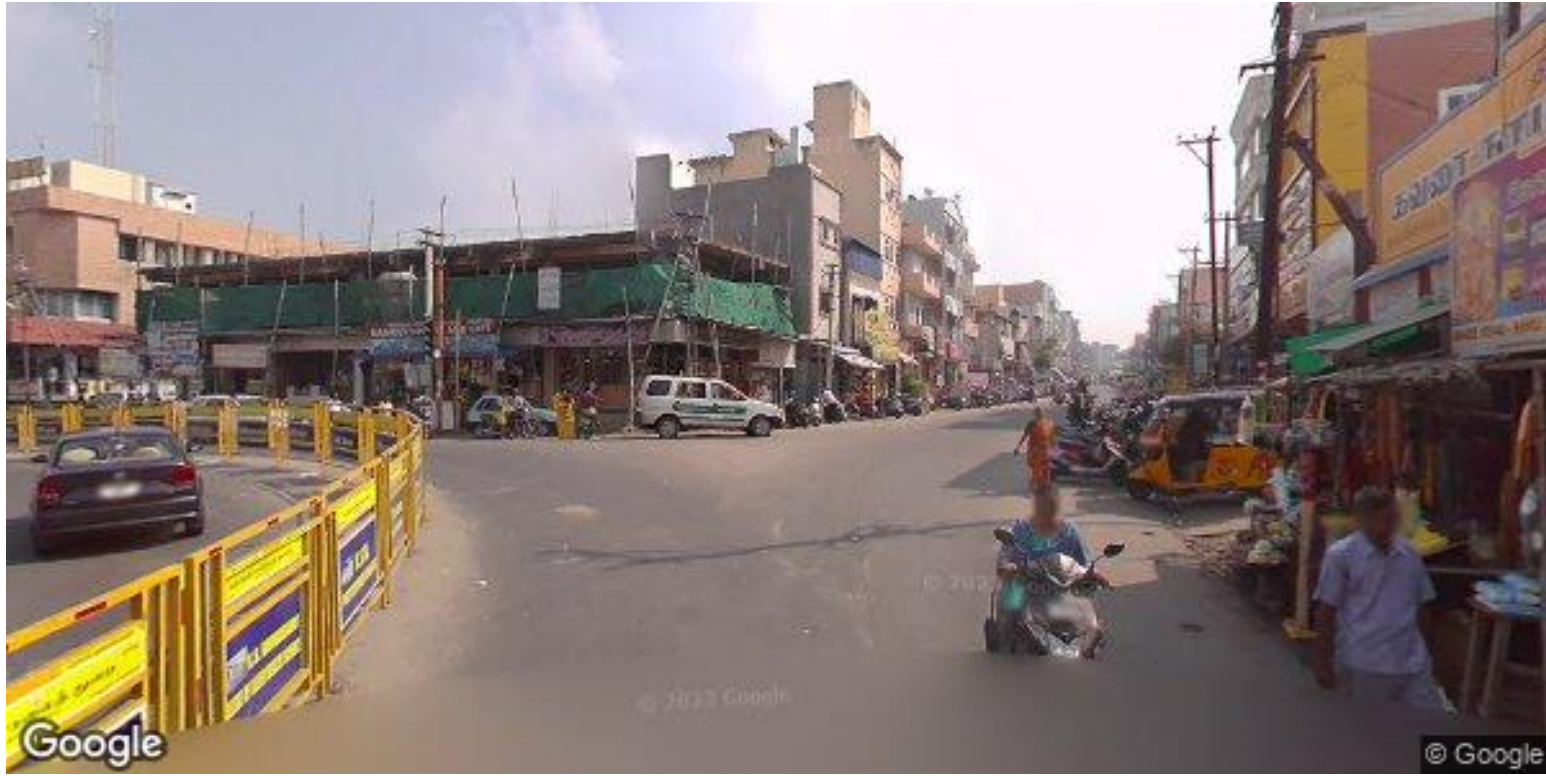
**Coordinates:** 11.37862, 77.89488

**Risk Type:** Turn

**Risk Level:** High

**Speed Limit:** 15 KM/Hr

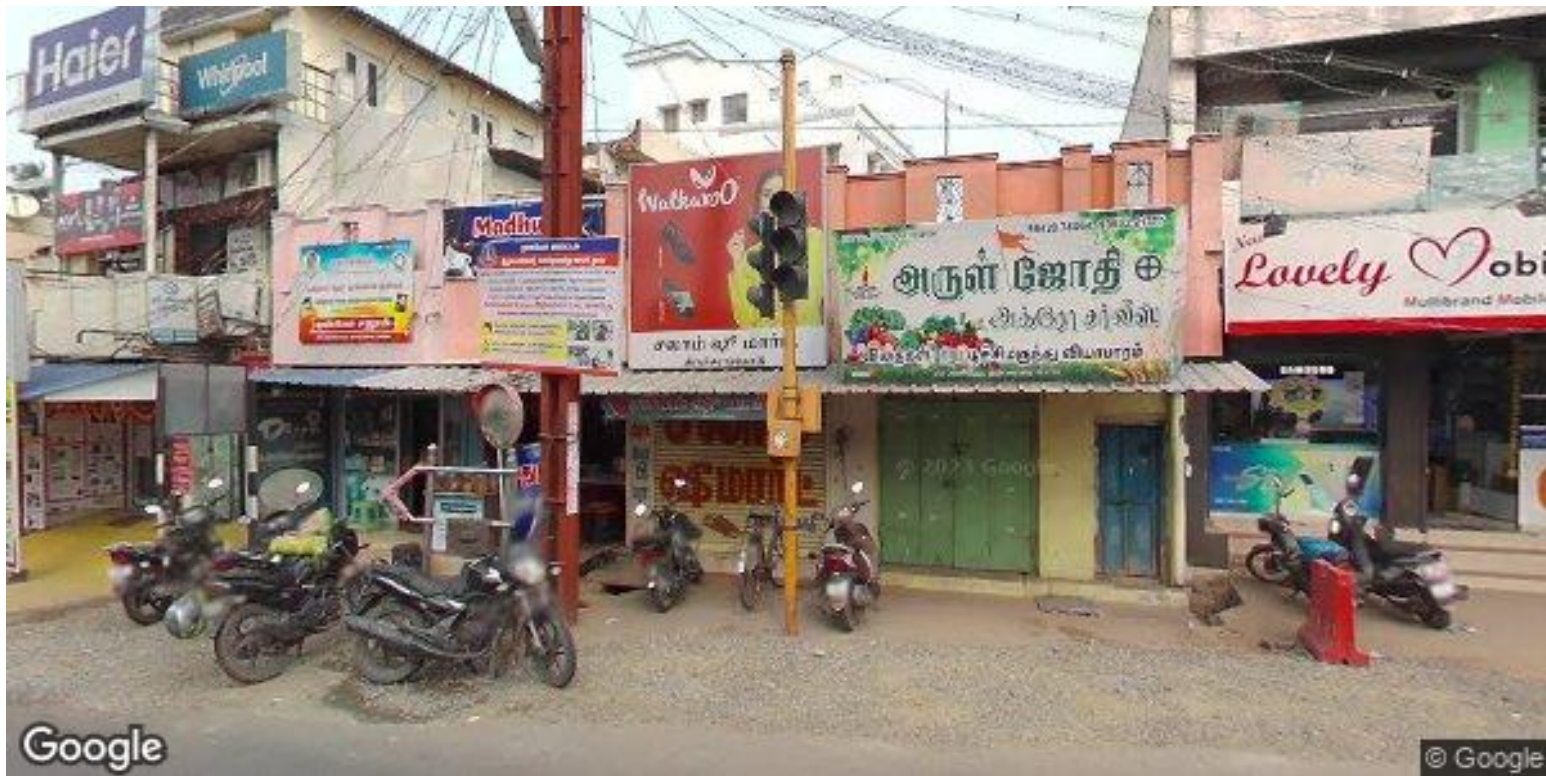
**Coordinates:** 11.37850, 77.89453

**Risk Type:** Turn

**Risk Level:** High

**Speed Limit:** 15 KM/Hr

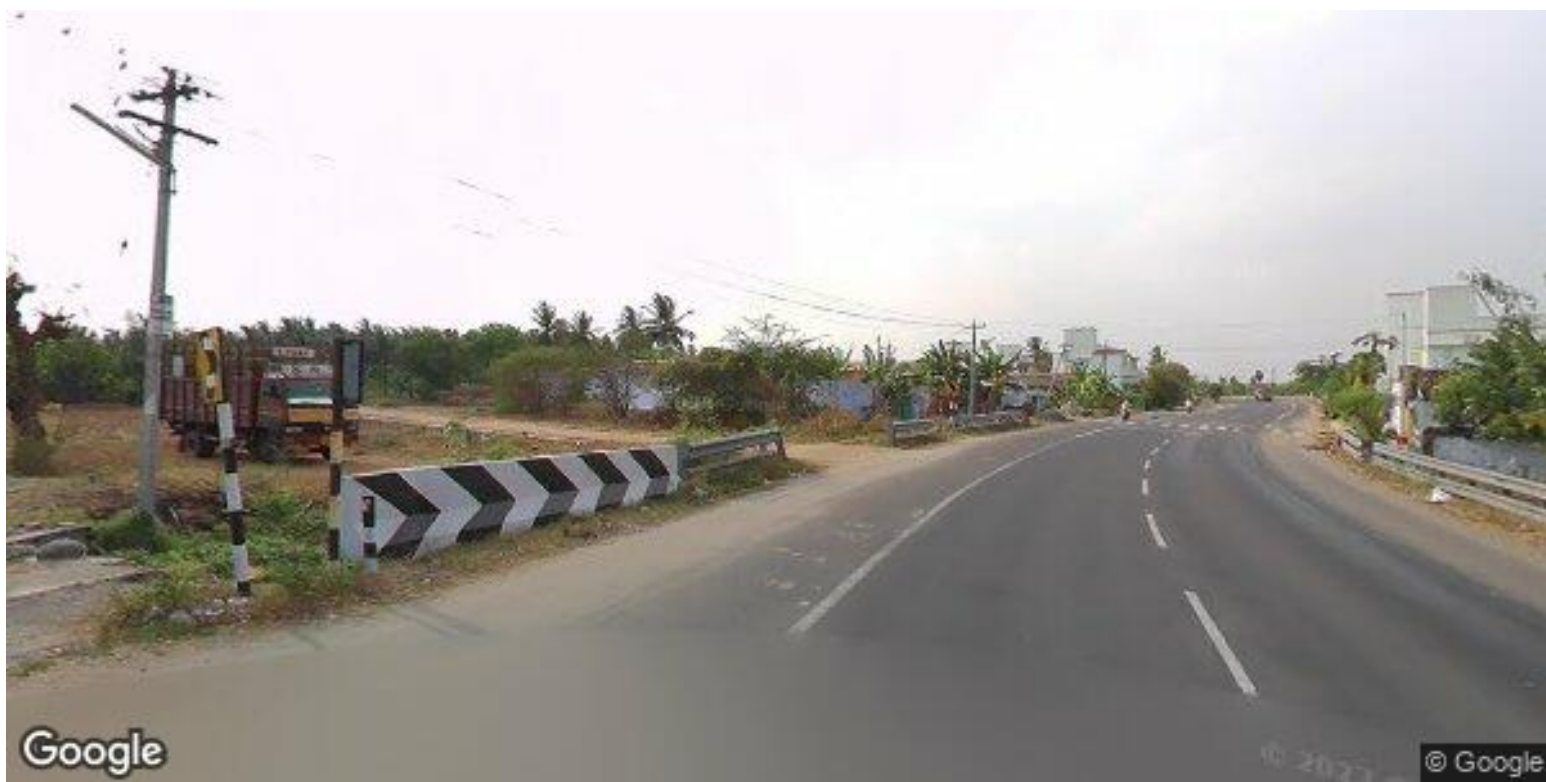
**Coordinates:** 11.16755, 78.01568

**Risk Type:** Turn

**Risk Level:** Medium

**Speed Limit:** 30 KM/Hr

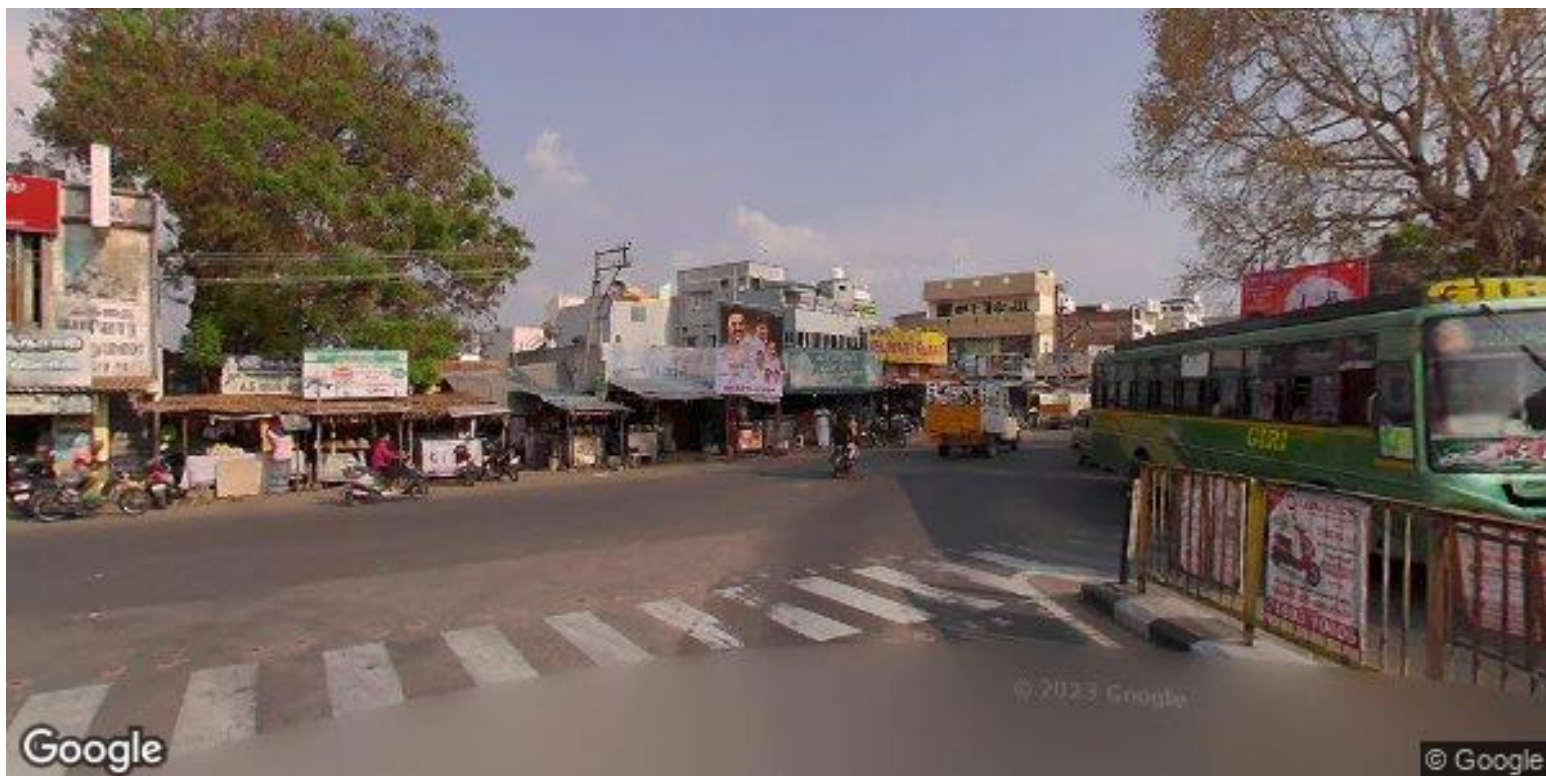
**Coordinates:** 11.15579, 78.02169

**Risk Type:** Turn

**Risk Level:** Medium

**Speed Limit:** 30 KM/Hr

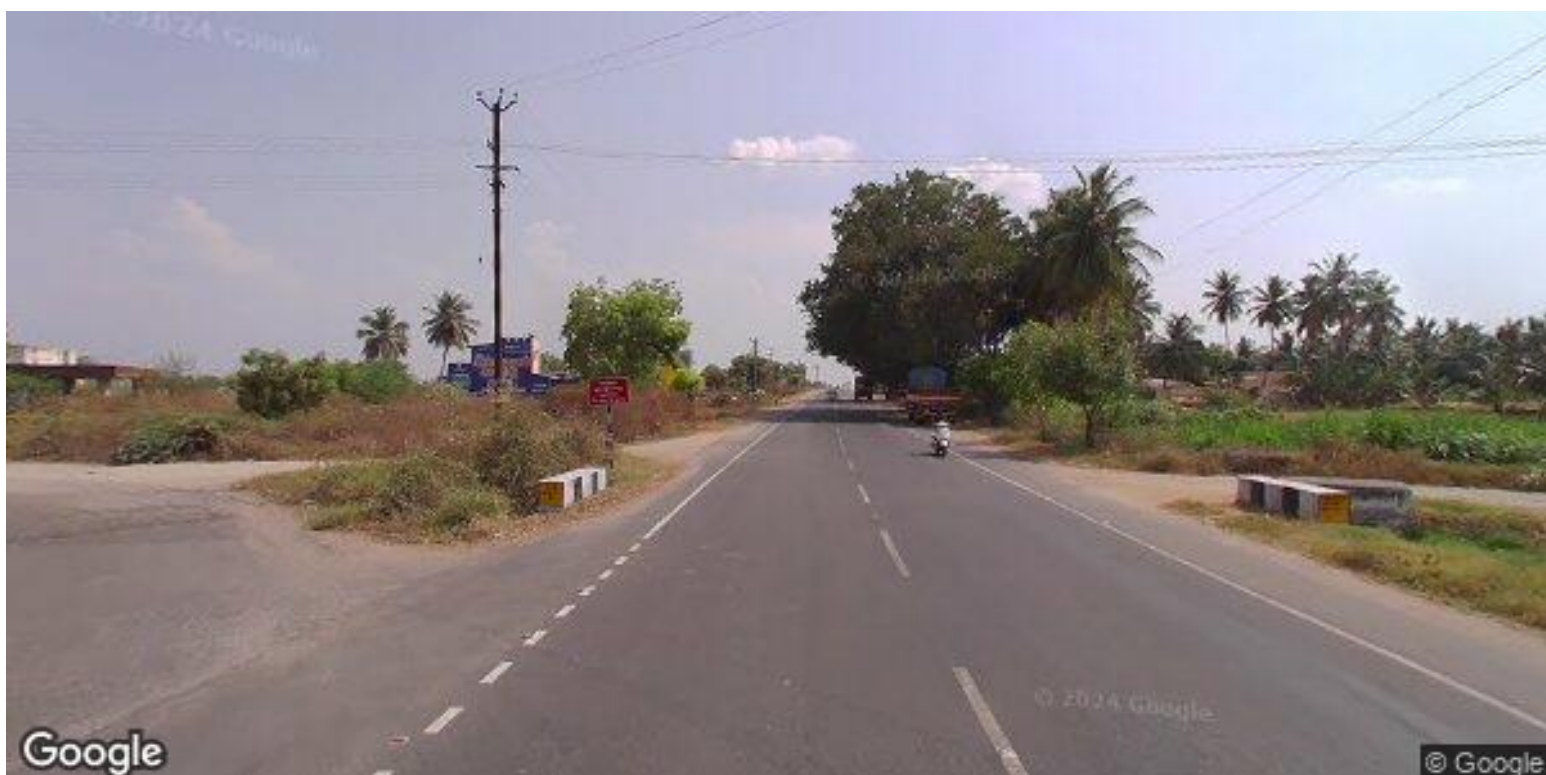
**Risk Type:** Turn  
**Risk Level:** High  
**Speed Limit:** 15 KM/Hr  
**Coordinates:** 11.14545, 78.02208

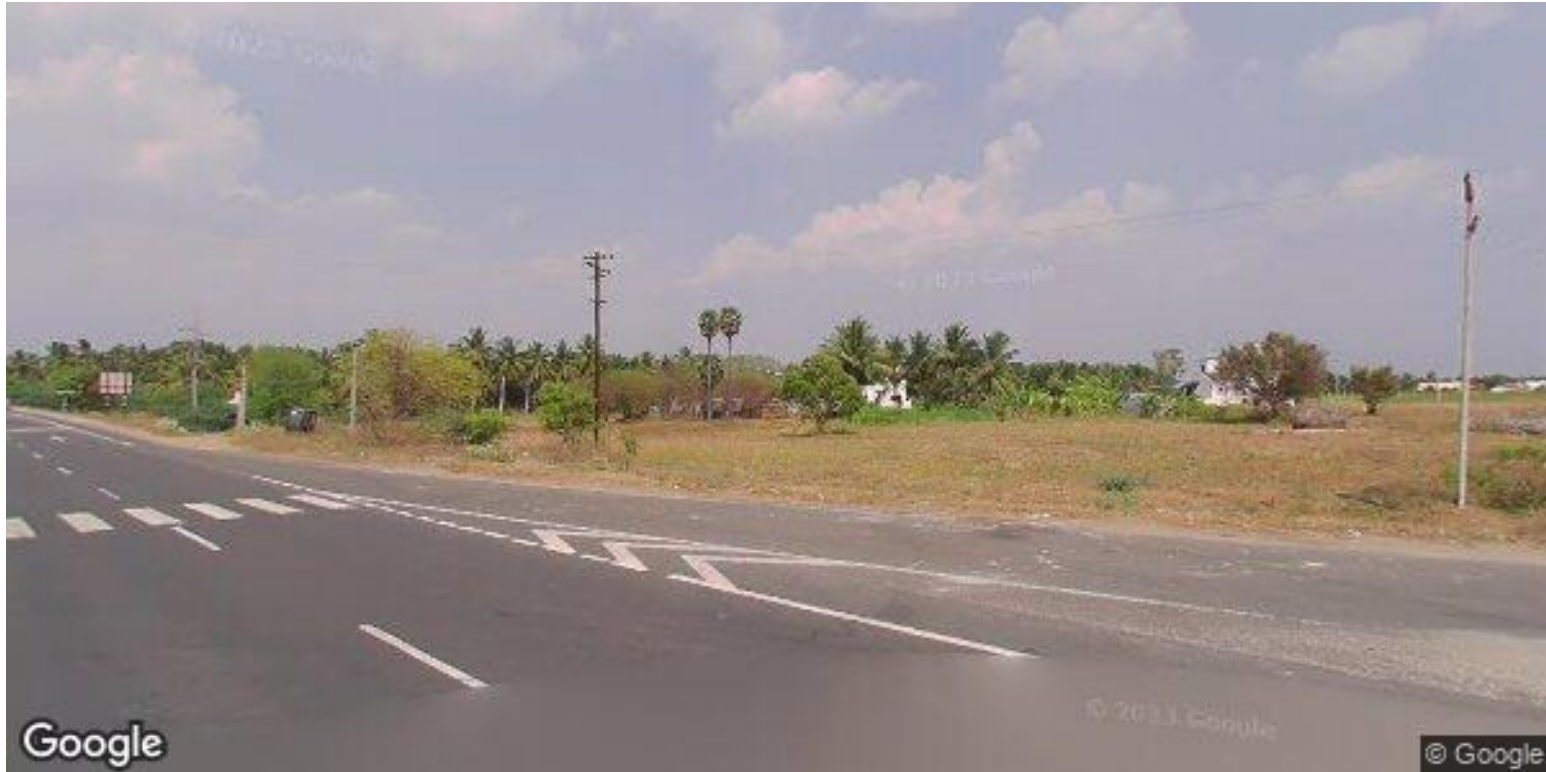
**Risk Type:** Turn  
**Risk Level:** High  
**Speed Limit:** 15 KM/Hr  
**Coordinates:** 11.14480, 78.02291

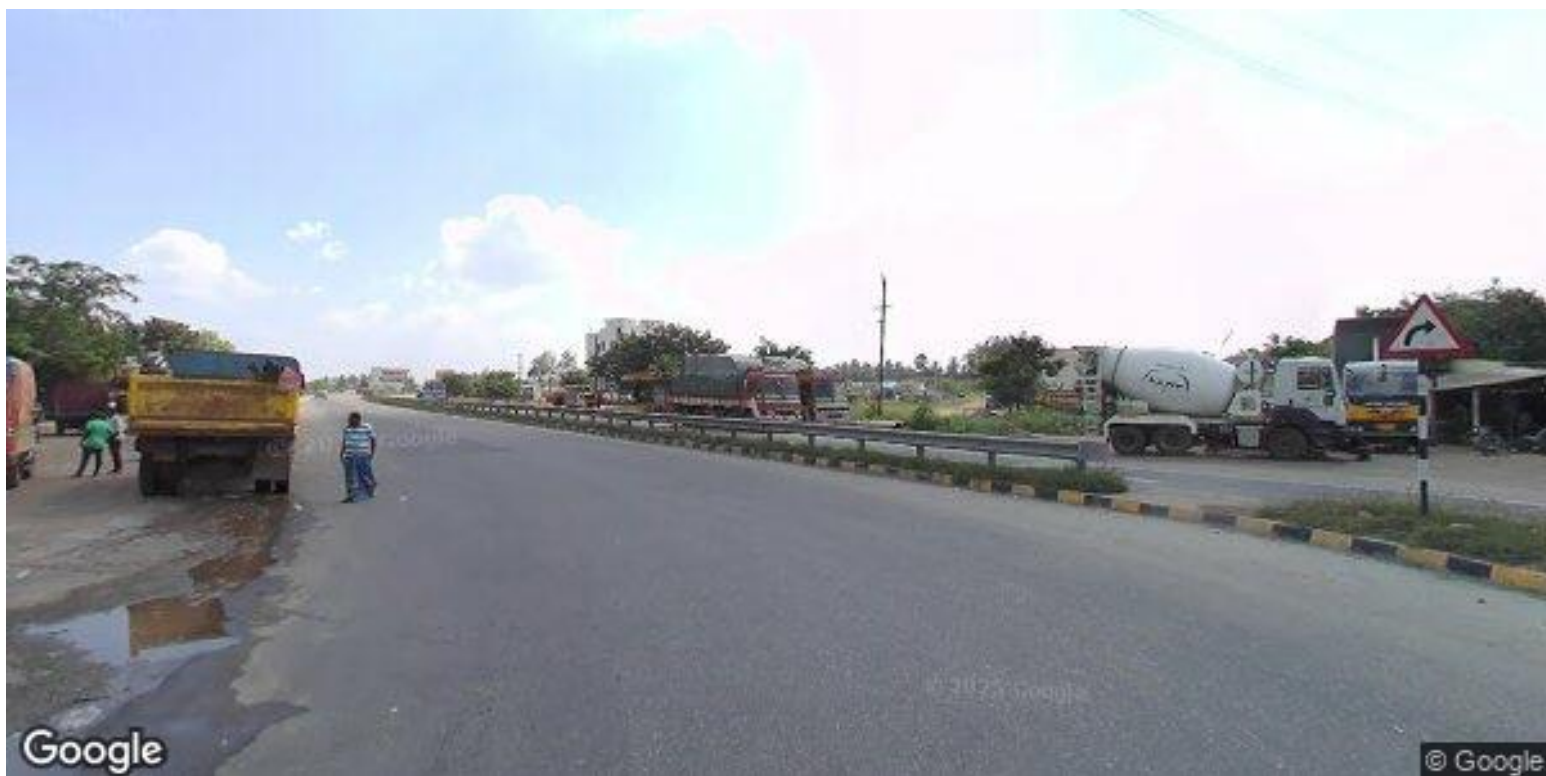
**Risk Type:** Turn  
**Risk Level:** Medium  
**Speed Limit:** 30 KM/Hr  
**Coordinates:** 10.92922, 78.05481

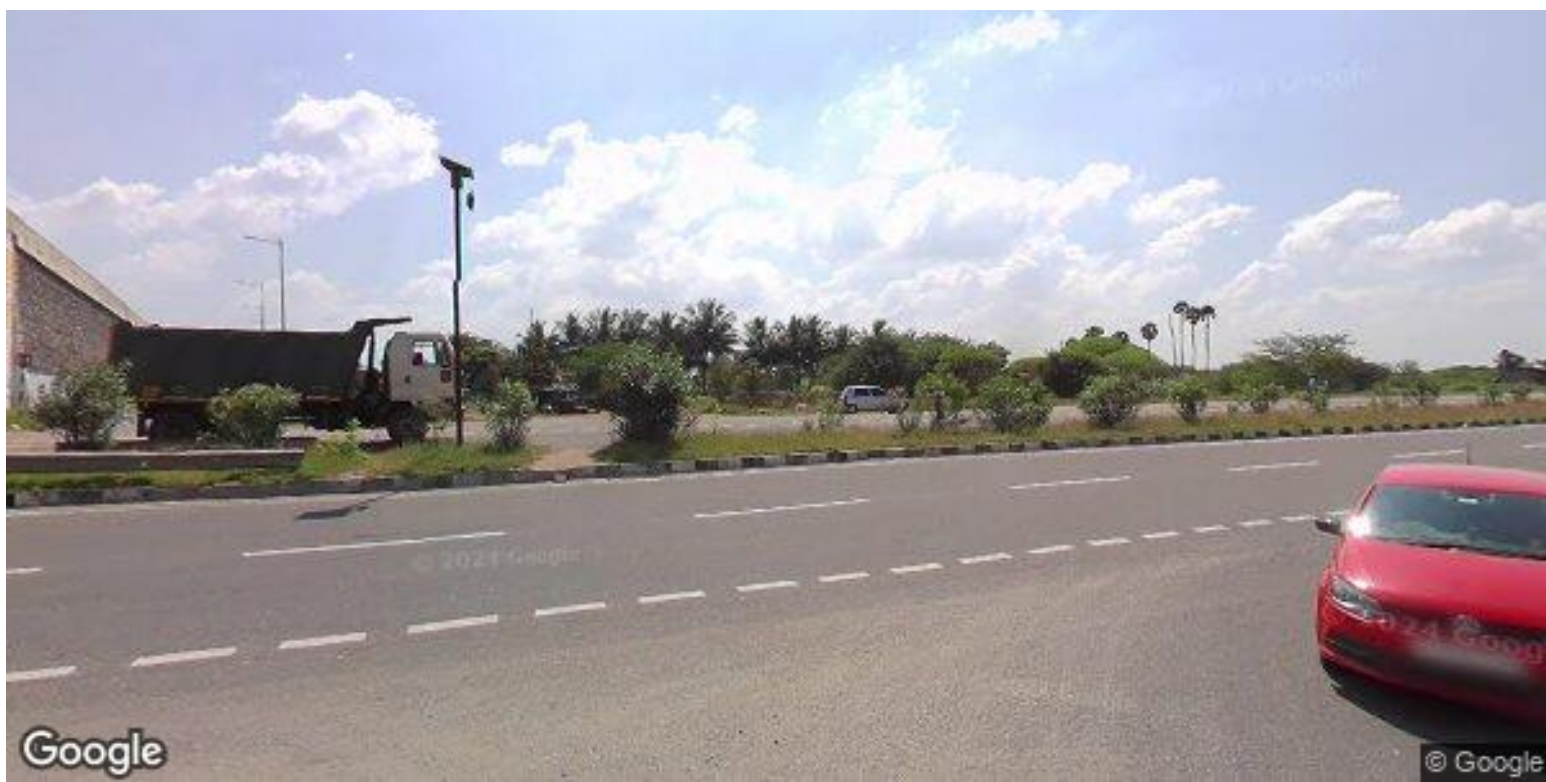
**Coordinates:** 10.90784, 78.09916

**Risk Type:** Turn

**Risk Level:** High

**Speed Limit:** 15 KM/Hr

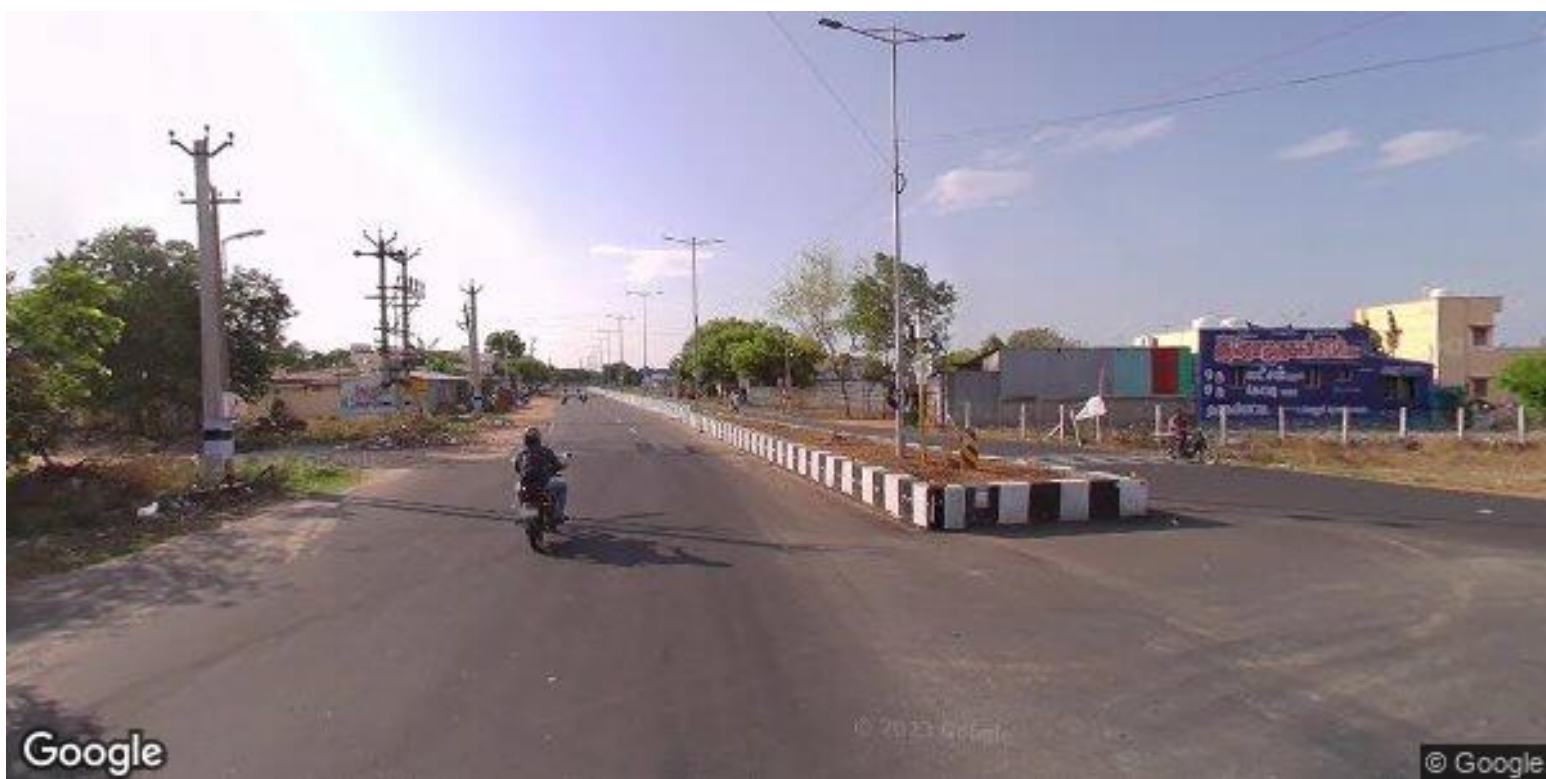
**Coordinates:** 10.91105, 78.09714

**Risk Type:** Blind Spot

**Risk Level:** Blind Spot

**Speed Limit:** 10 KM/Hr

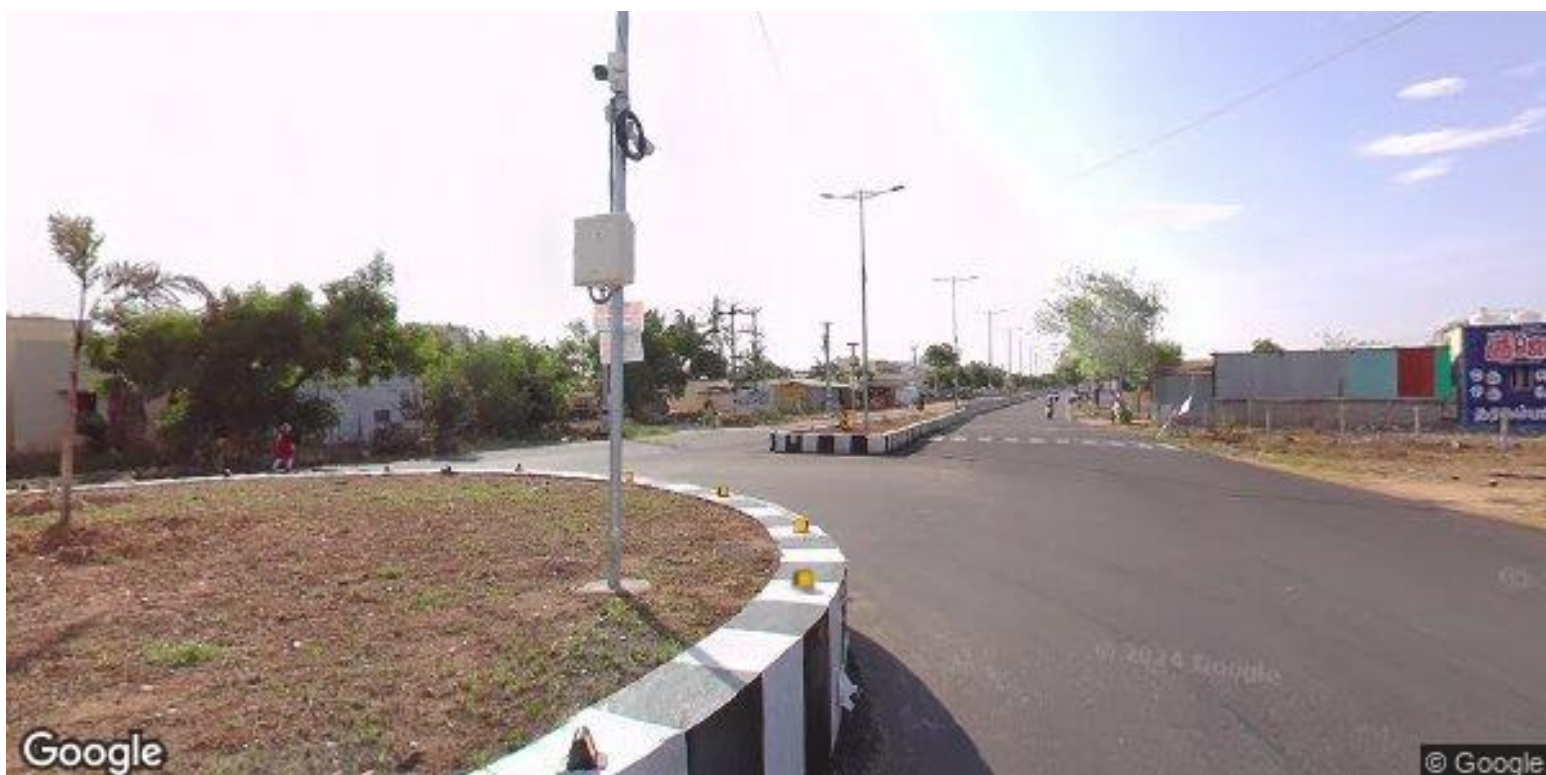
**Coordinates:** 10.91103, 78.09733

**Risk Type:** Turn

**Risk Level:** High

**Speed Limit:** 15 KM/Hr
