## JOURNEY RISK MANAGEMENT (JRM) STUDY

### Salem Terminal TO YADHAVAN AGENCIES

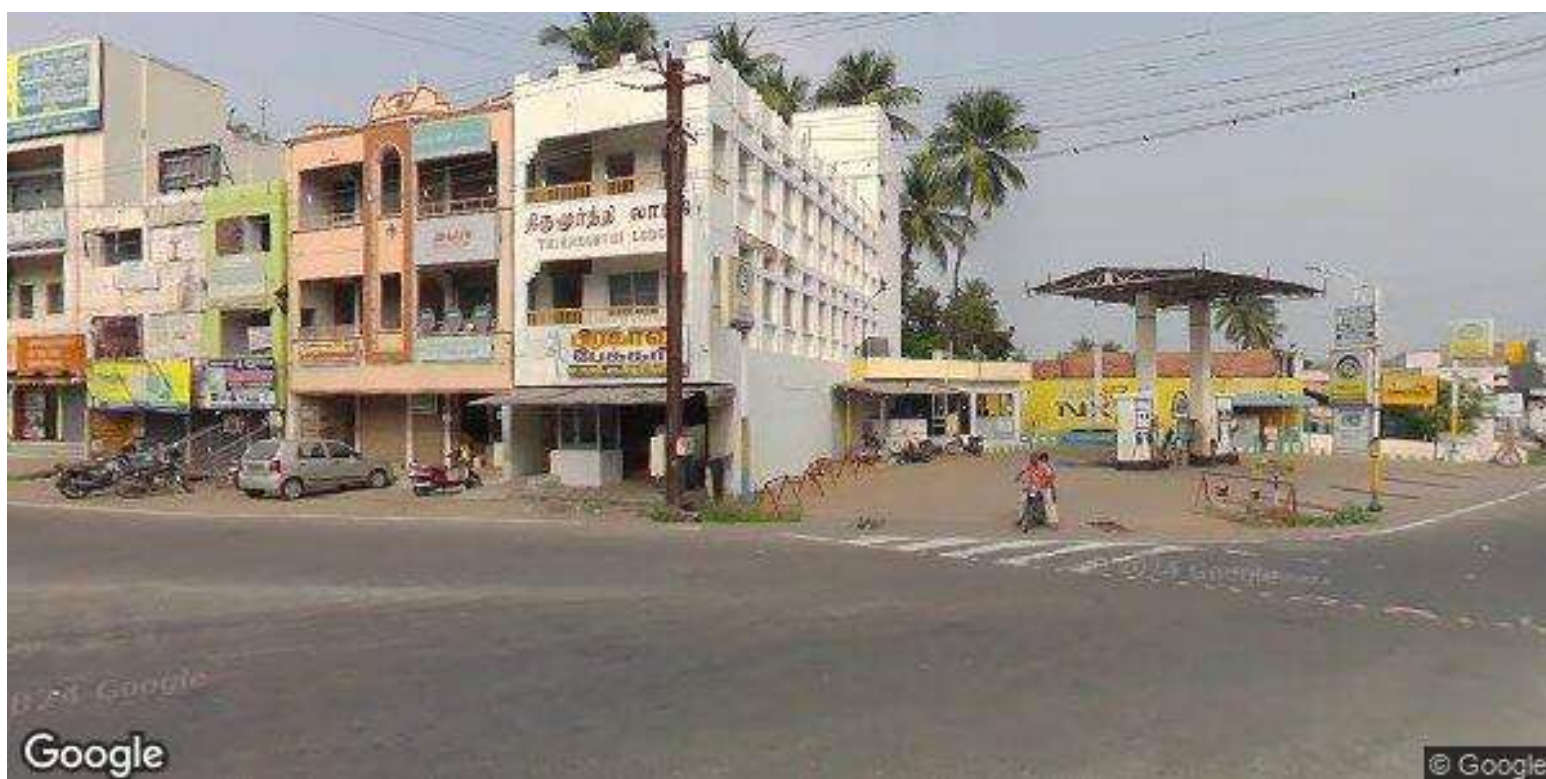
**Coordinates:** 11.00172, 77.56268

**Risk Type:** Roundabout

**Risk Level:** High

**Speed Limit:** 15 KM/Hr

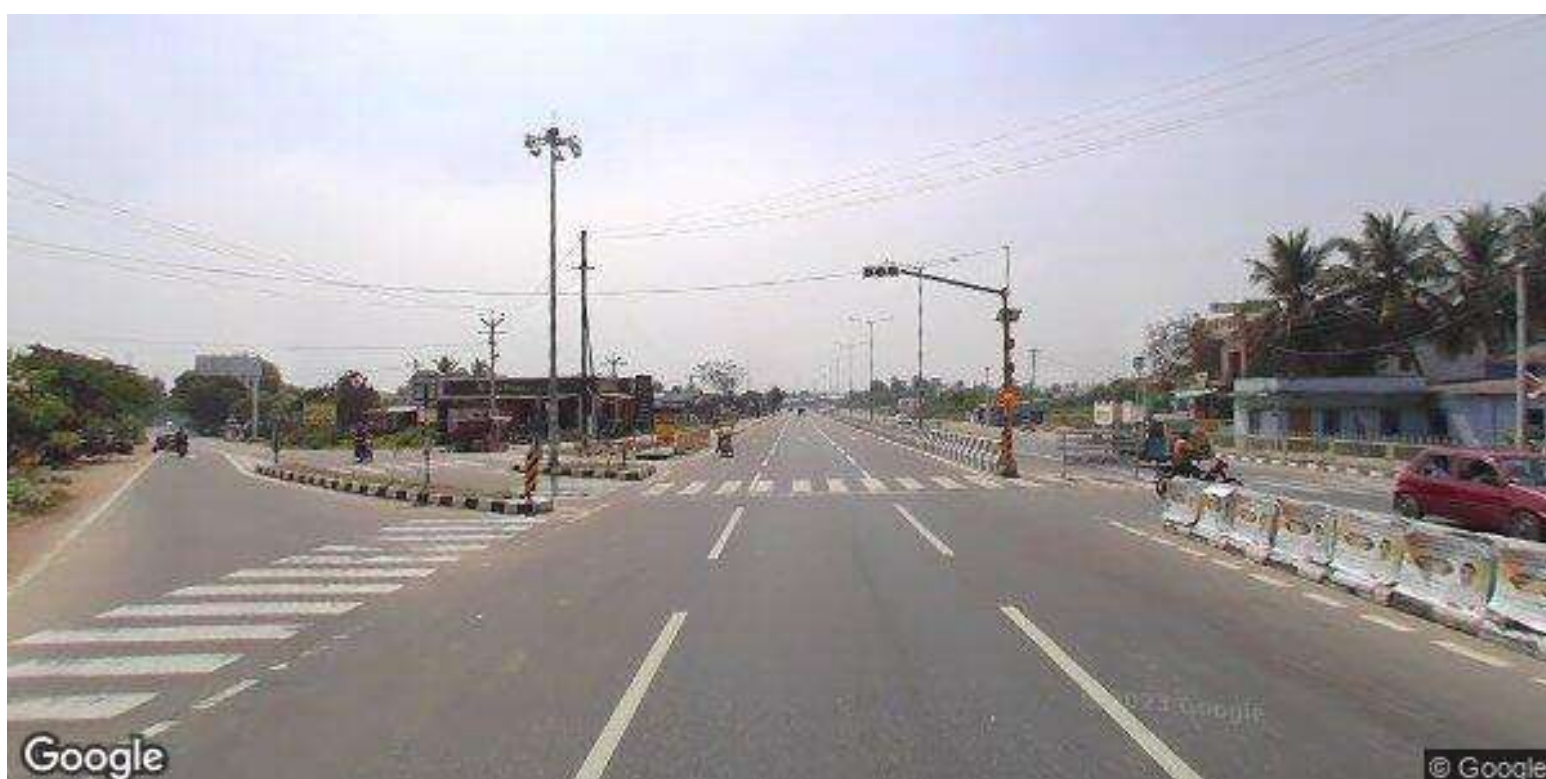
Coordinates: 10.7474551, 77.5187942

Risk Type: U-Turn

Risk Level: High

Speed Limit: 10 KM/Hr

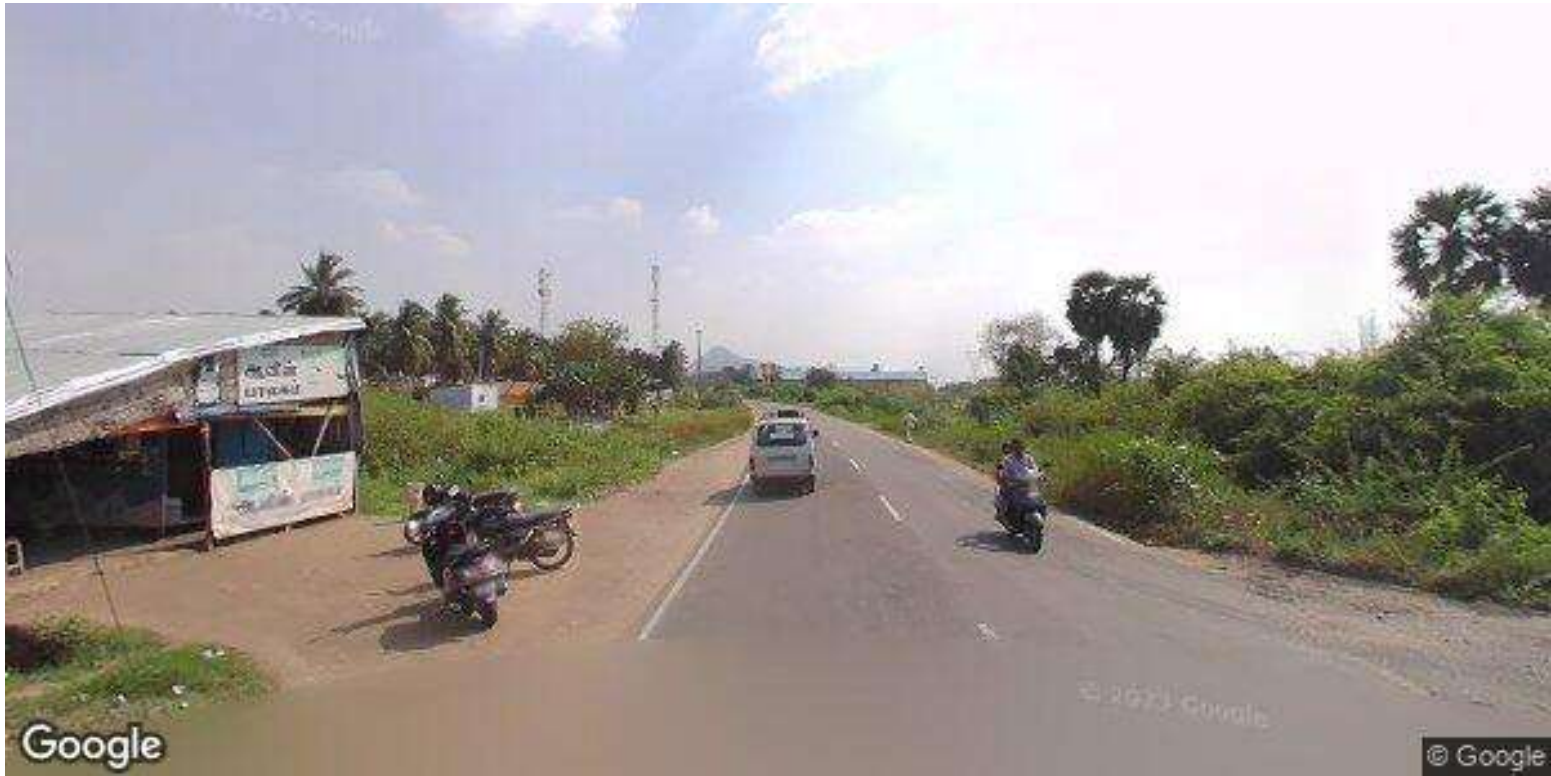
Coordinates: 11.44022, 77.87546

Risk Type: Turn

Risk Level: High

Speed Limit: 15 KM/Hr

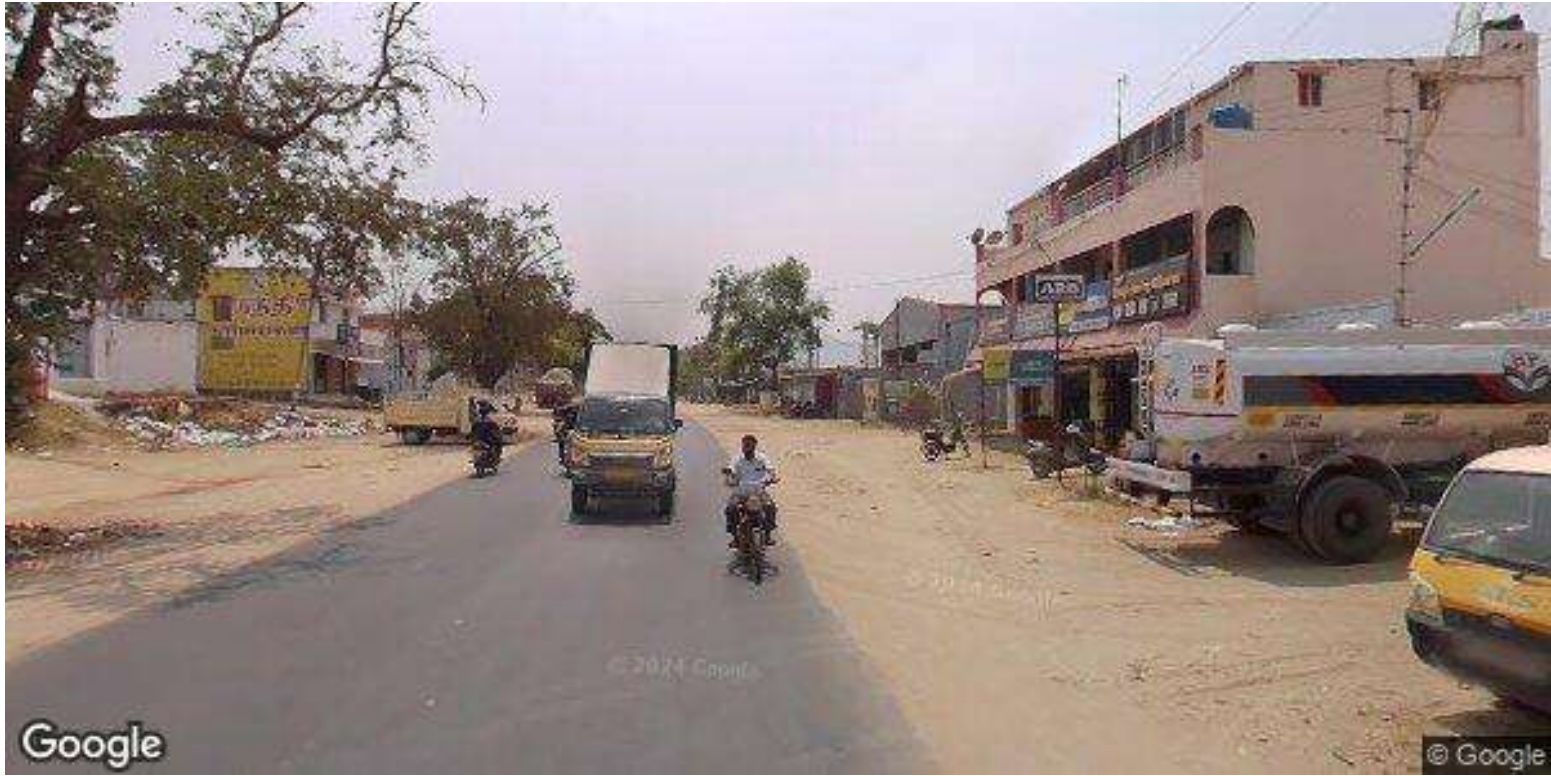
Coordinates: 11.39976, 77.88382

Risk Type: Turn

Risk Level: Medium

Speed Limit: 30 KM/Hr

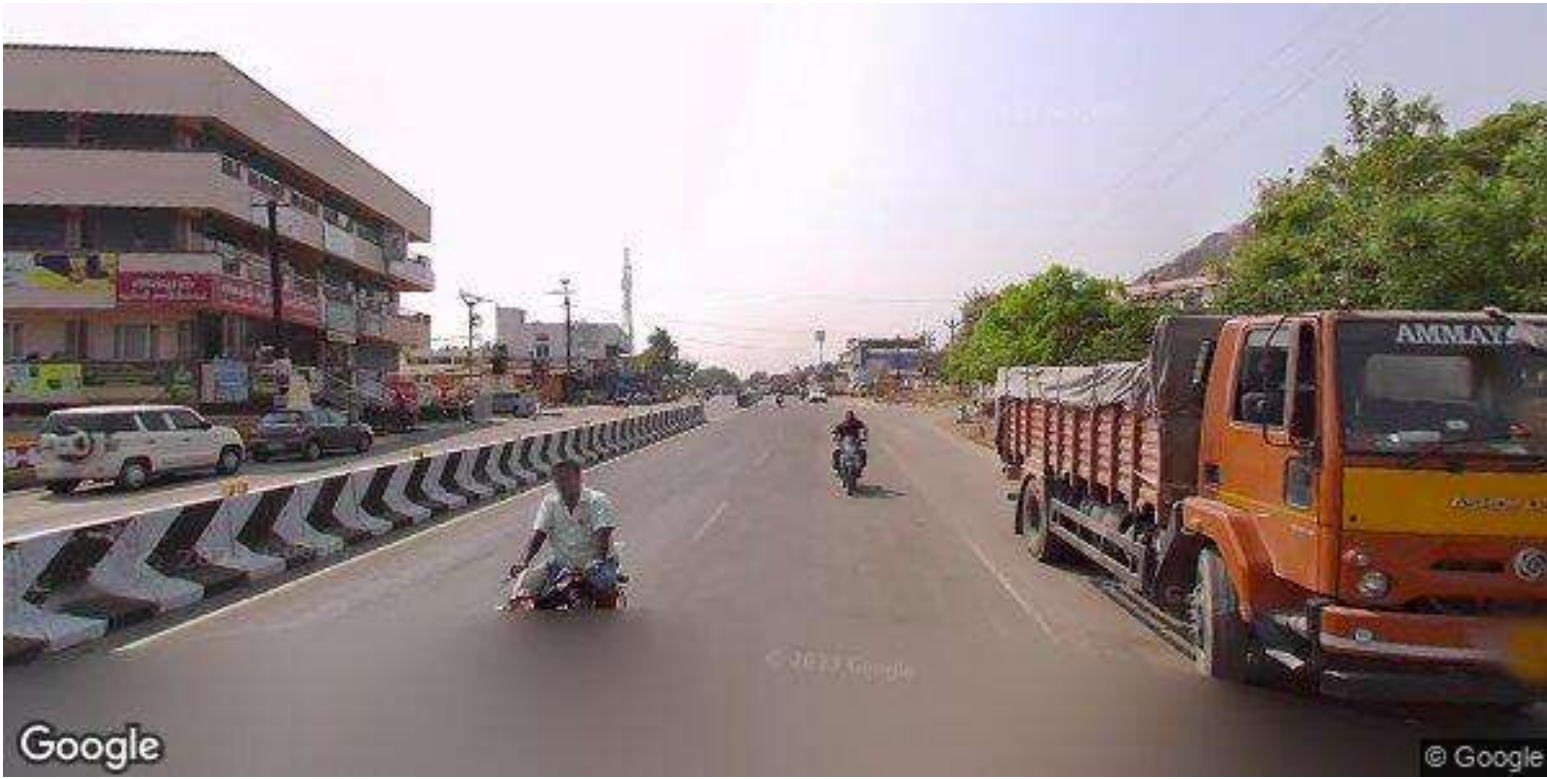
**Risk Type:** Turn  
**Risk Level:** Medium  
**Speed Limit:** 30 KM/Hr  
**Coordinates:** 11.39690, 77.88852

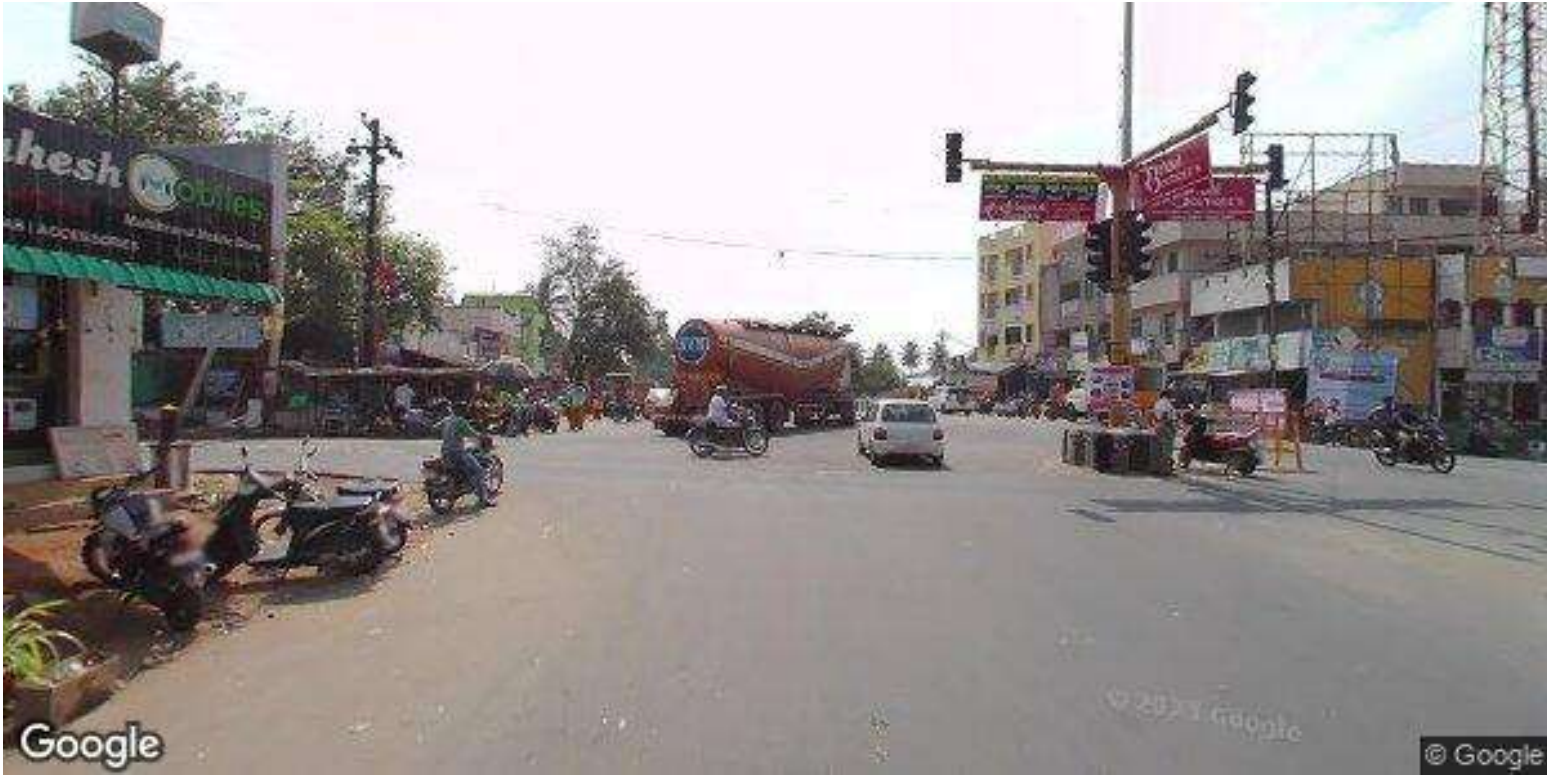
**Risk Type:** Turn  
**Risk Level:** High  
**Speed Limit:** 15 KM/Hr  
**Coordinates:** 11.36616, 77.88885

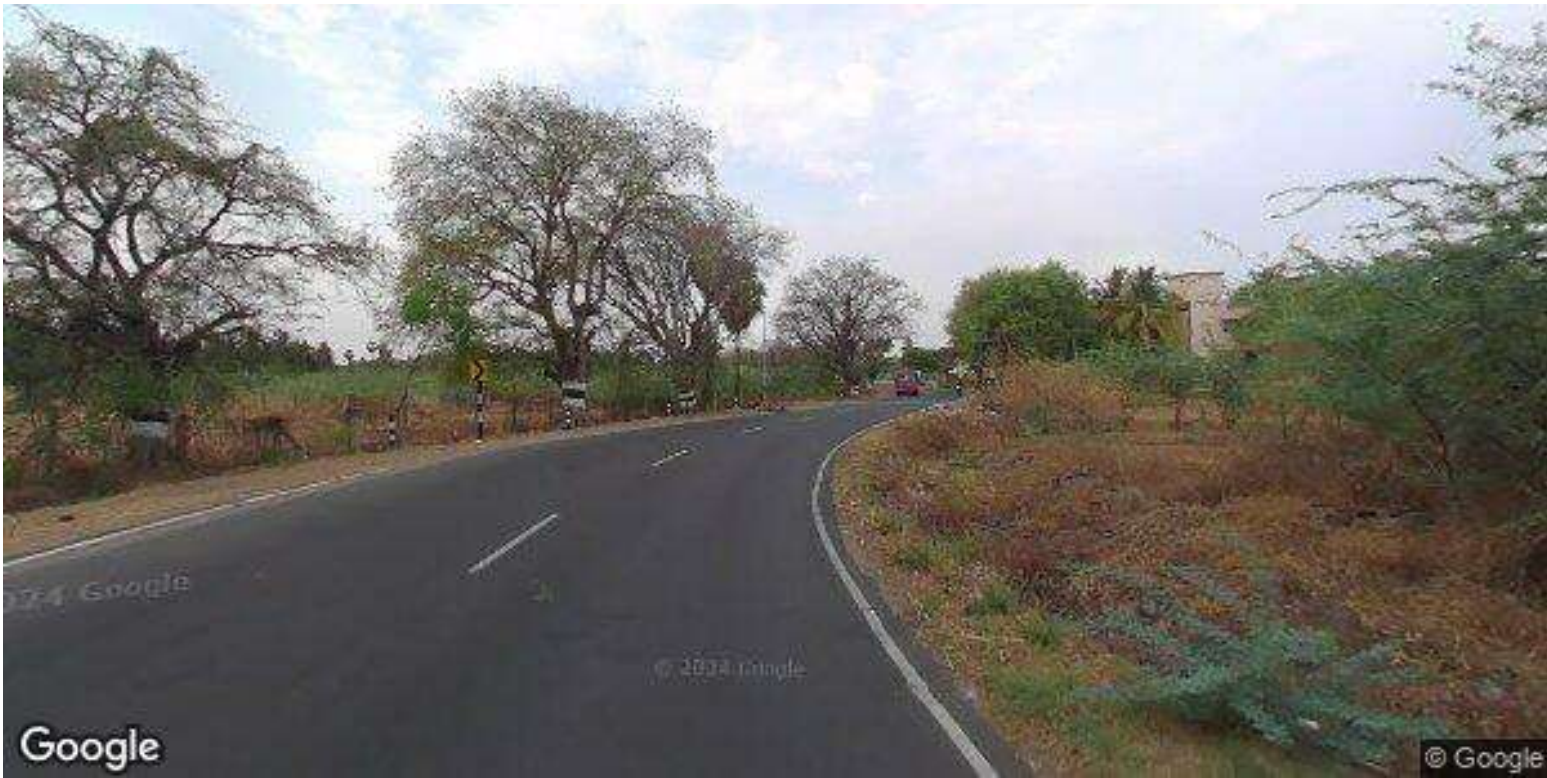
**Risk Type:** Turn  
**Risk Level:** Medium  
**Speed Limit:** 30 KM/Hr  
**Coordinates:** 11.34067, 77.86347

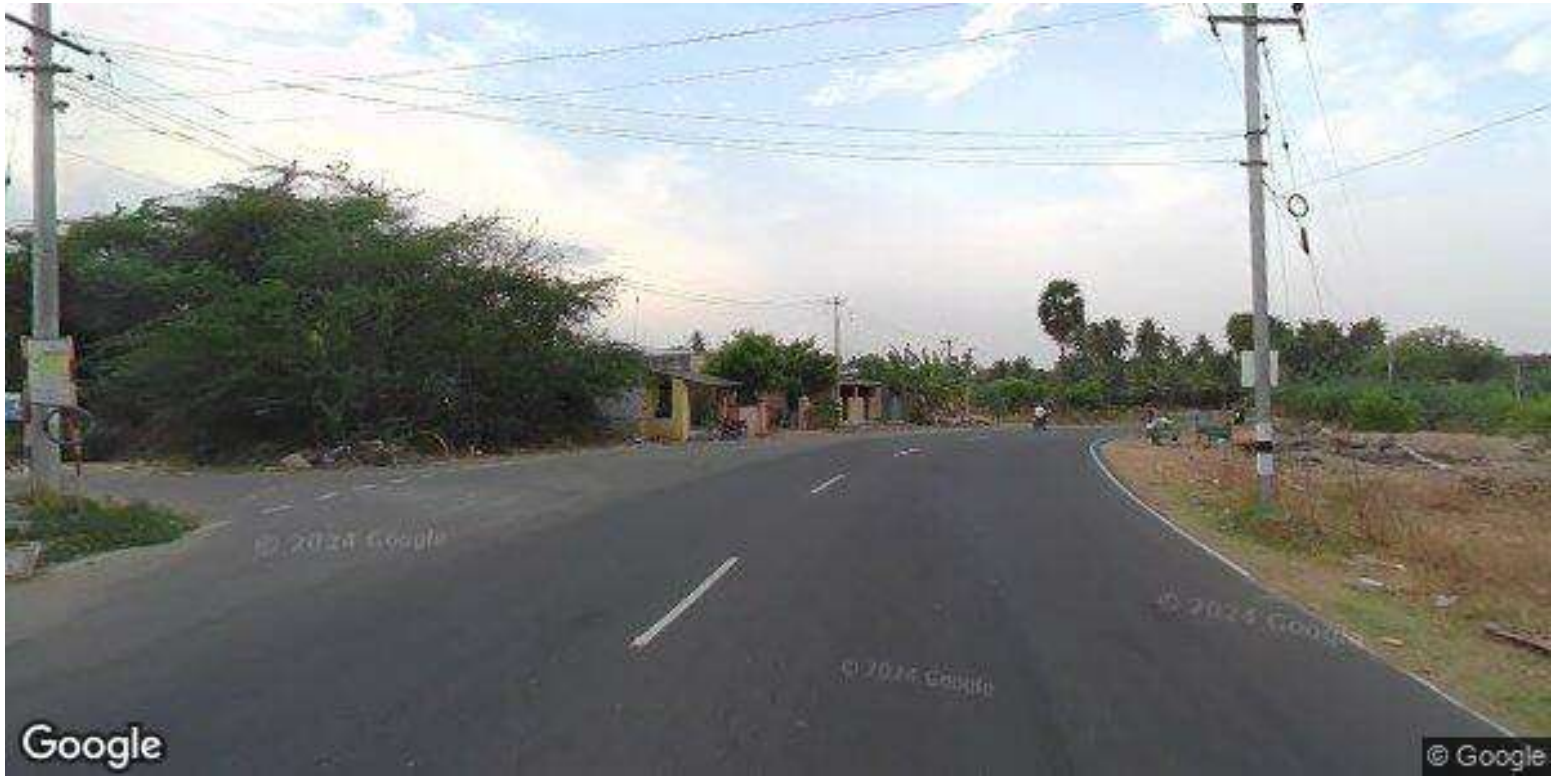
**Risk Type:** Turn  
**Risk Level:** High  
**Speed Limit:** 15 KM/Hr  
**Coordinates:** 11.33854, 77.86216

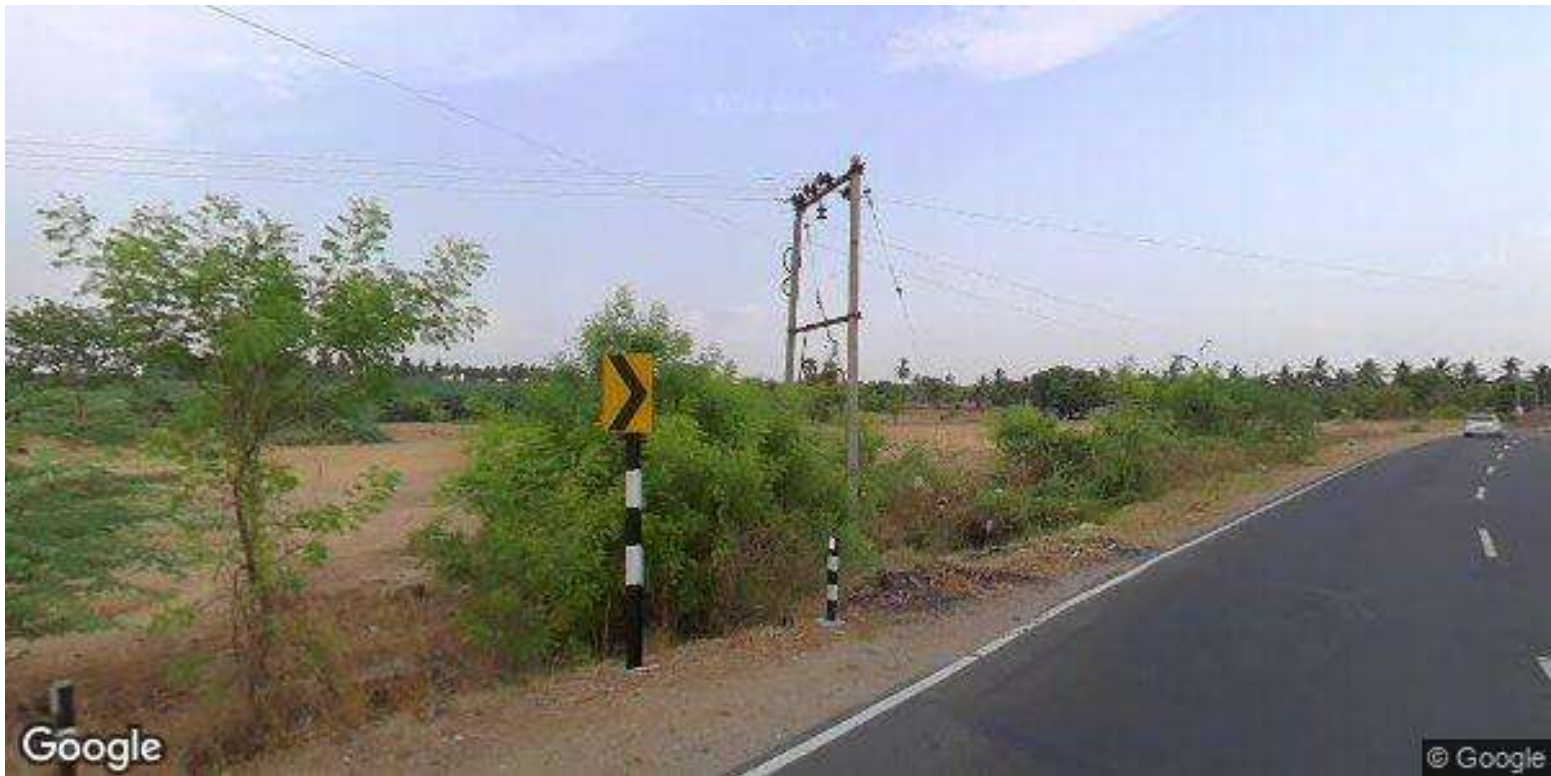
**Risk Type:** Turn  
**Risk Level:** Medium  
**Speed Limit:** 30 KM/Hr  
**Coordinates:** 11.33778, 77.86236

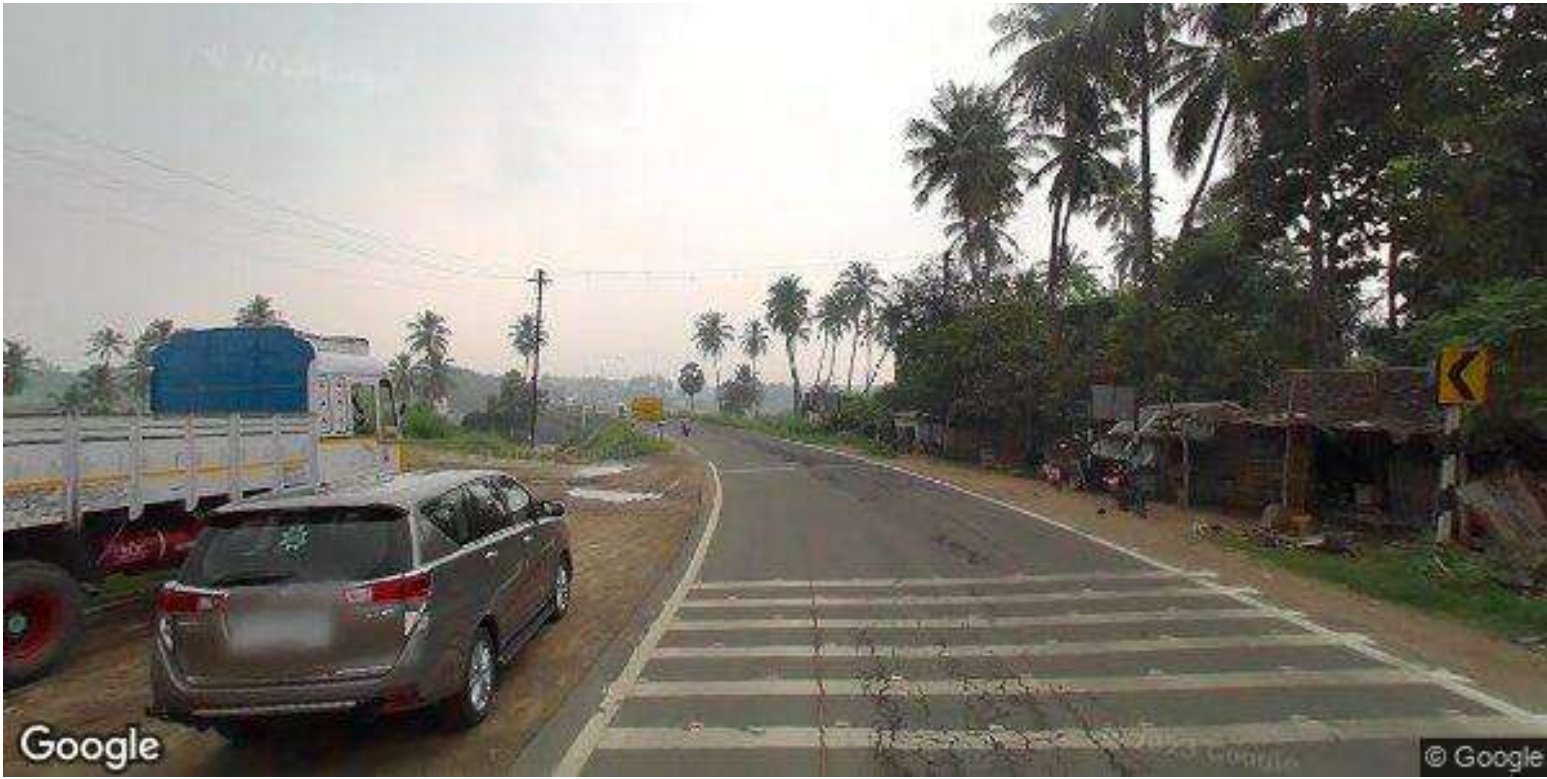
**Risk Type:** Turn  
**Risk Level:** Medium  
**Speed Limit:** 30 KM/Hr  
**Coordinates:** 11.30952, 77.77587

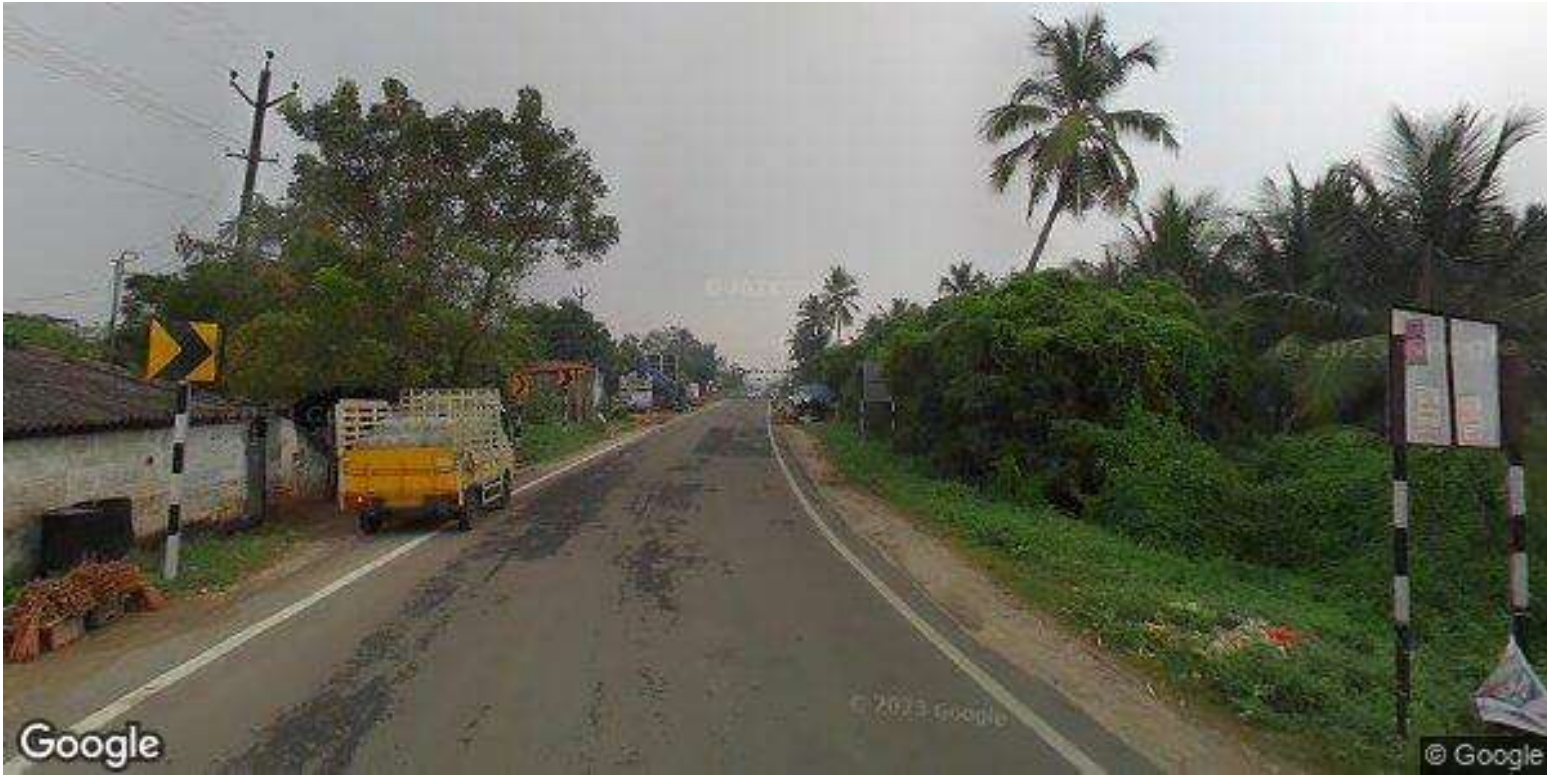
**Risk Type:** Turn  
**Risk Level:** Medium  
**Speed Limit:** 30 KM/Hr  
**Coordinates:** 11.30973, 77.76712

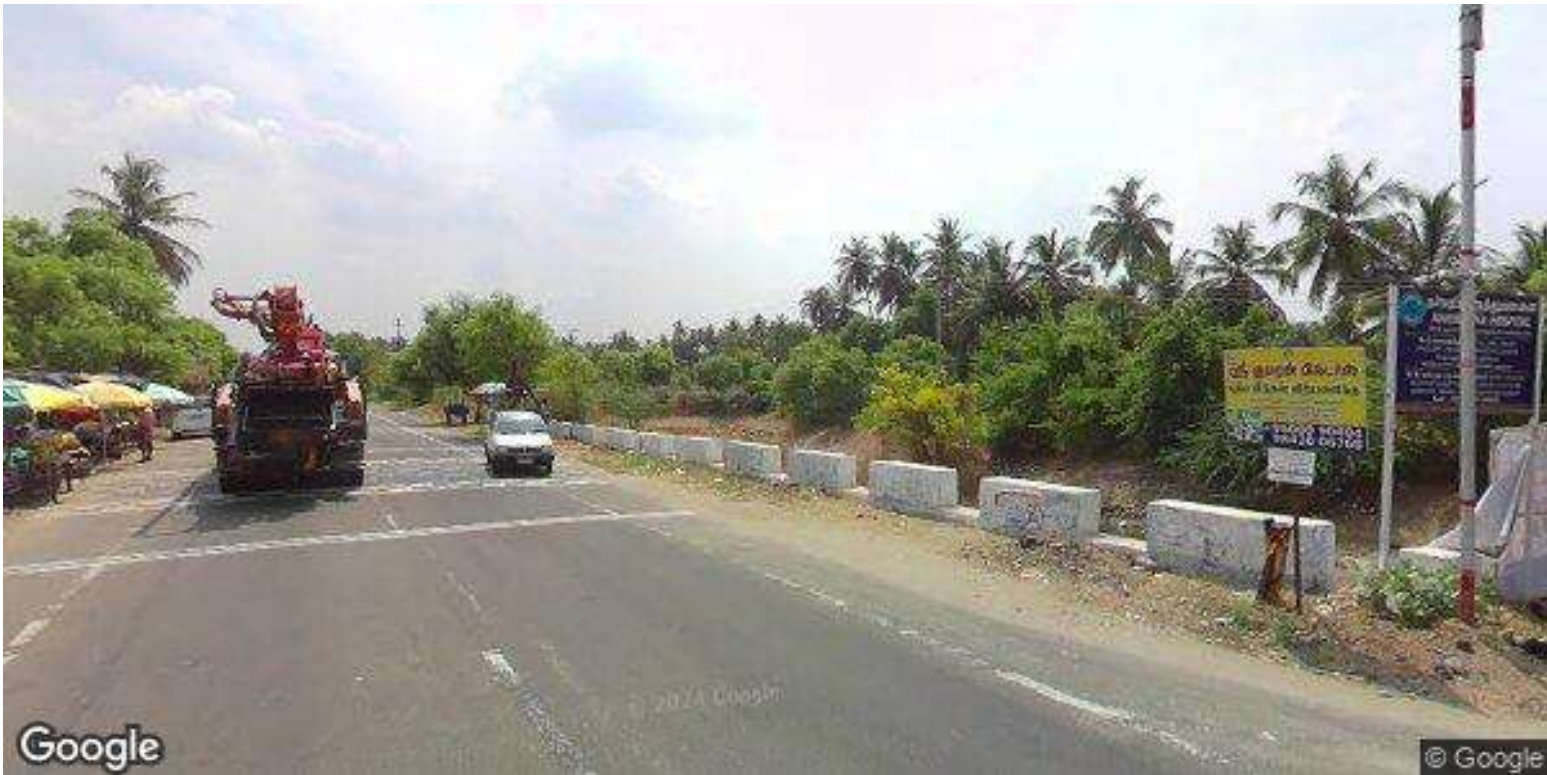
**Risk Type:** Turn  
**Risk Level:** High  
**Speed Limit:** 15 KM/Hr  
**Coordinates:** 11.29490, 77.74685

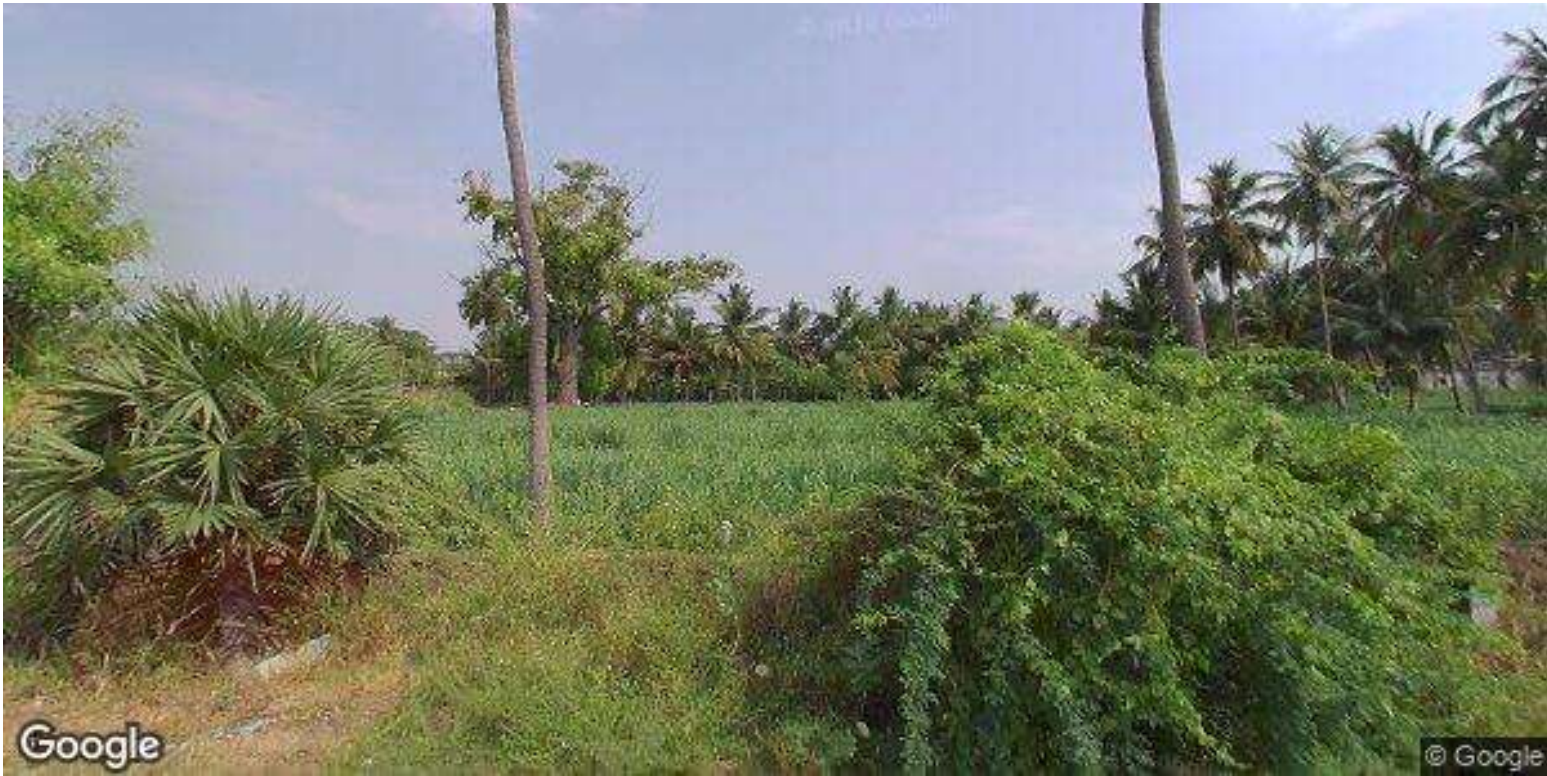
**Risk Type:** Turn  
**Risk Level:** High  
**Speed Limit:** 15 KM/Hr  
**Coordinates:** 11.29125, 77.74646

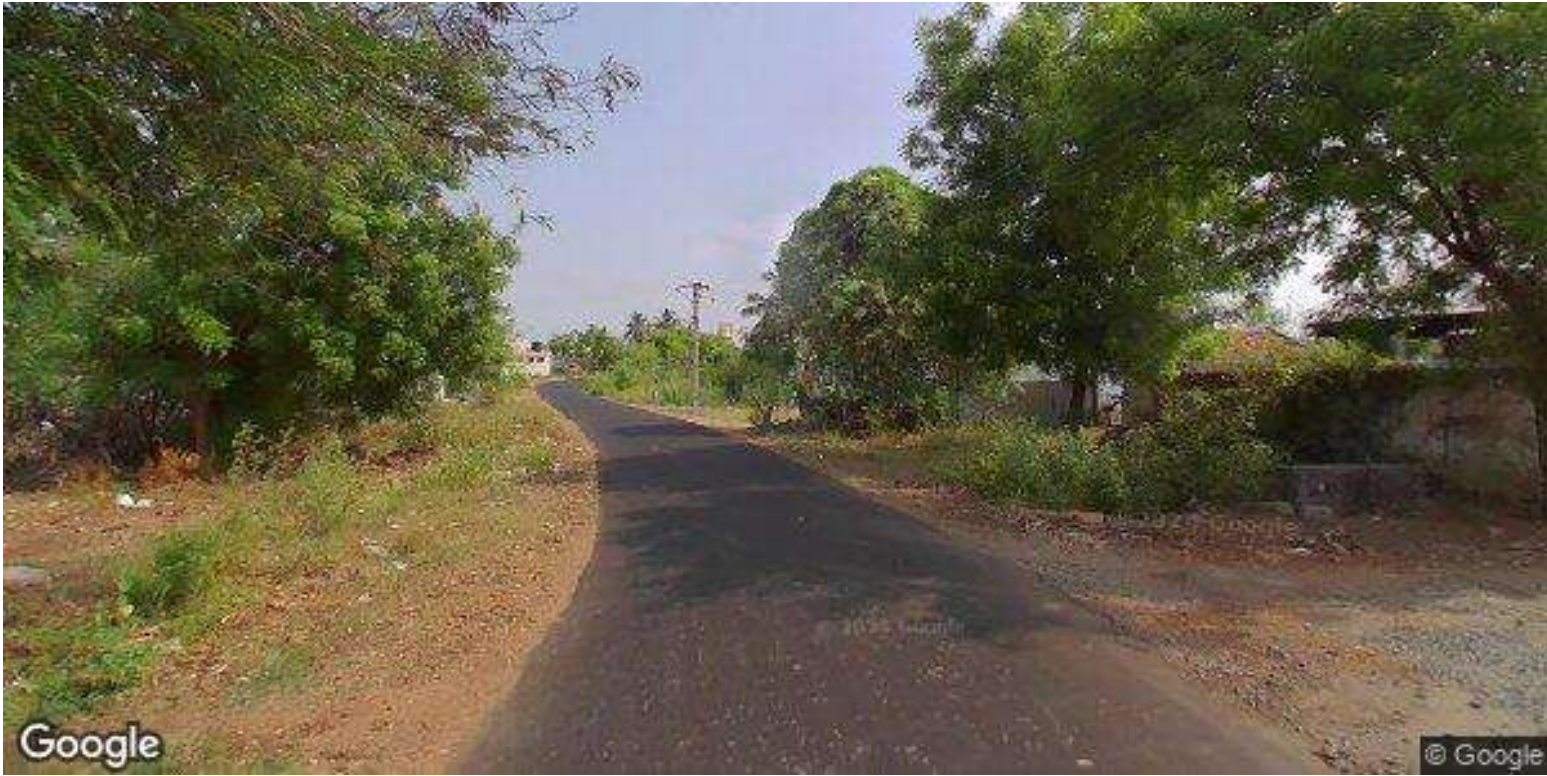
**Risk Type:** Turn  
**Risk Level:** Medium  
**Speed Limit:** 30 KM/Hr  
**Coordinates:** 11.28844, 77.74319

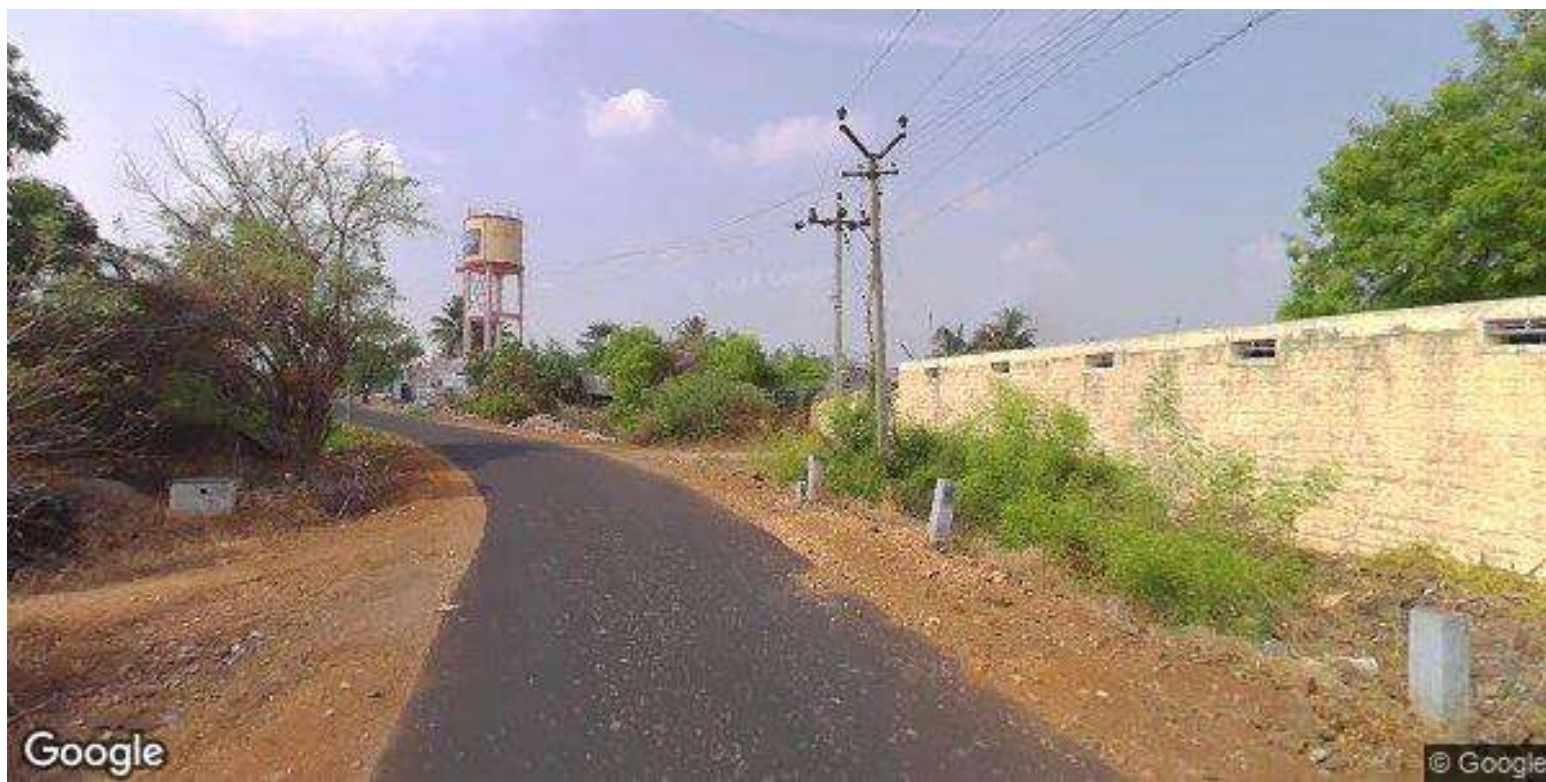
**Coordinates:** 11.28573, 77.74281

**Risk Type:** Turn

**Risk Level:** Medium

**Speed Limit:** 30 KM/Hr

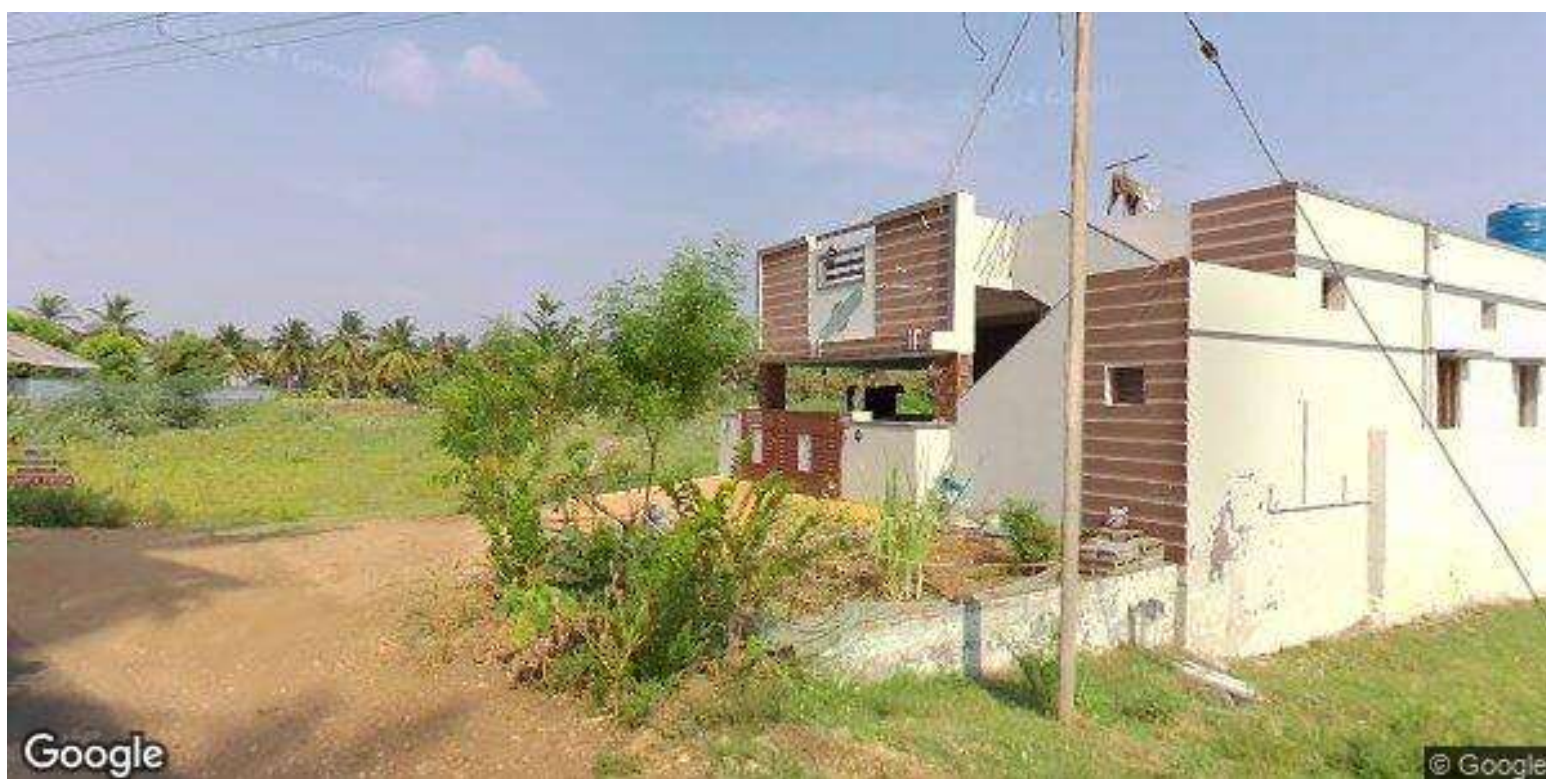
**Coordinates:** 11.27319, 77.72981

**Risk Type:** Turn

**Risk Level:** High

**Speed Limit:** 15 KM/Hr

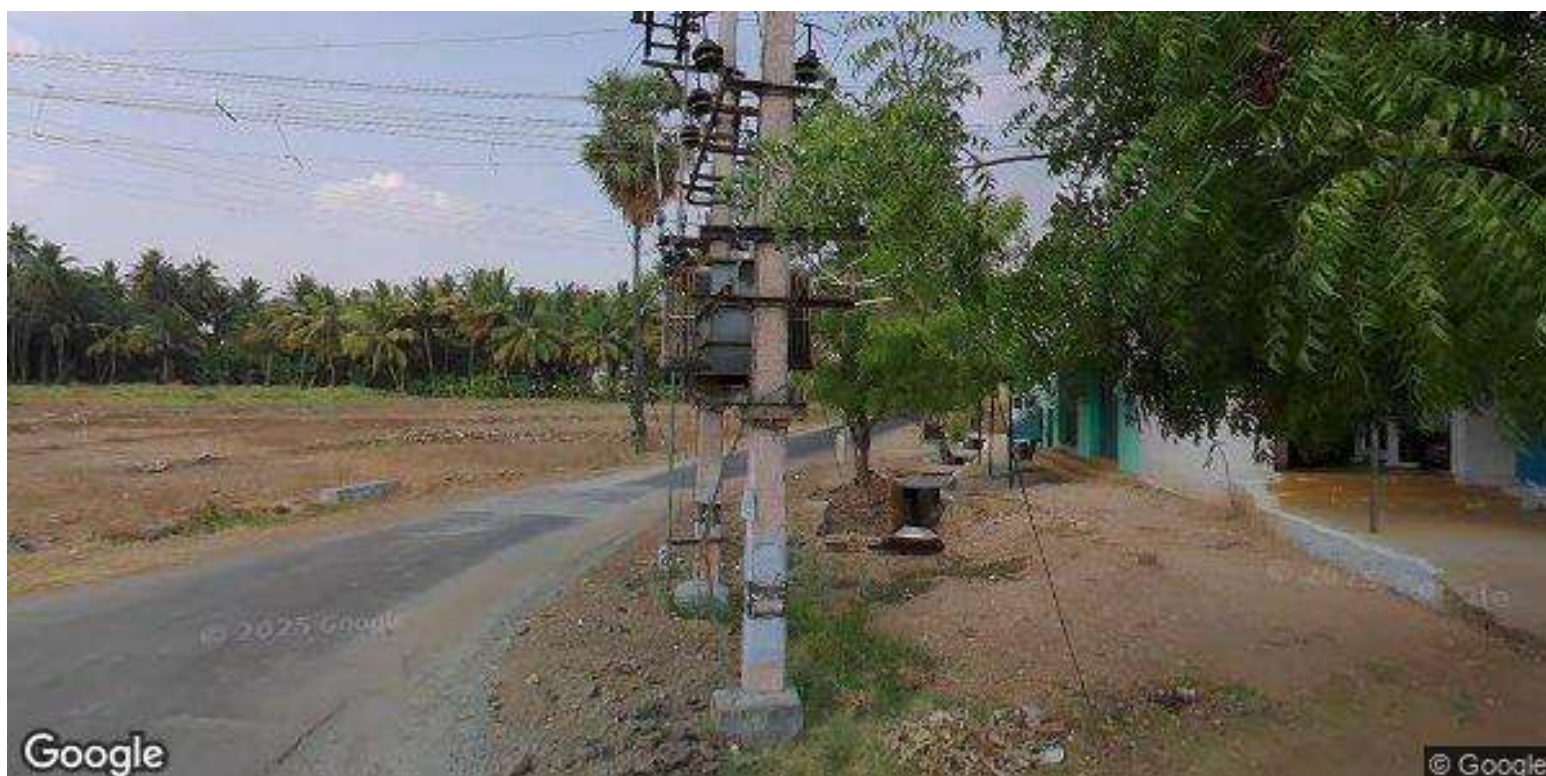
**Risk Type:** Blind Spot  
**Risk Level:** Blind Spot  
**Speed Limit:** 10 KM/Hr  
**Coordinates:** 11.27330, 77.72715

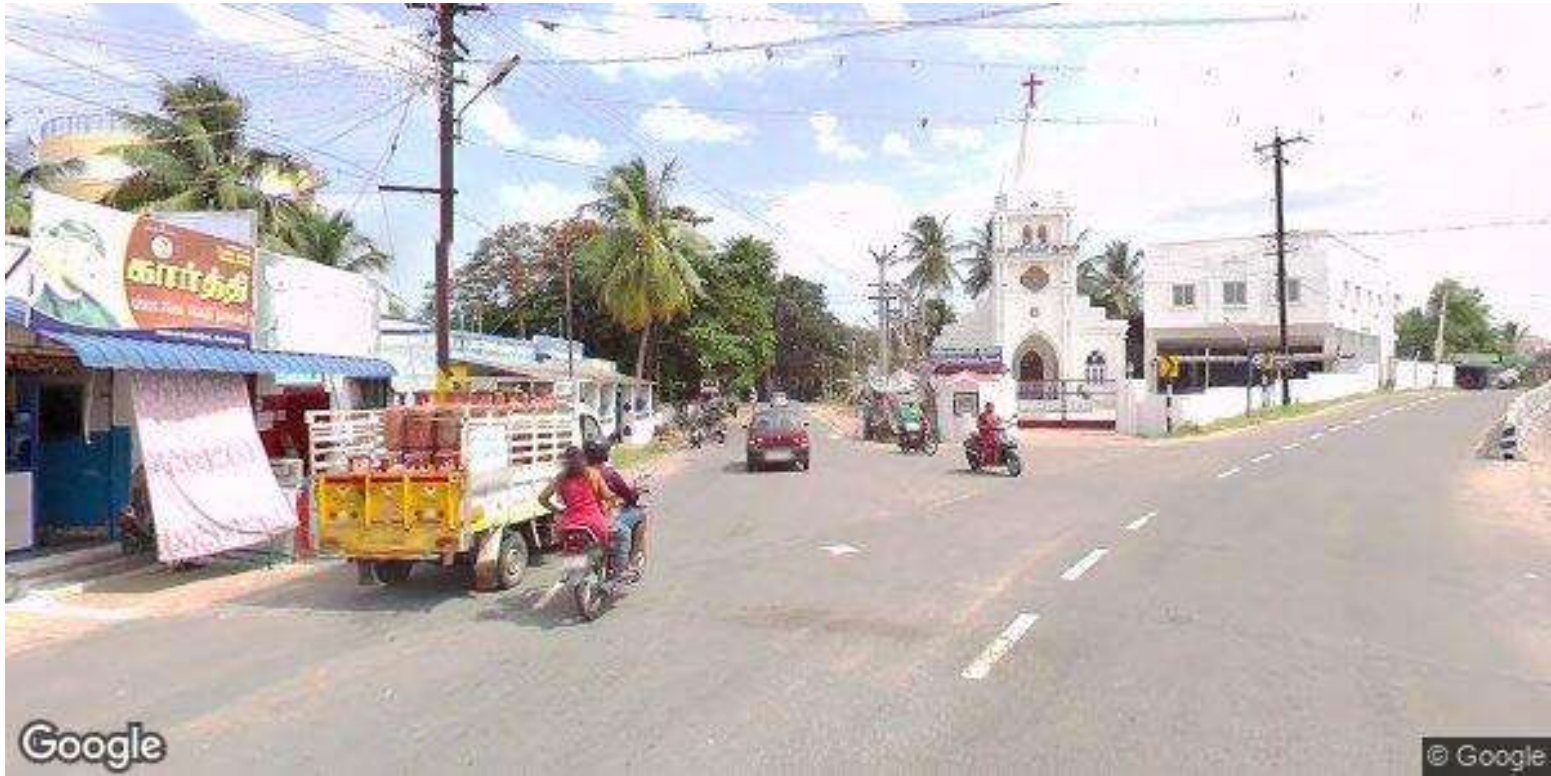
**Risk Type:** Turn  
**Risk Level:** Medium  
**Speed Limit:** 30 KM/Hr  
**Coordinates:** 11.23054, 77.71796
